**JURISDICTIONAL DETERMINATION OF WATERS OF THE UNITED STATES
AND SUPPLEMENTAL DOCUMENTATION**

Tres Palacios Creek Drainage Improvement Project
City of El Campo, Wharton County, Texas

FEMA SRL Grant: 06-TX-2011-008

May 2012

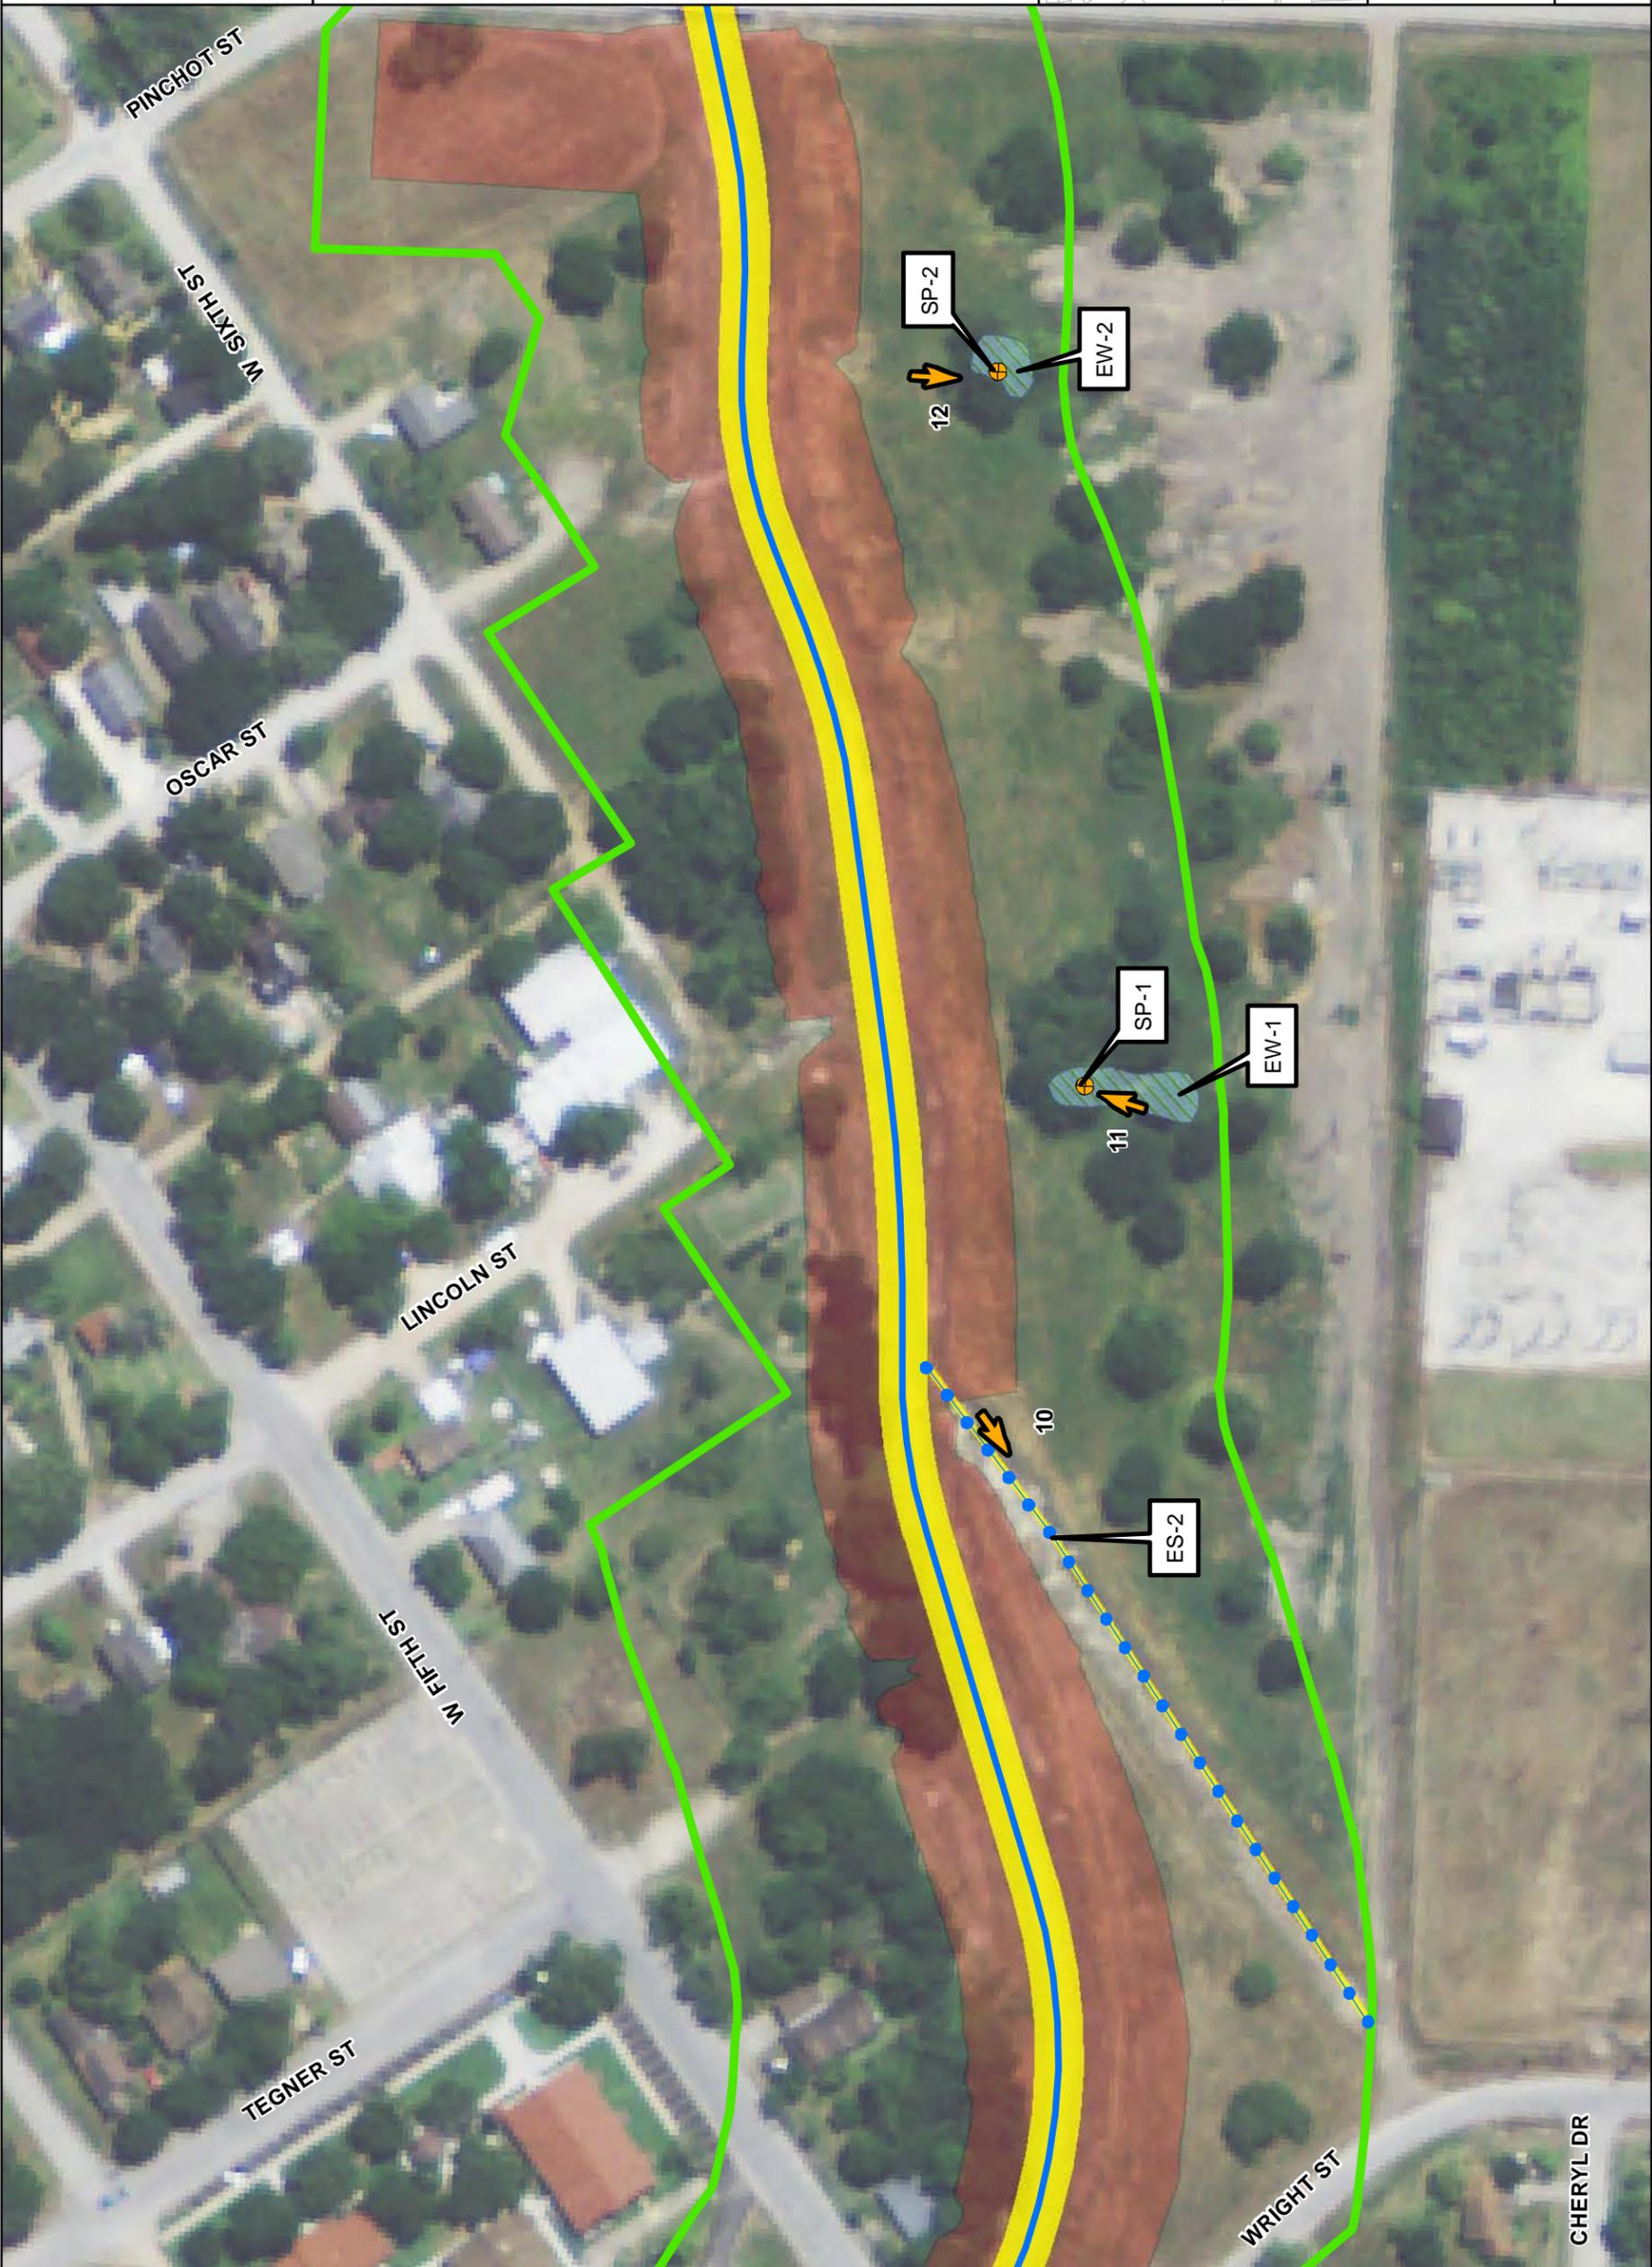
Study Area Map
Tres Palacios Jurisdictional
Determination
Figure 3

Figure 3, Sheet 4 depicts the two wetlands observed within the study area. The following discussion provides a general summary of each of the wetland indicators observed within the sampling points of the two wetlands, based on USACE wetland delineation guidelines cited in **Section 2.0**. This is followed by a description of specific data collected that were used to define the limits of wetlands. **Appendix B** contains copies of wetland data sheets for each wetland. Photographs from each data point location are provided in **Appendix C**. **Table 4** provides a summary of all mapped wetland areas.

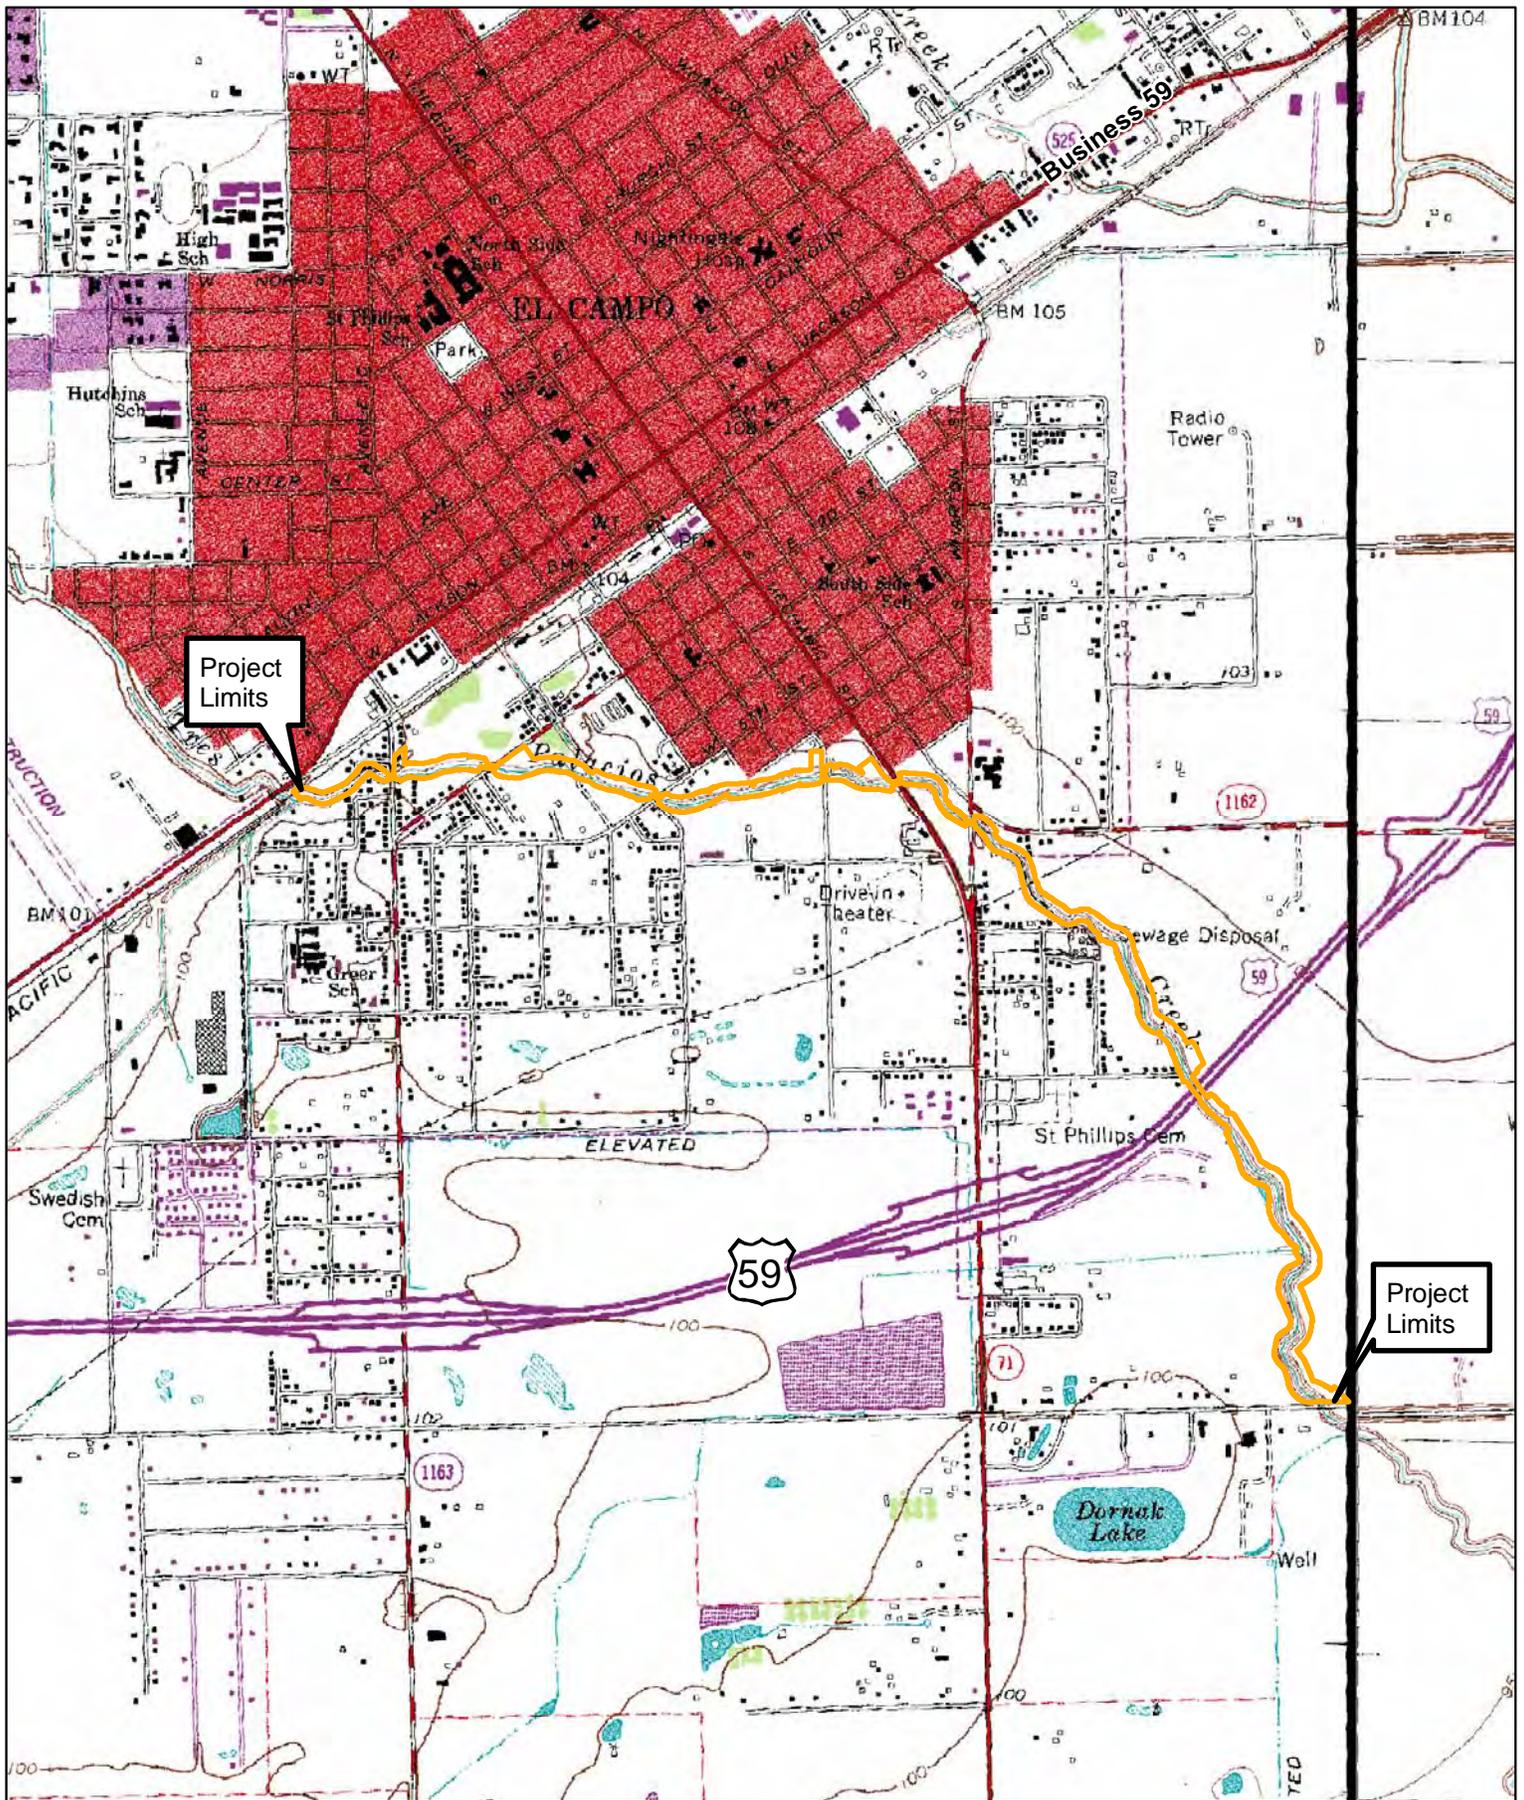
United States Geological Survey
Topographic Map
Tres Palacios Jurisdictional Determination

The United States Geological Survey (USGS) Quadrangle Map for “El Campo, Texas” (**Appendix A, USGS Topographic Map**) shows the study area with relatively flat topography generally sloping toward Tres Palacios Creek. Features shaded in violet are 1981 photorevisions of the original USGS map published in 1965. The map shows the Tres Palacios Creek flowing east and then southeast in the study area. The northern three-fourths of the study area are developed within and near the City of El Campo. Two unnamed tributaries of Tres Palacios Creek are shown, flowing across the study area to Tres Palacios Creek. Along the southeastern end of the study area, Stage Stand Creek is mapped. One isolated pond to

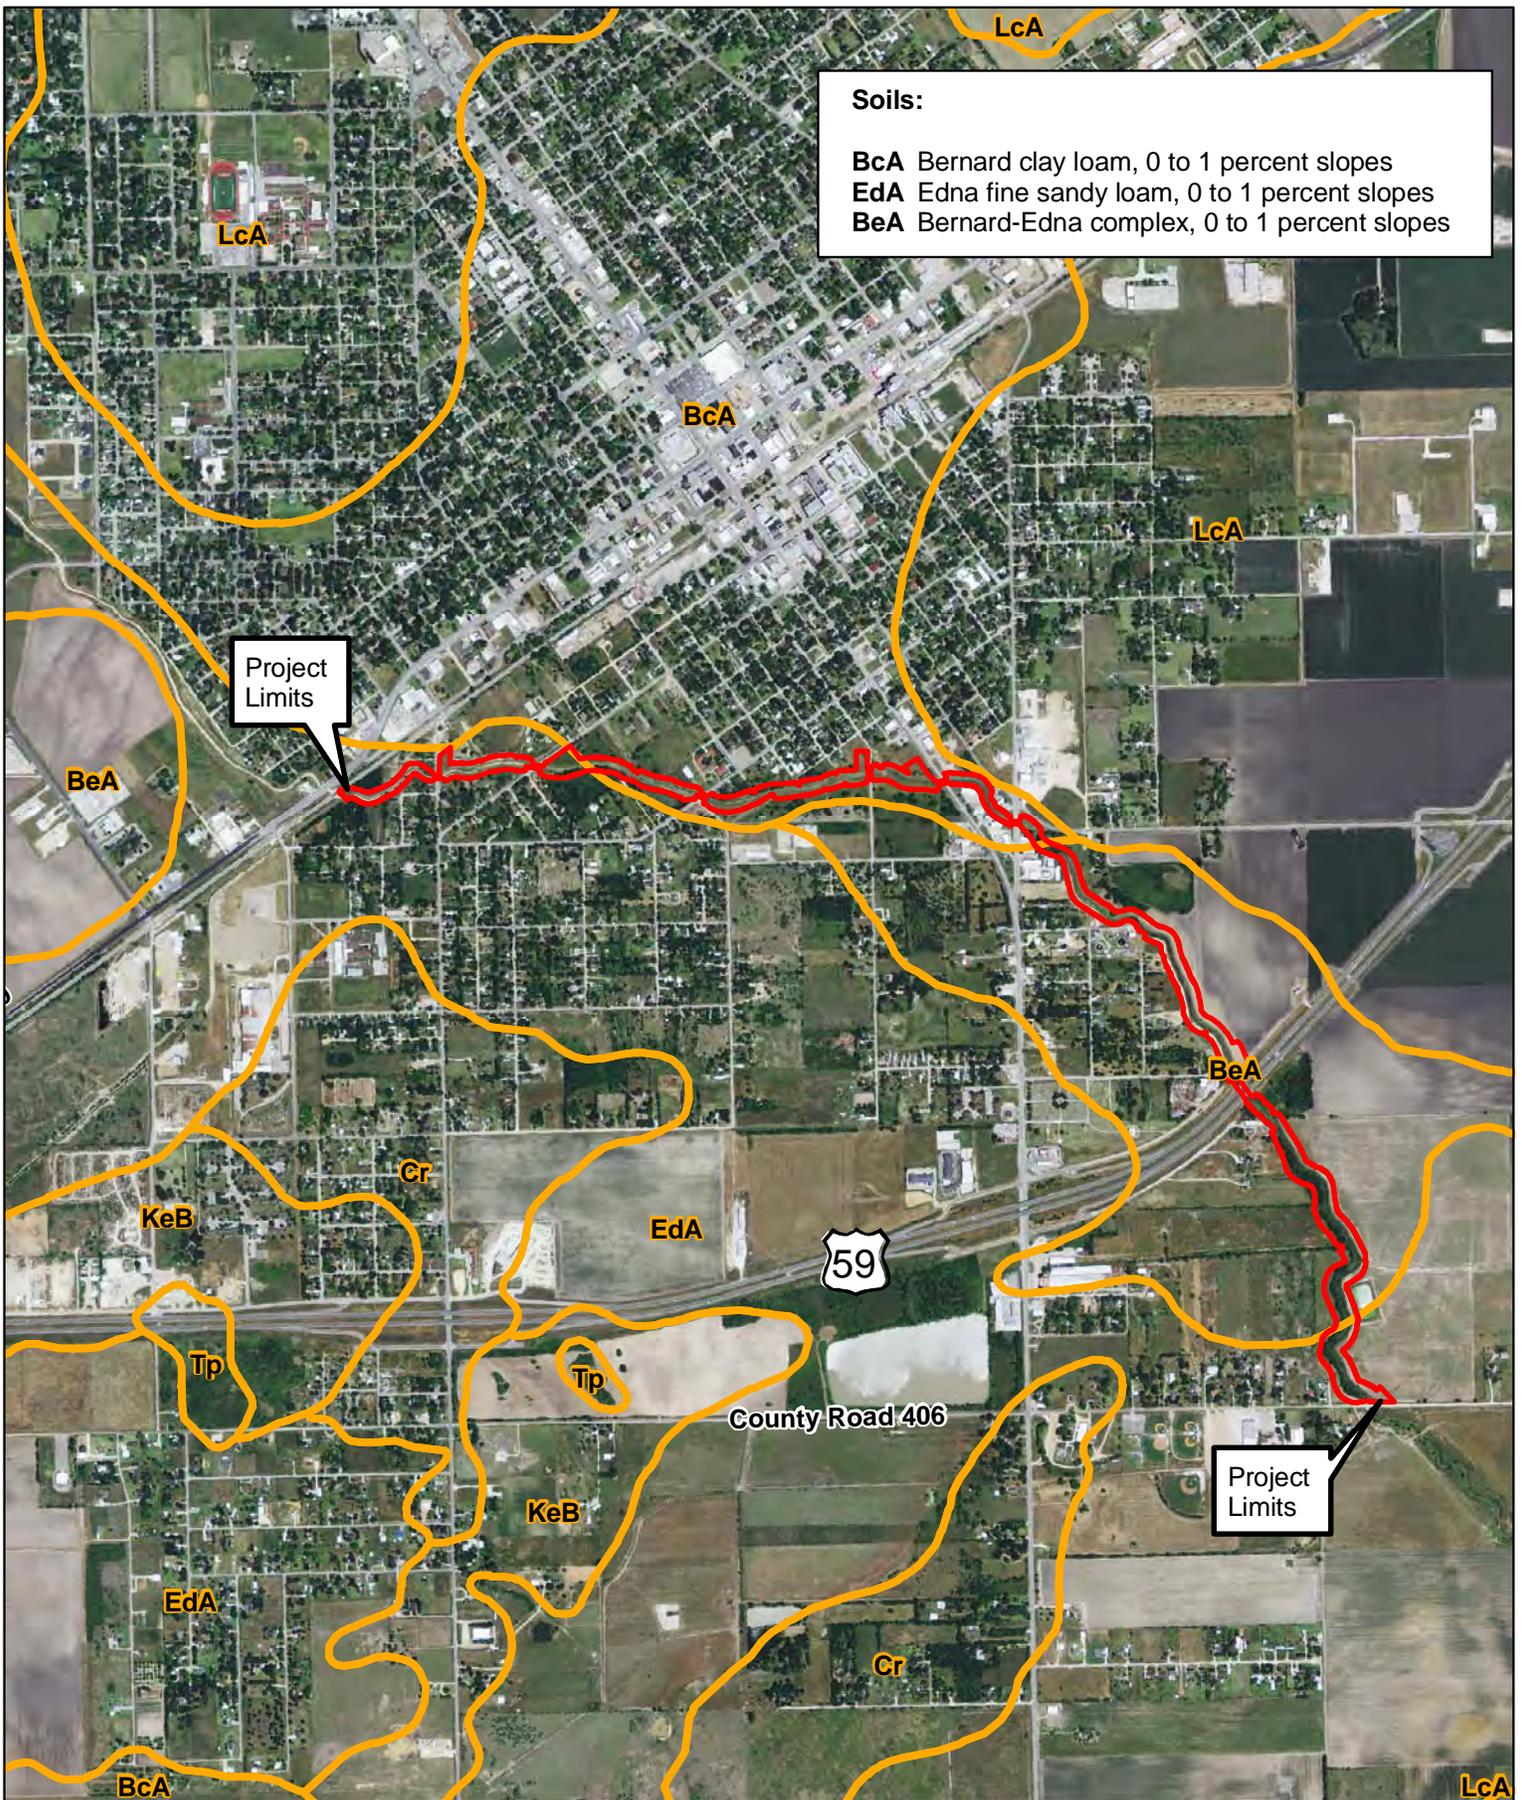
Soils:
BcA Bernard clay loam, 0 to 1 percent slopes
EdA Edna fine sandy loam, 0 to 1 percent slopes
BeA Bernard-Edna complex, 0 to 1 percent slopes

All three soil units identified within the study area are listed as hydric on the National Resources Conservation Service (NRCS) state hydric soil list for Wharton County. These soils, Bernard clay loam, Edna fine sandy loam, and the Bernard-Edna complex, occur on uplands. All are somewhat poorly drained to poorly drained with very slow permeability and high water capacity. The majority of the study area is within the Bernard-Edna complex and Bernard clay loam mapped unit; only a small portion is within the Edna fine sandy loam soil unit.

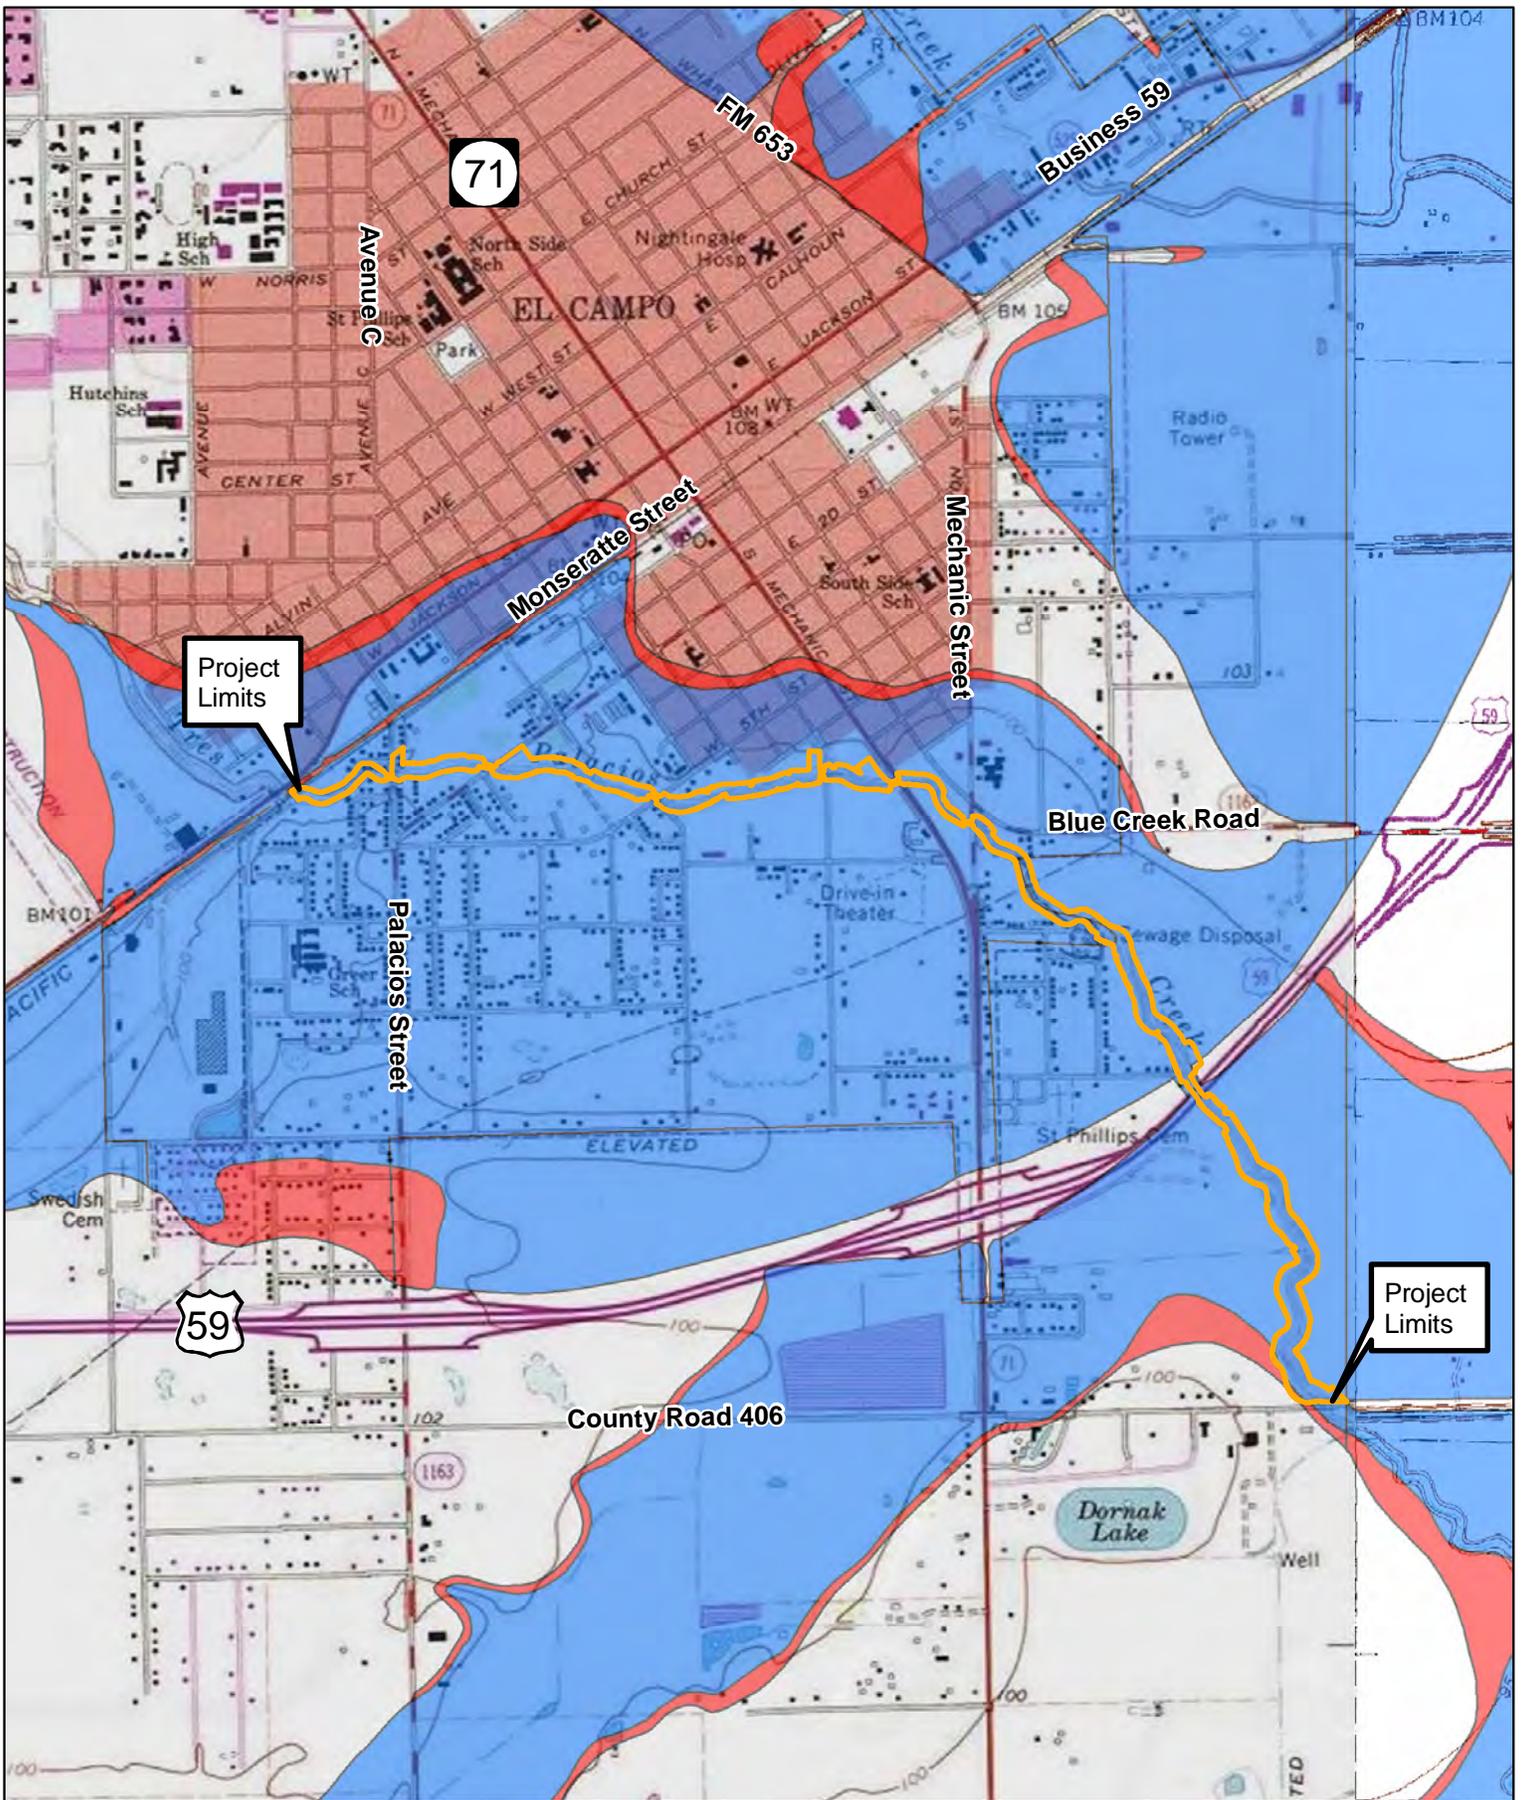
| <p>Legend</p> <ul style="list-style-type: none"> Proposed Project Location FEMA Zone A (1% chance flood zone) FEMA Zone X (0.2% chance flood zone) | <p>FEMA Floodplain Map Tres Palacios Jurisdictional Determination</p> | <p>N</p> <p>0 1,000 2,000</p> <p>Feet</p> |

Per the FEMA flood insurance rate map (FIRM) of Wharton County, Tres Palacios Creek is shown with a broad floodplain throughout the study area (**Appendix A, USGS Topographic & Floodplain Map**). According to map panels 48481C0510E and 48481C0520E, effective April 5, 2006, the entire study area is mapped within Zone AE (1% annual chance flood hazard) with the exception of small portion within Zone X (0.2% annual chance flood hazard). Wide floodplains can also be seen on these panels for Stage Stand Creek and Tributary to Tres Palacios Creek. Both flow toward the study area from the west.

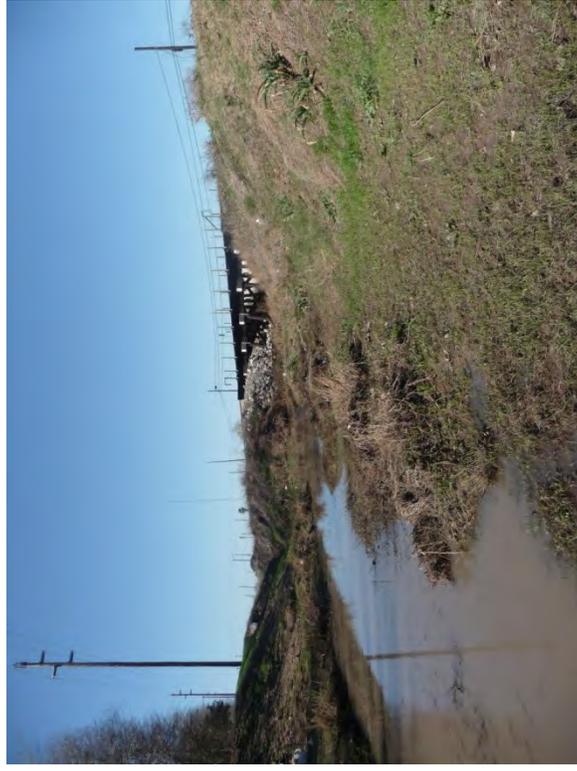
Photo 2: Looking northwest at the Southern Pacific Railroad bridge. Tributary to Tres Palacios Creek is visible on the left side of Tres Palacios Creek.

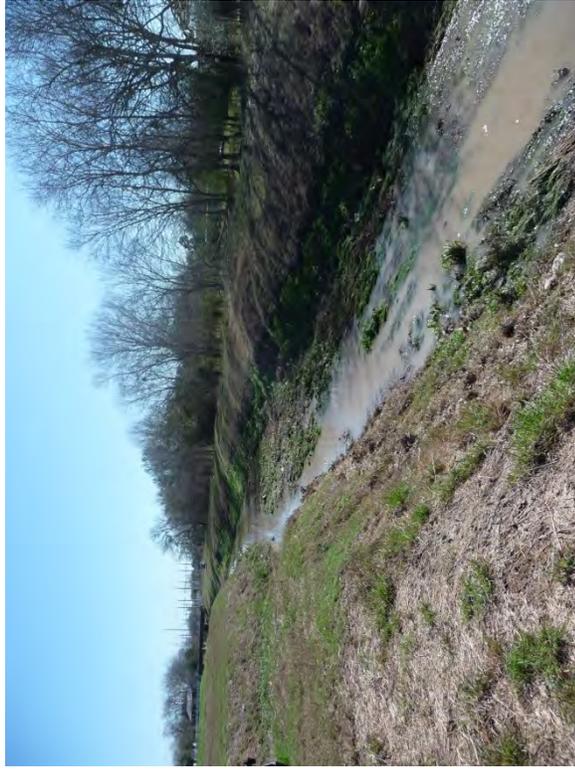
Photo 7: Looking southwest, toward the West 5th Street Bridge. Ephemeral Stream ES-1 can be seen on the left side of the picture.

During two separate site investigations, water was present in ES-1. A direct OHWM connection to Tres Palacios Creek was observed and a review of the USGS topographic map indicated the presence of the stream. During rain events, ES-1 drains a large area to the north of the study area and holds back water for Tres Palacios Creek. Based on these factors, ES-1 contributes more than a speculative or insubstantial effect on the chemical, physical, or biological integrity to Tres Palacios Creek and would be considered a water of the United States.

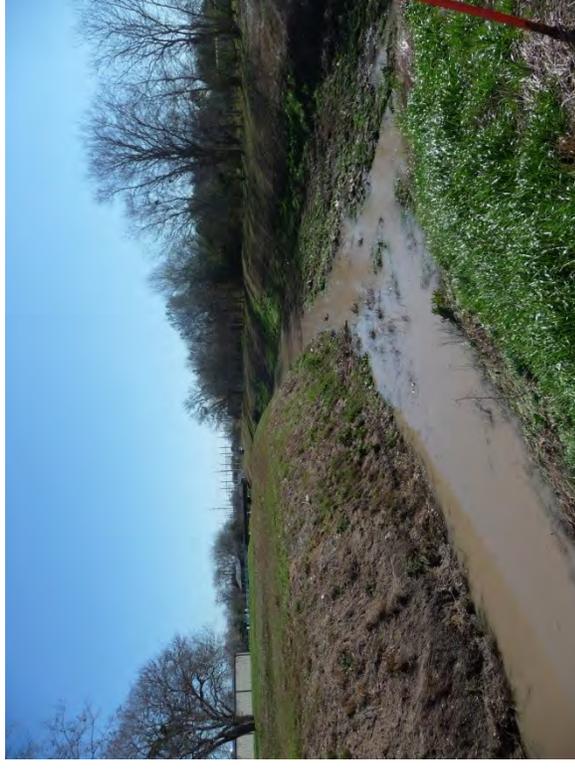
Photo 8: Looking southeast toward the Tres Palacios Creek from ES-1.

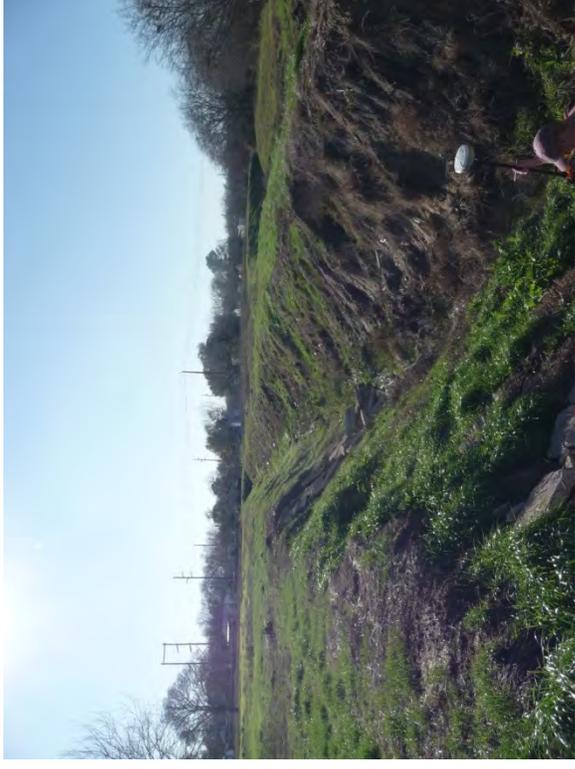
Photo 10: Looking southwest, upland Ephemeral Stream ES-2.

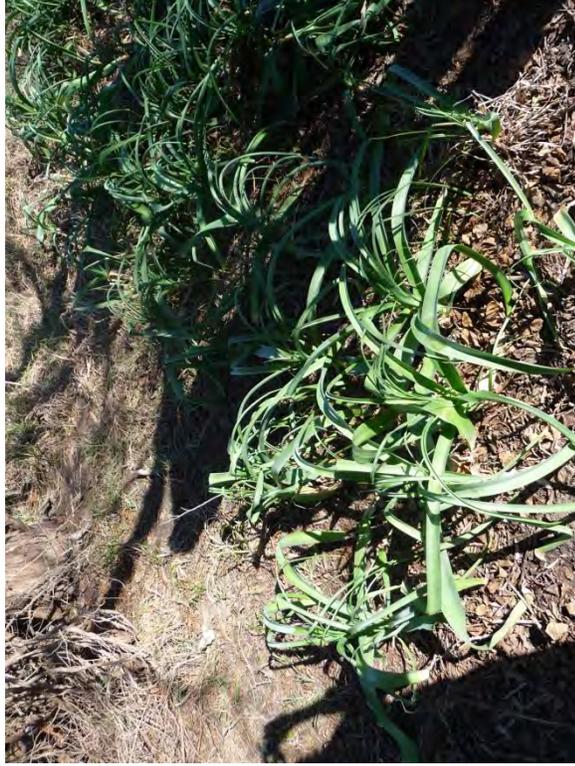
Photo 11: Wetland 1, representative vegetation and geomorphic position shown.

Surface hydrology indicators observed in mapped wetland areas generally consisted of water marks on the trees and water-stained leaves. Field observation of saturation was present in EW-1; however, no water was seen at EW-2. Along with the primary indicator of water marks and water-stained leaves, geomorphic position and crawfish burrows were also included as secondary indicators for these areas.

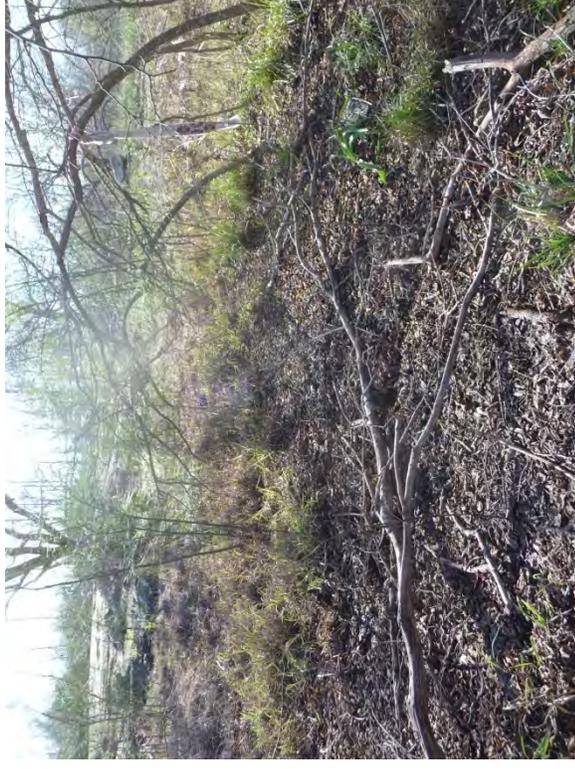
Photo 12: Wetland 2, representative vegetation, water-stained leaves, and geomorphic position shown.

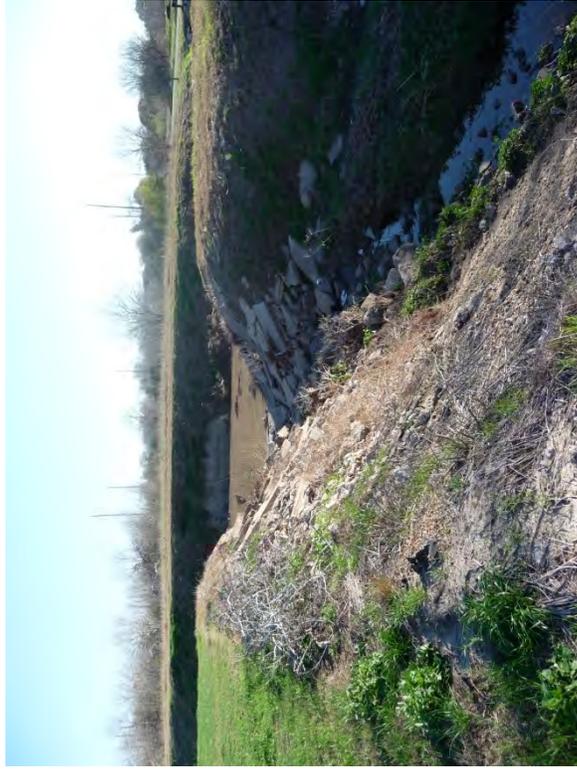
Photo 13: Looking southeast toward Tres Palacios Creek from upland Ephemeral Stream ES-3.

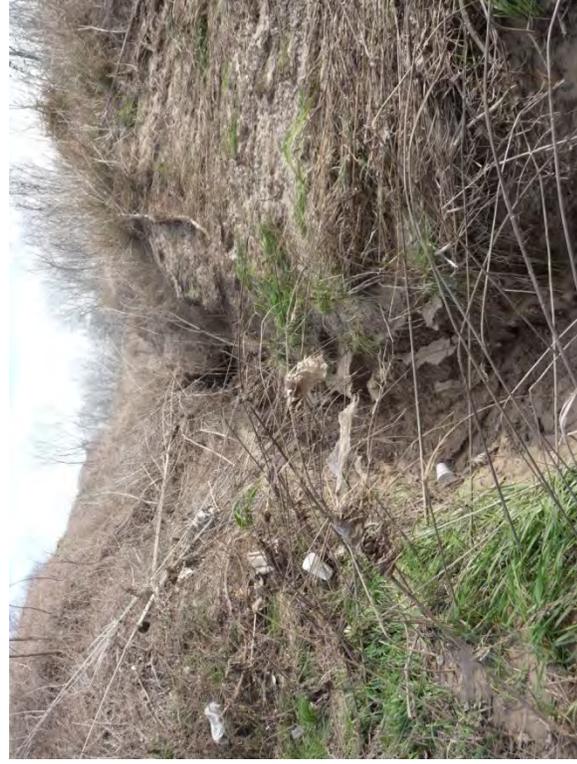
Photo 20: Looking northeast, view of upland Ephemeral Stream ES-4.

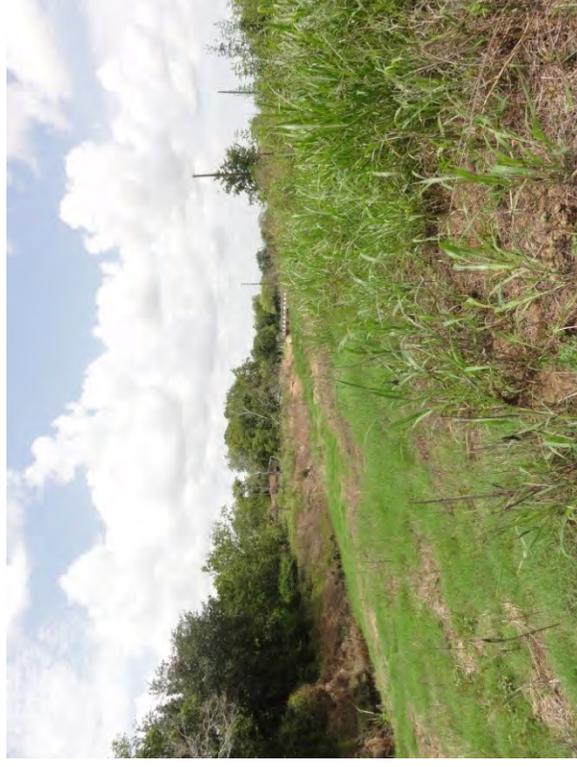
Photo 2: Looking west, a view of the maintained vegetation near Sample Point 3.

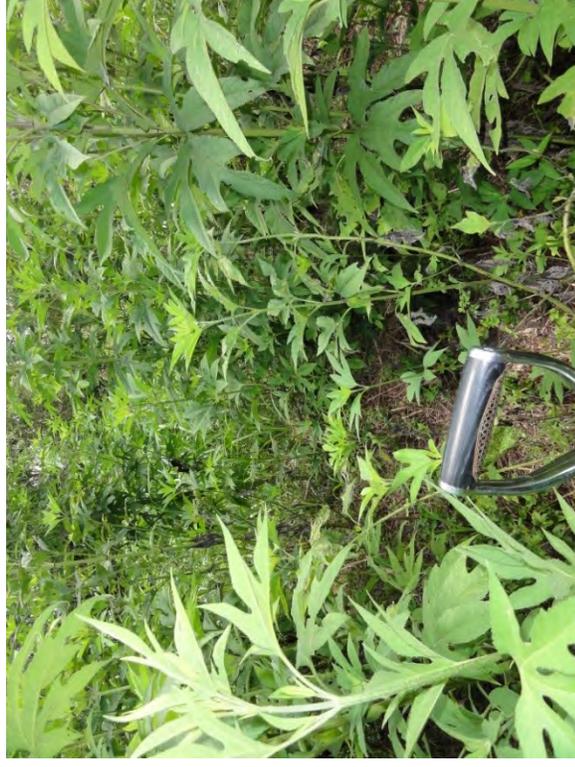
Photo 4: Looking south at Sample Point 7. Dense vegetation is present.
