**CULTURAL RESOURCE SURVEY
ALONG TRES PALACIOS CREEK
IN EL CAMPO,
WHARTON COUNTY, TEXAS**

Technical Report 20

August 2012

AmaTerra Environmental, Inc.
Austin, Texas

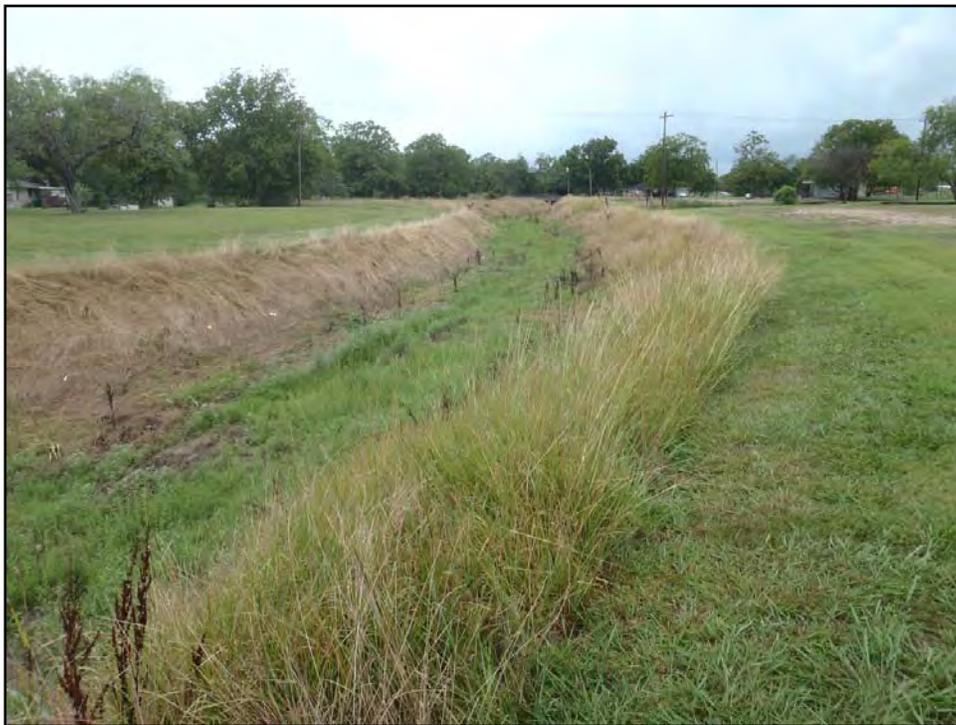
Figure 6. Tres Palacios Creek Channel east of Palacios Street, facing west.

The character of the project area was found to vary from residential neighborhood (**Figure 6**) to brushy floodplain (**Figure 7**) to open rangeland (**Figure 8**). As can be seen in historic aerial photographs, the entire APE had been previously disturbed in some measure by previous dredging-related projects dating back as far as the 1950s. **Figure 9** depicts a freshly dredged portion of the project area in 1964.

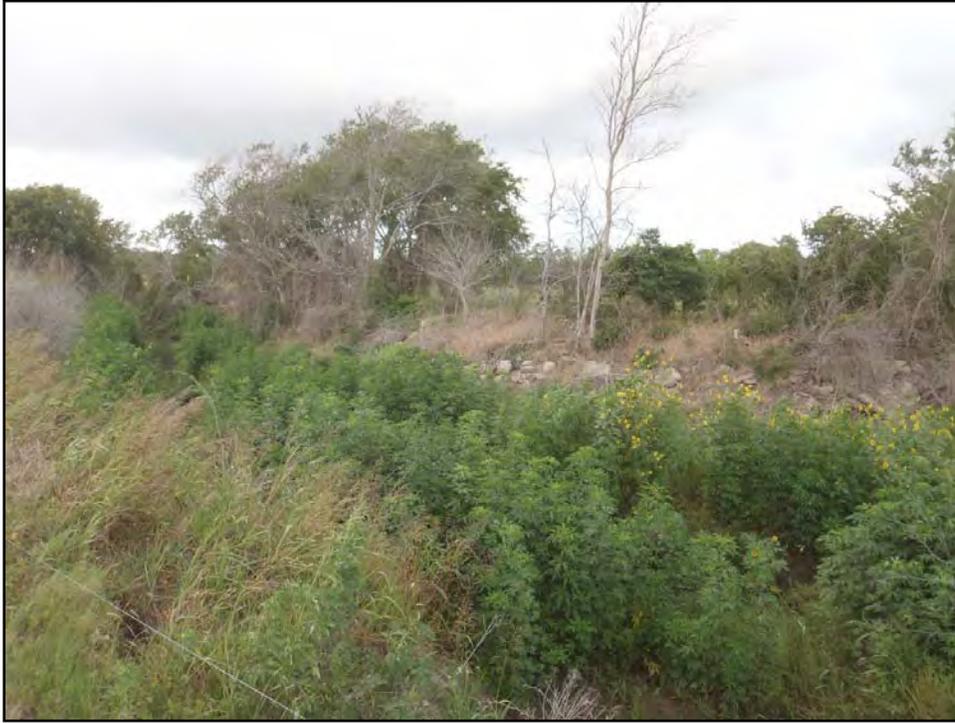
Figure 7. Tres Palacios Creek Channel south of US 59, facing south.

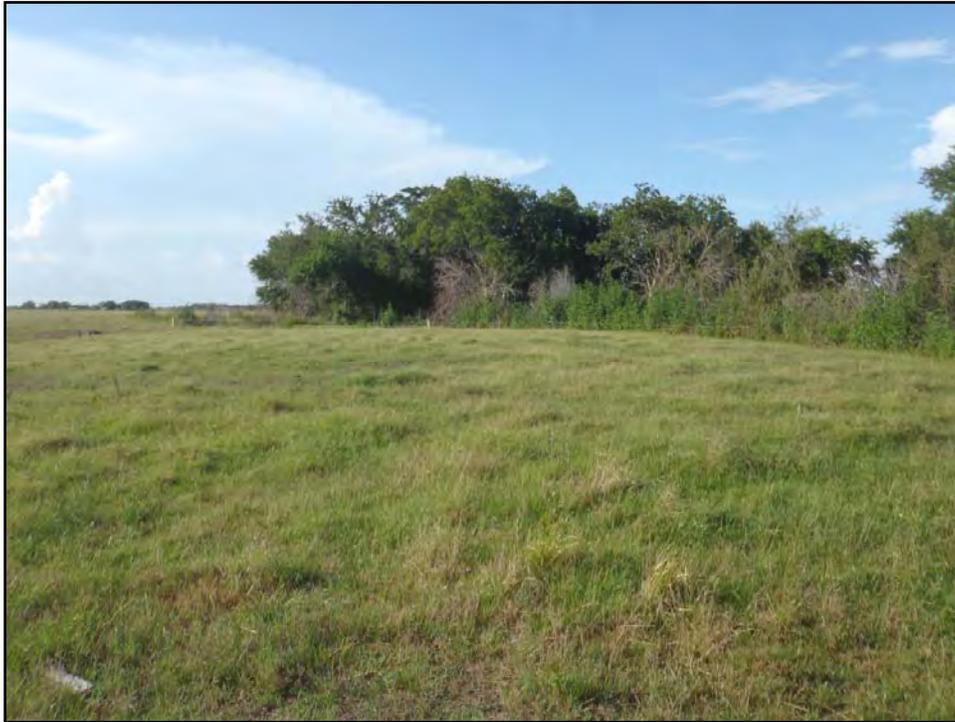
Figure 8. Tres Palacios Creek Channel north of County Road 406, facing south.

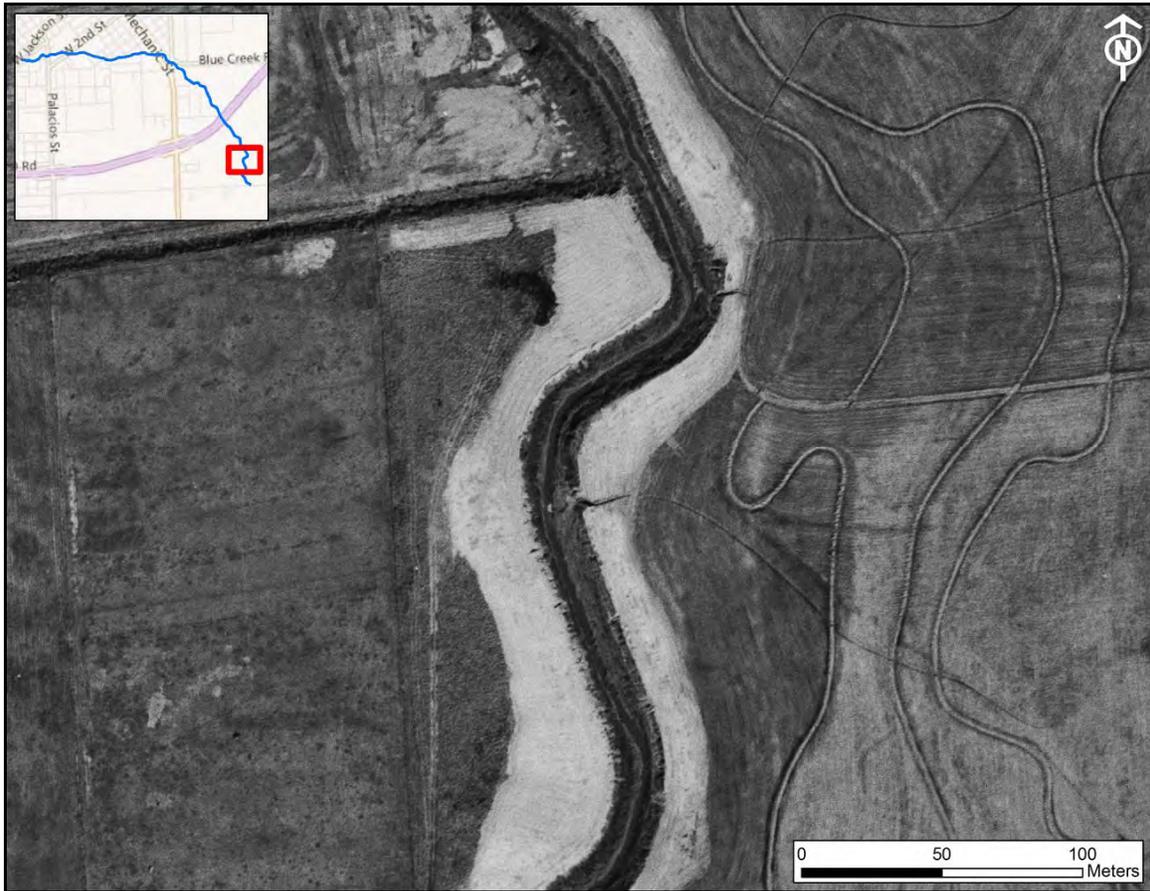
Figure 9. 1964 aerial photograph of freshly dredged segment of Tres Palacios Creek Channel north of County Road 406.

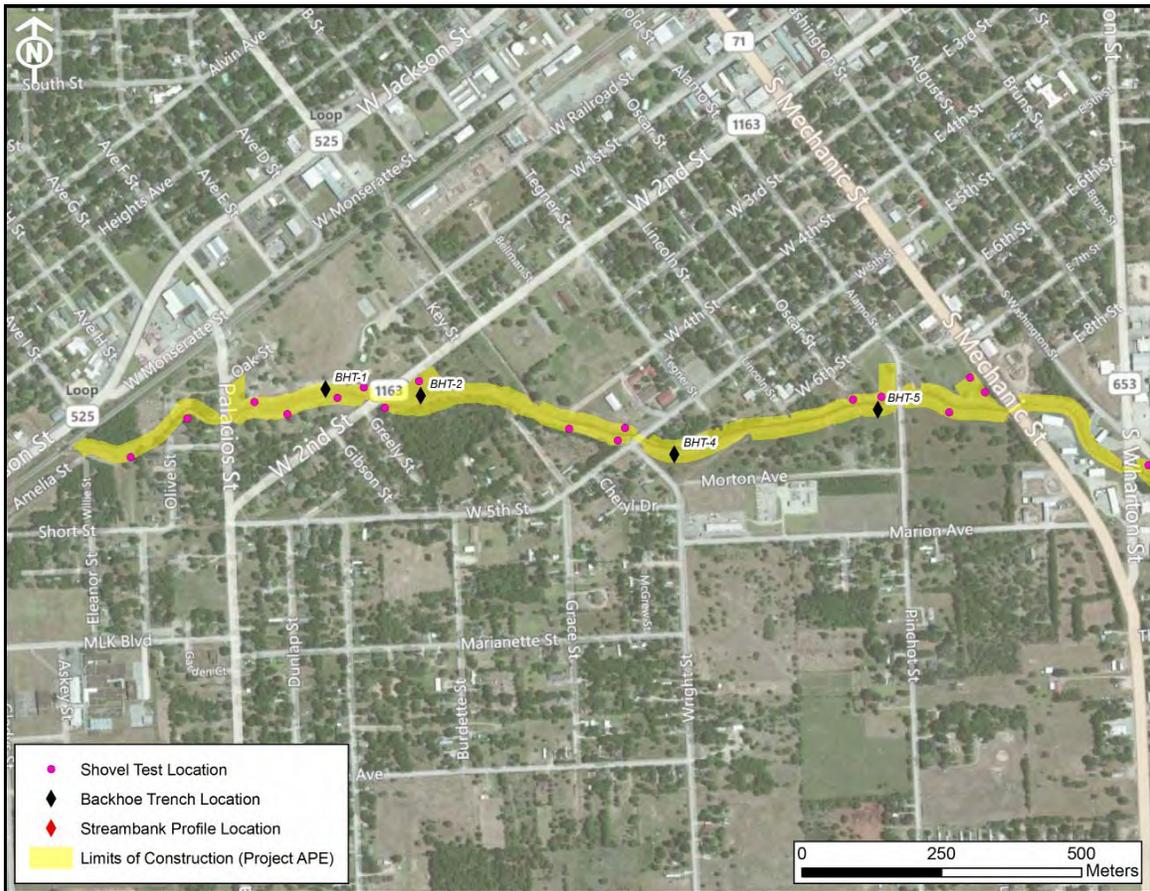
Shovel tests varied from 10 to 60 cmbs, averaging 30 cmbs. Shovel tests encountered consistent mottled clay with varying amounts of sand throughout the project area with very little variation. Trash debris was found to depths over 30 cmbs at several locations, indicating that shovel tests were within a disturbed zone, mostly likely piled dredge spoils. Nearly all of the shovel test locations were determined to be disturbed, truncated by grade-scraping, or capped by dredge spoils. Visual inspection of the creek channel

Figure 10. Map one of two, plotting shovel tests, bank profiles, and backhoe trenches carried out within the project area.

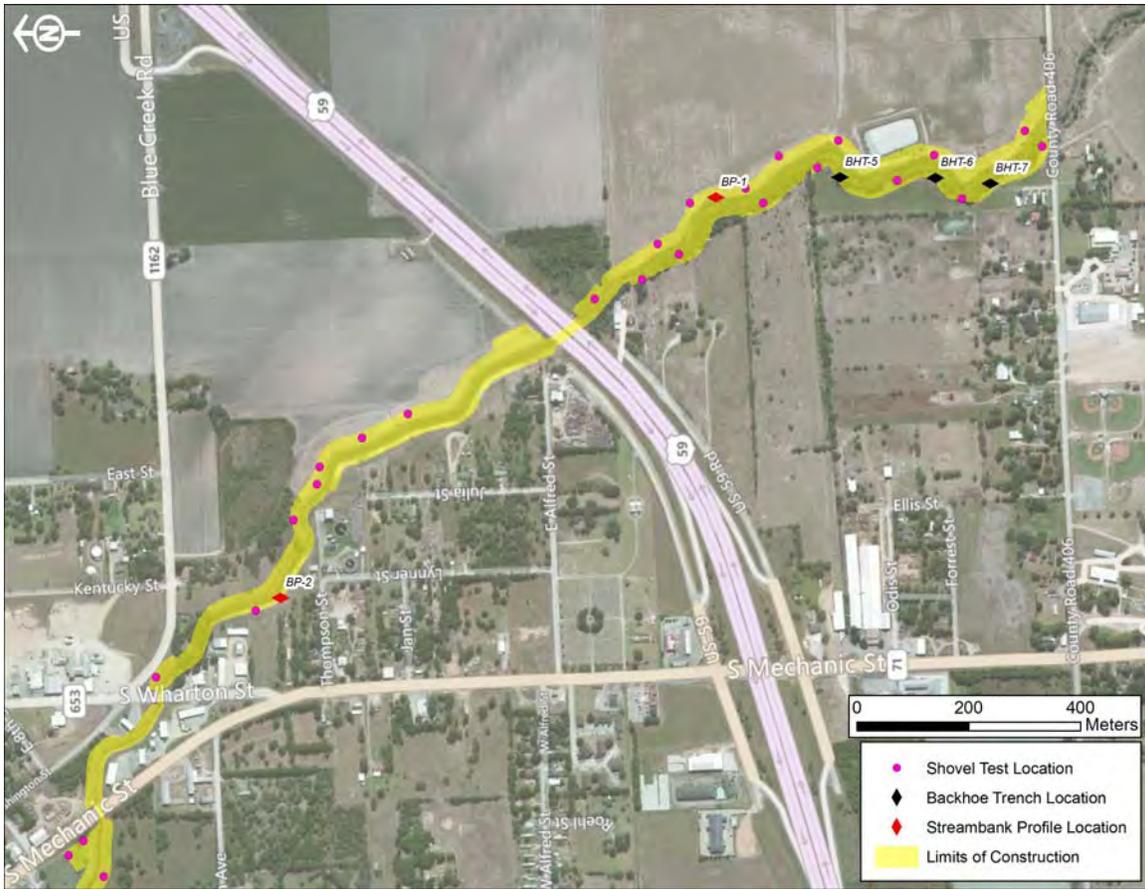
Figure 11. Map two of two, plotting shovel tests, bank profiles, and backhoe trenches carried out within the project area.

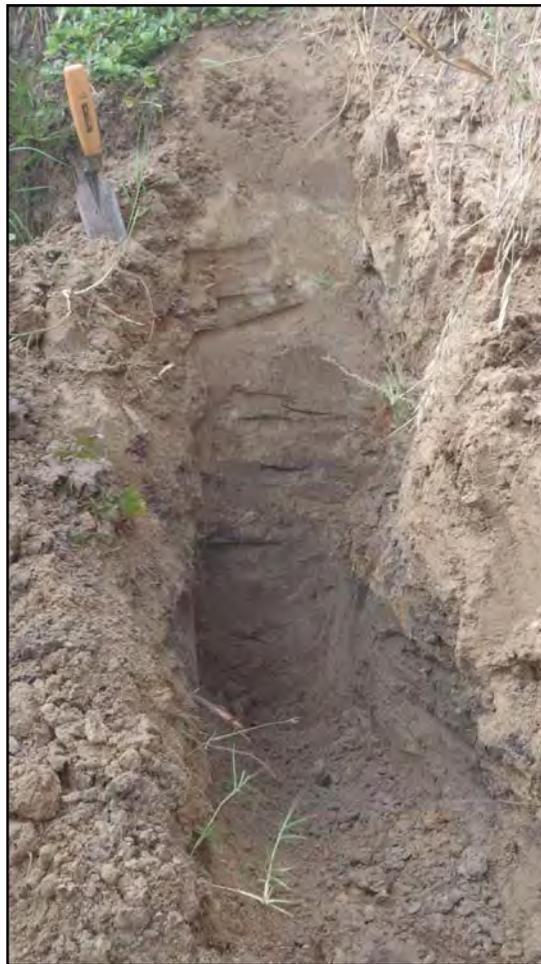
At two locations along Tres Palacios Creek, where exposed bank deposits seemed to contain *in situ* sediments, bank profiles were drawn to aid in interpreting the local geology. At a steep point of exposed bank, a shovel was used to create as near a vertical cut as possible for as deep as possible. In both profiles, depths attained were around 1.5 meters below the surface. Both profiles, though over one kilometer apart, were nearly identical, with sandy overfill underlain by mottled sandy clays and basal gray clays (**Figure 12**). Some manganese and calcium carbonate nodules less than 1 centimeter in diameter were noted in the lower extent of these profiles. No transported pebbles were noted in either profile.

Figure 12. Stream bank profile dug south of US 59 on the left bank of Tres Palacios Creek, facing south.

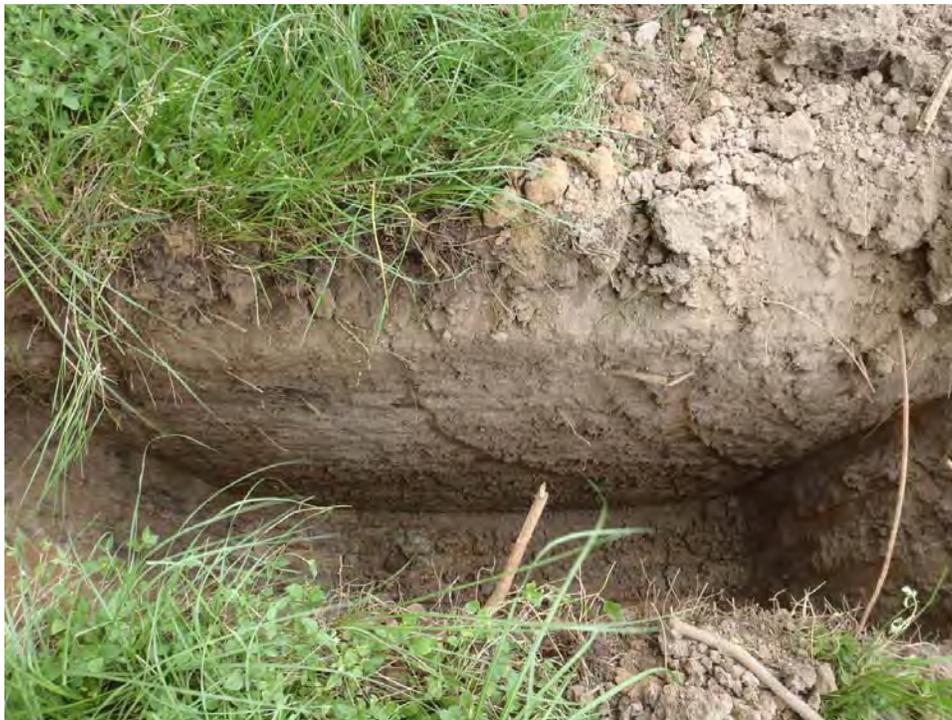
Following shovel testing and visual inspection of the APE, backhoe trenches were excavated at seven locations along Tres Palacios Creek. Trenches were excavated using a mini-backhoe supplied courtesy of the City of El Campo Public Works Department. Trenches were excavated to depths of 1.5 to 2 meters in depth and were photographed, profiled, and backfilled at the time of excavation (**Figure 13**). These trenches, like the bank profiles, demonstrated continuity from the start to end of the project area. All seven units had a capping layer of disturbed topsoil overlaying mottled sandy clays to depths of around 1.5 meters, beneath which a gray clay extended. The basal clay contained manganese nodules and calcium carbonate nodules generally less than one cm in diameter. Backhoe Trench 5 is presented in **Figure 14** as a typical trench profile.

Figure 13. Backhoe Trench 6 south wall profile, facing south.

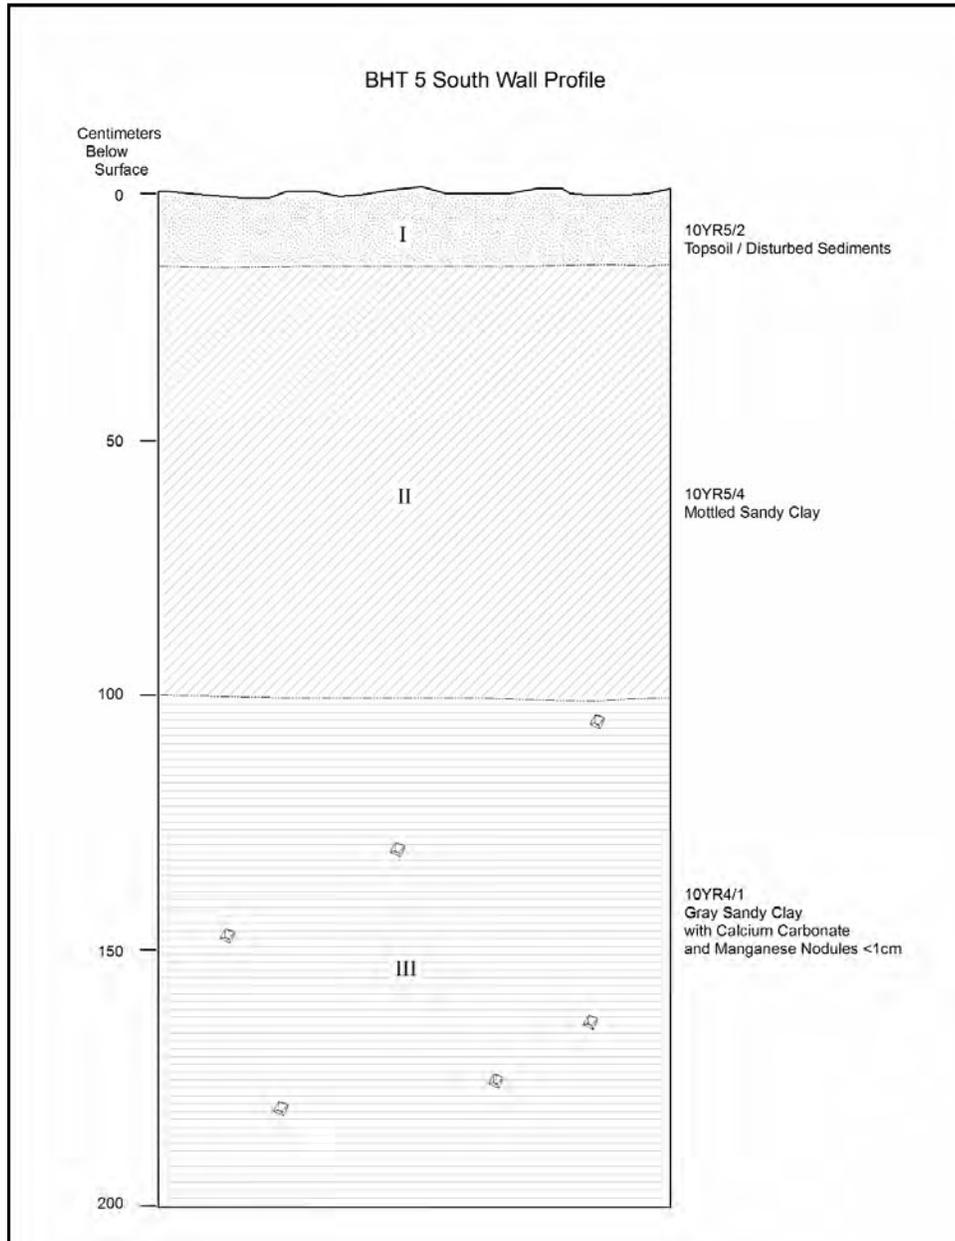
Figure 14. Backhoe Trench 5 south wall profile.

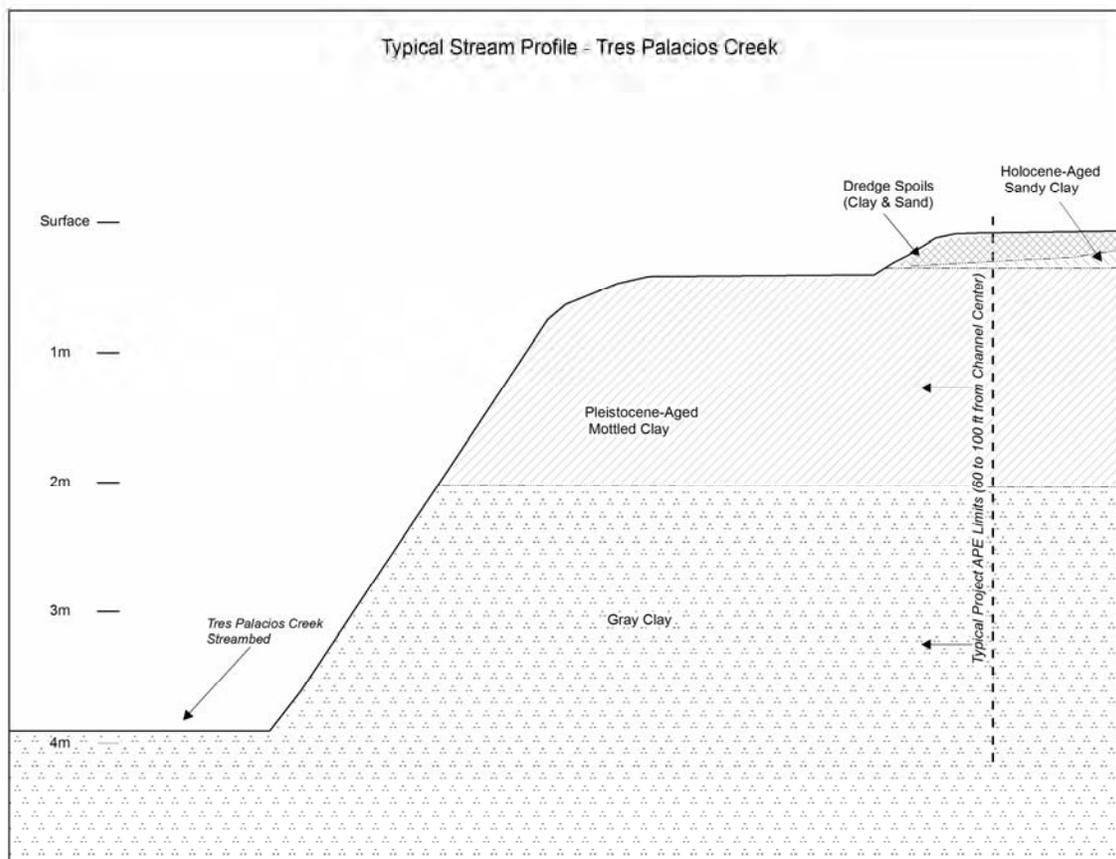
Based on the visual assessment, shovel testing, and trench and bank profiling, a typical stream channel and APE profile was formed (**Figure 15**). This profile demonstrates the extent of alteration that has occurred within the stream bank and surrounding area as a result of previous dredging. Spoils have been removed from the bottom of Tres Palacios' creek channel, piled on the banks, then moved further from the creek by scraping a flat platform immediately outside the channel walls. During the scraping process, most of the

Holocene deposits have been removed and/or blended into the dredged material and older strata. While surface deposits of Holocene sediment remain in places throughout the project area, it is so disturbed and thin that the potential for intact prehistoric deposits is remote.

Figure 15. Typical Stream Profile of Tres Palacios Creek indicating extent of previous disturbances.

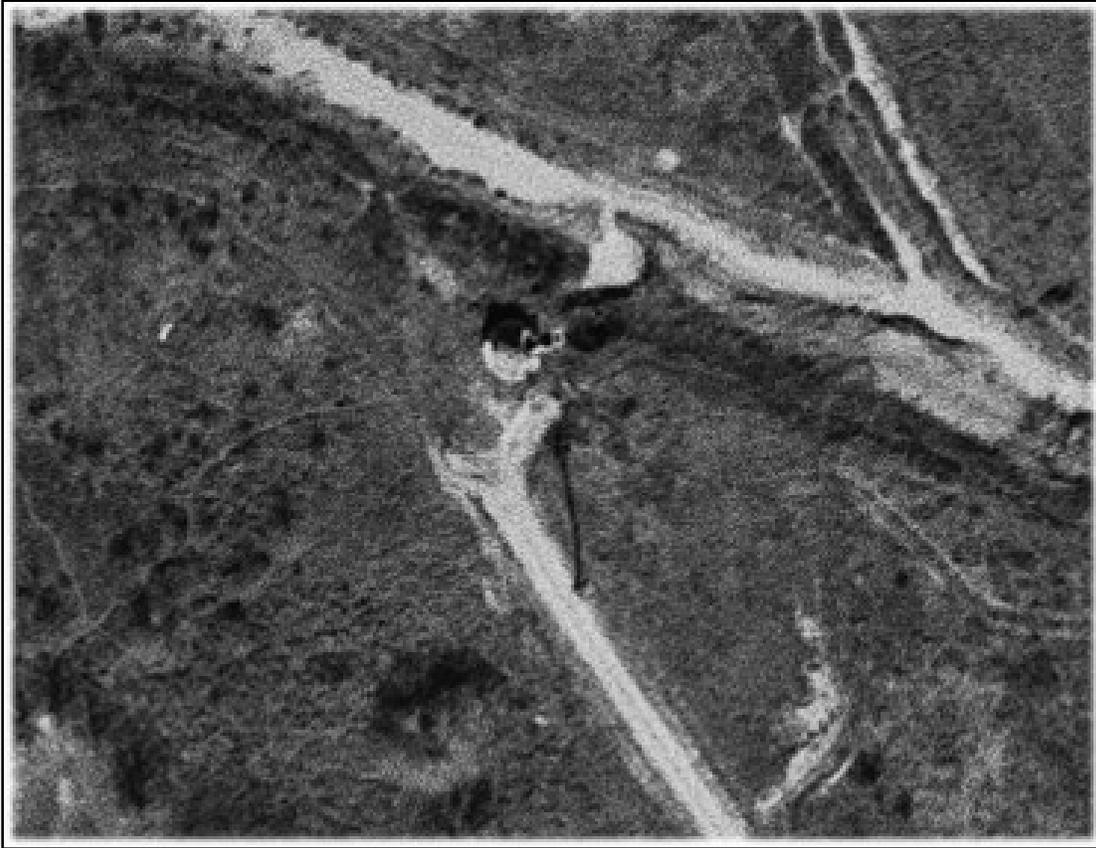
A pump house was encountered off Vasa St., near the northern end of the project area (Site ID 4). An aerial photo from 1964 (**Figure 16**) reveals that the original structure was likely moved, demolished, or heavily modified. It has no historic significance under Criteria A, B, or C.

Figure 16. Pump house location on 1964 aerial photograph.

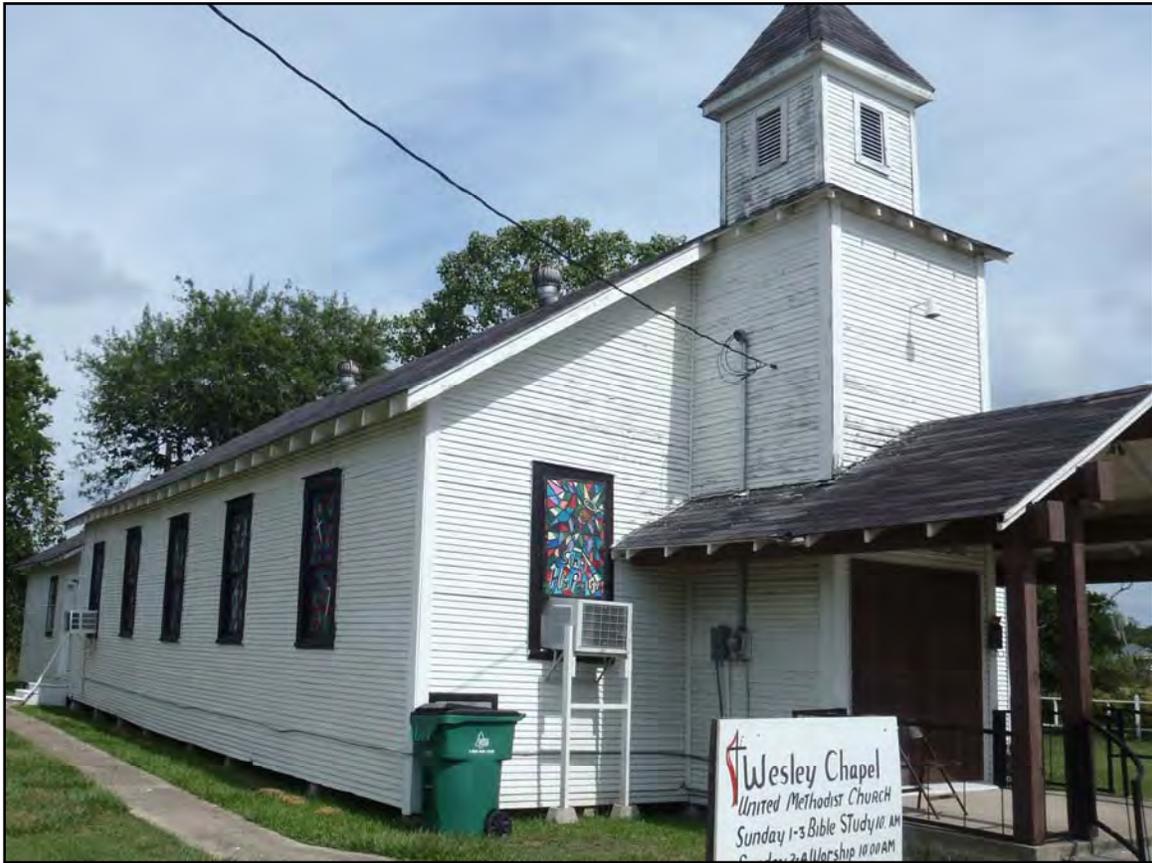
Wesley Chapel United Methodist Church (**Figure 17**), located at 202 Olive Street, is considered as eligible for listing as on the National Register of Historic Places (NRHP) under Criterion C at the local level, in the area of Architecture. The church appears on the 1931 Sanborn map and was likely constructed around this same period. The structure appears to be largely original, suffering little in the way of modifications, and is a good example of an African-American center steeple, wood-frame church.

Figure 17. Wesley United Methodist Church, 202 Olive Street.

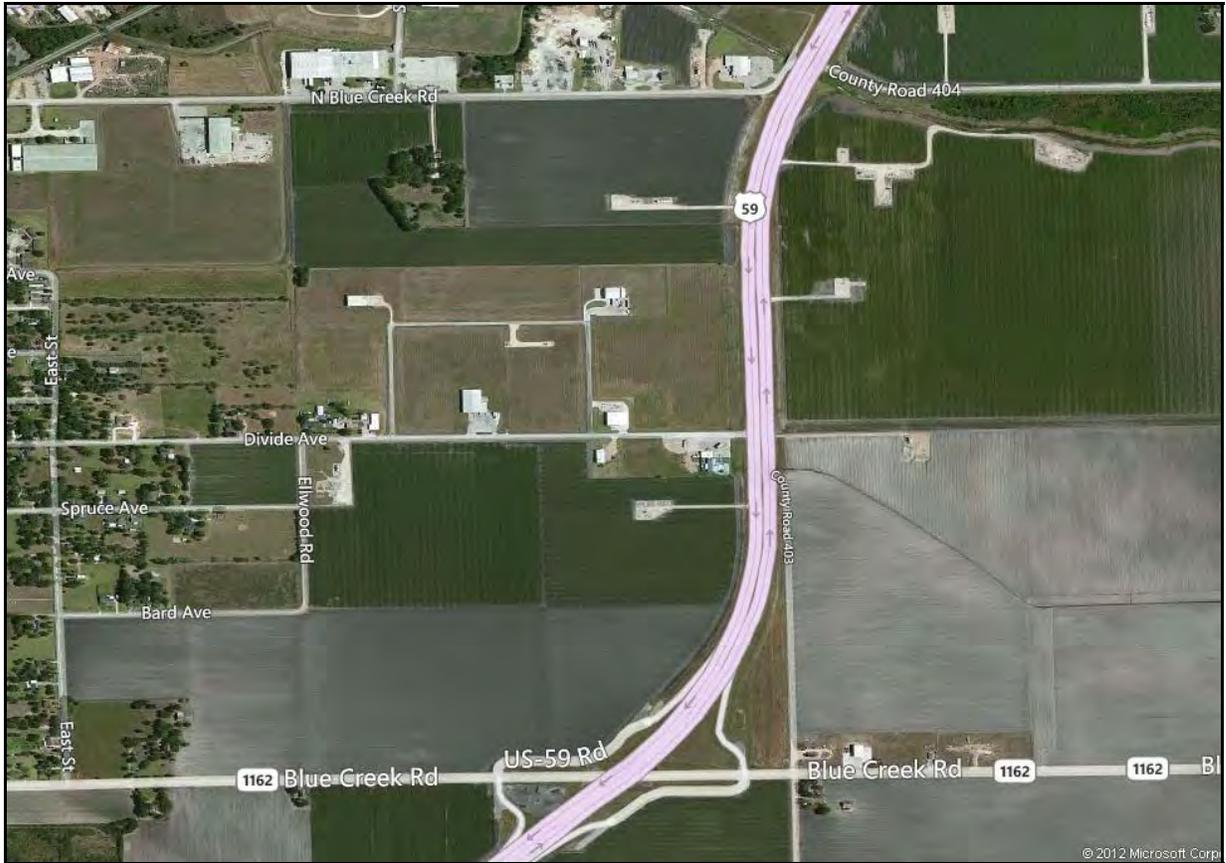
Figure 20. 2012 aerial of El Campo, east of the of project area, showing a large number of commercial/industrial properties in the historically agricultural area.

Although the project area may be classified as semi-rural, little distinguishes it from El Campo proper. The built environment is a mix of historic-age single-family homes, industrial/commercial properties, undeveloped land, and modern infill. The project area—as a whole—has few of the defining characteristics of a rural historic district, and what historic-age architecture exists is unremarkable both individually and as a collective whole. Some properties near the southern terminus have agricultural buildings associated with them, where agricultural activity is still present. However, it also appears that many of the agricultural structures previously in the area (**Figure 18**) are now no longer present (**Figure 19**). This could be due to factors such as the construction of US-59 or changes in industry/farming practices. Additionally, the large agricultural plots with one residential complex present appear to have suffered from sub-dividing and more modern residential infill. There are also commercial and/or industrial properties, constructed within the past twenty years, now located within the area (**Figure 20**). These factors impact integrity of

setting, design, feeling, land use, and spatial organization. No evidence suggests the area has any association with persons of historic importance, and the historic-age built environment lacks architectural significance as a district. As such, the survey identified no eligible historic districts or rural historic landscapes in the project APE.

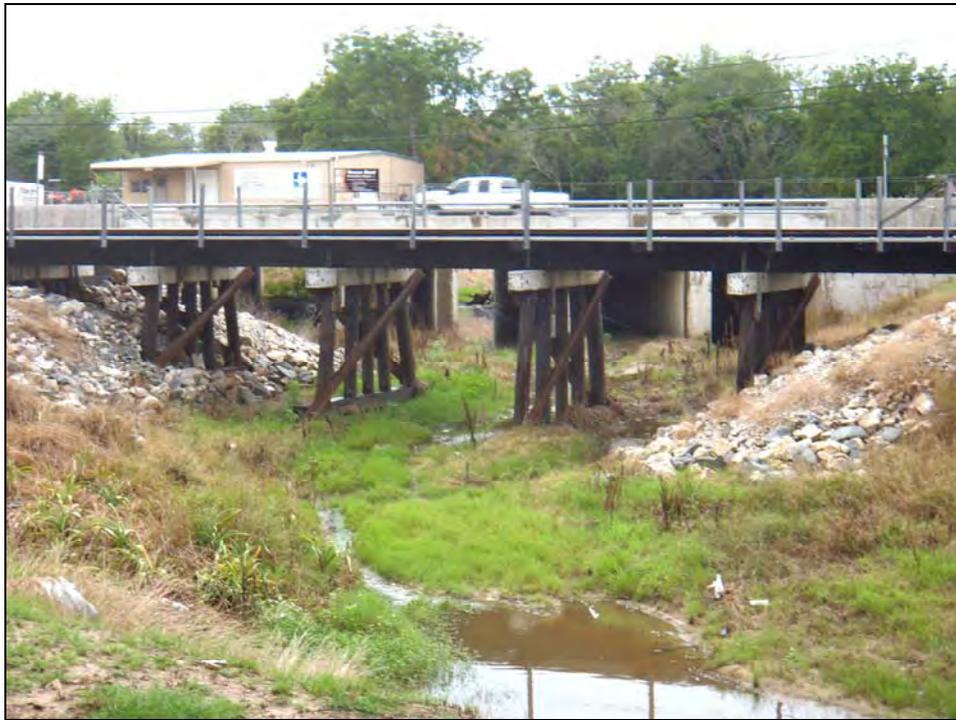
Map I.D. #: 1
Site Location: No Address – Railroad bridge at Palacios Creek
UTM Coordinates: 14 764443E/ 3231897N
Function/use: TRANSPORTATION/ bridge
Date: c. 1960
Style/form: Utilitarian/ Concrete deck with timber piers
NRHP eligibility: Not eligible
Comments: None.

View facing west.

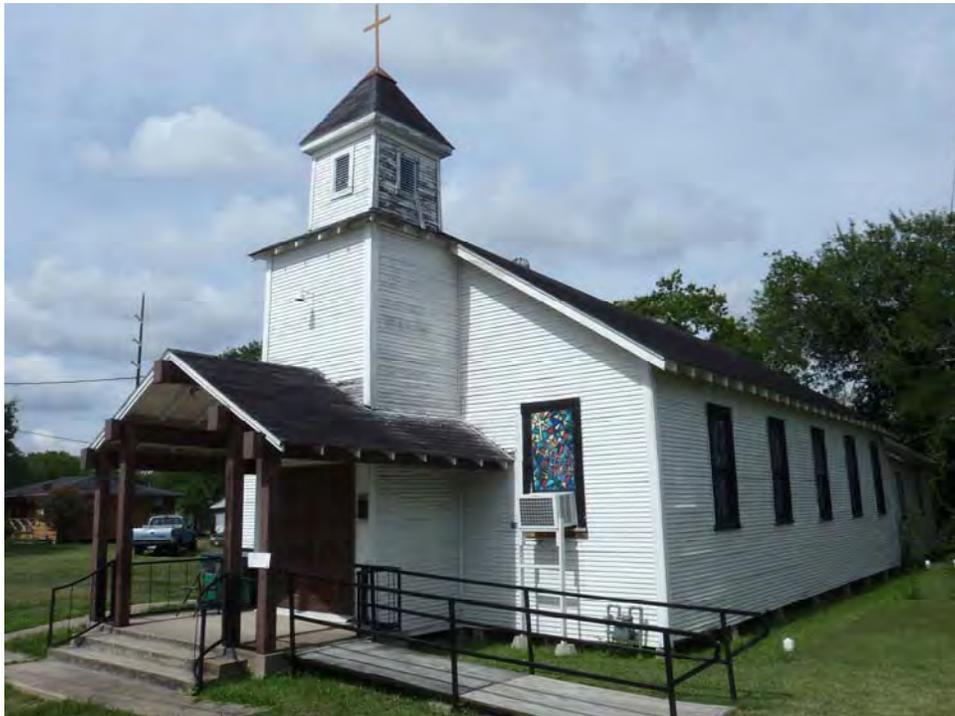
Map I.D. #2B

Map I.D. #: 2A
Site Location: 202 Olive Street
UTM Coordinates: 14 764611E/ 3231886N
Function/use: RELIGIOUS/ church
Date: c. 1930
Style/form: Center steeple vernacular / Front gabled roof with steeple
NRHP eligibility: **Yes, C**
Comments: None.

View facing west.

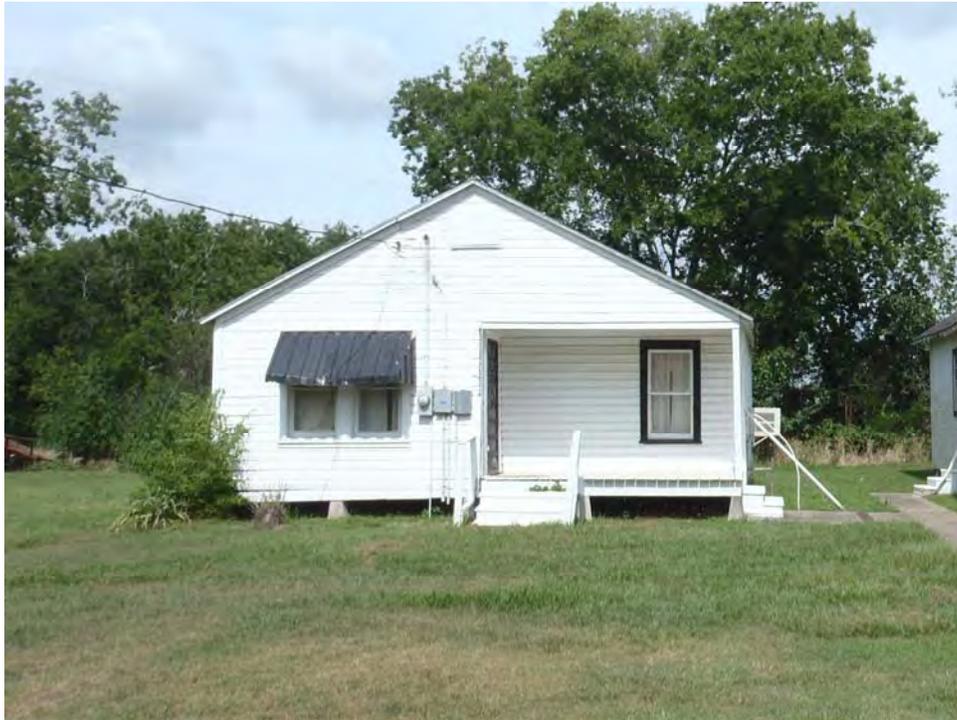
View facing northwest.

Map I.D. #: 3A
Site Location: 200 Palacios St.
UTM Coordinates: 14 764703E/ 3231977N
Function/use: DOMESTIC/ single dwelling
Date: 1963 (Wharton Co. Appraisal District)
Style/form: Ranch/ Hipped roof
NRHP eligibility: Not eligible
Comments: None.

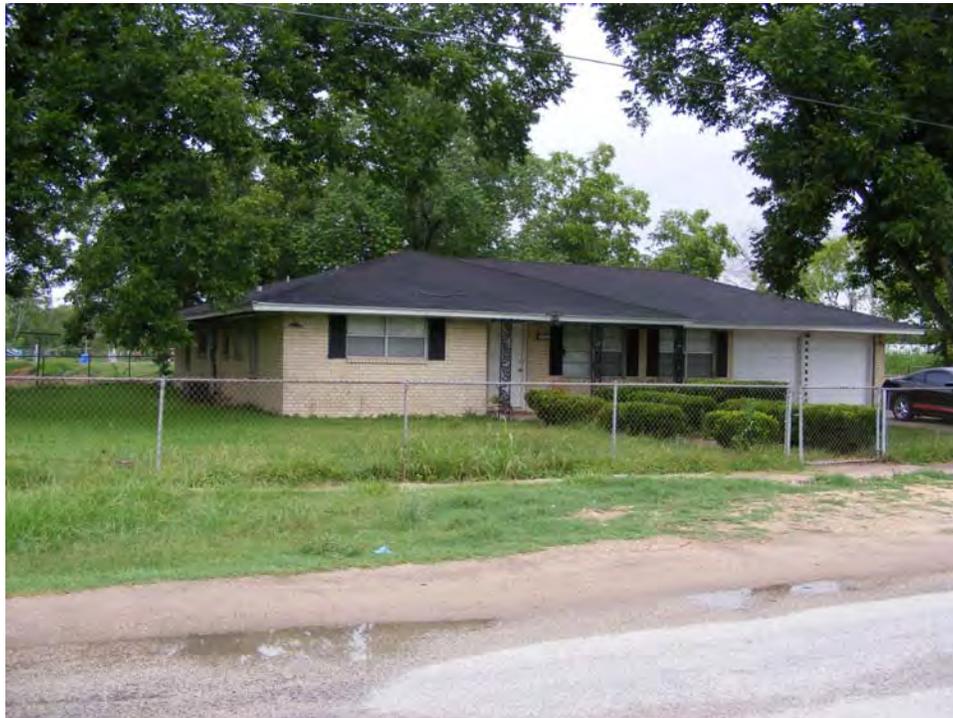
Map I.D. #3B

View facing northwest.

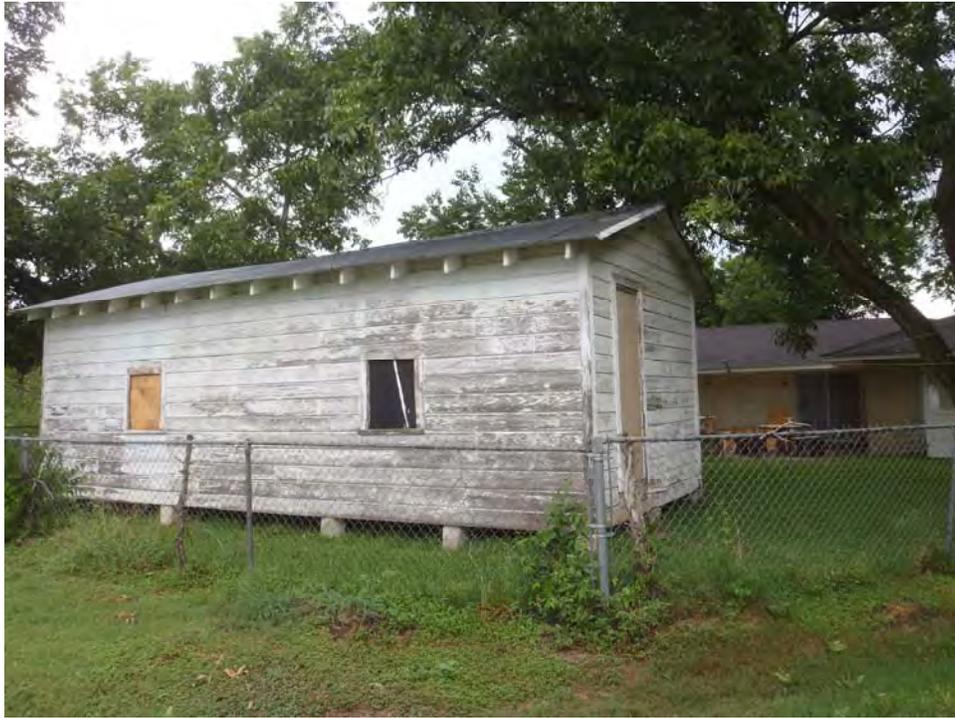
View facing northeast.

Map I.D. #: 4
Site Location: No Address – Vasa St.
UTM Coordinates: 14 765242E/ 3231964N
Function/use: IRRIGATION/ pump house
Date: c. 1960
Style/form: Utilitarian/ Side gabled roof
NRHP eligibility: Not eligible
Comments: None.

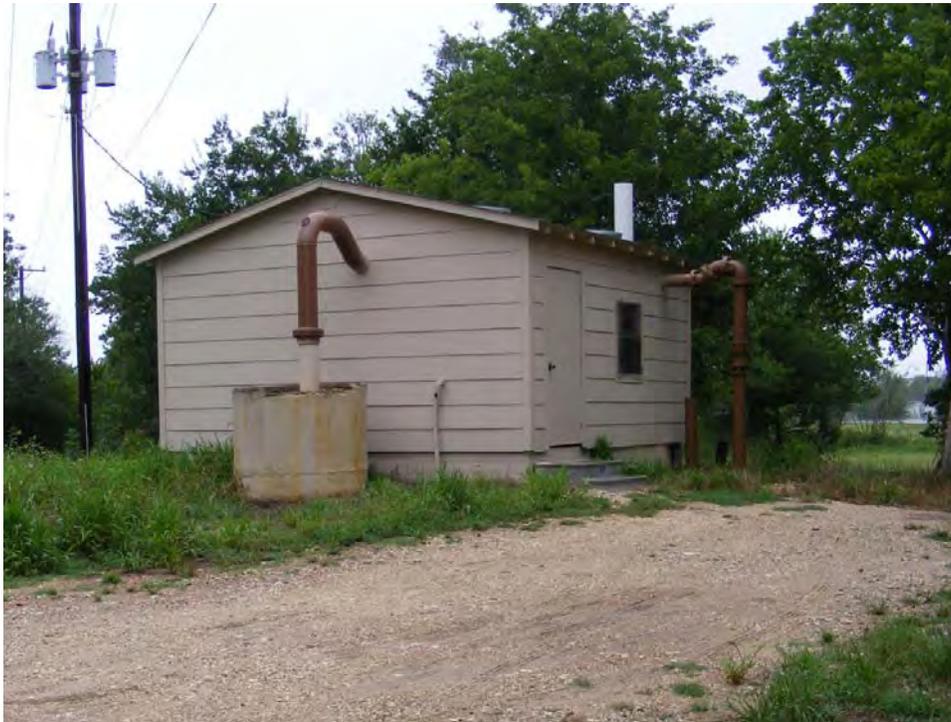
View facing northeast.

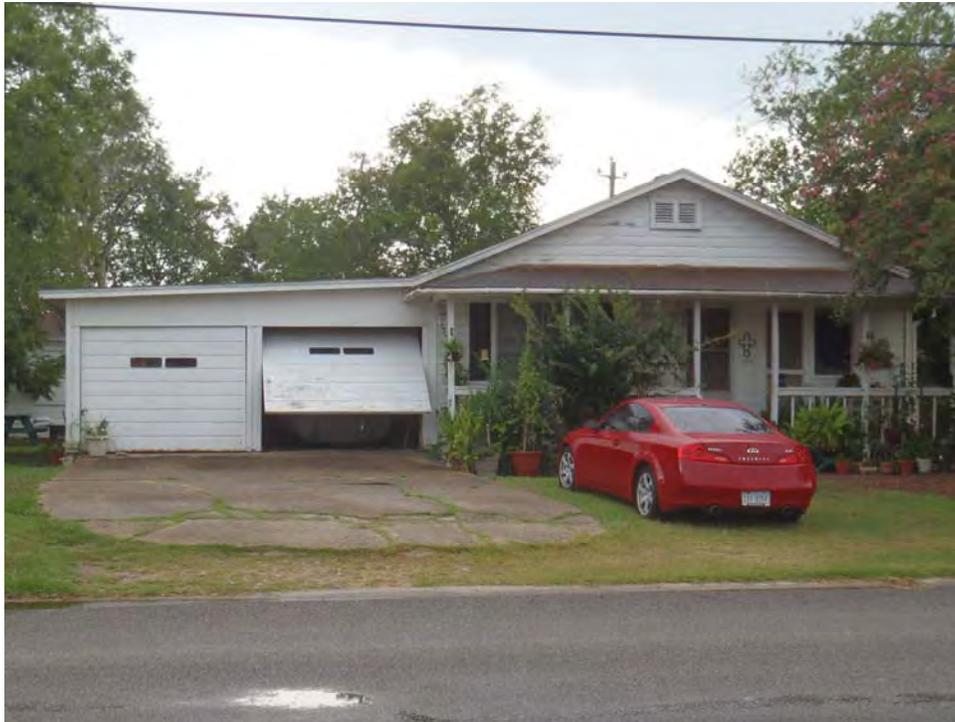
Map I.D. #5B

Map I.D. #: 5A
Site Location: 505 W. 5th St.
UTM Coordinates: 14 765510E/ 3231924N
Function/use: DOMESTIC/ single dwelling
Date: 1955 (Wharton Co. Appraisal District)
Style/form: Minimal traditional/ Front gabled roof
NRHP eligibility: Not eligible
Comments: None.

View facing southeast.

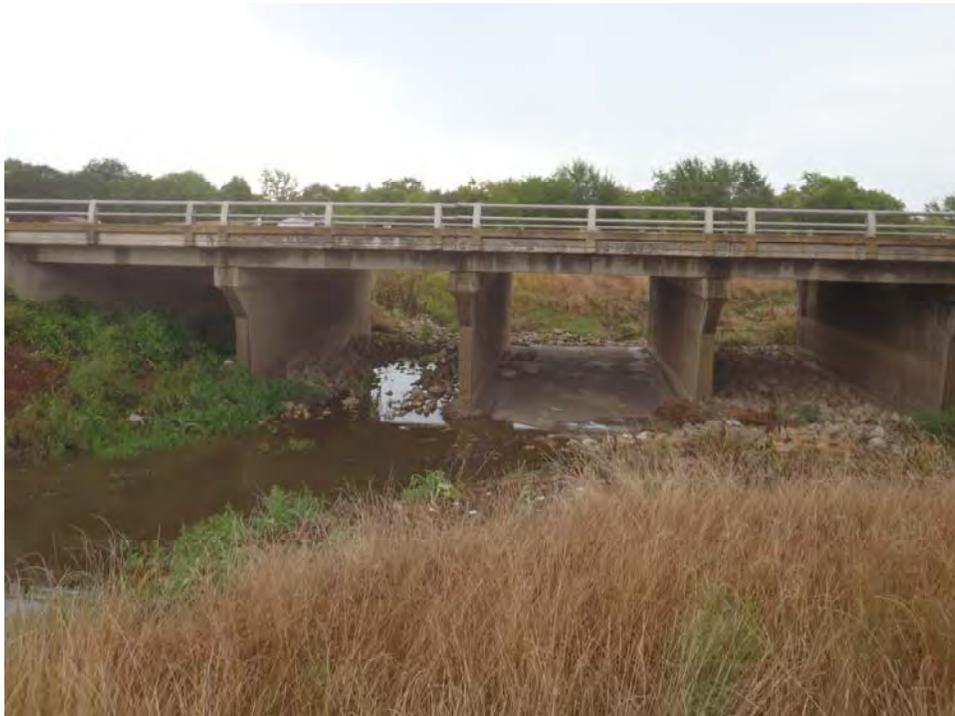
Map I.D. #: 6
Site Location: 2322 Webb Lynn Rd
UTM Coordinates: 14 766134E/ 3231974N
Function/use: TRANSPORTATION/ bridge
Date: 1930 (Reconstructed 1964)
Style/form: Utilitarian/ Simple span deck, concrete flat slab
NRHP eligibility: Not eligible
Comments: None.

View facing east.

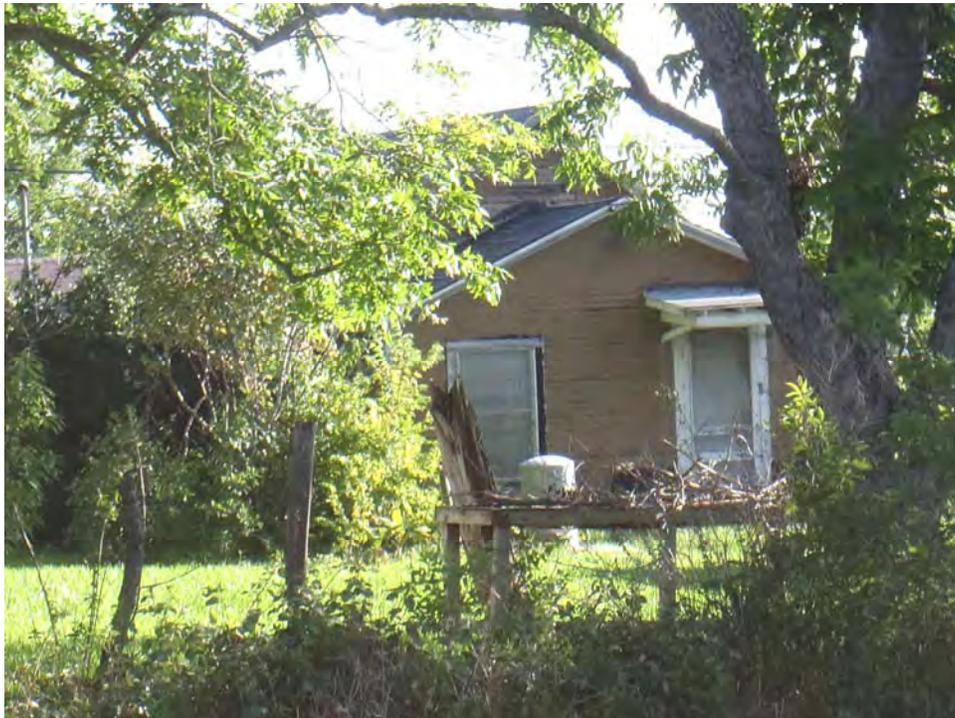
Map I.D. #7B

Map I.D. #: 7A
Site Location: No Address – Blue Creek Rd.
UTM Coordinates: 14 766483E/ 3231820N
Function/use: DOMESTIC/ single dwelling
Date: c. 1940
Style/form: Minimal traditional/ Front gabled roof
NRHP eligibility: Not eligible
Comments: None.

View facing northeast.

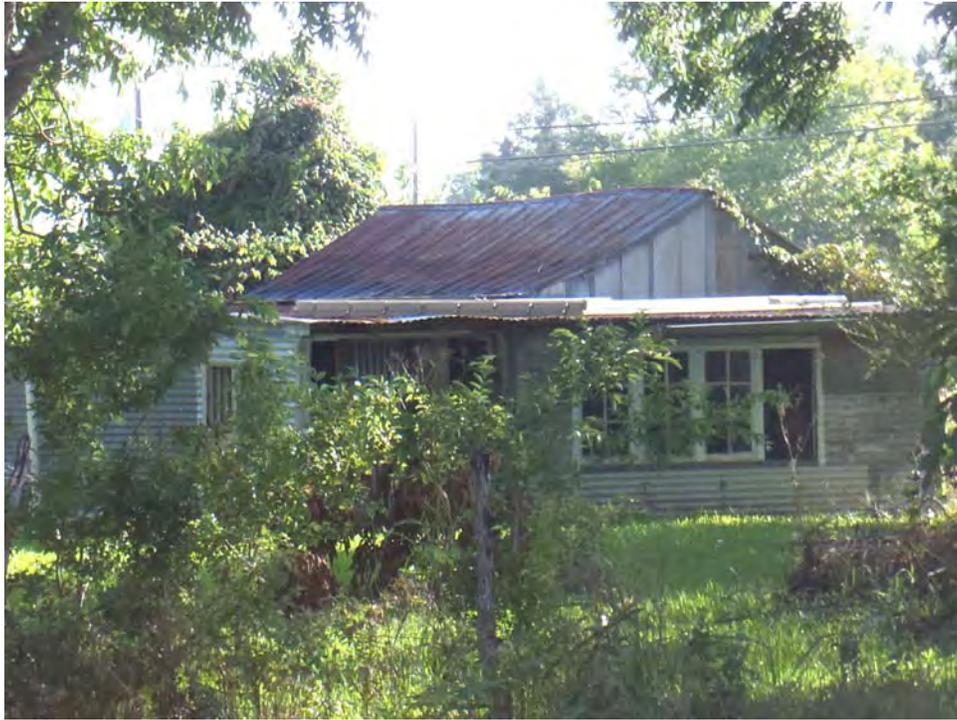
Map I.D. #7C

View facing northeast.

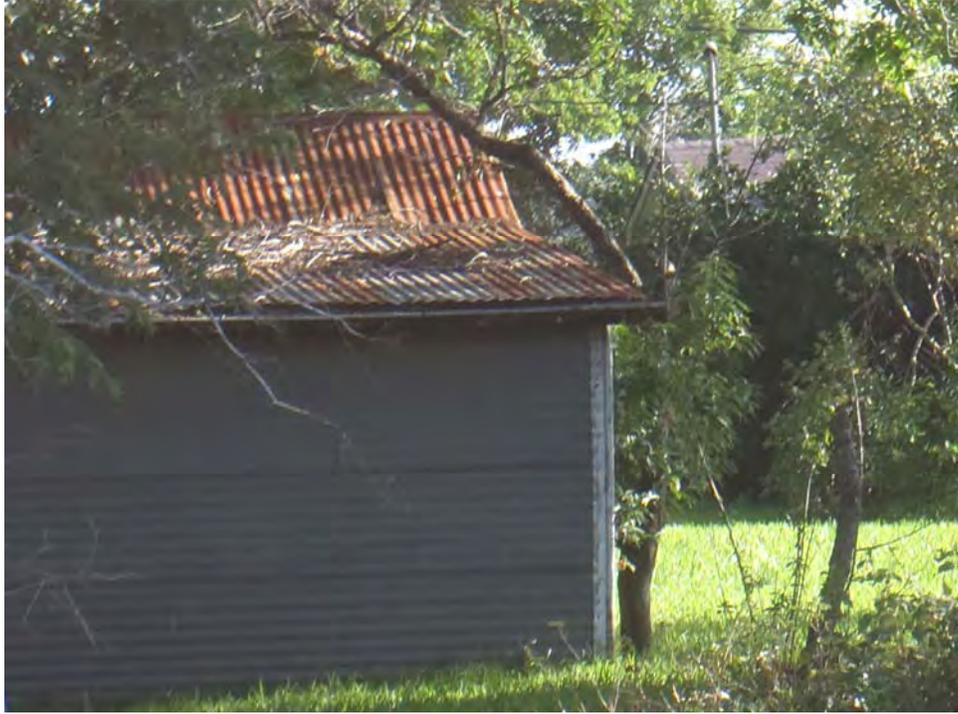
View facing northeast.
