Loss Avoidance Study

Jefferson Parish, Louisiana

Hurricane Isaac, 2012

Hurricane Isaac, August 2012
Losses Avoided Through Hazard Mitigation

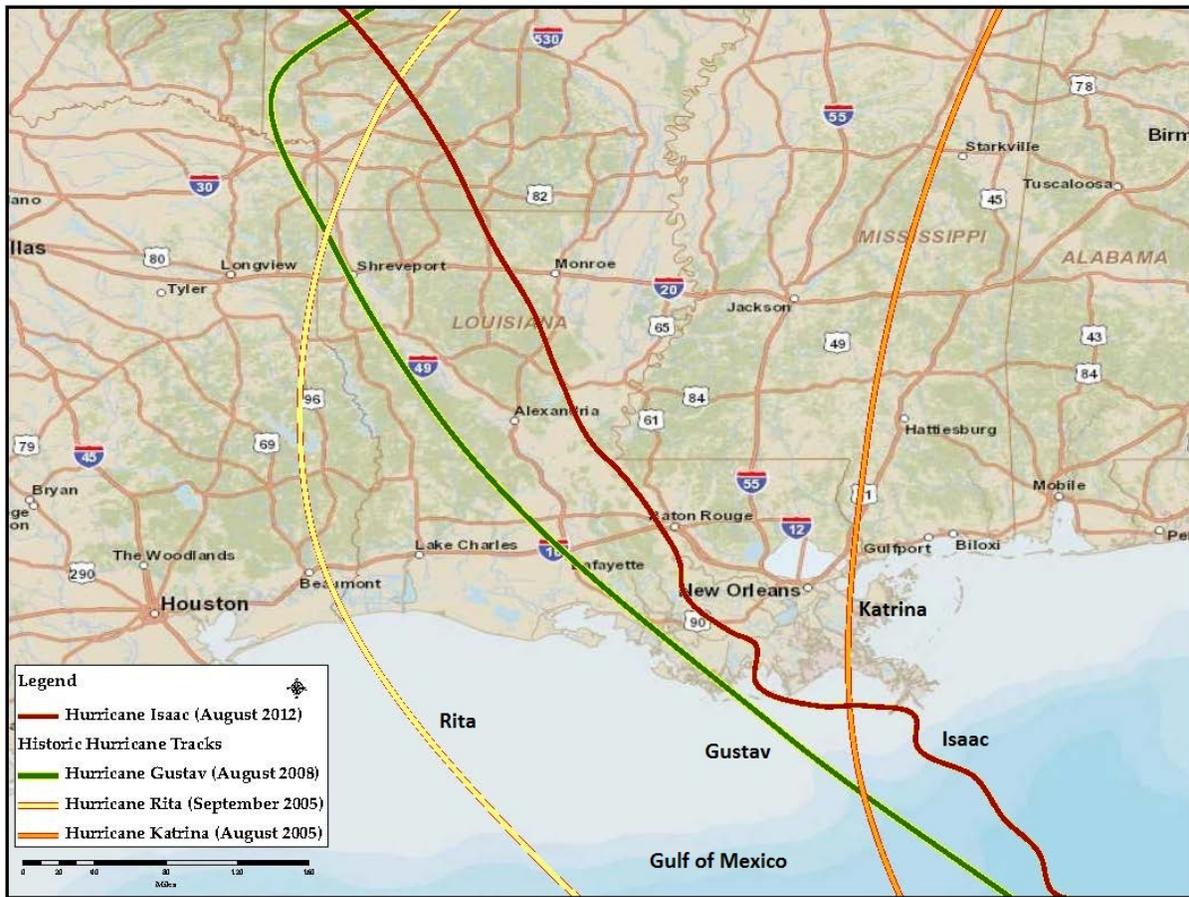
Figure 1.1 Historic Hurricane Storm Tracks

Southeast Louisiana, no stranger to destructive hurricanes, has been hammered repeatedly over the years. In 1969 Hurricane Camille pounded the southern coast as a Category 5, Katrina (Category 3) in August 2005, then Rita (Category 3) the next month in September 2005, Gustav (Category 2) in August 2008 and finally, Isaac in August 2012 (see Figure 1.1).

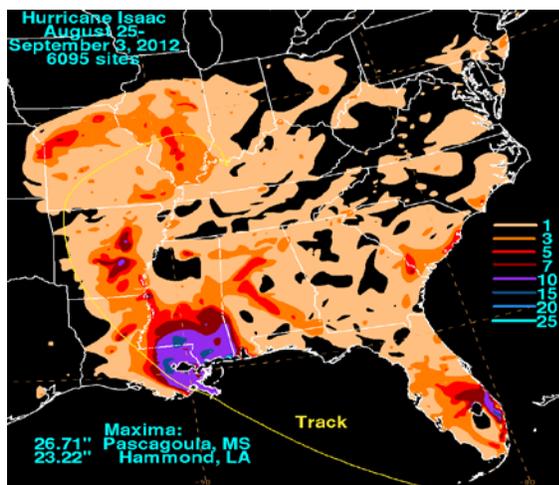
Figure 1.2 Average Rainfall 10”-15” in SE Louisiana from August 25- September 3, 2012 (NWS)

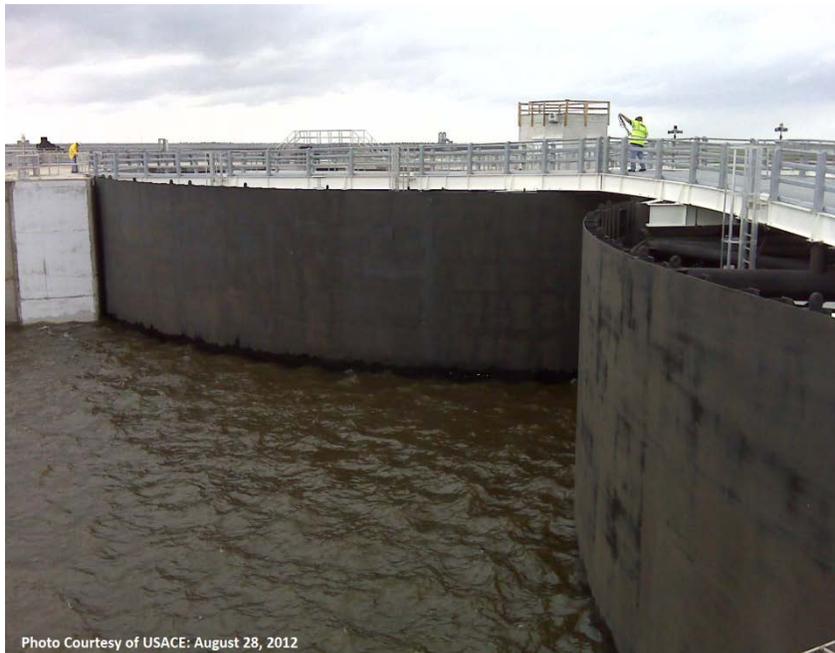
The initial Hurricane Isaac storm surge that swept across Grand Isle, LA, was a moderate 3 foot plus surge, but as it moved into the marshes of Jefferson Parish and up Barataria Bayou, the levels were 6.5 feet or greater. There are no levees on either side of Barataria Bayou and as it overflowed its banks many residential and commercial properties were inundated by the surge.

Figure 1.4 Inner Harbor Surge Barriers Closed During Hurricane Isaac

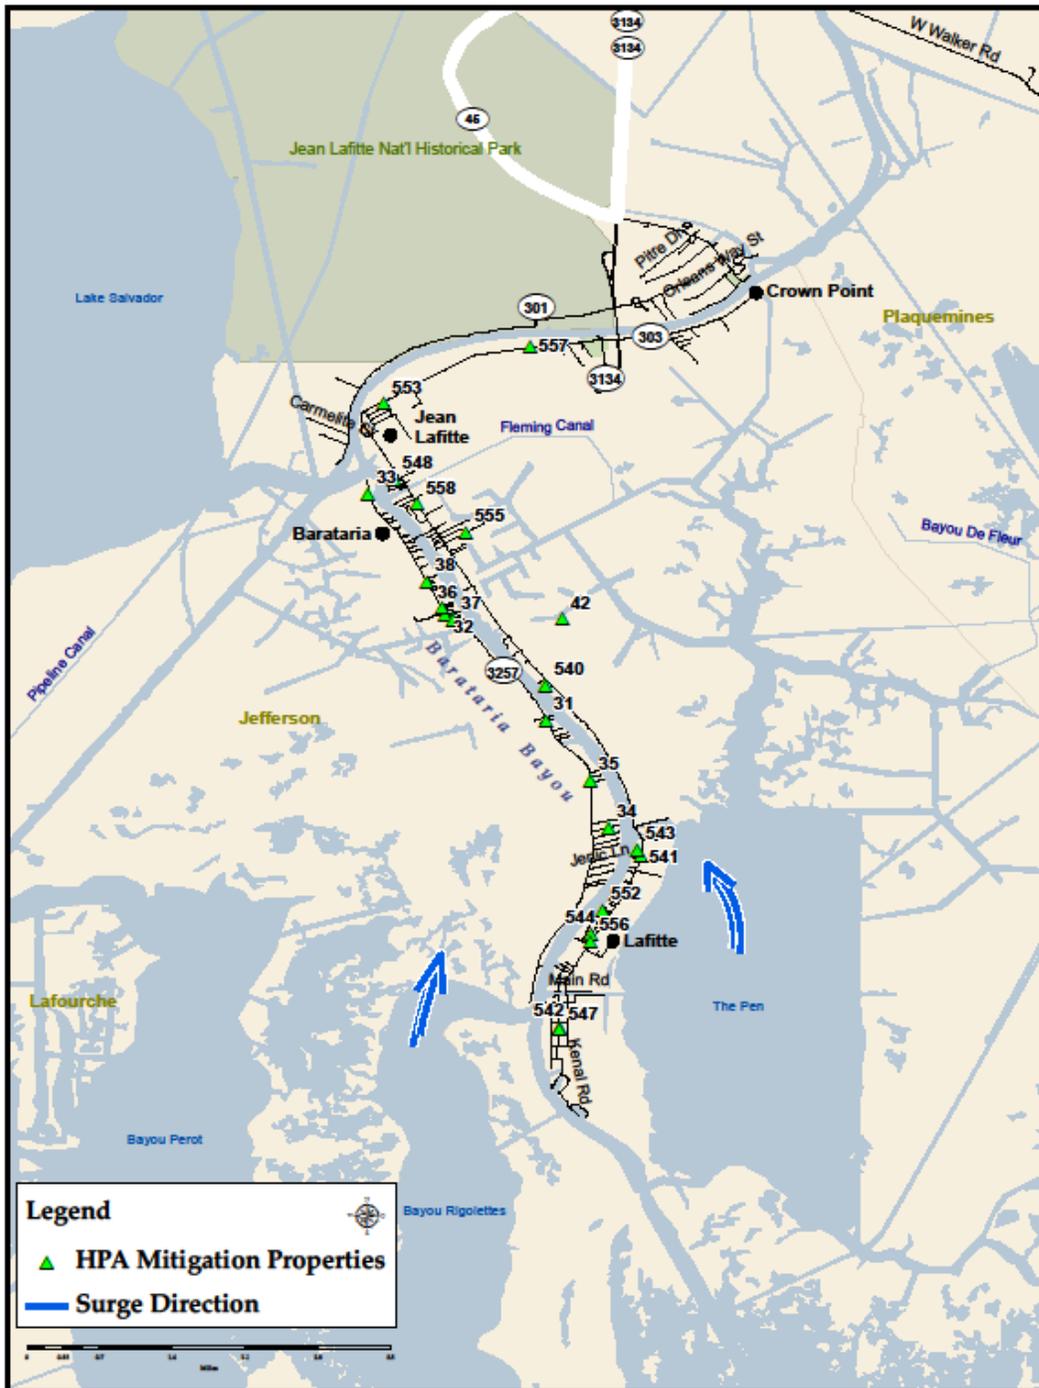
Figure 1.5 West Bank of Jefferson Parish along Barataria Bayou. Selected Mitigation Properties are shown in green.

The major areas affected by the high storm surge levels were the towns of Lafitte, Barataria, Jean Lafitte, and Crown Point. These communities experienced similar flooding during Hurricane Katrina and many property owners decided to elevate their homes post-Katrina (see Figure 1.5). Homes along Barataria Bayou that had been elevated were not flooded during Hurricane Isaac; but most non-elevated homes were inundated and many severely damaged. Most of the homes that had been elevated post-Katrina used Federal funds from the FEMA Hazard Mitigation Grant Program (HMGP). This report will document the performance of these properties during a major storm surge flooding event.

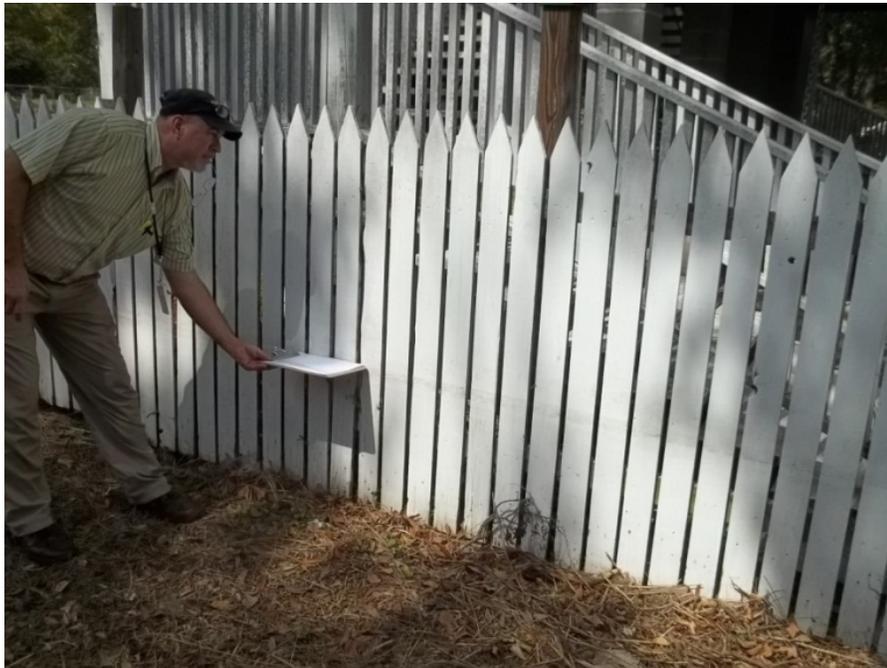
Figure 3.1 LAS Team Member Locating High Water Marks (HWMs)

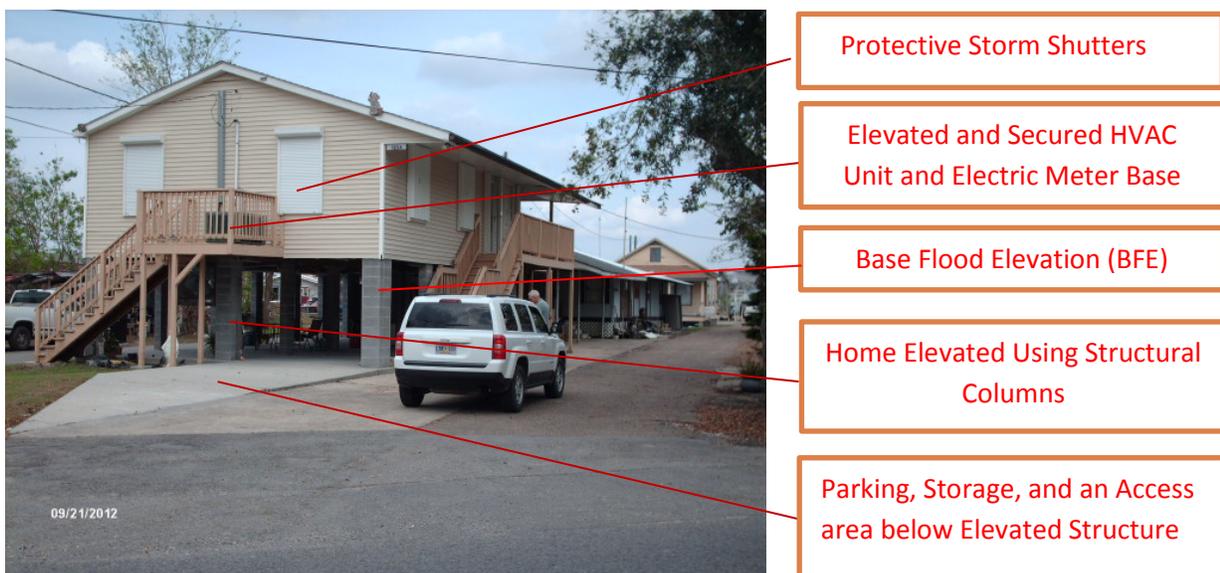
The home in Figure 3.2 represents a FEMA “Best Practices” approach to hazard mitigation. The critical consideration is to get the home above the base flood elevation (BFE), and preferably one foot or more higher than the BFE- this additional elevation above the BFE is known as “freeboard”. The home has 2.7’ of freeboard which represents an excellent “best practices” scenario.

Figure 3.2 Typical Elevated Structure in Jefferson Parish

The home in figure 3.2 (previous page) has concrete filled CMU block columns. The concrete block columns must be tied together with concrete foundation beams below elevation grade,

In addition to this extra freeboard, the homeowners installed high wind rated storm shutters on all windows. Hurricane Isaac did not exceed design wind speed levels (which are 100 mph or more in coastal areas). However, storm shutters also provide excellent protection from wind-borne debris during high wind events. Broken windows expose the home to wind-driven rain and debris potentially causing additional damages.

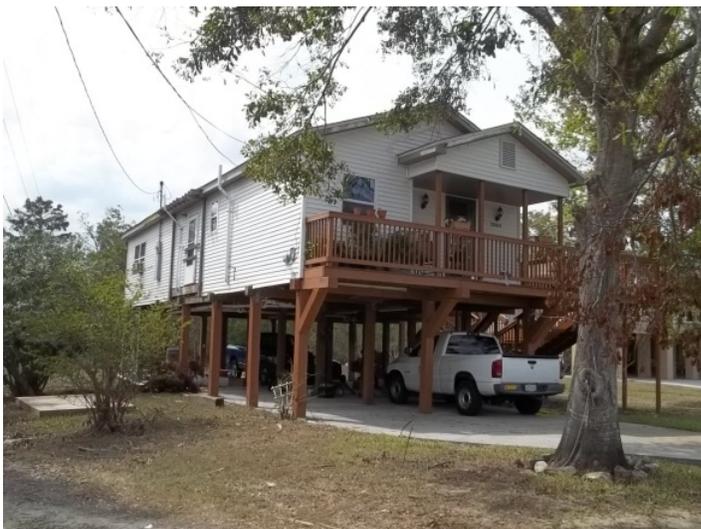
The home in figure 3.4 was elevated using pressure treated wooden piles driven into the earth

Figure 3.4 Elevated Home with Pressure Treated Driven Piles

and tied together with grade beams. If the driven piles do not have cross bracing they must be connected together below grade using a concrete and steel reinforced grade beam. This is required to prevent lateral forces upon the piles from high winds, fast moving storm surge waters or wave action upon the pilings. Properly engineered and installed, the pile driven foundation meets IBC code requirements for Coastal Areas (see *FEMA 550 Recommended Residential Construction for Coastal Areas*).

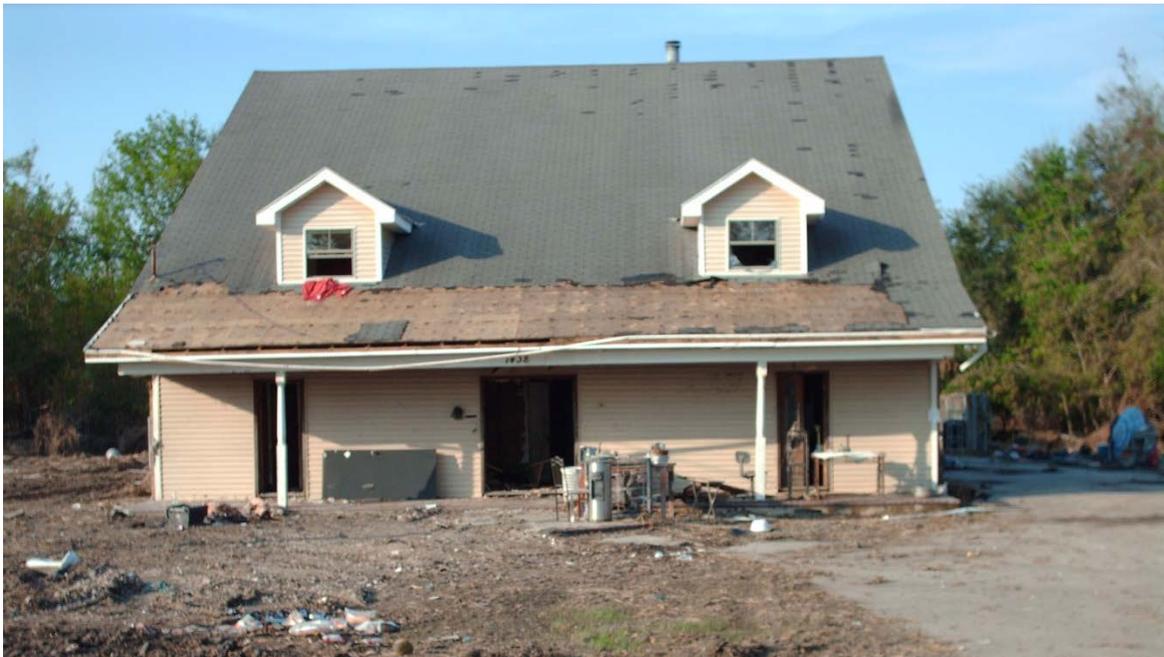
Figure 4.1 Non Elevated Home – Totally Inundated by Hurricane Isaac Storm Surge

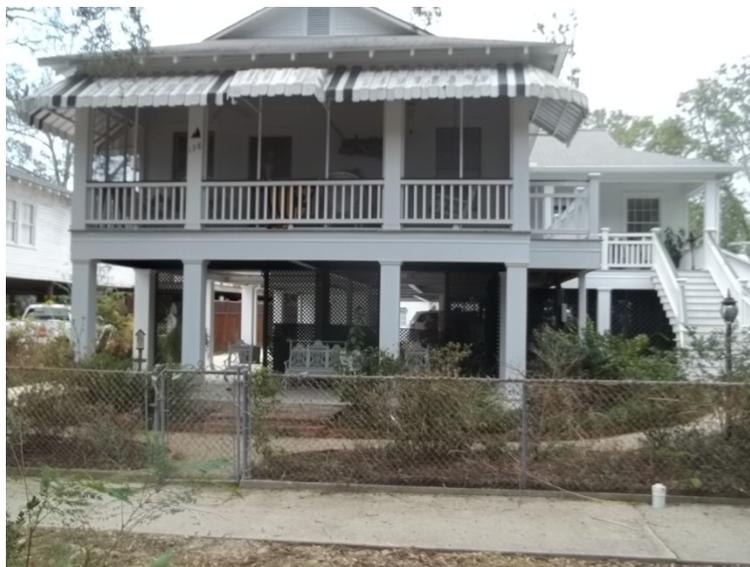
Figure A.1 Elevated Home. Fence Covered in Flood Debris from Isaac.

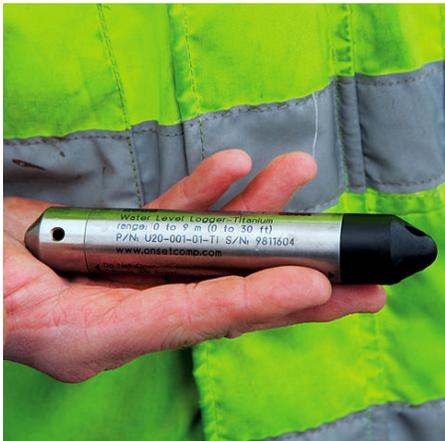
Figure B.1 Typical Sensor Used by USGS Hydrologists

Three data sources were used to collect high water marks (HWMs). The HPA team collected **field data**, wherever possible using debris lines and water stain lines. This requires early deployment to the field as HWMs are perishable data often lost after several rains or as a result of community cleanup efforts or even homeowner pressure washing of the debris and stain lines.

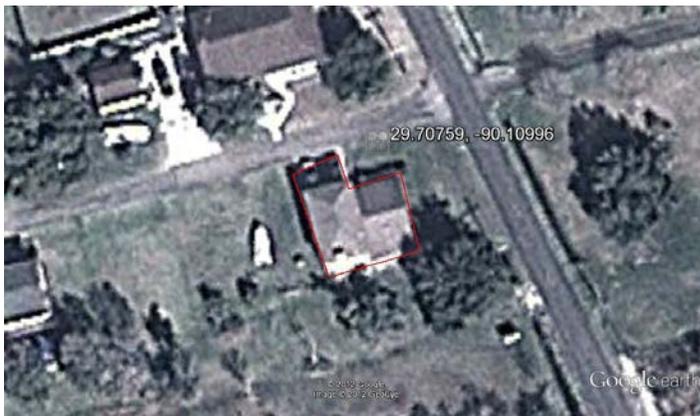
In some cases, field measurements were required to get actual perimeter measurements of the property. This was the most accurate method, but also the most time consuming. When documented data was available, the official square footage numbers were utilized. Team observations indicated that the Google Earth calculations had an approximate 20% error factor.

Figure B.2 Google Earth Aerial Measurements

The square footage of the residence was another critical piece of data needed. For determined data gaps a work-around strategy was developed by calculating square footages using **Google Earth Pro**. This was accomplished by locating the property with lat/long coordinates, securing a view directly overhead, using the Google Earth ruler/polygon tool and outlining the roof. Once the outline is complete, Google Earth provides the perimeter measurements and the area measurements. Subtract the roof overhang by subtracting the perimeter measurement from the area measurement to estimate square footage measurements. The limitations of this method are accuracy and availability when trees blocked the overhead view.
