# Loss Avoidance Study

St. Tammany Parish, Louisiana

Hurricane Isaac, 2012

DR-4080-LA

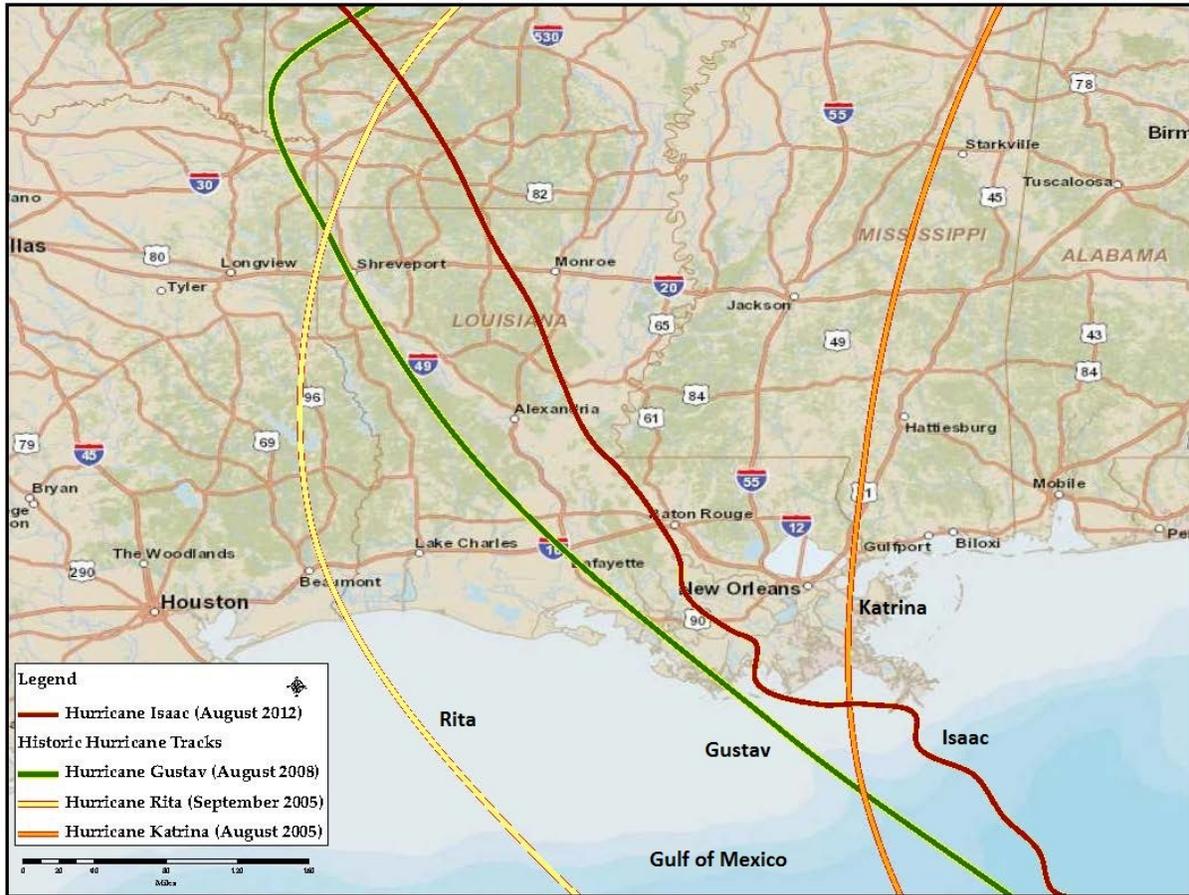
Figure 1.1 Historic Hurricane Storm Tracks

Southeast Louisiana, no stranger to destructive hurricanes, has been hammered repeatedly over the years. In 1969 Hurricane Camille pounded the southern coast as a Category 5, Katrina (Category 3) in August 2005, then Rita (Category 3) the next month in September 2005, Gustav (Category 2) in August 2008, and finally, Isaac in August 2012 (see Figure 1.1).

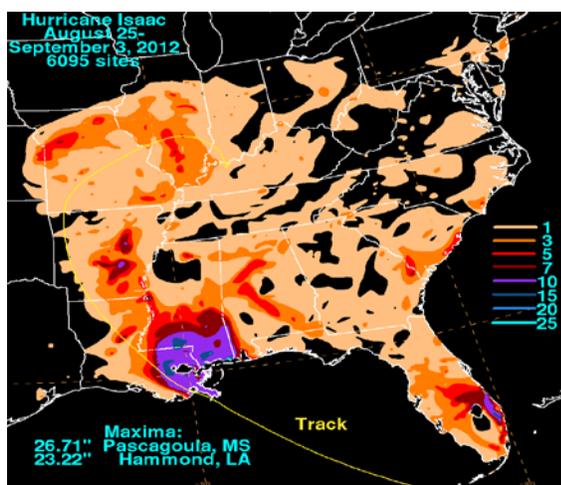
Figure 1.2 Average Rainfall 10”-15” in SE Louisiana from August 25- September 3, 2012 (NWS)

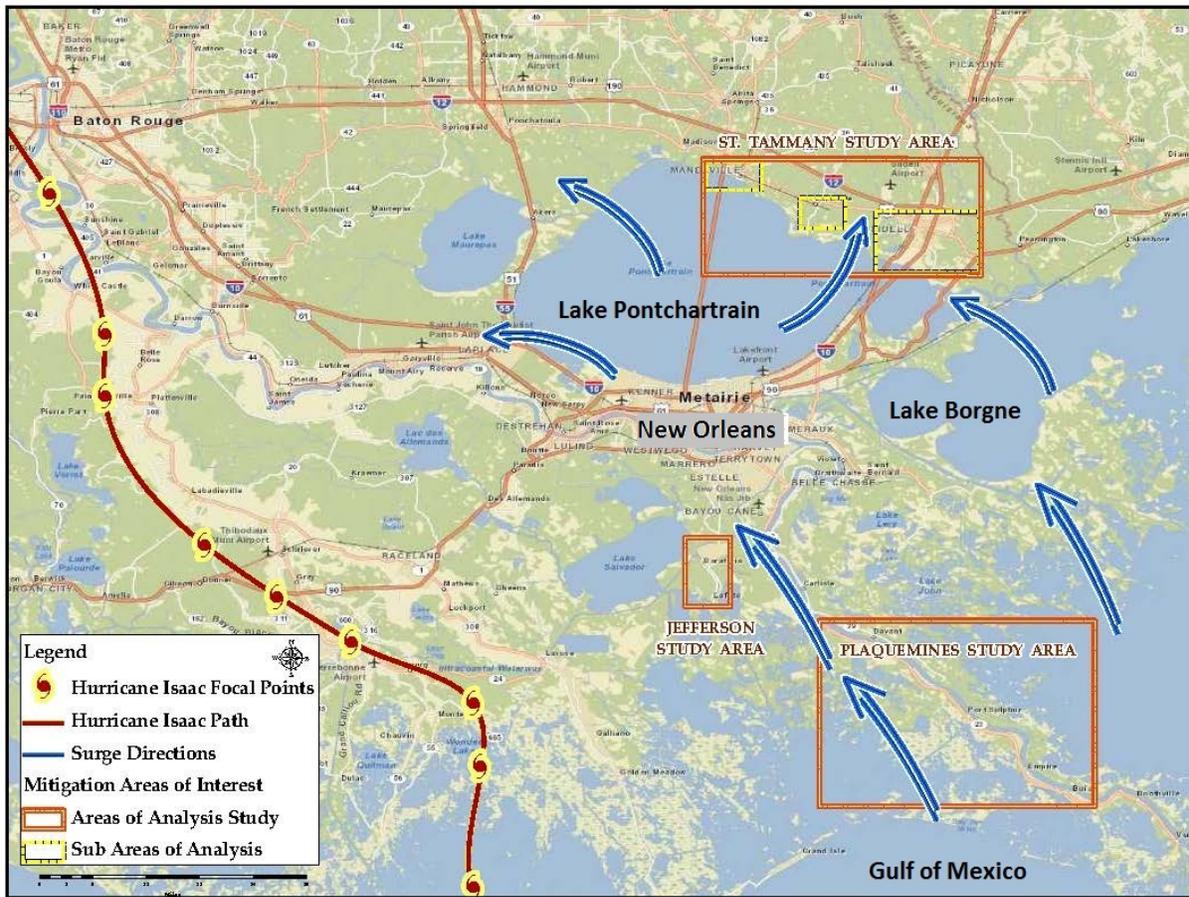
**Figure 1.3 Hurricane Isaac Path and Storm Surge- St. Tammany Study Area in Upper Box**

The storm path as pictured above should be understood to represent the general path but not the scope of the storm. As a very broad storm, all of the areas around it and especially in the upper right quadrant such as Jefferson Parish, Plaquemines Parish and the north and west shore of Lake Pontchartrain all suffered extreme storm surge (see arrows in Figure 1.3).

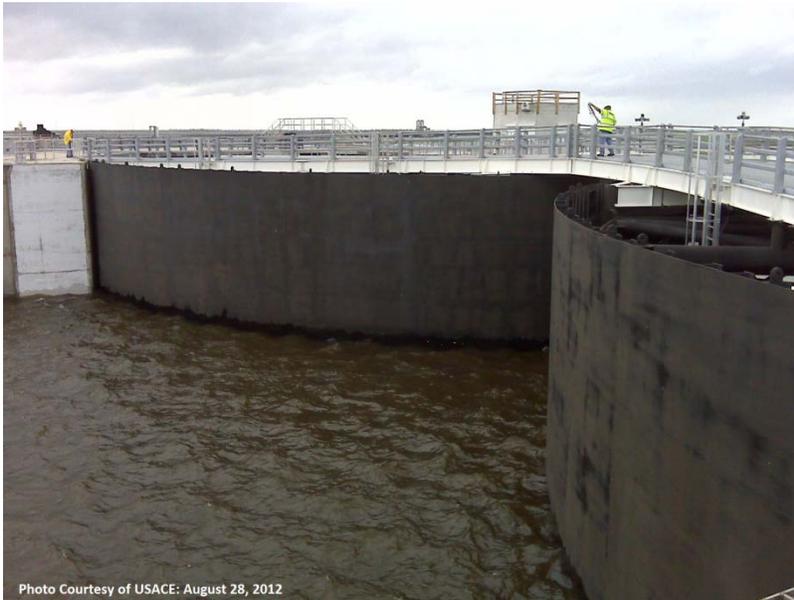
**Figure 1.4 Inner Harbor Surge Barrier Closed During Hurricane Isaac**

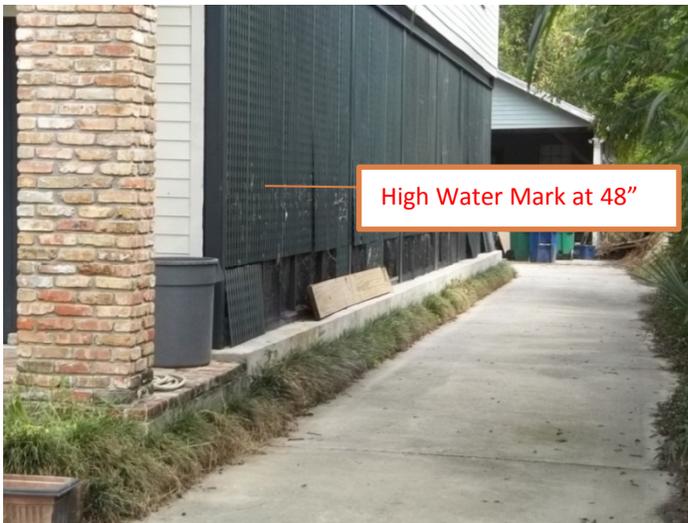
Figure 3.1 High Water Mark (HWM) on Residence in Mandeville, LA

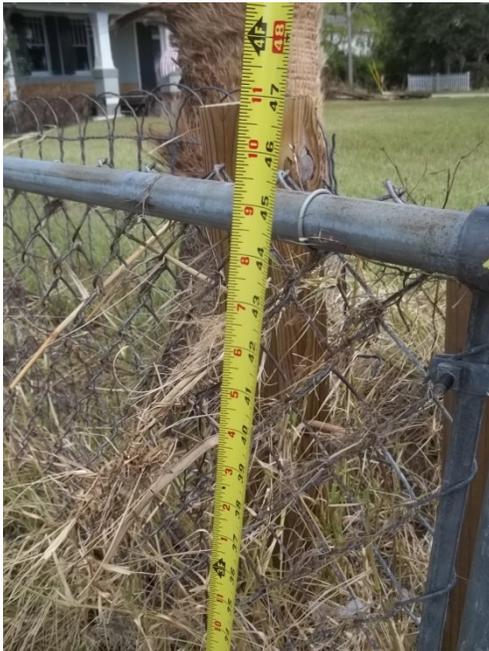
**Figure 3.2 HWM Data Collection**

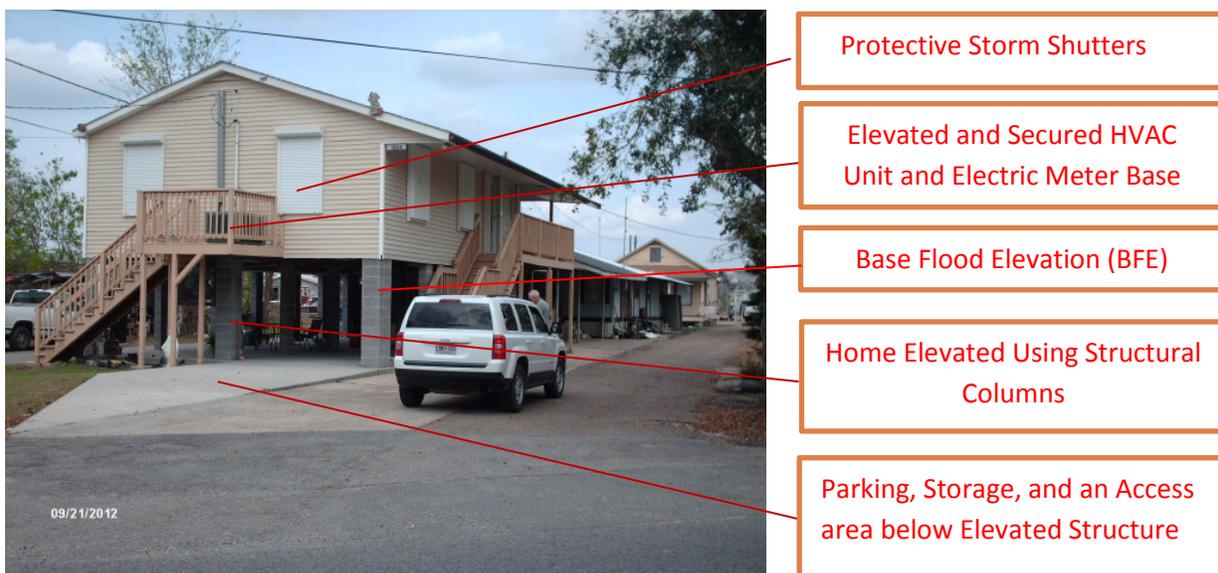
Figure 3.3 Typical Elevated Structure

The home in Figure 3.3 represents a FEMA “Best Practices” approach to hazard mitigation. The critical consideration is to get the home above the base flood elevation (BFE), and preferably one foot or more higher than the BFE- this additional elevation above the BFE is known as “freeboard”. The home has 2.7’ of freeboard which represents an excellent “best practices” scenario.

In addition to this extra freeboard, the homeowners installed high wind rated storm shutters on all windows. Hurricane Isaac did not exceed design wind speed levels (which are 100 mph or more in coastal areas). However, storm shutters also provide excellent protection from wind-borne debris during high wind events. Broken windows expose the home to wind-driven rain and debris potentially causing additional damages.

The home in Figure 3.3 (previous page) has concrete filled CMU block columns. The concrete block columns must be tied together with concrete foundation beams below elevation grade,

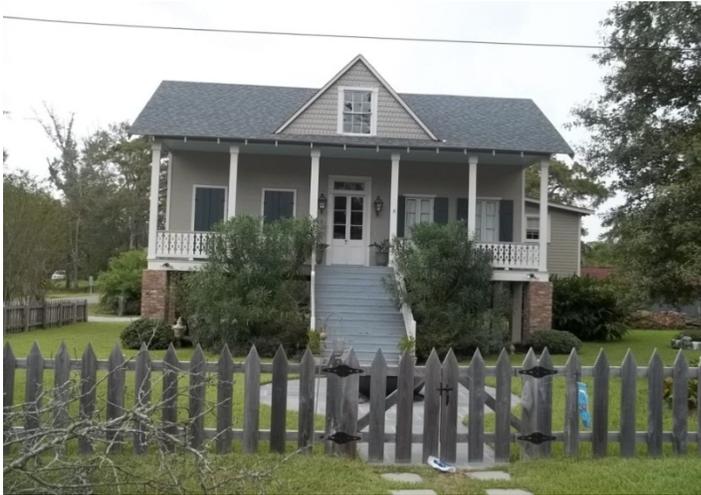
Figure 3.4 Elevated Home with CMU Columns faced with Brick

and a 4 inch slab. The entire system is connected with steel 5/8" reinforcing bars in the beams below the grade and turned up into the block columns. The columns usually have 4 steel vertical bars and the entire block column poured with concrete and tie connects to the main structure. Again, the system must be properly engineered and built to code specifications as adopted by the local jurisdiction. One advantage of the concrete block system is that the columns can be "faced" with decorative brick for a very attractive appearance (see Figure 3.4).

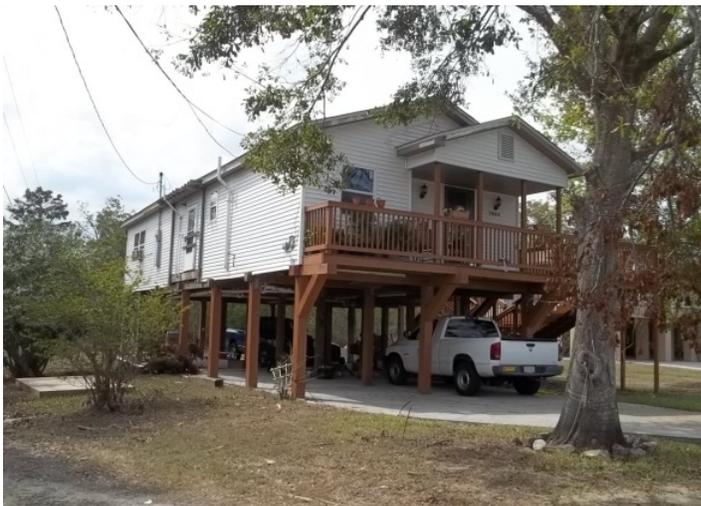
Figure 3.5 Elevated Home with Pressure Treated Driven Piles

The home in Figure 3.5 was elevated using pressure treated wooden piles driven into the earth and tied together with grade beams. If the driven piles do not have cross bracing they must be

connected together below grade using a concrete and steel reinforced grade beam. This is required to prevent lateral forces upon the piles from high winds, fast moving storm surge waters or wave action upon the pilings. Properly engineered and installed, the pile driven foundation meets IBC code requirements for Coastal Areas (see *FEMA 550 Recommended Residential Construction for Coastal Areas*).

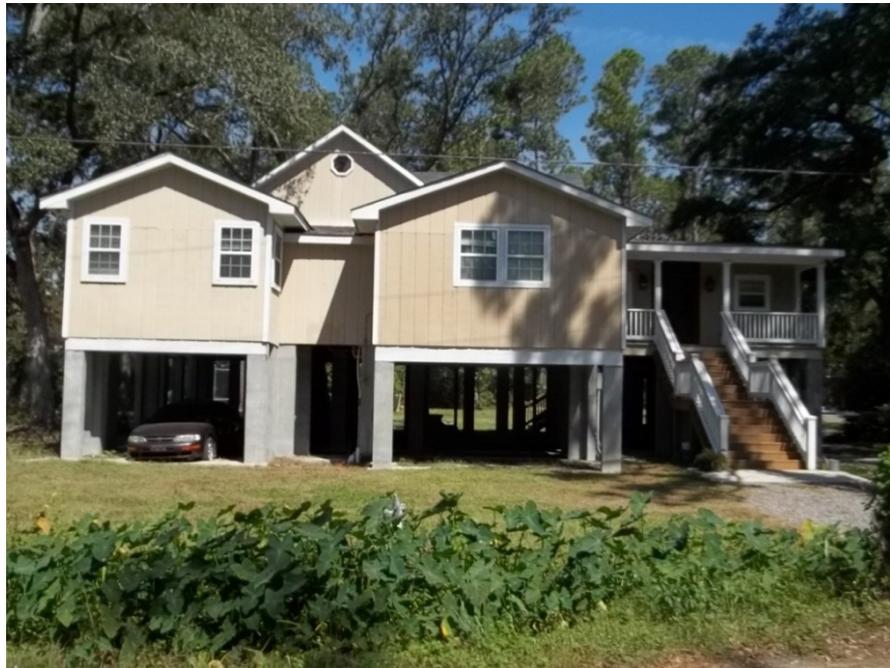
**Figure 5.1 Elevated Property in Slidell, LA**

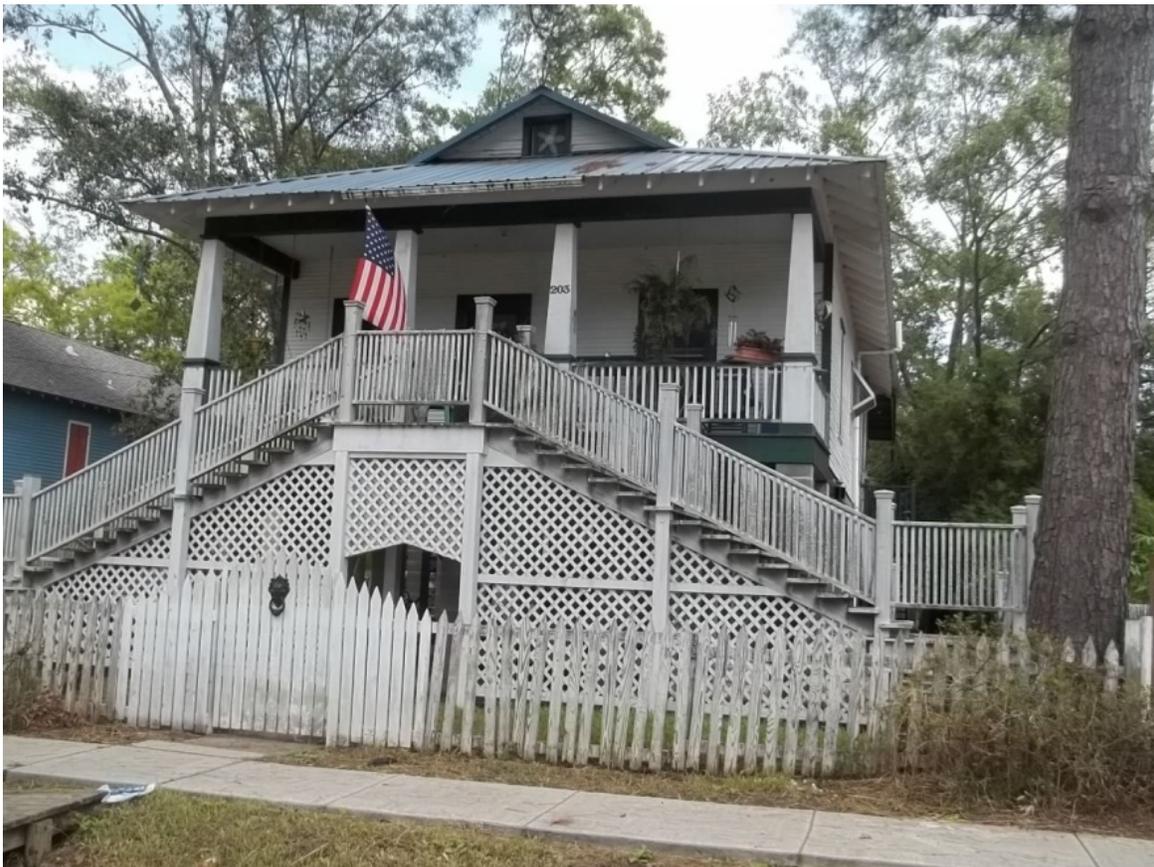
**Figure 5.1 Historic Home in Mandeville- Elevated above the BFE**

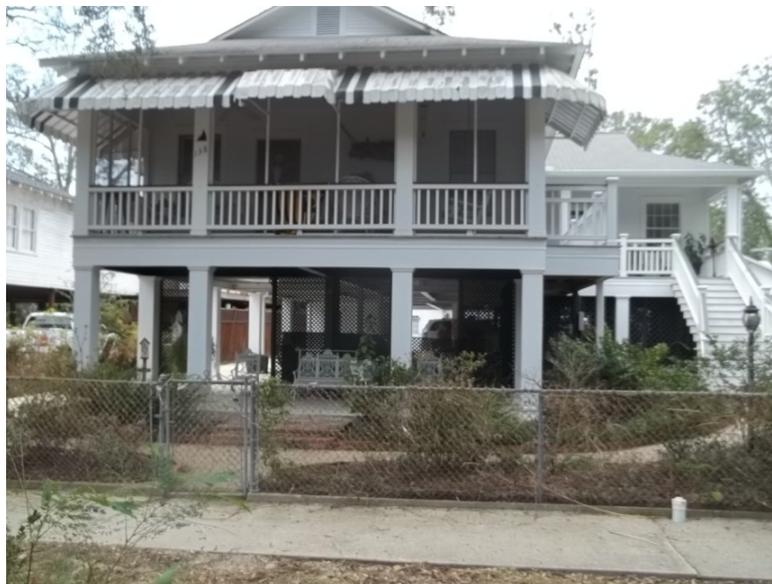
**Figure A.1 Elevated Home. Fence Covered in Flood Debris from Isaac.**

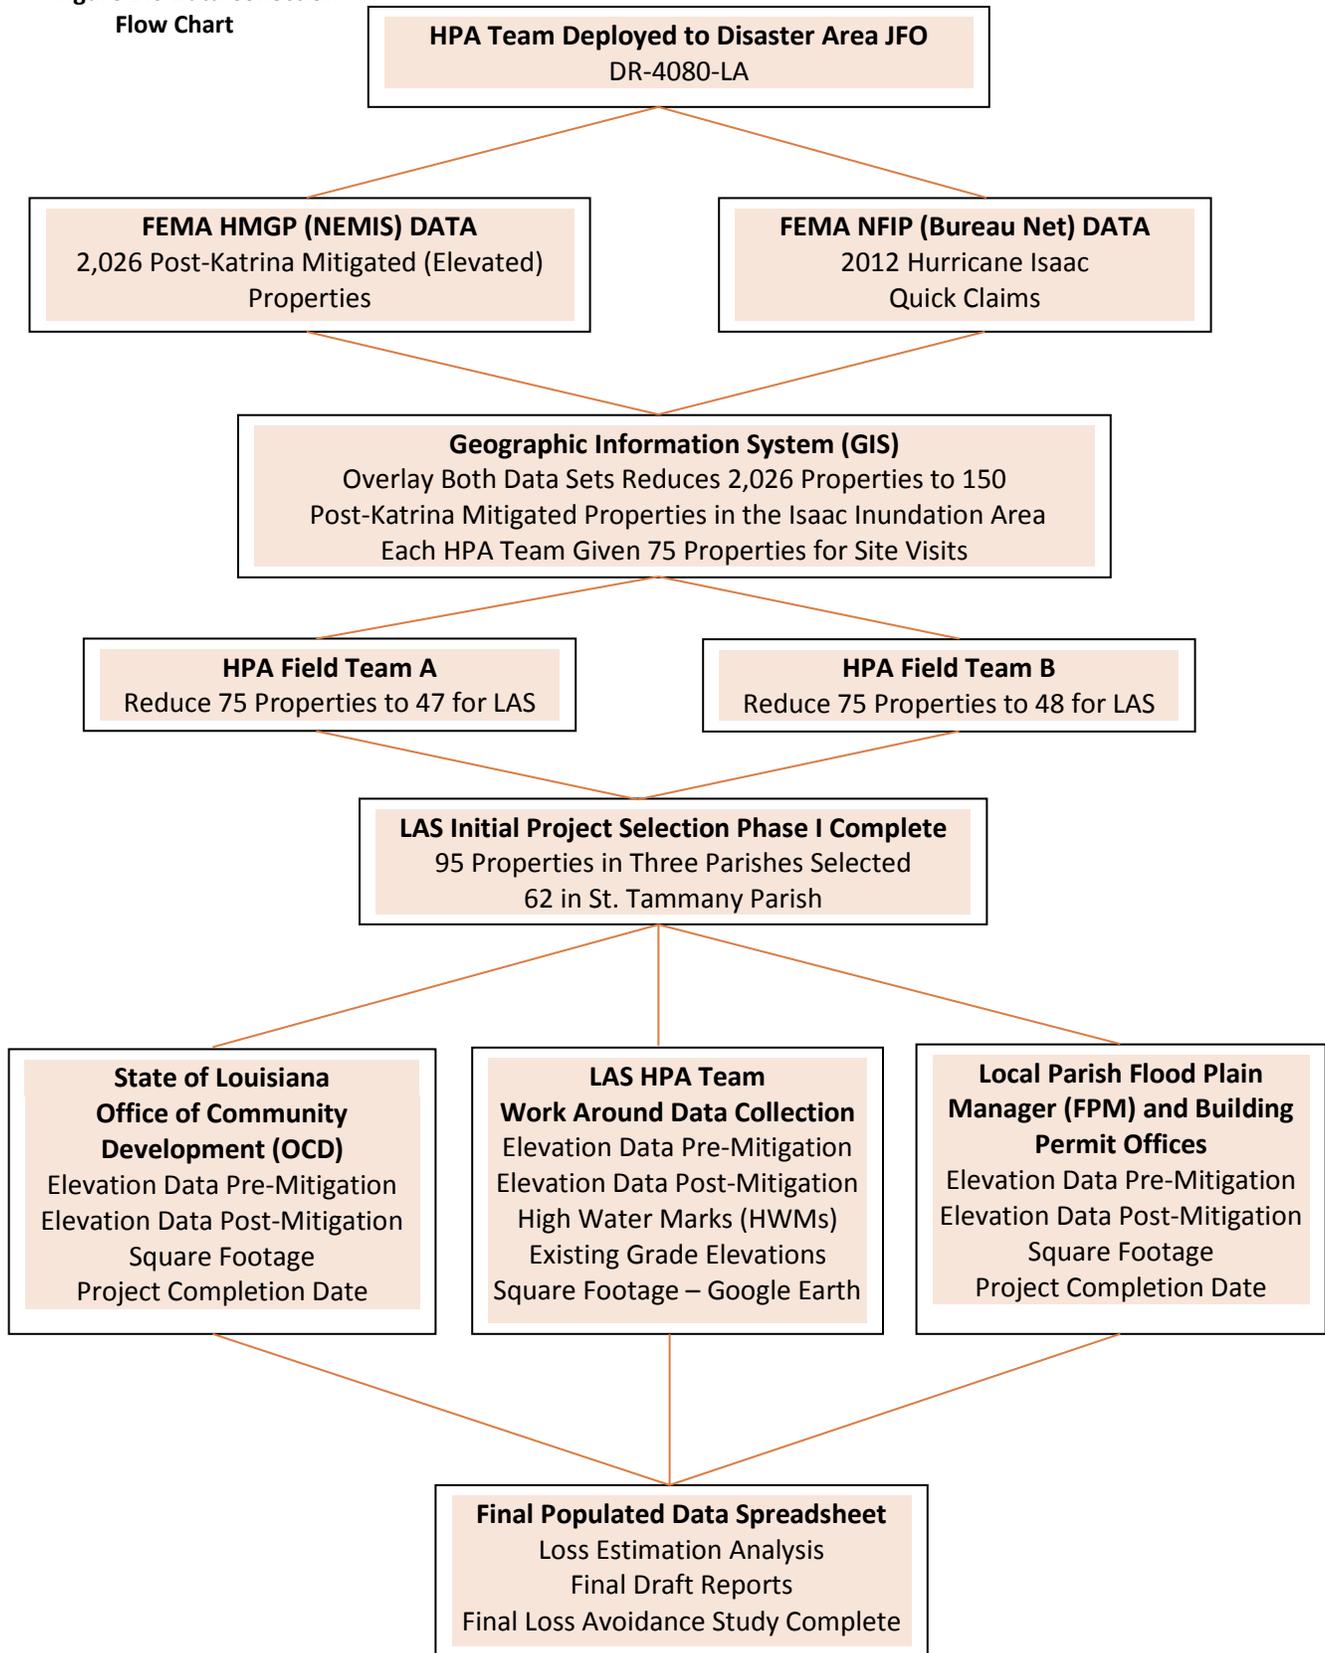
**Figure B.0 Data Collection  
Flow Chart**

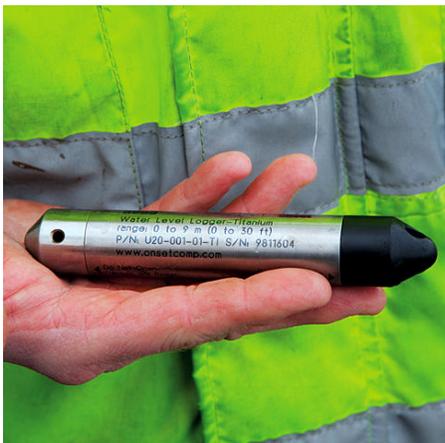
Figure B.1 Typical Sensor Used by USGS Hydrologists

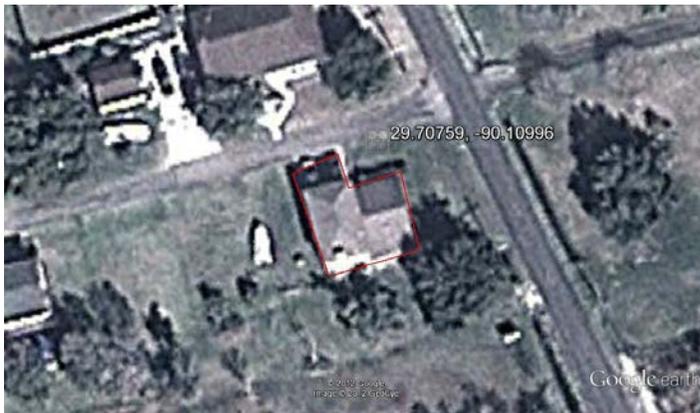
Figure B.2 Google Earth Aerial Measurements

In some cases, field measurements were required to get actual perimeter measurements of the property. This was the most accurate method, but also the most time consuming. When documented data was available, the official square footage numbers were utilized. Team observations indicated that the Google Earth calculations had an approximate 20% error factor.
