Owego Elementary School Facility Relocation Project

Phase I Environmental Site Assessment

Tax Map No. 493001-117.15-2-13
Owego Elementary School & Play Fields
1 Christa McAuliffe Drive
Tax Map No. 493001-117.15-2-3
Undeveloped Southeast Corner
Village of Owego
Tioga County, New York

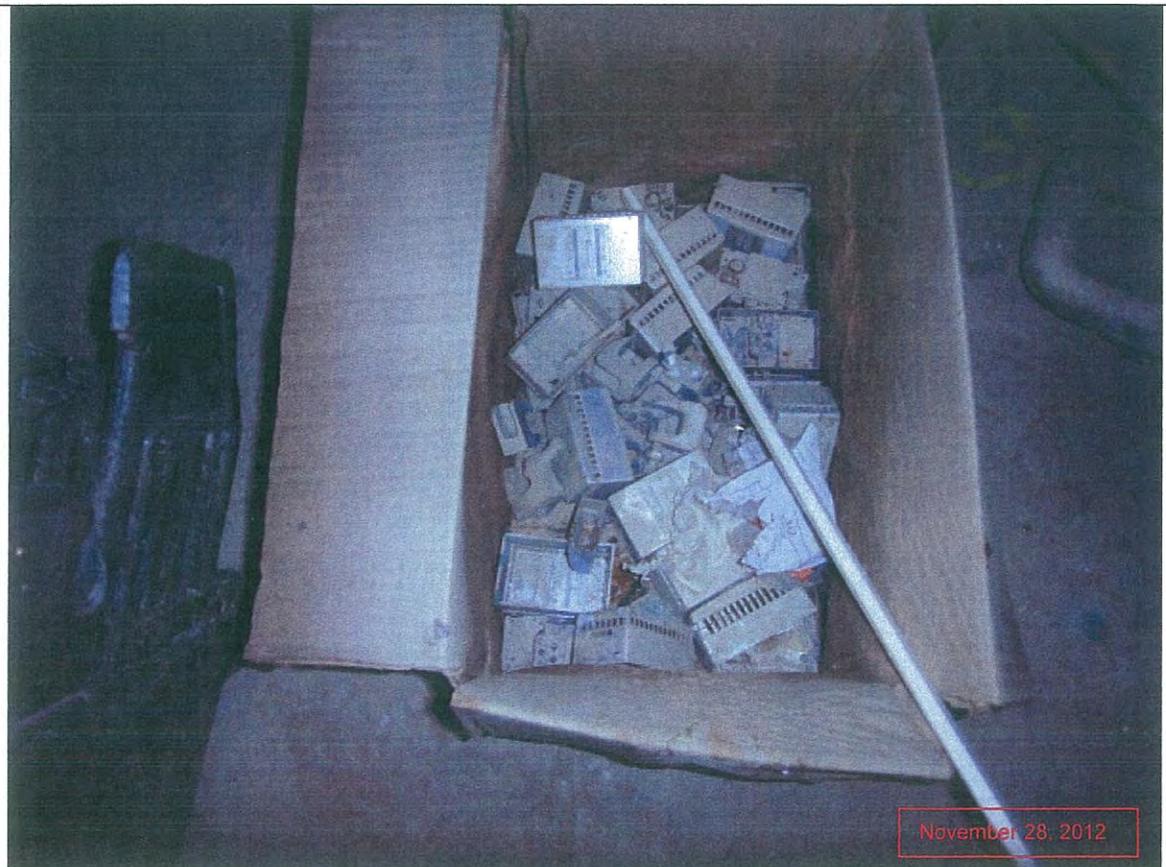
- **Mercury**
A visual inspection for potential mercury use or storage was completed. A box containing removed thermostats and fluorescent bulb lighting fixtures were identified in the boiler room of the school during the site inspection. The mercury content of the thermostats and fluorescent bulbs is unknown at present. We suggest further investigations be conducted to quantify the mercury content of the thermostats and fluorescent bulbs and that based upon that characterization this material should be removed and managed according to applicable regulatory requirements.

Owego Elementary School
Boiler Room: Suspected Mercury Containing Thermostats

the school during the site inspection. Fluorescent bulb lighting fixtures were identified during the site inspection. The mercury content of the thermostats and fluorescent bulbs is unknown at present. We therefore recommend that further investigations be conducted to quantify the mercury content of the thermostats and fluorescent bulbs and that based upon that characterization the material should be removed and managed according to applicable regulatory requirements.

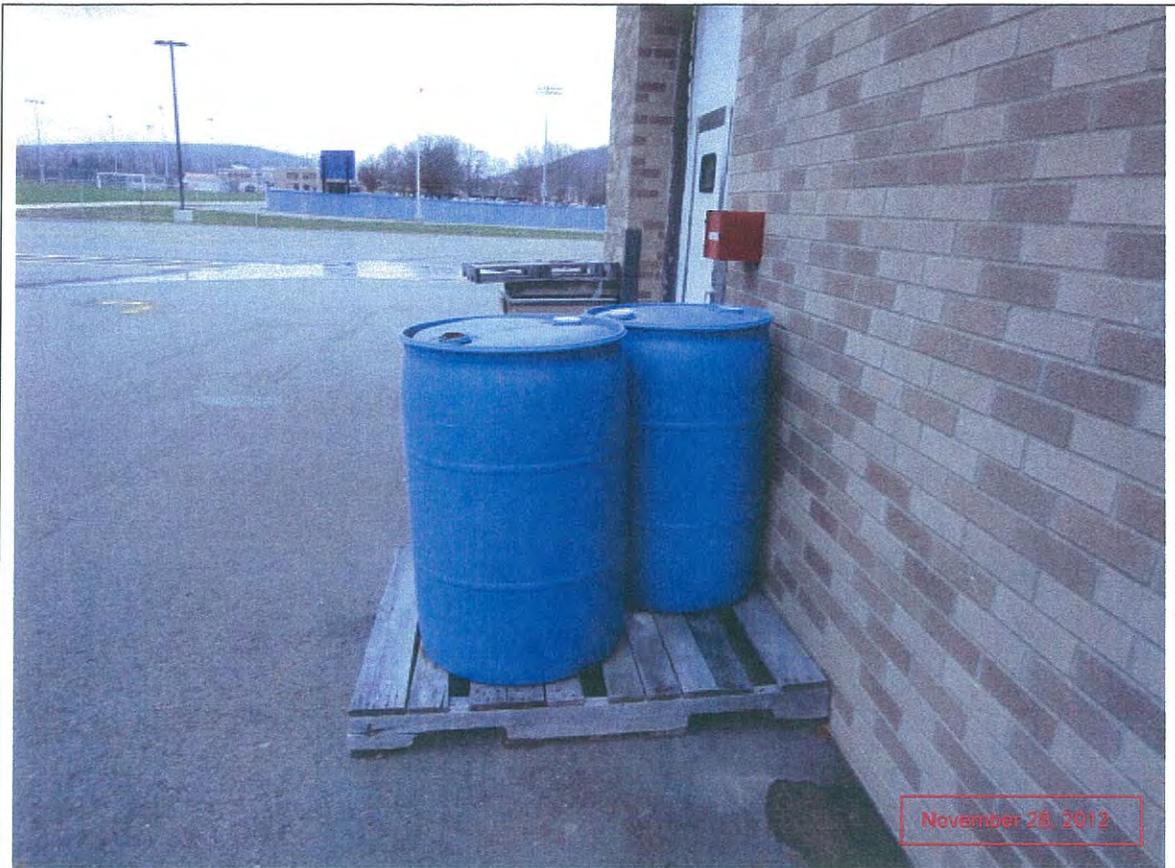
Unidentified substance containers were observed during the site inspection. There were two unlabeled, 55 gallon in size, plastic drum containers, situated on of a pallet, and exteriorly to the boiler room of the school. We therefore recommend that the contents of the drum be sampled to characterize the material and that based upon that characterization the material should be removed and managed according to applicable regulatory requirements.

List amount, contents, location, labeling, condition:
2- 55 gallon plastic drums, unknown contents, north exterior of boiler room, no labeling, good

Owego Elementary School
Unlabeled 55 Gallon Plastic Drums With Unknown Contents

- **Unidentified Substance Containers**
Unidentified substance containers were observed during the site inspection. There were two unlabeled, 55 gallon in size, plastic drum containers, situated on of a pallet, and exteriorly to the boiler room of the school. We therefore suggest that the continents of the drum be sampled to characterize the material and that based upon that characterization the material should be removed and managed according to applicable regulatory requirements.

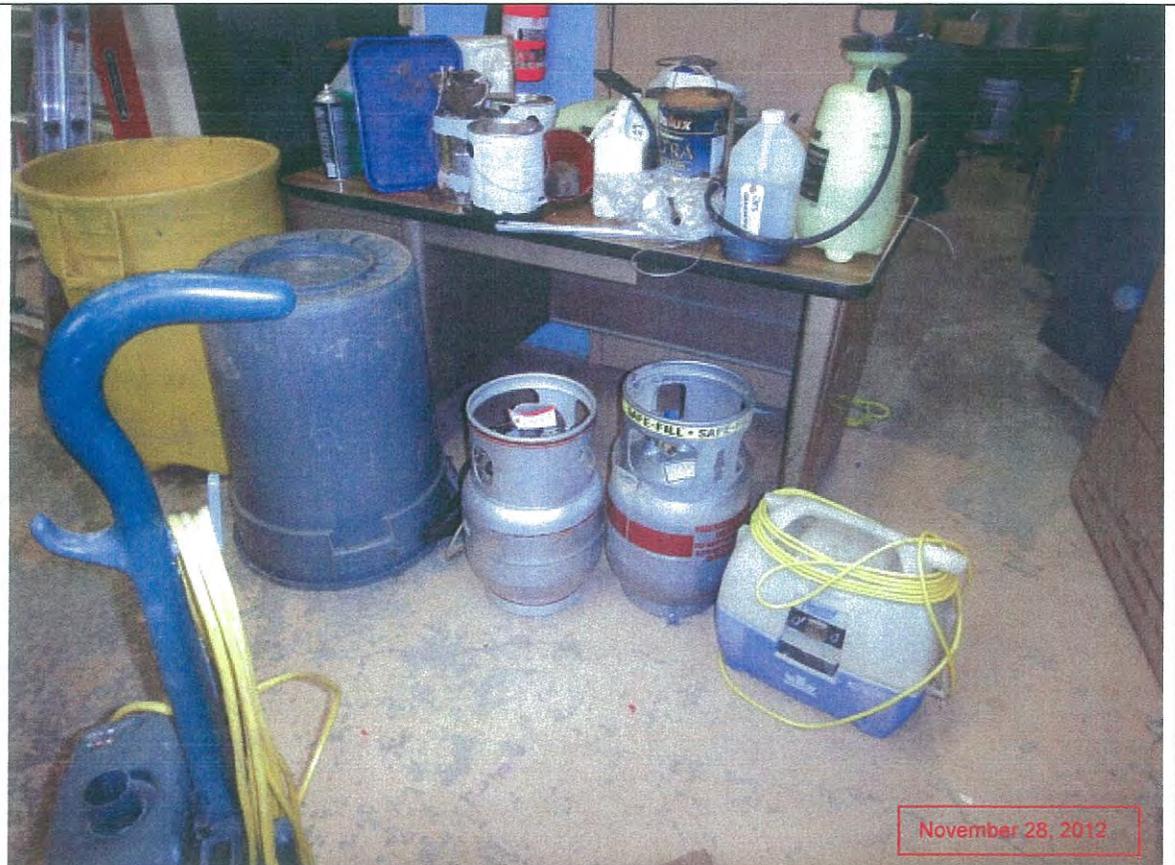
Hazardous substances and petroleum products were identified onsite during the inspection and situated in the boiler room and the maintenance office of the school. These consist of small amounts of Alkaline Caustic Liquid (boiler water descaler), OES Generator Oil, Air Compressor Oil, 50/50 Mix Antifreeze, Acetone, Enamel Paint Spray Cans, PVC Cement/Cleaner, Paint Thinner, and Forklift Propane Cylinders. (See site photographs). We therefore recommend that the hazardous substances and petroleum products identified onsite during the inspection be removed and managed according to applicable regulatory requirements.

List Hazardous Materials, Amounts, Container Size, Storage Location, Condition:
Alkaline Caustic Liquid, 2 gallon, 3 gallon, Boiler Room, Fair
OES Generator Oil, 025 gallon, 1 gallon, Maintenance Office Table, Fair
Air Compressor Oil, 0.5 gallon, 1 gallon, Maintenance Office Table, Fair
50/50 Mix Antifreeze, 1 gallon, 1gallon, Maintenance Office Table, Fair
Propane, 2 fork-lift tanks, 33 lb., Maintenance Office Table, Good
Enamel Paint Spray Can, 6 cans, 11 ounce, Maintenance Office Flammable Locker, Good
Acetone, 1 can, 1 Quart, Maintenance Office Flammable Locker, Good
PVC Cement, 3 cans, 1 Pint, Maintenance Office Flammable Locker, Good
PVC Cleaner, 1 can, 1/2 Pint, Maintenance Office Flammable Locker, Good
Paint Thinner 1 can, 120 Fl. Oz., Maintenance Office Flammable Locker, Good

Owego Elementary School
Maintenance Office: Hazardous Material Storage

- **On-Site Hazardous Substances and Petroleum Products**
Hazardous substances and petroleum products were identified onsite during the inspection and situated in the boiler room and the maintenance office of the school. These consist of small amounts of Alkaline Caustic Liquid (boiler water
