## Only House Left Standing: Building Code Saves House

### Full Mitigation Best Practice Story

#### *Jackson County, Mississippi*

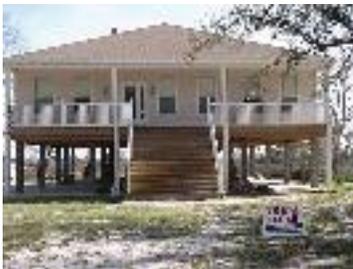
Robert and Sandra Harris' elevated house was the only one left standing on Wiggins Street after Hurricane Katrina hit.

The Harris' house was constructed using both pile and pier foundations. Pier foundations are located along the sides and center of the house, while pier foundations spread across the front and rear of the house. Both are reinforced with rebar for additional strength. The concrete piers are eight feet in height and rest on spread footings. The piles consist of 10-inch by 10-inch posts made of pressure-treated solid pine. They are embedded six feet into the ground and are continuous to the top of wall elevation. This method of construction provides greater strength by eliminating the need for joints or connections. By embedding the posts deep into the ground, the surrounding soil aids in the prevention of overturning. The piles and piers work

Connectivity is an important element of any building's construction. There is connectivity in the Harris' house from the foundation to the roof. The posts were connected to other structural components using the proper size galvanized bolts and hurricane straps. Hurricane straps can be used to connect the top of the wall to the roof as well as connect the bottom of the wall and flooring to the post. Harris credits the large posts and the connectivity method of construction for saving his house from serious hurricane damage.
