Cloverport Slope Stabilization

Full Mitigation Best Practice Story

Breckinridge County, Kentucky

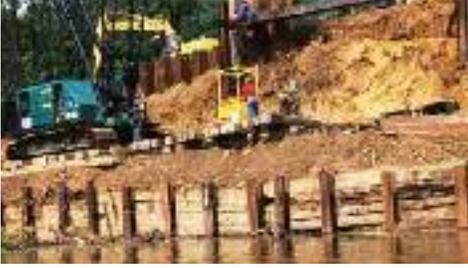
Cloverport slope stabilization.

The Creekview mitigation project was comprised of two phases. Phase I involved the testing and inspection of the slope in order to determine how to best proceed with Phase II. Phase I also included driving massive interlocking pilings into the side of the bank to ensure its stabilization. The second phase of the project included the construction of a 220-foot sheet pile wall in order to stabilize the slope, and re-grading the earth below the wall in order to create a flatter and more stable stream bank. Seventy-foot-long tiebacks were driven into the bank wall for more stability, and 600 tons of riprap was added to the channel lining between the new wall and the creek.
