# Construction in the Floodplain

Spring 2011 NMFS/FEMA  
Workshops  
DeeAnn Kirkpatrick

## 3 Case Studies

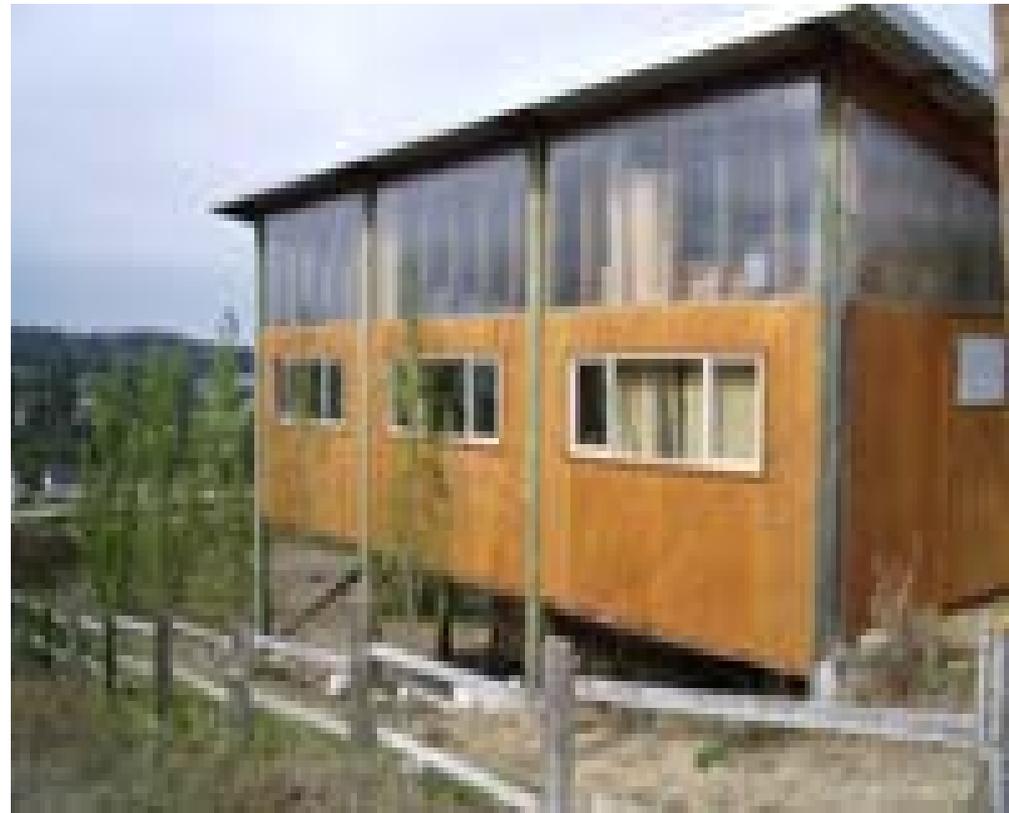
- Infrastructure - house, yard, driveway, patio, 2,700 ft<sup>2</sup>
- Pin construction
- Grading 700 ft<sup>2</sup>  
(driveway, patio)
- Clearing – 3000 ft<sup>2</sup>  
blackberry, alders  
grasses

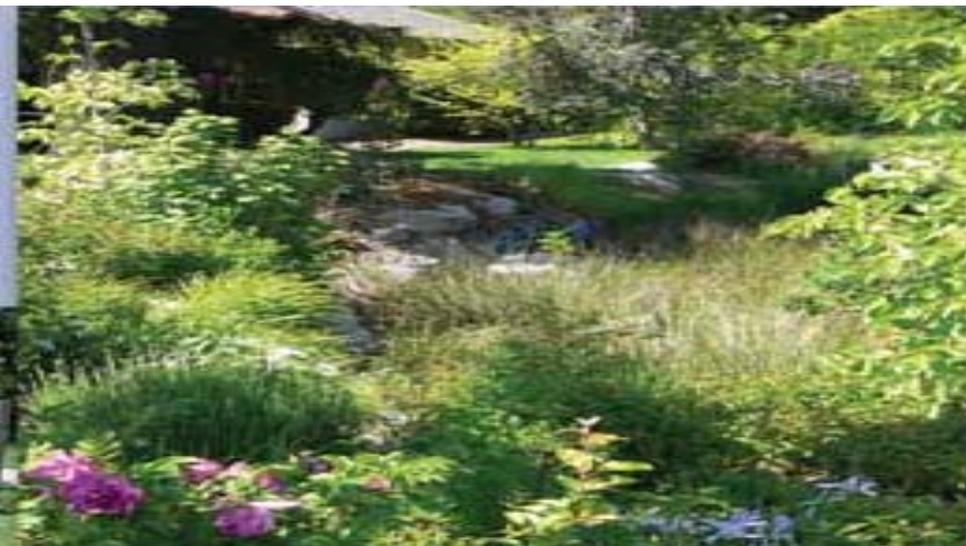
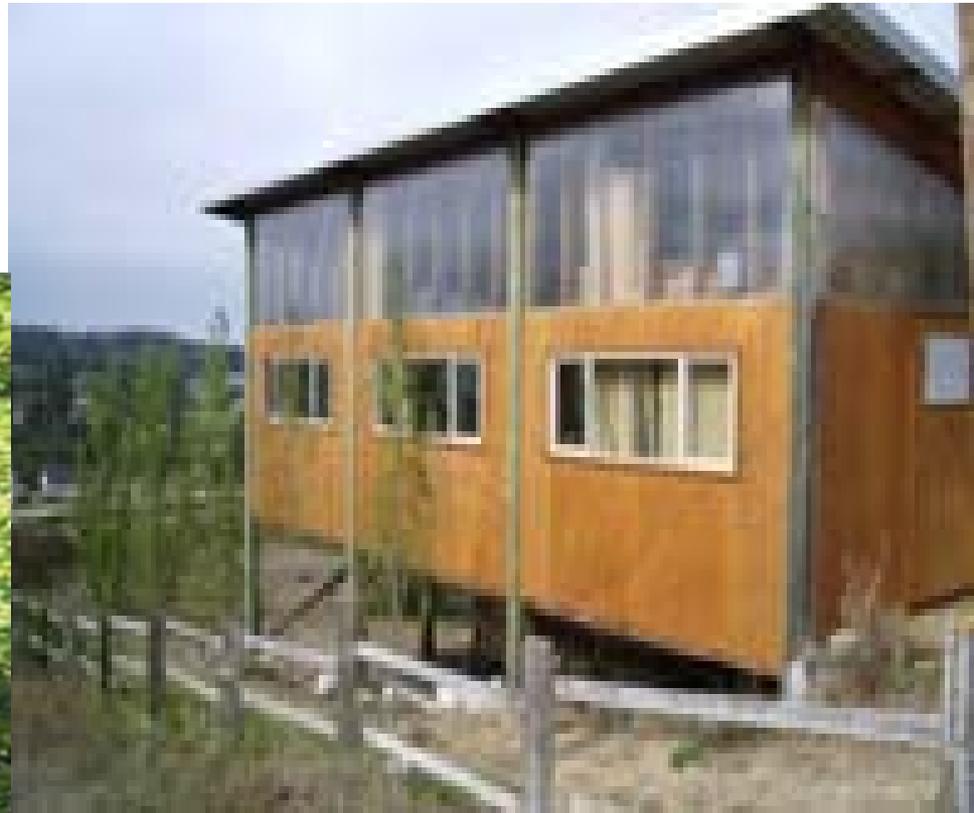
## Stormwater – LID

- Pin construction
- Rain Garden

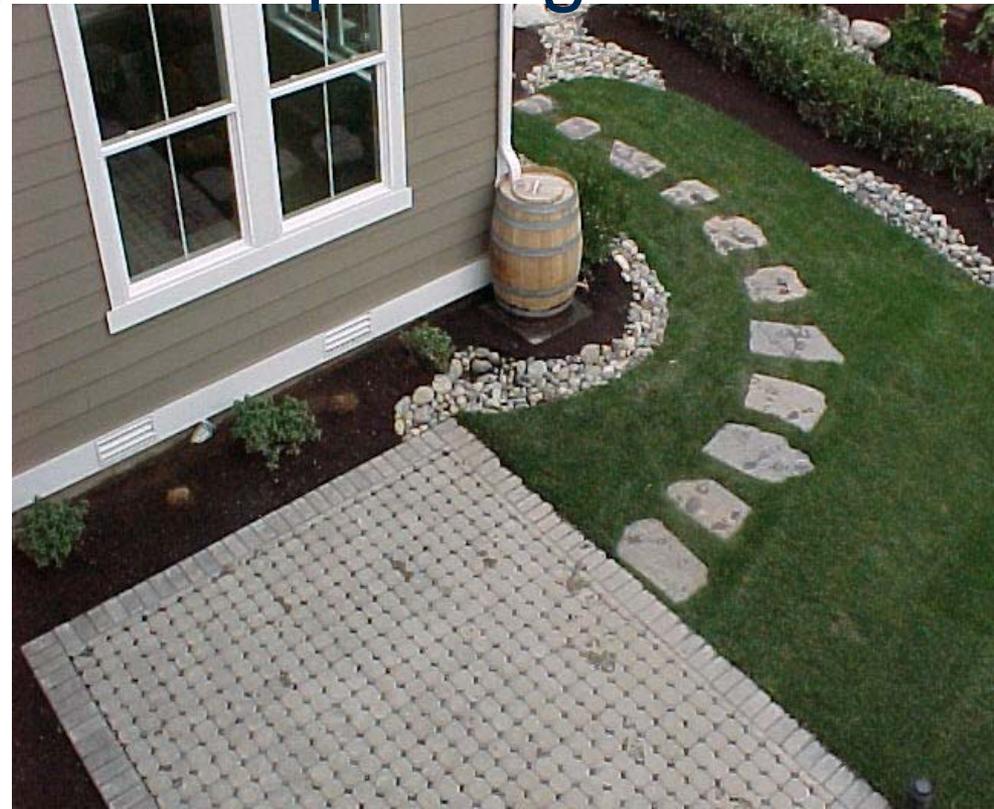
**Stormwater** - Collecting and dispersing roof-top runoff to rain

barrel and rain garden

Dispersing runoff from  
driveway and patio to  
porous pavers

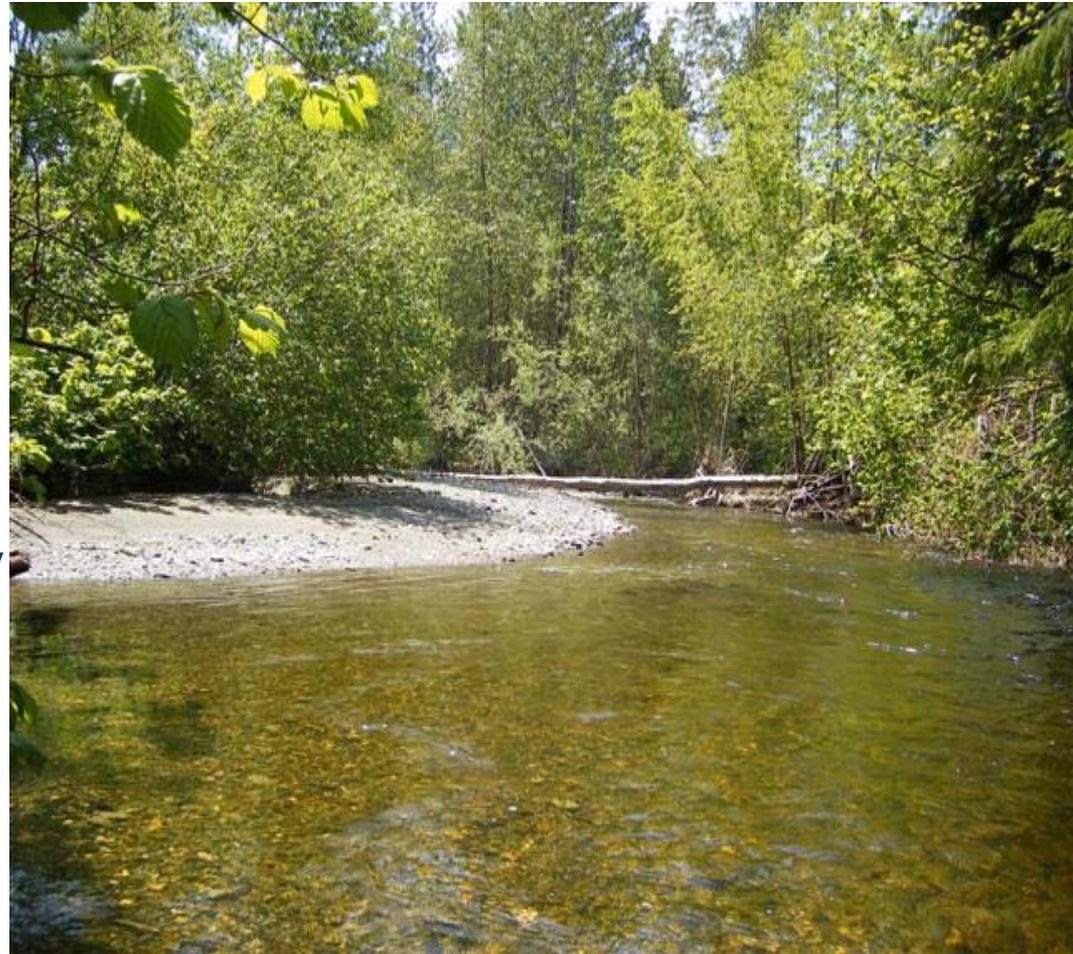
**Vegetation –**  
Replaced  
function by providing  
2x cleared area,  
Added plant diversity

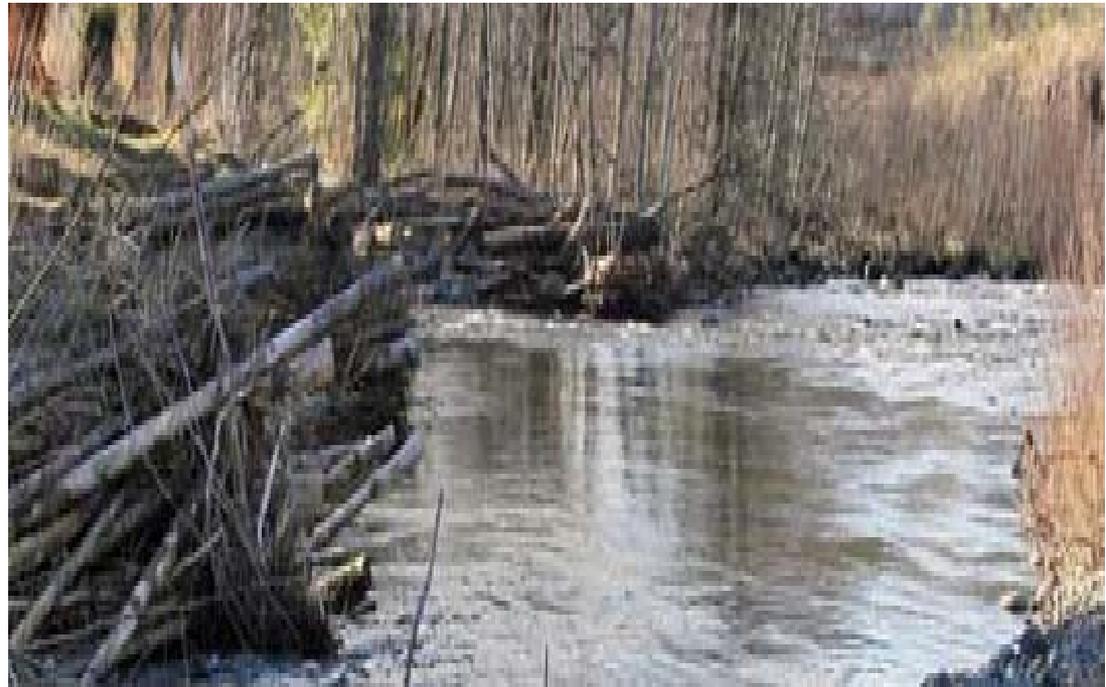
### **Bank Stability –**

No bank stabilization  
needed to protect  
house located  
away from river  
channel and  
direct flow path

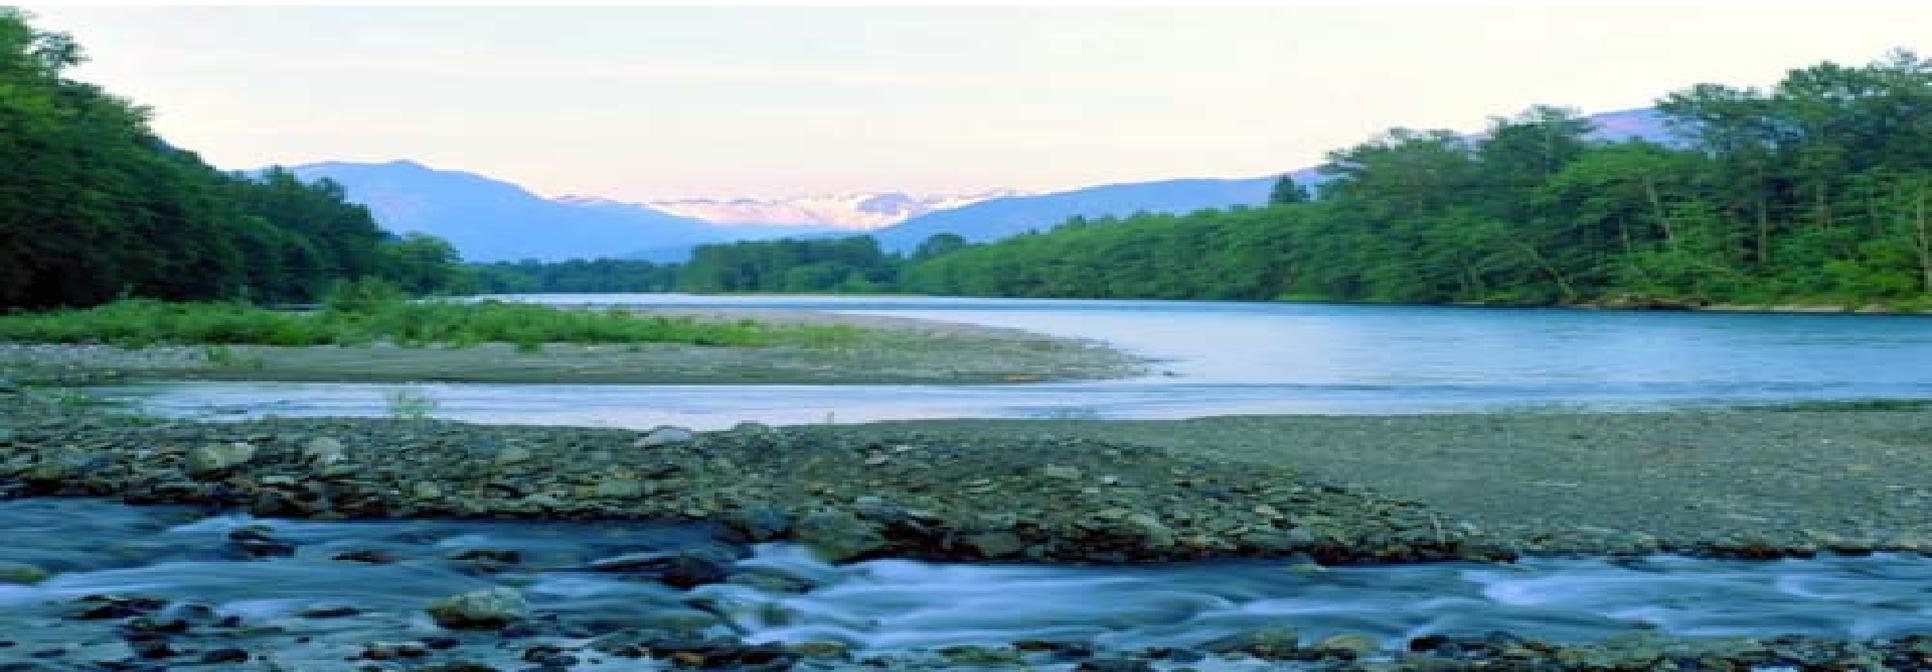
### **Channel Migration** – house sited outside of identified CMZ

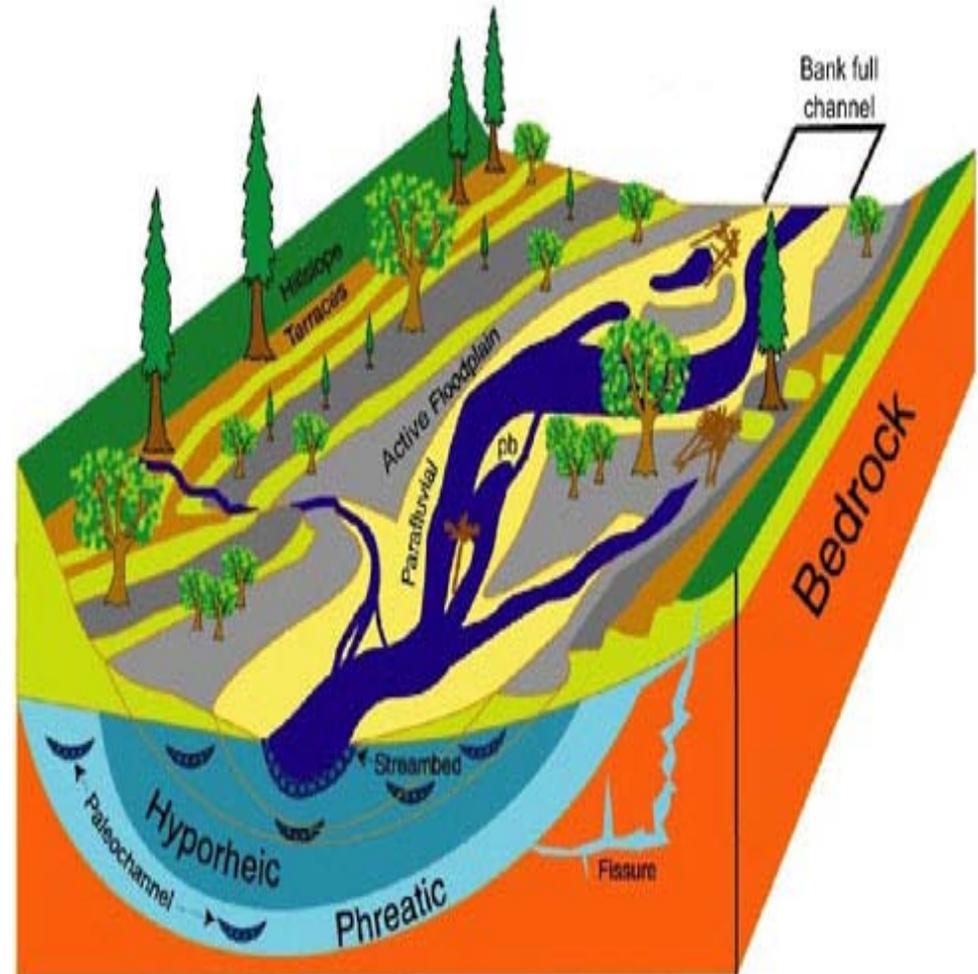
**Hyporheic Zone** –  
Surface, groundwater  
hyporheic zone flow  
exchange main-  
tained due to pin  
construction and sw  
infiltration measures

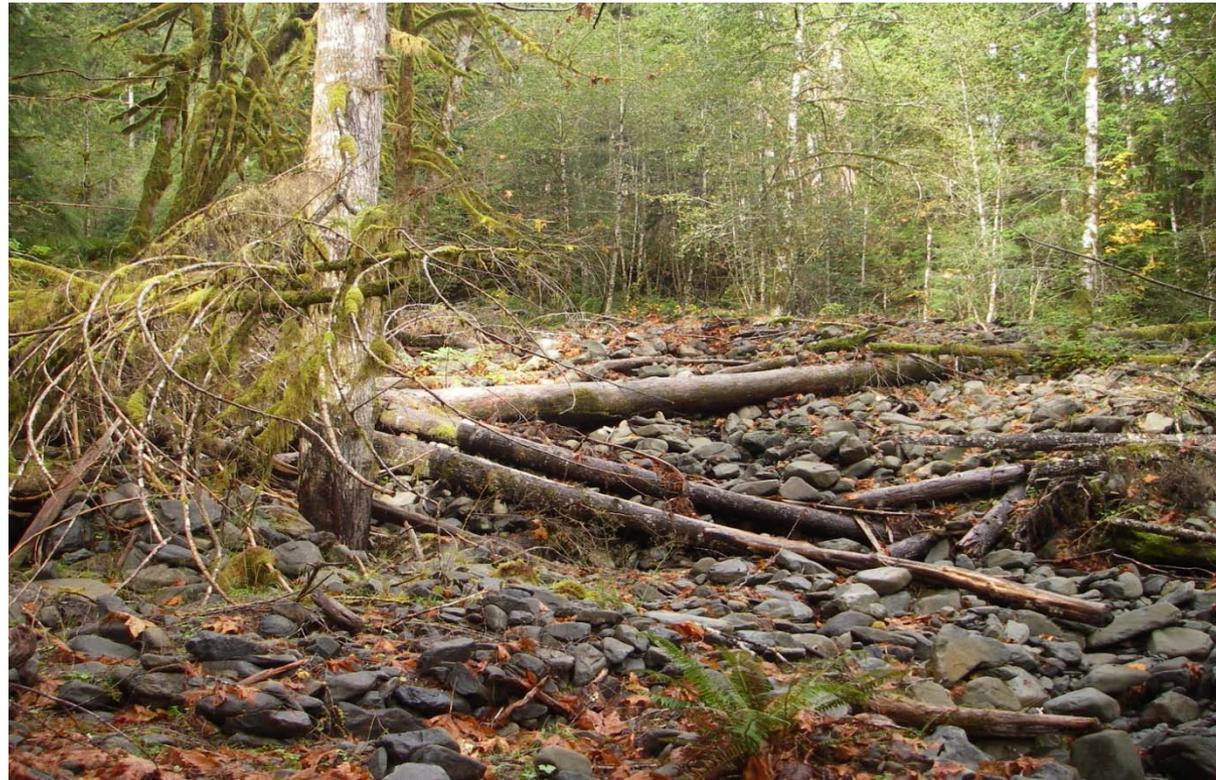
**Large Wood** – 5 pieces of wood removed  
from building  
site

Replaced on  
site in lower  
floodplain

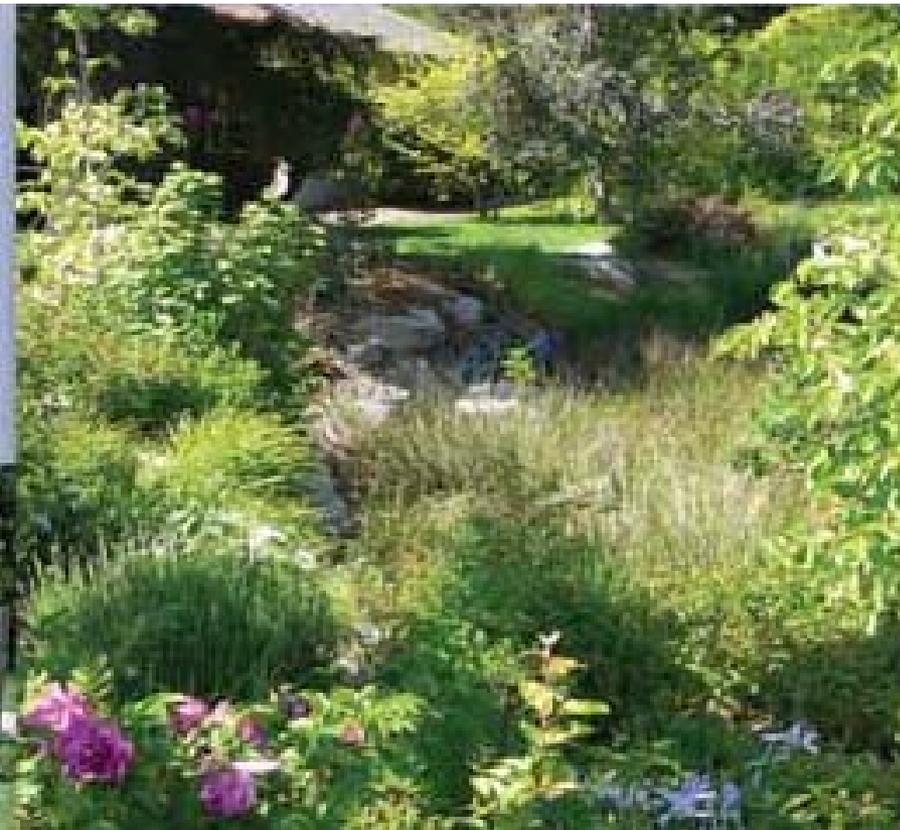
### **Stormwater – Used LID**

Collecting and dispersing roof-top runoff to rain garden and new wetland area

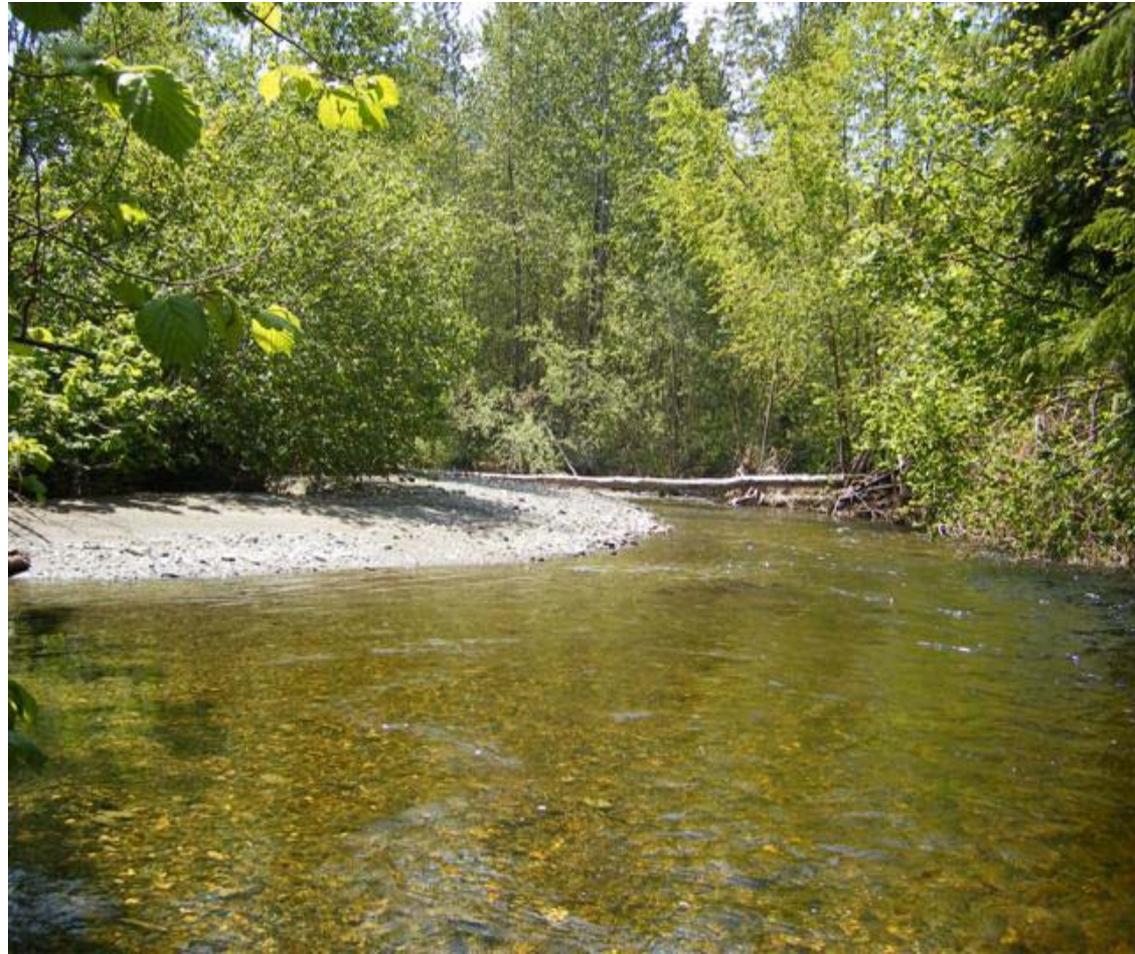
**Vegetation –**  
Enhanced function  
by planting larger  
graded area,  
increasing  
plant diversity

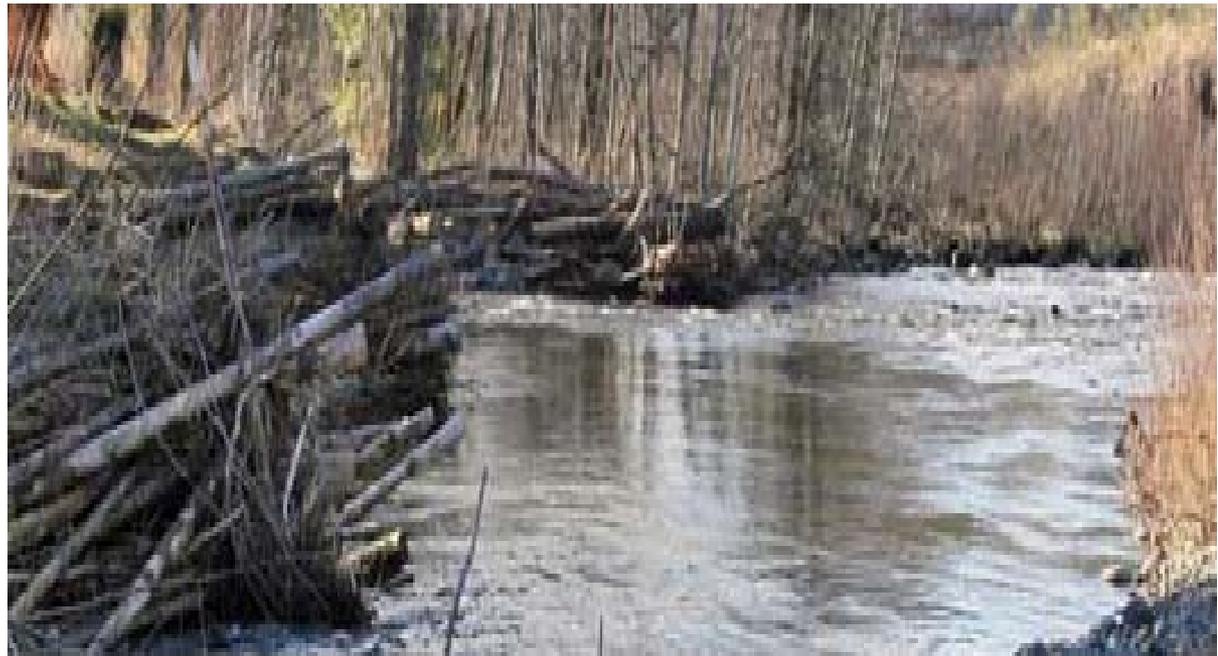
Bank Stability – No bank stabilization  
needed as structure was sited away  
from channel  
and flow  
path

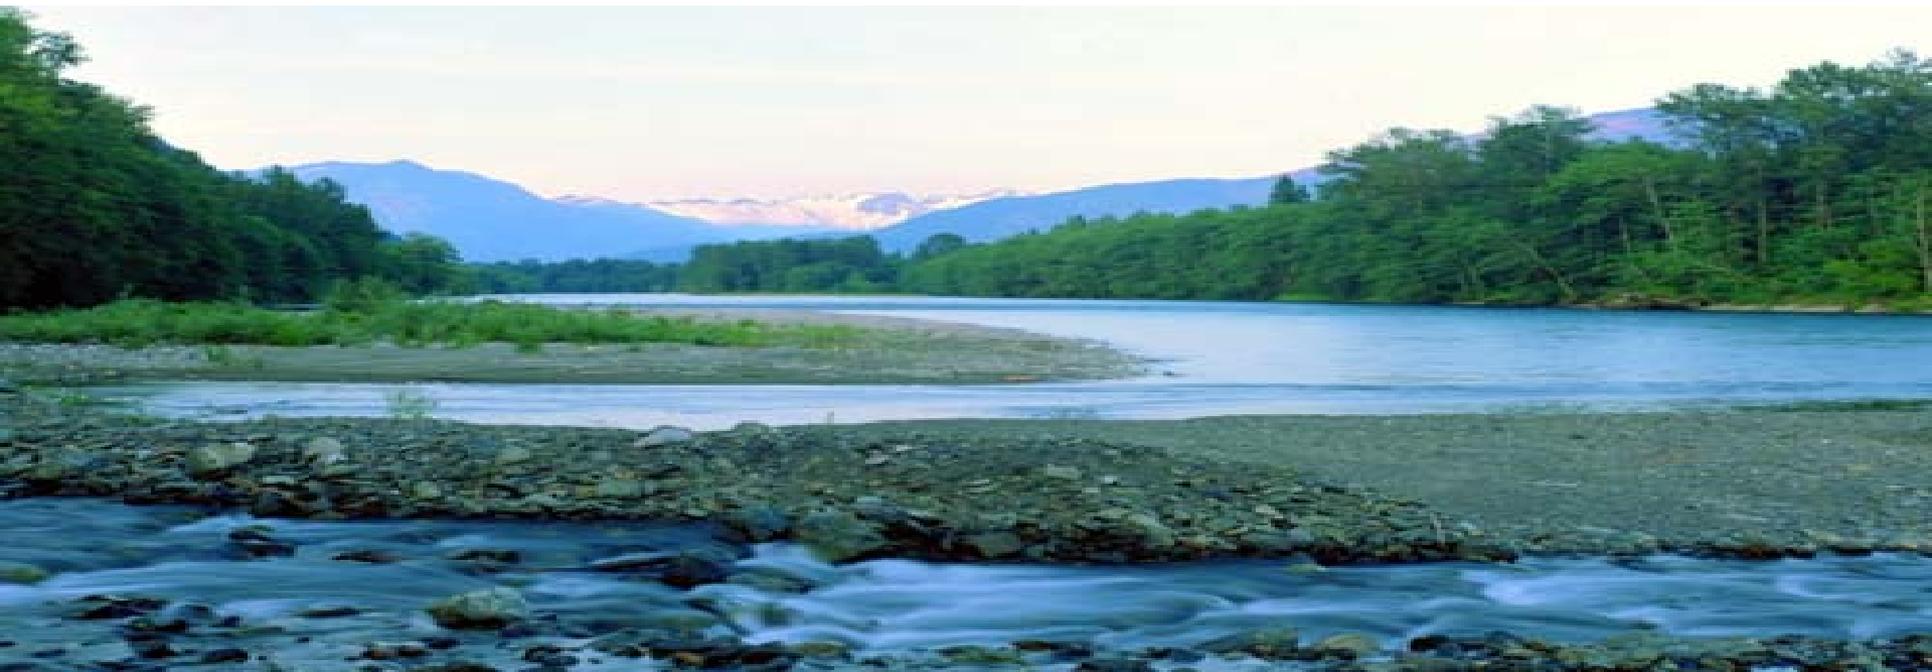
**Channel Migration** – house sited outside  
identified CMZ

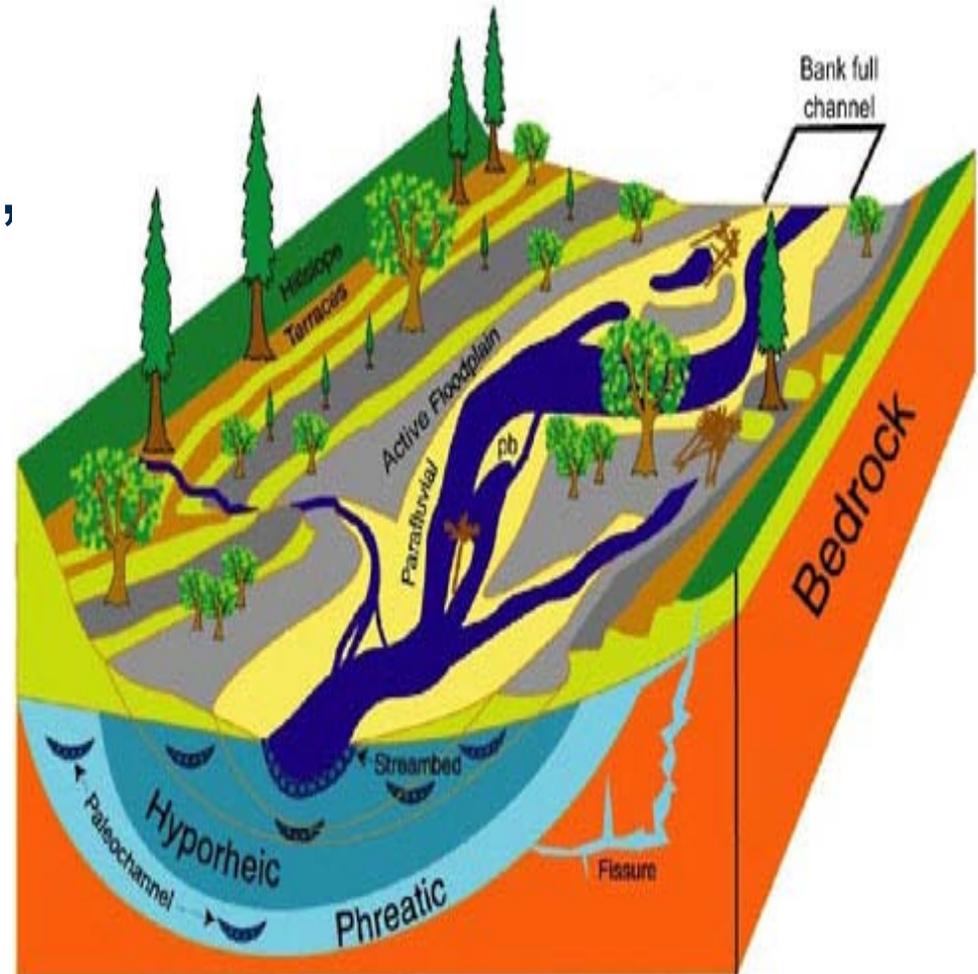
**Hyporheic Zone –**  
Surface, groundwater,  
hyporheic zone  
exchange maintained  
due to rain garden,  
wetland & vegetated  
flood storage area

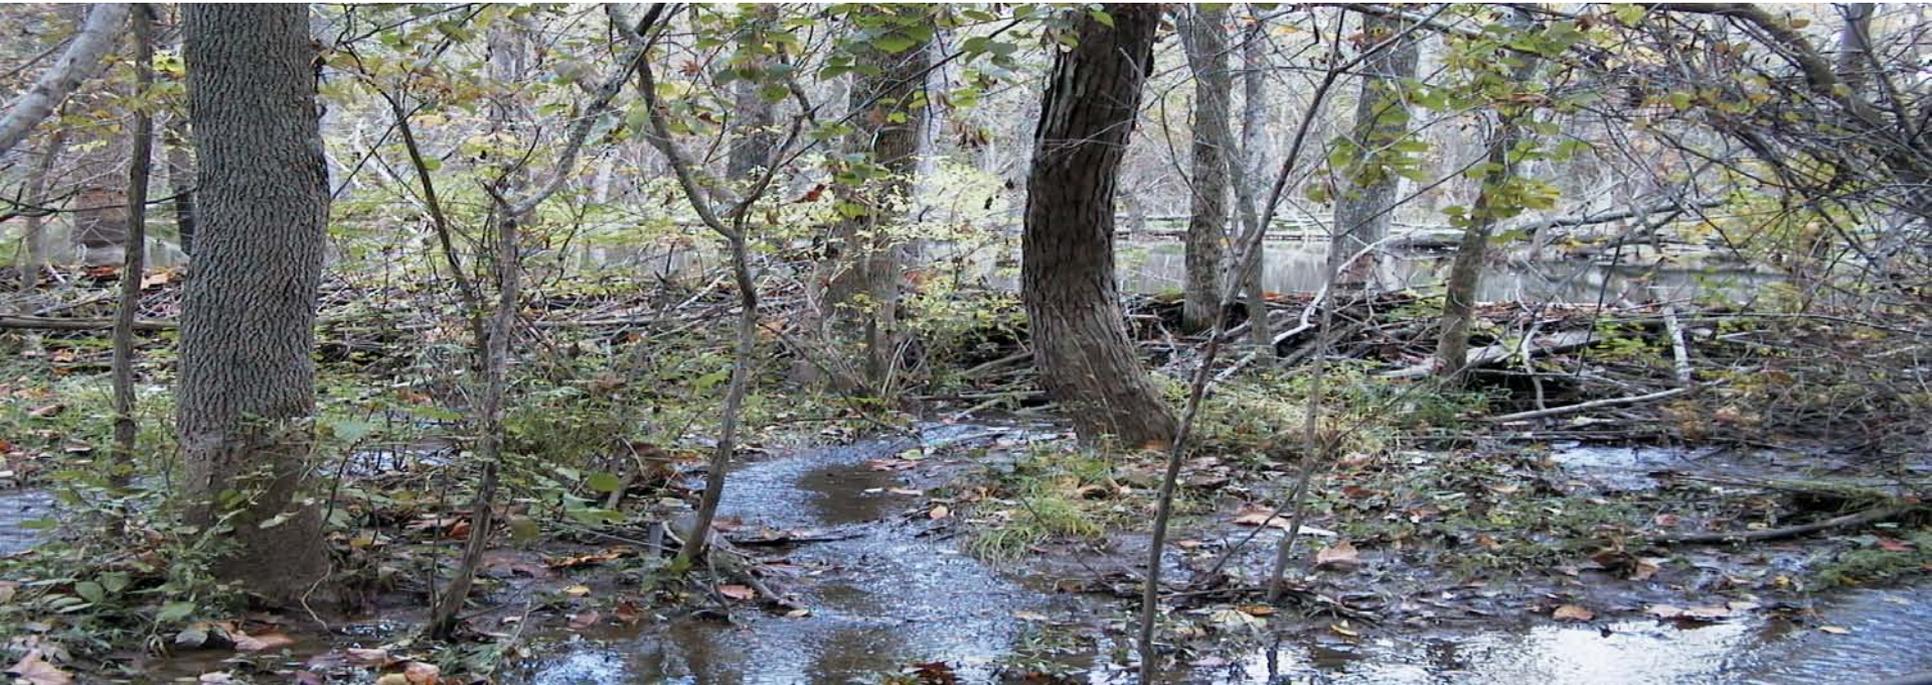
**Wetlands** – 300 ft<sup>2</sup> disturbed reed canary grass wetland replaced with 1,700 ft<sup>2</sup> shrub/meadow wetland/storage area

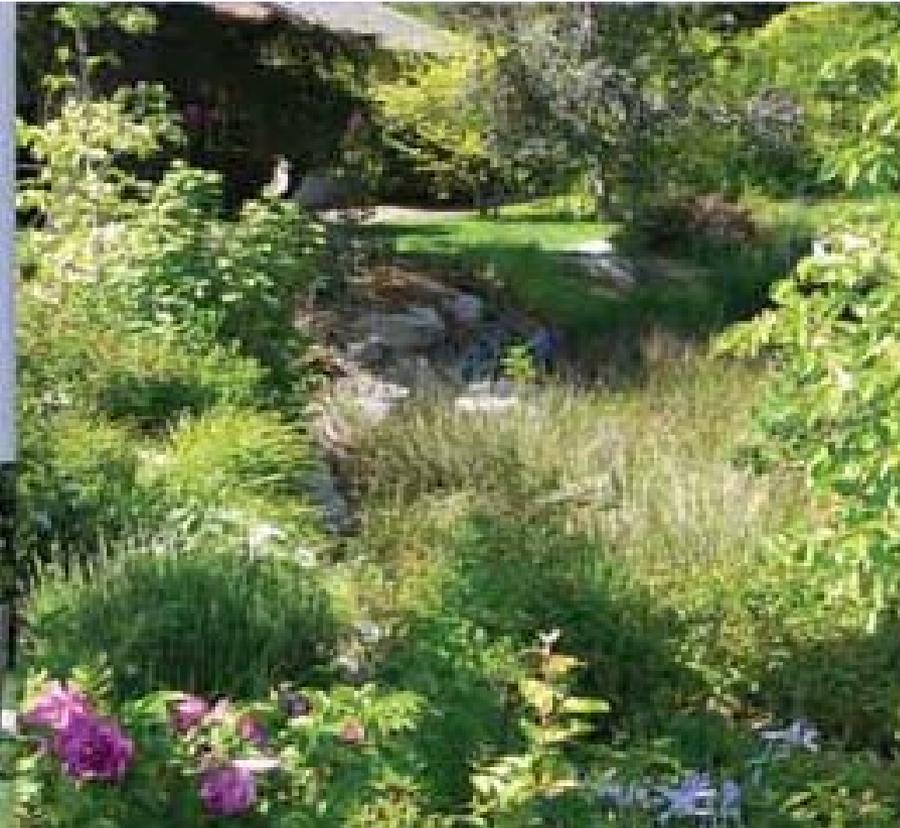
### **Stormwater – Used LID**

Collecting and dispersing roof runoff to rain garden

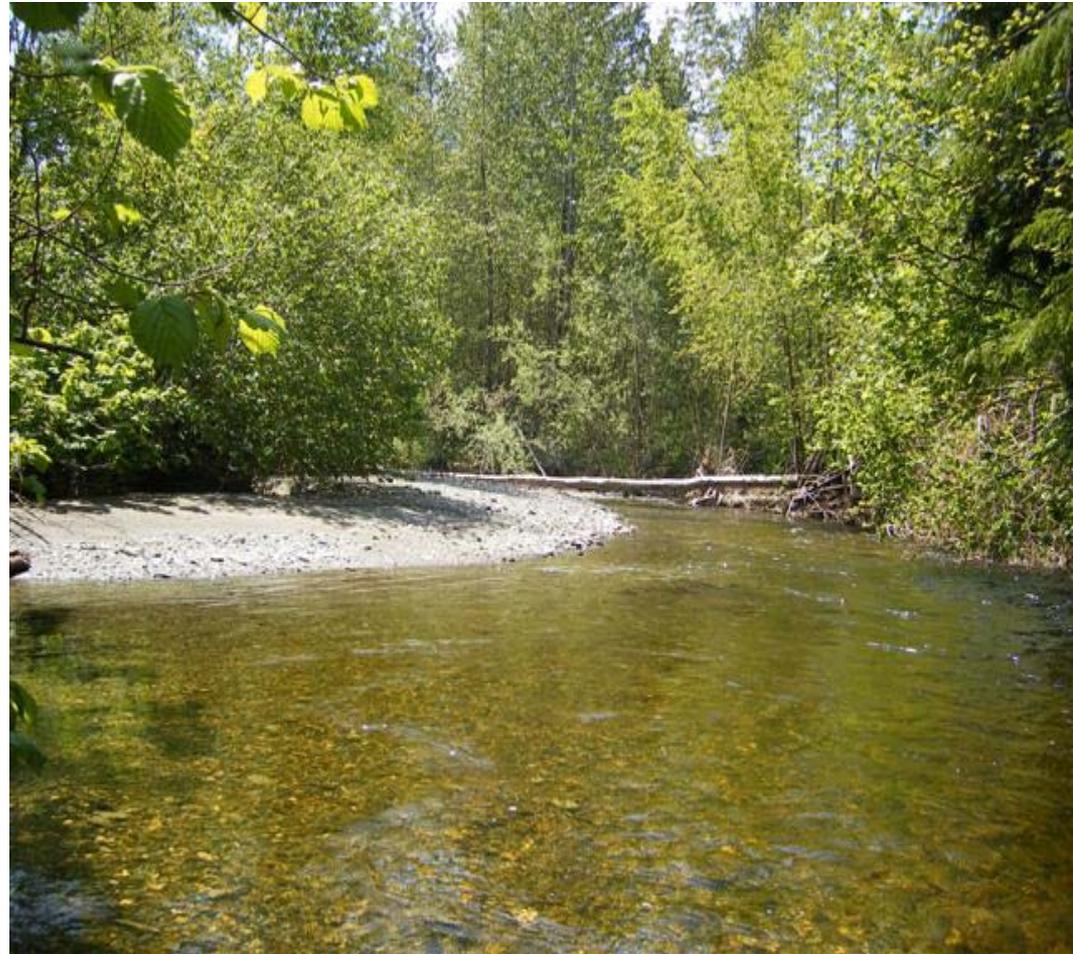
**Vegetation –**  
Provided 400 ft<sup>2</sup>  
improved vegetation  
function in riparian  
buffer

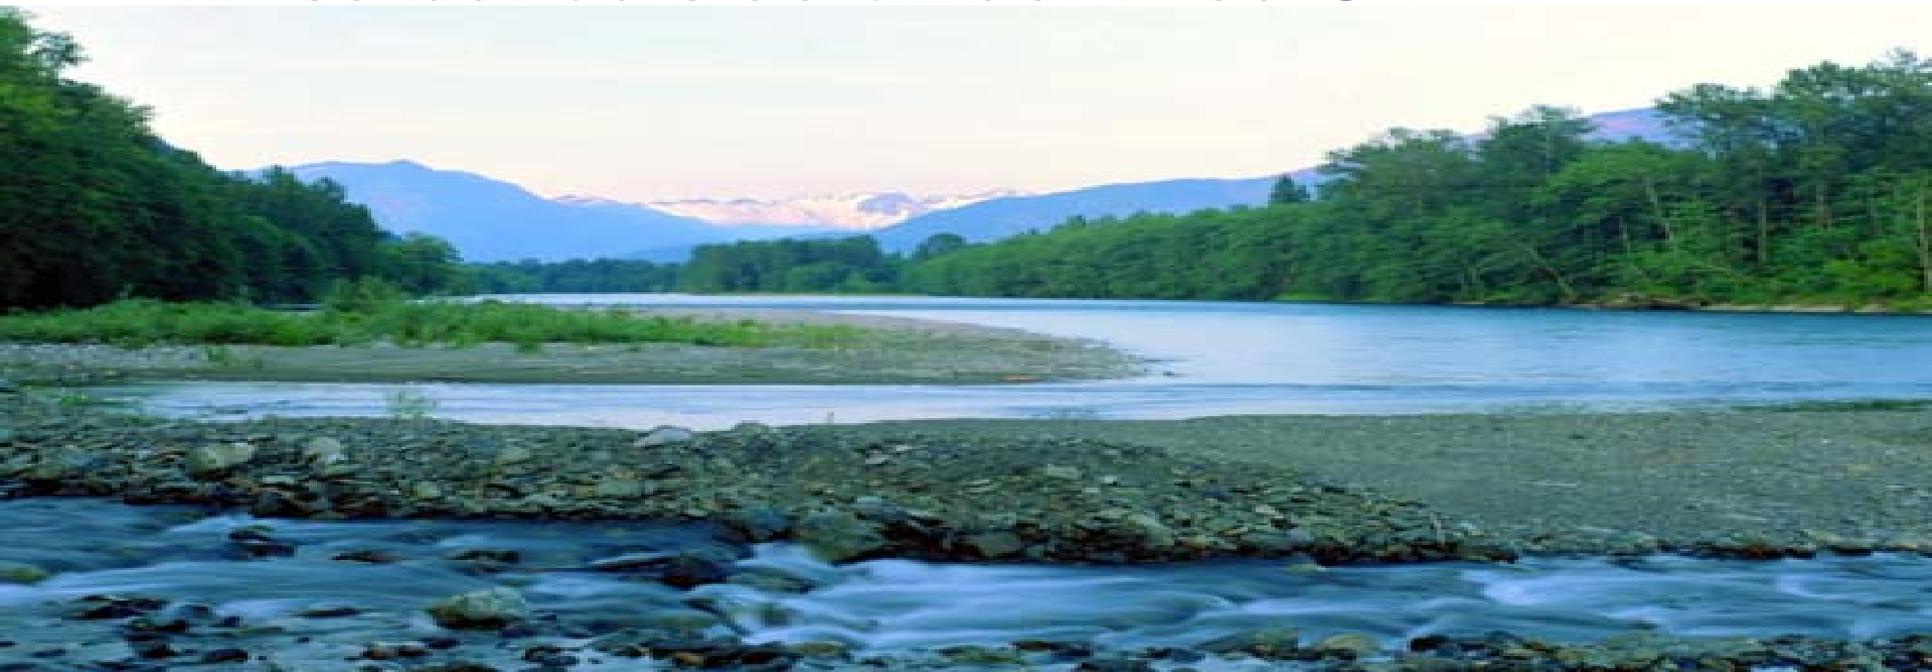
**Channel Migration** – house sited in riparian buffer portion of the Protected Area but outside of identified CMZ

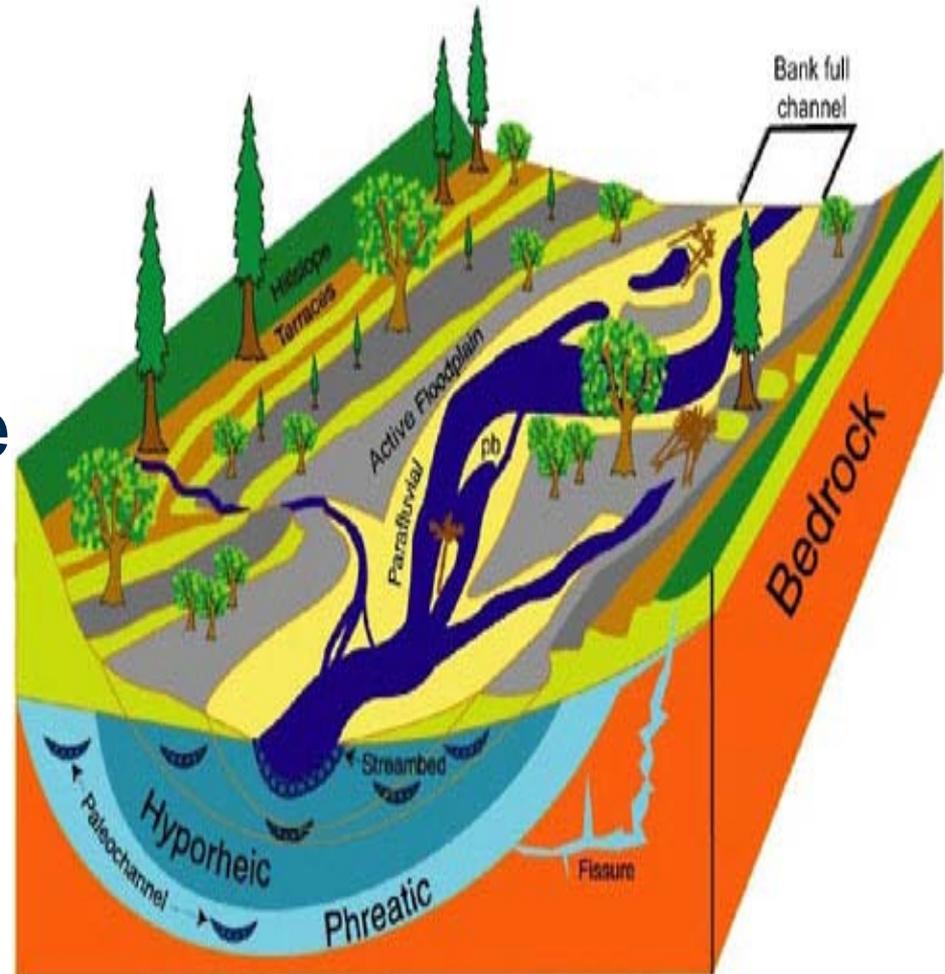
**Hyporheic Zone –**  
Maintain flow between surface, groundwater and hyporheic zone due to rain garden, planted area, and infiltration under house.

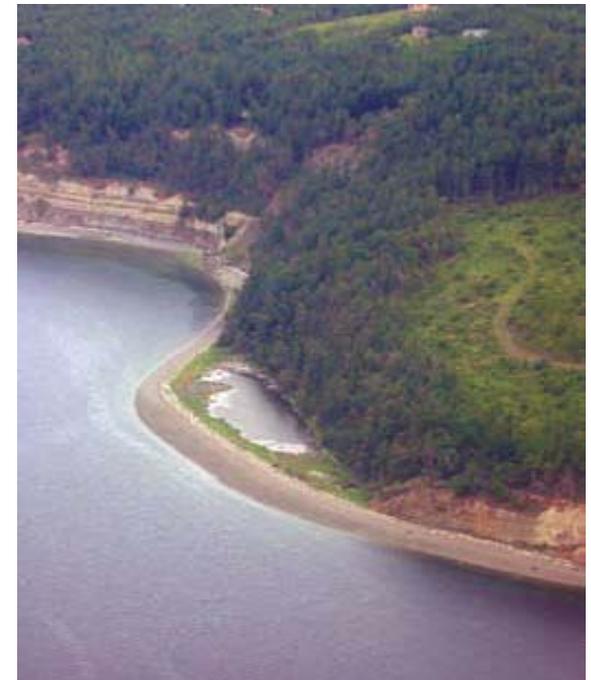
- 350 ft<sup>2</sup> addition on pilings, no effect on flood storage
- No aquatic fish habitat in floodplain e.g., saltwater lagoons

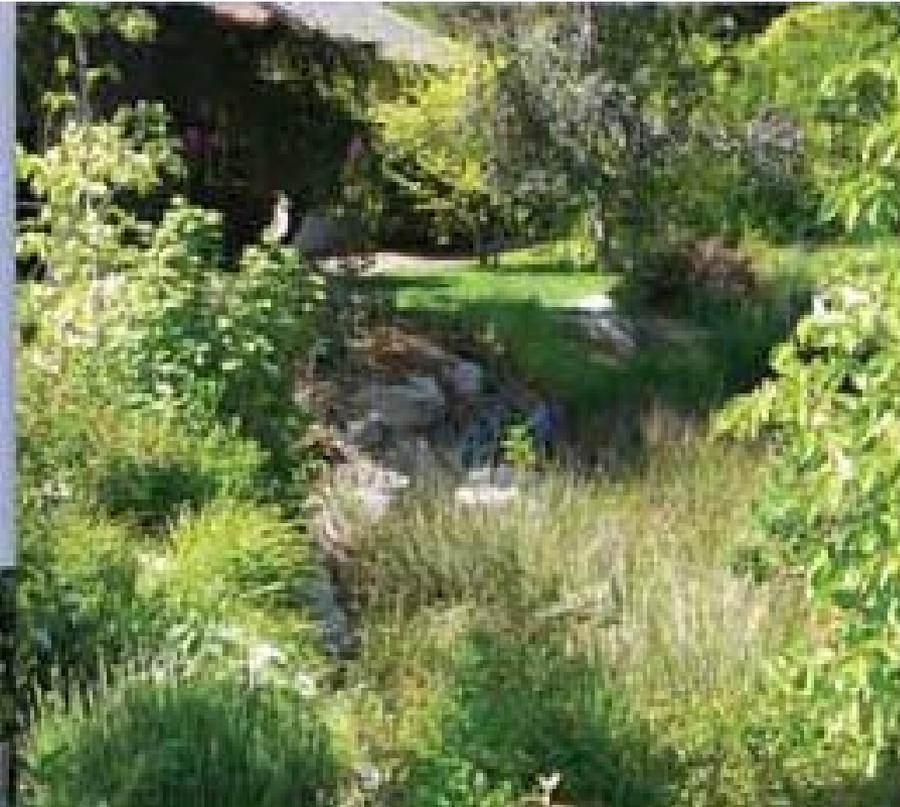
### **Stormwater – Used LID**

Collecting and dispersing roof runoff to created native vegetation area

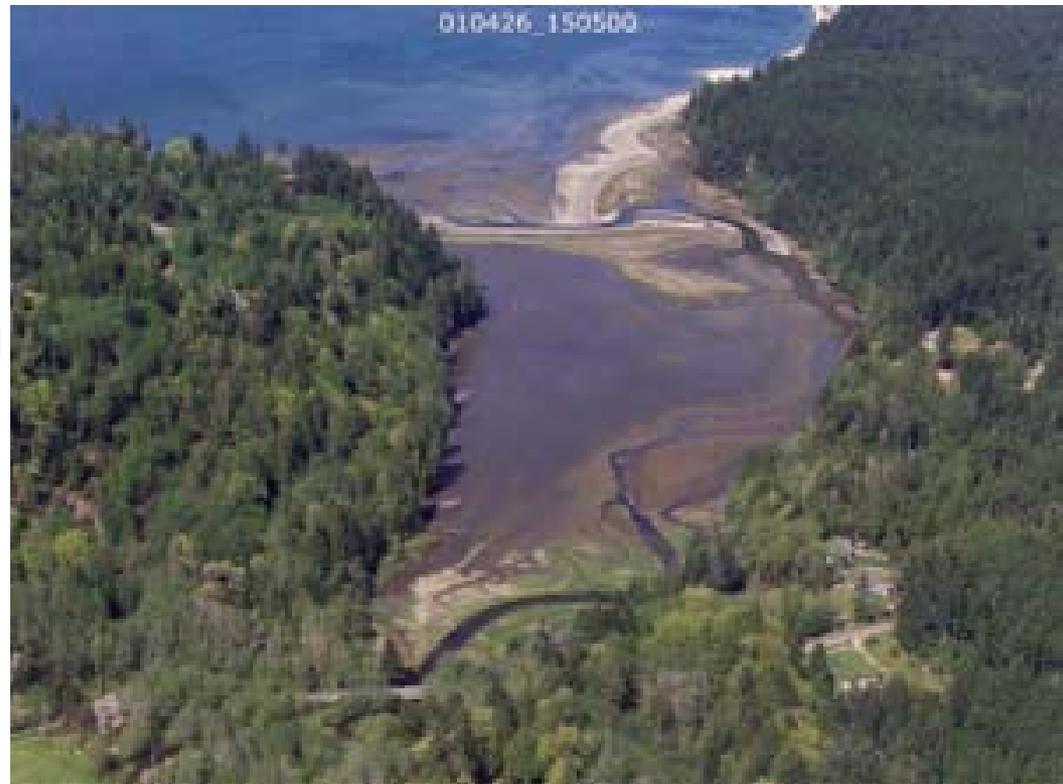
**Vegetation –**  
Provided 400 ft<sup>2</sup>  
improved vegetation  
function in riparian  
buffer

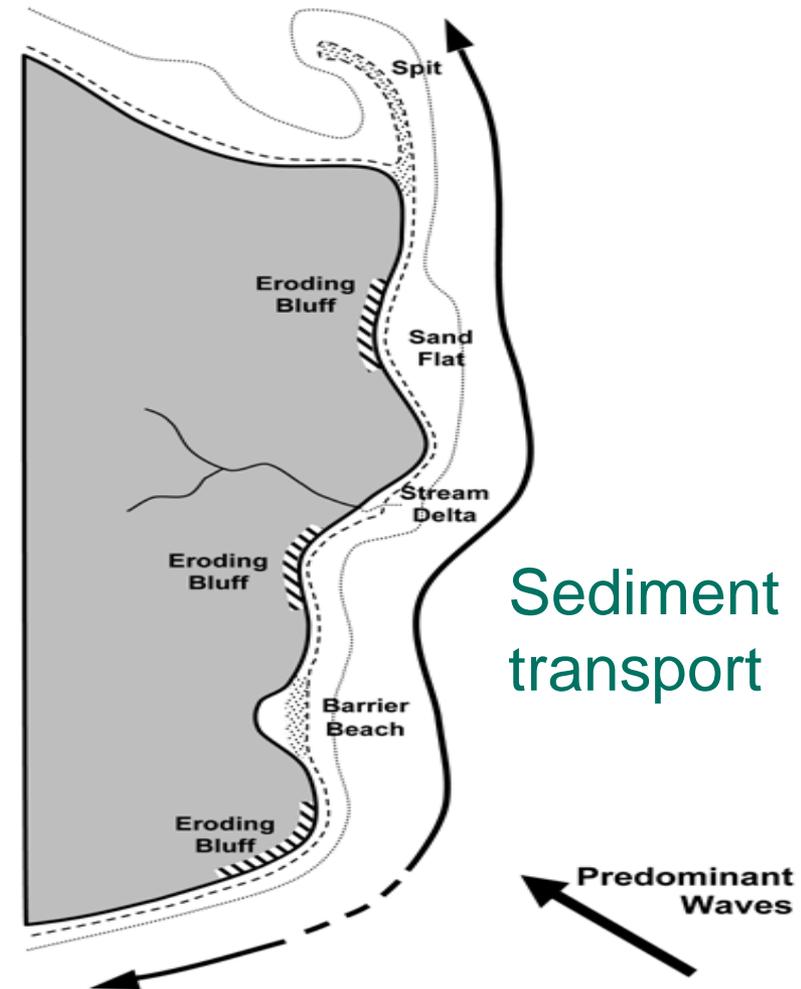
**Longshore sediment transport** – house sited in riparian buffer of shoreline but above beach sediment processes
