# B Structural Steel and Steel Connections

## B.1 Structural Steel

## **B.4 Examples of WTC 1 and WTC 2 Connection Capacity**

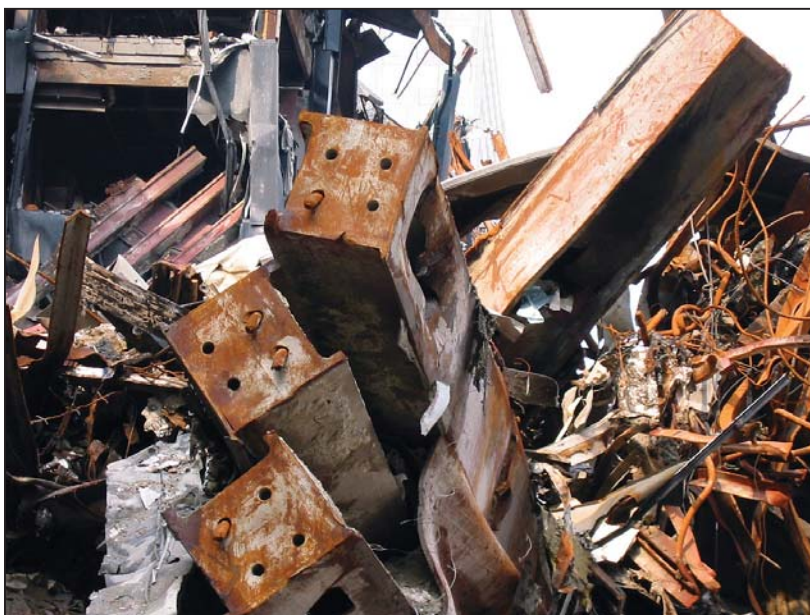
high. The cross-sectional shape of the columns can be seen in Figure B-1. These varied in length from 12 feet 6 inches to 38 feet, depending on the plate thickness and location.

Figure B-1 Exterior column end plates.

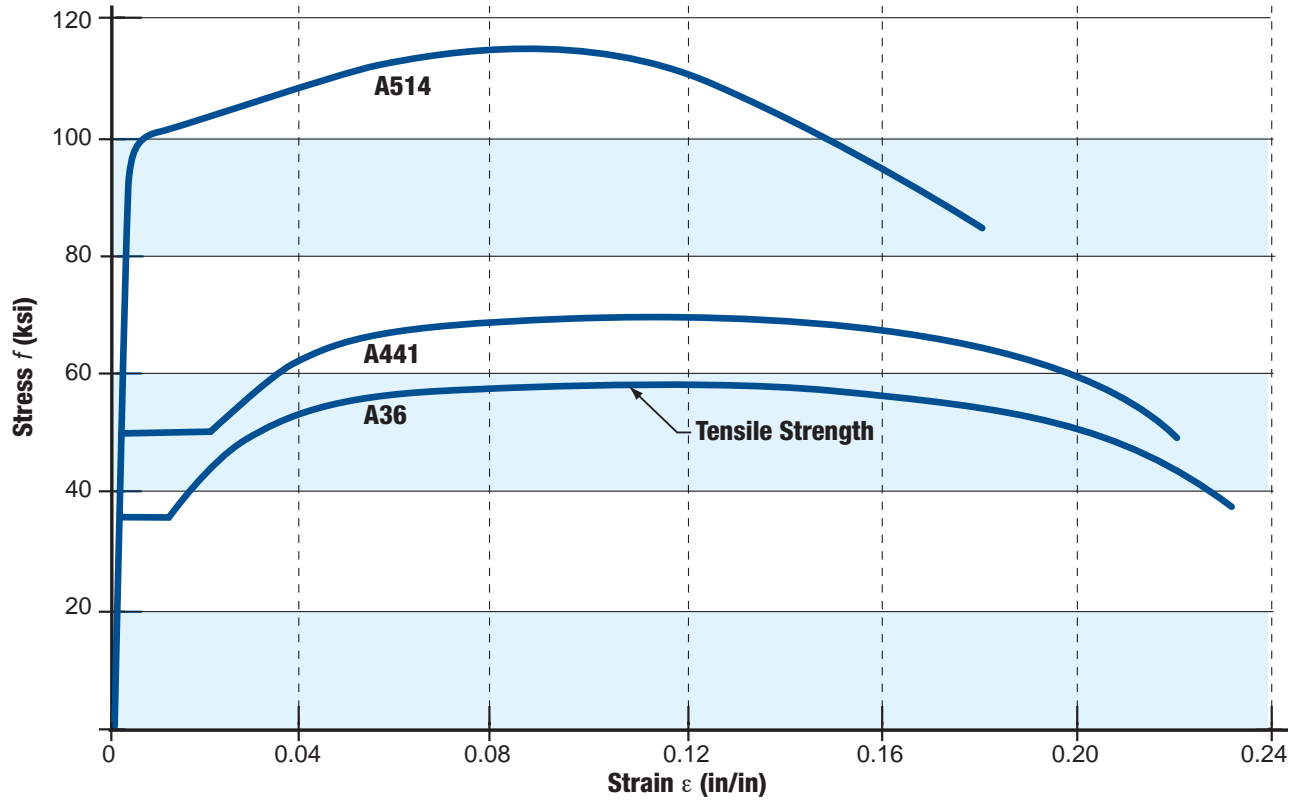
In lieu of actual WTC steel properties, typical stress-strain curves characteristic of 3 of the 12 steels used in the design and construction of the WTC complex are shown in Figure B-2 for three ASTM-designation steels with minimum specified yield strengths of 36 ksi (A36), 50 ksi (A441), and 100 ksi (A514). In general, as the yield strength of the steel increases, the yield-to-tensile-strength ratio (Y/T) also increases. For A36 steel, Y/T is approximately 0.6, whereas for A514 steel, Y/T is approximately 0.9. The yield plateau for five steels (yield points 36, 50, 65, 80, and 100 ksi) can be highly variable for structural steels, as is apparent from a comparison of the expanded initial portions of the five steels shown in Figure B-3. At the higher yield strength associated with quenched and tempered alloy steels, there may not be a distinct yield plateau; instead, the steels exhibit gradual yielding and nonlinear behavior with strain hardening.

Figure B-2 Tensile stress-strain curves for three ASTM-designation steels (Brockenbrough and Johnston 1968, Tall 1974).

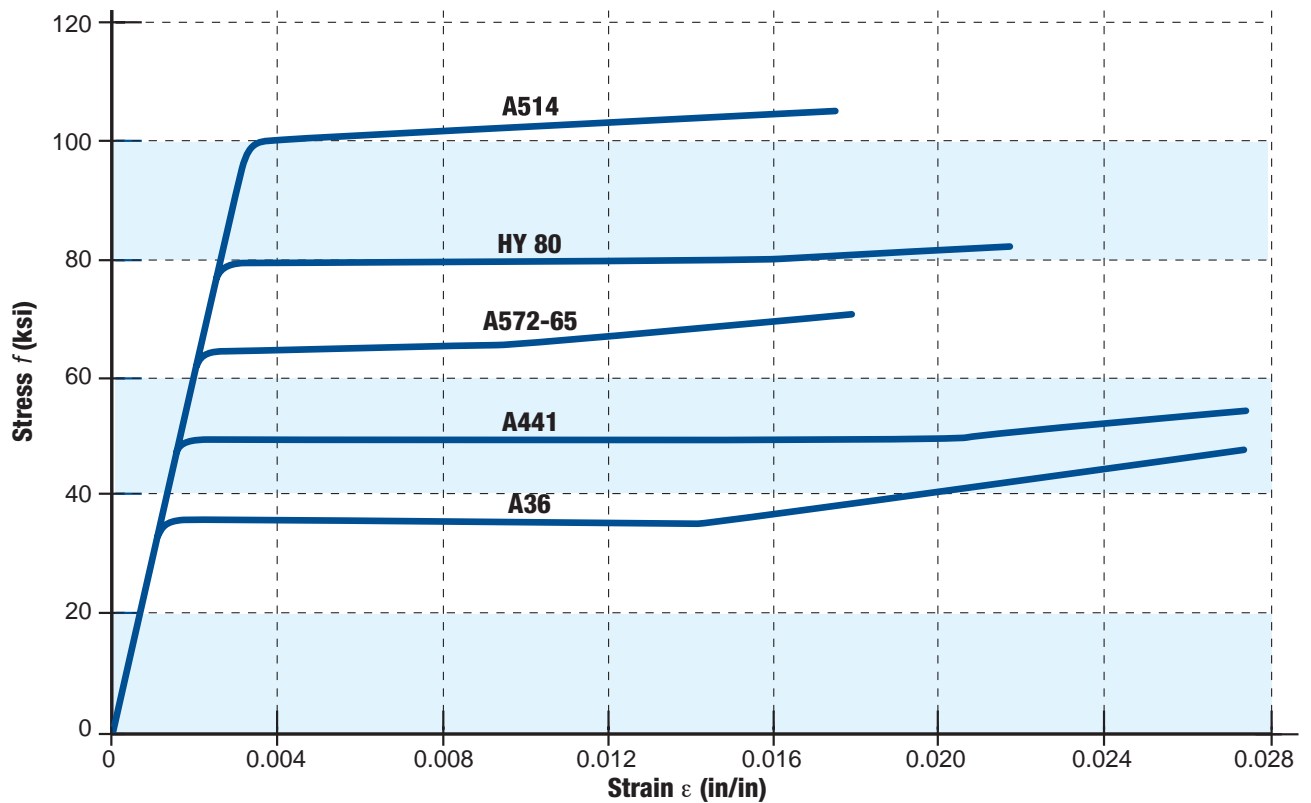
Figure B-3 Expanded yield portion of the tensile stress-strain curves (Tall 1974).

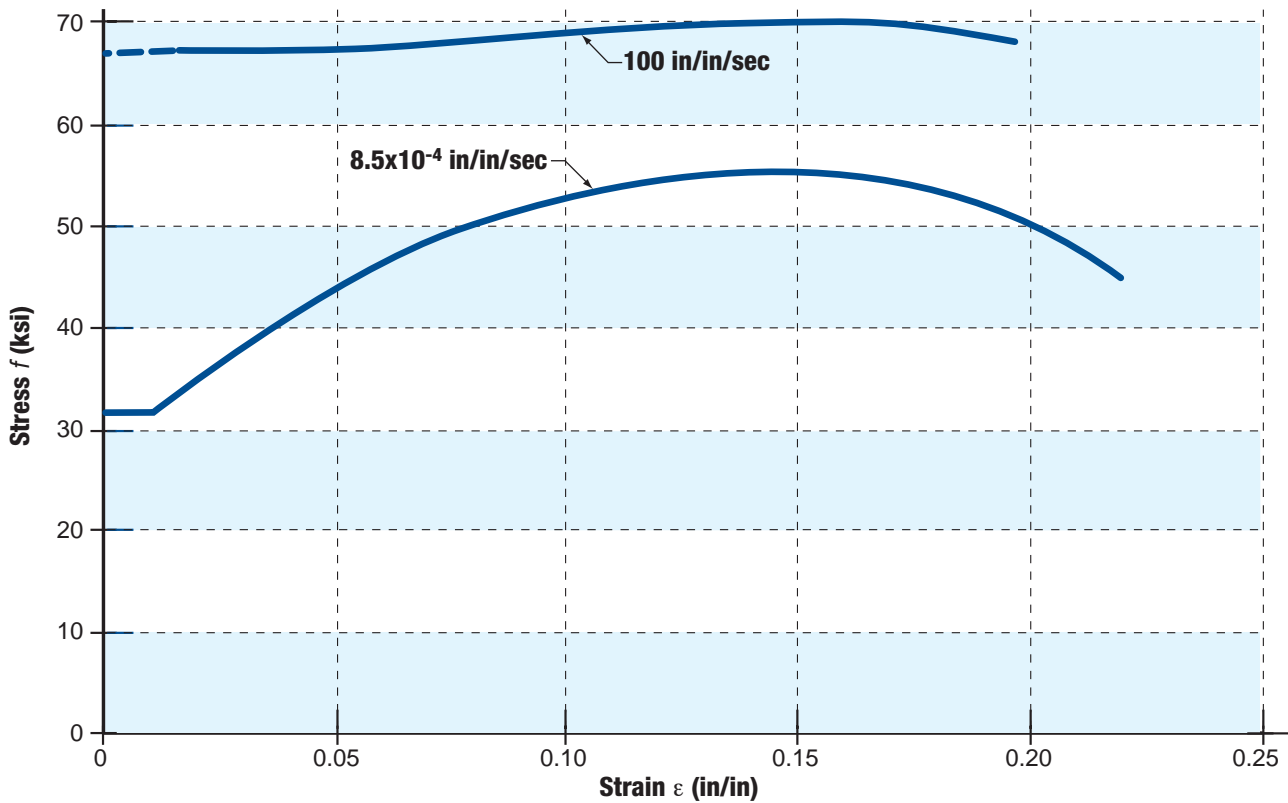
High strain rates tend to increase the observed yield strength and tensile strength of steel, but may also reduce the ductility. There is a greater influence on the yield point than on the tensile strength. Figure B-4 compares the effect of a very high strain rate (100 in/in/sec) for a mild carbon steel with a more usual test speed of 850 micro in/in/sec. In this example, the yield point more than doubled, whereas the tensile strength was increased about 27 percent, and the Y/T ratio approached unity.

Figure B-4 Effect of high strain rate on shape of stress-strain diagram (Tall 1974).

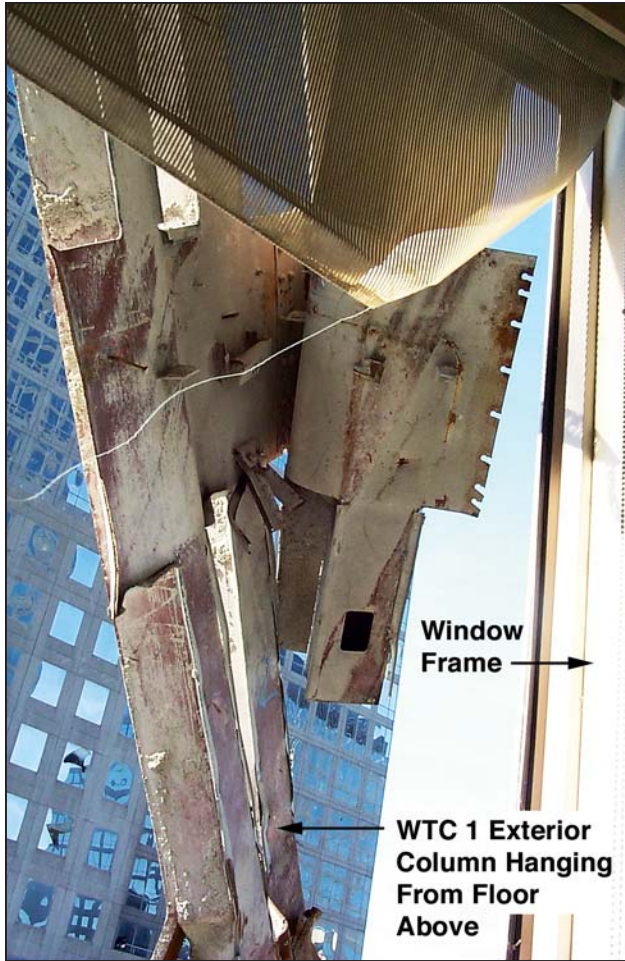
Figure B-5  
Column tree showing bolt bearing shear failures of spandrel connection.

Collapse of the WTC towers resulted in failure of the bolted shear splices that connected the spandrel beams together at each of the prefabricated column trees. Several modes of failure were observed in these connections. Figure B-5 showed an example of bearing strength failure of the spandrel plate. The loading appeared to be a combination of unanticipated moment and tensile loading. The following example examines the shear rupture capacity of one of the bolts. The spandrel plate thickness was assumed to be 3/8 inch, which was observed at the columns with 1/4-inch plate used in Figure B-7.

Hence, the failure mode observed in Figure B-5 is consistent with the predicted capacity.

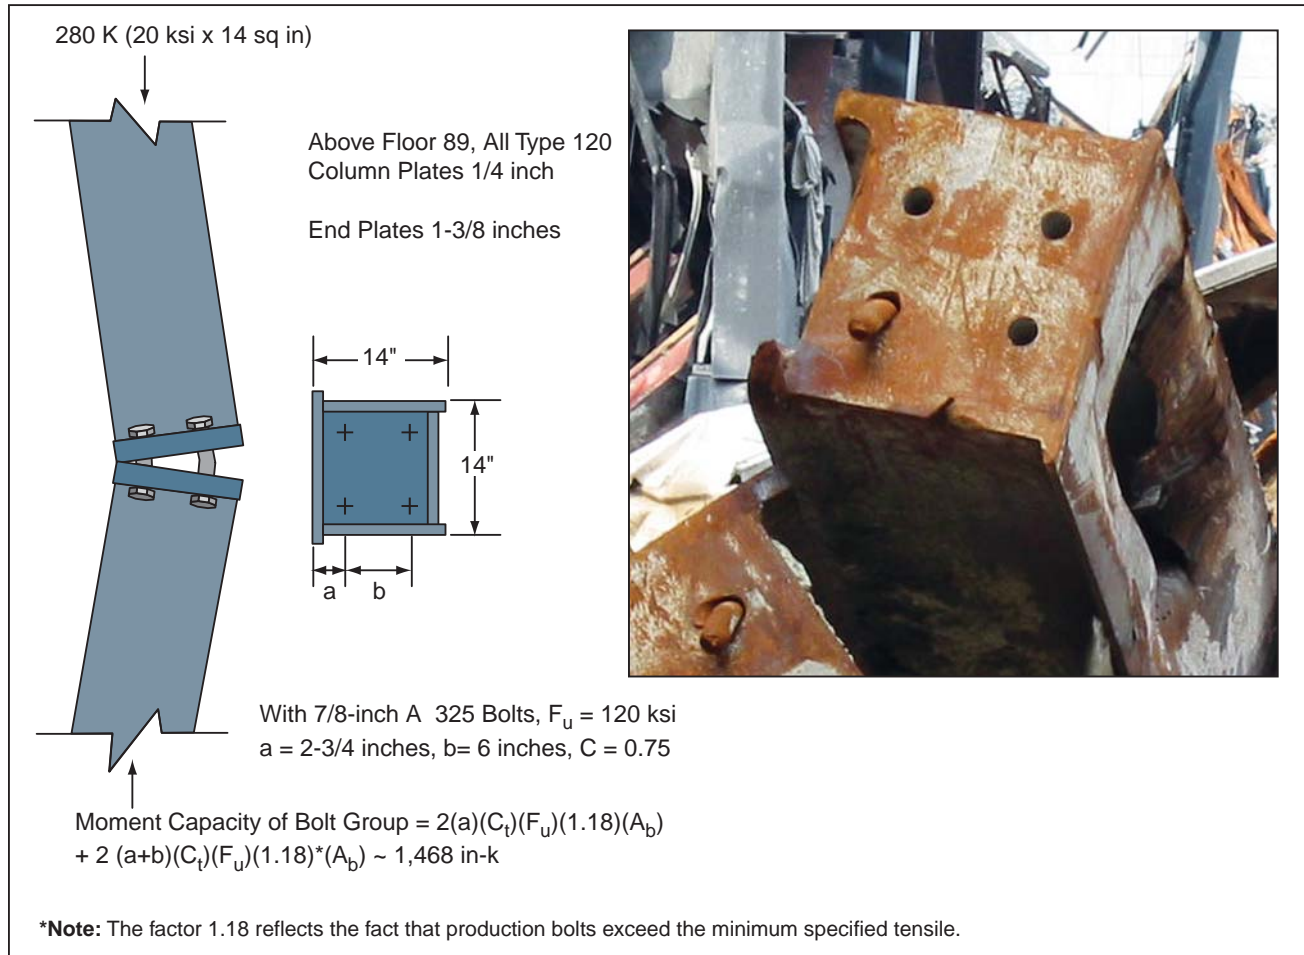
Collapse of the WTC towers resulted in failure of many of the bolts in bolted end plate connections as the columns were subjected to large and unanticipated out-of-plane bending. In the majority of cases, the A325 high-strength bolts reached their tensile capacity and failed in the threaded stress area. The example shown in Figure B-7 examines the flexural capacity of the bolted end plate in a column in the impact area where the column plate thickness was 1/4 inch.

The simple moment capacity of the bolt group is 20 to 30 percent of the plastic moment capacity of a column fabricated from steels with a 50 to 100 ksi yield point, assuming no axial load in the columns. The end plates at the columns splice have a 11-3/4-inch x 14-inch cross-section. The columns are subjected to axial load from the dead load acting on the structure. For the as-built structure, the moments acting on the bolted splice are small, because the splices were located at the column inflection points and the resultant of the applied axial load and moment is within the middle third of the 12-inch-deep bearing connection. Assuming an axial stress of 20 ksi in the column, the corresponding axial force acting on the base plate is 280 kips. As the columns lose lateral support and deform out-of-plane from overloading eccentricities and from the thermal effects, the bending moment acting on the column splice does not introduce significant forces into the bolted end plate connection until the eccentricity exceeds 2 inches. As the eccentricity increases, the applied bending moment will exceed the bolt preload stress when the eccentricity reaches approximately 4 inches. Continued deformation will exceed the ultimate moment capacity of the connection and result in instability as the eccentricity approaches 4.5 inches.

Figure B-7 Bent and fractured bolts at an exterior column four-bolt connection.

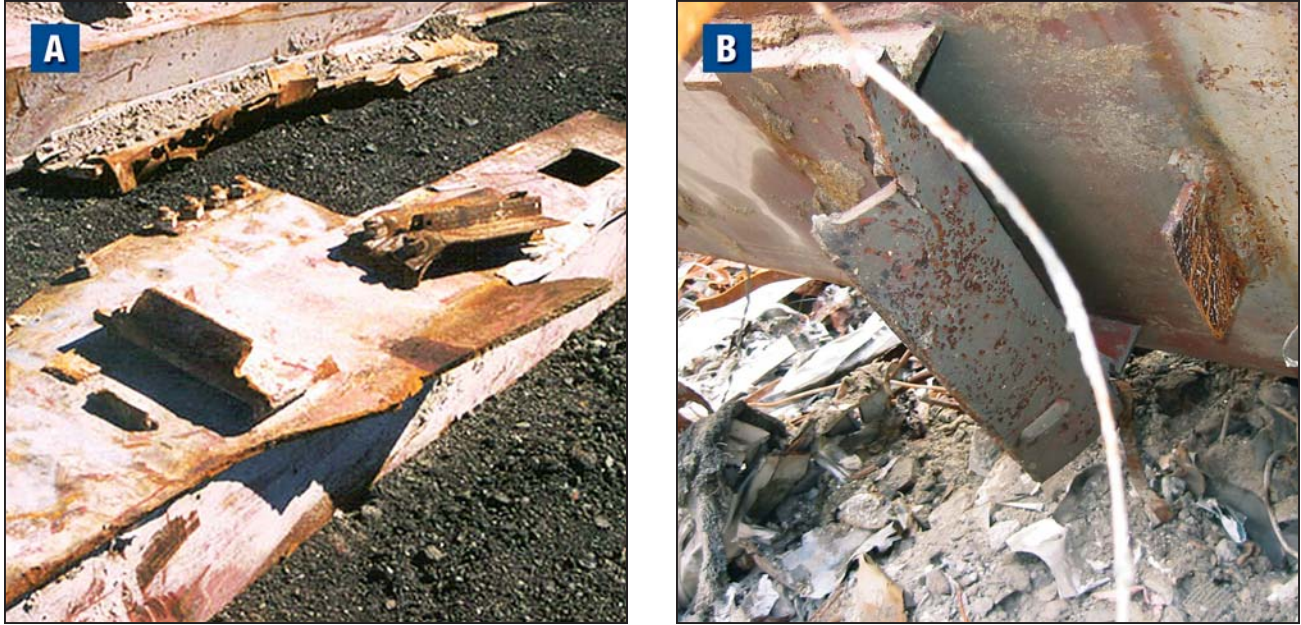
Figure B-9 shows several of the failure modes of the truss connections to the chord bearing seat and spandrel beam. The gusset plate welded to the spandrel beam and the top chord failed by tensile fracture of the plate. The gusset plate connection was primarily resisting the floor diaphragm support to the column. After fracture, the slotted holes in the seat would allow rigid body motion of the trusses until the 5/8-inch bolts came into bearing. That resulted in partial fracture in the seat of the fillet welds attaching the fill plate to the spandrel beam. The seat angle welded connection to the fill plate remained intact as this separation occurred and final block shear failure developed in the outstanding angle leg at the two slotted bolt holes.

It is probable that, once the 3/8-inch gusset plate fractures, the next lower bound resistance is provided by the bearing capacity of the two 5/8-inch bolts on the beam seat angle. This failure also tore off the ends of the angle even though the tensile capacity of those segments was predicted to be higher.

Figure B-9 (A) Visco-elastic damper angles bolted to angle welded to spandrel plate and (B) failed bearing seat connection.

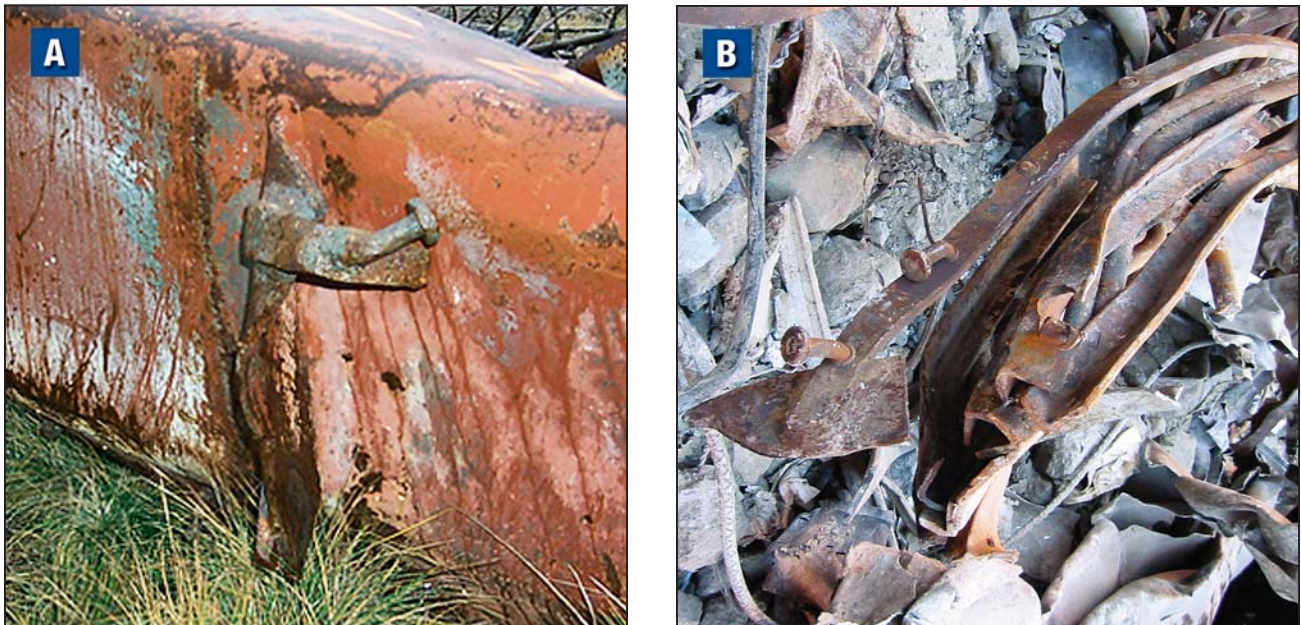
It should also be noted that each truss top chord provided a horizontal diagonal plate brace (1-1/2 inches x 1/2 inch) to the two adjacent columns. These members were welded to welded bracket plates on each adjacent column/spandrel member, as illustrated in Figure B-10. In this case, it would appear that the diagonal plate braces fractured on their gross section or tore the bracket plate. The component of ultimate strength of the two diagonal plate braces normal to the column/spandrel member is about 85 percent of the tensile capacity of braces, which would be 76 kips.

Figure B-10 (A) Bracket plate welded to the column/spandrel plate and (B) horizontal plate brace with shear connectors welded to the failed bracket.

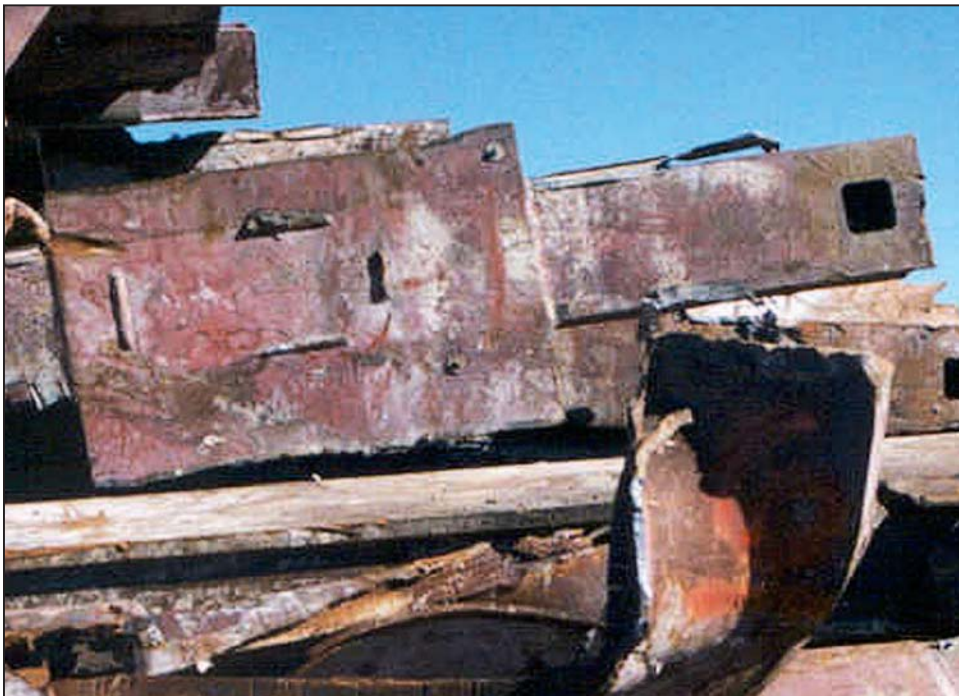
Many of the bearing seat brackets and the damper angle connections on the column/spandrel beam plate were completely sheared off. Only the weld segments remained on face of the column/spandrel beam plate (Figure B-11). This mode of failure appears to be due to excessive vertical overloads on the floor system. This is in contrast with the failure mode exhibited in Figure B-9 where the bearing seat bracket has pulled away from the column/spandrel plate, after fracture of the top chord gusset plate.

Figure B-11  
Shear failure of floor truss connections from column/spandrel plate.
