# Best Practices for Minimizing Wind and Water Infiltration Damage

## HURRICANE MICHAEL IN FLORIDA

Recovery Advisory 2, June 2019

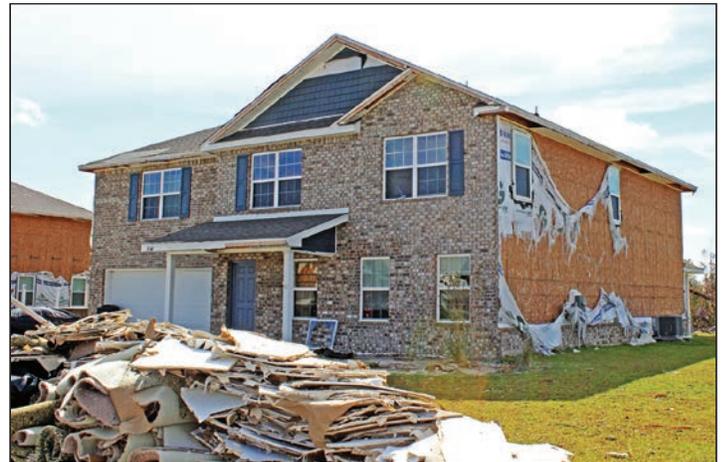
Note that roof covering damage is not visible in the photograph. The resulting interior water damage is indicated by the debris pile near the curb.

**Figure 1: House with typical envelope damage (siding, soffit, and fascia cover) observed on newer buildings after Hurricane Michael (Panama City area)**

This Recovery Advisory presents important recommendations to reduce wind and water infiltration damage to new and existing residential buildings. The recommendations discussed are from existing Federal Emergency Management Agency (FEMA) Building Science resources, including recovery advisories published after Hurricane Irma, and also include new recommendations and best practices based on observations made by the Mitigation Assessment Team (MAT) after Hurricane Michael struck in 2018 (Figure 1 shows an example of observed damage).

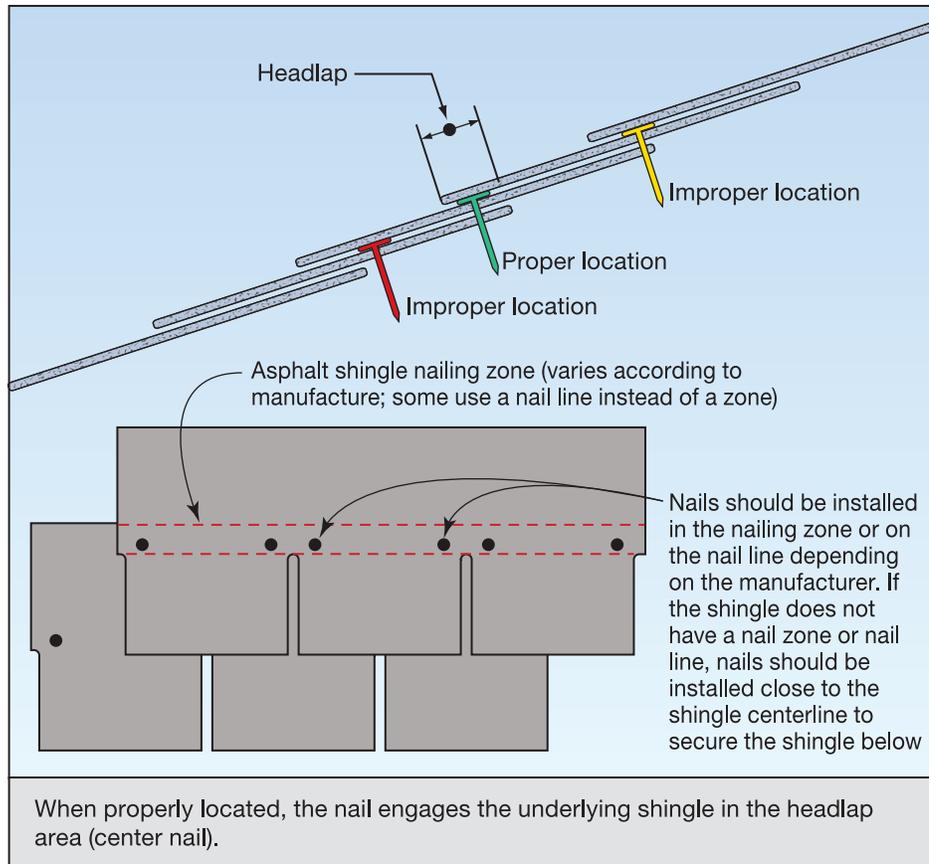
**Figure 2:  
Proper and improper locations  
of shingle fasteners**

Table 1 provides guidance that will help to improve performance of asphalt shingles in high-wind areas. Table 2 identifies the required classification of asphalt shingles based on the basic wind speed. Figures 2 and 3 illustrate the correct and incorrect fastener location for asphalt shingles.

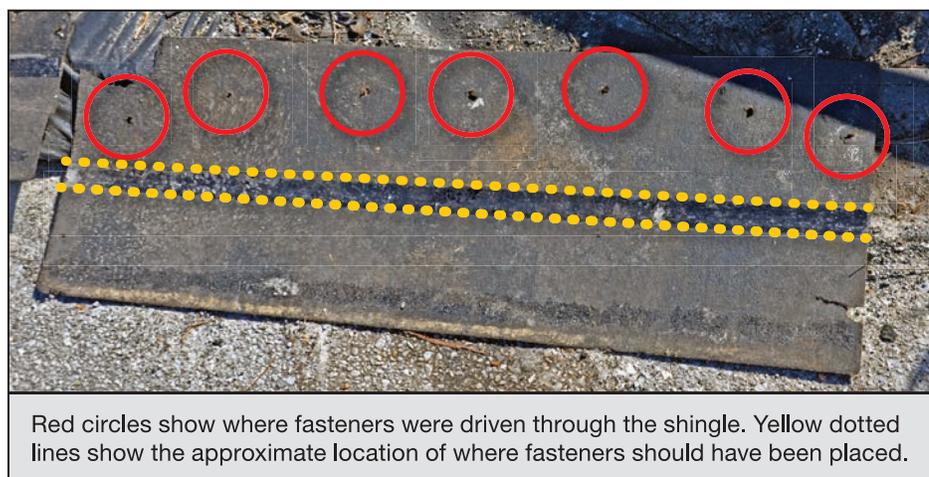
**Figure 3:  
Incorrect location of fasteners  
in an asphalt shingle**

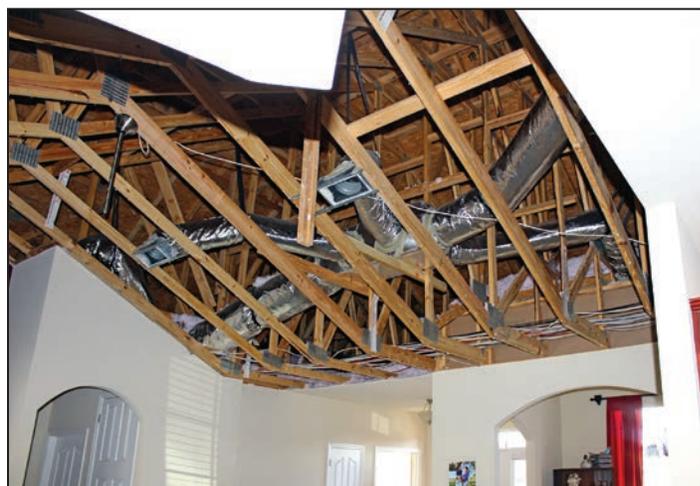
**Figure 4: House with significant interior damage from water intrusion (Panama City area)**

Interior damage occurred when ridge shingles and the ridge vent were blown off; the drywall on the ceiling collapsed and was removed.

**Ridge vents and off-ridge vents.** The loss of vents, particularly ridge vents, can expose large openings in the roof deck to water infiltration. The interior of the home shown in Figure 4 suffered extensive interior water damage due to the failure of ridge shingles and the ridge vent. The ceilings in several rooms were saturated with water and collapsed. According to the homeowner, roof damage was limited to the loss of ridge shingles and ridge vents. Table 5 provides guidance that will help improve performance of ridge vents and off-ridge vents in high-wind areas.

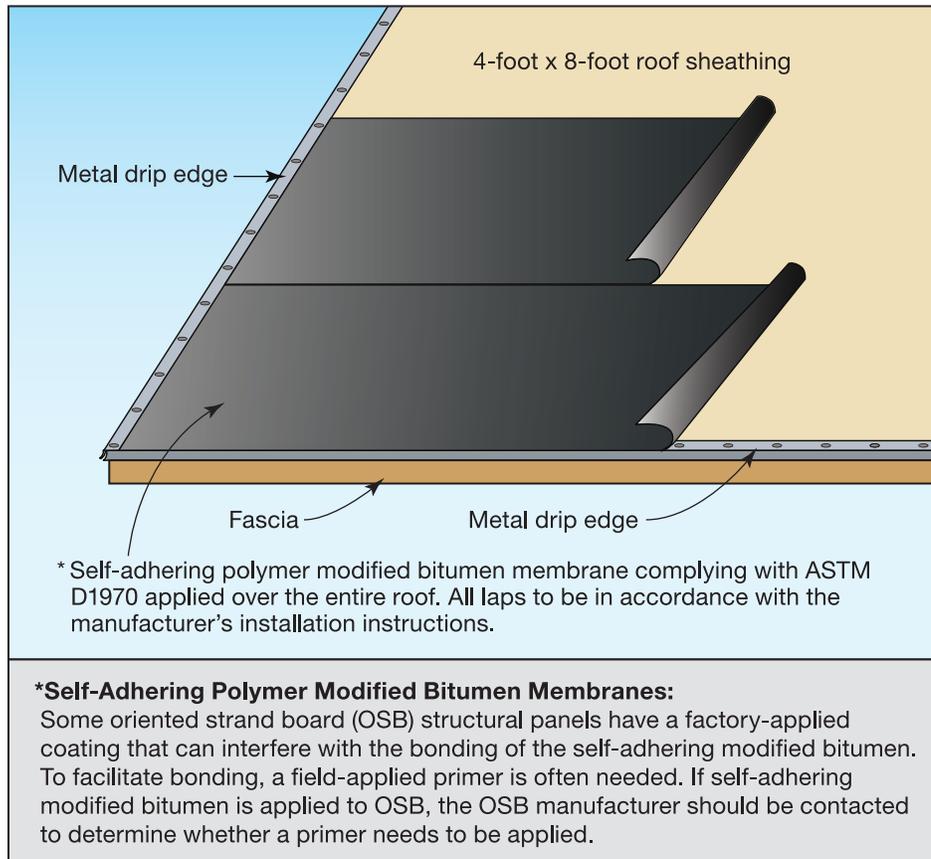
**Figure 5:**  
**Option 1 for installing a sealed roof deck to reduce water infiltration through the roof**

Figures 5, 6, and 7 illustrate three options for installing a sealed roof deck under the primary roof covering. These sealed roof deck methods have been tested by IBHS and qualify for the FORTIFIED designation (see text box). Additional information on underlayment to reduce water intrusion can be found in FEMA P-499 (Technical Fact Sheet No. 7.2) and FEMA P-55 (Section 11.5.1.1).

The benefits of a sealed roof deck were demonstrated in the residence shown in Figure 8. The metal roof covering of the home in the Panama City area was punctured by asphalt shingles that blew off an adjacent building during Hurricane Michael. Although the metal roof was damaged, the home had a sealed roof deck constructed in accordance with Option 1 shown in Figure 5 and did not suffer any interior water damage.

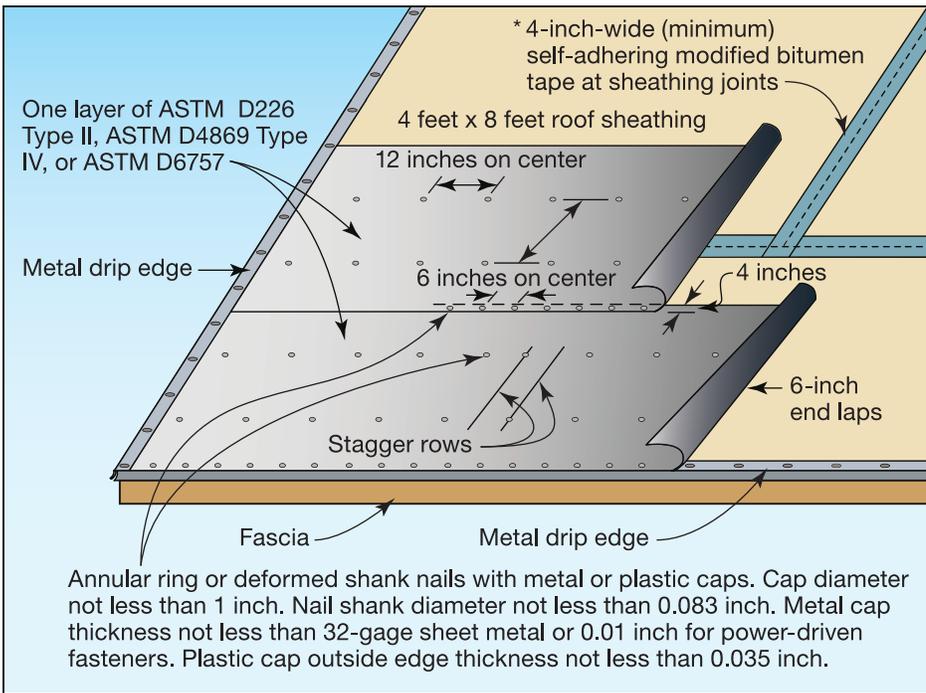
**Figure 6:**  
**Option 2 for installing a sealed roof deck to reduce water infiltration through the roof**

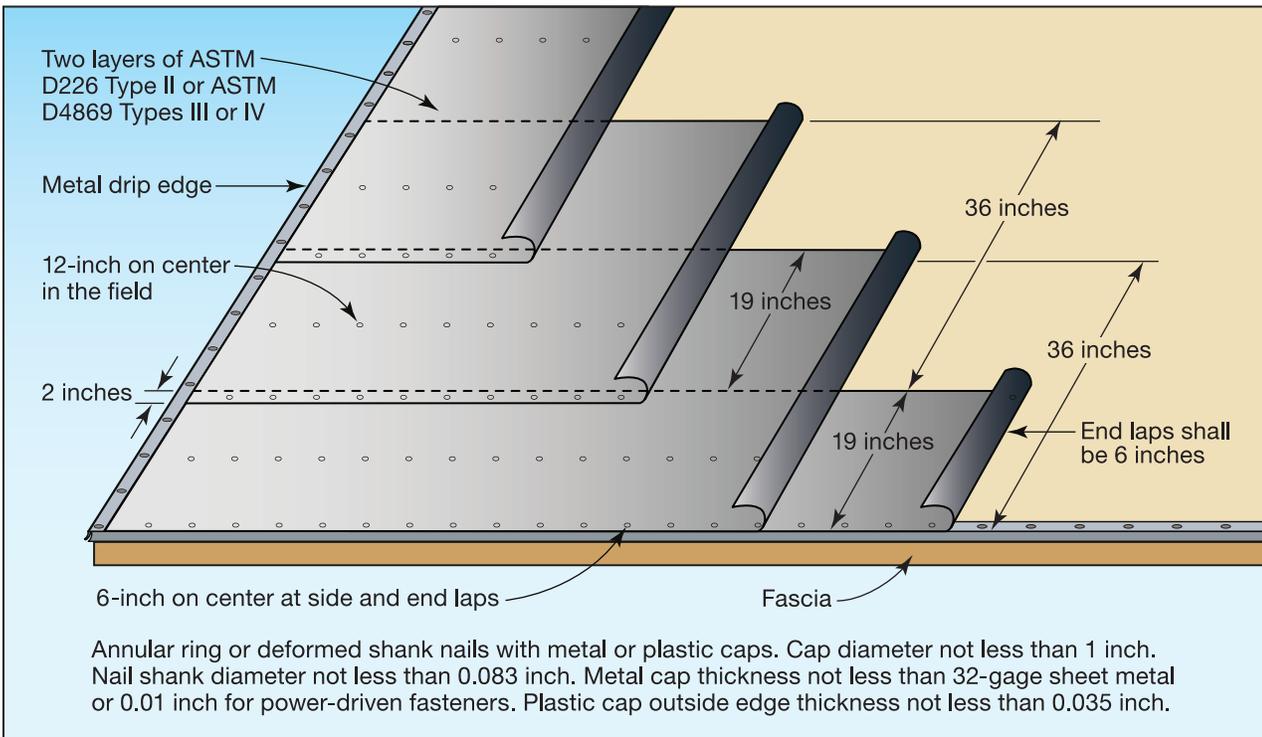
**Figure 7: Option 3 for installing a sealed roof deck to reduce water infiltration through the roof**

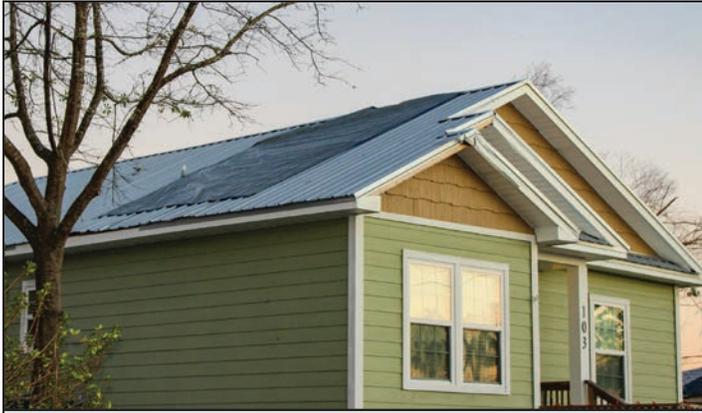
**Figure 8:**  
**Successful sealed roof deck (Panama City area)**

Example of a sealed roof deck that successfully protected a home during Hurricane Michael after wind-borne debris punctured the metal roof covering.

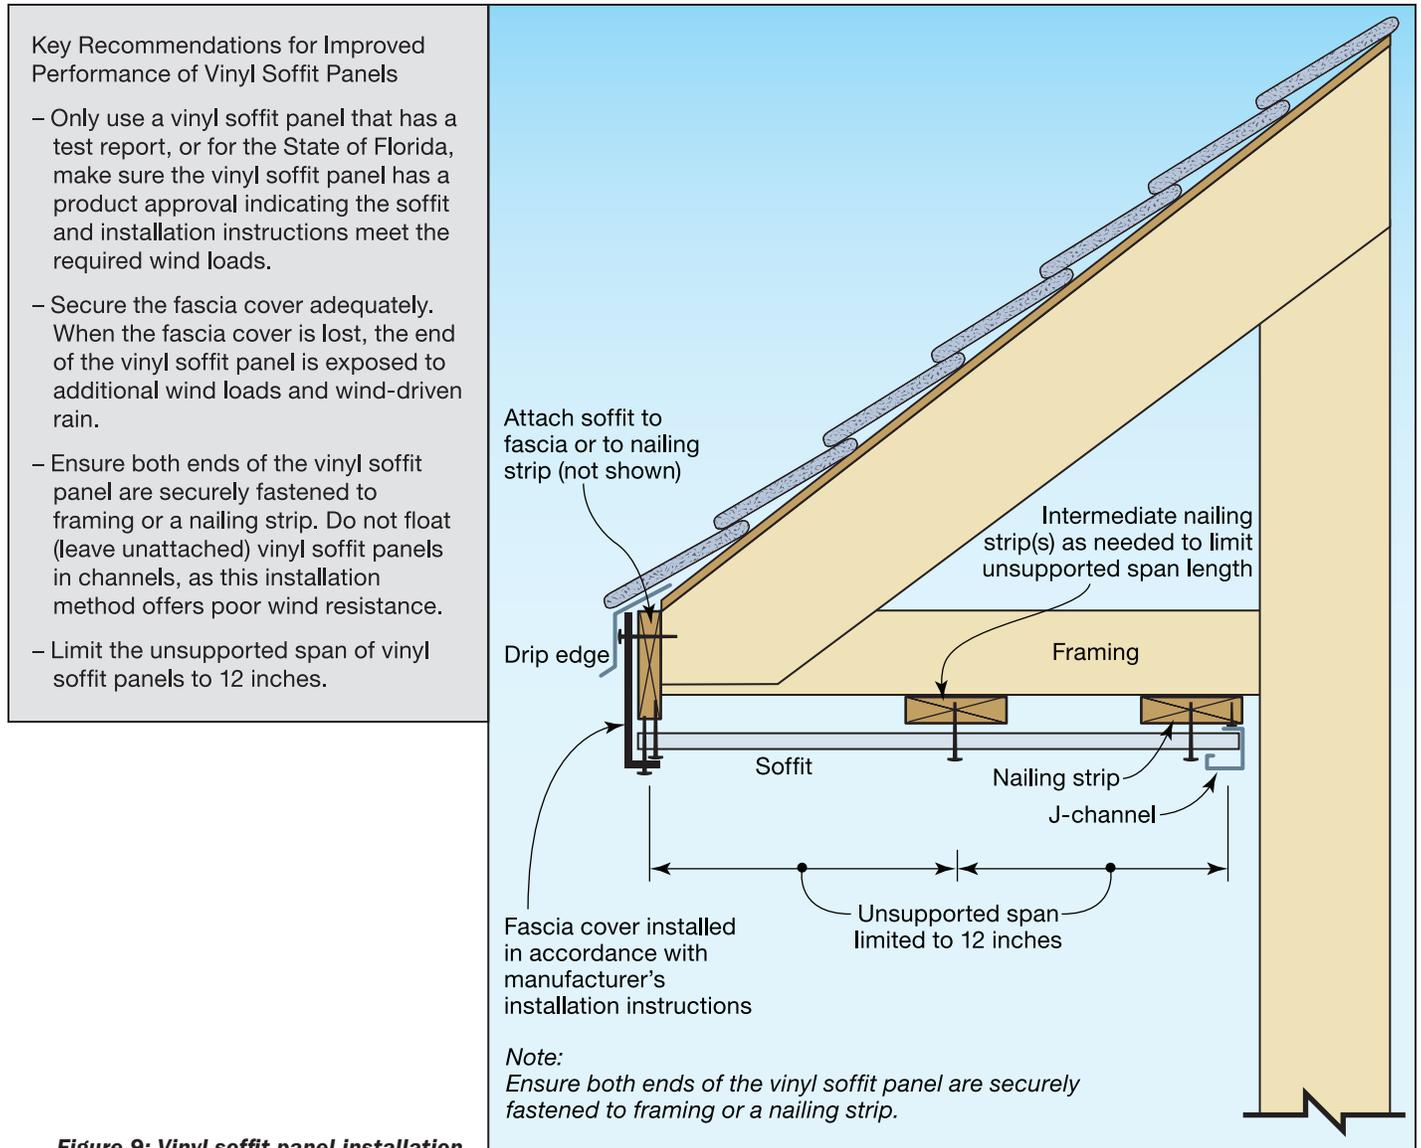
**Figure 9: Vinyl soffit panel installation**

Table 9 provides guidance that will help improve performance of soffits in high-wind areas. Figure 9 illustrates proper installation for vinyl soffit panels.

Item	Key Points	Source for Information / Guidance
Design	Determine the required wind loads. Use soffits that were designed or tested for wind loads specified for the adjacent walls. If appropriate, use a prescriptive option for wood structural panel soffits.	<ul style="list-style-type: none"> <li>Hurricane Irma in Florida Recovery Advisory 2, <i>Soffit Installation in Florida</i> (in FEMA P-2023, 2018)</li> </ul>
Testing and labeling	To reduce water intrusion, verify that soffit vents are tested for resistance to wind and wind-driven rain.	<ul style="list-style-type: none"> <li>ICC: TAS 100(A)</li> </ul>
Installation	At a minimum, fasten soffit panels at the wall and the fascia. Be sure to install fascia coverings in accordance with the manufacturers' installation instructions.	<ul style="list-style-type: none"> <li>Technical Fact Sheet No. 7.5, <i>Minimizing Water Intrusion Through Roof Vents in High-Wind Regions</i> (in FEMA P-499, 2010)</li> <li>This advisory: Figure 9, "Vinyl soffit panel installation"</li> </ul>
