Successfully Retrofitting Buildings for Wind Resistance

HURRICANE MICHAEL IN FLORIDA

Recovery Advisory 1, June 2019

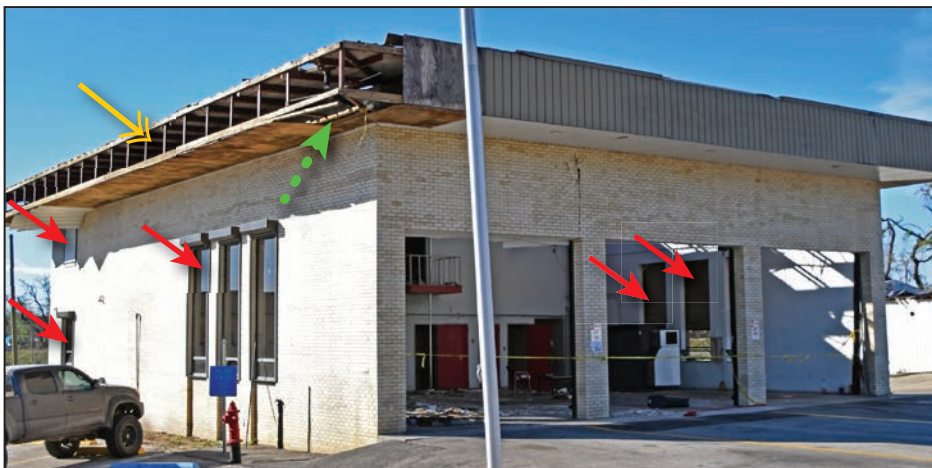
Figure 1: General view of the damaged fire station

The red arrows indicate the retrofitted storm shutters. Wind-driven rain entered the building at the damaged fascia and soffit (yellow and green arrows).

Overall effectiveness of the retrofit project. At the fire station and community building, the wind retrofit successfully protected windows, but the buildings as a whole were not protected and did not perform well. At both buildings, the roof membrane and several roof deck panels were blown off, as shown in Figure 4: Aerial view of the fire station and community building and Figure 5: Portions of the fire station’s fascia and soffit coverings, and their plywood substrate, were blown away (Figure 1: General view of the damaged fire station and Figure 5:). The damage to the fascia, soffit, and roof allowed wind-driven rain to enter the building. Figure 5: is a view from within the apparatus bay showing where several roof deck panels blew off. A built-up roof was installed over insulation boards attached to cementitious wood-fiber deck panels over steel joists. This type of roof deck on buildings of that era typically possess limited wind uplift resistance. The community

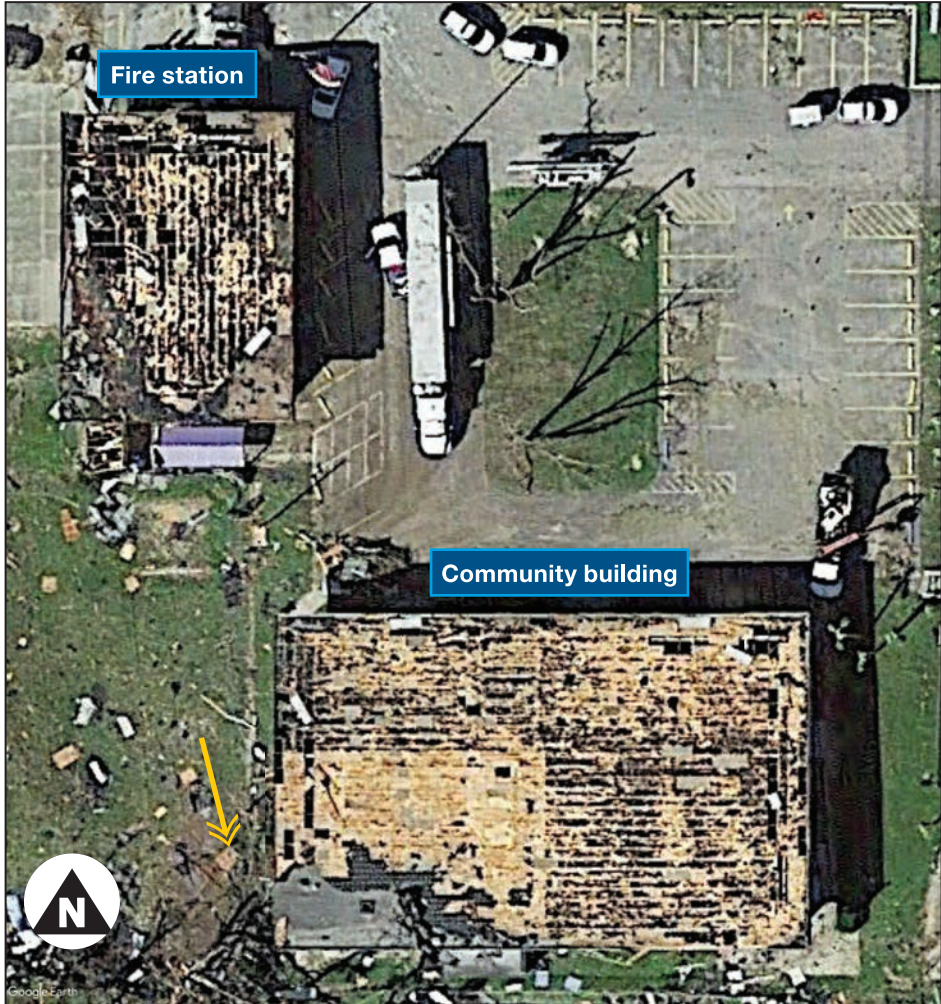
Figure 4: Aerial view of the fire station and community building

building suffered similar damage to the fire station (Figure 4).

Only a small portion of the roof membrane remained on both buildings. Several roof deck panels were blown off each building. The yellow double arrow indicates roof deck panels on the ground that became wind-borne debris.

Result. The community decided to demolish both the fire station and community center because of the damage that occurred during Hurricane Michael. The cost of repairing the fire station was estimated as more than 80 percent of the cost of a new building. Construction of a new fire station is expected to take 3 to 4 years because of competing budgeting priorities in the county due to hurricane damage.

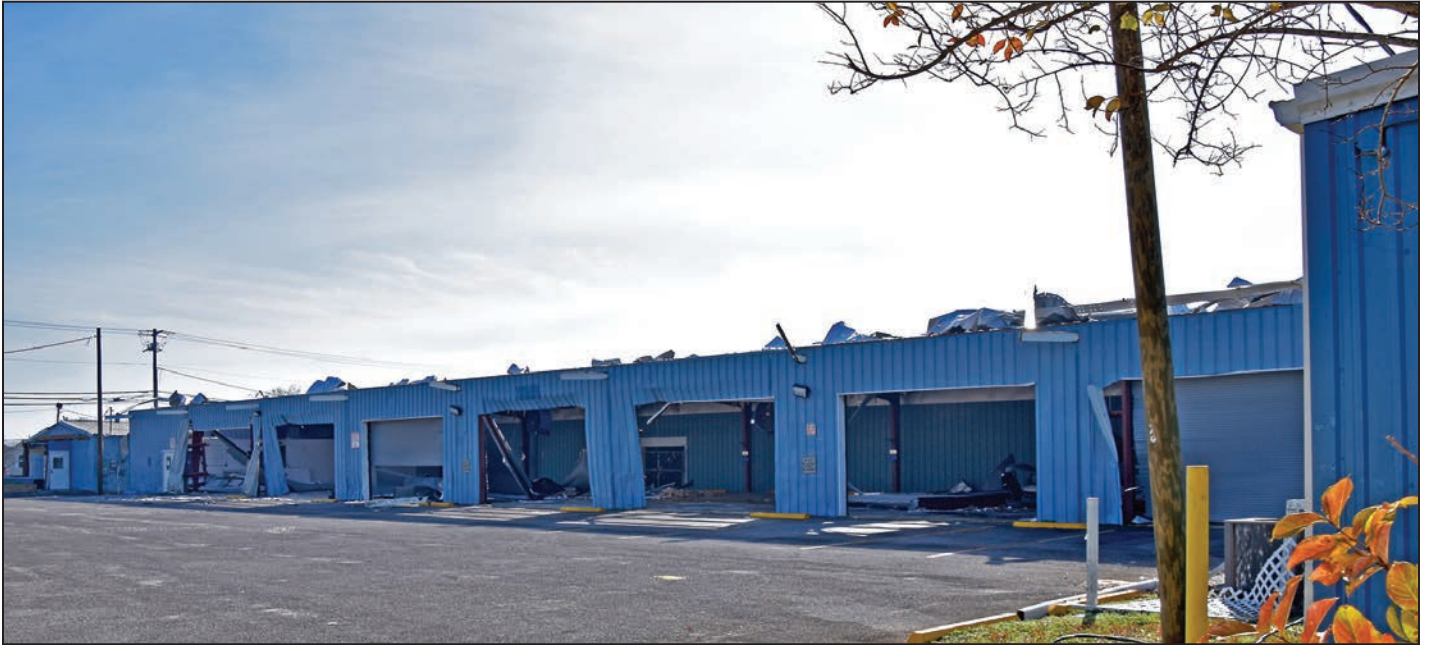
Performance of retrofitted elements. Figure 6: General view of the damaged retrofitted rolling doors and roof panel damage shows the portion of the building that was retrofitted with rolling doors. All of the seven retrofitted rolling doors failed. The door frames appeared to be adequately attached to the original steel rough opening framing members, but the rough opening members failed because they had inadequate wind resistance (Figure 7).

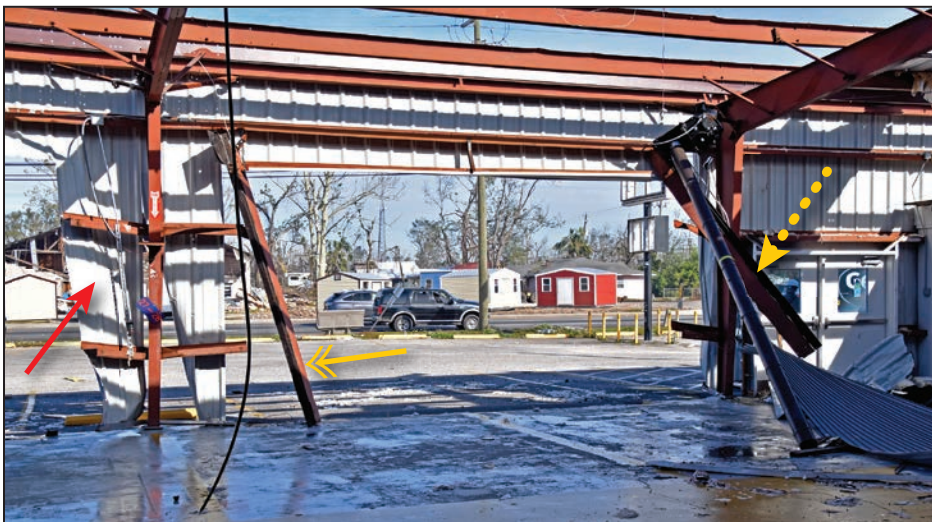
Figure 7: View of door failure caused by inadequate wind resistance of rough opening members

The yellow arrows indicate the failed rough opening jamb and header framing members. The red arrow indicates a missing rough opening jamb member at an adjacent door.

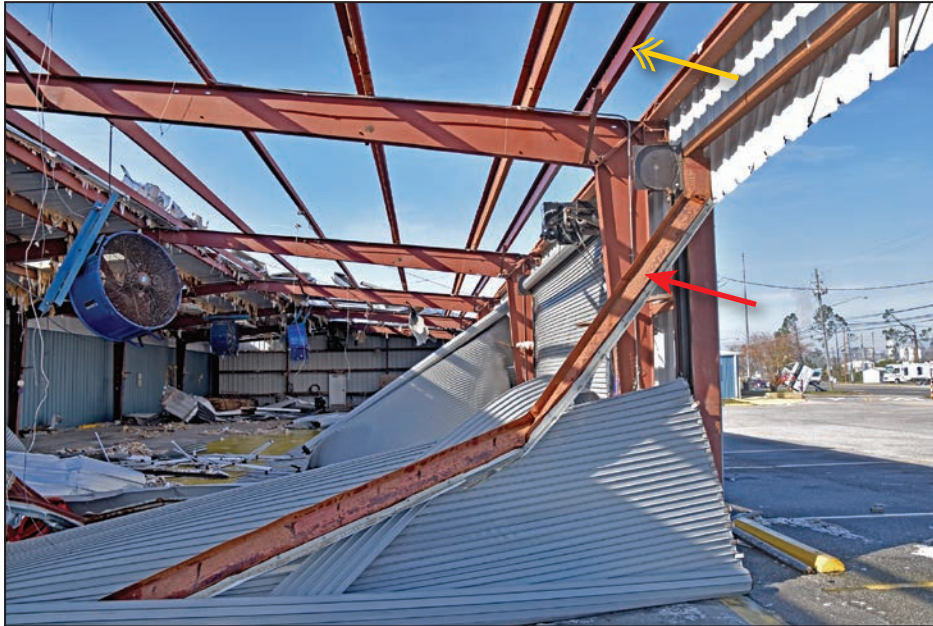
Figure 8:
View of the new purlin

The yellow double arrow indicates the added purlin to increase uplift resistance. The red arrow indicates a failed rough opening header.

Because earlier wind load code provisions were inadequate, older buildings often have insufficient wind uplift resistance in the roof corner and perimeter edge zones; therefore, it can be appropriate to strengthen wind uplift resistance in those zones. Although an additional roof purlin was installed in the perimeter edge zone in 2011 in an attempt to retrofit the roof framing (Figure 8:), the purlin retrofit was ineffective in preventing roof panel blow-off. A large number of roof panels (R-panels)² were blown off. The roof panels typically pulled over their exposed fasteners. Figure 9: shows an aerial view of the main building complex at the fairground in which the roof damage is visible.

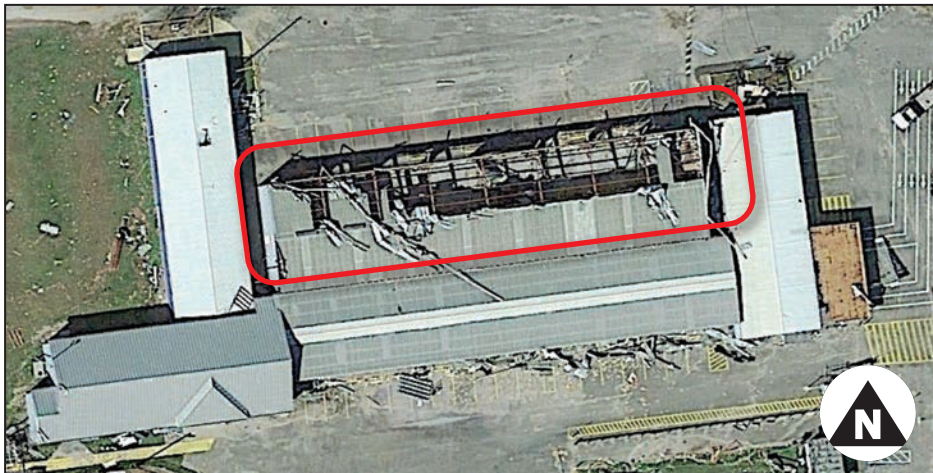
Figure 9:
Aerial view of the main building complex

The area shown in Figures 6 through 8 is within the red rectangle. The door and purlin retrofit work was insufficient to prevent significant damage.

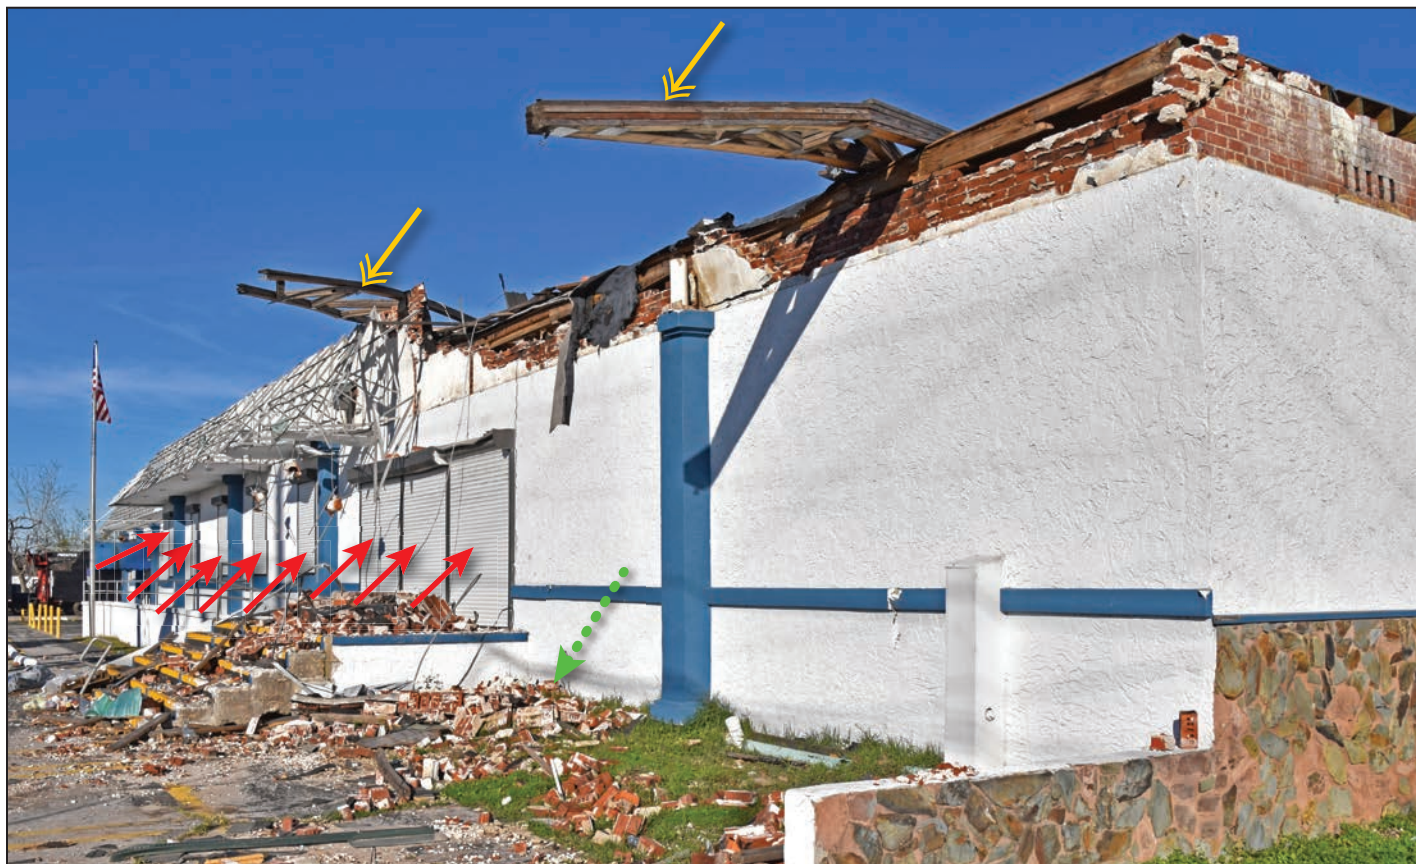
Figure 10: Roll-down shutters were not damaged during Hurricane Michael, but trusses failed

Performance of retrofitted element. There was no apparent damage to the retrofitted storm shutters during the hurricane, but they did not appear to be struck by wind-borne debris (most of them were on the leeward side of the building) (Figure 10).

The red arrows indicate the retrofitted storm shutters. Two roof trusses are indicated by the yellow double arrows; the other trusses were blown off the roof. The green dashed arrow indicates collapsed brick.

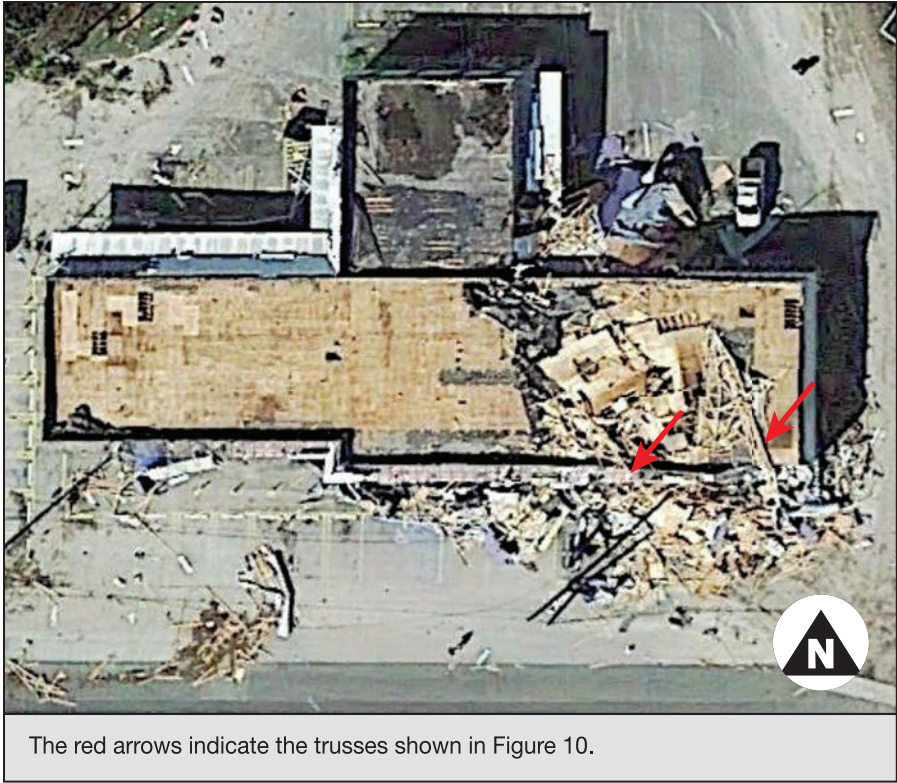
Figure 11: Aerial view of the police station is an aerial view of the building. The wind retrofit performed in 2011 did not achieve its intended purpose because the structural deficiencies were not mitigated at the time the roll-down shutters were installed.

The red arrows indicate the trusses shown in Figure 10.

Result. Repairing the damage caused by Hurricane Michael was determined not to be cost effective, so the building was demolished. The building owner indicated that it is likely to be 3 to 4 years before a new facility is constructed.

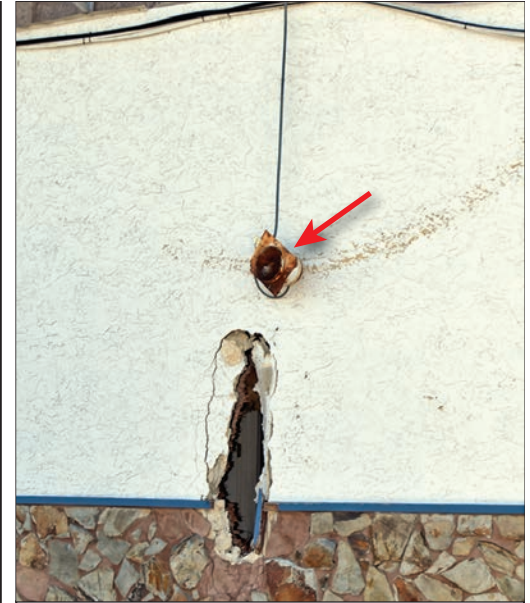
Figure 12: Wall penetrated by wind-borne debris

Overall effectiveness of retrofit project. Other portions of the building were not strengthened when the shutters were retrofitted, and the building suffered significant damage during the hurricane as a result. Specifically, the roof trusses were not retrofitted. All of the trusses that supported the sloped roof were blown away (Figure 10: Roll-down shutters were not damaged during Hurricane Michael, but trusses failed). With loss of the entire sloped roof structure, rain was able to enter throughout the building. Also, high-momentum wind-borne debris struck an adjacent wall (Figure 12: Wall penetrated by wind-borne debris).³

The white portion of the wall was stucco over metal lath over plywood over studs. The debris penetrated the interior gypsum board sheathing. The red arrow indicates a dangling light fixture that fell from the soffit.

³ If building operations criteria call for no debris entry through walls, walls could be retrofitted to increase debris resistance.

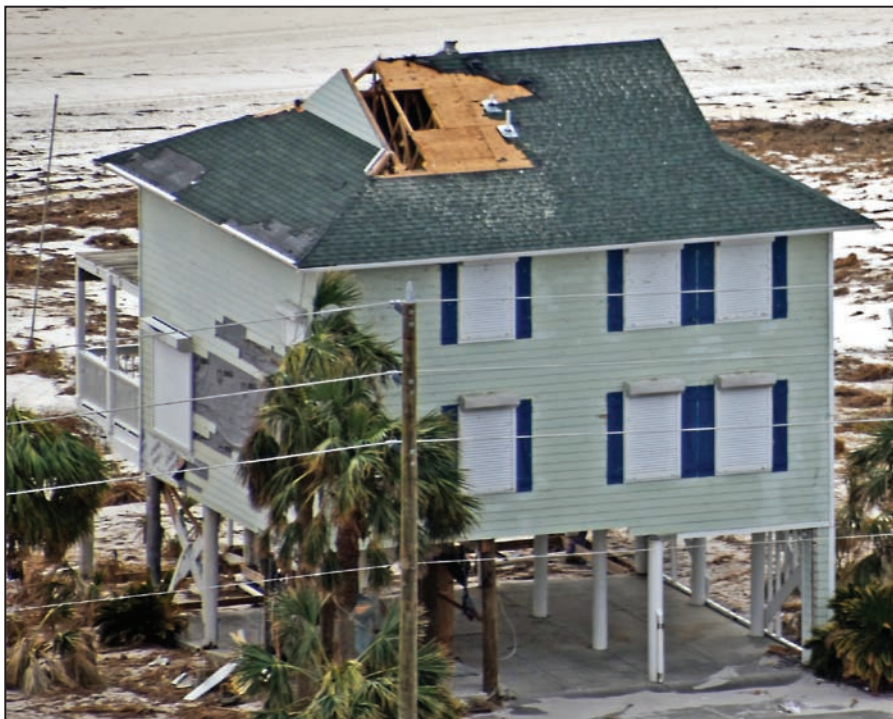
Based on available records, the residence shown in Figure 13: Residence where retrofitted shutters performed well, but significant damage was sustained when rain entered at blown-off roof deck panels (Port St. Joe, FL) was constructed around 1994. It was retrofitted with roll-down storm shutters at an unknown time.

Performance of retrofitted elements. There was no apparent damage to the retrofitted roll-down storm shutters during the hurricane, but they may not have been struck by wind-borne debris.

Overall effectiveness of retrofit project. The roof decking was not retrofitted at this residence, and as a result, roof deck panels were blown off during the hurricane. The wind retrofit of the shutters was ultimately ineffective for this residence because a significant amount of rain entered the building when the roof was damaged by wind.

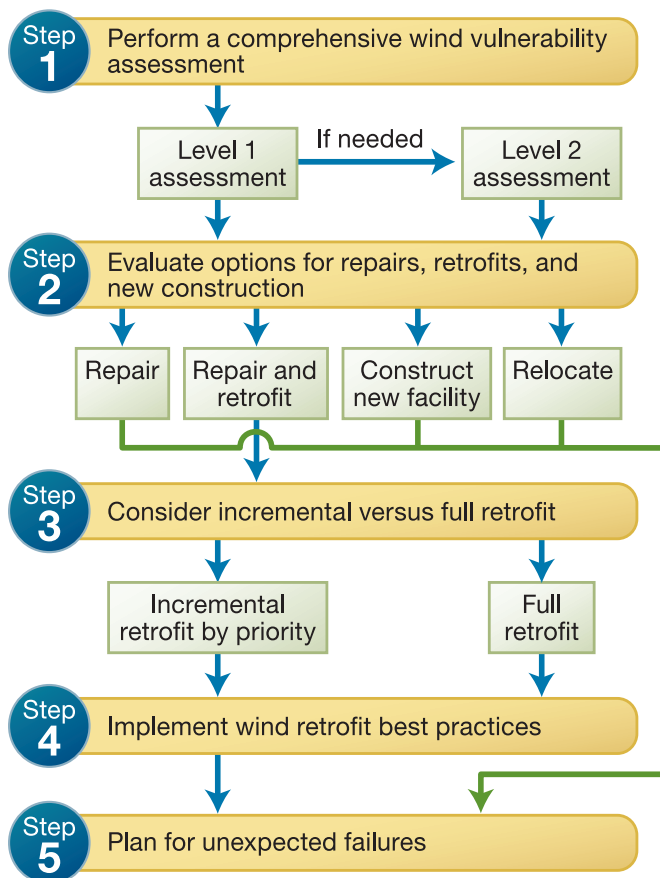
Figure 14: Flowchart showing five-step approach to improving wind resistance

To achieve the intended performance level, all building elements that may be vulnerable to wind damage should be identified, and a comprehensive plan for executing the needed retrofits should be developed. The five-step process outlined in Figure 14 is an approach for consideration.

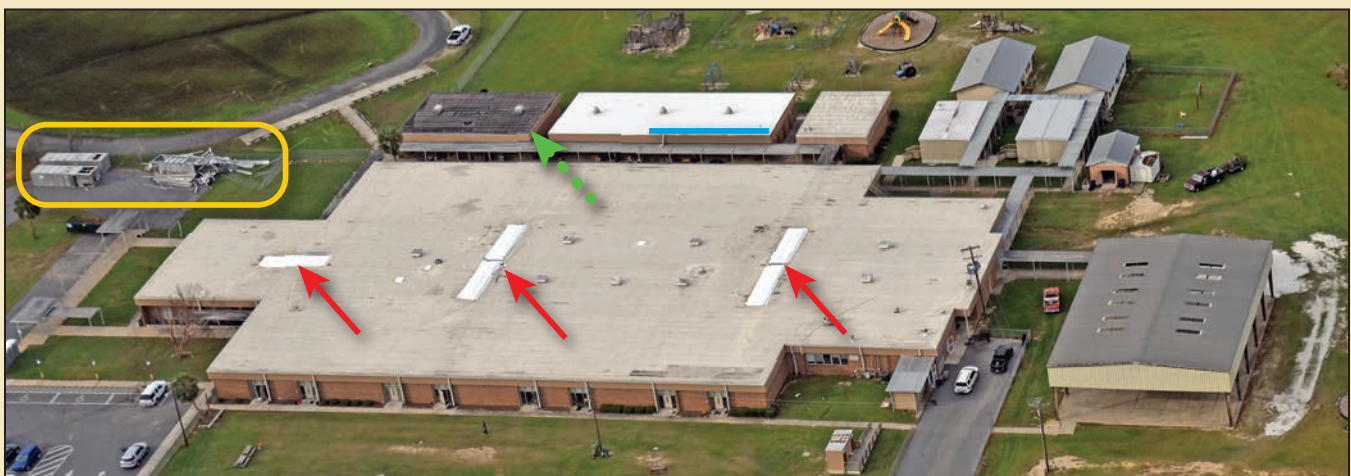
STEP 2: EXAMPLE OF A DAMAGED BUILDING THAT COULD BE EVALUATED PER THE FOUR OPTIONS OF STEP 2

This Blountstown, FL, school opened in 1970 and was damaged during Hurricane Michael. This building offers an example of a damaged building that could be evaluated using the four options of Step 2.

The building had cementitious wood-fiber roof deck panels over steel joists (the same type of deck/structure shown in Figure 5:). The three large HVAC units that blew off their curbs were moved to the area within the yellow rectangle; one unit blew off the roof and damaged the wall of another building, indicated by the green arrow. Water entered the school at the open curbs (shown as white areas [red arrows] where there are temporary patches over the curbs on which the three units sat before the storm) and at several locations where the wind-borne equipment tore the roof membrane. At least one window was broken by wind-borne debris. The blue line indicates where metal edge flashing blew off. Some of the smaller pieces of rooftop equipment were also damaged. There were numerous roof punctures in the main roof area.

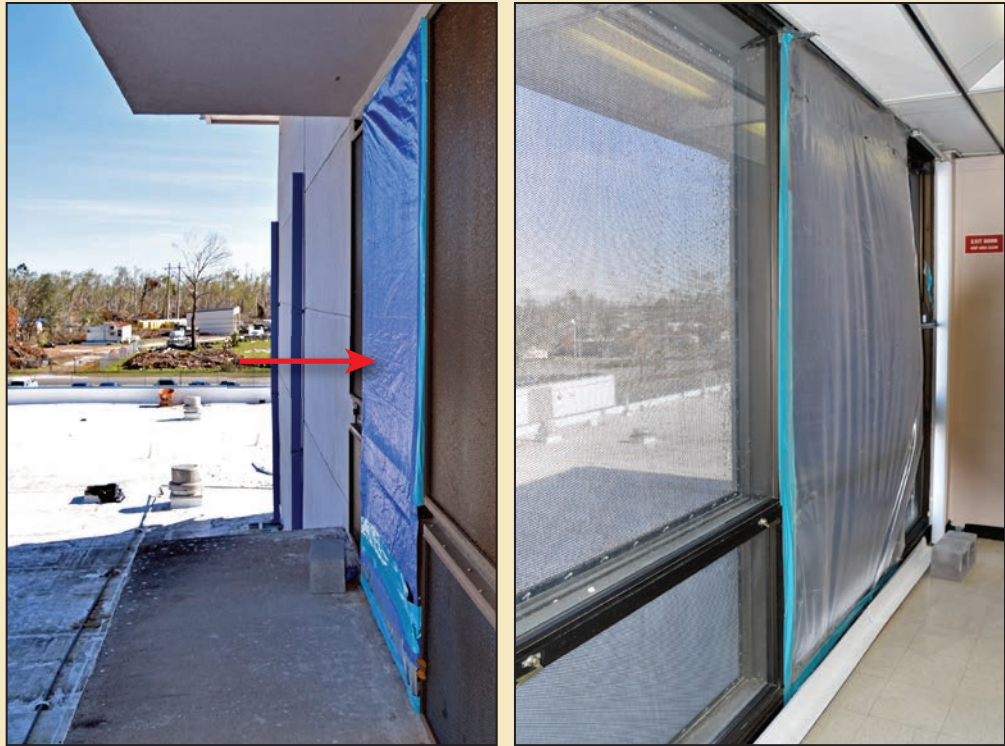
View of a window that failed under positive wind pressure

This school in Panama City, FL, was retrofitted with permanently mounted screen shutters. At one of the windows protected by a screen, positive pressure caused the failure of the window frame, and glass was blown into the room, injuring two occupants.

The left photo is a view of windows protected by permanently mounted screen shutters. The red arrow indicates the primary wind direction during the hurricane. The right photo is a view of the window that failed due to positive pressure exceeding the resistance of the window frame.

As a best practice, it is recommended that existing windows be replaced with new tested window assemblies rather than installing shutters if the existing windows do not possess sufficient wind pressure resistance. For facilities that cannot tolerate entrance of wind-driven rain, existing windows can be field tested to evaluate leakage potential (part of a Level 2 evaluation) or can be replaced with windows that comply with American Architectural Manufacturers Association (AAMA) 520, *Voluntary Specification for Rating the Severe Wind-Driven Rain Resistance of Windows, Doors and Unit Skylights* (2012).⁷

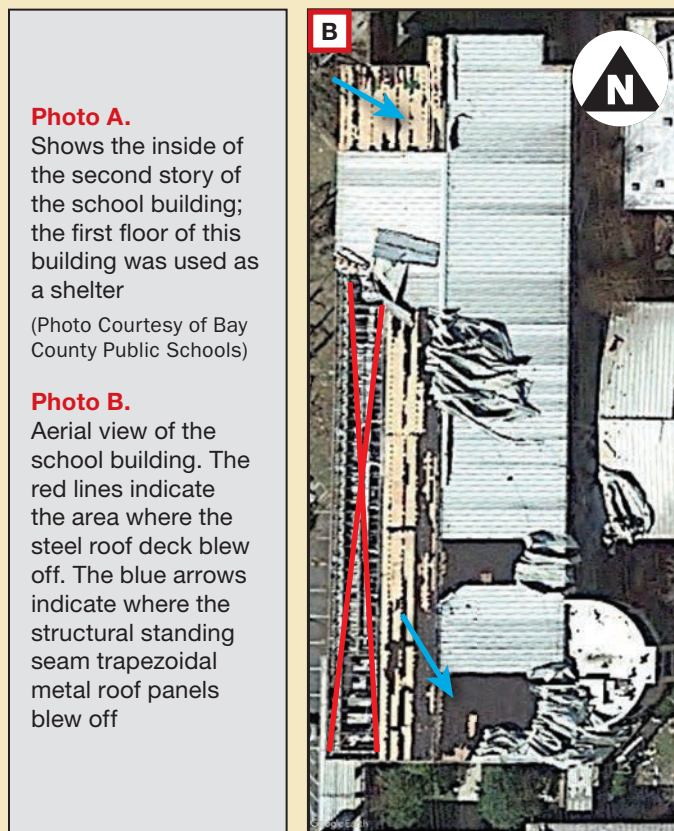
Photo A. Shows the inside of the second story of the school building; the first floor of this building was used as a shelter

While the occupants remained safe on the first floor during the hurricane, the steel roof deck blew off the second floor (Photo A). Floor assemblies generally provide greater overhead protection than roof assemblies, so using the first floor for sheltering benefitted the occupants. However, once the roof deck was lost, occupants were evacuated and relocated to a nearby building.

Because building occupants were in the building during the hurricane, it can be assumed the roof failure was unexpected. The failure of the roof offers an example of an unexpected failure that highlights the need for contingency planning. A contingency plan for a building that is occupied during a hurricane such as this one could be used to specify a plan of action should the building become damaged, including relocating occupants to an undamaged portion of the building or evacuation under certain damage conditions.
