## **FINDING OF NO SIGNIFICANT IMPACT**

### **Environmental Assessment for the Pheasant Branch Creek Trail, Bridges, and Streambank Restoration Project Middleton, Dane County, Wisconsin Public Assistance Program Federal Emergency Management Agency, Department Of Homeland Security Disaster #DR-4402-WI, Project # 88229, PW 593**

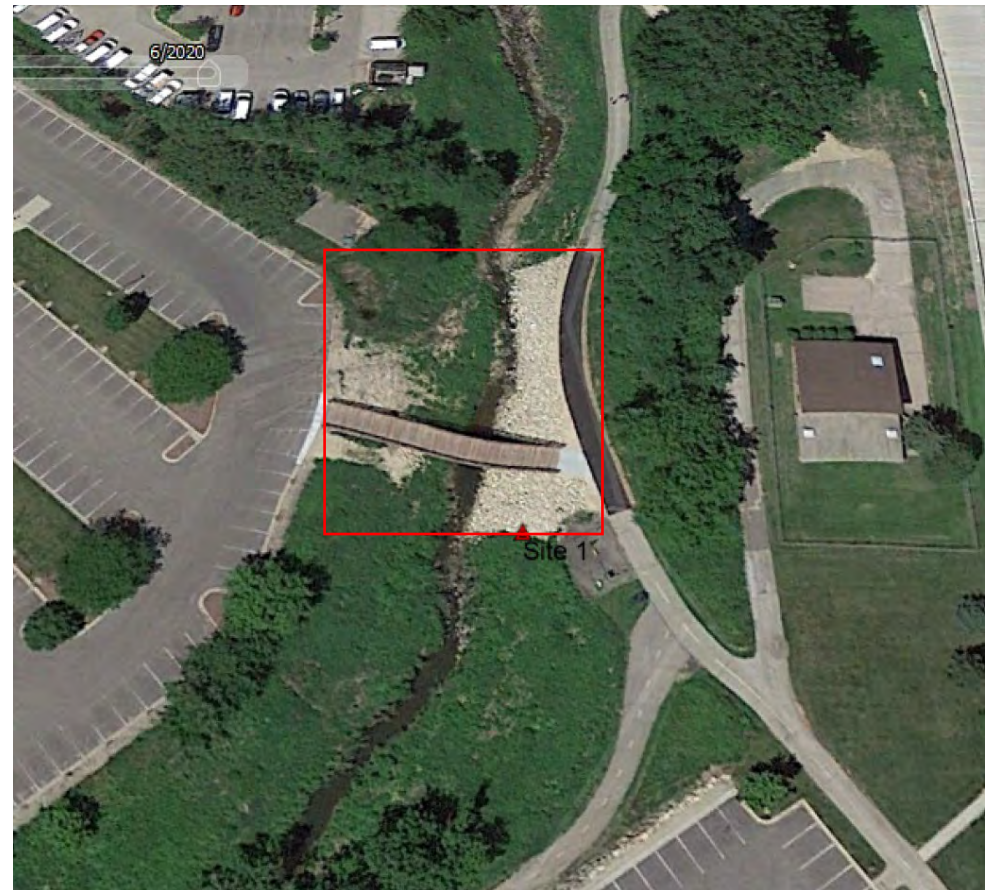
Figure 4: Site 1, (43.09109, -89.53173), action area marked in red. Reset pedestrian bridge on new abutment with stone toe protection. Work completed in summer 2020. Google Earth Aerial, 2018 (directly after flooding event) and 2020 (after repairs completed).

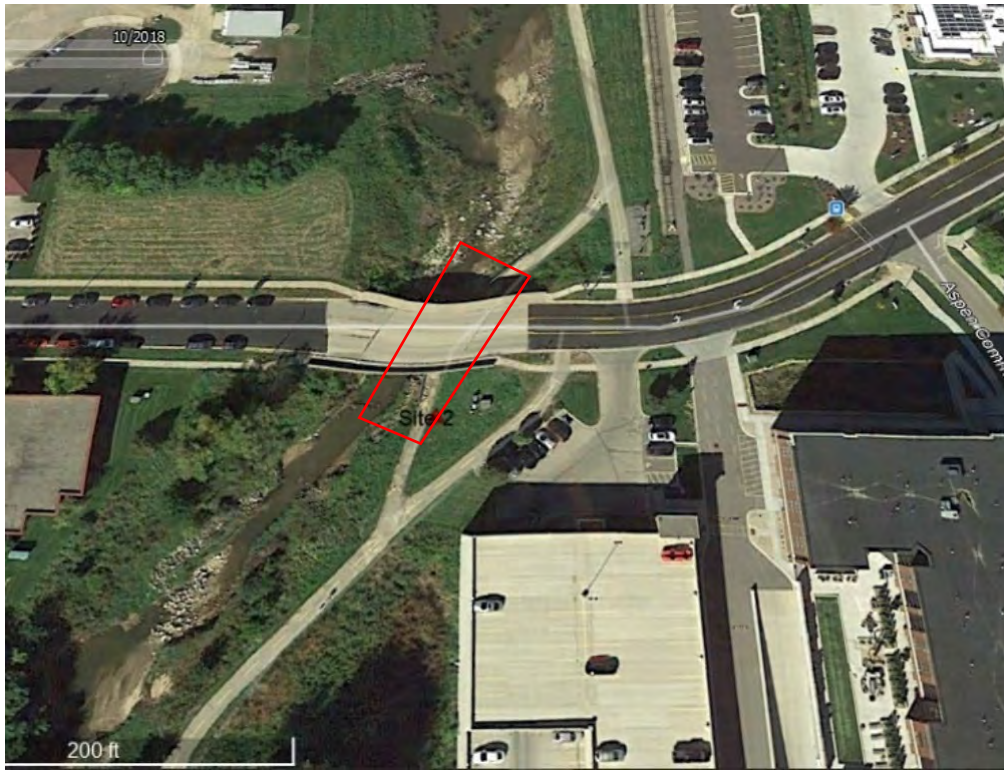
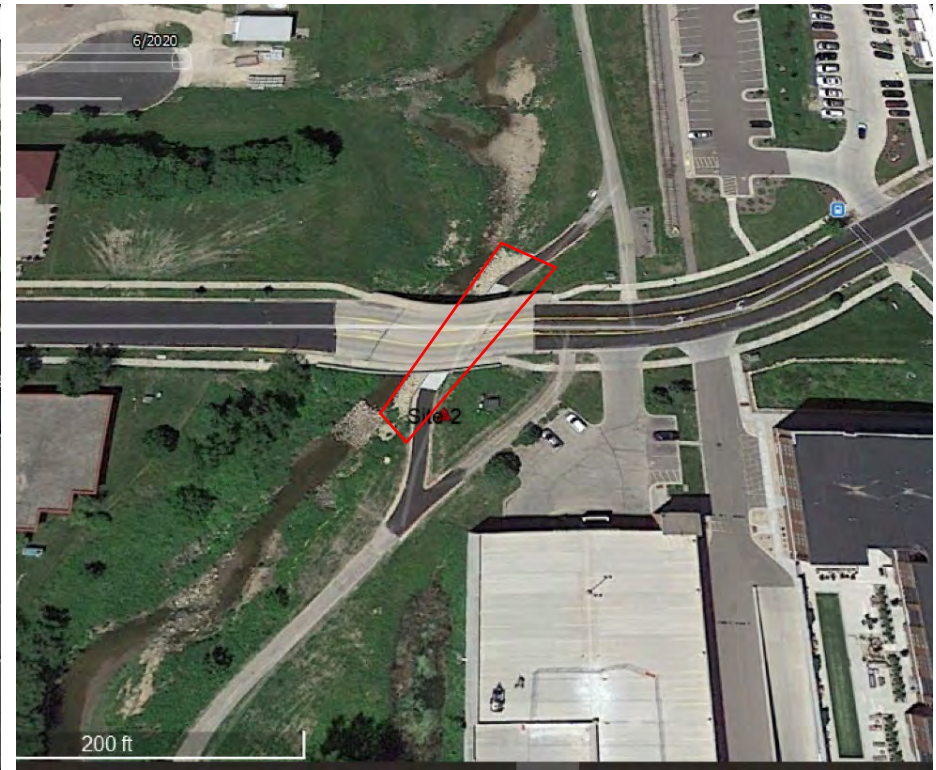
Figure 5: Site 2, (43.09257, -89.53106), action area marked in red. Rip-rap replaced under Market Street bridge. Section of asphalt recreation trail was resurfaced. Work completed in summer 2020. Google Earth Aerial, 2018 (directly after flooding event) and 2020 (after repairs completed).

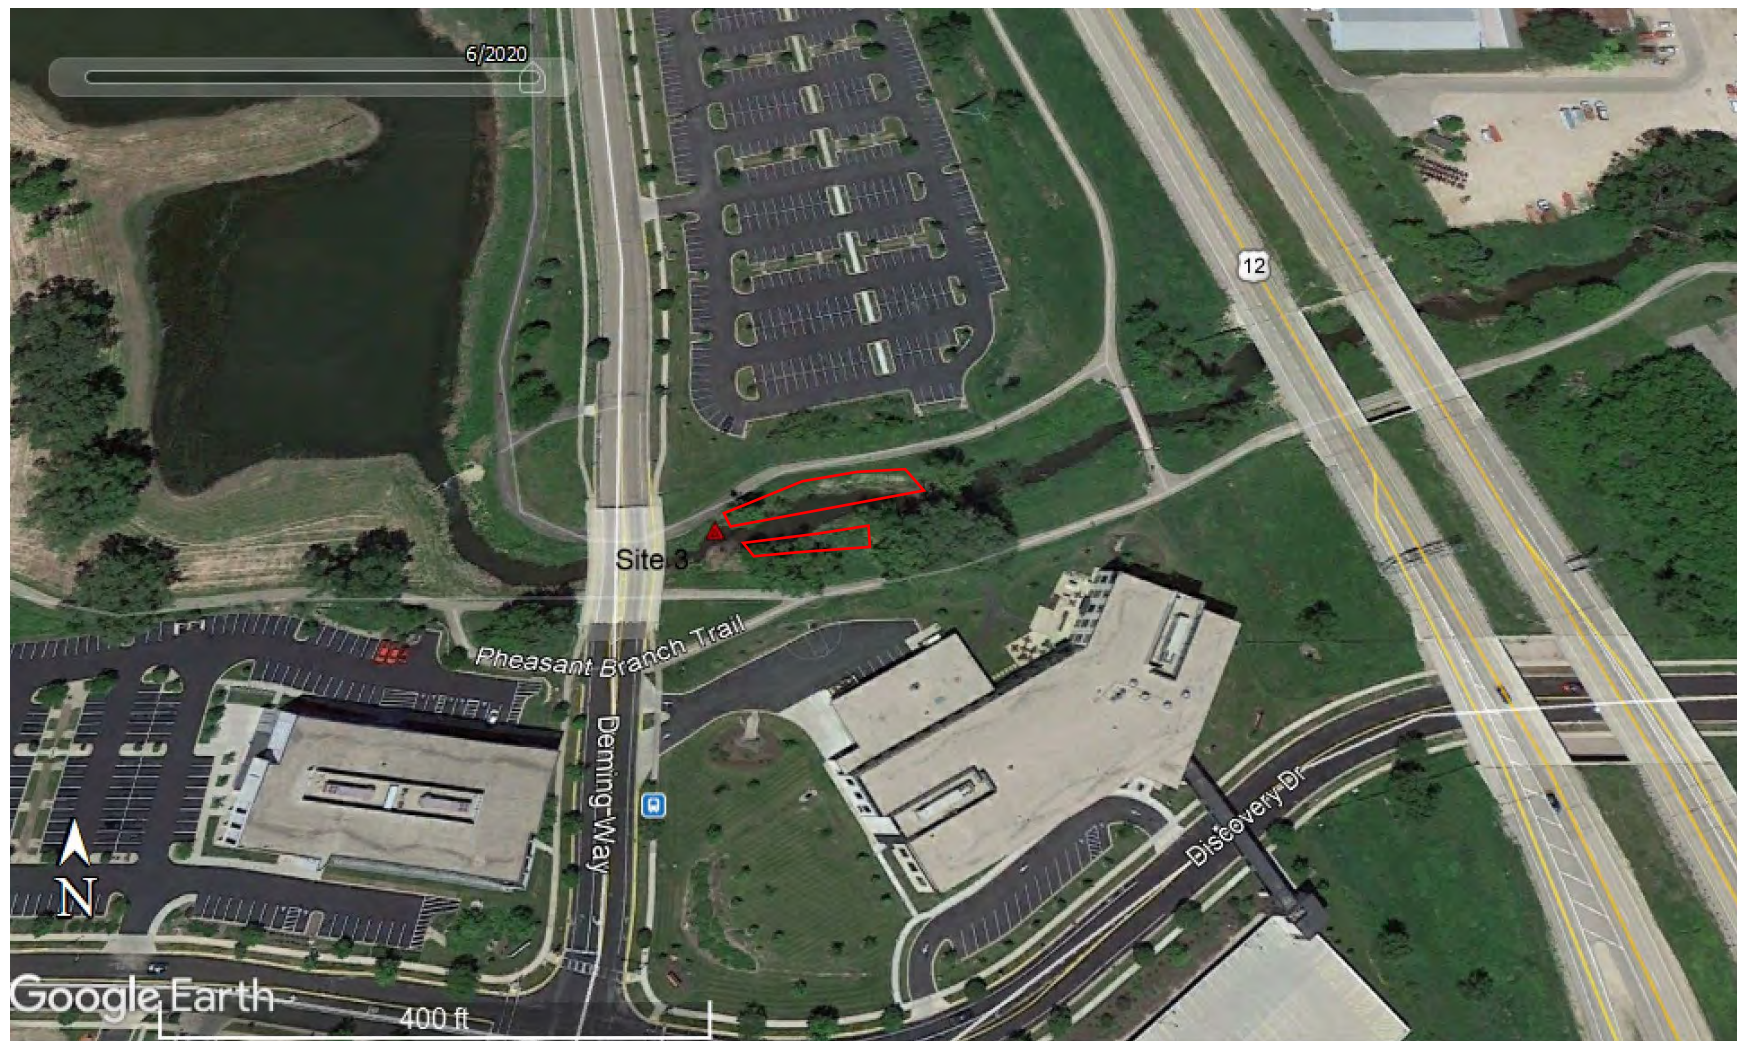
Figure 7: Site 3, Station 0+00 to 6+50 (43.10268, -89.51803), action area marked in red. Stone toe protection and slope grading on north and south banks. Google Earth Aerial, 2020 data.

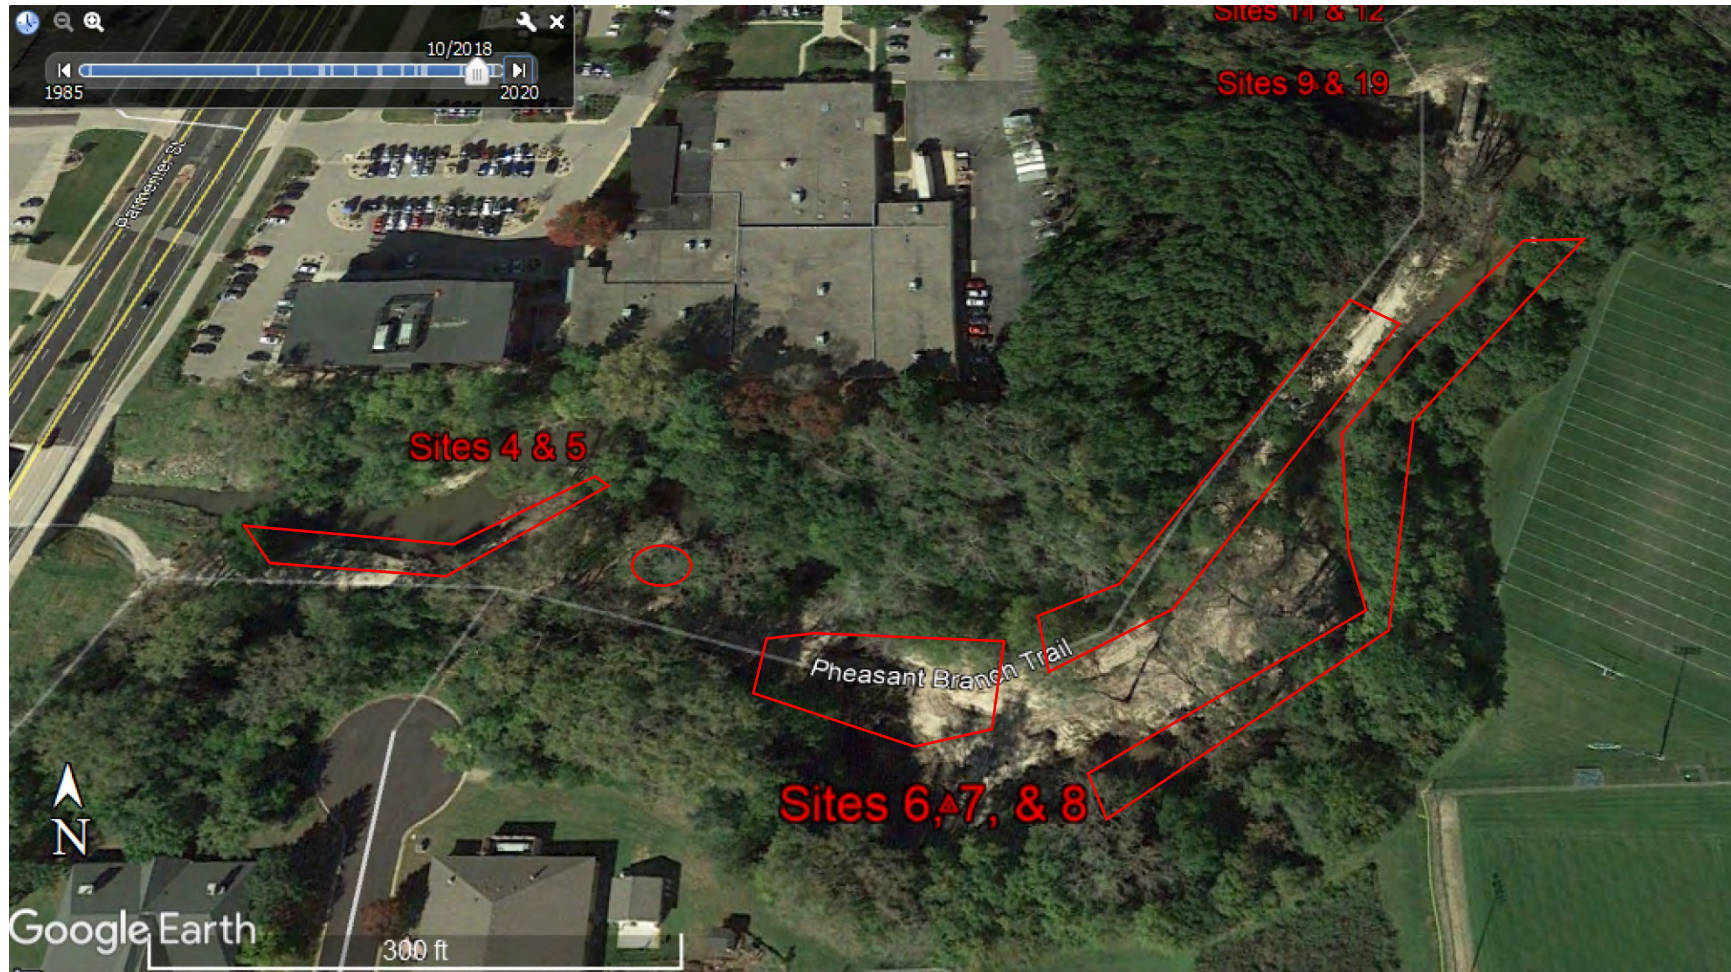
Figure 3: Sites 4&5, Station 23+50 to 29+00 (43.10340, -89.51008) and Sites 6, 7, and 8, Station 29+00 to 36+50 (43.10264, -89.50896), action area marked in red. Stone toe protection and slope grading on south banks. Replacement of pedestrian bridge and asphalt trail. Google Earth Aerial, 2018 data (directly after flooding event).

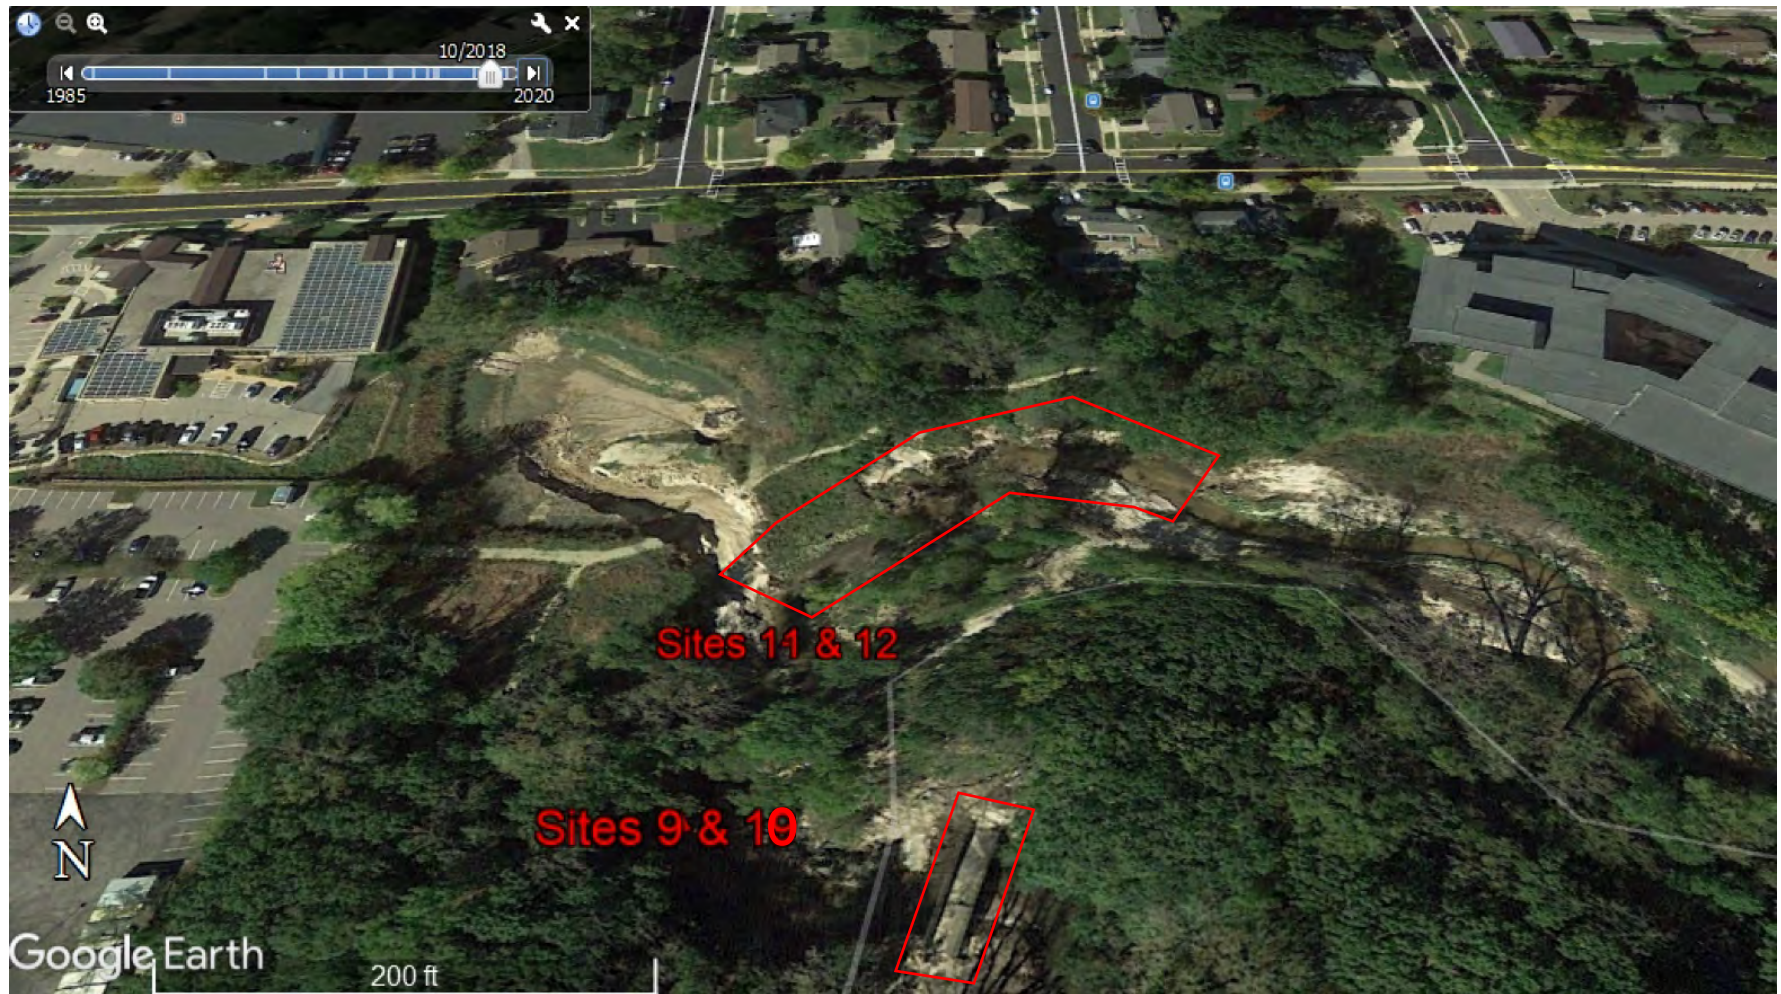
Figure 9: Sites 9&10, 36+50 to 41+50 (43.10432, -89.50780), Sites 11&12, 41+50 to 47+50 (43.10476, -89.50767) to (43.10517, -89.50693). Action area marked in red. Stone toe protection and slope grading on east bank and proposed root wad composite on west bank. Replacement of asphalt pedestrian trail. Google Earth Aerial, 2020 data.

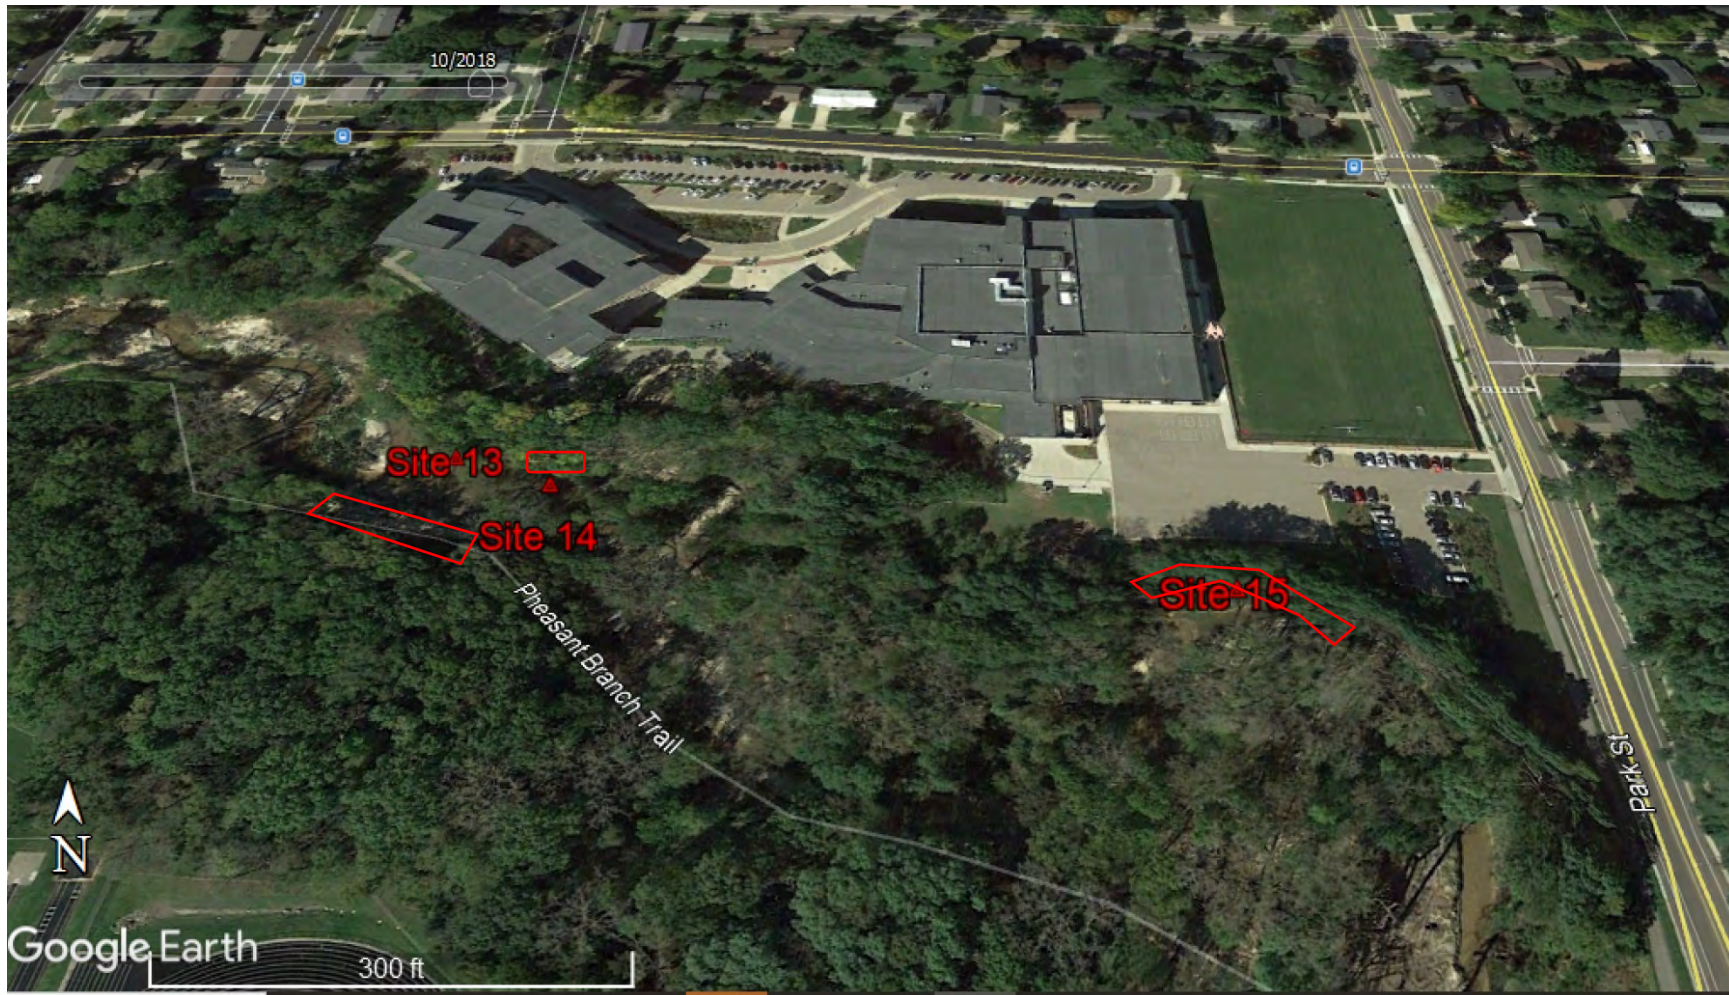
Figure 10: Site 13, 47+50 to 51+50 (43.10446, -89.50564), Site 14, 51+50 to 59+50 (43.10437, -89.50533), and Site 15 59+50 to 67+50 (43.10401, -89.50334). Action area marked in red. Stone toe protection and slope grading on south bank, replacement of sheet pile on north bank, and replacement of asphalt pedestrian trail. Google Earth Aerial, 2018 data.

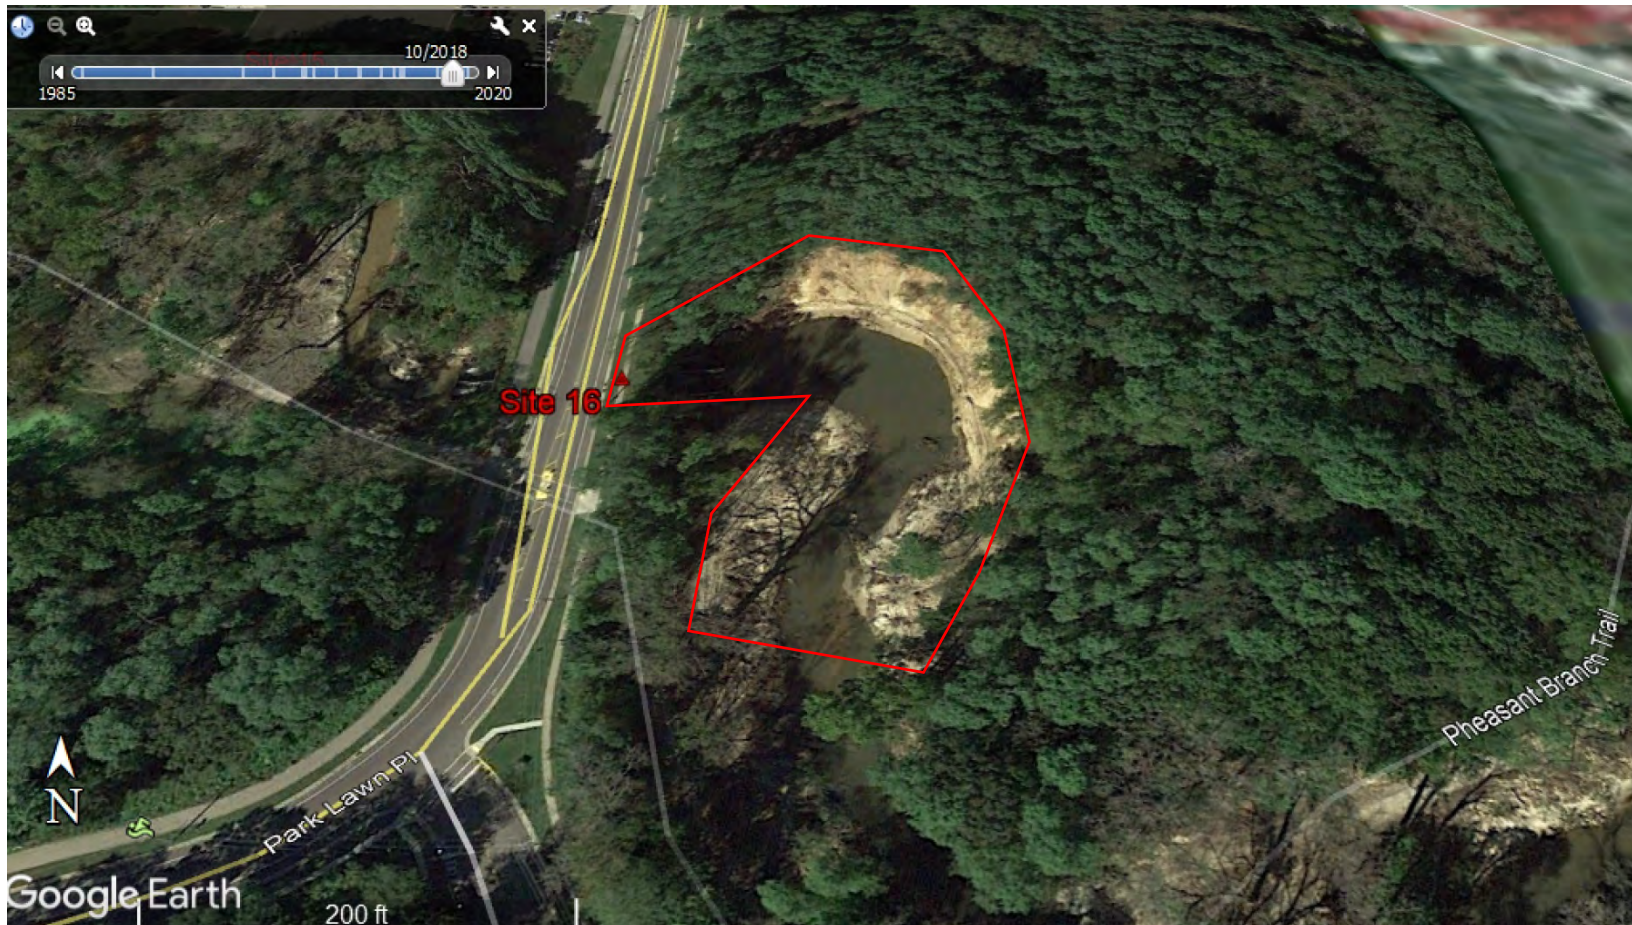
Figure 11: Site 16, 67+50 to 73+00 (43.103024, -89.502220 to (43.102802, -89.501125). Action area marked in red. Proposed streambank grading. Google Earth Aerial, 2018 data.

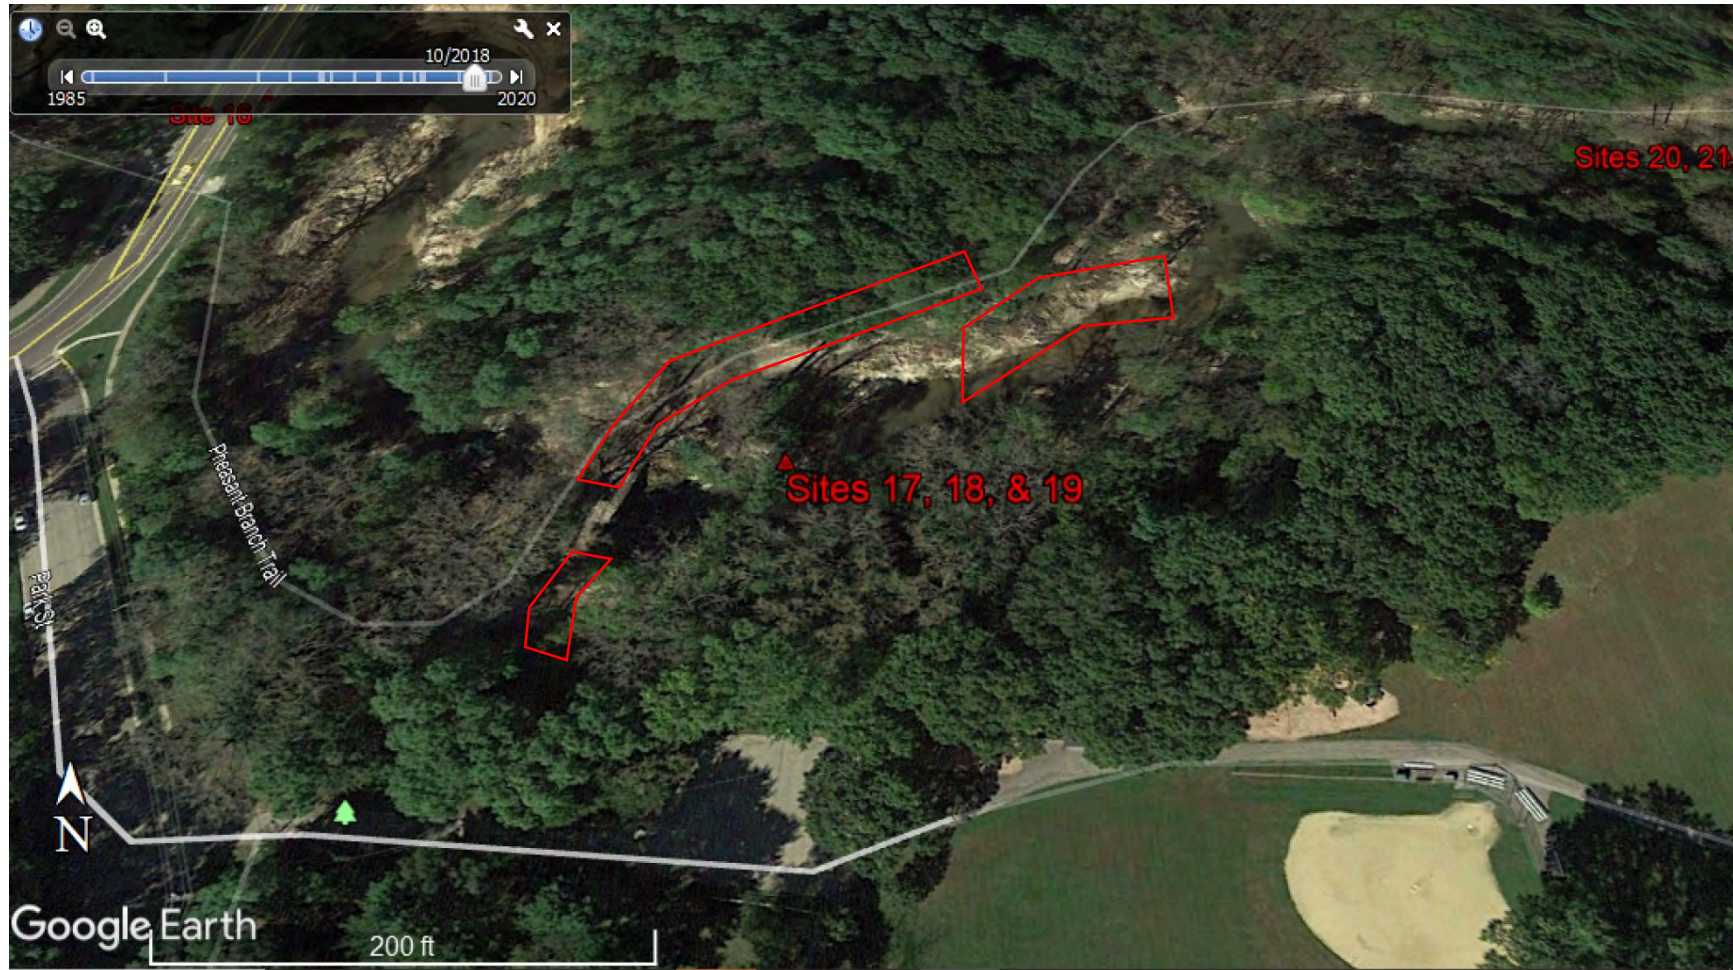
Figure 12: Site 17, 18, & 19, 73+00 to 80+00 (43.10190, -89.50077 to 43.10266, -89.49984). Action area marked in red. Stone toe protection and slope grading on south bank, replacement of sheet pile on north bank, and replacement of asphalt pedestrian trail. Google Earth Aerial, 2014 data.

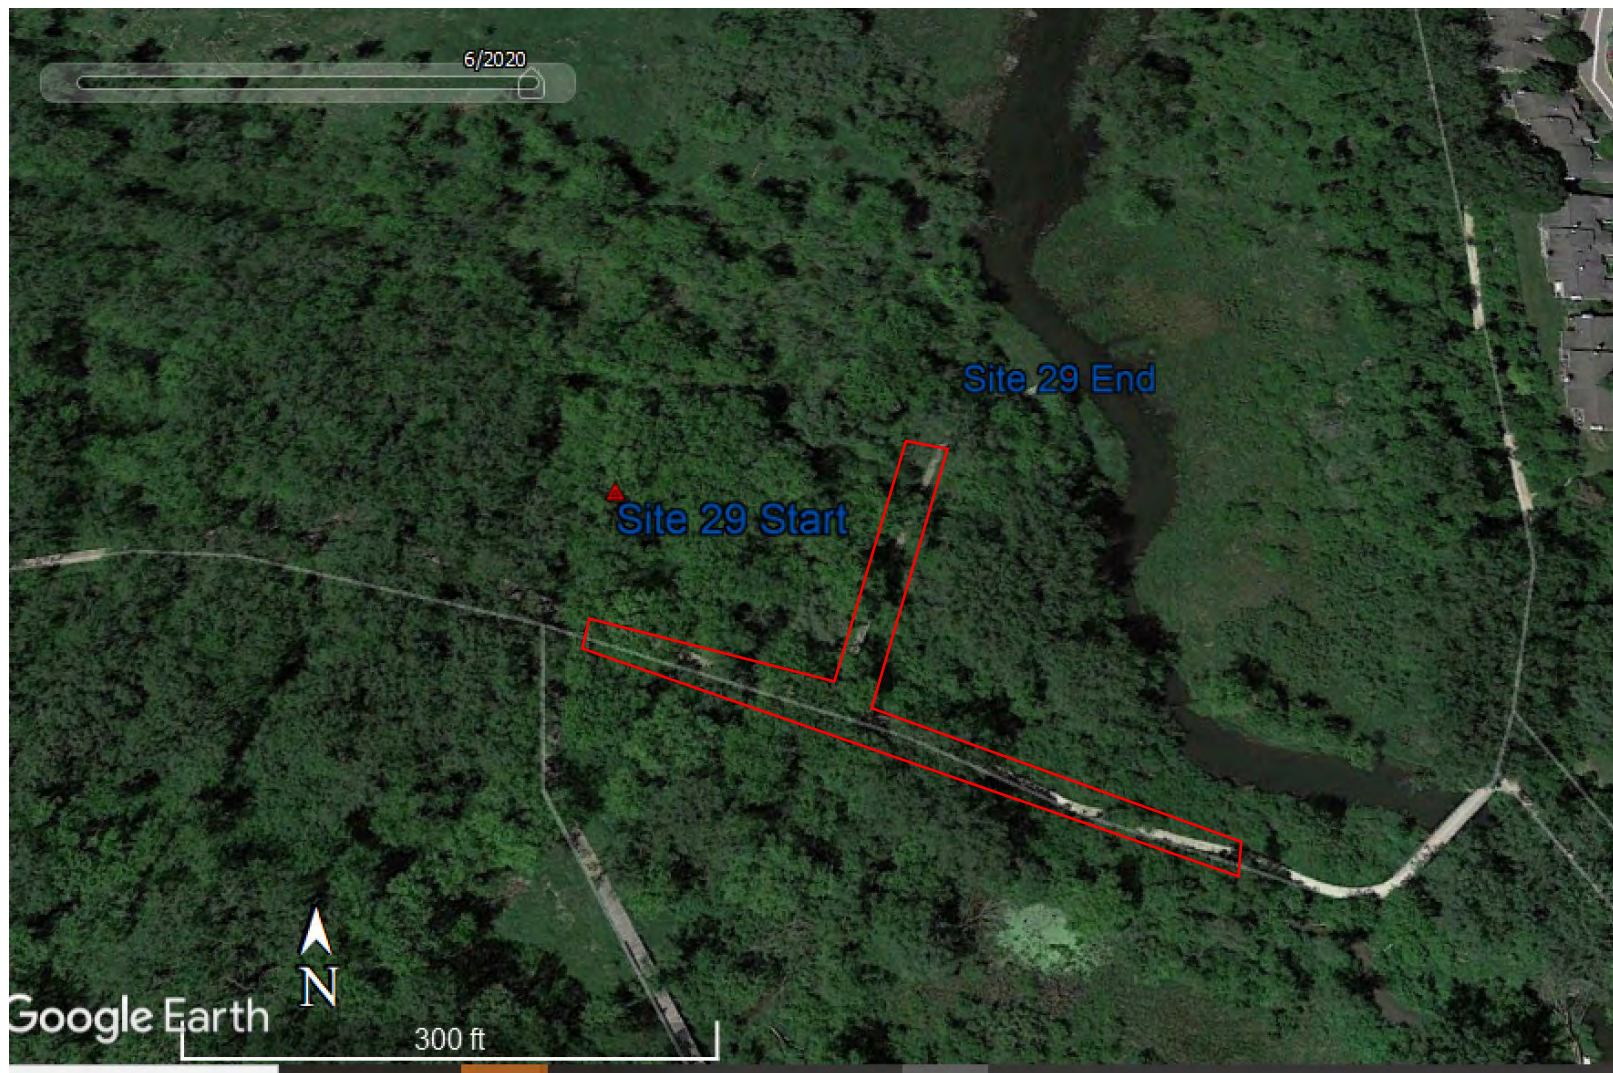
Figure 17: Site 29 (43.10872, -89.48625 to 43.10915, -89.48410). Action area marked in red. Replacement of erosion mat, fill, and root wad intermittently on east and west bank. Replacement of trail surface and pedestrian bridge. Google Earth Aerial, 2020 data.

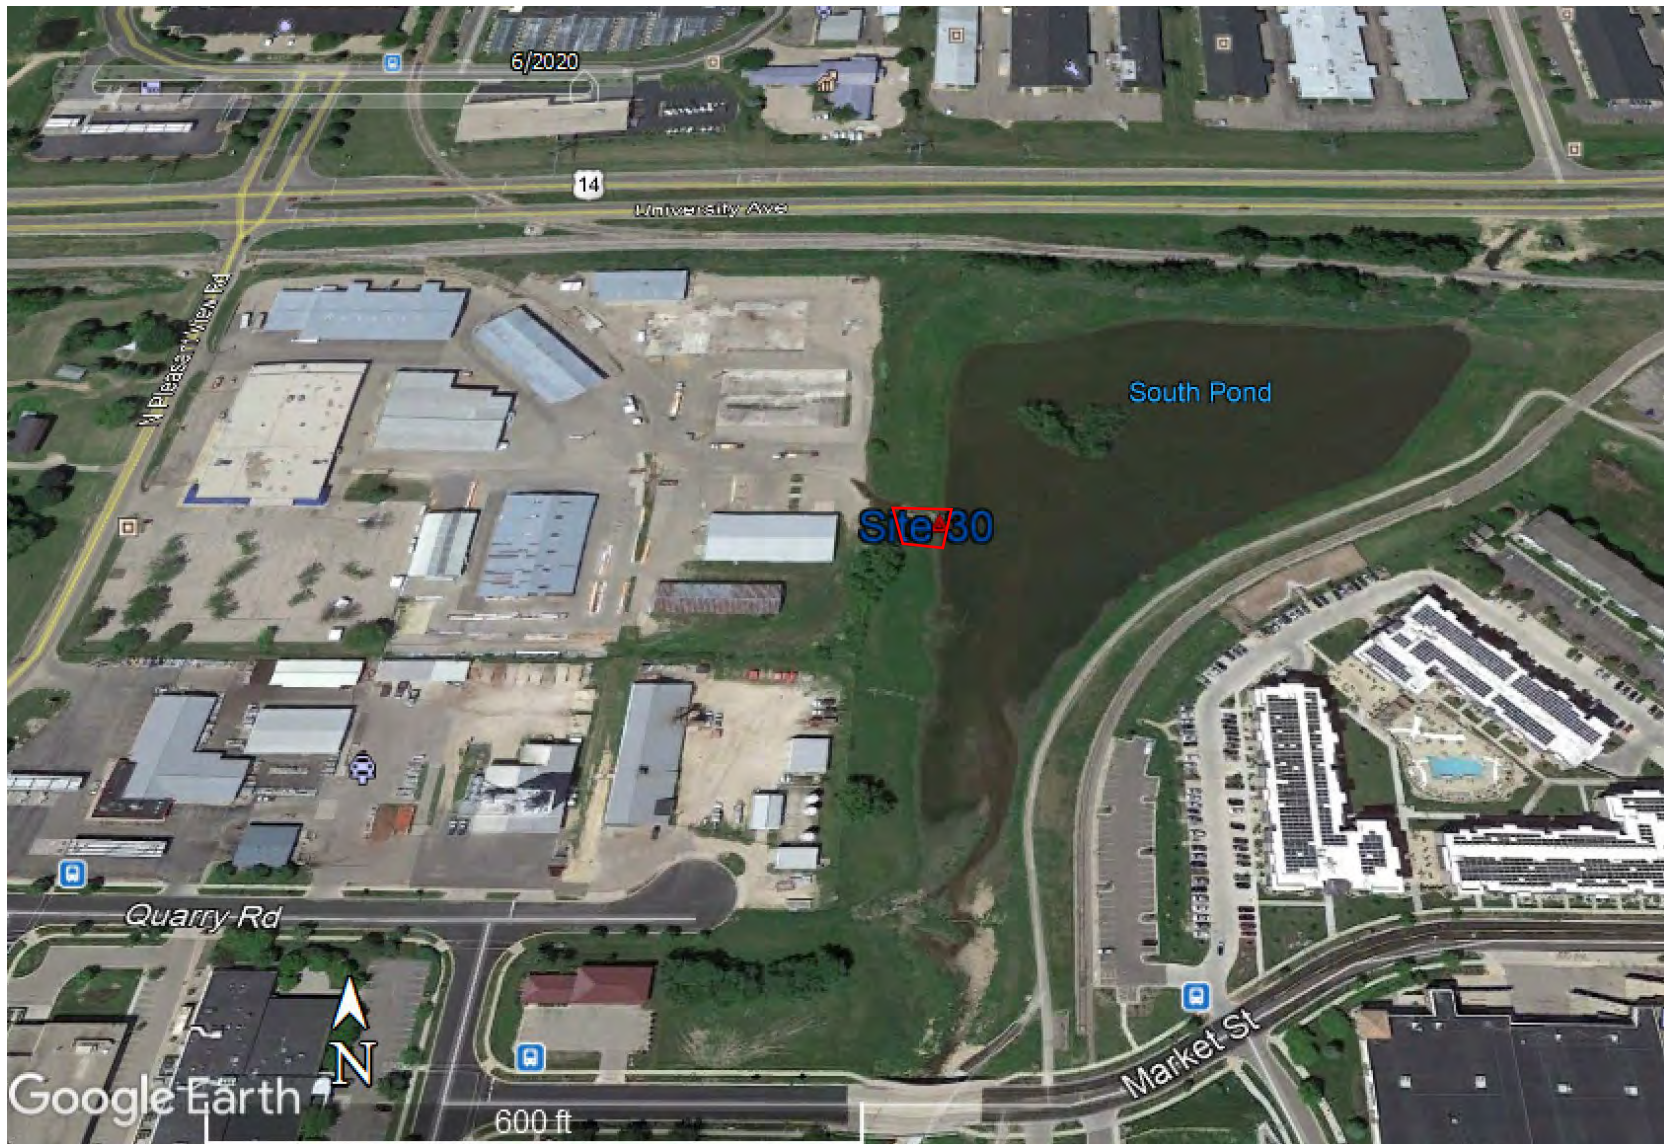
Figure 18: Site 30 (43.09473, -89.53109). Action area marked in red. Replacement of rip-rap surrounding drainage outlet on South Pond.  
Google Earth Aerial, 2020 data.

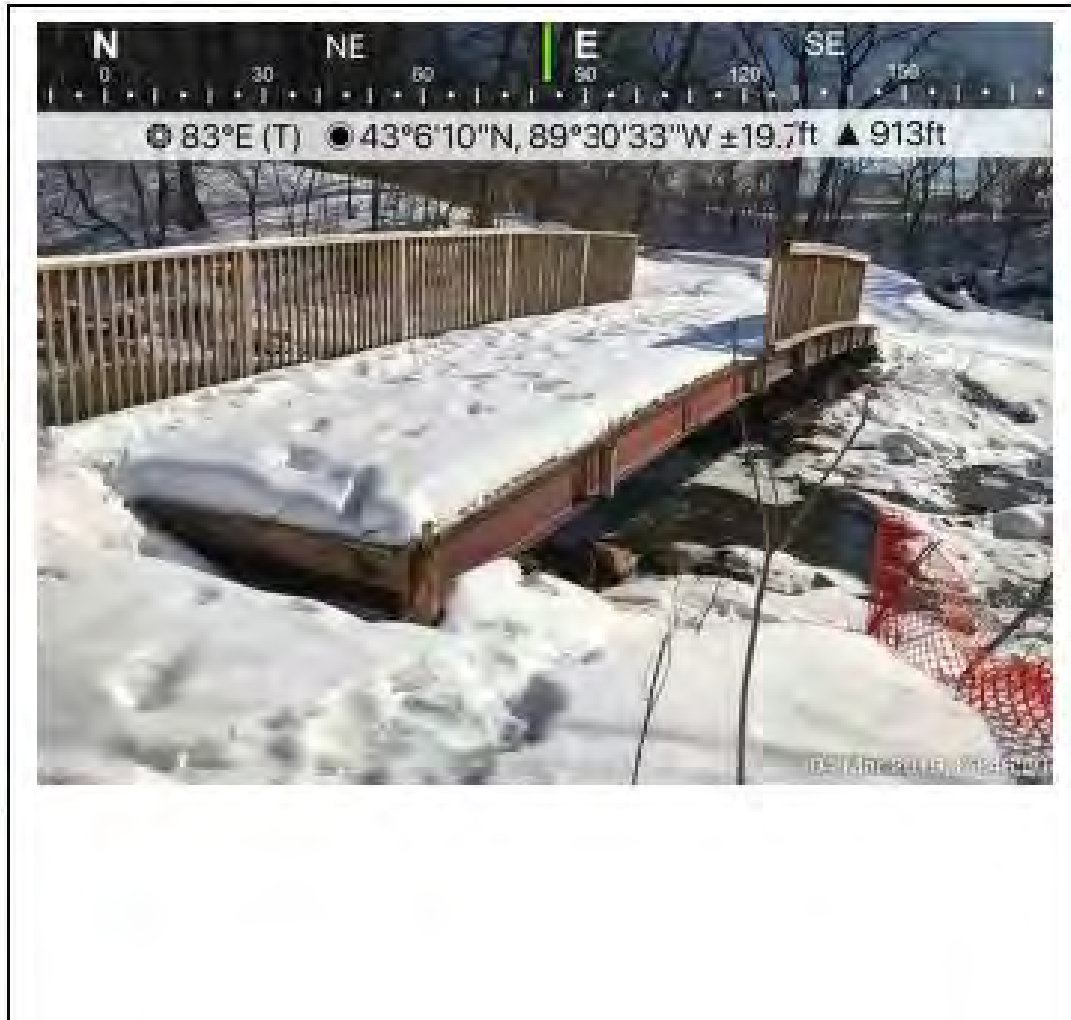
Photo 9: Sites 6 & 7 (March 2019) taken at 43.103016, -89.509429. View of damaged pedestrian bridge and eroded rip-rap on abutment. Asphalt path to be resurfaced.

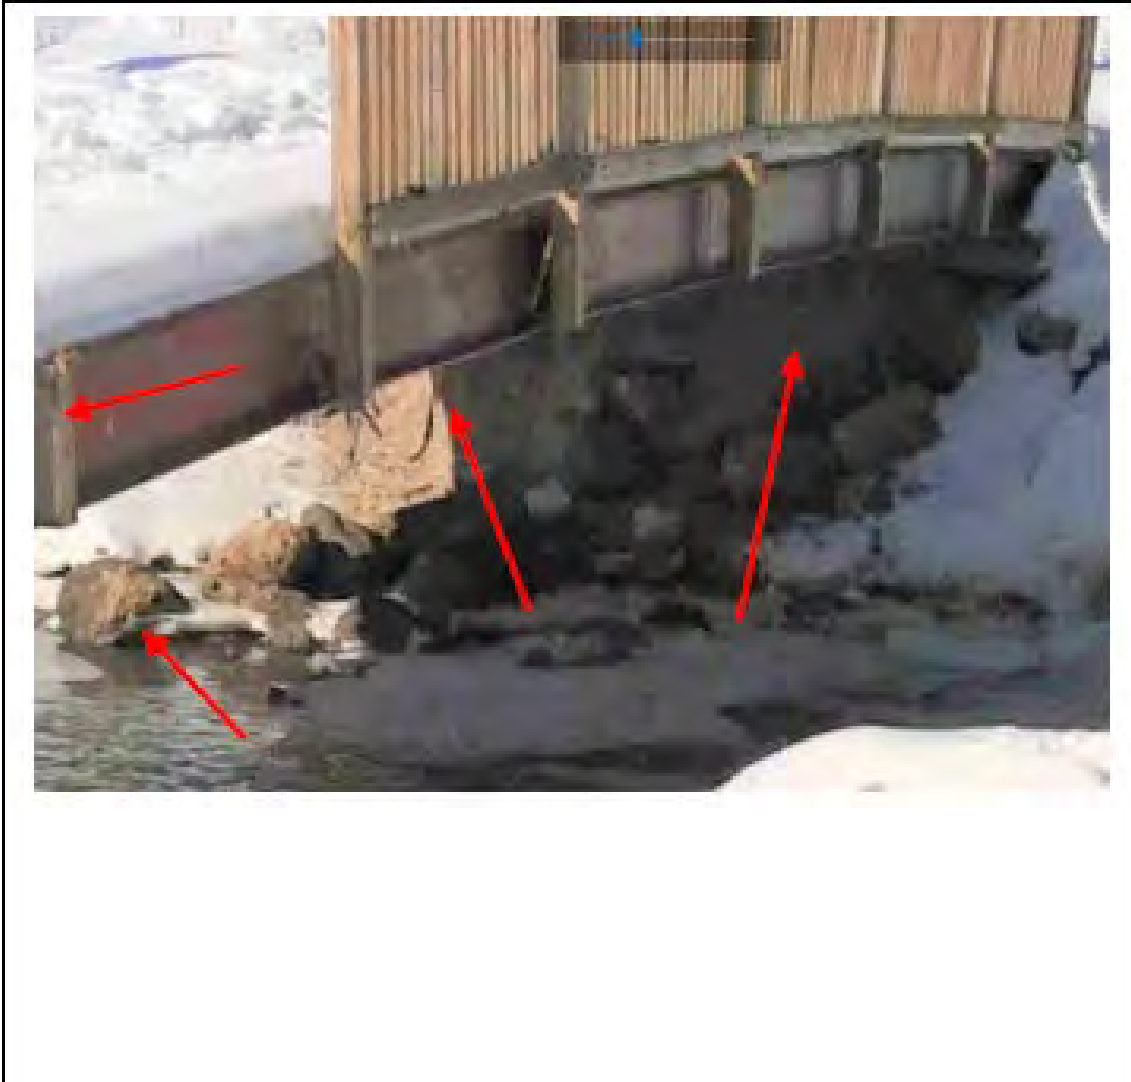
Photo 10: Site 6 (March 2019) taken at 43.103016, -89.509429. View of eroded rip-rap on abutment of damaged pedestrian bridge.

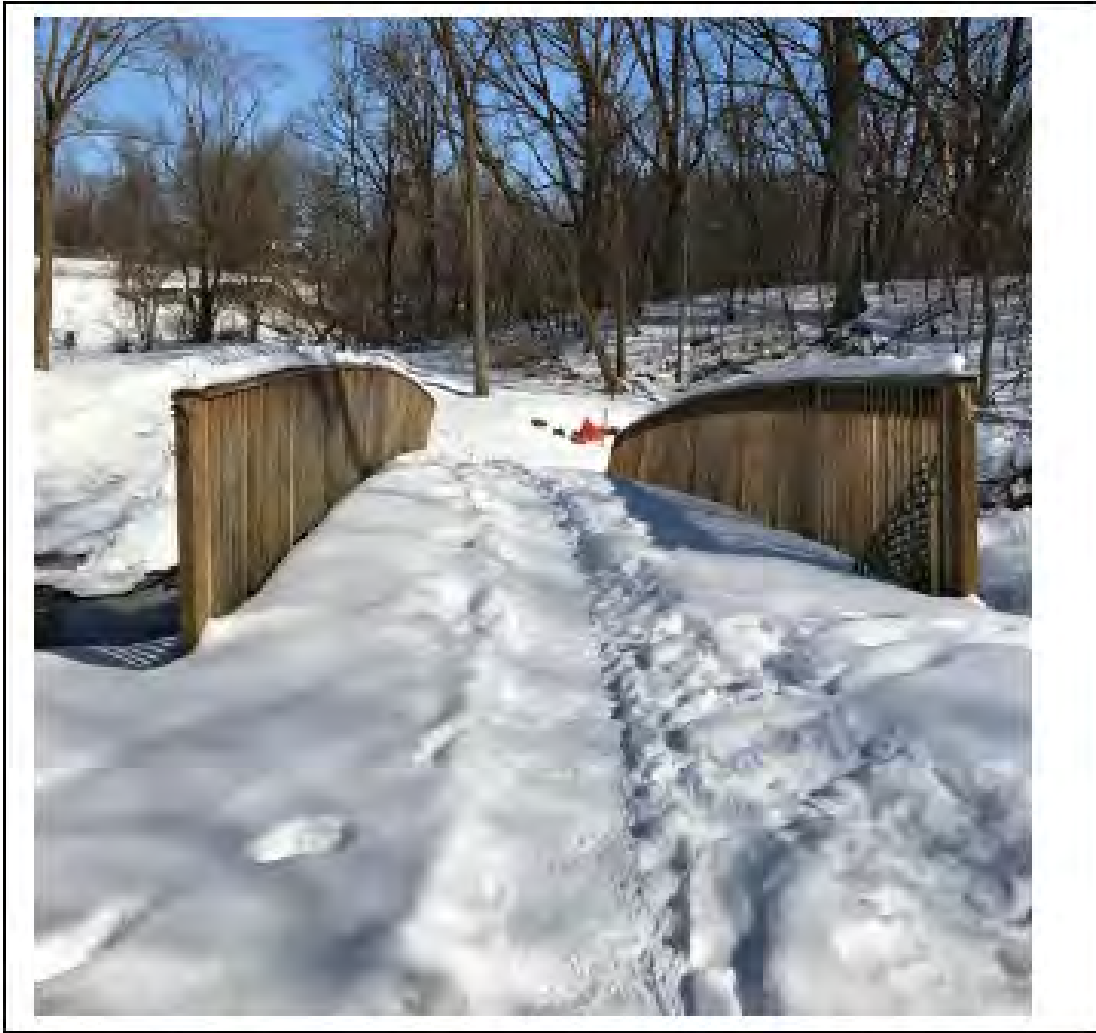
Photo 17: Site 10 (March 2019) taken at 43.104170, -89.507500. View of damaged asphalt path before and after pedestrian bridge.

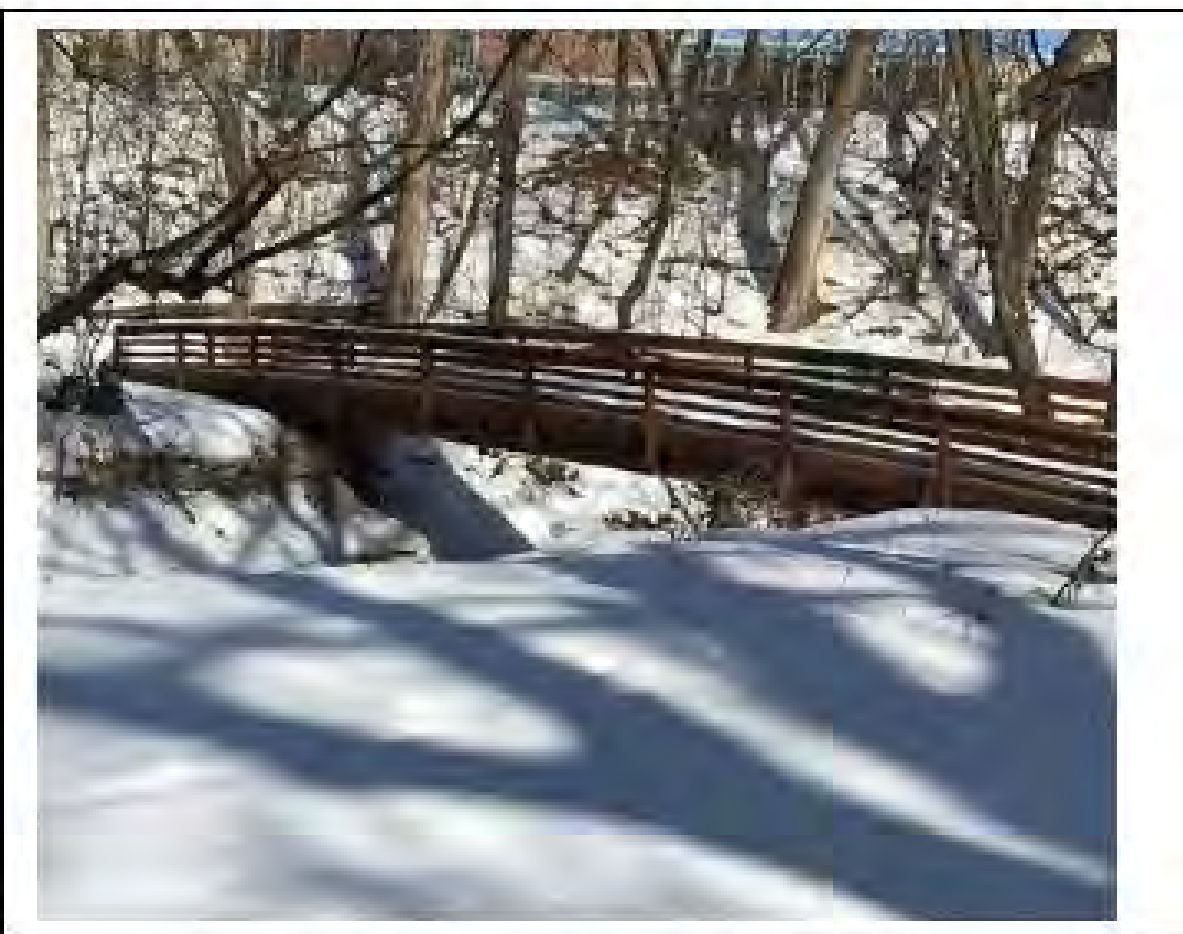
Photo 23: Site 14 (March 2019) taken at 43.104287, -89.505070. No damage to pedestrian bridge. Recreation path will be resurfaced.

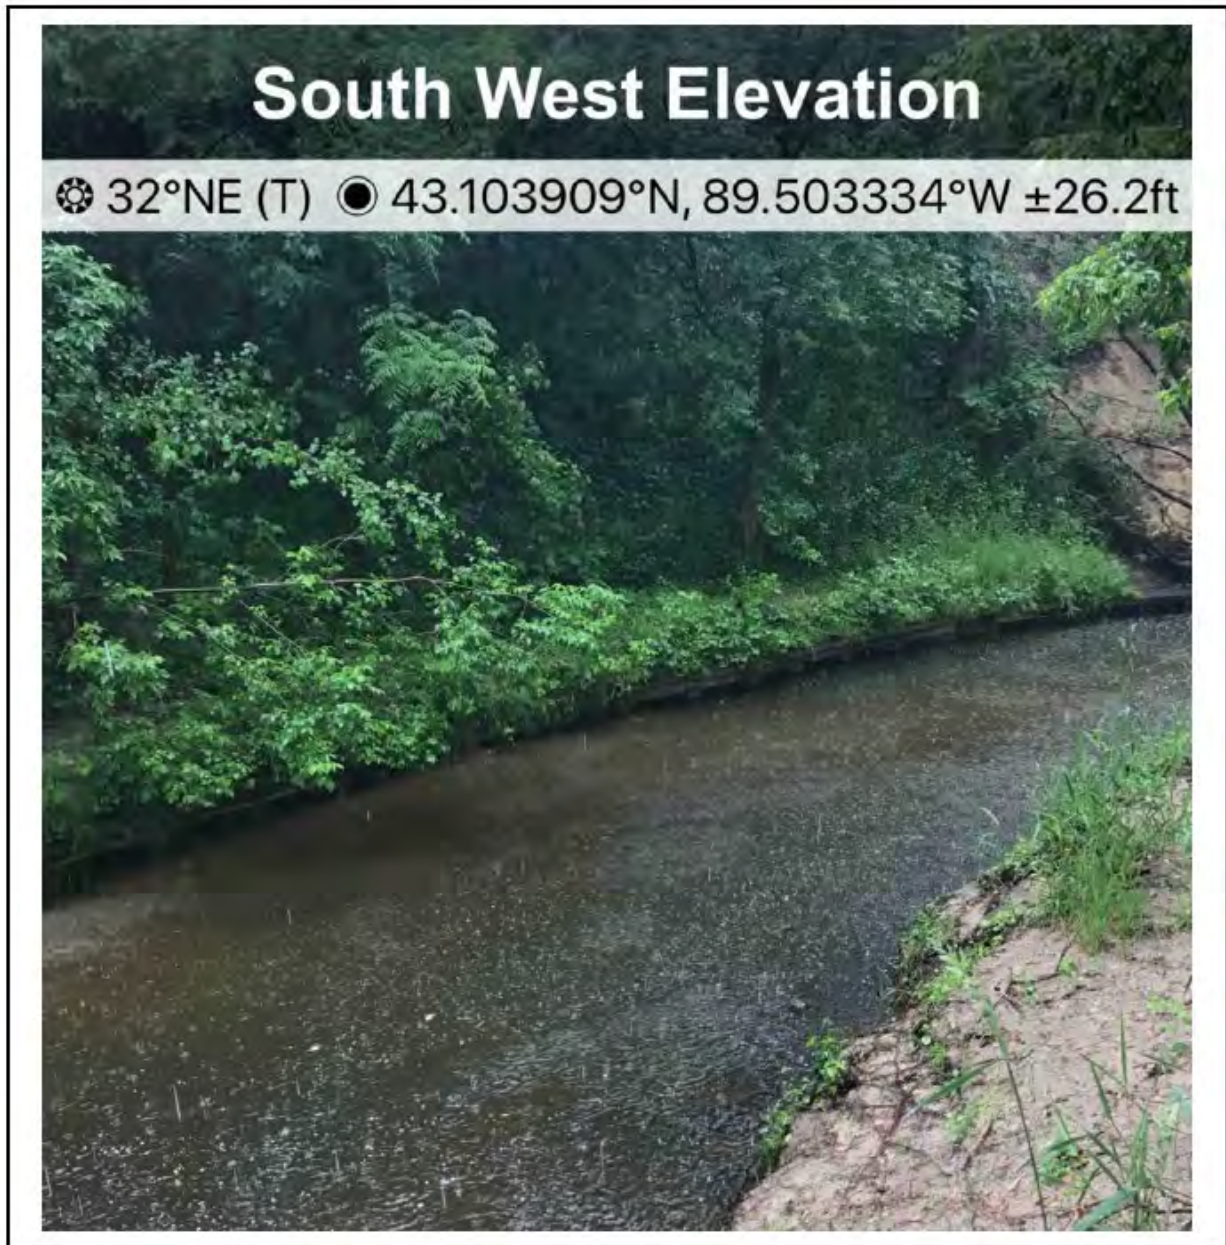
Photo 24: Site 15 (May 2019) taken at 43.103909, -89.503334. View of damaged sheetpile wall on north streambank.
