## **FINDING OF NO SIGNIFICANT IMPACT**

### **Environmental Assessment for the Pheasant Branch Creek Trail, Bridges, and Streambank Restoration Project Middleton, Dane County, Wisconsin Public Assistance Program Federal Emergency Management Agency, Department Of Homeland Security Disaster #DR-4402-WI, Project # 88229, PW 593**

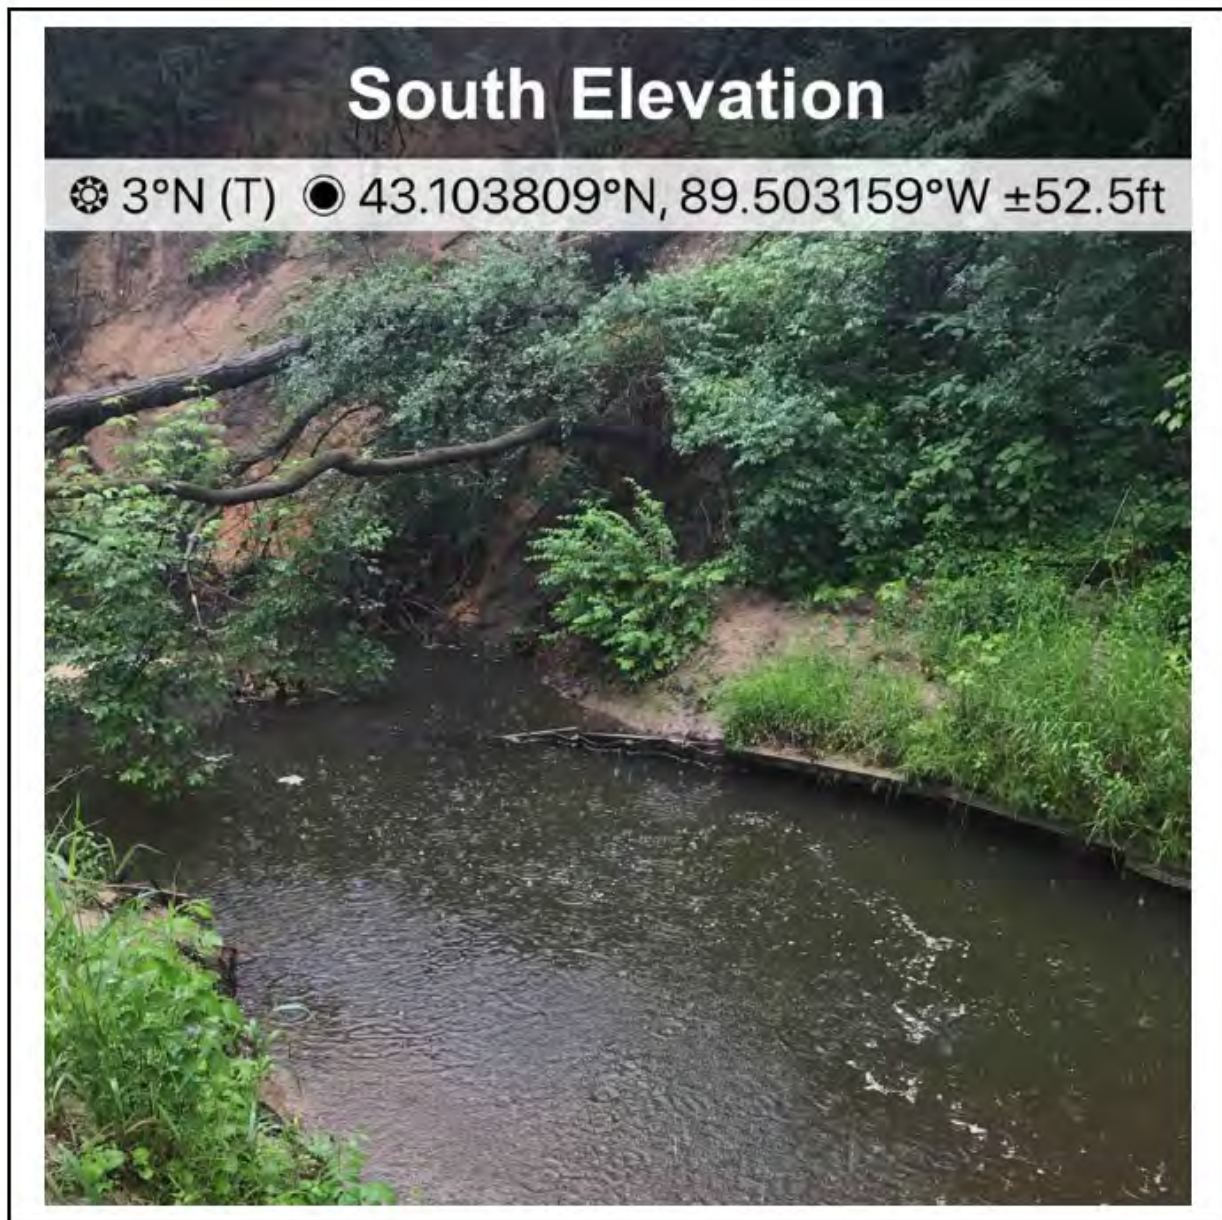
Photo 25: Site 15 (May 2019) taken at 43.103809, -89.503159. View of damaged sheetpile wall on north streambank.

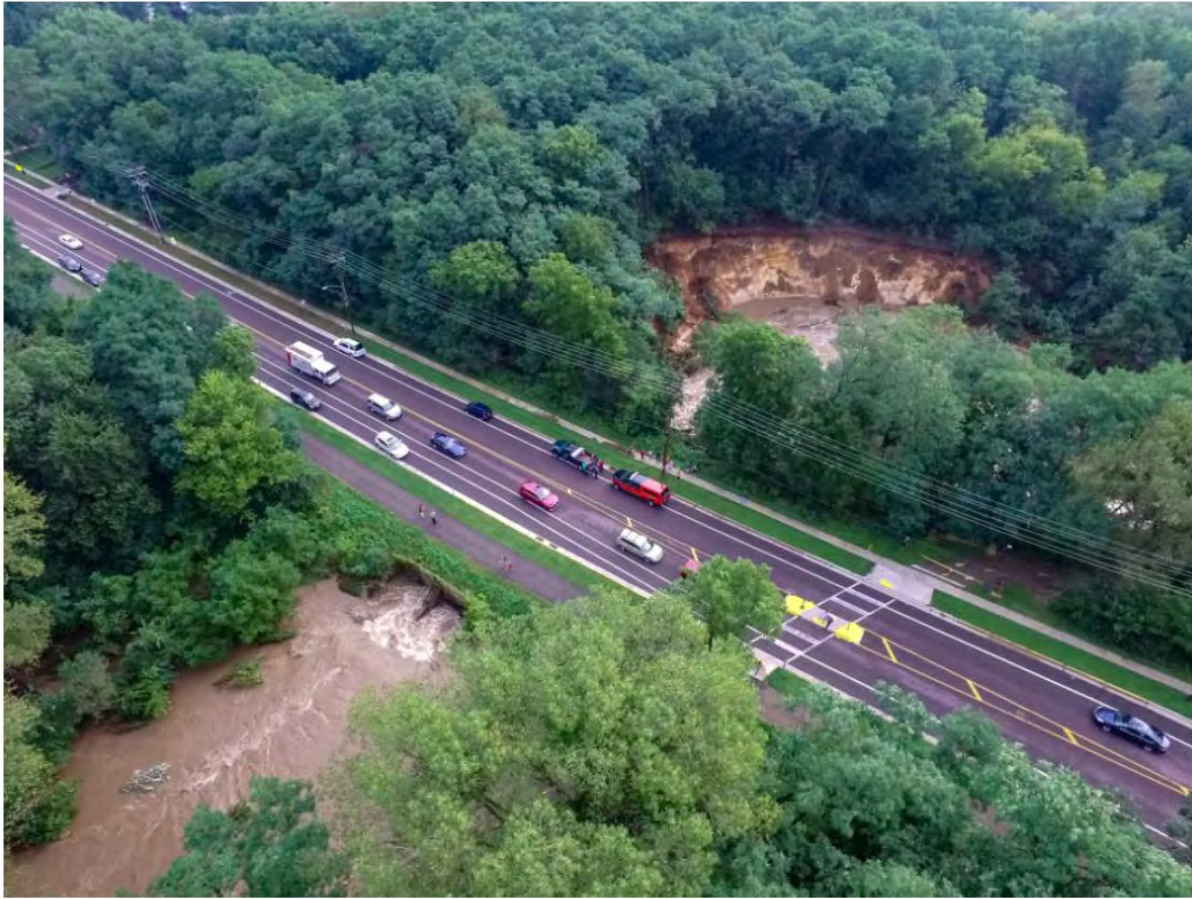
Photo 26: Site 16 (September 2018). Screen capture taken from drone footage. View of damaged north streambank at Park Street.

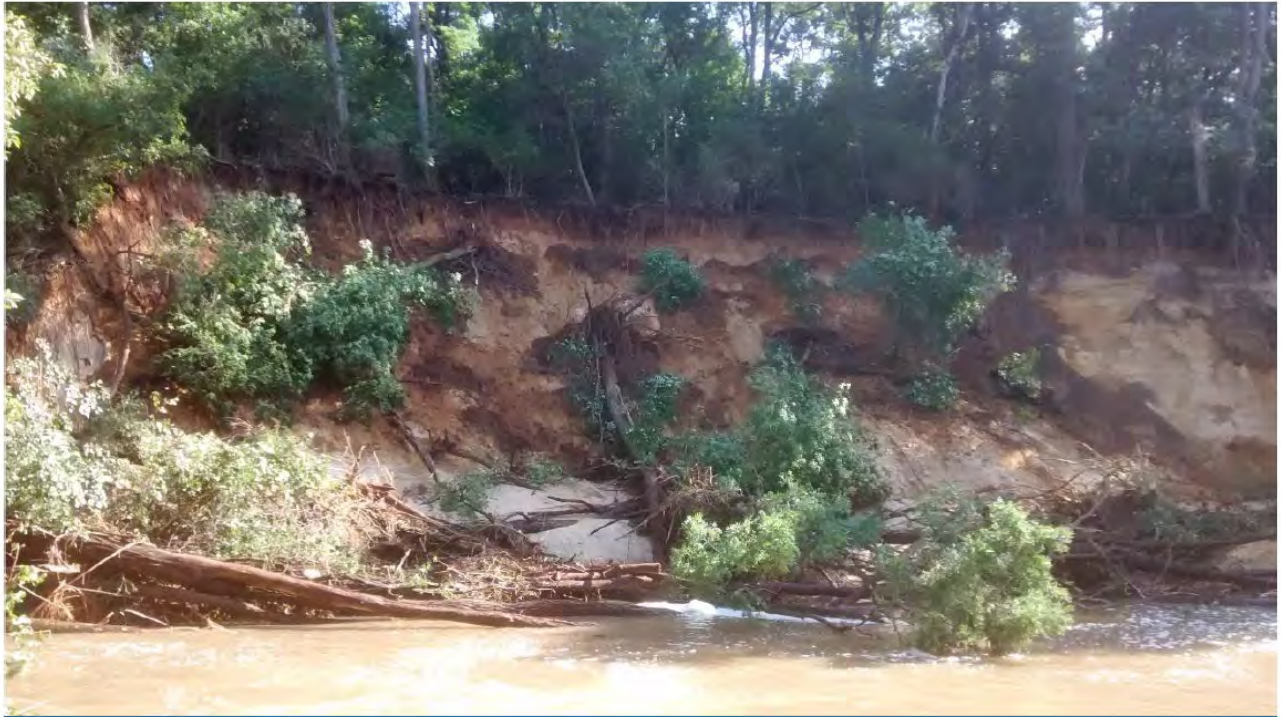
Photo 27: Site 16 (September 2018) taken at Park Street. View of eroded north streambank after storm.

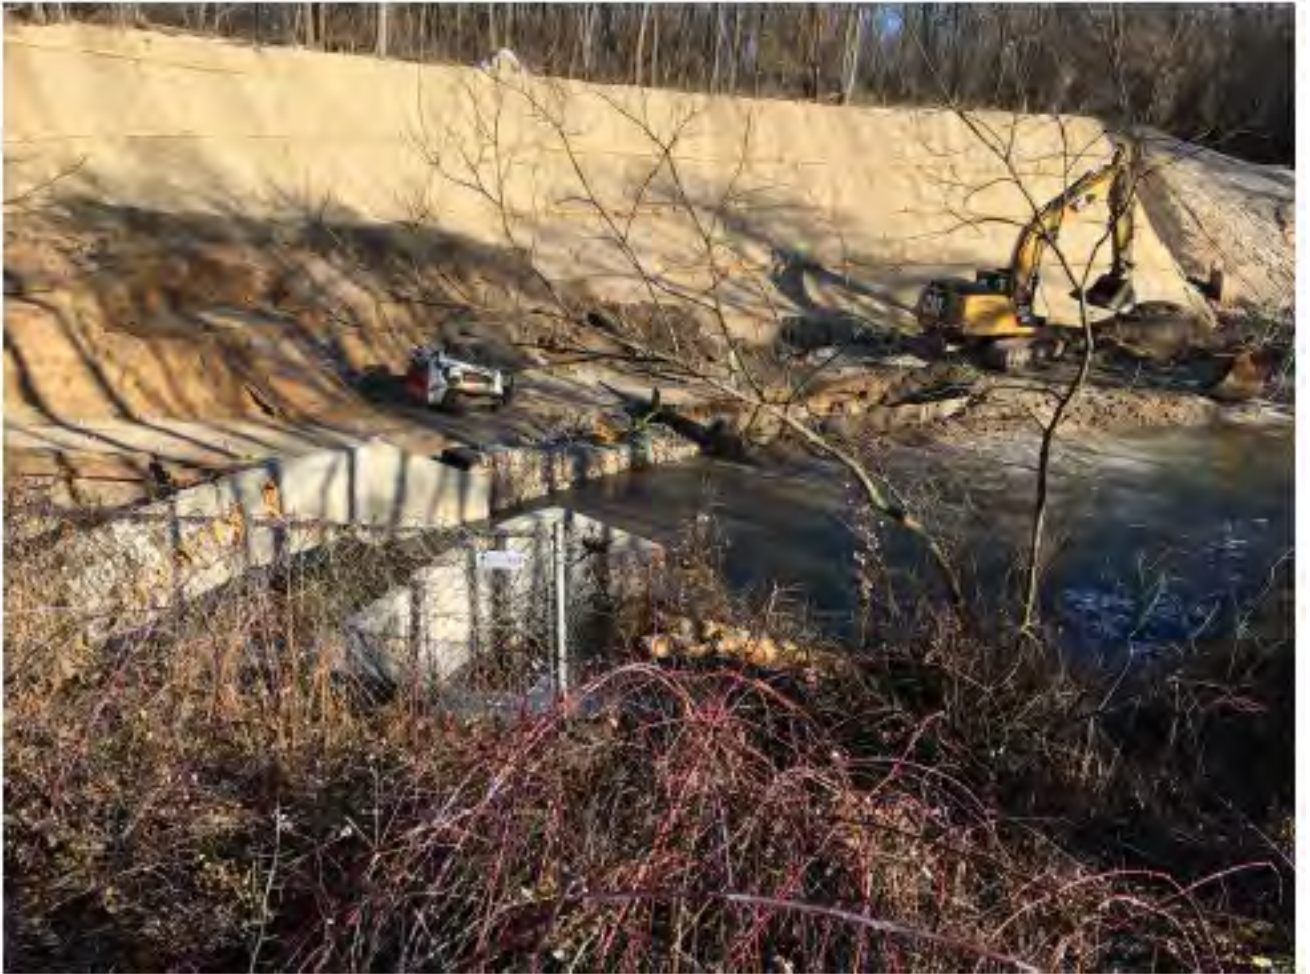
Photo 30: Site 16 (December 2019). Photo taken at Park Street facing east. View of repairs to eroded north streambank. Work completed in 2019.

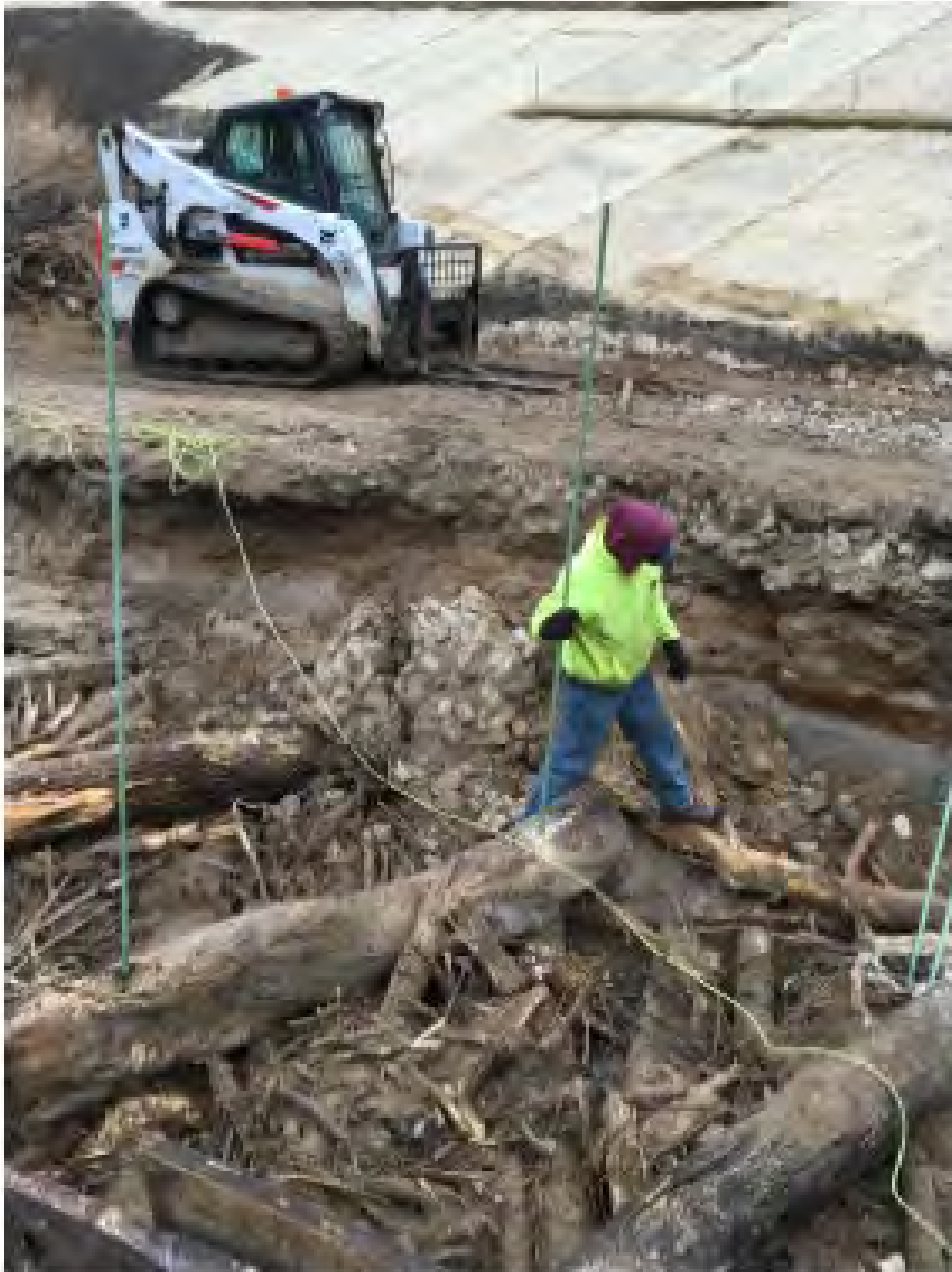
Photo 31: Site 16 (December 2019). Park Street. View of installation of footer logs and root wads to eroded north streambank. Work completed in 2019.

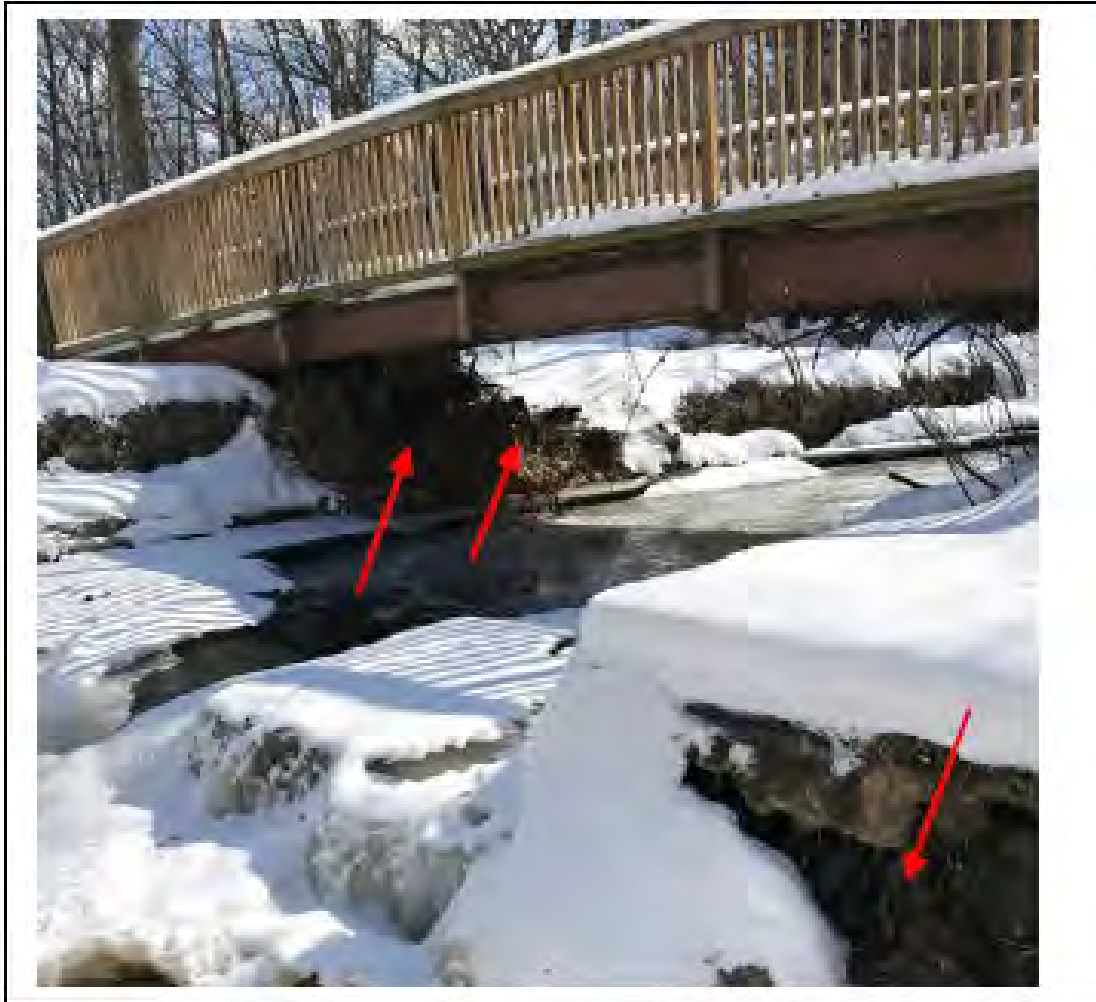
Photo 35: Sites 20 & 21 (March 2019) taken at 43.103065, -89.498190. View of displaced rip-rap surrounding pedestrian bridge abutment. Trail will be resurfaced to pre-disaster condition.

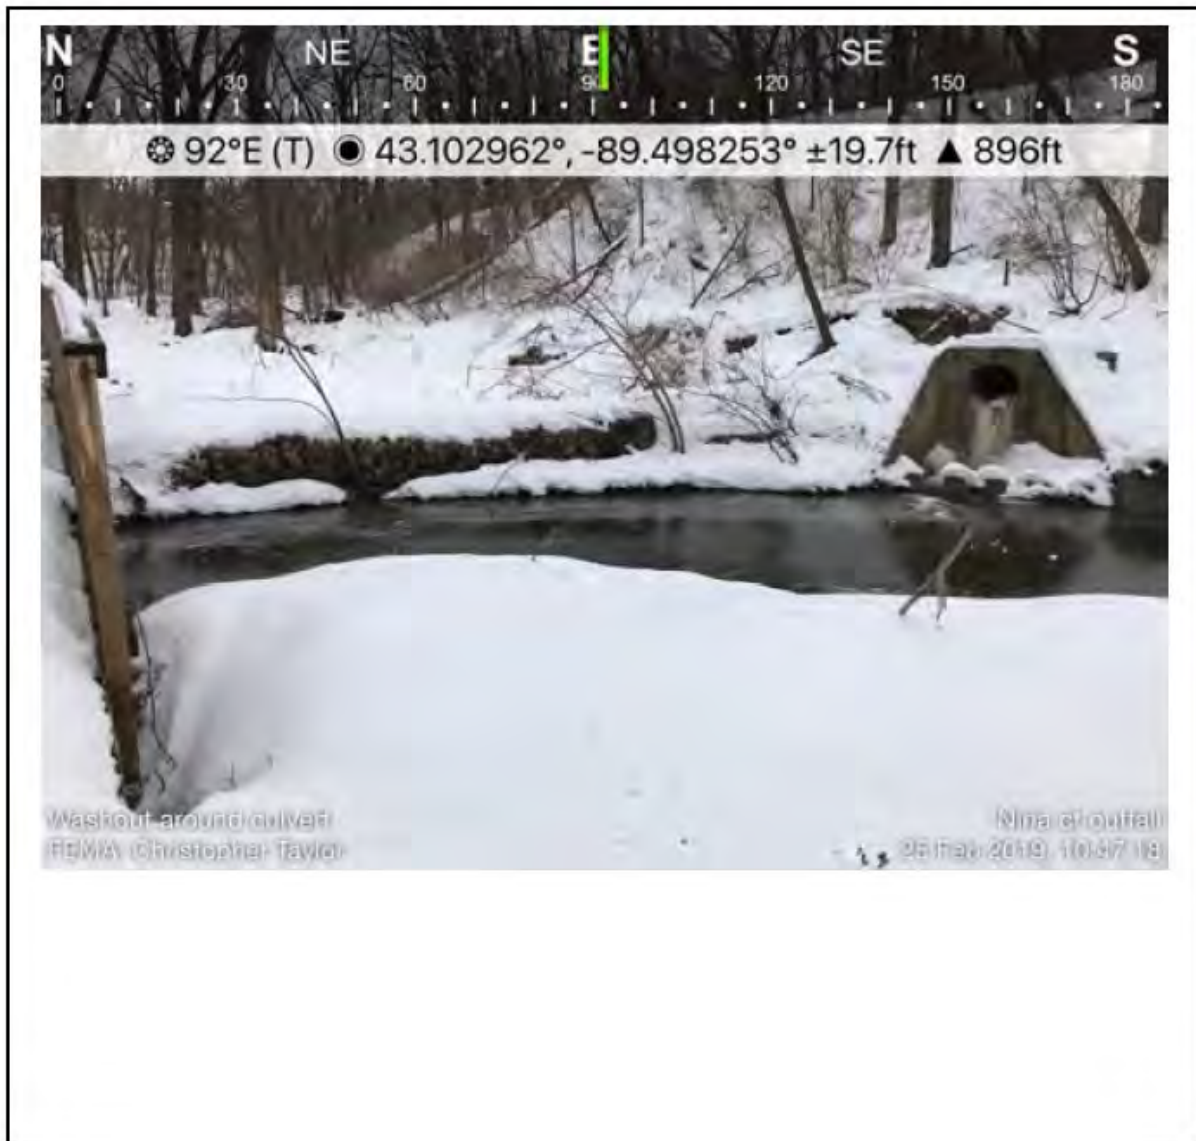
Photo 36: Site 22 (February 2019) taken at 43.102962, -89.498253. View of displaced rip-rap surrounding Nina Court outfall.

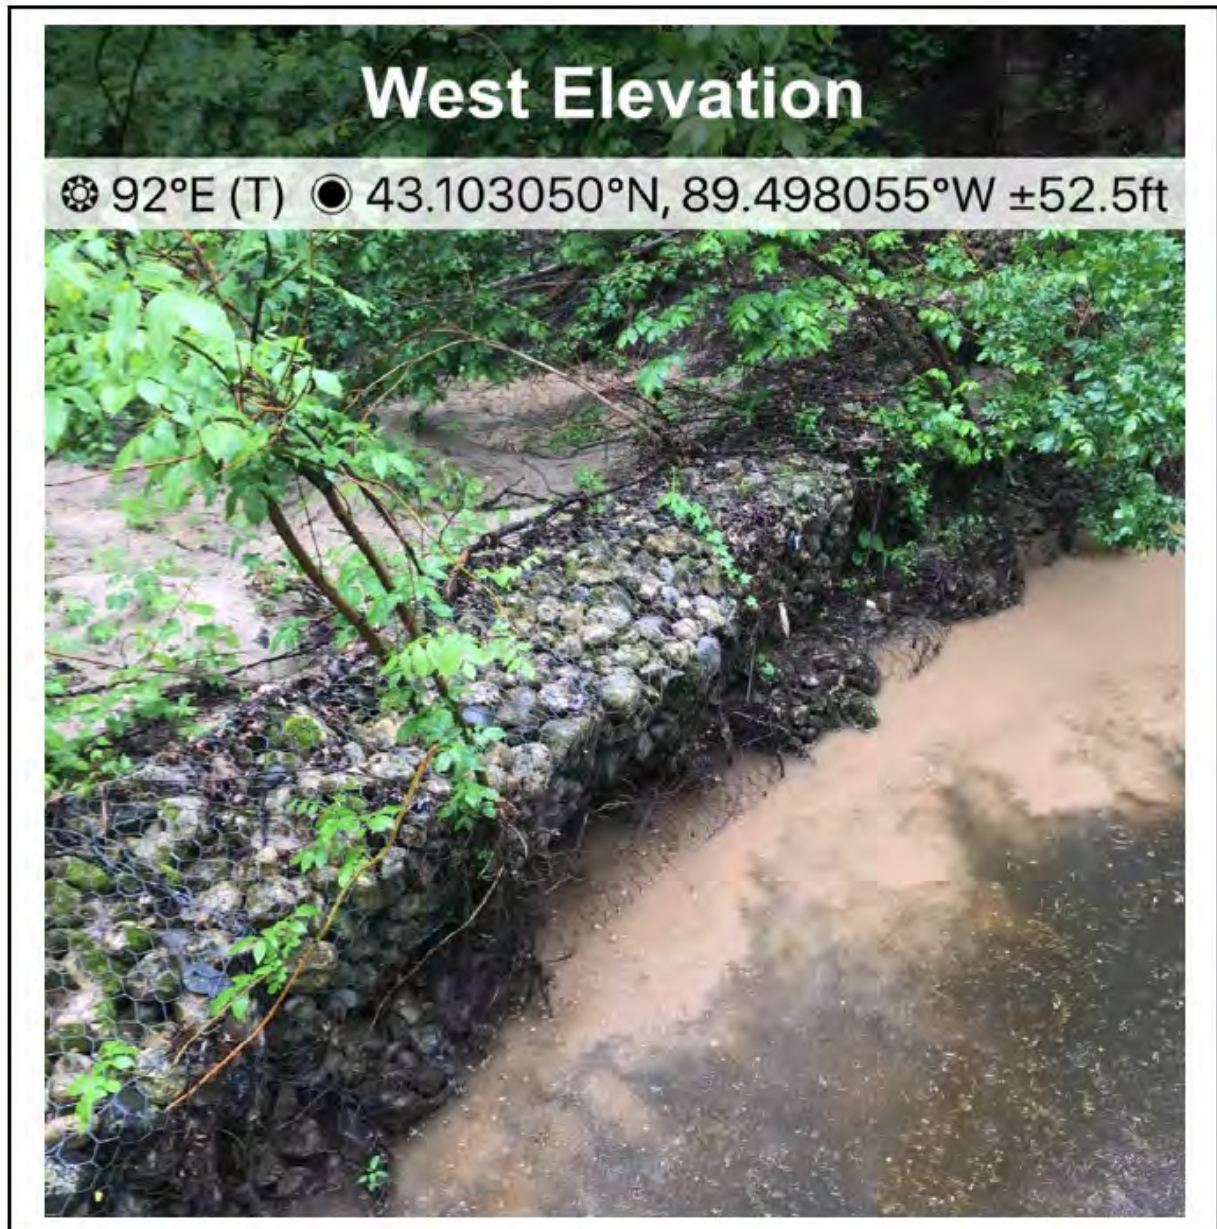
Photo 37: Site 23 (May 2019) taken at 43.103050, -89.498055. View of damaged gabion wall.

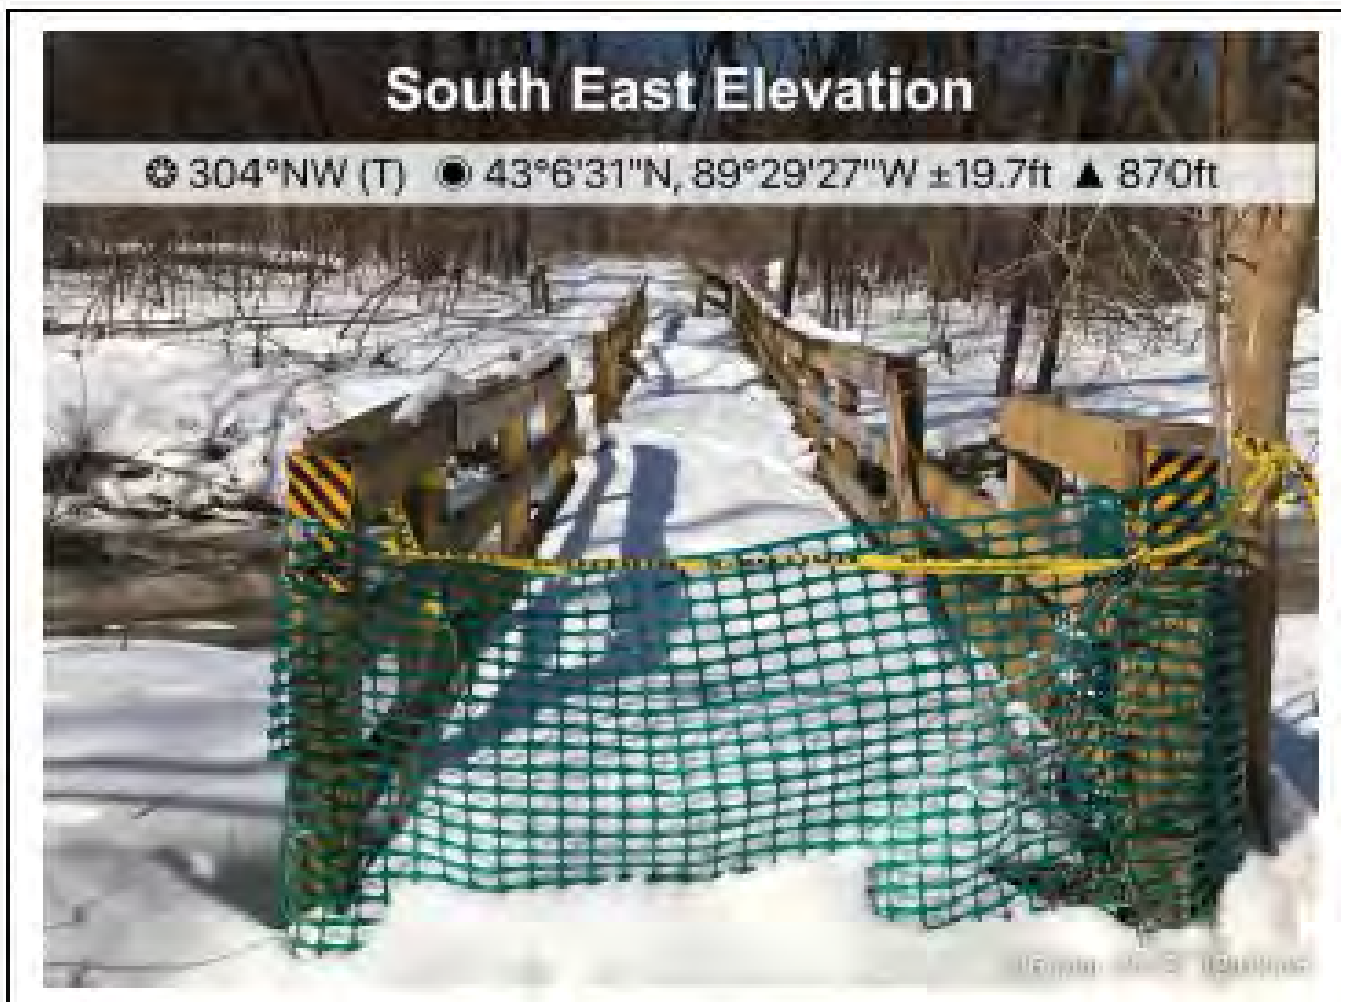
Photo 43: Site 28 (March 2019) taken at 43.10864, -89.49090. View of damaged pedestrian bridge and trail. Bridge repairs are not eligible for FEMA funding. Trail will be resurfaced to pre-disaster condition.

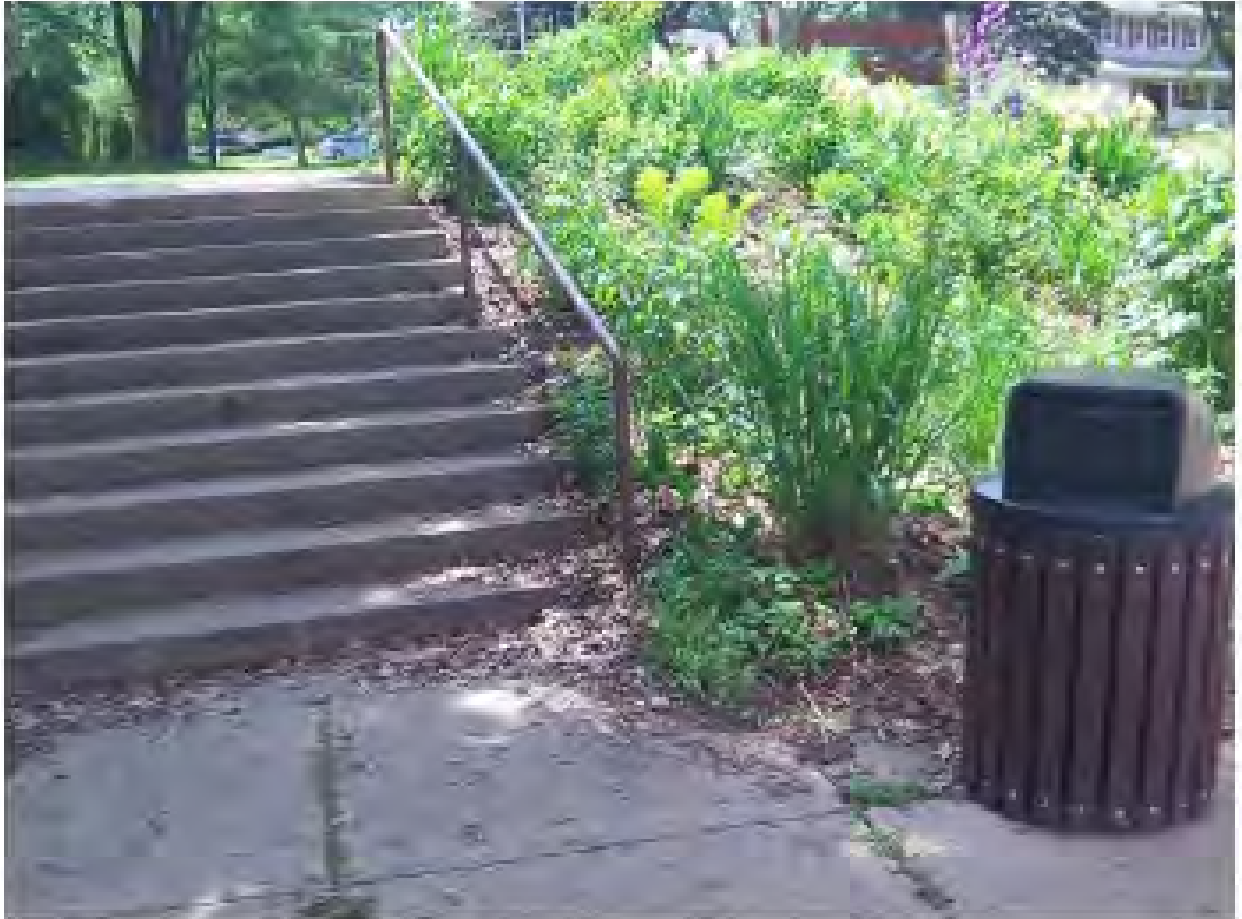
Photo 44: Site 31 (date unknown) taken at 43.089930, -89.506948. Damaged stairs.

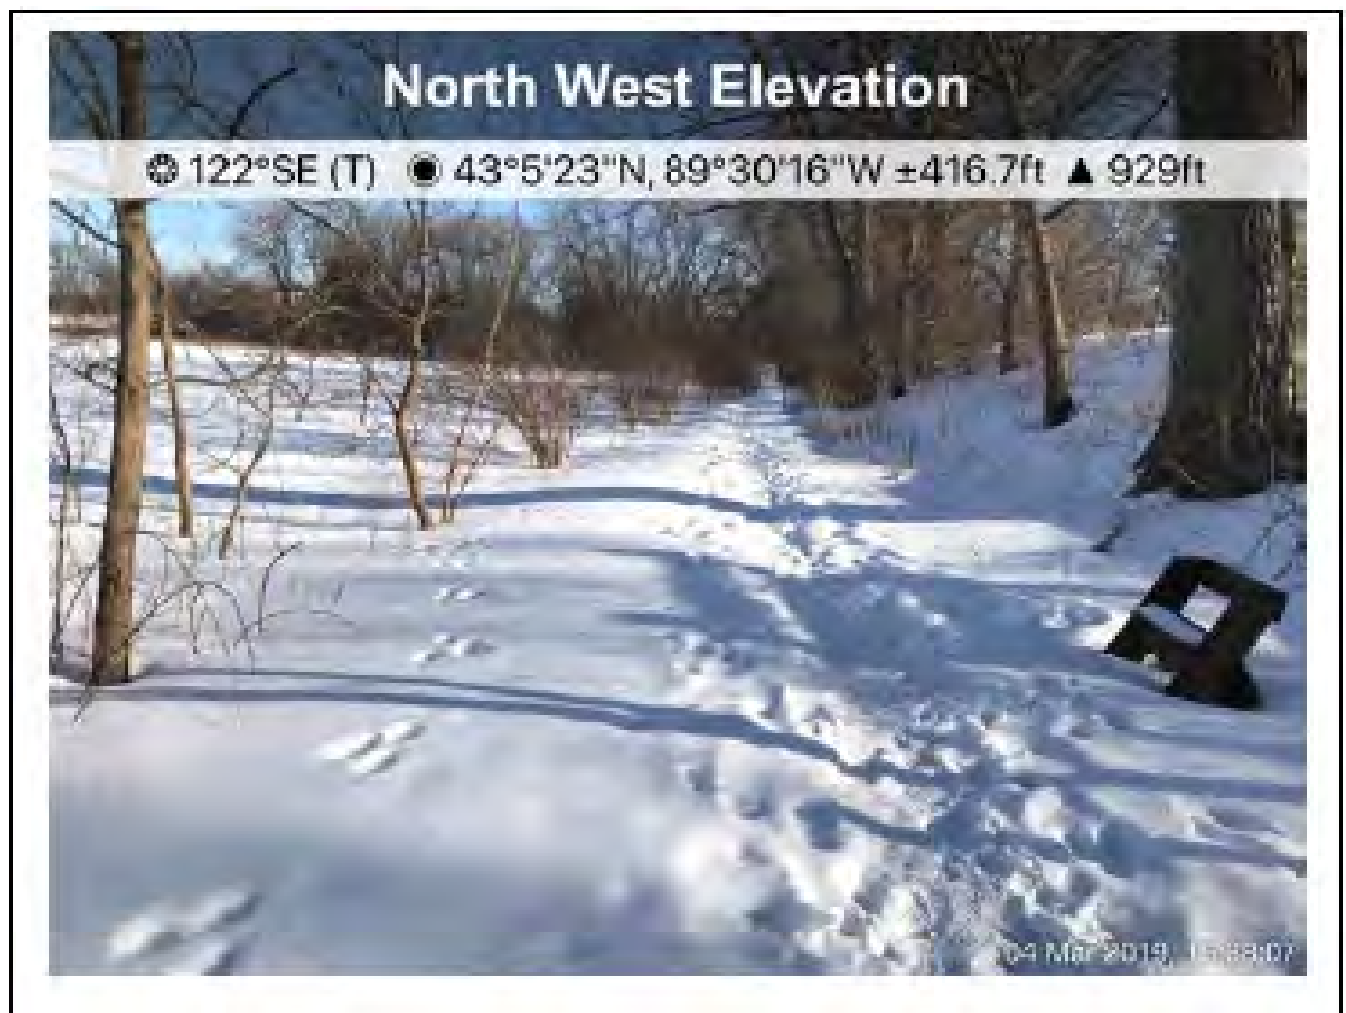
Photo 44: Site 32 (March 2019) taken at 43.091254, -89.502157. Damaged recreational trail.

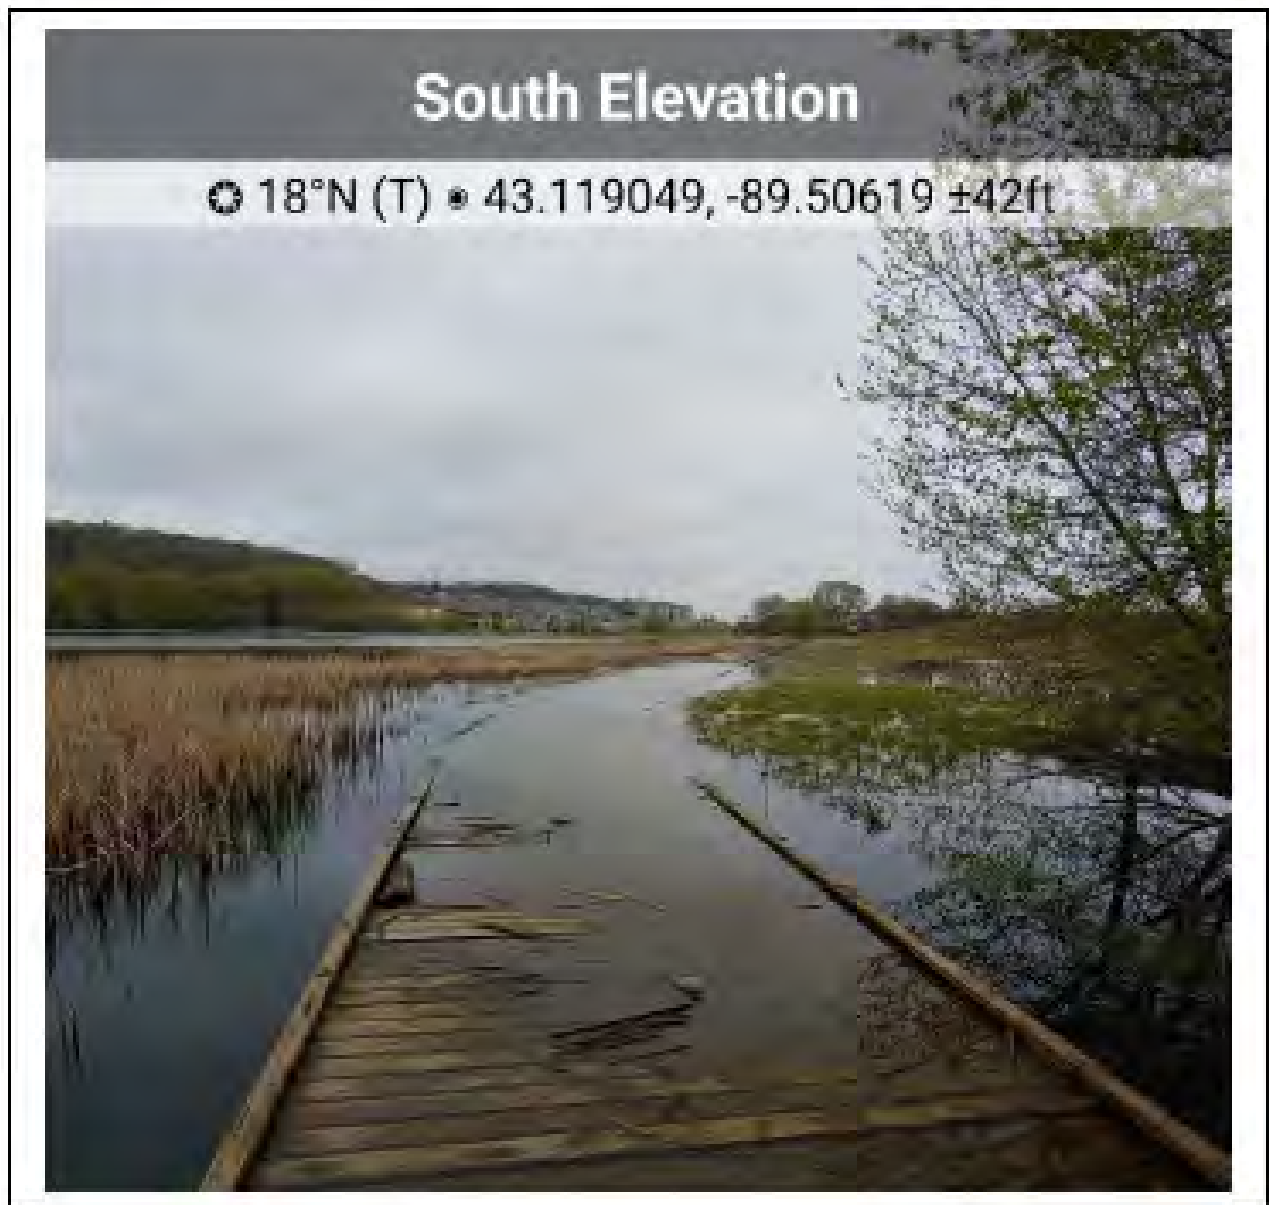
Photo 47: Site 35 (May 2019) taken at 43.11905, -89.50619. Graber Pond. View of damaged boardwalk.

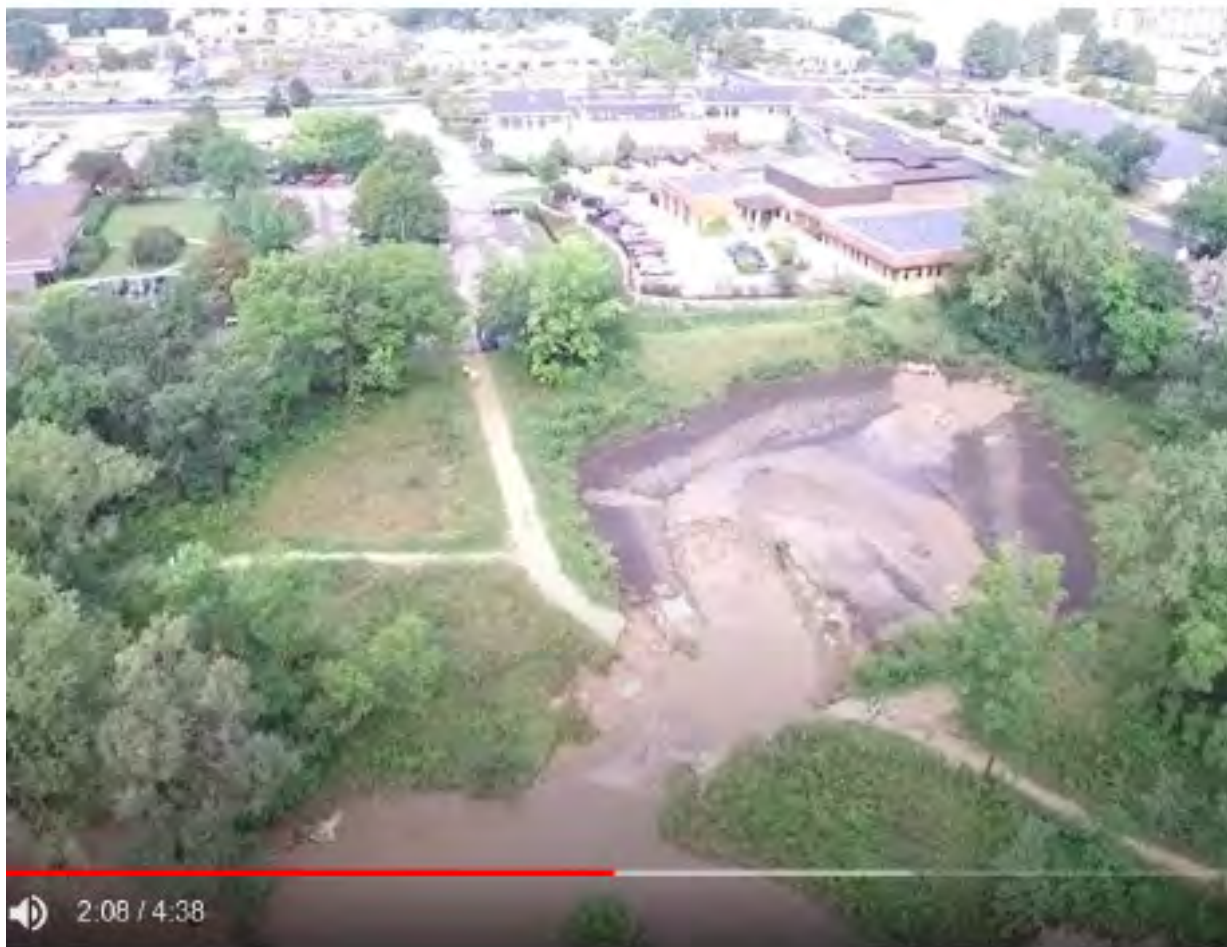
Photo 48: Site 36 (August 2018), provided by the applicant. Taken at 43.10524, -89.50864. Donna Pond. View of collapsed embankment.

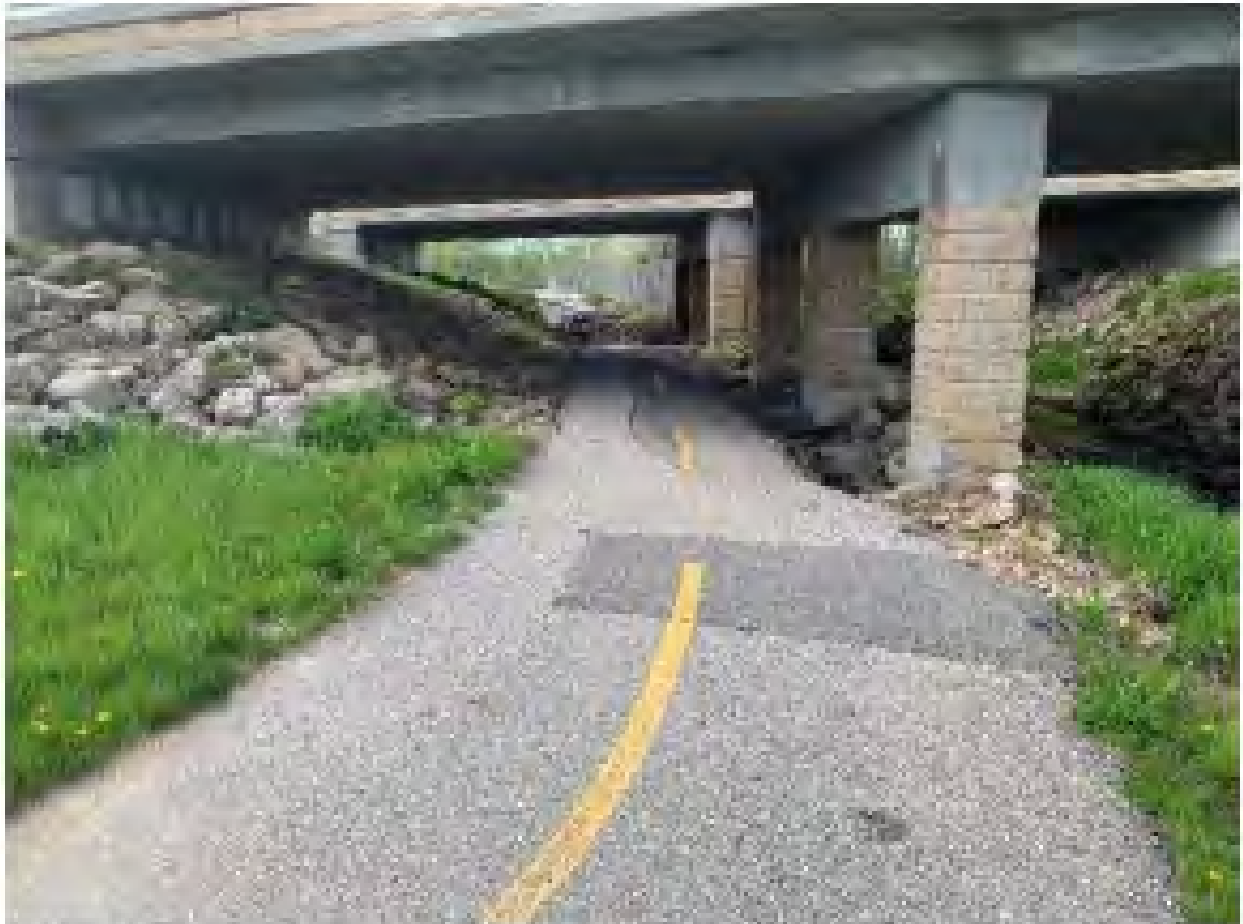
Photo 49: Site 37. Taken at 43.11126, -89.53614. Airport Road underpass. View of damaged asphalt trail and displaced rip-rap.

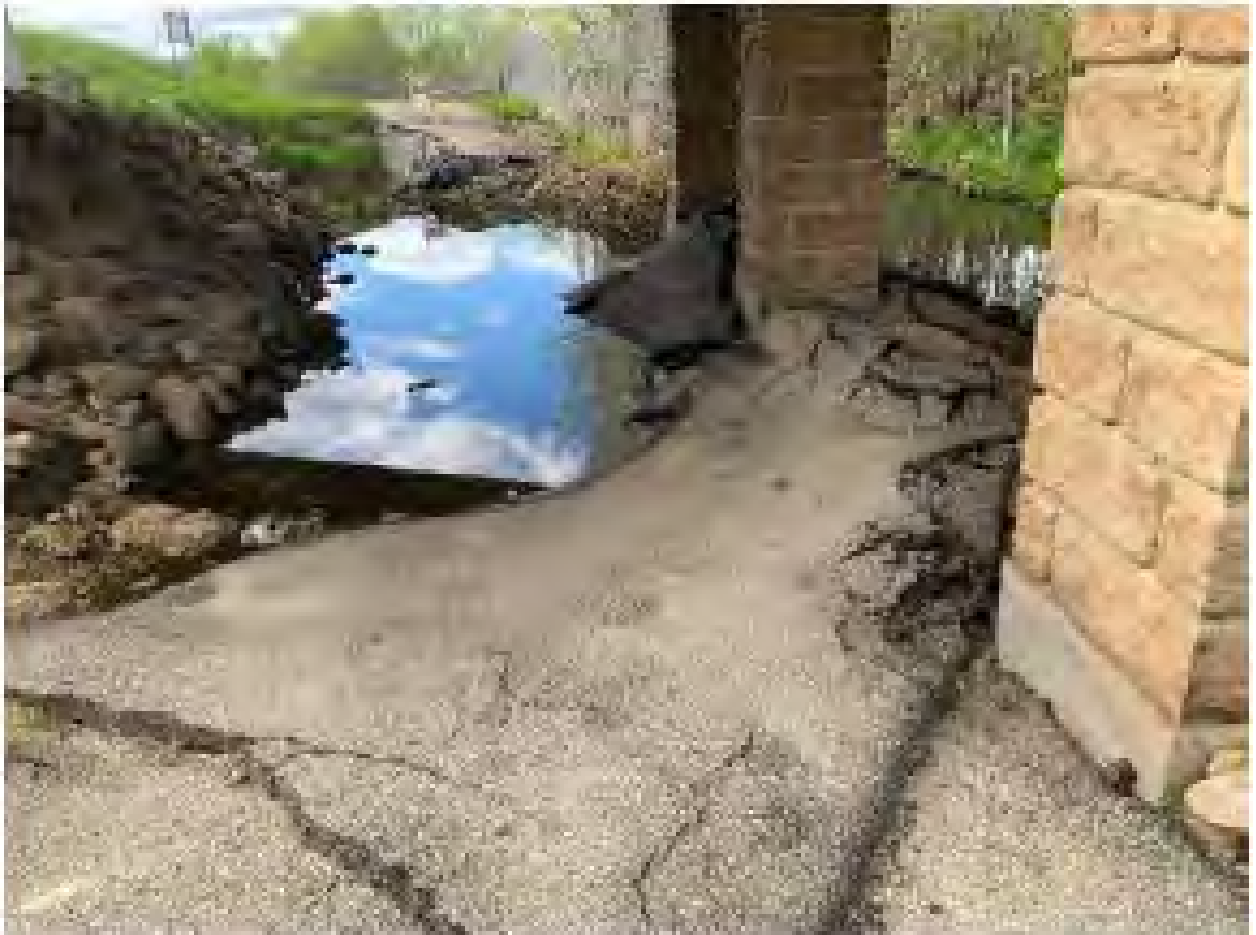
Photo 51: Site 37. Taken at 43.11126, -89.53614. Airport Road underpass. View of damaged asphalt trail and displaced rip-rap.

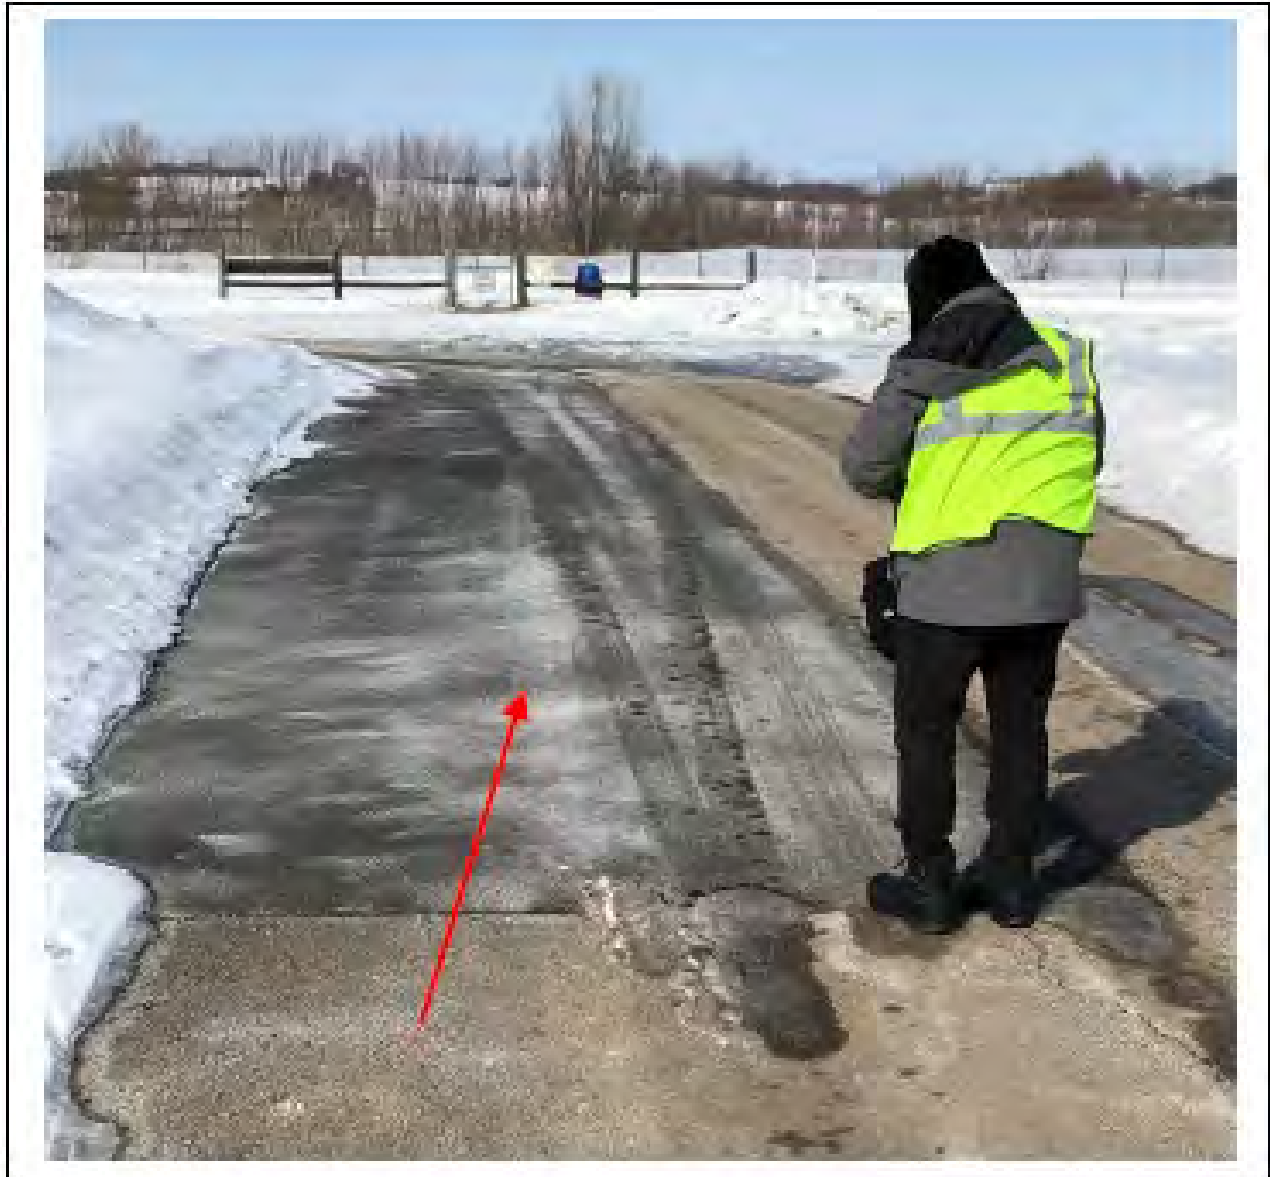
Photo 52: Site 38. Taken at 43.11229, -89.54029. Klein Park. View of damaged asphalt trail.
