APPENDIX J FLORA AND FAUNA STUDY AND USFWS CONCURRENCE LETTER

Descriptive Study of Flora and Fauna

CARRAÍZO RESERVOIR DREDGING PROJECT MUNICIPALITIES OF CAGUAS AND GURABO, PUERTO RICO

PUERTO RICO AQUEDUCT AND SEWER AUTHORITY

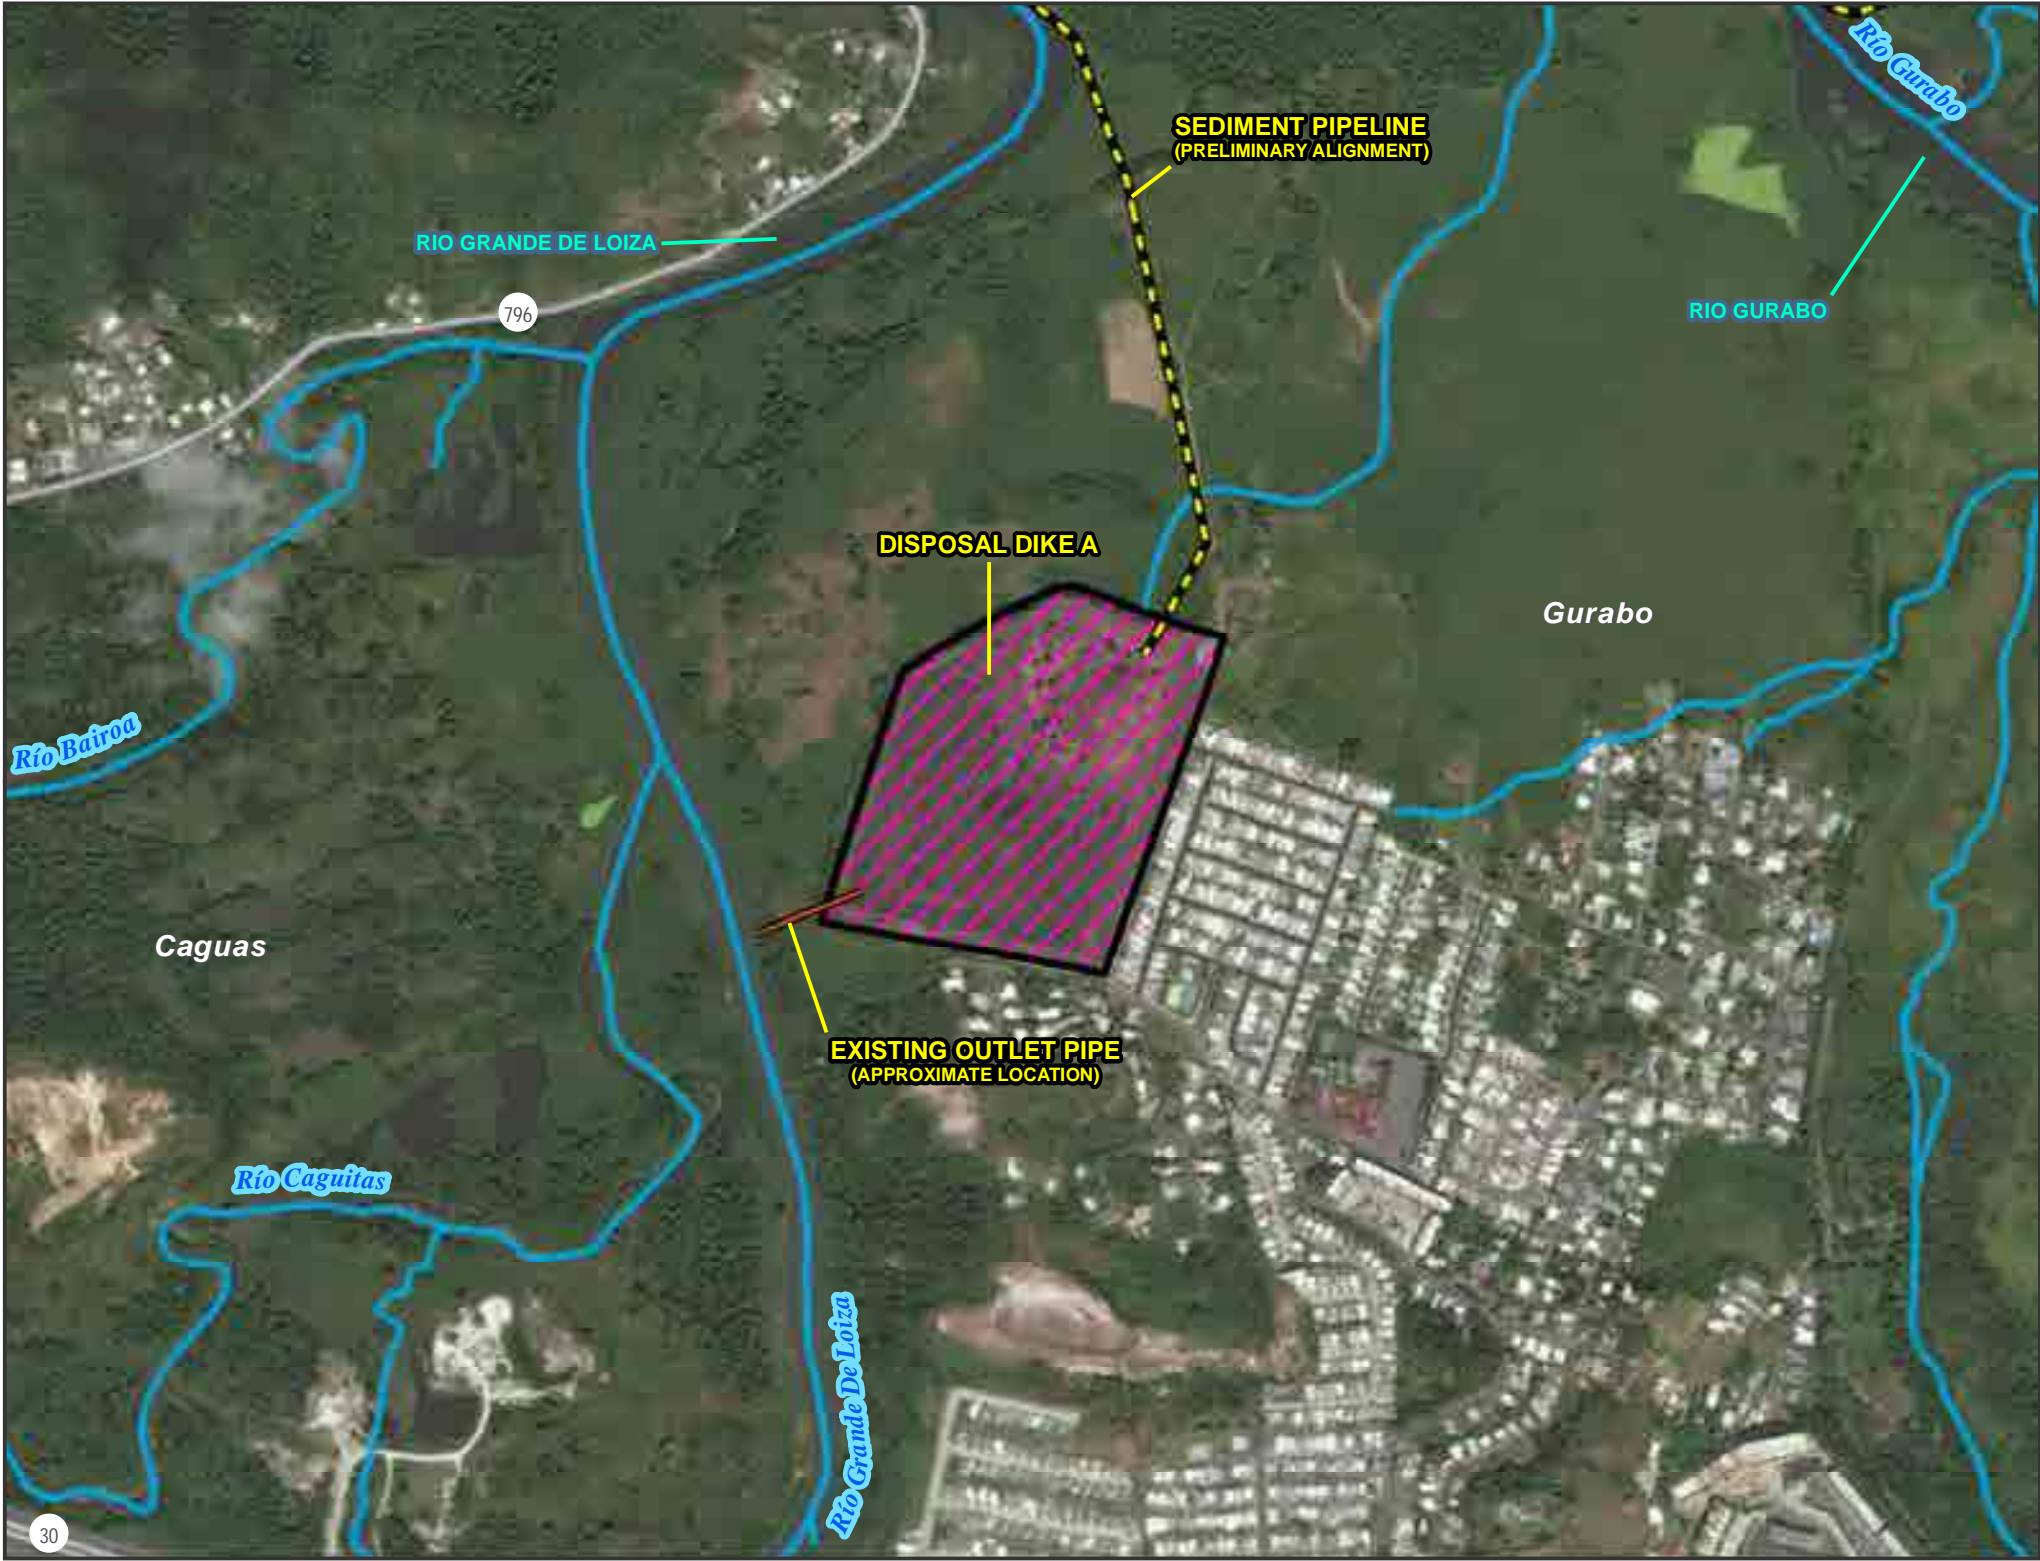
Figure 4: Hydrography within the Vicinity of Dike A

Descriptive Study of Flora and Fauna
Carraízo Reservoir
Dredging Project
Figure 4: Hydrography
within the Vecinity of Dike A

The hydrographic map (**Figure 4, Appendix A**) shows a creek along the eastern side of the study site. This watercourse does not currently have permanent or seasonal base flow. It is possible that this creek was impacted by the quarry activities that took place within the disposal dike A. In the conceptual design of dike A that is described in the Final Environmental Impact Statement prepared on December 15, 1995, the headwaters of this creek are shown approximately at 300 meters from the northeastern corner of the study site. The Río Grande de Loíza is found at approximately 145 meters to the southwest corner of dike A. The Río Grande de Loíza discharges into the Atlantic Ocean.

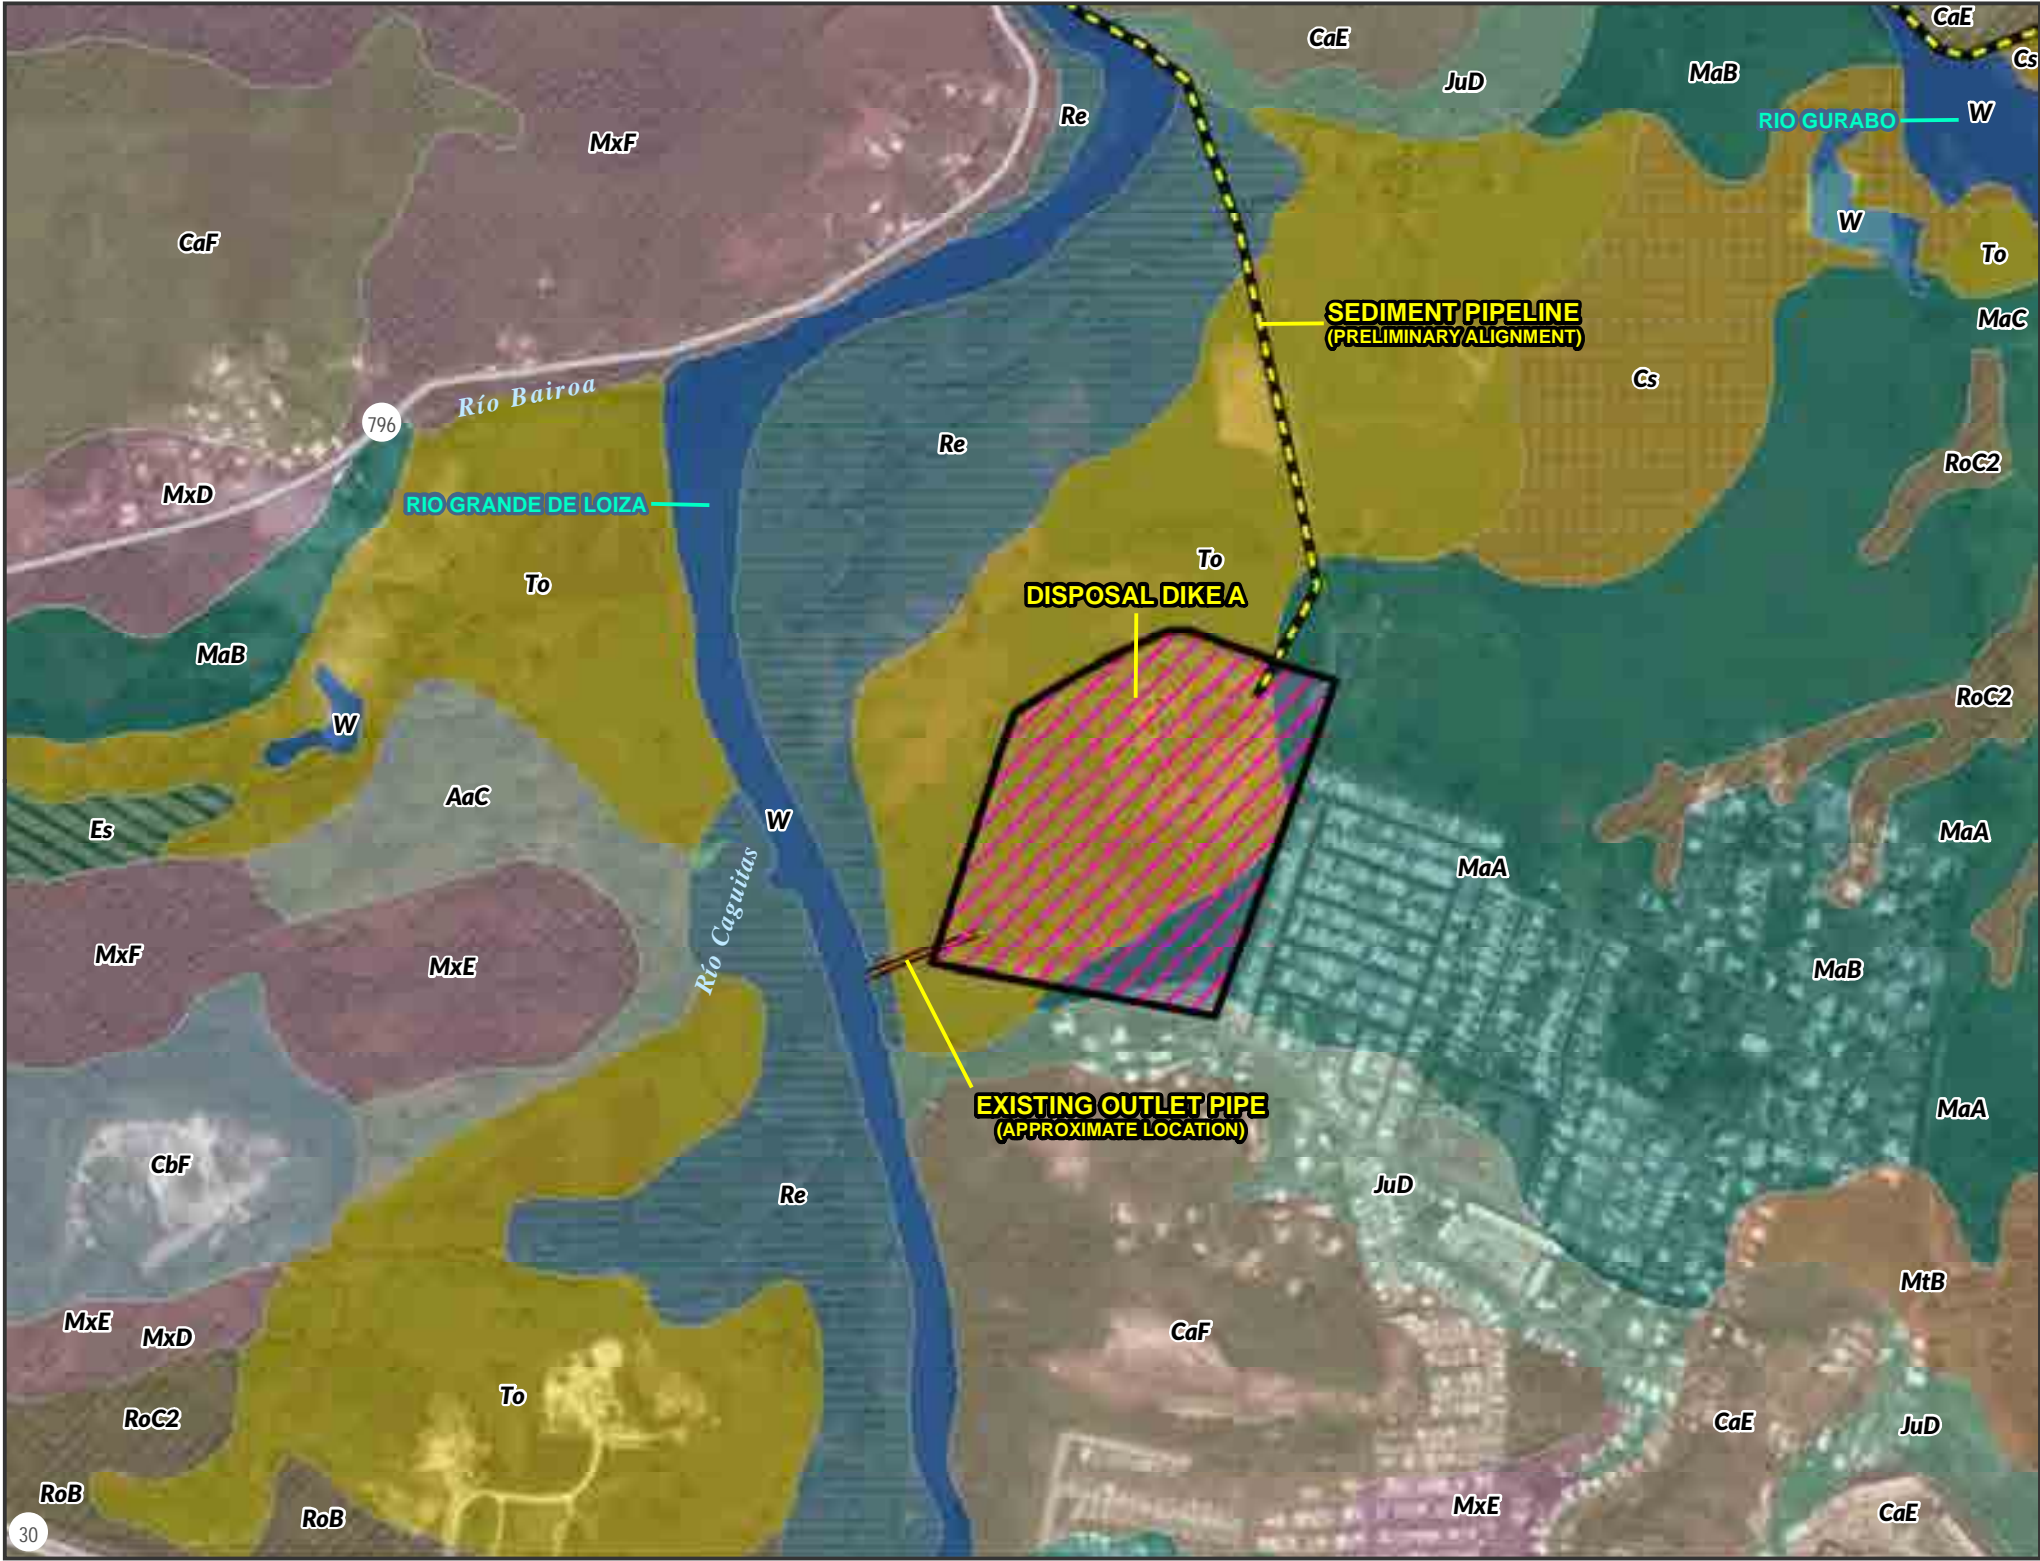
Figure 5: Soils within the Vicinity of Dike A

According to the U.S. Department of Agriculture's Soil Conservation Service, soils within Dike A are classified as Juncos clay, 12 to 20% slopes (JuD), Mabi clay, 0 to 2% slopes (MaA), Toa silty clay loam, 0 to 2% slopes (To) and Reilly sandy loam (Re). **Figure 5 (Appendix A)** shows the soil map for the study area. **Table 1** includes the description of these soils.

Descriptive Study of Flora and Fauna
Carraízo Reservoir Dredging Project
Figure 5: Soils within the Vecinity of Dike A

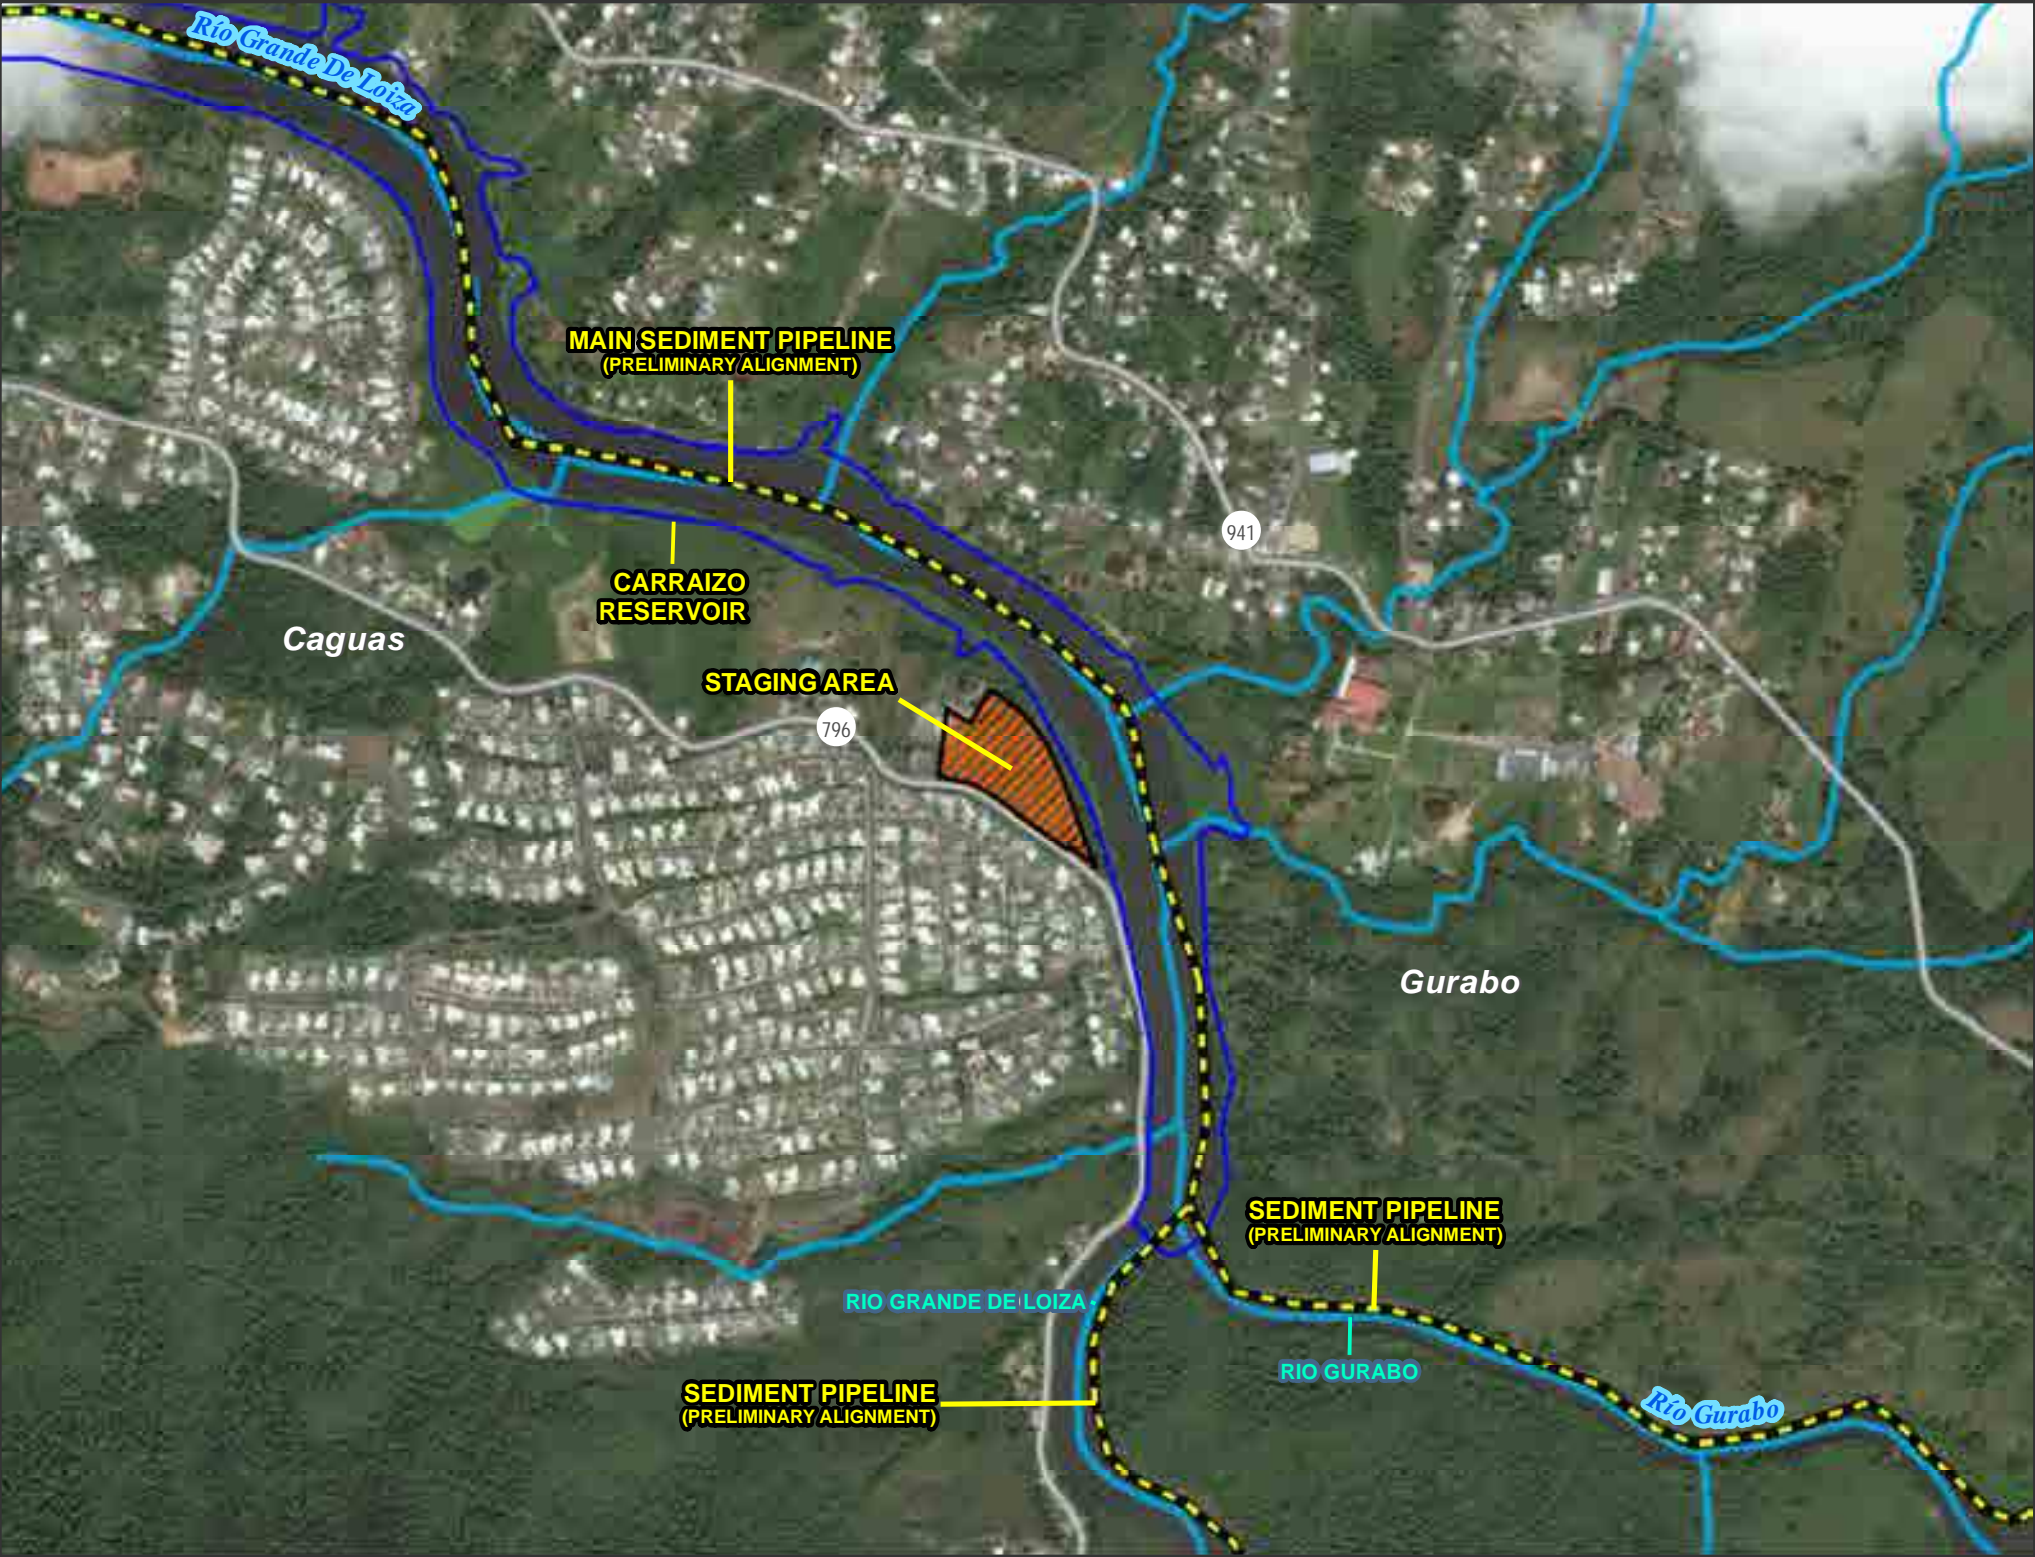
Figure 13: Hydrography within the Vicinity of the Staging Area

There are no hydrographic features within the Staging Area (**Figure 13, Appendix A**). However, the Carraízo Reservoir (Río Grande de Loíza) is adjacent to the north, northeast, east and southeast sides of the study site. The Río Grande de Loíza discharges into the Atlantic Ocean.

**Descriptive Study of Flora
and Fauna**
**Carraízo Reservoir
Dredging Project**
**Figure 13: Hydrography within
the Vecinity of the Staging Area**

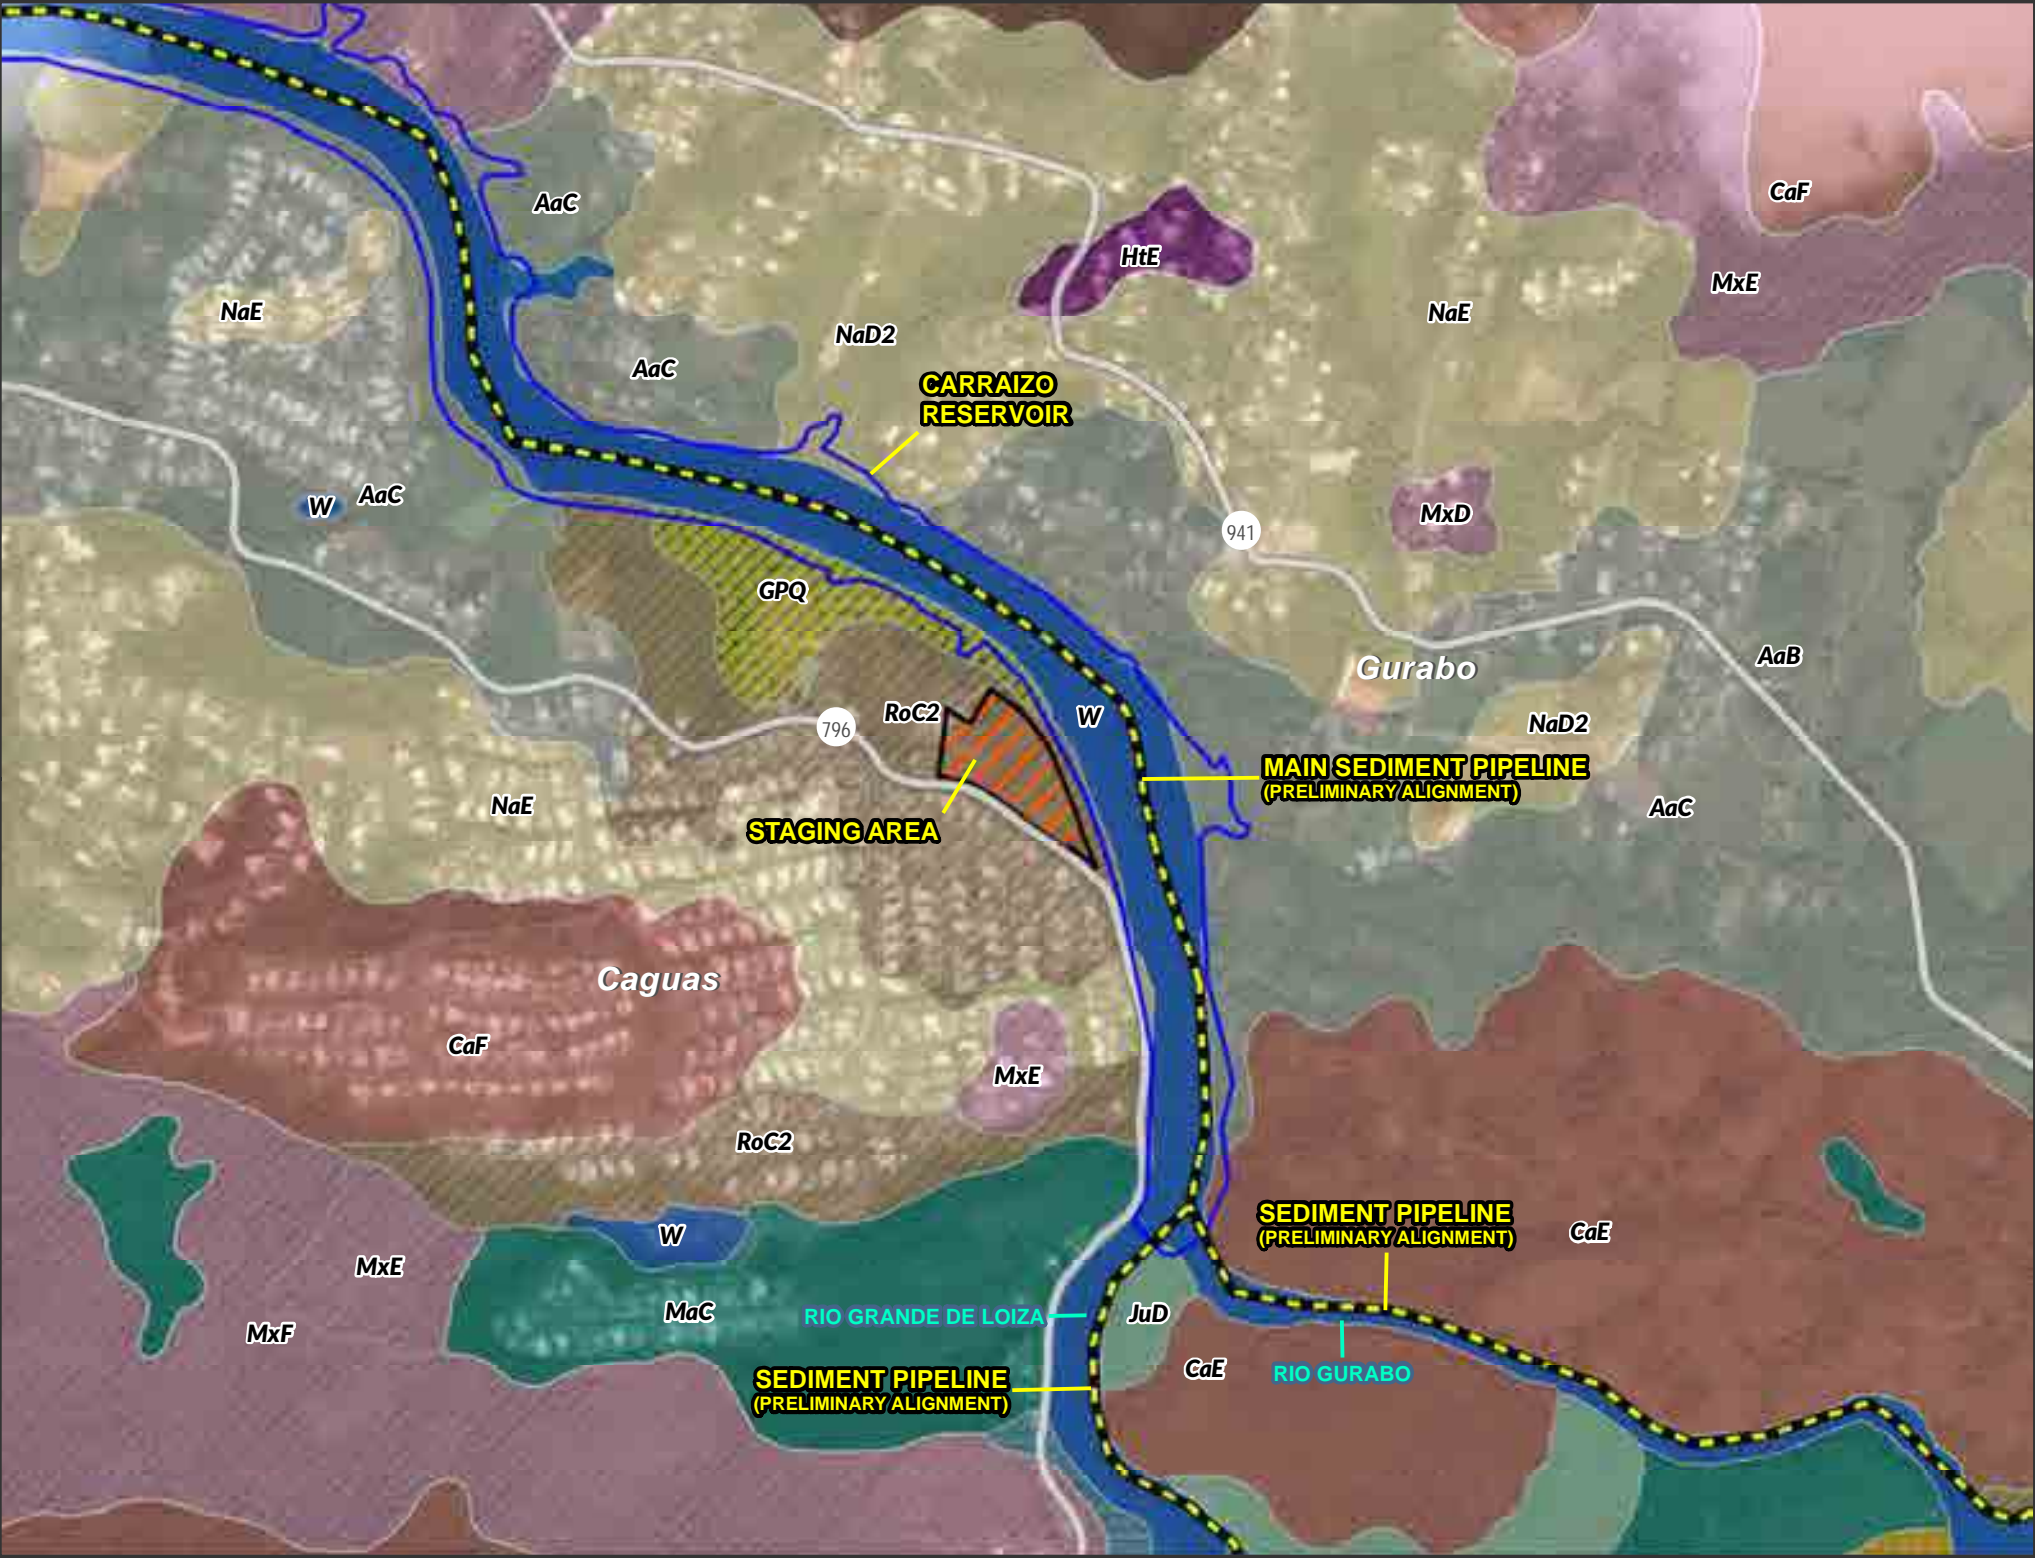
Figure 14: Soils within the Vicinity of the Staging Area

According to the U.S. Department of Agriculture's Soil Conservation Service, soils within the Staging Area are classified as Canteras and Graveros (GPQ) and Rio Arriba clay, 5 to 12% slopes (RoC2). **Figure 14 (Appendix A)** shows the soil map for the study area. **Table 4** includes the description of these soils.

Descriptive Study of Flora and Fauna
Carraízo Reservoir Dredging Project
Figure 14: Soils within the vicinity of the Staging Area

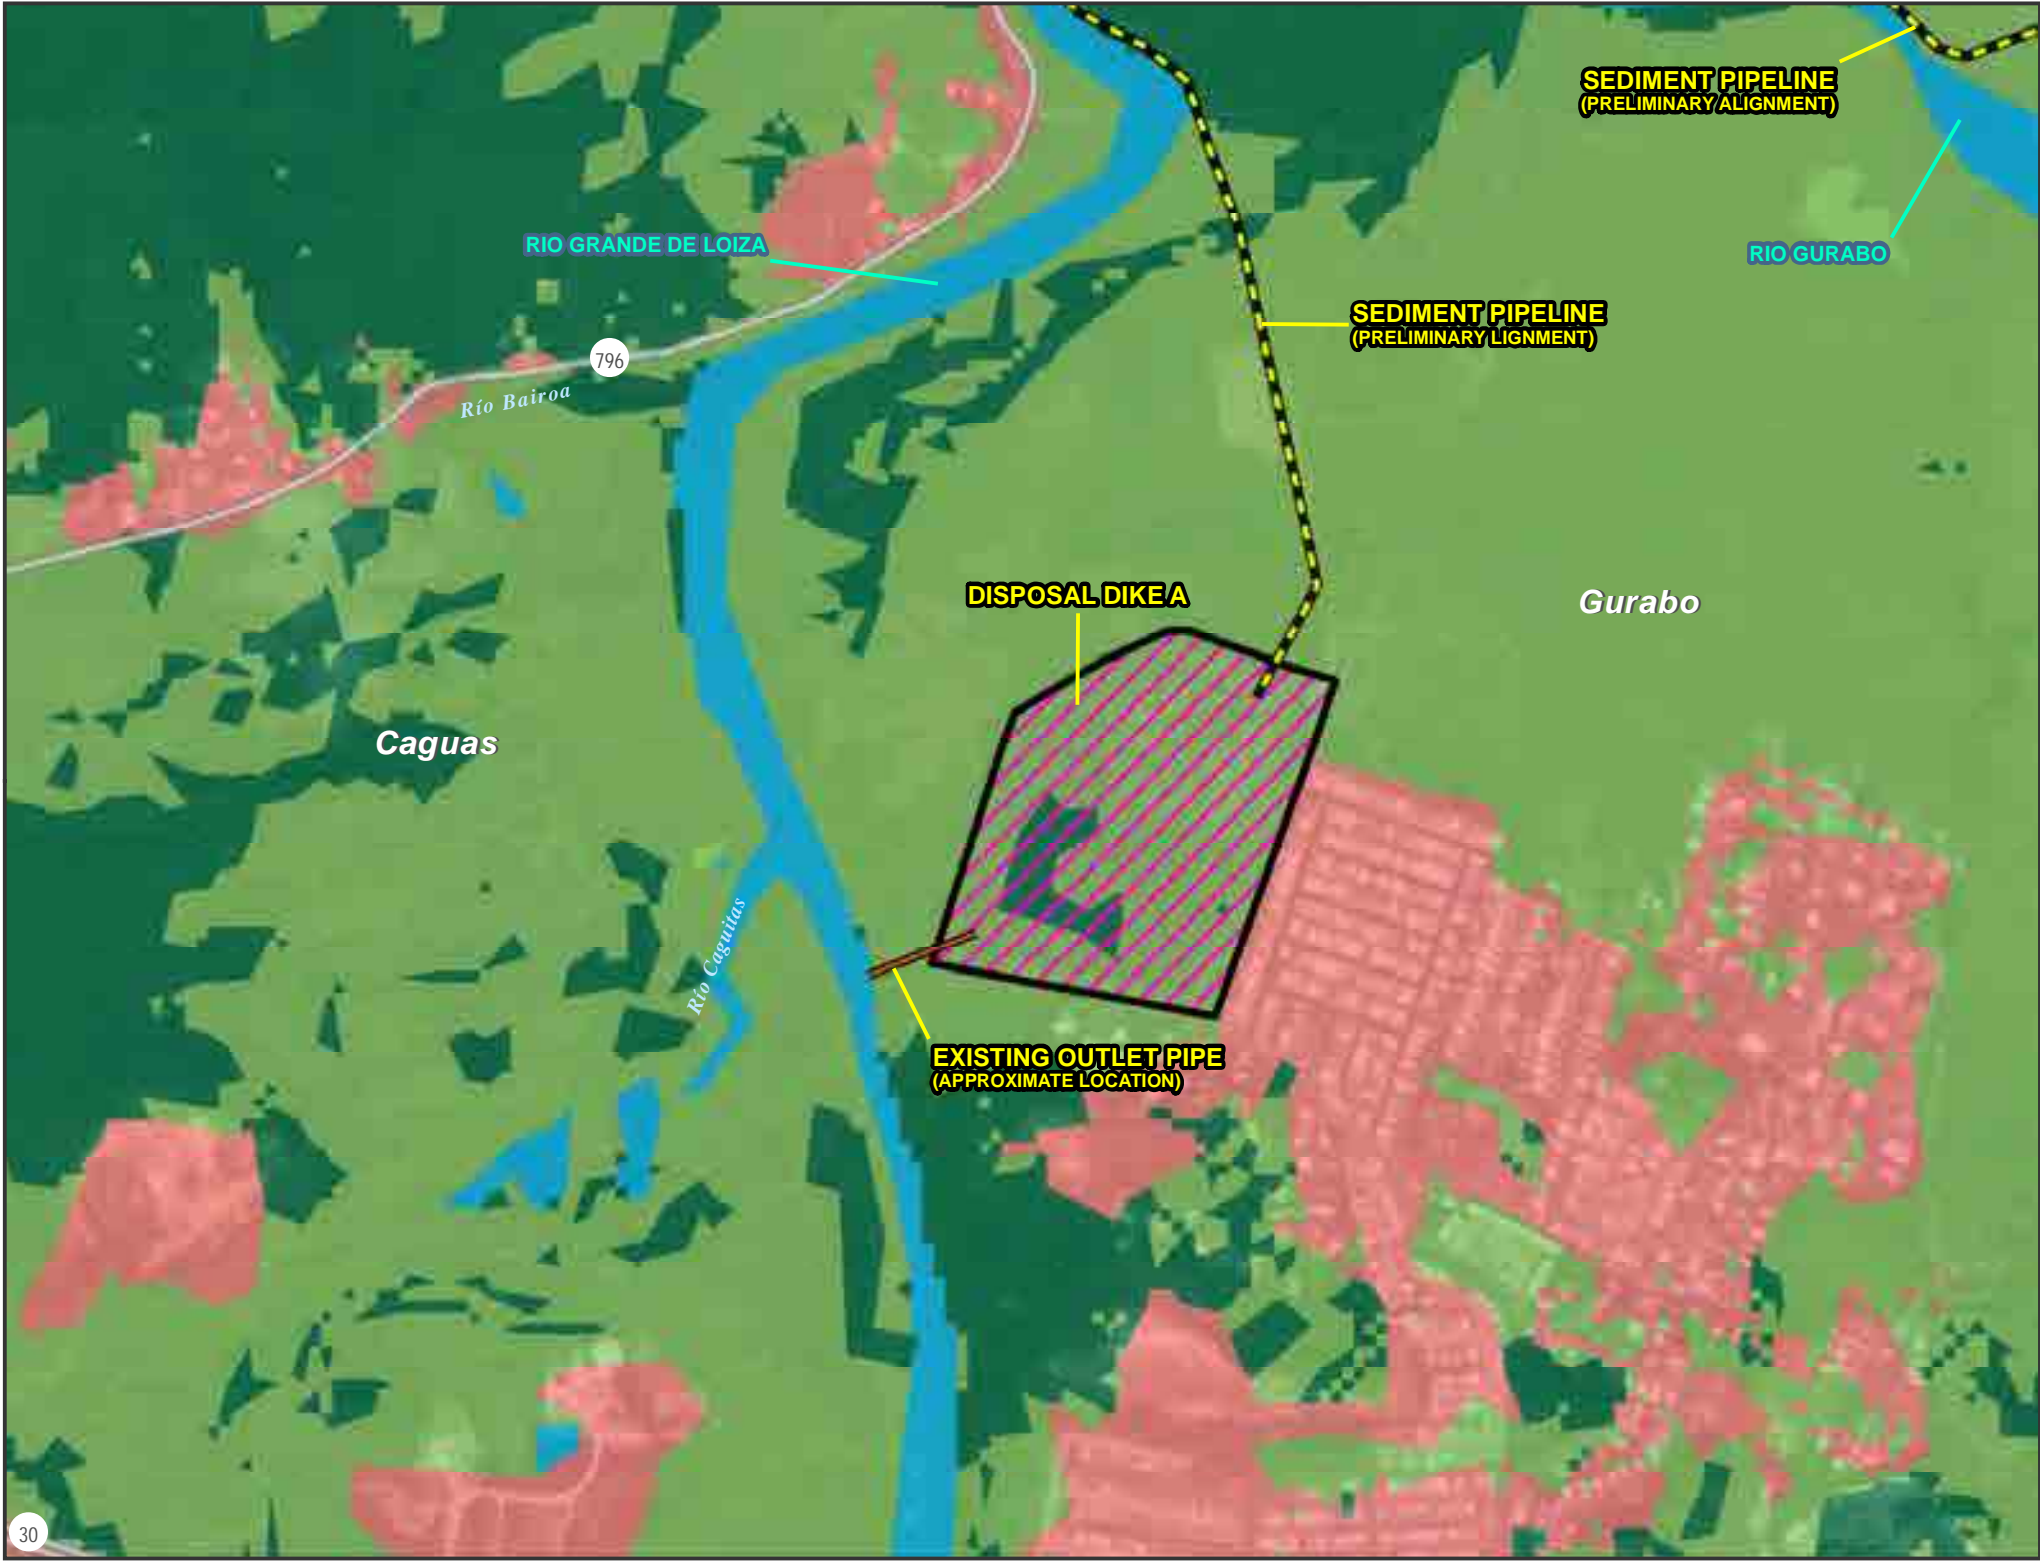
Dike A is mostly covered by an association of shrub (dominated by *Mimosa pellita*) and herbaceous vegetation (mostly dominated by *Paspalum fasciculatum*), especially in the lower areas of the dike. However, trees have grown within the northeast corner, where sediments from the former dredging activities were deposited, and also along the outer perimeter of the dike. Slurry pipe segment is mostly dominated by *Paspalum fasciculatum*. According to Helmer et al. (2002), the dike A is mostly covered by pastures and agriculture/hay (see **Figure 17, Appendix A**).

Descriptive Study of Flora and Fauna
Carraízo Reservoir
Dredging Project
Figure 17: Land Cover within the Vicinity of Dike A

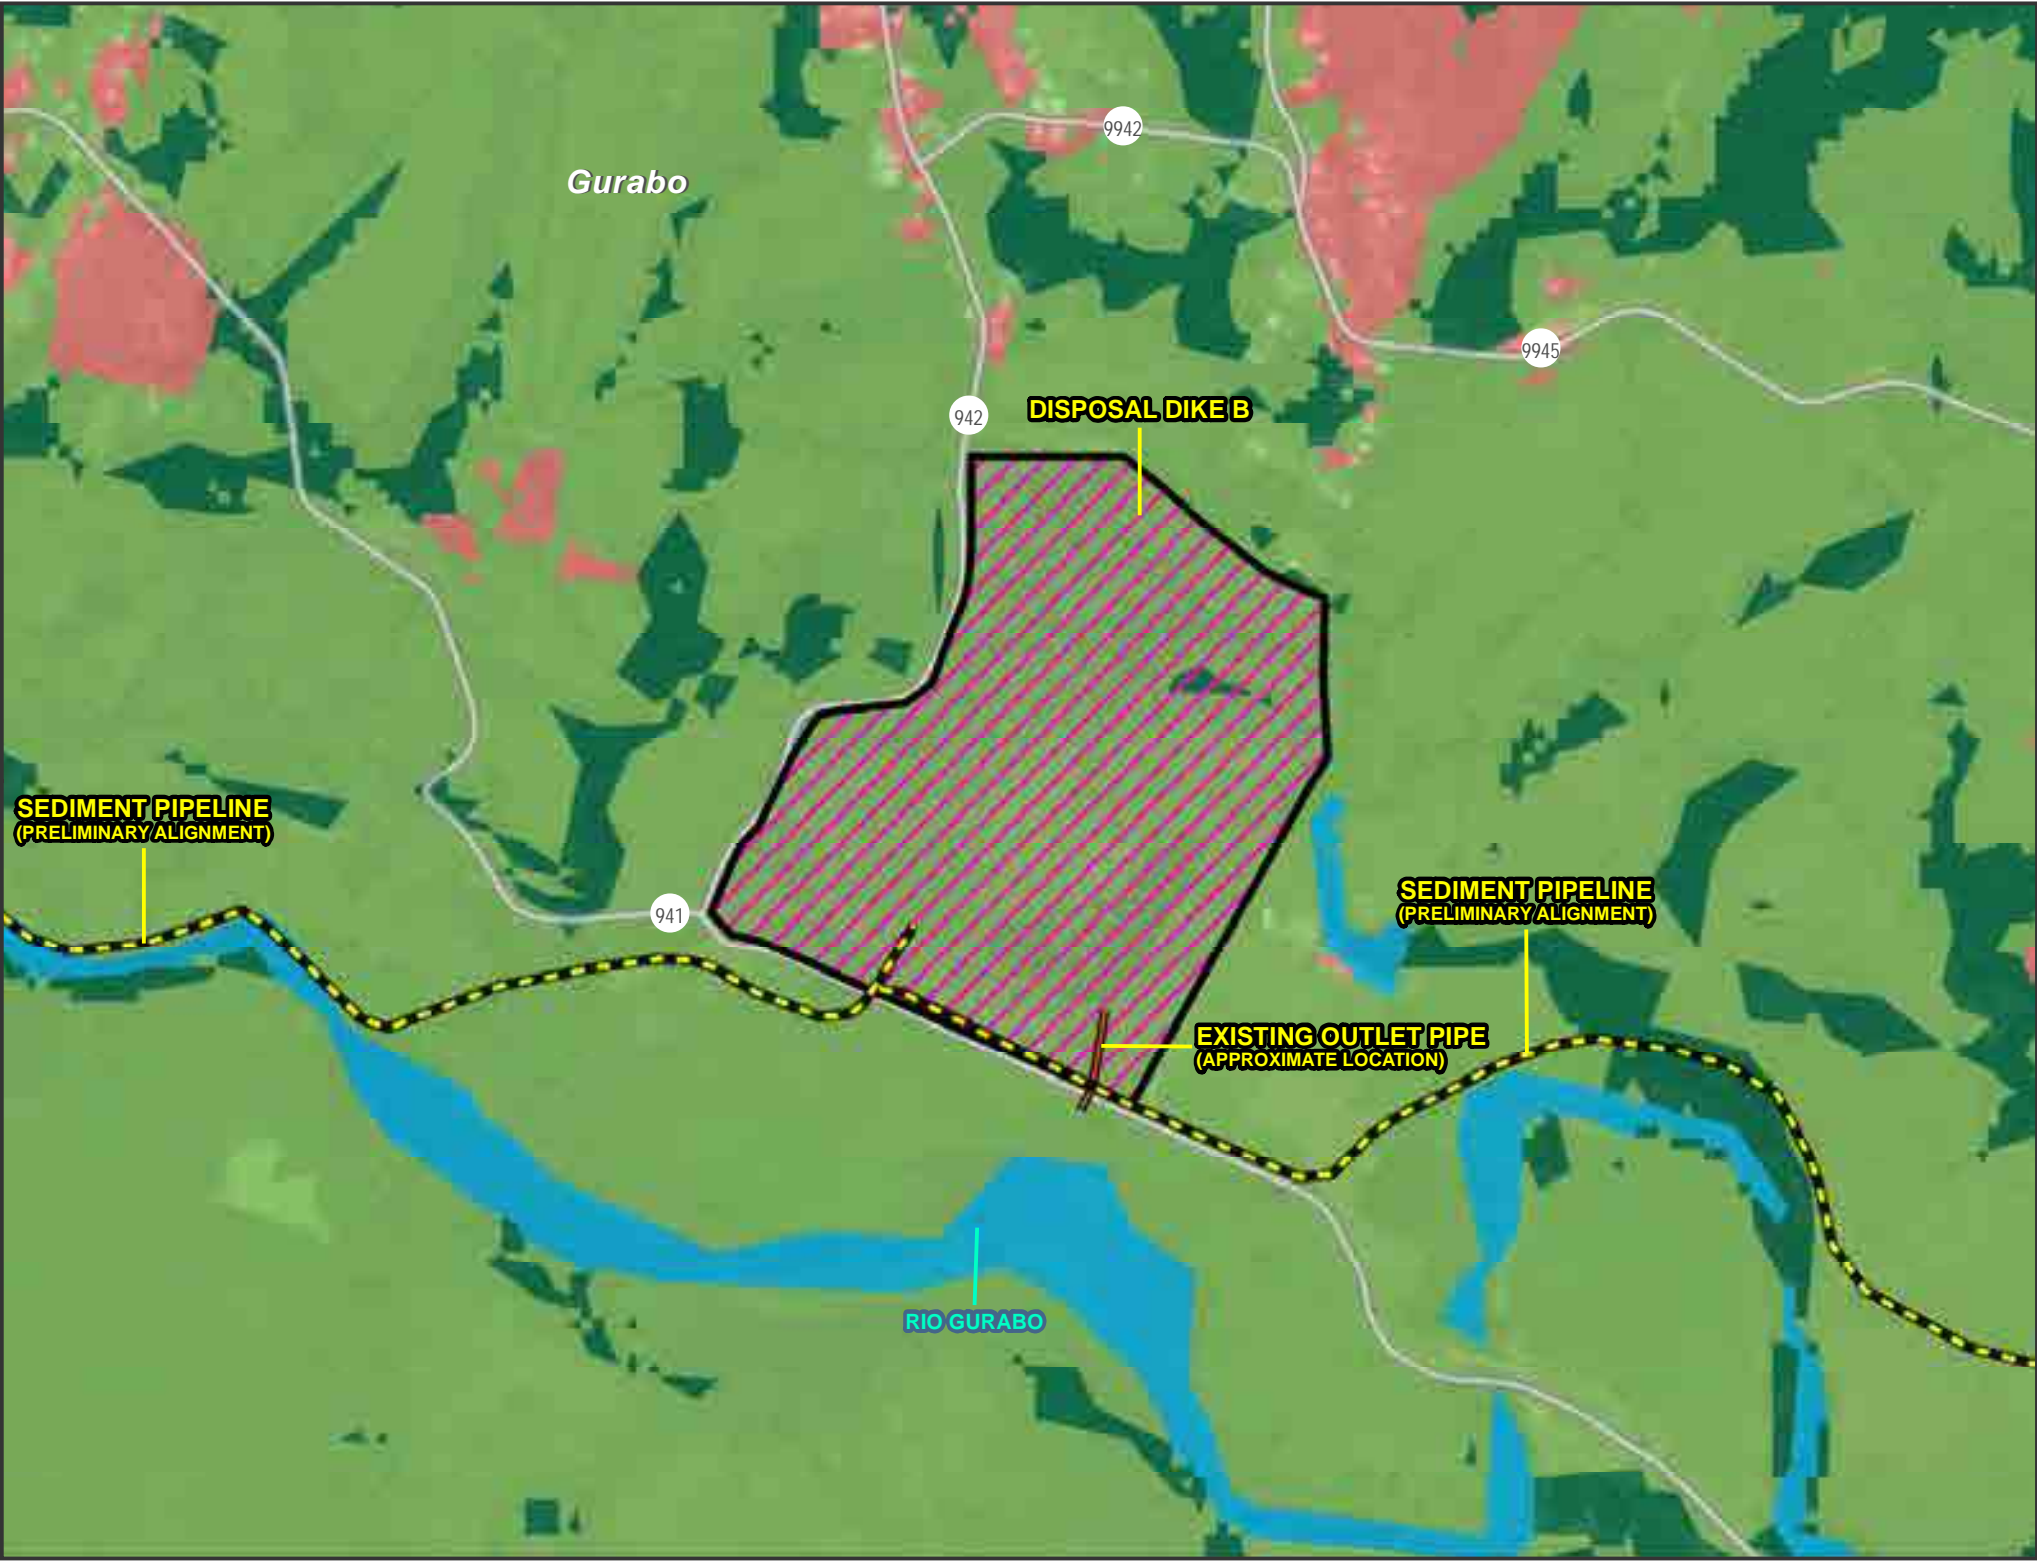
Descriptive Study of Flora and Fauna
Carraízo Reservoir Dredging Project
Figure 20: Land Cover within the Vicinity of Dike B

The dike B is mostly covered by an association of shrub (dominated by *Mimosa pellita*) and herbaceous vegetation (mostly dominated by *Paspalum fasciculatum*), especially in the inner slopes of the dike. There is a pond in the center of dike B, which shallow areas are dominated by hierba de enéas (*Typha domingensis*) and species from the Cyperaceae family. The pond is mostly open water, but seasonally it is covered by herbaceous species, also from the Cyperaceae family (mostly *Rhynchospora holoschoenoides*). Scattered trees are mostly found in higher ground areas to its north, or in the outer slopes. Slurry pipe segment is mostly dominated by *Paspalum fasciculatum*. According to Helmer et al. (2002), the dike B is mostly covered by lowland moist seasonal evergreen forest/shrub (see **Figure 20, Appendix A**).
