APPENDIX J FLORA AND FAUNA STUDY AND USFWS CONCURRENCE LETTER

Descriptive Study of Flora and Fauna

CARRAÍZO RESERVOIR DREDGING PROJECT MUNICIPALITIES OF CAGUAS AND GURABO, PUERTO RICO

PUERTO RICO AQUEDUCT AND SEWER AUTHORITY

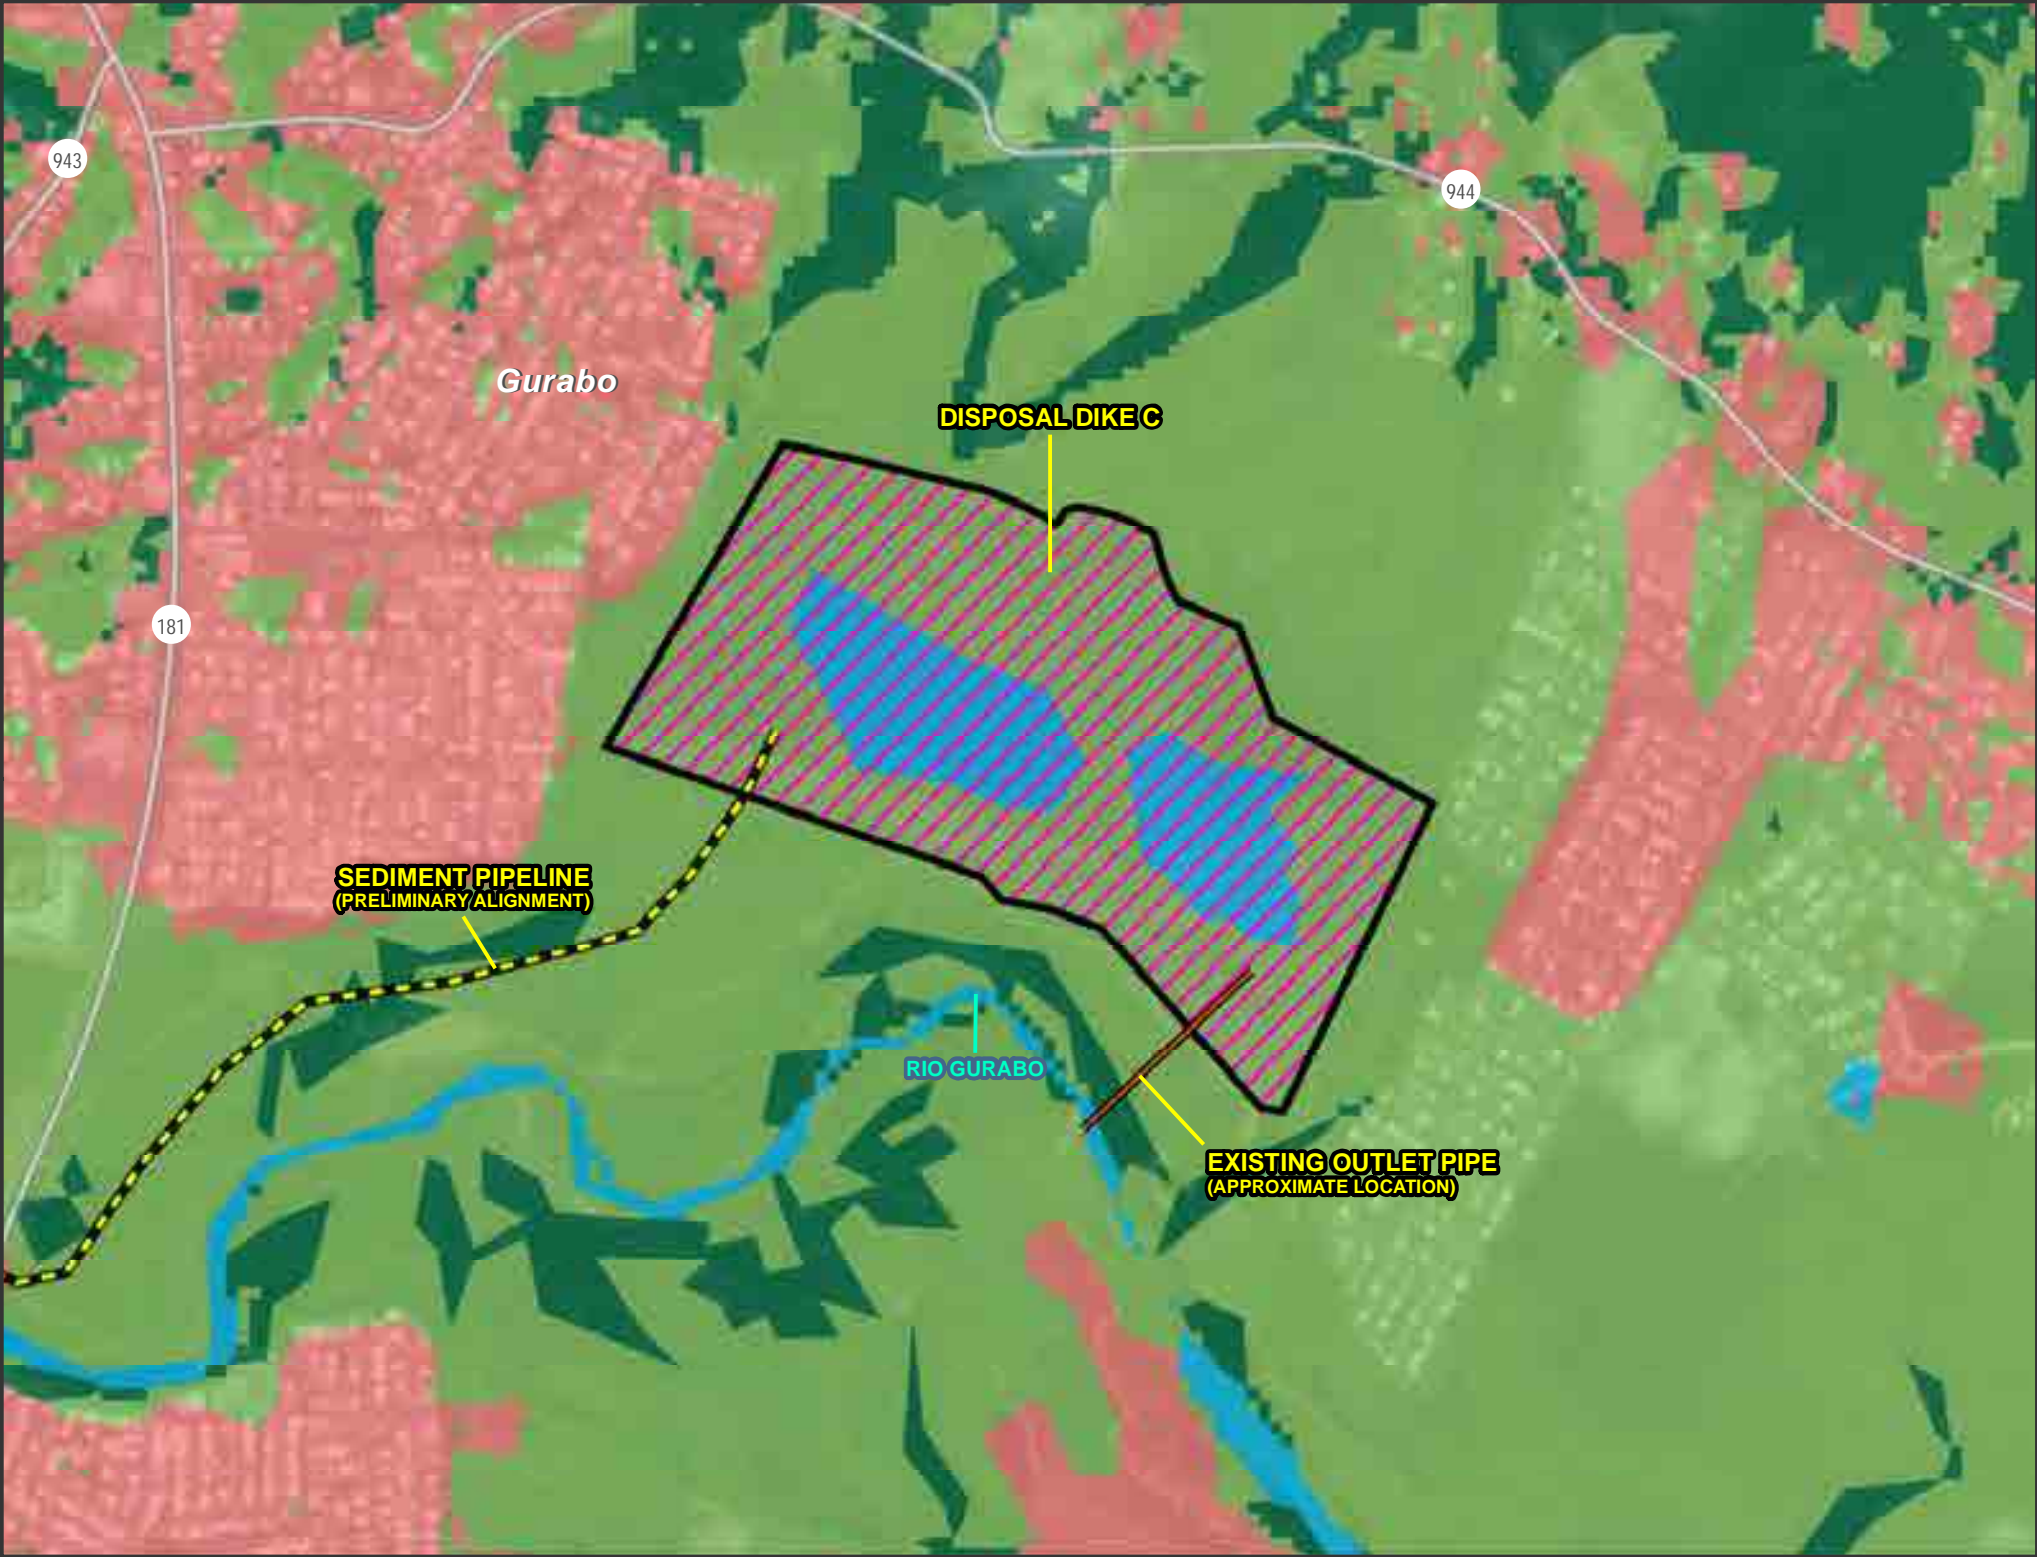
The dike C is mostly covered by an association of shrub (dominated by *Mimosa pellita*) and herbaceous vegetation (mostly dominated by *Paspalum fasciculatum*), especially in the inner slopes and the center of the dike. However, trees have grown within the southwest corner, where sediments from the former dredging activities were deposited. Slurry pipe segment is mostly dominated by *Paspalum fasciculatum* and *Bambusa vulgaris*. According to Helmer et al. (2002), the dike C is mostly covered by pastures and agriculture/hay (see **Figure 23, Appendix A**).

Descriptive Study of Flora
and Fauna
Carraízo Reservoir
Dredging Project
Figure 23: Land Cover within
the Vicinity of Dike C

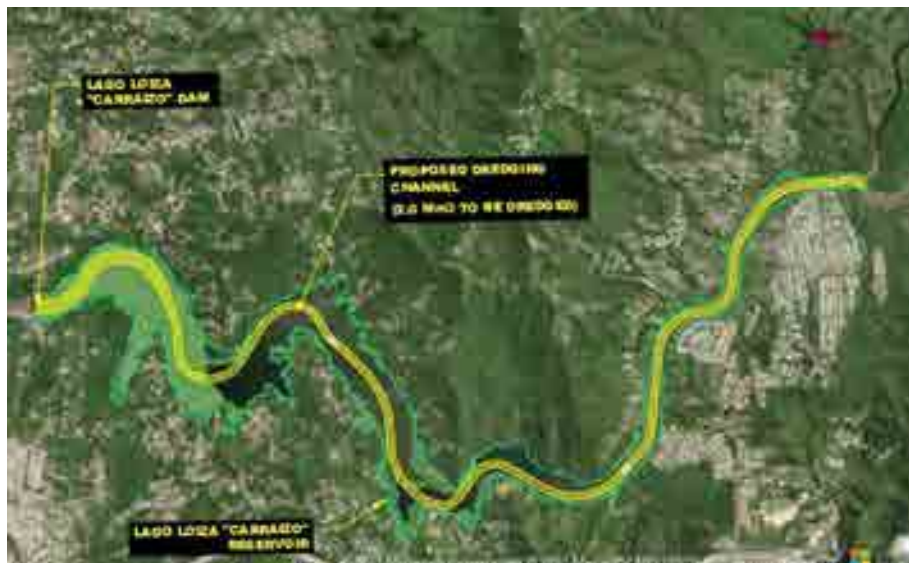
Figure 2. Conceptual design of dredging channel, courtesy of Puerto Rico Aqueduct and Sewer Authority

- **Dredging:** The Applicant will dredge a channel at the bottom of the lake to remove approximately 2.0 Mm³ of sediment along the reservoir using hydraulic dredges with a centrifugal pump.

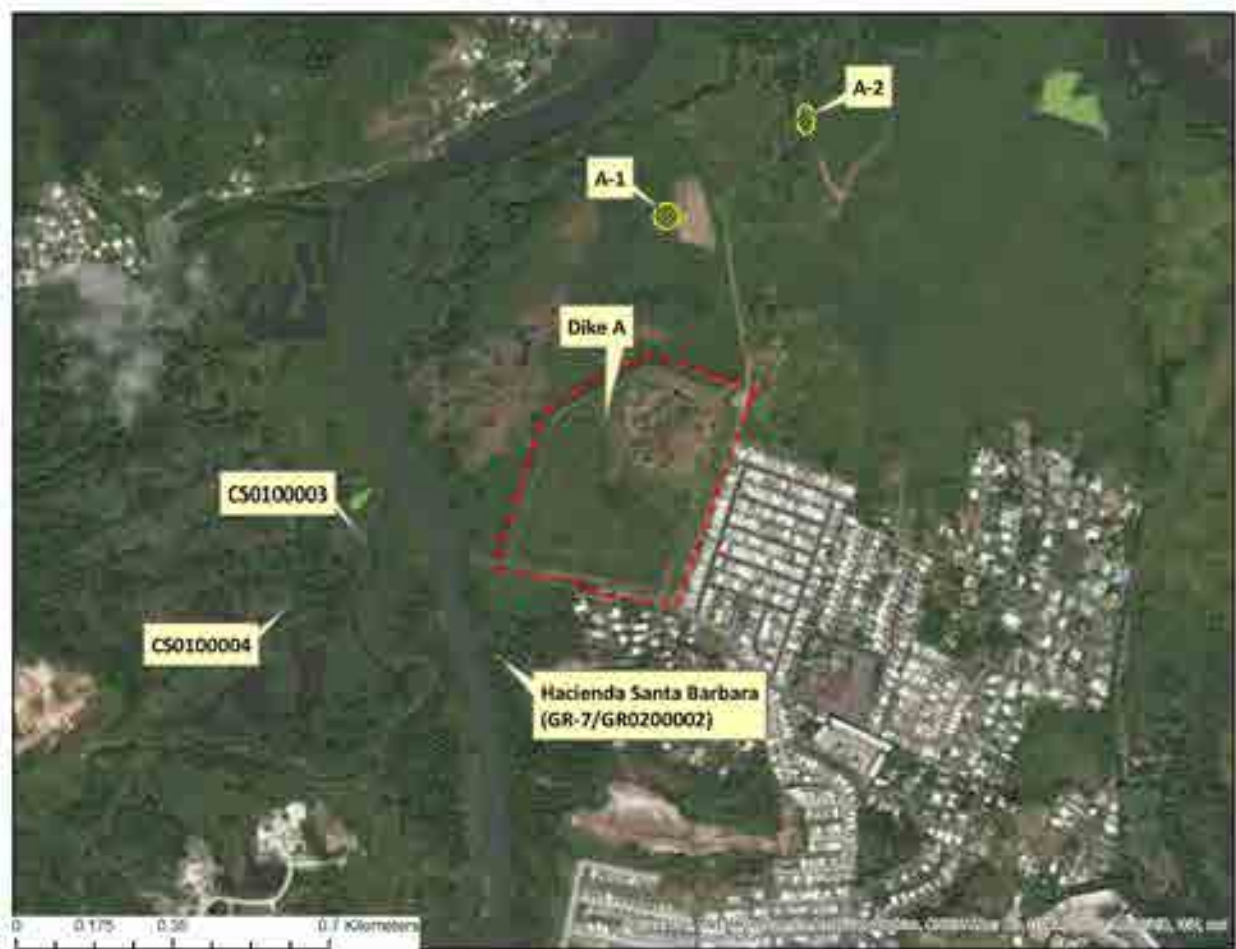
Figure 4. Dike A or “Area A” area of potential effect (APE) showing the areas of archaeological deposits documented by Ortiz Aguilú in 1996 and the location of Hacienda Santa Bárbara.

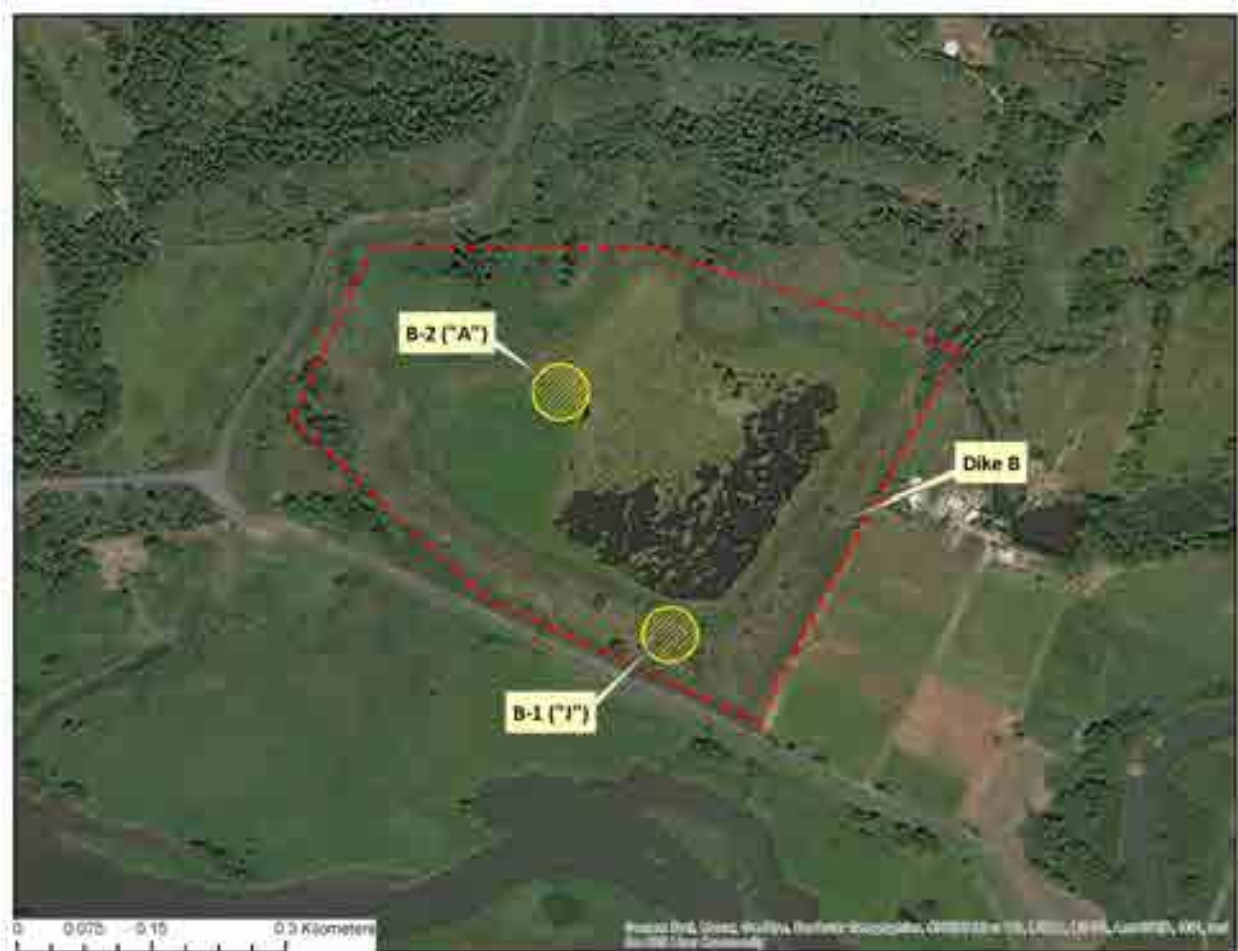
Figure 5. Dike B or “Area B1” area of potential effect (APE) showing the areas of archaeological deposits documented by Ortiz Aguilú in 1996.

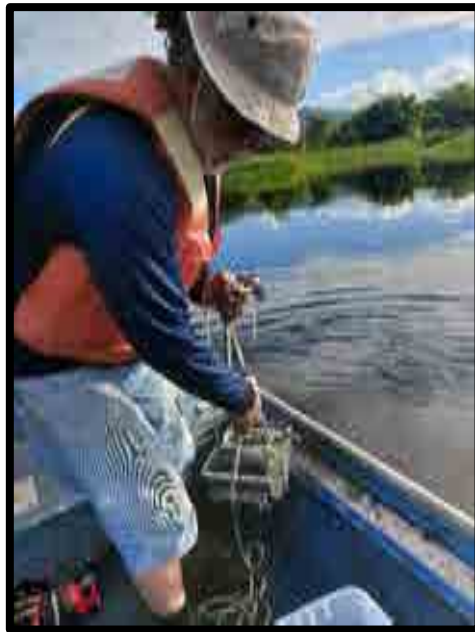
Figure 2. Petite Ponar Dredge sediment sampling equipment used in Carraizo Peservoir

The sediment was collected with a bottom dredge (**Figure 2**), specifically a stainless steel Petit Ponar dredge with a weight and volume of 6.8 kg (24 lb), 2.4 Liter volume and a sample area of 152 x 152 mm (6 x 6"). The dredge is suitable for bottoms with muddy or fine sediments, in deep areas (Ramírez, 2010).

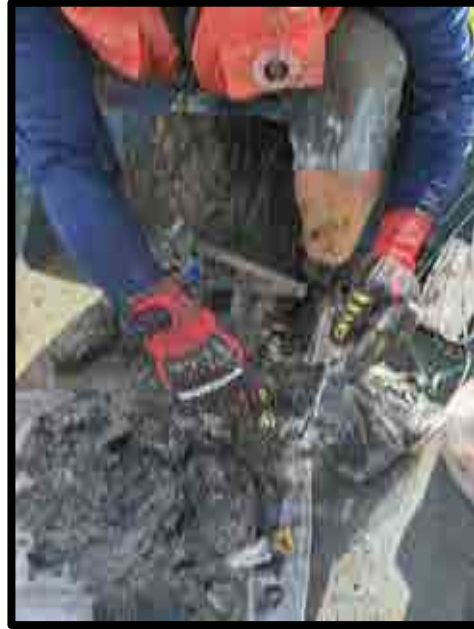
Figure 3. Sediment Collection.

The sediment was deposited or in plastic bags (**Figure 3**), fixed with 4% formaldehyde and kept in beach coolers with ice to prevent altering or decomposing the organisms, these samples are examined in the laboratory using a microscope.
