Marshall Fire Mitigation Assessment Team: Wildfire-Resilient Detailing, Joint Systems, and Interfaces of Residential Building Components

Revised April 2025

DR-4634

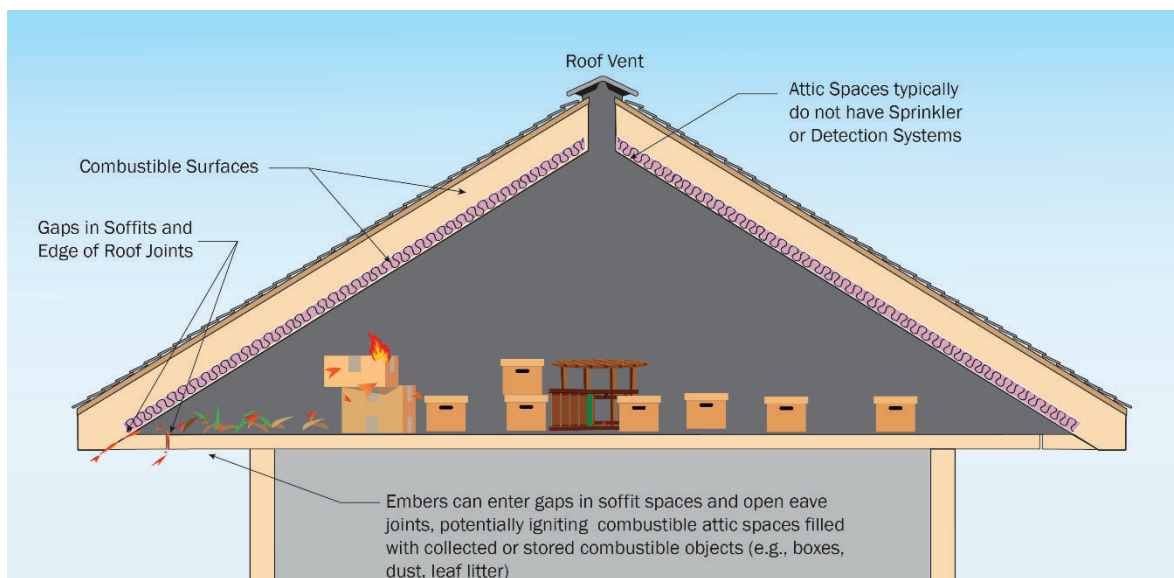
Figure 2. Example of gaps in open eaves, soffit spaces and edge of roof construction leading to ember penetration and potential ignition of various combustible surfaces, collected materials or storage goods common in attic spaces.

Similarly, gaps in the exterior envelope of various roof components and details (e.g., edge of roof, around fire-rated or protected vents, open eave rafter, or joist blocking details) can lead to embers penetrating combustible attic spaces (see Figure 2). Attic spaces can typically contain large amounts of combustible surfaces and stored goods, accumulated dust and debris, and other materials that can readily ignite from embers if they penetrate gaps, joints, or interfaces at the roof-attic envelope. In addition, attics in residential homes do not typically contain fire detection or suppression systems even if the home is provided with a residential sprinkler system. In the event an interior building fire ignites in the attic space due to ember intrusion, the fire will typically go unnoticed and potentially lead to total building loss.

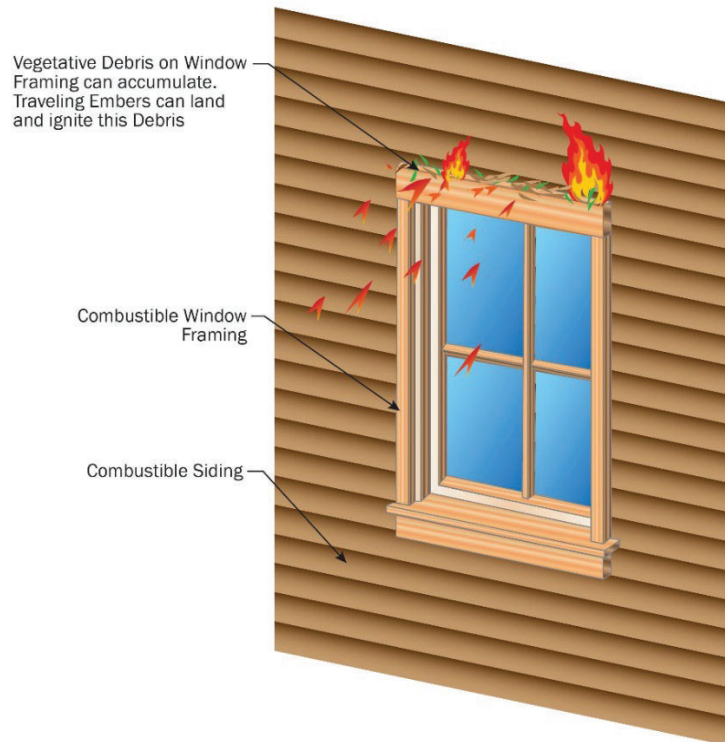
Figure 3. Vegetative debris (e.g., pine needles) and embers can accumulate at window-to-wall joints, as well as other joints throughout the exterior envelope of a home.

materials where debris and embers can collect. In the event embers collect or get lodged at these joints (whether horizontal or vertical joints) ignition of vegetative debris or surrounding combustible trim, cladding or other construction materials is possible, and can eventually lead to ignition of interior wall cavities. For roof-to-roof joints, where the roof system is not fire-rated or Class A (such as for wood shingle roofs), debris and ember accumulation can lead to ignition of the roof covering itself and potentially any combustible underlayment, which may eventually lead to fire penetrating into the roof or attic space.

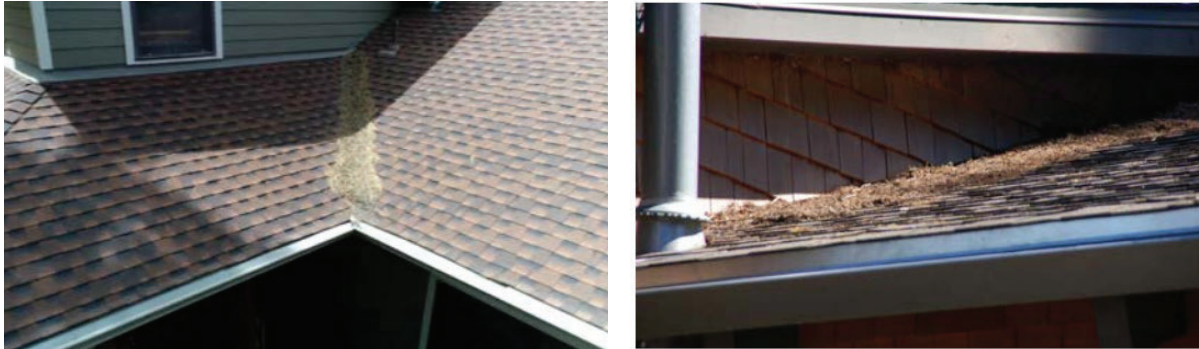
Figure 4. Vegetative debris (e.g., pine needles) and embers can accumulate at roof valleys (left, Source: NFPA®) and at the base of the wall on the roof of this split-level house (right, Source: Stephen Quarles).

Various roof-to-wall joints and interfaces in the roof envelope oftentimes create areas where vegetative debris and embers accumulate creating major sources of ignition vulnerability (see Figure 4). Most roof joints and interfaces proximate to dormers and other wall systems (at roof level) accumulate vegetative debris throughout the year (see Figure 3). During a fire event, embers will also accumulate in these locations oftentimes leading to ignition of the vegetative debris and potential ignition of adjacent combustible dormer or wall siding. As shown in Figure 4, both images depict a Class A roof comprised of fire rated asphalt composition shingles, where vegetative debris has collected in close proximity to a non-fire rated dormer or wall system. In a fire event, embers can readily ignite the debris, and while unlikely lead to breach of the fire rated roof system, will result in a

flaming exposure to the adjacent non-fire rated siding, potentially leading to ignition of not only the cladding but also the interior wall assembly.

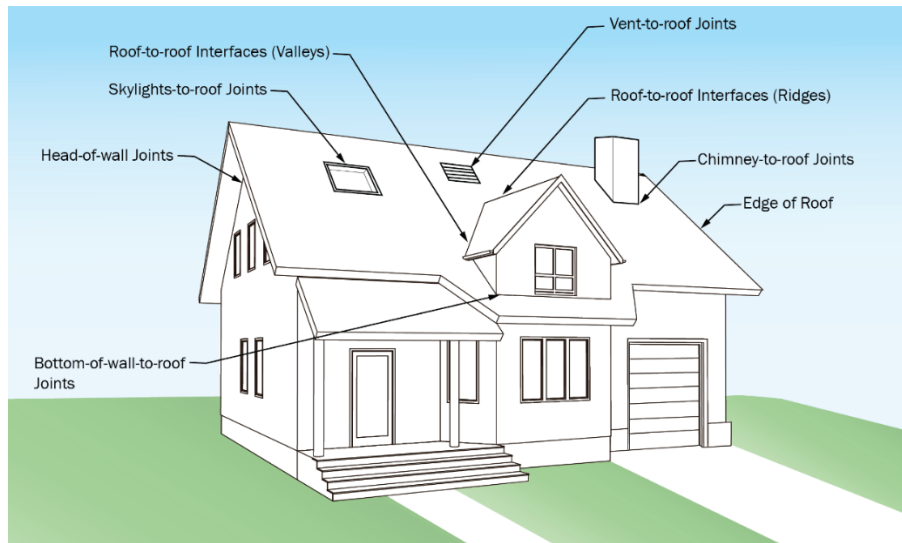
Figure 5. Various locations of vulnerable joints, penetrations, and interfaces throughout the exterior envelope of a residential structure to wildfires.

While wildfire-specific fire test standards and associated “listed” WUI building products are still limited, there are actions that still can be taken based on best practices to increase wildfire resiliency of joints and other building component interfaces throughout the exterior envelope of a building. The guidance below targets new construction and retrofits to existing buildings, detailing various actions for key building components that are commonly found in residential construction. See Figure 5 for an overview of building envelope locations.

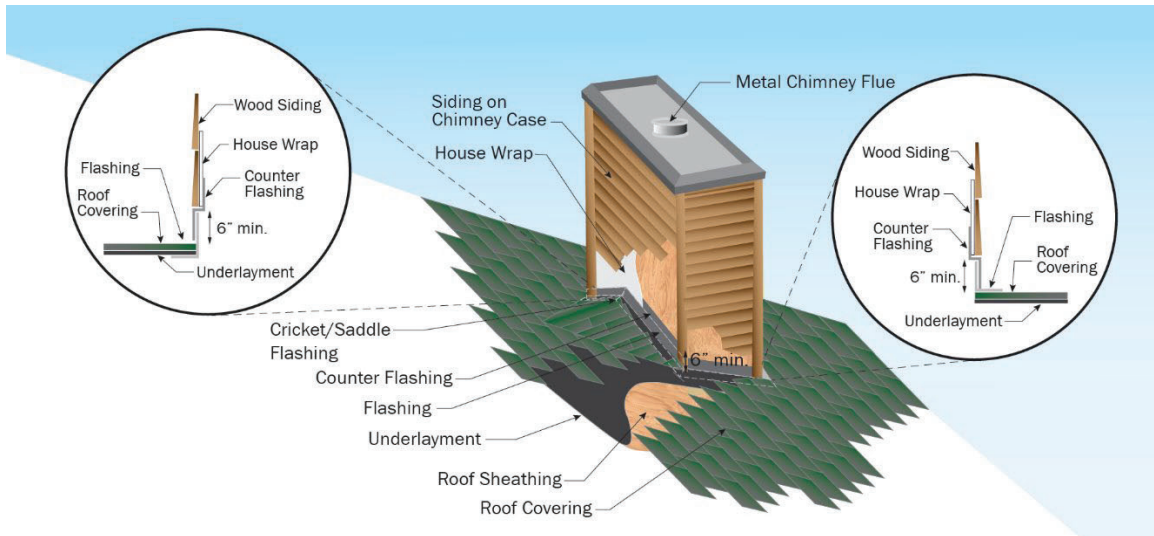
Figure 6. Example of fire-resistant caulking and non-combustible underlayment at the chimney-to-roof joint.

Where chimneys are constructed with an exterior chase comprised of combustible siding or other combustible materials (see Figure 6), install noncombustible metal flashing and counter flashing that protects the roof-to-chimney chase joint for at least 6 vertical inches above the roof surface. The metal flashing should be lapped above the roof covering material extending vertically up along the exterior side of the chimney chase before being “let in” behind the chase siding at the lap joint with combustible siding kept 4–6 inches above the roof surface (see Figure 6). Corrosion-resistant metal flashing is one material that might be used to accomplish this. Alternatively, “local” replacement of siding (i.e., chase area only) with non-combustible materials would also be acceptable.

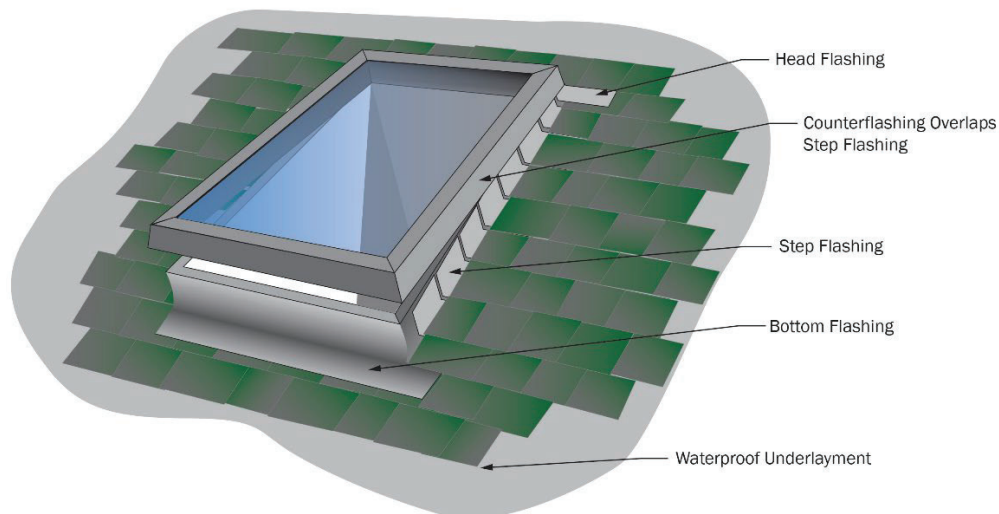
Figure 7. Example of flashing details for skylight-to-roof joint.

For other types of roof penetrations (e.g., vents, skylights), ensure the joint at the penetration and the roof assembly is well sealed to minimize the entry of embers (see Figure 7 for example of skylight-to-roof interface). Roof penetrations should be sealed per manufacturer’s instructions, where available. Where no instructions are available, this can be achieved with fire-resistant caulk, noncombustible mortar, compressed mineral wool, fire-rated expanding foam, or metal flashing. For enhanced protection, use a rated exterior penetration firestop system. Special considerations should be taken when considering the installation of a rated exterior penetration firestop system, such as ensuring the system installed is listed for use in the appropriate type of roof system.

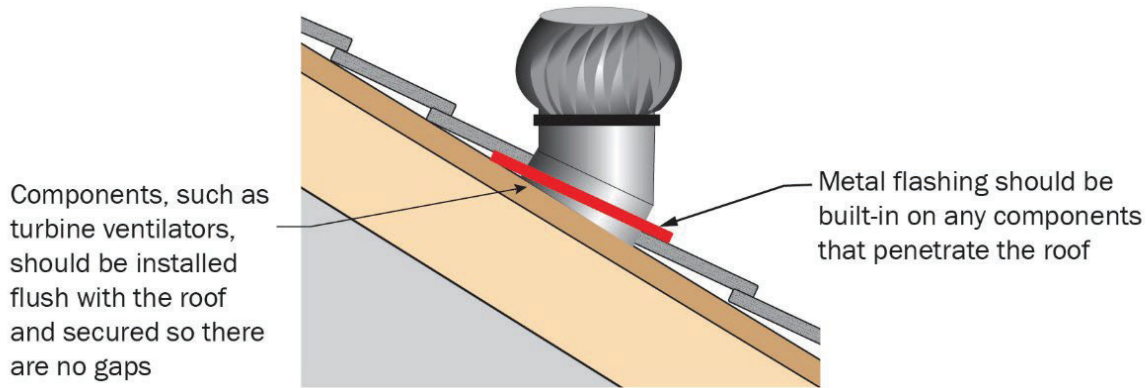
Figure 8. Example of a through penetration detail at the roof.

For retrofits, replace existing vulnerable roof penetrations and surrounding shingles. When replacing penetrations, follow manufacturer’s recommendations for sealing the gaps that might be created by the installation (see Figure 8).

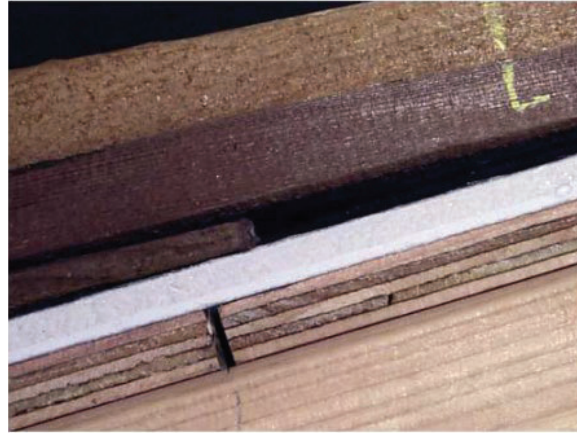
Figure 9. Vertical cross-section through Class A rated roof assembly consisting of exterior-rated, fire-retardant treated wood shakes and underlying fiberglass gypsum board (in white). The joints between the wood sheathing (below) and gypsum are staggered. (Credit: Stephen Quarles)

Most homes have roof decks comprised of wood (e.g., plywood or oriented strand board). For more protection, a layer of fiberglass gypsum panelized product between the decking and the roof covering should be installed. Where fiberglass gypsum board is installed, ensure that the joints between the gypsum and wood sheathing panels are staggered (UCANR, 2023), as shown in Figure 9. This strategy is particularly useful where roof coverings have a gap between the covering and the roof deck (i.e., barrel-style and some metal coverings).

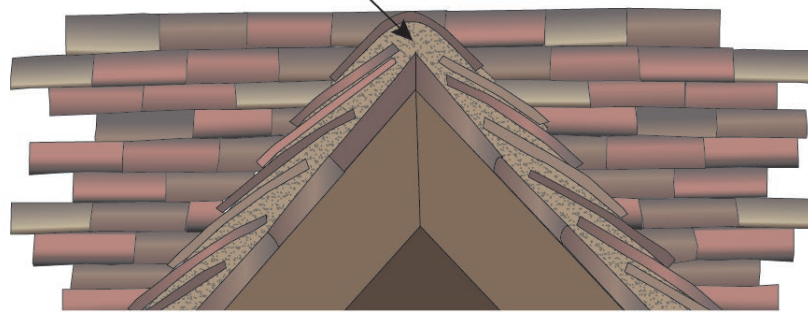
Mortar Mix Applied
to Fill Gaps

Figure 10. Example of mortar mix used to seal gaps at roof ridge edges.

Roof ridges can oftentimes have roof caps that create additional surfaces and gaps leading to ember accumulation and/or entrapment of vegetative debris, which can ignite during a wildfire. In addition, roof ridge edges can also be susceptible to having large gaps that are vulnerable to the collection of vegetative debris and ember intrusion. As these areas are difficult for homeowners to keep clear of debris or inspect annually, various wildfire detailings are recommended to reduce wildfire vulnerabilities. For roof caps that also serve as attic ventilation (e.g., underlying ridge vents), ensure that these ridge vents are provided with ember and flame-resistant vent protection. Where roof caps do not serve as attic ventilation, ensure that any gaps are sealed. For roof ridge edges or terminations, ensure any gaps are filled with a noncombustible material (see Figure 10). Typically, a mortar mix is easier to use in these locations.

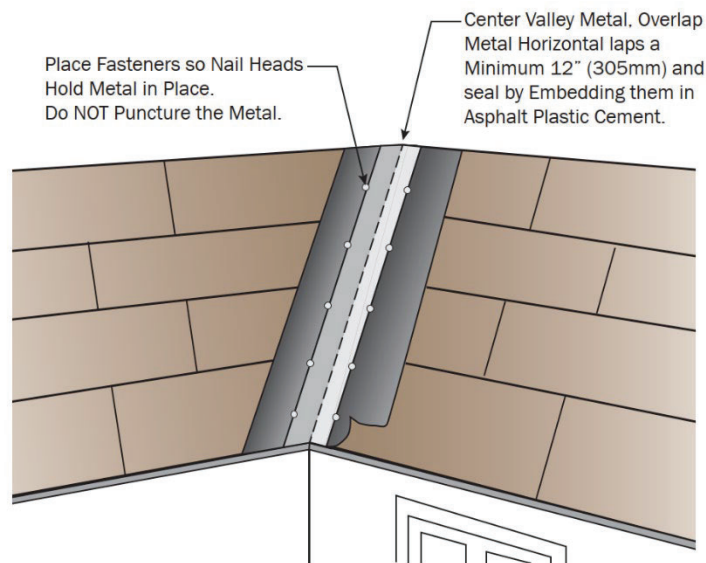
Figure 11. Example showing roof valley flashing installation.

Provide roof valley joints with metal valley flashing with an underlying mineral surfaced cap sheet incorporated into the assembly. See manufacturer's guidelines for properly installing the underlayment (see Figure 11 for an example).

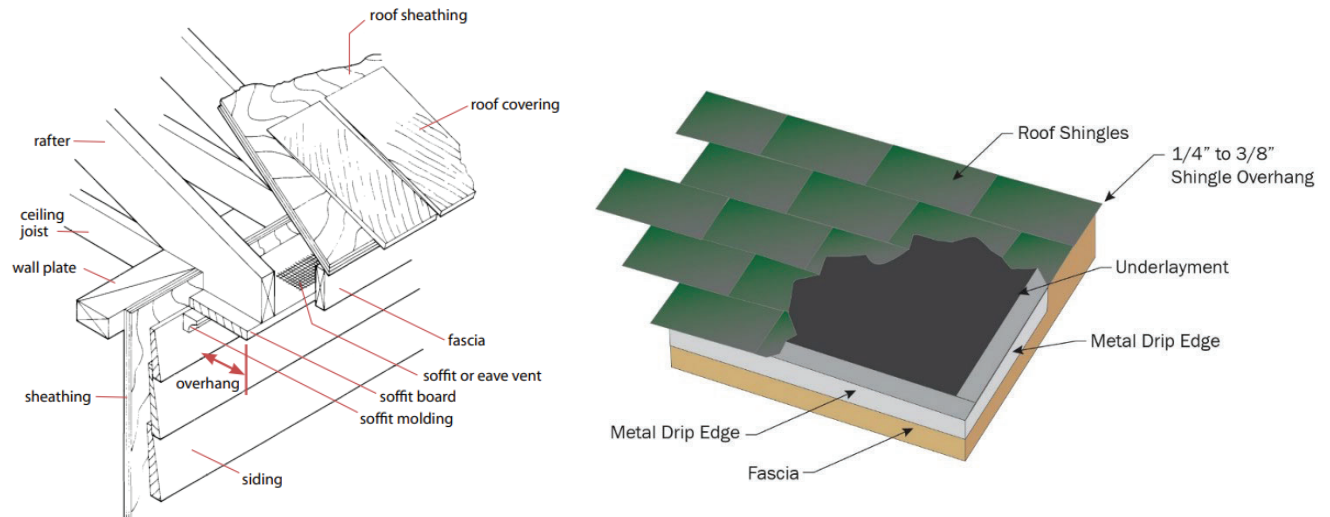
Figure 12. Schematic of the edge of roof detail (left) (adapted from Sherwood and Stroh, 1989) Use of metal drip edge to limit embers from entering gaps at the roof edge, particularly at the fascia where gutters are attached (right) (adapted from SFPE WUI Handbook, 2023).

Install a metal drip edge or flashing to protect the roof edge (particularly at all rake and eave edges) to minimize ember entry to the attic via materials burning in a rain gutter or wind-blown embers impinging on the area at the edge of the roof (see Figure 12).

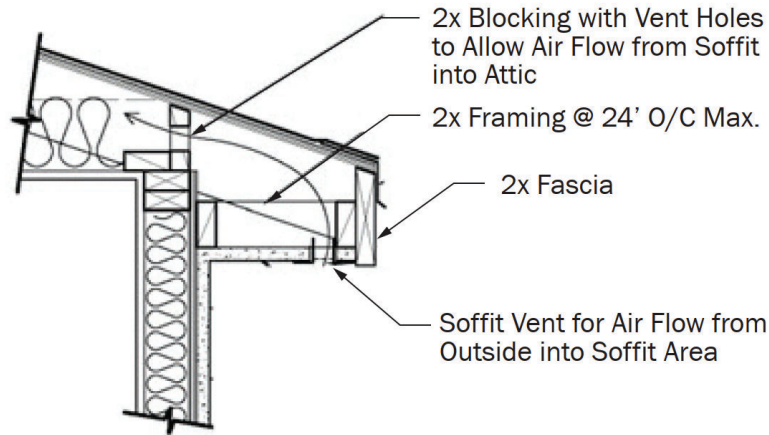
Figure 13. Diagram of construction details that allow air to flow from the soffit into the attic (adapted from UCANR, 2010).

Provide fire-resistant caulking at any gaps at the joint between the head-of-wall and roof or ceiling. Use noncombustible construction where possible (in both new construction & retrofits). Protect exterior walls with 2-inch nominal solid blocking between exposed rafters at all roof overhangs, under exterior wall coverings on sides exposed to native vegetation (see Figure 13). For more information, see NFPA 1140, 2022 Edition, Section 25.6.2.

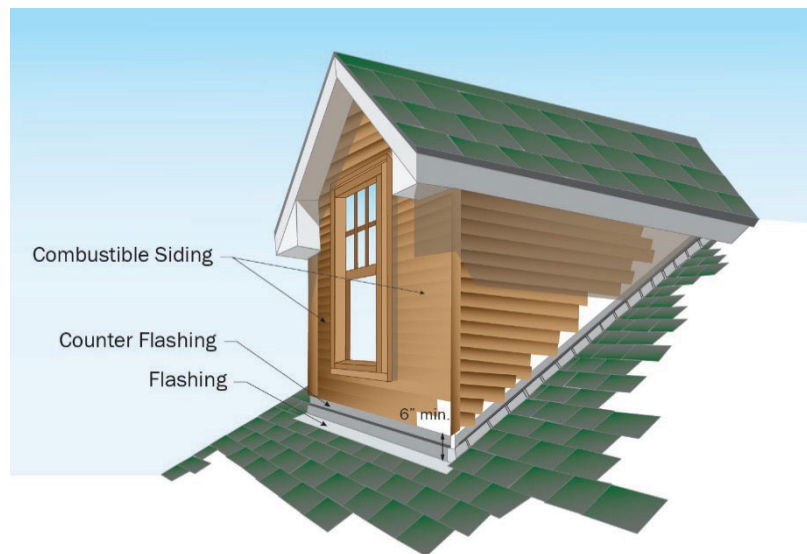
Figure 14. Example of metal flashing installation at bottom-of-wall-to-roof joint.

Provide fire-resistant caulking at any gaps at the joint between the bottom-of-wall-to roof joint. Where the wall siding is comprised of combustible materials install noncombustible metal flashing and counter flashing that protects the roof-to-wall joint for at least 6 vertical inches above the roof surface. The metal flashing should be lapped above the roof covering material extending vertically up along the exterior side of the wall siding before being “let in” behind the siding at the lap joint, with combustible siding kept 4–6 inches above the roof surface (see Figure 14). Corrosion-resistant metal flashing is one material that might be used to accomplish this. Alternatively, “local” replacement of siding with non-combustible materials would also be acceptable.

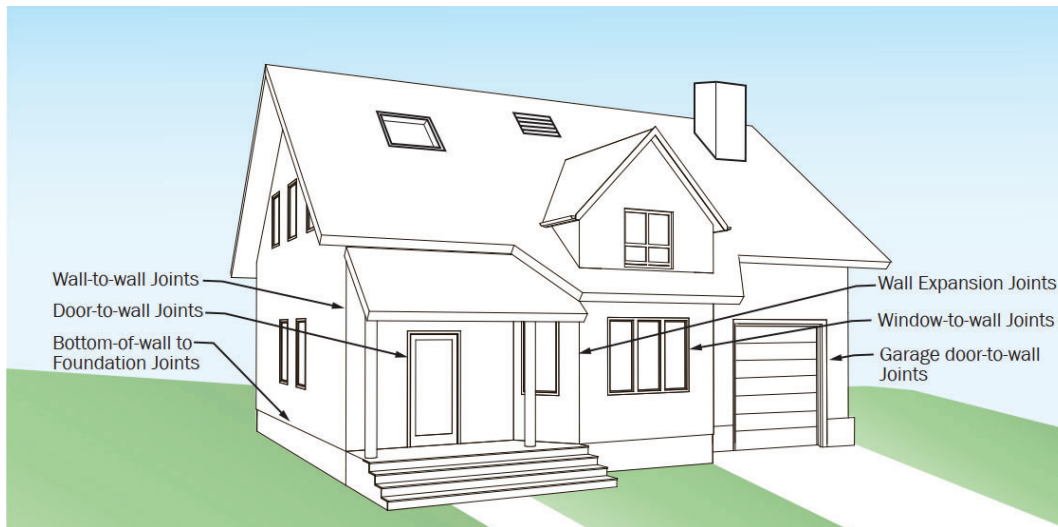
Figure 15. Various locations of vulnerable joints, penetrations, and interfaces throughout the interior of a residential structure to wildfires.

The guidance below targets new construction and retrofits to existing buildings, describing various actions for wall joints, penetrations, and detailing that are commonly found in residential construction. See Figure 15 for an overview of building joint locations.

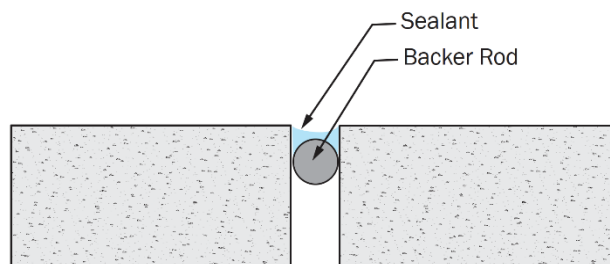
Figure 16. Plan view cross-section of exterior wall joints, where a backer rod is placed to fill joint (adapted from Armacell, 2017).

Seal gaps in wall joints with fire-resistant firestopping products. For wood stud construction with composite panel siding (e.g., fiber cement siding), consider incorporating metal flashing with an underlying mineral surfaced cap sheet into the assembly. (Refer to Figure 7 and Figure 14 for metal flashing installation examples). For concrete-to-concrete wall construction, consider installing recessed polyethylene backer rods compressed into the joint with fire sealant flush to exterior wall surfaces (see Figure 16).

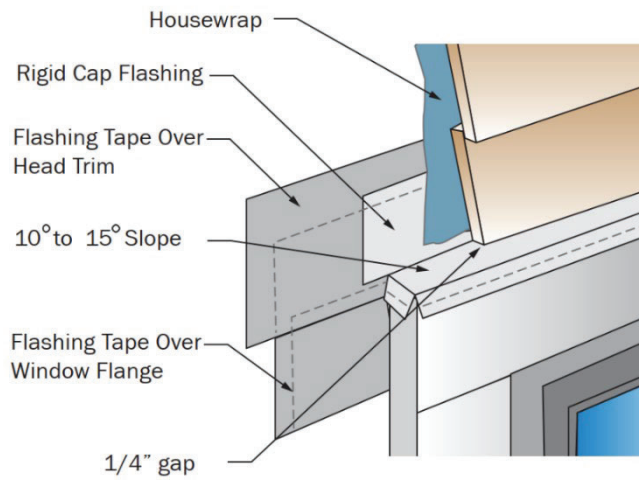
Figure 17. Example of rigid cap flashing installation at window-to-wall joints (adapted from Fine Homebuilding).

Ensure the space between the window and the framing is well sealed. Where possible, incorporate the use of rigid cap flashing at the bottom-of-wall-top-of-window joint between the underlayment and

wall siding (see Figure 17). Replace vinyl window frames with frames comprised of noncombustible materials (e.g., metal clad wood, aluminum).

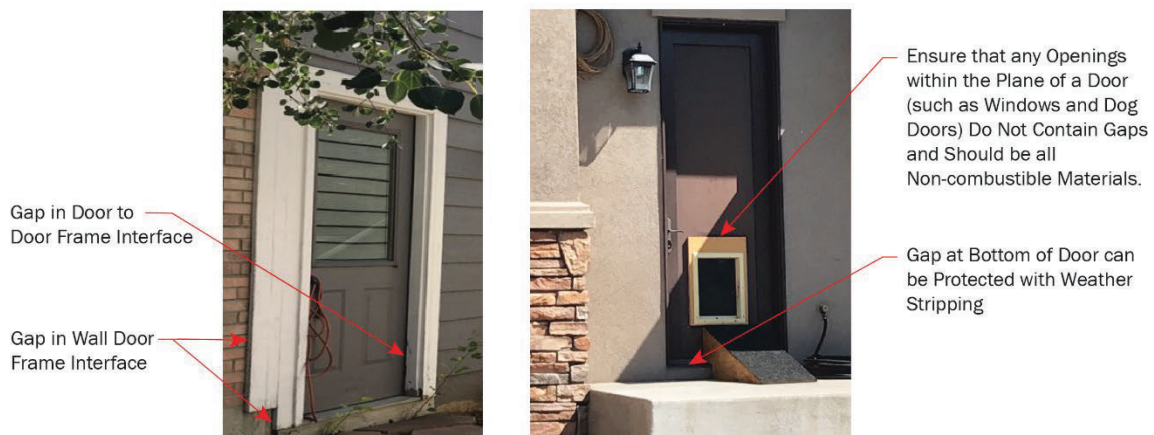
Figure 18. Examples of door-to-wall joints. Where openings in the plane of a door exist, such as dog doors or windows, the gaps around the openings should be filled caulking, mineral wool, or similar non-combustible material. In addition, the opening itself should be protected from ember intrusion that can be deployed during a wildfire incident (e.g., provide a noncombustible shutter).

Ensure the space between the door and the framing is well sealed. Where possible, incorporate the use of rigid cap flashing at the wall-to-door interface, between the underlayment and wall siding (see Figure 18).

Where gaps are present, utilize appropriate weatherstripping, firestopping and/or penetration materials/products as needed. Figure 18 above demonstrates some gaps that may be appropriately filled with firestopping materials.

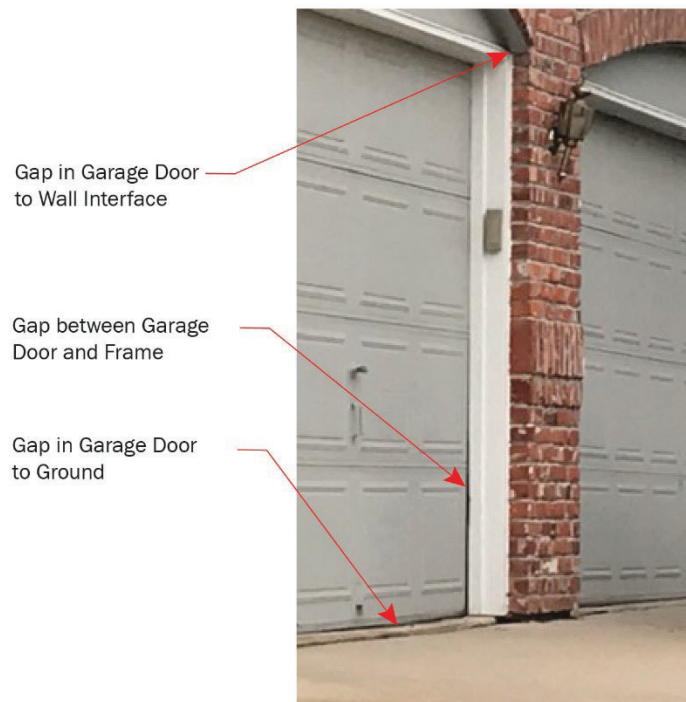
Figure 19. Example of gaps at garage-door-to-wall joint.

Make sure the space between the garage door, framing, and concrete slab is well sealed to minimize the entry of embers. Ensure weather sealing is provided and in good condition. Where possible, incorporate the use of rigid cap flashing around the joint of the wall-to-garage door frame interface, between the underlayment and wall siding (see Figure 19).

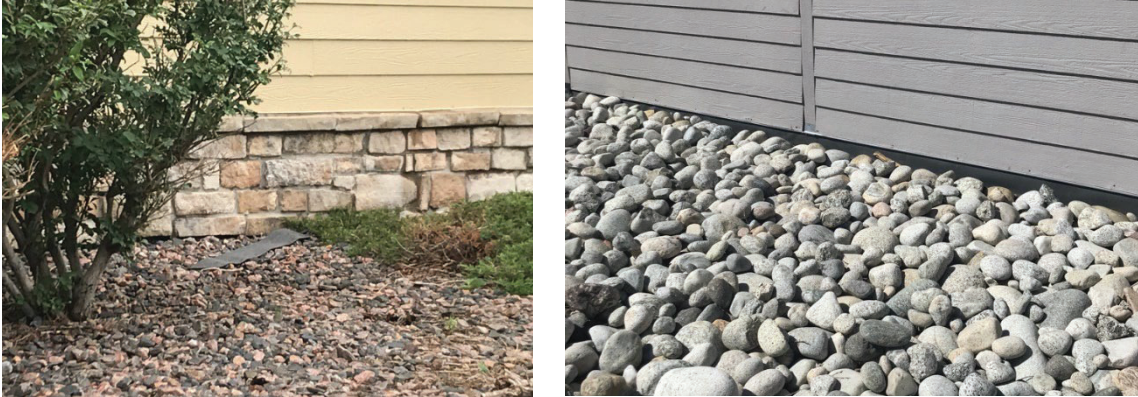
Figure 20. Examples of noncombustible separation at bottom-of-wall-to-foundation joints (Left: noncombustible separation, right: metal flashing).

Block gaps in siding with firestopping materials (e.g., mineral wool, fire caulking, and fire-rated sealants). Where possible, install a minimum of 6-inch noncombustible vertical separation where horizontal surfaces meet the wall. Please note that this 6-inch minimum assumes very minimal combustibles in the near-home zone (0–5 feet), which should be kept free of combustibles. This could be a separation created by noncombustible materials, or metal flashing, as demonstrated in Figure 20.

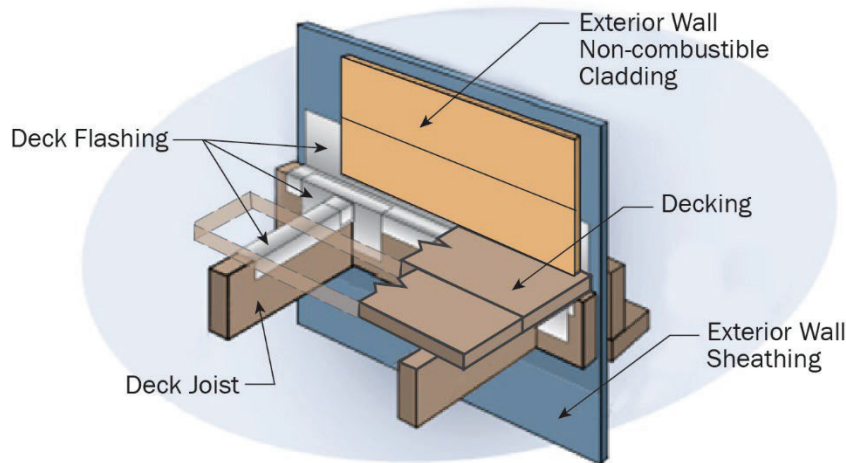
Figure 21. Example installation of metal flashing on ledger boards.

- Install metal flashing on ledger boards that are attached without gaps (see Figure 21).
- Seal gaps with appropriate firestopping and fire caulking.
