Draft Environmental Assessment

# Caliente Youth Center Bridge Flood Mitigation Project

FEMA PDM-PJ-09-NV-2012-002

*November 2013*

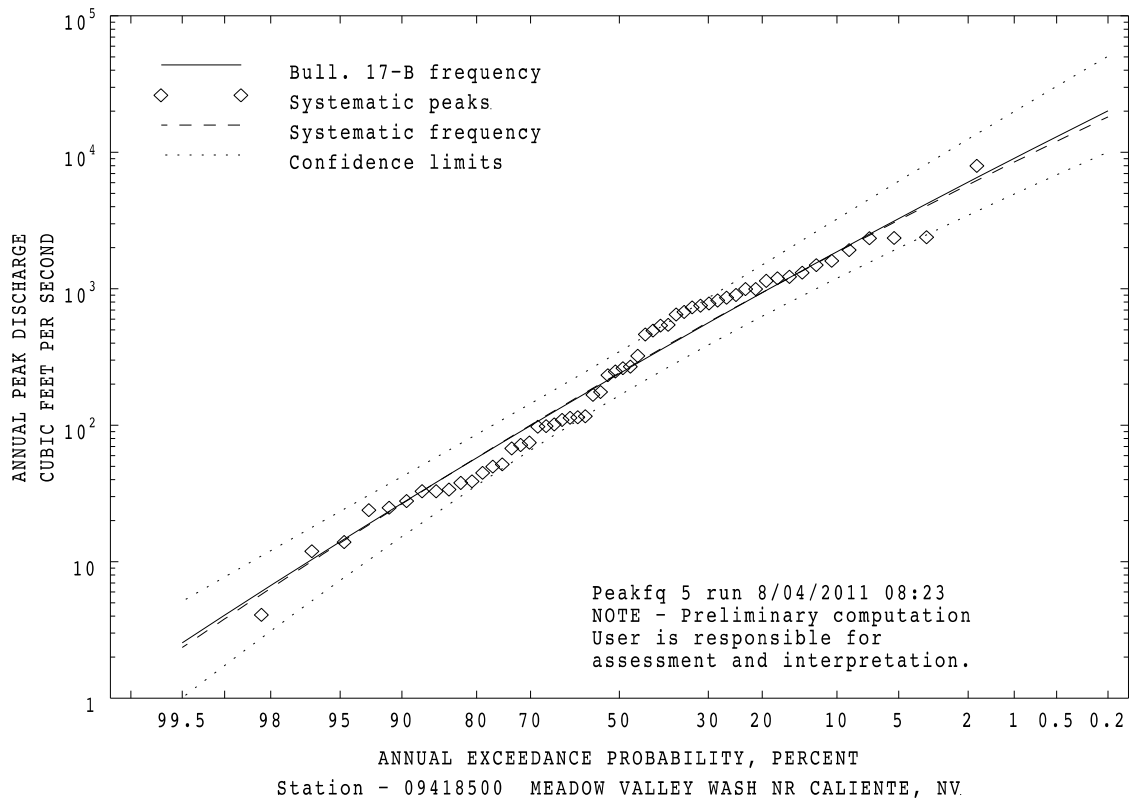
Figure 1. Preliminary flood frequency curve for USGS Streamgaging Station 09418500 Meadow Valley Wash near Caliente, Nevada.

An approximate flood frequency curve was developed using the U.S. Geological Survey (USGS) annual peak runoff series from Streamgaging Station 09418500 Meadow Valley Wash at Caliente. The period of record for the gage is 56 years. The flood-frequency curve is displayed on Figure 1. What is important to observe is that the 2005 event was between a 50- and 100-year event and the 2010 event was between a 5- and 10-year event. Although these flood events occurred on Meadow Valley Wash (where the USGS gage is located), it is reasonable to assume that flows from Clover Creek were of approximately the same recurrence interval. That is, the peak discharge from Clover Creek for the 2005 event was probably between a 50- and 100-year event and that from the 2010 flood was probably between a 5- and 10-year flood event.

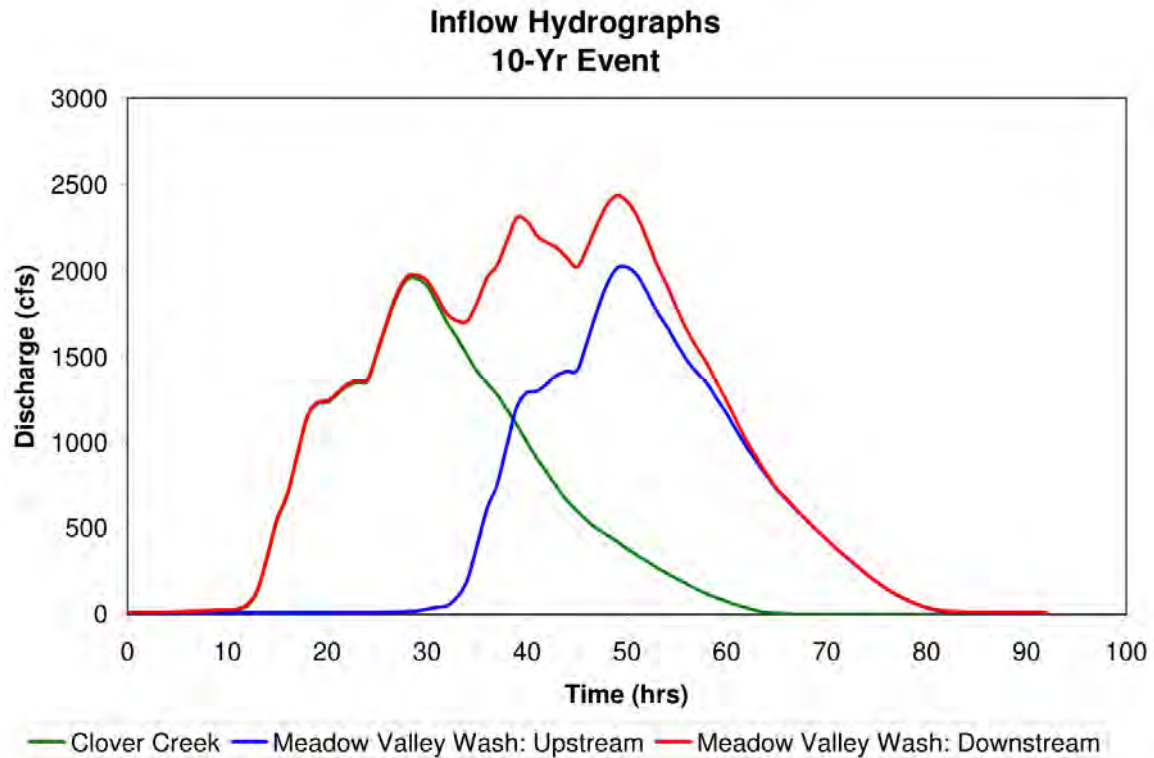
Figure 2. Hydrographs from the 10-year design event from Meadow Valley Wash and Clover Creek (from Philips, 2008).

What is important to observe from Figure 2 is that the time to peak discharge from the two watersheds differs by many hours, with a relatively small amount of flow in Meadow Valley Wash at the time the peak from Clover Creek arrives at the study area. Therefore, for the purposes of analyzing the CYC access road crossing of Clover Creek and development of alternatives, a relatively low flowrate (100 cfs) was used in Meadow Valley Wash and the base flood discharge (100-year event) was used in Clover Creek. Once a design was confirmed, then the results were checked using the FEMA effective model in which it is assumed that flood peaks arrive contemporaneously.

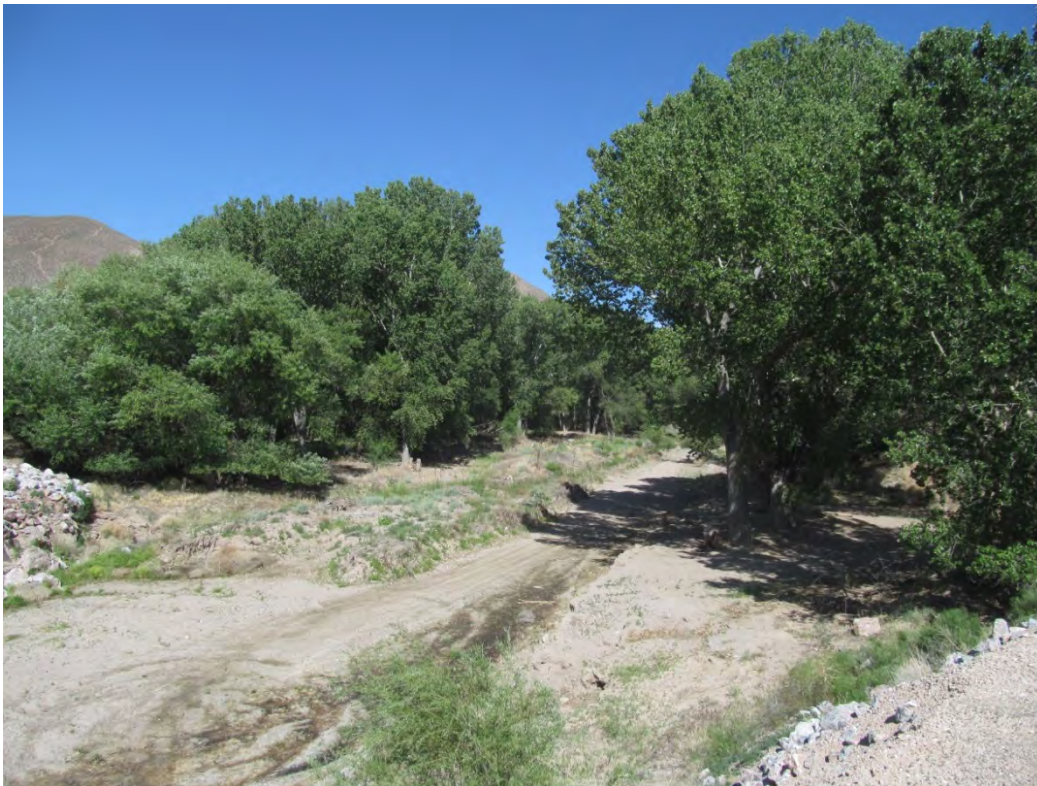
Figure 4. Vegetated bed of Clover Creek Wash; view east.

In the project area, Clover Creek Wash constitutes a broad (100-300 ft.), deep (~20-30 ft.) drainage that is filled with recent alluvium, sand, and silt (Figure 4). Its banks are not reinforced except on both upslope (east) sides and the north downslope side of the half-pipe culverts, where sections of rip-rapped boulders are present. Tree cover is dense east of the culvert but less so to the west, thinning in the vicinity of the railroad bridge. The intersection between Clover Creek Wash and Meadow Valley Wash lies entirely outside the project area, a few hundred feet west of the railroad bridge.

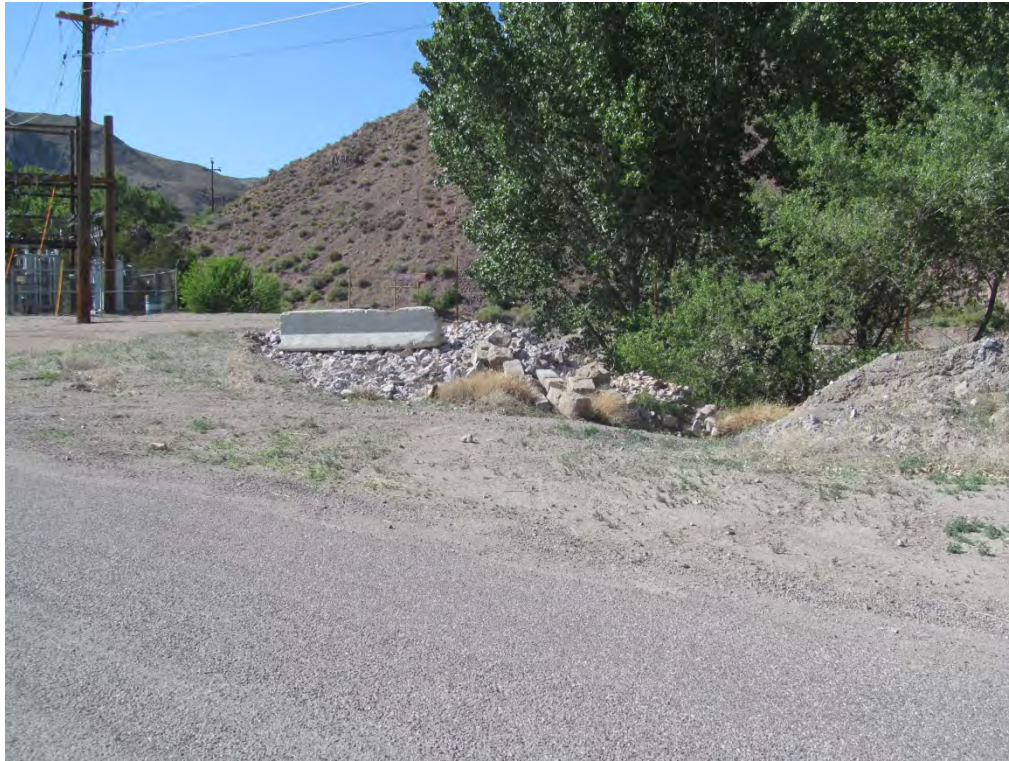
Figure 9. Concrete and perlite rubble at south edge of Clover Creek Wash; view northwest.

As noted earlier in Chapter 2, the general condition of land surfaces within the APE is highly built and disturbed. While the north edge of Clover Creek Wash is in more or less natural condition, the south edge is highly disturbed. Within the APE are piles of concrete (Figure 9), asphalt, and cut perlite; concentrations of modern refuse; and heaps of cut vegetation. An unpaved road parallels the south side of the wash, and immediately south of it, just outside the east end of the APE, is an old square cement foundation underneath a large tree (Figure 10). This foundation was probably part of the stockyards at the UPRR railroad yard, which once lay directly southeast of the current APE (Figure 11).

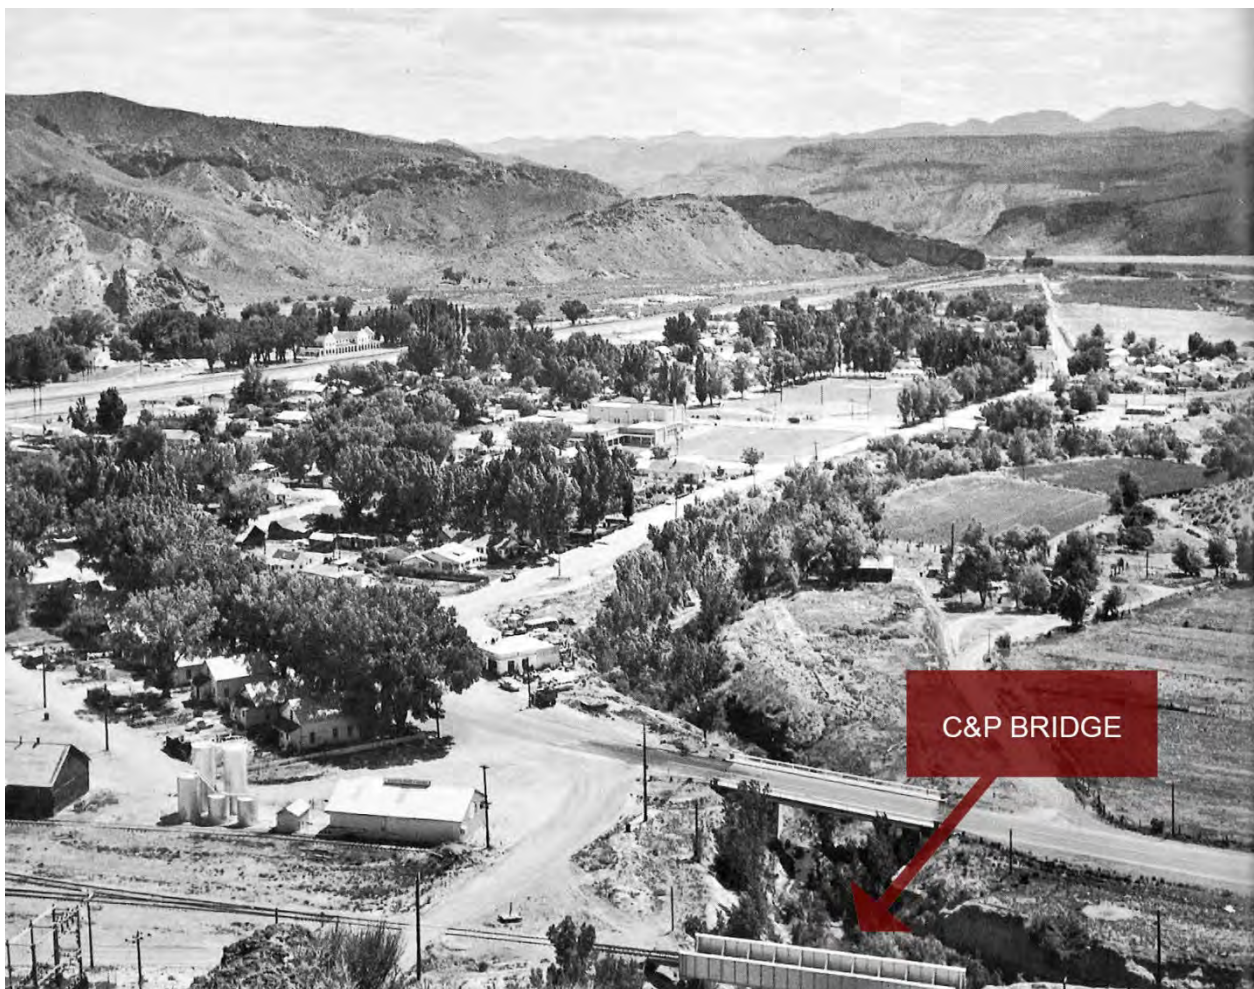
Figure 12. Historic photo of Caliente with portion of current project area in foreground (from Myrick 1963); view southwest. Note location of C&P bridge.

In fact, two photographs presented by Myrick (1963:650, 670) are relevant to the evaluation of the bridge and its location. The first (see Figure 12) provides a viewshot southeast into Caliente that includes a portion of the current project area. This photo shows the bridge in its original and present location (bottom right edge of the image), complete with tracks leading into the former switchyard of the UPRR; although undated, the photo must have been taken sometime prior to 1960. The railway looks to be defunct by this time, judging by the amount of dirt covering the railroad tracks along an unimproved road that is now Caliente Youth Center Drive. The bridge also has no associated facilities or mechanisms and appears to rest on a wooden substructure (like the present one), unlike the concrete substructure supporting it in an earlier photo (Figure 31, above) that depicts the aftermath of a flood in 1938. These images demonstrate that, while the bridge likely remains in its original 1911 location, it rests on a wooden substructure that replaced an original concrete foundation sometime after 1938. As shown in Figure 12 and Figure 31, various external mechanisms that were part of the bridge prior to 1938 (e.g., single posts, overhead wires) had been removed by ca. 1960.

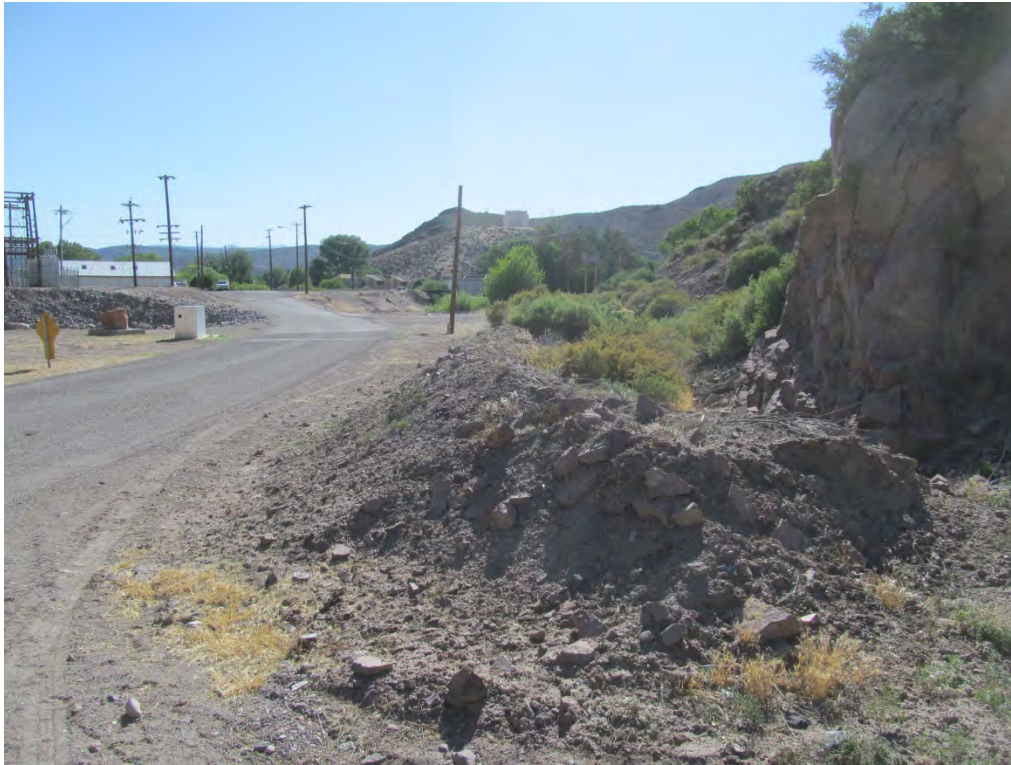
Figure 14. Fill-constructed berm at north end of 26LN6830, Concentration 1; view southwest.

The entryway to the Caliente Youth Center also appears to be recently graded. Paralleling the west side of the road, north of the wash, and all along the west side of the grassy area into the Youth Center property, is a tall (3-ft.), loose berm composed of multiple piles of fill (Figures 14 and 15). The berm is more than 300 ft. long and extends well beyond the north end of the APE on to the grounds of the Youth Center. According to staff at the Caliente Youth Center, this berm is composed of alluvial material that is regularly excavated from Clover Creek Wash in an effort to prevent seasonal flooding of the entry road (Jamie Killian [Caliente Youth Center Superintendent], personal communication 2013). The volume of fill in this berm contains a wide variety of historic refuse and represents one of the two main concentrations of artifacts at 26LN6830 (see below). A plastic ranch-style fence has also been recently installed along the road within the entryway, extending southward from the property into the north end of the site (see Figure 15).

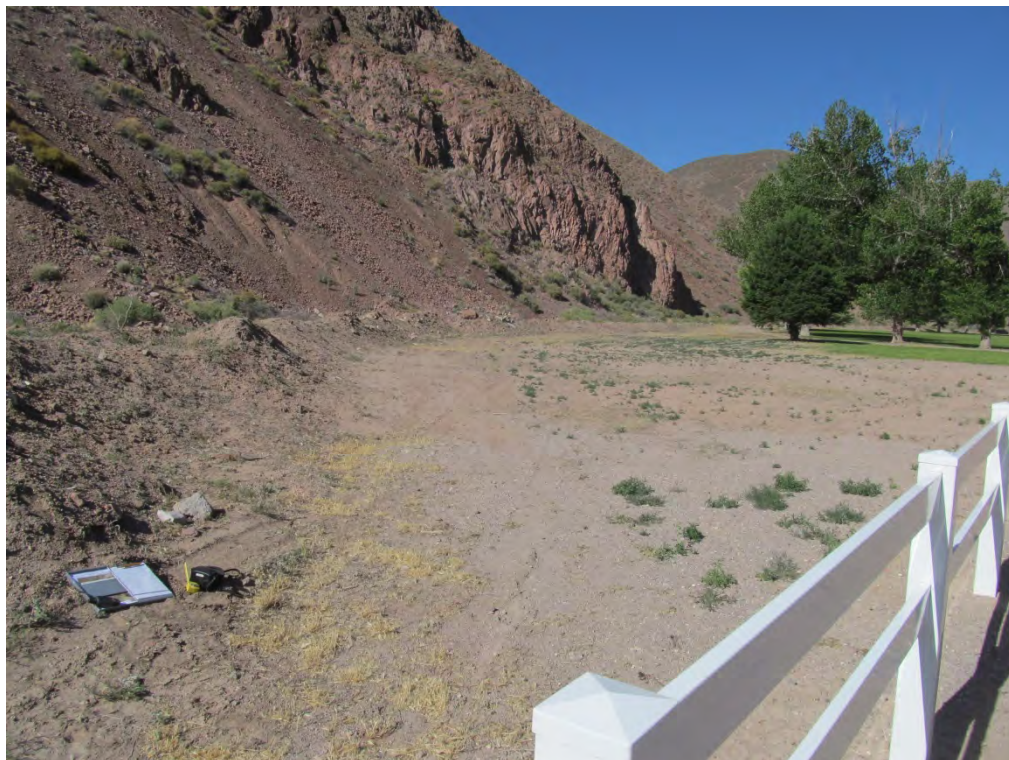
Figure 15. Extension of berm outside APE, site 26LN6830, Concentration 1; view northeast.

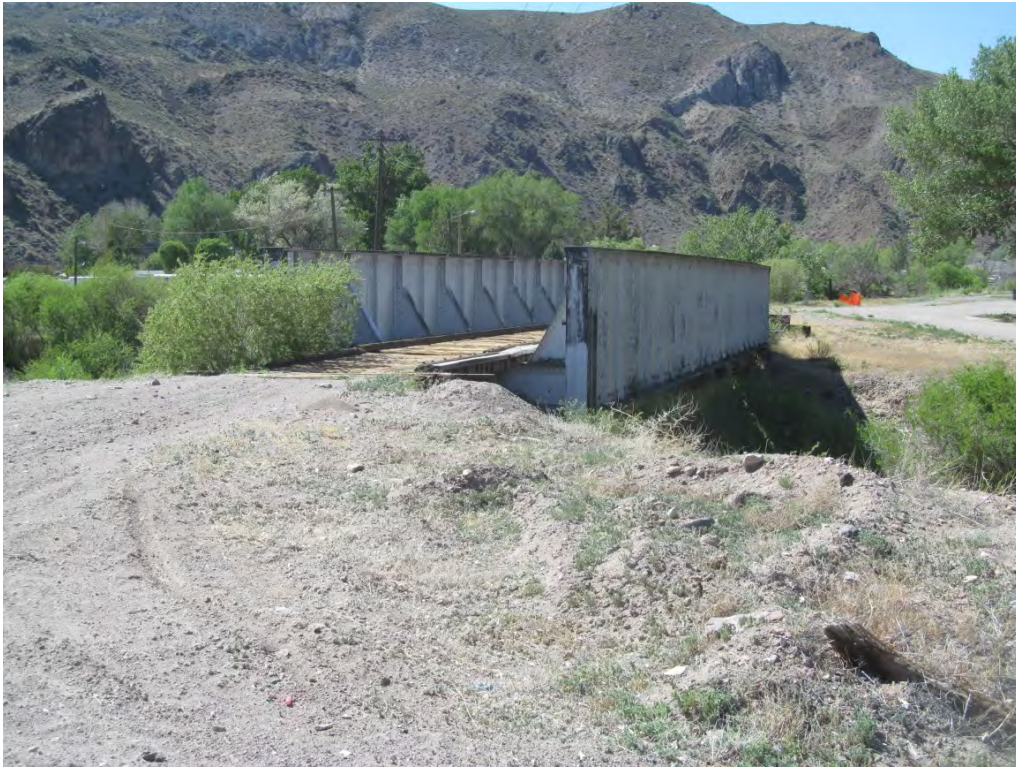
Figure 24. East end of C&P bridge, view northwest.

Situated just beyond the southwest edge of the APE is an old, abandoned railroad bridge crossing Clover Creek Wash (Figures 24 and 25). It was formerly a feature of the C&P Railroad, a branch of the UPRR’s Salt Lake Route. At present there are no tracks running to or over the bridge and the structure is used for pedestrian traffic only. The bridge has been spraypainted silver and is evidently repainted on a regular basis to erase tagging/graffiti. Its deck ties show footwear from pedestrian use but the steel section of the bridge is otherwise unworn and undamaged. Its wooden substructure, however, appears to be slowly deteriorating and is in need of repair.

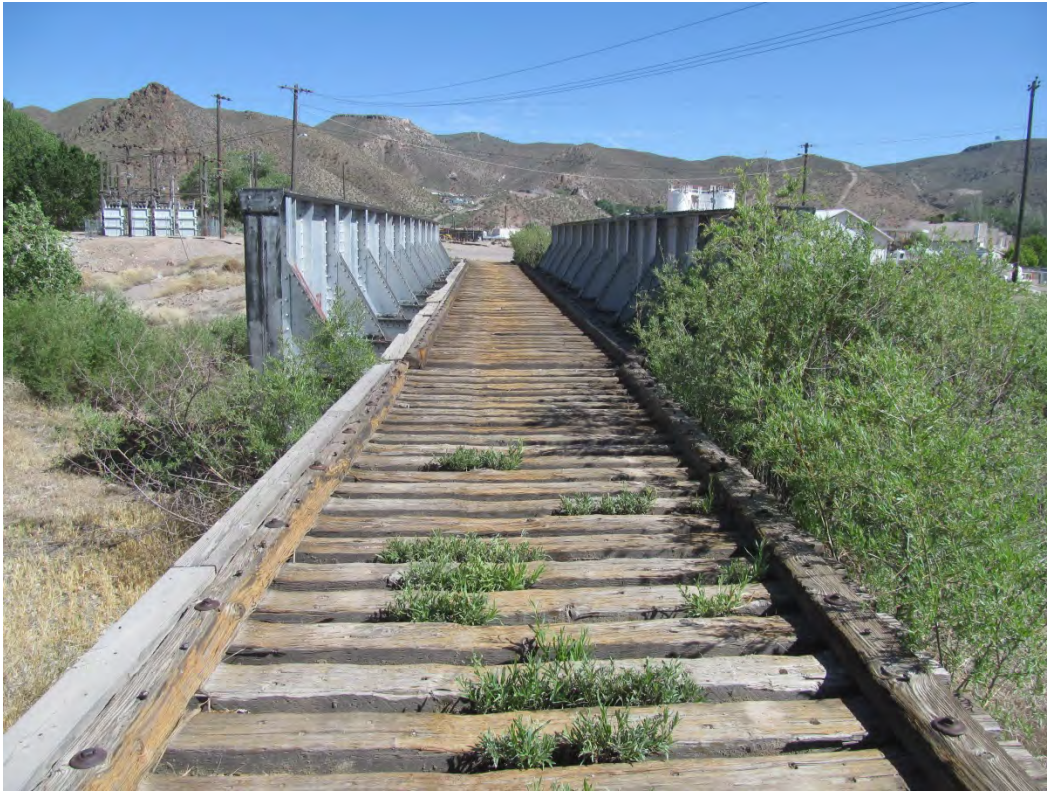
Figure 26. West end of C&P bridge, view southeast.

The C&P bridge is a common pony (thru-truss) plate-girder steel bridge supported by an abutment of vertical wooden pilings capped with a stacked beam-and-tie platform (Figure 26). The steel girders flanking the bridge are attached to the deck with knee braces. The deck itself consists of wooden railroad ties bolted directly to the substructure, which is composed of approximately 10 floor beams that span the width of the bridge. The floor beams are connected by steel I-beam stringers and secured by narrow cross-beams along the bottom of the substructure (Figure 27). The steel bridge is approximately 60 ft. long and 8 ft. wide with 4-ft. high girders. Both ends of the bridge are connected to short approach decks composed entirely of stacked beams and large wooden beam stringers with attached railroad ties (Figure 28). The supports under this approach (Figure 29) appear temporary and may have been installed for bridge access after the flood of 1938 (see below) or when the rails were taken up ca. 1965. Other than the wooden ties remaining on the bridge deck, all others were removed along with the rails.

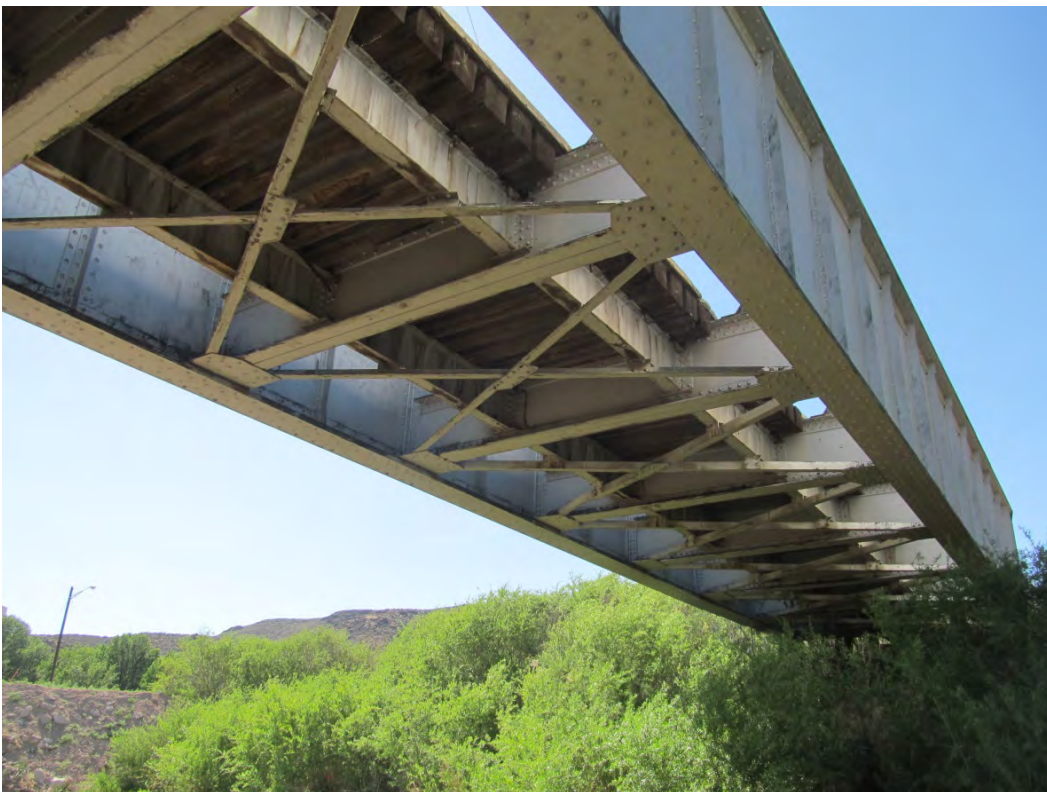
Figure 27. Underside of C&P bridge showing I-beam construction.

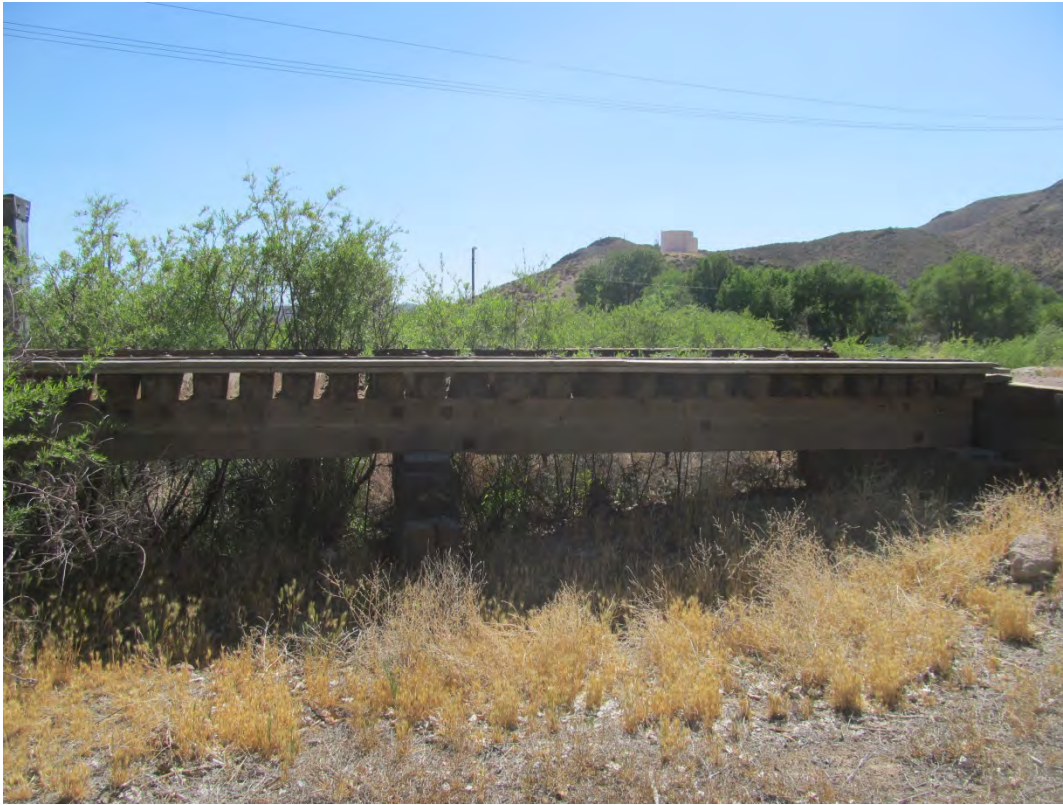
Figure 28. Profile of C&P bridge west approach deck, view southwest.

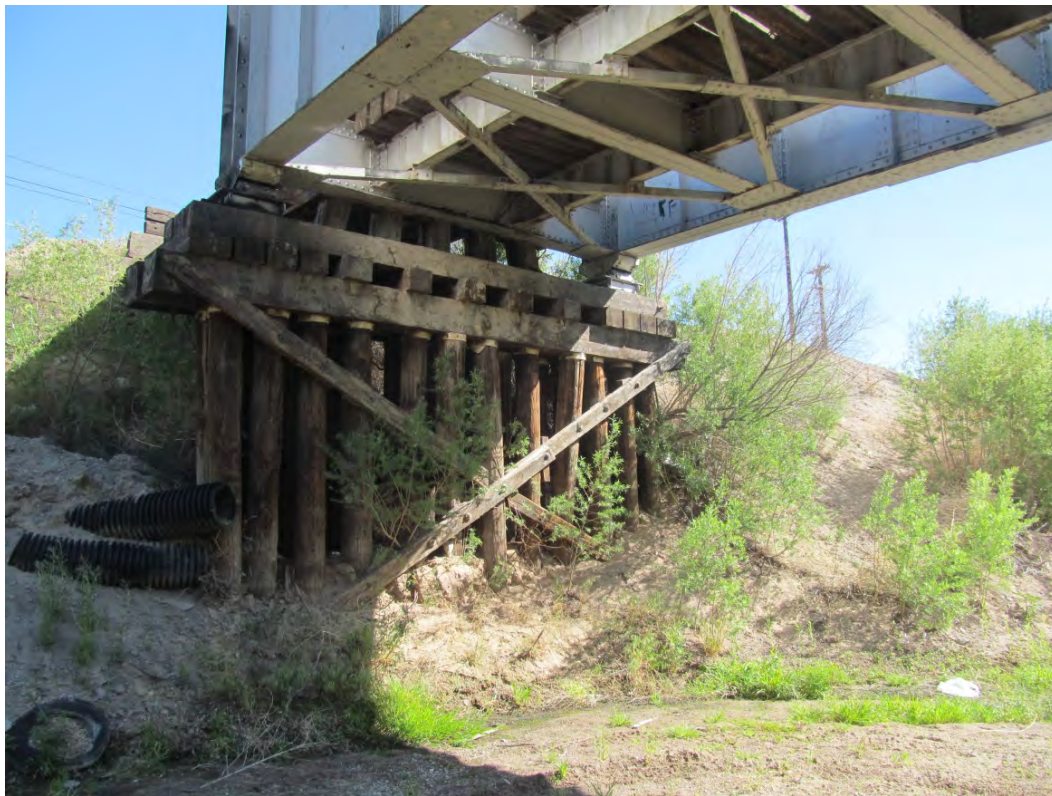
Figure 29. Substructure of west end C&P bridge, view southeast.

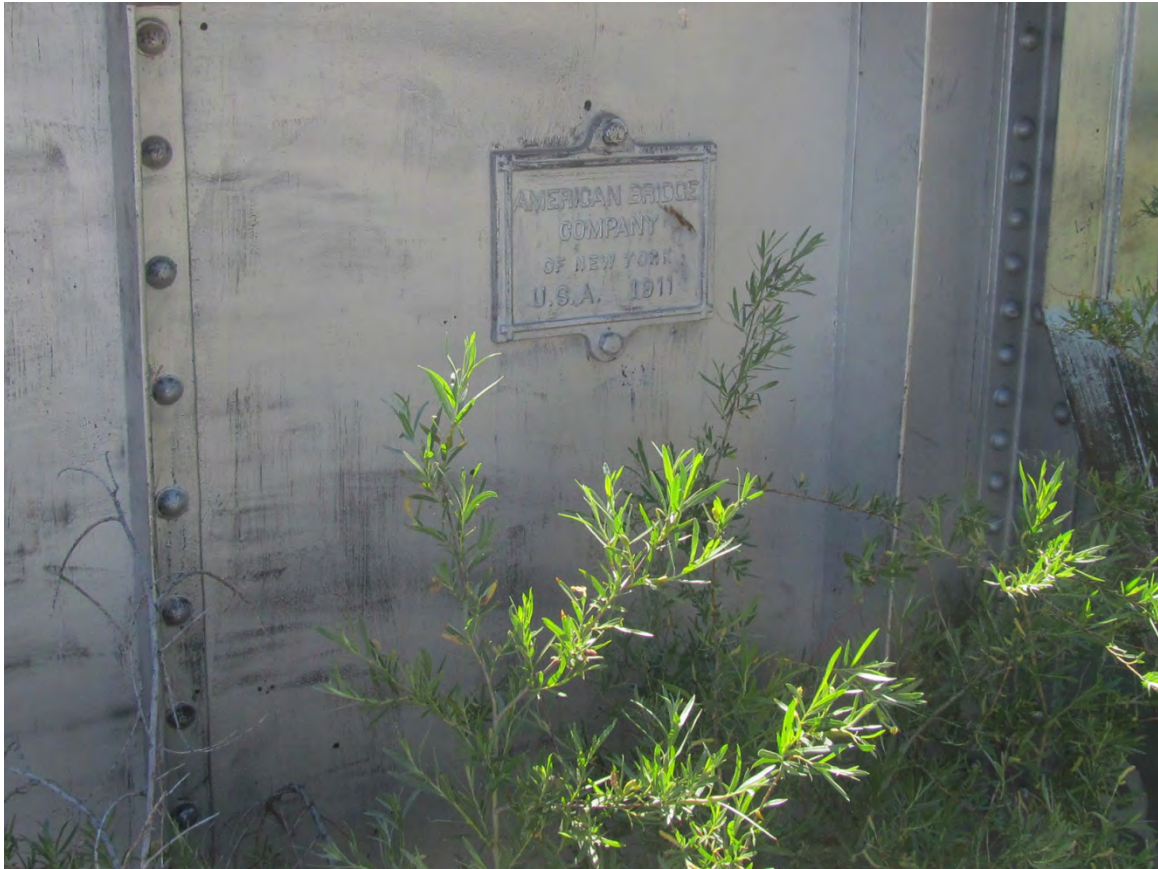
Figure 30. Plaque of American Bridge Company, 1911.

A girder plate at one end of the bridge features a bolted-on steel plaque indicating the bridge was manufactured by the American Bridge Company of New York, U.S., 1911 (Figure 30, above). The American Bridge Company (ABC) was the largest and most widely used manufacturer of pre-fabricated steel bridges during much of the twentieth century and is still in business (as American Bridge). ABC was formally incorporated in New Jersey in 1900 by J. P. Morgan and Company (American Bridge Company 2013; Deseret News 1902). It was an independent company for less than a year, when most of its stock was acquired by United States Steel Corporation, of which it became a subsidiary. That first year ABC also purchased 24 other bridge companies, representing most of its competitors and amounting to nearly 50 percent of the nation's steel bridge fabricating capacity. One of these new subsidiaries, the American Bridge Company of New York, was responsible for all ABC sales, contracts, and erection from January 1901 to December 1913. ABC bridges of various designs for railroad or highway use were manufactured and partially pre-assembled at the factory, then packaged and shipped to the bridge site where installation was completed. Pony truss bridges were typically used on railroad grades because their shallow construction depth required little change in the height of the grade. Given that a devastating flood damaged much of the C&P track and Caliente facilities in 1910, the installation of a new bridge over the Clover Valley Wash in 1911 is logical and implies that the bridge is original to its location.

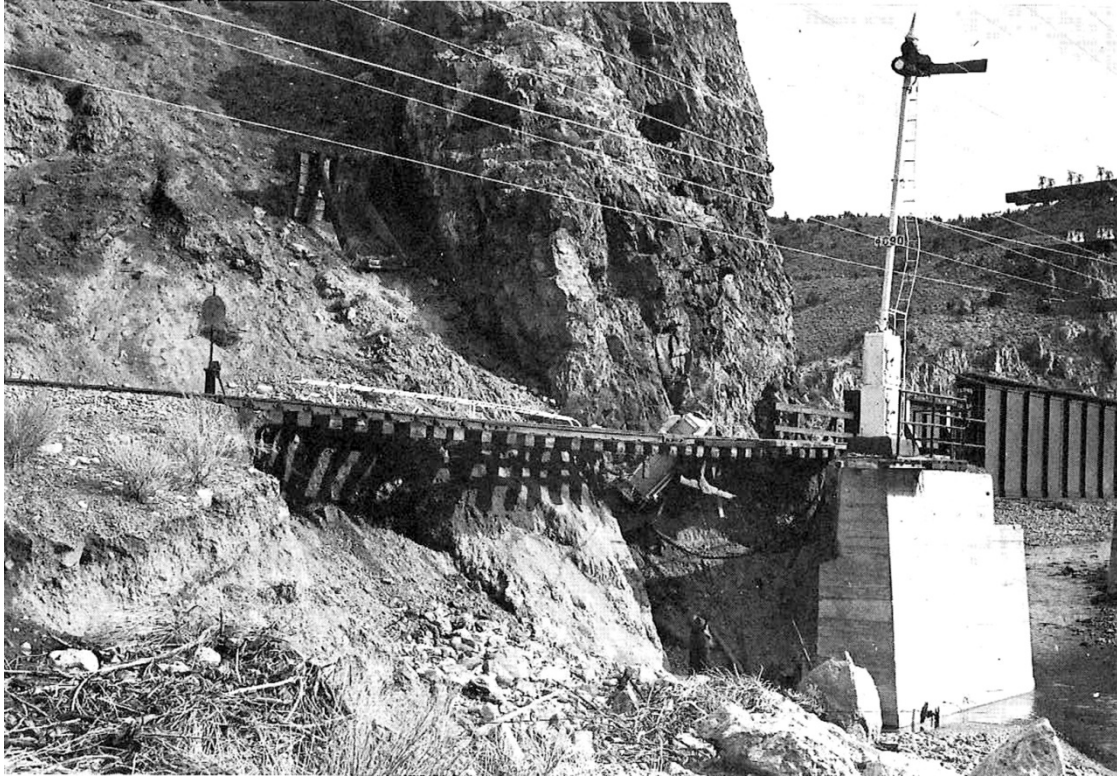
Figure 31. Historic photo of C&P bridge, washed out by 1938 flood (from Myrick 1963).

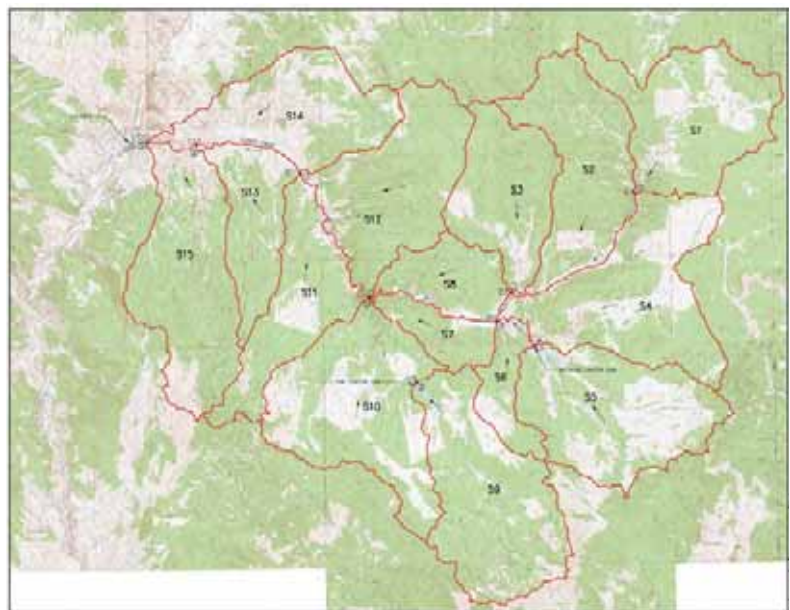
Clover Creek Watershed

Furthermore, flood flow conveyance and sediment transport were modified by flood control structures placed upstream from the project site by the U.S. Army Corps of Engineers. The Pine Canyon and Mathews Canyon flash flood control structures in the Clover Creek watershed upstream from Caliente reduce historical flushing

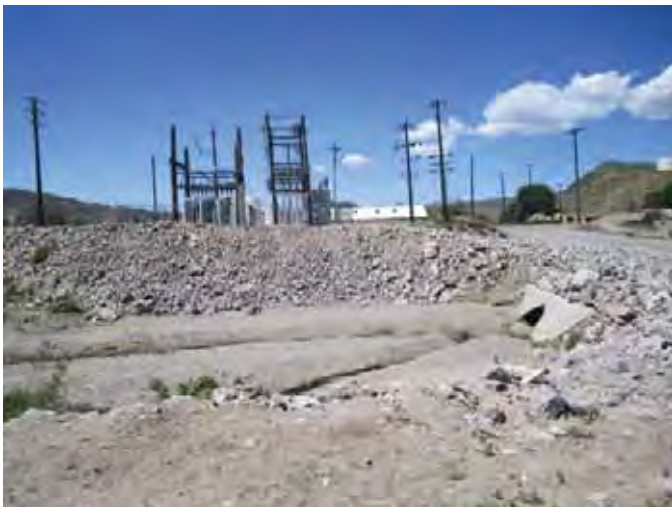
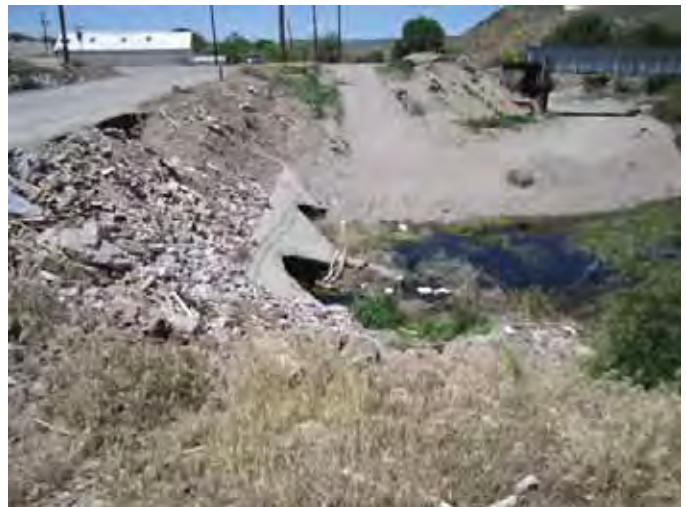
**Photographs taken of the project site June 2011.**

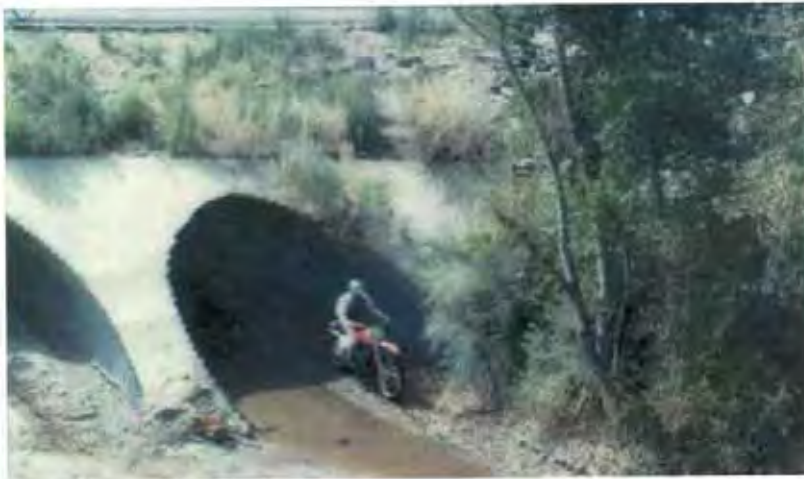
CYC Access Road Culverts circa 1978 -- wash silted in more than 8 feet

events in the adjacent higher elevations coupled with construction of several flood-protection reservoirs resulted in sediment aggradation and debris buildup in the Clover Creek culverts. Sediments generated from a 5-year, 24-hour storm event can create channel bed aggradations up to 3 feet at the upstream end of the culvert, which will totally block the culvert entrance.

Repeated flooding of the access road because of reduced culvert conveyance remains a problem. Because of accumulated sediments, the culverts under the CYC access road now have only 1.5 to 2.0 feet of free opening (out of 12 feet). If this crossing is not removed and replaced with an improved structure, the access road and surrounding improvements remain at risk of flood inundation from relatively frequent hydrologic events. Additionally, critical infrastructure is at risk with the electrical substation being in close proximity to the wash and sewer and water infrastructure being located under the roadway but above the existing culvert. If the access road is damaged during a future flood event, it is likely both the sewer and water infrastructure will be destroyed.

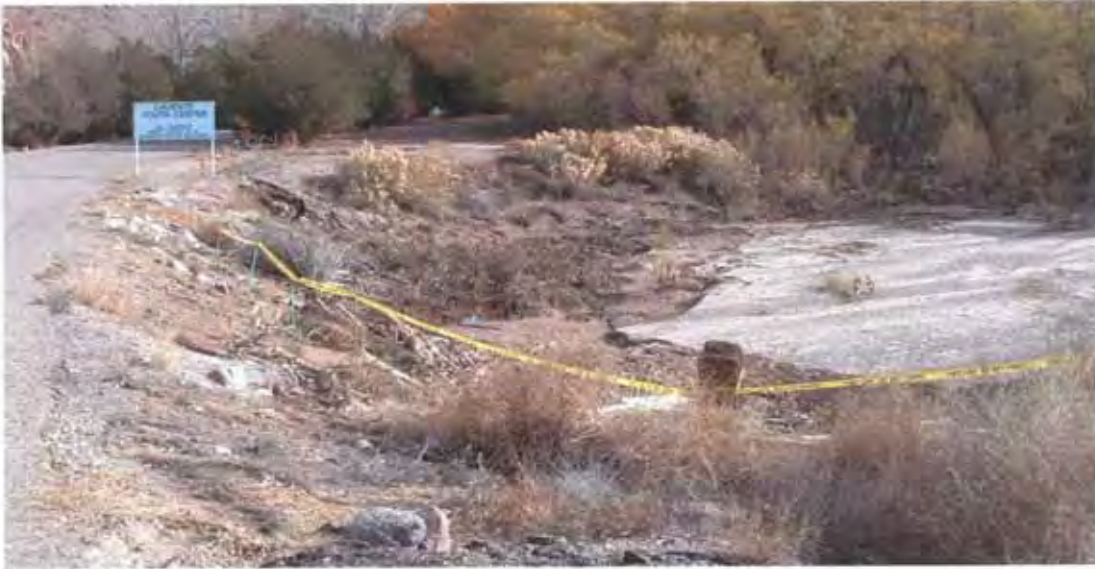
Caliente Youth Center Entry Road -- November 18, 2004

A flood event in January 2005 jeopardized the safety of residents and staff by eliminating emergency vehicle access for evacuation of the CYC facility, creating the potential for flooding of adjacent CYC structures. Flows emanating from the Clover Creek watershed exceeded culvert capacity and overtopped the roadway by three to five feet. Concern for the rising waters resulted in an air evacuation of the residing children and CYC staff with Blackhawk helicopters from Nellis Air Force Base. During this event, significant flooding also occurred further downstream through the community that resulted in damage to homes, roads, businesses, and utilities. Damages were over \$856,656 and included the destruction of the City's municipal drinking well.

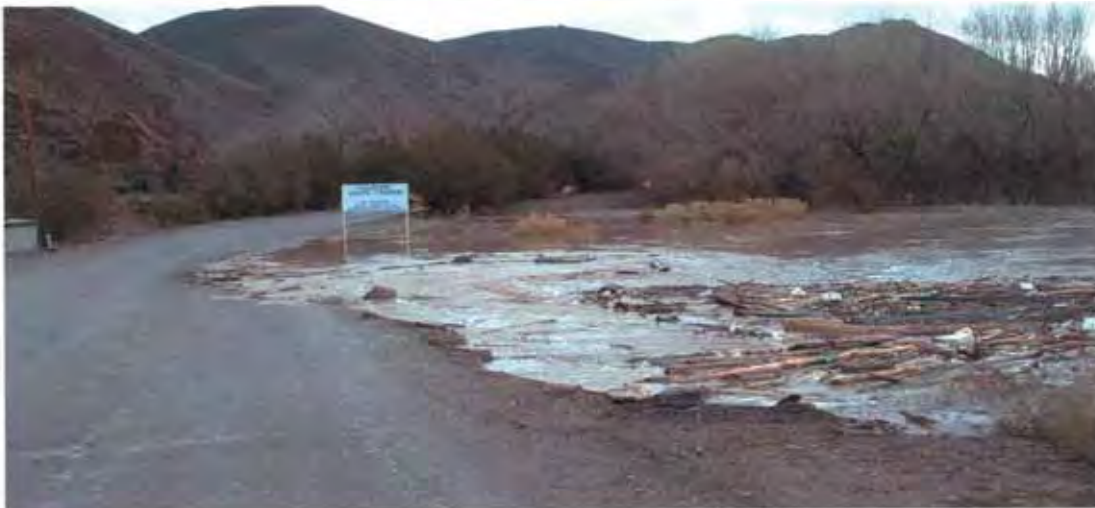
Caliente Youth Center Access Road - 1/10/05

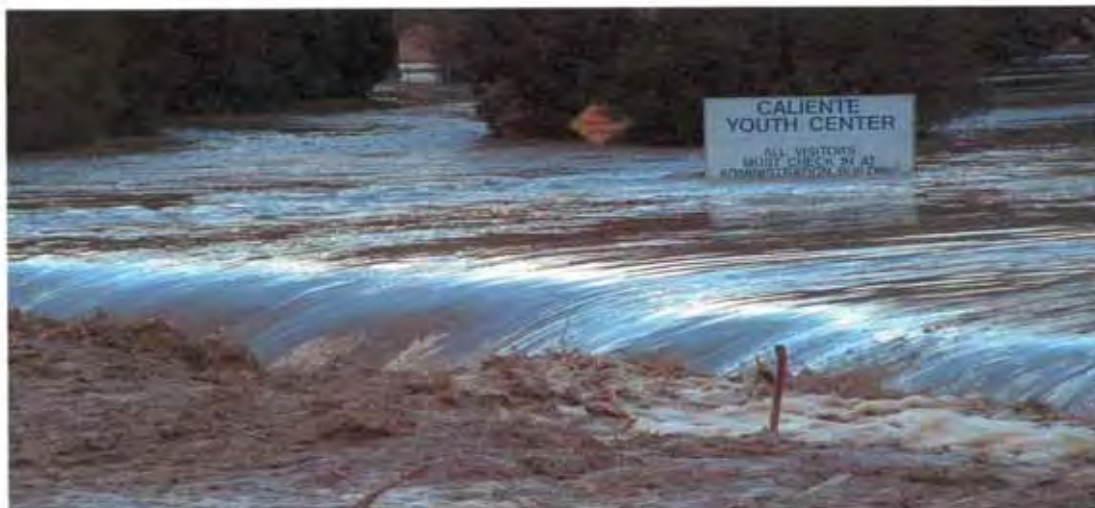
Caliente Youth Center Access Road - 1/11/05

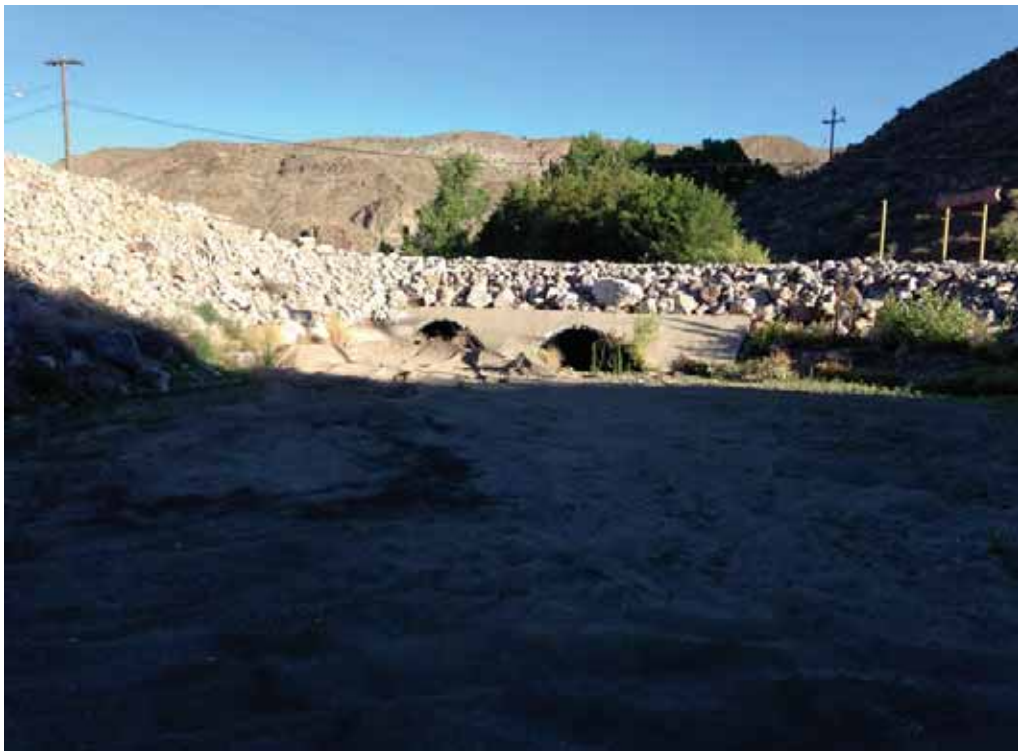
Clover Creek – looking west toward existing culverts/project site.
