## 6.3 ARCHITECTURAL COMPONENTS

### 6.3.4 CEILINGS

#### 6.3.4.3 SUSPENDED HEAVY CEILINGS

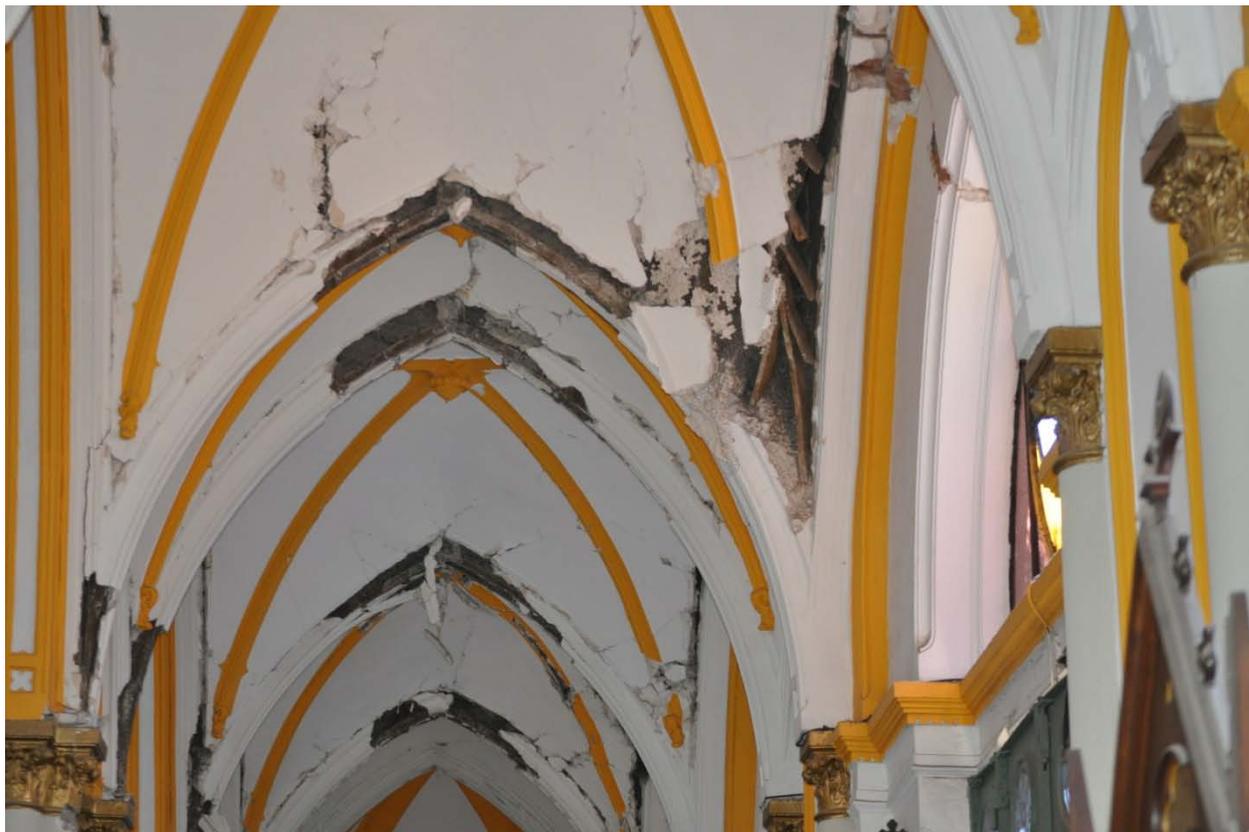
Figure 6.3.4.3-1 Damage to ornate wire lath and plaster ceiling in the 2010 magnitude-8.8 Chile Earthquake (Photo courtesy of Eduardo Fierro, BFP Engineers). Wire lath is attached to arches or to wood furring suspended from the roof framing.

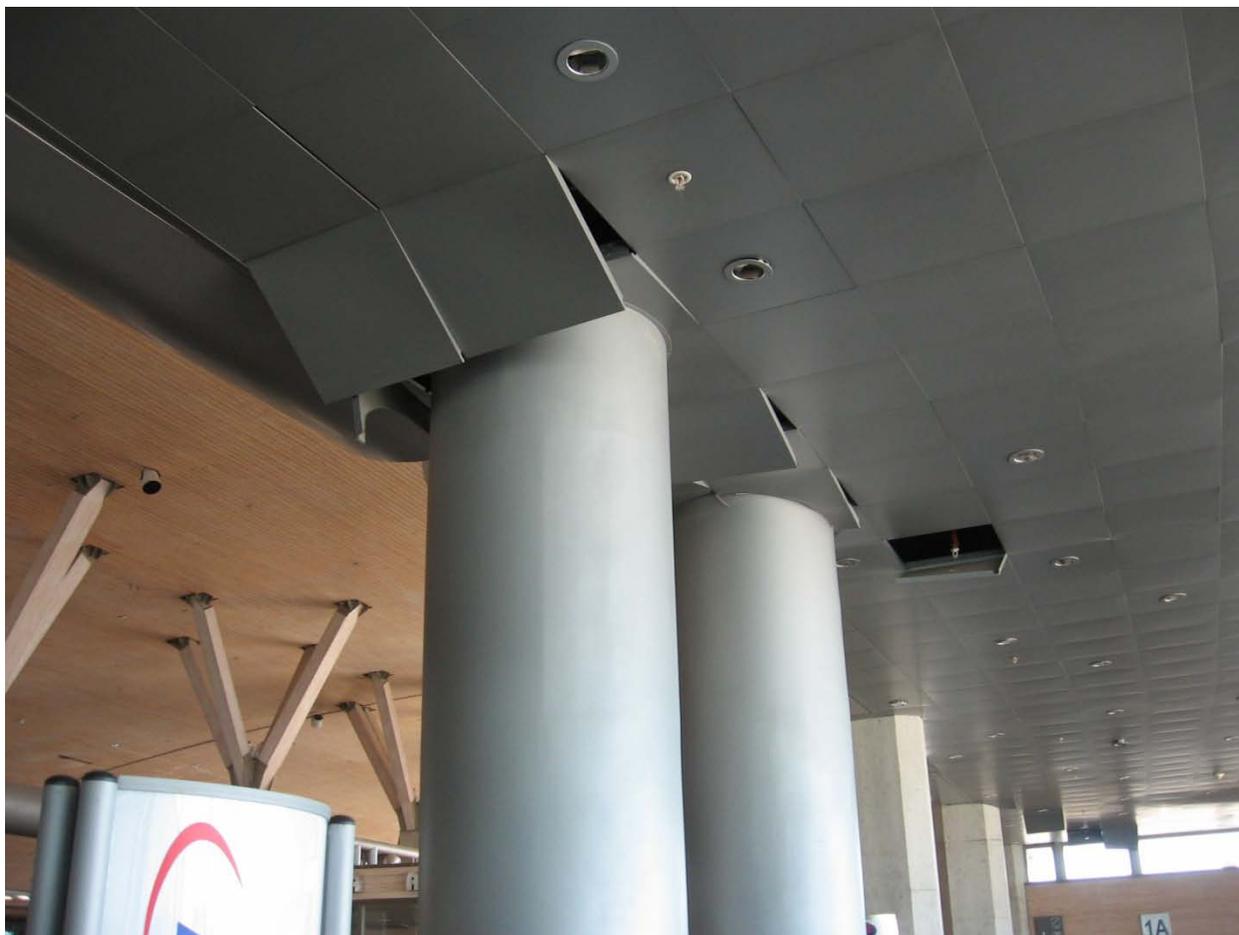
Figure 6.3.4.3-2 Damage to suspended metal panel ceiling system and fire sprinklers at Concepción airport, primarily at far end and around column obstructions in the 2010 Chile Earthquake (Photos courtesy of Rodrigo Retamales, Rubén Boroschek & Associates). The metal panel was strong enough to fail the sprinkler head shown at lower left.

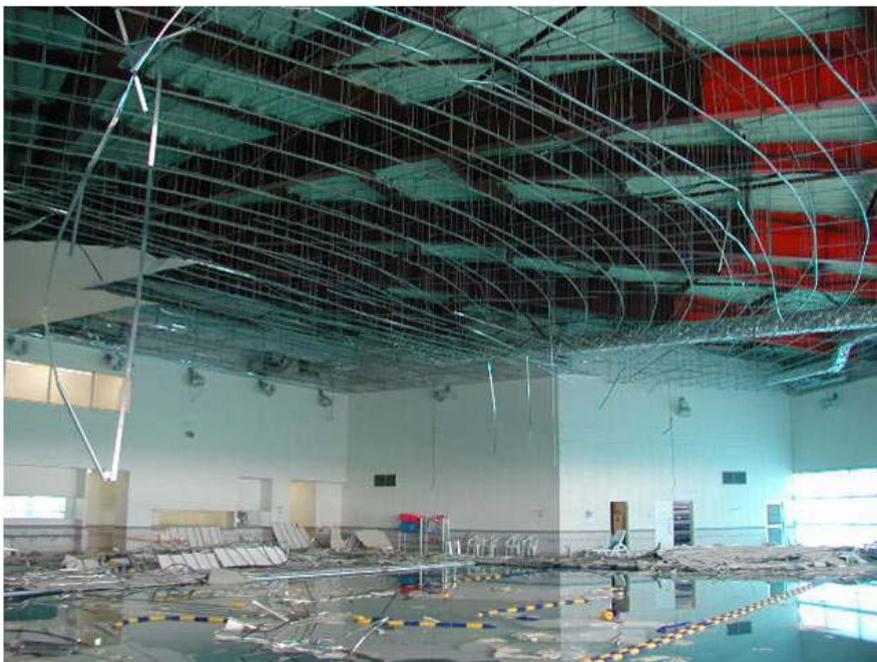
Figure 6.3.4.3-3a Complete collapse of a large suspended gypsum board ceiling over a swimming facility in Japan (Photo courtesy of Shojiro Motoyui, Tokyo Institute of Technology). This type of failure has been replicated on the E-defense shake table and occurs when the U-shaped clip holding the cross furring (M-bar) to the main runners (channel) opens into a V-shape and drops the furring grid. This type of failure is not common in the U.S.

- Mechanical connectors between the component parts of the ceiling assembly must be chosen carefully to avoid failures. Catastrophic failures of ceiling systems in Japan have been replicated during shake table testing because the U-shaped mechanical clip used to hang the cross furring from the main runner can open during an earthquake, dropping the cross furring and drywall as shown in Figures 6.3.4.3-3.

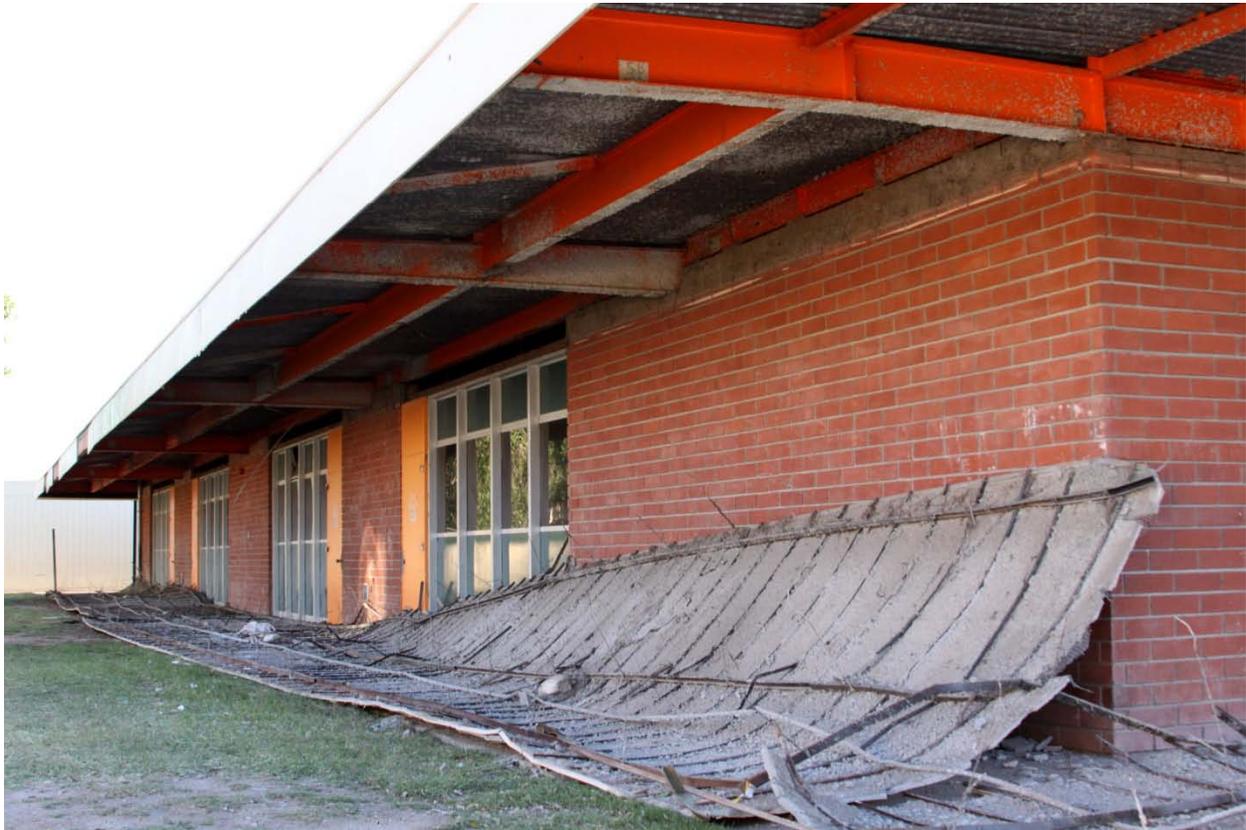
Figure 6.3.4.3-4 Collapse of exterior soffit at Jefferson Elementary School in Calexico in the 2010 Baja California Earthquake; approximately 1200 sq ft of soffit collapsed at this school built in the 1960's (Photo courtesy of Baja Earthquake Reconnaissance Team, Earthquake Engineering Research Institute (EERI), published in the EERI July 2010 Newsletter).

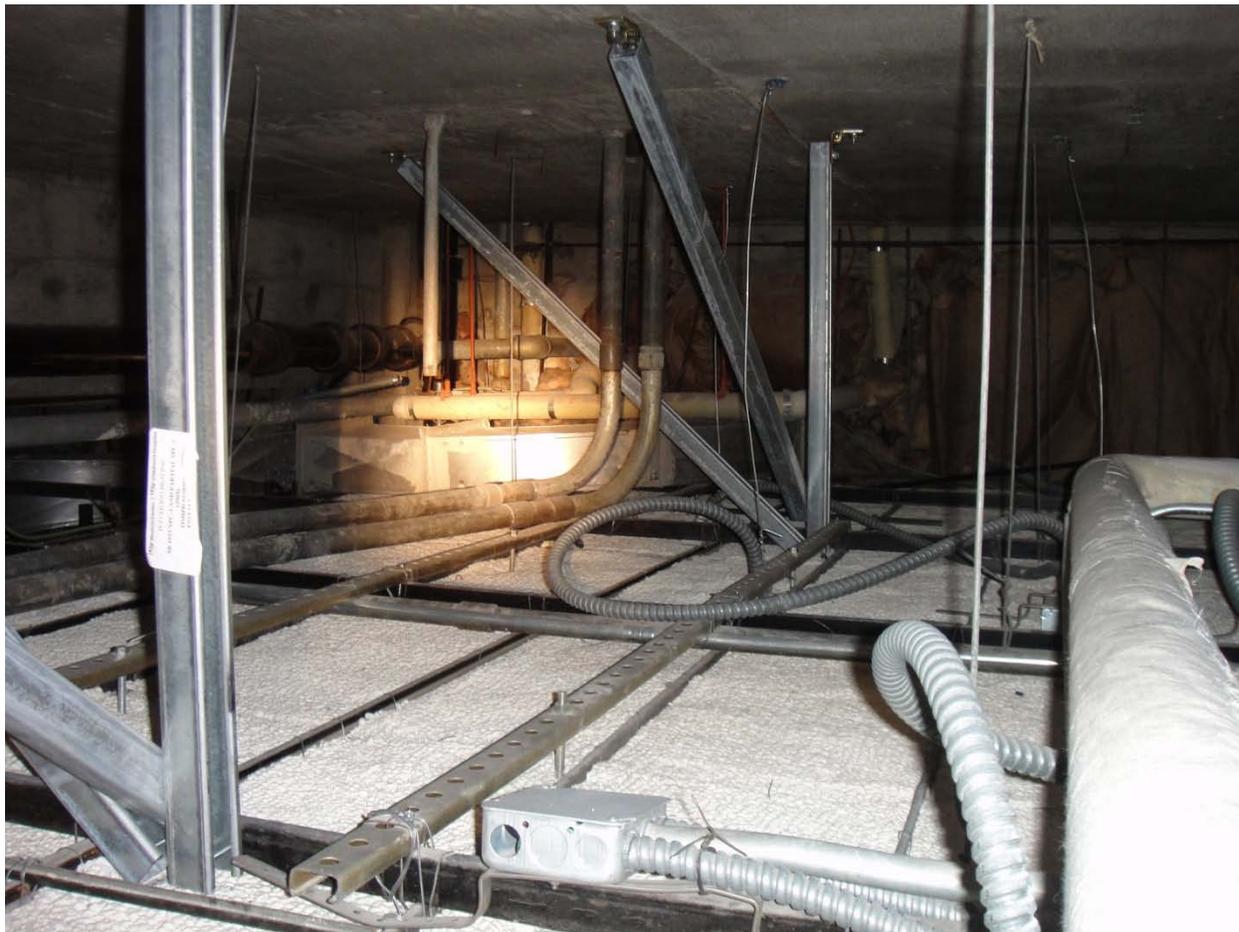
Figure 6.3.4.3-5 Details of suspended and braced gypsum board ceiling in California hospital. Rigid bracing is provided at 6 ft by 8 ft on centers. Note cross furring saddle tied to black channel (main runner) from below; supplementary framing for lights runs parallel to cross furring and saddle tied to main runner from above (Photo courtesy of Maryann Phipps, Estructure).
