6.3 ARCHITECTURAL COMPONENTS

6.3.8 STAIRWAYS

6.3.8.1 STAIRWAYS

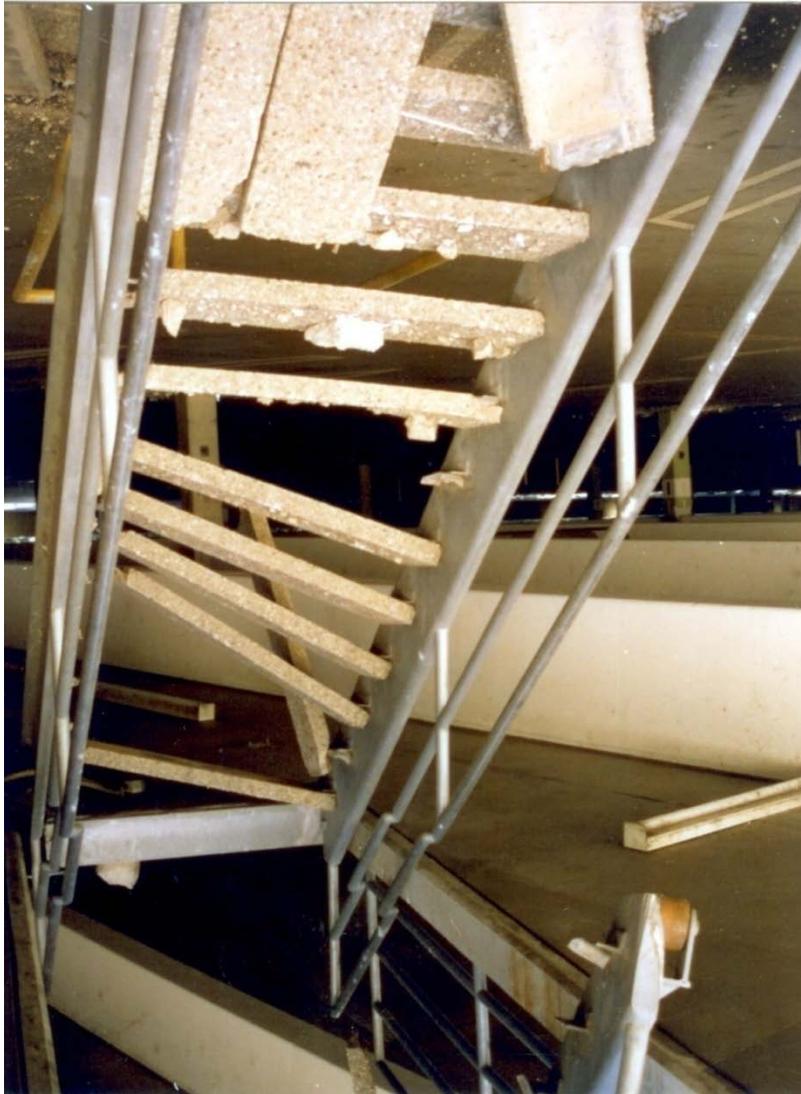
Figure 6.3.8.1-1 Damaged stairway in the 1994 magnitude-6.7 Northridge, California earthquake (Photo courtesy of Wiss, Jenney, Elstner Associates).

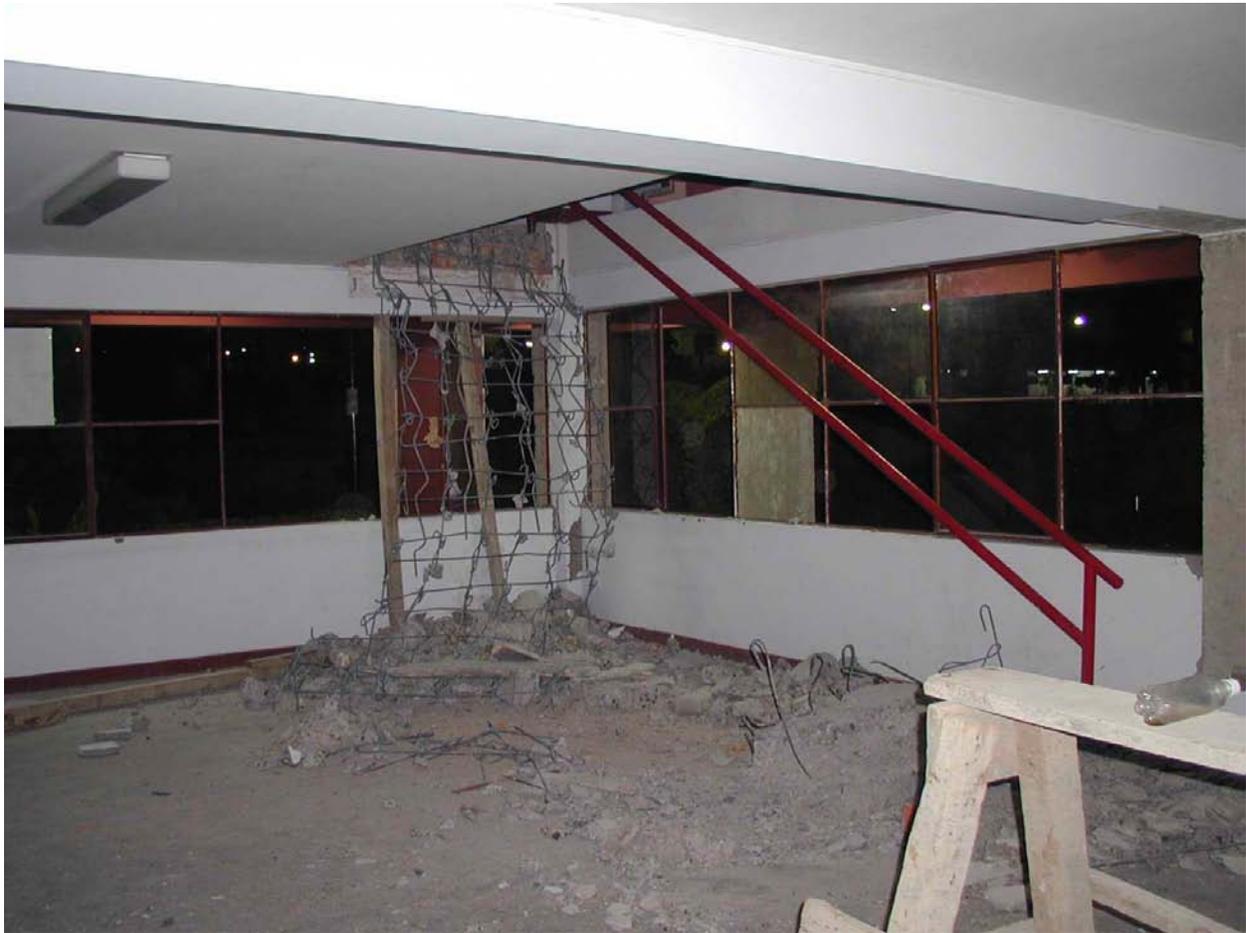
Figure 6.3.8.1-2 Stair damaged beyond repair in the 2001 magnitude-8.4 Peru Earthquake; concrete demolished prior to photo (Photo courtesy of Eduardo Fierro, BFP Engineers).

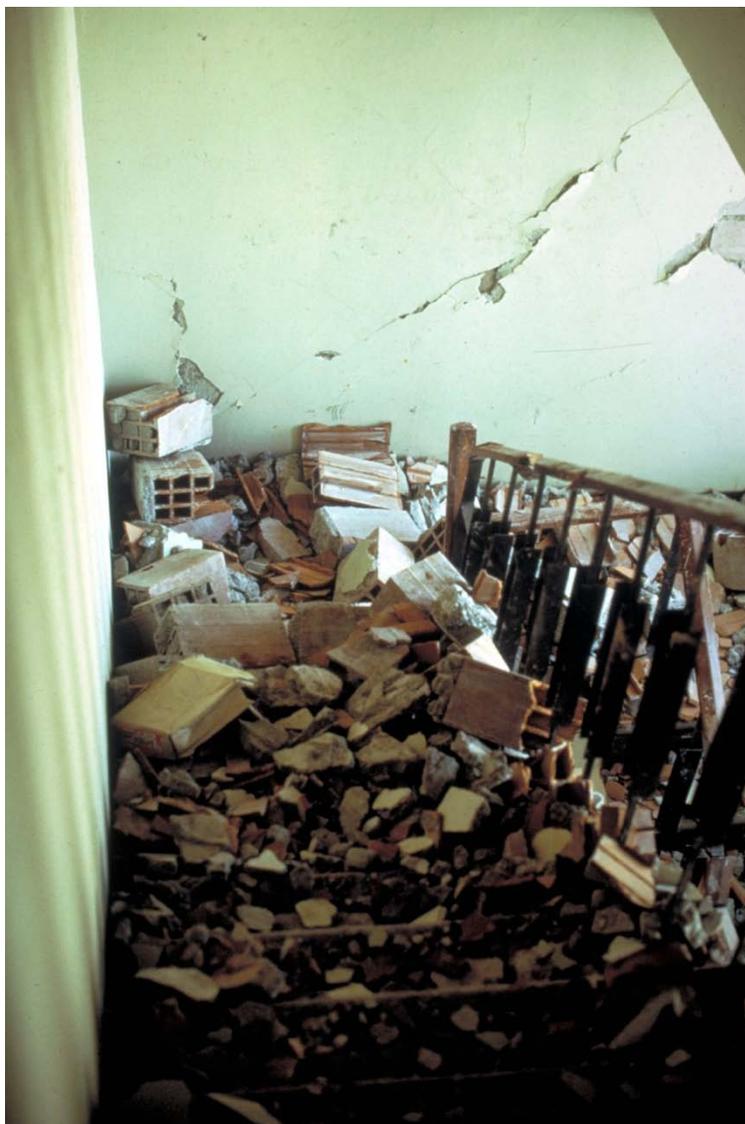
Figure 6.3.8.1-3 View of stairway in the Banco Central Building, Managua, Nicaragua after the 1972 magnitude-6.2 Managua Earthquake. Most of the stairs were covered with debris that resulted from the failure of the hollow tile partitions surrounding the stairs. This photograph highlights the need to not only prevent direct damage to stairway framing and connections, but also to protect against damage to surrounding walls (Photo courtesy of PEER Godden Collection, No. J94).

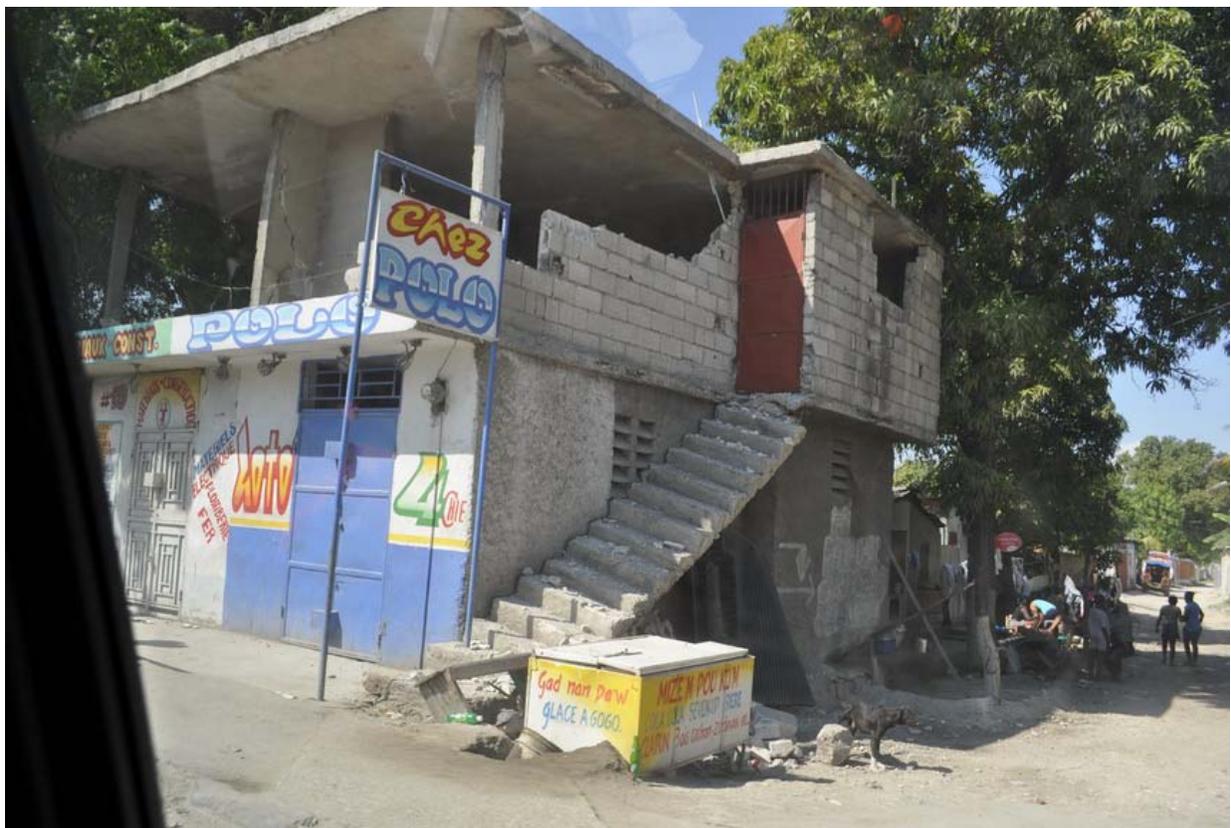
Figure 6.3.8.1-4 Concrete stair dangling from landing above in the 2010 magnitude-7 Haiti Earthquake (Photo courtesy of Eduardo Fierro, BFP Engineers).

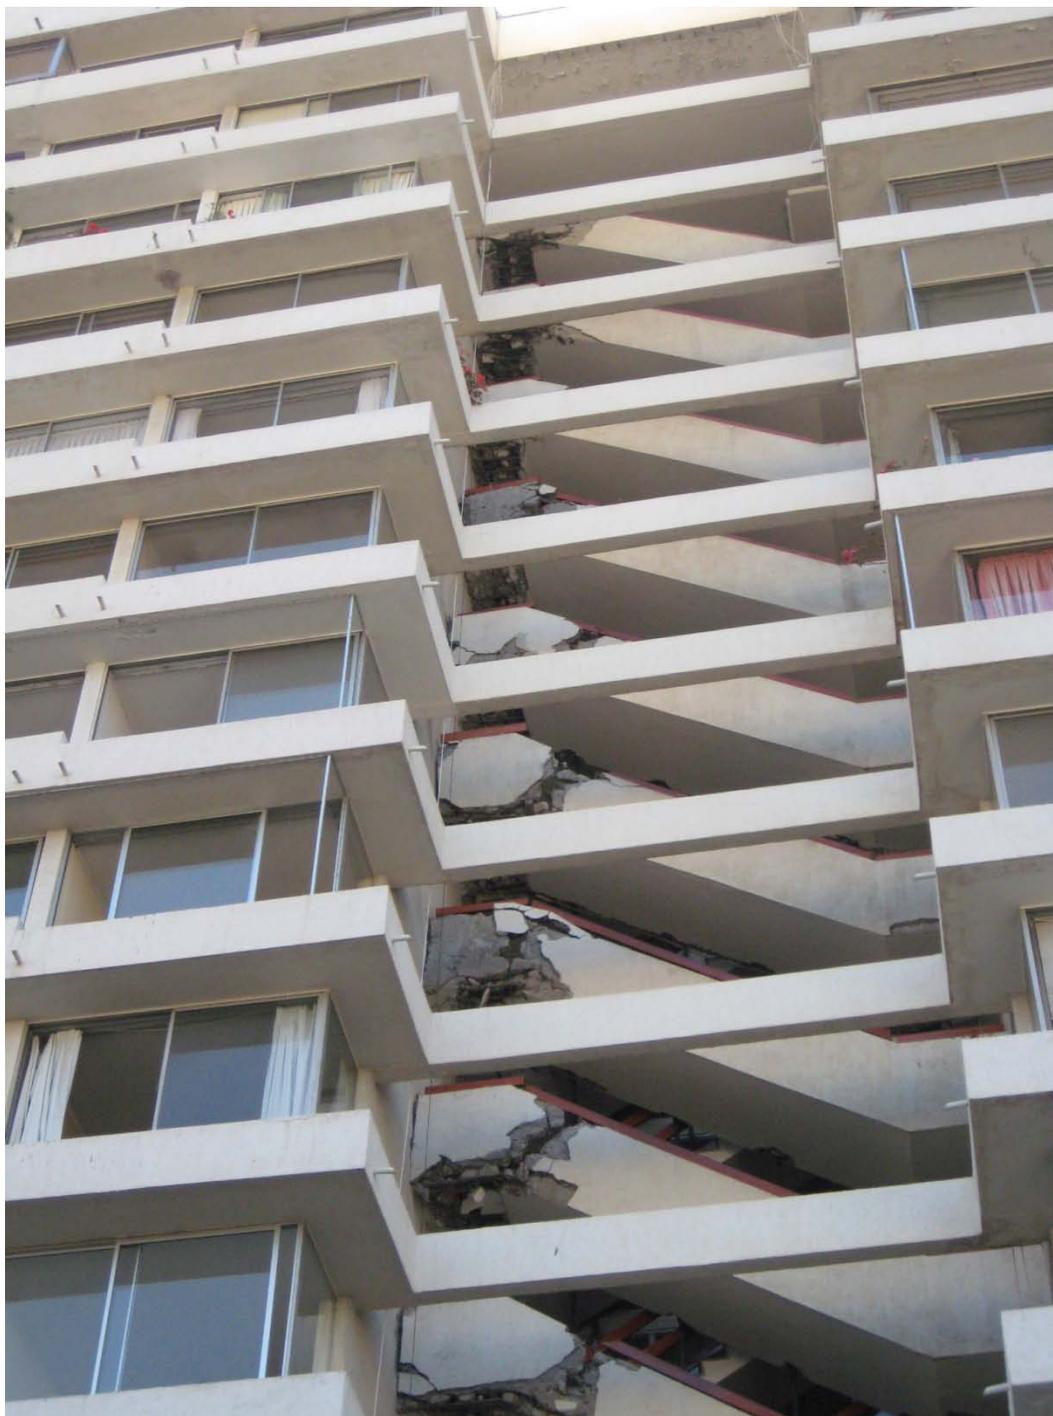
Figure 6.3.8.1-5 Stairs damaged up the full height of this apartment building in Viña del Mar in the 2010 magnitude-8.8 Chile Earthquake (Photo courtesy of Santiago Pujol, Purdue University). The stairs were rigidly attached at adjacent floors and behaved like diagonal braces although they were neither designed nor detailed to function as structural braces.
