## 6.4 MECHANICAL, ELECTRICAL, AND PLUMBING COMPONENTS

### 6.4.7 ELECTRICAL AND COMMUNICATIONS EQUIPMENT

#### 6.4.7.1 CONTROL PANELS, MOTOR CONTROL CENTERS, AND SWITCHGEAR

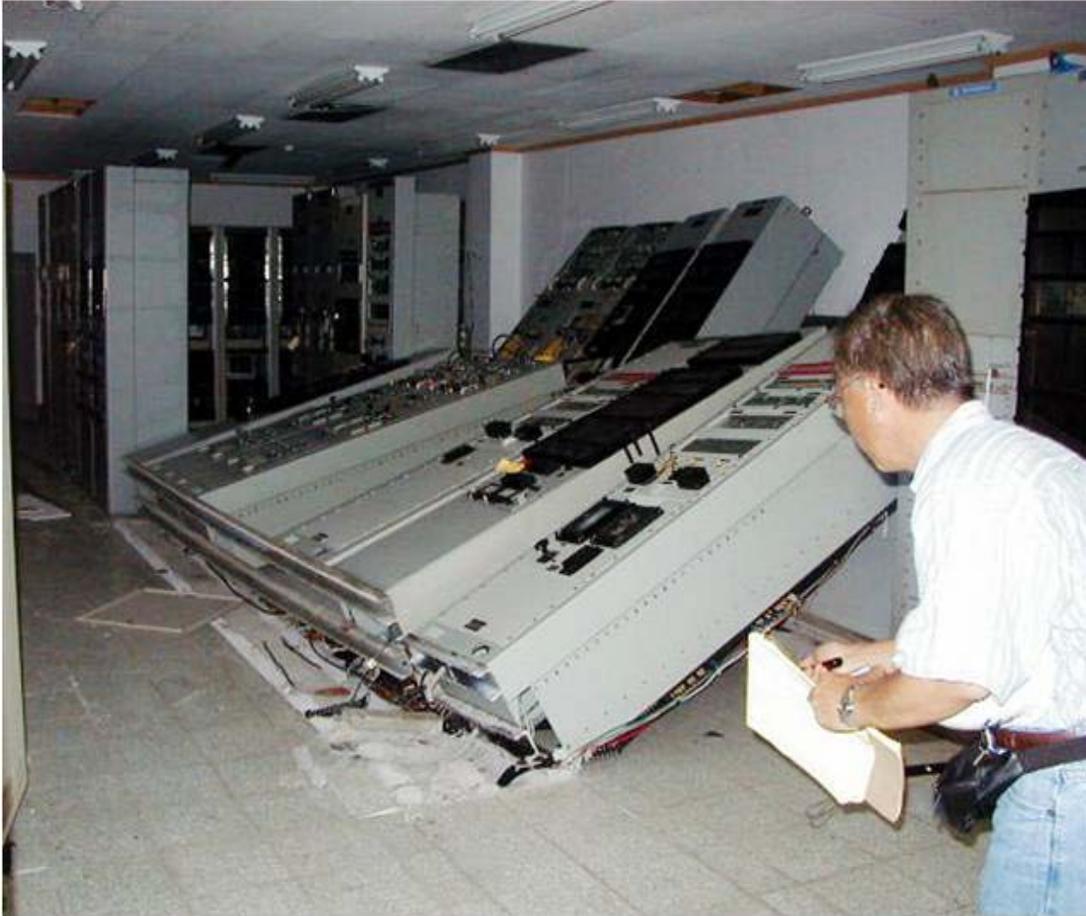
Figure 6.4.7.1-1 Overturned equipment in the 1985 magnitude-8 Mexico Earthquake (Photo courtesy of Degenkolb Engineers).

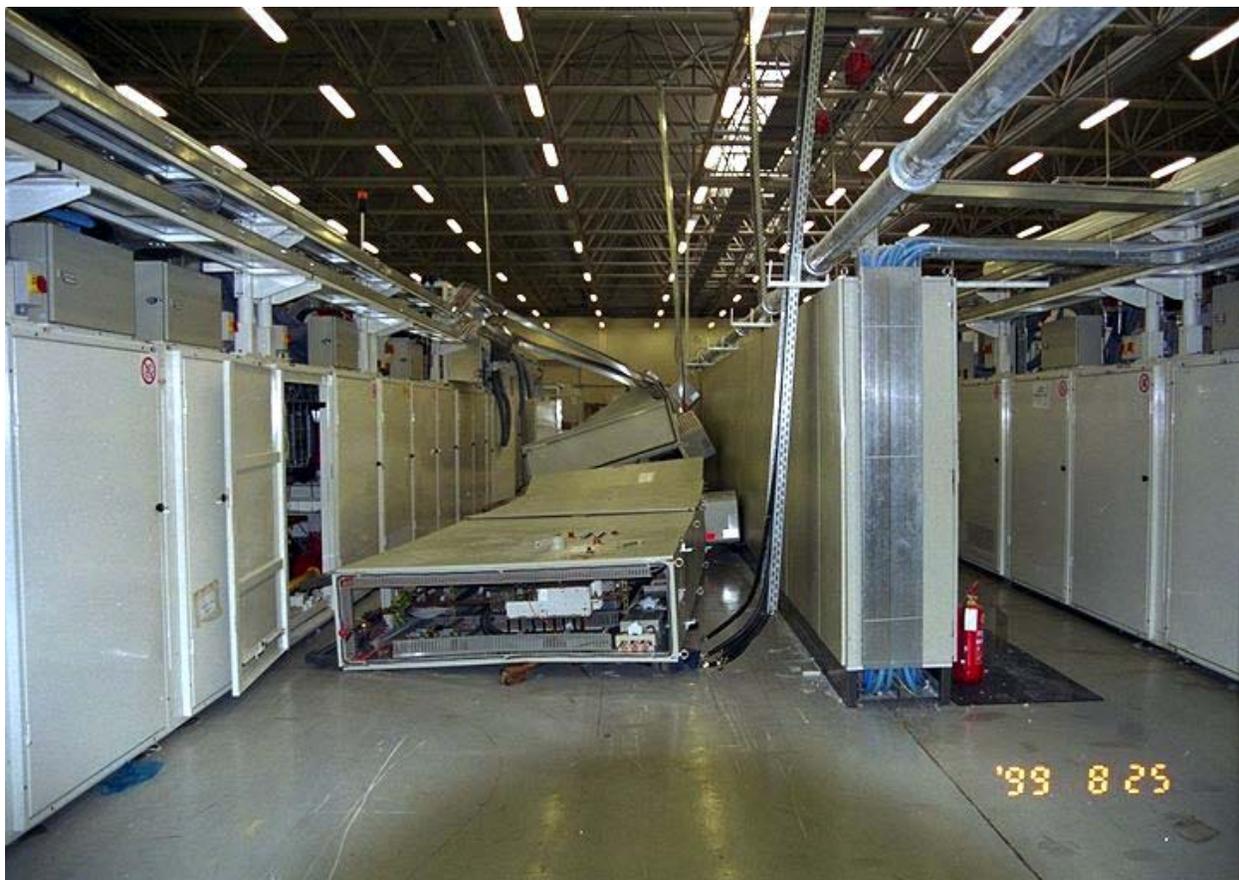
Figure 6.4.7.1-2 Unanchored electrical cabinets overturned in a paper products plant during the 1999 magnitude-7.4 Izmit, Turkey earthquake (Photo courtesy of NISEE Izmit Collection, No. IZT-682, photograph by Halil Sezen).

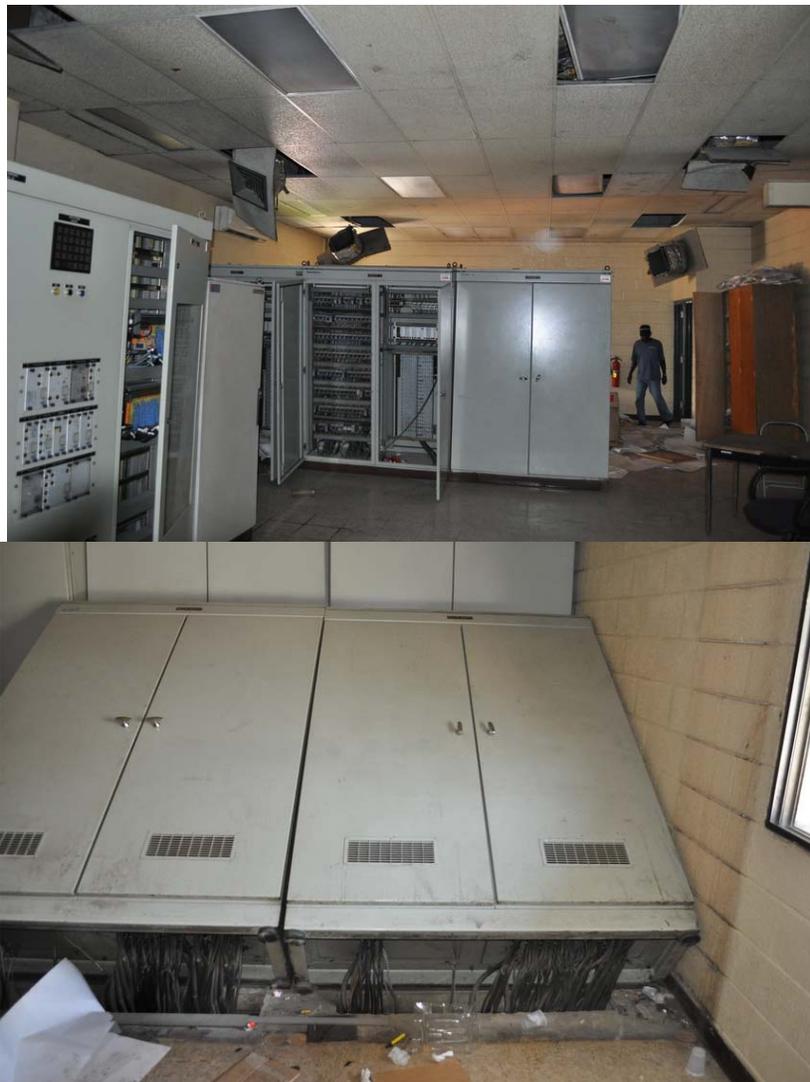
Figure 6.4.7.1-3 Damage to unanchored electrical cabinets at power plant in Port-au-Prince in the 2010 magnitude-7 Haiti Earthquake (Photos courtesy of Eduardo Fierro, BFP Engineers).

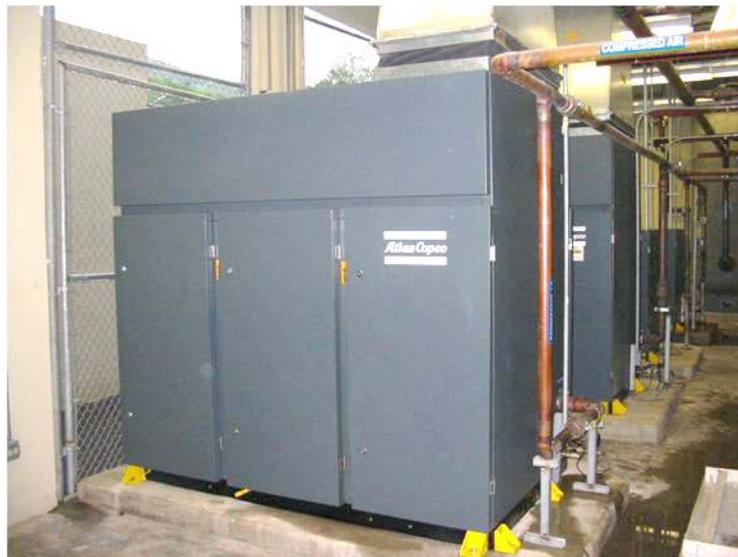
Figure 6.4.7.1-4 Equipment cabinets retrofitted with unidirectional snubbers at base (Photo courtesy of Mike Griffin).

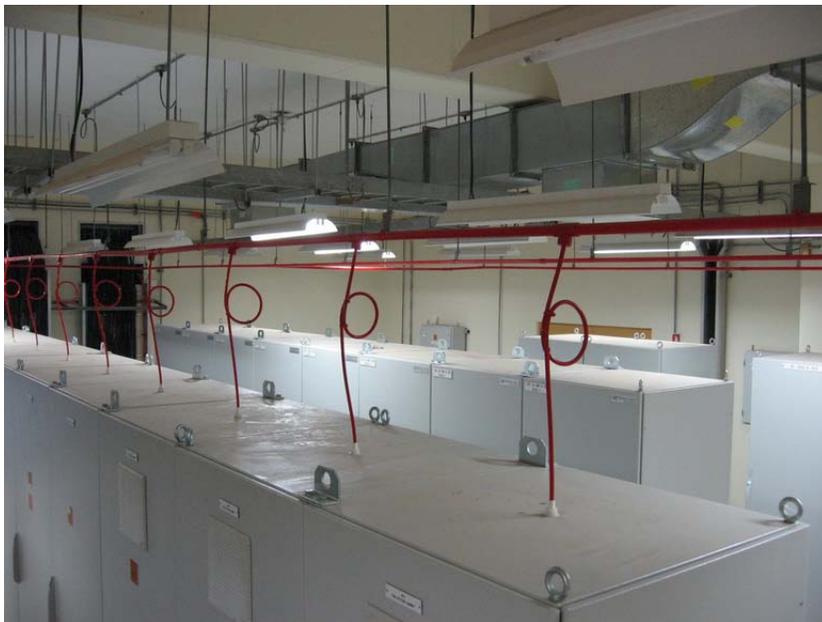
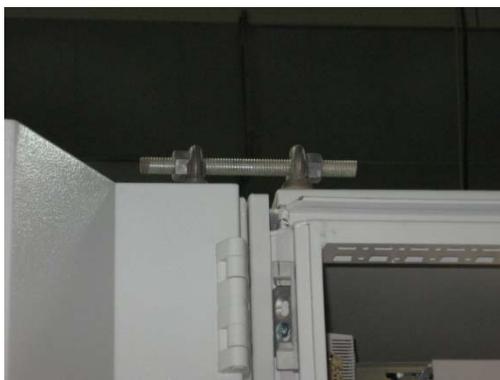
Figure 6.4.7.1-5 Installation that performed well in the 2010 magnitude-8.8 Chile Earthquake; cabinets anchored at base. Some cabinets tied together side by side using existing lifting hooks at top of cabinets (Photos courtesy of Rodrigo Retamales, Ruben Boroschek & Associates).

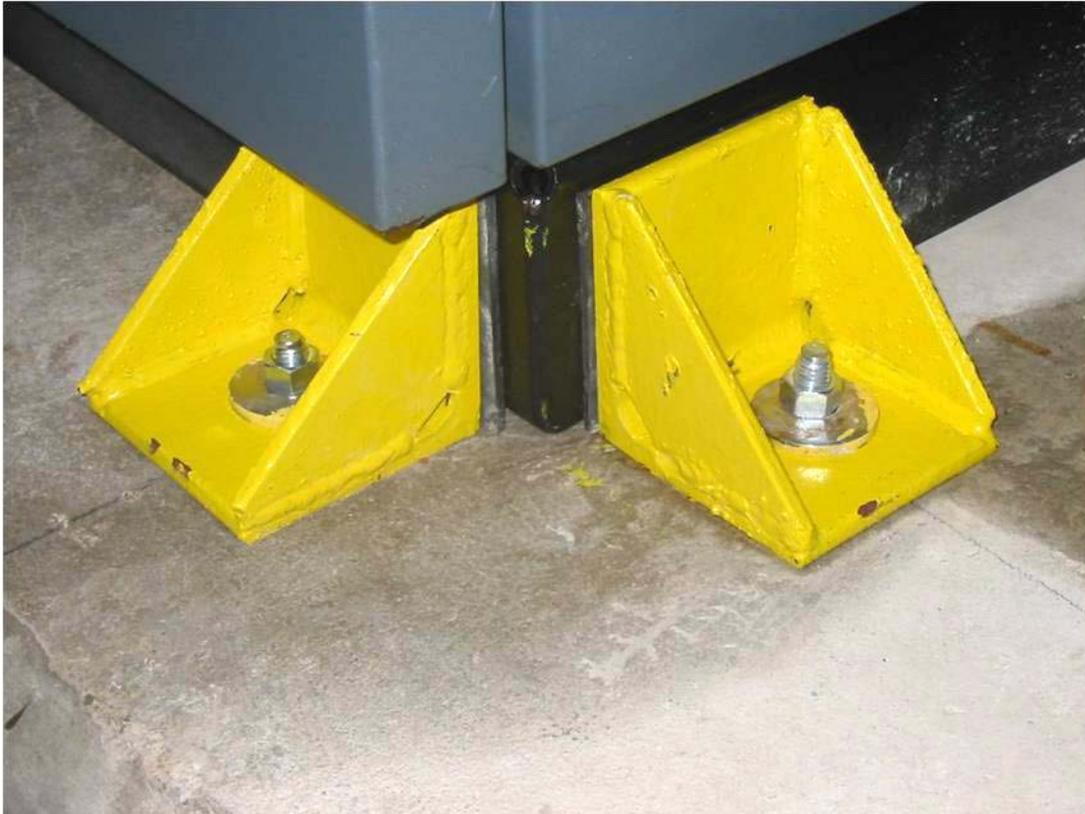
Figure 6.4.7.1-6 Close up of snubbers (Photo courtesy of Mike Griffin).

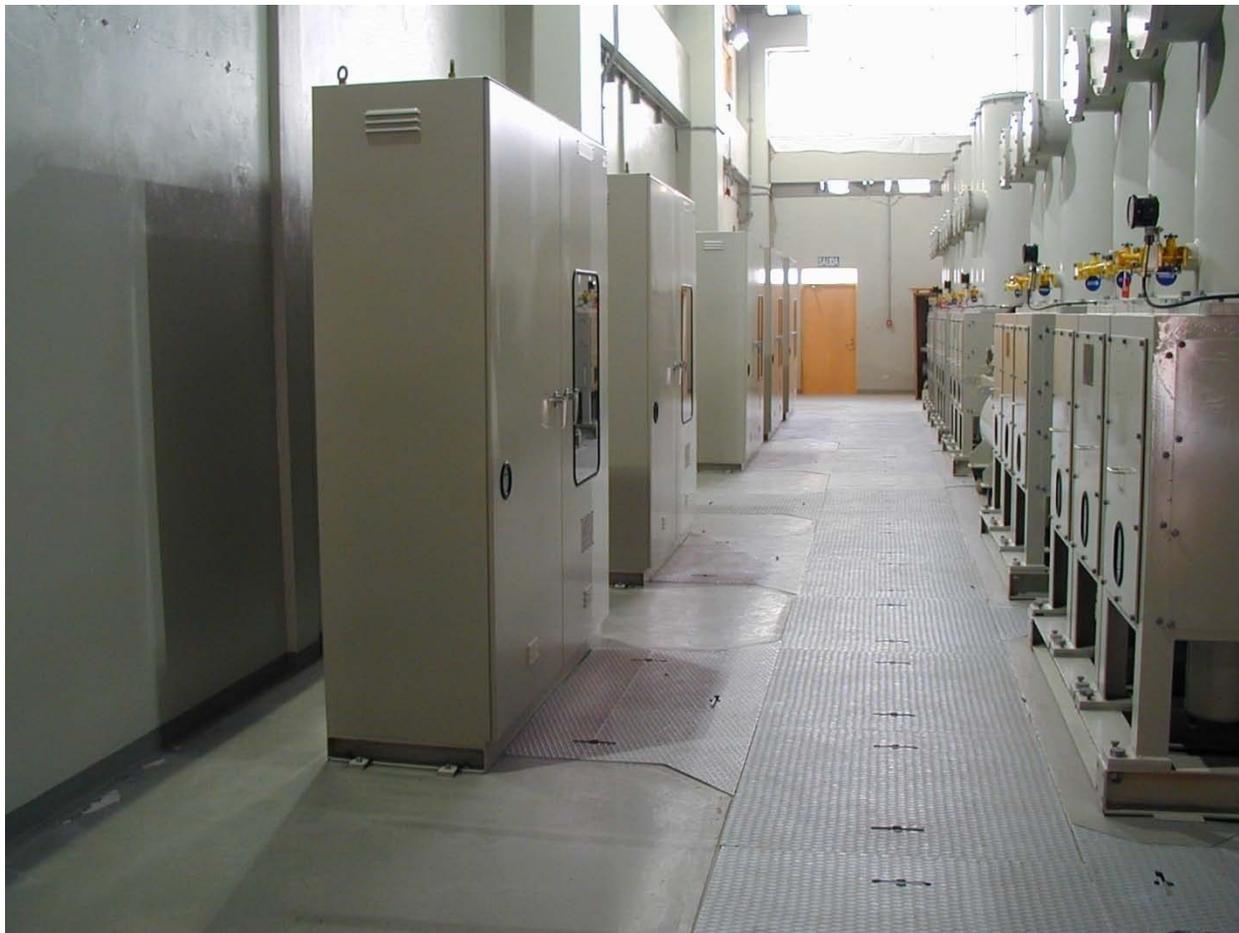
Figure 6.4.7.1-7 Postearthquake strengthening of anchorage for electrical cabinets from the 2001 magnitude-8.4 Peru Earthquake (Photo courtesy of Eduardo Fierro, BFP Engineers).

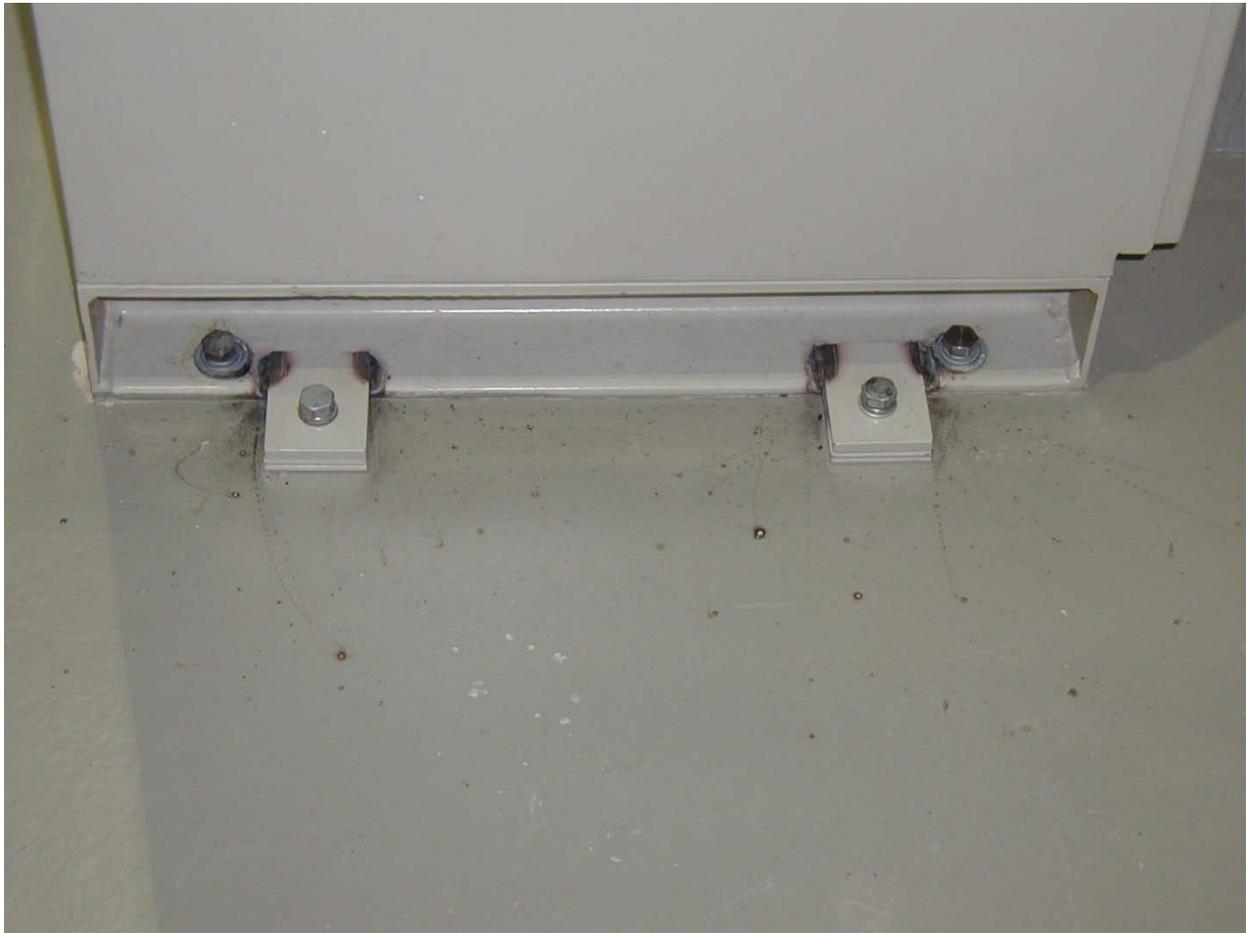
Figure 6.4.7.1-8 Detail of postearthquake strengthening from the 2001 Peru Earthquake (Photo courtesy of Eduardo Fierro, BFP Engineers).

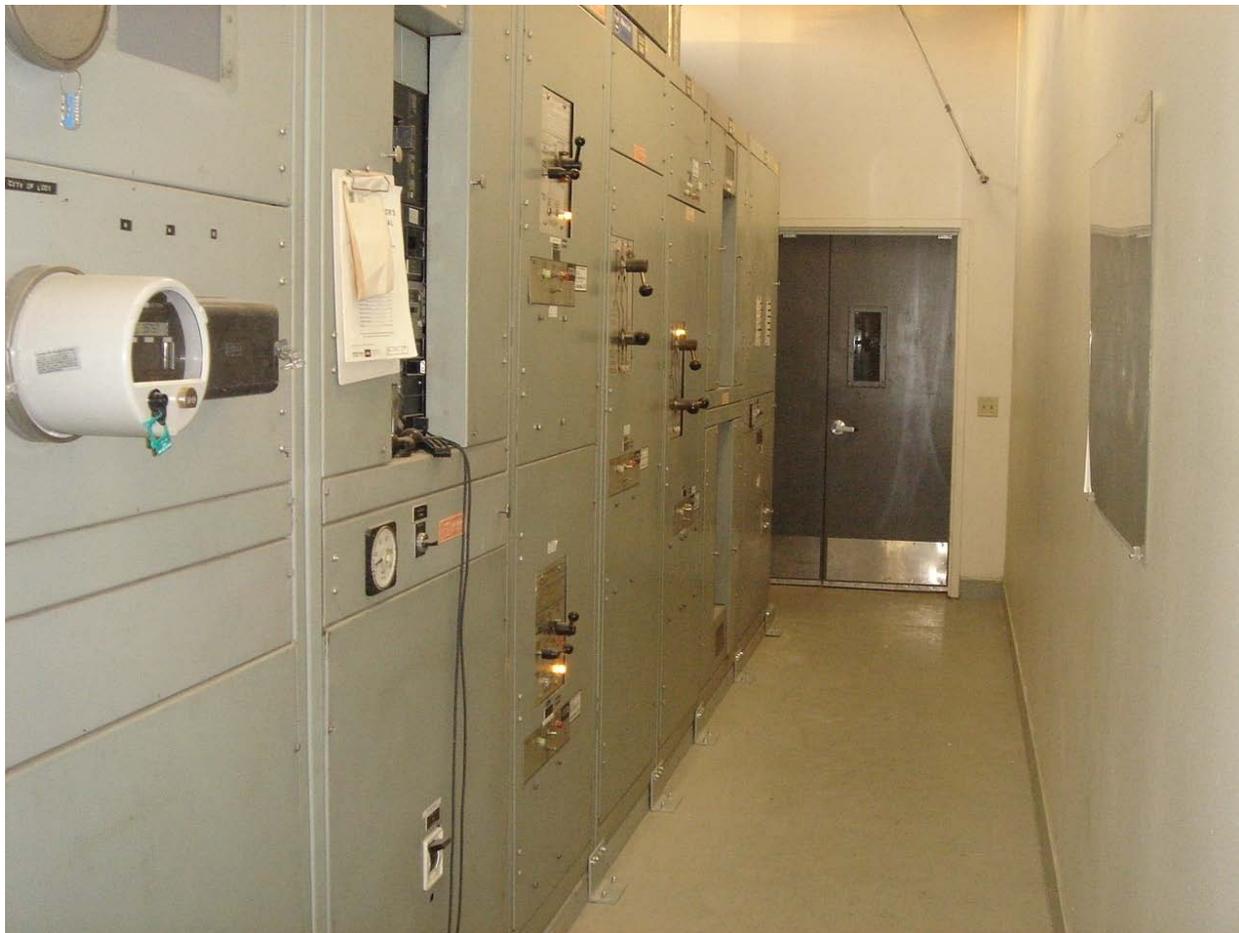
Figure 6.4.7.1-9 Anchorage for electrical cabinets. Anchorage to wall at top of cabinets is also present but not visible (Photo courtesy of Maryann Phipps, Estructure).

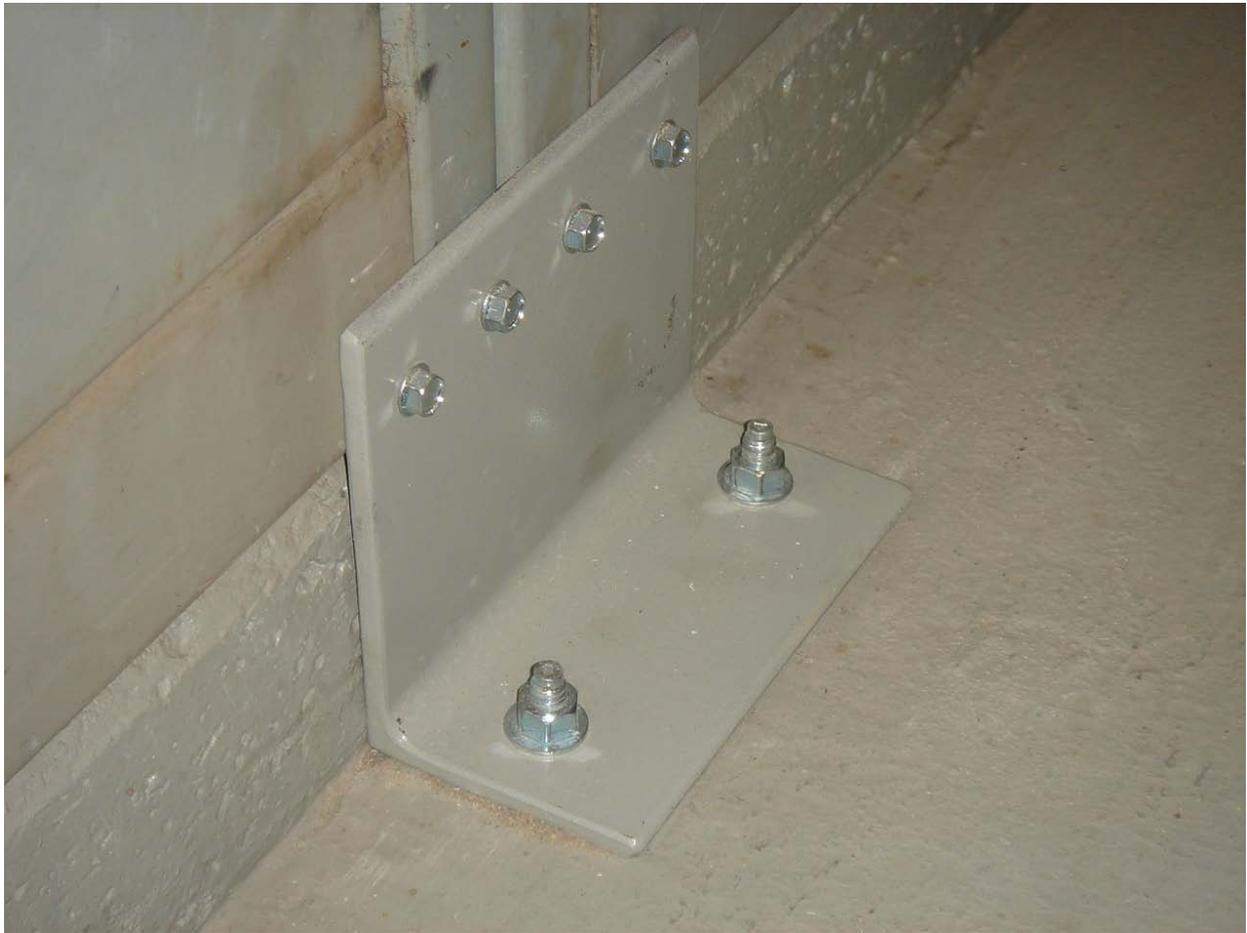
Figure 6.4.7.1-10 Detail of cabinet base anchorage (Photo courtesy of Maryann Phipps, Estructure).

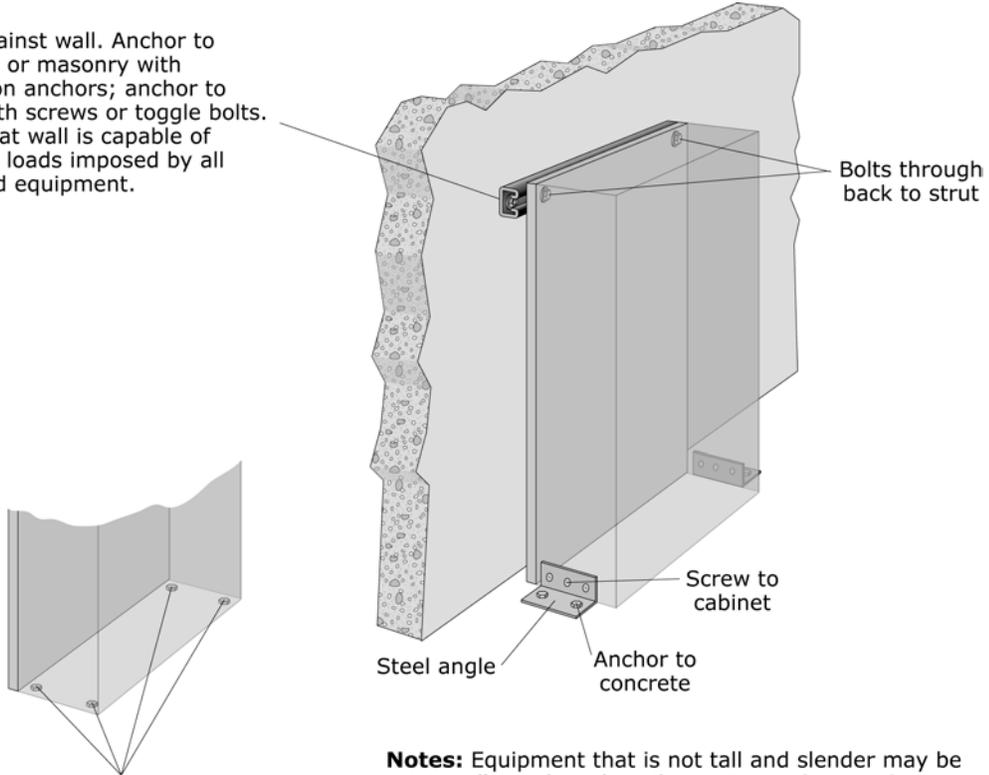
Strut against wall. Anchor to concrete or masonry with expansion anchors; anchor to studs with screws or toggle bolts. Verify that wall is capable of resisting loads imposed by all anchored equipment.

Alternate: anchor directly through base if unit is premanufactured for base anchorage and access is available

Figure 6.4.7.1-11 Electrical control panels, motor controls centers, or switchgear (ER).

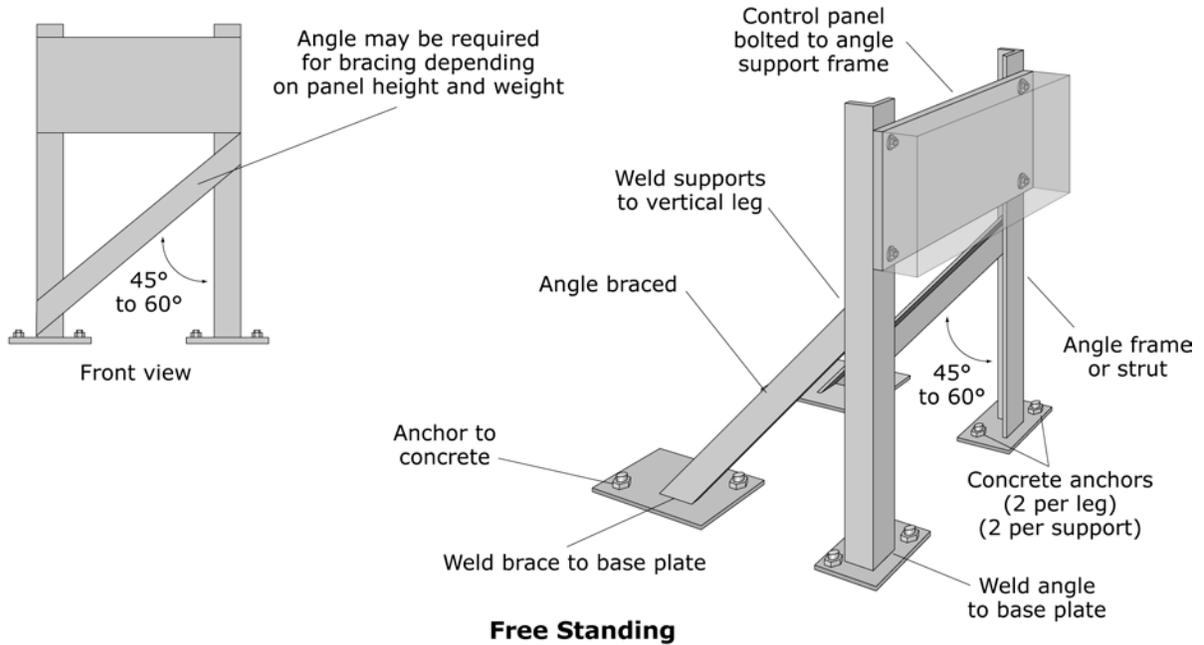
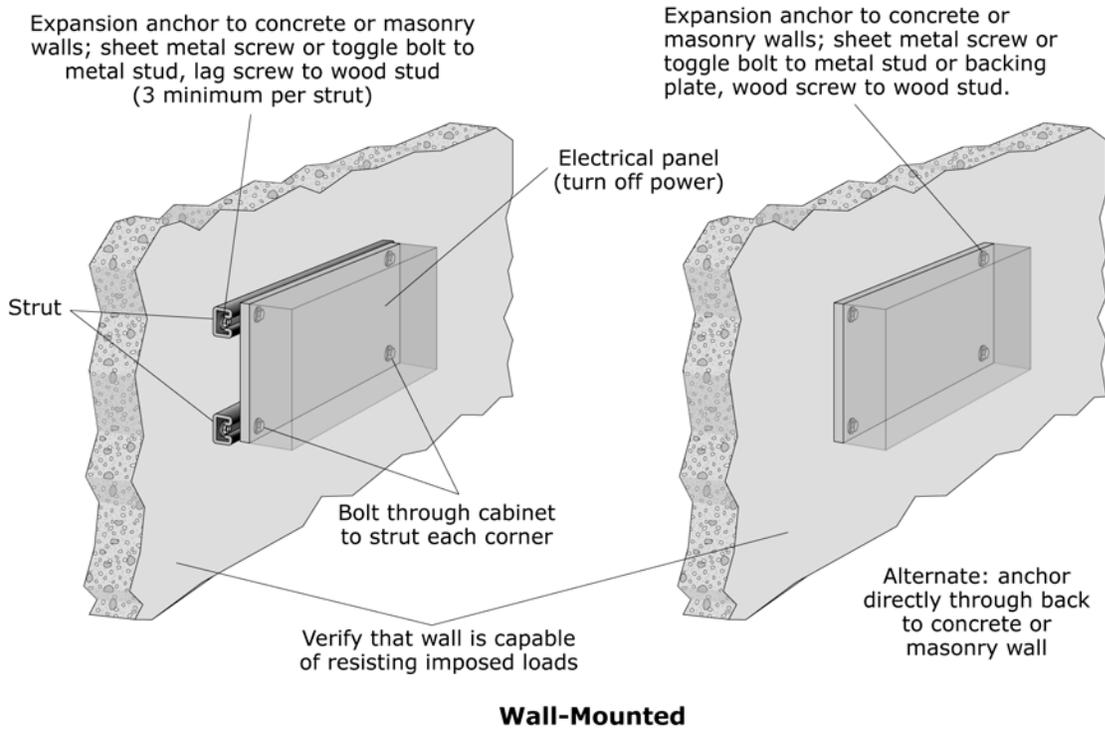
Figure 6.4.7.1-12 Free-standing and wall-mounted electrical control panels, motor controls centers, or switchgear (ER).
