HURRICANE IKE IN TEXAS & LOUISIANA

3 Performance of Residential Buildings (Flood and Wind), One- to Two-Family and Multi-Family

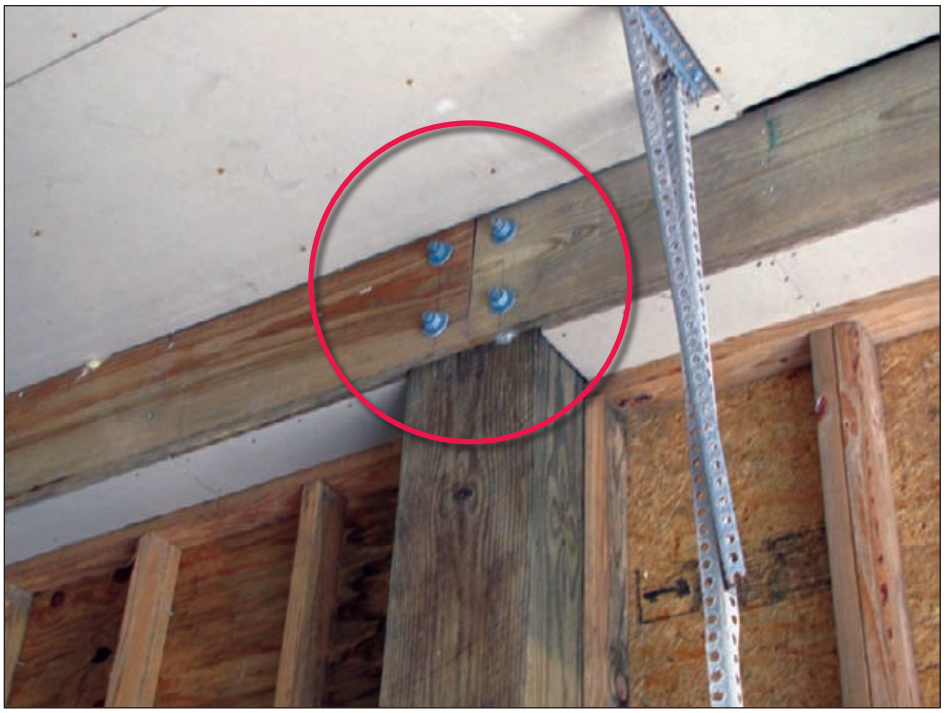
In most buildings the MAT evaluated, timber construction was used and the tops of the piles or columns were connected to the elevated buildings with bolted connections (Figure 3-5). This type of connection provides limited fixity; weakness in this type of connection can be overcome in some instances through the use of larger piles or columns and other design details that help to stiffen the foundation.

Figure 3-5.
Typical bolted connection between wood columns and wood beams

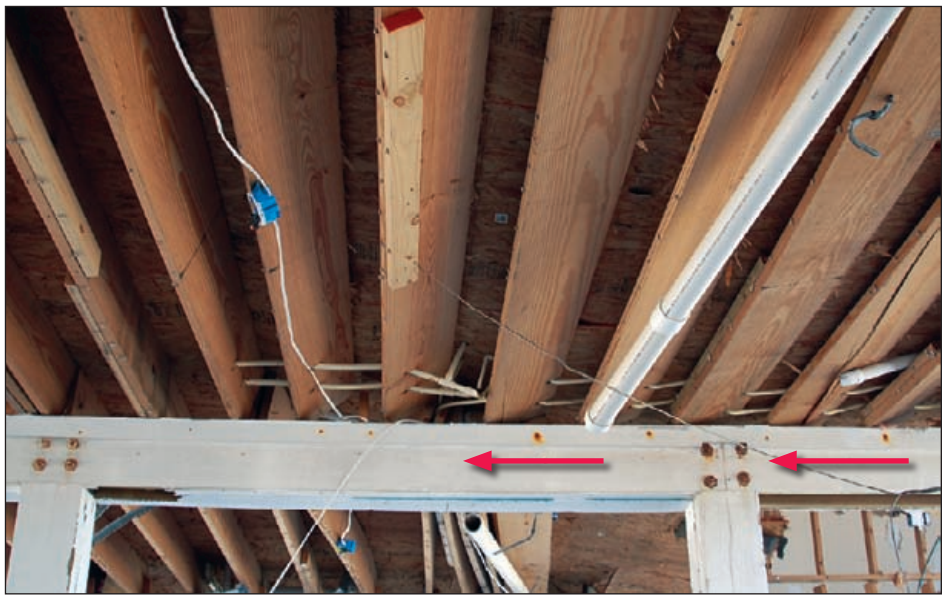
Figure 3-7. The landward displacement of shore-parallel floor joists indicates the onset of wave damage to an elevated floor system (Bolivar Peninsula, TX)

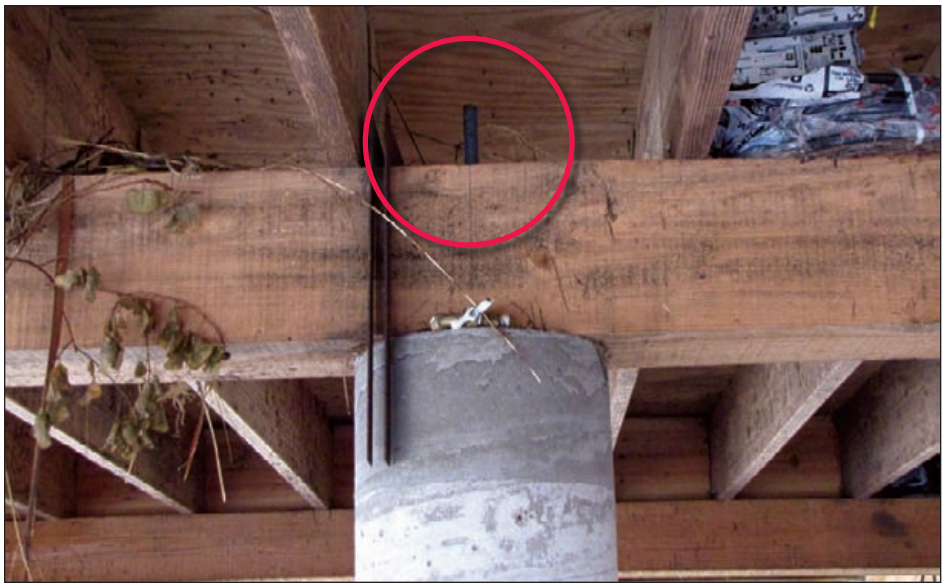
Figure 3-25.
A ⅝-inch diameter galvanized steel anchor bolt in red circle (with washer and nut, not visible in this photograph) provided connections between beam and column for the house shown in Figure 3-24. This does not appear to be an engineered connection.

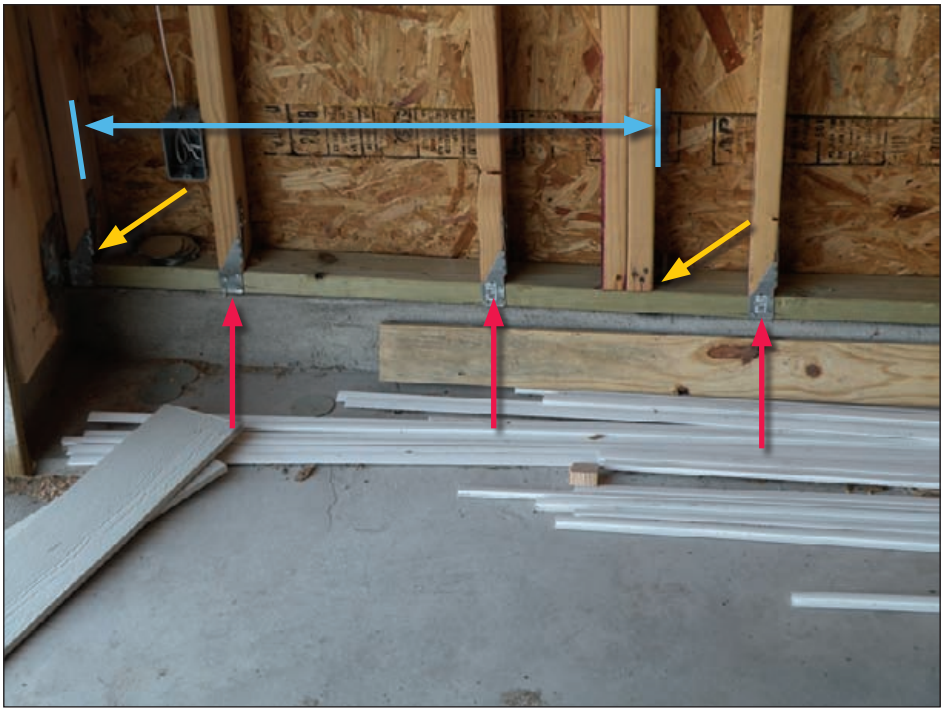
Figure 3-52.
Studs and sill plate connected in new house (sill bolts yellow arrows and clips red arrows). However, sill bolts are spaced too far apart (2 feet is the maximum spacing allowed) and did not have 3-inch by 3-inch by 1/8-inch washers per 2003 IRC and TDI-adopted IBHS guidelines. Blue line shows 3-foot spacing (Webster, TX).

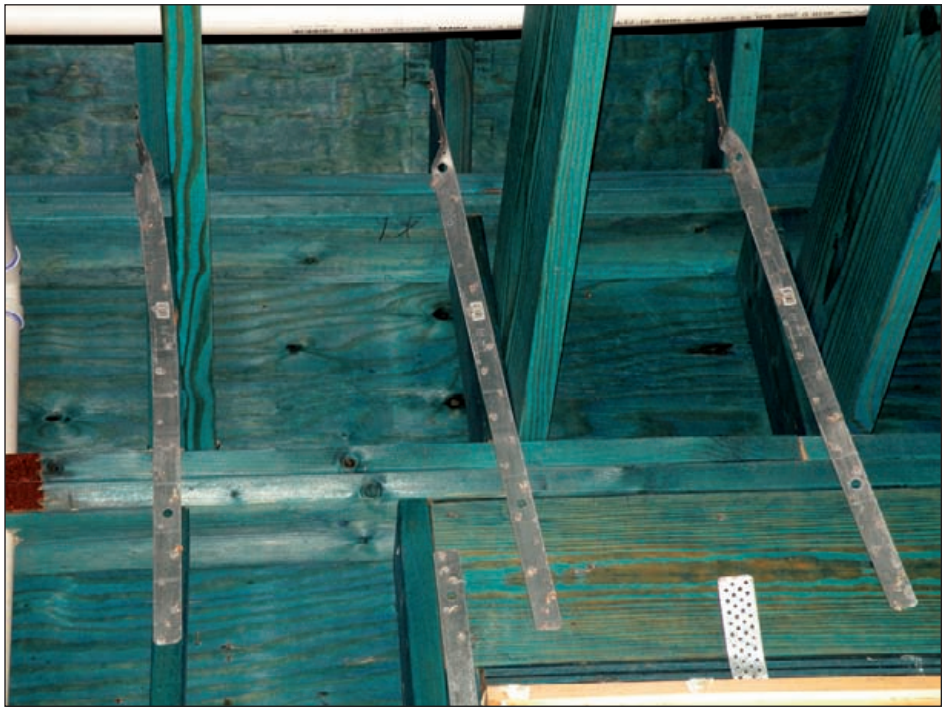
Figure 3-54.
Wall-to-roof strapping. Details for uncommon framing details should be specifically provided by the designer on building plans, including specifying the specific connection and application to ensure a continuous load path.

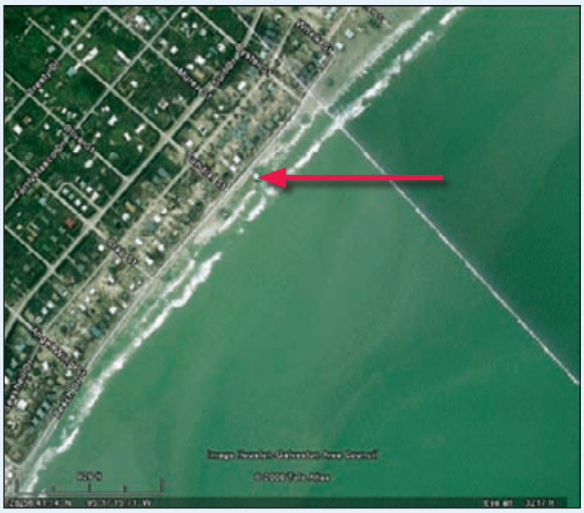
SURFSIDE BEACH, TX

The closer a building is located to the shoreline, the more vulnerable it becomes. This is not only due to the increasing flood forces close to the shoreline, but also because a building's foundation designed for a given location and set of conditions (ground elevation, stillwater flood depth, wave height, etc.) will find itself exposed to a different set of conditions (lower ground, higher wave height, etc.) as the shoreline erodes over time, and the building may not be able to withstand those new conditions. A classic case is Surfside Beach, TX, where long-term erosion had resulted in dozens of houses standing on the beach, seaward of the line of vegetation. Many of these houses were ordered removed by the State of Texas; some were removed, but others remained and litigation resulted. Hurricane Ike destroyed most of the houses standing on the beach (see photos below).

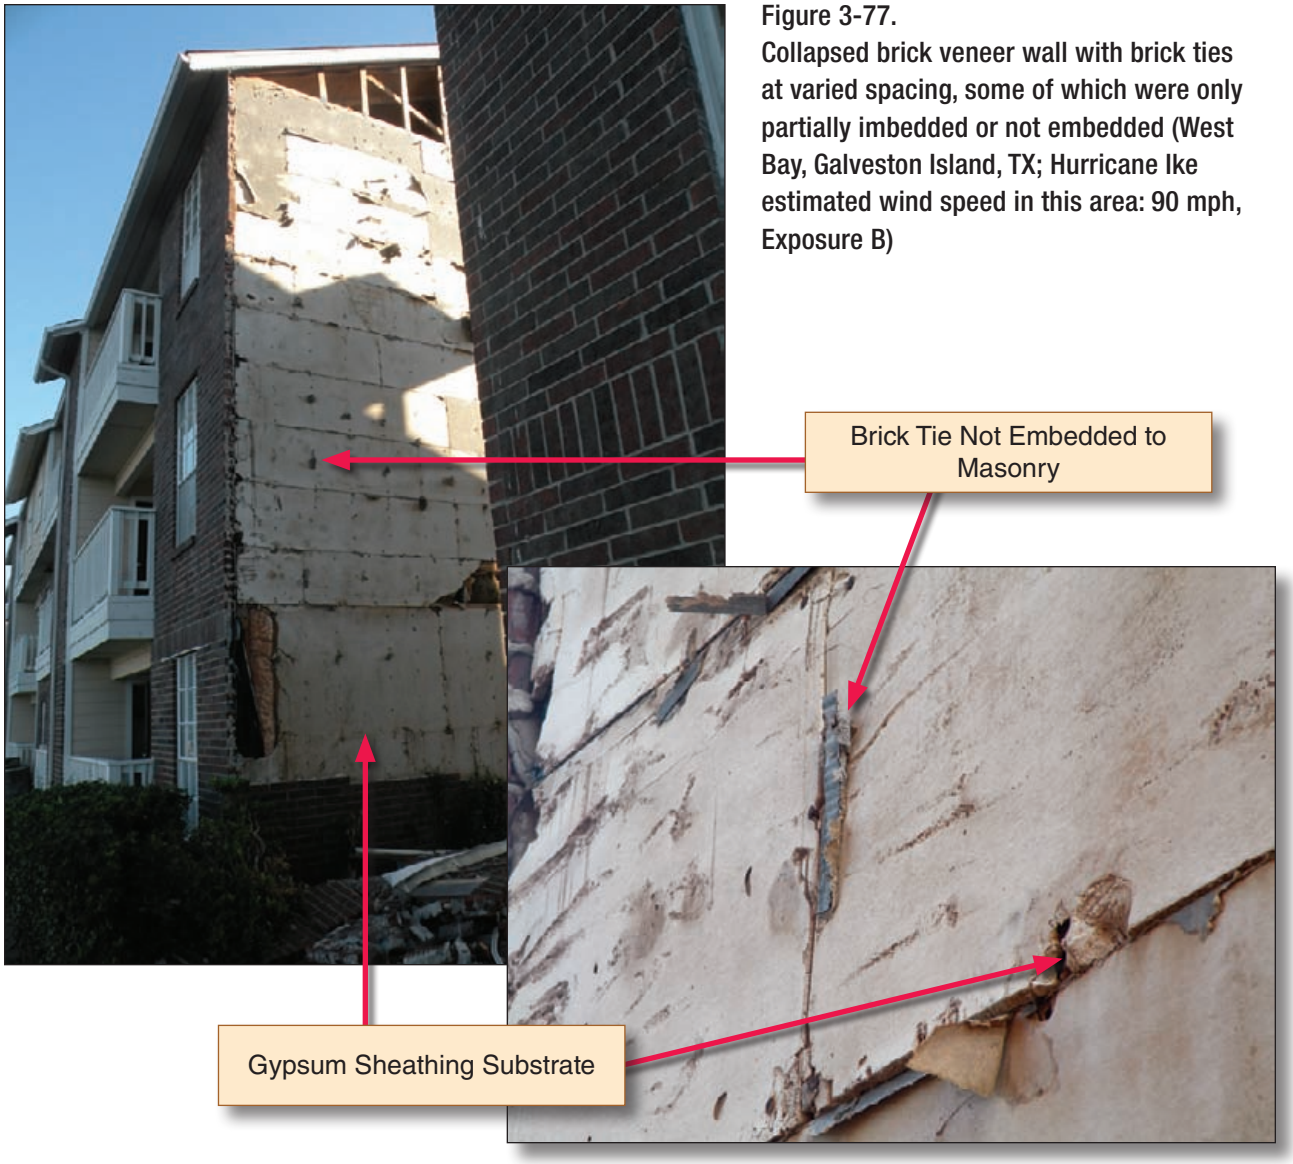
Numerous brick veneer failures were observed at one Galveston apartment complex. Figure 3-77 shows failed brick veneer at one complex. The brick ties were randomly spaced with the horizontal spacing ranging from 32 inches to 16 inches on-center and the vertical spacing ranging from 48 inches to 24 inches on-center. Many of the corrugated ties were rusted and broken, were not embedded in the masonry, or had minimal embedment. Figure 3-78 illustrates common problems with brick veneer installations and Figure 3-79 illustrates proper methods of installation.

Figure 3-77.
Collapsed brick veneer wall with brick ties at varied spacing, some of which were only partially imbedded or not embedded (West Bay, Galveston Island, TX; Hurricane Ike estimated wind speed in this area: 90 mph, Exposure B)

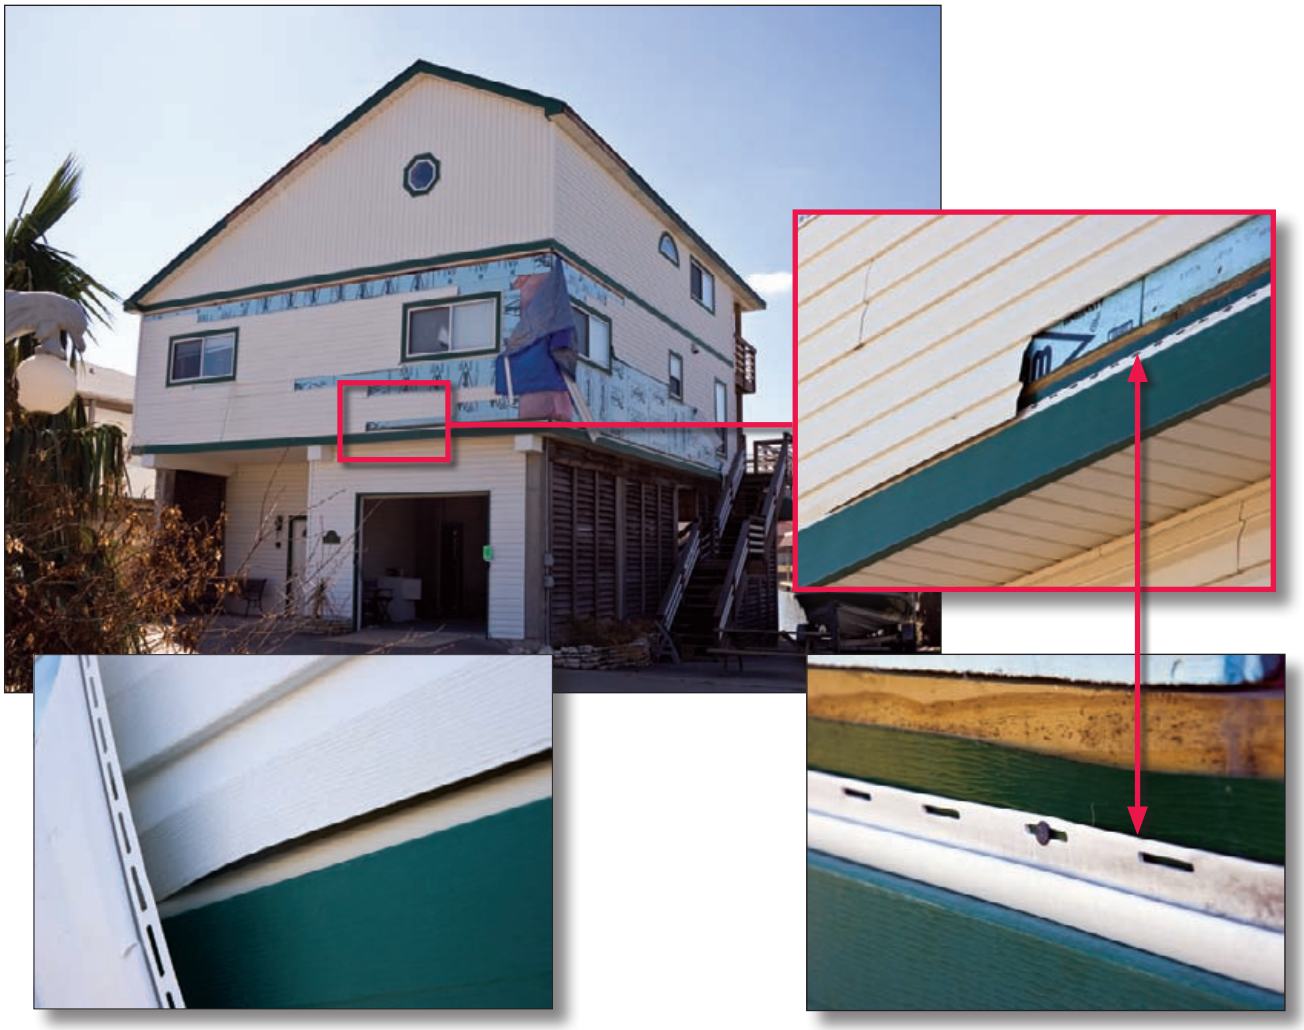
Figure 3-81. Improper installation led to extensive loss of siding up the house wall. The bottom lock of the lowest course of siding was cut off, and utility trim substituted for the correct starter strip. The poorly retained bottom edge pulled out under wind pressure, leading to extensive loss of siding up the house wall (Tiki Island, TX; Hurricane Ike estimated wind speed in this area: 88 mph, Exposure B).

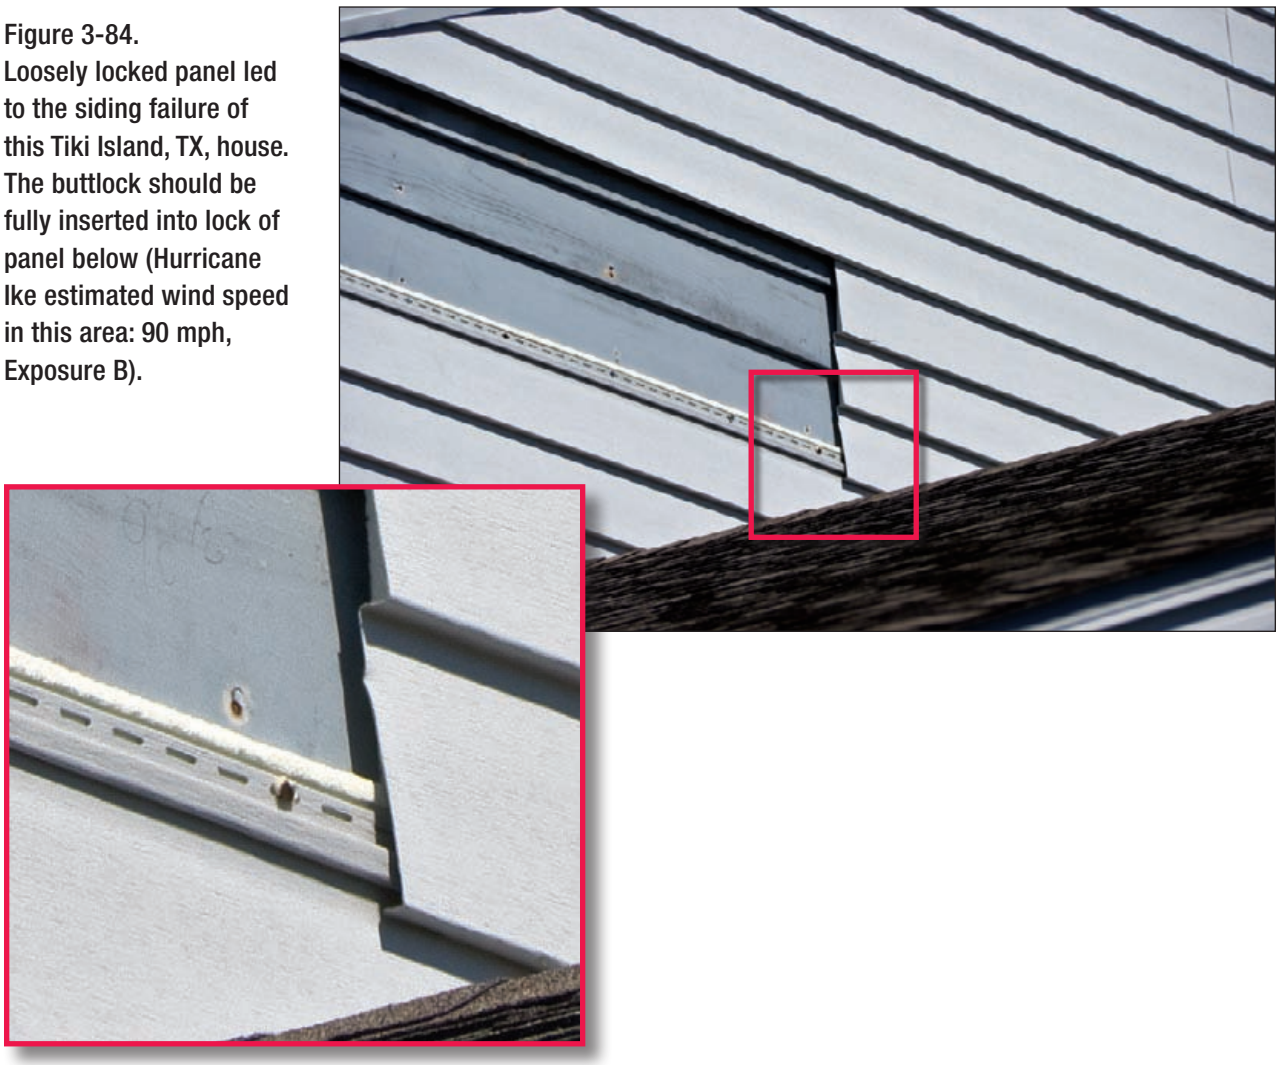
Figure 3-84.
Loosely locked panel led to the siding failure of this Tiki Island, TX, house. The buttlock should be fully inserted into lock of panel below (Hurricane Ike estimated wind speed in this area: 90 mph, Exposure B).

Each course of siding should be installed by pushing the buttlock firmly upward into the lock of the course below until it snaps into place and goes no further. The siding should be held in the lock by pushing up from the bottom while the first several fasteners are placed to hold it in position. Siding should never be pulled up from the nail hem. When properly installed, siding should be able to slide back and forth without undue force; neither tight fasteners at the nail hem nor friction in the buttlock should prevent the siding from sliding. Installers should properly locate the starting points for siding on adjacent walls and check alignment of horizontal lines every course or two to avoid needing to make adjustments further up the wall.

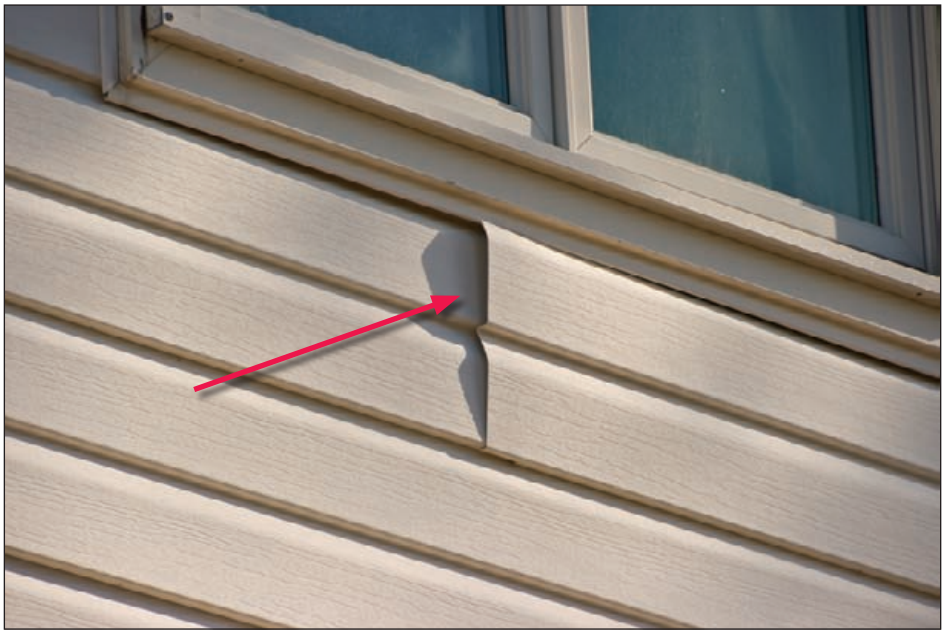
Figure 3-86.
Siding partially detached by wind as a result of improper placement of joint directly under window. Factory-notched end is not held by utility trim (Tiki Island, TX; Hurricane Ike estimated wind speed in this area: 88 mph).

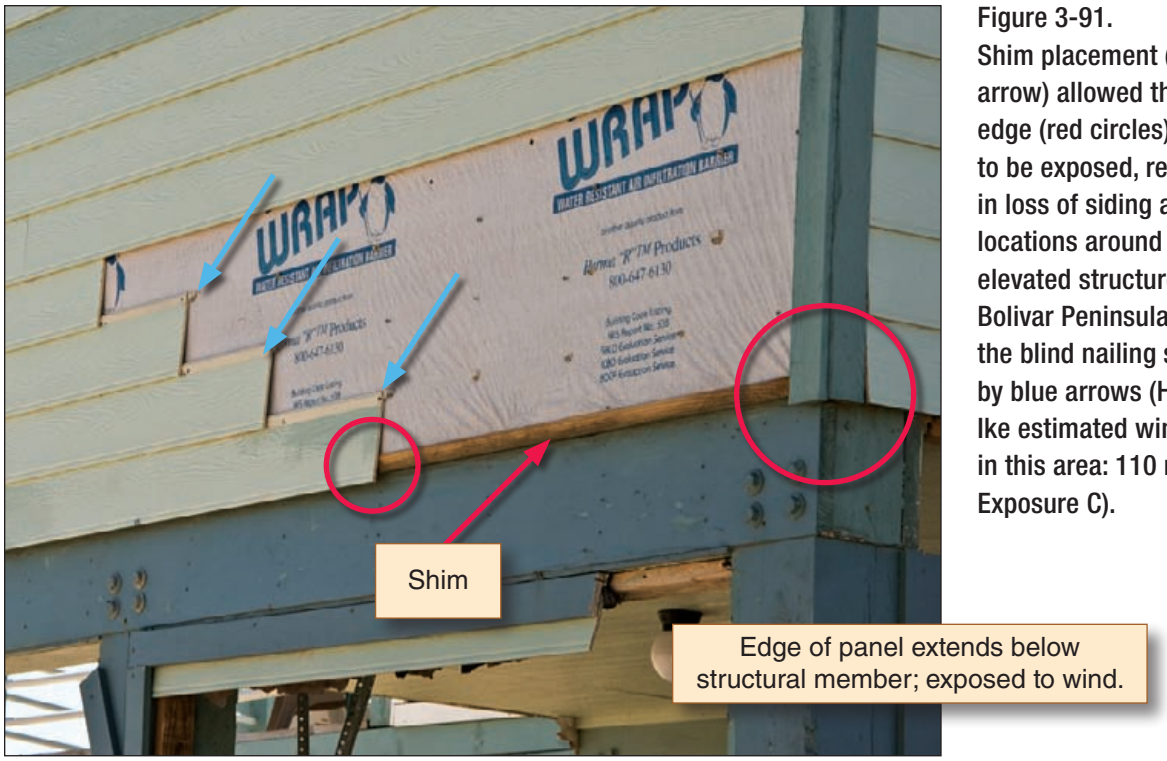
Figure 3-91.
Shim placement (red arrow) allowed the lower edge (red circles) of siding to be exposed, resulting in loss of siding at several locations around this elevated structure on Bolivar Peninsula, TX. Note the blind nailing shown by blue arrows (Hurricane Ike estimated wind speed in this area: 110 mph, Exposure C).

Shims under lap siding should be placed flush with the bottom of the first course, and panel siding should be fastened tightly to the substrate so that no gap is created at the lowest edge. Consideration should be given to placing a trim piece below the lower edge of the siding to fully close off the edge. Neither lap siding nor panel siding should extend below the lowest structural member of an elevated building, where it would be exposed to the full force of the wind (Figure 3-92).

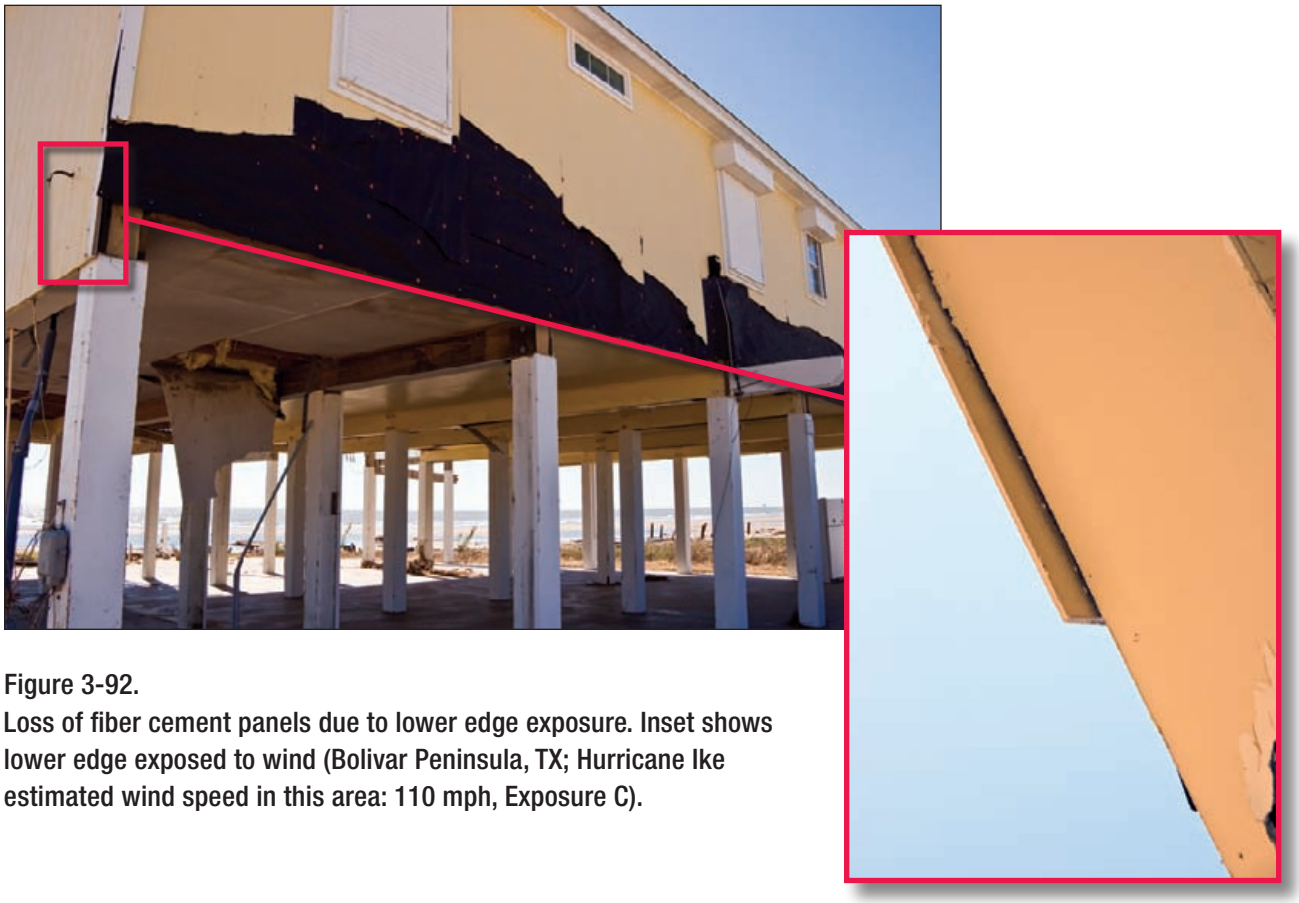
Figure 3-92.
Loss of fiber cement panels due to lower edge exposure. Inset shows lower edge exposed to wind (Bolivar Peninsula, TX; Hurricane Ike estimated wind speed in this area: 110 mph, Exposure C).

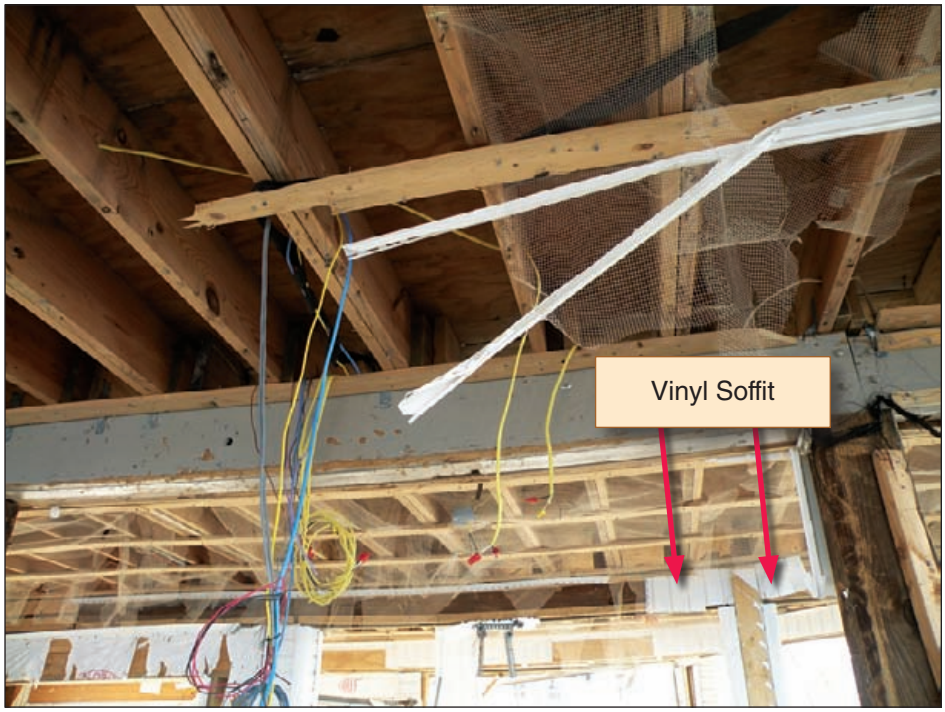
Where floodwaters did not reach the underside of the building, damage due to wind accelerating underneath the building was often observed. In these cases, vinyl soffit was often blown off. In some cases, but not all, the sheathing above the soffit was also removed. The vinyl soffit covering on the Tiki Island house shown in Figure 3-122 was probably blown off by wind action rather than storm surge.

Figure 3-121.
Tiki Island house with vinyl soffit applied without sheathing removed by storm surge (netting was used to contain insulation in joist space)

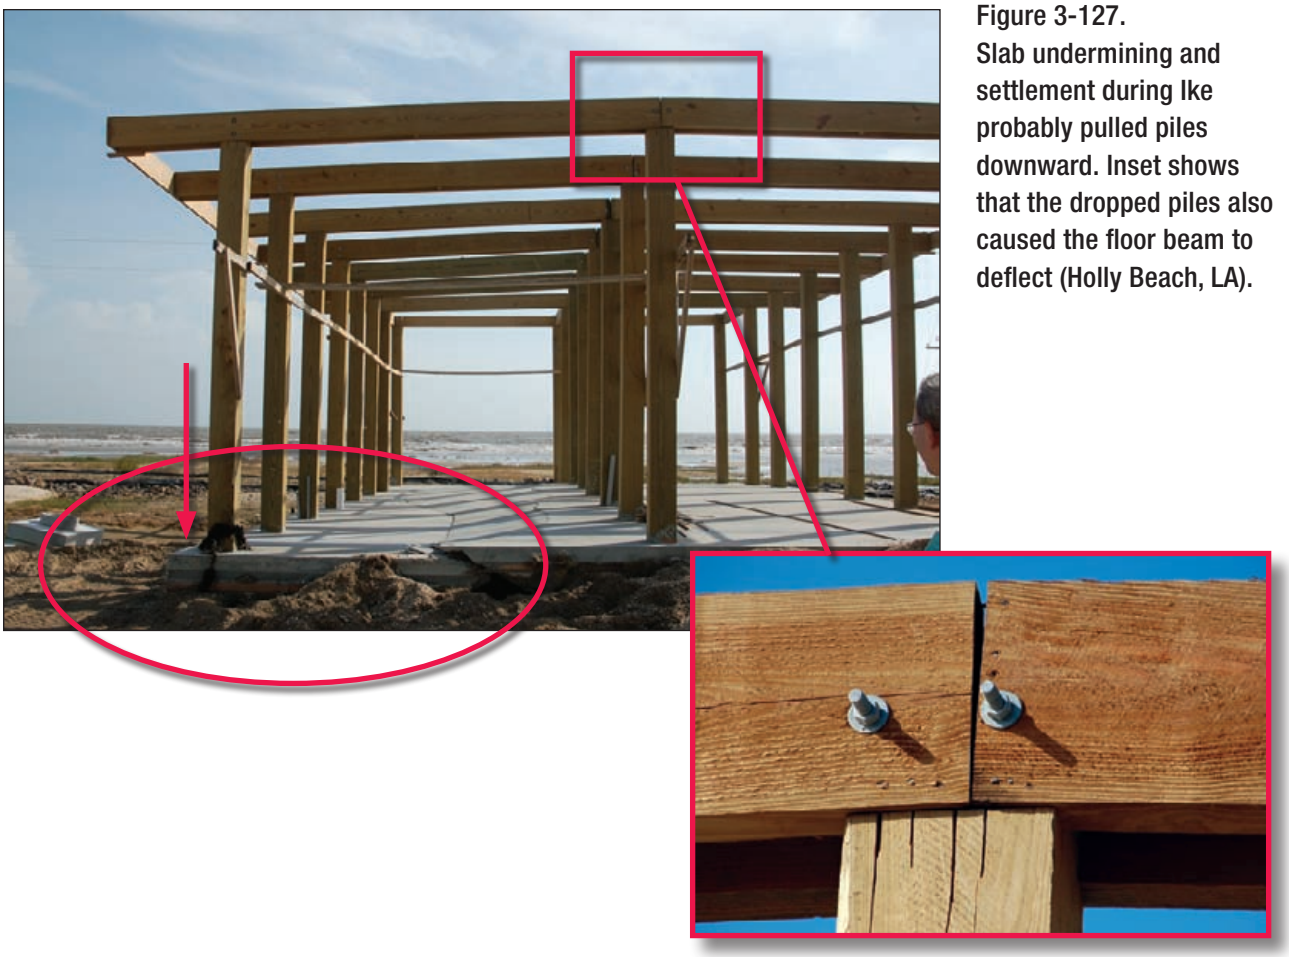
Figure 3-127.
Slab undermining and settlement during Ike probably pulled piles downward. Inset shows that the dropped piles also caused the floor beam to deflect (Holly Beach, LA).

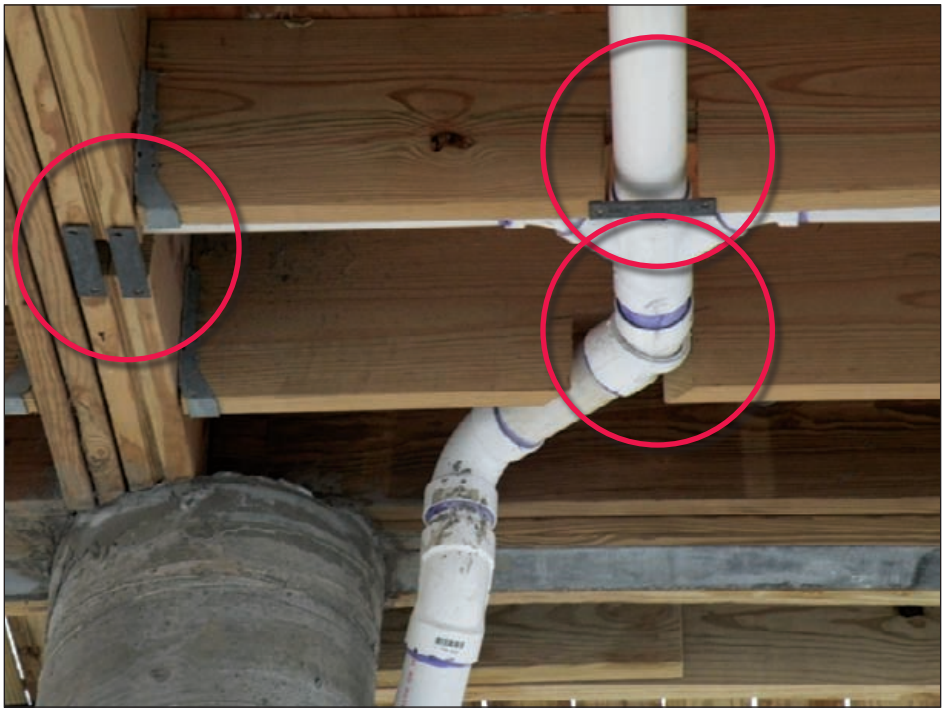
Figure 3-131. Floor joists and beams were notched to allow for plumbing (Sulphur, Calcasieu Parish, LA)
