HURRICANE IKE IN TEXAS & LOUISIANA

4 Performance of Critical Facilities

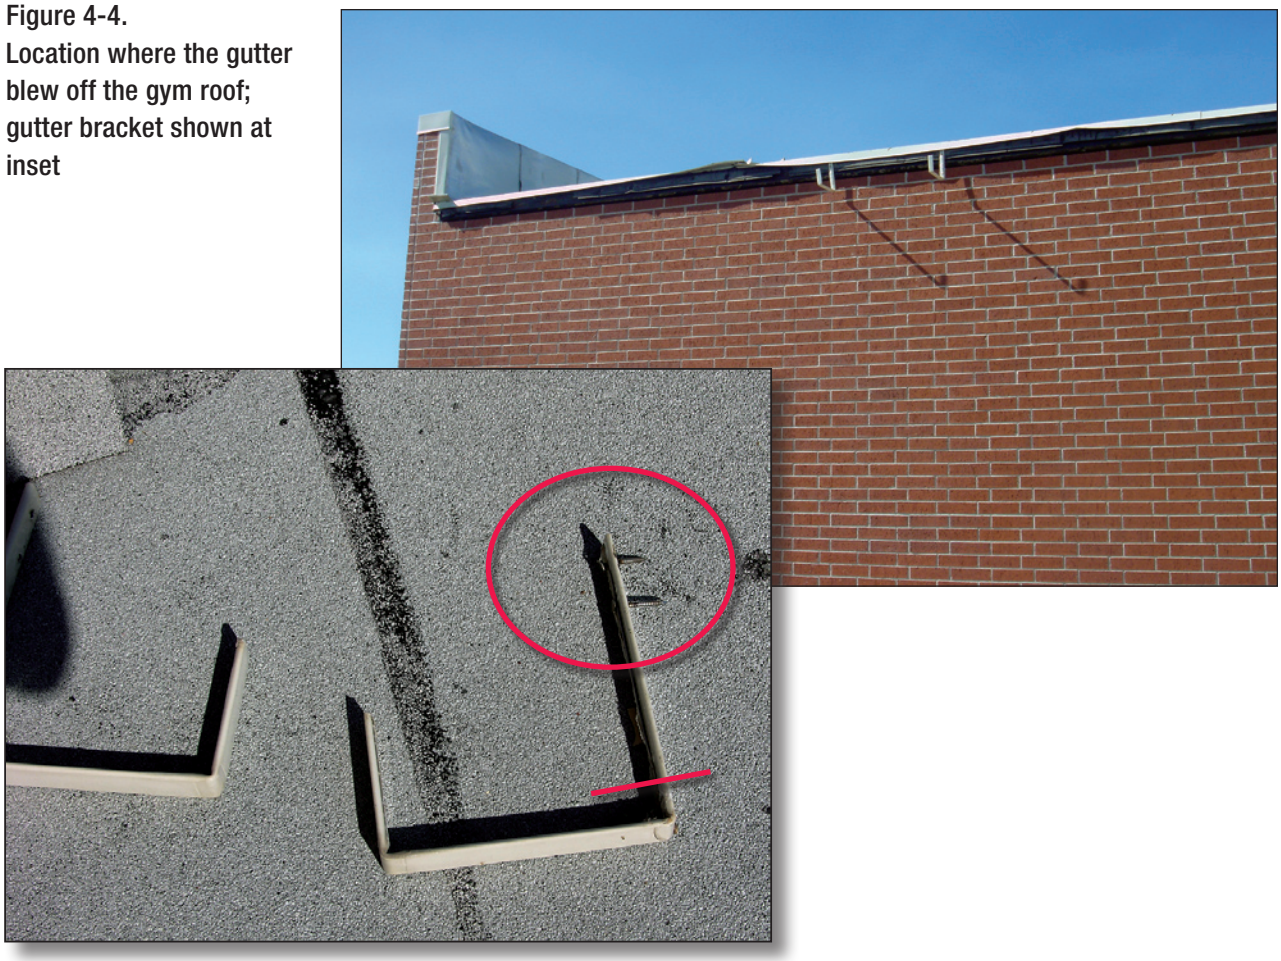
The gutter and most of its brackets blew off the gym roof (Figure 4-4), but the roof membrane did not progressively peel as is typically the case when a gutter is blown away. The brackets were attached with two ring-shank nails, both of which were located near the top of the bracket, as shown in the inset in Figure 4-4. Since both fasteners were near the top of the bracket, they provided little resistance to outward rotation (moment) as the wind pulled and lifted the gutter away from the building. Significant permanent outward deformation was observed at gutters at other roof areas of the building (similar to the condition shown by the inset at Figure 4-41). To resist the moment force, a screw should have been placed near the lower edge of the bracket, as shown by the red line in the inset at Figure 4-4. Screws should be used to attach brackets because they are more resistant than nails to dynamically induced pull-out forces. The gutter brackets were not attached to the gutter (see discussion in Section 4.3.2).

Figure 4-4.
Location where the gutter blew off the gym roof; gutter bracket shown at inset

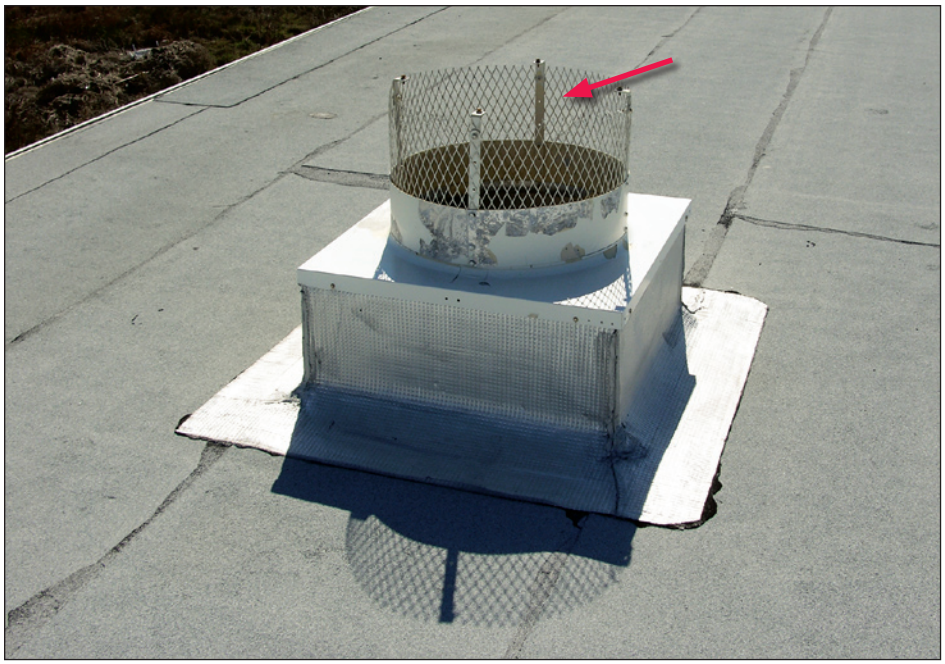
The MAT observed the rooftop equipment on the facility. The rooftop exhaust fans had too few fasteners, although none of the fans blew away during this storm. The exhaust fans were attached with two screws per side; for this location, FEMA 543, *Design Guide for Improving Critical Facility Safety from Flooding and High Winds: Providing Protection to People and Buildings* (2007), recommends six screws per side. The hood blew off two units, which allowed rain to enter the building (Figure 4-5).

Figure 4-5.
Wind blew off the hood, allowing rain to directly enter the building

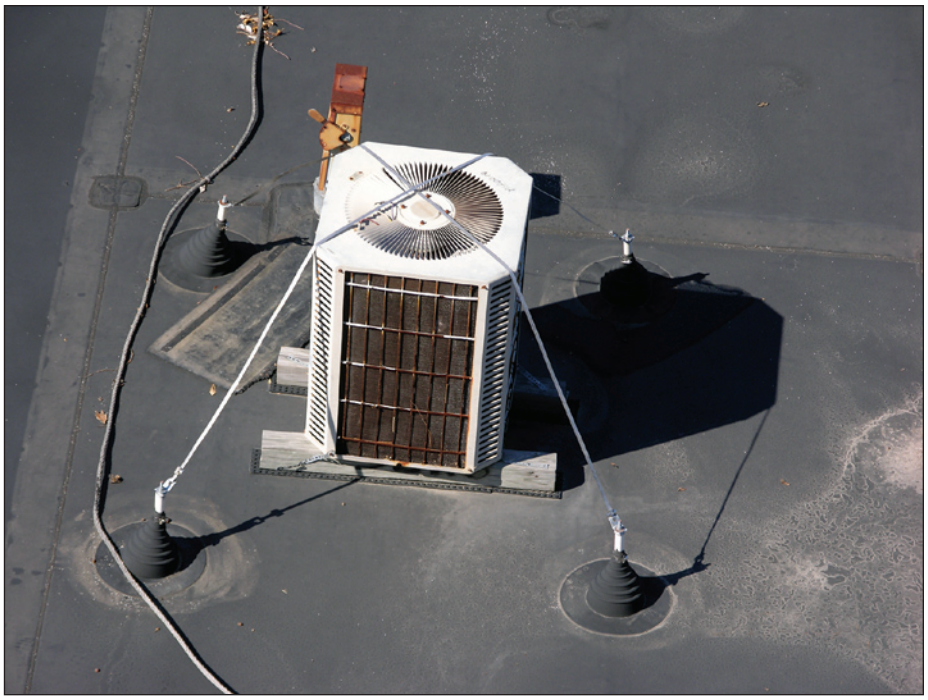
General Wind Damage. The facility experienced some water leakage at the three-story wing shown in Figure 4-14. Some of this leakage was likely due to damaged rooftop equipment. The MAT observation of the roof on this portion of the facility indicated that at least one fan cowling was blown away. No special attachment was provided for the fan cowlings (such as that shown in FEMA 577, *Design Guide for Improving Hospital Safety in Earthquakes, Floods, and High Winds: Providing Protection to People and Buildings* [2007]). However, special attachment was provided for the condenser shown in Figure 4-15. Strapping condensers is a practice that is recommended in FEMA 543 and 577. Unless strapped, condensers frequently topple over.

Figure 4-15.
Condenser with tie-down cables

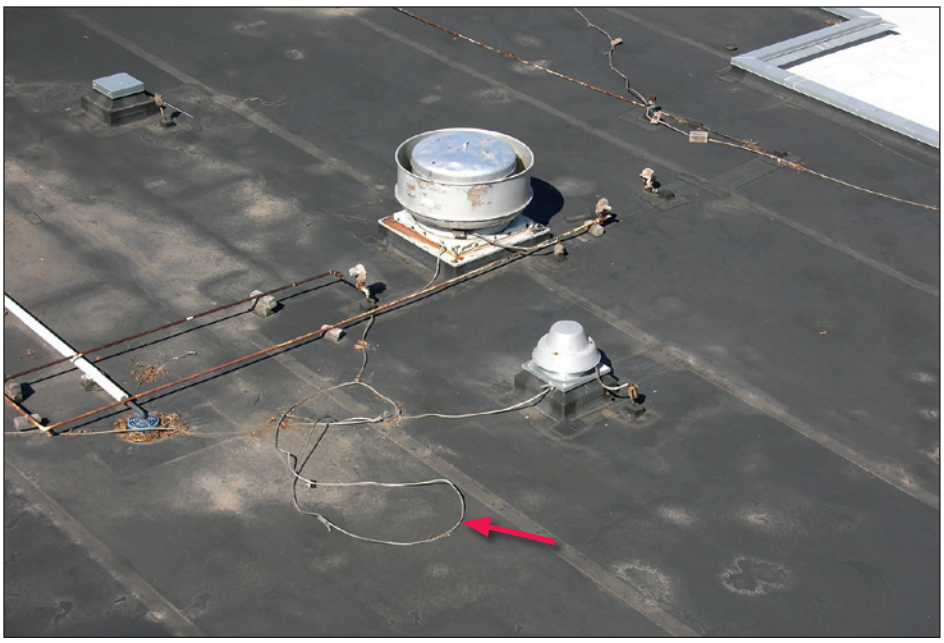
In a few areas, the lightning protection system (LPS) conductors became detached from the roof membrane (Figure 4-16). Loose conductors can puncture and tear roof membranes, and they no longer provide the intended protection. FEMA 543 and 577 provide guidance for attachment of LPSs to resist wind.

Figure 4-16.
Detached LPS conductor

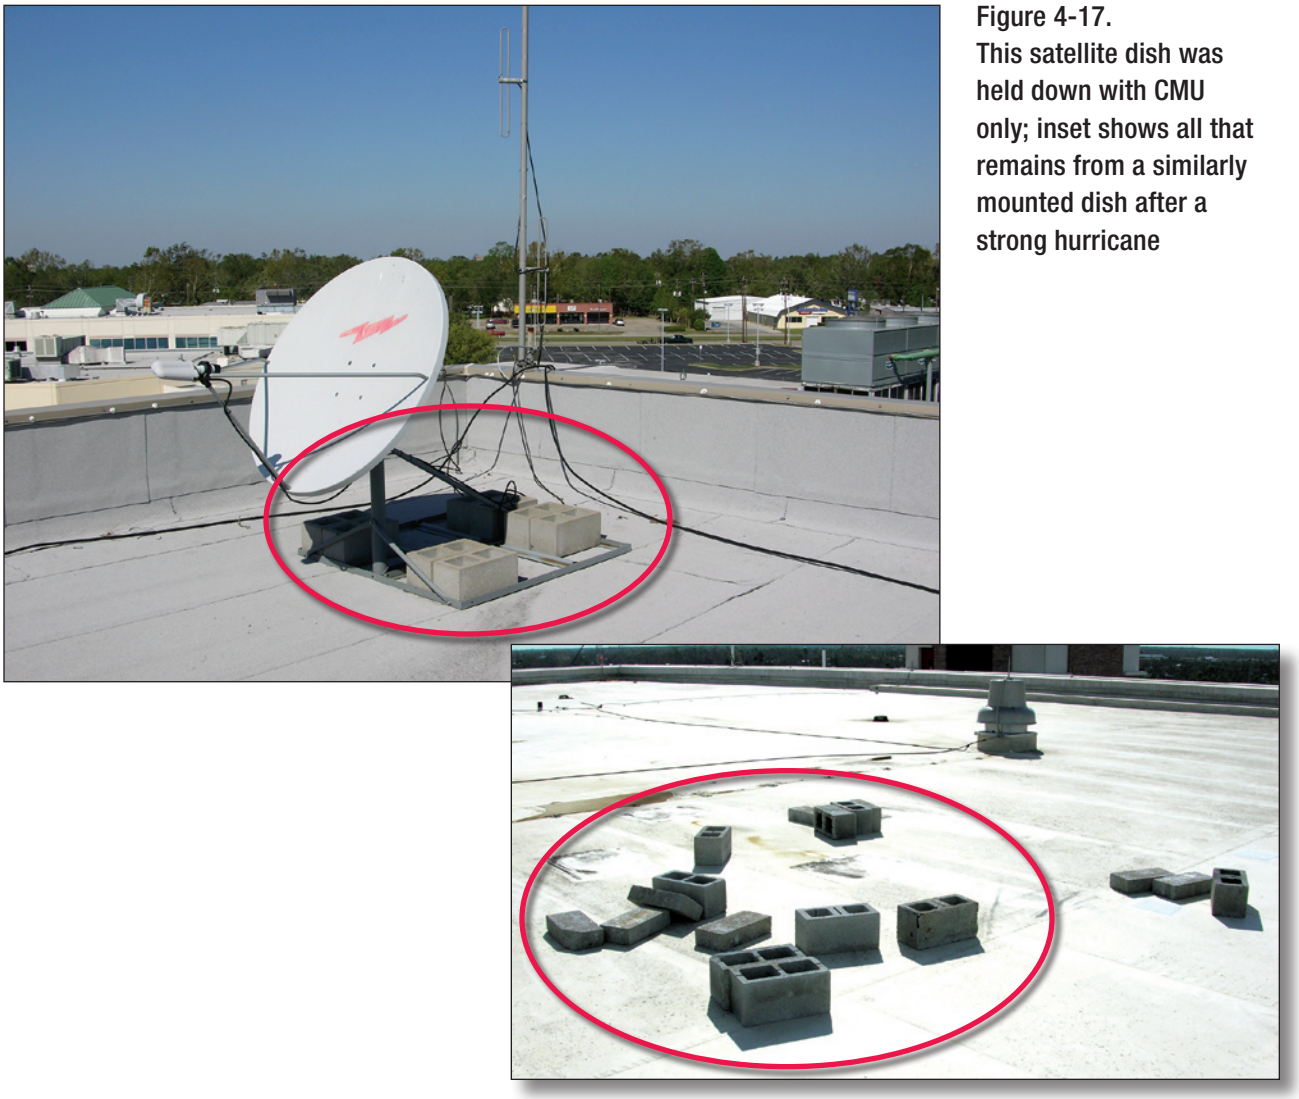
The satellite dish shown in Figure 4-17 was held down only with CMU. This attachment technique was adequate for the winds experienced at this site, but dishes attached by this method have failed in other hurricanes, as shown in the inset at Figure 4-17. The dish shown in the inset was blown completely off the roof; only the CMU remained (FEMA 488).

Figure 4-17.
This satellite dish was held down with CMU only; inset shows all that remains from a similarly mounted dish after a strong hurricane

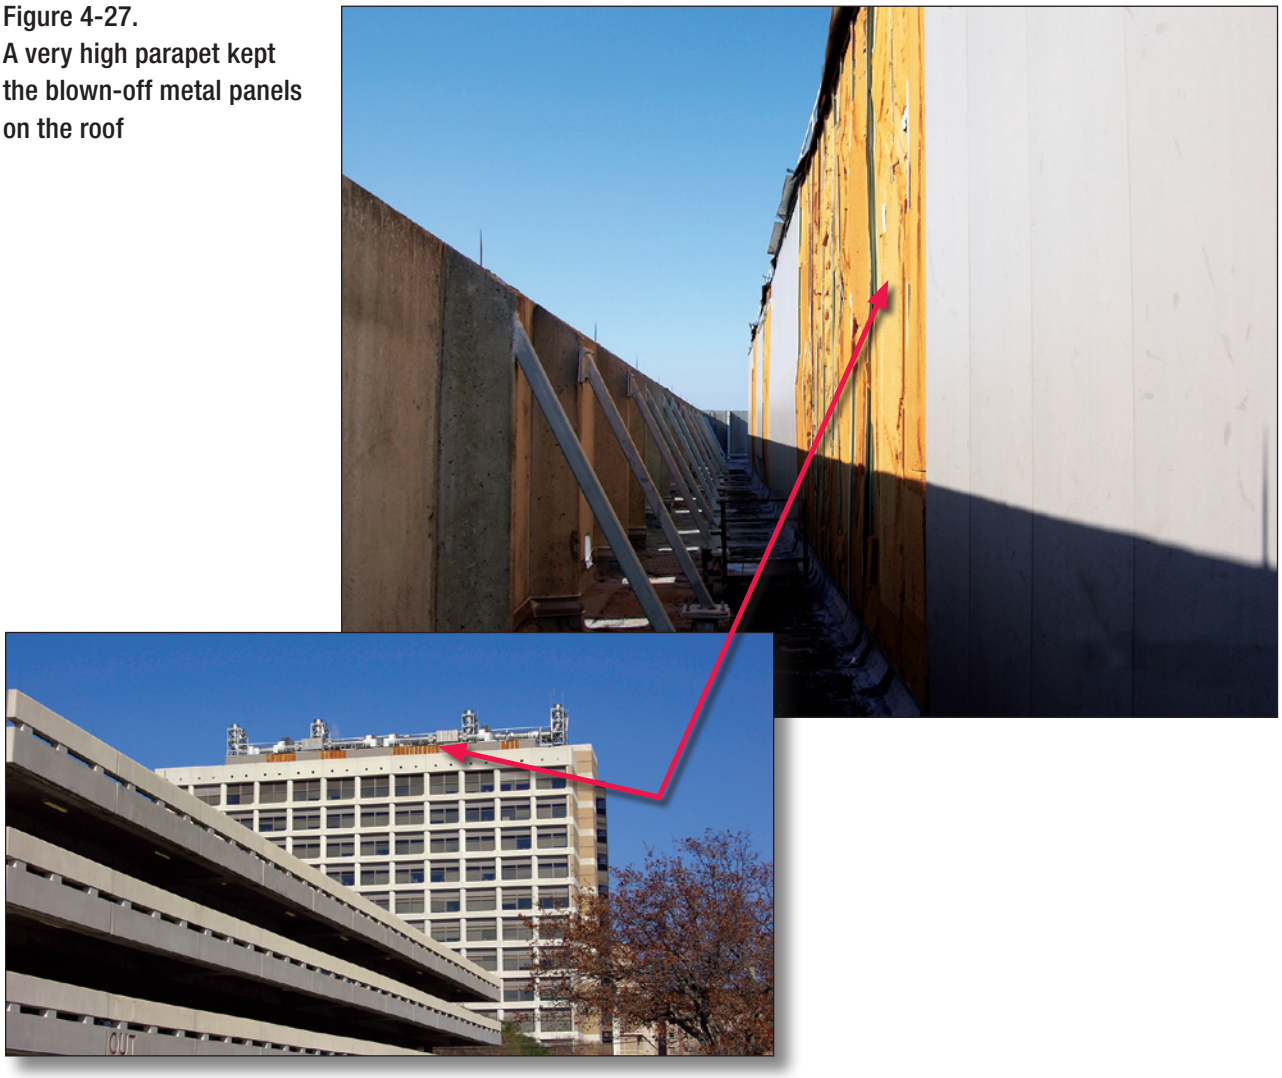
At the building shown in the inset of Figure 4-27, several penthouse wall panels were damaged. The panels consisted of inner and outer metal skins, with a foam insulation core. As shown in Figure 4-27, several of the outer skins blew away. The panels appeared to have been job-site fabricated, rather than having been produced as composite panels in a factory. The presence of the very high parapet prevented the metal skins from being blown from the roof and potentially damaging other parts of the facility as windborne debris. At another building, blown off EIFS was observed at a wall and at the soffits of an enclosed elevated walkway between two buildings.

Figure 4-27.
A very high parapet kept the blown-off metal panels on the roof

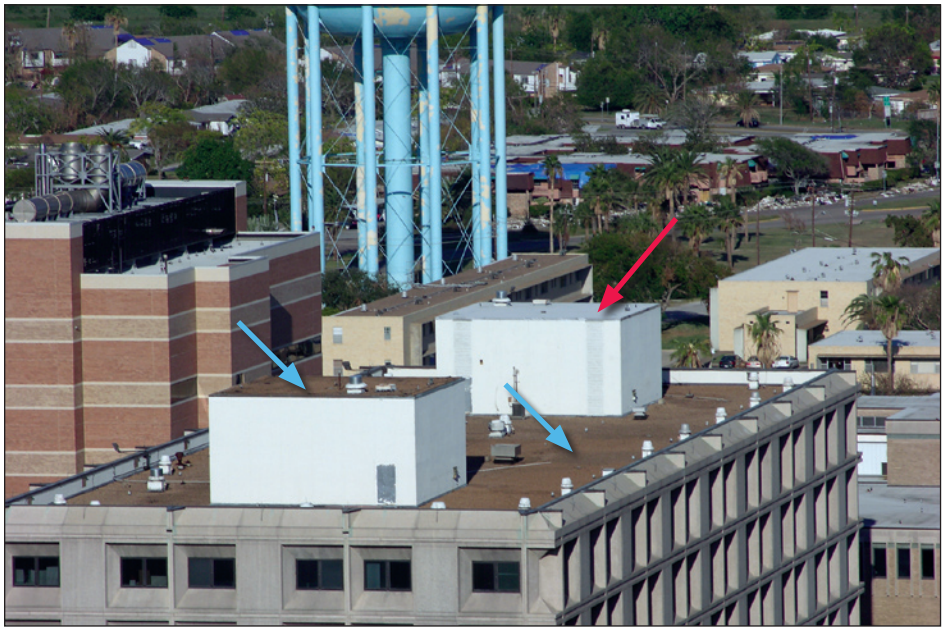
At the time Hurricane Alicia struck this campus in 1983, many of the buildings had aggregate-surfaced BURs and several windows on the campus were broken by wind-blown aggregate. Since Alicia, when buildings have been reroofed, they were not replaced with aggregate surfacing. However, at the time of Hurricane Ike, some aggregate-surfaced BURs still existed, such as that shown in Figure 4-28. One of the penthouse roofs was blown off during the storm. At the time of the MAT observation, that roof had been replaced by the white membrane shown by the red arrow.

Figure 4-28.
The roofs shown by the blue arrows were aggregate-surfaced BURs at the time Ike struck; the roof shown by the red arrow is a new roof replacing one that blew off

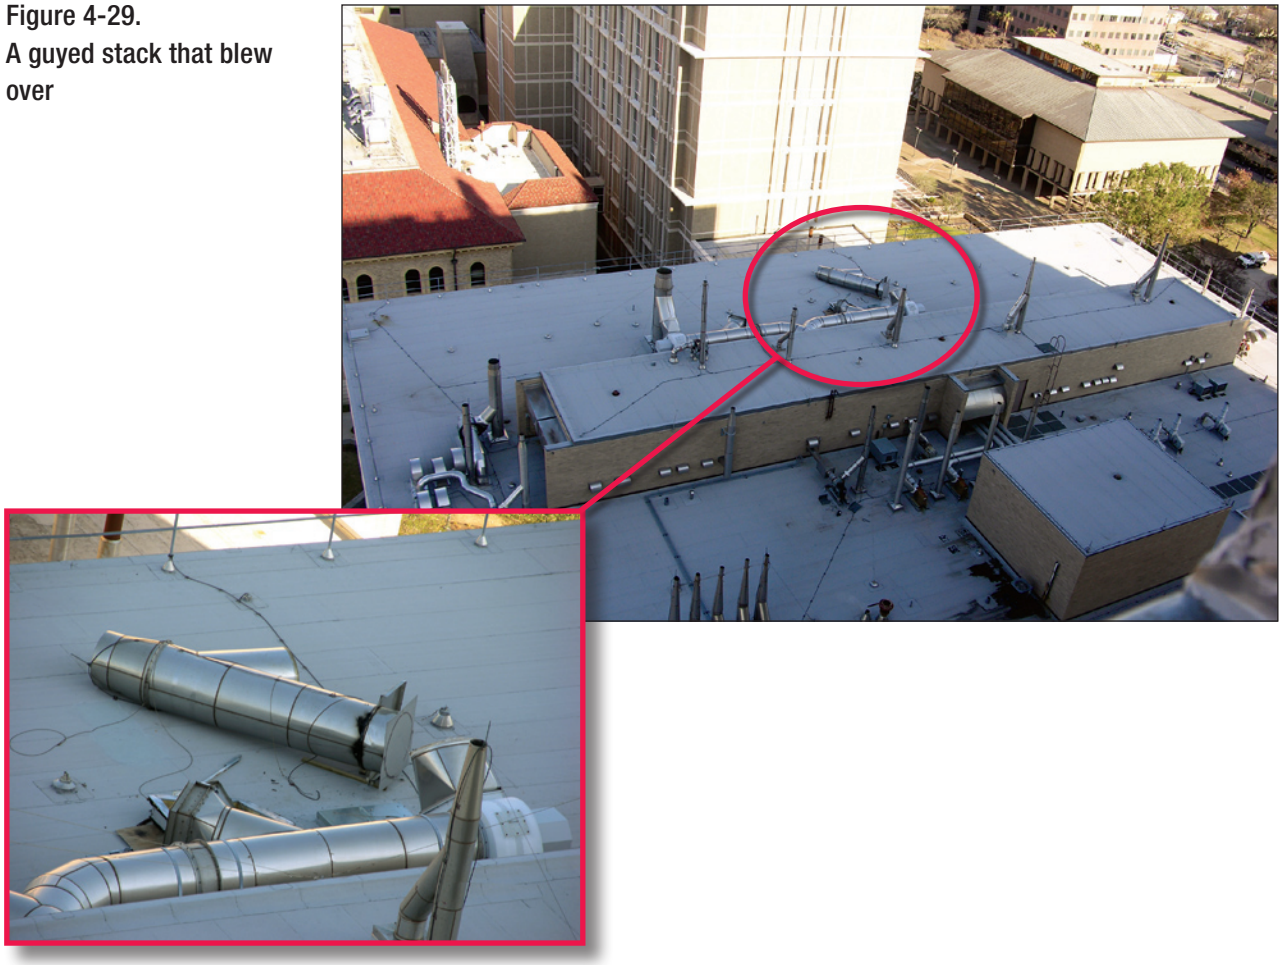
Figure 4-29.
A guyed stack that blew over

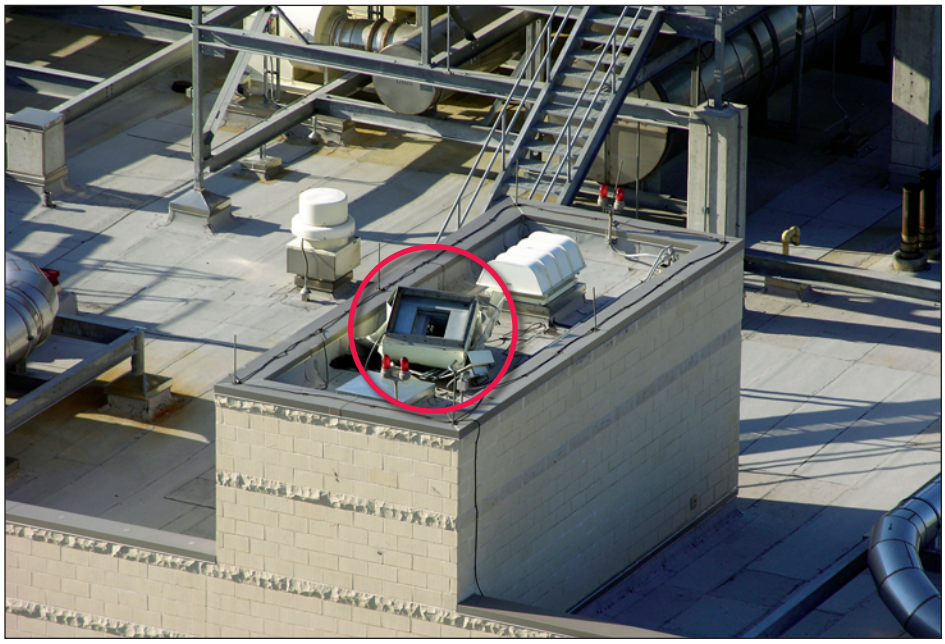
Figure 4-30.
A relief air hood blew off the curb allowing rainwater to enter the building

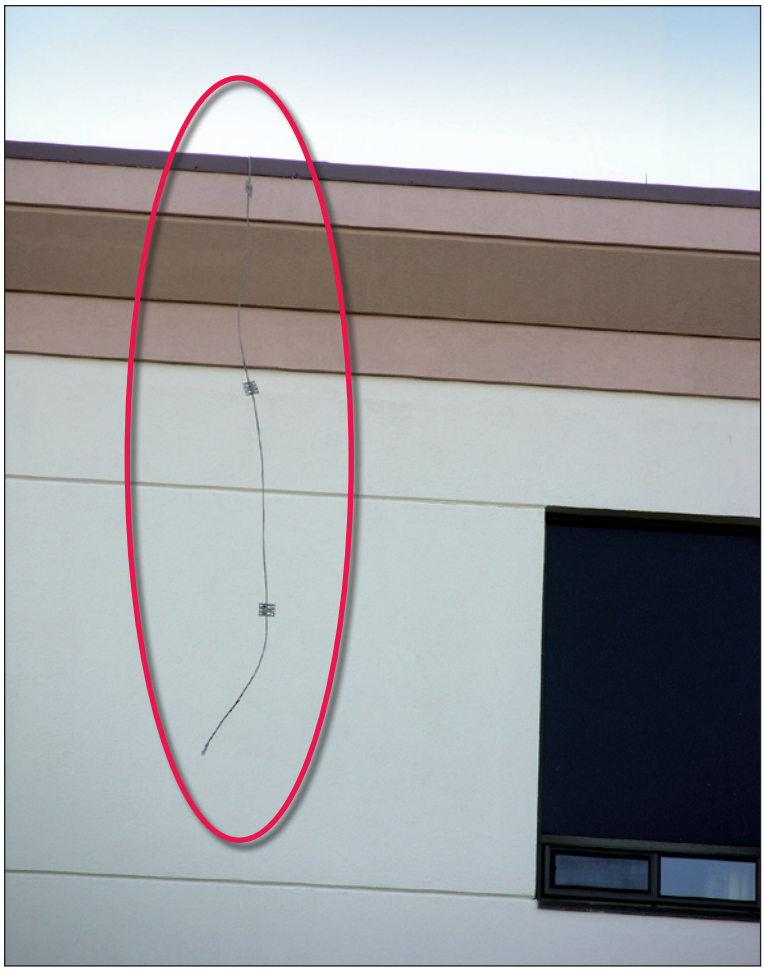
Figure 4-40.
Detached LPS conductor

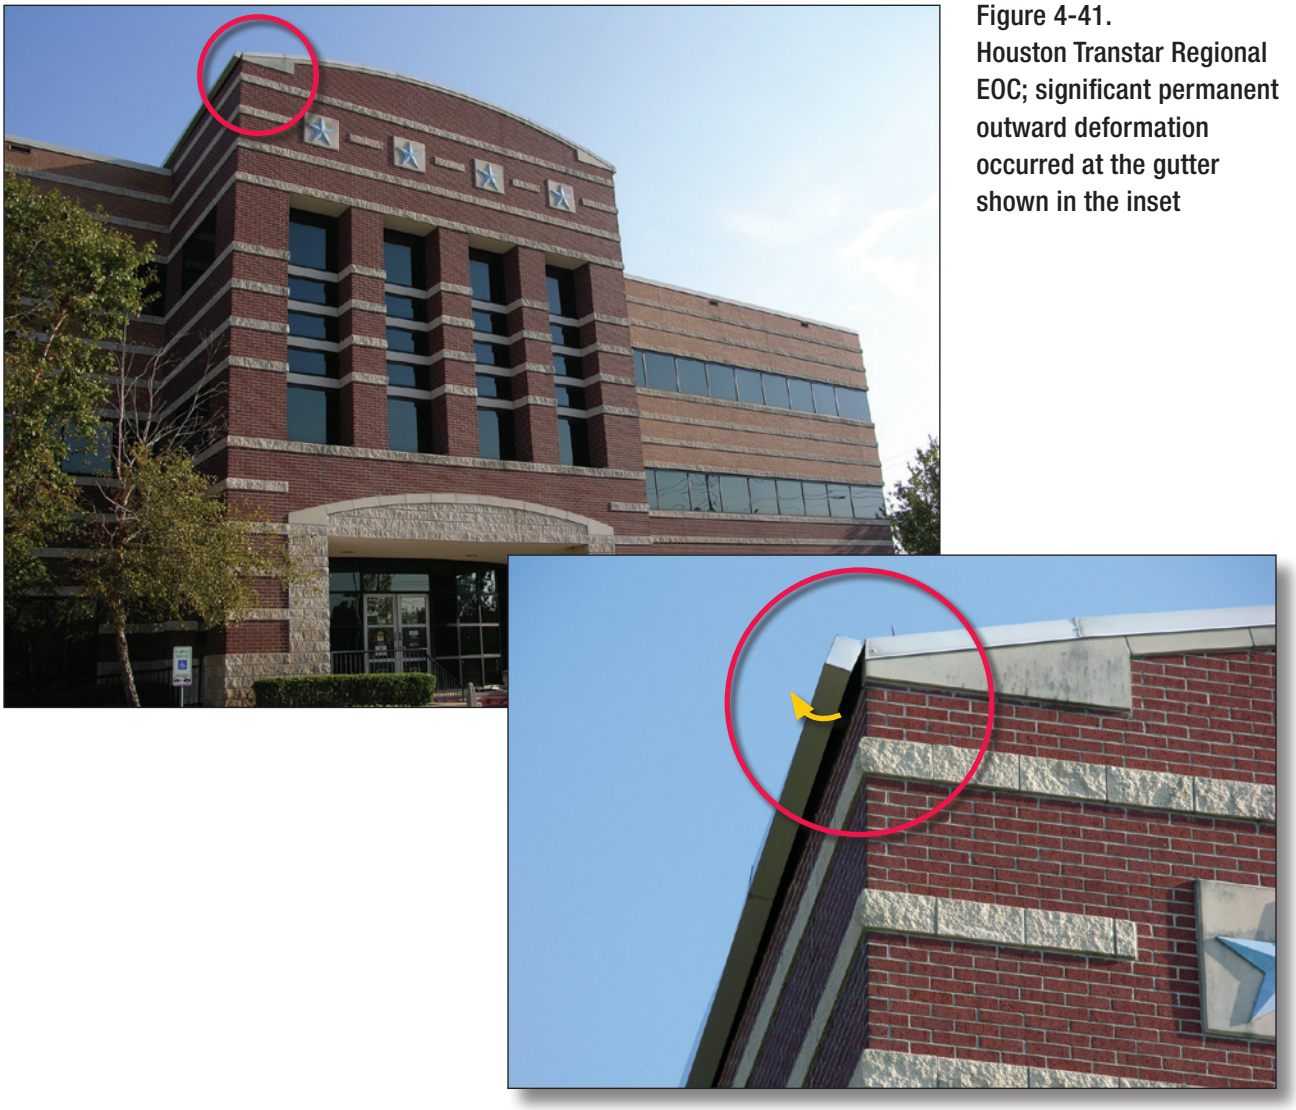
Figure 4-41.
Houston Transtar Regional EOC; significant permanent outward deformation occurred at the gutter shown in the inset

General Wind Damage. Hurricane Ike caused outward deformation of the gutter shown in the Figure 4-41 inset. Had the winds been stronger, the gutter would have likely blown off. Additionally, several pieces of coping blew off the building. The outer face of the coping is 8 inches and the inner face is 4 inches (Figure 4-42). Continuous cleats are located along both sides of the parapet. The cleats were attached with roofing nails driven through the horizontal flange (blue arrow at Figure 4-42). In addition, a few widely-spaced nails were driven through the vertical flange (red arrow in Figure 4-42). The nailing provided very little resistance to outward deflection of the cleat and coping. While most of the continuous inner and outer cleats remained on the building, several sections of coping and at least one cleat blew off once the amount of deflection was sufficient for the coping to disengage from the cleat. The blown-off cleat had a face nail that was 75 inches in from the end of the cleat, hence over 6 feet of this cleat was unrestrained from outward deformation.

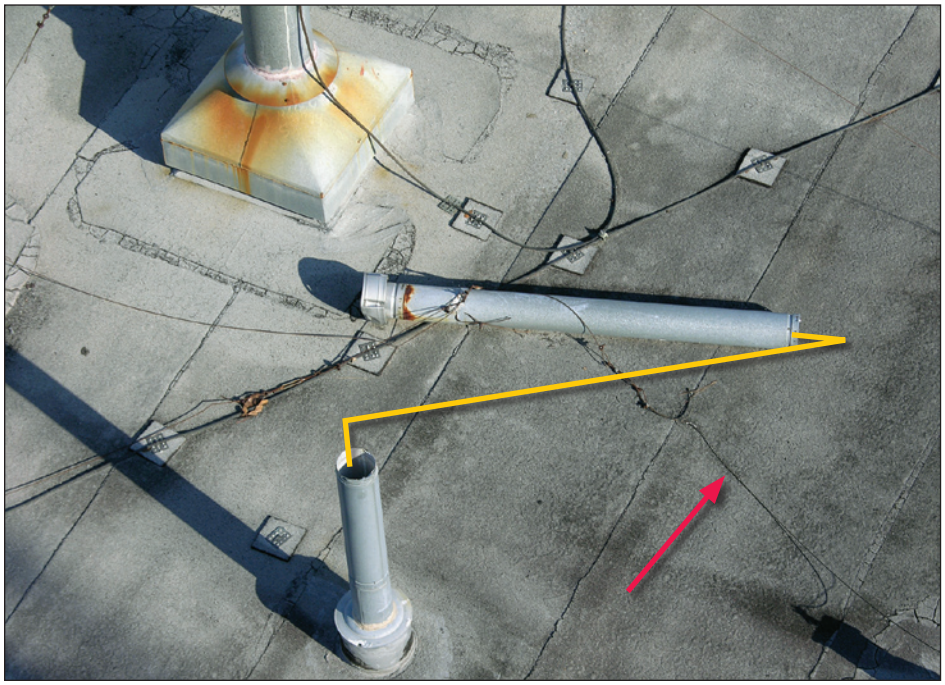
Additional damage included minor leakage at a building expansion joint and toppling of a tall flue on a lower level roof, even though it was guyed (Figure 4-45). The tautness of guys should be checked annually to avoid toppling of flues.

Figure 4-45.
Guyed flue blew over (red arrow indicates one of the guys)

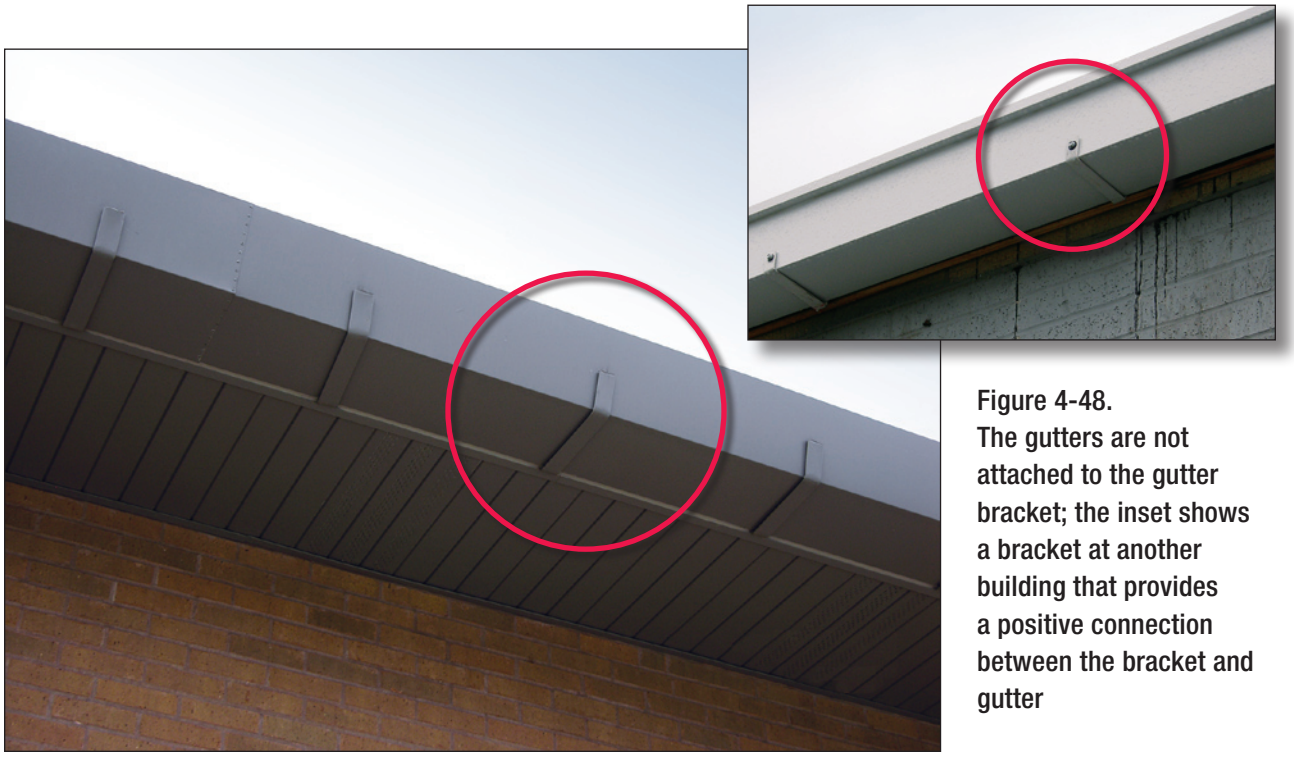
The gutter brackets shown in Figure 4-48 do not provide a positive attachment between the gutter and bracket. However, the winds during Hurricane Ike were not of sufficient strength to blow off the gutters. Screwing the gutter to the brackets, as shown in the inset at Figure 4-48 (the inset photo is from an HMPG project in Port Neches), would be prudent. However, to avoid leakage at the fasteners between the bracket and gutter, the bracket should extend near or to the top of the gutter so that the fastener would be above the waterline.

Figure 4-48.
The gutters are not attached to the gutter bracket; the inset shows a bracket at another building that provides a positive connection between the bracket and gutter

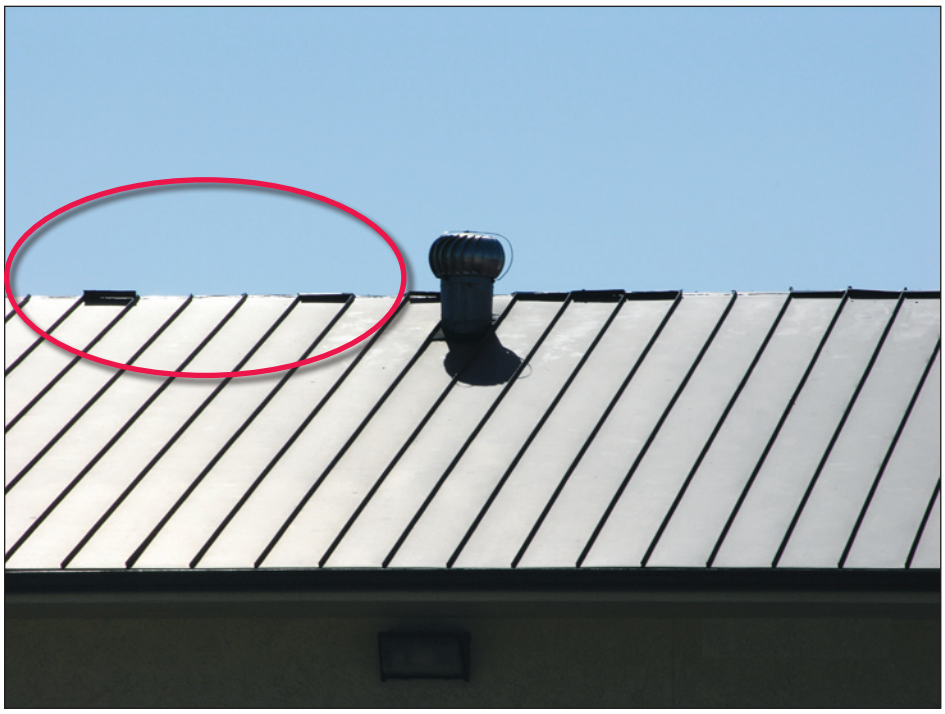
General Wind Damage. A portion of the ridge flashing was blown off the metal roof (Figure 4-67). Leakage did not occur, so the roof underlayment was apparently correctly lapped over the ridge. However, loss of flashing can make roof panels more susceptible to blow-off.

Figure 4-67. The oval shows where ridge flashing blew away
