HURRICANE IKE IN TEXAS & LOUISIANA

7 Recommendations

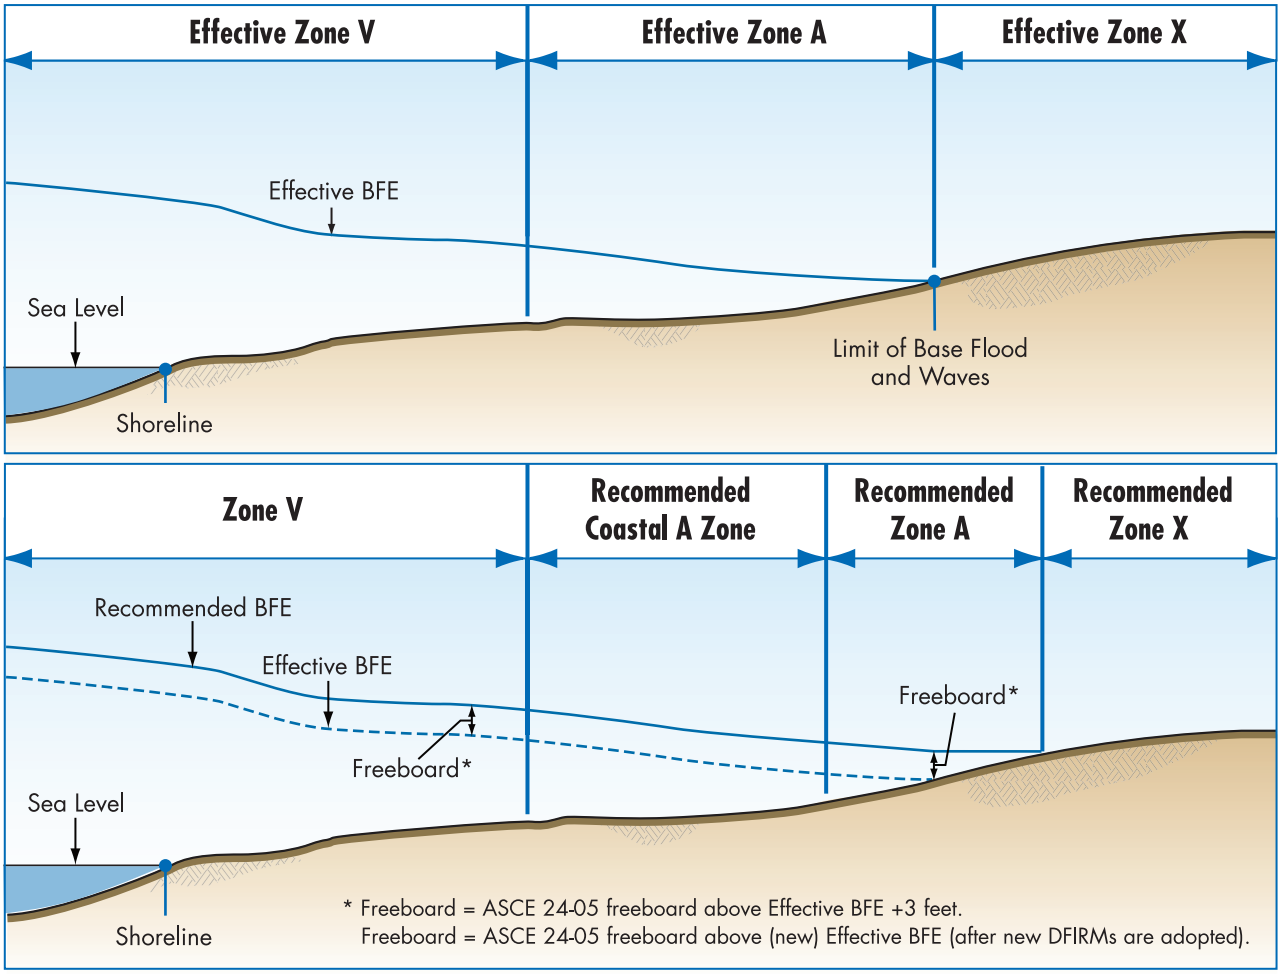
BFEs shown on Effective FIRMs should not be used for reconstruction purposes in Ike-affected communities unless communities can demonstrate that Effective BFEs are adequate. Thousands of residential buildings were damaged or destroyed by Ike's flooding, many of them constructed at or above the Effective BFEs. New flood studies are underway in Louisiana and Texas; preliminary flood maps have been produced in parts of Louisiana, but Texas preliminary maps are not expected before the end of 2009.

Widespread damage outside the SFHA was observed; the Ike MAT recommends taking flood mitigation measures in the areas beyond the landward limit of the Effective SFHA, where there are likely to be no flood-resistant design and construction requirements (i.e., beyond Zone A and within Zones B, C, shaded X, or X), and in Zone A, which could experience Coastal A Zone or even Zone V conditions during a base flood.

Figure 7-1. Comparison of Effective BFEs and flood hazard zones (upper figure), with MAT-recommended freeboard and flood hazard zones (lower figure)

> ***Recommendation #4:*** Until new DFIRMs are available and adopted, the MAT recommends requiring the following freeboard above the currently Effective BFEs for new construction, substantial improvements, and repair

of substantial damage: freeboard specified by ASCE 24-05, plus 3 feet. Once new DFIRMs are available and adopted, the MAT recommends requiring new construction, substantial improvements, and repair of substantial damage to be elevated to or above the freeboard elevation specified by ASCE 24-05.

Recommendation #5: Enforce Zone A design and construction standards in the area between the Effective SFHA landward limit and a ground elevation equal to the adjacent Zone A Effective BFE plus freeboard. This recommendation should be implemented before and following the adoption of new DFIRMs.

Recommendation #6: Enforce ASCE 24-05's Coastal A Zone design and construction requirements in areas presently mapped as Zone A on the Effective FIRM. This recommendation should be implemented before the adoption of new DFIRMs; following adoption, Coastal A Zone requirements should be adopted in the area between the LiMWA and Zone V.
