BUILDING PERFORMANCE: HURRICANE INIKI IN HAWAII

OBSERVATIONS, RECOMMENDATIONS, AND TECHNICAL GUIDANCE

FEDERAL EMERGENCY MANAGEMENT AGENCY
FEDERAL INSURANCE ADMINISTRATION

JANUARY 29, 1993

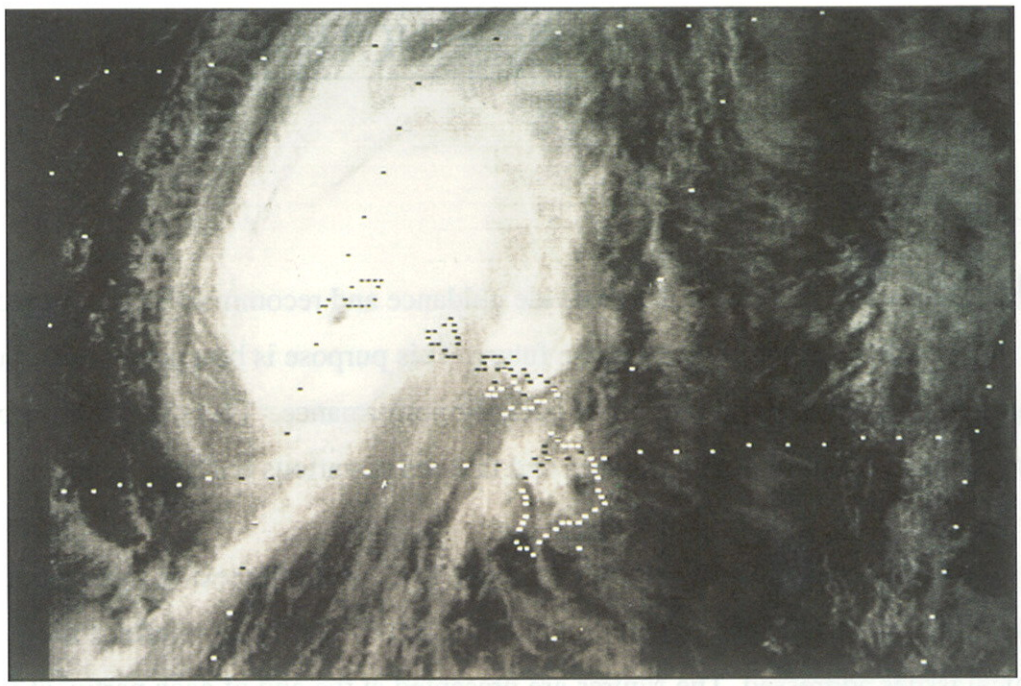
FIGURE 1. *The eye of Hurricane Iniki crossed the Kauai coast just west of Port Allen near Kaumakani just before 4:00p.m. Hawaiian Standard Time on September 11, 1992.*

Hurricane Iniki was a small but intense hurricane as it moved northward across the Island of Kauai during the late afternoon hours of September 11, 1992. The eye of Iniki crossed the Kauai coast just west of Port Allen near Kaumakani just before 4:00 p.m. Hawaiian Standard Time (HST). Iniki left behind a path of destruction, with property damage expected to approach 1.8 billion dollars. On Kauai alone, Iniki destroyed or damaged 14,350 homes. Of that total, 1,421 were destroyed and another 5,152 suffered major damage. Damage on Kauai was widespread, with the most severe damage occurring on the south, east, and north ends of the island. Even with such widespread and severe damage, only three deaths were attributed directly to the storm. The low loss of life can be attributed to ample warning time, an excellent response by the State of Hawaii Office Civil Defense System, the evacuation of all coastal areas, and the high level of awareness created by previous press coverage of Hurricane Andrew in Florida and Typhoon Omar in Guam.

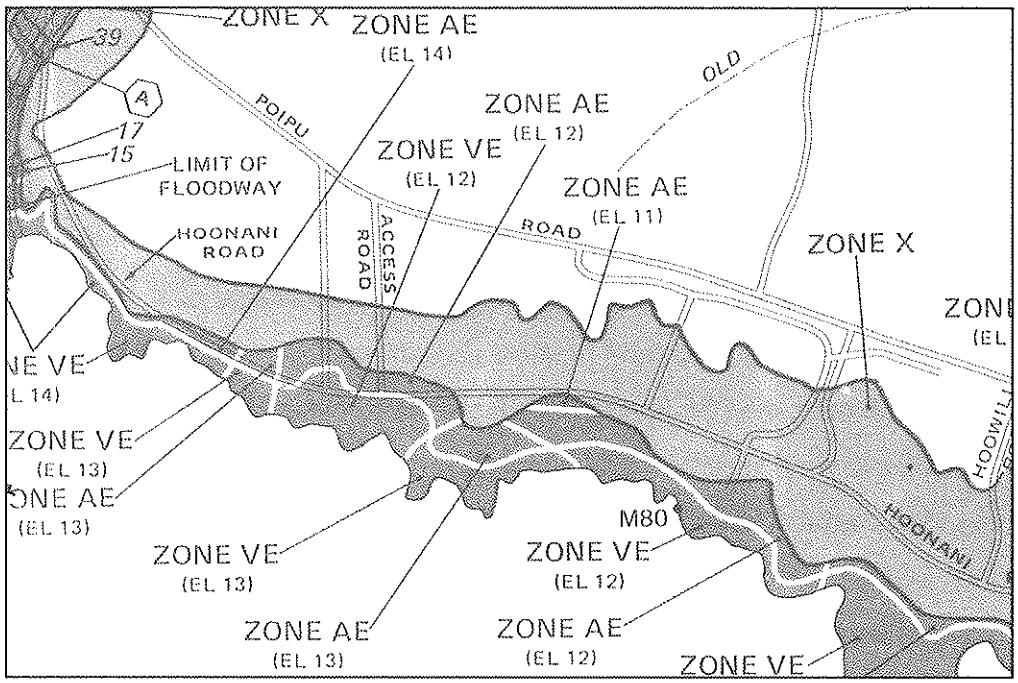
Along some oceanfront property such as Poipu Beach (FIGURE 3) and Hanalei (FIGURE 4), Coastal High Hazard Areas have been mapped. These areas are designated as V zones (velocity zones) on the FIRM. A V zone is an area subject to 100-year coastal flooding with waves 3 feet or greater in height. Consequently, additional design considerations are necessary for construction in V zones. Such considerations include use of pile and column foundations, leaving the area under the elevated building open to allow for free passage of velocity flood waters, and ensuring that foundation embedment is sufficient to withstand erosion and localized scour.

FIGURE 3. *Portion of Flood Insurance Rate Map (FIRM) for Kauai County covering the Poipu Beach area. Note predicted 100-year flood heights of 12 to 14 feet above mean sea level.*

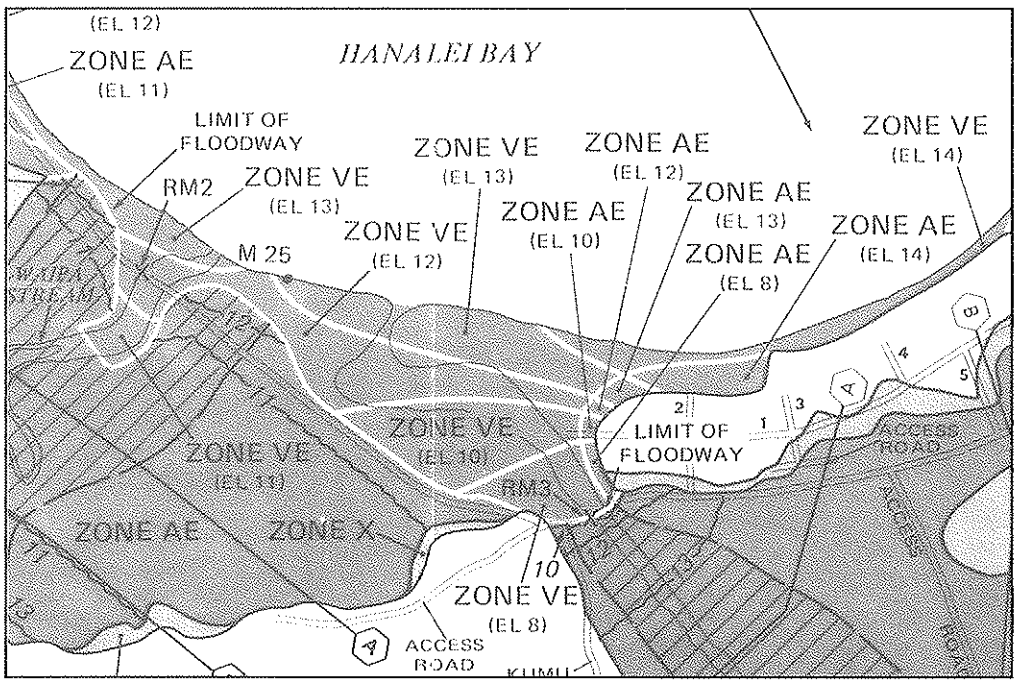
FIGURE 4. *Various flood hazard zones, including velocity (V) Coastal High Hazard zones, on the Kauai County FIRM (Hanalei example).*

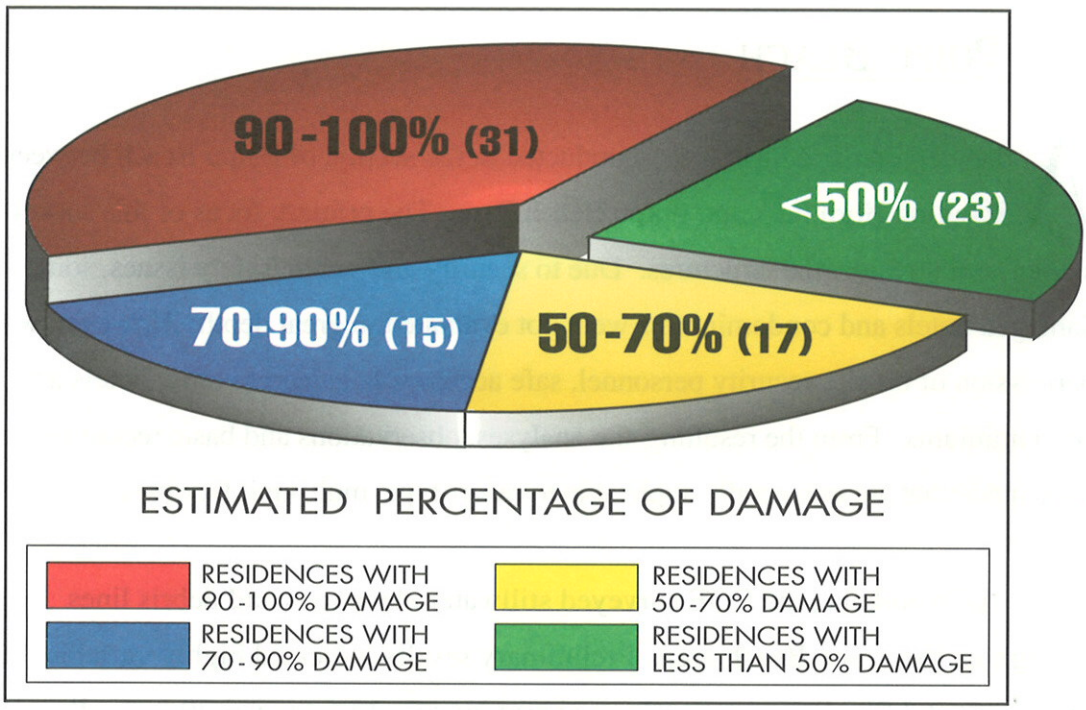
Coastal flooding in the section from Spouting Horn Park to Poipu Beach Park was severe and widespread, resulting in substantial damage to an estimated 60 or more single-family, detached residences (FIGURE 6). Several condominiums and hotels fronting the ocean also sustained significant flood damage to their lowest (ground level) units. Table 1 provides a preliminary inventory of damaged buildings for particular segments. The damage was caused by direct wave impact on buildings that were constructed without adequate consideration of the potential flood hazard. Additional damage was caused by debris impact. This debris included lava rocks, trees, detached pieces of buildings, and in some cases entire buildings that rammed adjacent structures (FIGURE 7).

FIGURE 6. *Results of preliminary field inventory of damaged residential buildings — Poipu Beach Park to Spouting Horn Park. Numbers in parentheses are building counts.*

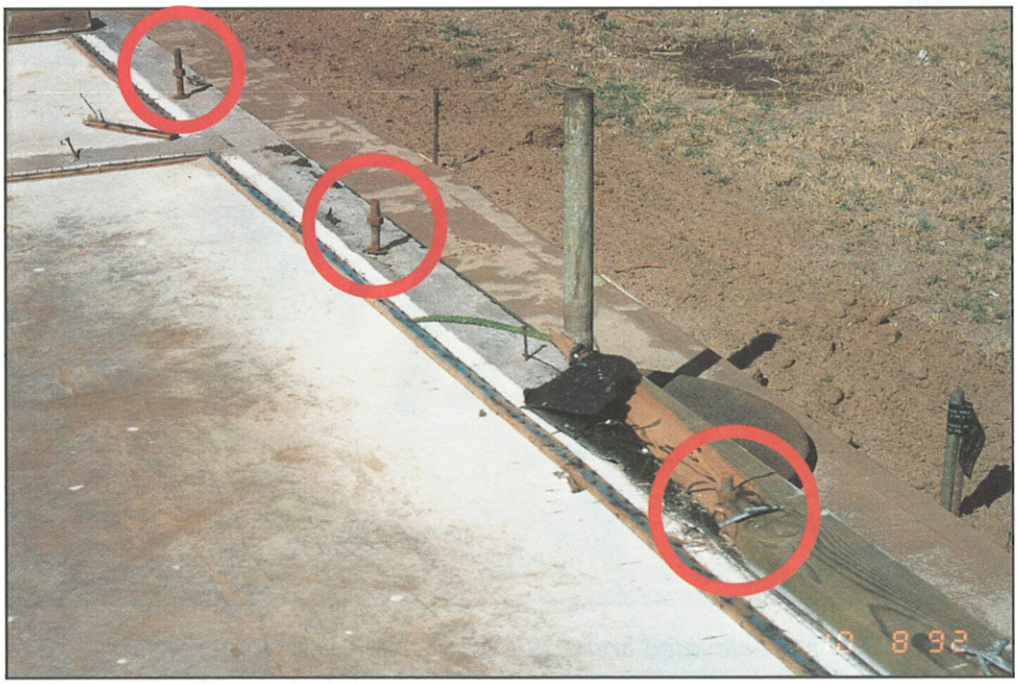
FIGURE 12. *Non-elevated building at Poipu Beach destroyed by coastal flooding. Sill plate ripped from anchor bolts.*

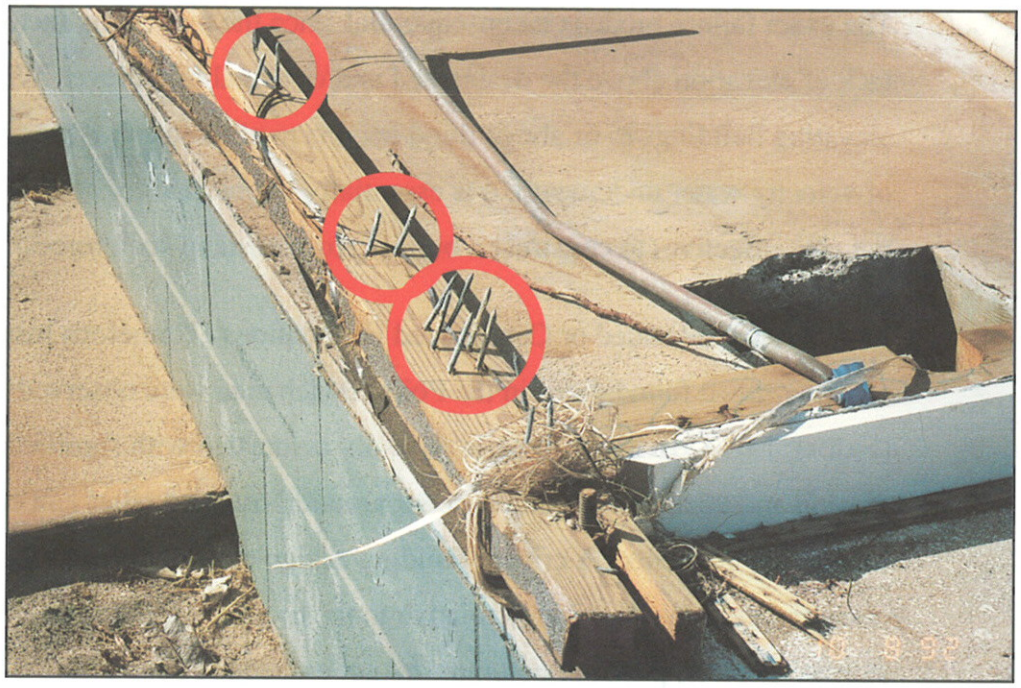
FIGURE 13. *Non-elevated building at Poipu Beach destroyed by coastal flooding. Vertical members ripped from sill plate.*

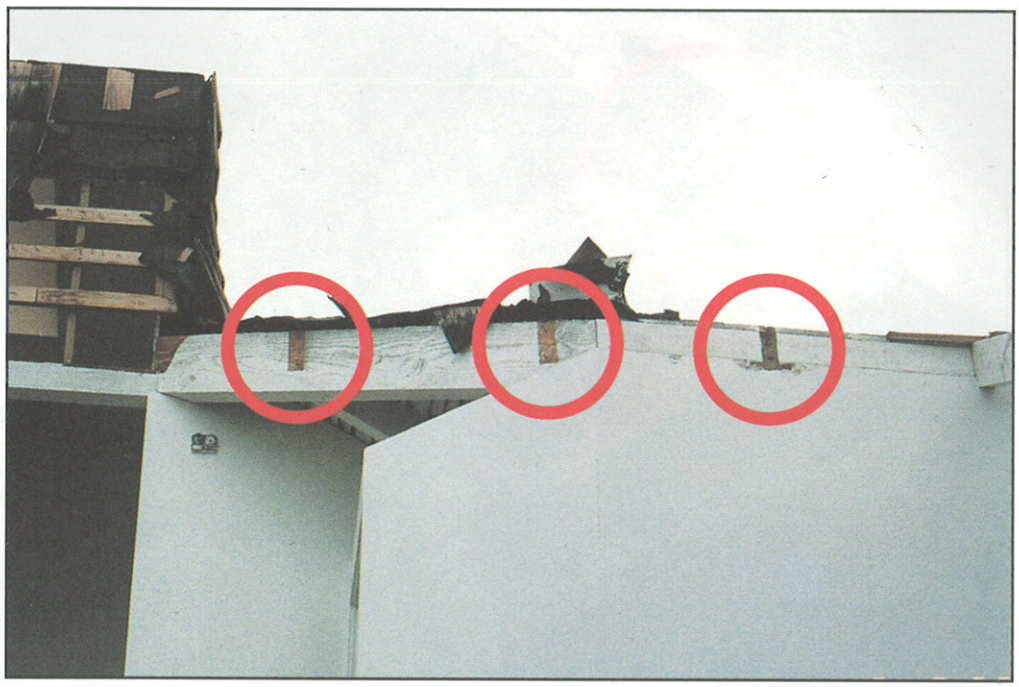
- Inadequate design.
- Reliance on simplistic and inadequate nailing procedures to construct the roof structures (FIGURES 22, 23, and 24).
- Reliance on simplistic nailing procedures to connect the roof structure to the wall system (FIGURE 25).

FIGURE 22. *Roof rafter construction with simple nailing or toenailing failed under uplift forces. Note two nails used to connect each rafter to hip beam.*

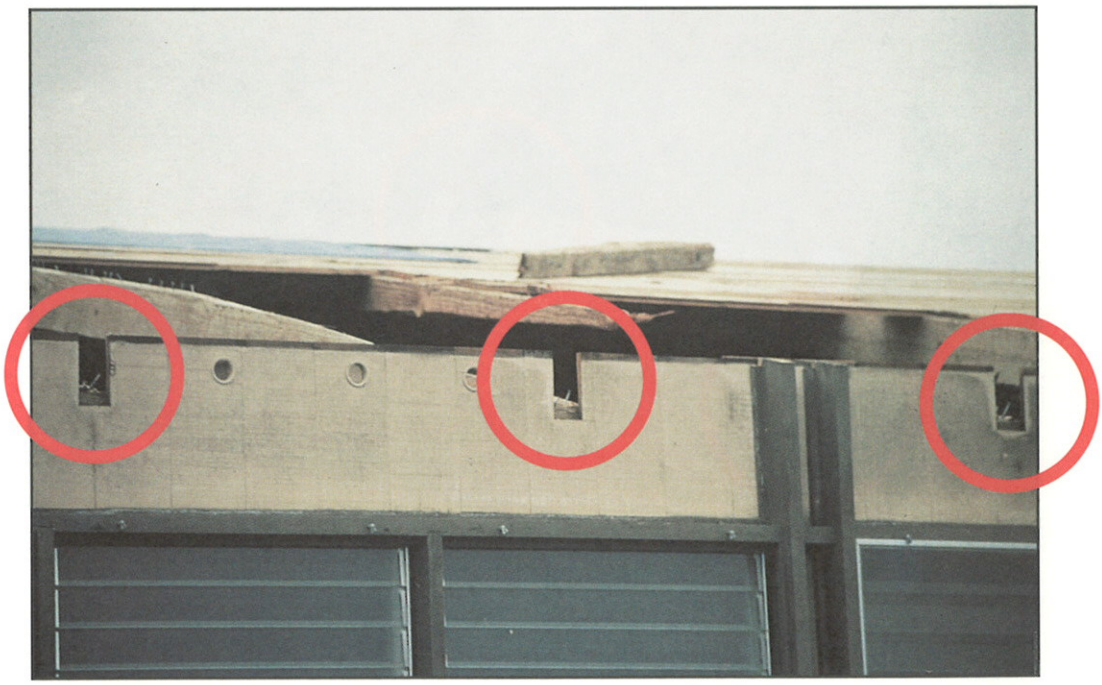
FIGURE 25. *Toenailing of roof rafters to wall system. At this critical connection, toenailing does not provide the load transfer path necessary to withstand uplift forces.*

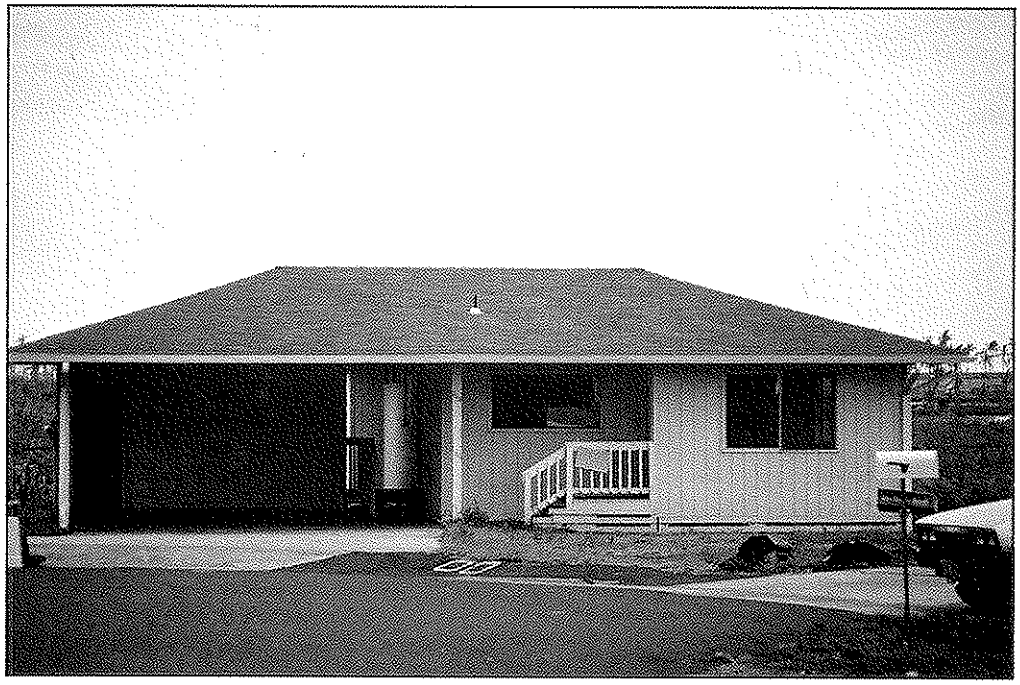
Gabled roof structures were invariably more failure-prone (FIGURE 31). Hip roofs (FIGURE 32) generally performed better than gabled-end roofs, clearstory roofs (offset roof peak), and other steeply pitched roof systems . The geometric discontinuity in these roof lines made the roofs susceptible to high localized wind-induced external pressure on eaves and soffits (FIGURE 33).

FIGURE 32. *Low-pitched hip roofs are aerodynamically superior and generally performed better than steeply pitched gable-end roofs.*

- The design of more aerodynamic building shapes should be encouraged, where feasible. Substituting low-angled hip roofs for steep angled, gabled-end, and clearstory roofs, and other such designs would be particularly advantageous (FIGURES 82 and 83).

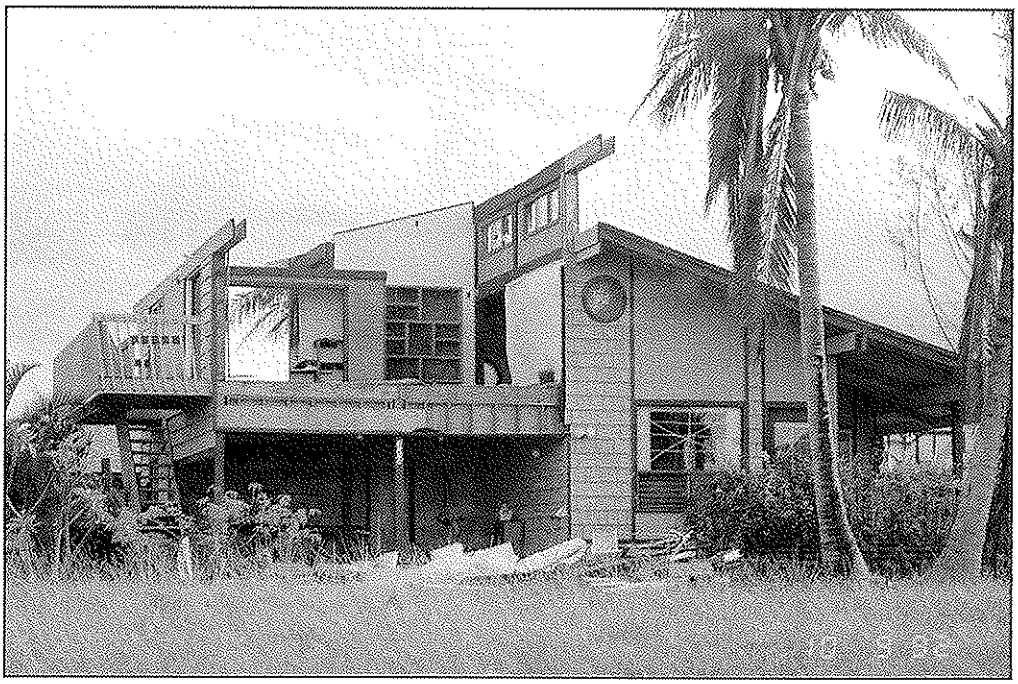
FIGURE 33. *Offset roof peak provides geometric discontinuity and results in greater localized wind-induced pressure, which can lead to roof and then wall failure.*

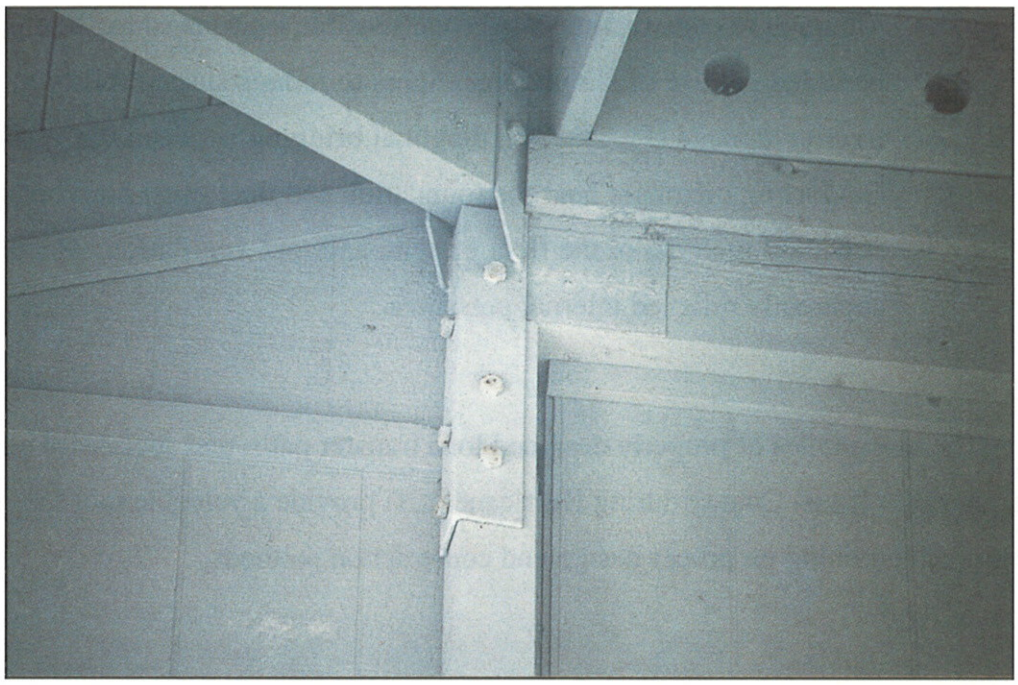
FIGURE 35. *Example of very successful heavy-gauge metal fastener connecting roof and wall systems. Note the over the top application and the number and size of lag bolts used for attachment.*

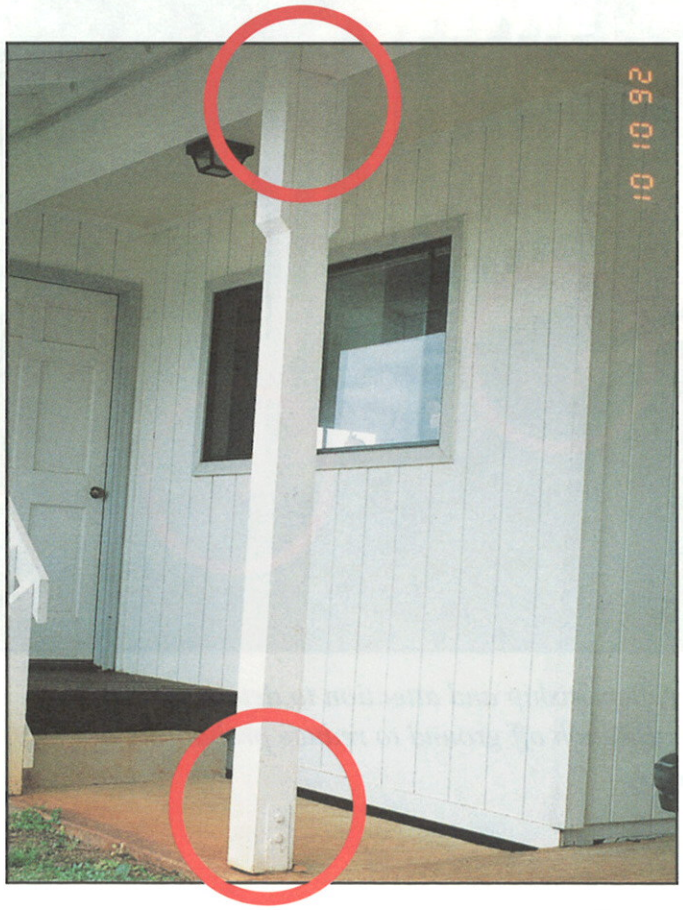
FIGURE 36.
Wood splice or strap provides a secure connection between wall and roof systems. Bolted metal anchor provides secure connection between vertical member and foundation. This is a fine example of a continuous load path.

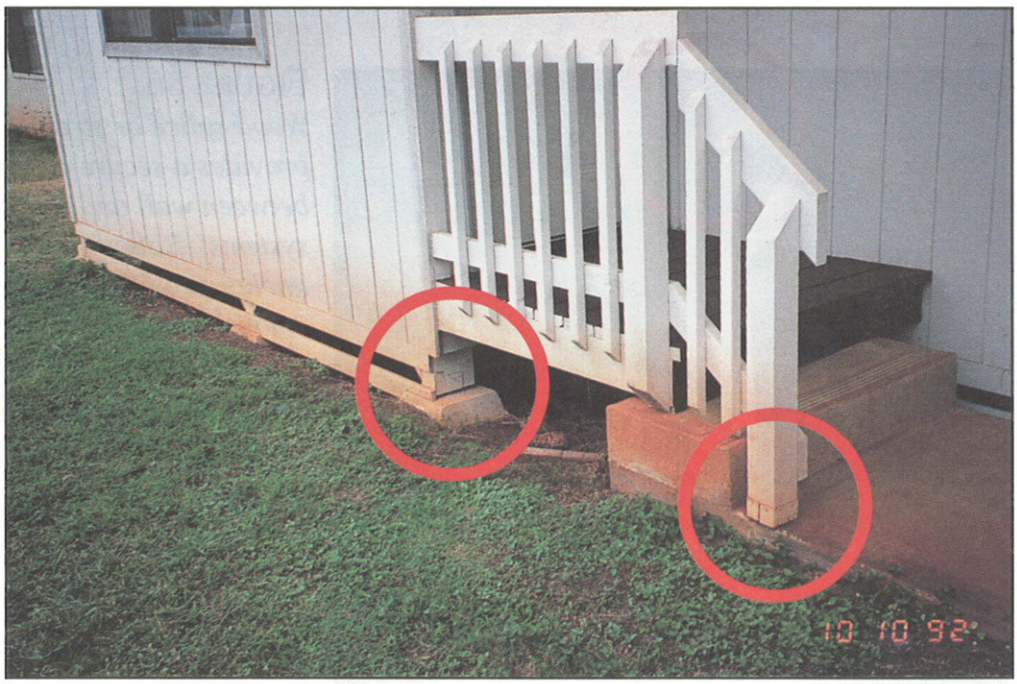
- Attention to construction details and sensible workmanship. Examples included the use of simple procedures to reduce susceptibility to termite damage (FIGURE 37), diagonal bridging between the vertical supporting members near the foundation and the lowest horizontal structural member of the floor system, and roof ventilation, which apparently relieved internal pressures.

FIGURE 37. *Sensitive craftsmanship and attention to detail: Vertical preservative-treated posts 1/4 inch off ground to reduce probability of termite infestation and decay.*

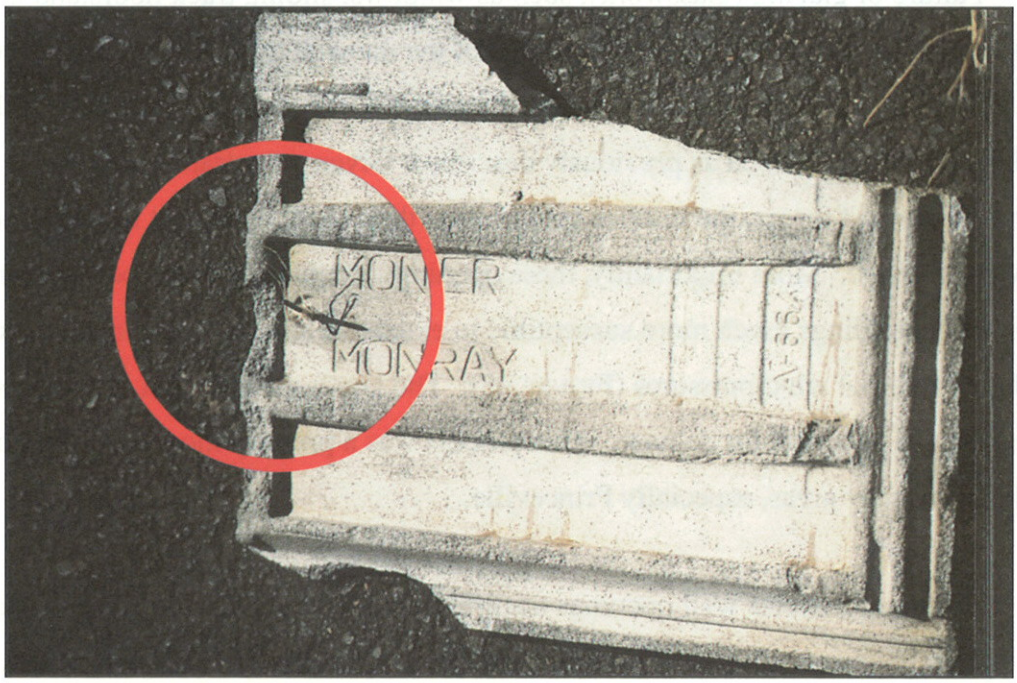
FIGURE 45. *Heavy concrete tile attached at one point with undersized nail. It was also observed that neighboring tiles had not been nailed.*

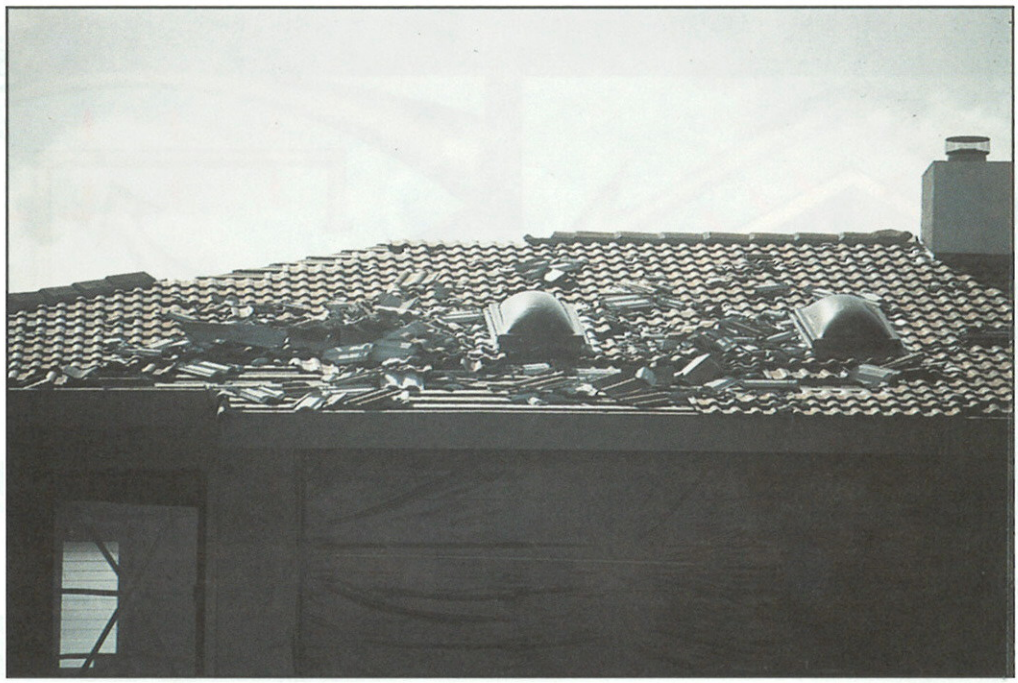
one piece allows wind to effectively penetrate under and lift the next piece. This explains the chain-reaction failure mode of shakes and tiles once debris impact or improper attachment allowed wind to remove the first few pieces of cladding (FIGURE 46).

FIGURE 46. *Roof cladding system composed of interdependent elements. Failure of one tile led to failure of adjacent tiles in a "chain reaction" effect.*

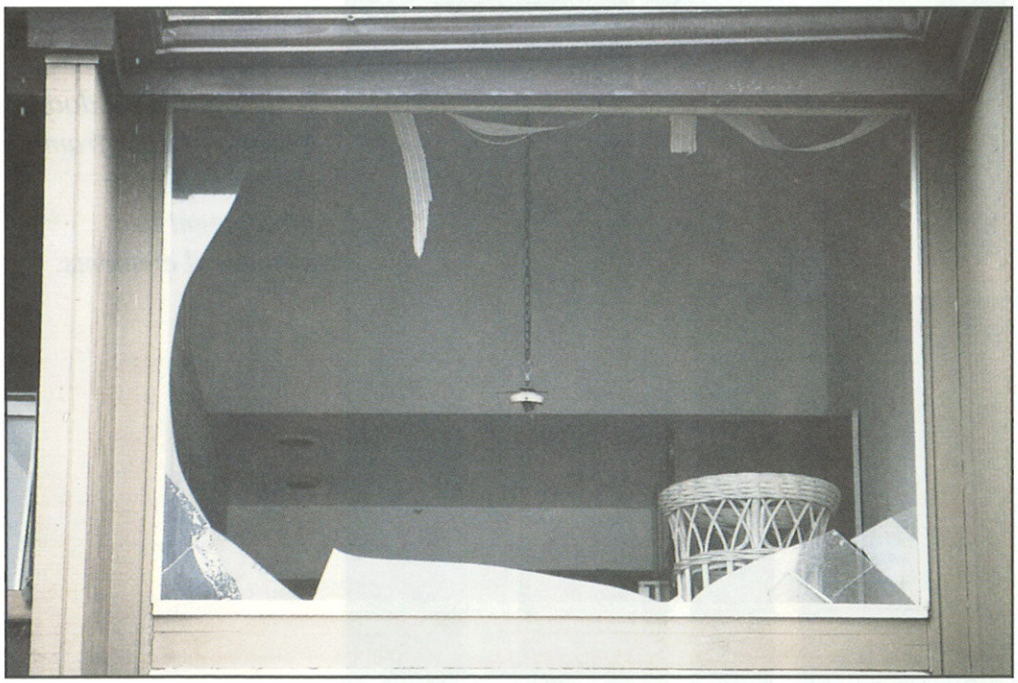
Failure of exterior wall openings occurred in two ways: 1) shattering of glazing from projectile impact (FIGURE 47) and 2) implosion or explosion of glazing due to the combination of wind pressure and improper installation (FIGURE 49).

FIGURE 47. *Glazing broken by windborne debris or direct wind pressure.*

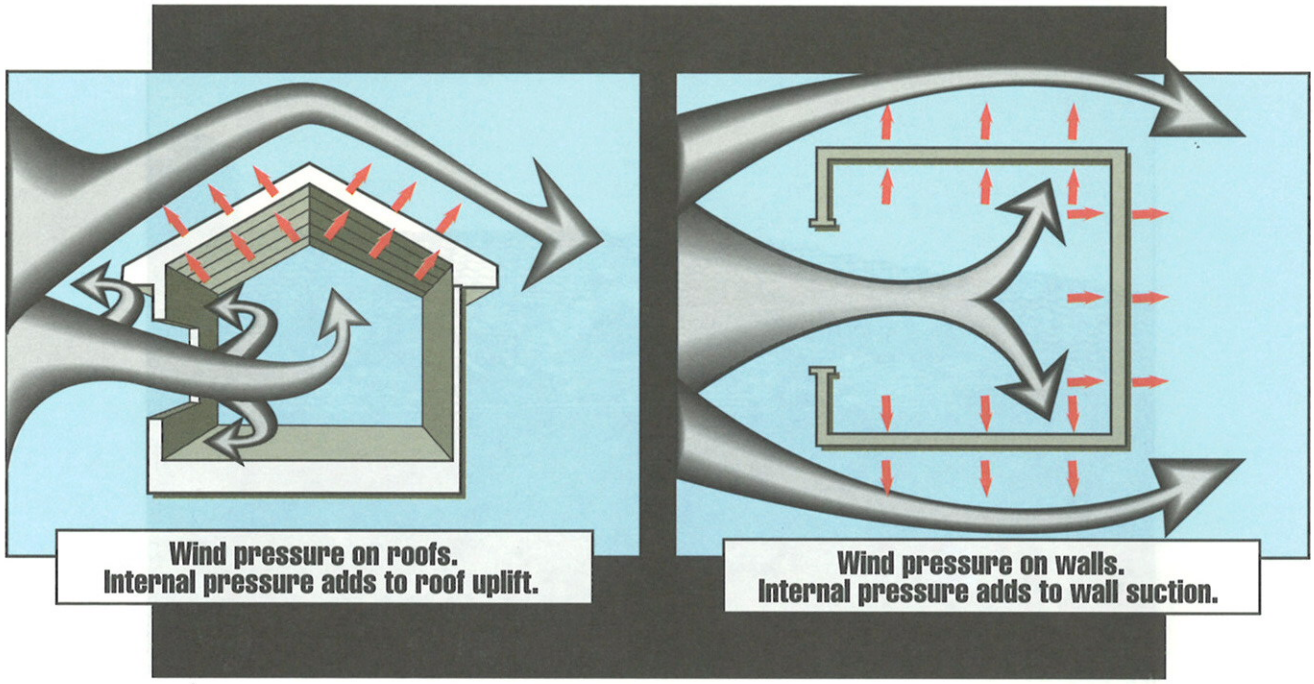
FIGURE 48. *Loss of opening protection allows wind entry and increases internal exposure.*

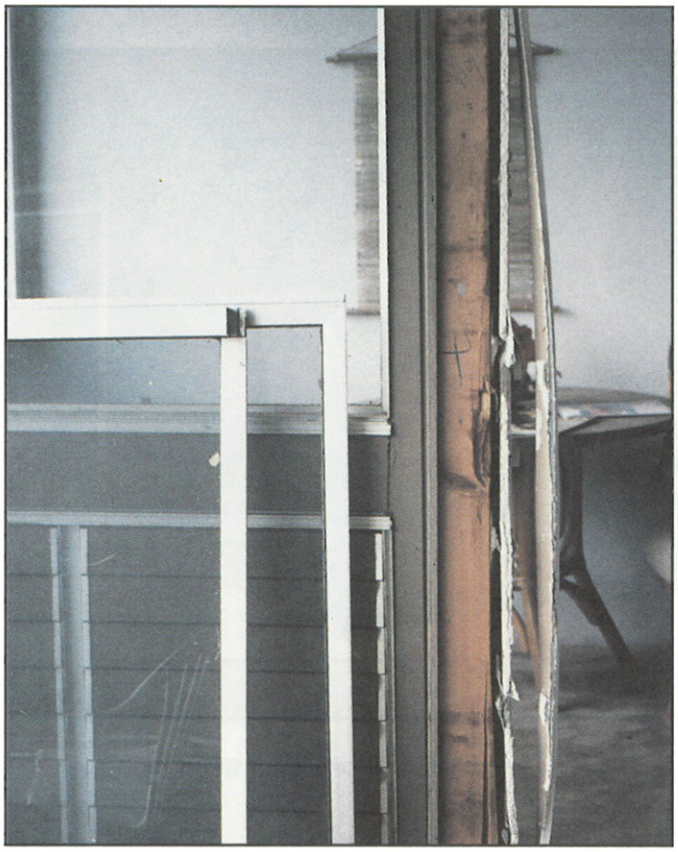
FIGURE 49. *Implosion of transparent shatter-resistant sliding door. Failure of door frame due to improper attachment to structural elements.*

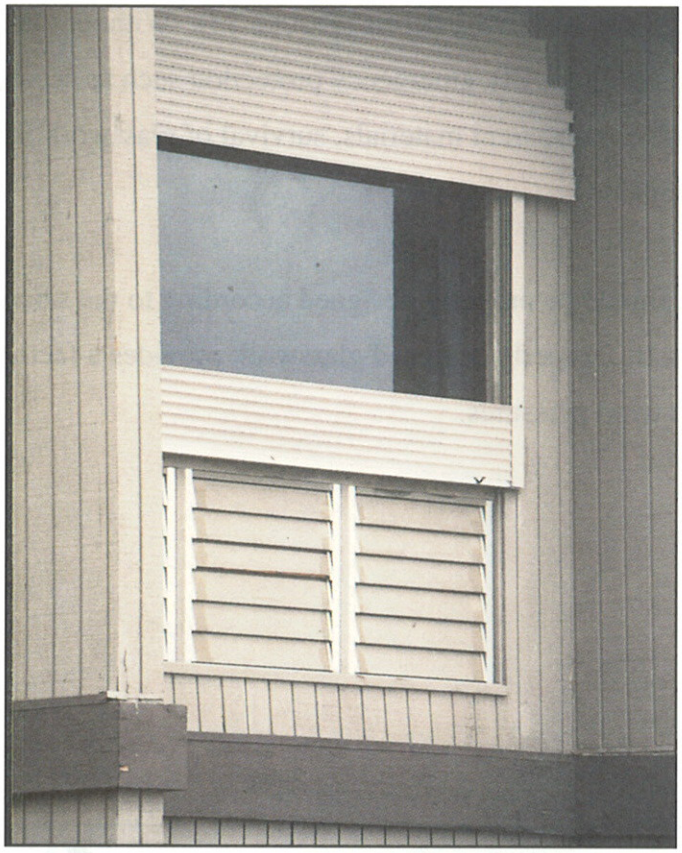
FIGURE 54.
In-place protective devices for glazing reduced the occurrence of building envelope failures.
