ATTACHMENT 6

Page 13 of the Appeal Resolution Document accompanying the September 26, 2000 Preliminary Map

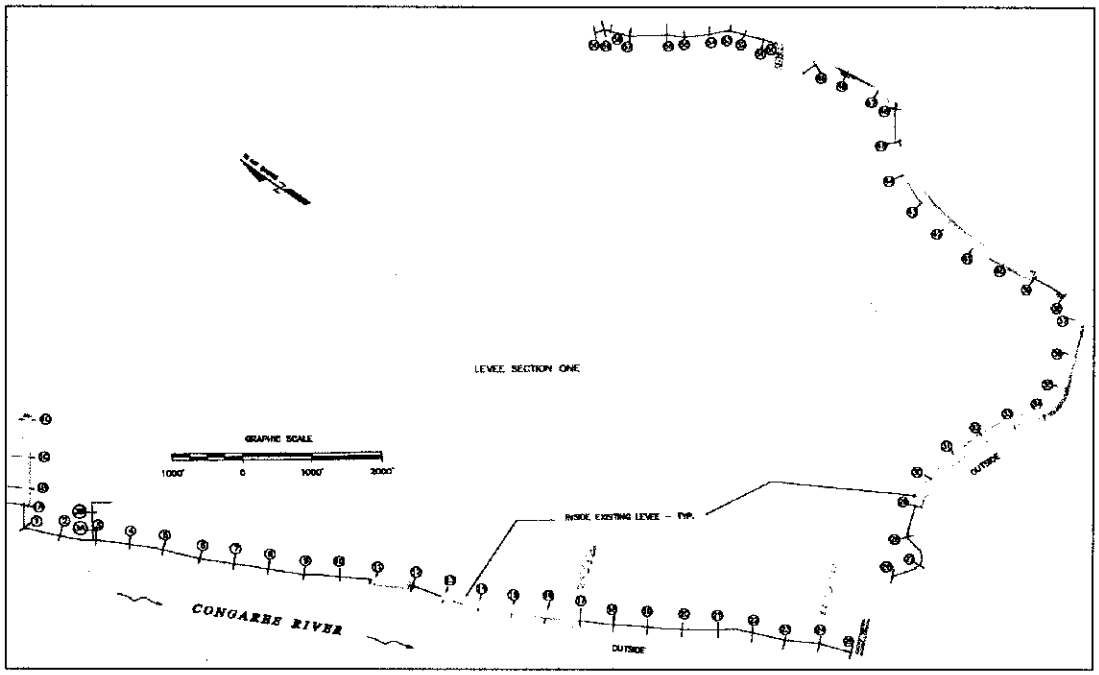
Figure 2. Dike Sections Conducive to Piping Failure
