# E. FEMA Hurricane Katrina Recovery Advisories

# Reconstruction Guidance Using Hurricane Katrina Surge Inundation and Advisory Base Flood Elevations

## HURRICANE KATRINA RECOVERY ADVISORY

**Purpose:** To discuss available flood hazard information and to recommend reconstruction practices using Advisory Base Flood Elevations (ABFEs).

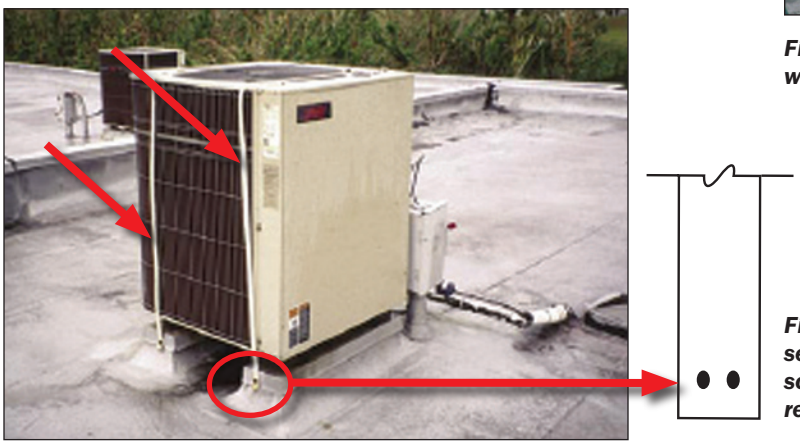
***Figure 7. This condenser had supplemental securement straps (see arrows). Two side-by-side screws with the proper edge and end distances are recommended at the end of the strap.***

**Condensers:** In lieu of placing rooftop-mounted condensers on wood sleepers resting on the roof (see Figure 6), it is recommended that condensers be anchored to equipment stands. (Note: the attachment of the stand to the roof deck also needs to be designed to resist the design loads.) In addition to anchoring the base of the condenser to the stand, two metal straps with two side-by-side #14 screws or bolts at each strap end are recommended (see Figure 7).

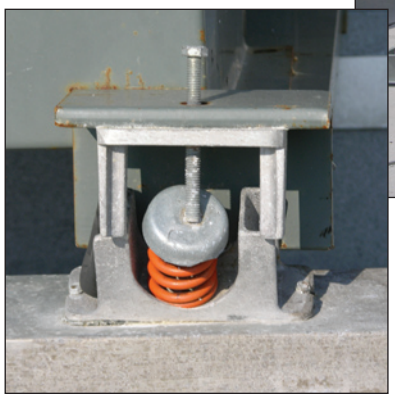
***Figure 8. The equipment on this stand was resting on vibration isolators that provided lateral resistance but no uplift resistance (above). A damaged vibration isolator is shown in the inset (left).***

**Vibration Isolators:** When equipment is mounted on vibration isolators, an isolator that has sufficient resistance to meet the design uplift loads should be specified and installed, or an alternative means to accommodate uplift resistance should be provided (see Figure 8).

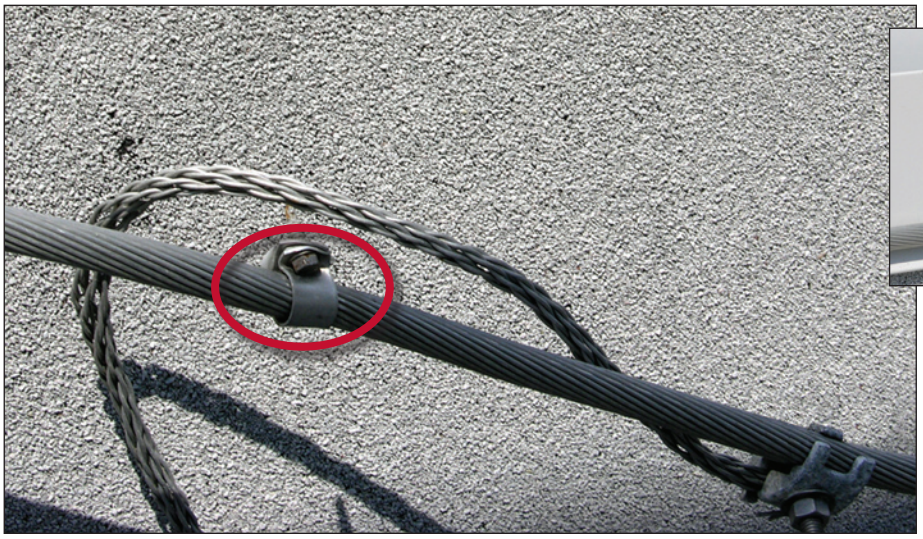
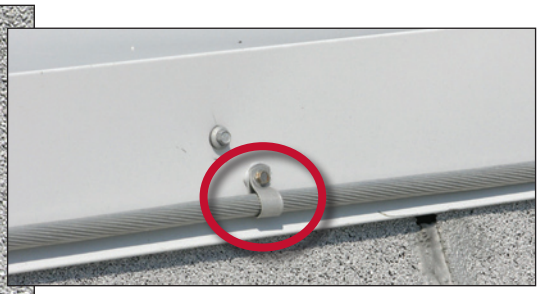
***Figure 4. This conductor was attached to the coping with a looped connector (above). However, a gasket was not installed between the connector and the coping. Also, because the connector screws were too short to engage the wood nailer, the screws pulled out and the conductor was displaced in some areas (figure at left).***

**Parapet attachment:** When the parapet is 12-inch high or greater, it is recommended that the air terminal base plates and conductor connectors be mechanically attached with #12 screws that have 1.25 inch minimum embedment into the inside face of the parapet nailer and properly sealed for watertight protection. In lieu of conductor connectors that have prongs, it is recommended that mechanically attached looped connectors be installed (see Figure 4).

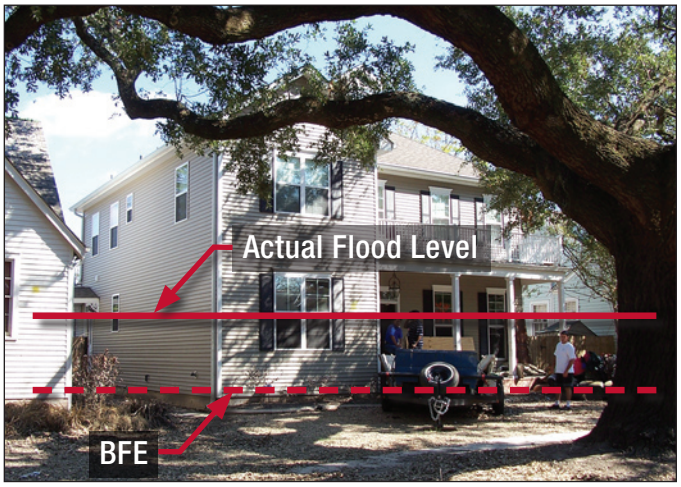
***Figure 1. Levee failures and overtopping during Hurricanes Katrina and Rita (2005) resulted in flood levels (solid red line) several feet above the BFE (dashed red line) over large portions of the greater New Orleans area.***
