6 Observations on Personal Protection and Sheltering

6.1 SHELTERS

6.1.1 Types of Shelters

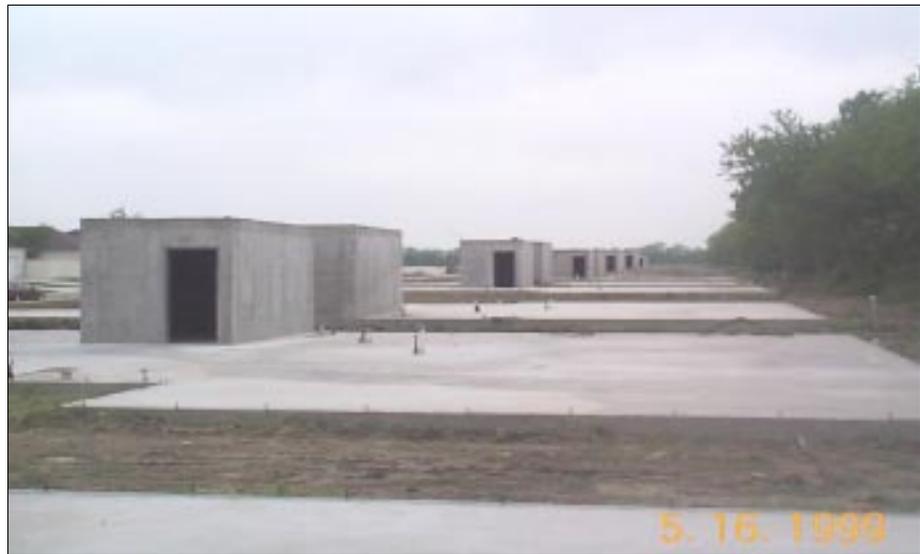
Family-size shelters situated near or in the residence for immediate use in the case of danger were evident throughout Oklahoma and Kansas. In Oklahoma, the BPAT observed a few above ground in-residence shelters that had been added to their existing homes or incorporated into the construction of their new homes. In Kansas, no above ground in-residence shelters damaged by the tornadoes were inspected by the BPAT. However, the BPAT did inspect new reinforced concrete above ground in-residence shelters that were being constructed in Wichita, Kansas (Figure 6-7).

FIGURE 6-7: Above ground in-residence shelters under construction in Wichita, Kansas.

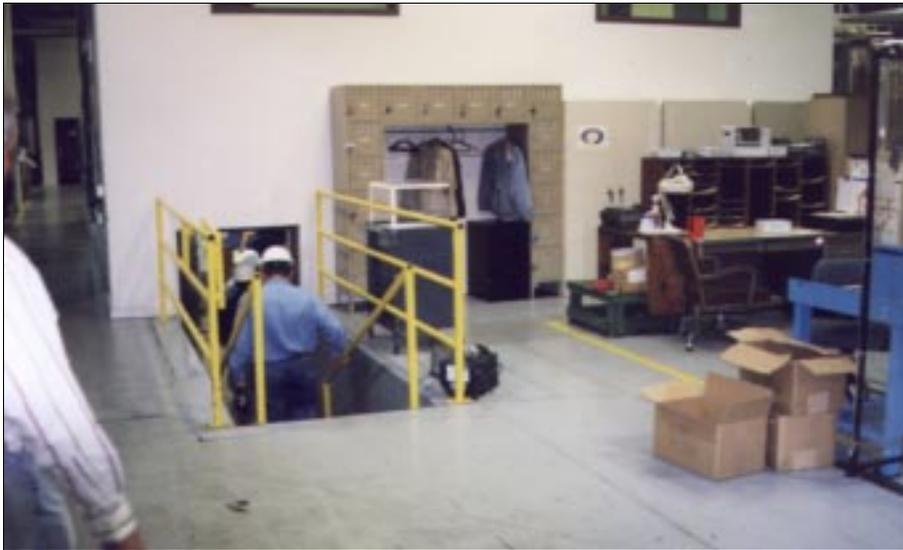
Group-sized shelters were the second type of shelter observed. A group-sized shelter was located within a plastics manufacturing plant in Haysville, Kansas, and is intended to accommodate factory workers (Figure 6-8). The plant's shelter functioned daily as a conference and lunch room for employees. Although a violent tornado damaged other buildings on the plant site, the building containing this shelter received damage only in one isolated area, where a partial roof collapse occurred. Other smaller group-sized shelters were observed at a new manufactured home rental development, which provided precast concrete shelters (1 per 4 homes) (Figure 6-9). None of the group-size shelters observed by the BPAT were directly impacted by a tornado on May 3, 1999.

FIGURE 6-8: Entrance to the plastics manufacturing plant group shelter in Haysville, Kansas.

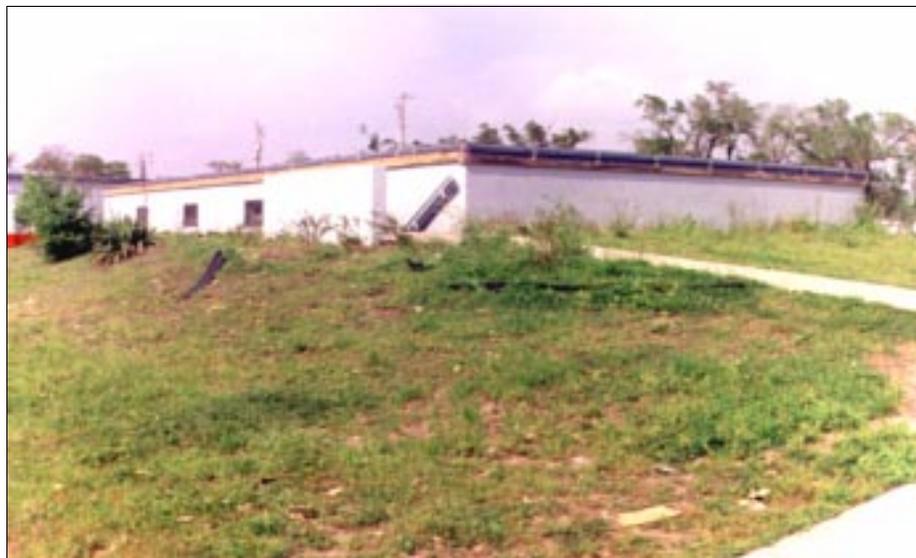
Community-sized or mass shelters were also inspected by the BPAT. A manufactured home community shelter in Wichita, Kansas, was constructed partially underground, located at one end of the large development, and was intended to house all residents of the development (Figure 6-10).

Approximately 200 people reportedly sought shelter in this building during the May 3, 1999, tornadoes. Another community-sized shelter was located underground and under the concrete bleachers in the Mid West High School gymnasium in Mid West City, Oklahoma (Figure 6-11). Approximately 500 people sought shelter here during the May 3, 1999 tornado (the shelter has a

capacity of 3,500). A similar shelter is located at Del City, Oklahoma, High School. Members of the community are generally aware of the location of these shelters. Interviews with residents of the manufactured home community indicated that parking was a problem at the community shelter. In contrast, ample parking is available near the gymnasiums for those seeking shelter.

FIGURE 6-10:
Manufactured home
development community
shelter in Wichita,
Kansas.

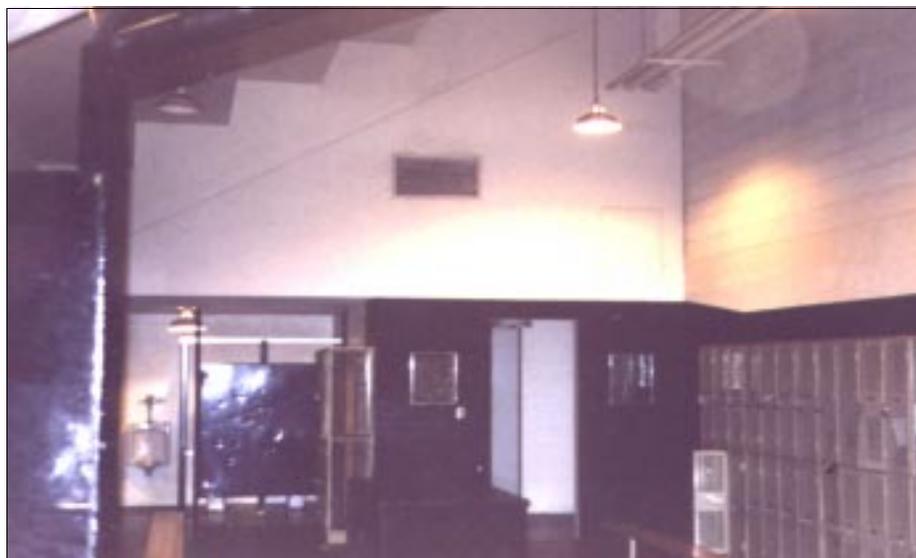
FIGURE 6-11: Community
shelter, Mid West High
School gymnasium in Mid
West City, Oklahoma.

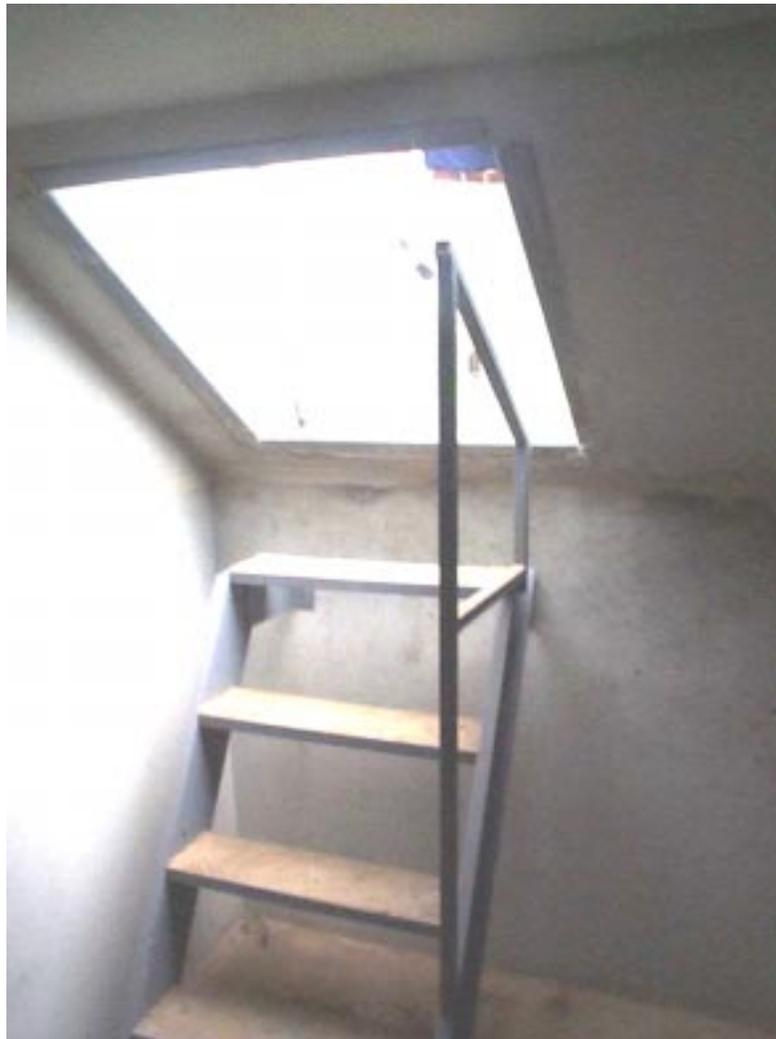
The observed above ground in-residence shelters were easily accessible by the home occupants. Observed door widths would have allowed access by wheelchair or otherwise disabled occupant. The group or community shelters observed by the BPAT had restrictive entrances that may have hampered access to the shelters by persons with disabilities. Figure 6-16 shows stairs leading to the entrance of a community shelter in Kansas. Additionally, several of the community shelters were locked and required authorized admission. Access to the community shelter in Figures 6-10 and 6-16 was restricted to community members without pets and the travel distance from the far end of the development to the shelter was approximately several city blocks. The group shelters observed also require access via stairs at both the plastics manufacturing plant and the manufactured home rental development. Figure 6-17 shows the stairs required to access the group shelter and the manufactured home rental development.

FIGURE 6-17: Stairway access to group shelter at manufactured home rental development, Wichita, Kansas. This development was not affected by any of the tornadoes that struck on May 3, 1999.

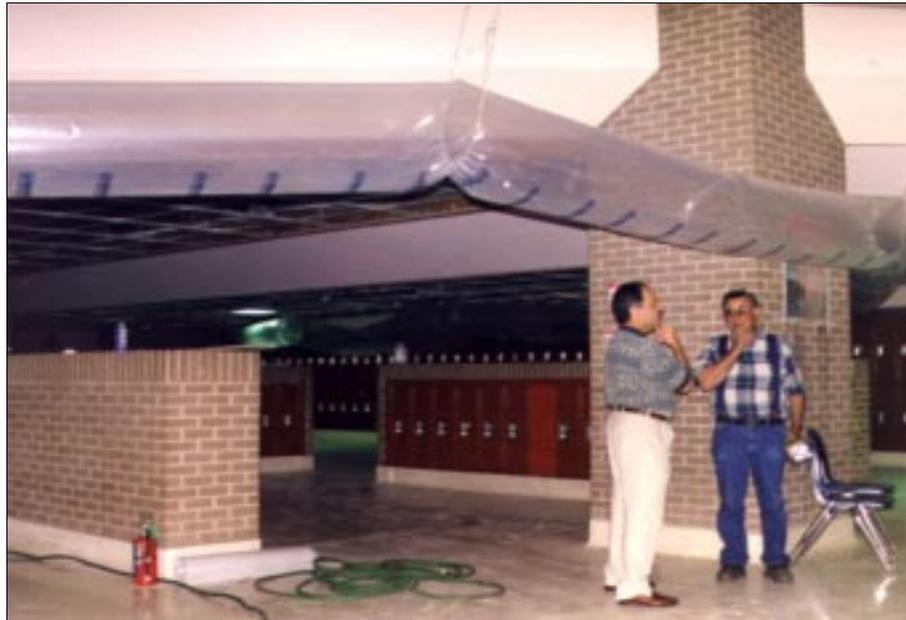
The emergency plans of five public schools were reviewed by the BPAT. Westmoore High School, located in the City of Moore, was within 100 yards of the vortex of a violent tornado and received building envelope and roof structure damage. Just prior to the storm, several hundred students and parents occupied the auditorium. In accordance with the emergency plan, most of the students and parents were moved to a predetermined area in a central core of the building where they successfully took refuge (Figure 6-29). Other individuals reportedly took refuge in a reinforced concrete stairwell adjacent to the auditorium.

FIGURE 6-29: Westmoore High School, Moore, Oklahoma, central locker core - a designated place of refuge.
