4 Observations on Residential Property Protection

4.1 Single-Family Conventional Construction

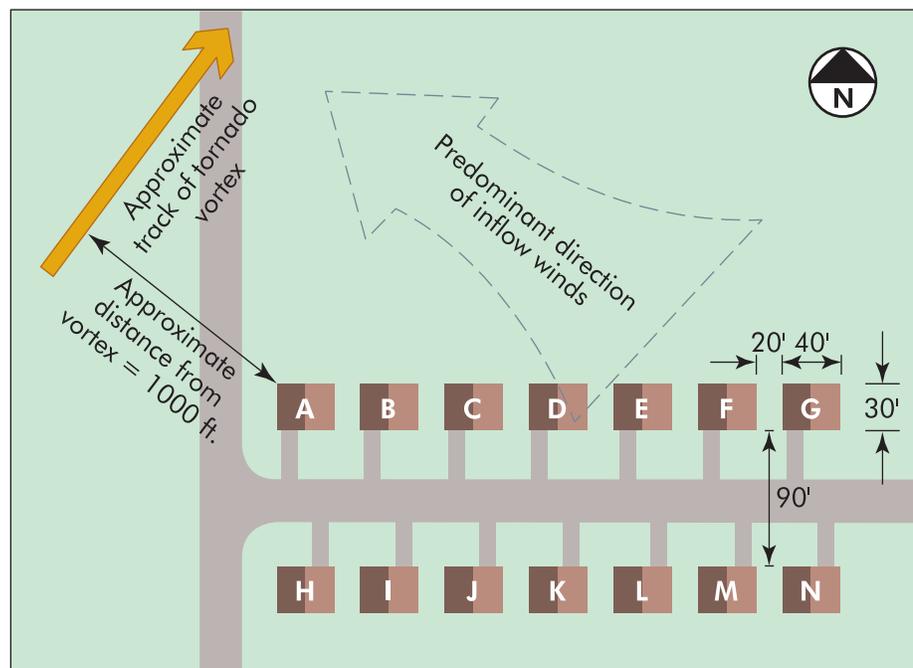
FIGURE 4-21: Partial schematic map of an Oklahoma City subdivision that was affected by inflow winds from a violent tornado.

Homes located at H and A are shown in Figure 4-22. The damage states of the two homes are significantly different even though they are located directly across the street, approximately 95 feet apart, from one another and may have experienced relatively similar wind conditions based on the approximate track location (Figure 4-21). The home located at H had seven broken windows, primarily at the back of the home as a result of debris generated from a failed wooden fence. It also had one breached glass entry door, and lost approximately 60% of its roof covering. The home located at A lost its entire roof structure and several exterior walls. This was likely due to the failure of the garage door from inward wind forces. For the remaining houses, similar “across-the-street” damage gradients were observed between the homes, A through G and H through N, with the exceptions of the home at location F, which did not lose its entire roof structure, and the home at location G, which did not lose any roof structure, but did sustain severe roof framing damage due to uplift.

Several failed garage doors were observed lying at the back of the garage for many homes (A through G), indicating that the garage doors failed due to positive (inward) pressure. These failures of the garage doors are believed to have initiated or contributed to the catastrophic roof and exterior wall failures for homes A through G, a direct consequence of load increase due to a large breach in the building envelope. Examples of this may be seen in Figures 4-22 and 4-23. Note that the failed garage door in Figure 4-22 is crumpled up against the car, suggesting a door failure under positive pressure. A partial roof failure (house F) is depicted in Figure 4-23. In this case, the garage door was also found within the garage as shown in the picture inset. The observed location of the failed garage door and the localized roof damage suggests that the failed garage door may have initiated or played an important role in the roof failure. Many of the moderately to severely damaged homes observed had a significant amount of structural damage to the garage area and to the immediate surrounding area, but did not necessarily have the same magnitude of structural damage at the opposite side of the building where no garage was located.

For several of the homes, H through N, it was observed that the garage doors had sustained permanent deformation due to negative (outward) pressure loads. This observation supports the assumption that the garage doors for homes A through G located across the street failed in positive pressure, as shown in Figure 4-22 for the home located at A. This door failed under a positive load. Full scale pressure tests on garage doors performed in laboratories have demonstrated that a typical garage door is significantly stronger in negative (outward) loading than in positive (inward) loading, which may explain why no garage doors completely failed on the homes, H through N (assuming comparable winds).

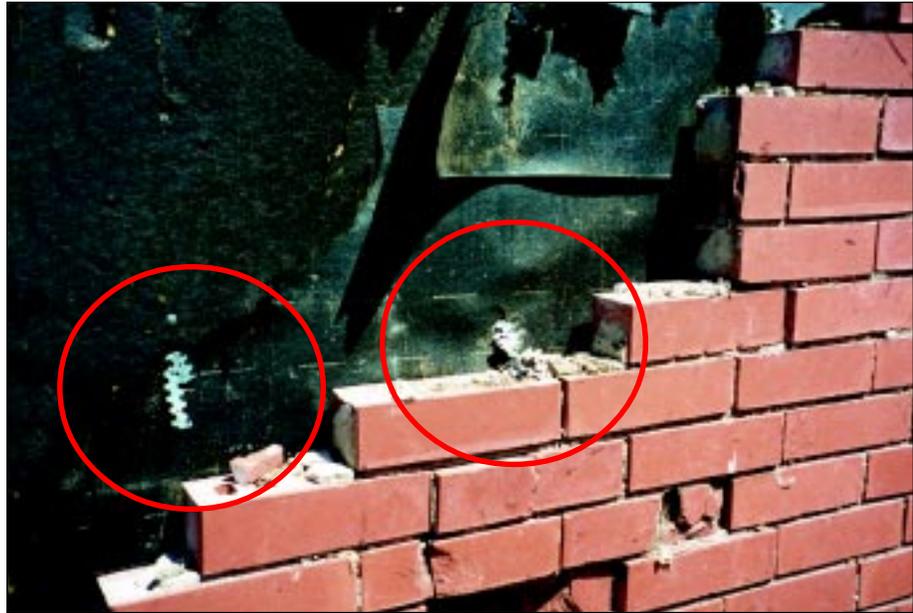
FIGURE 4-39: Failure of brick veneer wall of home located along the periphery of a violent tornado in Oklahoma City. Masonry ties are circled.

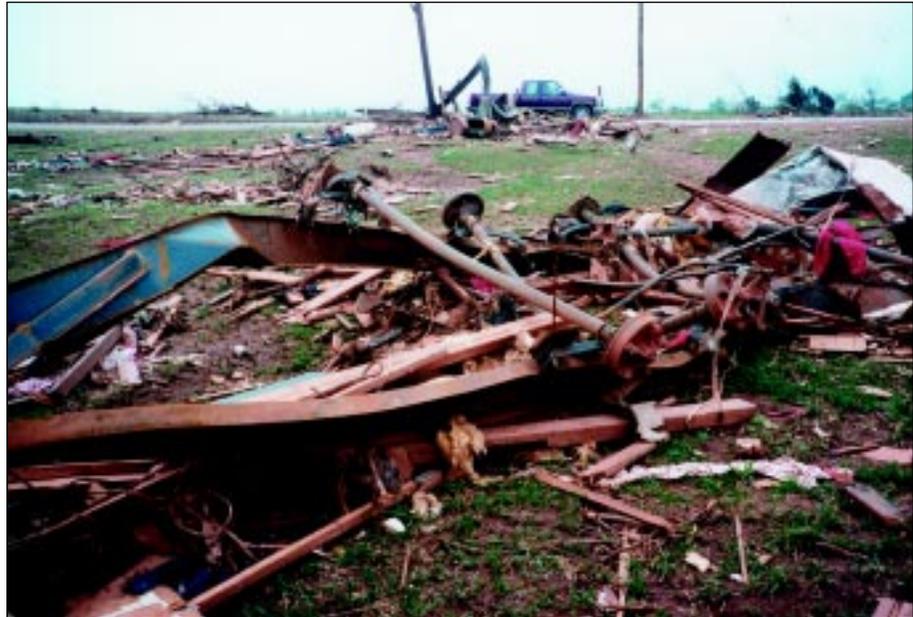
tornado vortex was approximately 300-400 ft away from this home. At the original site, vertical and diagonal straps remained attached to the ground anchor, but had failed about 2 to 3 ft from the anchors (Figure 4-48). The first anchors had been fastened about 12-ft from the east end. Both the number of anchor straps and tensile capacity of the straps were inadequate to resist wind uplift forces (Figure 4-49).

FIGURE 4-49: *Strap anchoring failure most likely led to the displacement of this chassis, Bridge Creek, Oklahoma.*

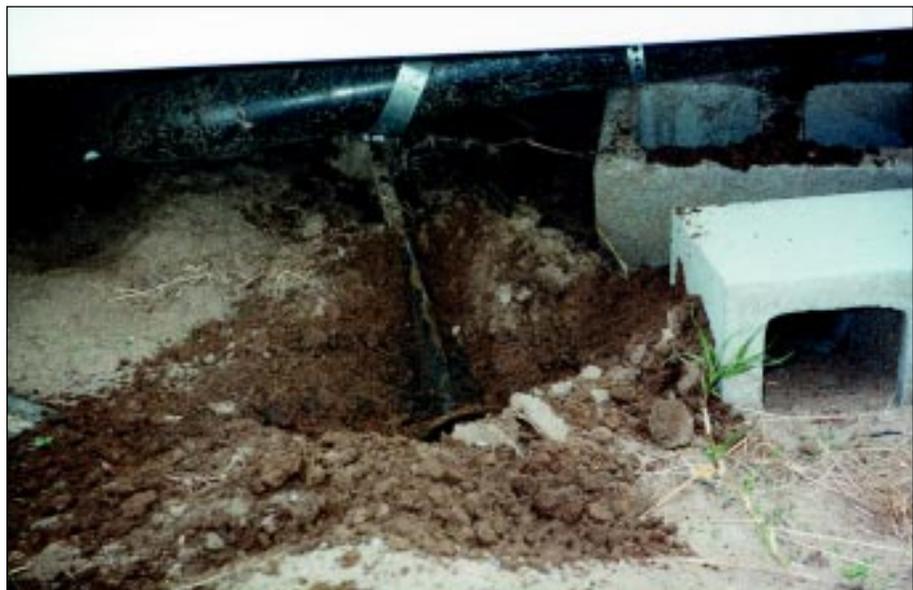
After completing several site visits in the Oklahoma City Metroplex, the BPAT visited Mulhall, Oklahoma, and then Wichita, Kansas. There several double-wide manufactured houses damaged by a strong tornado were inspected. One 28-ft by 60-ft home had rotated on its piers, 2 ft to the east at the north end and 1 ft to the west at the south end. Three helical anchors were pulled out of the ground that had been installed about 1 ft into the ground on the northwest end of the home (Figure 4-50). Anchor straps that were still attached to ground anchors and chassis beams were loose, which allowed lateral move-

FIGURE 4-50: *Ground anchor of manufactured home pulled from soil. This home in Wichita, Kansas, was located within the inflow area of a strong tornado.*
