**Issues, Resolutions, and Research Needs Related to Dam Failure Analysis Workshop
Oklahoma City, Oklahoma
June 26 -28, 2001**

Embankment Dam Failure Analysis

Dayton Dam Canal Embankment Failure & Repair

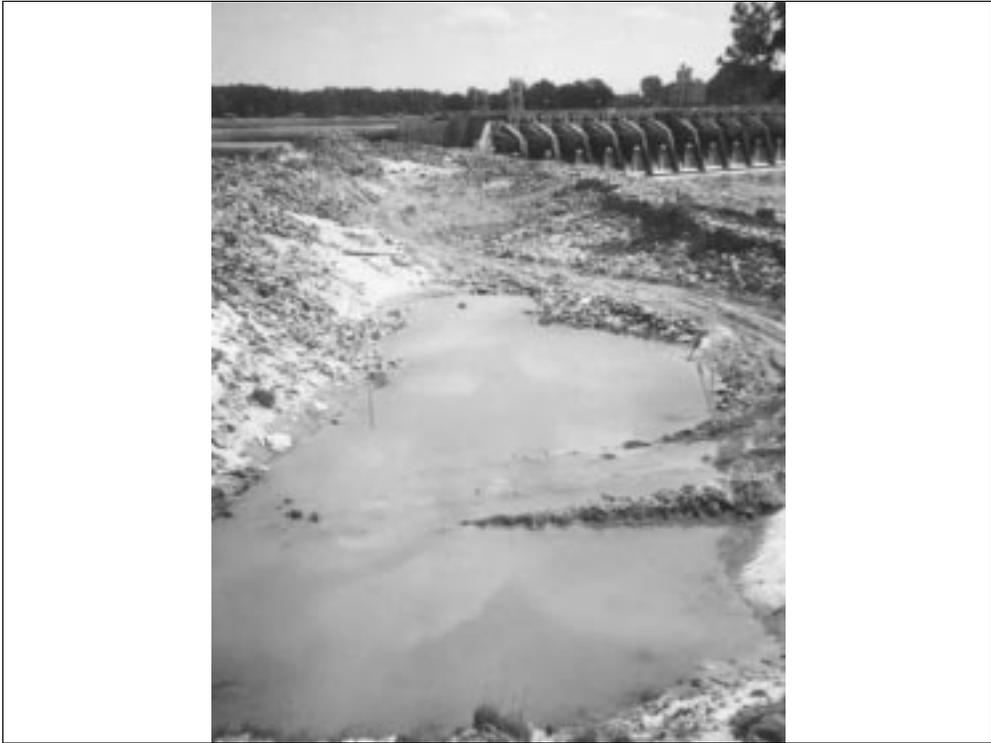
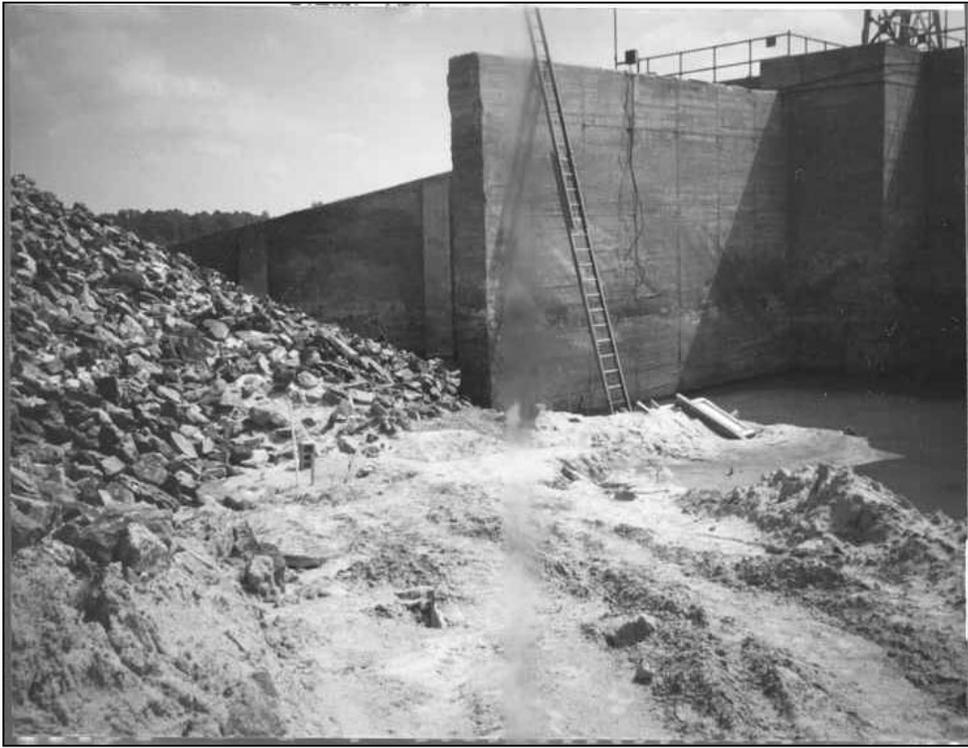
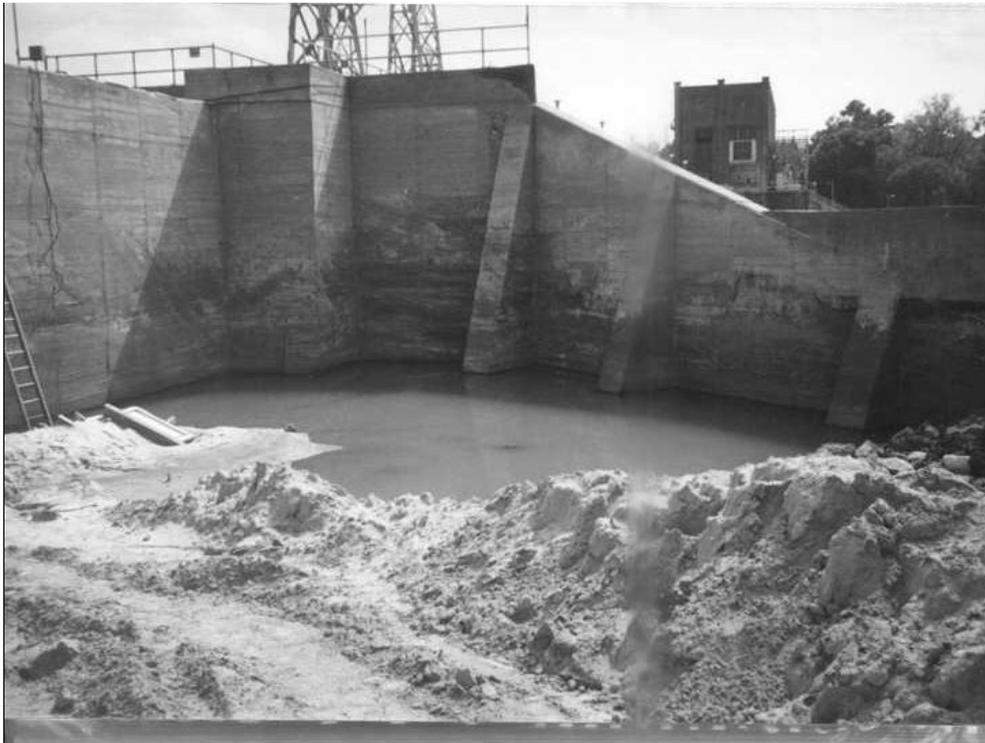
Lake Blackshear Dam

- **Reasons to Prevent Overtopping of an Embankment Even When Covered With a Good Growth of Grass**

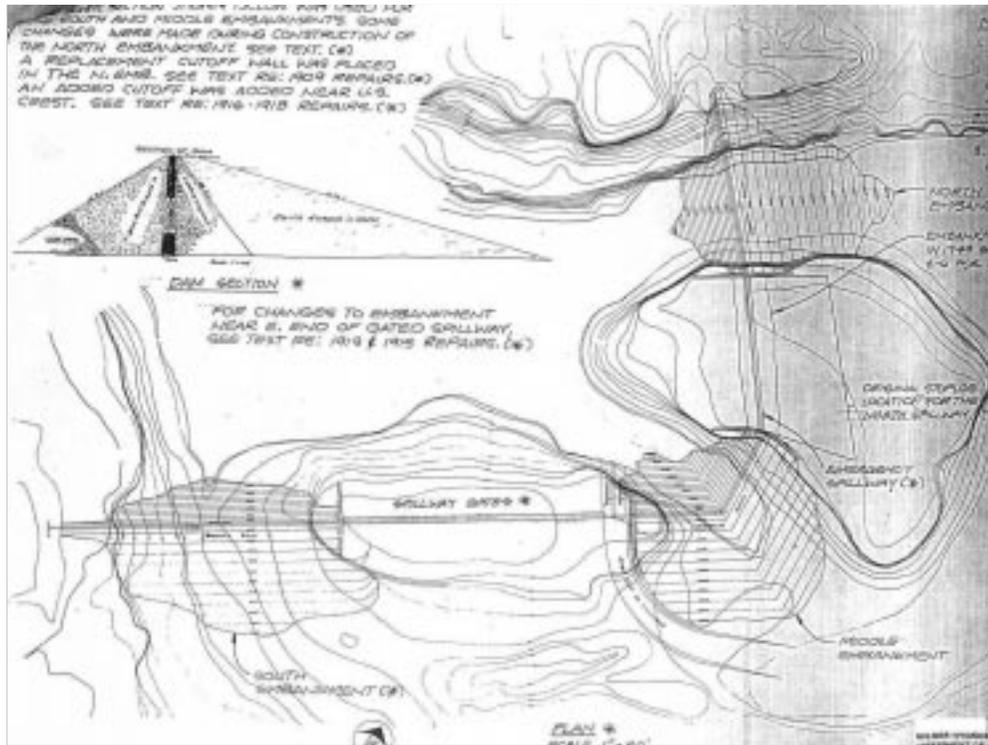
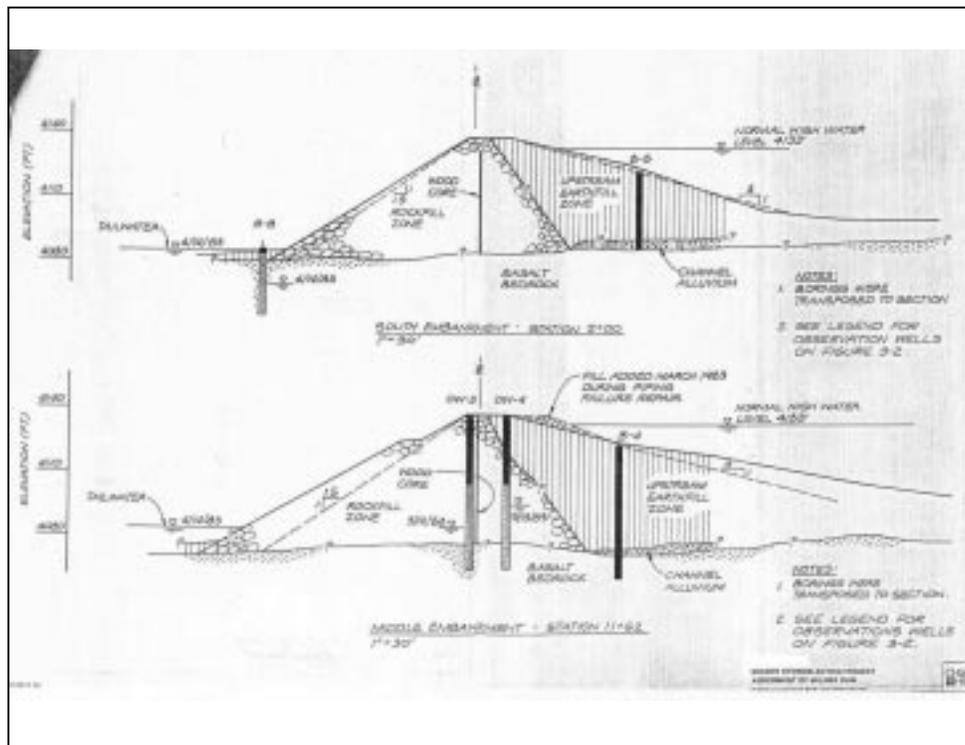
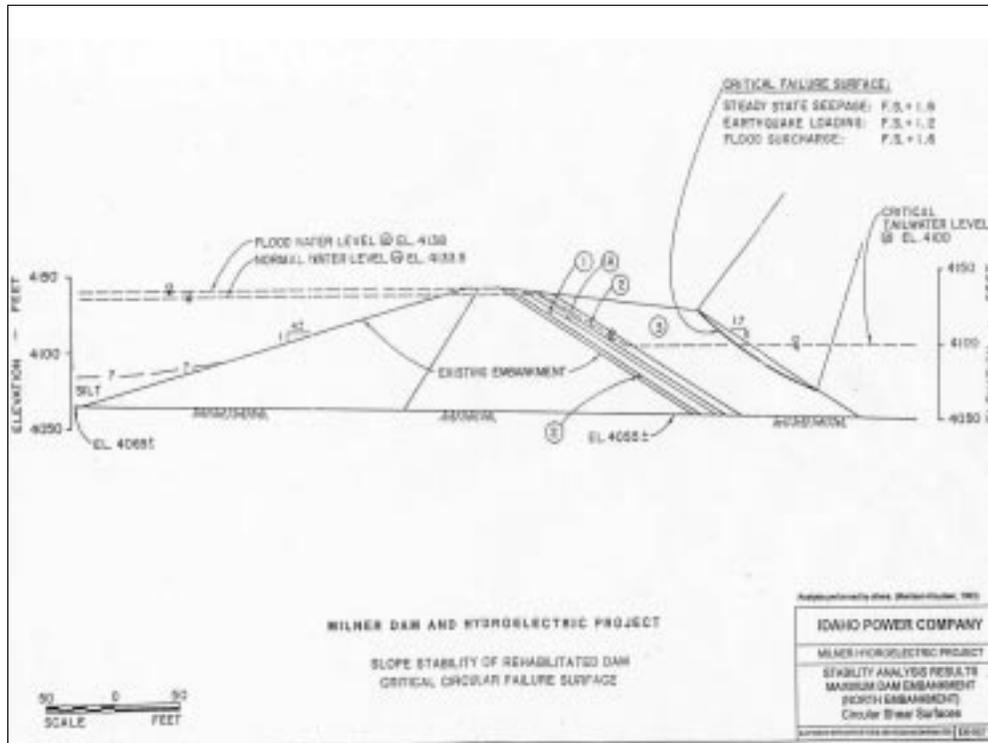
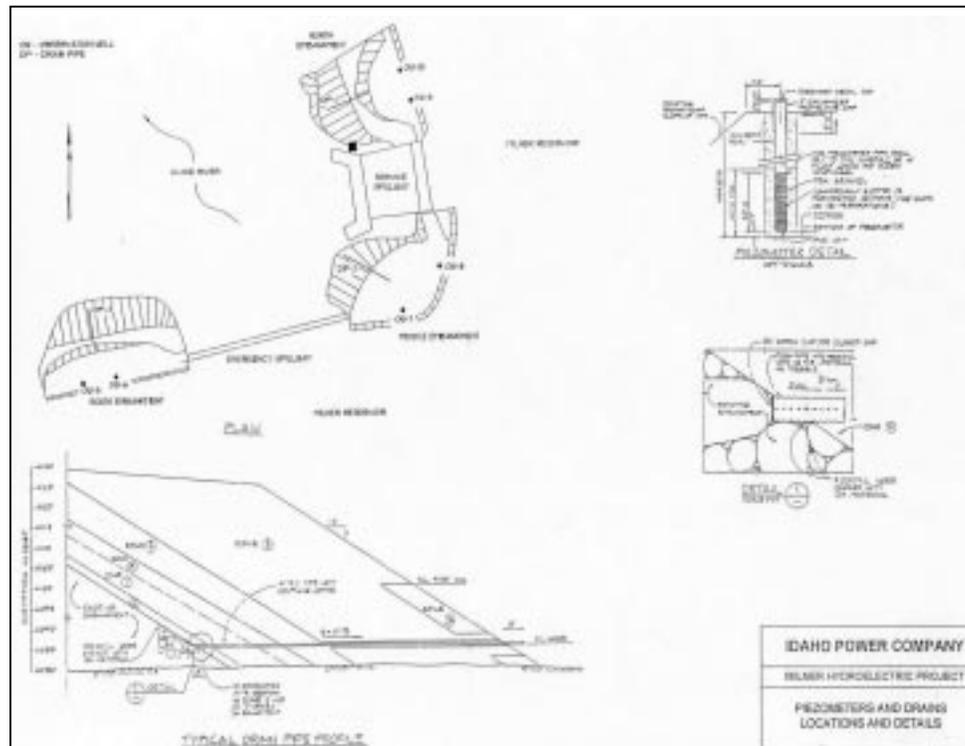
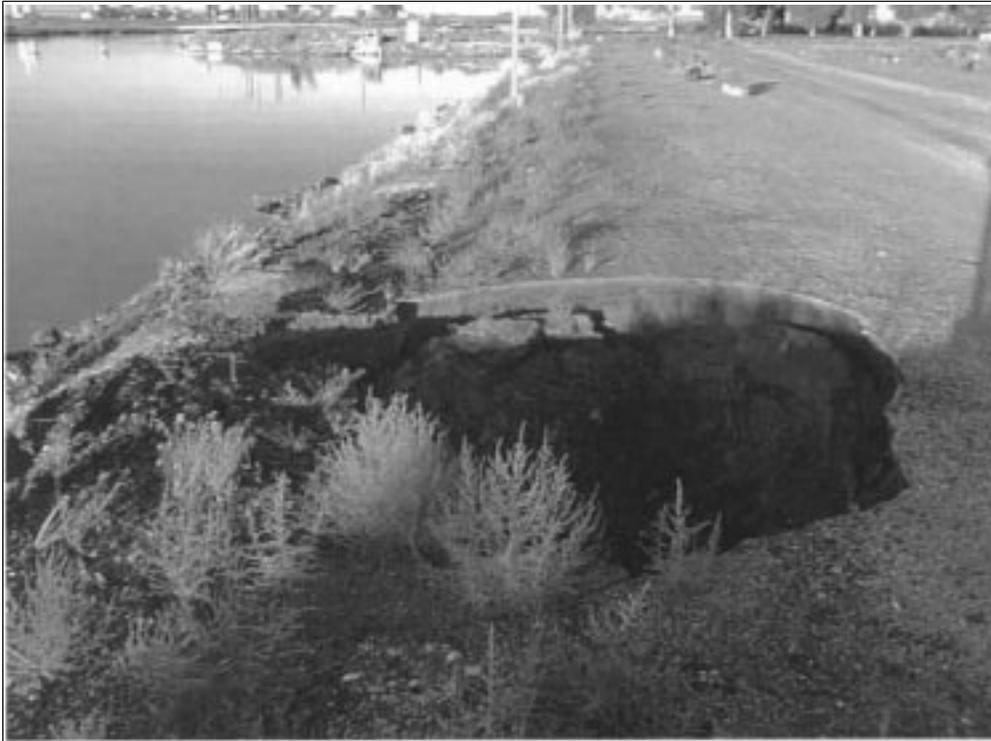
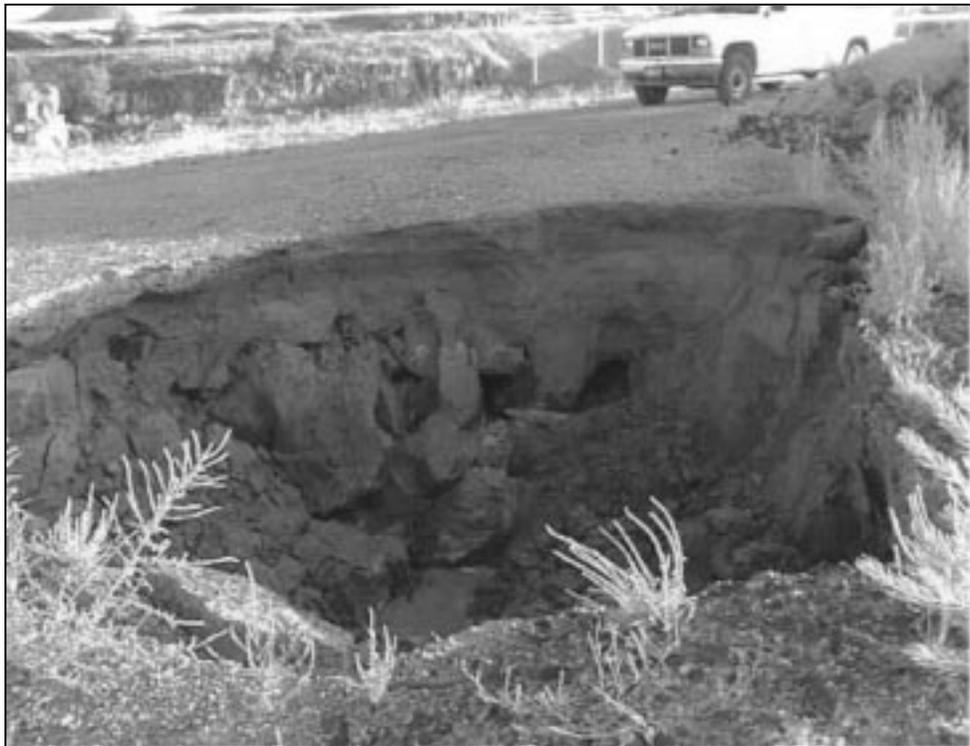
Milner Dam

- **Control of Seepage Flow Through the Embankment, Foundation, And Abutments to Prevent Internal Erosion (Piping)**
- **The Slopes Must be Stable During all Conditions of Reservoir Operations**
- **Do Not Permit Unacceptable Deformations Under Earthquake Conditions**

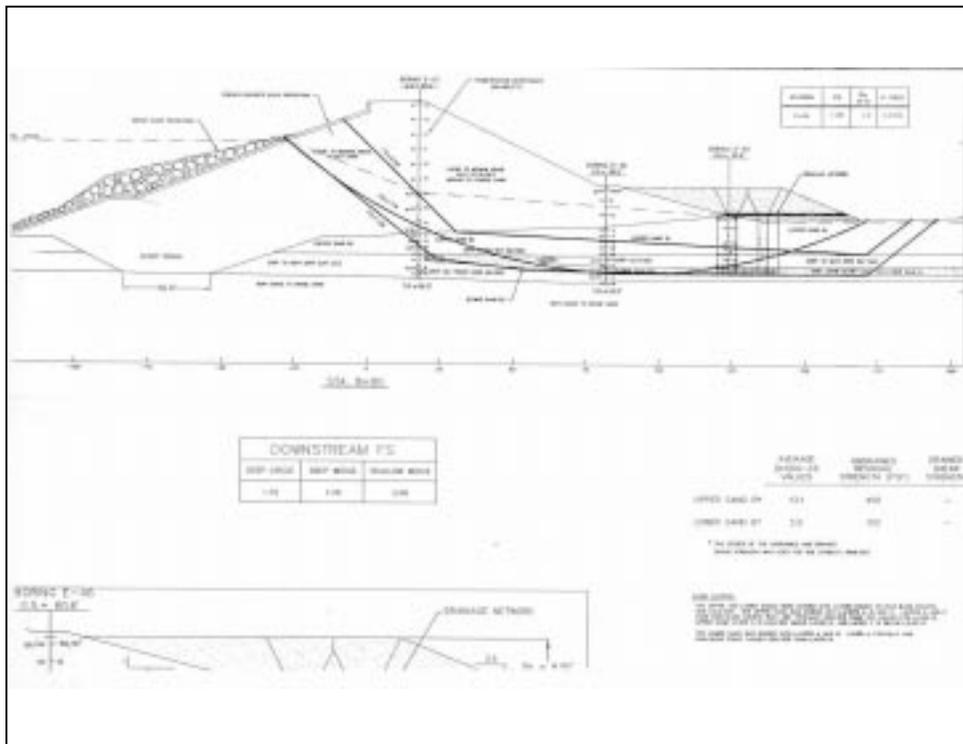
Santee Cooper East Dam

- **The Embankment, Foundation, Abutments, and Reservoir Rim Must be Stable and Must Not Develop Unacceptable Deformations Due to Earthquake Loadings**
- **Use of Hand Calculations to Confirm Computer Calculations**

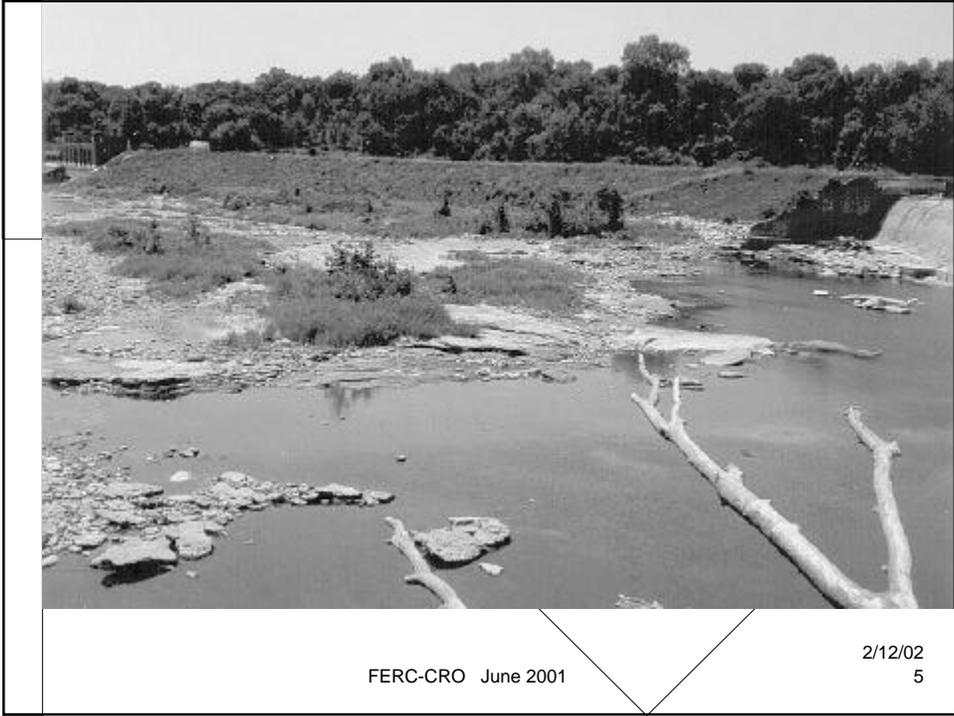
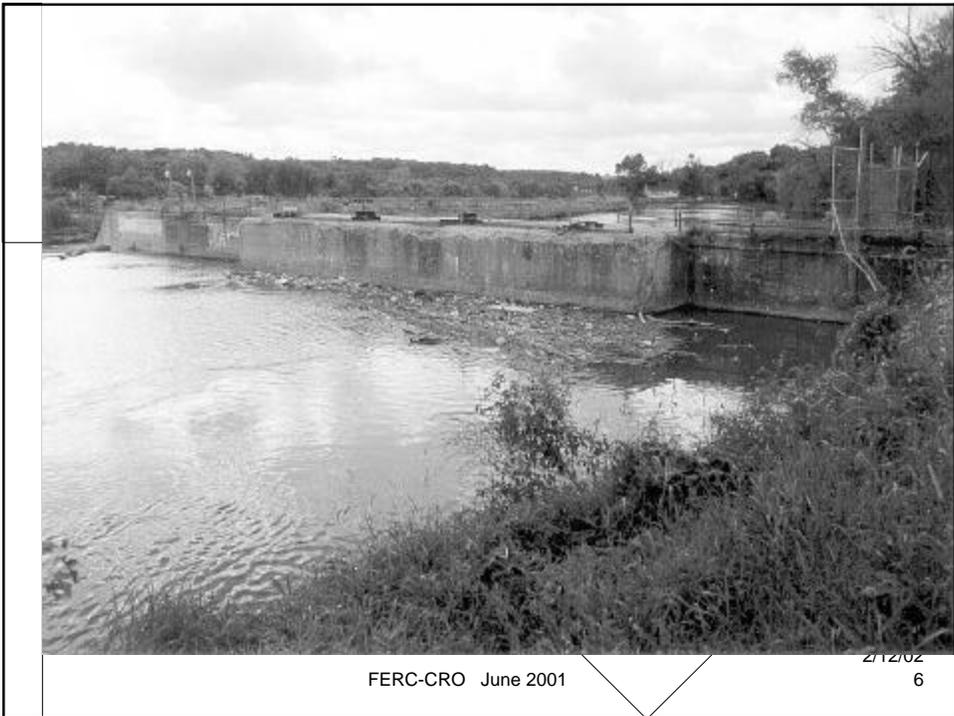
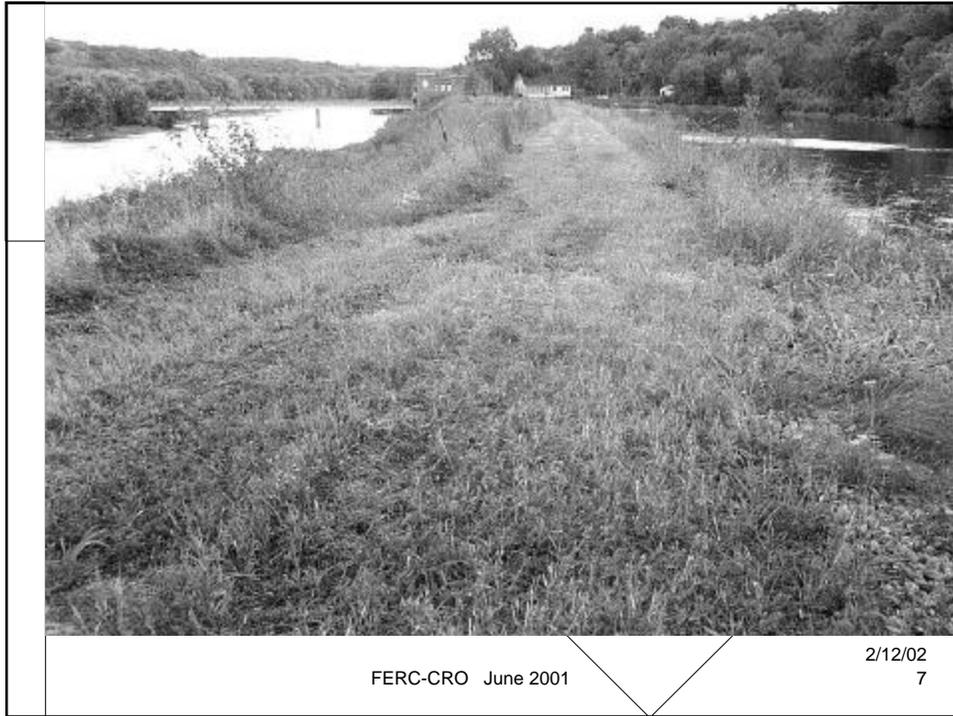
Events Leading Up to the Breach

- On July 17, 1996, 16.91 inches of rain over an 18-hour period was recorded at the Aurora precipitation gage, which is located about 40 miles upstream of the dam. As a result, the reservoir rose throughout the following day.
- At 4 p.m., on July 18th, the water level was at about 2 feet below the crest of the headgate structure, and rising about 1 foot per hour. The tailwater was also still rising and was beginning to encroach on the substation.
- At that time, the substation owner ordered the plant be taken off line so that the power could be cut to the substation.
- As a result, the level in the canal rose about 3 feet at the powerhouse, and began to overtop the canal embankment around both sides of the powerhouse.

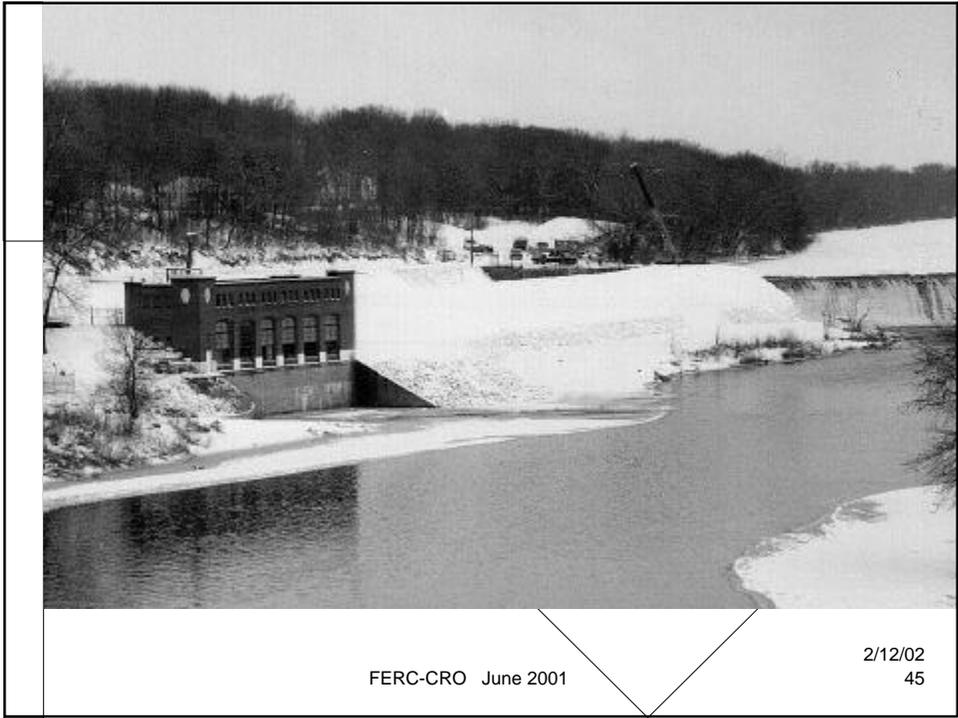
August 27, 1997 Inspection

- The following two photographs show the progress of the reconstruction work.
- At the time of this inspection, the contractor was reconstructing the canal invert.
