# General Characterization of Damage

# 3

## 3.1 Flood Effects

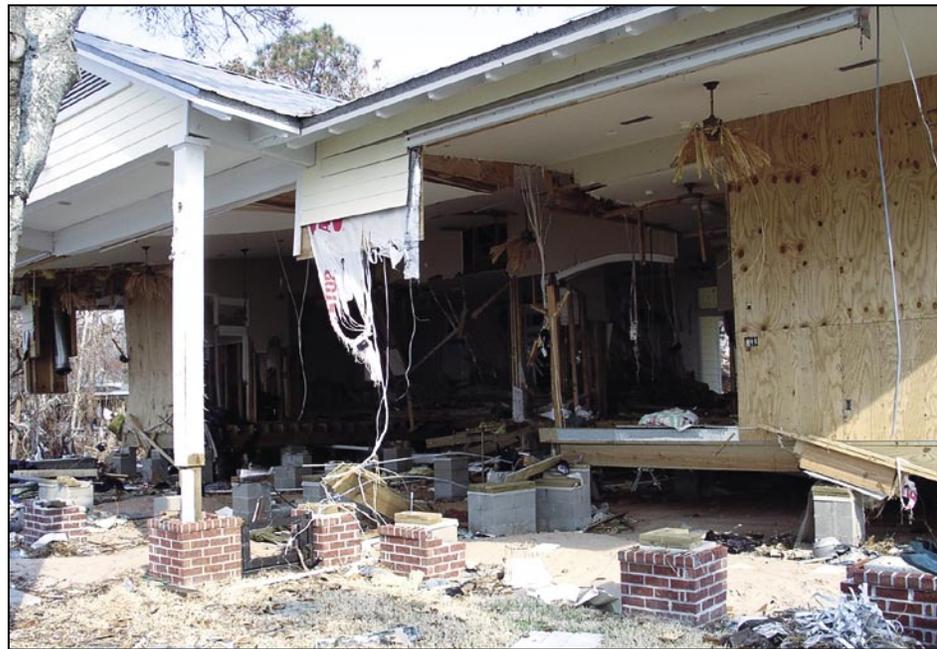
**Figure 3-3.** This building, which was less than 2 years old, was constructed on piers at the current BFE of 9 feet. It was severely damaged by high storm surge, and wave and debris impacts. (Big Lagoon)

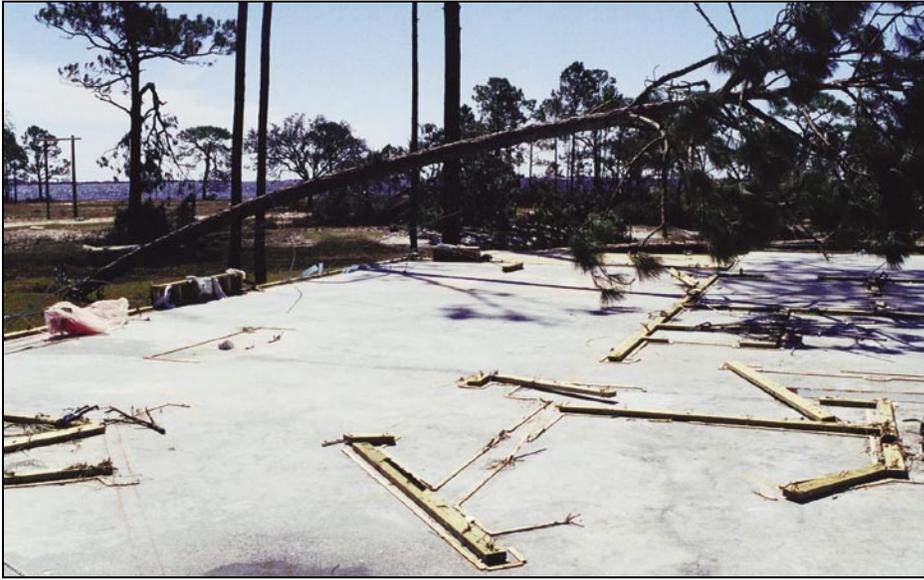
severe surge, wave, and debris damage when flood levels exceeded the BFE by 2-4 feet. Note that Figure 3-5 shows a pile-elevated building near the building shown in Figure 3-8.

**Figure 3-8.** This new building was constructed to the BFE, but was wiped off its foundation (slab atop stem walls) by Ivan. The destruction was likely due to storm surge, wave action, and floodborne debris, although wind could have contributed to the breakup of the building (note pine tree leaning over slab). (Big Lagoon)
