Mitigation Assessment Team Report

Hurricane Ivan in Alabama and Florida

Observations, Recommendations,
and Technical Guidance

FEMA 489 / August 2005

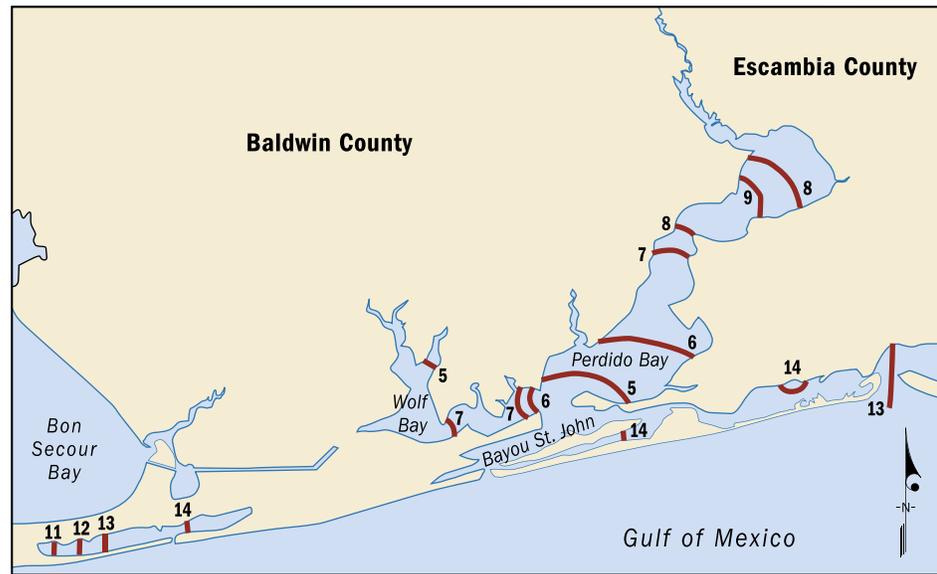
Figure 1-2.
Surge elevation contours
in Baldwin County,
Alabama

Surge elevation contours in Baldwin County are shown in Figure 1-2. HWM elevations along the open coast of Baldwin County were generally 2-3 feet higher than the effective BFEs shown on the FIRM. However, the HWM elevations along some of the inland bays (Bayou St. John, Perdido Bay, and Wolf Bay) were found to differ from the BFEs by only +/- 1 foot. It should be noted that several HWM elevations could not be compared to effective BFEs because the areas are currently mapped as Zone X, without established elevations.

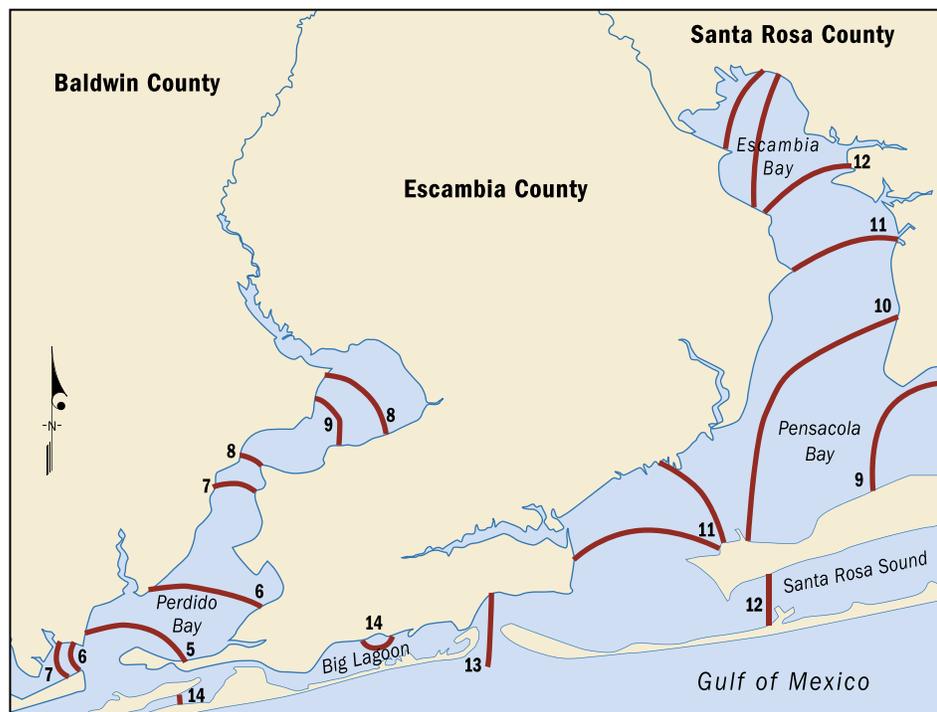
Figure 1-3.
Surge elevation contours
in Escambia County,
Florida

Figure 1-3 shows the surge elevation contours in Escambia County. Here, the HWM elevations in the inland bay areas varied greatly from the effective BFEs. Along Perdido Bay, the HWM elevations were found to be approximately 0-2 feet higher than the effective BFEs. Along Big Lagoon, HWMs were generally 6-8 feet higher than the BFEs. Along Pensacola Bay, they were about 4 feet higher, and along Escambia Bay, generally 5 feet higher. As with Baldwin County, it should be noted that several HWM elevations could not be compared to effective BFEs because the areas are currently mapped as Zone X, without established elevations.

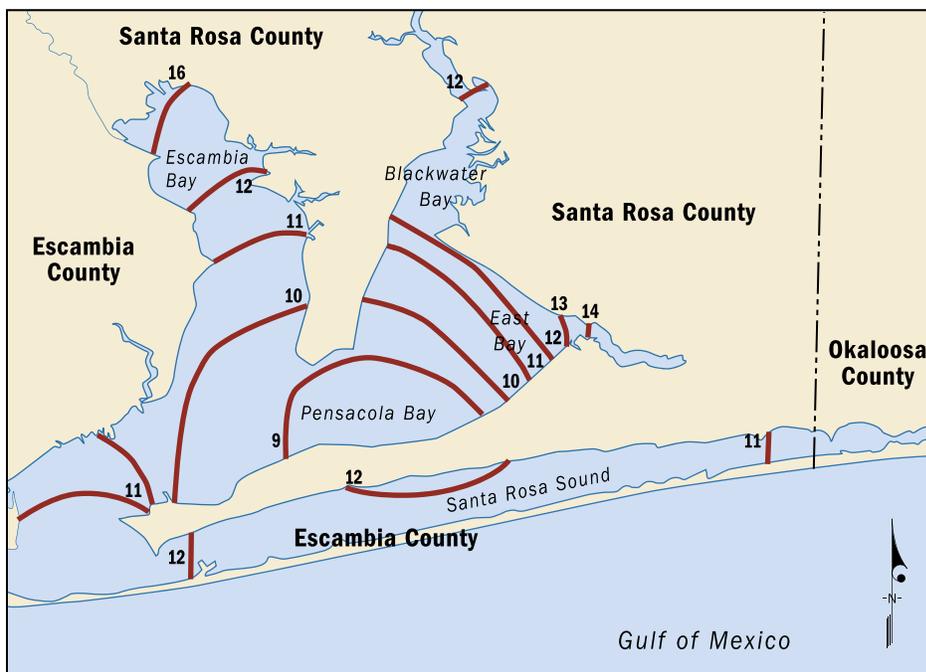
Figure 1-4.
Surge elevation contours
in Santa Rosa County,
Florida

Figure 1-4 shows the surge elevation contours in Santa Rosa County. The HWM elevations in Santa Rosa County were generally found to be much higher than the effective BFEs in the inland bay areas. Along Pensacola Bay, the HWMs were generally 2-6 feet higher than the effective BFEs. However, there were also instances where the two elevations were equal, such as at Garcon Point along Pensacola Bay (both equal to 10 feet). Along Escambia Bay, the HWMs were found to be approximately 3-4 feet higher than the BFEs, and along East Bay, approximately 3-6 feet higher. Along the northern shoreline of Santa Rosa Sound, the HWM elevations differed from the BFEs by about +2 feet, while along Blackwater Bay, the HWMs were about 2-4 feet higher than the BFEs. As with the other impacted counties, several HWM elevations could not be compared to effective BFEs because the areas are currently mapped as Zone X, without established elevations.

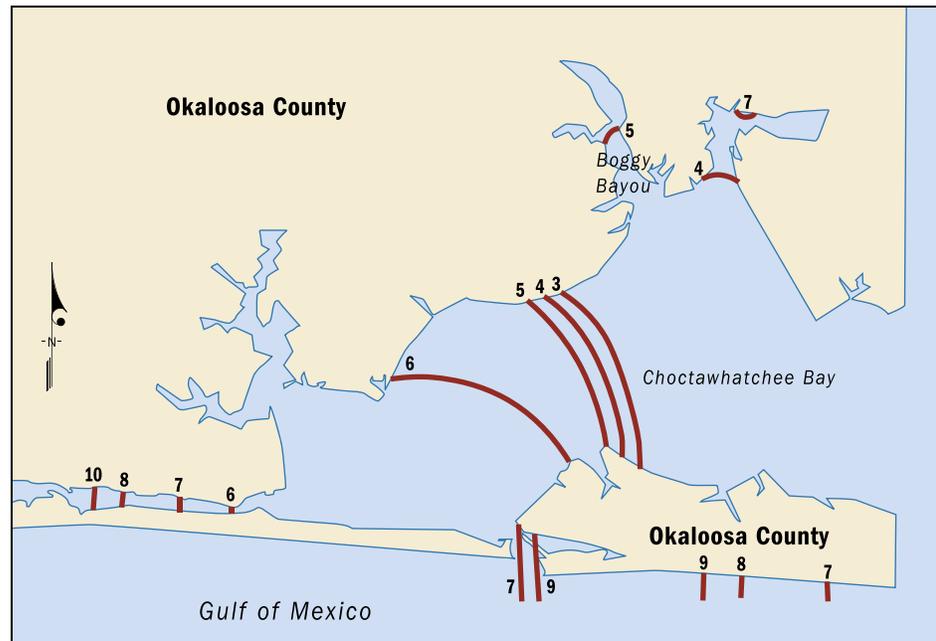
Figure 1-5. Surge elevation contours in Okaloosa County, Florida

Surge elevation contours for Okaloosa County are shown in Figure 1-5. HWM elevations along the open coast of Okaloosa County were generally equal to or lower than the effective BFEs shown on the FIRM. The HWM elevations along some of the inland bays, such as Boggy Bayou, were found to be 2-3 feet lower than the effective BFEs. Again, it should be noted that several HWM elevations could not be compared to effective BFEs because the areas are currently mapped as Zone X, without established elevations.

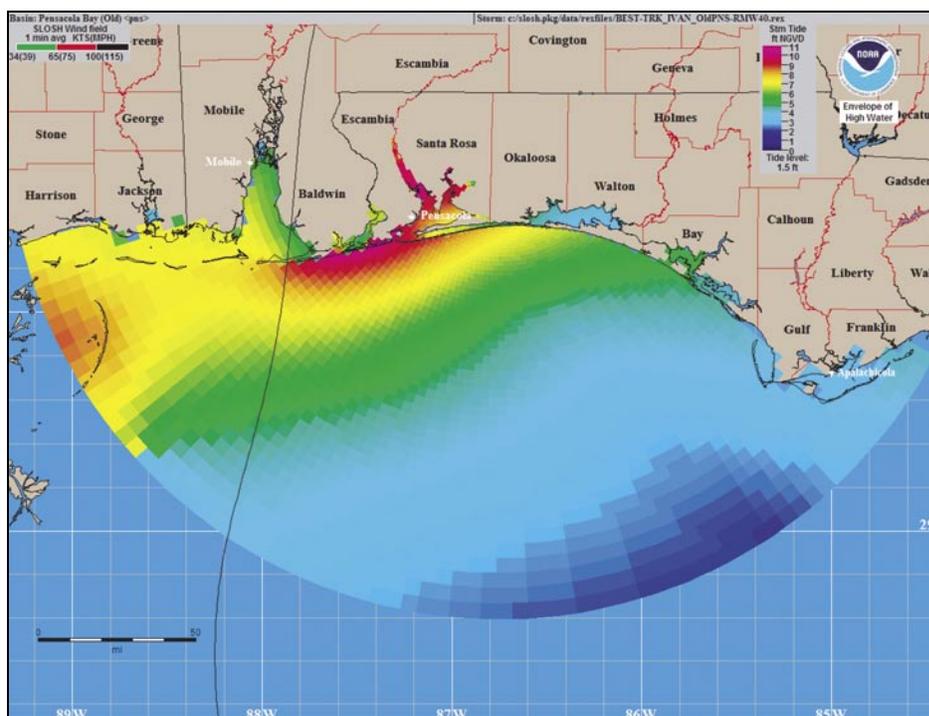
Figure 1-6.
The SLOSH model
Envelope of High Water
(EOHW) for Pensacola
Bay, Florida

The NOAA *Sea, Lake and Overland Surges from Hurricanes* (SLOSH) model prediction run output shows that the maximum surge conditions moved across the area as the storm tracked across the coast. Figure 1-6 shows the results of the SLOSH model for Hurricane Ivan. The hurricane crossed the coast in the general area of Gulf Shores and Orange Beach. Because it tracked north-northeast from there, Mobile Bay and most of the Alabama coast was exposed to the weaker “left-front” storm quadrant. In Alabama, the major storm surge struck Orange Beach, Gulf Shores, and the peninsula between Bon Secour Bay (the southeastern corner of Mobile Bay) and the open gulf. In Florida, the first major surge was along the open coast, at Perdido Key.

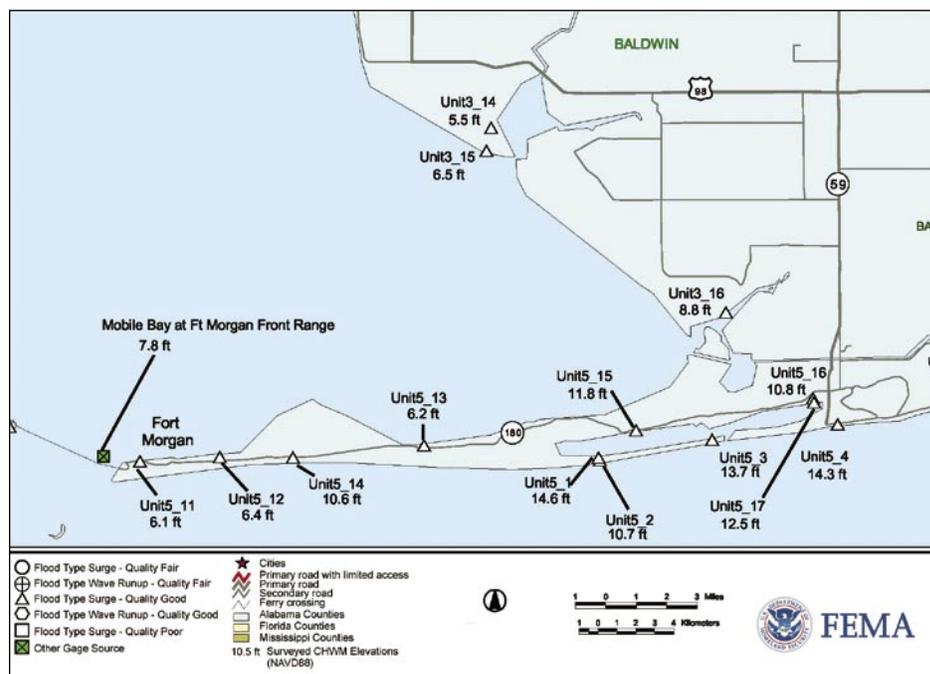
Figure 1-9. CHWM surveyed elevations for West Beach/Fort Morgan area

Figures 1-9 and 1-10 show the CHWM elevations in Orange Beach, Ono Island, West Beach, and Fort Morgan. The surge height, determined from water marks in sheltered locations such as interior rooms, ranged between 12 and 14.5 feet along this portion of the open Alabama shore. Much of the beach system was overtopped or overwashed.

Figure 1-9 shows that the CHWM elevations were much lower along the eastern shore of Mobile Bay in Baldwin County compared to the open coast. Data on Figures 1-8 and 1-9 show that elevations on the order of 6.5 feet were characteristic of this eastern shore of Mobile Bay.

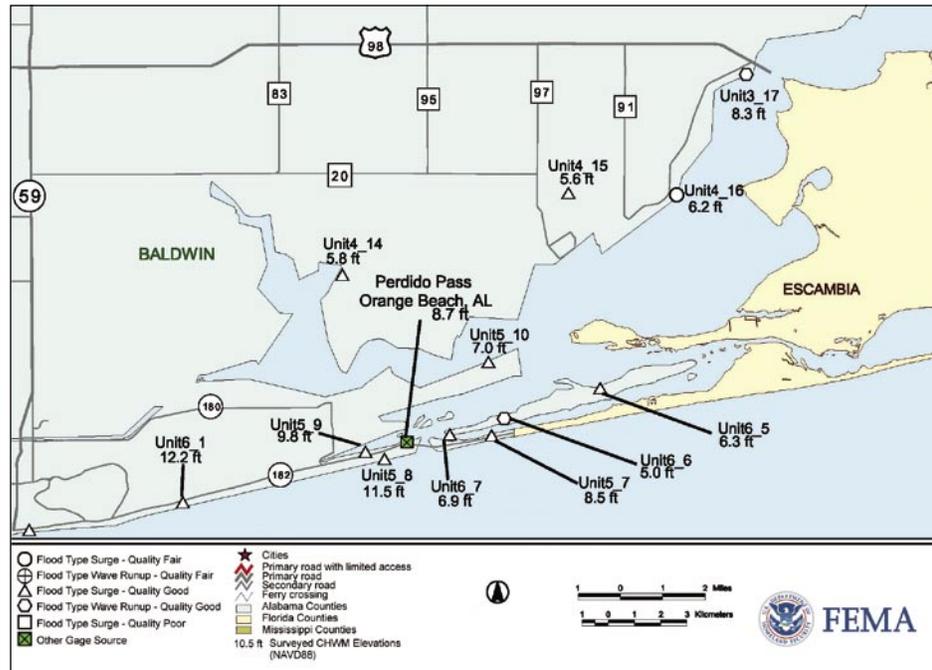
Figure 1-10.
CHWM surveyed
elevations for Orange
Beach/Ono Island

The open gulf CHWM elevations decrease slightly near Perdido Pass, possibly because of the flow into Perdido Bay. Figure 1-10 shows that CHWM elevations in the lower Perdido Bay were 6 to 7 feet. Data from the Florida side of upper Perdido Bay (not shown) indicated that the water level increased towards the head of the bay with values in the range of 8.5 to 9 feet at its northern end. The surge was then amplified as it propagated up the lower Perdido River such that the U.S. Geological Survey (USGS) gauge at Barrineau Park indicated a level of 14 feet above the preceding river level. A similar effect appears to have affected the head of Wolf Bay as shown on Figure 1-10.

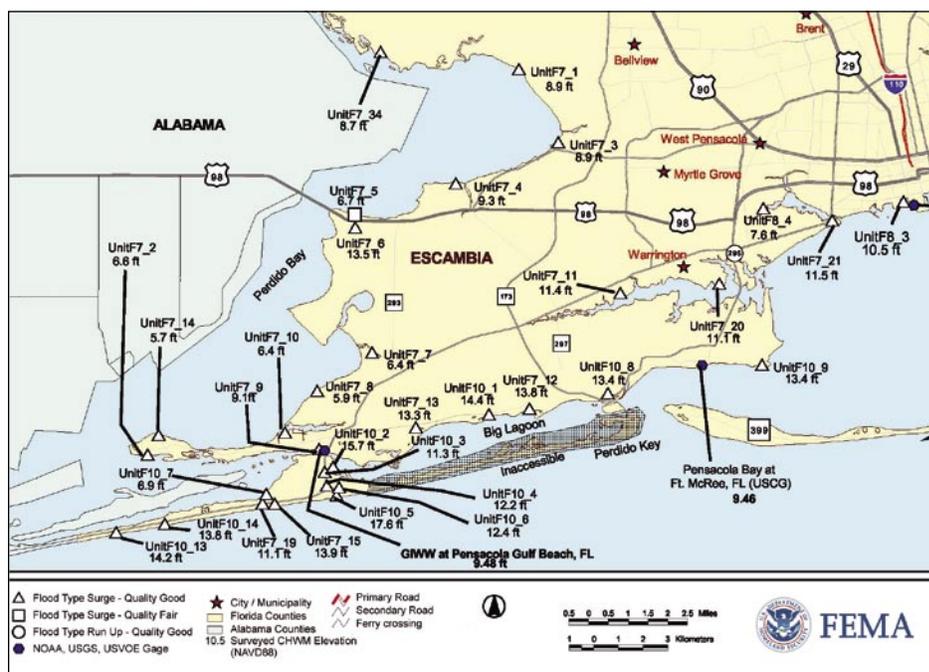
Figure 1-11. CHWM surveyed elevations for Innerarity Point and Perdido Key areas

The highest CHWM elevations in Florida occur in the Perdido Key area (see Figure 1-11). Much of this barrier island was overtopped. Such overtopping of the barrier island would allow a huge volume of water to enter Big Lagoon, and this could explain the very high CHWM elevations along the mainland coast (Figure 1-11). Figure 1-11 also shows that there was a noticeable difference in the CHWM elevation over the length of Perdido Bay. Both Ono Island and Innerarity Point have high ground well above the flood elevation. It appears that bay water was displaced towards the upper bay faster than it could be refilled from the gulf. This results in a differential in the CHWM elevations of about 3 feet over the 12-mile length of the open bay.

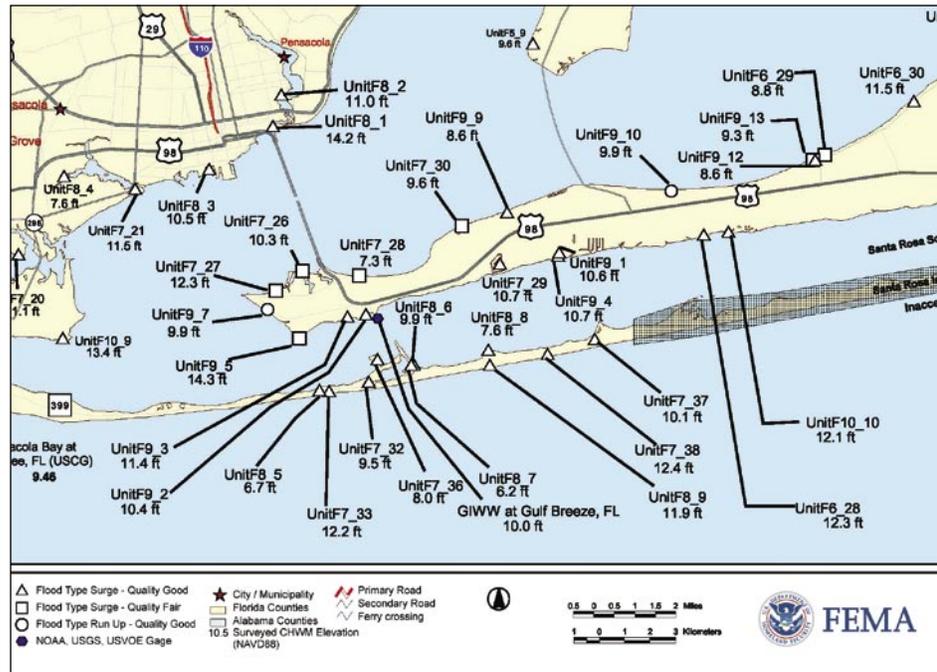
Figure 1-12.
CHWM surveyed
elevations for Pensacola/
Gulf Breeze area

Figure 1-12 shows the area between the entrance to Pensacola Bay and Garcon Point in the northwest corner. Much of the barrier island was subject to extensive damage by the surge. This includes overtopping and overwashing at many locations. The road was buried in many places, and access to the island was restricted for weeks. The surge along the Pensacola Beach Barrier Island may have been limited by the low height of the land. With nothing to back up against, the surge passed over the island into Santa Rosa Sound and lower Pensacola Bay. The differences in the CHWM elevations between the gulf and sound sides support this inferred surge behavior.

The Santa Rosa Peninsula, which lies behind the barrier island, has ground that is much higher than the maximum surge elevation. Figure 1-12 shows that the surge setup along the southern peninsula shoreline had elevations on the order of 11 and 12 feet. This is in contrast with values of 6 to 8 feet only 2 miles away across Santa Rosa Sound. These CHWM values also demonstrate that the volume of water within the Sound increased dramatically during the surge.

Figure 1-12 shows also that wind-driven water piled up along the south-facing shores of the Naval Air Station, the western suburb of Warrington, and the Port of Pensacola. This also brought high surge levels into Bayou Grande, Bayou Chico, and Bayou Texar. Maximum surge elevations throughout Pensacola Bay and the lower portions of Escambia and Blackwater Bays appear to have been on the order of 9.5 to 11 feet.

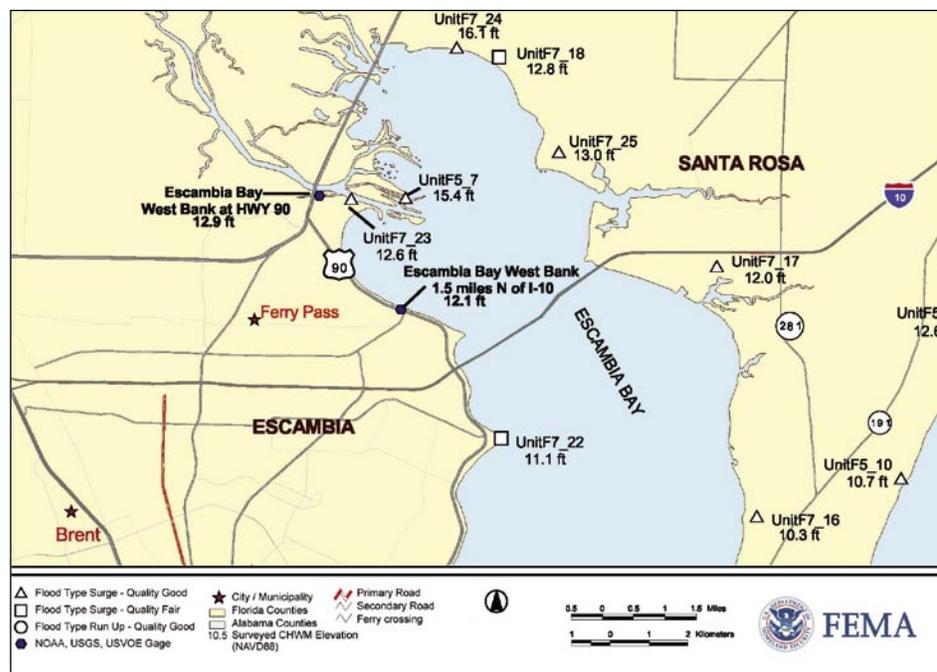
Figure 1-13.
CHWM surveyed
elevations for Upper
Escambia Bay area

Figures 1-13 and 1-14 are centered on the Escambia and Blackwater arms of the estuary. In both cases there is a clear pattern of surge amplification towards the heads of these bays. The highest observed elevation in Escambia Bay was 16 feet in Floridatown at the north end of Escambia Bay. The Ward Basin is near the north end of Blackwater Bay just south of the I-10 highway. Here, the surge elevation reached close to 13 feet. In general, the CHWM elevations are a few feet higher along the shores of the arms of the estuary than in the main portion of Pensacola Bay.

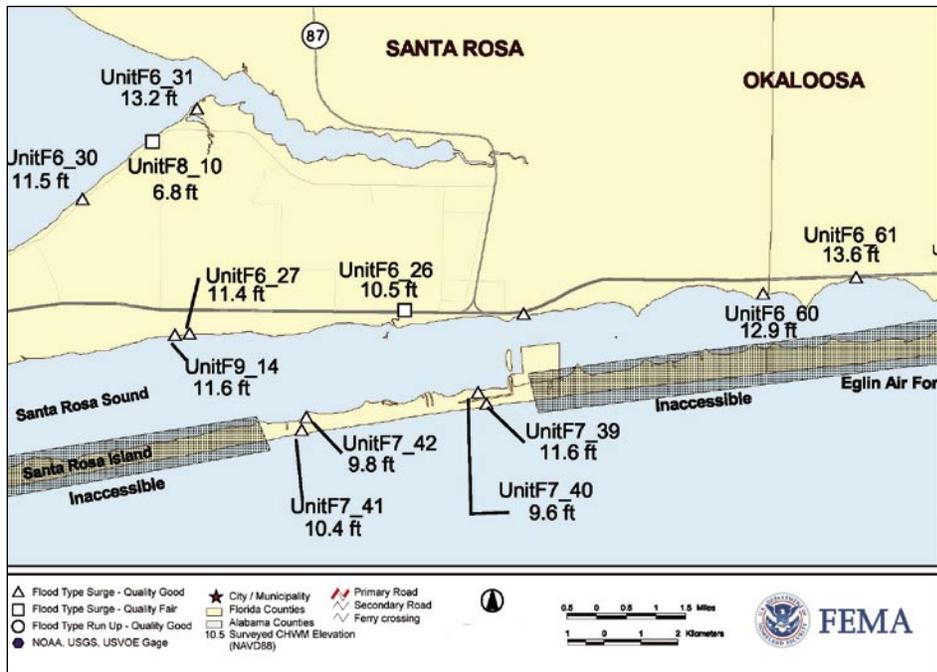
Figure 1-15. CHWM surveyed elevations for Holley Navarre area

Figure 1-15 shows the eastern portion of Santa Rosa Sound near Navarre and the East Bay arm of the Pensacola Estuary. The CHWM elevations along the open gulf shore are consistent with the values further west. Considerable portions of this part of the island were overtopped or overwashed. Much of the barrier island was inaccessible due to road damage and burial.

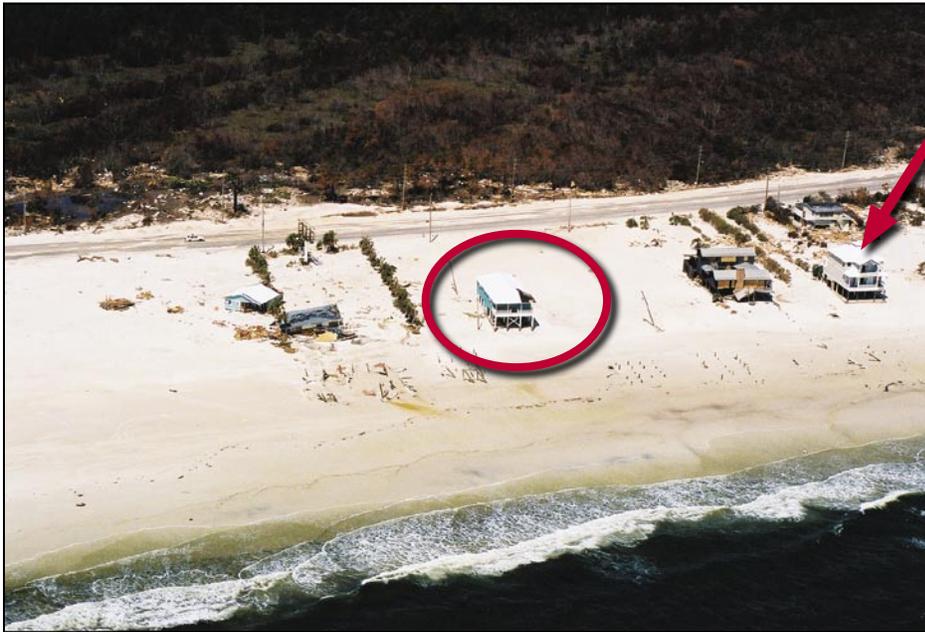
- Houses built to the 1985 BFEs and foundation requirements were generally at a disadvantage compared to those houses built to the 1983 and 2002 requirements.
- The surviving houses in Figure 2-5 were all built on pilings, even though it appears NFIP regulations did not require construction on pilings at those locations (the houses are within approximately 250 feet from the road, where all the FIRMs show Zone A).
- The surviving houses were all near the rear and middle of the beach where wave effects would have been reduced somewhat. None of the houses on the front row in this area survived.

- The surviving houses in Figure 2-5 were likely built with the lowest floor above the BFEs shown on the FIRMs. The CHWM figures in Chapter 1 show Ivan stillwater elevations of approximately 12 to 14 feet NAVD in the area, and wave heights could have been several feet higher yet (the highest BFE within 600 feet of the road was 14 feet NAVD between 1983 and 1985).

Figure 2-5. Ivan damage at the west boundary of Orange Beach. Houses are missing from piles and piles are broken near the ground level. (See Figures 2-6 and 2-7 for ground photos.) (Orange Beach/State Park boundary)

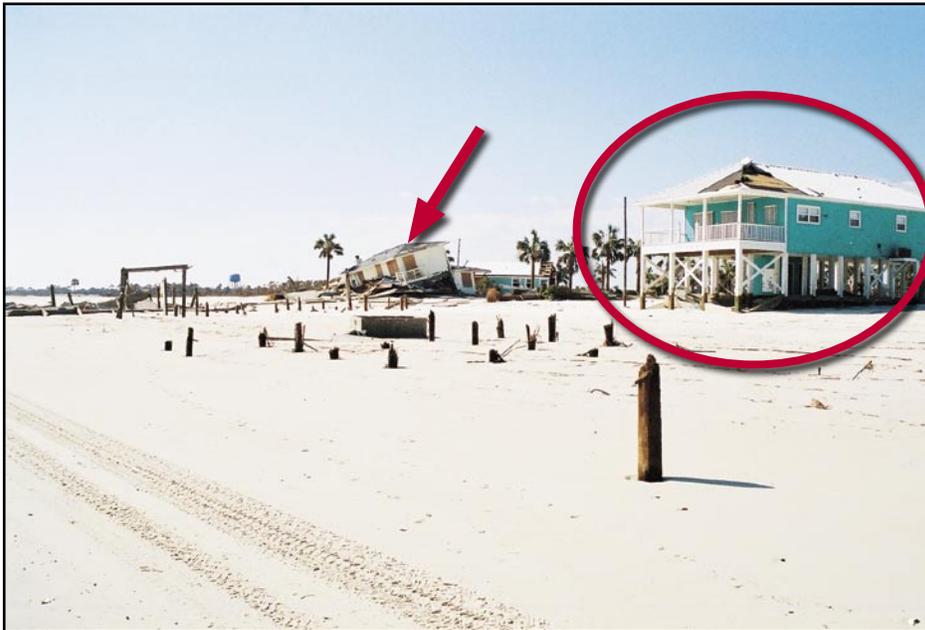
Figure 2-6. Ground photo of the same area as Figure 2-5. At this location, all houses seaward of the blue house (circled) were destroyed by Ivan. Some houses (arrow designates the left house in Figure 2-5) washed landward largely intact. Other houses were completely destroyed. The likely cause was pile breakage due to inadequate pile size and/or insufficient elevation of the houses, combined with large lateral (flood and wind) loads acting on the houses.

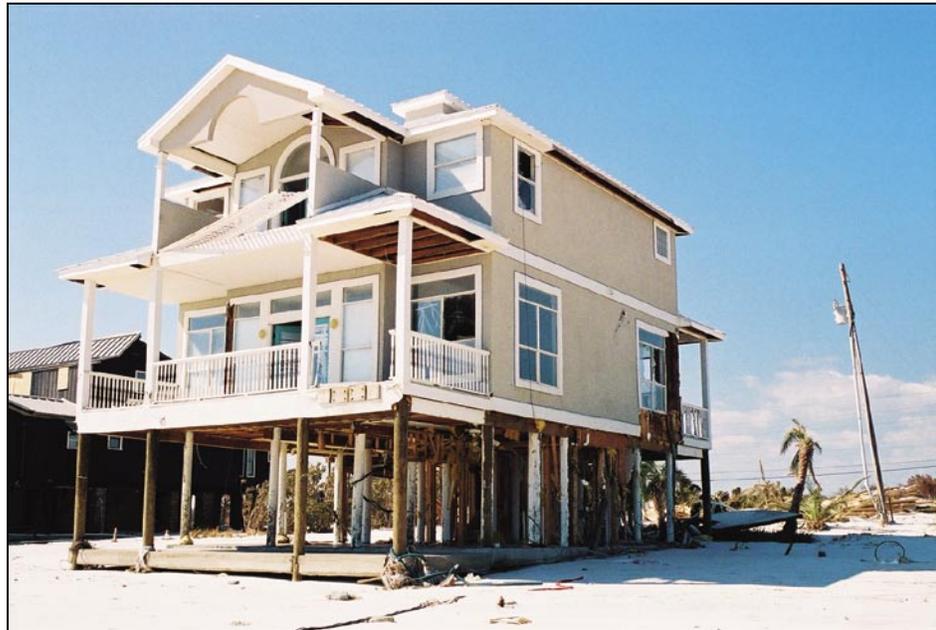
Figure 2-7. Building on the right side of Figure 2-5 survived, although it sustained destruction of the lower enclosed area and suffered extensive internal damage due to wind (soffit loss, window breakage, rainfall penetration).

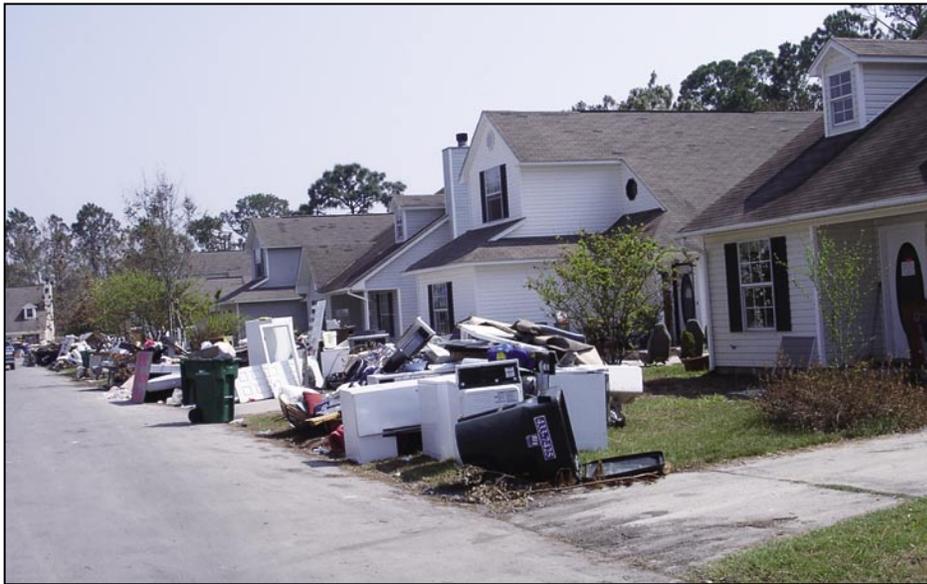
Figure 2-10 shows some of the houses in the newly mapped area. These buildings are on ground estimated at +/- 7 feet NGVD, approximately 700 feet north of Bay Street (1,000 feet from Santa Rosa Sound) and within 1,000 feet of Harrison Avenue. The FIRMs in Figure 2-9 show the changes that have occurred in the vicinity. The houses were constructed in flood hazard Zone B, outside the SFHA shown on the 1985 FIRMs, but had 2 to 4 feet of water inside as a result of Hurricane Ivan. Some property owners said their lenders had not notified them when the flood maps changed, and they had not purchased flood insurance.

Figure 2-10. Typical houses at Birdseye Circle, which had 2 to 4 feet of flooding inside the houses. This area was mapped as being outside the SFHA on the 1985 FIRM, which likely governed the construction standards that were followed when the house was built.

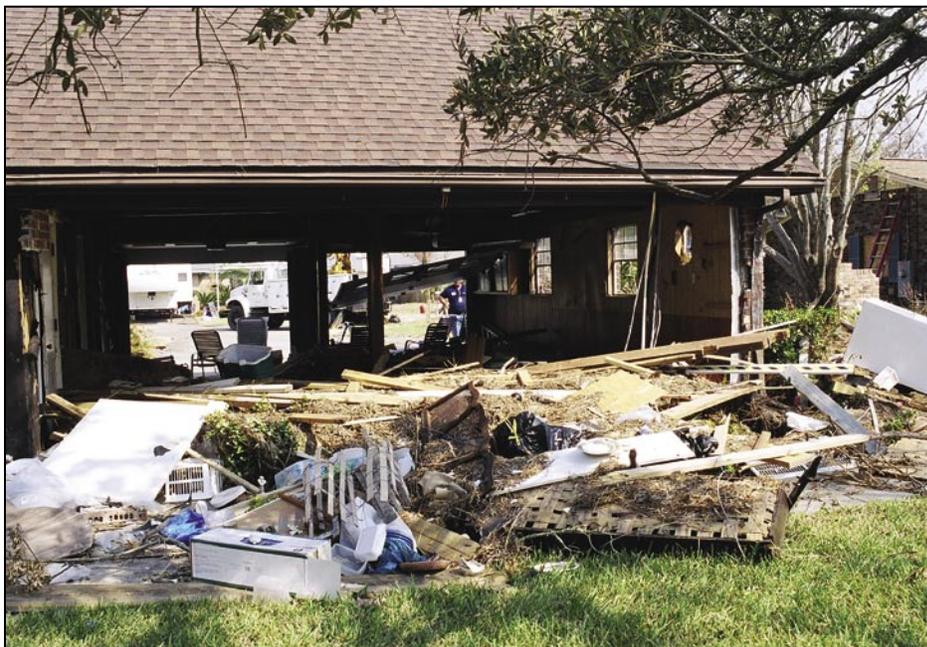
Many houses constructed along the west end of Bay Street (approximately 1 mile west of Harrison Avenue) were older, pre-FIRM houses, and were likely built on land with grade elevations of 5 to 6 feet NGVD. These houses were later mapped by the 1985 FIRM as Zone B or Zone AE with a BFE of 7 feet NGVD and by the 2000 FIRM as Zone AE with a BFE of 9 feet NGVD. Figure 2-11 shows a typical house along the west end of Bay Street that was damaged heavily during Ivan. The house

was most likely in Zone B at the time of construction (but is currently mapped as Zone AE elevation 9 feet NGVD). The figure shows significant damage due to storm surge and wave and floating debris impacts, which are typical of V-Zone conditions. The HWM (stillwater) in this area was approximately 11 feet, as shown on Figure 1-12. Based on FEMA's current flood hazard mapping methodology, the 11-foot stillwater elevation and a ground elevation of approximately 6 feet would yield a wave crest elevation of approximately 13 to 14 feet NGVD during Ivan. The house shown in Figure 2-11 undoubtedly experienced V-Zone conditions during Ivan.

Figure 2-11. Typical damage to houses along Bay Street that were impacted by surge and wave effects from Santa Rosa Sound. This house on the west end and south side of Bay Street was constructed with a slab-on-grade foundation. The house was either pre-FIRM or constructed in Zone B (1985 FIRM) and is currently mapped as Zone AE with a BFE of 9 feet. The house undoubtedly experienced V-Zone conditions. (Santa Rosa County)

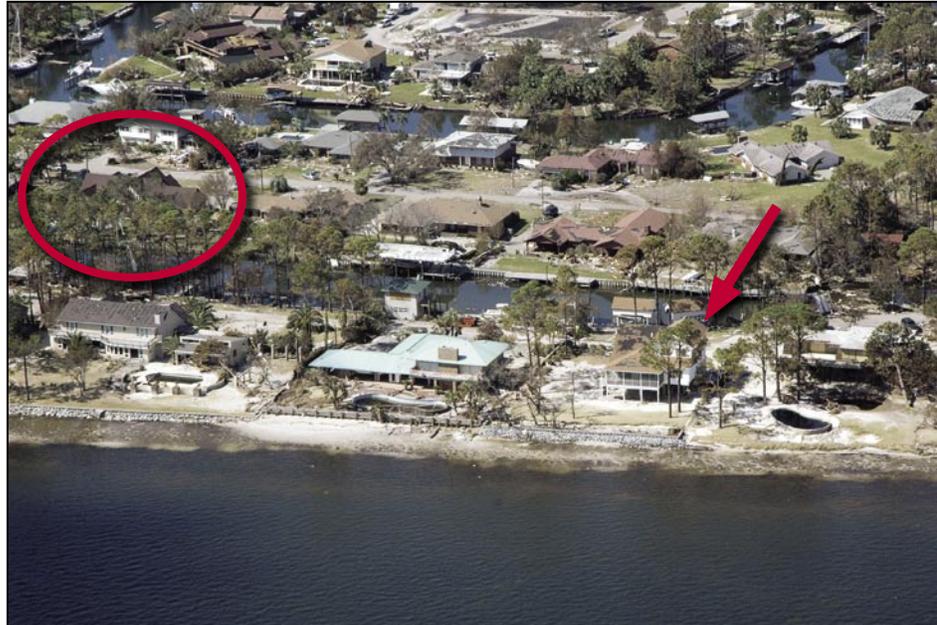
Figure 2-12 is an aerial photograph showing houses along Bay Street (above the canal) that were impacted by storm surge, waves, and floodborne debris. These houses were likely constructed in Zone B, according to the 1985 FIRM; however, many were likely built prior to the 1985 FIRM. Although the surge and wave impacts from Hurricane Ivan in the area produced V-Zone conditions, the current FIRM shows these houses in Zone AE with a BFE of 9 feet.

Figure 2-12 also shows houses constructed along Santa Rosa Sound that experienced different levels of damages based on the elevations of their lowest floors. The white house on the bottom right was constructed above the BFE on a pile foundation and higher than other nearby houses, which were constructed on a slab or stem wall foundation. The lower houses were severely damaged by storm surge, waves, and debris impacts. The white house and other nearby pile-supported houses along this shoreline appear to have been constructed several feet above the BFE, which prevented significant flood damages; based on elevation certificates, two of the pile-supported houses in this area were constructed to an elevation of 15 feet, over 5 feet above the minimum elevation requirement.

Figure 2-12. Aerial view of houses along Bay Street (above the canal) and Santa Rosa Sound that were heavily damaged by storm surge and wave impacts. The circled house is the same house shown in Figure 2-11. The house on the lower left is the same house shown in the background of Figure 2-13. Houses elevated above the BFE on pilings (see arrow) sustained far less flood damage than houses at lower elevations.

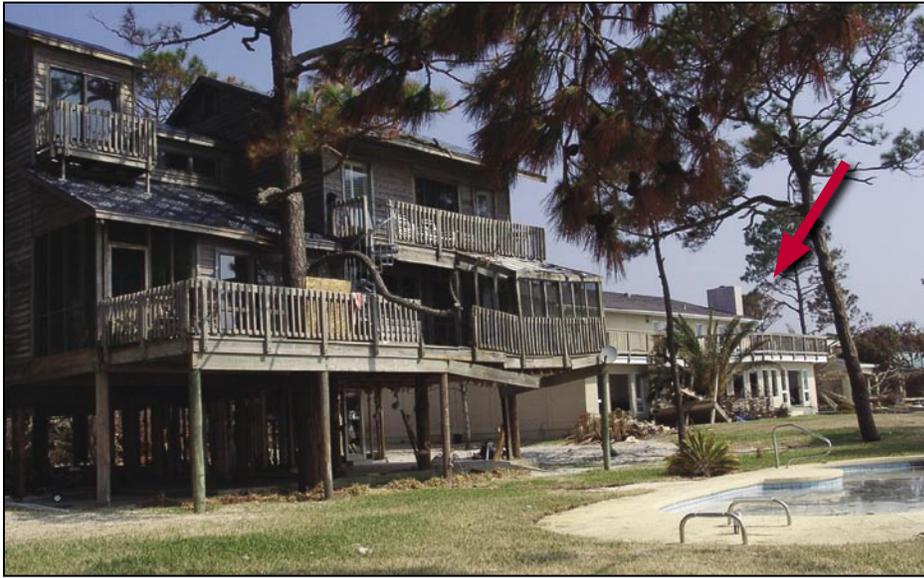
Figure 2-13. The house in the foreground was constructed on piles and had minimal flood damage during Ivan, although it lost a pile support for the deck. The house in the background (see arrow) was constructed at much lower level and sustained significant flood damage throughout the first floor. The damaged house is also shown on the left side of Figure 2-12.

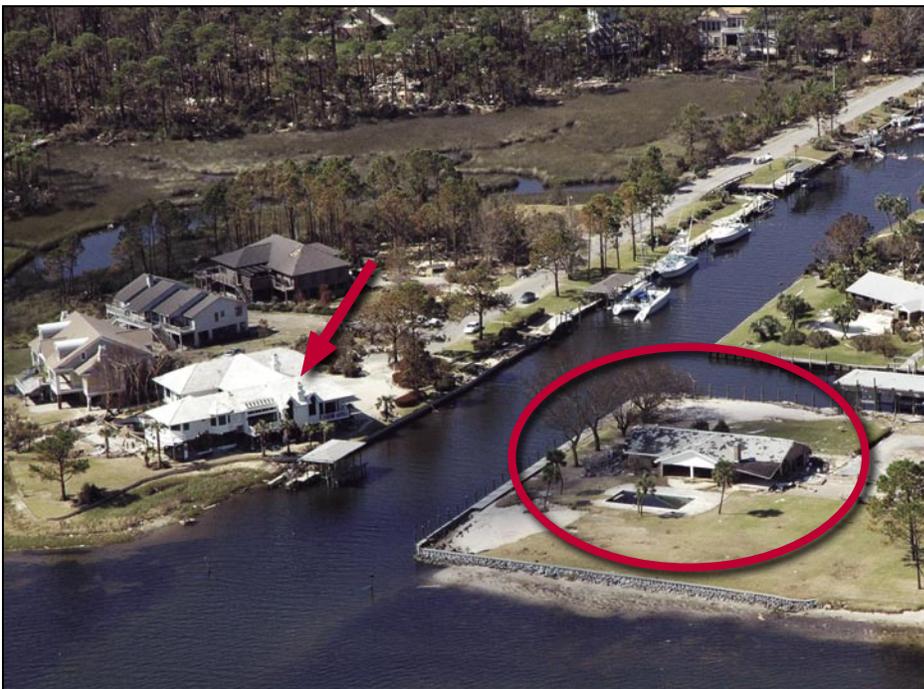
Figures 2-14 and 2-15 show a house on Santa Rosa Sound that was heavily damaged by waves and floodborne debris. The house was likely constructed when the area was mapped as Zone B, but the effective FIRM shows the house in Zone AE with a 10-foot BFE. Like the other nearby houses, this house undoubtedly experienced V-Zone conditions during Ivan. Had this house been elevated on a substantial pile foundation, as was the house west of the canal entrance (see arrow) or the white house in Figure 2-12, the flood damage would probably have been minimal.

Figure 2-14. The house on the right (circled), which is at the west end of Del Mar Drive, south of Bay Street, along the Santa Rosa Sound, was heavily damaged by storm surge and wave and debris impacts. The same house is shown in Figure 2-15. The effective FIRM shows the house in a Zone AE with a BFE of 10 feet. Note minimal flood damage occurred to the newer, pile-elevated house west of the canal entrance (arrow).

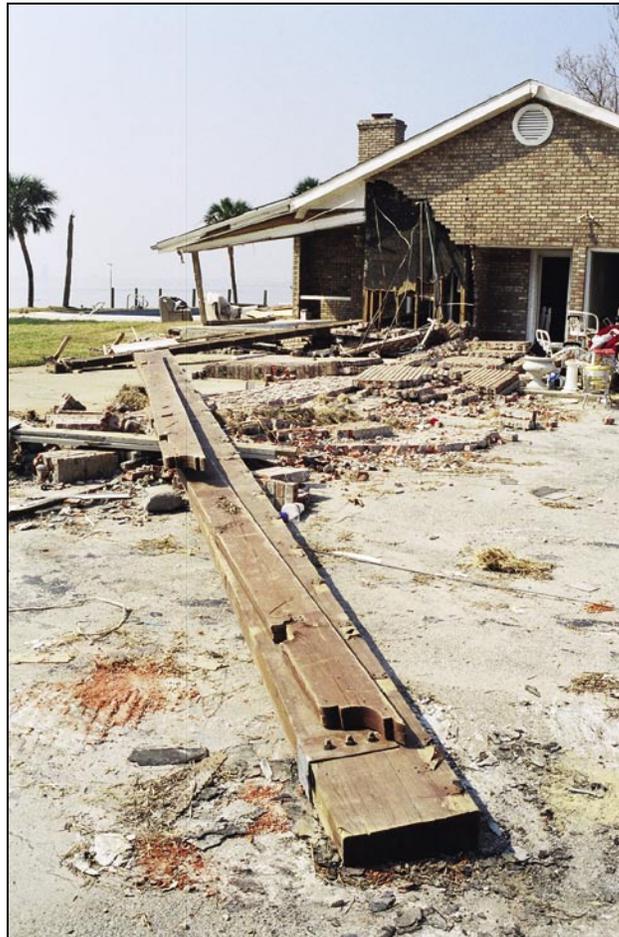
Figure 2-15.
This house, located on Santa Rosa Sound and circled in Figure 2-14, was severely damaged by surge, wave, and debris impacts. The large timber that washed into the house reportedly originated across the Sound in Pensacola Beach

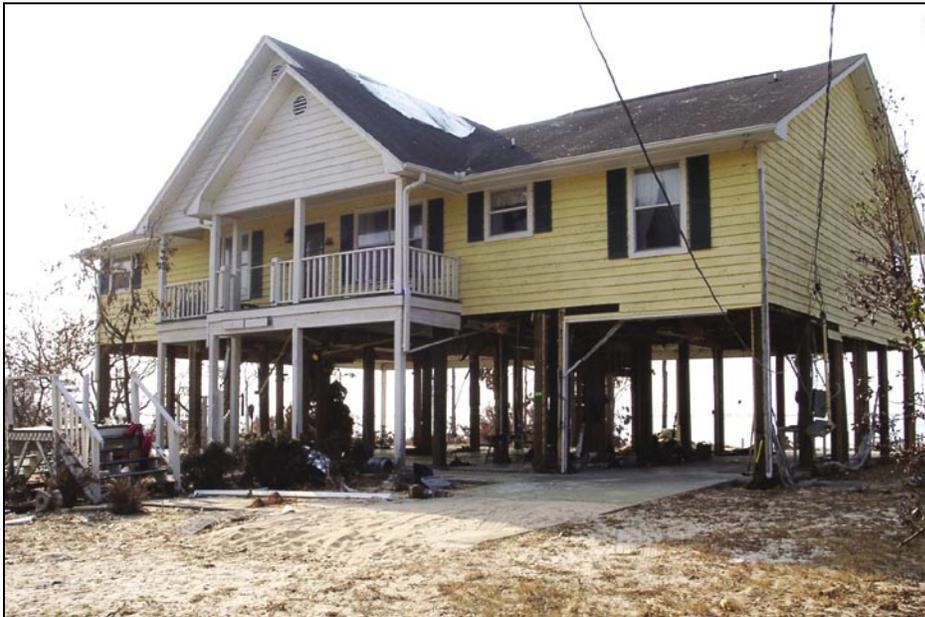
Figure 3-5.
Buildings constructed
on piles and elevated
several feet above the
BFE sustained less flood
damage than adjacent
buildings at lower
elevations. (Big Lagoon)

severe surge, wave, and debris damage when flood levels exceeded the BFE by 2-4 feet. Note that Figure 3-5 shows a pile-elevated building near the building shown in Figure 3-8.

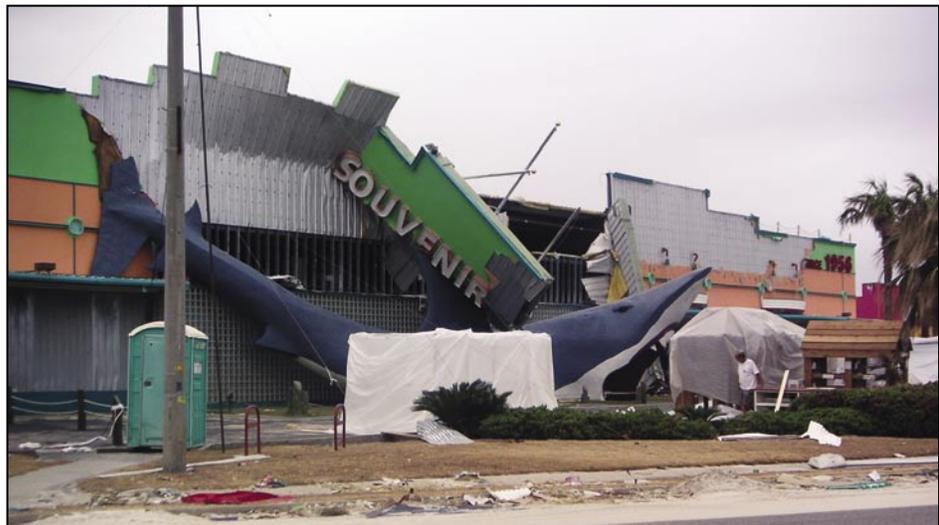
Figure 3-24.
Pre-engineered metal
building damage
(Orange Beach)

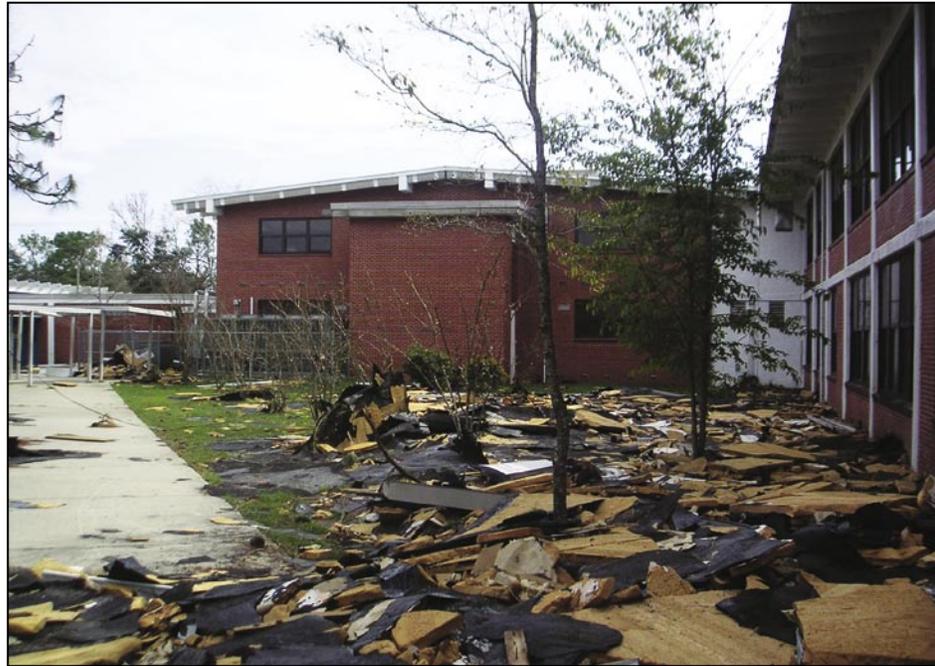
The MAT focused on the damage and loss of function observed at many critical and essential facilities such as hospitals, schools, and shelters. Damage and resulting loss of function was most often the result of building envelope damage, as seen in Figures 3-25 and 3-26. Rooftop equipment damage was widespread. Little structural wind damage was observed.

Figure 3-26.
Roof covering and roof
deck damage to middle
school (Pensacola)

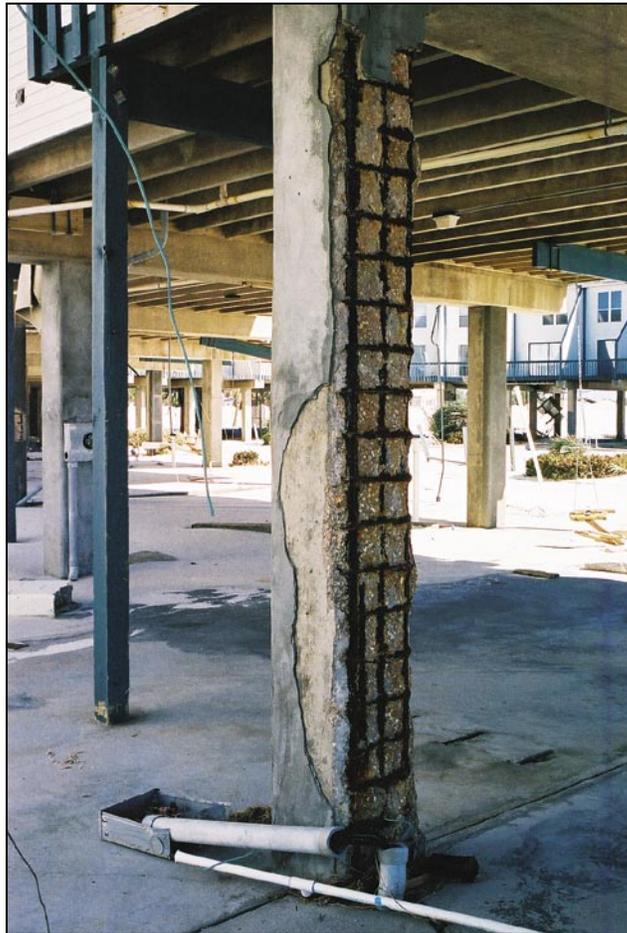
Figure 3-28. Severe corrosion of reinforcing steel and spalling of the concrete columns supporting the post-Frederic building shown in Figure 3-27. Note evidence of prior attempts to repair the columns.

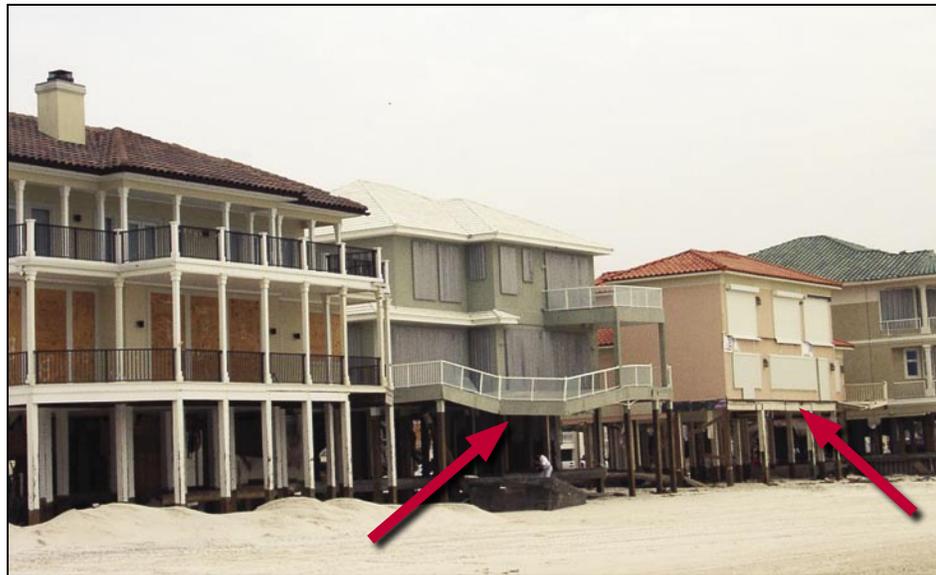
In instances where pile-elevated buildings had their lowest floor at or just below the wave crest elevation during Ivan, damage to the floor system was observed. Figure 4-5 shows a typical example, where the piles and shore-perpendicular floor beams performed as intended, but where the wave crests struck the shore-parallel floor joists. The

Figure 4-5. Floor joists were pushed landward when the wave crest elevation was above the floor beam. (Gulf Shores)

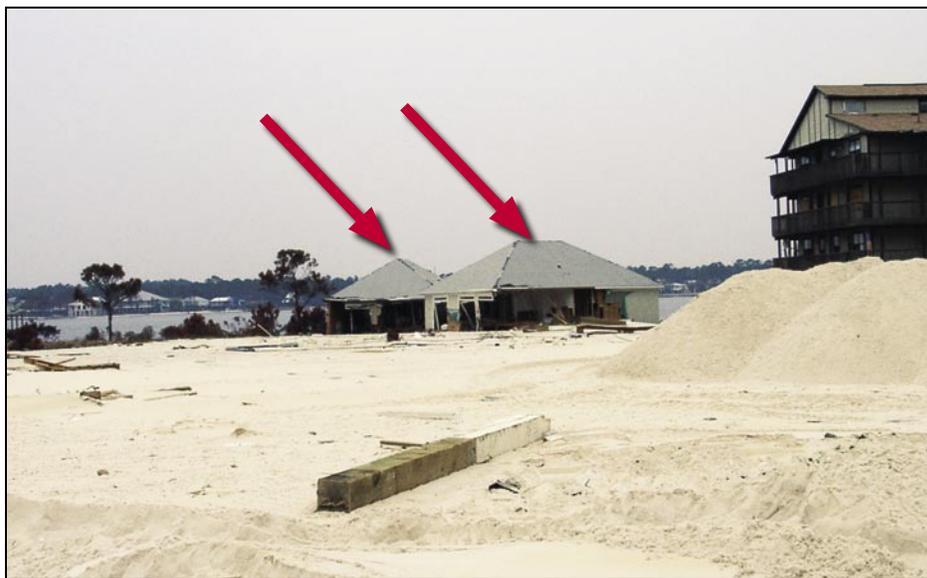
Figure 4-9. These houses floated off their pile foundations (shown in Figures 4-8 and 3-2), probably a result of inadequate pile embedment.

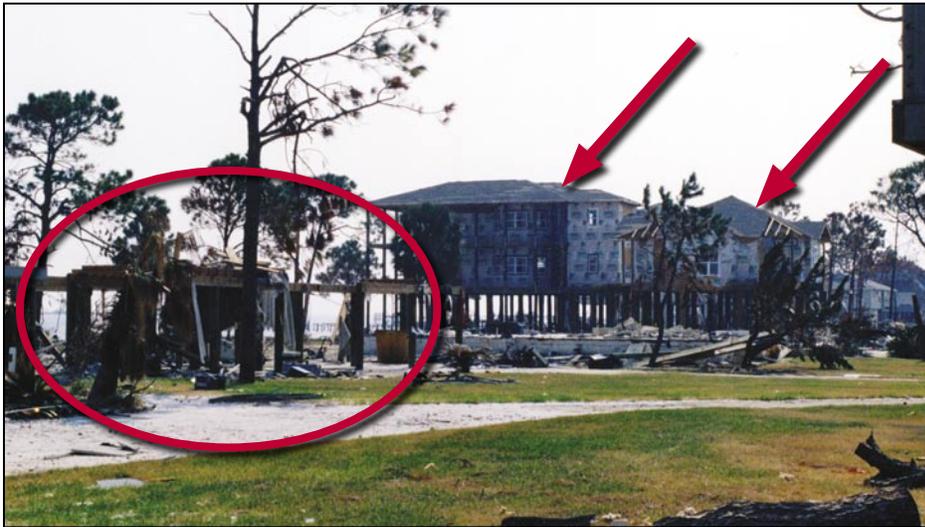
Figure 4-12. House at left (circle) was torn from its pile foundation. New houses under construction (arrows, see Figure 4-31 also) survived Ivan (Big Lagoon).

The destroyed house on the left side of Figure 4-12 was in the Grande Lagoon neighborhood, approximately $\frac{3}{4}$ mile across Big Lagoon from the barrier island, Perdido Key. Perdido Key was completely overwashed by Ivan, and stillwater flood levels in the vicinity of Grande Lagoon were approximately 13 to 14 ft NGVD (see Figure 1-11), with wave crest elevations higher. Flood hazard zones and BFEs shown on the FIRMs for this area ranged from VE, elevation 11 feet NGVD, to AE, elevation 9 feet NGVD. Figure 4-13 shows the same house (circled) with several nearby, pile-elevated houses that were also destroyed. It should be noted that some older but intact houses in the neighborhood were observed to have poor connections between the floor beams and the elevated houses. Wind might also have contributed to the structural failures seen in Figures 4-12 and 4-13.

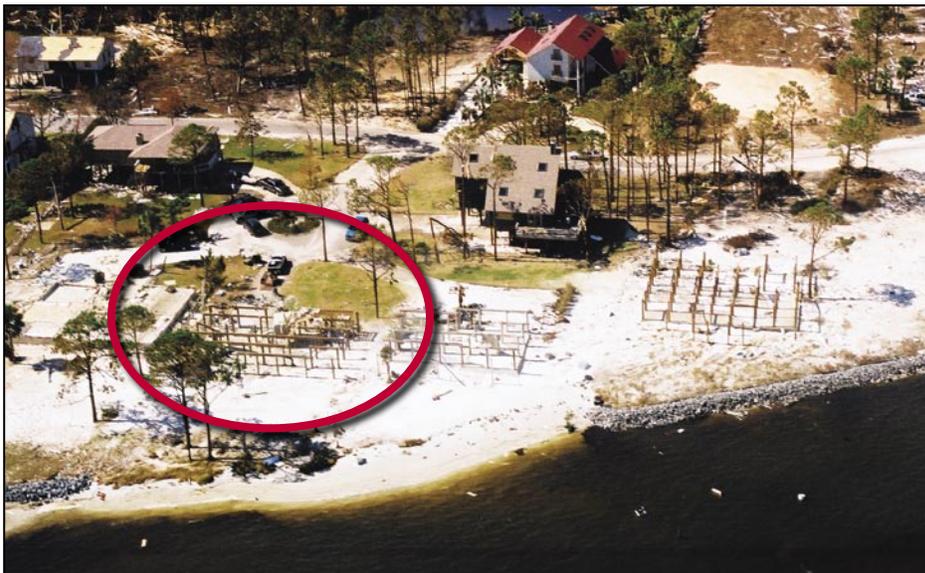
Figure 4-13. Same destroyed house as in Figure 4-12 (circled). Note adjacent pile-elevated houses near shoreline, also destroyed (Big Lagoon).

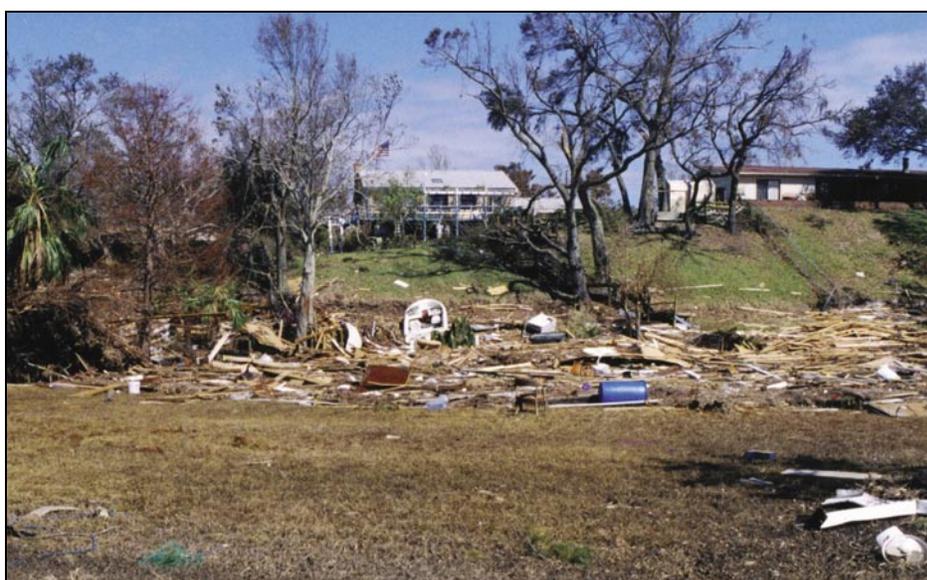
Figure 4-16. Ground view of some of the debris shown in Figure 4-15.
