Mitigation Assessment Team Report

Hurricane Ivan in Alabama and Florida

Observations, Recommendations,
and Technical Guidance

FEMA 489 / August 2005

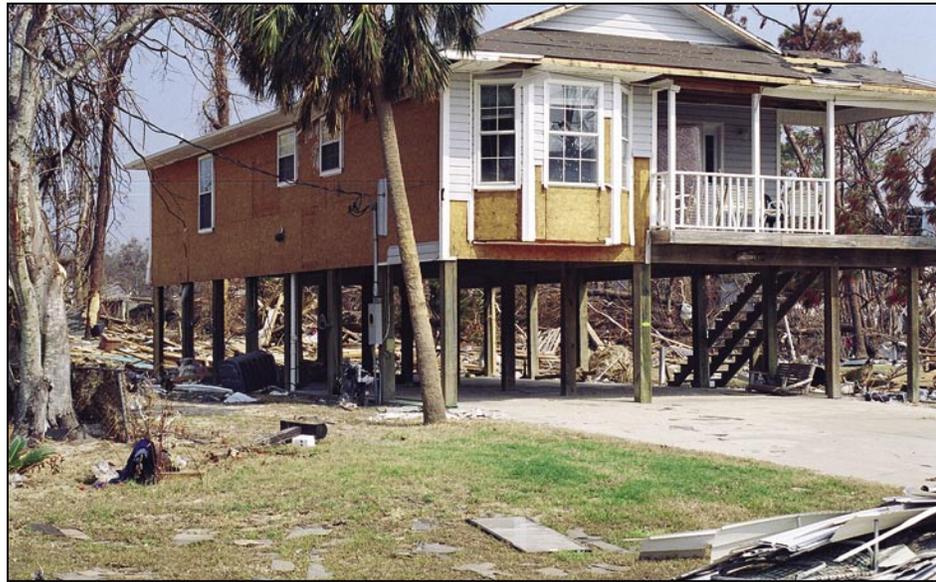
Figure 4-17. This house located near Sinton Drive successfully resisted flood forces since it was elevated higher than the BFE on piles (note the wind damage: loss of vinyl siding, soffit and roof covering). Lower, adjacent houses (see Figure 4-18) were destroyed. (Big Lagoon)

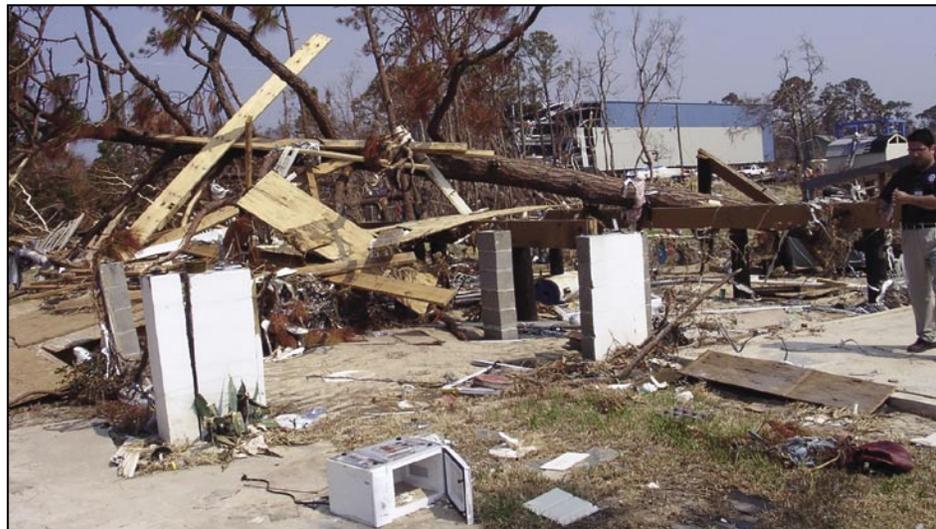
Figure 4-18. This photo shows the destroyed building adjacent to the house in Figure 4-17. It was destroyed (knocked off the masonry pier foundation) by some combination of storm surge, wave and debris impacts, and wind. (Big Lagoon)

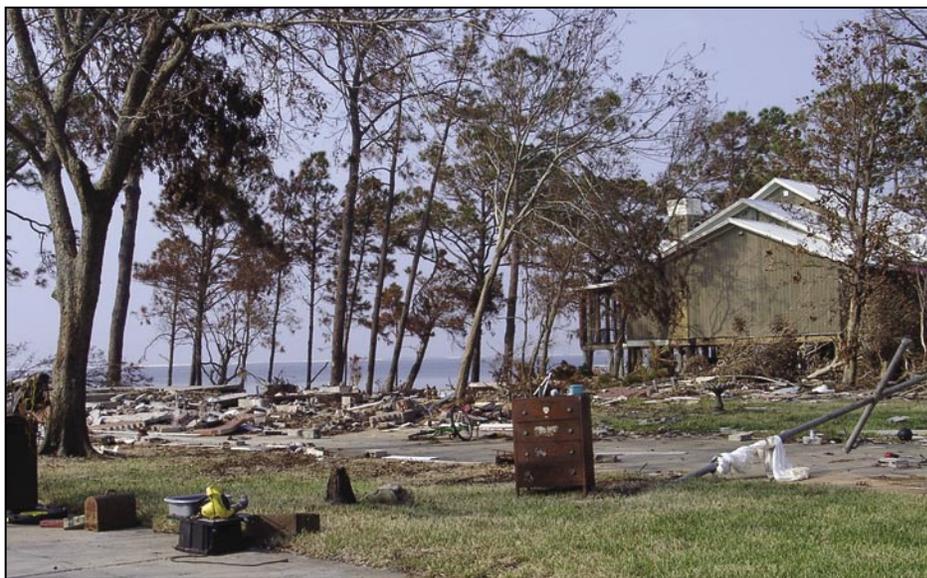
Figure 4-19. The pre-FIRM building constructed on a slab foundation (foreground) was completely destroyed, yet the adjacent building constructed on piles at a higher elevation remained intact and suffered relatively little damage. (Big Lagoon)

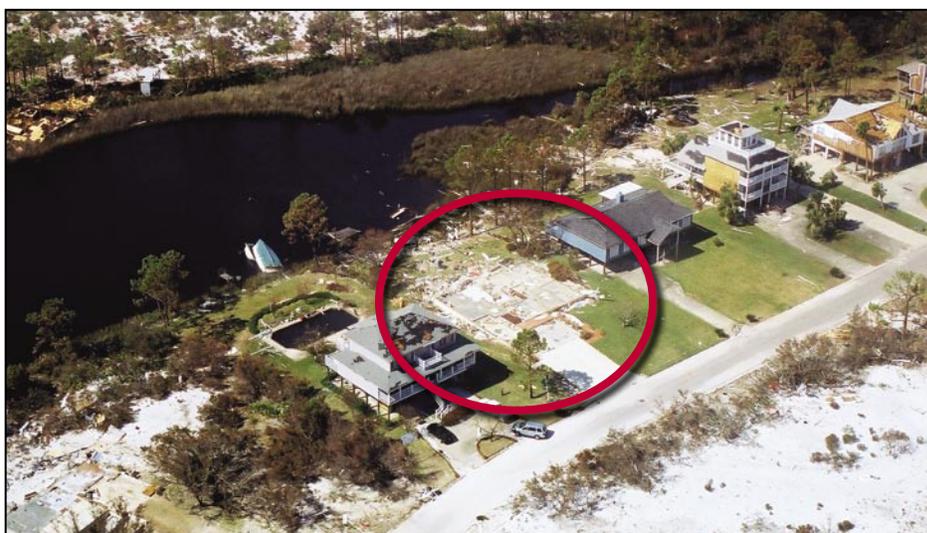
Figure 4-20. Destruction of slab-on-grade house (circled) in the Grande Lagoon neighborhood. Adjacent houses elevated on piles above the BFE sustained destruction of ground level enclosures and some wind damage, but survived. (Big Lagoon)

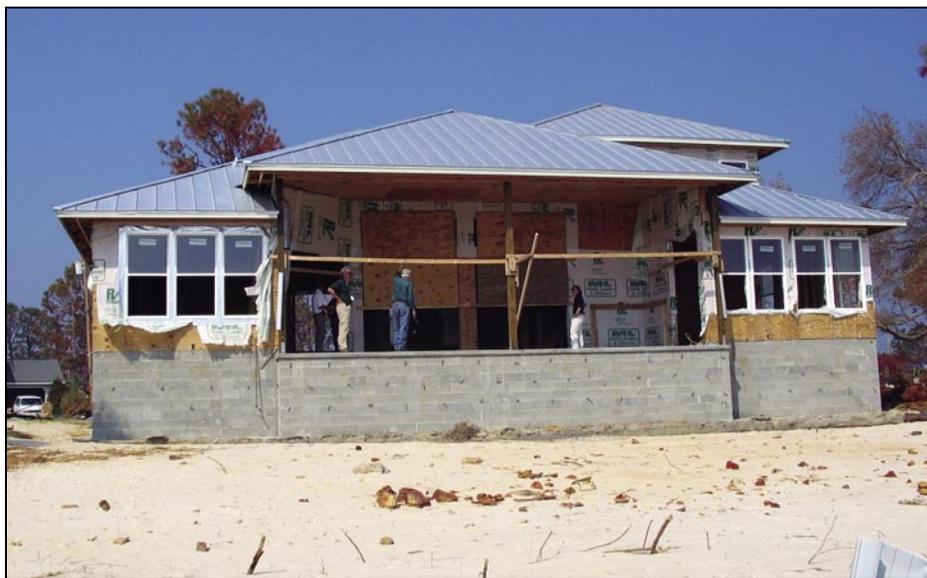
Figure 4-26. This stem foundation elevated the house above the BFE and performed well. The house, which was under construction at the time of Ivan, sustained minor flood damage to the walls and the columns under the porch. (Tiger Point, Santa Rosa Sound)

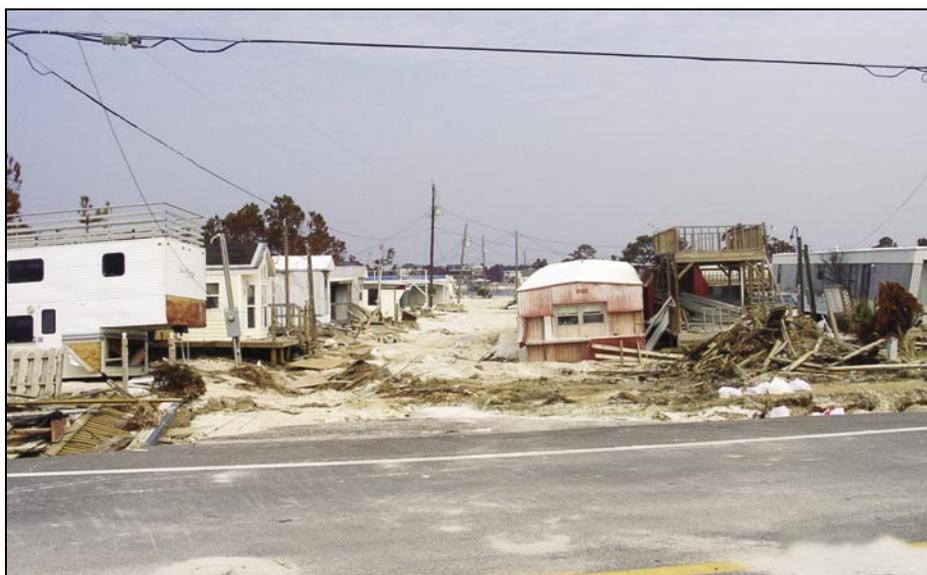
Manufactured houses placed on unreinforced, dry-stacked block piers were observed to shift in some cases due to the storm surge and wave action effects. Figures 4-30 through 4-32 provide several examples of piers shifting under manufactured houses. These types of piers are not suitable for coastal areas.

Figure 4-30. Manufactured home park where houses experienced storm surge, scour, and foundation collapse (Orange Beach)

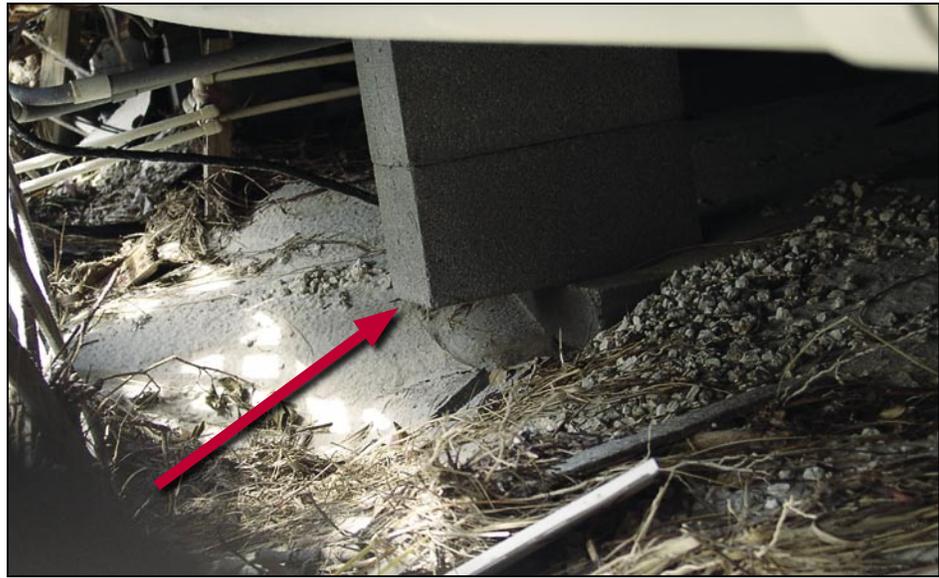
Figure 4-31.
Unreinforced, dry-stacked
block piers slid off of
footings. (Orange Beach)

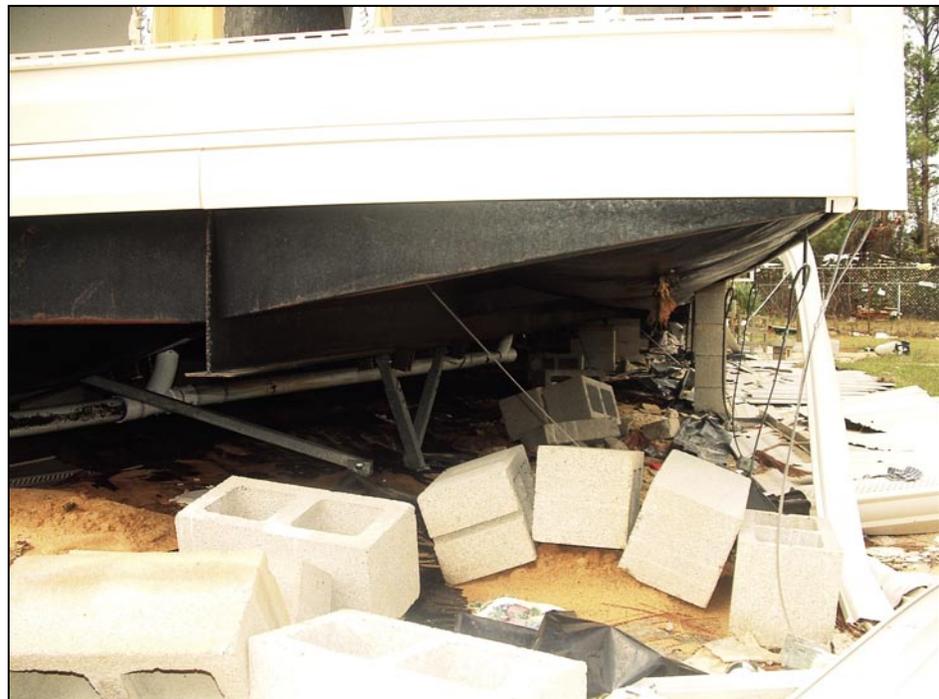
Figure 4-32.
Dry-stacked pier failure
(Orange Beach)

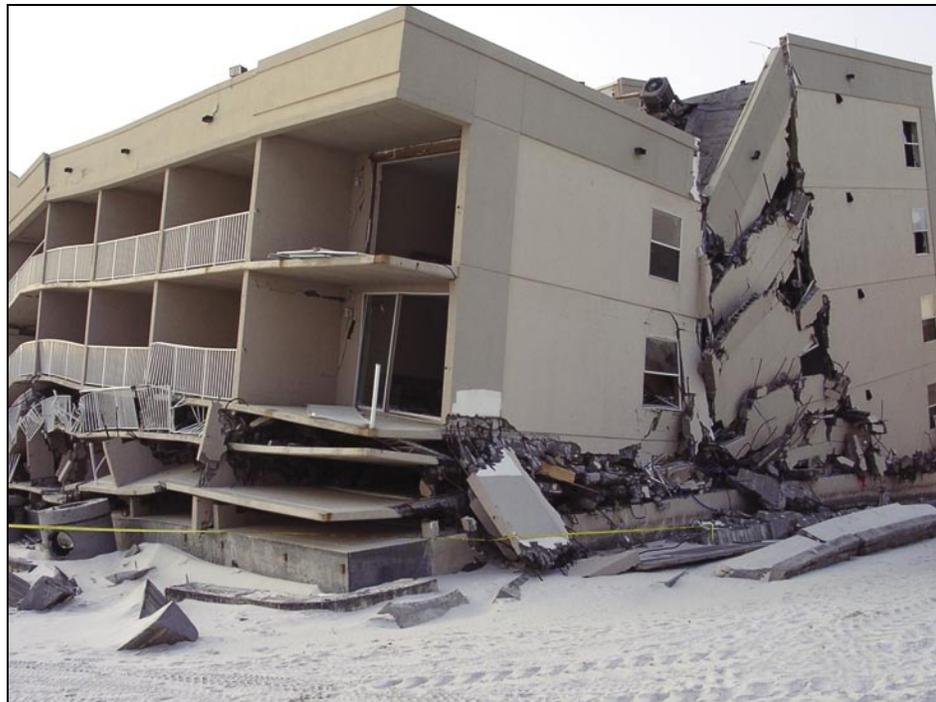
Figure 4-34.
Close-up of building
shown in Figure 4-33
(Orange Beach)

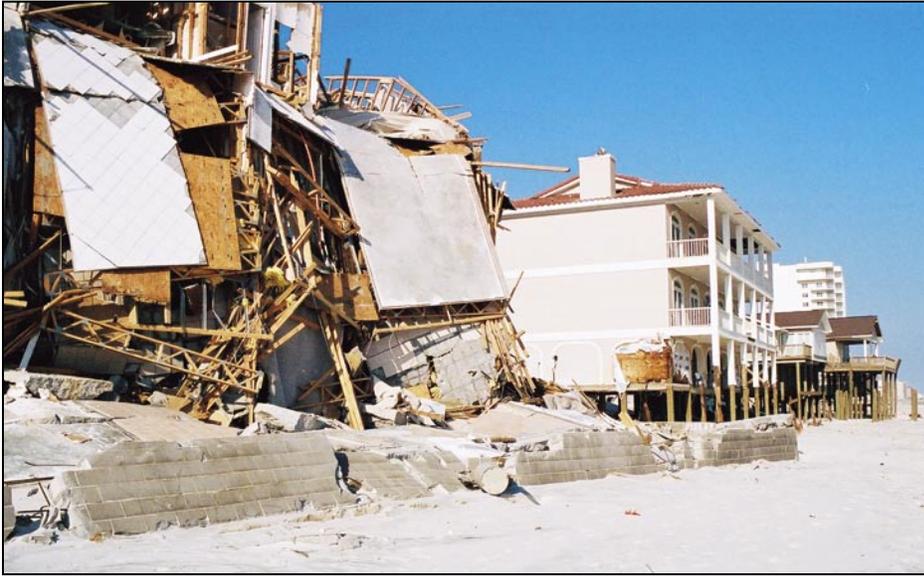
Figure 4-35. Shallow foundation failure. Note success of pile support structures in the background. (Orange Beach - Perdido Key)

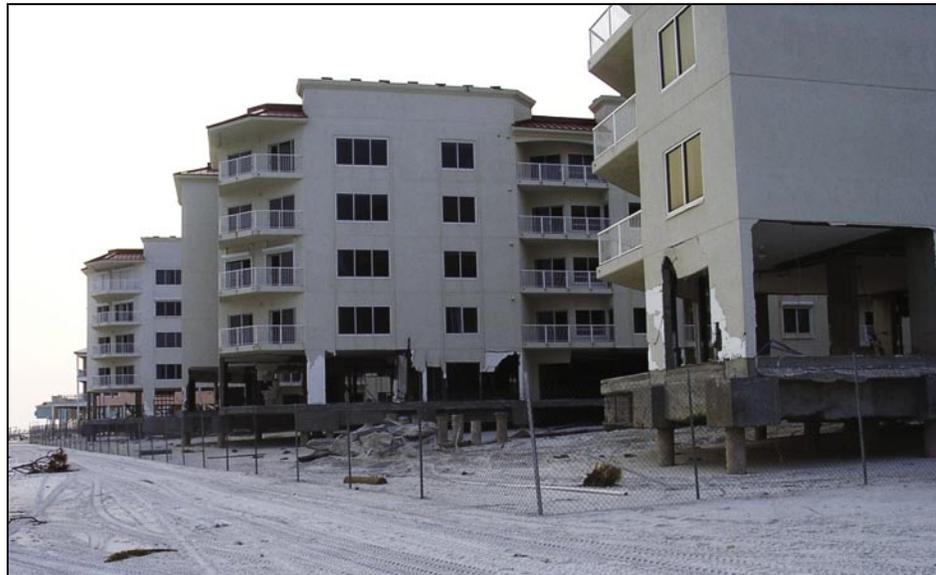
Figure 4-42.
Multi-story buildings on piles, impacted by storm surge, waves, and erosion, which damaged many lower area walls and floors (Orange Beach)

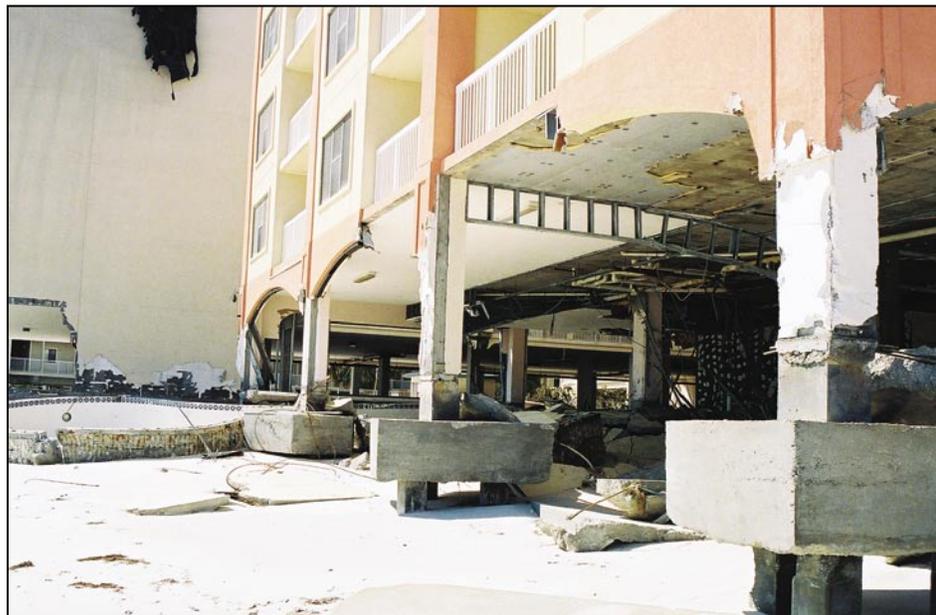
Figure 4-43.
Although the pile foundation and structural elements survived, damage to lowest floor exterior walls, interior partitions, and floor slabs occurred during Ivan. (Orange Beach)

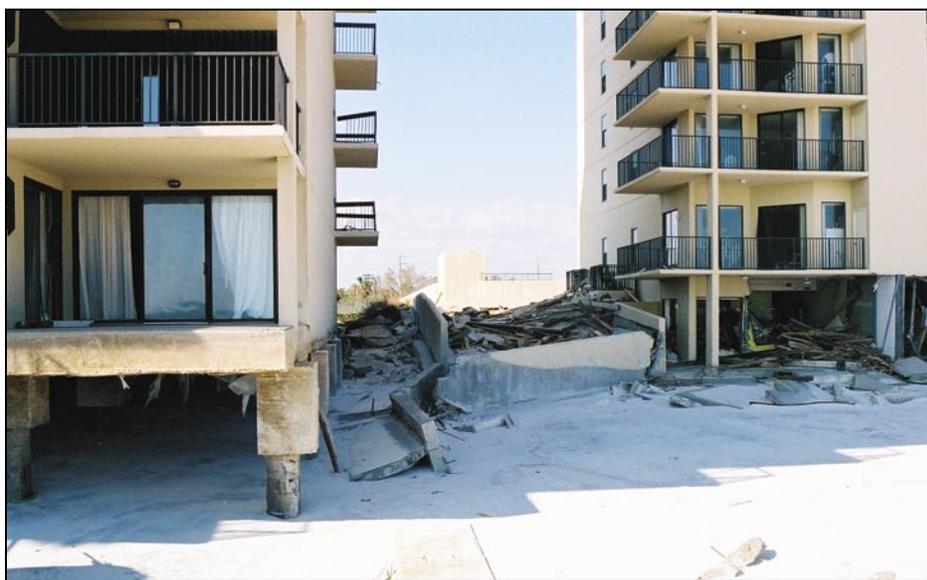
Figure 4-44. Pile foundations alone are not enough; elevation of the lowest floor is also critical. The building on the left shows minimal damage, while the building on the right with the lower-level living units experienced significant non-structural damage. (Orange Beach)

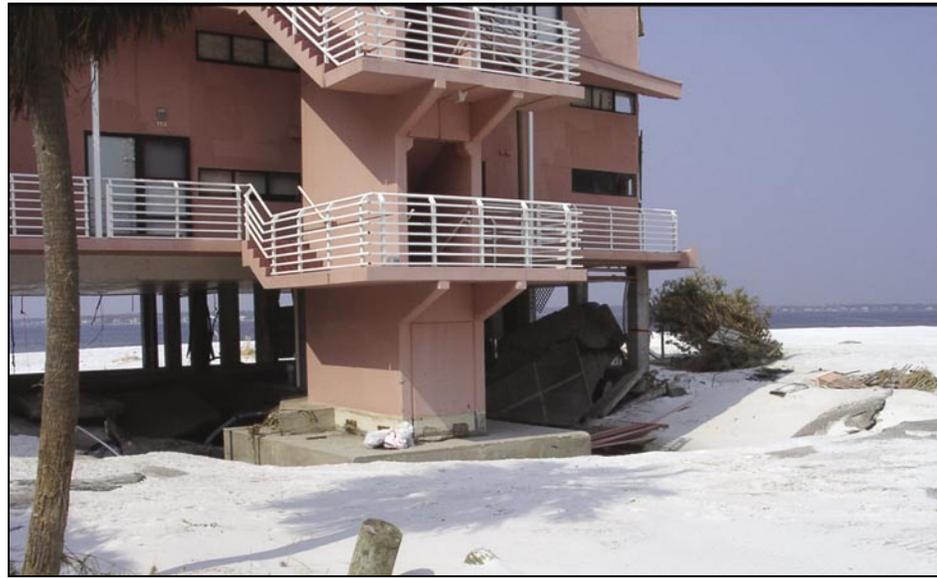
Figures 4-45 and 4-46 show a pile and column supported building at Pensacola Beach that sustained little flood damage, despite severe scour around its foundation, since use of the grade level area was limited to parking and building access.

Figure 4-45.
This condominium on a deep foundation is located on the back side of the barrier island, north of Ft. Pickens Road. This building was severely damaged by wind, along with some utility damage in the lower level, and severe scour around the concrete pile caps. Since it was constructed on deep foundations and there were limited enclosures below the first floor, damage caused by storm surge was limited. (Pensacola Beach)

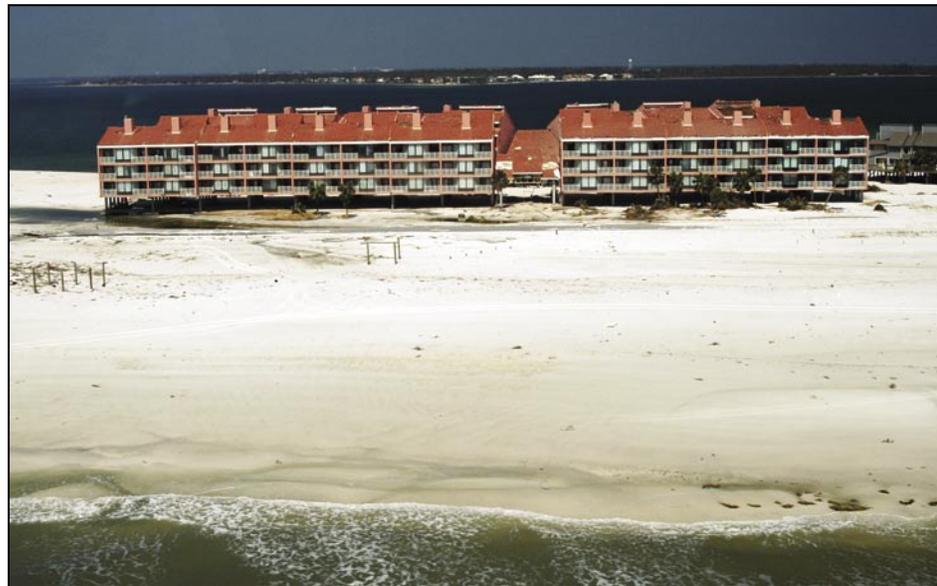
Figure 4-46.
Aerial view of the building shown in Figure 4-45 (FL DEP photo) (Pensacola Beach)

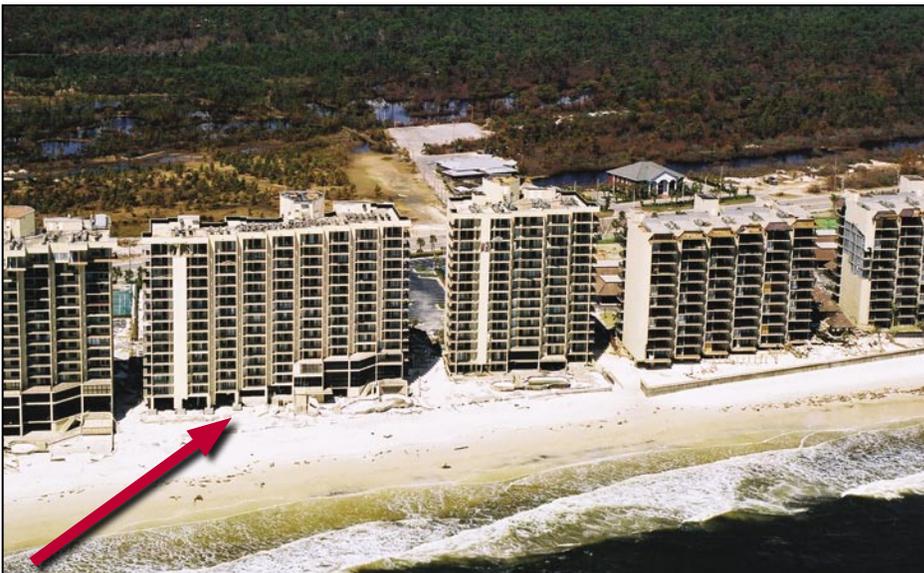
bulkheads, pools, decks, and lower floor spaces were damaged or destroyed. Figure 4-49 again illustrates the relative damages associated with deep and shallow foundations during Ivan; the 5-story building in the center (shallow foundation) collapsed, while the buildings on either side (deep foundations) sustained flood damage to the ground level enclosures and parking areas only.

Figure 4-48. Most of the first floor units in these buildings were severely damaged (see Figures 4-53 and 4-54). (Orange Beach)

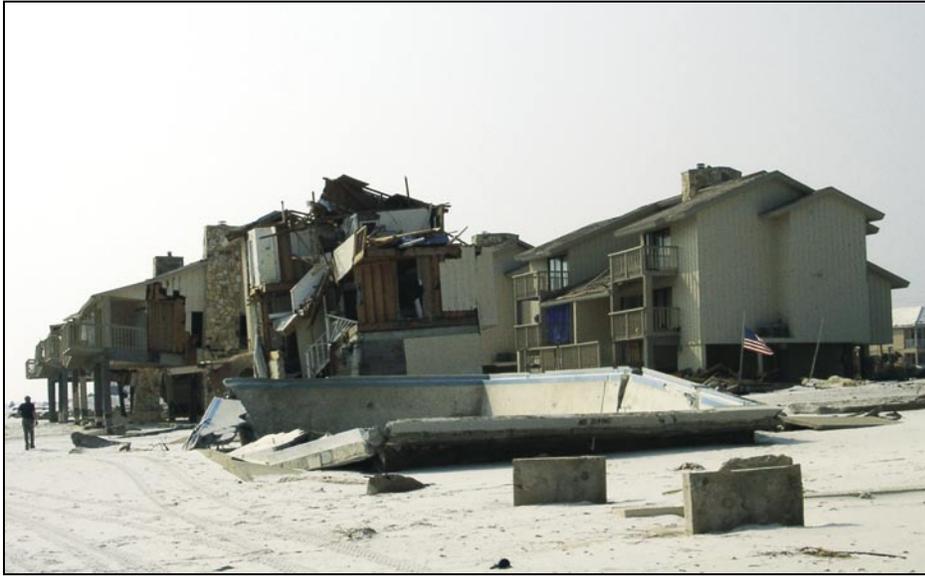
High storm surge, waves, and erosion resulted in frequent damages to bulkheads, pools, and pool decks. Figure 4-50 shows a typical pool failure. Lightweight bulkheads (particularly those constructed of vinyl and timber) sustained significant damage during Ivan (see Figures 4-51 and 4-52). Some concrete bulkheads failed, but the more substantial ones remained intact. However, even intact concrete bulkheads were sometimes overtopped and suffered erosion on the landward side (see Figures 4-53 and 4-54).

Figure 4-50.
Typical pool failure
(Pensacola Beach)

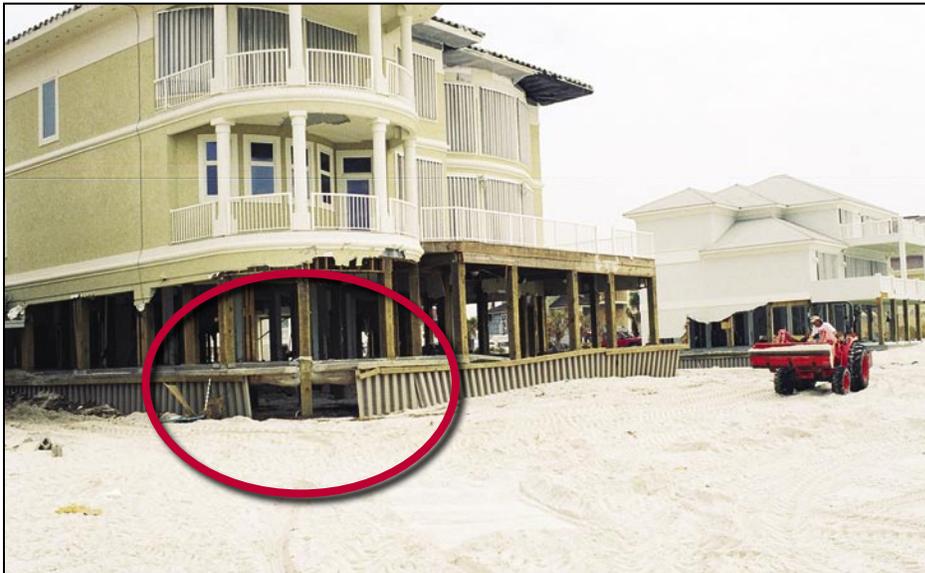
Figure 4-51.
Retaining wall failure
(Gulf Shores)

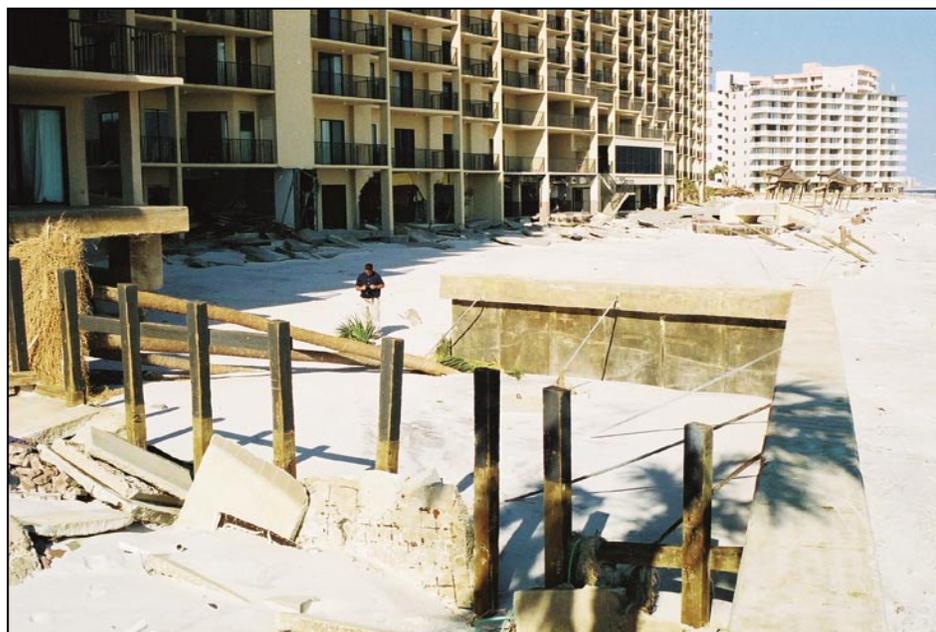
Figure 4-53.
Bulkhead remained intact, but short return wall allowed erosion
(Orange Beach)

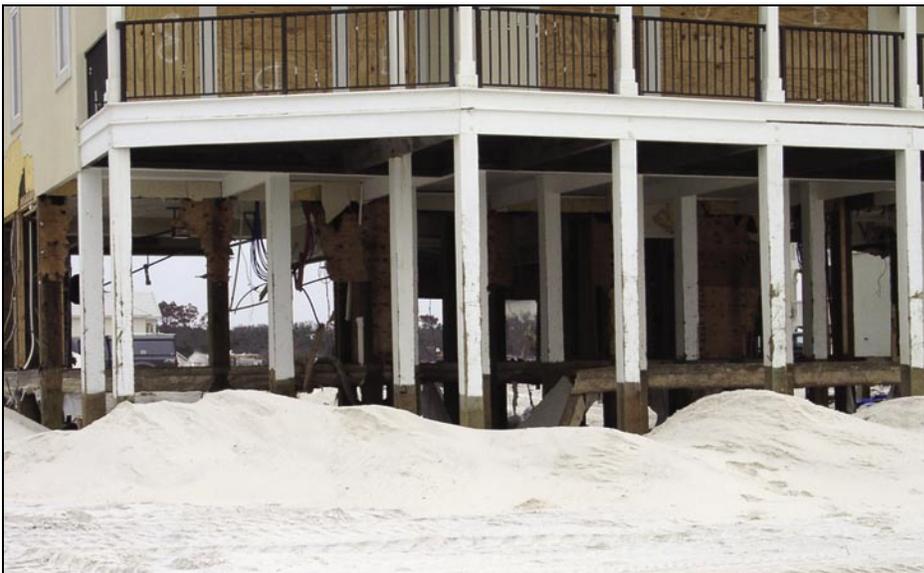
Figure 4-55. Sand below slab completely eroded away, causing the total failure of slab, but grade beams remained intact. (Gulf Shores)

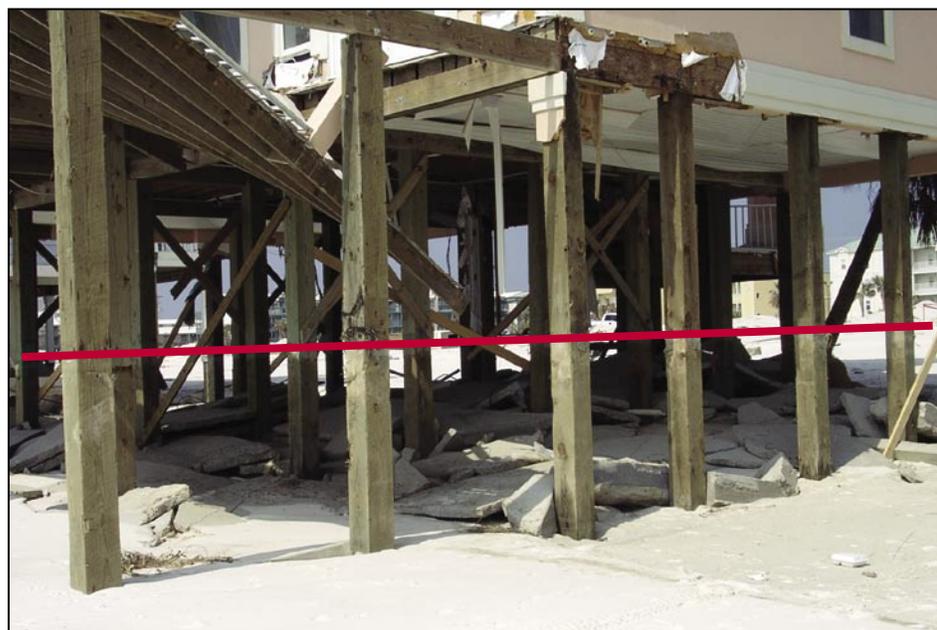
Figure 4-57.

Typical non-structural concrete slab failure. Horizontal line indicates previous location of soil level and slab. (Orange Beach)

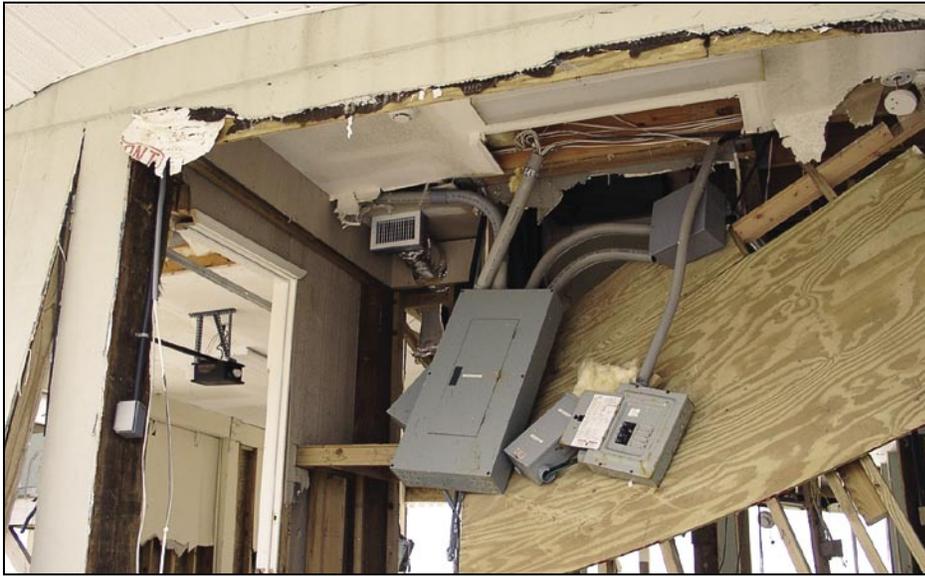
- ☒ Some breakaway walls did not break away cleanly, causing damage to wall finishes above the breakaway panels (see Figure 4-60).
- ☒ In some cases, utilities were connected to the walls, thereby preventing a clean wall failure (see Figure 4-61).
- ☒ In some cases, breakaway walls were installed across pilings instead of between pilings (see Figure 4-62).

Figure 4-61.
Failure of interior partition to break away cleanly due to the attachment of utilities (Gulf Shores)

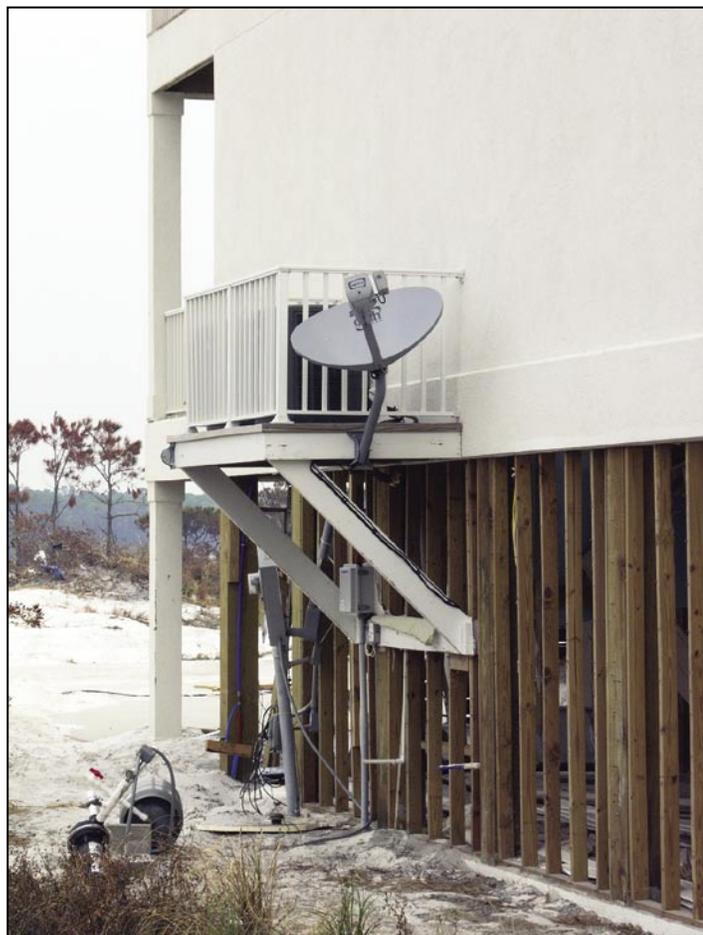
Figure 4-64.
Diagonal condenser platform members are susceptible to wave and waterborne debris damage. Cantilevered condenser platforms are preferable (see Figure 8-3). (Gulf Shores)

HVAC equipment should be elevated above the BFE and preferably to the same elevation as the lowest floor of the building. The equipment should be supported to prevent damage from flooding and fastened to resist blow-off from high winds. The preferred approach is a cantilevered platform (see Figure 8-3). Other acceptable support systems include knee-braced platform supports (with the bottom of knee braces above wave and debris impacts), and pile supports (with piles substantial enough to resist all flood loads and anticipated erosion and scour). Shallow and/or small diameter post or pile supports should not be used under any circumstances in coastal flood hazard areas.

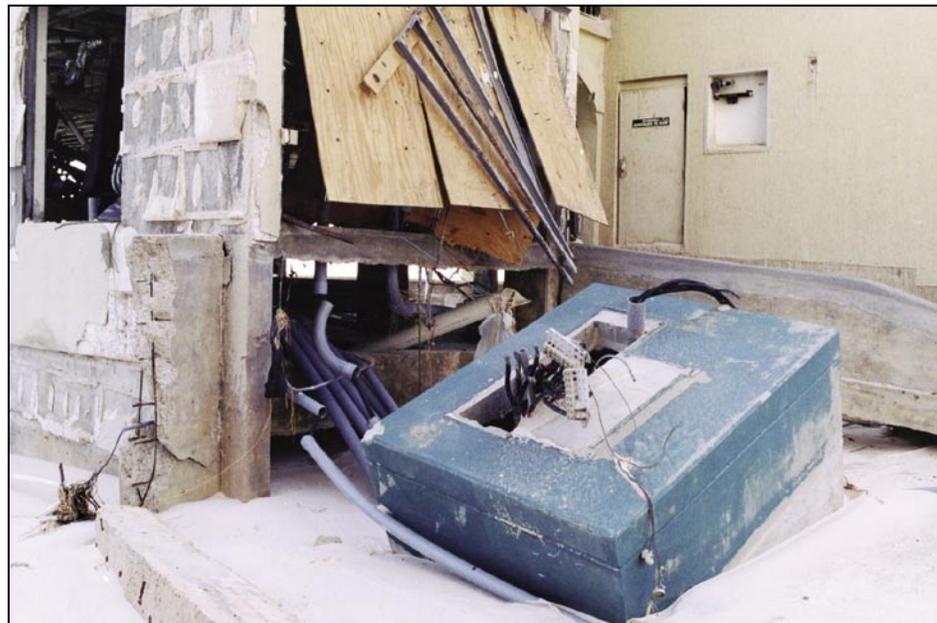
Figure 4-68.
Erosion and flood damage to multi-family electrical transformer and interior mechanical room (Perdido Key)

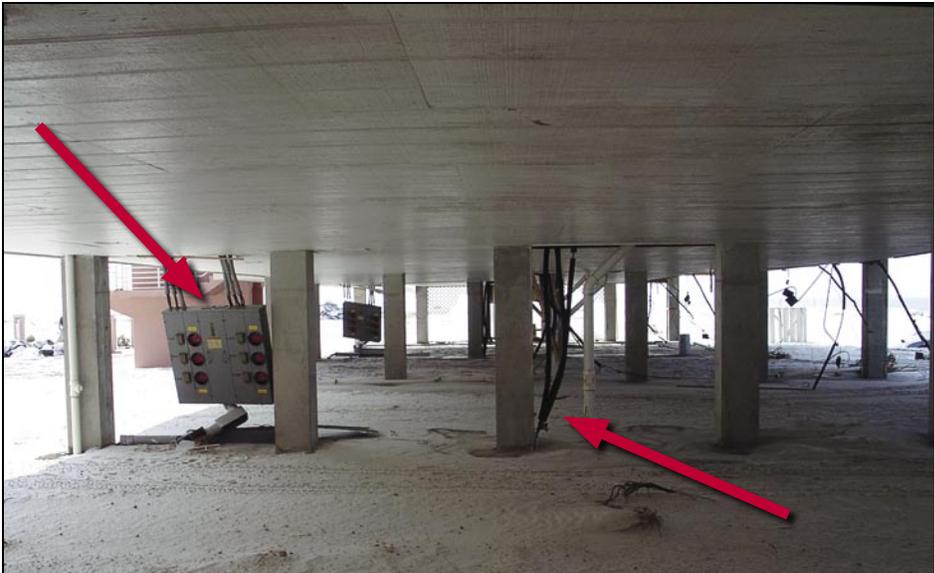
Figure 4-70.
Damage to the electrical panel, but utility lines were located appropriately (beside an interior pile) (Pensacola Beach)

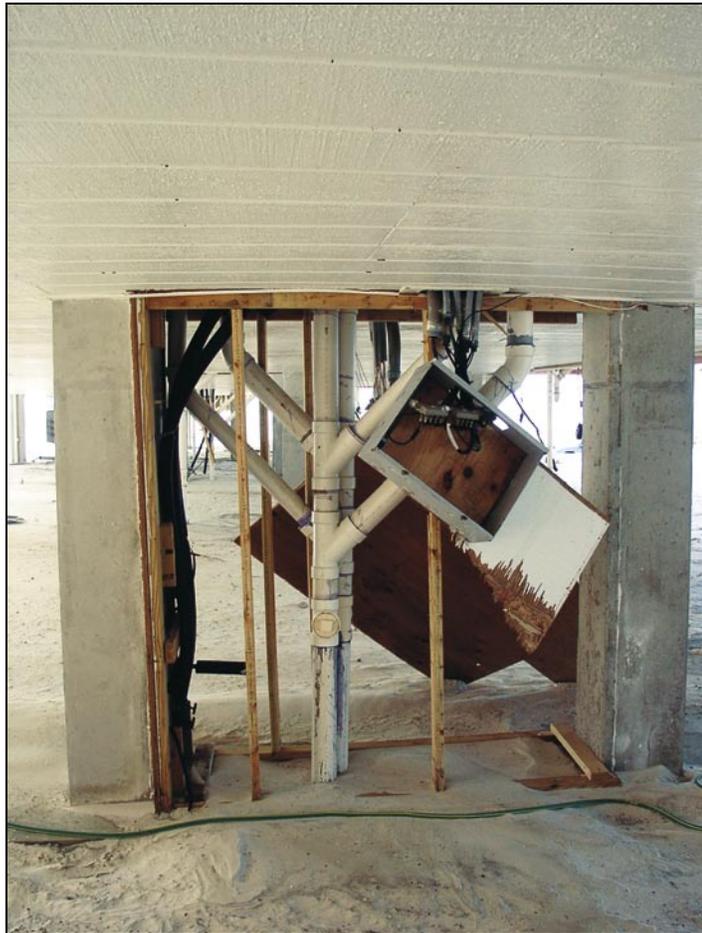
Figure 4-71.

Drain lines constructed between interior piles (which helped to protect them from flood forces), although electrical box was connected to plywood panel and was destroyed (Pensacola Beach)

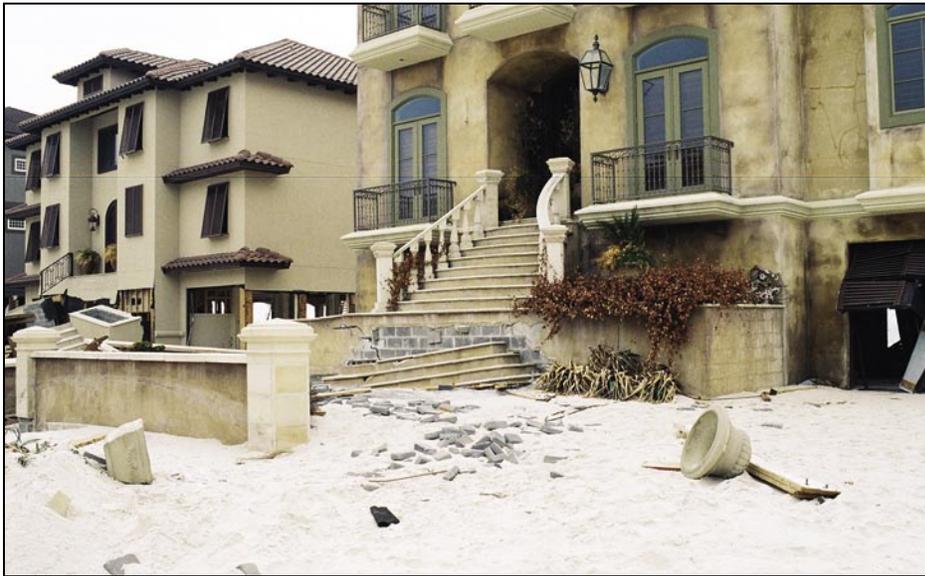
Figure 4-72. Massive stairs that will obstruct flows could deflect waves and debris into the elevated building. This type of stair structure is a violation of the V-Zone free-of-obstruction requirement. (Gulf Shores)

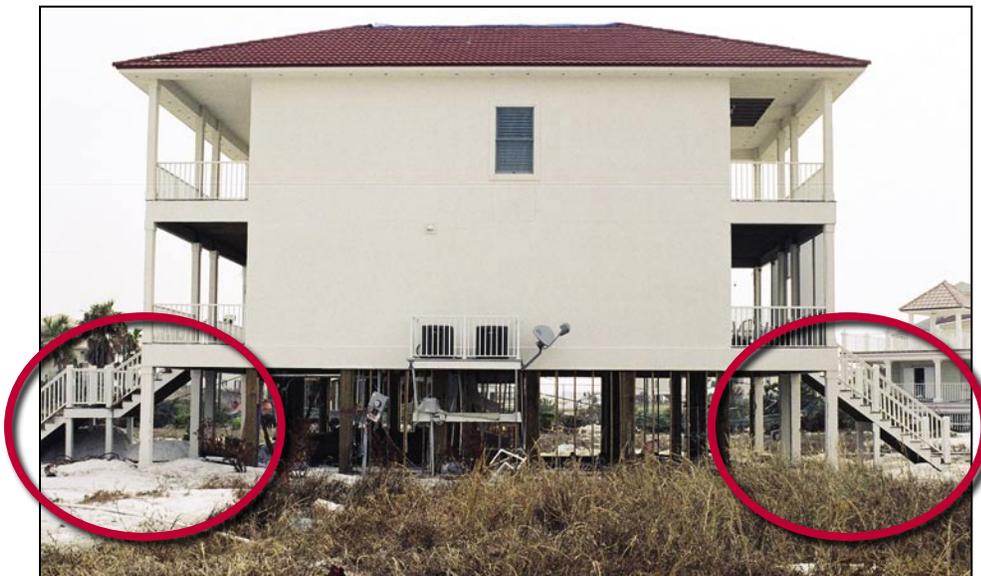
Figure 4-73. Stairway structures (circled) that will minimize obstructions to flow and potential adverse effects on the elevated building (Gulf Shores)

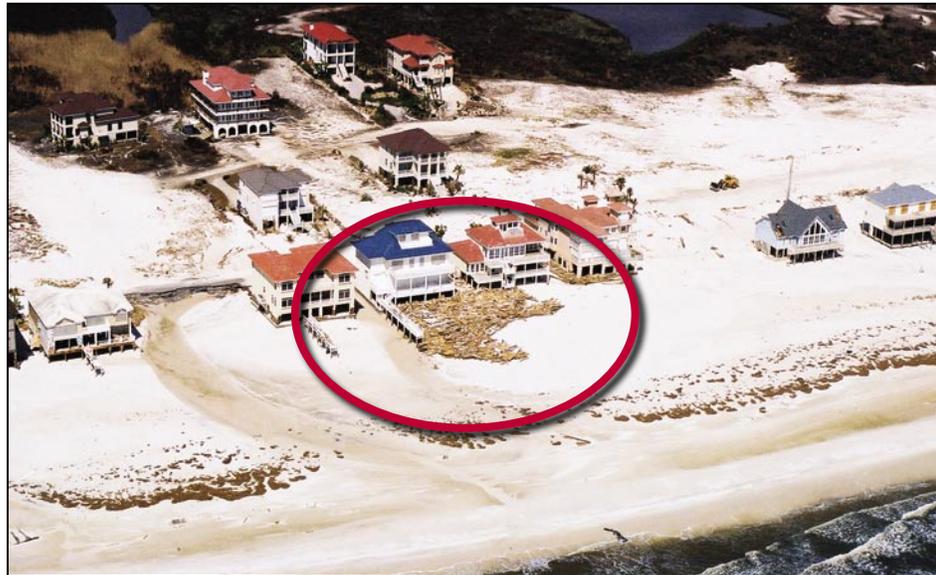
Figure 4-74.
Large accumulation of debris trapped between house and dune walkover (Gulf Shores)

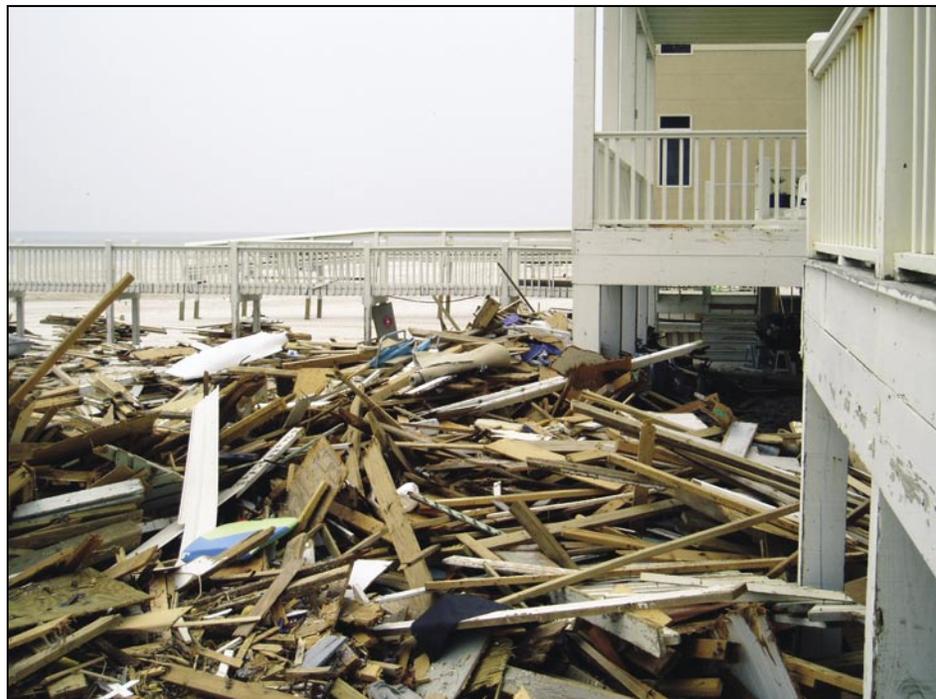
Figure 4-75.
Ground level photograph of debris shown in Figure 4-74 (Gulf Shores)

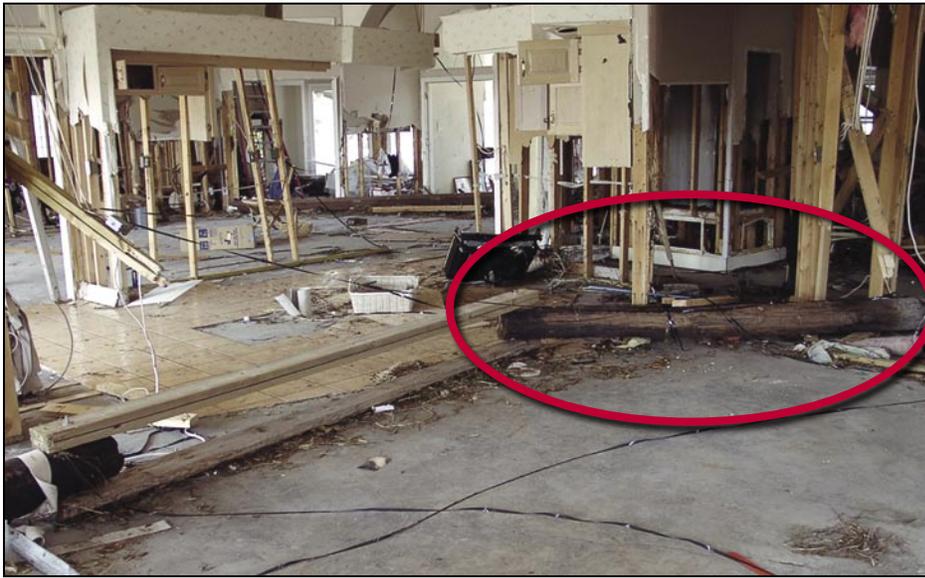
Figure 4-76.
Marine pile debris
washed into this house
in the back bay. (Oriole
Beach)

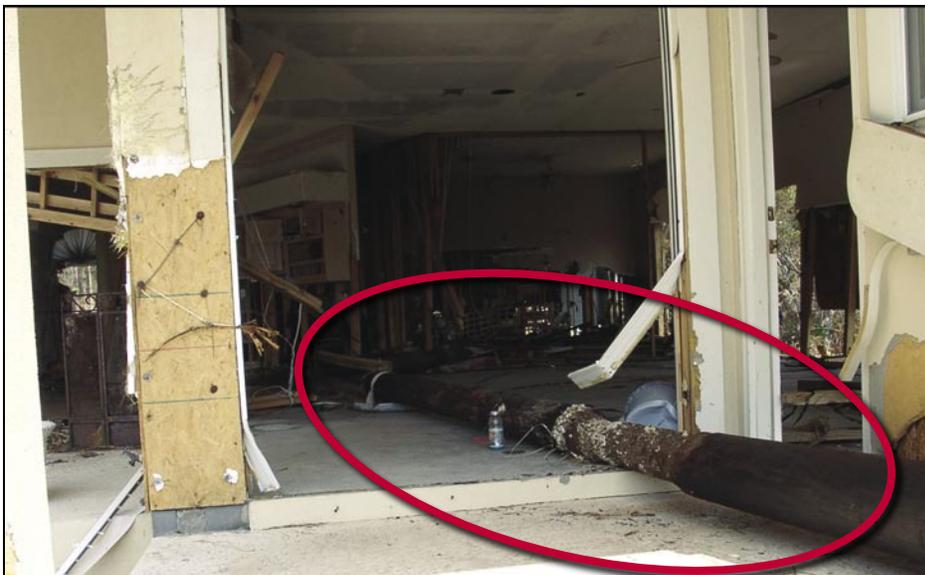
Figure 4-77.
Same marine pile as
shown in Figure 4-76.
Note the size and the
length of the pile, which
caused significant
damage. (Oriole Beach)

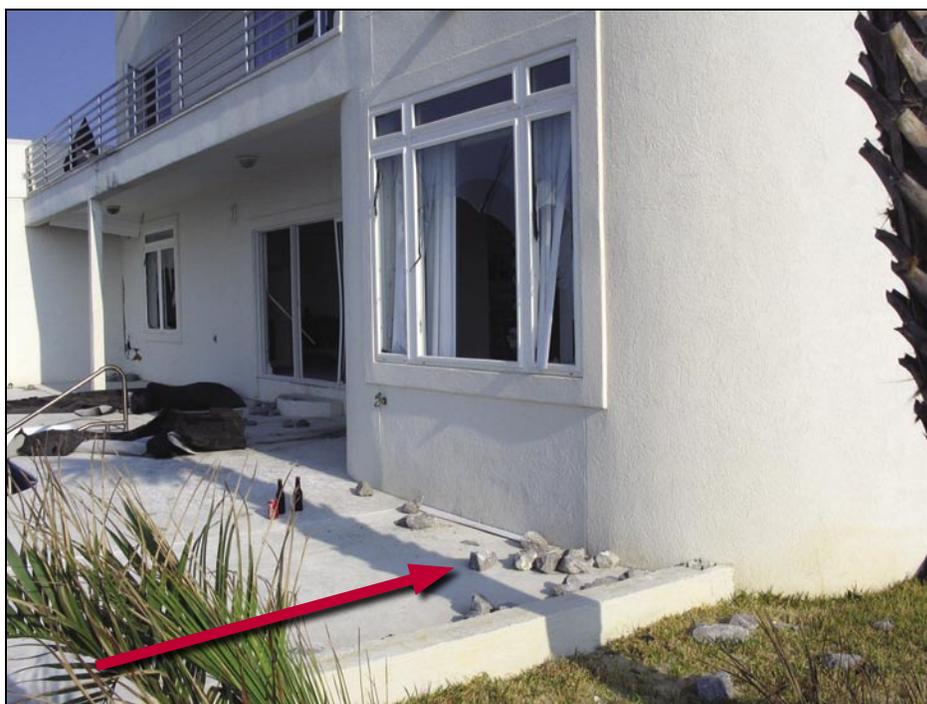
Figure 4-80. Small stones from a nearby revetment were likely propelled by waves into this north-facing sound side house, breaking windows and sliding glass doors. (Gulf Breeze)

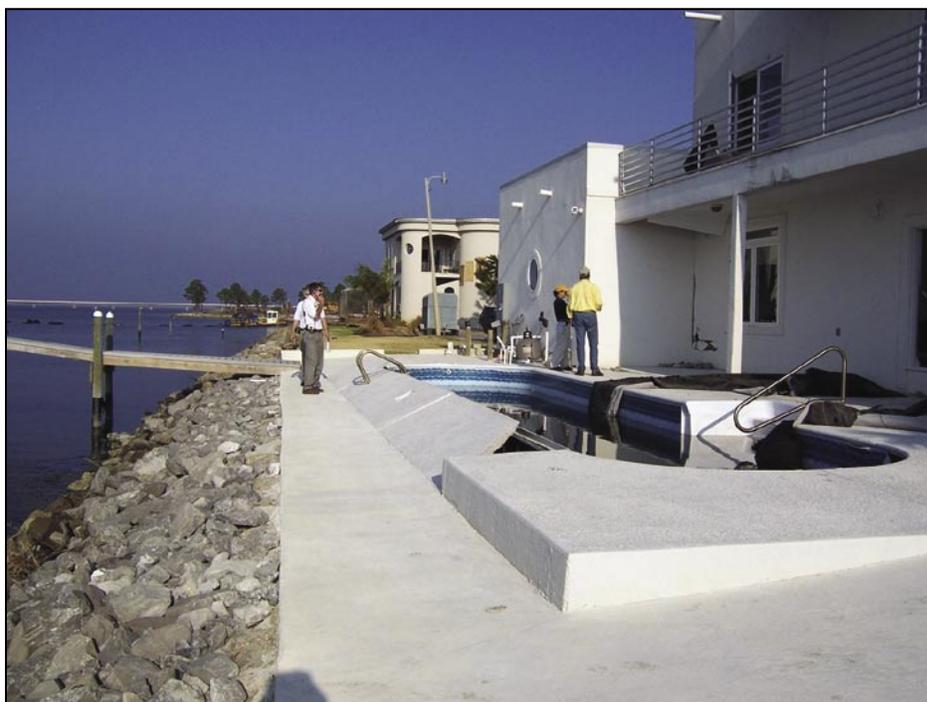
Figure 4-81. The small stone revetment contributed stones which were propelled by waves and struck the house, shown in Figure 4-80 (Gulf Breeze)

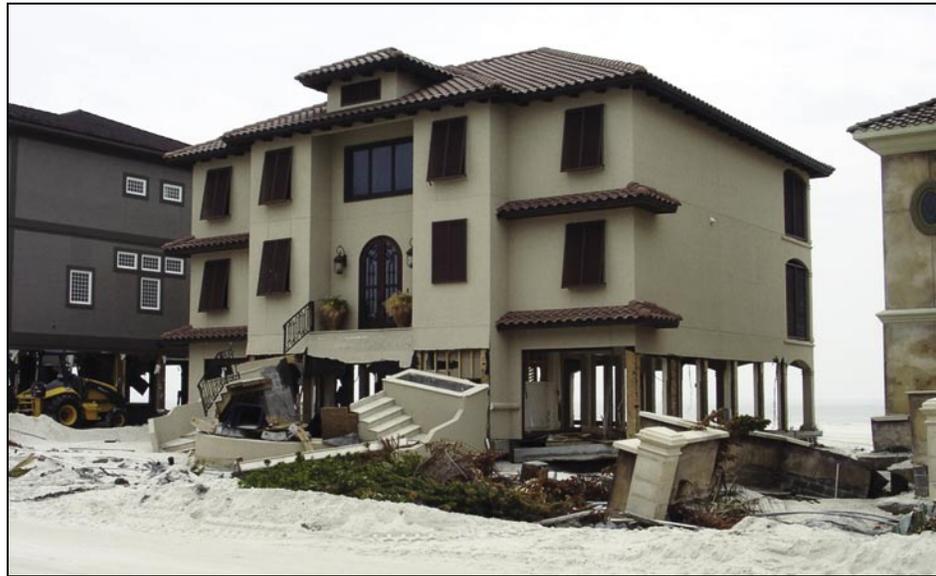
In the areas damaged by Hurricane Ivan, the MAT observed few houses new enough to have been built under the FBC 2001 or the IBC 2003. In addition, the actual wind pressures were below the code prescribed pressures; therefore, Ivan could not be considered a true “code design-level test.” Therefore, it is difficult to evaluate the effect of new codes. It did appear that newer wood-frame houses generally performed well structurally. Efforts in the last 15 years to increase the quality of coastal construction, such as the SBC SSTD-10, Hurricane Resistant Residential Construction Standard, and FEMA 55, *Coastal Construction Manual*, have been successful. Many newer houses observed by the MAT had significant damage due to storm surge below their elevated floors as expected, but showed little signs of structural damage due to wind or water (see Figure 4-83).

Figure 4-83.
Storm surge damaged
the lower portion of
this house, but no wind
damage was observed.
(Gulf Shores)
