Mitigation Assessment Team Report

Hurricane Ivan in Alabama and Florida

Observations, Recommendations,
and Technical Guidance

FEMA 489 / August 2005

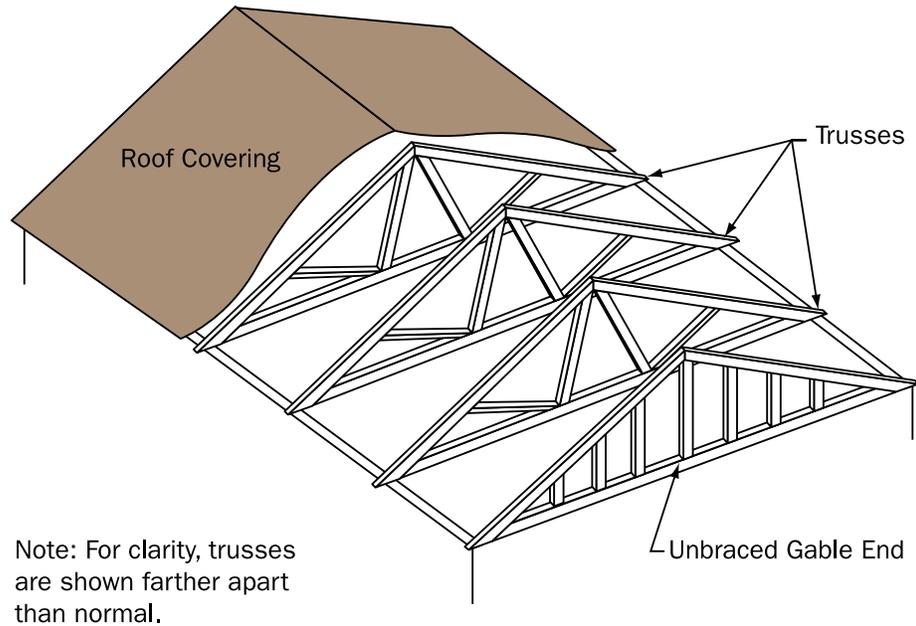
Another common failure point was wood-frame gable end walls. These are commonly under designed or improperly constructed. Often, a typical roof truss is the only support element behind the wall covering of the gable as shown in Figure 4-85. Trusses are constructed with the weak dimension of the lumber turned normal to the plane of the truss. This means that when a typical truss is used alone as the wall framing for the gable end wall, the truss members must resist the wall's wind forces in their weak direction. On larger buildings, the height of the gable end wall from the plane of the ceiling up to the peak of the gable is often taller than the story heights below. In these cases, even wall studs would have to be strengthened in order to be adequate. The truss members are typically not capable of carrying the bending forces in this manner. In cases where adequate wall stud framing is present in the gables, the problem is typically the absence of adequate bracing where the gable end wall sits on top of the wall below. This point is a hinge and must be braced by framing to transfer the wind loads into the lateral load resisting system. Figure 4-85 illustrates the arrangement of these structural members in typical light-frame construction. The framing shown in Figure 4-86 shows a truss resisting the wind loads with its weak axis. This was in an upscale house under construction, so the problem is still not being addressed in all cases. The condominium building shown in Figure 4-87 had no evidence of any bracing at the hinge point in its gable end wall framing.

Figure 4-86.
Roof truss with 2x4s
oriented in the weak
direction resisting the
wind loads on a gable
end wall (Ono Island)

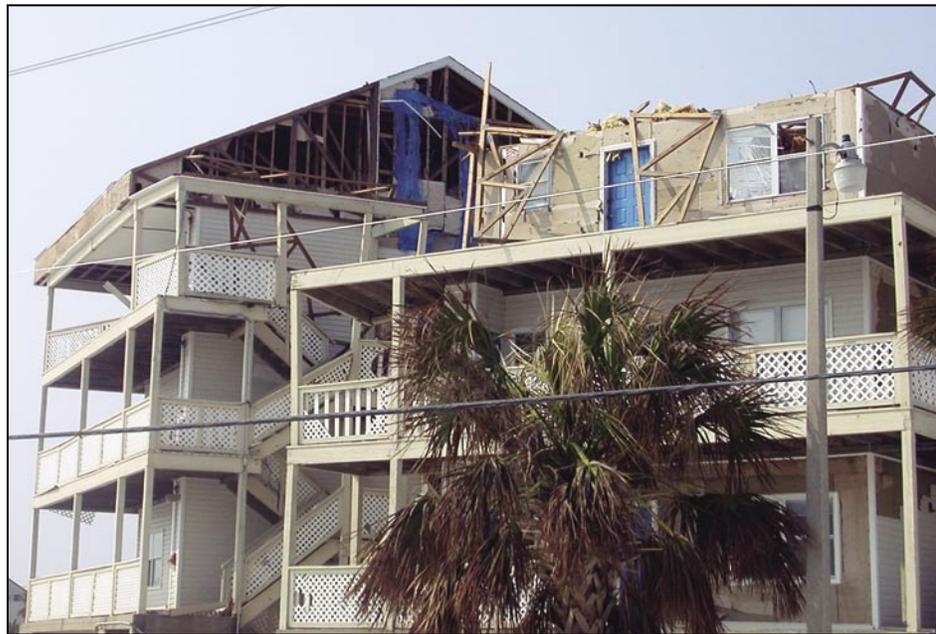
complete the load paths, as illustrated in Figure 4-82, was the cause of damage. The MAT observed several buildings such as the ones shown in Figures 4-88, 4-89, and 4-90, which suffered the total loss of the roof framing due to improper anchorage of the roof framing to the walls.

Figure 4-89.
Roof framing damage due
to lack of connections
from roof to wall
(Pensacola Beach)

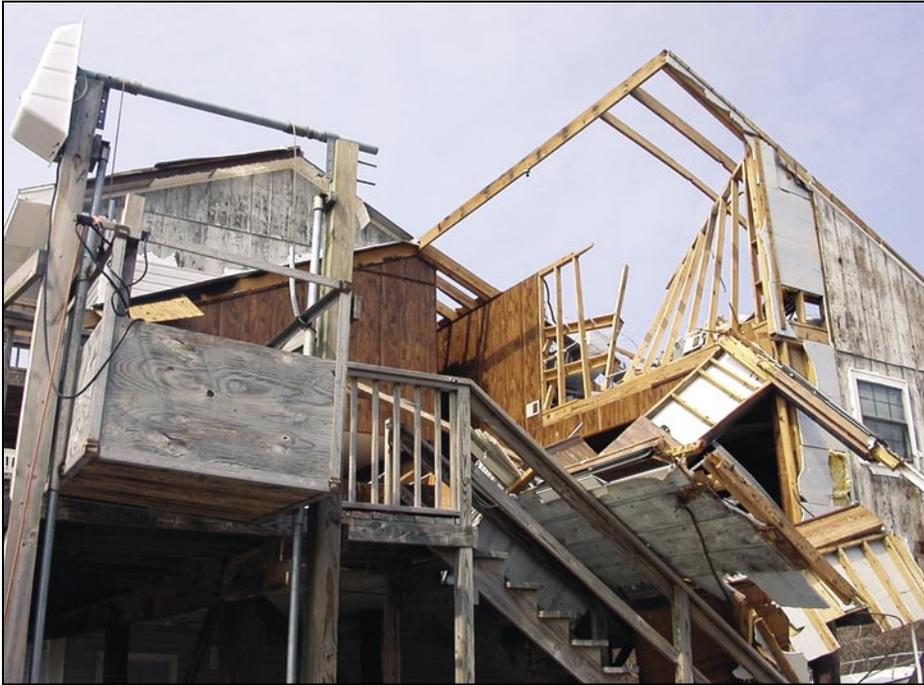
Figure 4-90.
Roof framing damage due to lack of connections from roof to wall (Ono Island)

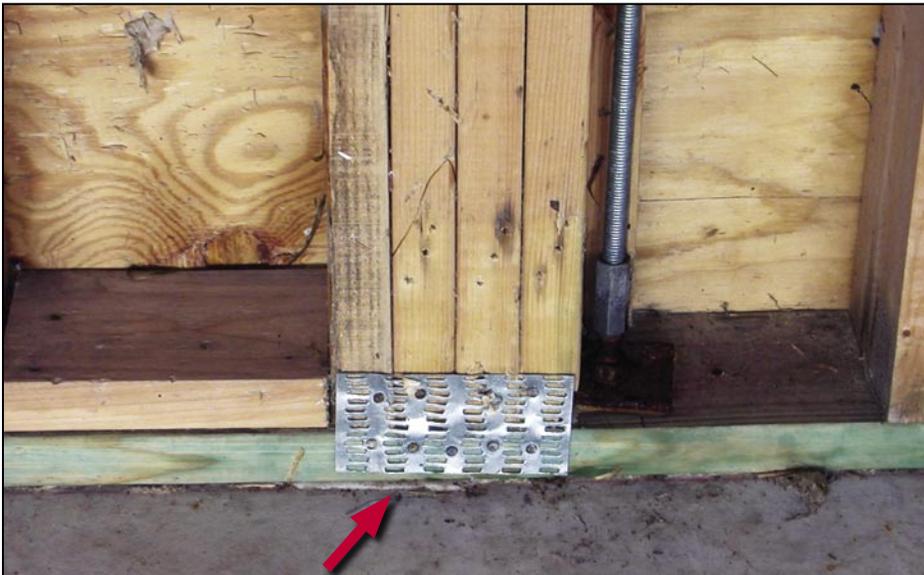
Figure 4-91.
Improper use of a wood truss press plate connector to substitute for stud hold-downs (Oriole Beach)

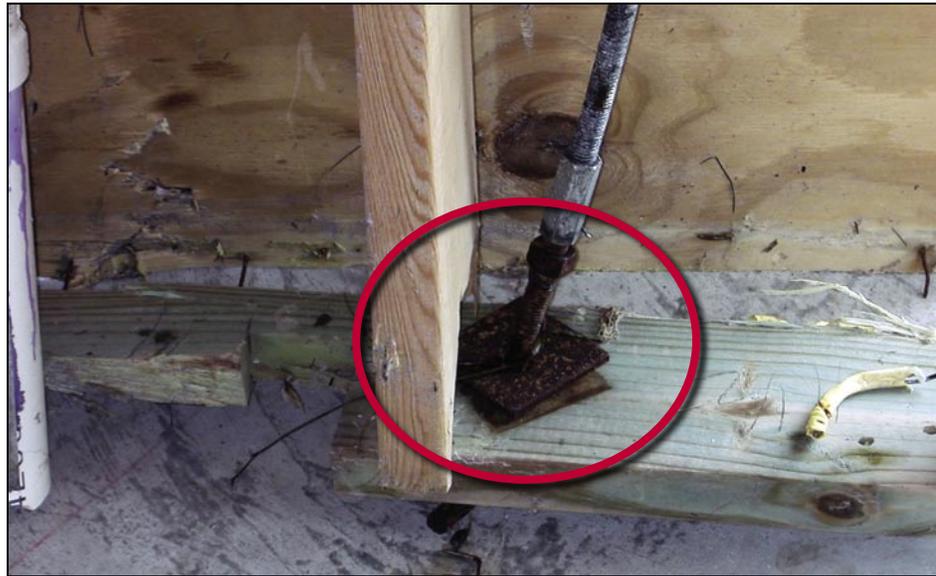
Figure 4-93.
Improper strapping
(Ono Island)

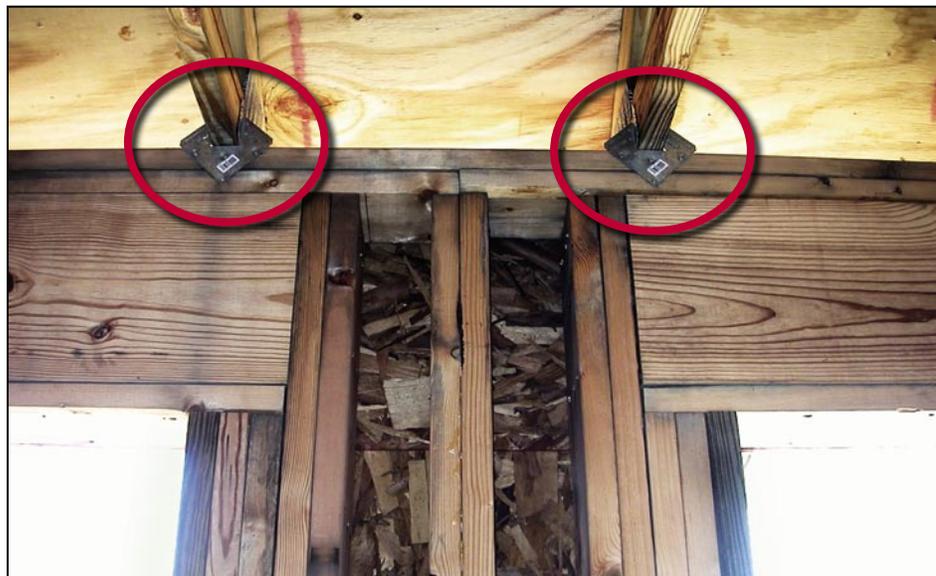
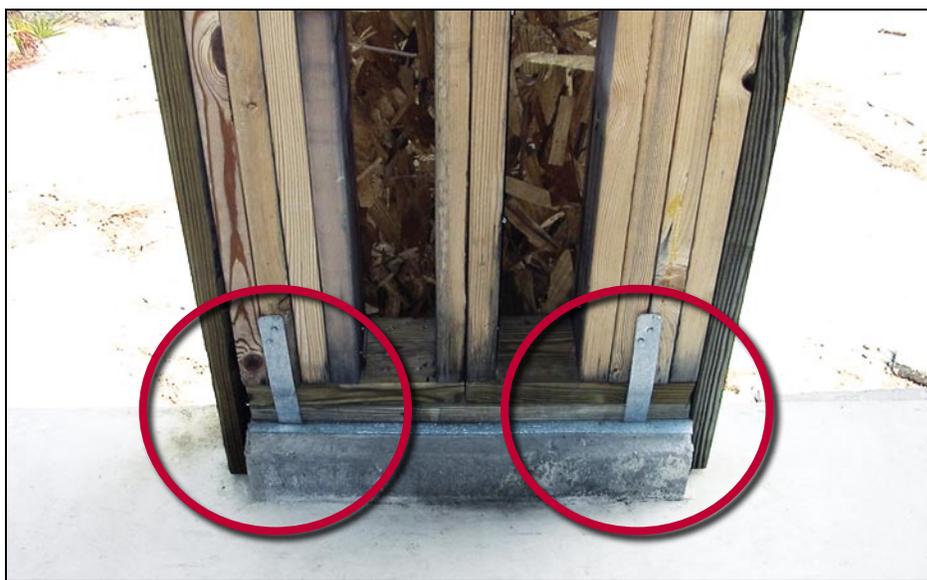
Figure 4-94.
Wall studs between
garage doors with
inadequate hold-downs
(Ono Island)

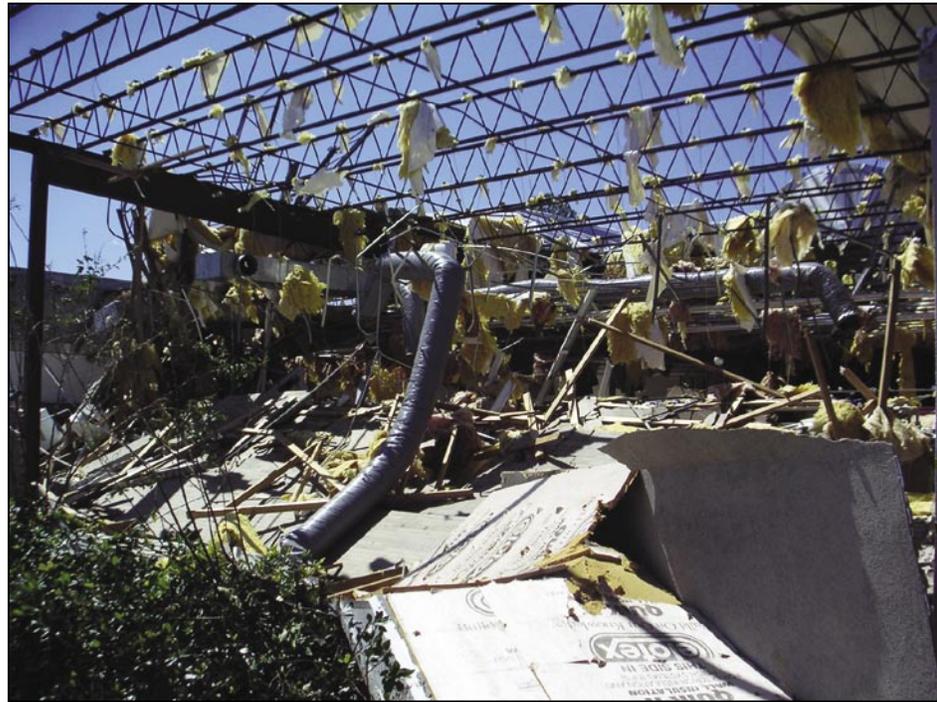
Masonry construction is commonly used for commercial buildings, such as shopping centers and office buildings. These buildings were supported on reinforced concrete foundations with shallow spread or deep foundation systems. Exterior load-bearing walls were constructed utilizing concrete masonry unit (CMU). The roof decks were observed to be supported by open web steel joists with metal deck. Very little structural damage was observed in this type of construction. Where structural damage was observed, it seemed to be isolated and a result of poor design or construction or a problem with a particular type of material installation such as shown in Figure 4-95. This building was in an area of relatively low wind speeds, yet suffered catastrophic failure while an adjacent retail center had only minor damage.

Figure 4-95.
Metal roofing failure
(Foley)

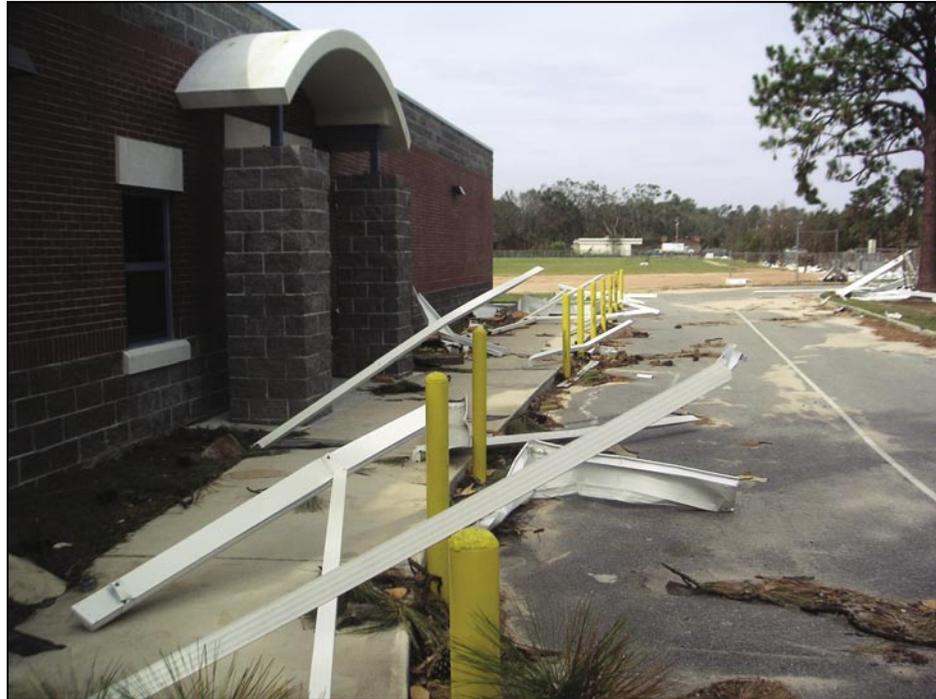
Structural damage to accessory structures was observed by the MAT throughout the path of Hurricane Ivan. Carports, canopies, fences, and screen walls were all observed to sustain wind damage. Typical metal canopies between buildings on school campuses did not fare well, as shown in Figure 4-98.

Figure 4-98.
Collapsed metal canopy
at a middle school
(Pensacola)

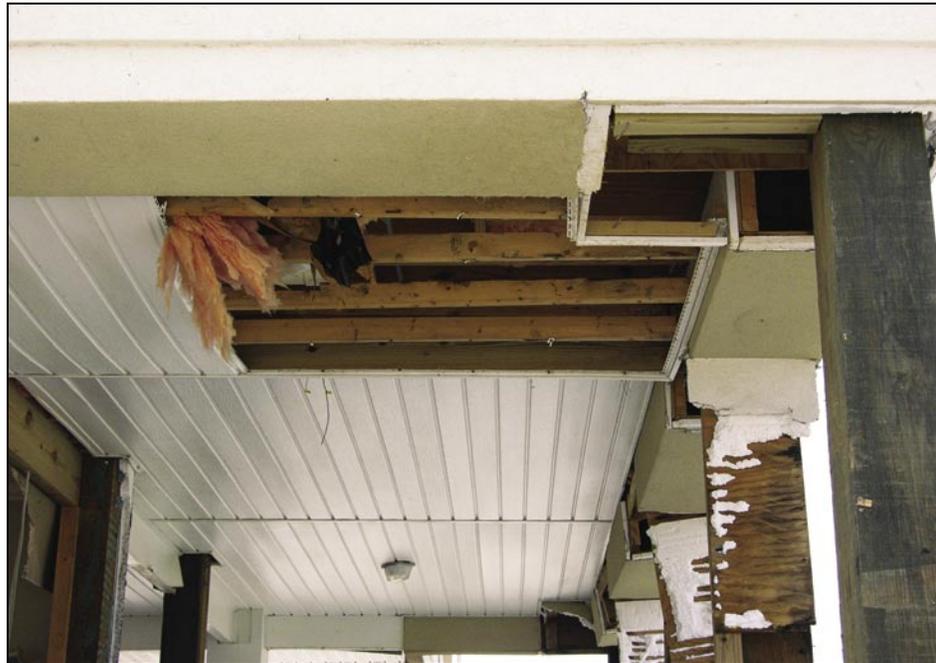
Sheathing was typically installed on the underside of bottom-floor joists on elevated buildings. Besides protecting batt insulation that is placed between joists, sheathing can also protect electrical and plumbing lines from floodborne debris. A variety of sheathing materials were observed. Vinyl siding and plywood were the most common, but gypsum board was observed on three buildings, and corrugated metal was observed on one building. The majority of the buildings with vinyl experienced sheathing loss (Figure 5-1). For further discussion of vinyl siding, see Section 5.3.2.

Figure 5-1.
Loss of vinyl siding panels from the underside of an elevated residence in Gulf Shores (Laguna Key)

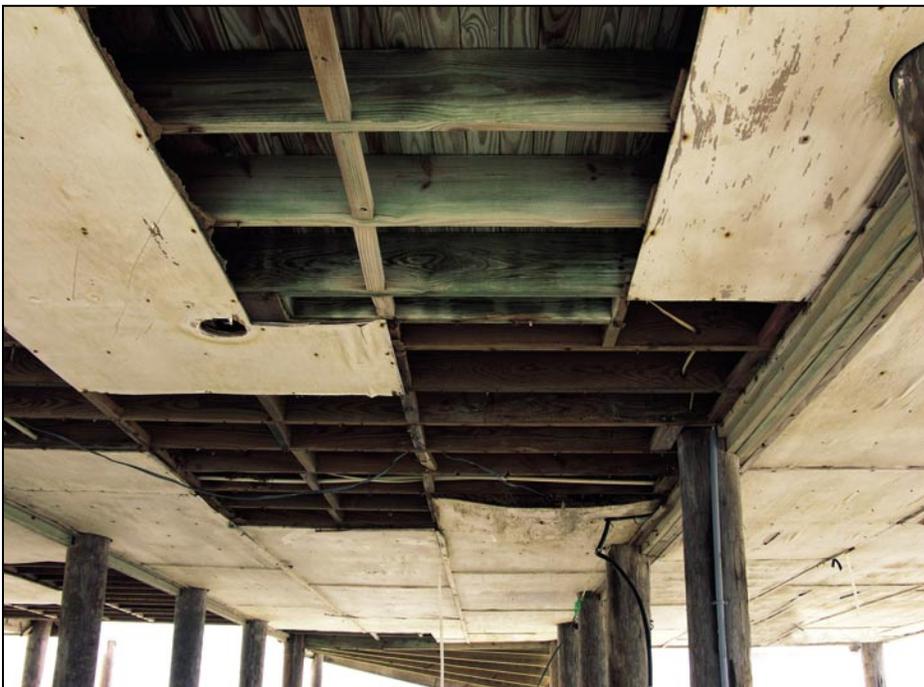
The plywood panels typically performed well, but some losses were experienced (Figure 5-3). Nails were typically used to attach the sheathing. Fastener corrosion was common and some of the nail heads were totally corroded away. Fastener spacing along the joists was often about 12 inches on center. Although the long edge of the sheathing typically occurred over blocking, fastener spacing along the long edge was often only about 16 inches on center.

Figure 5-3.
Loss of plywood from the
underside of an elevated
residence in Gulf Shores
(West Beach)

Fast-moving floodwater and peaking waves likely caused some of the sheathing loss, including complete loss of gypsum board at one building. Gouging of sheathing (including penetration of plywood) by floodborne debris was also observed. However, the majority of the sheathing loss appeared to be caused by wind accelerating as it passed beneath the elevated building. ASCE 7, FBC, and IBC do not provide guidance on determining design wind loads on sheathing on the underside of elevated buildings. Hence, professional judgment in specifying attachment is needed.

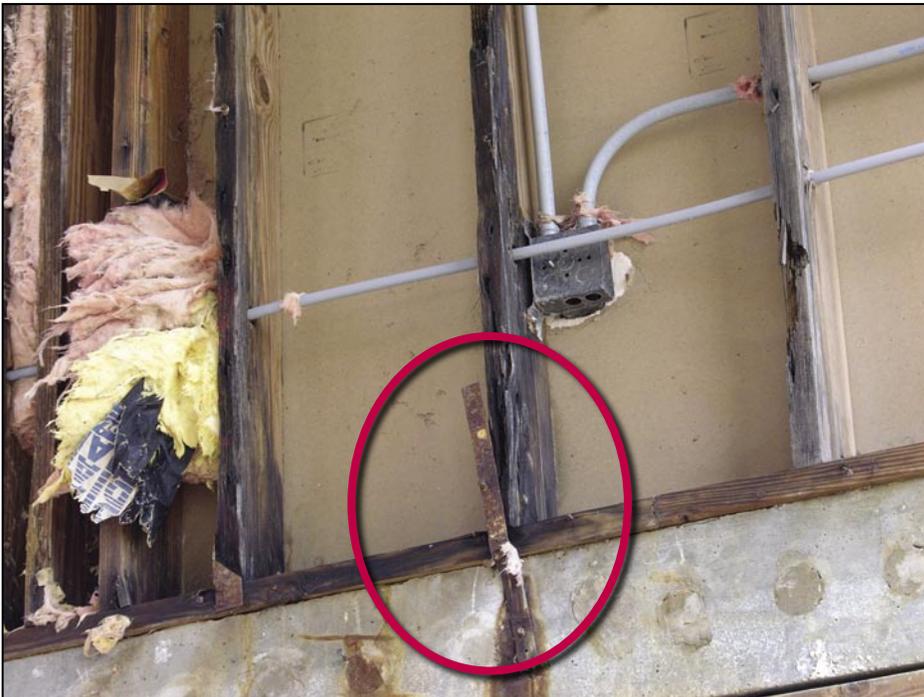
Figures 5-10 through 5-12 show dry rotted studs and sheathing, indicating long-term moisture intrusion behind the molded expanded polystyrene (MEPS) insulation. Both of these buildings used a barrier EIFS design, rather than the newer drainable EIFS design. (No drainable EIFS designs were observed.) At the condominium in Figure 5-10, the synthetic stucco was installed over MEPS over gypsum board over wood studs. Essentially all of the gypsum board blew off (the boards typically pulled over the fasteners). Some of the gypsum board on the interior side of the studs was also blown off. Note the missing studs on the second level at the left. Stud failure may have initiated the EIFS blow-off. Note the metal diagonal stud bracing straps. Two of the windows were broken by debris.

Figure 5-11 is another view of the condominium complex shown in Figure 5-10. The studs were severely rotted and the metal connectors were very corroded.

Figure 5-11.
Severely deteriorated studs and corroded metal connectors

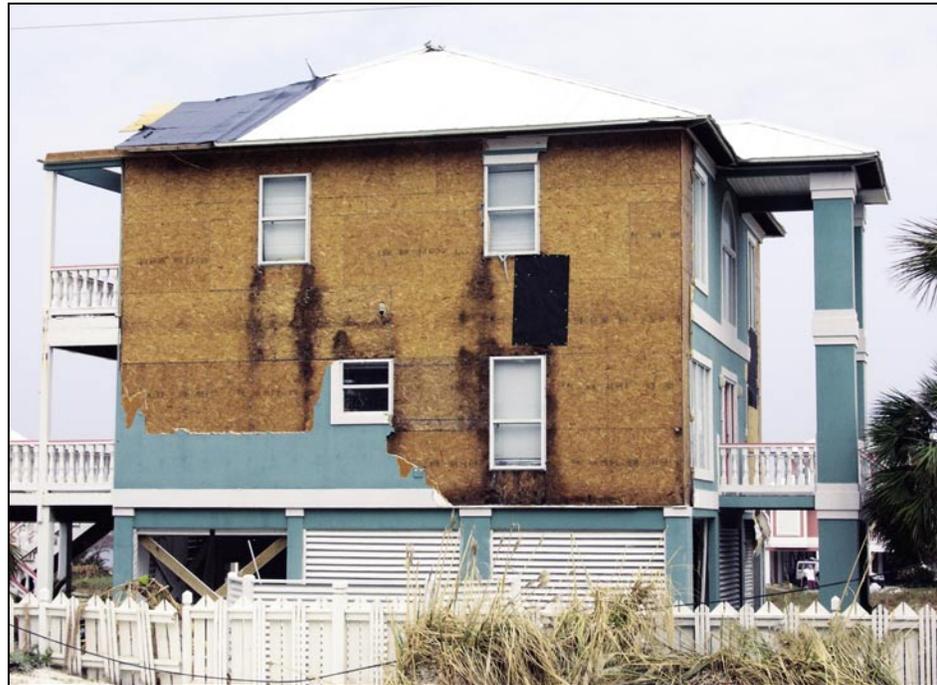
Figure 5-12.
Blown off EIFS revealed severely rotted oriented strand board (OSB) due to water infiltration at windows and wall penetrations. Roof decking blown off of a building with a 5-V crimp metal panel roof.

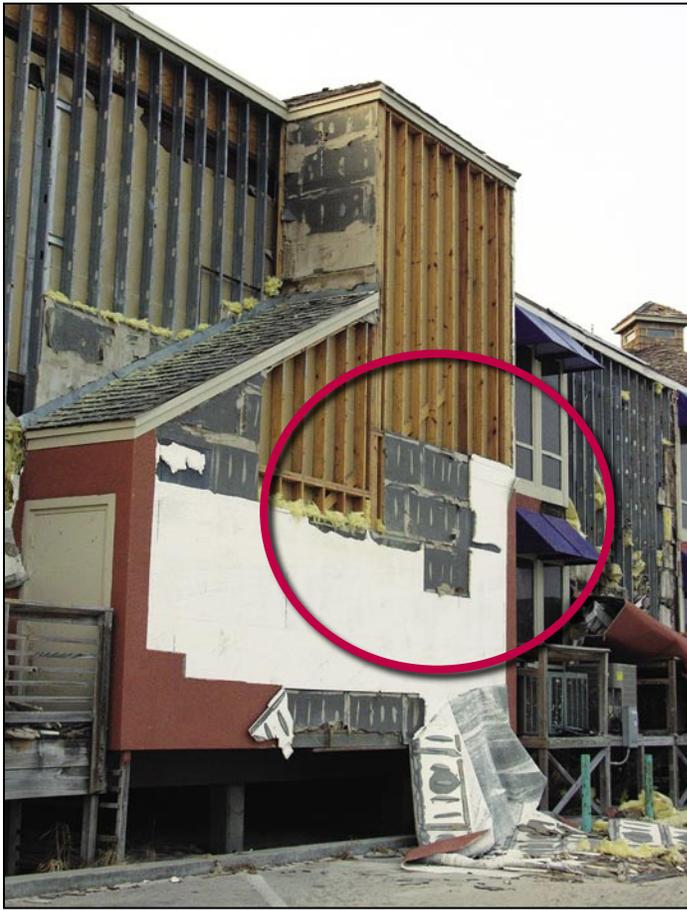
Figure 5-13 shows common planes of failure of EIFS installed over wood and metal studs. Typically, separation of the synthetic stucco from the MEPS is likely a secondary failure plane. Initial failure is likely caused by detachment of the MEPS from the gypsum board, or detachment of the gypsum board from the studs. When the MEPS detaches from the gypsum board, the gypsum board can suffer strength reduction due to wetting from the wind-driven rain, and it, too, will often then blow off during a hurricane.

On the building shown in Figure 5-13, wood studs were used in the center section and metal studs were used on adjacent sections. In the center area, gypsum board detached from the studs. Near the bottom of the wall and above the MEPS, the gypsum board is still attached, but the MEPS separated from the gypsum board. At the white area, the synthetic stucco separated from the MEPS. Note the attachment of the MEPS to the gypsum board. Adhesive is nearly continuous at the perimeter of the MEPS boards, and four vertical lines of adhesive occur in the field of the boards (the vertical lines are of different lengths and none of them extend all of the way to the board edges). Adhesive should have been continuously applied throughout the entire board area.

Figure 5-13.
Loss of EIFS on a commercial building

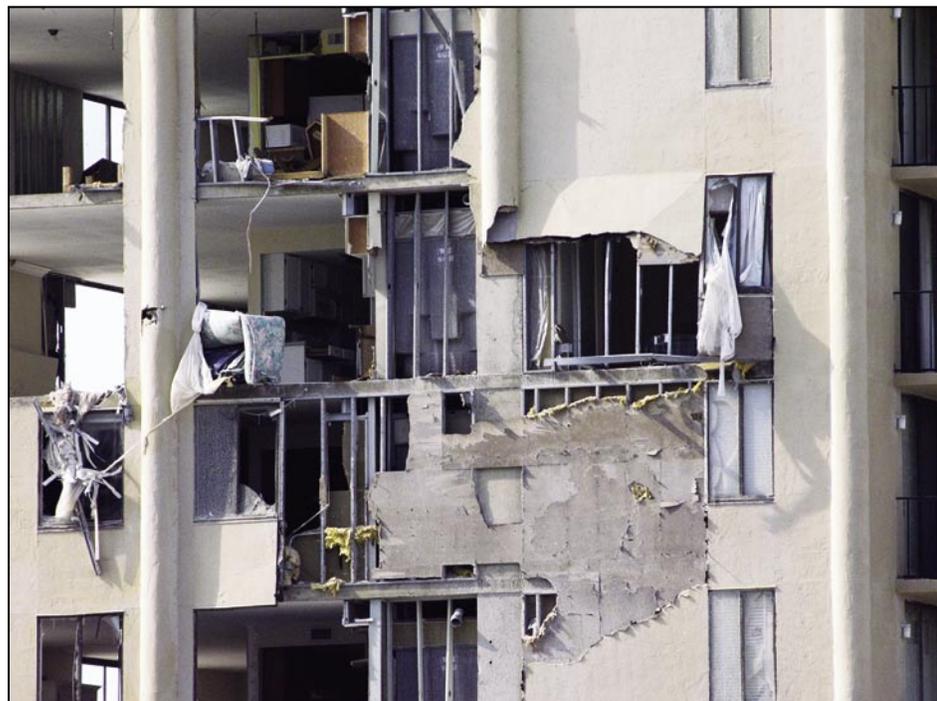
A few buildings with traditional stucco walls were observed. Figures 3-21, 5-22 and 5-23 show significant damage to non-load-bearing stucco walls on two mid-rise condominiums. In several areas, the metal stud system failed; in other areas, the gypsum sheathing blew off the studs; and in other areas, the metal lath and stucco blew off the gypsum. It appeared that failure of the stud track connections initiated most of these failures. Figure 5-23 illustrates a serious potential risk to residents.

Figure 5-22.
Failure of non-load-bearing stucco wall
(close-up of Figure 3-21)
(Perdido Key)

As with EIFS assemblies, attention to attachment of studs to the building, attachment of gypsum board to the studs, and attachment of the lath are critical in achieving good wind performance.

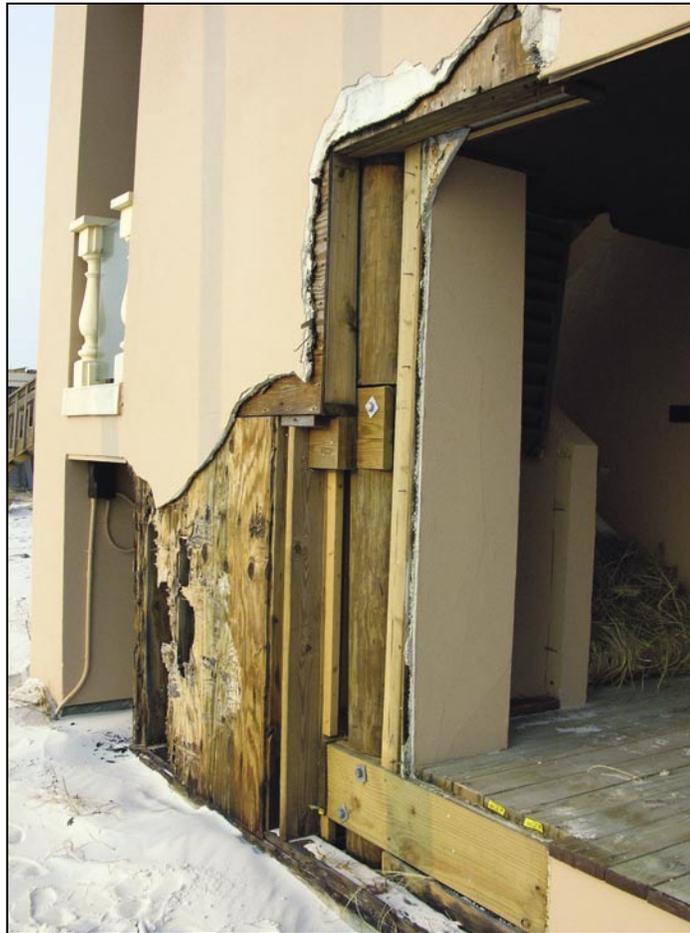
On a few buildings, stucco was applied over plywood over wood studs. At the residence shown in Figure 5-24, the plywood was severely rotted. Figure 5-25 shows failure of stucco applied over cast-in-place concrete. Similar failures were observed in Puerto Rico following Hurricane Georges (see FEMA 339, *Hurricane Georges in Puerto Rico*, March 1999).

Figure 5-24.
Six-year old, stucco-sheathed residence with severely rotted plywood (Pensacola Beach)

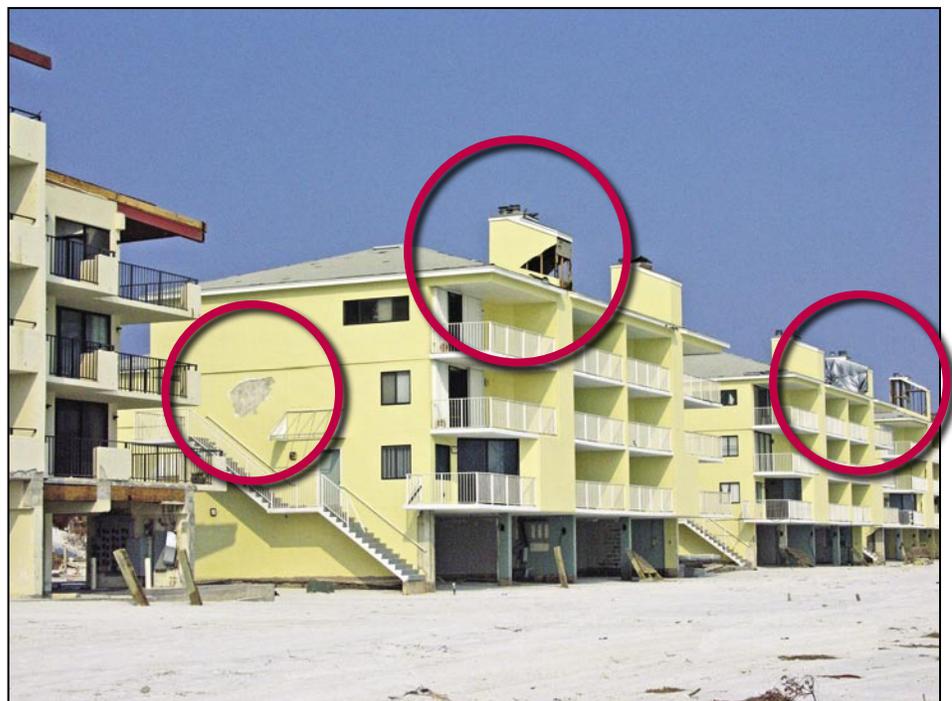
Figure 5-25.
At the end wall of the center building, stucco blew off the concrete substrate. Some of the chimney walls made of stucco over gypsum board over wood studs were also blown away.

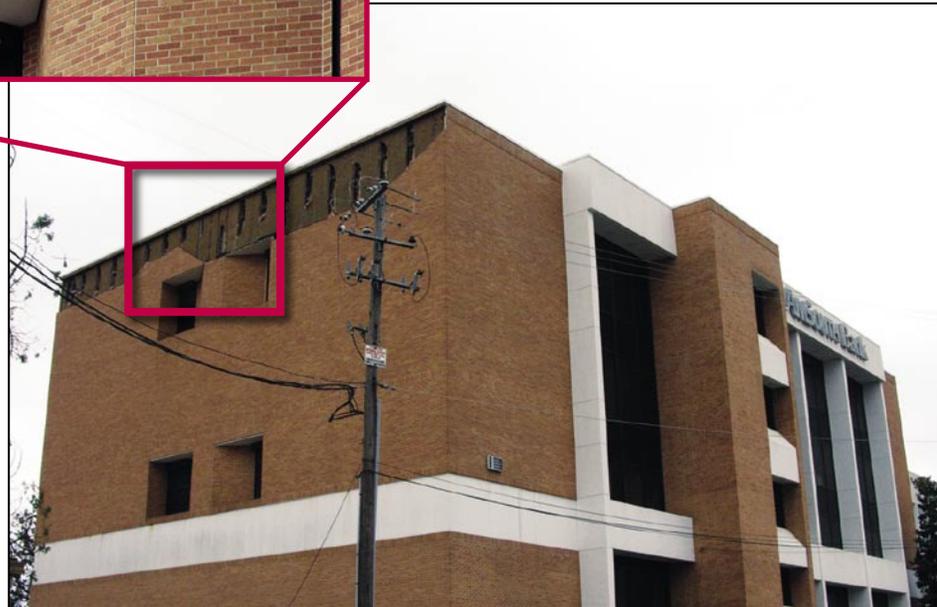
Several buildings with brick veneer were observed. Figure 5-26 shows failure on an office building. The majority of the corrugated ties remained attached to the steel studs. The ties were spaced approximately 18 inches on center vertically and 16 inches on center horizontally. According to another investigation team that had access to the building, the primary mode of failure was tension failure of the ties due to severe corrosion. Based on the Brick Industry Association's (BIA) *Technical Notes 28B – Brick Veneer/Steel Stud Walls*, “corrugated ties are not permitted when brick veneer is supported by steel stud backing.” In part, this provision is based on the greater corrosion susceptibility of corrugated ties versus round ties (i.e., water is more likely to remain for a longer period of time on the flat surface of corrugated ties). The tie spacings were closer than the maximum recommended in *Technical Notes 28B*, which is 18 inches on center vertically and 32 inches on center horizontally, yet still failed due to corrosion.

Figure 5-26.
Brick veneer failure on an office building
(Pensacola).

For the building shown in Figure 5-26, because the contract documents were not available, it is unknown whether use of the incorrect ties was a design or application error. For the residence shown in Figure 5-27, failure to embed the ties into the mortar joints was a major workmanship error. Failure to embed ties was documented in a Hurricane Opal report by The Masonry Society (*An Investigation of the Effects of Hurricane Opal on Masonry*, The Masonry Society, July 1996). Opal struck the Florida Panhandle in 1995.

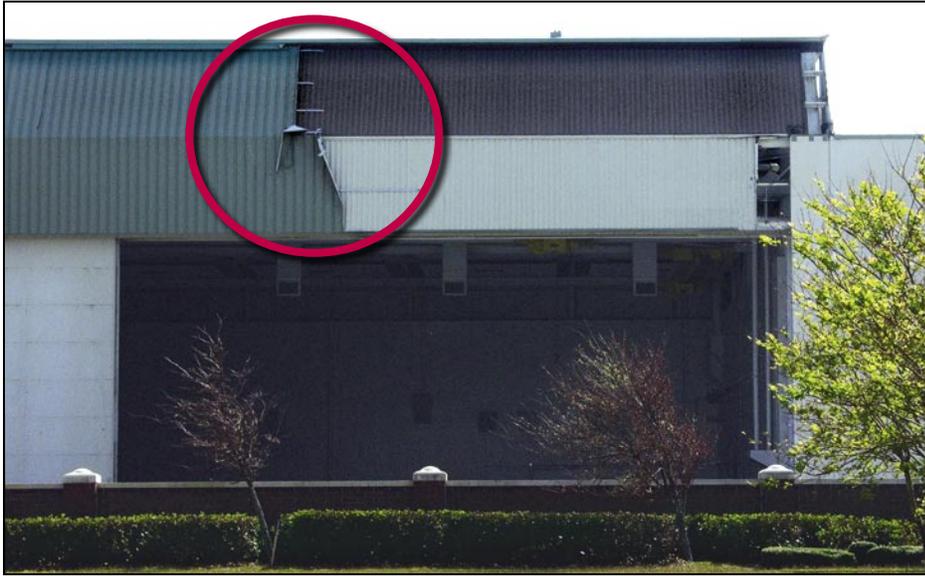
Another wall panel failure was observed at a hangar (Figure 5-29). New panels had been installed over older panels. In one area, the top leg of a channel had been screwed at 63" and 43" to the old panels. The bottom leg had been screwed at 21" and 43". The new panels were attached with clips that were screwed at 12" on center to the hat channels. There were two screws per clip. The connections of the new panels to the hat channels were much stronger than the connections between the hat channels and old panels.

Figure 5-29. The green fascia panels had been installed over a previous metal panel system. The original panels remained in place, but the newer panels blew off due to inadequate hat channel attachment. (Pensacola)

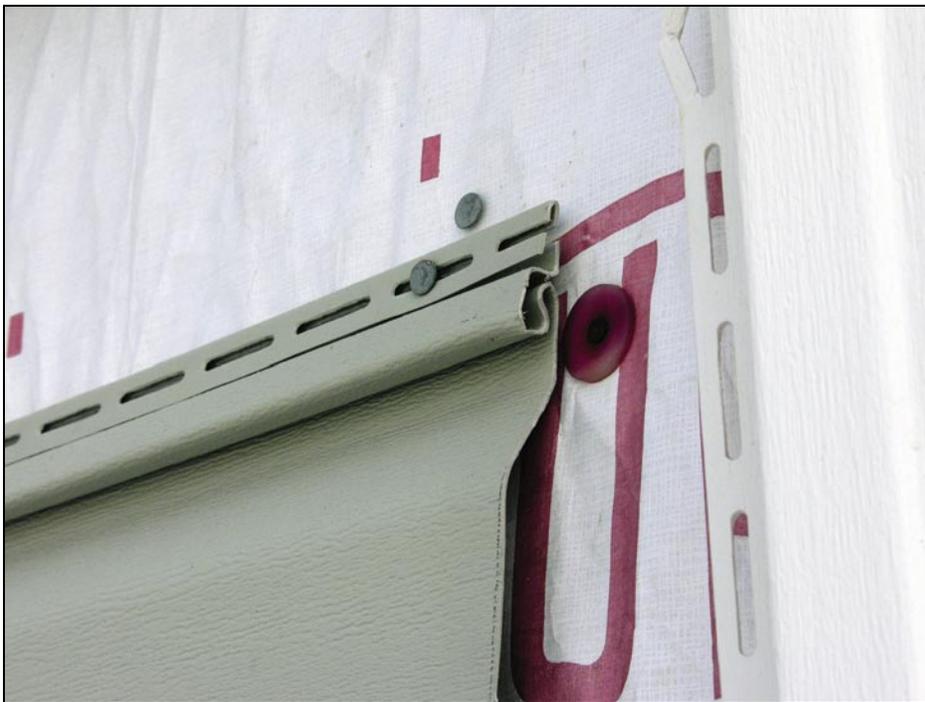
Figure 5-32. A double thickness of vinyl occurred at the nailing flange. This provided greater fastener pull-over resistance. However, many of the panels pulled over the nail heads.

Vinyl siding that was blown off typically tore around the fastener points. Staples were used to attach the siding on some residences, but large headed nails were typically used. The 2003 IBC requires a maximum fastener spacing of 16". ASTM D 4756, *Standard Practice for Installation of Rigid Poly (Vinyl Chloride) (PVC) Siding and Soffit* also specifies a maximum spacing of 16". The 2001 FBC does not specify a maximum limit.

Thirty-four fastener spacing dimensions were measured on eight residences. The spacings on each of the residences were quite variable. On six of the eight residences, one or more spacings exceeded 16". The residence with the most excessive measurements had spacings of 27 ½", 25", 25" and 29". At the residence shown in Figure 5-31 with the high-wind siding, the greatest spacing was 21". However, of the eleven measurements taken at that residence, eight were 14" or less.

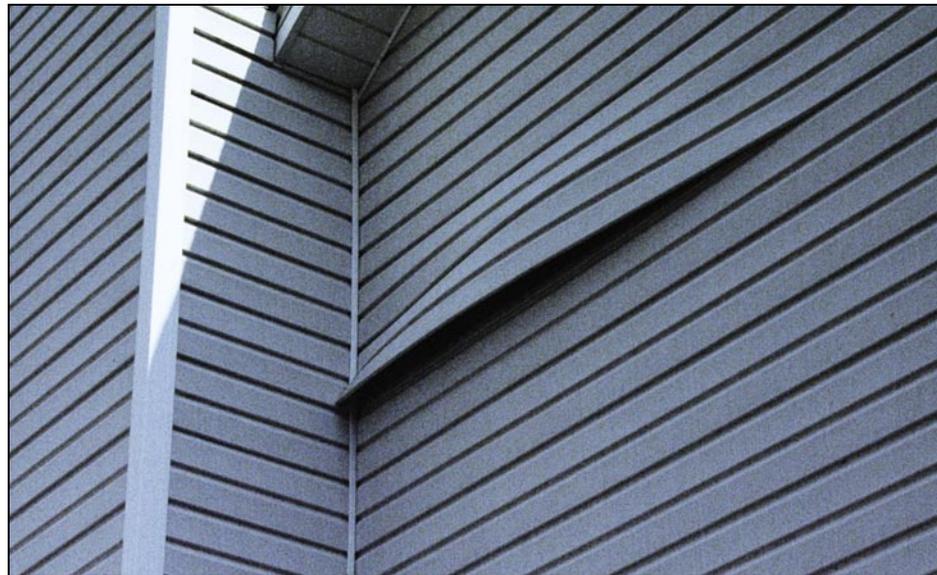
In some cases, the MAT believes that the blow-off was triggered by unlatching of the buttlock, which is the bottom portion of the panel (see Figures 5-33 and 5-68). Once the panel unlatches from the retainer slot just below the nailing flange, the panel is free to rotate outward where it can be caught by the wind and blow off. The magnitude of the unlatching issue, compared to the strength of the nailing flange and fastener spacing, is unknown. When unlatched, panels are very susceptible to blow-off.

Figure 5-33.
When a panel becomes unlatched, it becomes very susceptible to blow-off.

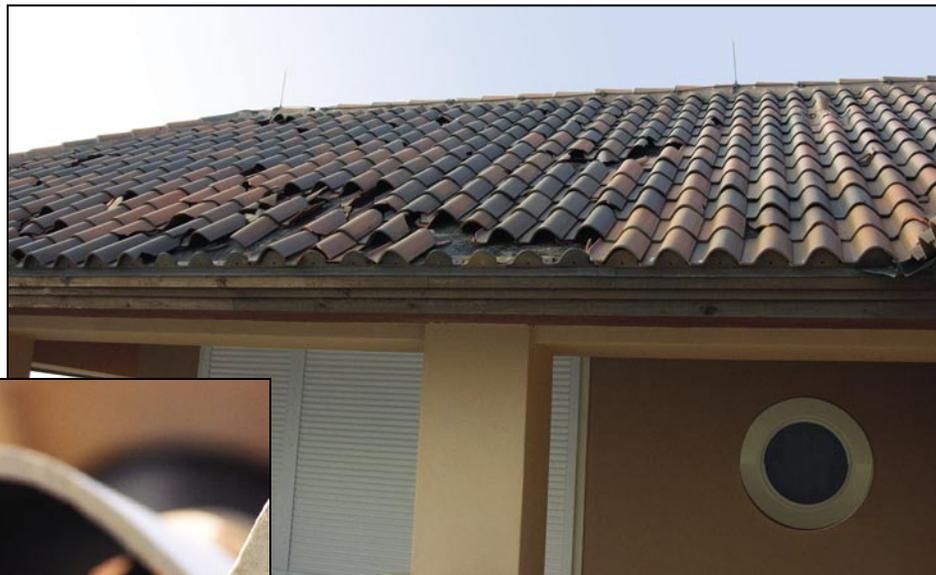
Another direct-to-deck roof is shown in Figure 5-42. This six-year-old residence was adjacent to the ocean. Several of the fastener heads had corroded off, thus allowing the tiles to lift over the fasteners.

Figure 5-42.
The fastener heads on this direct-to-deck mechanically attached tile roof had corroded. The six-year old house sat near the ocean.

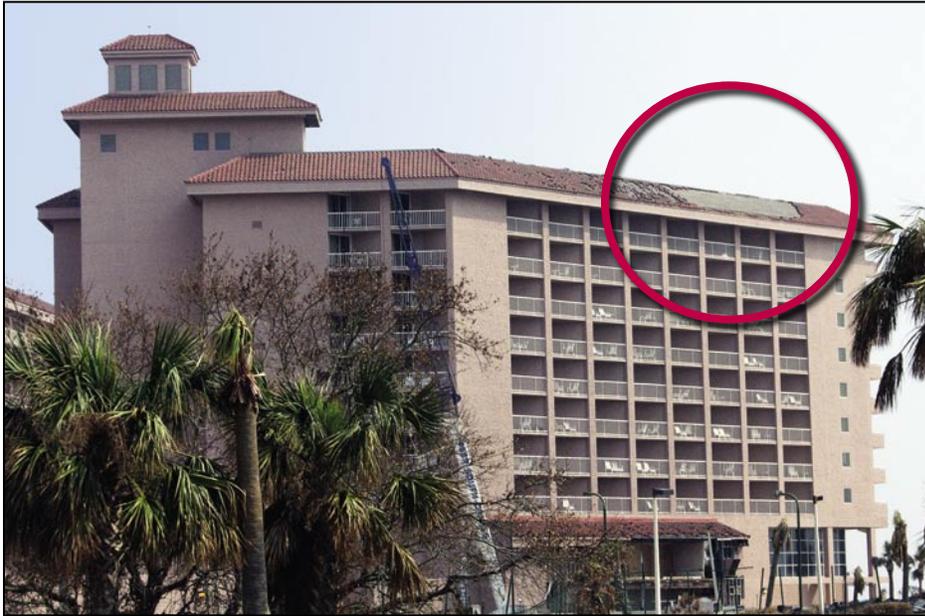
Several batten-attached roofs were observed. Tiles flying from a mid-rise building, such as that shown in Figure 5-43, can sail a considerable distance and have very destructive energy.

Figure 5-43.
Loss of several batten-attached tiles from a mid-rise building

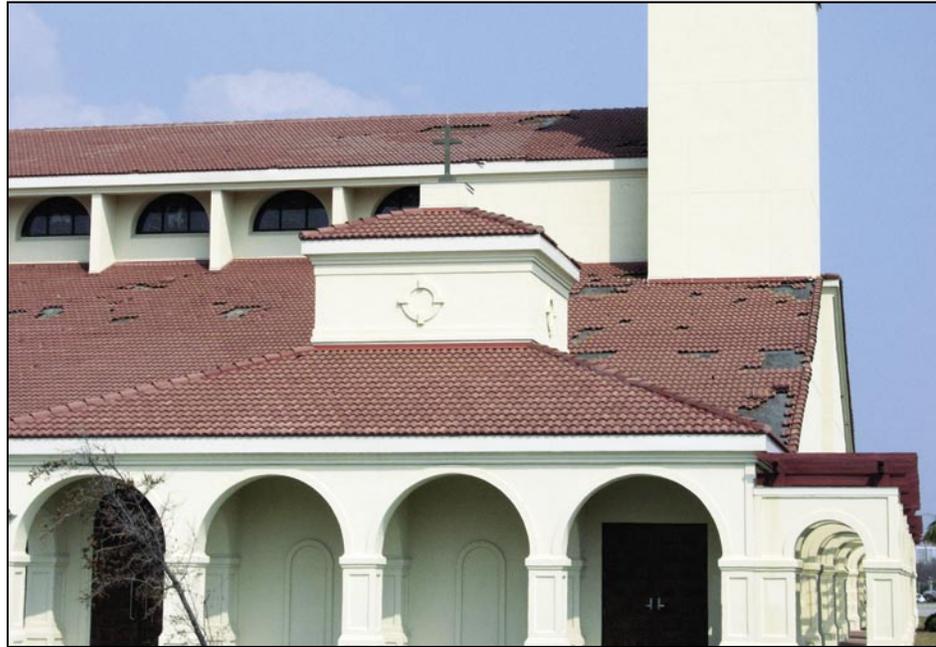
Tiles were blown off of several areas of the roof shown in Figure 5-48. These failures were caused by significant workmanship errors, wherein too little adhesive was applied (Figures 5-49 and 5-50).

Figure 5-48.
These tiles were foam-set. See Figures 5-49 and 5-50.

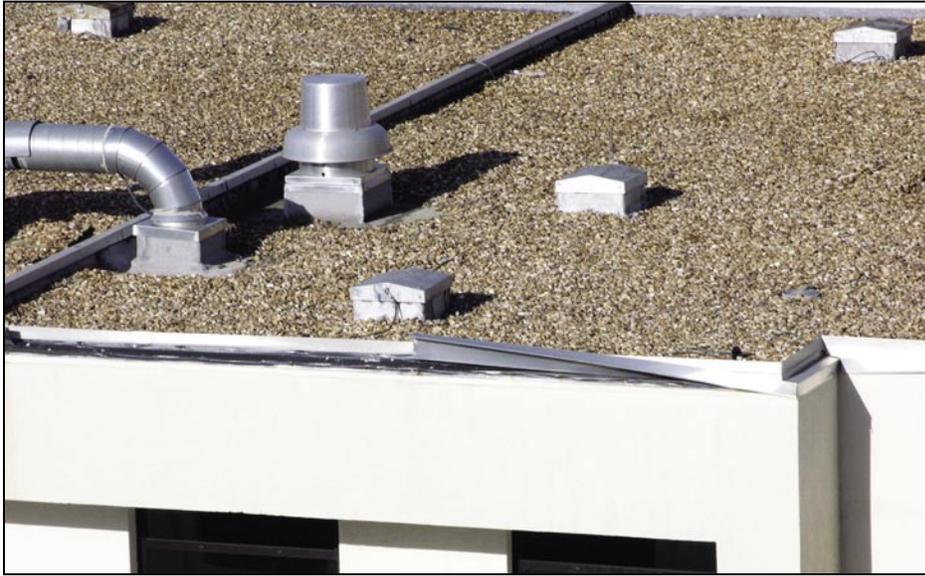
Figure 5-57. Although the metal edge flashing lifted, a progressive membrane lifting and peeling did not occur. Some aggregate ballast was blown off an adjacent higher roof. (Pensacola)

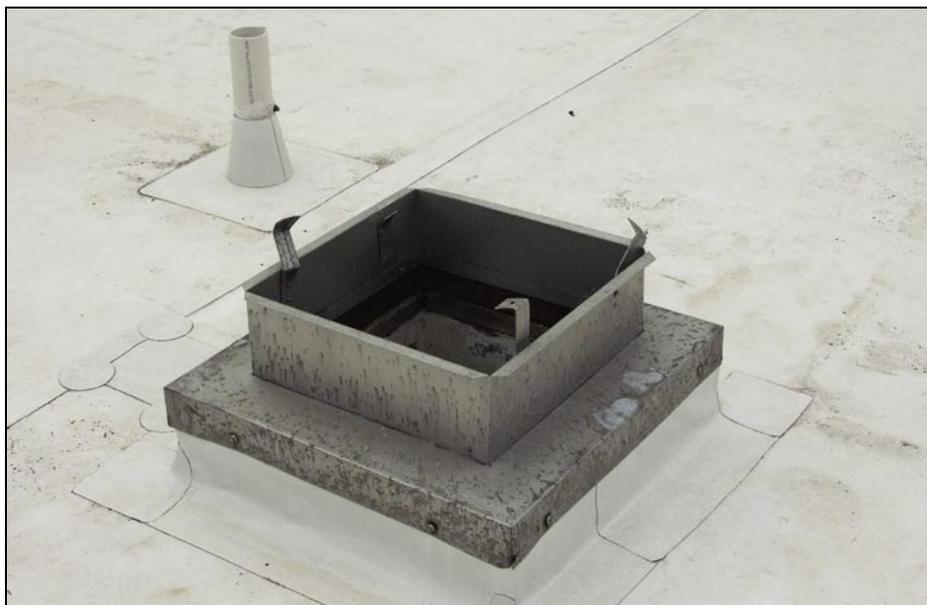
Figure 5-71.
Loss of the hood at this relief air vent allowed rainwater to directly enter the school. (Pensacola)

Many of the observed schools experienced widespread rainwater damage due to breached building envelopes, which resulted in disruption or loss of school operations. In some cases, such as that shown in Figure 5-71, the envelope damage was minor, but lack of quick emergency repairs allowed significant rainwater to subsequently enter the building.

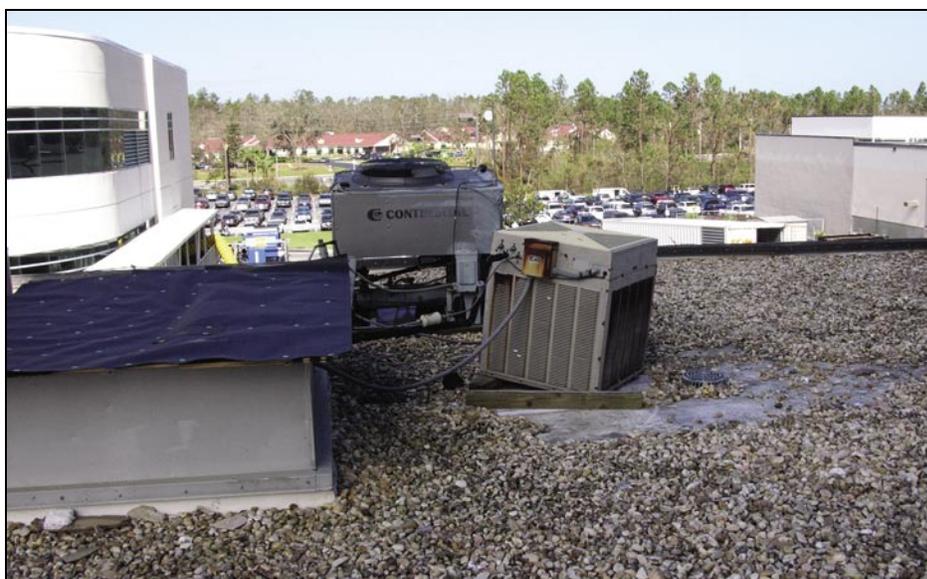
Figure 5-72 shows loss of a relief air hood and displacement of a sleeper-mounted condenser. Sleeper-mounted condensers do not provide resistance to uplift or lateral wind loads.

Figure 5-72.
At this hospital, the condenser moved off the sleepers and a nearby relief air hood was blown away. (Pensacola)

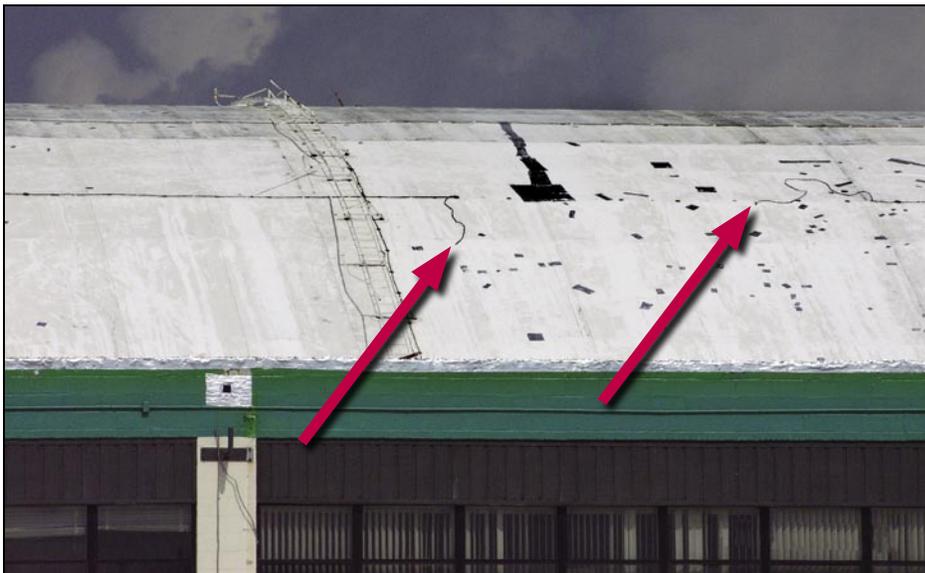
LPS failures were typically the result of poorly anchored systems. Connectors often fail by opening up and releasing the conductor cable or they debond from the roof (Figure 5-78). Figure 5-79 illustrates the number of roof membrane punctures that can be caused by loose LPS conductors.

Figure 5-79.
The LPS conductor on this hangar became detached and punctured the roof membrane in several locations. (Arrows show ends of loose cable.) (Pensacola)

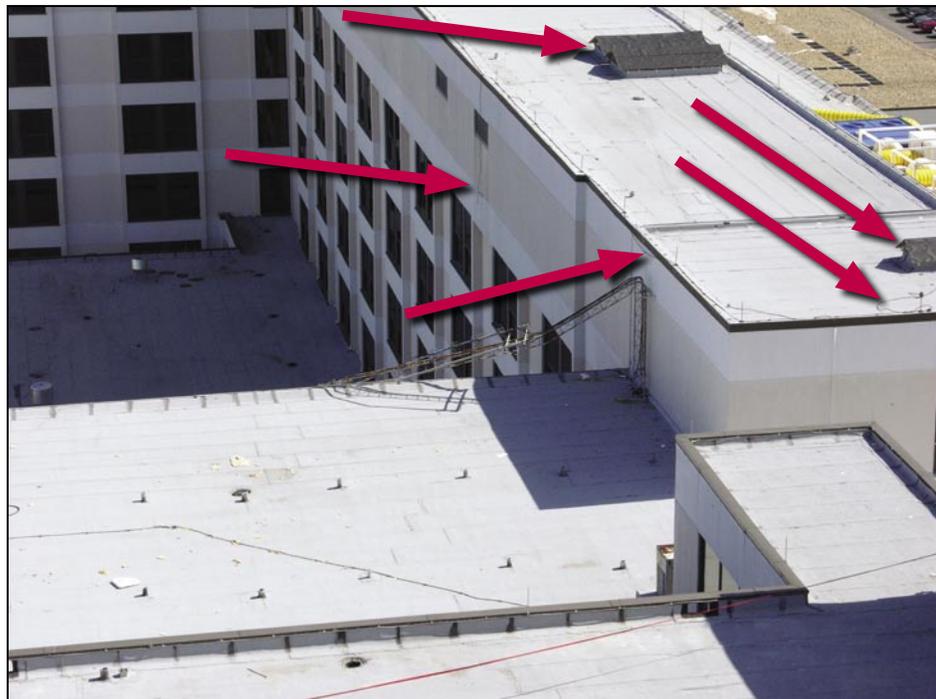
Figure 5-81.
The antenna at this hospital collapsed. The LPS was also displaced in a few areas (red arrows). Rooftop equipment was also damaged. (Pensacola)

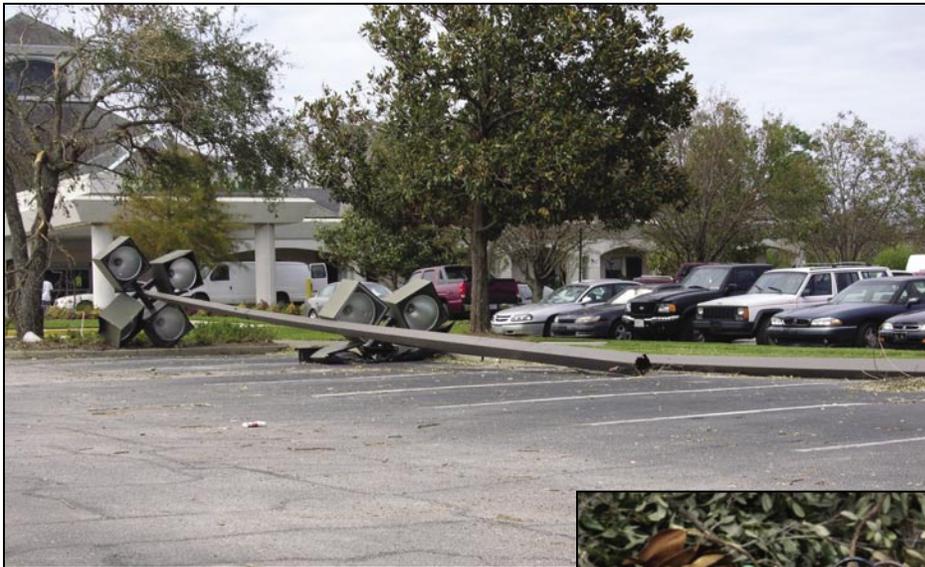
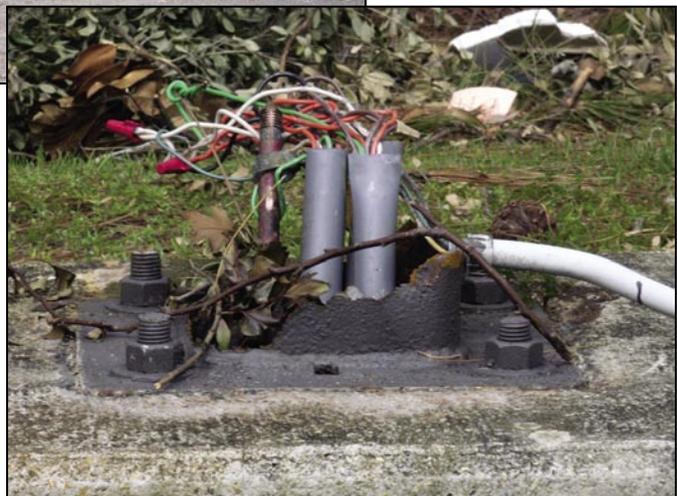
Figure 5-82 shows collapsed light fixtures. These failures were caused by severe corrosion.

Figure 5-82.
Collapsed light fixtures
at a hospital. The bottom
of the tube was severely
corroded (see inset).
(Pensacola)
