Mitigation Assessment Team Report

Hurricane Ivan in Alabama and Florida

Observations, Recommendations,
and Technical Guidance

FEMA 489 / August 2005

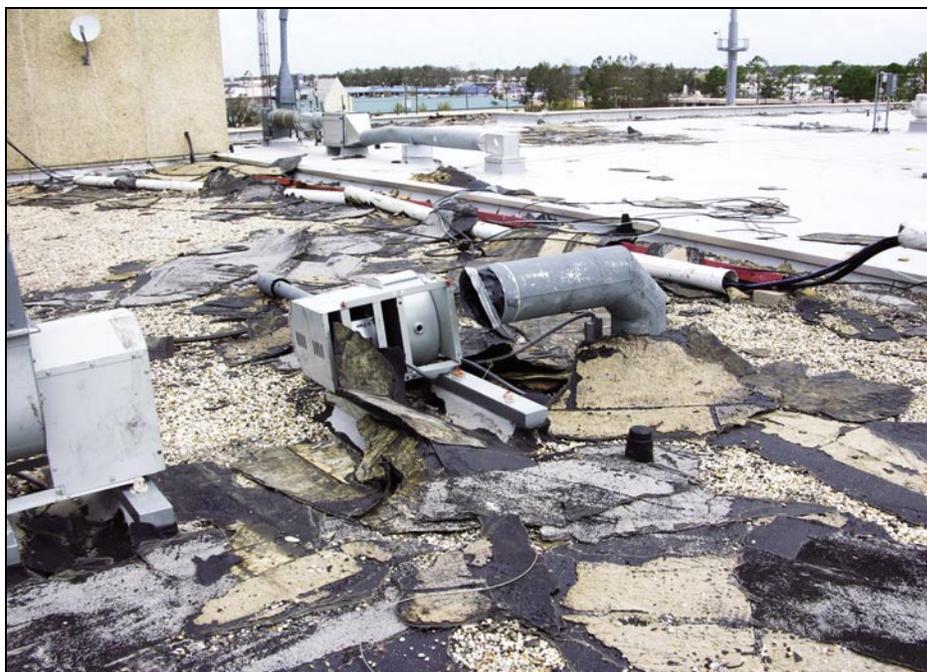
The original building had two floors above grade. A new two-story addition was joined to the original building. Construction of the addition was essentially complete when Hurricane Ivan struck. A large roof membrane blow-off was experienced in one area (Figure 6-1). The damaged membrane was a BUR with a field-applied mineral surfacing over light weight insulating concrete (LWIC). The LWIC was likely installed over a structural concrete deck. Although the rooftop equipment was inadequately attached on both the original and new portions of the building, the equipment was likely damaged by windborne roof debris rather than wind pressure. The modified bitumen roof membrane on the new addition was also damaged. The membrane lifted and tore at a roof drain and the base flashing at the

parapet was displaced. A portion of the coping was also displaced. Some of the windows on the original building were shuttered, but some were not – at least one window was broken (likely by windborne debris). A portion of the LPS on the new addition was dislodged.

Figure 6-1. General view of the roof membrane and rooftop equipment damage at the Escambia County Sheriff's Office/EOC. The roof at the upper right is on the new addition. The mineral surfaced BUR landed on an aggregate surfaced BUR. (Pensacola)

Six days after the hurricane struck, emergency repairs had not been made to the roof and open ductwork on this important facility. Demands for repair crews are enormous in the aftermath of a hurricane like Ivan. To ensure priority service, it is prudent for owners of critical and essential facilities to have pre-established agreements with contractors to perform emergency inspection and repair if needed.

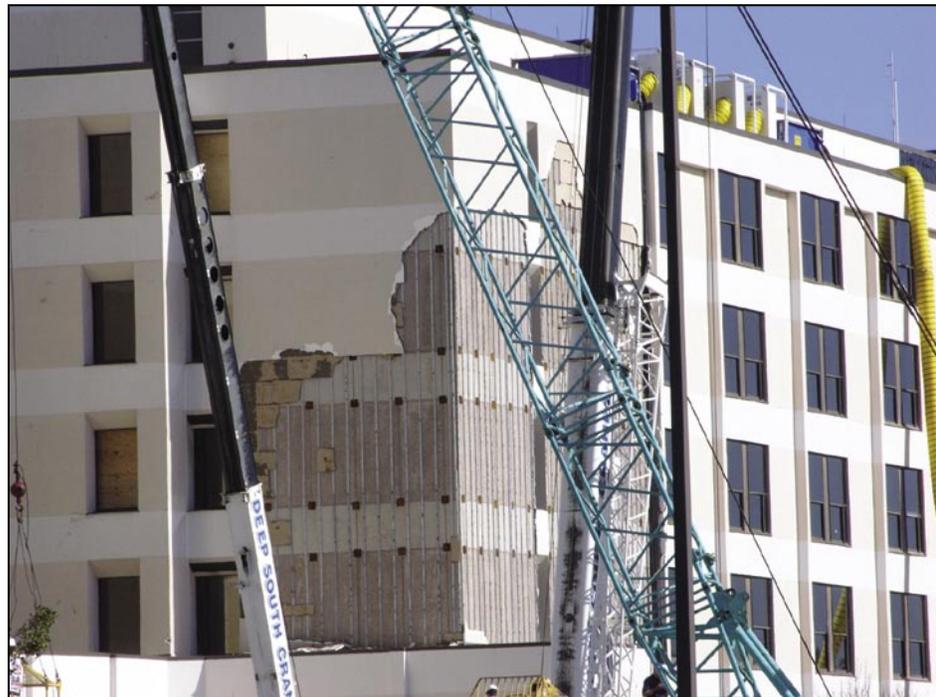
Figure 6-2.
View of EIFS damage
at hospital building
(Pensacola)

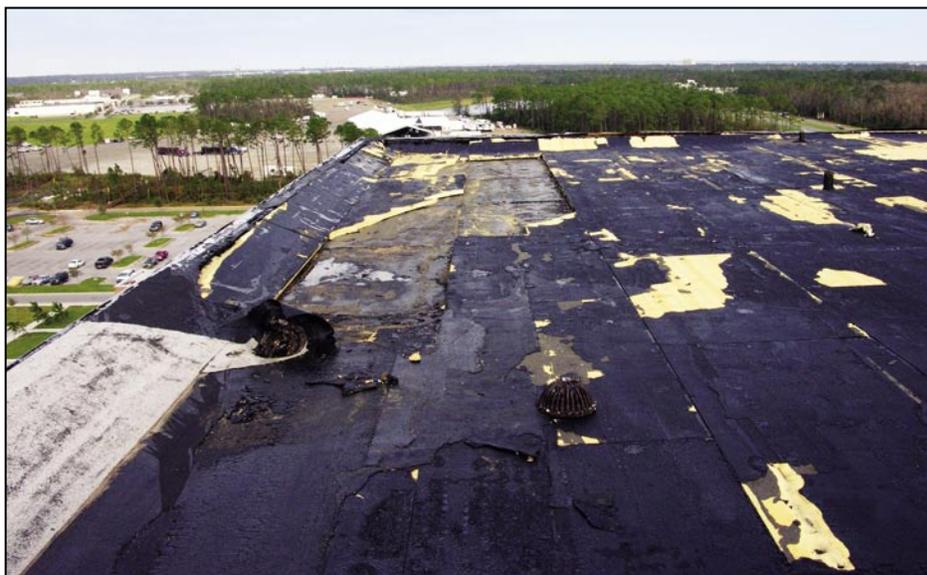
- At the Pensacola Naval Hospital complex, two patient floors were taken out of service because of minor rainwater leakage due to roof membrane blow-off from a large portion of the roof (Figures 6-3 and 6-4). The concrete roof deck was effective in minimizing leakage. The modified bitumen membrane had been installed over polyisocyanurate insulation mopped to the concrete deck. The blow-off was initiated by lifting and peeling of the metal edge flashing, or lifting of the wood nailers that the edge flashing was attached to, or by debonding of an insulation board from the deck. Debris from the roof broke several of the second and third floor windows (including some glazed with tempered glass) (Figure 6-4). Roof debris also damaged several antennas (Figure 5-80).

Figure 6-3. General view of upper roof of the Pensacola Naval Hospital. Note the missing insulation boards near the corner of the roof. (Pensacola)

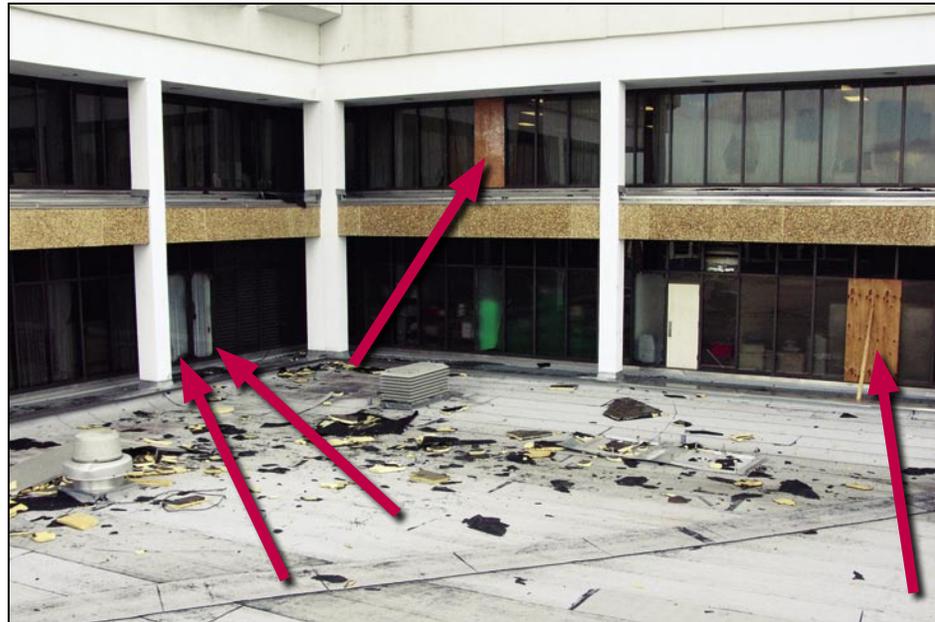
Figure 6-4.
View of a portion of the lowest floor roof showing broken 2nd and 3rd floor windows and debris from the roof above shown in Figure 6-3

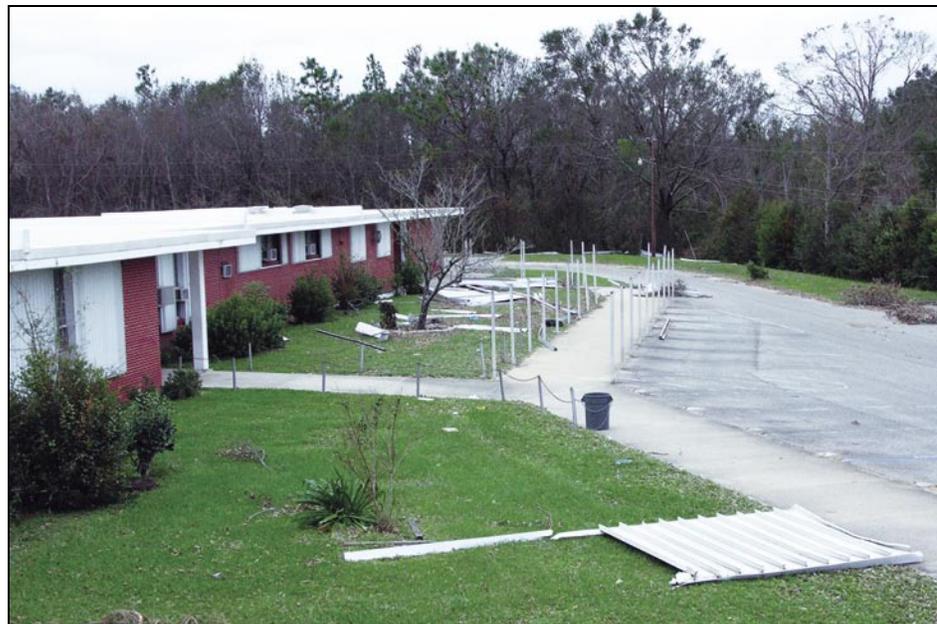
Figure 6-5.
Walkway canopy
collapse at Bellview
Middle School. Stronger
winds could have turned
the debris into lethal
missiles. (Pensacola)

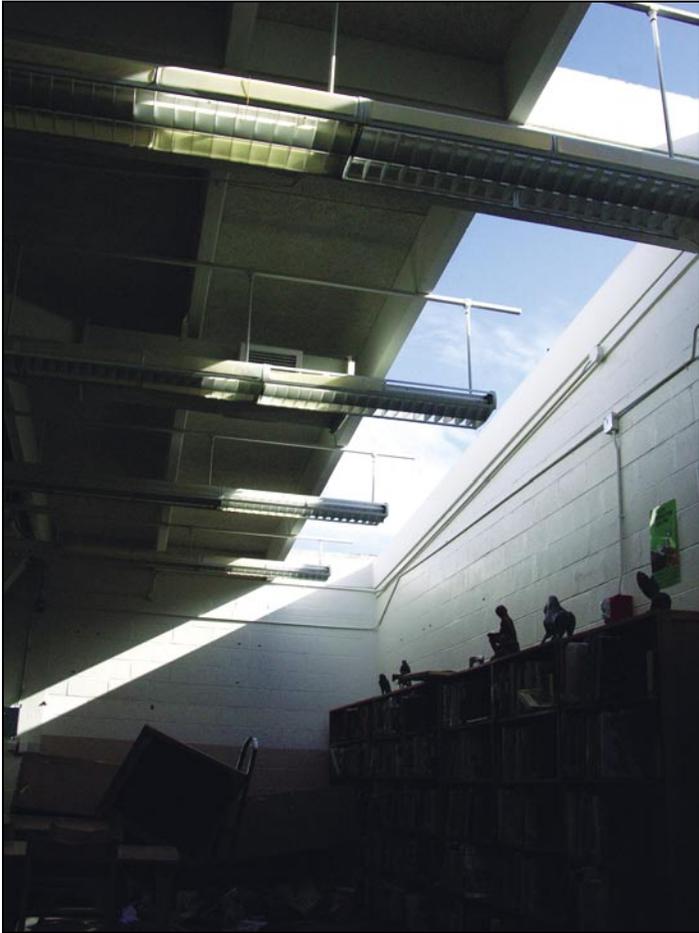
Figure 6-6.
Loss of cementitious wood-fiber roof deck panels at Workman Middle School (Pensacola)

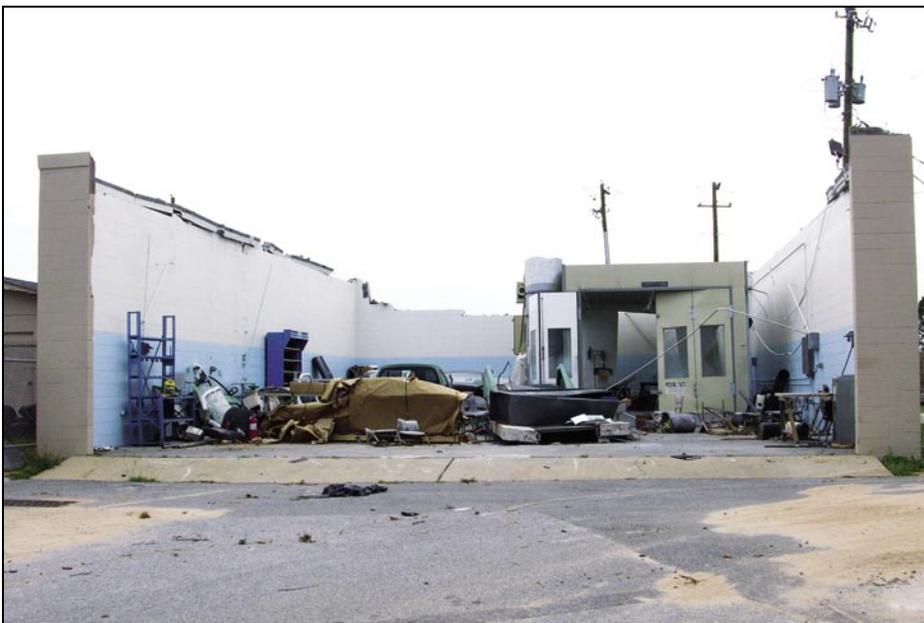
Figure 6-7.
Loss of the roof structure and rear portion of the CMU load-bearing wall at the George Stone Career Center auto shop (Pensacola)

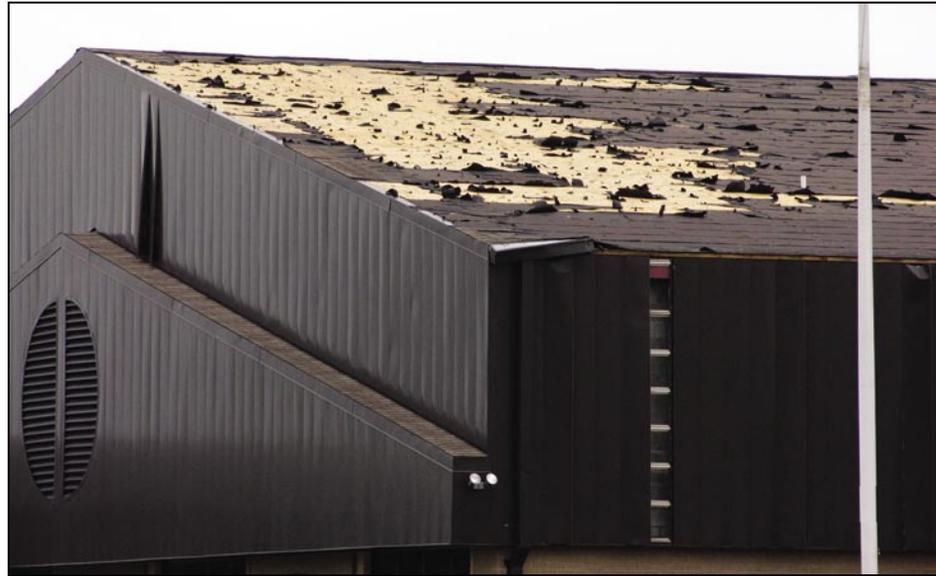
The Jim C. Bailey Middle School (built in 1995) was used as a shelter. Rainwater entered the building in several different areas where asphalt shingles, underlayment, rooftop equipment, and metal wall panels were blown off (Figure 6-8). The shingles were attached with only four nails instead of six, which the roofing industry recommends in high wind areas. The nails were incorrectly located (they were too high and at one of the shingles, an end nail was 2 ½ inches rather than 1 inch from the end). People were moved from one portion of the building to another to escape the rainwater leakage.

Figure 6-8.
Loss of asphalt shingles and underlayment at the Jim C. Bailey Middle School. Note the displaced wall panels at the upper left and the missing panel in the lower right.
(Pensacola)

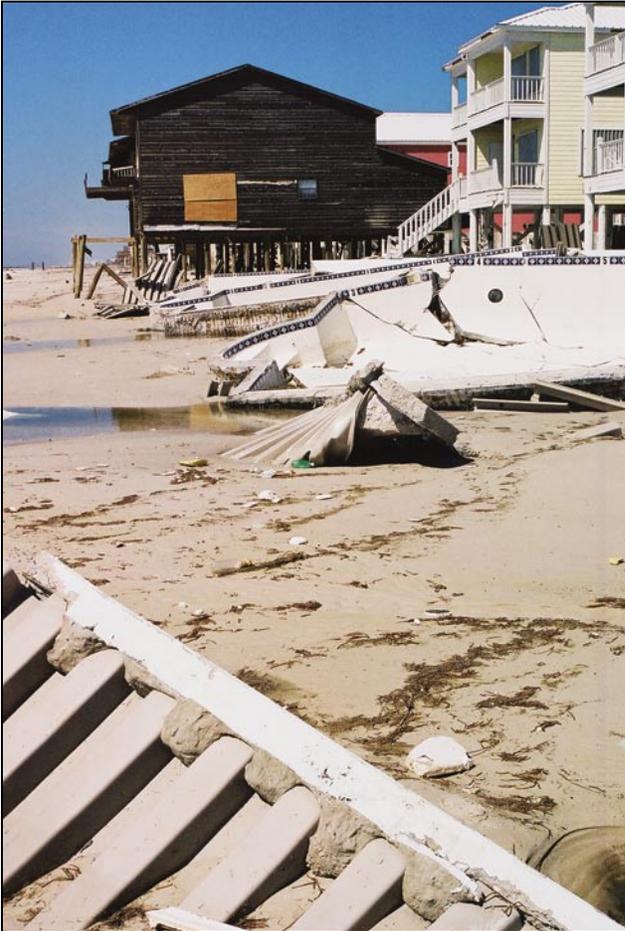
Pools and bulkheads suffered extensive damage and should be viewed as sacrificial features during a major hurricane.

Figure 7-6.
Typical failure of swimming pools and bulkheads
(Gulf Shores)

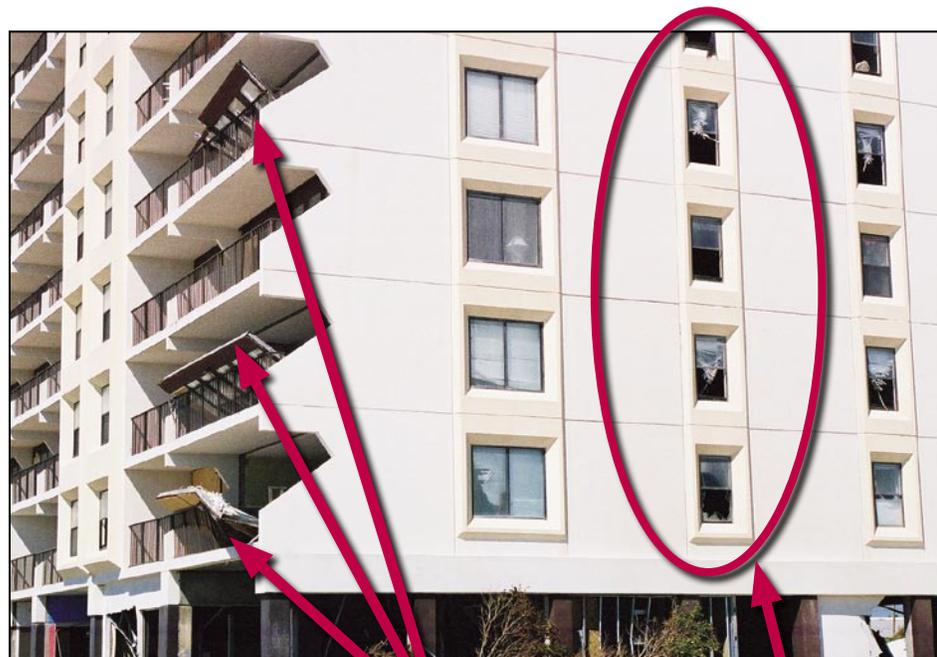
At the condominium shown in Figures 7-8 and 7-9, an unusual window failure resulted in extensive secondary damages. The lower portion of the small windows shown in Figure 7-8 were inward-opening hopper windows (i.e., they were hinged along the bottom of the window frame). Because the latch at the top of the hoppers was very weak and incapable of resisting the positive wind pressure applied to the glazing, many of the hoppers opened. The open windows allowed an increase in the internal pressure. The high internal pressure pushed over the interior partitions (Figure 7-9). The high internal pressure also exerted load on the curtain wall facing the ocean, which combined with the exterior suction load to cause the curtain walls to fail. The curtain wall's metal stud tracks were attached with powder driven fasteners into the concrete slab. The number of fasteners was insufficient to resist the applied loads.

Figure 7-8.
Window damage caused
exterior wall failure
(Gulf Shores)

Internal and external pressures combined
to cause exterior wall failure

Window breaches caused
an increase in internal
pressure

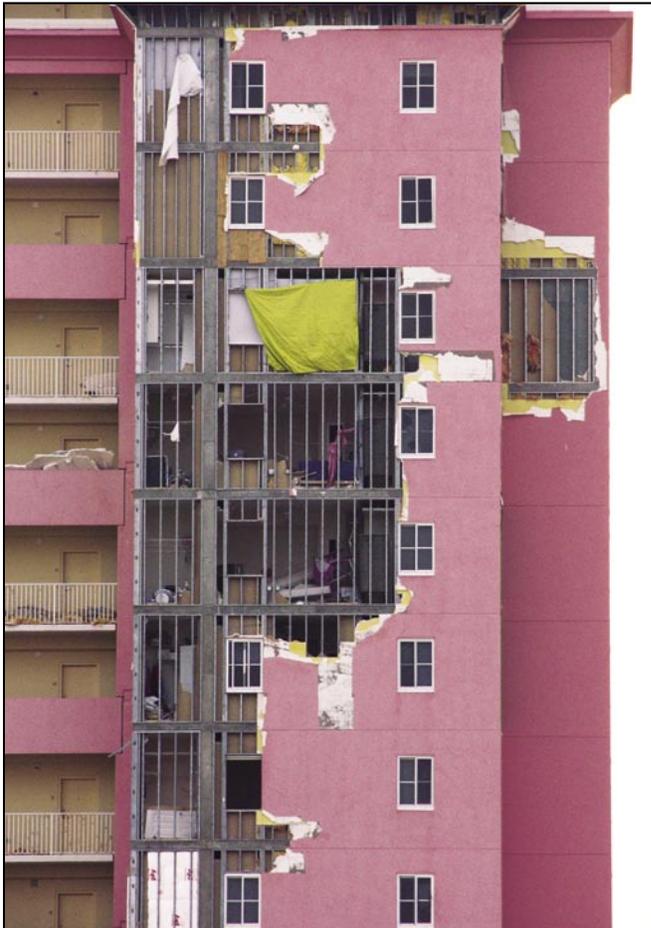
Figure 7-11:

- In general, EIFS performed very poorly. For many buildings, the poor performance resulted in significant rainwater infiltration damage (see Figure 7-11). Much greater attention is needed in the design and application of EIFS, and improvements are needed in design guides and testing.

In this EIFS failure, the majority of the gypsum board detached from the studs. At some living units, the gypsum board on the interior side of the studs was also blown off, thus exposing the units directly to the hurricane.

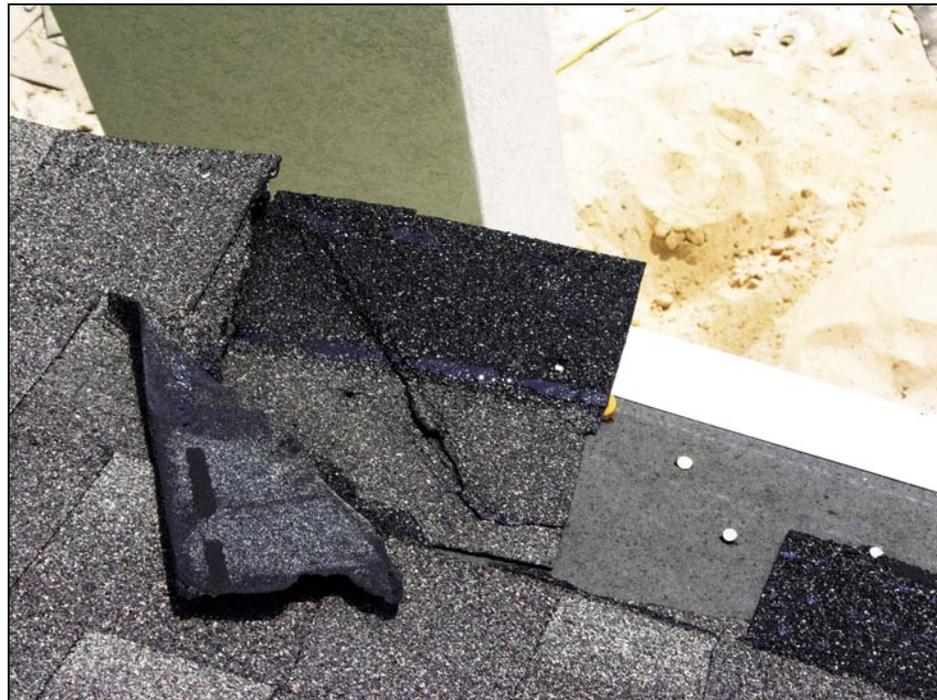
Figure 7-12. Rather than cutting off the tabs, the starter course on this new roof was turned 180 degrees. Hence, the tabs of the first row were free to lift because they were not adhered in the self-seal adhesive on the starter.

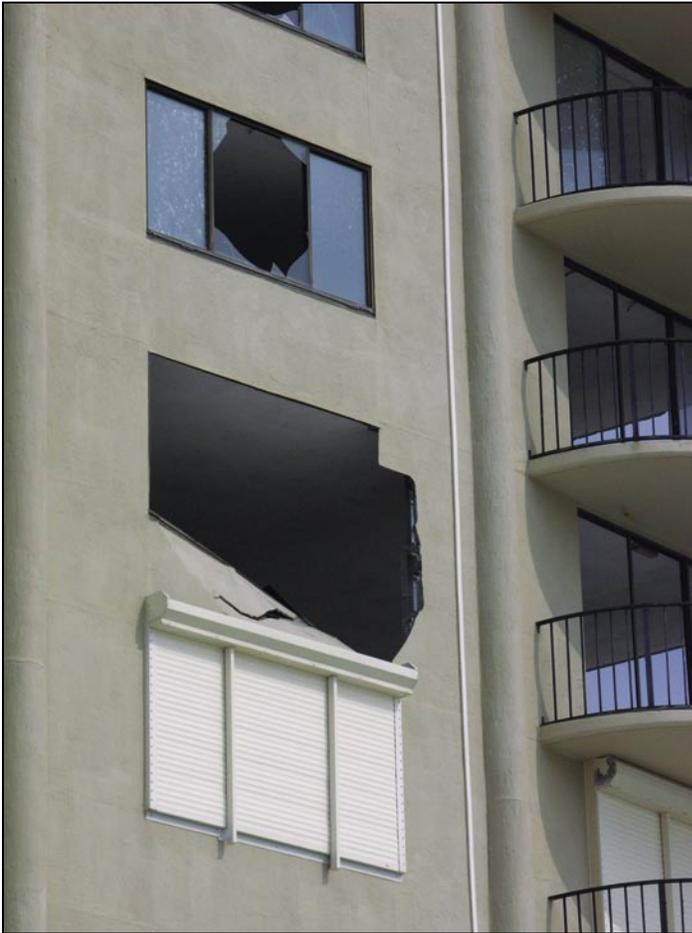
- Many homes and businesses that experienced only contents damage could have prevented these losses if their openings were protected. Success in designing the structural frame to resist wind loads and internal pressures was partially negated by significant losses to building contents (Figure 7-14).

If aggregate roof surfaces do not occur within the parameters given in ASCE 7, then for most buildings, glazing protection above 60 feet above grade is generally not needed (although isolated damage may occur as shown in Figure 7-15). On some critical or essential facilities, as a very conservative measure, protecting glazing above 60 feet may be prudent. For these buildings, a special evaluation, including consideration of the basic wind speed, characteristics and proximity of other buildings, and characteristics of the building being considered should be conducted to determine if glazing protection above 60 feet is appropriate.

Figure 7-14.
Glazing at the top two window units broken by debris, while the entire middle window unit was blown away. The shuttered window unit was not damaged.

Figure 7-15.
A few of the upper level windows were broken.

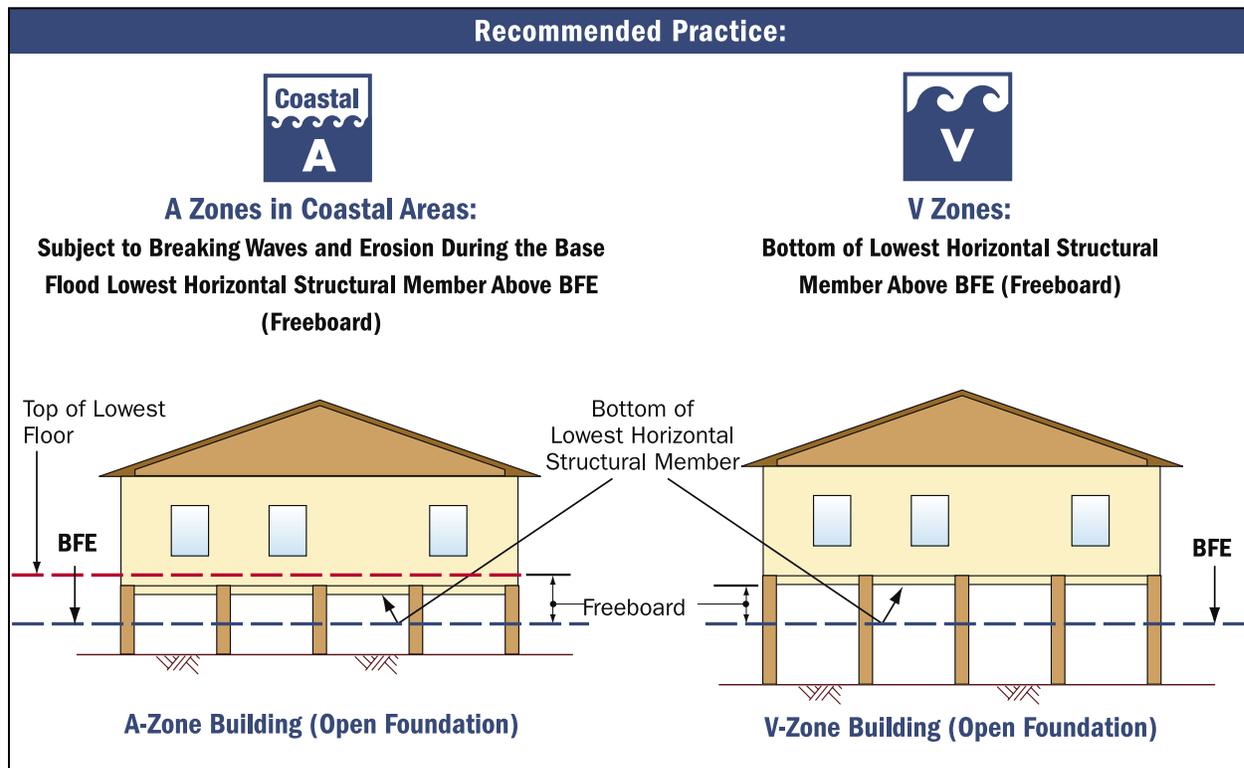
Figure 8-1. Freeboard and open foundations are recommended for V Zones and coastal A Zones.

- **Freeboard** – Require freeboard for all structures in all flood hazard zones with the amount varying with building importance (see ASCE 7-05 and ASCE 24-05 for building importance classification and freeboard requirements) and anticipated exposure to wave effects (see Figure 8-1). When using pile foundations, elevate the lowest floor a minimum of one story above grade to allow for parking and storage, which is the current practice by some builders.

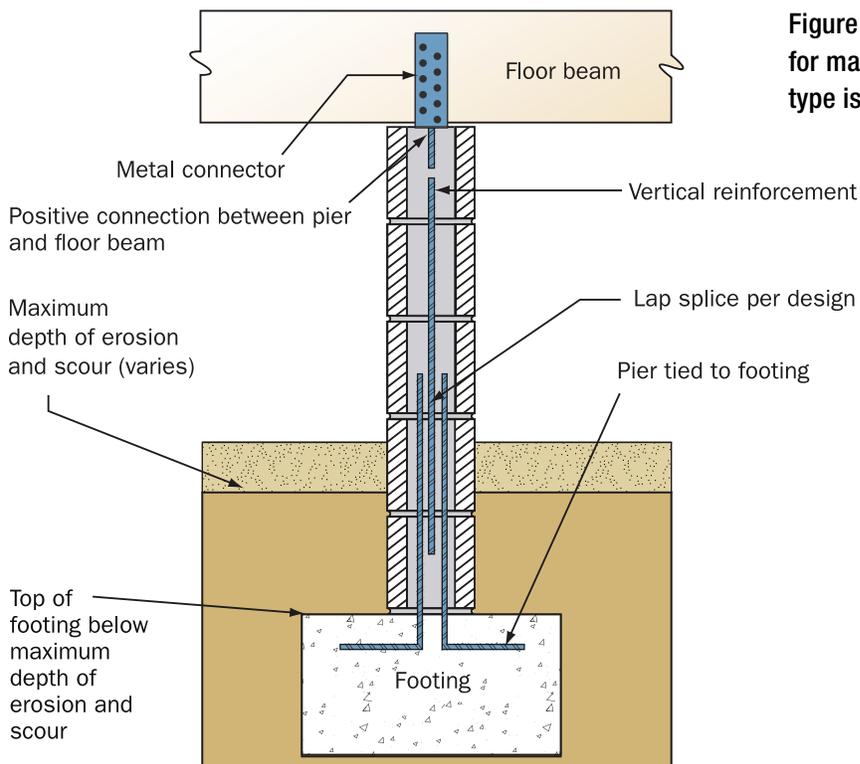
Figure 8-2. Recommended design details for masonry piers where this foundation type is appropriate

Pier foundations should be used only where soil characteristics and flood conditions permit, and where their design and construction are consistent with the details shown in Figure 8-2. Although this is a common foundation type, its performance in coastal areas has been poor where erosion, waves, and/or debris are present.

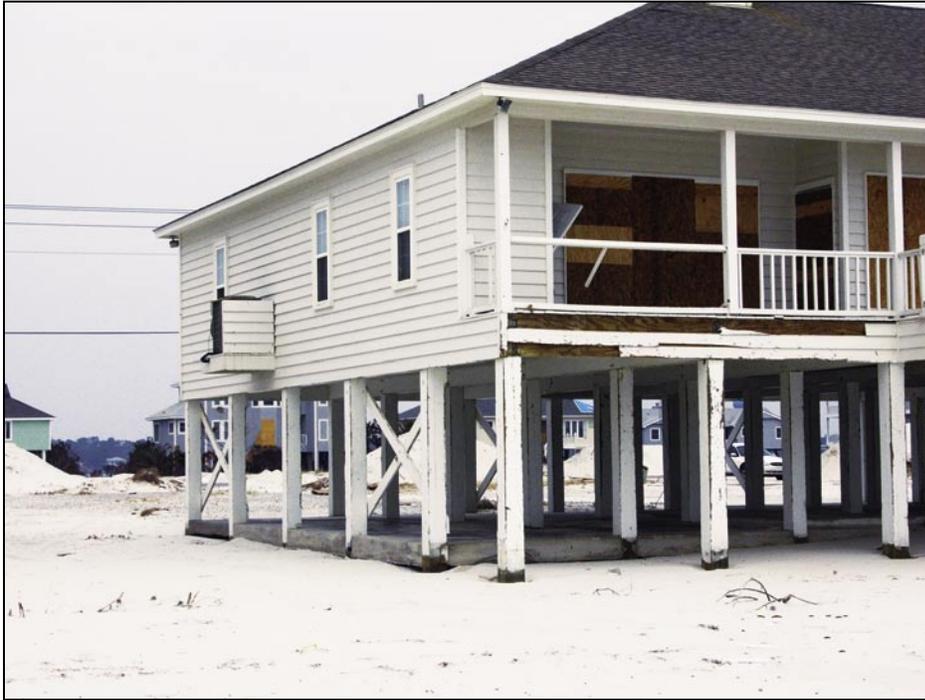
Figure 8-3.
A cantilevered platform.

HVAC equipment should be elevated above the BFE and preferably to the same elevation as the lowest floor of the building. The equipment should be supported to prevent damage from flooding and fastened to resist blow-off from high winds. The preferred approach is a cantilevered platform (see Figure 8-3). Other acceptable support systems include knee-braced platform supports (with the bottom of knee braces above wave and debris impacts), and pile supports (with piles substantial enough to resist all flood loads and anticipated erosion and scour). Shallow and/or small diameter post or pile supports should not be used under any circumstances in coastal flood hazard areas.

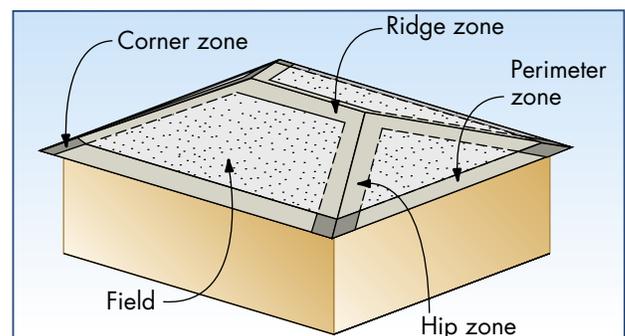
Figure 1. For critical and essential facilities, clip all tiles in the corner, ridge, perimeter, and hip zones.

If it is decided to use tile on a critical or essential facility and if the tiles are mechanically attached, it is recommended that clips be installed at all tiles in the corner, ridge, perimeter, and hip zones (see ASCE 7-02 for the width of these zones). (See Figure 1)

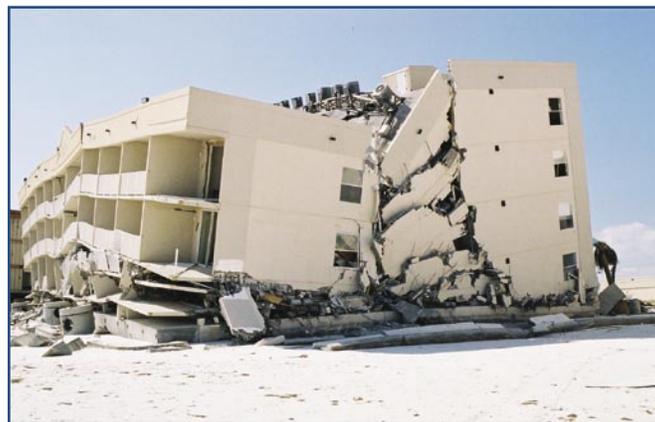
A well-built but poorly sited building can be undermined and will not be a success (see Figure 1). Even if a building is set back or situated farther from the coastline, it will not perform well (i.e., will not be a success) if it is incapable of resisting high winds and other hazards that occur at the site (see Figures 2 and 3).

Figure 1. Poorly sited building on shallow foundation undermined by erosion.

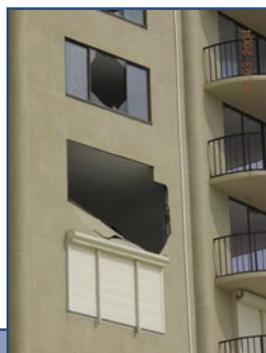
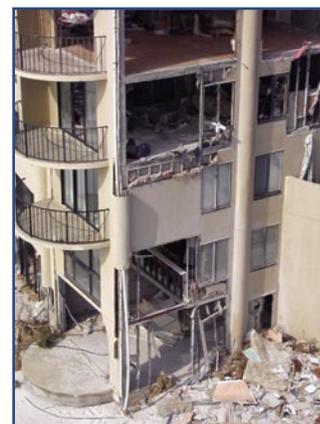
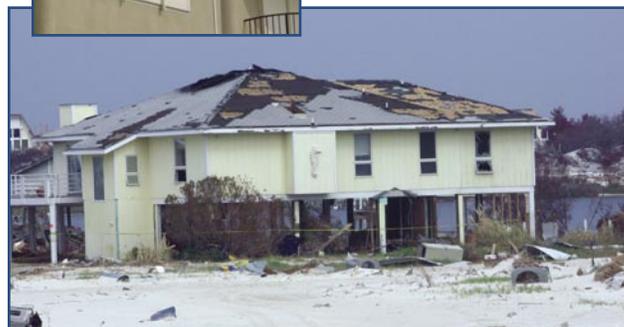
Figure 2. Well-sited buildings that still sustained damage due to building envelope and connection failures.

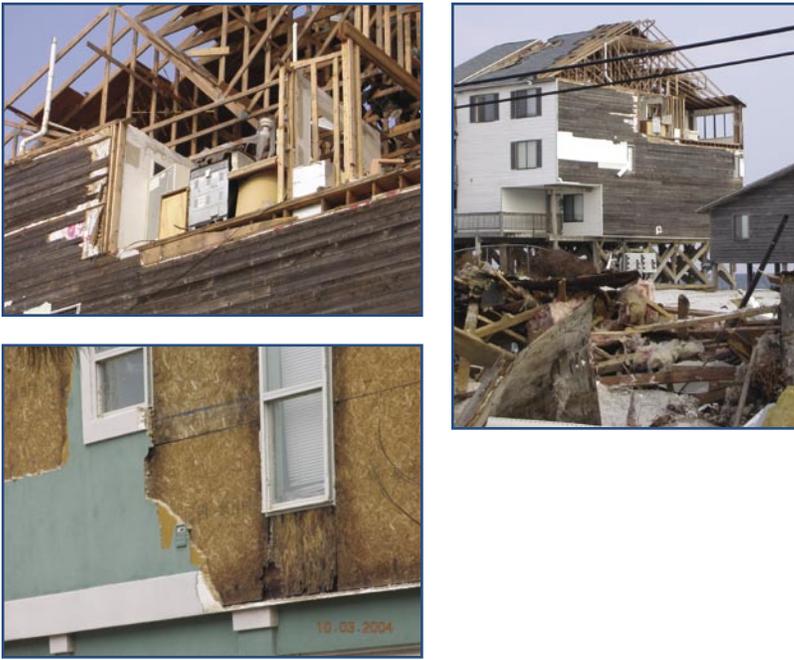
Figure 3. Well-sited building that still sustained damage due to building envelope and connection failures.

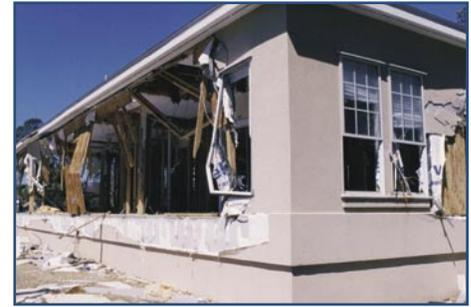
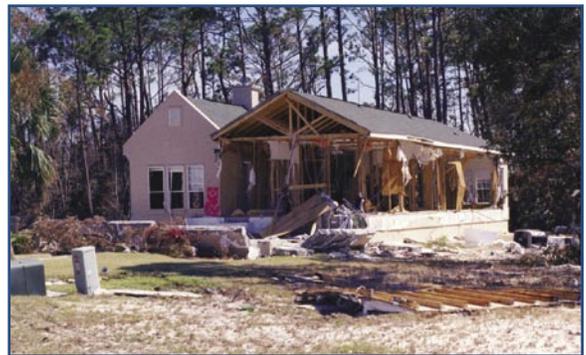
Similarly, a building compliant with the regulatory requirement that the lowest floor be elevated to the Base Flood Elevation (BFE) can still be damaged when the flood elevation exceeds the BFE (see Figure 4 and the discussion of lowest floor elevation in item 3 on the next page). The BFE is the expected elevation of flood waters and wave effects during the 100-year flood.

Figure 4. Compliant building damaged when the flood elevation exceeded the BFE.

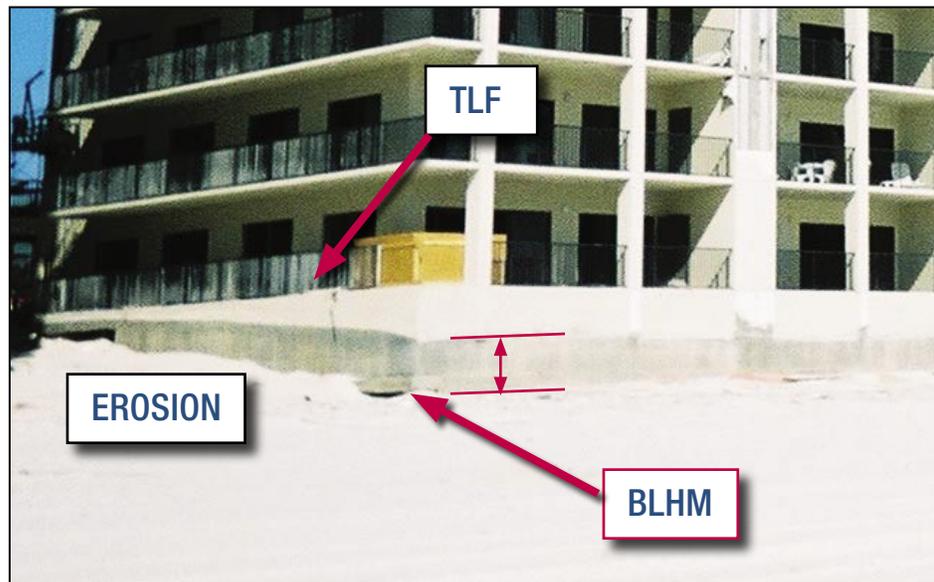
Figure F-5. Floor intact, wall intact damage state

- 13 percent of the buildings and 12 percent of the lowest floor living units sustained no damage whatsoever (floor intact, walls intact). See Figure F-5.

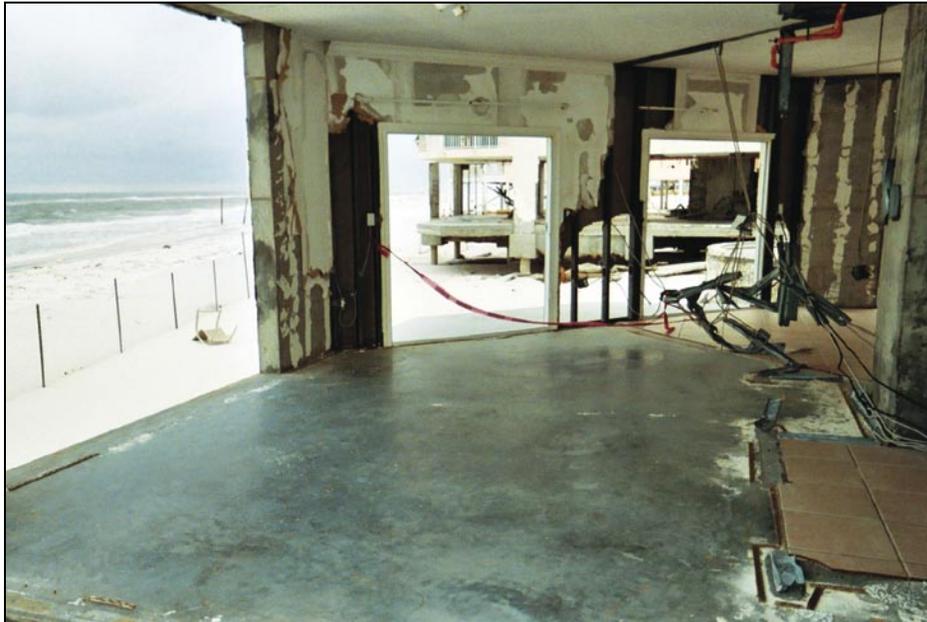
Figure F-6.
Floor intact, wall
destroyed damage state

- The most common lowest floor living unit damage state encountered was “floor intact, walls destroyed,” occurring in 44 percent of the buildings and 43 percent of the lowest floor living units. See Figure F-6.
- 31 percent of the buildings and 25 percent of the lowest floor living units sustained complete lowest floor destruction (floor destroyed, walls destroyed). See Figure F-7.
- 183 (79 percent) of the lowest floor living units sustained wall destruction (across all floor damage states). These units would likely have been classified as substantially damaged had they been individual buildings instead of units of high-rise structures.

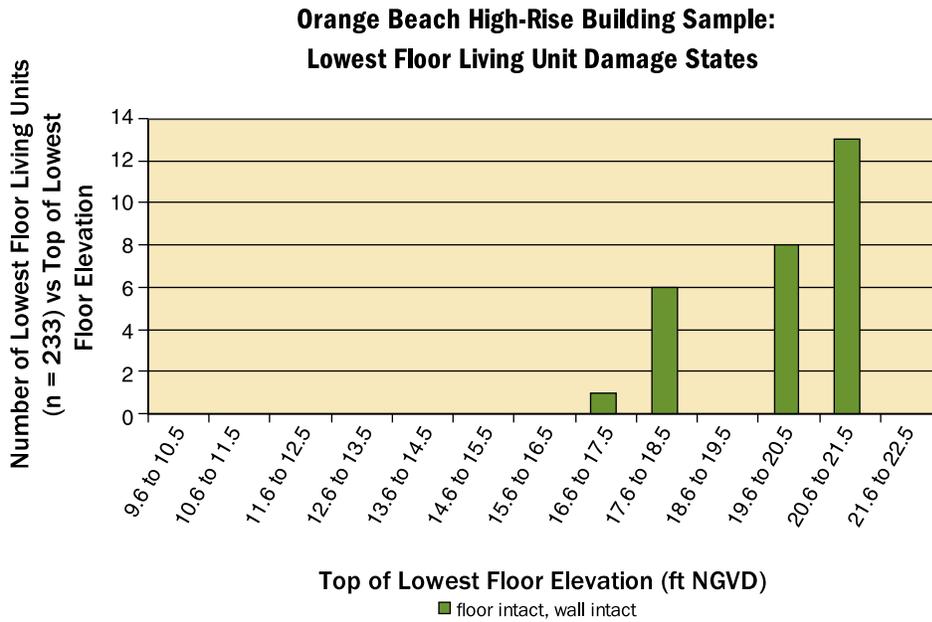
Building damage states were compared against lowest floor elevations. Not surprisingly, buildings with the lowest floor elevations had more wall and floor destruction than buildings with higher floor elevations (see Table F-5, Figure F-8 and Figure F-9).

Figure F-8.
Floor intact, wall intact
damage state versus top
of lowest floor elevation

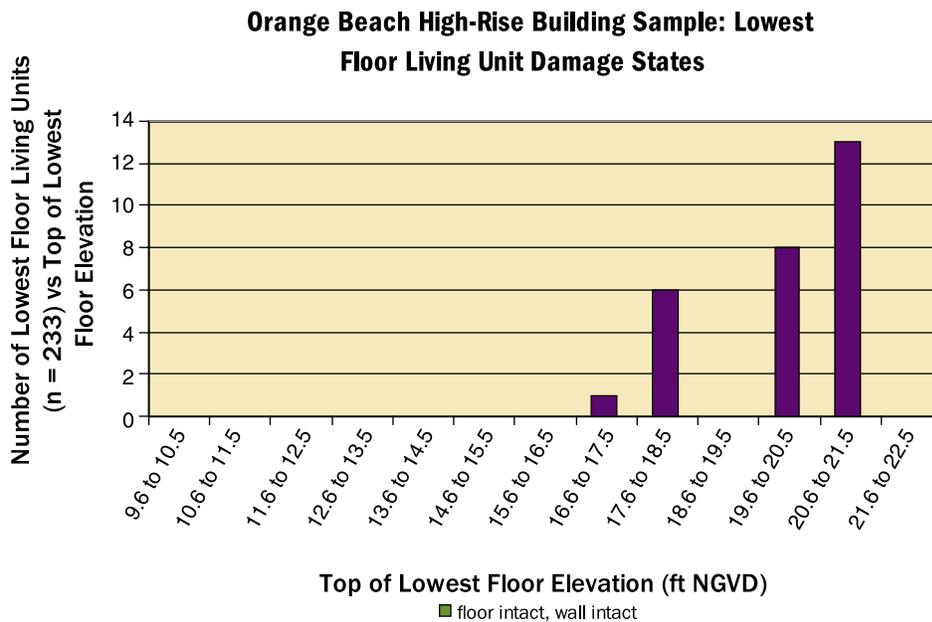
Figure F-9.
Floor destroyed, wall
destroyed damage state
versus top of lowest floor
elevation
