4 Structural Performance

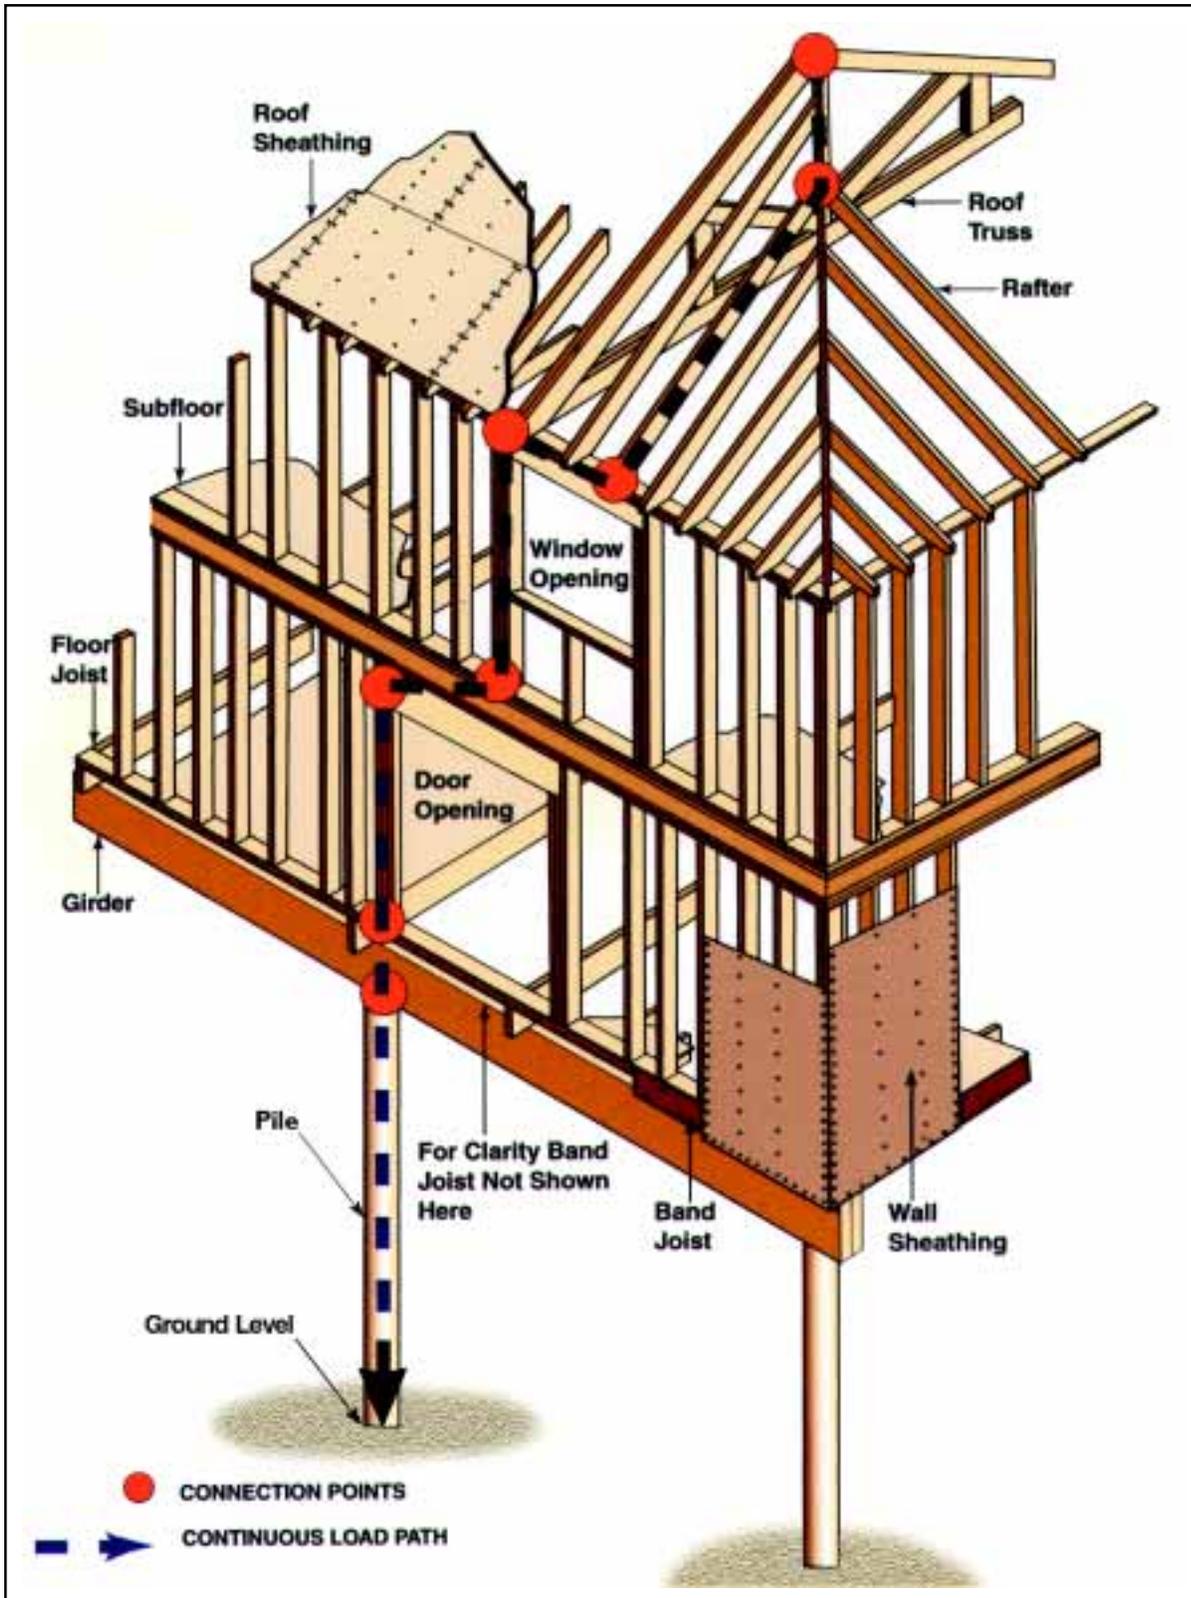
FIGURE 4-1 If a building has a continuous load path, forces and loads acting on any portion of the building will be transferred to the foundation of the building. This transfer occurs through building structural members (i.e., columns and beams) and the connections between these members. In this figure, the load path from the roof structure to the foundation is illustrated for an elevated, two-story wood-frame building.
