## HURRICANE

*Katrina*

## IN THE GULF COAST

## 5. Building Envelope Performance

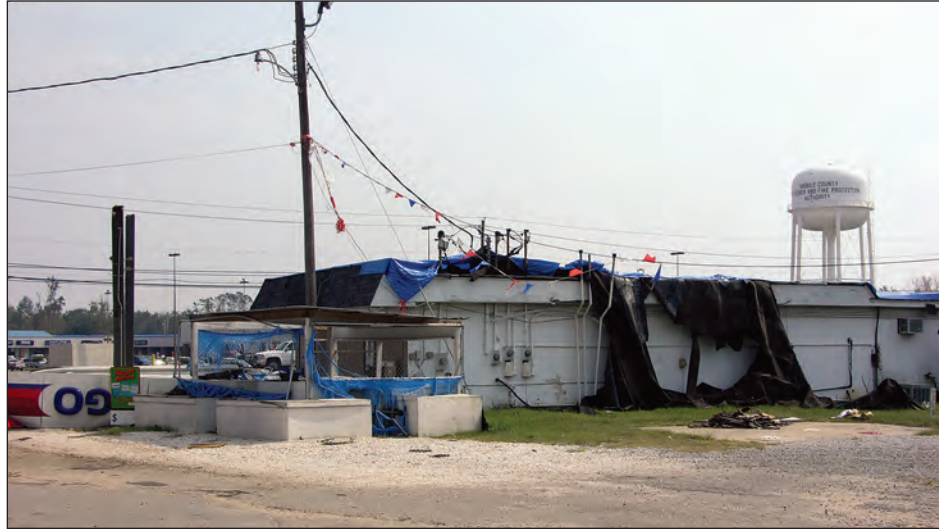
**Figure 5-1.**  
**Blow-off of a modified**  
**bitumen roof membrane**  
**at a service station. Note:**  
**The cantilevered canopy**  
**over the pumps was flipped**  
**upside down (estimated**  
**wind speed: 85 mph.**  
**Mobile, Alabama<sup>1</sup>).**

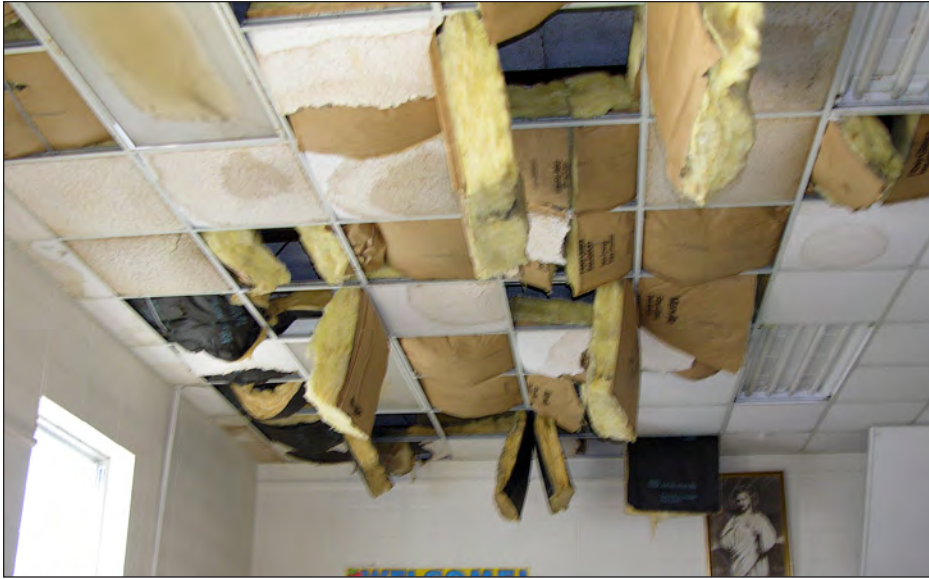
Figure 5-2.  
After the roof membrane blew off this school, water saturated the fiberglass insulation and ceiling boards, and several of the ceiling boards collapsed (estimated wind speed: 120 mph. Biloxi, Mississippi).

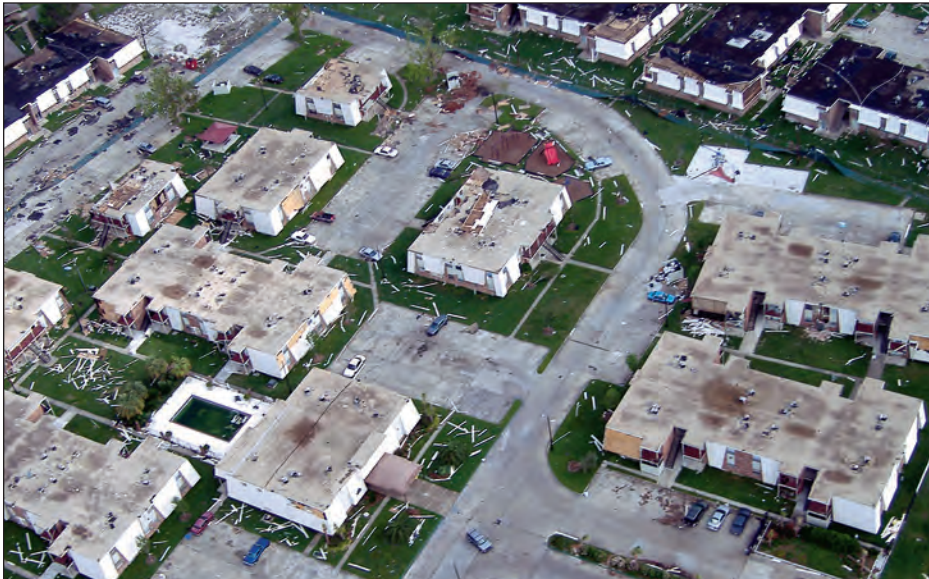
Figure 5-3.  
A substantial amount of siding (the white lines scattered around the ground) blew off this housing complex (estimated wind speed: 105 mph. Harvey, Louisiana area).

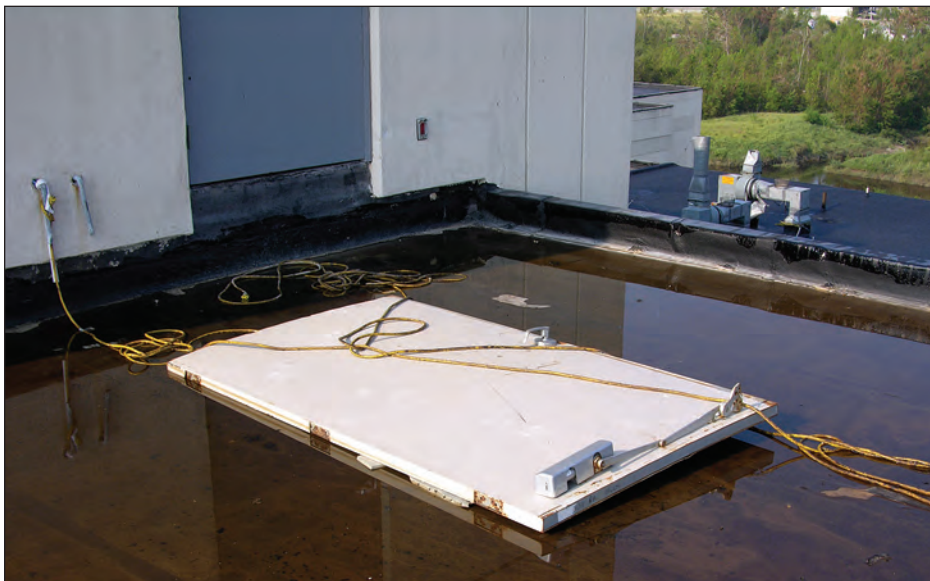
**Figure 5-5.**

Personnel door damage was observed on a limited number of buildings. Observed damage included door frames that detached from the building (likely caused by inadequate fastening to the building) and doors that blew from their hinges (likely caused by use of inadequately sized screws) as illustrated by Figure 5-5. One door on a new residence under construction blew off when the hinges detached from the frame. The door/frame was a pre-hung assembly that used very short screws to attach the hinges to the frame (otherwise, the screws would have projected from the frame and been a potential safety hazard during installation). After the frame was installed in accordance with most manufacturers' instructions, the short screws should have been replaced with stronger permanent screws.

A penthouse door on this hospital blew off its hinges. Blown-off doors allow entrance of rain, and tumbling doors can puncture roof membranes (estimated wind speed: 130 mph. Gulfport, Mississippi).

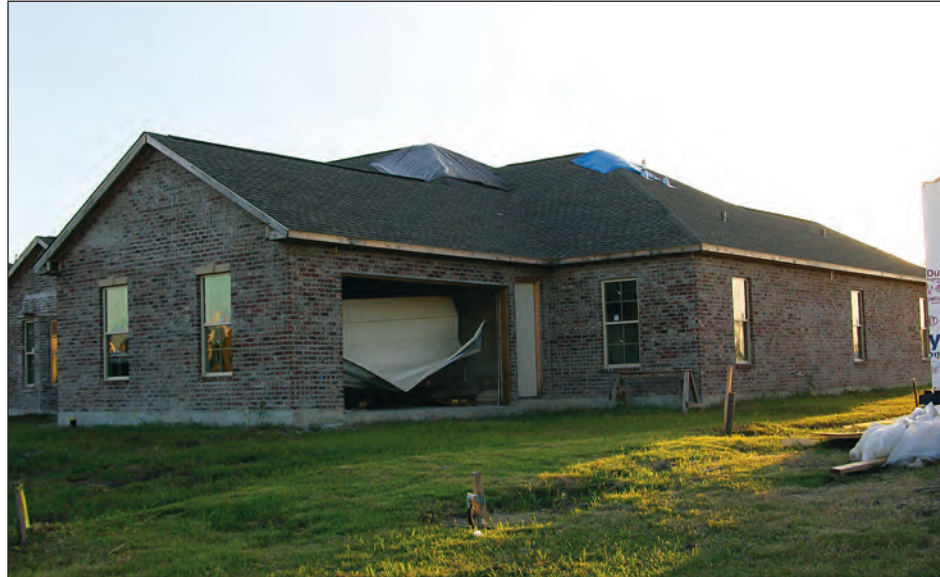
Several damaged residential garage doors were observed, some of which were damaged by floodwater, while others were damaged by wind. Figure 5-6 shows wind-induced damage at a house under construction. Damaged doors were typically displaced from their tracks, but in some

**Figure 5-6.**  
Positive pressure blew this garage door from its tracks. At some other residences, negative pressure blew doors outward. Note the damage to the asphalt shingles (estimated wind speed: 110 mph. Belle Chase, Louisiana).

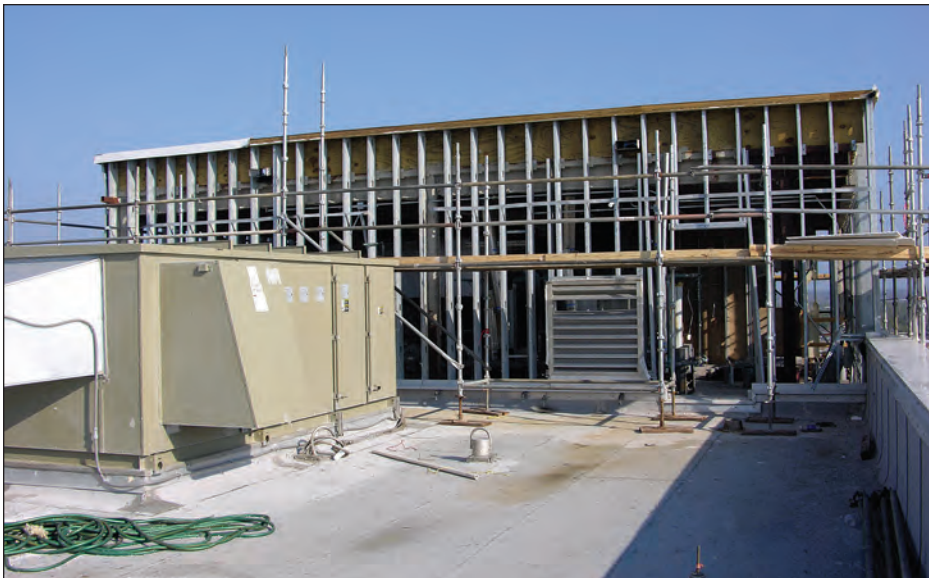
Figure 5-10 shows loss of EIFS on a penthouse on a new 13-story building (there was also extensive loss at the main walls). The gypsum board detached from the 8-inch-deep steel studs spaced 16 inches on center. The gypsum board was attached with screws that were irregularly spaced. Along one stud near the corner, the screws were spaced at 8, 25-1/2, and 12-1/2 inches. Along another stud in the corner region, the screws were spaced at 14, 12, and 21-1/2 inches. Away from the corner region, the screws along one stud were spaced at 12, 10-1/2, 12-1/2, and

10-1/4 inches. Along another nearby stud, the screws were spaced at 10, 12, 8-1/4, 4-3/4, and 11 inches. Surprisingly, the screws were typically spaced farther apart in the corner region (where the wind loads are the highest). Away from the corners, the screws should have been spaced in the range of a maximum of 6 inches on center. In the corner areas, the screws should have been spaced in the range of a maximum of 4 inches on center and the studs should have been at a maximum of 12 inches on center. Because contract documents were not available, it is unknown whether the spacing deficiencies were due to design or workmanship errors.

Figure 5-10. Loss of EIFS on penthouse of a new 13-story building in Exposure C. The gypsum board was attached with irregularly spaced screws and detached from the steel studs (estimated wind speed: 120 mph. Biloxi, Mississippi).

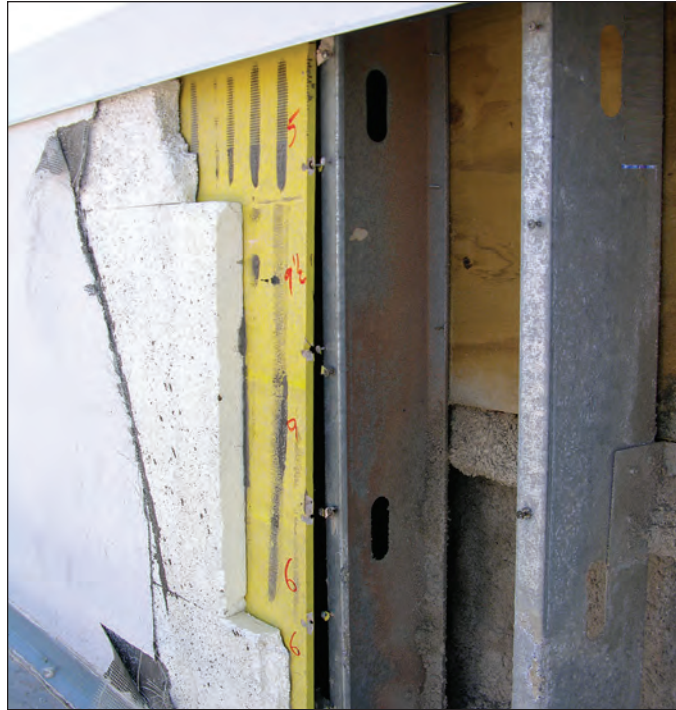
Figure 5-11.

Along another wall of the penthouse in an area outside of the corner region, the screws along the end of a gypsum board panel were spaced at 5, 9-1/2, 6, 6, 4, and 4-1/2 inches. Along the next stud, the intermediate row was spaced at 21-1/2, 10, and 13 inches. As shown in Figure 5-11, in one area the molded expanded polystyrene (MEPS) insulation detached from the gypsum board. The MEPS had been adhered with vertical lines of adhesive. Adhesive should have been continuously applied throughout the entire board area.

The MEPS had been set in rows of adhesive rather than in a continuous layer of adhesive. Note the inadequate edge distance of the fasteners along the end joint. The building was located in Exposure C (estimated wind speed: 120 mph. Biloxi, Mississippi).

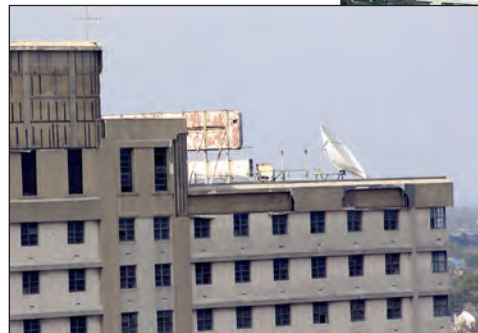
Figure 5-12.

Figure 5-12 shows a building that had been re-skinned with EIFS (new metal framing had been installed over the original walls). In some areas, the gypsum board blew off the new metal framing, but in other areas the metal framing was blown away because it was inadequately attached to the building.

This building had been re-skinned with EIFS. In some areas, the gypsum board blew off the studs (arrows). In other areas, the metal framing was blown away (square/ inset) (estimated wind speed: 105 mph. New Orleans, Louisiana).

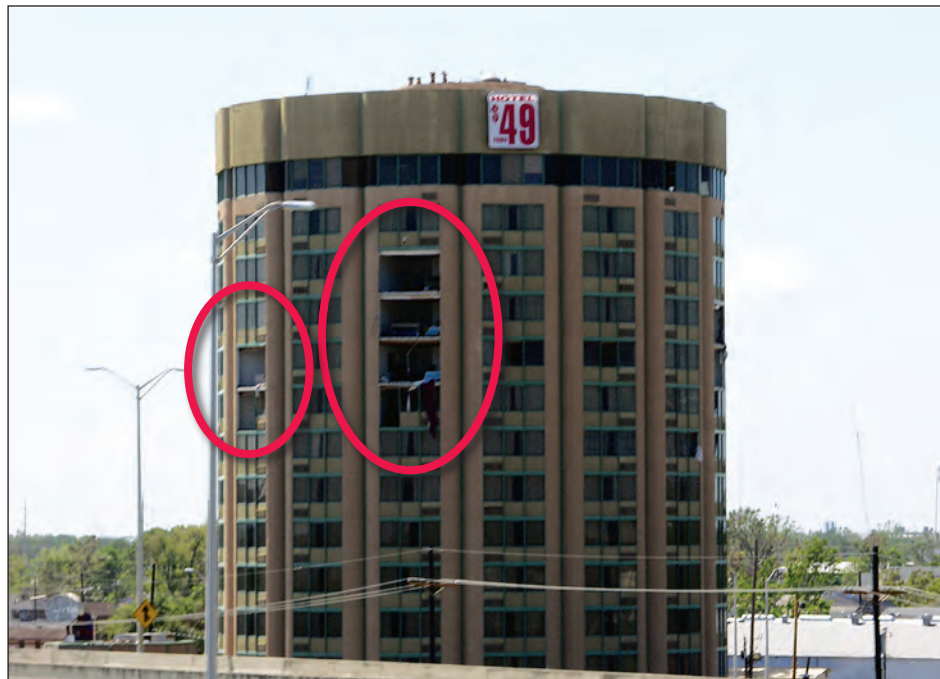
Figure 5-14.  
Collapse of non-load-  
bearing walls at a hotel  
(estimated wind speed:  
105 mph. New Orleans,  
Louisiana)

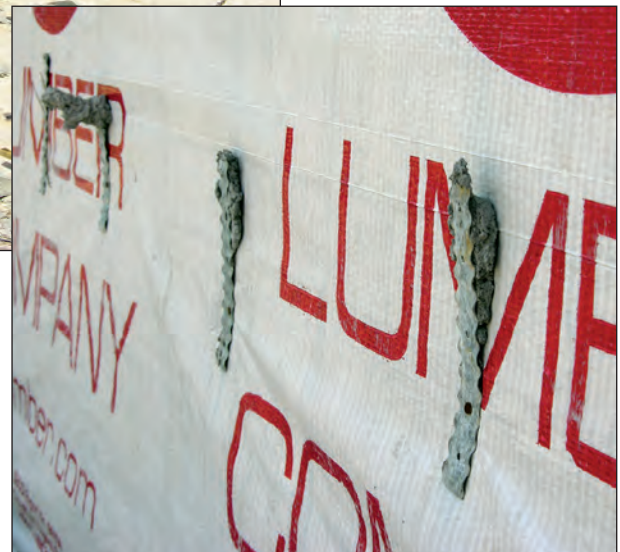
Several buildings with failed brick veneer were observed. The majority of the failed brick veneers were applied over wood stud framing; however, some of the failed veneers were applied over CMU (in some instances, the CMU also failed). Figure 5-15 shows failed brick at a house that was under construction. The ties were typically spaced at 16 inches on center horizontally. Vertical spacing varied. The first row was 19 and 21 inches above the footer. The second row was 22 and 24 inches above the first row, and the third row was 18 inches above the second row. Some of the smooth-shank tie nails pulled from the studs. Many of the ties had never been embedded into the mortar joints, which was a major workmanship error.

Figure 5-15. Collapsed brick veneer wall that was under construction. Several of the ties had not been embedded into the mortar joints (square/inset) (estimated wind speed: 125 mph. Waveland, Mississippi).

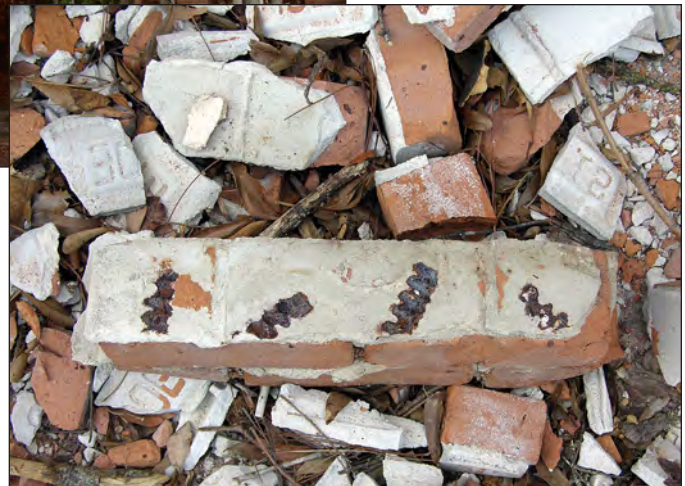
Figure 5-17.  
Partial collapse of  
brick veneer at an  
apartment building;  
the ties were corroded  
(inset) (estimated wind  
speed: 115 mph. Slidell,  
Louisiana).

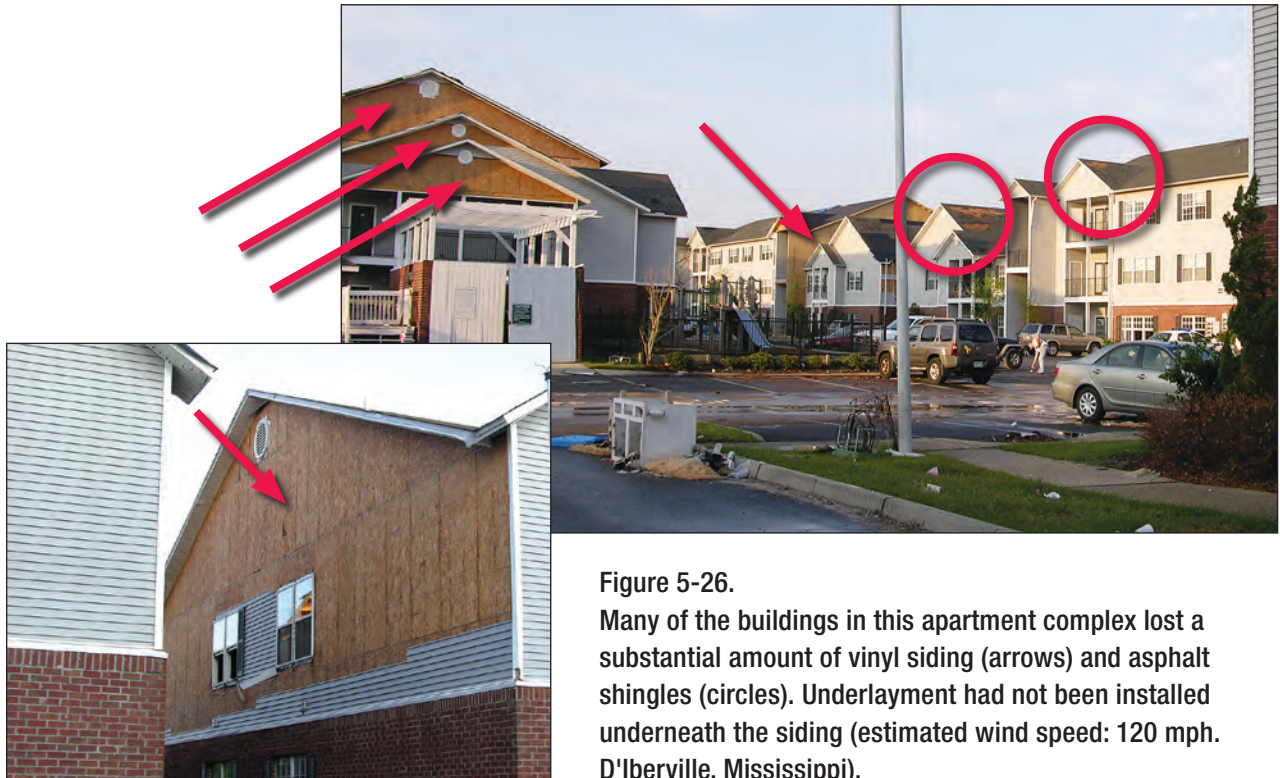
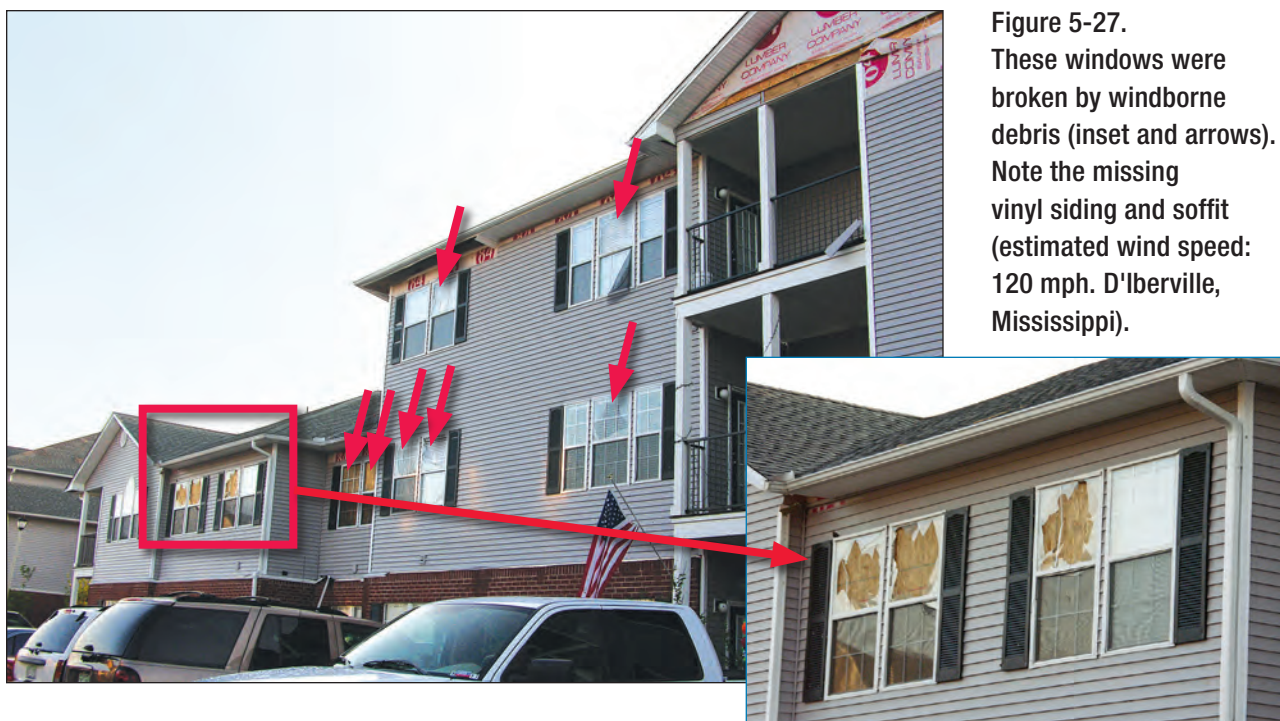
Many of the windows in the apartment complex shown in Figure 5-26 were broken (see Figure 5-27), which is not surprising considering the large amount of vinyl siding, vinyl soffit, and asphalt shingles that were blown off of these buildings.

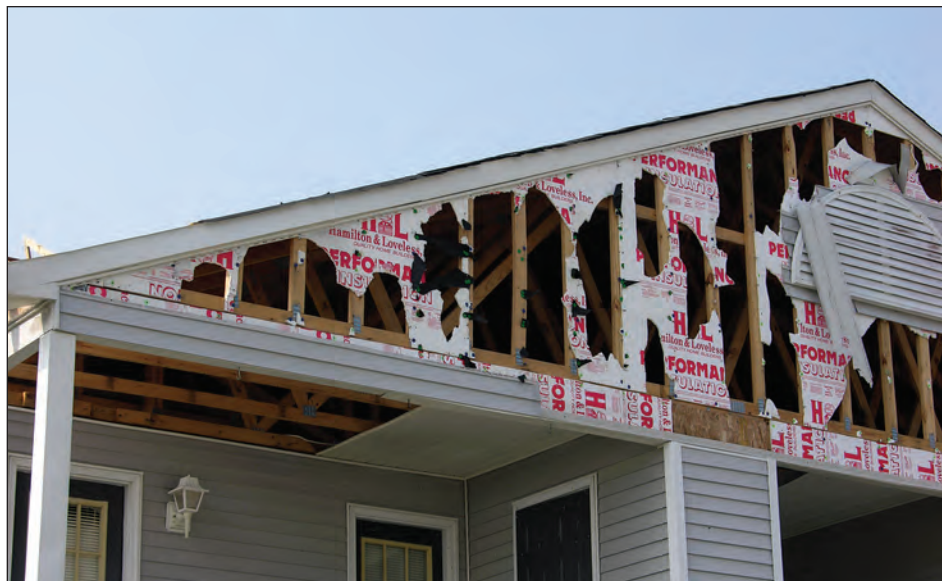
In several areas investigated by the MAT, siding at gable end walls had been installed over plastic foam insulation (i.e., there was no plywood or oriented-strand board [OSB]). With blow-off of the vinyl siding, the foam insulation was typically also blown away (see Figure 5-28). With loss of both the siding and foam insulation, wind-driven rainwater was free to enter the attic space. When this occurred, typically the attic insulation became saturated and the ceiling collapsed.

**Figure 5-28.**  
Loss of vinyl siding and  
foam insulation at a gable  
end wall. Note the missing  
vinyl soffit (estimated wind  
speed: 130 mph. Long  
Beach, Mississippi).

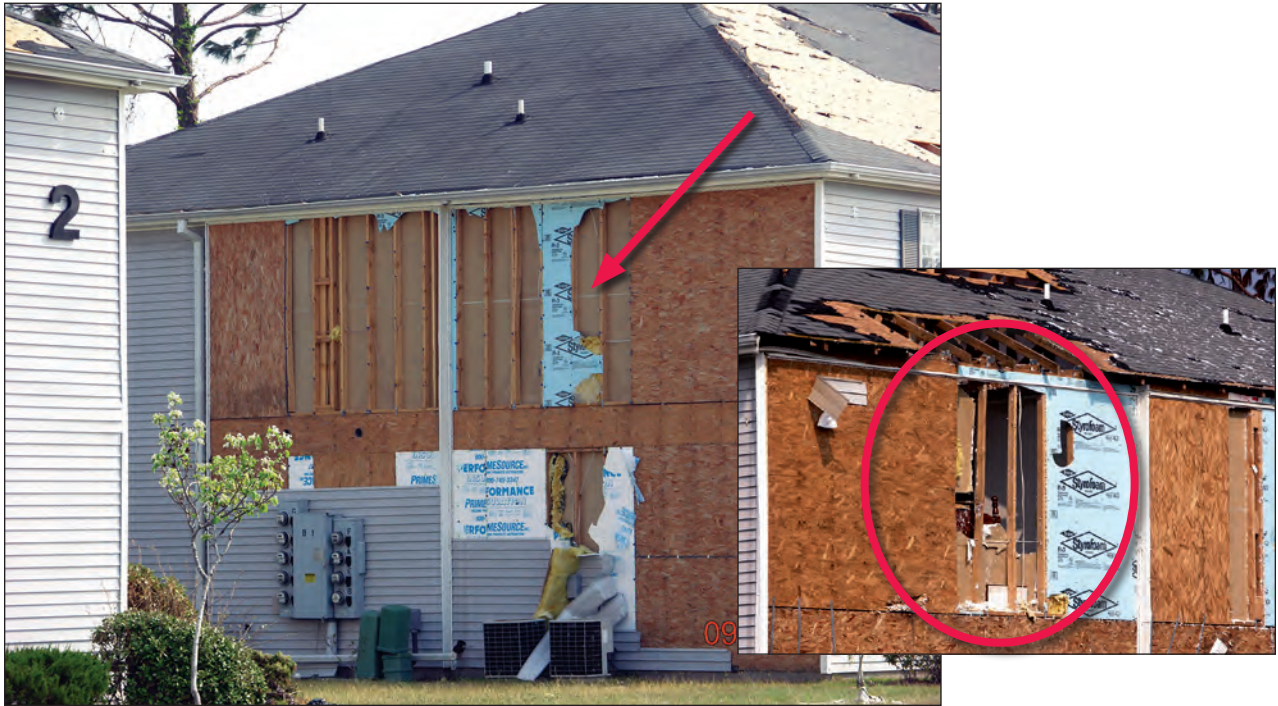
On several buildings, siding was also installed over foam insulation at portions of walls, as shown at the apartment complex in Figure 5-29. At this complex, OSB had been installed in corner areas (in order to provide shear walls), but between the corner areas only plastic foam insulation occurred between the studs and vinyl. With loss of both the siding and foam insulation, wind-driven rainwater was free to enter the wall cavity. Also, where the wood sheathing was not present, wind-blown debris of only moderate energy could easily penetrate the building and injure occupants. With the vinyl in place, the center area of the walls shown in Figure 5-29 consisted of vinyl siding, foam insulation, stud cavity, and gypsum board on the interior side of the studs. As shown in the inset in Figure 5-29, in one area the vinyl, foam insulation, and interior gypsum board were blown away and there was no protection of occupants from windborne debris.

OSB was installed at the corner areas, but only foam insulation was present over the studs in the field of the wall. Most of the foam was blown away at this end wall (arrow). At some areas in this complex, the gypsum board on the interior side of the studs was also blown away (circle) (estimated wind speed: 130 mph. Long Beach, Mississippi).

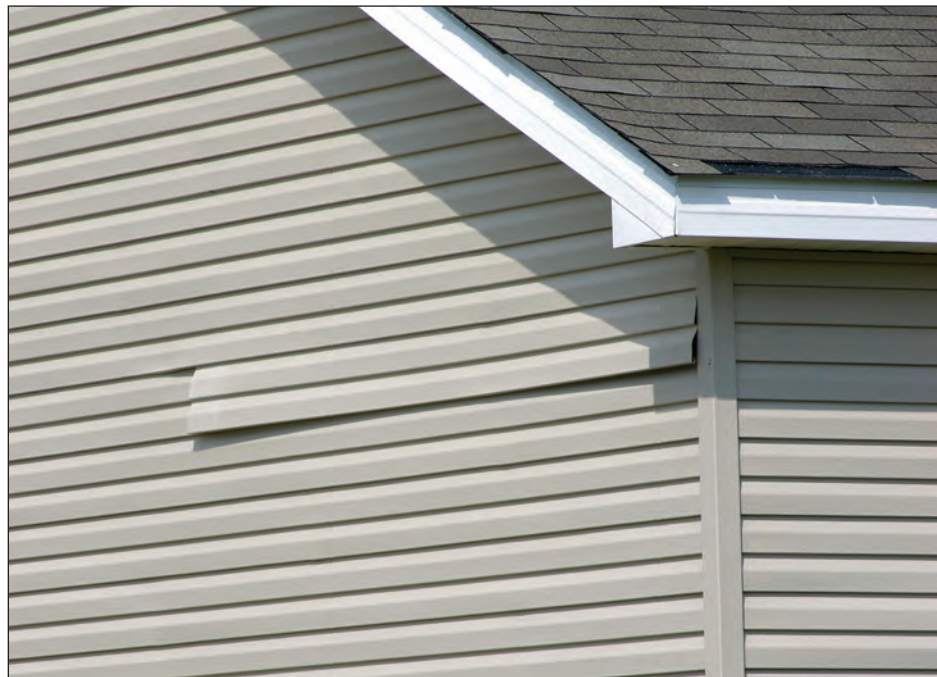
**Figure 5-30.**  
When a panel becomes unlatched, it becomes very susceptible to blow-off (estimated wind speed: 120 mph. Ocean Springs, Mississippi).

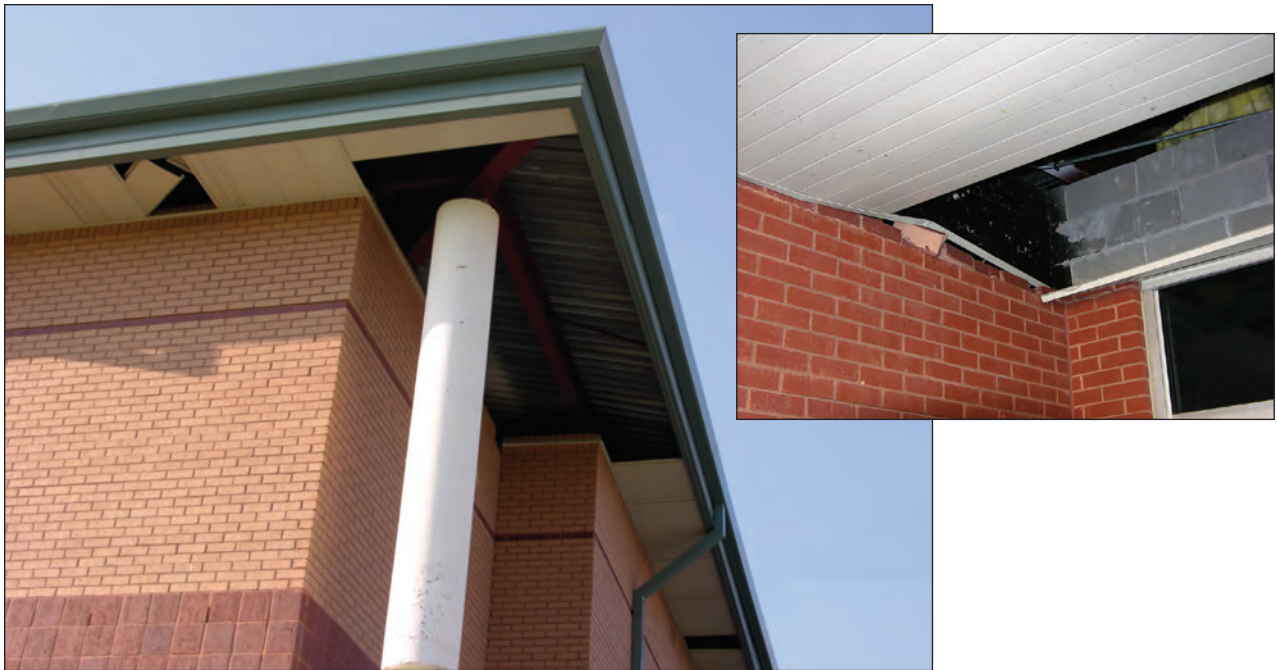
Figure 5-31.

Vinyl soffits were discussed in the vinyl siding section, and damaged soffits were shown in Figures 5-27 and 5-28. Figure 5-31 shows loss of metal soffit at a school that was completed in 1997. Some of the soffit panels were perforated. In one area, the soffit support angle was attached to the top row of brick veneer (inset in Figure 5-31). Wind created positive (i.e., upward-acting) pressure on the soffit panels. This load was transferred to the support angle and then to the bricks, which lacked sufficient strength to carry the uplift load. This failure illustrates the importance of soffits being designed and constructed to carry positive and negative pressures, and the importance of load-path continuity. With loss of the soffit, wind-driven rainwater was able to enter the ceiling space, whereupon several ceiling boards became saturated and collapsed. Soffit failure can also increase the magnitude of positive pressure within attics and exert more load on the roof structure and coverings (see Section 10.2.3.1 for further discussion).

Loss of metal soffit at a school. At the area shown in the inset, the soffit support angle was inadequately anchored (estimated wind speed: 130 mph. Gulfport, Mississippi).

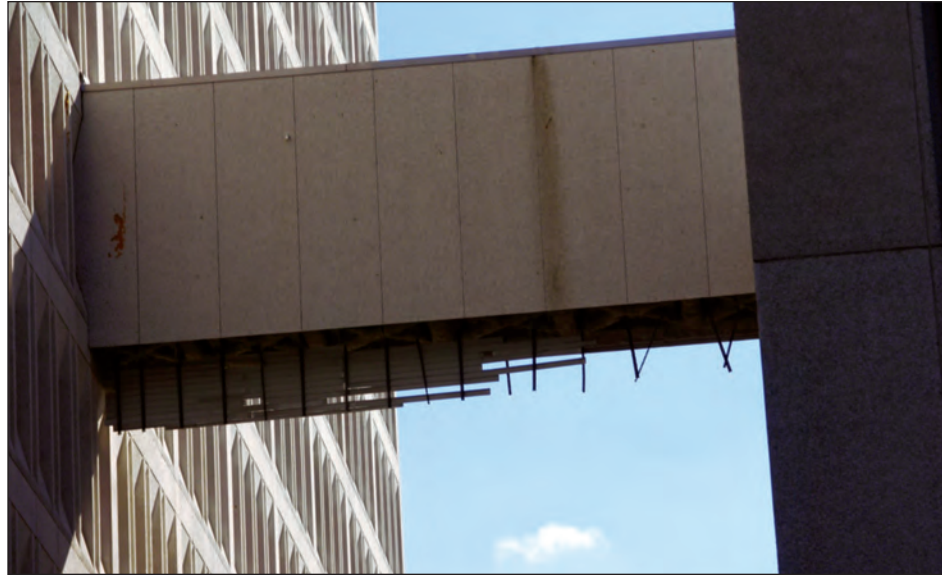
Figure 5-32.  
Loss of metal soffit from  
an elevated walkway  
(estimated wind speed:  
105 mph. New Orleans,  
Louisiana)

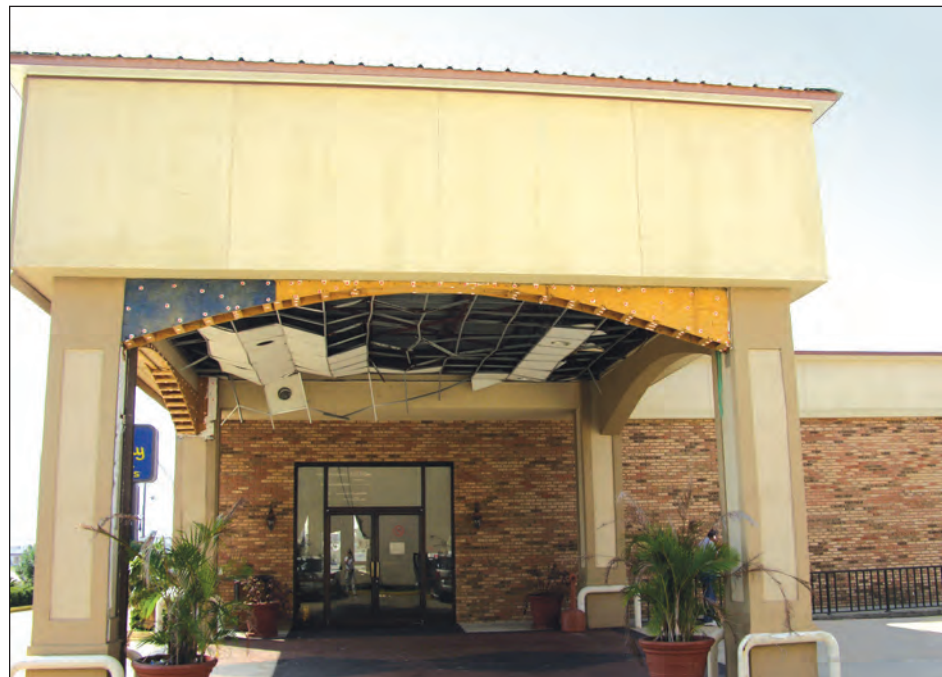
Figure 5-32 shows loss of metal soffit from an elevated walkway at a courthouse in downtown New Orleans. Figure 5-33 shows loss of soffit boards from a suspended grid system. The grid system did not have compression struts to resist positive pressure. In addition to the soffit damage itself, windblown soffit panels can break windows.

Figure 5-33.  
Loss of soffit at canopy.  
The grid support did  
not have compression  
struts (estimated wind  
speed: 130 mph. Gulfport,  
Mississippi).

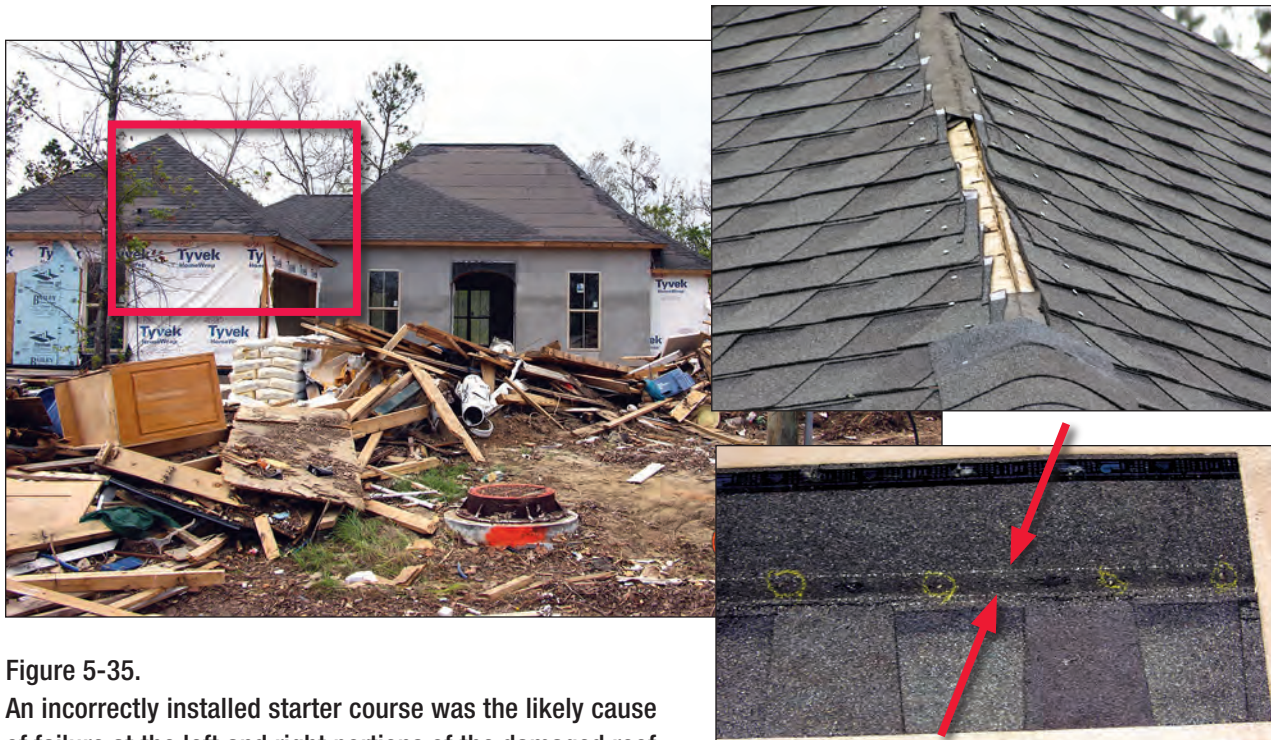
Figure 5-35.

A large number of relatively new shingle roofs (including several houses still under construction) experienced shingle damage. Figure 5-35 shows a new house that lost many shingles. The starter course was incorrectly installed (as discussed later) and there was no metal drip edge. Some of the shingles were superficially bonded to one another, underlayment was not lapped over a portion of the hip, the underlayment along the hip was cut in several locations (apparently while the shingles were being trimmed), the hip nails were incorrectly located, and several of the hip shingles did not bond, or were only superficially bonded, to one another. These shingles had a 1-1/2-inch-wide nailing strip and the majority of the nails were placed within the strip. The end nails were too far from the end (ranging from about 2 to 4 inches rather than 1 inch from the end). The field nails were somewhat uniformly distributed between the end nails; however, the manufacturer's literature indicates a different nailing pattern. These shingles had a Miami-Dade County (Florida) product approval label.

An incorrectly installed starter course was the likely cause of failure at the left and right portions of the damaged roof. Water was able to leak into the building where the underlayment was not lapped over a portion of the hip (estimated wind speed: 130 mph. Long Beach, Mississippi).

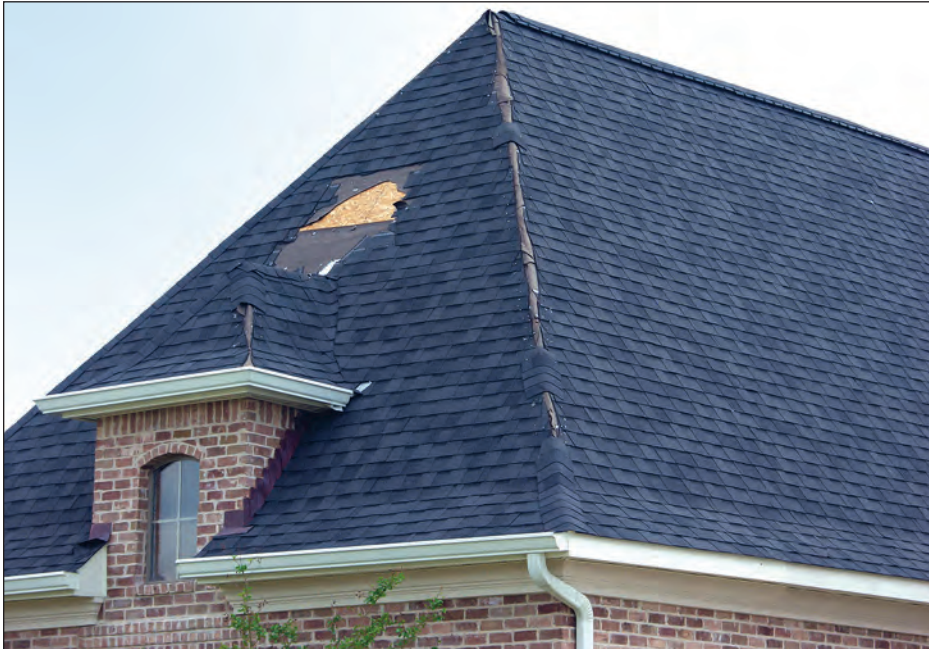
**Figure 5-36.**

Loss of hip shingles. The underlayment above the dormer was likely blown off due to increased turbulence caused by the dormer (estimated wind speed: 115 mph. Slidell, Louisiana).

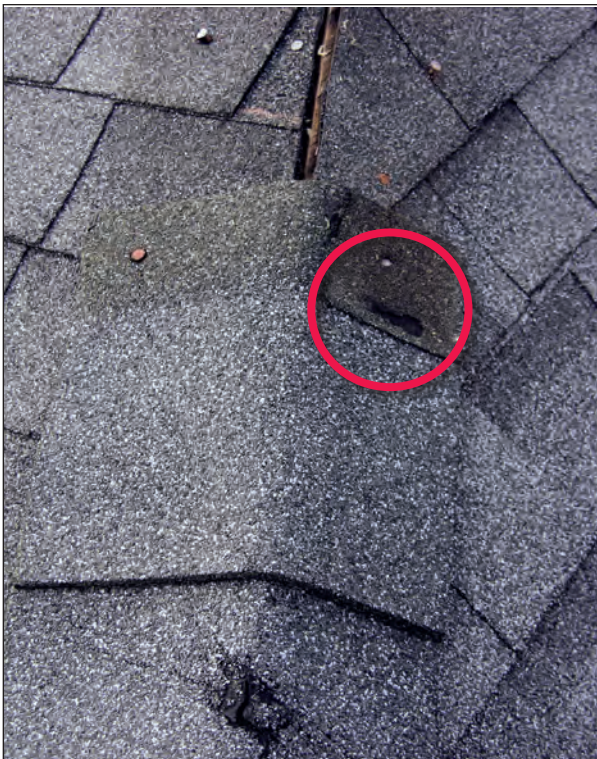
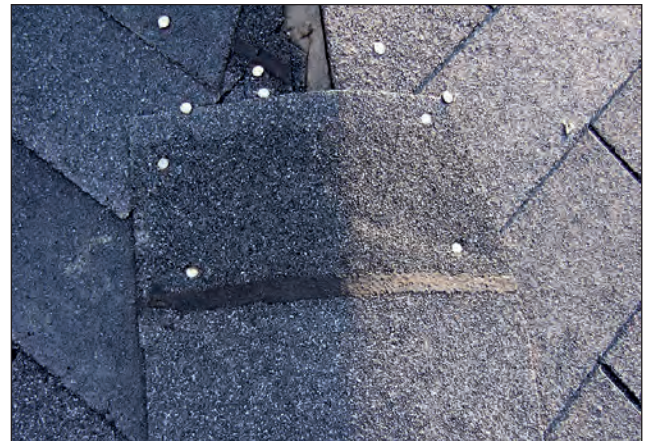
**Figure 5-37.**

as recommended by the industry. However, the hip and ridge shingles were blown off because of lack of bonding of the adhesive. Sometimes a limited amount of bonding occurred, but frequently none of the adhesive had bonded (Figure 5-37). Lack of bonding of hip and ridge shingles is common due to substrate irregularity along the hip/ridge line. Use of asphalt roof cement, as recommended in Technical Fact Sheet No. 20 in FEMA 499, ensures bonding.

At the hip on the left, the self-seal adhesive only made contact at a small area on the right side of the hip (red circle). At the hip at the right, no adhesive bonding occurred. The nails at both of these hips were above, rather than below, the adhesive line (estimated wind speed: 105 and 130 mph. Pascagoula and Gulfport, Mississippi, respectively).

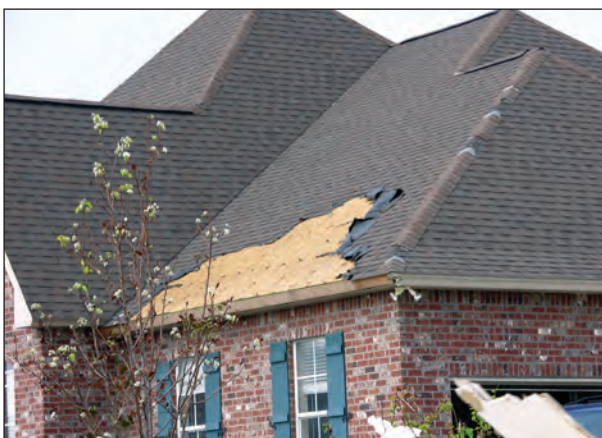
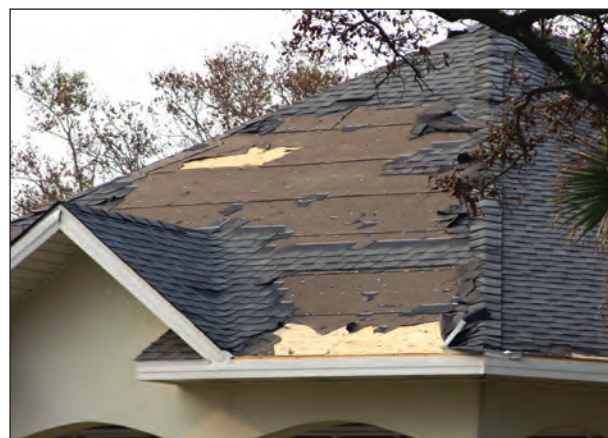
**Figure 5-39.** These two failures likely initiated at the eave due to an incorrectly installed starter course. Note that, at both roofs, a portion of the underlayment and some of the hip shingles were blown away (estimated wind speed: 115 and 105 mph. Slidell, Louisiana, and Pascagoula, Mississippi, respectively).

In addition to correctly installing the starter, use of asphalt roof cement to ensure bonding along the eave is recommended in Technical Fact Sheet No. 20 of FEMA 499. Due to substrate irregularities along the eave line, even when the starter is correctly installed, insufficient tab bonding can occur unless asphalt roof cement is applied.

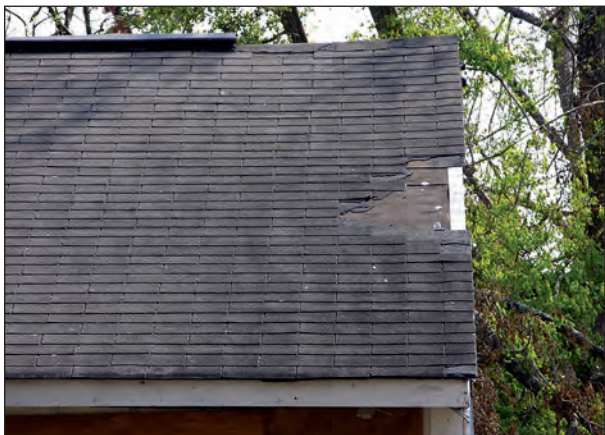
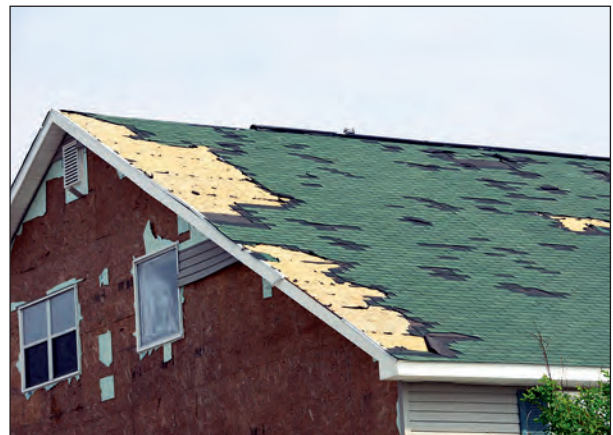
As with eaves, lifting and peeling failure often initiates at rakes and propagates into the field of the roof, as shown in Figure 5-40. Rakes are susceptible to failure due to the additional load exerted on the overhanging shingles (thus it is important to minimize the overhang as discussed above) and the configuration of the self-sealing adhesive. Along the long dimension of the shingle (i.e., parallel to the eave), the tab is sealed with self-sealing adhesive that is either continuous or nearly so. But along the rake, the ends of the tab are only sealed at the self-seal lines; therefore, the tabs are typically sealed at about 5 inches on center. Therefore, under high-wind loading, the adhesive at the rake end is stressed higher than the adhesive farther down along the tab. With sufficient wind loading, the corner of the tab at the rake can begin to lift up and progressively peel.

These shingle blow-offs likely were initiated by lifting and peeling of shingles along the rake. Note the loss of vinyl siding at the right photograph (estimated wind speed: 130 and 115 mph respectively. Long Beach, Mississippi, and Slidell, Louisiana, respectively).

On several damaged roofs, including the one shown on the left side of Figure 5-40, bleeder strips had been installed. Bleeder strips are shingles that are applied along the rake, similar to the starter course at the eave, as shown at Figure 5-41. A bleeder provides an extended straight edge that can be used as a guide for terminating the rake shingles. At first glance, it might be believed that a bleeder enhances wind resistance along the rake. However, it does not significantly enhance resistance because the concealed portion of the overlying rake shingle is the only portion that makes contact with the self-seal adhesive on the bleeder. As can be seen in Figure 5-42, the tab does not make contact with the bleeder. Hence, if the tab lifts, the shingle is placed in a peel mode, which can easily break the bond with the bleeder. Also, if the tabs are not cut from the bleeder and the cut edge placed along the rake edge (which was seldom done on the observed roofs), the bleeder's adhesive is too far inward to be of value.

To enhance the wind resistance of shingles along the rake, Technical Fact Sheet No. 20 in FEMA 499 recommends application of asphalt roof cement along the rake. By adding dabs of cement, as shown in Technical Fact Sheet No. 20 (and Figure 5-41), uplift load across the ends of the rake

shingles is distributed to the cement as well as the self-seal adhesive, thus minimizing the possibility of tab uplift and progressive peeling failure.

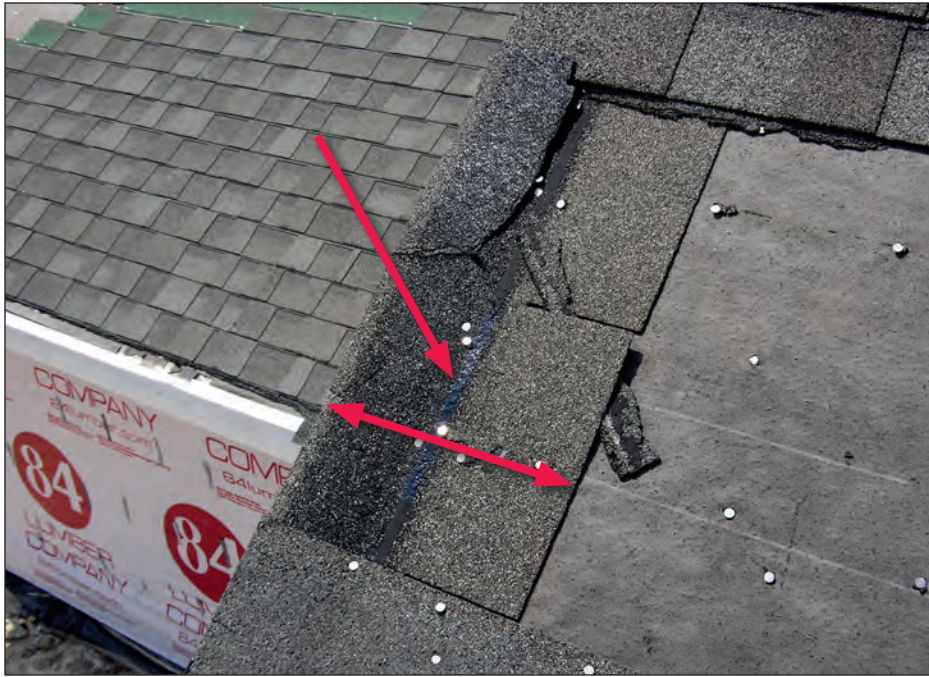
Figure 5-42.  
Blow-off of shingles  
at a new house under  
construction. A bleeder  
strip (double-arrow) was  
used along the rake.  
Note that the tab of the  
overlying shingle cannot  
make contact with the  
bleeder's self-seal  
adhesive (upper arrow)  
(estimated wind speed:  
125 mph. Waveland,  
Mississippi).

If bleeder strips are installed for alignment purposes, use of asphalt roof cement, as shown in Technical Fact Sheet No. 20 of FEMA 499, is still recommended.

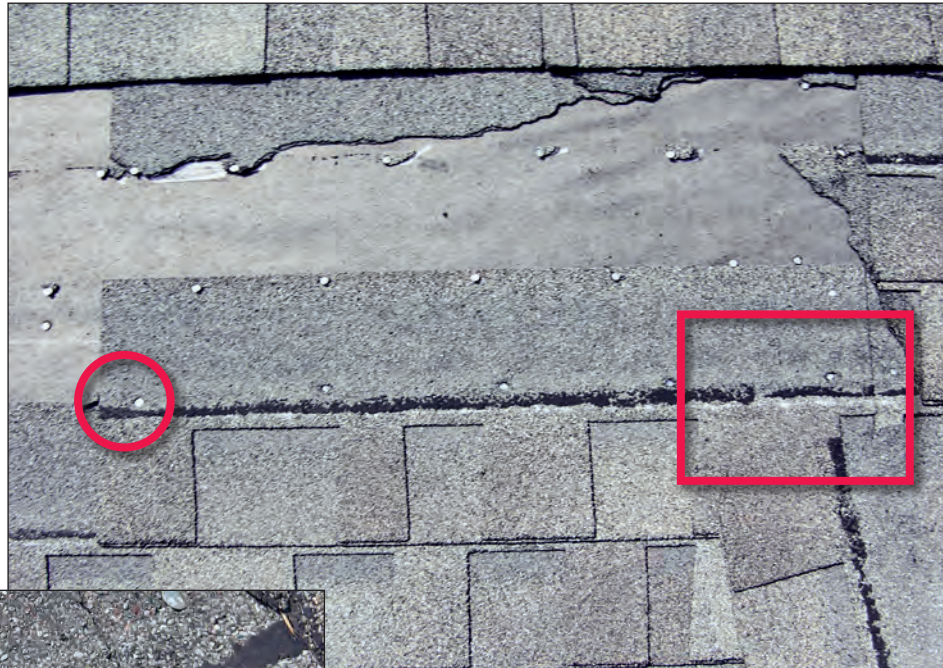
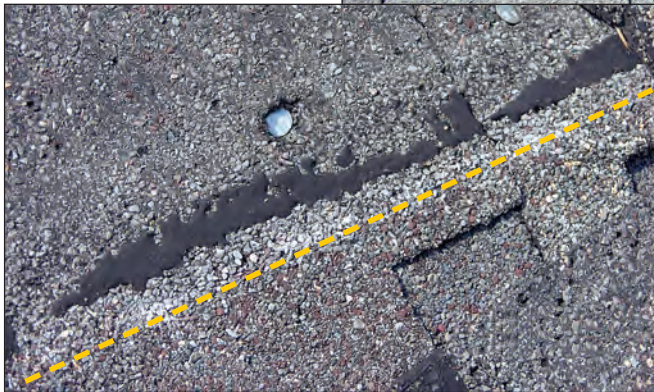
Figure 5-43.

Significant fastener mislocation occurred on nearly all of the damaged roofs observed (see Figures 5-43 and 5-44). Fasteners were typically located 1 to 2 inches above the nailing line (i.e., the line printed on the shingle by the manufacturer). End fasteners were often 2 to 3 inches from the end, rather than the industry-recommended 1 inch. Minor deviations from intended fastener locations should be expected; however, the deviations on nearly all of the damaged roofs were excessive.

When nails are too high above the nail line, they can miss the underlying shingle headlap or have inadequate edge distance as shown by the nail that is right of the circle in Figure 5-43 and illustrated in Figure 5-45. When using laminated shingles, high nailing may miss the overlap of laminated shingles; if the overlap is missed, the nail pull-through resistance is reduced (see Figure 5-46). High nailing may also influence integrity of the self-seal adhesive bond by allowing excessive deformation (ballooning) in the vicinity of the adhesive.

The nails at this house under construction were too far above the nailing line (underscored by dotted yellow line in inset) and too far from the ends (circle). They were also over-driven (square and inset) (estimated wind speed: 125 mph. Waveland, Mississippi).

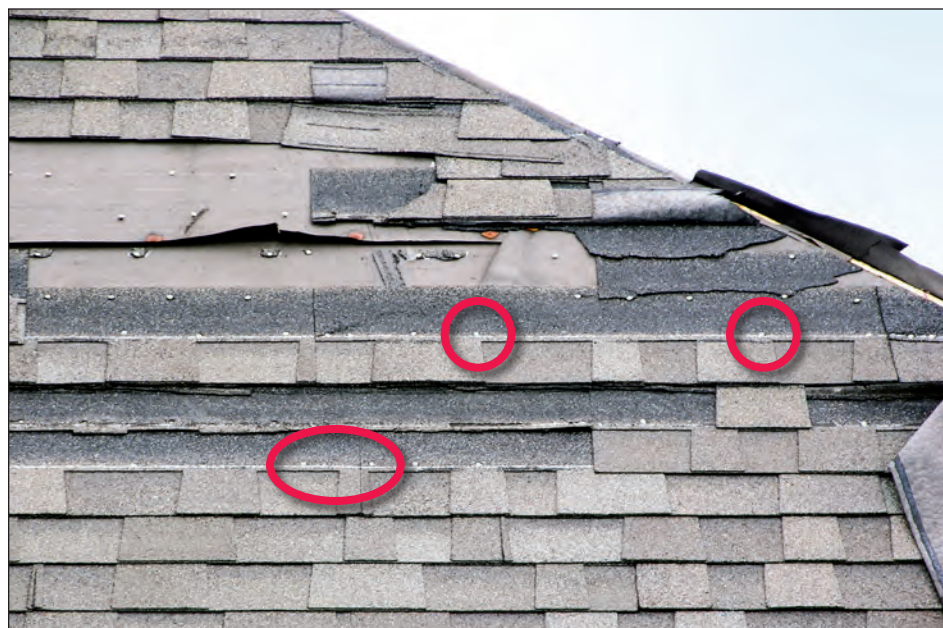
Figure 5-44.

The nails at this house under construction were placed quite close to the nailing line. However, some of the end nails were too far inward (the nail in the oval was several inches from the end). Distribution along the nail line was also a problem (the nails in the circles were much too far apart) (estimated wind speed: 115 mph. Slidell, Louisiana).

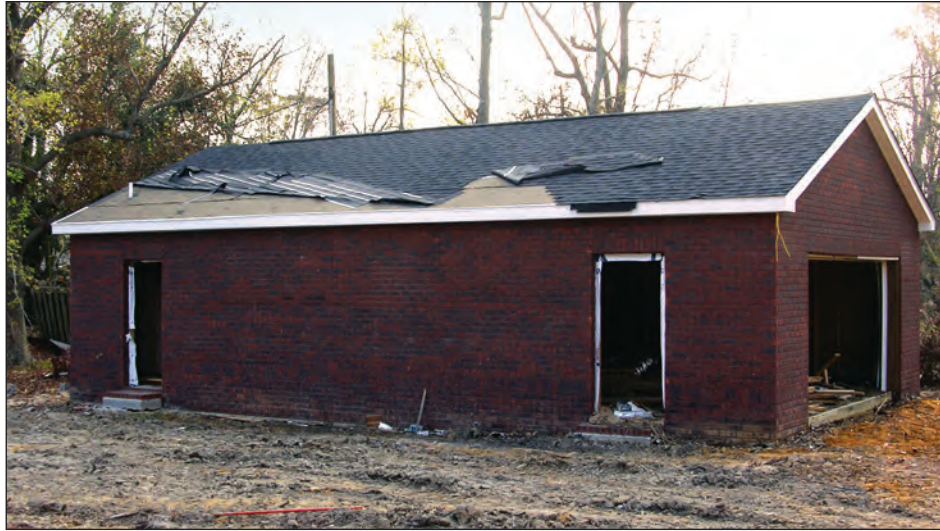
**Figure 5-47.**

The starter course was incorrectly installed at this recently completed roof. The starter course and eave course lifted. A progressive peeling occurred because there was inadequate nailing attachment to resist the peel forces (estimated wind speed: 105 mph. Pascagoula, Mississippi).
