## HURRICANE

*Katrina*

## IN THE GULF COAST

## 5. Building Envelope Performance

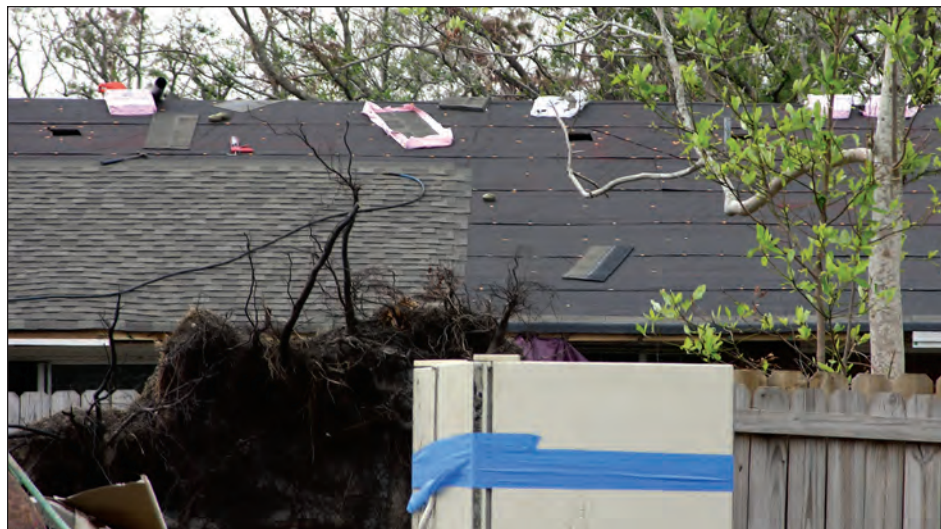
**Figure 5-48.**

This house was being re-roofed after the hurricane using the raking method. The starter course was incorrectly installed (estimated wind speed: 130 mph. Long Beach, Mississippi).

The National Roofing Contractors Association (NRCA) recommends that the raking method not be used and that shingles should be laid one course at a time from rake to rake starting at the eave.

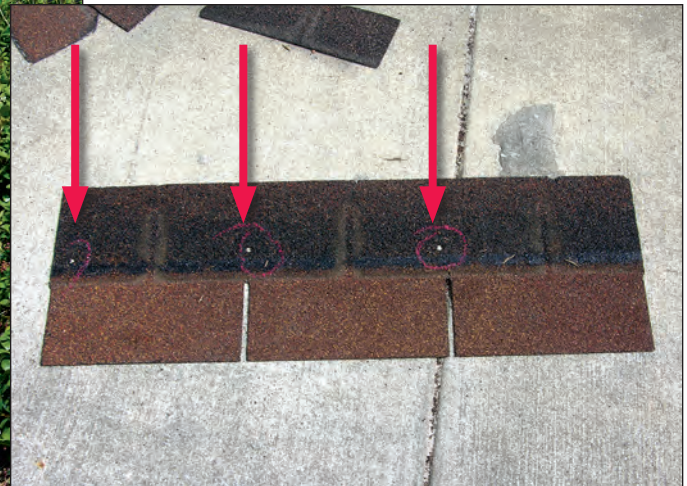
**Figure 5-50.**  
Many shingles were blown from a nursing home. Limited checking found three shingles that were missing the right end nail (see inset for one of these). The nails that were installed were placed very high (red arrows); many missed or just nicked the underlying headlap (estimated wind speed: 130 mph. Gulfport, Mississippi).

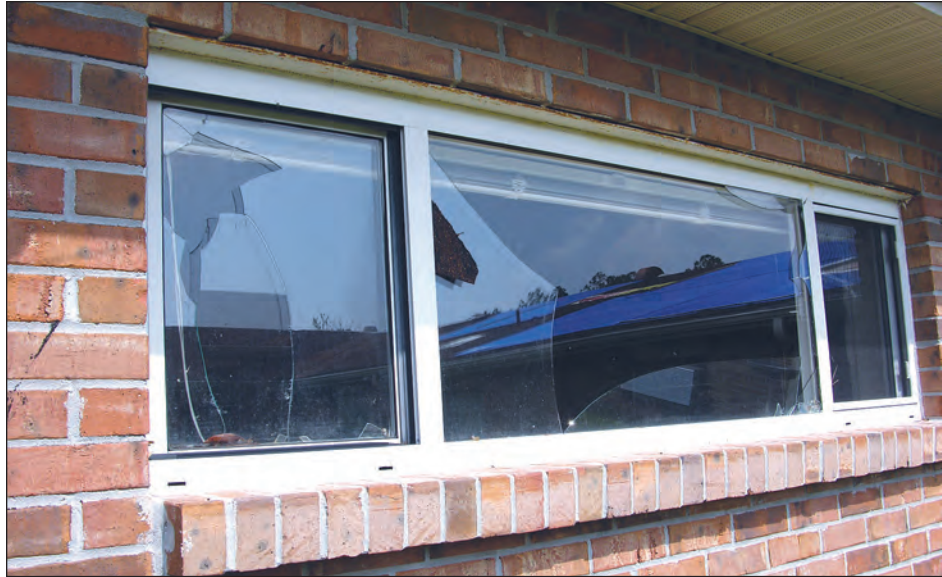
**Figure 5-51.**  
Windborne asphalt shingle debris broke several windows in this nursing home. A piece of shingle debris is embedded in the frame (estimated wind speed: 130 mph. Gulfport, Mississippi).

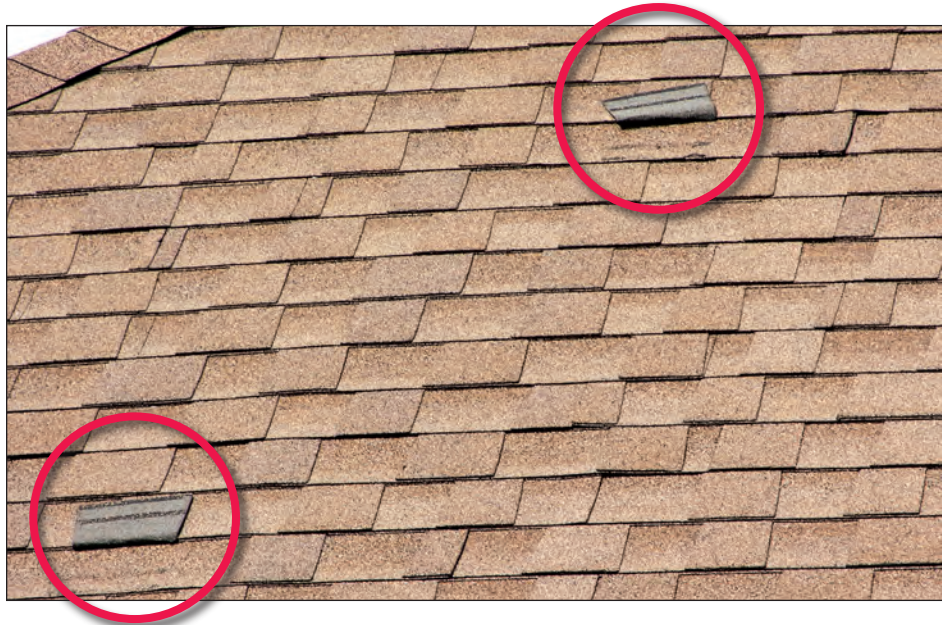
On a few roofs with architectural shingles, instances of blow-off of laminated tabs were observed (see Figure 5-52). This type of failure was due to an inadequate amount and/or strength of adhesive used in the manufacturing of the shingles.

**Figure 5-52.**  
Two laminated tabs were lifted (circles) at a house under construction (estimated wind speed: 120 mph. Ocean Springs, Mississippi).

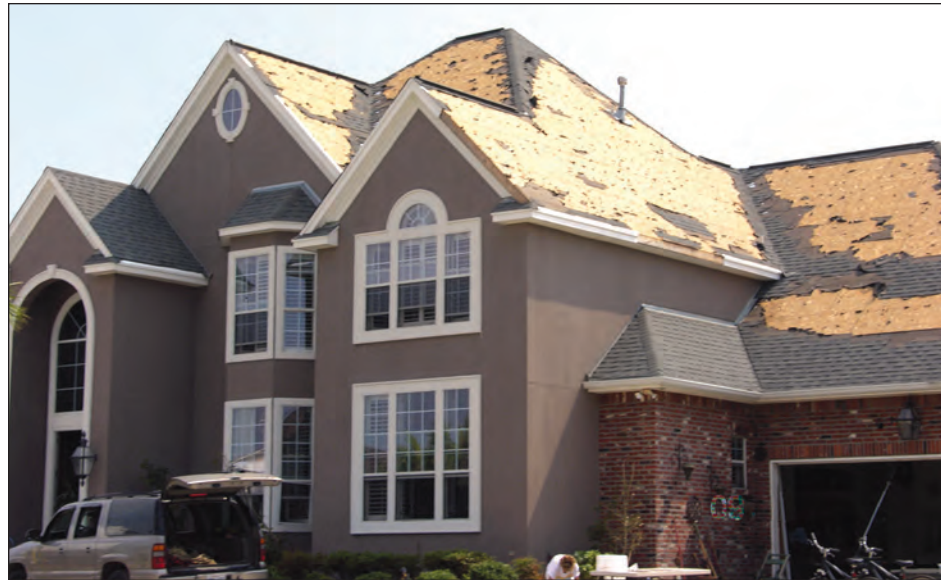
In some instances where shingles were blown off, the underlayment was not damaged and, therefore, provided some degree of protection from water infiltration. But in many other instances, the underlayment was also blown off (see Figure 5-54). Rain was then able to enter the building at the sheathing joints. In general, wind performance of exposed underlayment observed by the

**Figure 5-54.**  
Widespread loss of underlayment. With loss of underlayment, water is free to leak into the building and cause extensive interior damage (estimated wind speed: 115 mph. Slidell, Louisiana).

Technical Fact Sheet No. 19 in FEMA 499 provides recommended practices for underlayments on roofs in high-wind areas.

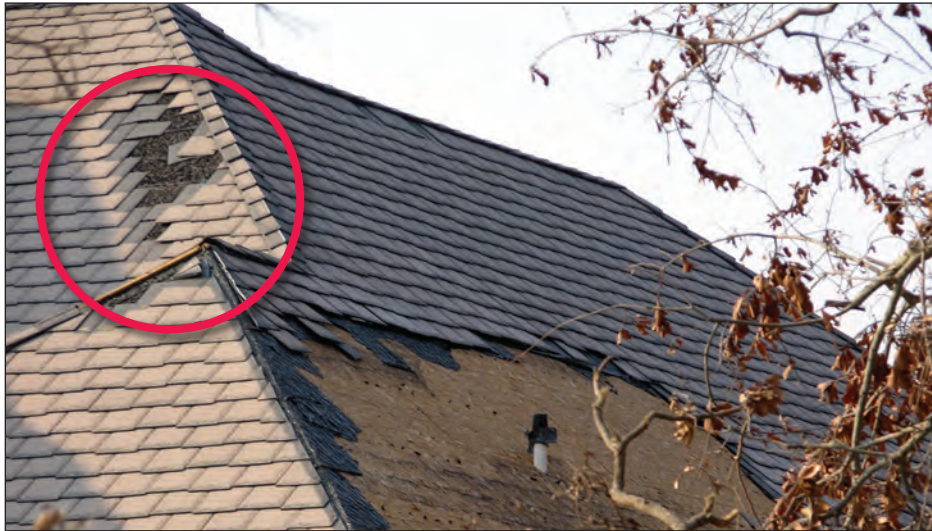
Fiber-cement and slate roof coverings have very limited market shares in the southeastern United States and there is limited information in the literature on the wind performance of these products. The MAT observed one roof with fiber-cement that simulated slate and one slate roof. Figure 5-55 shows the fiber-cement roof. It experienced damage in several areas, including many of the hip lines. The simulated slates were attached with two nails. The manufacturer's literature states the nails are to be placed between 1/2 and 1-1/2 inches above the exposure so that the nail penetrates the underlying simulated slate in the headlap area. However, the nails were typically placed a few inches above the exposure and they missed the headlap. Some of the nails pulled out of the deck, but many remained in place. In several instances, the simulated slates broke at the nail line.

**Figure 5-55.** Fiber-cement simulating slate. Note the loss of underlayment and the simulated slates broken at the nail line (circle). This house was located in Exposure C (estimated wind speed: 105 mph. Pascagoula, Mississippi).

In 2004, the manufacturer issued high-wind attachment recommendations, which consisted of placing 1-1/2x3/8 inch beads of adhesive over the nail heads. Adhesive was not used on the roof shown in Figure 5-55; however, that roof may have been installed prior to distribution of the 2004 recommendations.

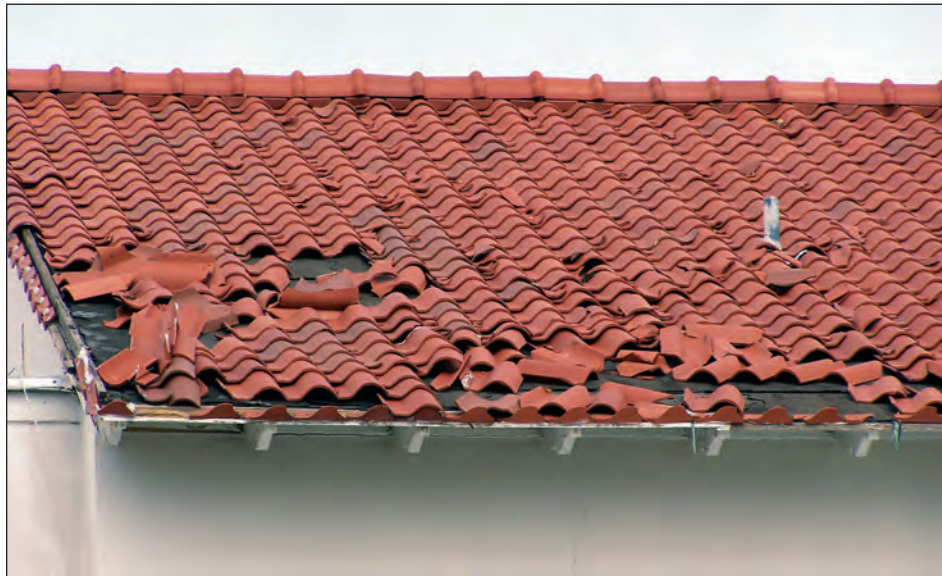
**Figure 5-57.**  
Damaged tiles at roof perimeter (estimated wind speed: 120 mph. VA Hospital Chapel, Biloxi, Mississippi)

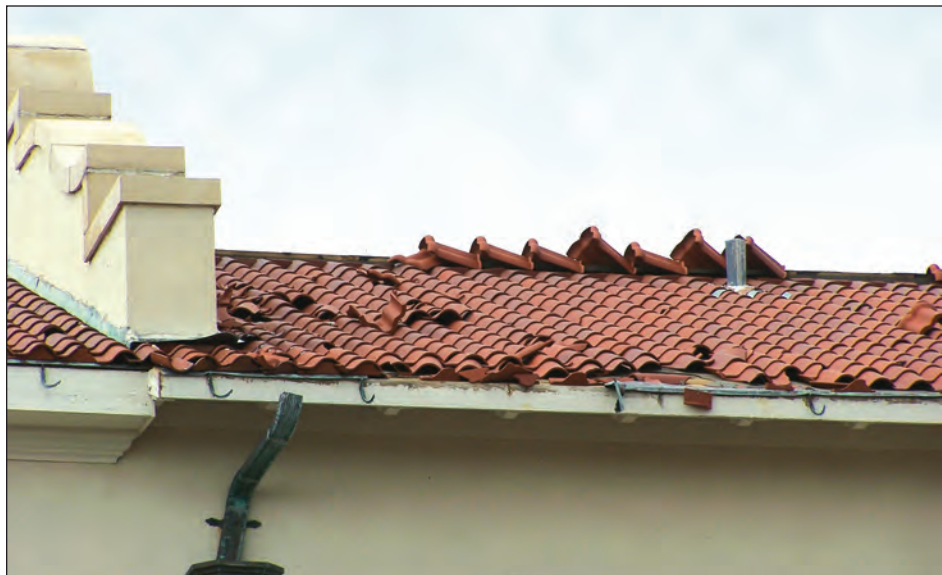
**Figure 5-58.**  
Wind turbulence behind parapet resulted in uplift of ridge tiles. Tile was also damaged along the eave (estimated wind speed: 120 mph. VA Hospital Patient Building, Biloxi, Mississippi).

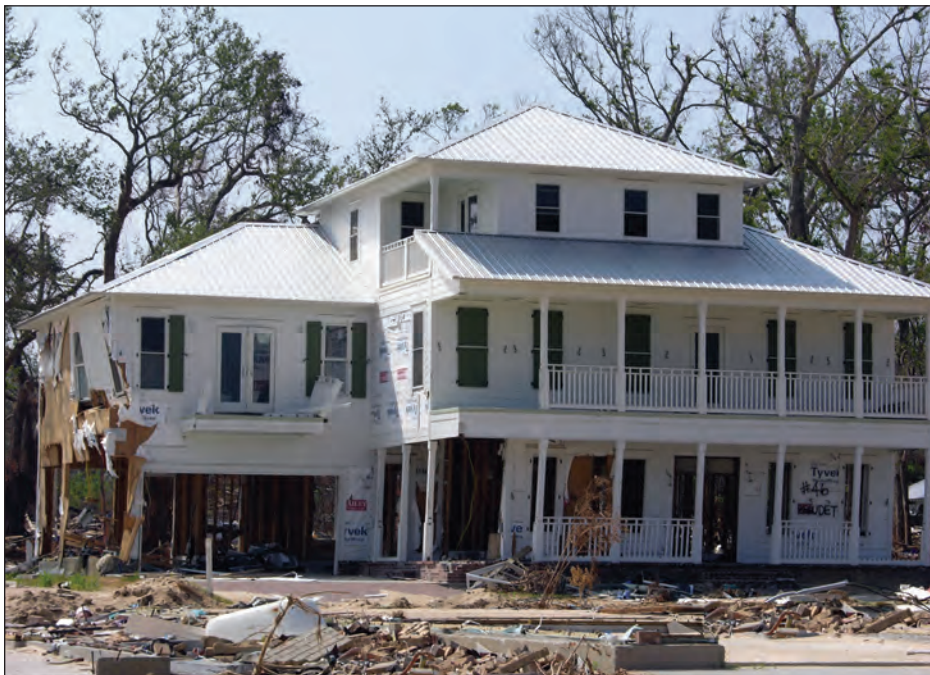
Figure 5-59.

This R-panel roof was not damaged. This house was located in an area that received some of the highest winds (estimated at 125 mph). The damage at the first and second floors was caused by storm surge. The surge pushed the first floor to the right. This "leaner" is considered to be a "survivor" (estimated wind speed: 125 mph. Bay St. Louis, Mississippi).

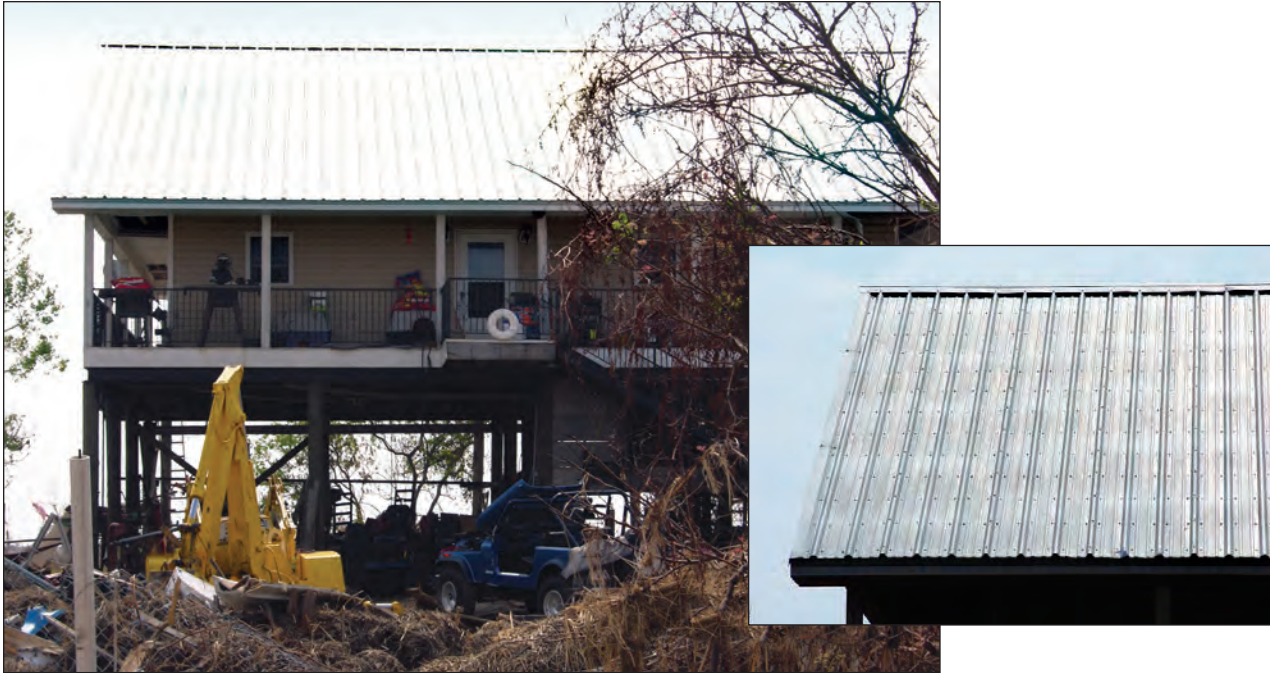
Exposed fastener panels generally performed well, as illustrated by Figure 5-59, although in several instances, hip and/or ridge flashings were blown away. Most of the exposed fastener panels were of the R-panel design, although a few 5V-Crimp roofs were observed. (A substantial number of 5V-Crimp roofs were observed by the Hurricane Charley MAT. For discussion and analysis of those investigations, see FEMA 488, *Mitigation Assessment Team Report, Hurricane Charley in Florida*.)

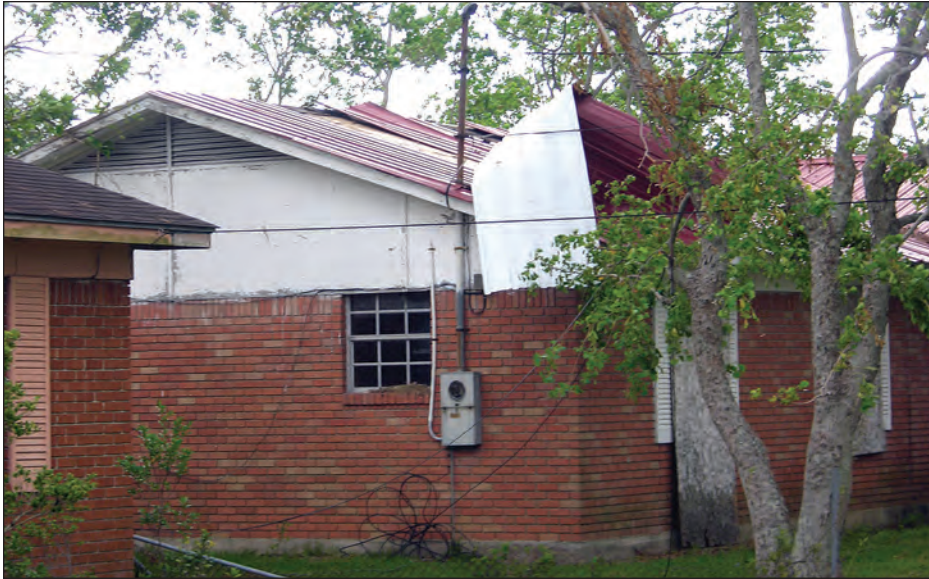
Figure 5-60.

Success or failure of exposed fastener panels was likely dependent upon fastener spacing (see Figure 5-60) and type, and whether or not the substrate lifted, as discussed later. Panel gauge may have also had some influence. Screws provided greater pull-out resistance than ring-shank nails, and were more resistant to dynamic loading. Another key element of good performance is the spacing of fasteners along the eave and at hip and ridge flashings. Close spacing at the flashings and eave is important to keep the flashings and panel ends from billowing during high winds.

The R-panel roof on this house located in Exposure C was very well attached. The screws were closely spaced horizontally and vertically, and at the panel side laps. The flashing fasteners were too far apart (12 inches on center), but the attachment was sufficient for these winds (estimated wind speed: 115 mph. Slidell, Louisiana).

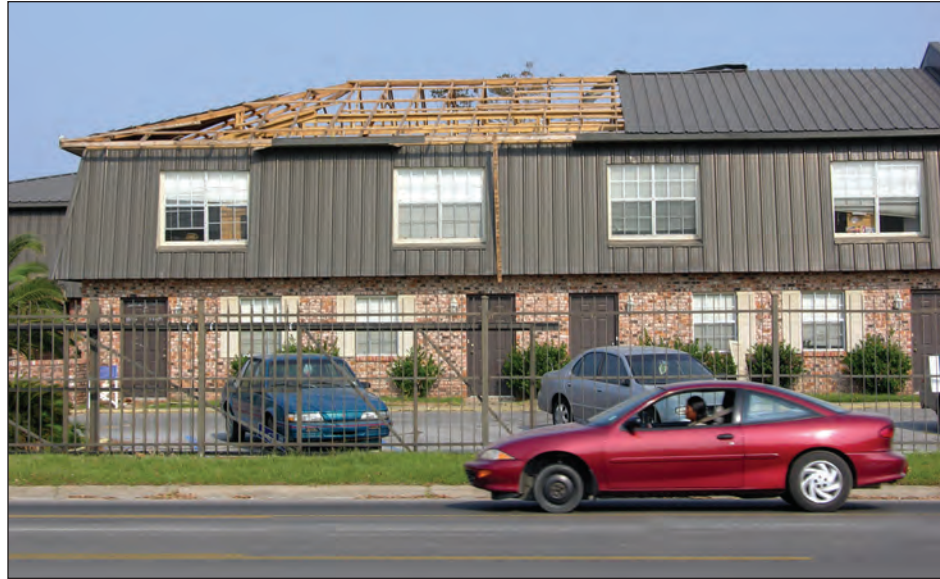
Figure 5-63 shows an apartment complex that did not incorporate roof decking. The trusses had 2x4 nailers installed directly over them. Several of the nailers were blown away, which resulted in a progressive failure of the R-panels. Since there was no roof decking, it was not possible to install underlayment. Thus with loss of the metal panels, the living units were exposed to massive rainwater infiltration.

**Figure 5-63.**  
Blow-off of nailers caused these panels to progressively fail. The nailers were installed directly over the trusses and, with loss of the panels, rainwater was free to enter the building (estimated wind speed: 105 mph. Pascagoula, Mississippi).

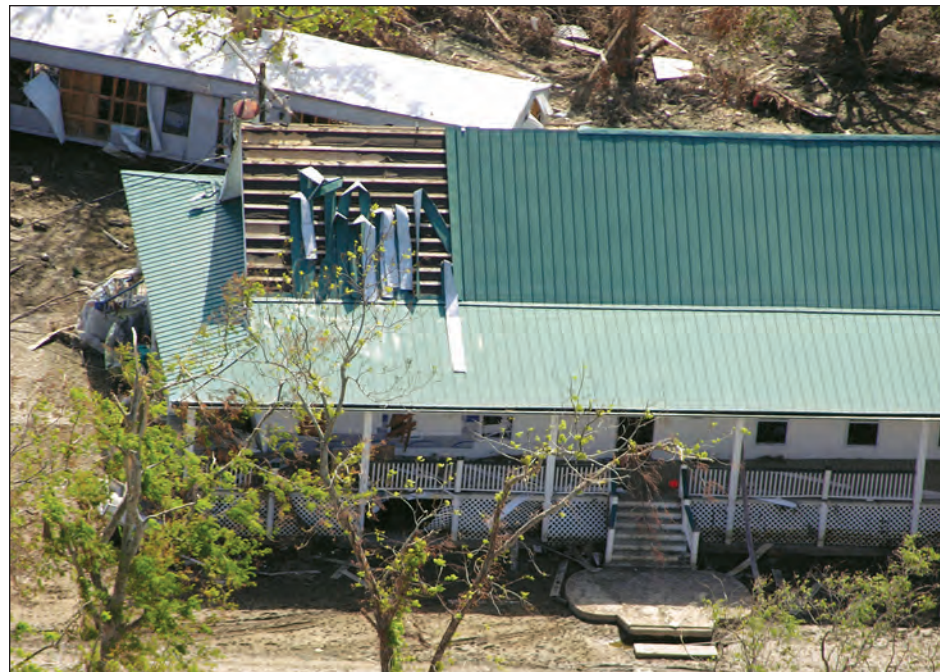
A variety of architectural and structural standing seam panels was also observed. As with the exposed fastener panels, some of the roofs were undamaged, others lost hip or ridge flashings, and others lost a large number of panels (see Figure 5-64). Performance of standing seam panels is a function of the strength of the panels and their interlock with the clips, clip spacing and attachment, and strength of the flashing attachments. Some of the failed hip and ridge flashings were attached with cleats rather than exposed fasteners. Cleat attachment is not as reliable as exposed fasteners.

**Figure 5-64.**  
Loss of architectural standing seam panels. The panels were installed over 2x4 nailers over underlayment and wood sheathing panels. Much of the exposed underlayment was blown away, thereby allowing rainwater infiltration (estimated wind speed: 130 mph. Buras, Louisiana).

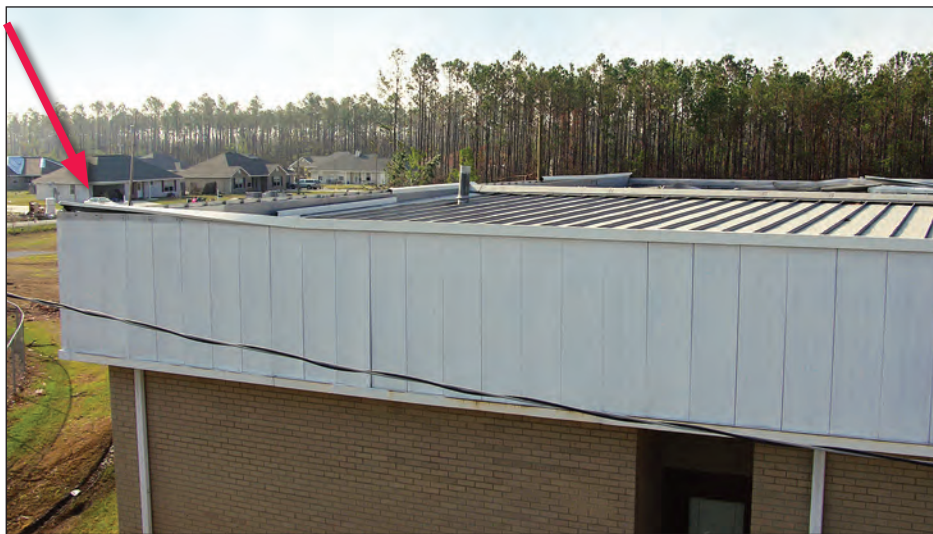
Two unusual installation practices were observed. At the school shown in Figure 5-65, the standing seams were not continuously seamed together. Rather, they were crimped at an erratic spacing (in one area, it was about 4 feet between 6-inch-long crimps). Lack of continuous seaming reduces uplift resistance of the panels and makes them susceptible to leakage. Some of the copings were blown off, and several suspended ceiling boards collapsed after becoming saturated from roof leakage.

**Figure 5-65.**  
The architectural standing seam panels on this school were not continuously seamed. Note the coping damage. This portion of the school was completed in 1988 (estimated wind speed: 125 mph. Waveland, Mississippi).

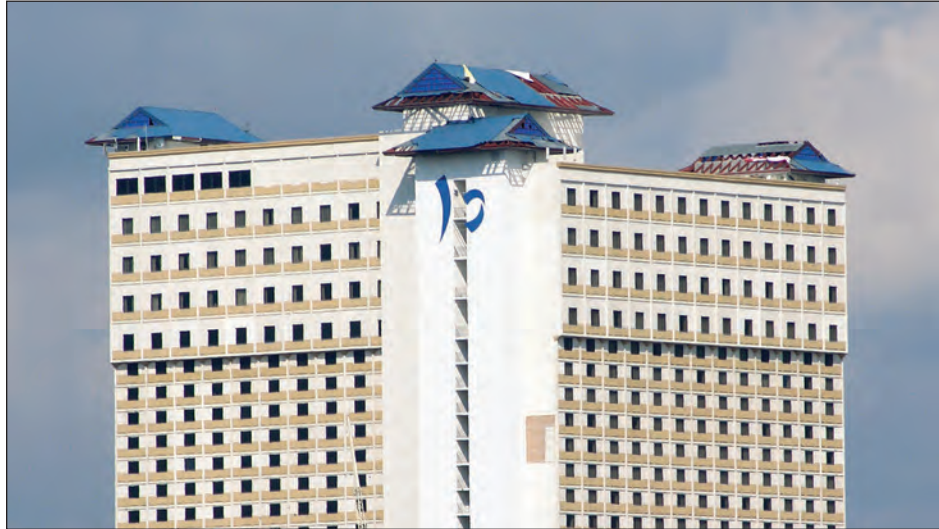
**Figure 5-67.**

When metal panels or hip/ridge flashings blow off (see Figure 5-67), they can become high-energy windborne debris that can damage buildings and other property and cause injury. These types of windborne debris can travel a considerable distance.

The steep-slope roof coverings on this high-rise building appear to be tile; however, they actually were metal panels that simulated tile. Several panels were blown off (estimated wind speed: 120 mph. Biloxi, Mississippi).

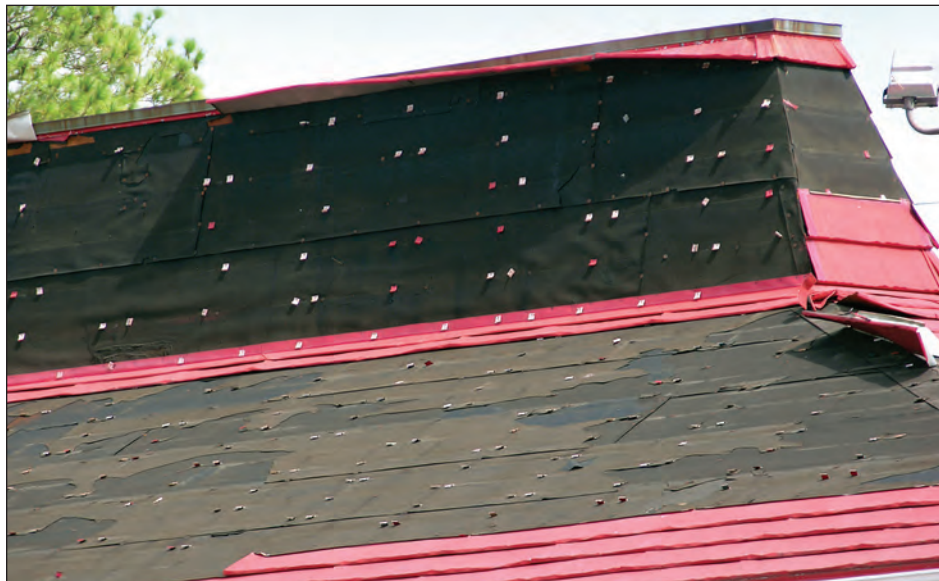
**Figure 5-68.**

A limited number of metal shingles were observed. Figure 5-68 shows an aluminum shingle that has been used on many fast-food restaurants throughout the United States. These shingles are attached with two stainless steel clips per shingle. Because these shingles are quite flexible, they deformed and lost engagement with the clip. Poor performance with this type of shingle has been observed in several previous hurricanes, dating back to Hurricane Hugo in 1989. Another aluminum shingle of somewhat similar design to that shown in Figure 5-64 also deformed and lost engagement with its clips. Some batten-attached metal shingles were also observed, but detailed investigations were not performed to determine the failure mode.

These aluminum shingles disengaged from their clips (estimated wind speed: 115 mph. Slidell, Louisiana).

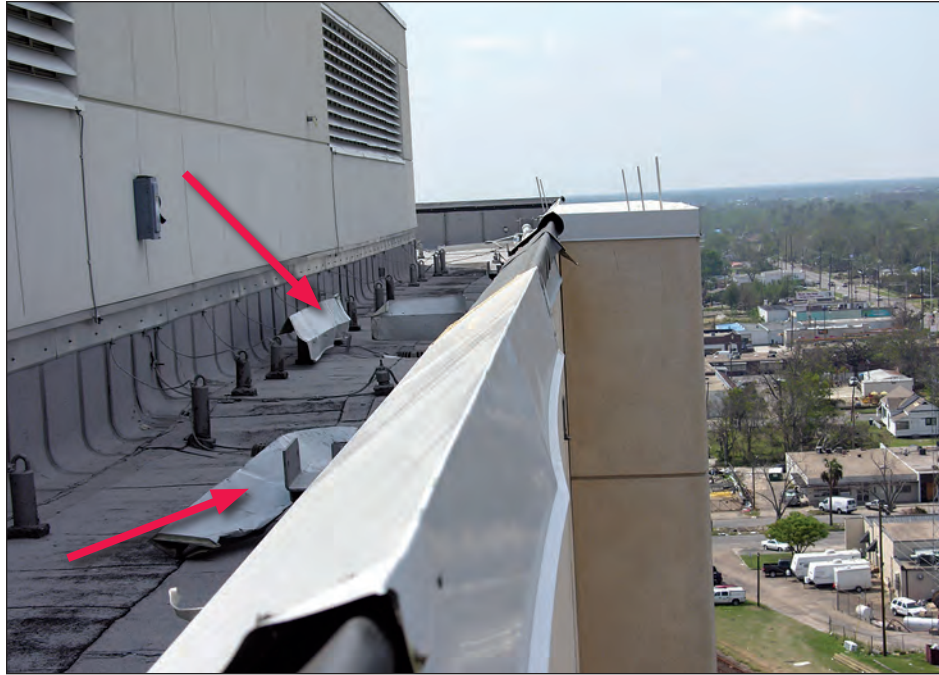
At the Federal courthouse shown in Figure 5-69, the coping had a 6-1/2-inch vertical face, but the hem on the continuous cleat was only 7/16 inch long.<sup>4</sup> High-wind loads caused deformation of the coping and cleat. Because of the limited engagement with the cleat, the outer face of the coping unlatched from the cleat. At several areas, the unlatched coping lifted, but remained attached to the parapet; however, some of the sections of coping were blown from the parapet. The courthouse was completed in 2003.

<sup>4</sup> The 2001 edition of *The NRCA Roofing and Waterproofing Manual* recommends a 3/4-inch long hem.

**Figure 5-69.**  
This coping unlatched from the cleat because the cleat hem was too short. Two sections of detached coping are resting on the roof (red arrows) (estimated wind speed: 130 mph. Gulfport, Mississippi).

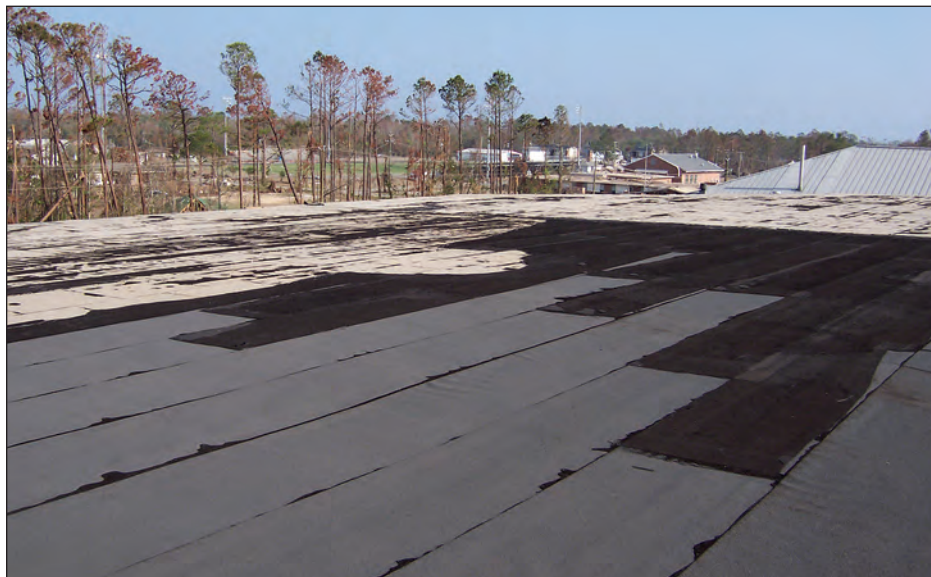
At the school gym roof shown in Figure 5-70, the modified bitumen membrane was set in hot asphalt over 4x4-foot perlite set in hot asphalt over mechanically attached polyisocyanurate insulation and glass mat gypsum roof board over metal deck. The membrane peeling was caused by failure of the edge flashing nailers. Rather than stacking continuous 2x nailers, a 2x nailer about 12 inches long was attached to the deck, followed by another 2x nailer of the same length on top of it. The upper nailer was attached with two power-driven fasteners. These discontinuous stacks were spaced at 4 feet 7 inches on center. A continuous top nailer was then attached to the stacks. The continuous top nailer lifted with the metal edge flashing and caused the membrane to lift and peel. This school was completed in 1998.

**Figure 5-70.**  
The modified bitumen membrane failure at this school was caused by lifting of the edge nailer (estimated wind speed: 130 mph. Pass Christian, Mississippi).

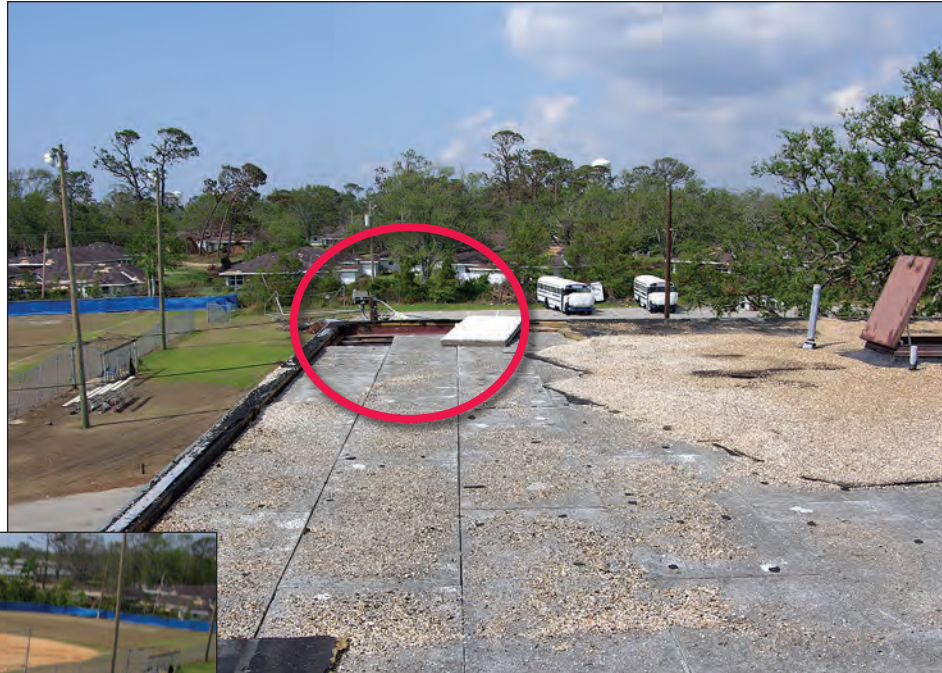
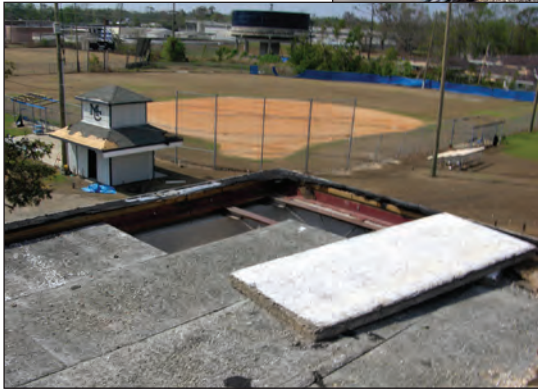
Figure 5-72.

The BUR on this school was blown off after one of the cementitious wood-fiber deck panels detached from the joists. Older cementitious wood-fiber deck attachments typically offered limited uplift resistance (estimated wind speed: 120 mph. Biloxi, Mississippi).

When buildings in hurricane-prone regions are reroofed, it is prudent to tear off the existing roof system down to the deck, so that the entire deck surface can be checked for attachment and deterioration. If inadequately attached or deteriorated decking is discovered, remedial action should then be taken as part of the reroofing project. By doing so, future wind damage associated with deck deficiencies can be avoided.

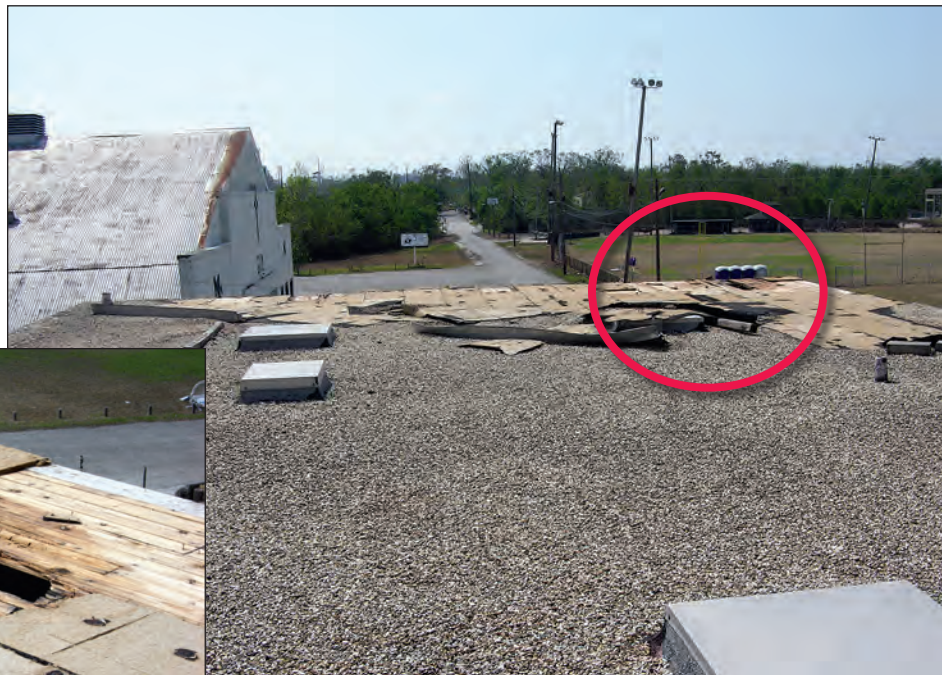
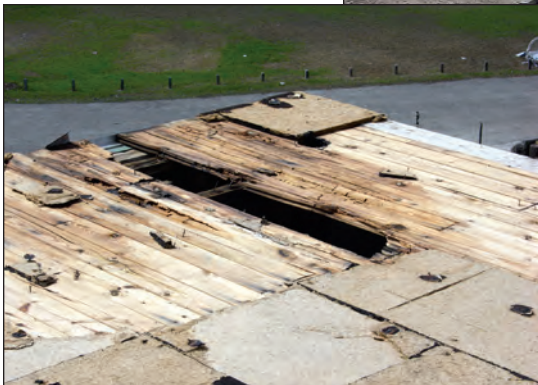
Figure 5-73.

The BUR on this school was blown off after a few of the rotted wood planks detached from the joists (estimated wind speed: 120 mph. Biloxi, Mississippi).

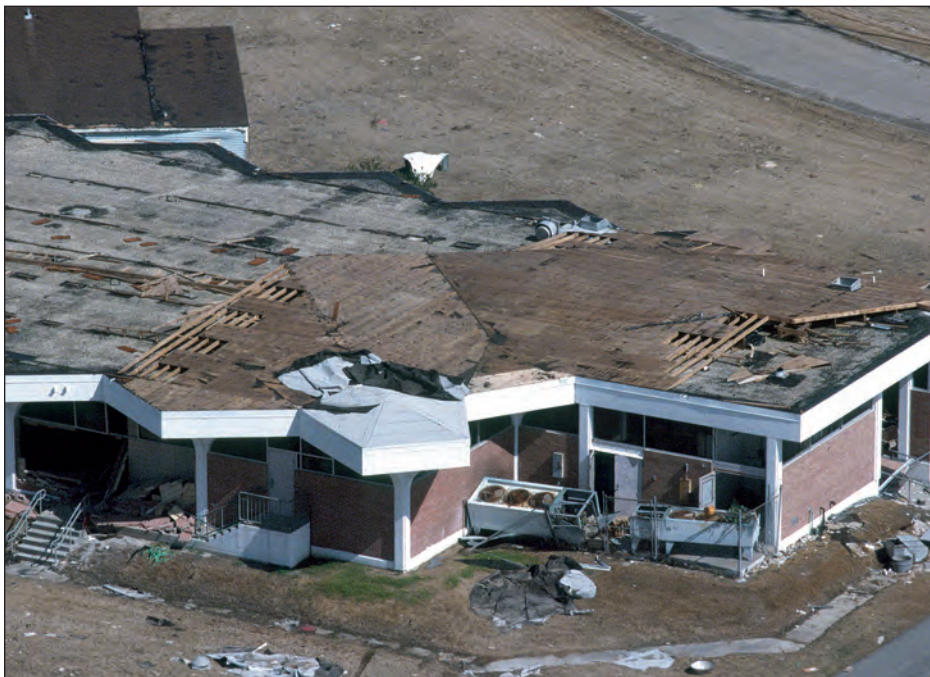
**Figure 5-74.**

Figure 5-74 illustrates another type of deck and deck support failure. This school originally had a low-slope BUR. As part of a reroofing project, a steep-slope conversion was made, wherein sloped wood framing was installed over the BUR, followed by plywood decking and a modified bitumen membrane. The wood framing blew away due to inadequate attachment. This illustrates the importance of load path and connections when steep-slope conversions are made.

The wood superstructure that was installed on this school as part of a steep-slope conversion blew away because of inadequate attachment (estimated wind speed: 125 mph. Port Sulphur, Louisiana).

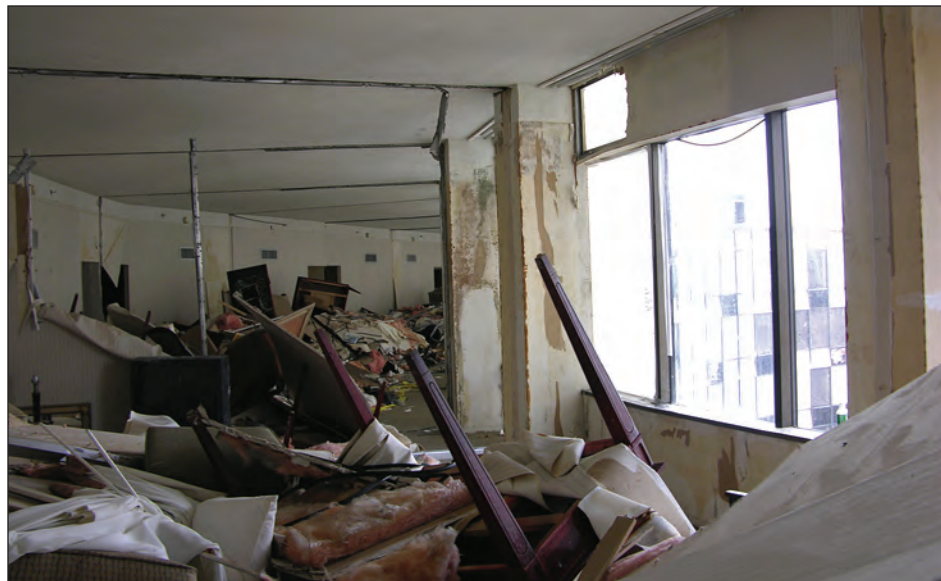
**Figure 5-75.**  
Interior view of the hotel shown in Figures 3-47 and 5-82. After the exterior glazing broke, wind knocked down the partitions between the guest rooms and water entered the building (estimated wind speed: 105 mph. New Orleans, Louisiana).

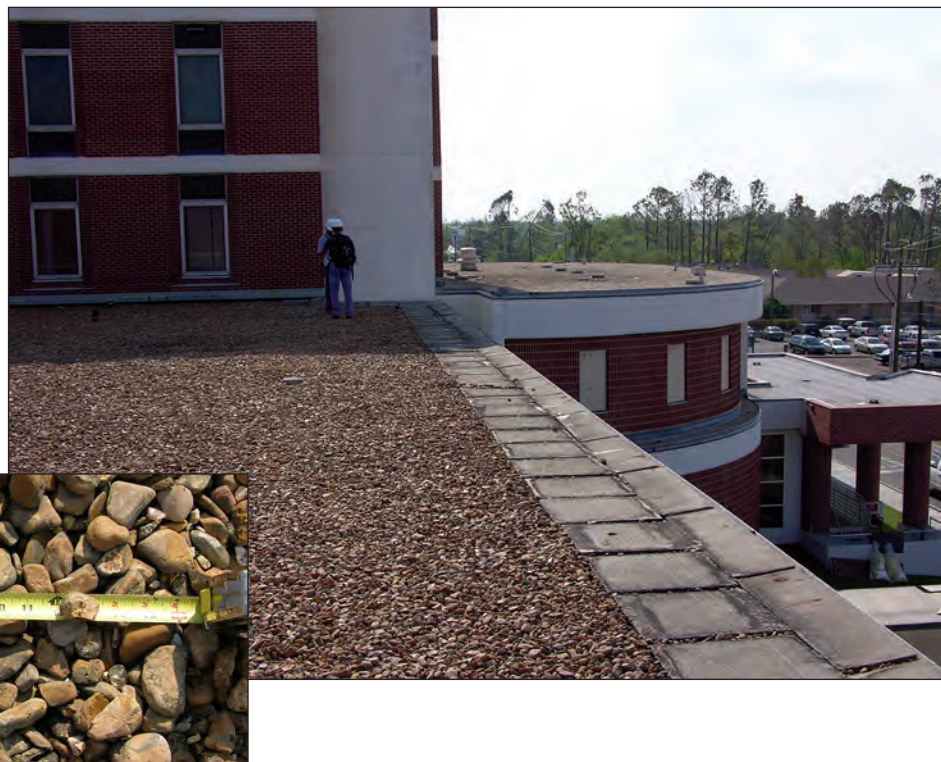
**Figure 5-77.**

Aggregate from this ballasted single-ply broke several of the windows in the wall beyond. The concrete pavers at the perimeter were not displaced. The aggregate (inset) does not comply with RP-4 requirements (estimated wind speed: 130 mph. Gulfport,

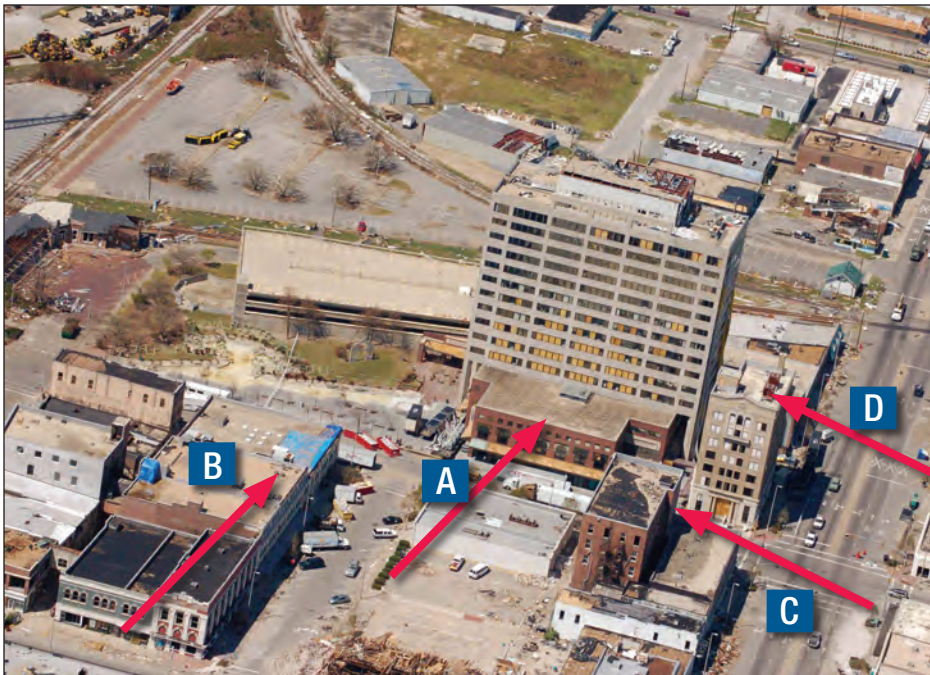
Figure 5-78.

The majority of the windows in the mid-rise building shown in Figures 5-78 and 5-79 were broken by aggregate from BURs. Most of the damage to the lower level windows was likely caused by aggregate from the podium roof adjacent to the tower (roof “A” in Figure 5-78). The south edge of the podium roof (the edge near the arrowhead in Figure 5-78) had a metal edge flashing. The roof sloped toward the tower; therefore, a parapet occurred along the east-west walls. The maximum height of the parapet was about 6 inches. Most of the aggregate that had been embedded in the flood coat was still embedded, but most of the loose aggregate had been blown away.

Wind in this area blew from two primary directions, from the southwest and east/southeast. Therefore, aggregate from the roofs on building “B” in Figure 5-78 likely impacted the tower

glazing. Several of the second-story windows in building “B” were also broken by roof aggregate. Aggregate from the roof of building “C” also likely impacted the tower. Portions of the BUR membrane and some of the wood plank decking on the five-story portion of building “C” also blew off, but there was no indication that membrane or deck debris struck the tower. Aggregate from building “D” may have also impacted the tower. Around the main roof of this seven-story building, there was a parapet in the range of 3 to 4 feet high. Aggregate on this roof was scoured, but because of lack of roof access it was not determined if aggregate was blown from the main roof. However, the parapet on the penthouse roof was about 18 inches high; therefore, aggregate was likely blown from this roof.

The south façade of the 15-story building had a large number of windows broken by aggregate from BURs. Damage was caused by aggregate from roof A, and likely from roofs B and C. Damaging aggregate may have also been blown from roof D (estimated wind speed: 130 mph. Gulfport, Mississippi).

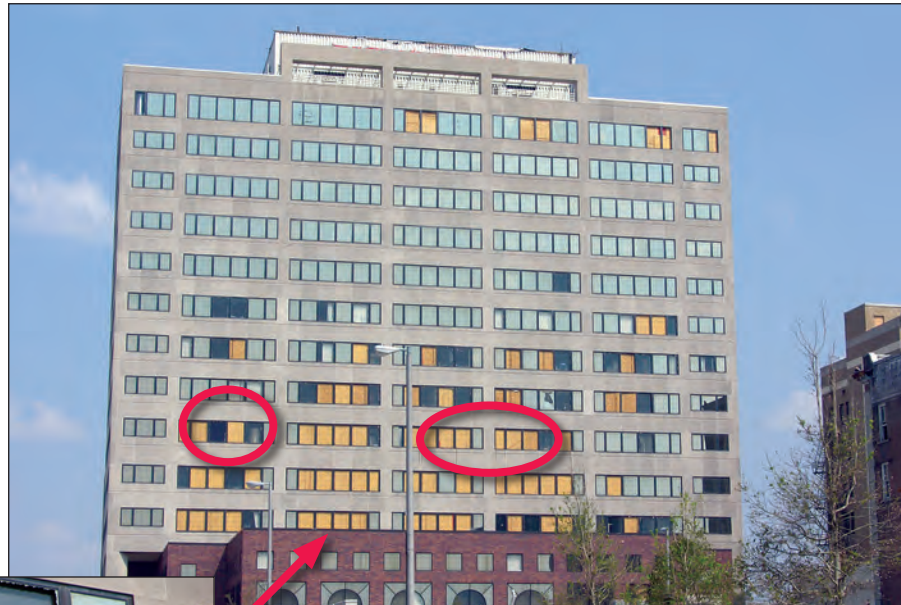
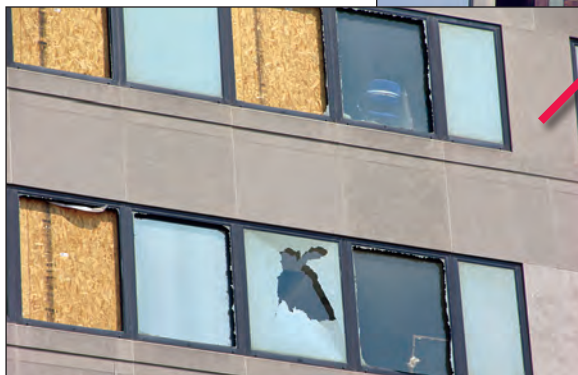
The tower windows were double glazed. Tempered glass was used for the outer pane. At some windows, only the outer panes were broken (the windows in Figure 5-79 that appear black and those that appear white [due to window blinds] are where the outer panes broke and the inner panes are still in place). However, at most of the broken windows, both the outer and inner panes were broken (at these windows, the openings were covered with OSB after the storm). With loss of both panes of glass, wind and water were able to enter the building. Ceiling boards were blown from their support grid and there was significant water damage to interior finishes and furnishings.

At the 15th (top floor), the outer pane at the west end broke, and the inner and outer panes broke at seven other windows as shown at Figure 5-79. As discussed in the ASCE 7 Commentary, during its flight, aggregate blown from roofs can be lifted 30 feet above the roof from which it blew. The 15th floor windows are well above the penthouse roof on the seven-story building “D”; therefore, it is unlikely that the 15th floor windows were broken by aggregate from roofs “A” - “D.” The main roof on the tower was also aggregate surfaced. The parapet around this roof was 30 inches high; therefore, aggregate was likely blown from this roof.

Another view of the tower shown in Figure 5-78. Roof "A" is shown by the arrow. At the black and white (circled) window areas, the outer pane broke. Temporary OSB enclosures were installed where the inner and outer panes broke (see inset) (estimated wind speed: 130 mph. Gulfport, Mississippi).

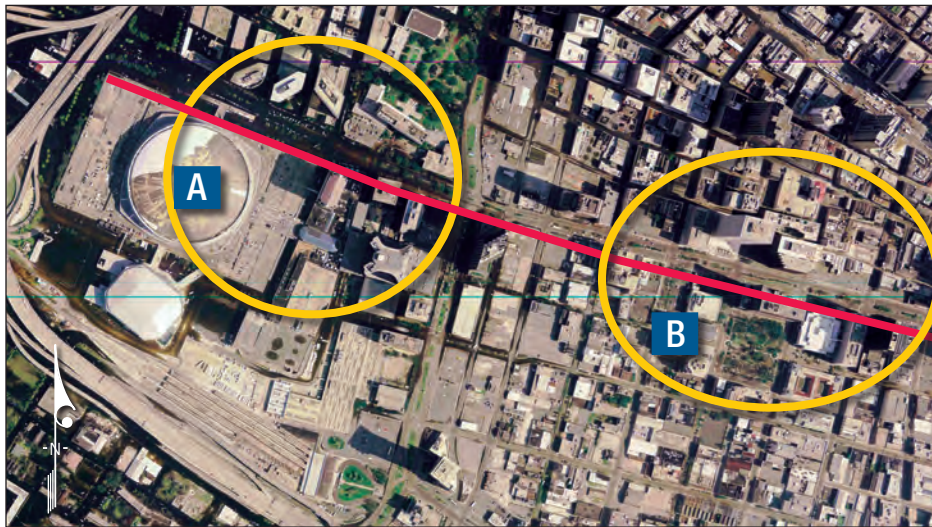
Figure 5-80.  
General locations of  
buildings (highlighted  
by yellow circles)  
along Poydras Street  
(highlighted in red)  
with extensive glazing  
damage. The Superdome  
is at the left of the figure.  
(estimated wind speed:  
105 mph. New Orleans,  
Louisiana.)

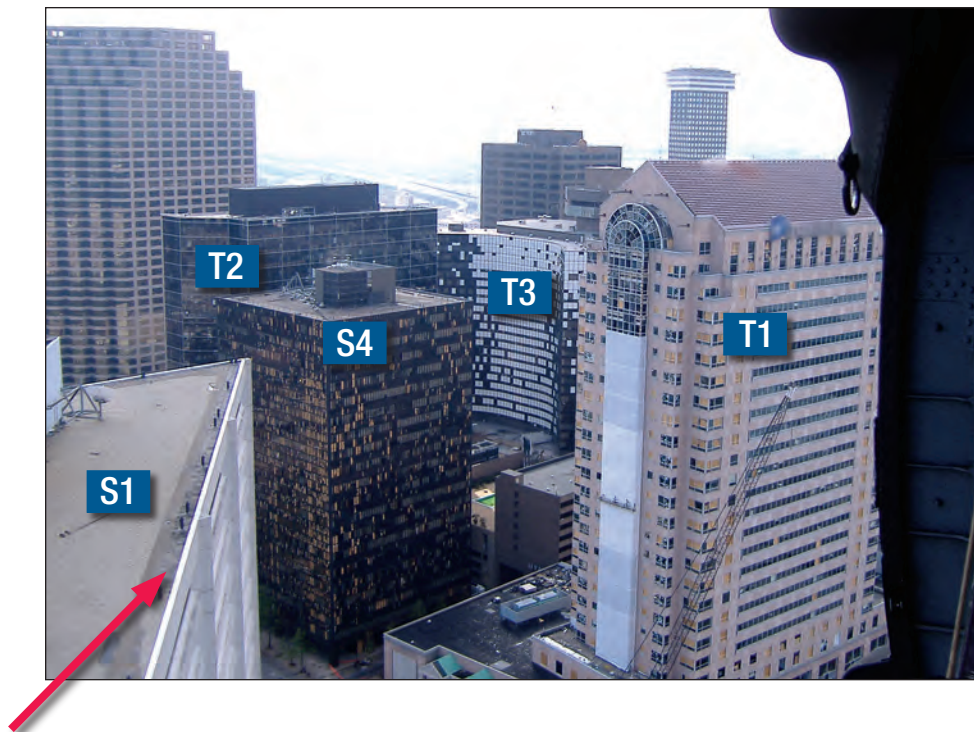
and T4 is a large skylight. These buildings are shown in Figure 5-82, and T2 and T3 are shown in Figure 3-48. Figure 3-29 is a ground-based view of T1, T3, and S4. The white areas at T1 and T3 are where plastic sheeting was installed at broken windows and spandrel panels. The brown areas at T1, T2, and S4 are where plywood was installed after the storm. Figure 5-83 is a close-up view of T1, Figure 5-84 is a close-up view of S4, Figure 5-85 is a closeup view of T2, and Figure 5-86 is a view of T4.

Figure 5-82.  
View of glazing damage  
at T1 - T3 and S4.  
Building S1 had an  
aggregate ballasted roof  
membrane; aggregate  
from this roof was one  
of the likely sources of  
debris (estimated wind  
speed: 105 mph. New  
Orleans, Louisiana).

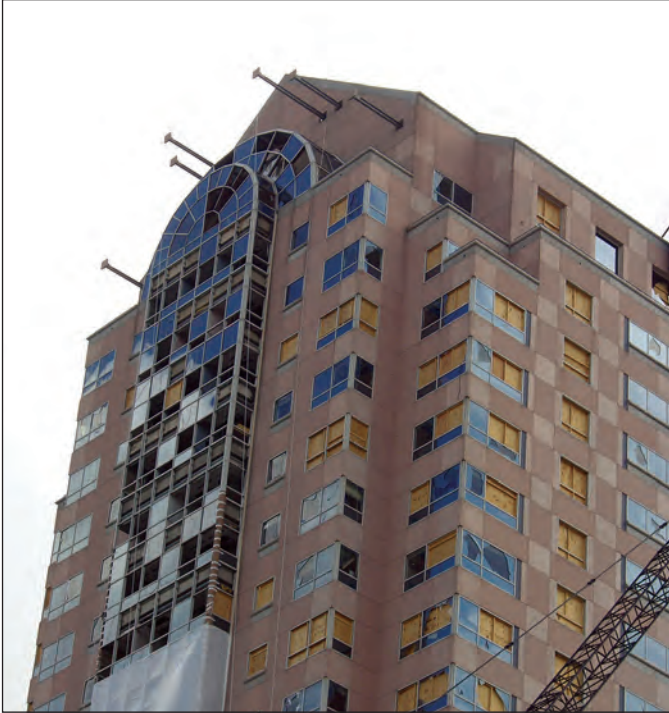
Figure 5-83.

Closeup view of T1 (estimated wind speed: 105 mph. New Orleans, Louisiana).

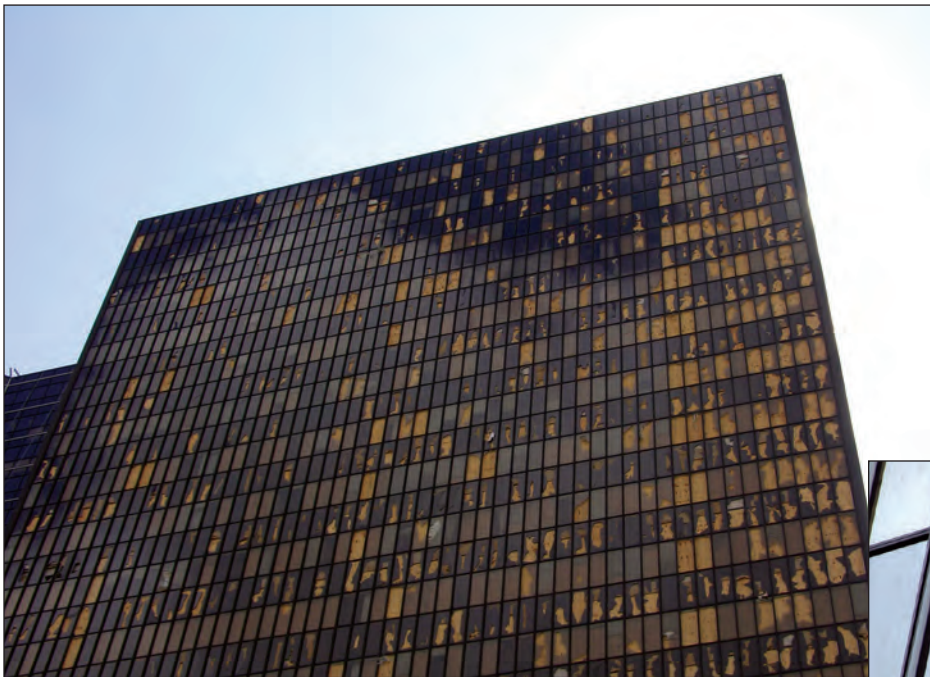
Figure 5-84.

Closeup view of the north façade of S4. The inset (west façade) shows broken windows and spandrel panels. The broken glass at the circle is indicative of impact by a large piece of aggregate (estimated wind speed: 105 mph. New Orleans, Louisiana).
