## HURRICANE

*Katrina*

## IN THE GULF COAST

## 5. Building Envelope Performance

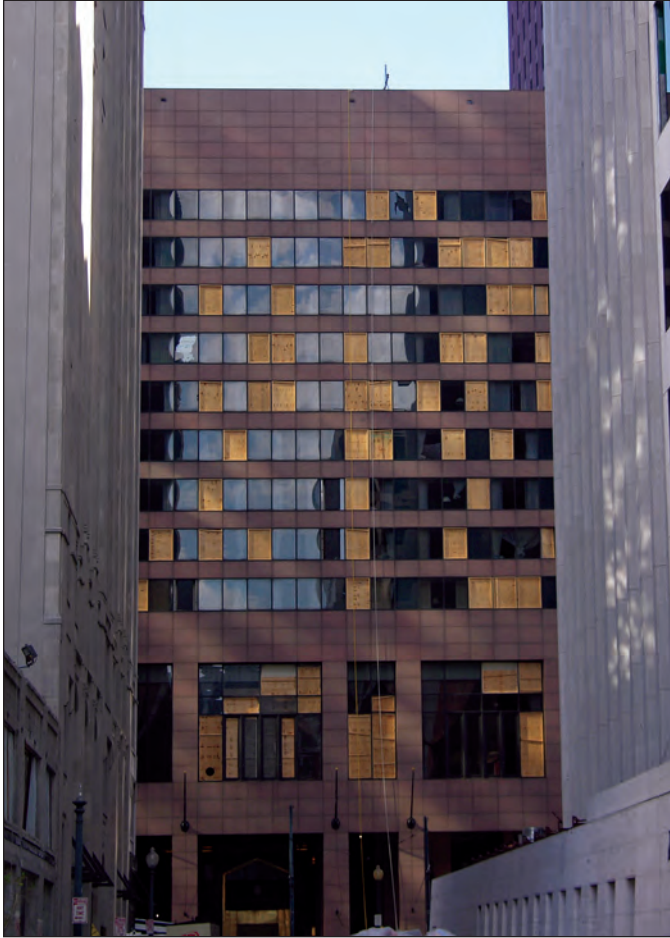
Figure 5-91.

*Building T5:* Several windows on the west façade of this 11-story building were broken (see Figure 5-91). A few isolated breaks occurred on the north and east façades. BURs occurred in the vicinity, but a likely source of aggregate debris was not definitively determined.

View of the west façade of T5. The tallest building in New Orleans is at the right (estimated wind speed: 105 mph. New Orleans, Louisiana).

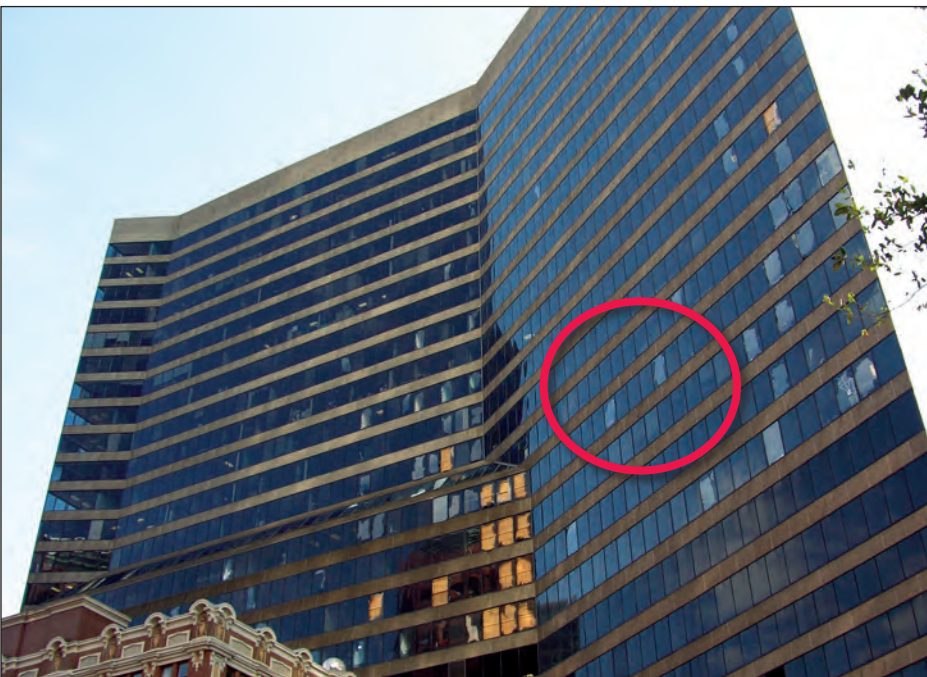
Figure 5-92.

*Building T6:* Several windows were broken on the north façade (see Figure 5-92). The likely sources of debris were the aggregate surfaced roofs on S6, which is directly across the street from T6 (see Figure 5-93). The narrow stair-stepped roofs (see Figure 5-94) appeared to be aggregate ballasted single-ply membranes. Metal roof panels were also blown from S6 and may have caused some of

the glazing damage. At least 20 windows on the west façade of T6 were also broken (in most cases, only the outer pane broke). The debris source for the west façade was not determined.

General view of T6. Plywood had been placed where the inner and outer panes had been broken. At most of the broken windows, only the outer pane broke (red circle). The building at the lower left did not have an aggregate roof surface (estimated wind speed: 105 mph. New Orleans, Louisiana).

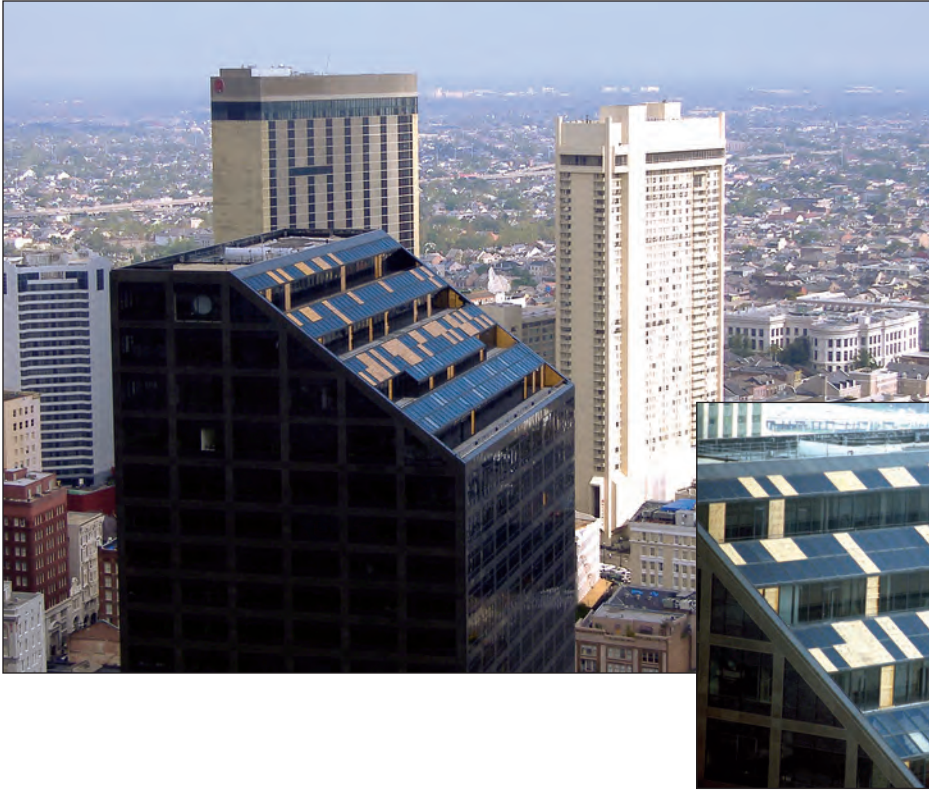
*Building T7:* This high-rise building is shown in Figure 5-93. It had sloped glazing that was sloped to the east (see Figure 5-95). Several of the outer panes of the sloped glazing were broken. Inner panes may have also been broken where plywood was installed after the hurricane. Several of the vertical windows adjacent to the sloped glazing were broken as well as a few windows on the east façade of the tower. A few windows were also broken on the north and south façades. The main roof and one of the stair-stepped roofs had ballasted single-ply membranes. A stone-protection mat occurred between the aggregate and membrane. Some aggregate was ramped against a portion of the west parapet. A substantial amount of aggregate was scoured and blown from the main roof (see Figure 5-96). The parapet appeared to be about 3 feet high. Aggregate from the main roof was the likely source of debris that broke the sloped glazing and nearby windows.

Figure 5-95.  
Aggregate ballast from the main roof of T7 was the likely source of debris that broke the sloped glazing and nearby windows (estimated wind speed: 105 mph. New Orleans, Louisiana).

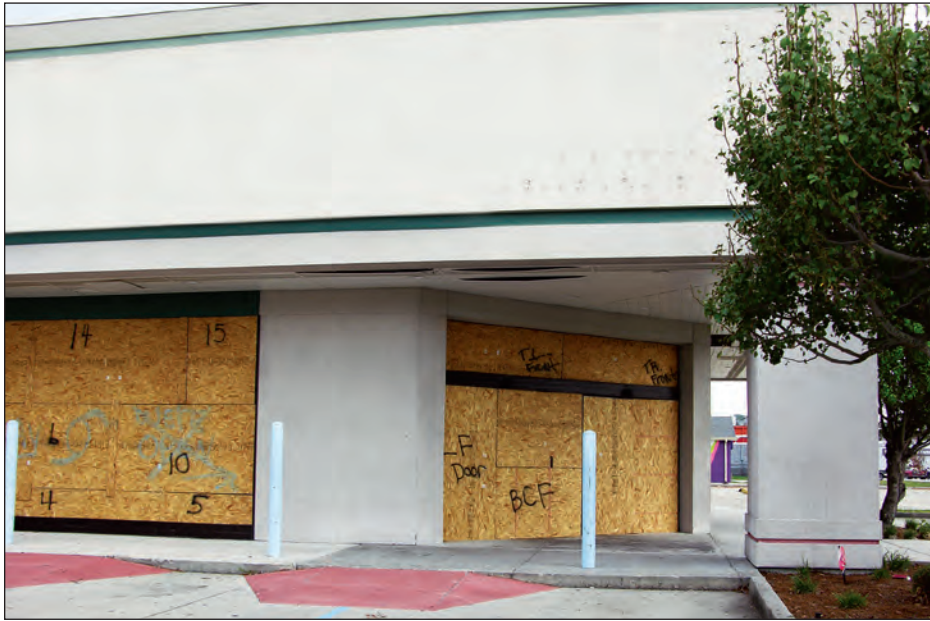
**Figure 5-98.**  
Pre-cut OSB shutters  
(estimated wind speed:  
115 mph. Slidell,  
Louisiana)

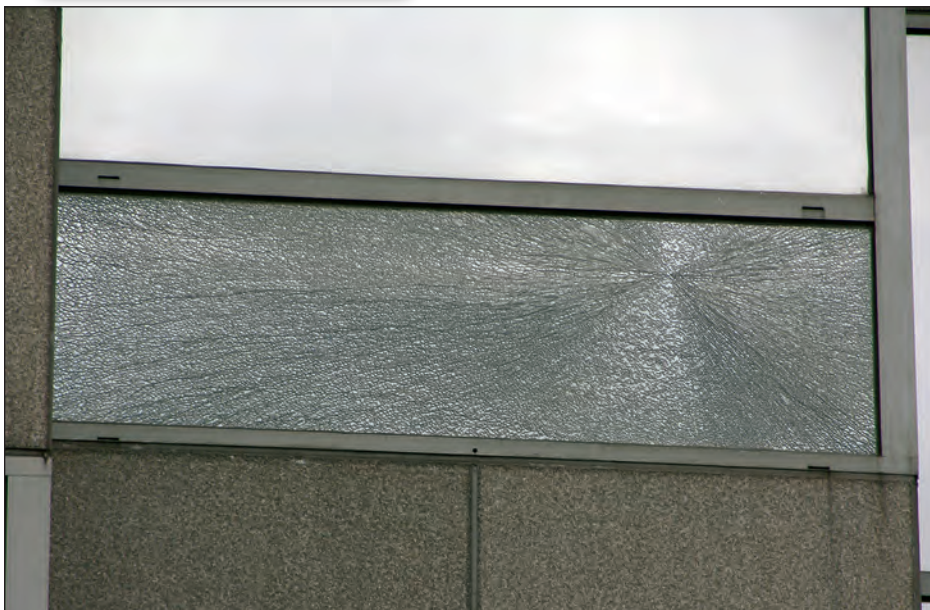
The MAT observed some laminated glass that had been impacted by debris. Except for the window shown in Figure 5-102, this glazing occurred in skylights as discussed in Section 5.5.5. When laminated glass breaks, the glass remains bonded to the plastic film between the panes, and the glazing remains in the frame. Although the glass will need to be replaced, costly interior water and wind damage is avoided.

**Figure 5-102.** The laminated glass broke, but remained in the frame and continued to provide wind and water protection (estimated wind speed: 105 mph. New Orleans, Louisiana).

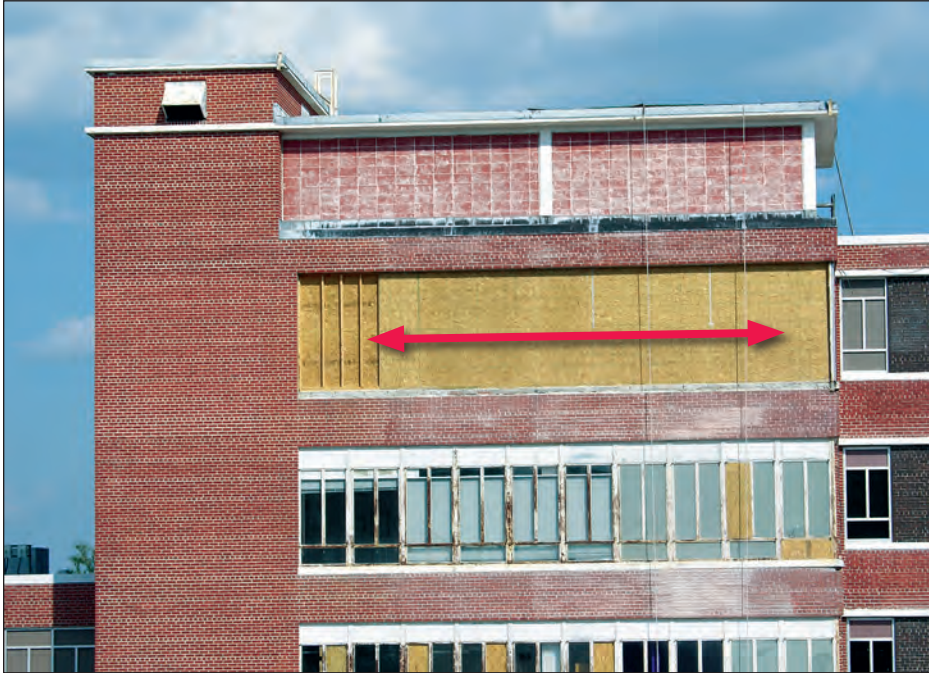
Figure 5-104.

At an older wing of a hospital in Gulfport, several window frames failed due to wind pressure (see Figure 5-104). Some of the glazing on the floors below were broken by pressure or debris. As discussed in Section 5.5.1, approximately 400 windows and spandrel panels were broken at this facility. This building was also damaged during Hurricane Camille.

The window frames on the upper floor failed (red arrow). Some of the windows on the lower level were broken by pressure or debris (estimated wind speed: 130 mph. Gulfport, Mississippi).

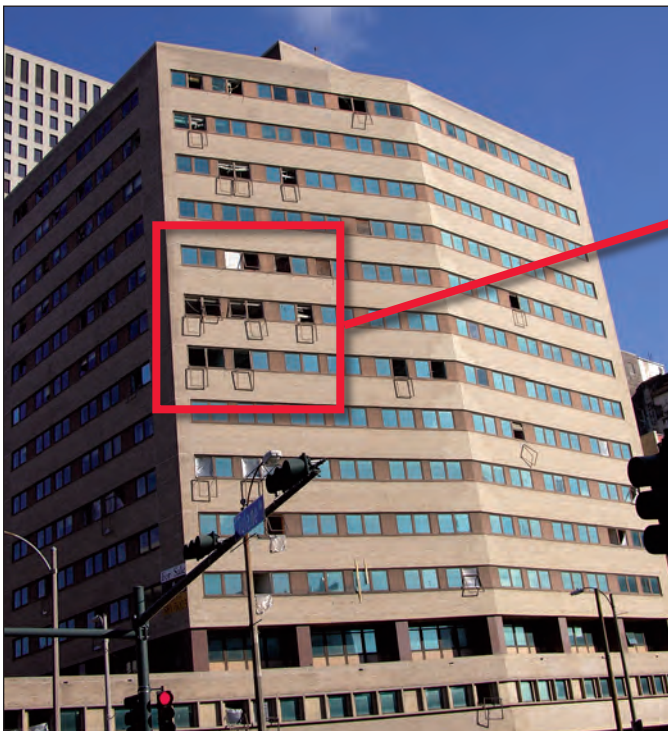
Frame failure due to wind pressure caused the loss of several windows in the office building shown in Figure 5-105.

Figure 5-105. Wind pressure caused frame failure at several windows in this building (estimated wind speed: 105 mph. New Orleans, Louisiana).

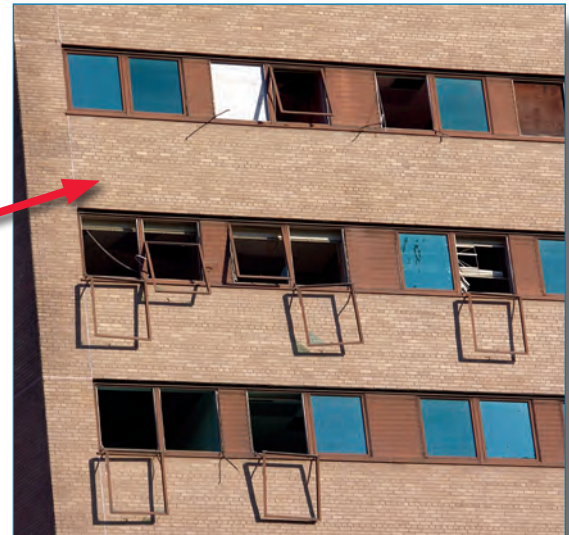
An unusual glazing failure is shown in Figure 5-106. This older brick building had been re-skinned with a curtain wall system. As part of the re-skinning, wood nailers had been attached

to the brick to provide anchorage for the curtain wall. A large number of spandrel panels were blown away. Several of the nailers had detached from the brick at the areas shown by the yellow circle and arrow. At the other missing spandrels, the panels had detached from the nailers.

Several spandrel panels detached from their wood nailers. In some areas, the nailers detached (red rectangle and arrow). The glazing at the yellow circles was likely broken by debris (estimated wind speed: 105 mph. New Orleans, Louisiana).

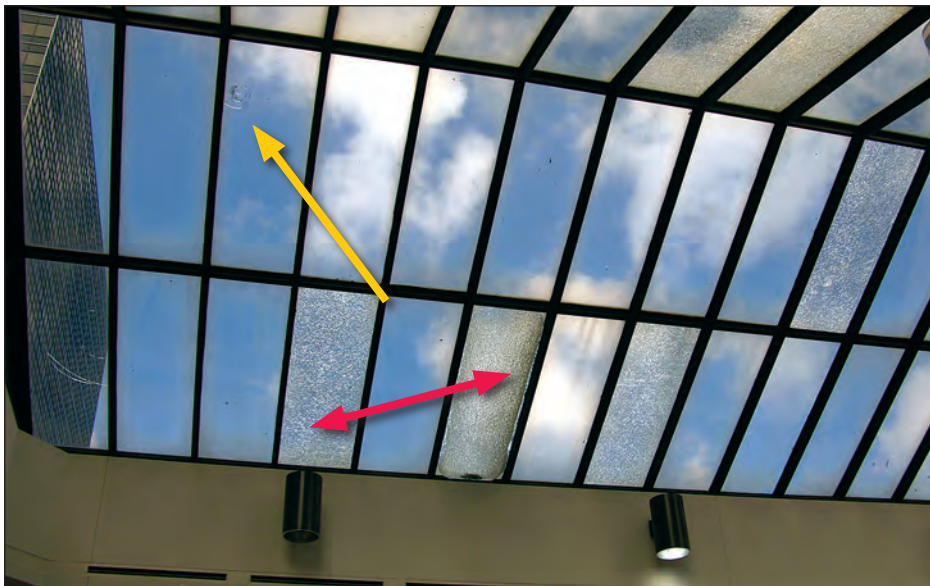
Figure 5-107. Six of the inner laminated panes were broken (two of them are shown by the red arrow). Three other breaks appeared to be at the outer panes (one of these is shown by the yellow arrow) (estimated wind speed: 105 mph. New Orleans, Louisiana).

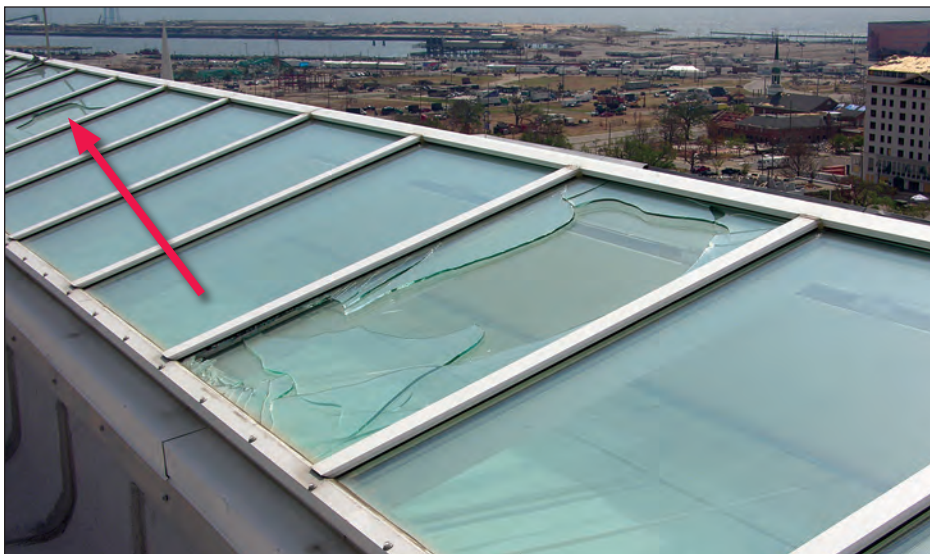
As discussed in Section 5.5.2, although the inner and outer panes were broken, the laminated glass avoided costly interior water and wind damage. However, unless the outer panes are also laminated, if the outer panes are broken, the shards become windblown debris (see Figure 5-108).

Figure 5-108. Skylight on a new eight-story Federal courthouse. Two of the outer panes were broken. Windborne shards can cause injury and damage buildings and vehicles (estimated wind speed: 130 mph. Gulfport, Mississippi).

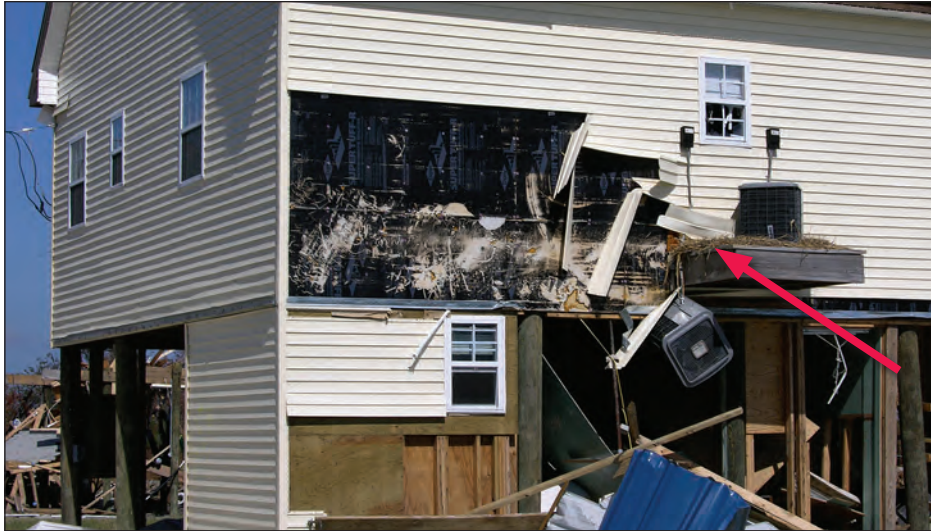
Figure 5-109.  
One of the condensers was blown off this cantilevered platform (estimated wind speed: 120 mph. Shell Beach, Louisiana).

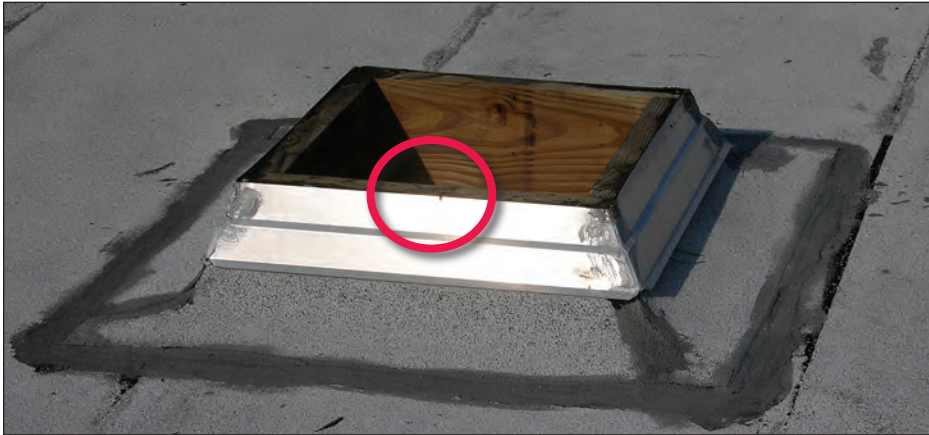
Figure 5-113.

As frequently observed following previous hurricanes, many fan and HVAC units were damaged. In several cases, the units were blown off the curbs because too few fasteners were used to attach the units to the curbs. The blown-off exhaust fan on the school in Figure 5-113 had been attached with only two screws. Had the fan been attached in accordance with the guidance in the Hurricane Katrina Recovery Advisory, *Attachment of Rooftop Equipment in High-Wind Regions* (Appendix E), there would have been five screws per side. Although the opening through the roof was small, a substantial quantity of rainwater was able to enter the school. Because of Katrina's widespread damage, this opening remained unprotected for more than a month after the storm.

The missing exhaust fan was attached with only two screws, one of which just grazed the top of the nailer (red circle). The screw that engaged the nailer was sheared off (estimated wind speed: 125 mph. Waveland, Mississippi).

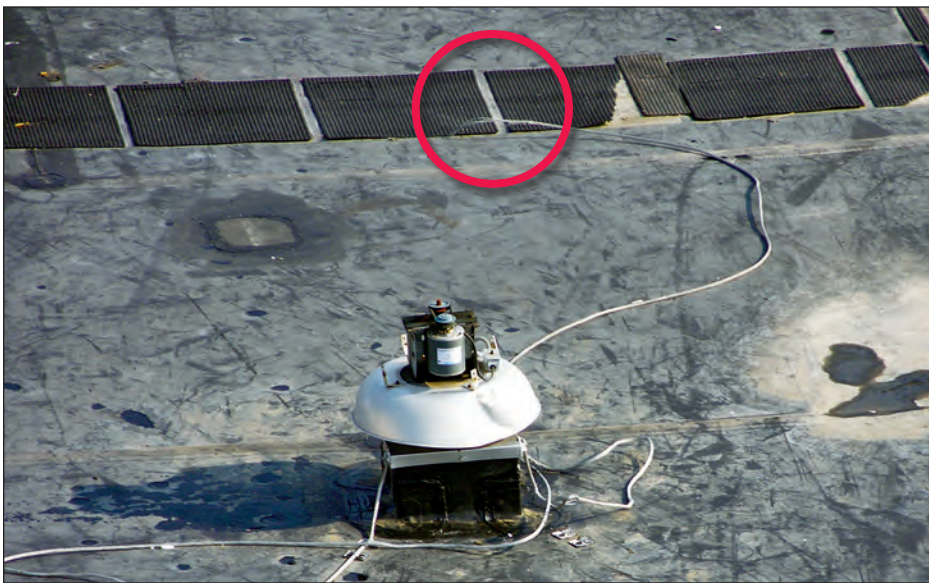
Figure 5-114.

At this hospital, the cowl was blown off the exhaust fan. Note also the loose LPS conductors (red circle, Figure 5-123) and missing walkway pads (estimated wind speed: 130 mph. Gulfport, Mississippi).

In many other cases, the fans remained attached to their curbs, but the cowlings were blown away (see Figure 5-114). The Hurricane Katrina Recovery Advisory, *Attachment of Rooftop Equipment in High-Wind Regions* (Appendix E), provides guidance for jobsite strengthening of cowlings. Another fan near the one shown in Figure 5-114 was struck and damaged by windborne debris (see Figure 7-18). At least for critical and essential facilities, this illustrates the benefits of placing rooftop mechanical equipment in penthouses so that the equipment is protected from debris and remains operational.

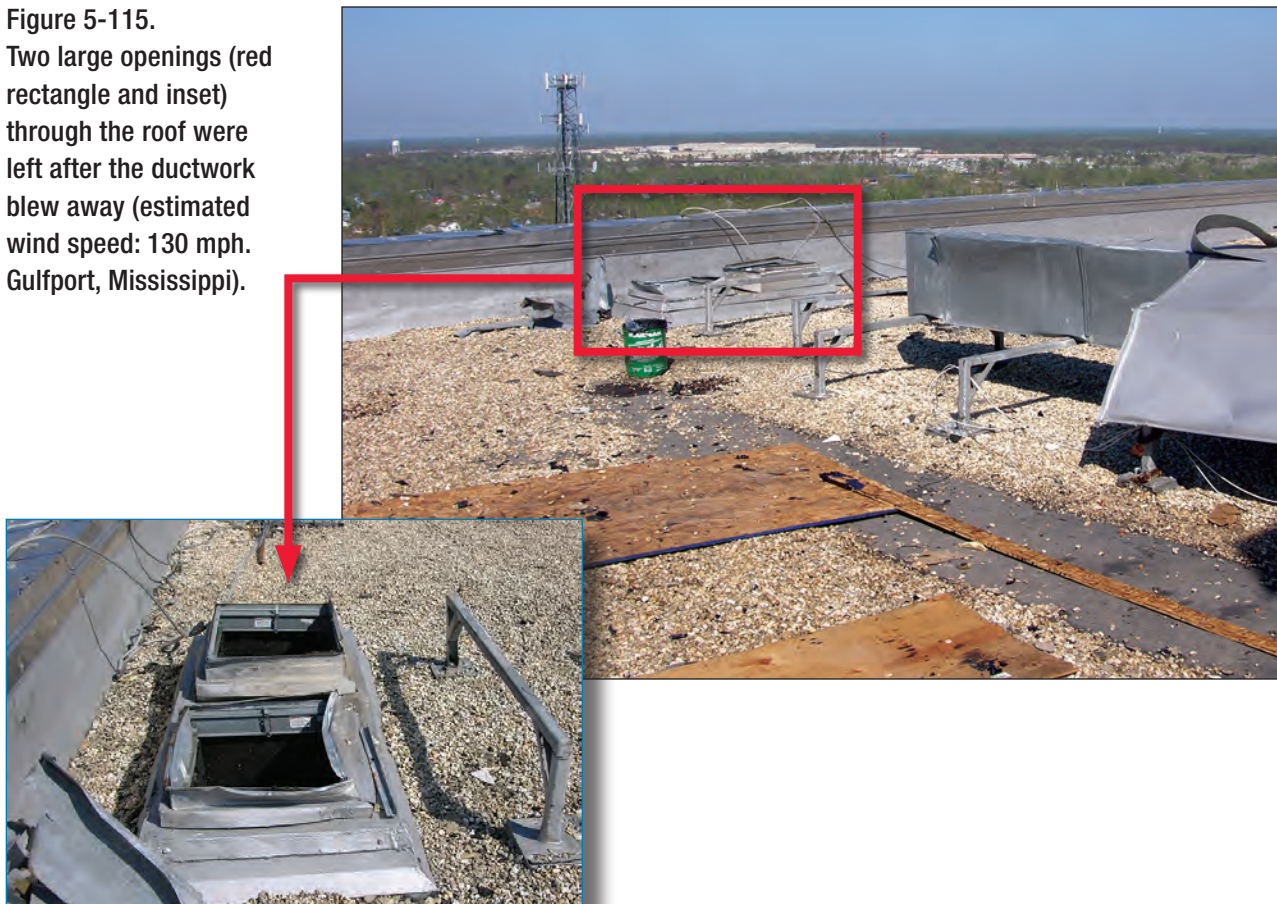
Rooftop-mounted ductwork was observed on a few buildings. At the building shown in Figure 5-79, portions of the ductwork were blown away as shown in Figure 5-115. The ducts rested on top of steel support channels. At the time of the MAT's observation, the openings through the roof had been unprotected for nearly a month after the storm.

Figure 5-115.  
Two large openings (red rectangle and inset) through the roof were left after the ductwork blew away (estimated wind speed: 130 mph. Gulfport, Mississippi).

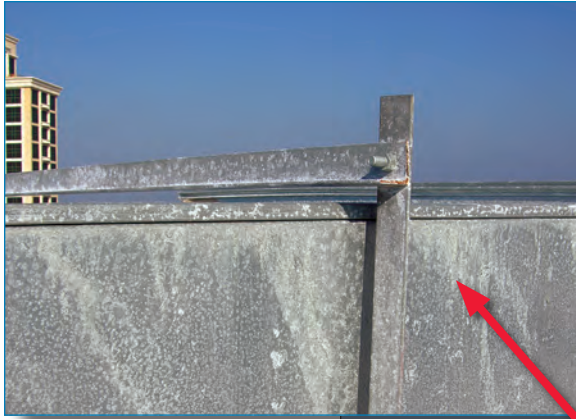
At the recently constructed 13-story building shown in Figure 3-44, the main duct runs were not damaged during this hurricane (see Figure 5-116). However, ducting on either side of a fan was blown away (see Figure 5-117). The main duct support frames were spaced at 8 feet on center. The frames were made from 1-1/2 x 1-1/2 x 1/8-inch thick angles. The frames were bolted together. The top horizontal angle was about 7/8 inch above the ducts.

Figure 5-116.  
These ducts were supported on steel angles (yellow arrow). A steel angle also occurred above the ducts (red rectangle and inset). The building was located in Exposure C (estimated wind speed: 120 mph. Biloxi, Mississippi).

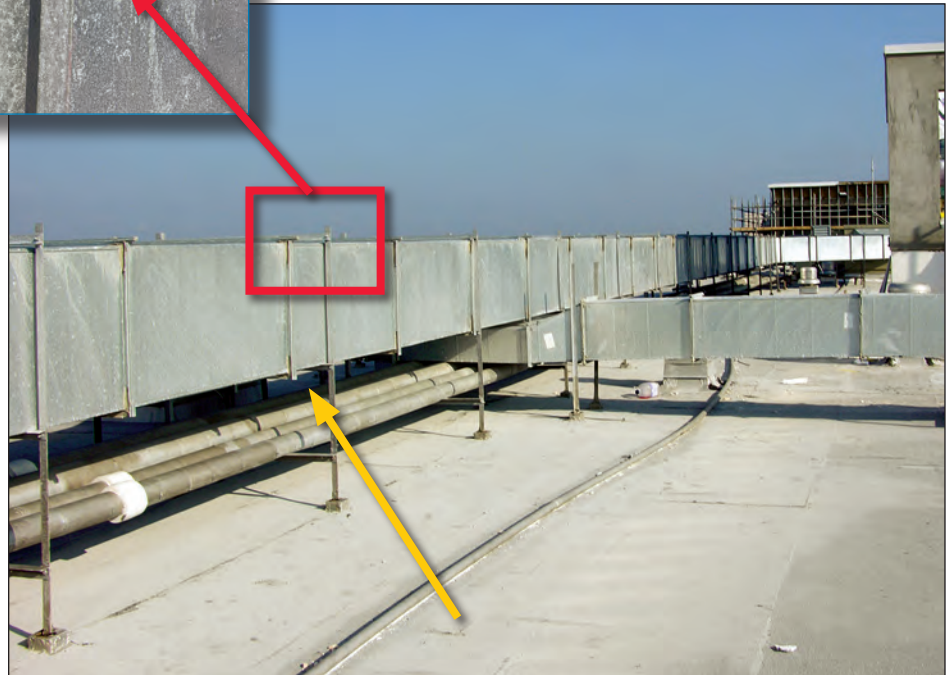
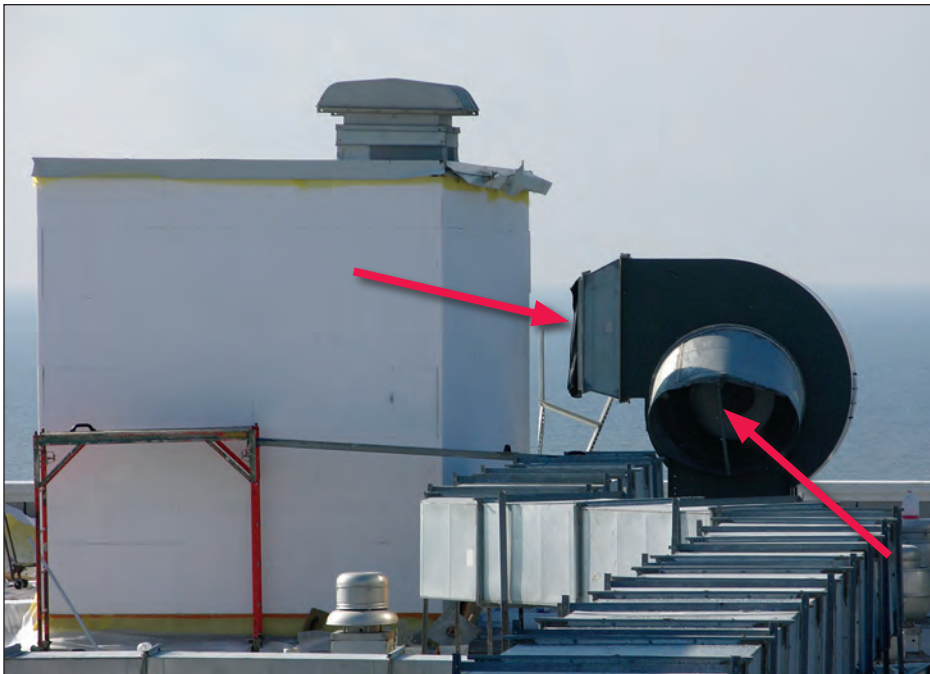
Figure 5-117.  
Opposite view of Figure 5-116. The ducting on either side of the fan was blown away (red arrows) (estimated wind speed: 120 mph. Biloxi, Mississippi).

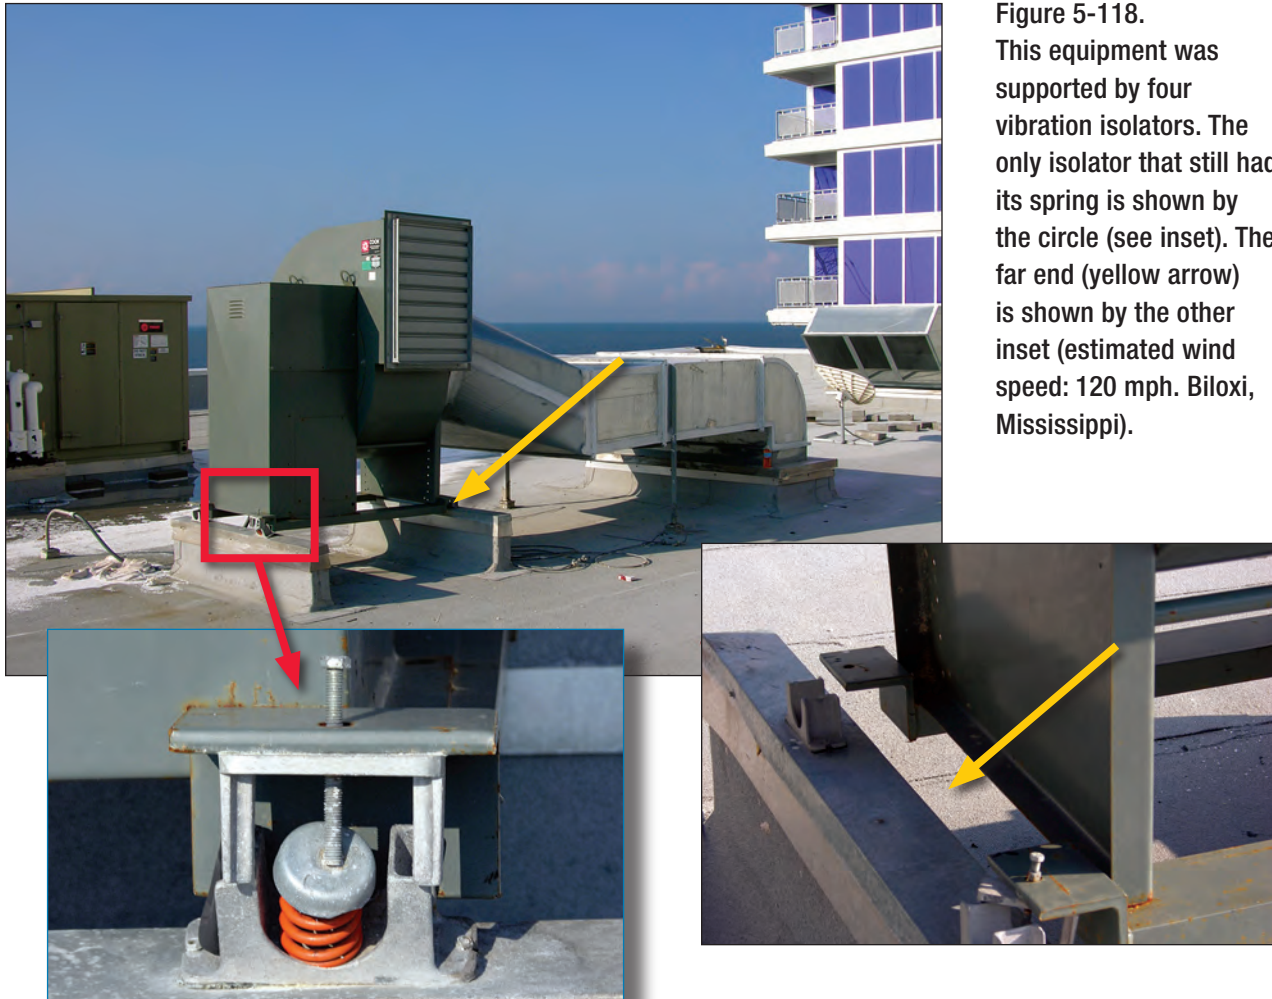
Figure 5-118. This equipment was supported by four vibration isolators. The only isolator that still had its spring is shown by the circle (see inset). The far end (yellow arrow) is shown by the other inset (estimated wind speed: 120 mph. Biloxi, Mississippi).

A particular type of vibration isolator was observed on a few new buildings. The isolator's design provided lateral resistance, but no uplift resistance. Because of the lack of uplift resistance, the equipment shown in Figure 3-61 was lifted up and blown away. Rainwater was able to enter the building at the duct openings through the roof. This same vibration isolator design was used on a lower roof of the building shown in Figure 5-116. At the equipment shown in Figure 5-118, the equipment was not blown away, but it was lifted up and three of the four springs were blown away. When equipment is mounted on vibration isolators, the isolator design needs to provide both lateral and uplift resistance, or an alternative means to accommodate lateral and uplift loads needs to be provided.

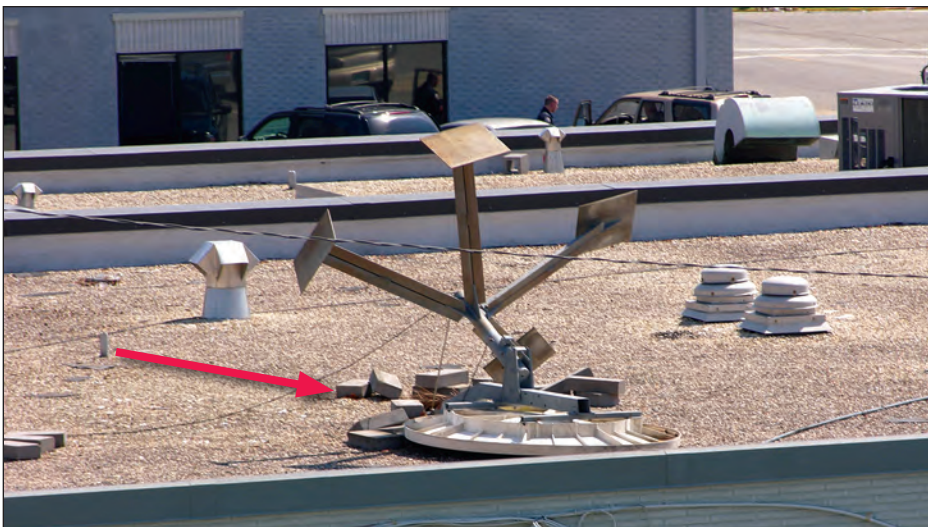
The MAT observed several satellite dishes that were blown over. Failed satellite dishes did not have positive connections to the roof structure. Rather, the dish support simply rested on the roof and was weighted down with concrete pavers (see Figure 5-120). Blown over satellite dishes can puncture roof membranes, and if blown from the roof can damage other buildings or vehicles.

**Figure 5-120.**  
This satellite dish was held down only with concrete pavers (estimated wind speed: 130 mph. Gulfport, Mississippi).

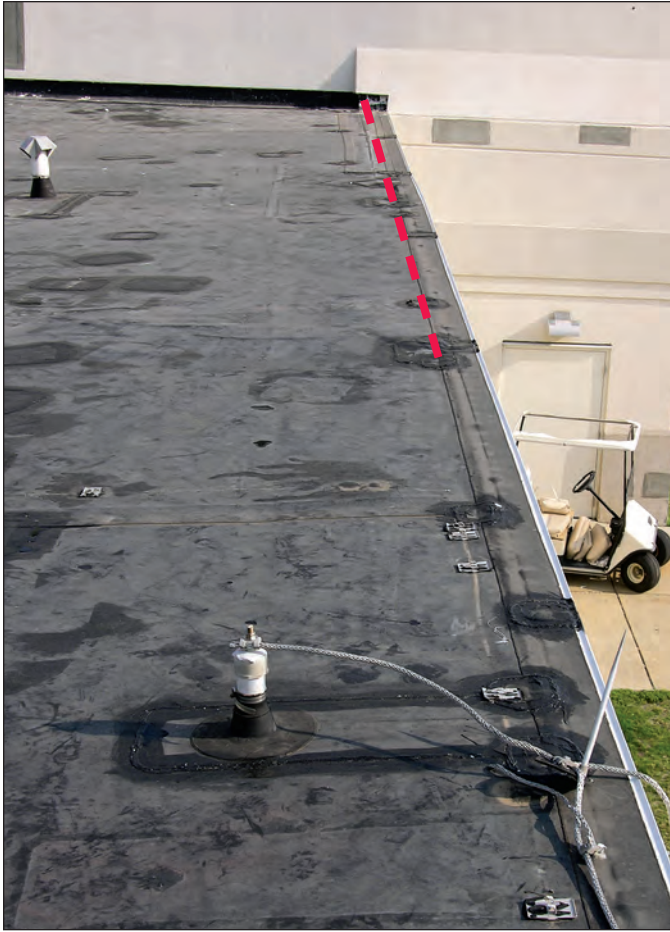
Figure 5-122.

LPS failures were typically the result of poorly anchored systems. Connectors often fail by opening up and releasing the conductor cable (see Figure 5-121) or they debond from the roof (see Figure 5-122). When conductors detach, the conductor ends can whip around and puncture and tear the roof membrane. At the hospital shown in Figures 5-122 and 5-123, several punctures had been patched after the hurricane. Some of the punctures were likely caused by loose conductors. At another hospital, a loose conductor whipped the exterior wall and punctured the EIFS in several locations (see Figure 5-124).

At this hospital, in the area of the dashed line the conductor connectors debonded from the roof membrane. In the foreground, the connectors are attached to the roof, but the conductor pulled from the prongs (estimated wind speed: 130 mph. Gulfport, Mississippi).

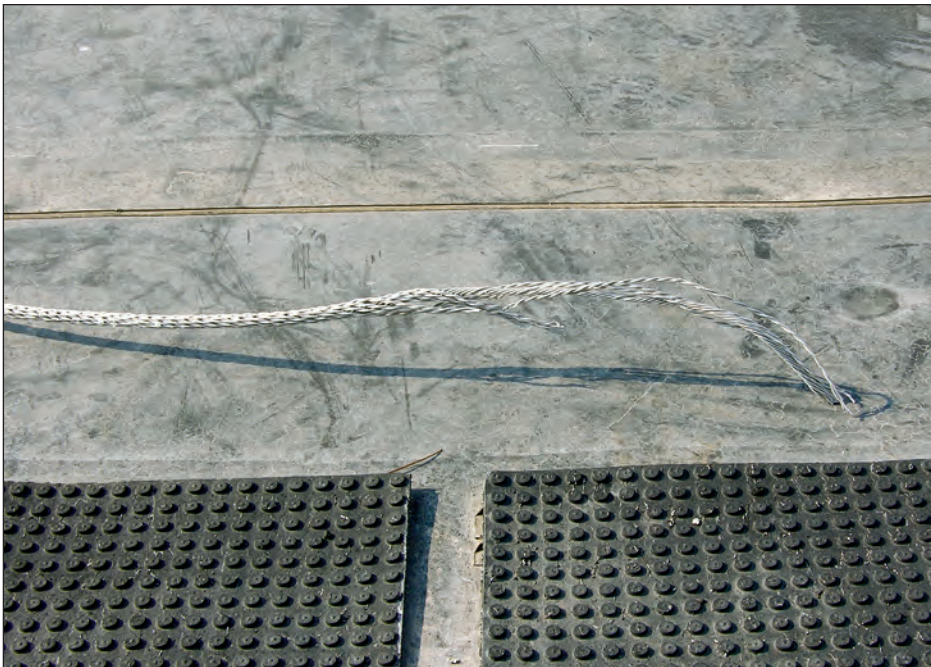
Figure 5-123.

View of an abraded end of a conductor that became detached at the hospital shown in Figures 5-114 and 5-122 (estimated wind speed: 130 mph. Gulfport, Mississippi).

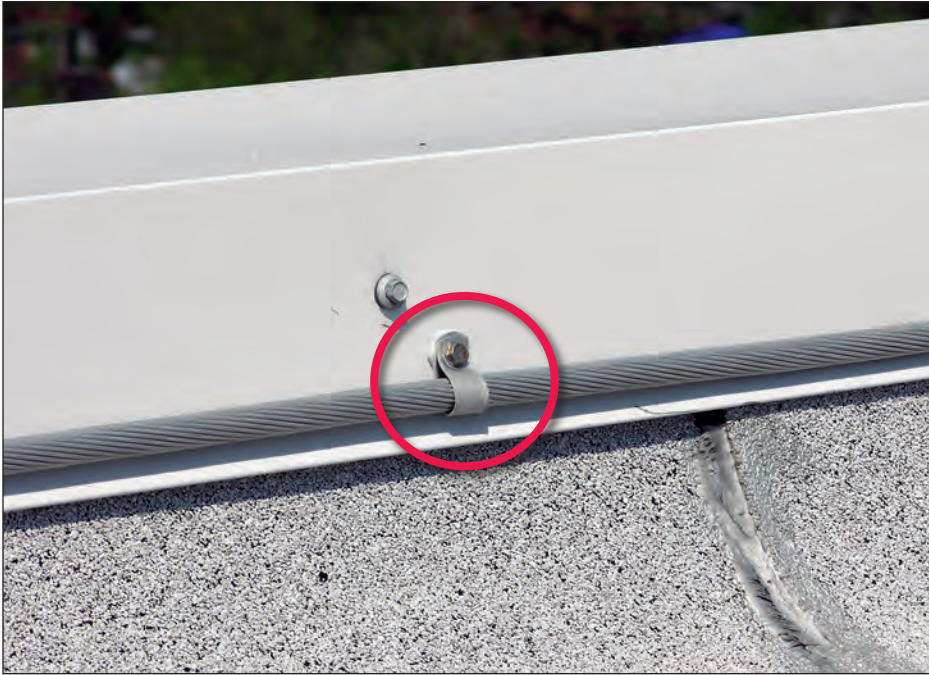
The other prudent practice was the use of mechanically attached looped connectors to attach the conductor to the coping (see Figure 5-126). A looped connector does not have prongs; therefore, this is a reliable connector (provided sufficiently long screws are used).

Figure 5-126. Screw-attached looped connectors were used to anchor this conductor (estimated wind speed: 130 mph. Gulfport, Mississippi).
