Mitigation Assessment Team Report

Hurricane Ian in Florida

Building Performance Observations,
Recommendations, and Technical Guidance

FEMA P-2342/December 2023

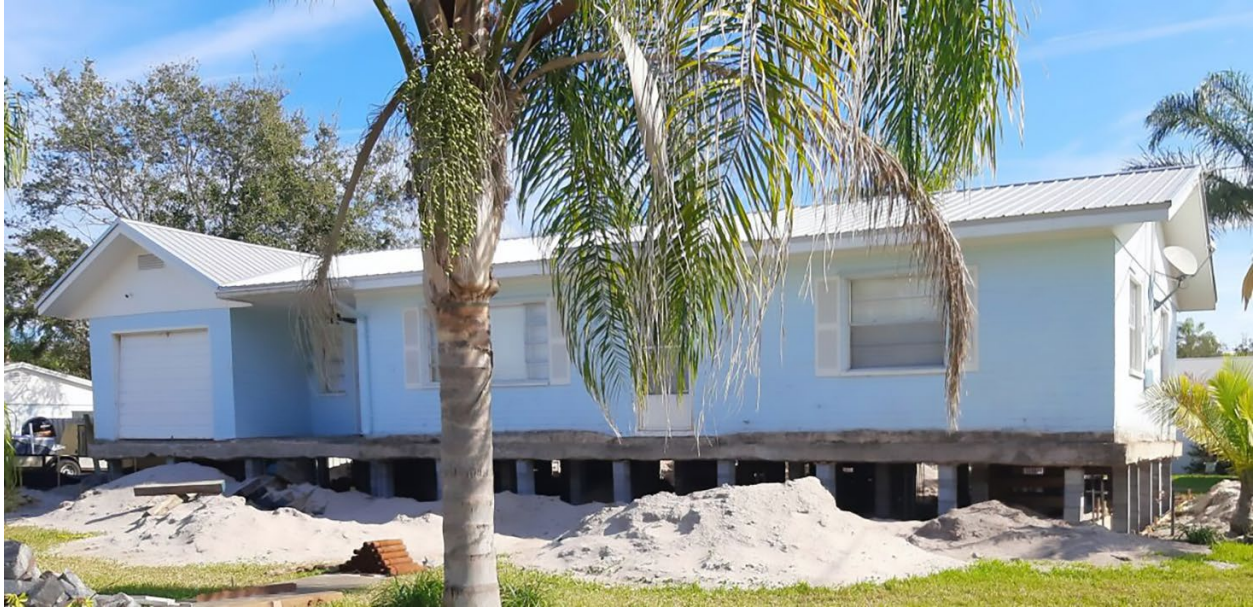
Figure 3-4: House in the process of being elevated (Volusia County, Zone AE)

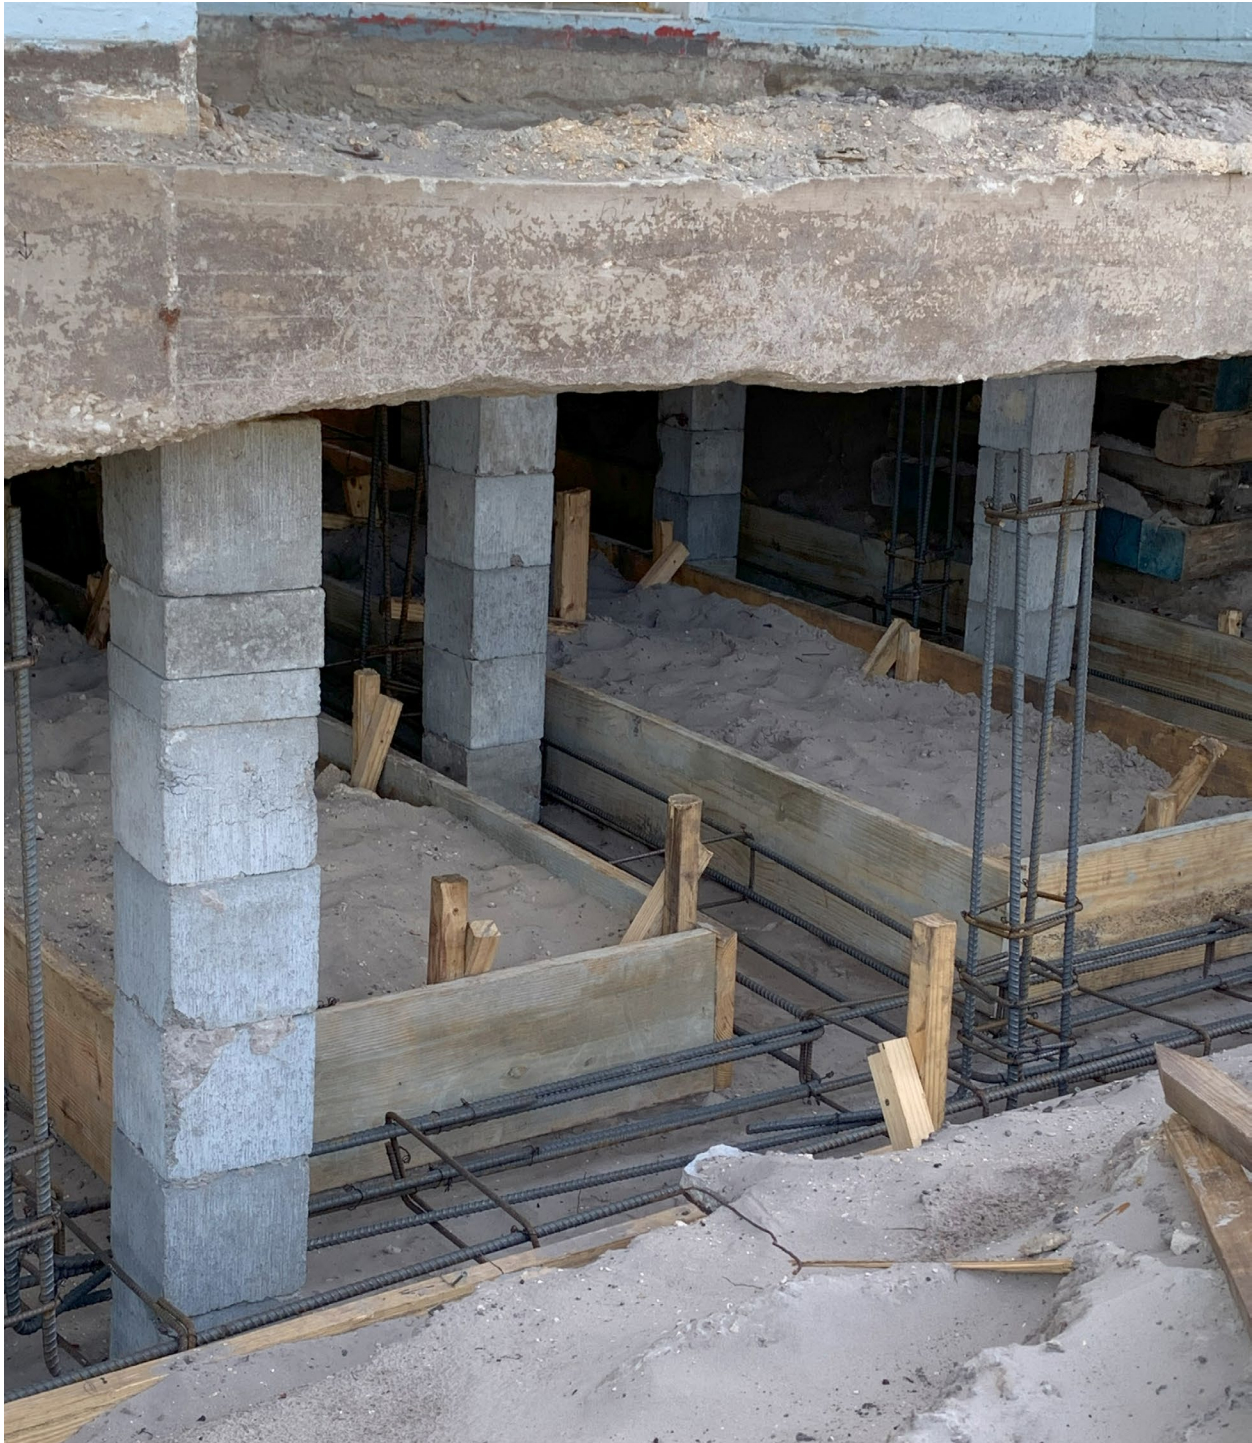
Figure 3-5: View of house elevation foundation preparation and support cribbing

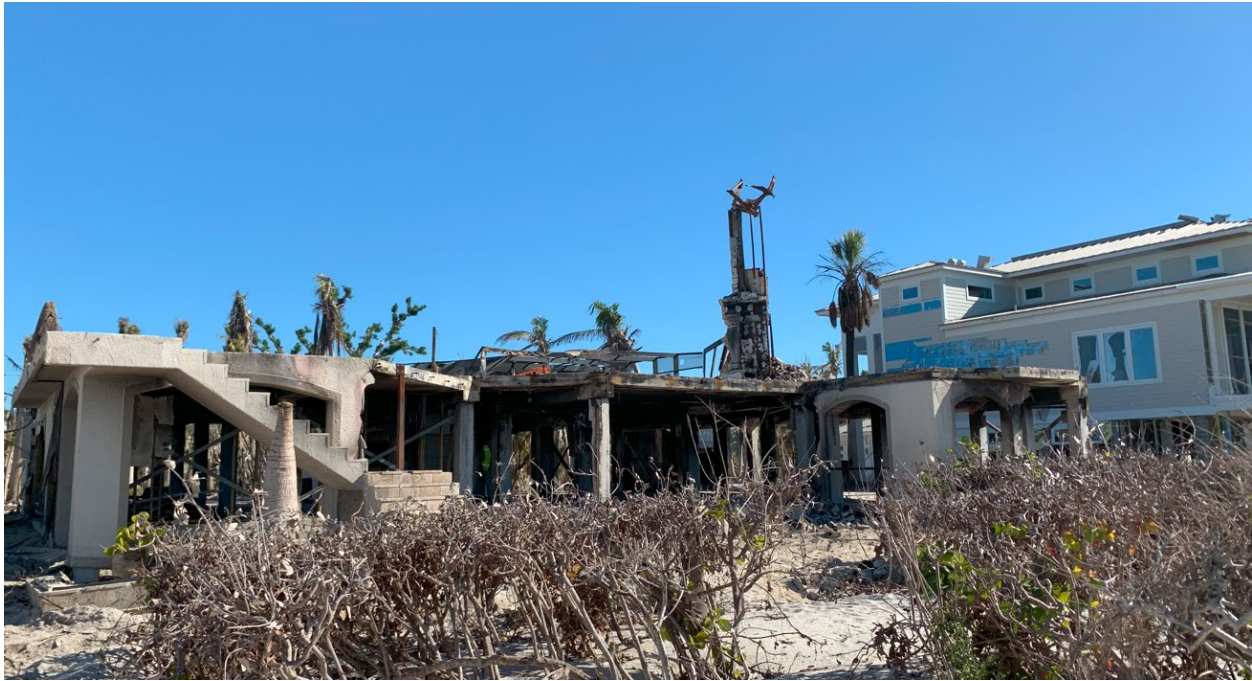
The MAT also spent some limited time on newer and unique challenges presented by Hurricane Ian. For example, the MAT observed building damage caused by an electric vehicle (EV) battery fire. Figure 3-6 depicts a house that caught fire from a neighboring house fire started by an EV battery fire. Various accounts of EV battery fires were noted during the MAT. The U.S. Fire Administration

(USFA) explains that EV batteries exposed to salt water are especially susceptible to short-circuiting because of the salt residue and can cause the battery to overheat, resulting in fires (USFA 2022).

Figure 3-6: House destroyed by fire spread from an EV fire in a neighboring house (Lee County, Zone AE and VE)

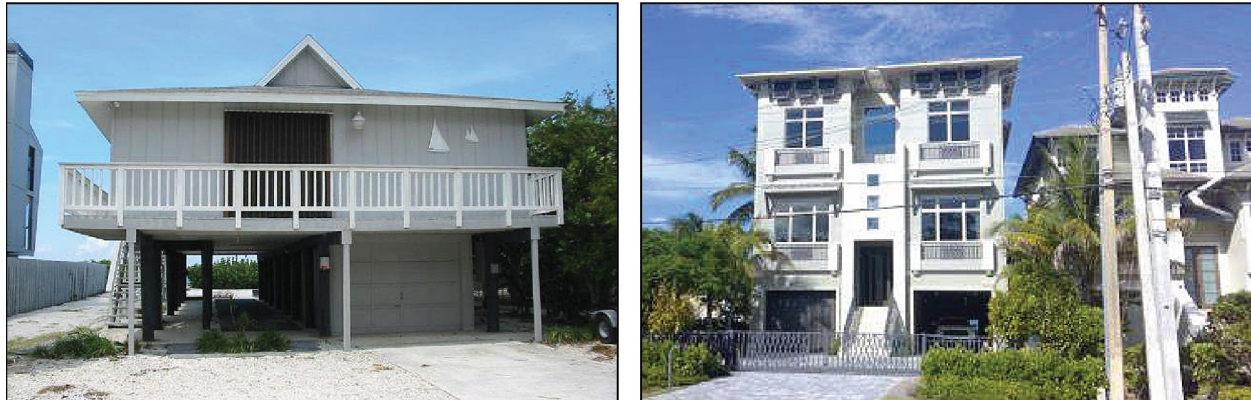
Figure 3-8 shows a typical 1970s beach cottage next to a typical 2010s multilevel structure. The impacts of construction techniques and material changes had a significant effect on building

Left image shows typical 1970's construction of a single elevated level on timber piles. The right image shows typical 2010's construction of a multilevel structure using CMU block.

Figure 3-8: Two houses, one constructed in the 1970s (left) and one constructed in the 2010s (right)

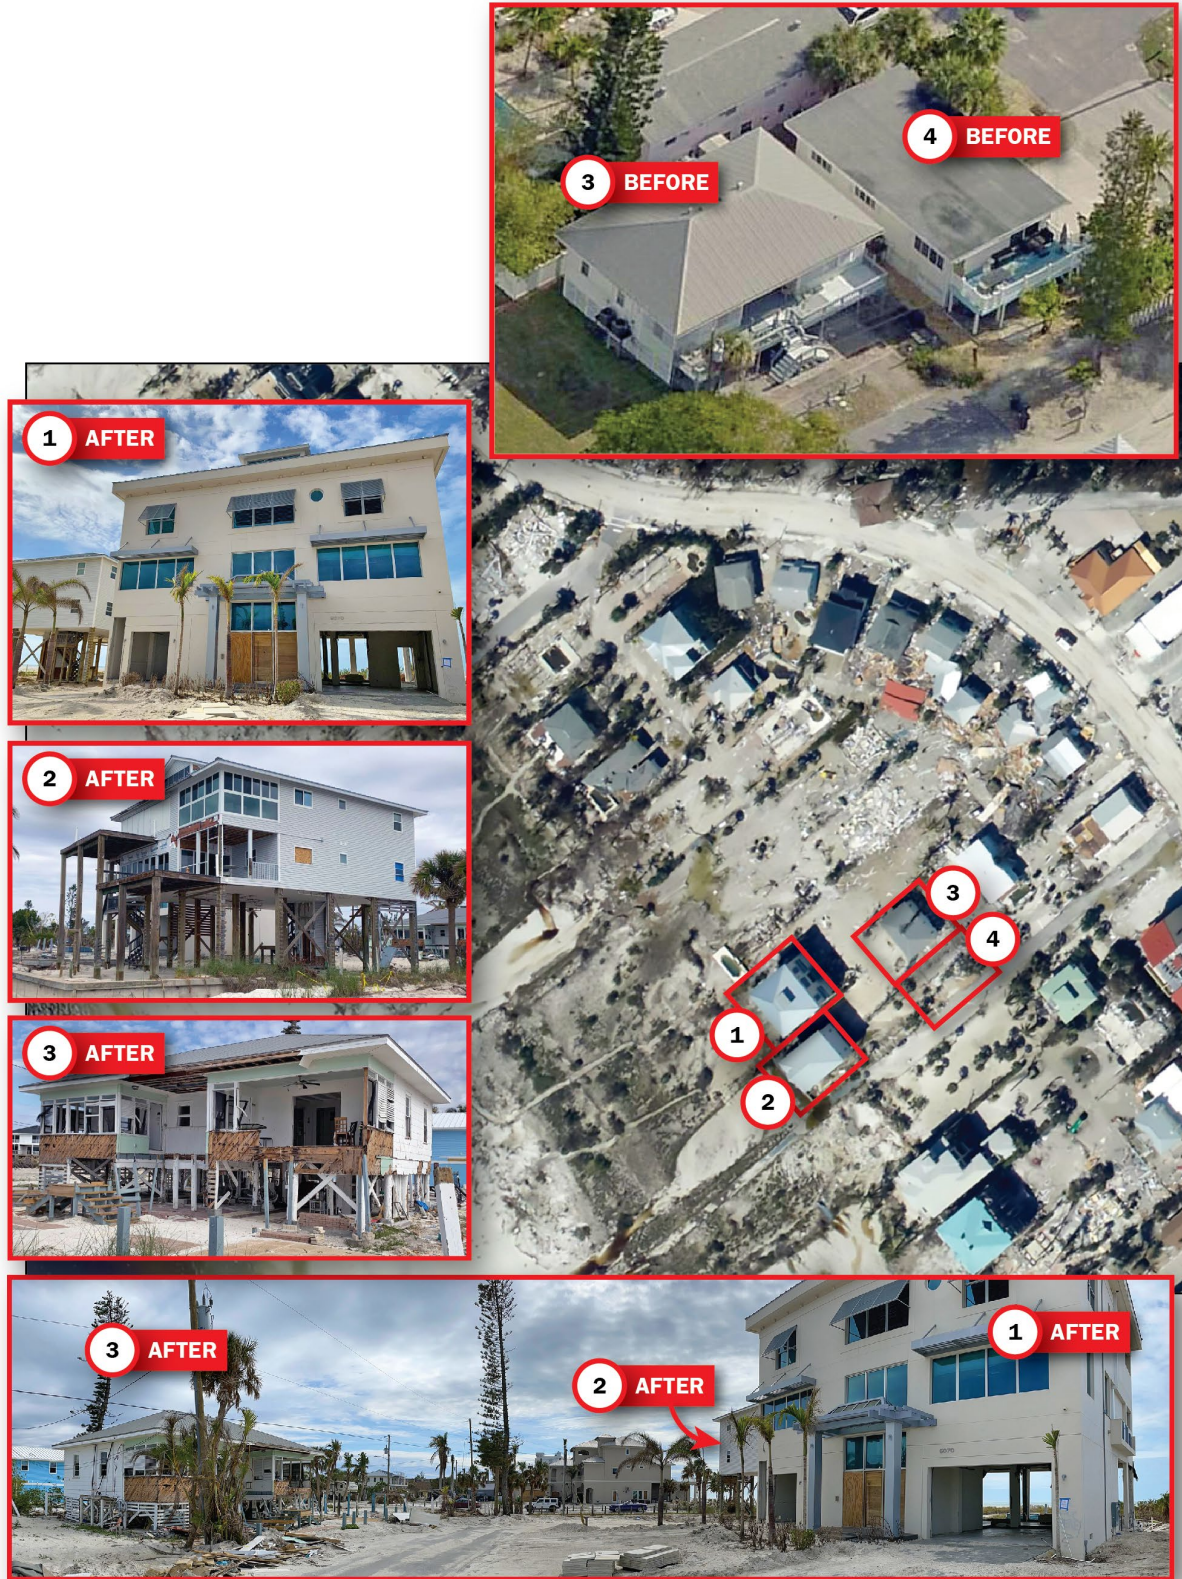
Figure 3-9 shows an area in Fort Myers Beach. All of the numbered structures shown in the figure are within Zone VE and are all fully or partially seaward of the CCCL. The structure labeled #1 is along the shoreline and was under construction during the MAT's assessment of building performance during Hurricane Ian. The ground floor of the structure has concrete columns with concrete masonry unit (CMU) breakaway walls and flood openings in the walls. The structure on the inland side of the street, labeled #3, was built in 1951, with modifications in 1981. The older structure is wood

construction and is raised on a pile foundation. While the older structure survived the coastal flood, the newer, larger, sturdier, oceanside structure #1 could have partially sheltered the older structure against wave attack by disrupting the wave propagation and reducing the wave heights reaching structure #3. Structure #4 (1956) was destroyed in Hurricane Ian. This light-framed house was built similar to Structure #3 but was not as sheltered. The front row home (#2), which was seaward of Structure #4, was built on an open pile foundation with wood slats for privacy that broke away, allowing for passage of surge and waves without obstruction. Other factors that could have contributed to the different performance of structures #3 and #4 are not known.

Figure 3-9: New concrete construction on coast (#1) could have provided shelter against waves to older, vulnerable structure (#3) on Fort Myers Beach (Lee County, Zone VE)

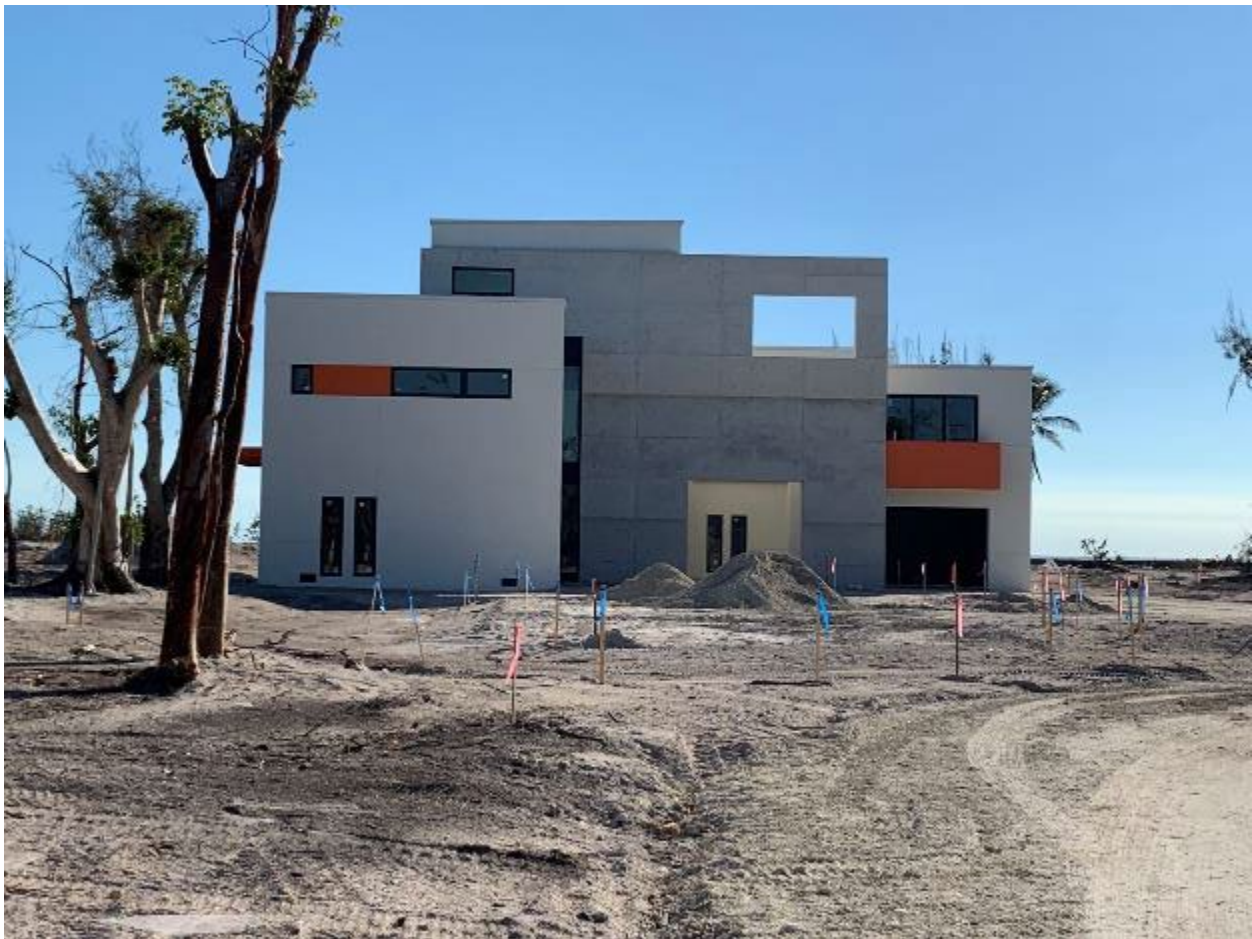
The evolution towards concrete and CMU construction along the coast was also observed in Sanibel Island (Figure 3-10) and Bonita Beach (Figure 3-11). The structure on Sanibel Island was under construction during Hurricane Ian. Vegetative debris lines were visible against the ceiling panels inside the lowest level, indicating that the storm surge completely inundated the lowest level of the structure. The structures on Bonita Beach, Figure 3-11, indicate a similar trend toward newer construction methods consisting of concrete and CMU. Sections 3.2 and 3.4.3 discuss the performance of breakaway walls as well as potential impacts of walls that survived acting as obstructions. In Bonita Beach, there were visible, ongoing, extensive repairs to breakaway walls perpendicular to the direction of wave action and flood flow, but it was obvious that the foundation had minimal structural damage outside of the loss of breakaway walls. Additional analysis is needed relative to the performance of the lack of walls breaking away parallel to the flood flow as to whether they influenced damage to adjacent structures.

Figure 3-10: Large CMU structure on Sanibel Island (Lee County, Zone VE, Seaward of CCCL)

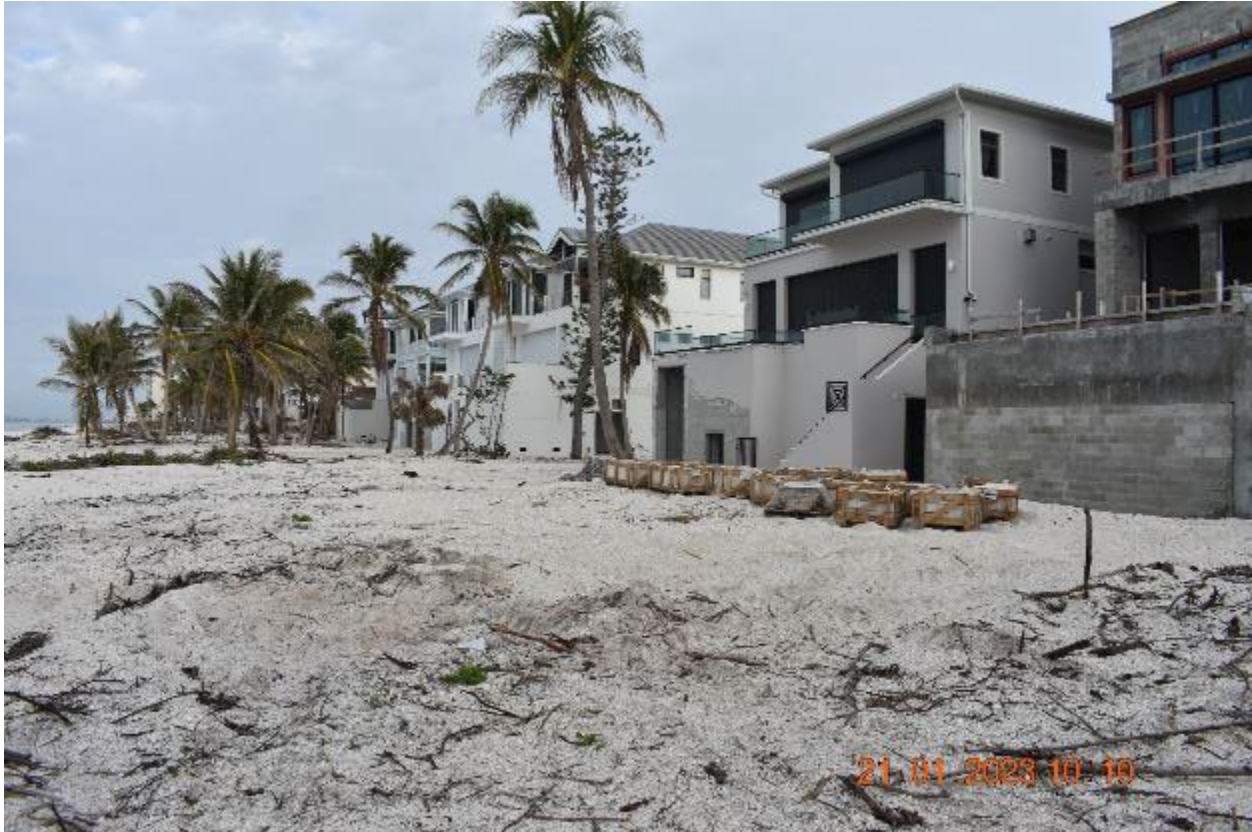
Figure 3-11: Large CMU structures on Bonita Beach (Lee County, Zone VE, Seaward of CCCL)

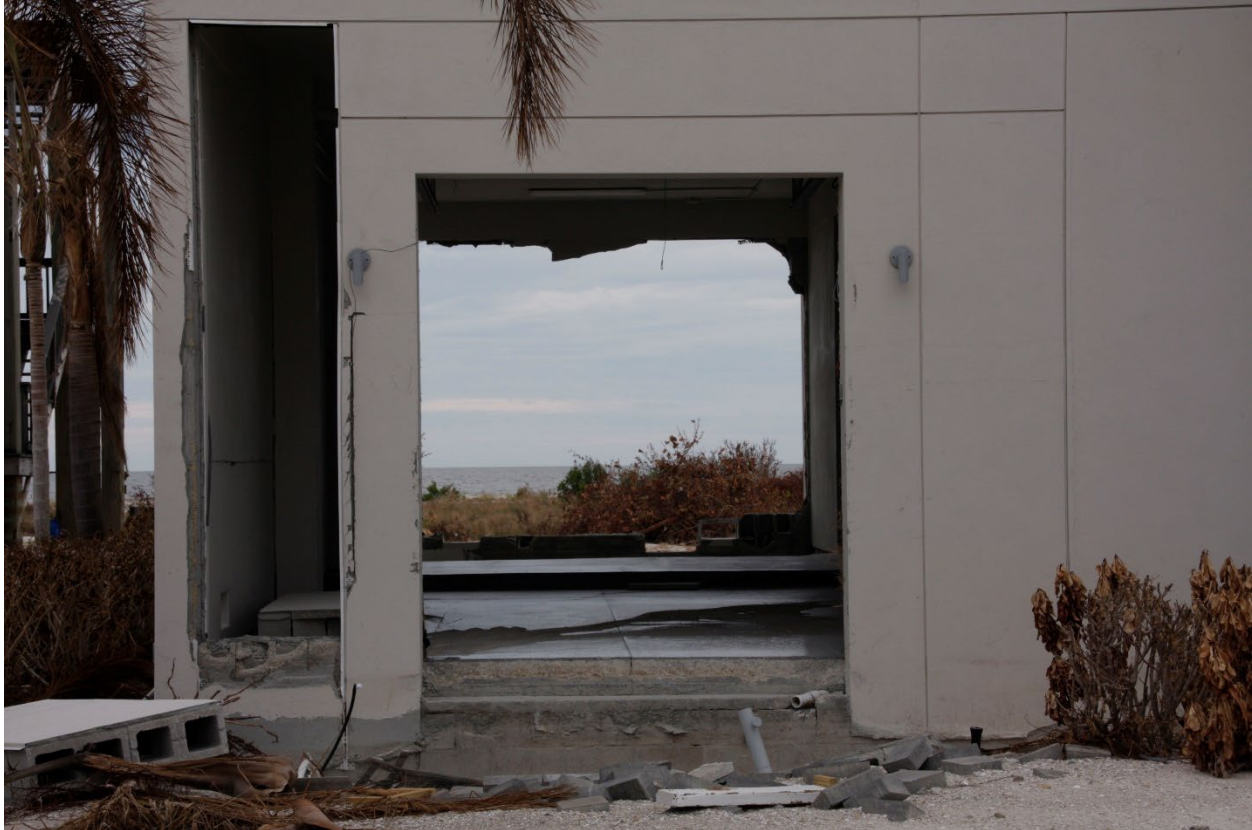
Figure 3-12 shows that CMU breakaway walls perpendicular to the flood flow failed (note that the front of the building is a garage door opening that acts as a breakaway wall), but the walls parallel to the flow did not break away. Construction of the structure began in 2022, and it was still under construction during the pre-MAT visit.

Figure 3-12: CMU breakaway wall in Fort Myers Beach (Lee County, Zone VE, Seaward of CCCL)

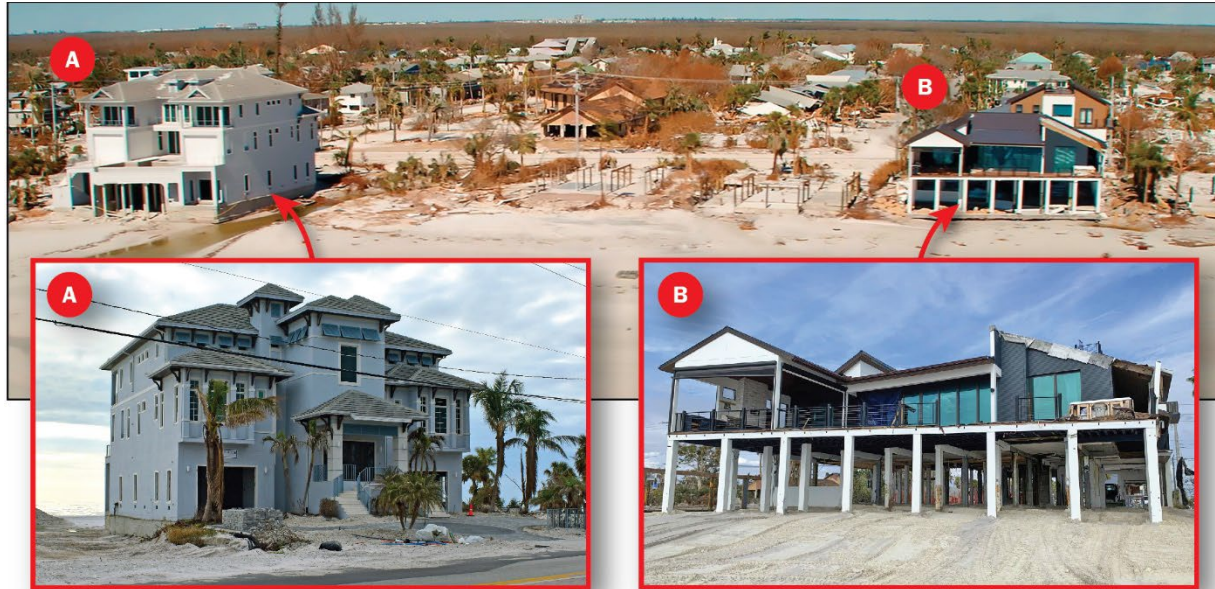
Figure 3-13 represents a section of shoreline in Fort Myers Beach that indicates differences in the performance of breakaway walls based on construction techniques. All images shown in Figure 3-13 are post-Hurricane Ian. Specifically, in this example, masonry breakaway walls constructed with flood openings and windows installed and parallel to the flow of water exhibited increased survival when compared to wood breakaway walls constructed without flood openings. Structure A is a 2018 CMU construction with flood openings and windows installed in the masonry breakaway walls. Structure A's masonry breakaway walls parallel to the flow remained intact while the windows in the walls failed. Structure B was built in 1990 and includes an addition built in 2020. The 1990 portion of Structure B had wood-frame breakaway walls while the 2020 portion had masonry breakaway walls. The 1990 portion likely did not contain flood openings in the walls while the 2020 portion did have flood openings. All the wood-framed breakaway walls in the 1990 portion broke away during Hurricane Ian and the only remaining ground-level wall structure was two portions of a masonry knee wall. Why two sections of the knee wall survived is unknown. Within the 2020 portion, some masonry breakaway walls installed parallel to the flow with flood openings remained intact.

Figure 3-13: Comparison of nearby breakaway walls in Fort Myers Beach (Lee County, Zone VE, Seaward of the CCCL)

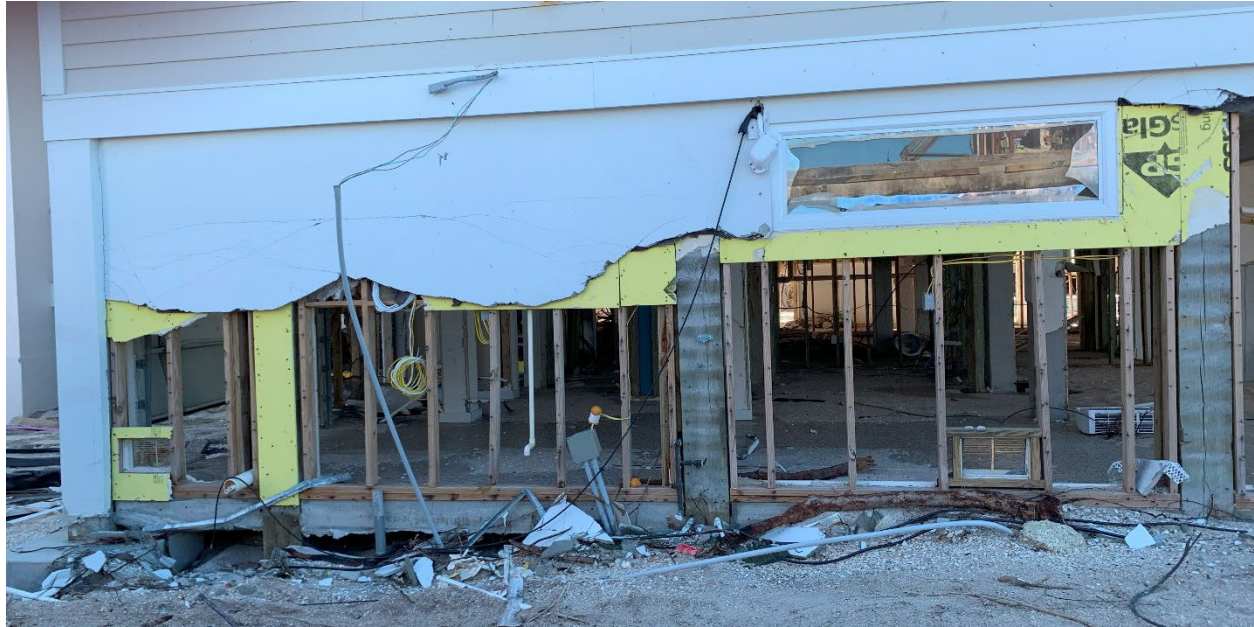
A structure (shown in Figure 3-14 and Figure 3-15) along the Gulf of Mexico coast on Sanibel Island built in 1987 with breakaway walls that partially failed was visited by the MAT. The enclosure was constructed with wood-framed breakaway walls finished with wall sheathing coated in lath and plaster (stucco). The structure is seaward of the CCCL. According to the Elevation Certificate, the top of the enclosure floor is 7.3 feet NAVD 88 and the bottom of the lowest horizontal structural member of the elevated floor is 12.0 feet NAVD 88. StEER recorded an HWM (surge only) of 15.4 feet NAVD 88 at the neighboring house. As shown in Figure 3-14, one of the Gulf front shore-parallel breakaway walls did not completely breakaway; the bottom 2x4 plate separated from the bottom permanent 2x4 nailer plate, but the top 2x4 plate did not separate from the top permanent 2x4 nailer plate. The wall appears to be properly framed to enable separation and failed in a typical manner in which the bottom plate disconnected and the wall swung from the top. The exterior finish of stucco and netting was continuous across a support column, which can prevent proper breakaway performance, but did not hinder performance in this instance. Figure 3-15 depicts shore-perpendicular breakaway walls for which the wood-framing remained in place. These breakaway walls also appear to be properly framed to enable separation, but the exterior finish of stucco and netting appears continuous across support columns. The shore-perpendicular breakaway wall wood framing remained in-place. This may have been a result of the interior and exterior finishes breaking away below the design load and, therefore, reducing the overall load on the wood frame. No structural damage was observed as a result of the partial failure of the breakaway walls.

Figure 3-15: Partial failure of shore-perpendicular breakaway wall on Sanibel Island (Lee County, Zone VE, Seaward of CCCL)

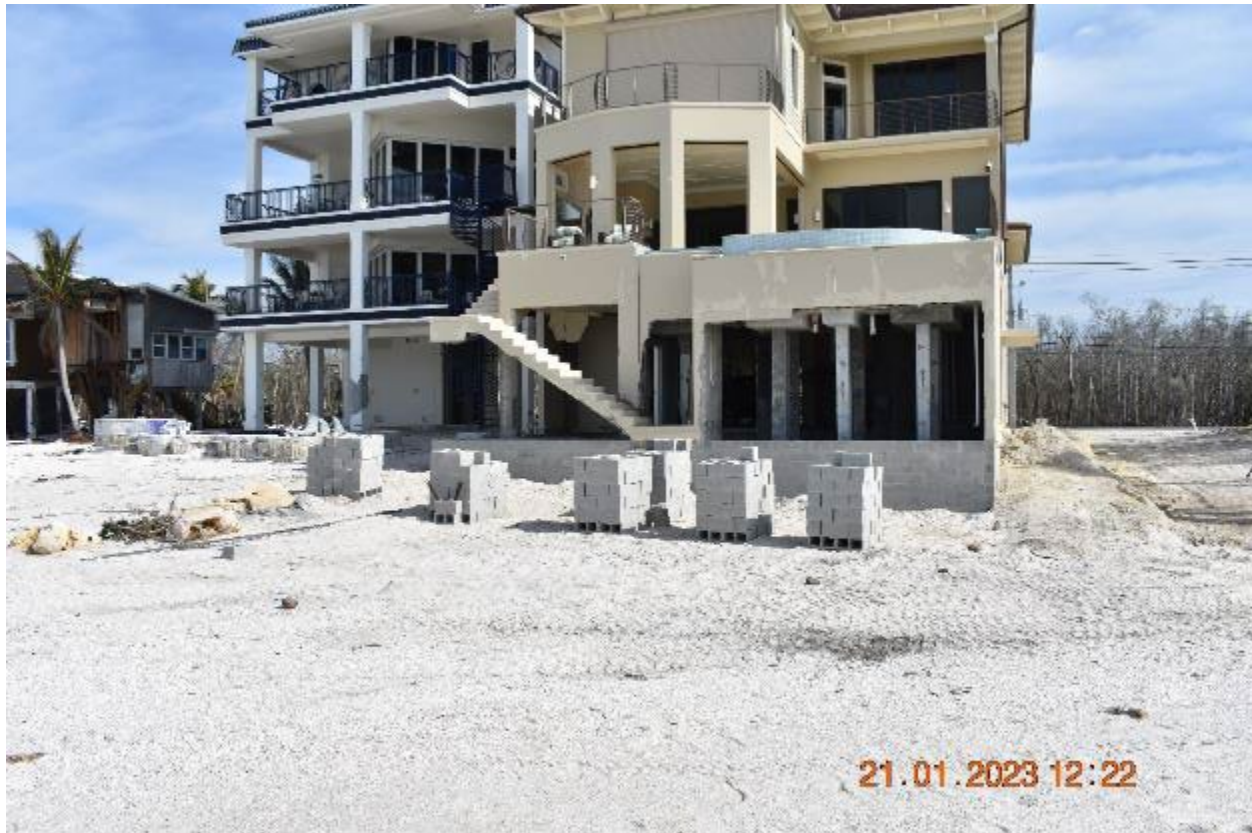
Many breakaway walls in buildings along Bonita Beach performed as intended, breaking away as a result of the flood loads. There was evidence of multiple ongoing repairs of CMU breakaway walls in buildings throughout Bonita Beach (Figure 3-16). These breakaway walls often enclosed spaces that were being used for other than the allowable uses (building access, vehicle parking, or storage). See the Section 3 introduction regarding the large amounts of debris observed in the floodplain, which the presence of non-flood damage-resistant materials below the BFE contributed to.

Figure 3-16: Staging of repairs to CMU breakaway walls in Bonita Beach (Lee County, Zone VE, Seaward of CCCL)

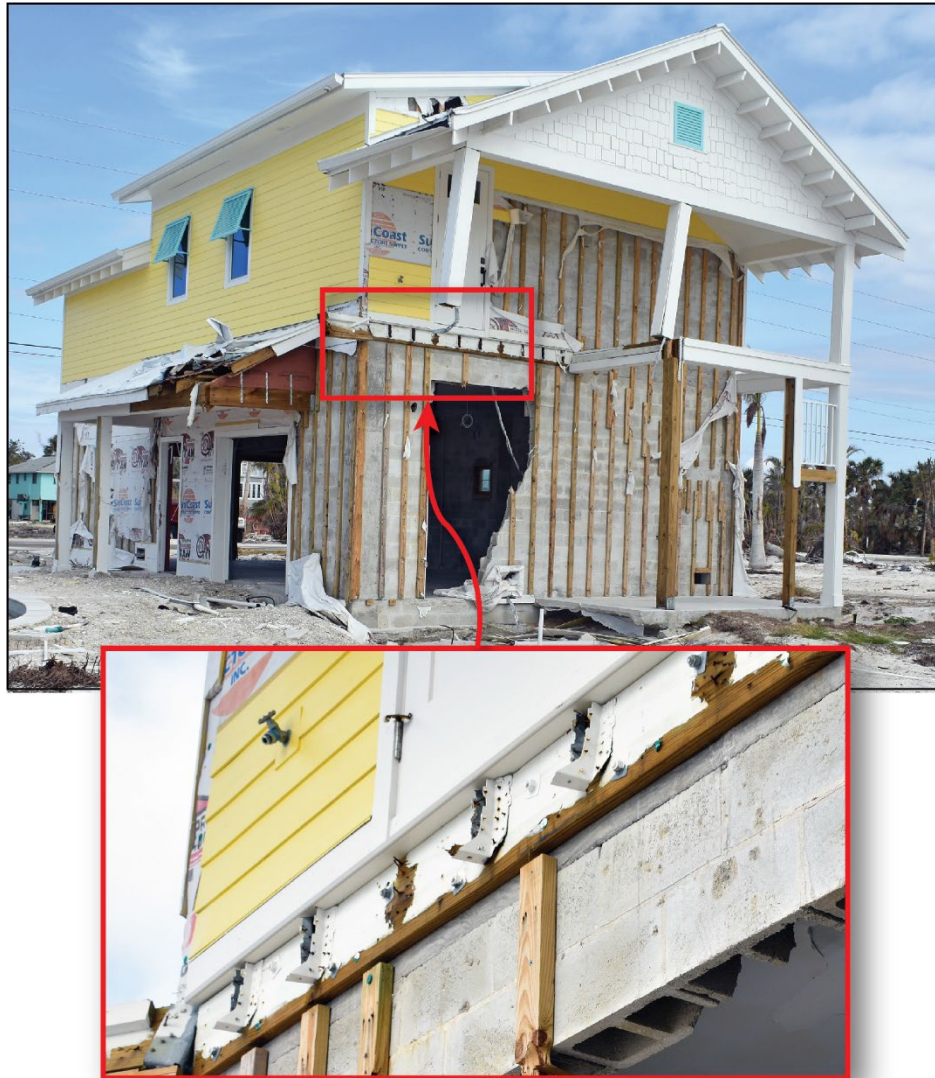
The Coastal Flood Team also observed porches that failed in a way that effectively rendered them a breakaway system, avoiding damage to the main structure. For the house pictured in Figure 3-18, a ledger board was fastened to the main structure, and the exterior floor joists were attached to the ledger with hangers. Upon separation, failure was experienced at the connections between the joists and joist hangers and the hangers to the ledger board, but the ledger board remained attached to the main structure. This likely reduced damage to the main structure as compared to framing approaches that would have incorporated the porch framing into the joist system of the main

structure, which could have racked the main structure (i.e., twisted the structural components out of plumb) during the loss of the porch structure.

An intact breakaway wall, which likely resulted in wave deflection that damaged the siding on the elevated portion of the house.

Figure 3-18: Structure (built in 2022) in Fort Myers Beach with damaged porch that cleanly separated from the main structure (Lee County, Zone VE, Seaward of the CCCL)

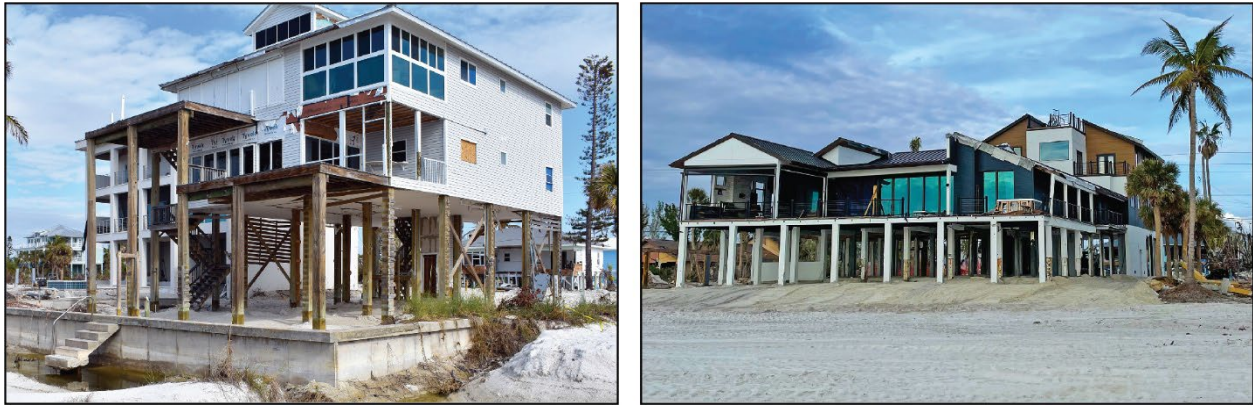
Some decks and porches withstood the coastal hazards without significant structural damage. These exterior attached structures appeared to be designed and constructed to the same standards as the main structure. The homes shown in Figure 3-19 had few remaining obstructions below their lowest floor post-hurricane, whereas Figure 3-17 and Figure 3-18 both depict buildings with obstructions below their lowest floors, which demonstrates that intact breakaway walls may divert waves upward (i.e., wave deflection and run-up), resulting in damage to exterior attached structures and wall

Figure 3-19: Single-family houses built in 2000 (left) and 1994 (right) in Fort Myers Beach with intact decks and porches (Lee County, Zone VE, Seaward of the CCCL)

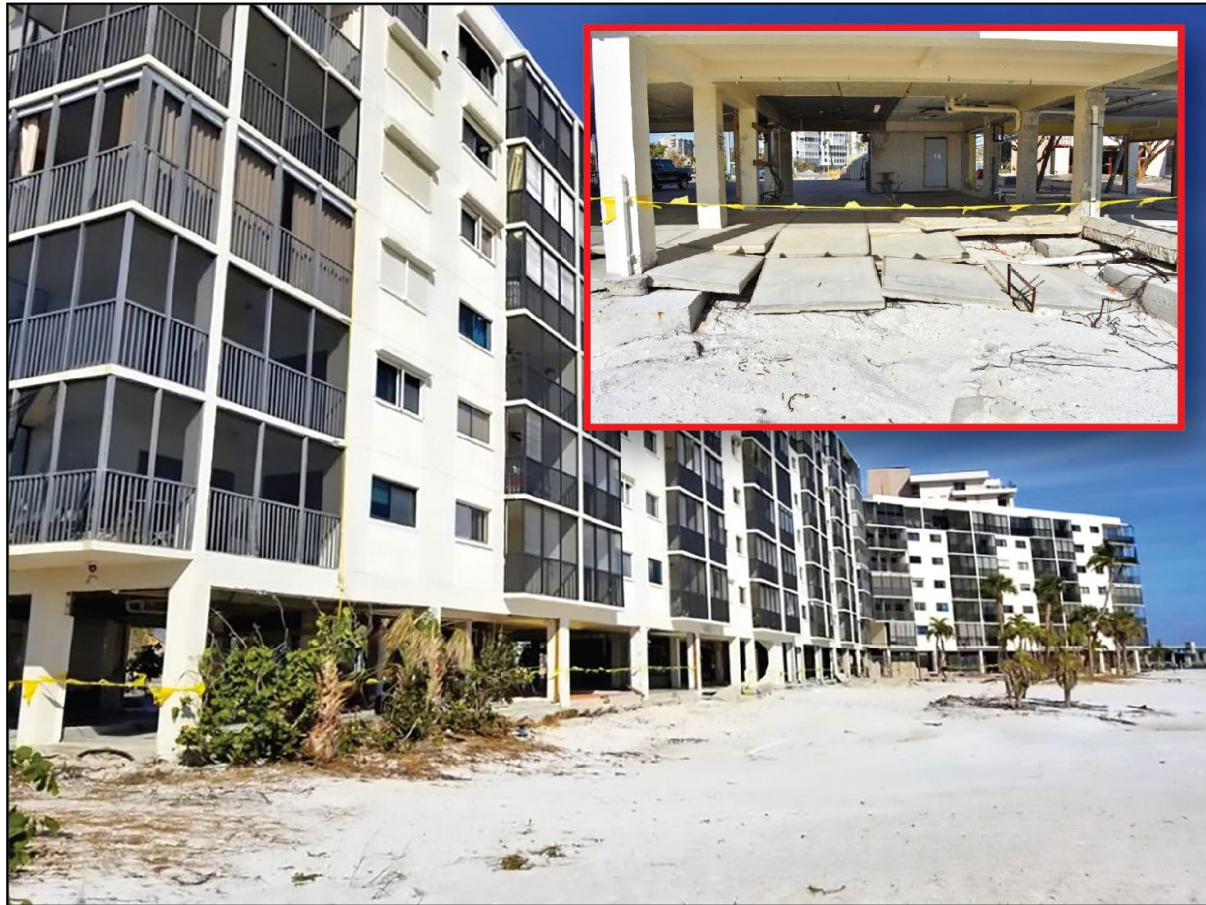
Scour was visible on the ocean side of several of the large condominium complexes in Fort Myers Beach. Flow paths were visible in the sand. In many of these situations, there was evidence of frangible concrete slabs breaking up, as they are intended to do, as a result of the loss of sand supporting them (Figure 3-20).

Figure 3-20: Frangible concrete slabs breaking up as intended due to the erosion of sand supporting them on Fort Myers Beach (Lee County, Zone AE, Seaward of CCCL)

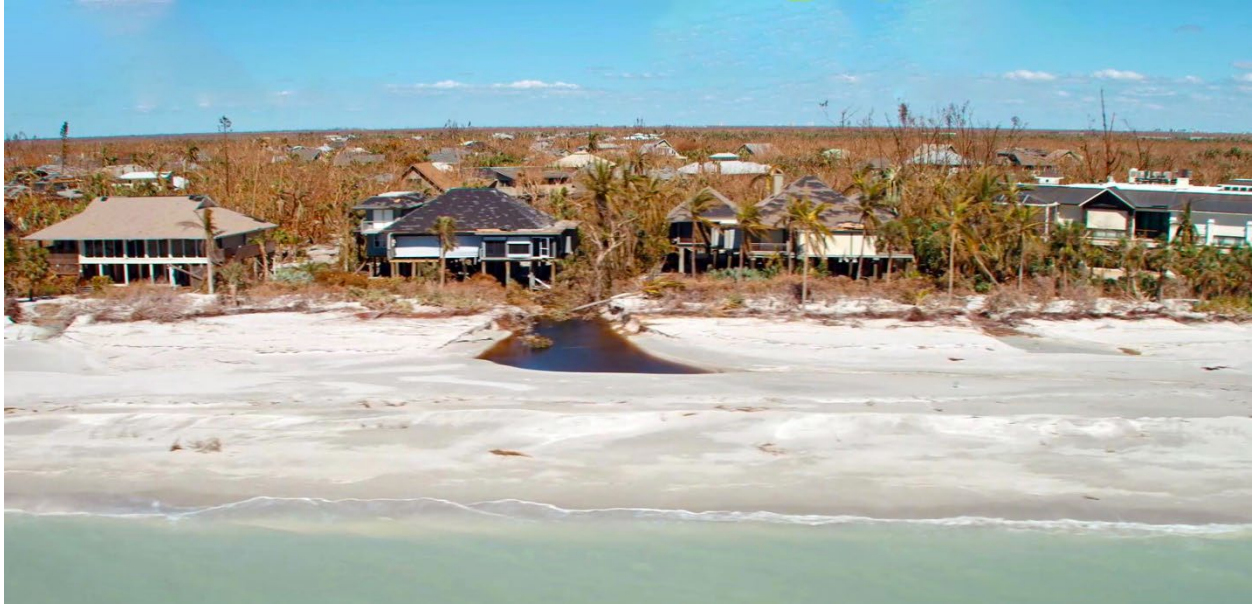
Figure 3-21: Scour channel depiction, captured October 2, 2022

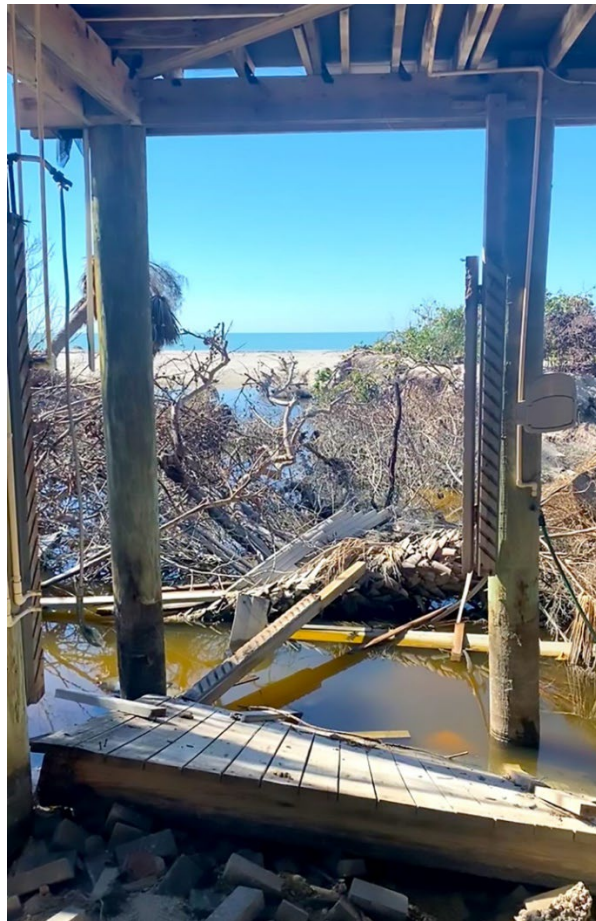
Figure 3-22: Scour channel and debris near deep pile foundation (Lee County, Zone VE, Seaward of CCCL)

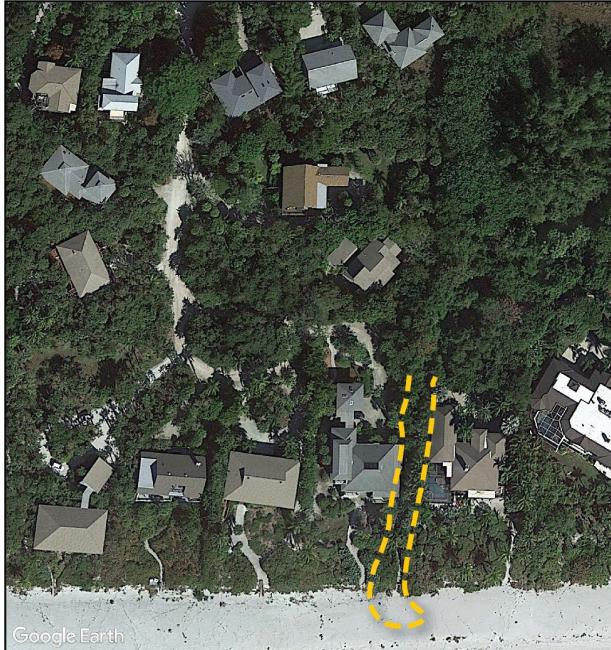
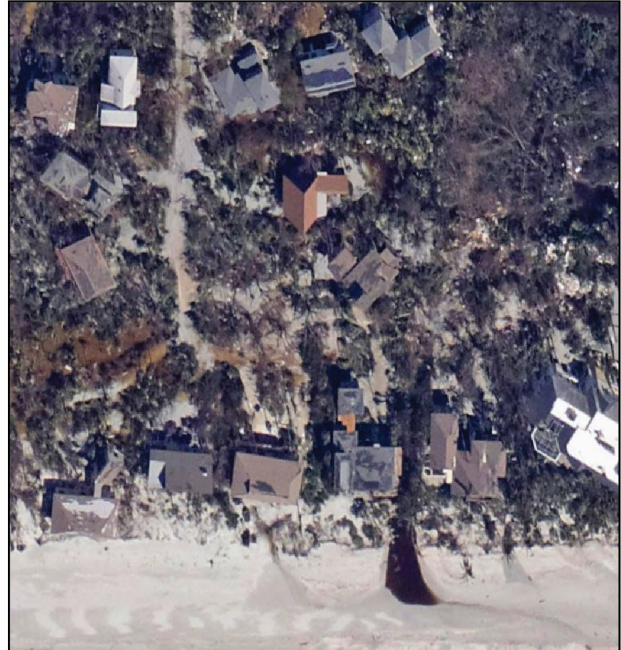
The yellow dotted line on the left image indicates the approximate location of the scour channel for reference.

Figure 3-23: Imagery of the scour channel location before (left) and after (right) Hurricane Ian

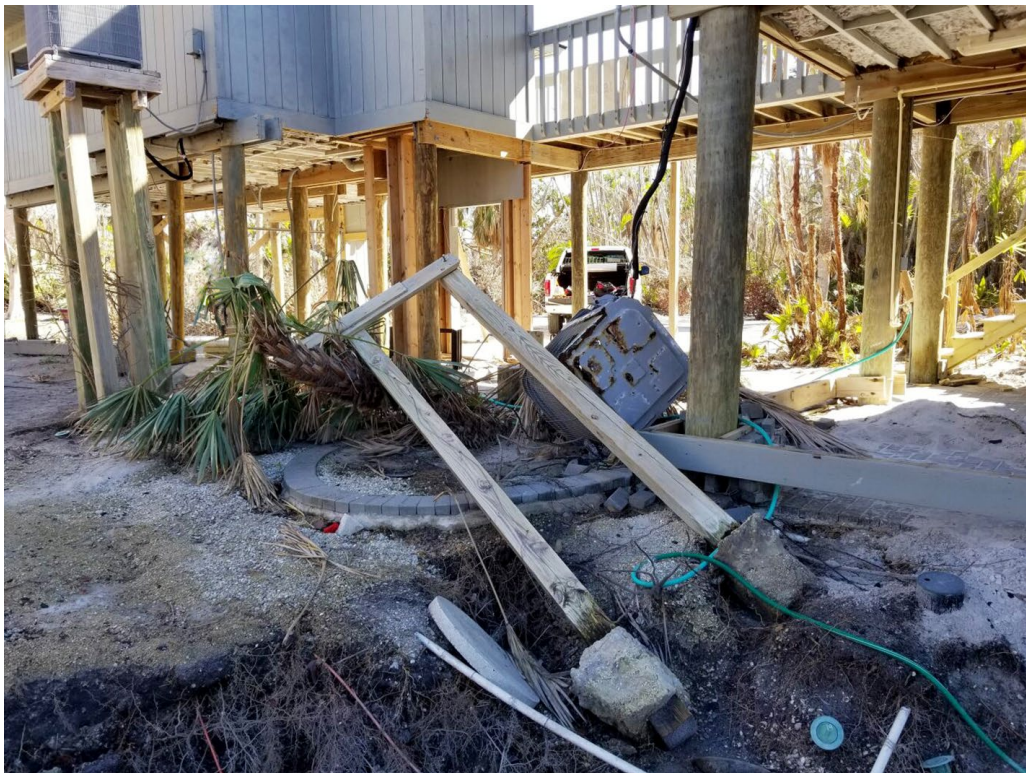
Multiple areas of coastal scour were visible on Sanibel Island immediately after Hurricane Ian struck. Because scour is known to negatively impact building performance when the building has not been designed for scour or the scour exceeds the design assumption, the MAT was interested in evaluating building performance in these locations. The NOAA post-disaster imagery and the Florida Geographic Information Office (FGIO)-collected data sets that were very helpful in determining the best areas to visit. Figure 3-21 is a scour channel on Sanibel Island that was captured by an FGIO helicopter on October 2, 2022; the MAT visited the channel on January 17, 2023 (Figure 3-22). The large scour channels that occurred along a great length of Sanibel Island could have adversely impacted structural foundations had those foundations not been adequately designed to withstand scour. The scour channel shown in Figure 3-21 was still present during the MAT visit, and the MAT observed visible scour around the outer foundation piles. The scour channel closely aligned with a preferential scour pathway visible in the pre-storm imagery of a dune walkover and connected to the corner of a large, vegetated, water retention area behind the houses on either side of the scour channel (Figure 3-23). There was no visible damage to the building piles, and the piles had not shifted. An air conditioning unit elevated on a platform was lost as a result of scour undermining the platform (Figure 3-24).

Figure 3-24: Scour resulting in the collapse of a platform supporting an air conditioning unit

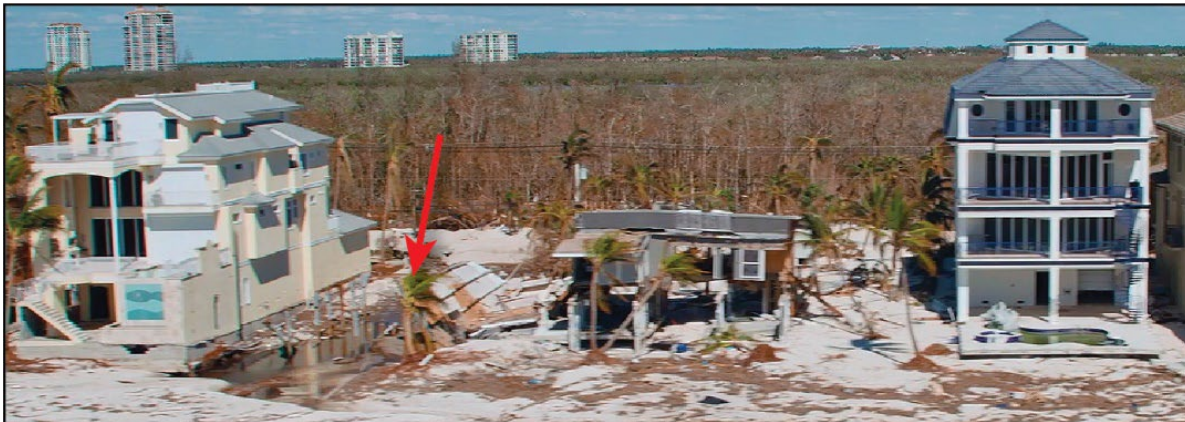
In Bonita Beach, a scour channel was visible near a large CMU residential structure that was built in 2008. The adjacent property was a wood pile-supported structure built in 1984 (Figure 3-25). The scour channel coincided with disturbed ground as an old septic tank and drain field and newer sewer lines were visible. This scour channel may have resulted from a combination of channeled flow due to the large adjacent structure and the preferential scour pathway through previously disturbed soils (Figure 3-26).

Figure 3-25: Scour beside and under houses in Bonita Beach (Lee County, Zone VE, Seaward of CCCL)

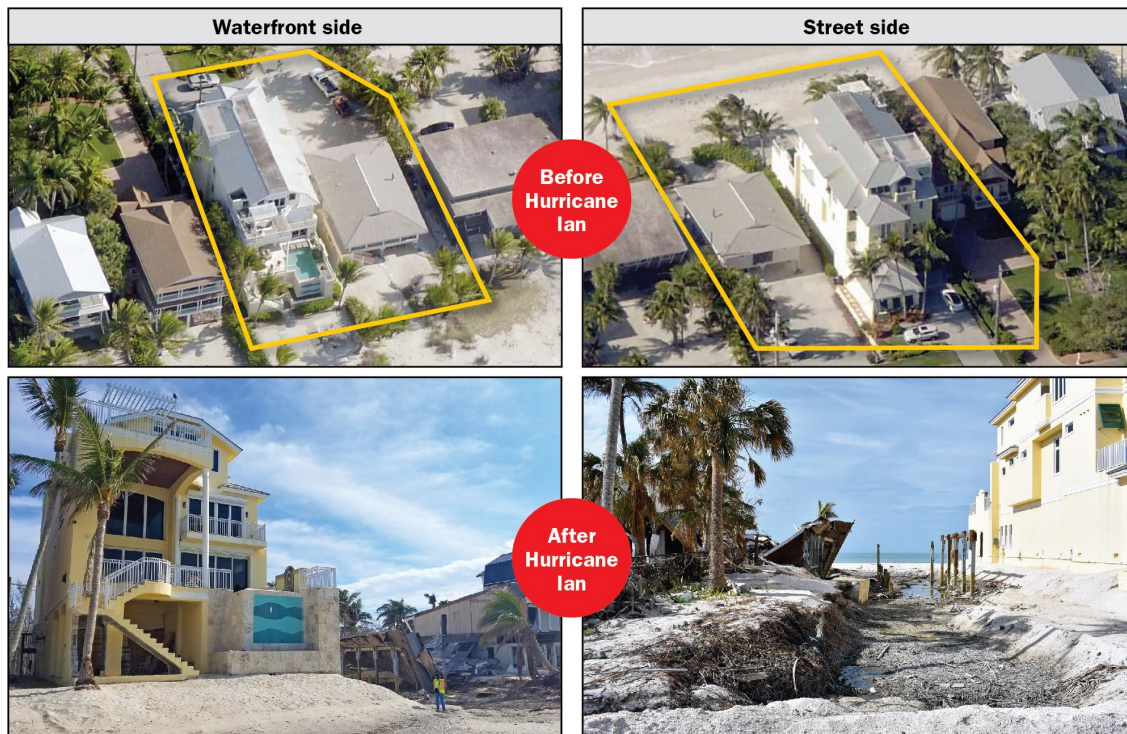
Figure 3-26: Photos before and after Hurricane Ian depicting significant scour on Bonita Beach (Lee County, Zone VE, Seaward of CCCL)
