Mitigation Assessment Team Report

Hurricane Ian in Florida

Building Performance Observations,
Recommendations, and Technical Guidance

FEMA P-2342/December 2023

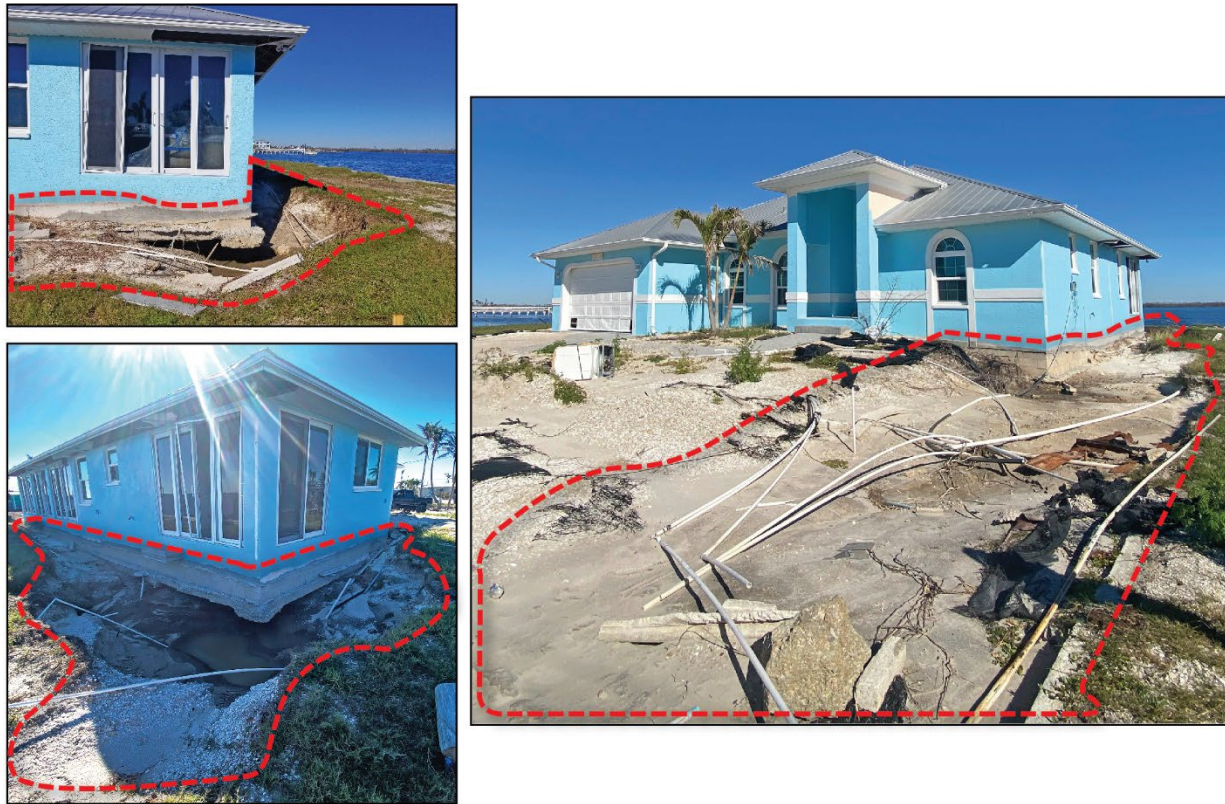
Preferential scour pathways, which can result in excessive localized scour, were also observed on Matlacha. Figure 3-27 depicts a house with scour along multiple sides of the house. The maximum observable scour depth was between 4 and 5 feet. The scour appeared to occur in areas where the ground had been disturbed for the installation of irrigation lines. Also notable is that the maximum scour occurs at the corners of the house, which is expected because of the velocity and flow change at the corners.

Figure 3-27: Scour surrounding a house and undermining the foundation in Matlacha (Lee County, Zone AE)

Whether the scour resulted in damage to the structure itself is unknown. However, the foundation appears to be a shallow foundation consisting of a slab on grade and, at a minimum, backfilling would be required to restore support of the building foundation. As shown in Figure 3-28, the building is located along the Matlacha Pass and is miles from the Gulf coast. Additionally, the building was in a FEMA mapped Zone A when constructed (1995); it is now in a Coastal A Zone as mapped on a revised FEMA FIRM (effective 2022). This example illustrates that the potential for scour and the consideration of designing with deep foundations should be taken into account when certain circumstances are present, such as being located on a waterway with the potential for high-velocity flow and flooding during storms.

Per FEMA P-55, *Coastal Construction Manual* (2011), equation 8.12, scour along a building wall is expected to be 0.15 times the horizontal length along the side of the building exposed to flow with a

limit of a maximum of 10 feet of scour. The house in Figure 3-27 is approximately 75 feet long with a 27-foot-long wall abutting the deepest scour area. For the house pictured in Figure 3-27, the expected maximum scour is 10 feet for the 75-foot-long back wall and 4 feet for the 27-foot-long abutting side wall. Although the wall scour calculation in FEMA P-55 provides a reasonable design baseline for coastal sites, the FEMA P-55 wall scour calculation should not be directly compared with scour documented in this subsection. This is because the flow direction during Hurricane Ian is not known, and the location of the house depicted in Figure 3-27 does not represent a typical coastal location as it is bordered by Matlacha Pass and not a large body of saltwater (e.g., gulf or ocean). This simple example helps provide better context as to the tremendous damage that can occur from scour if shallow foundation systems are used in Coastal A and V Zones that are subject to high-velocity flow. For these reasons, the IBC, IRC, and ASCE 24 require structures to be designed with foundation systems that accommodate local scour in Coastal A Zones and V Zones. See *FEMA Quick Reference Guide: Comparison of Select NFIP and 2018 I-Code Requirements for Special Flood Hazard Areas* (2018c).

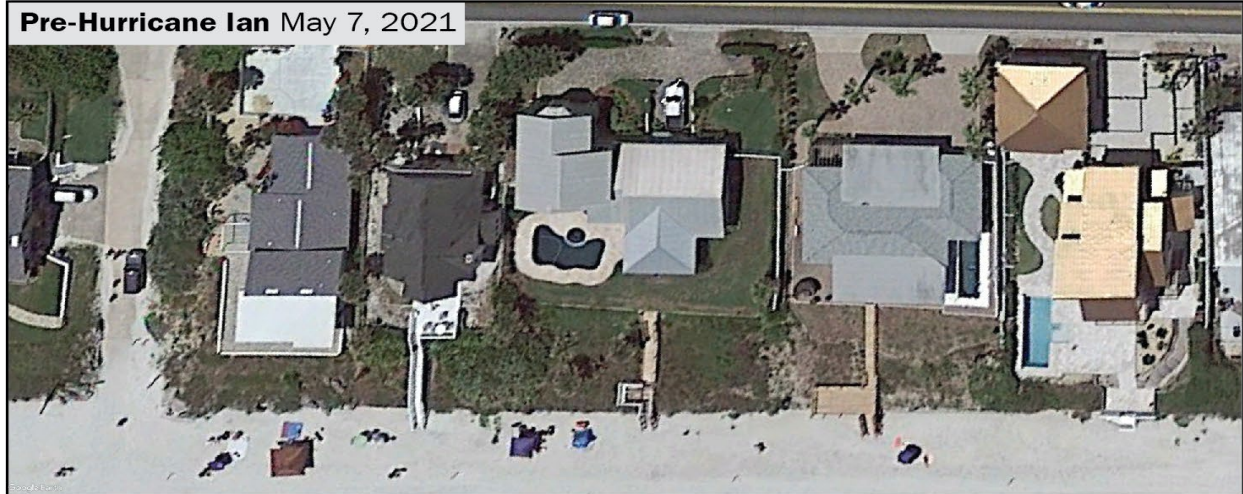
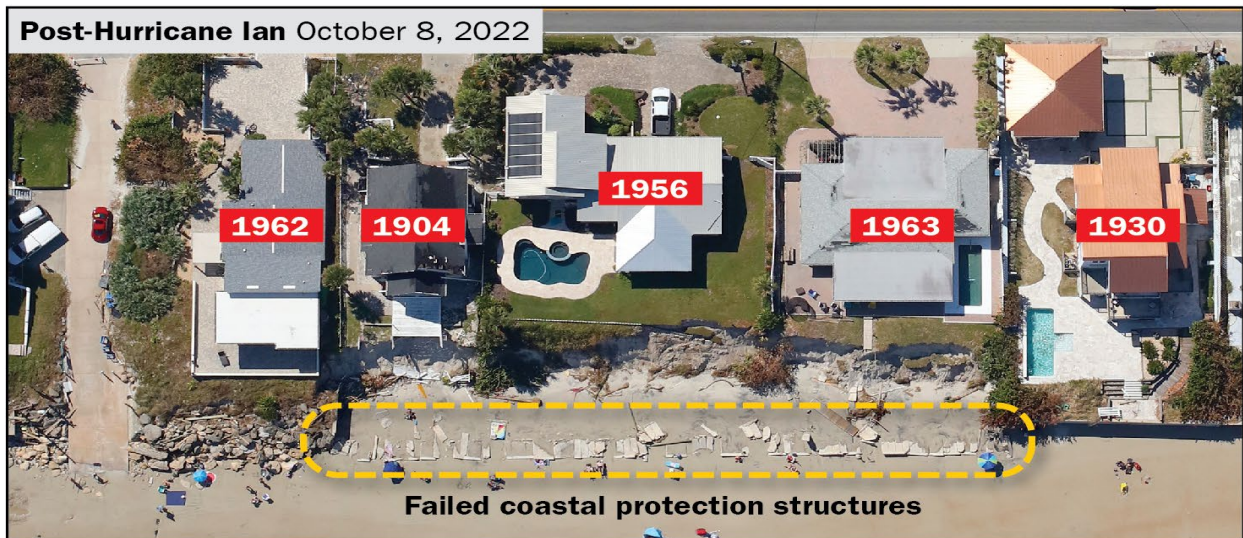
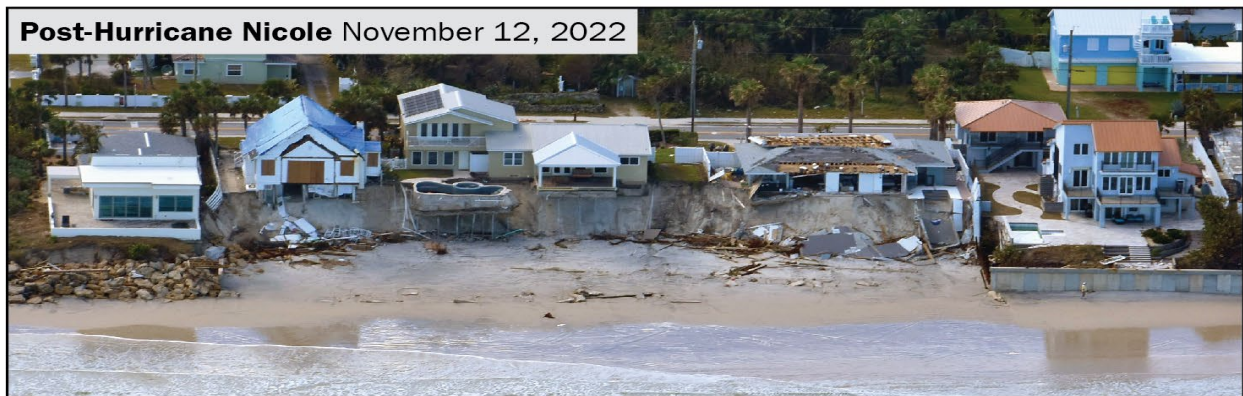
The MAT visited an area in Volusia County that was impacted by Hurricane Ian on September 28, 2022, and by Hurricane Nicole on November 10, 2022. The impact of the two storms—43 days apart—resulted in a significant amount of failed or damaged seawall sections and areas with large, severe dune erosion. In Wilbur-by-the-Sea, a stretch of three homes lost their fronting coastal protection structures during Hurricane Ian, and there was further erosion during Hurricane Nicole that resulted in damage to several of the structures (Figure 3-29). The failed coastal protection structures are shown in the second image in Figure 3-29; they are in front of the three middle houses and resemble a line of debris partially covered in sand. All the homes shown in Figure 3-29 were constructed before NFIP requirements came into existence. This stretch of shoreline is currently in a Zone VE on the 2017 effective FEMA FIRM, and the area of interest is seaward of the CCCL shown in Figure 3-30.

Figure 3-29: Dune erosion, bulkhead failures, and impacts on multiple structures in Wilbur-by-the-Sea (Volusia County, Zone VE/Unshaded Zone X)

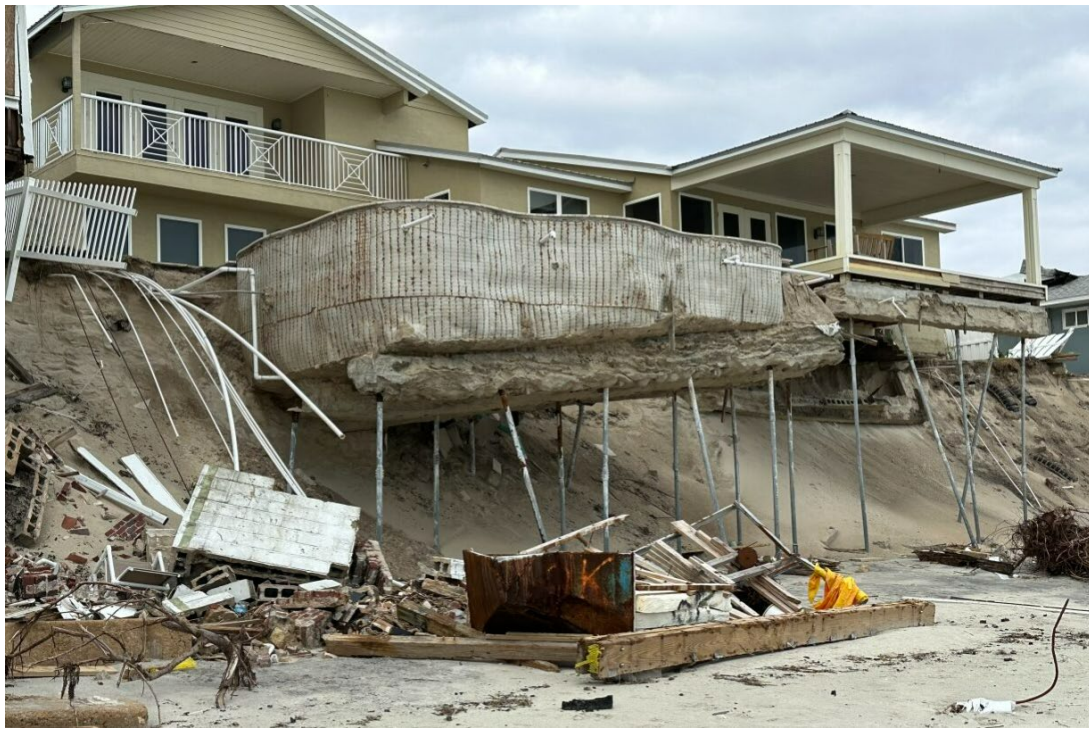
Figure 3-31: Dune erosion in Wilbur-by-the-Sea resulting in exposed foundation micropiles

The house depicted in Figure 3-31 is the third house from the left shown in Figure 3-29 and Figure 3-30 with a non-rectangular pool. The site of this house experienced erosion from both Hurricane Ian and Hurricane Nicole, which resulted in failure of the porch floor and exposure of the micropiles that support the porch foundation and pool. The pool and porch structure, both added in 2014, were structurally supported by a deep foundation system consisting of micropiles. Deep foundations are required by current building codes for such elements in a coastal high hazard area where soils are subject to scour or erosion. The neighboring houses to each side in Figure 3-31 were built more seaward in 1904 and 1963 before deep foundation elements were required. Neither of the neighboring houses had deep foundation elements visible and both lost portions of their structure.

The house in Figure 3-31 is located between two coastal transects on the FIRM. Each of these bordering transects (northern and southern) has a transect profile in the FIS for the 0.2-percent-annual-chance wave envelope, which shows the eroded dune profile for the 0.2-percent-annual-chance event. The eroded dune profile shown for both transects in Figure 3-32 depicts retreating dune erosion. Retreating dune erosion means the dune is expected to erode but will not result in a complete loss of the dune. The eroded profiles for both bordering transects depict the limit of erosion to be at the peak of the primary frontal dune (Figure 3-32). Based on publicly available elevation data (a site survey was not performed), the house in Figure 3-31 is situated such that the pool and porch are seaward of the dune peak and the main house is landward of the dune peak. Based on the observed erosion and the eroded profiles in Figure 3-32, the combined erosion from Hurricane Ian and Hurricane Nicole resulted in dune erosion similar to the erosion predicted for a 0.2-percent-annual-chance (500-year) event.

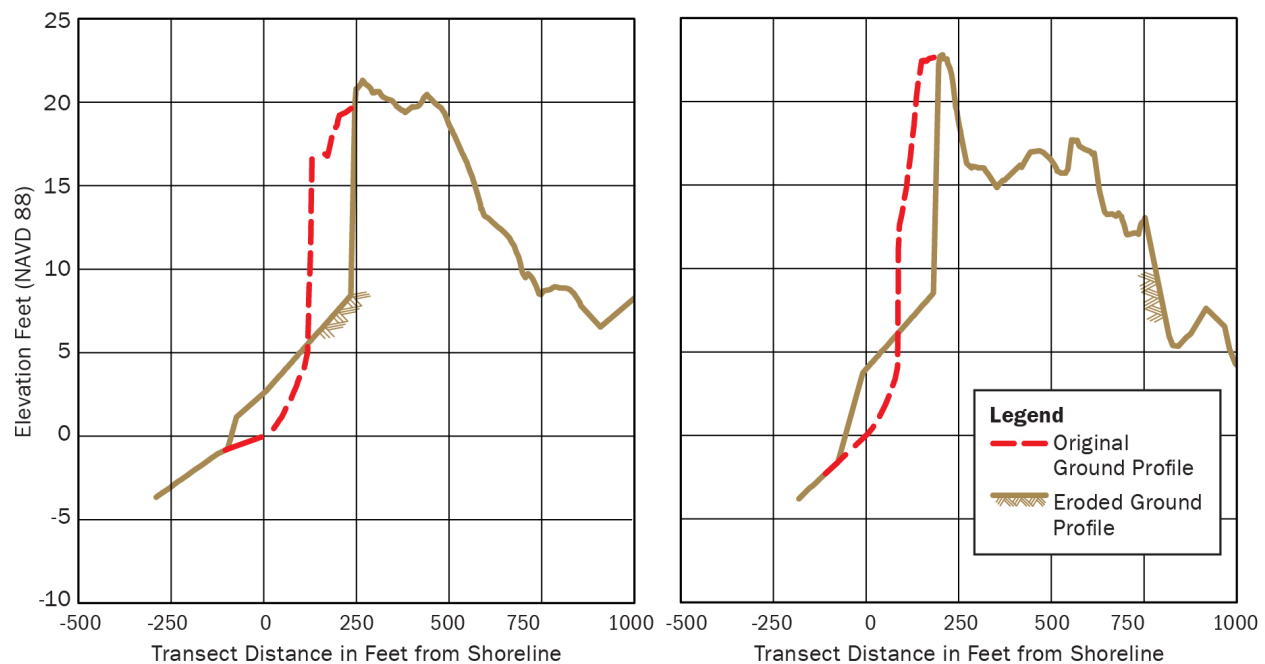
Figure 3-32: 0.2-percent-annual-chance eroded profiles for the northern (left) and southern (right) transects on either side of Figure 3-31

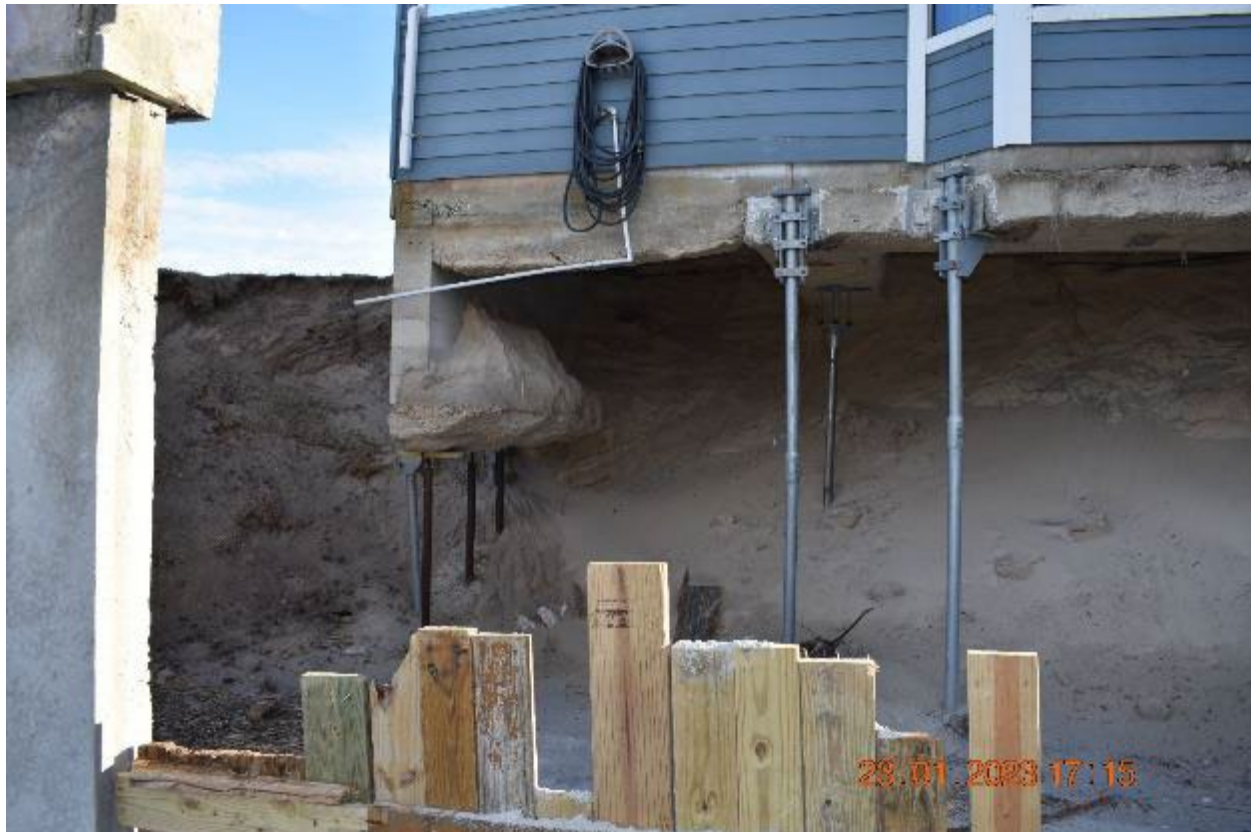
The structure in Figure 3-33 with a fronting vertical concrete seawall and return is in Port Orange and was built in an area classified as Zone X at the time of design and construction that remains Zone X under the currently adopted flood hazard map. This condominium complex abuts a nature area, and the coastal protection structure includes an end return. Adjustable lally columns were brought in as emergency measures to support the undermined corners of the residential structure. The residential structure was built in 1984 and is located seaward of the CCCL.

The condominium structure was behind a coastal protection structure, and erosion occurred by flow bypassing the end of the protective structure's return. This "red tagged" condo required multiple lally columns to provide support and stability until repairs could be accomplished.

Figure 3-33: Significant erosion occurred around and under the foundation of a condominium structure (Volusia County, Zone VE/Unshaded Zone X)

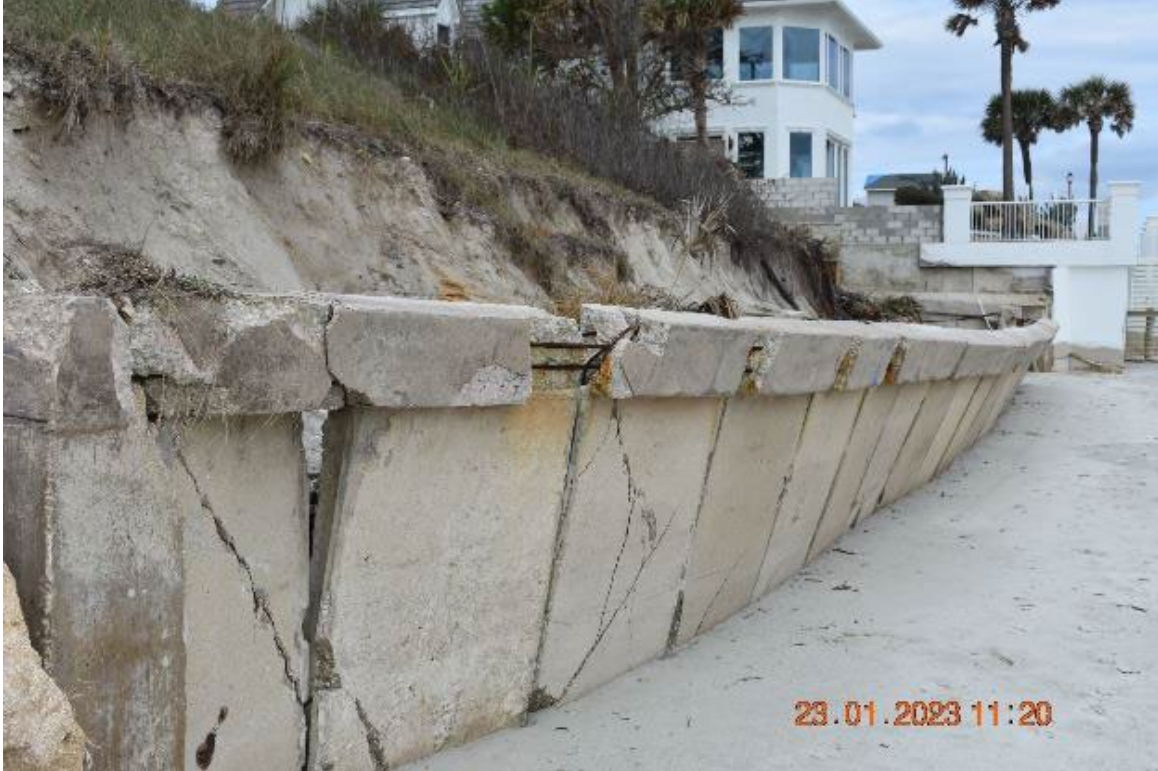
The MAT observed multiple failed coastal protection structures. Coastal protection structures are intended to resist wave action and prevent loss of sand/soil. Seawalls are a type of coastal protection structure that are either cantilevered or anchored and employ a tie-back system to assist with resisting overturning moments (Figure 3-34). Tie-back bars are used in bulkheads or retaining walls to provide additional support and stability to the structure. However, these bars can corrode over time due to exposure to the elements and other environmental factors, which can weaken the structure and potentially lead to failure (Figure 3-35). Figure 3-36 is an example where corroded tie-back bars were replaced; however, the soil around the tie-backs was removed due to the recent disturbance to replace the bars.

Figure 3-34: Failed coastal protection wall rotating seaward (Volusia County, Zone VE)

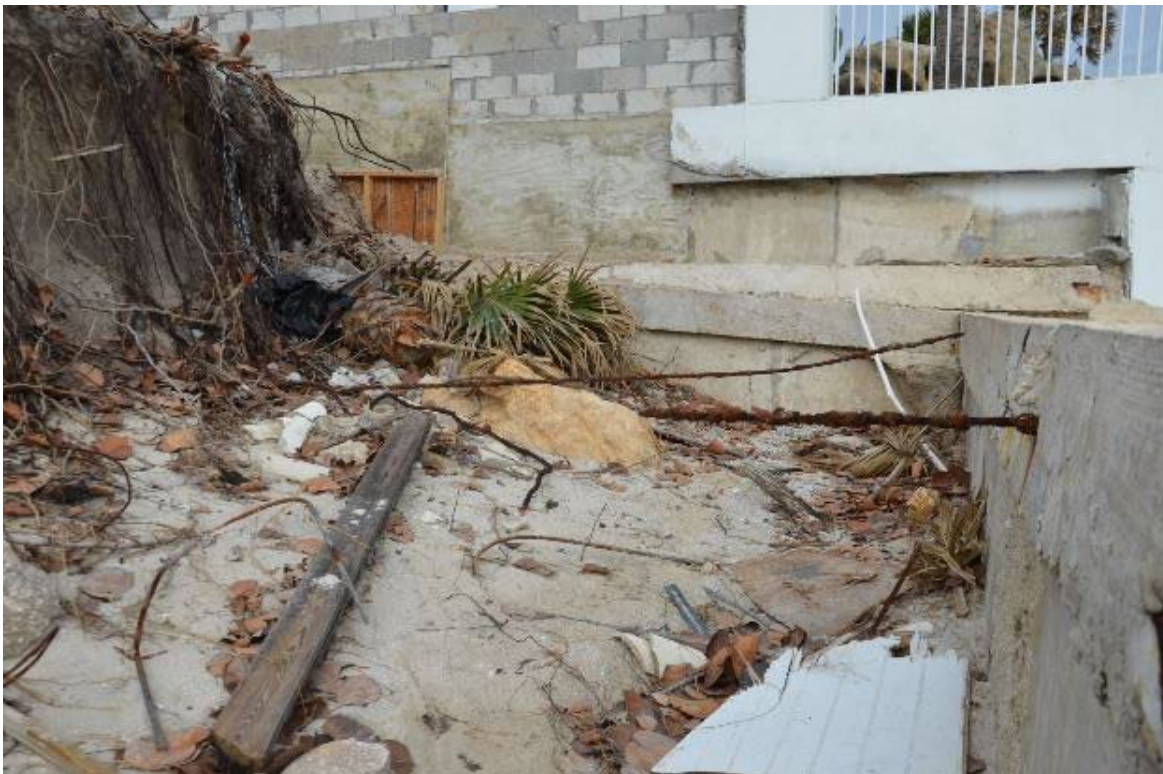
Figure 3-35: Corroded tie-back system of a coastal protection structure (Volusia County, Zone VE)

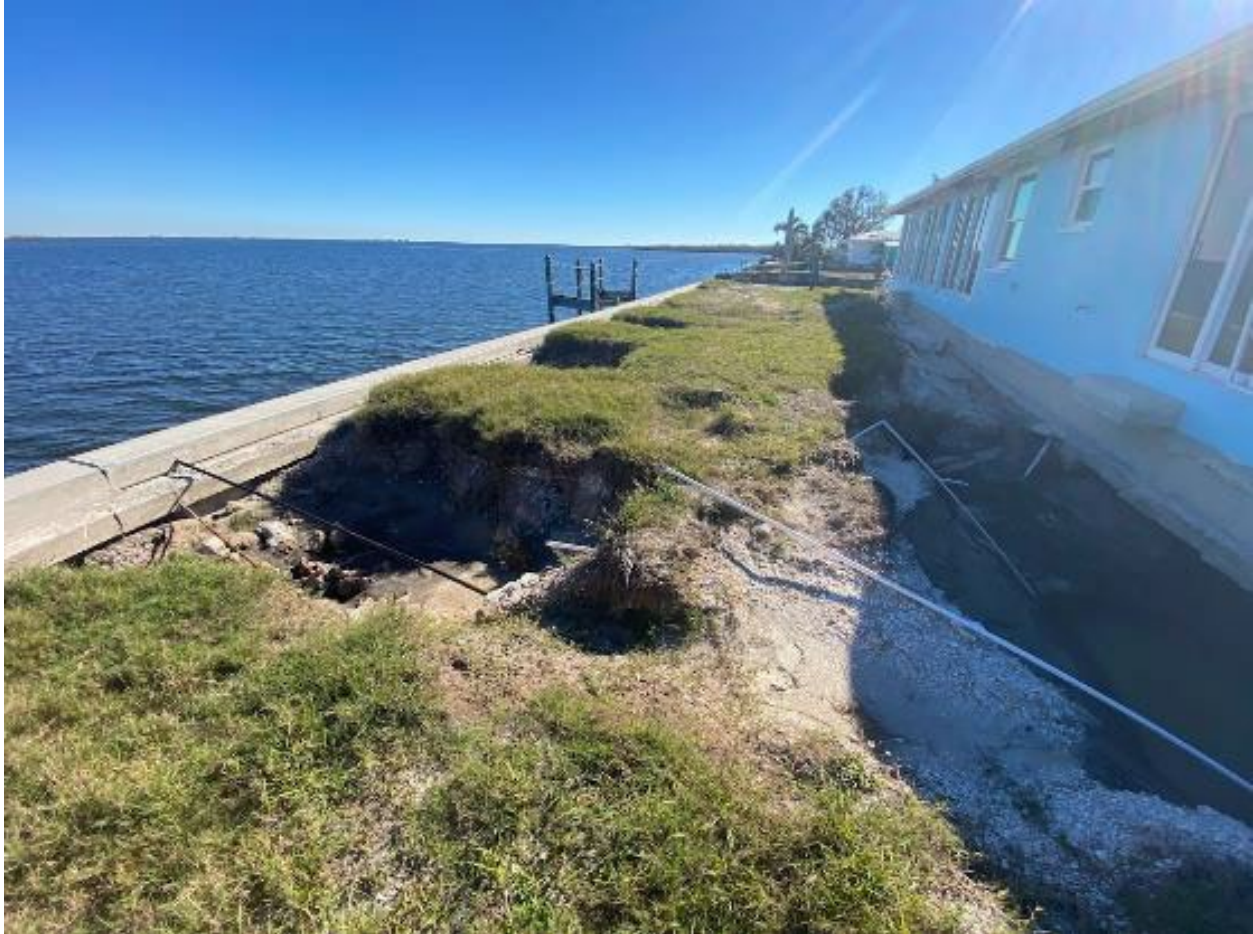
Figure 3-36: Example of exposed, newly installed, tie-back rods in Matlacha Isles (Lee County, Zone VE)

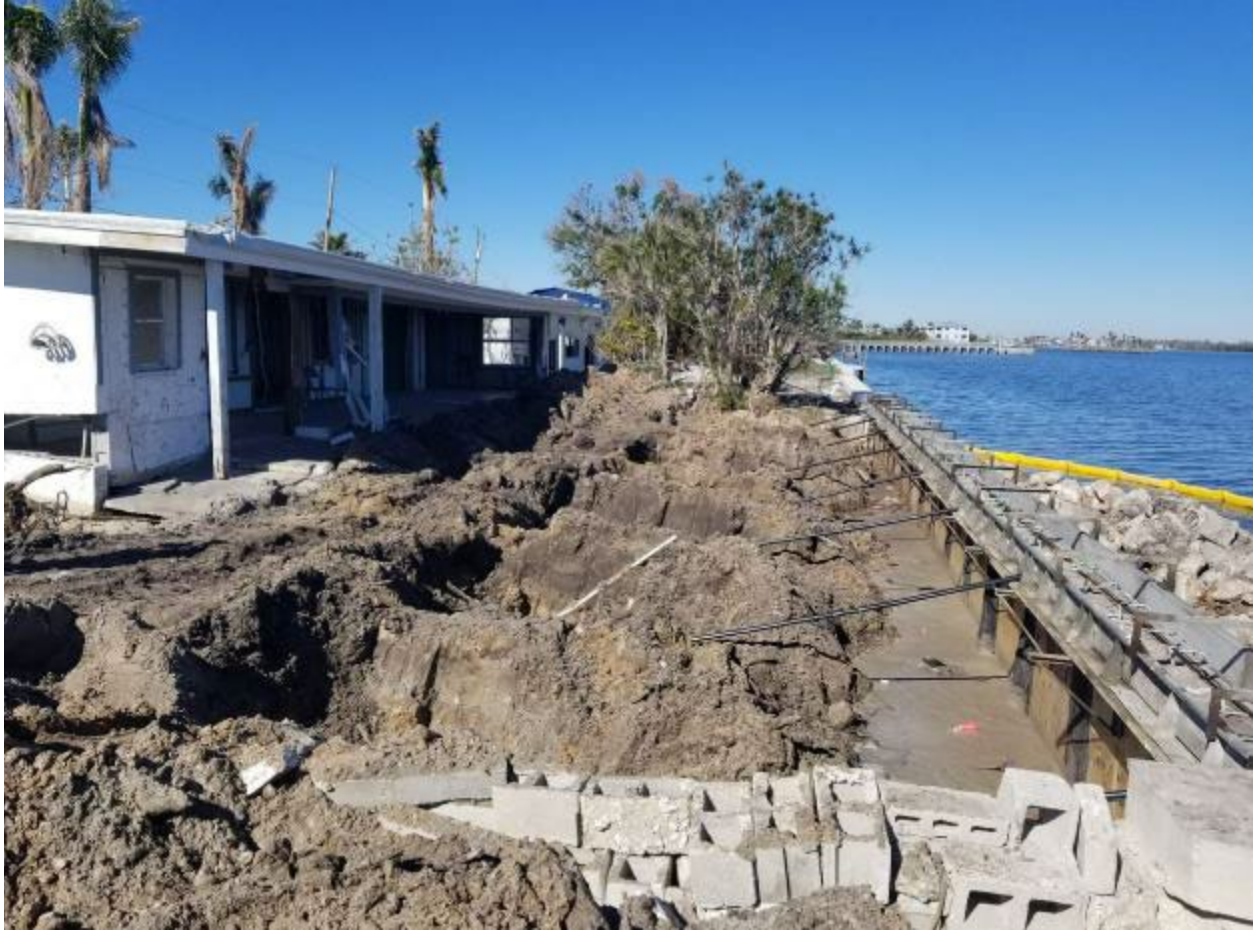
Figure 3-37: New seawall under construction after Hurricane Ian on Matlacha Isle (Lee County, Zone VE)

The MAT also observed various repairs on the coastal protection structures. The replacement of corroded steel tie-backs with sleeve-protected tie-backs was observed in Matlacha Isles along multiple coastal structures (Figure 3-37). In Volusia County, a seawall had tie-backs installed as an emergency repair to regain the structural capacity that was lost due to existing corroded tie-backs as shown in Figure 3-38.

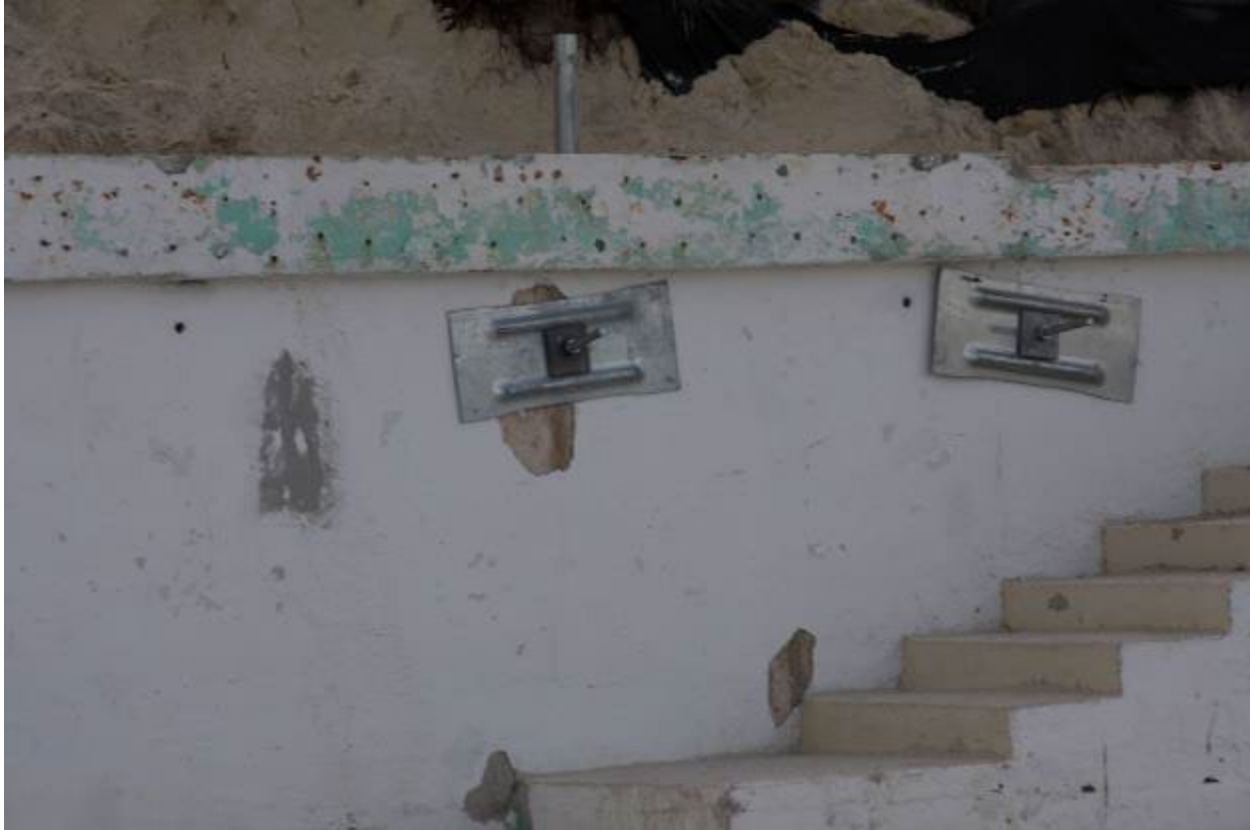
Figure 3-38: Emergency repairs to account for corroded tie-backs (Lee County, Zone VE)

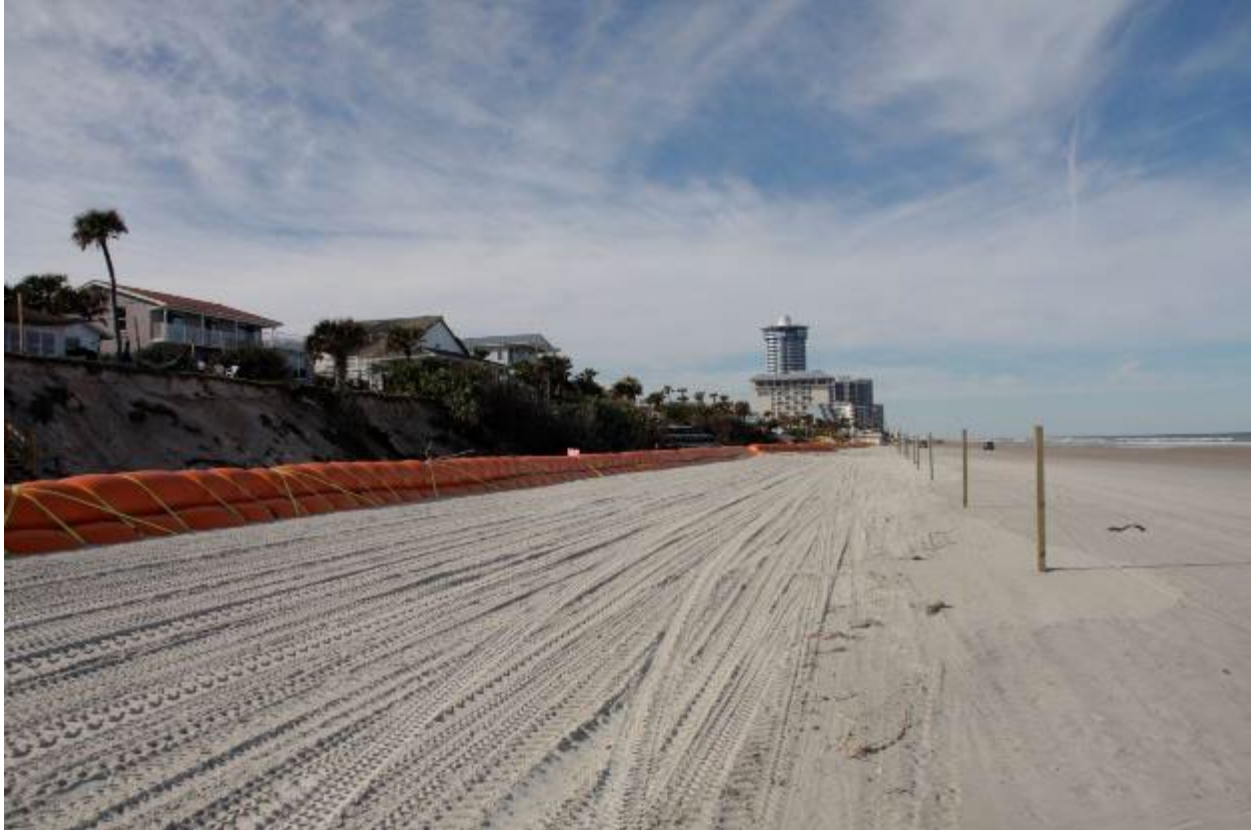
Figure 3-39: Temporary erosion control installed along Daytona Beach Shores to help counteract further coastal erosion in an area where seawalls were destroyed (Volusia County)

In areas with damaged coastal protection structures, several temporary measures were deployed to provide a temporary level of protection to long lengths of shoreline. FDEP supplied and approved placement of a water-filled tube system that acts as a barrier to reduce further erosion (Figure 3-39). The tubes were arranged in a pyramid and then temporarily anchored into the beach. These systems had to be removed at the start of turtle nesting season (beginning of May 2023). Additional temporary erosion control measures included textile bag cubes that were filled with sediment (Figure 3-40 and Figure 3-41) and vertical vinyl sheet walls employed to retain sediment until a permanent structure could be constructed (Figure 3-42).

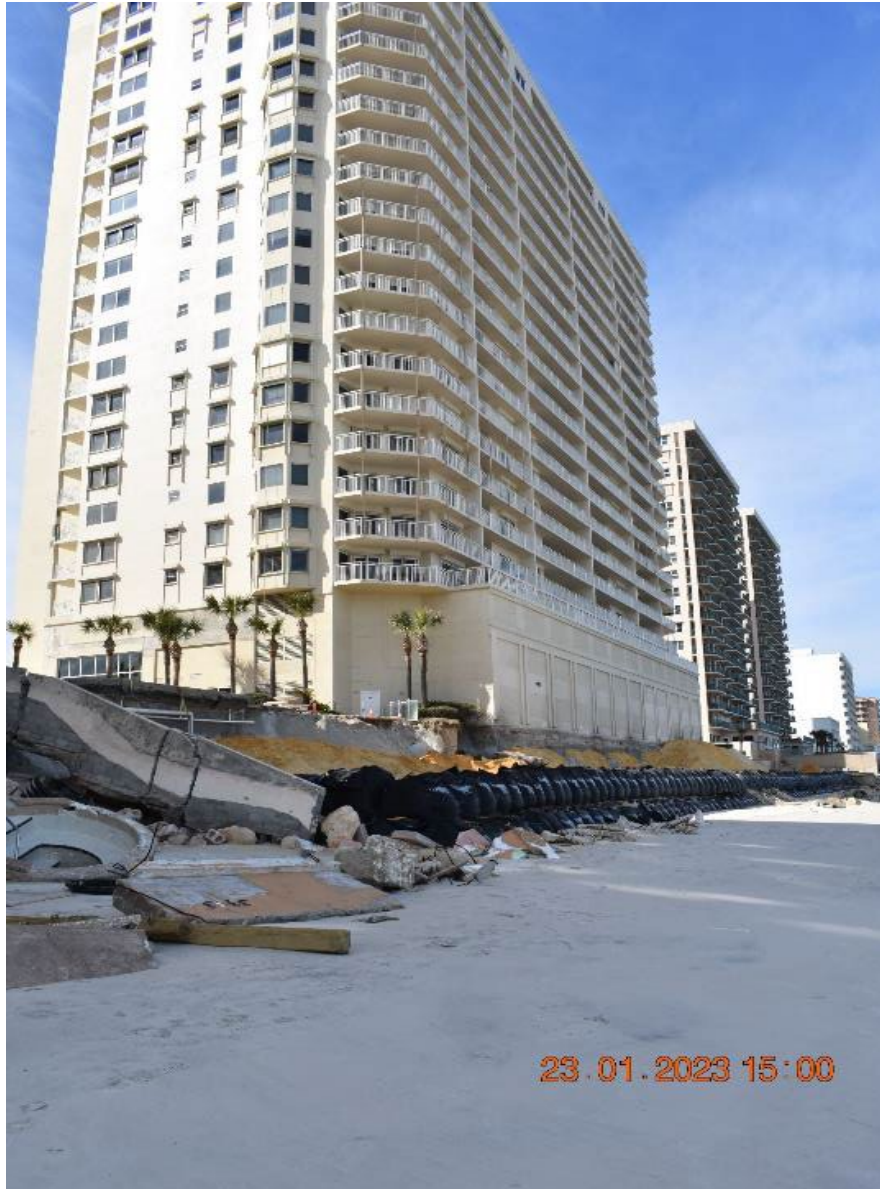
Figure 3-40: Large sediment-filled bags used to counteract further coastal erosion along an area of Daytona Beach Shores where seawalls were destroyed (Volusia County)

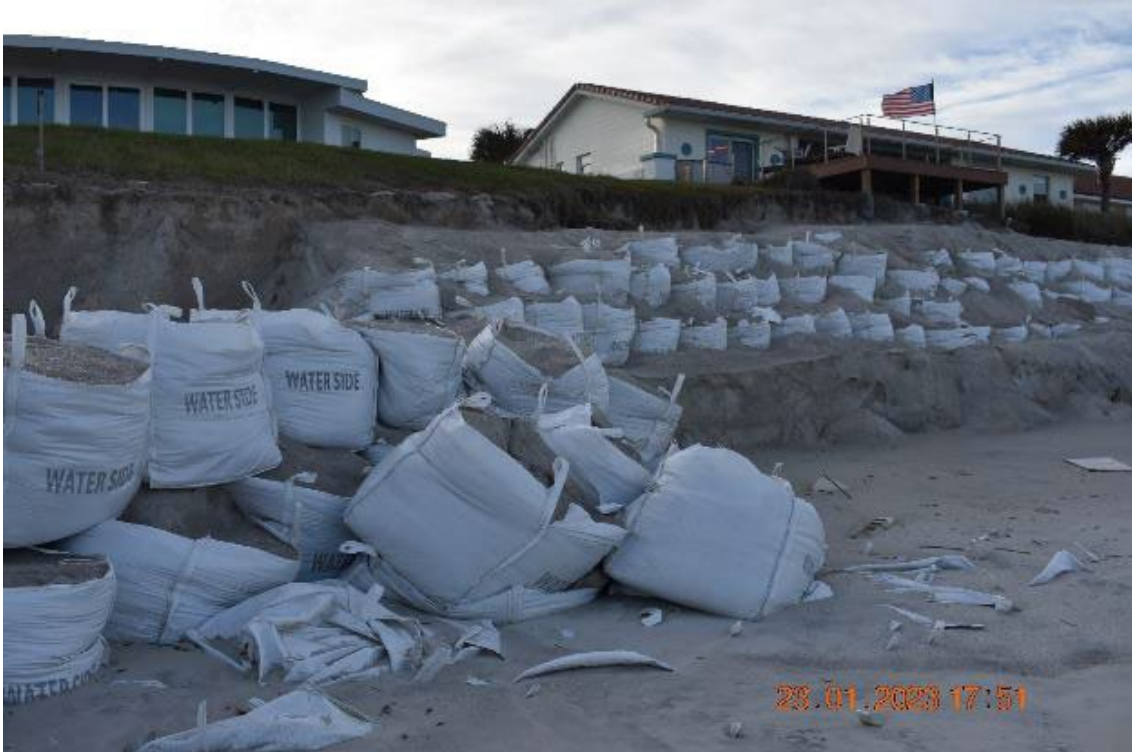
Figure 3-41: Sediment-filled bags used to counteract further coastal erosion in an area of Port Orange where seawalls were destroyed (Volusia County)

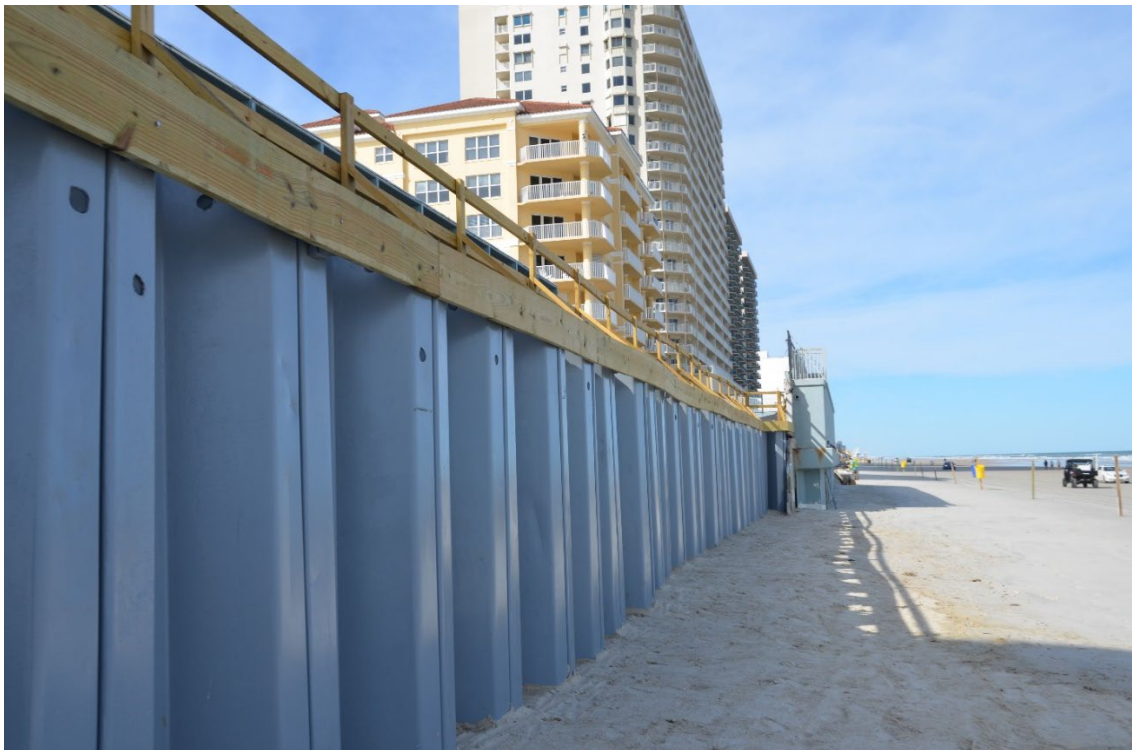
Figure 3-42: Vertical vinyl sheet wall piles installed along Daytona Beach to replace destroyed seawalls (Volusia County)

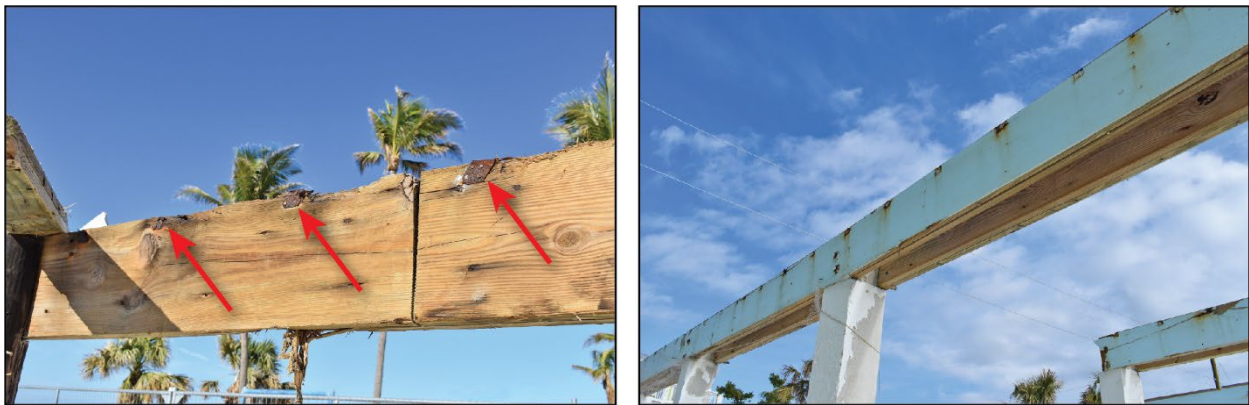
The examples depict rusted straps or ties that failed and helped enable the structure above to separate from the lowest horizontal structural member of the lowest floor.

Figure 3-43: Two locations on Fort Myers Beach with examples of rusted straps or ties

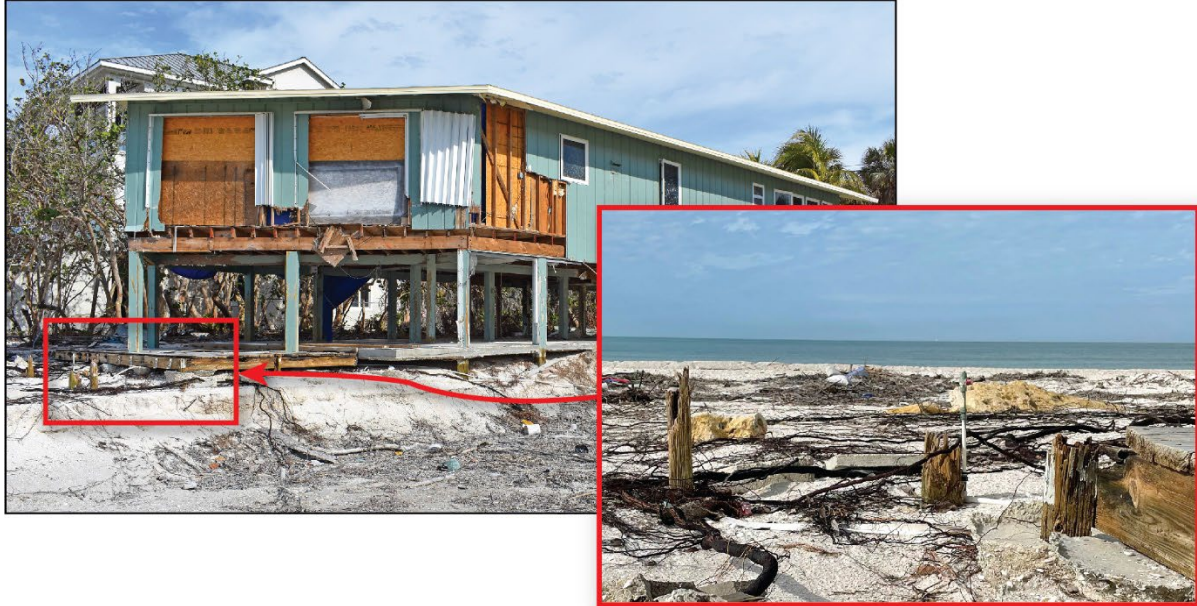
Figure 3-44: Deteriorated wood supports in Bonita Springs that failed during Hurricane Ian

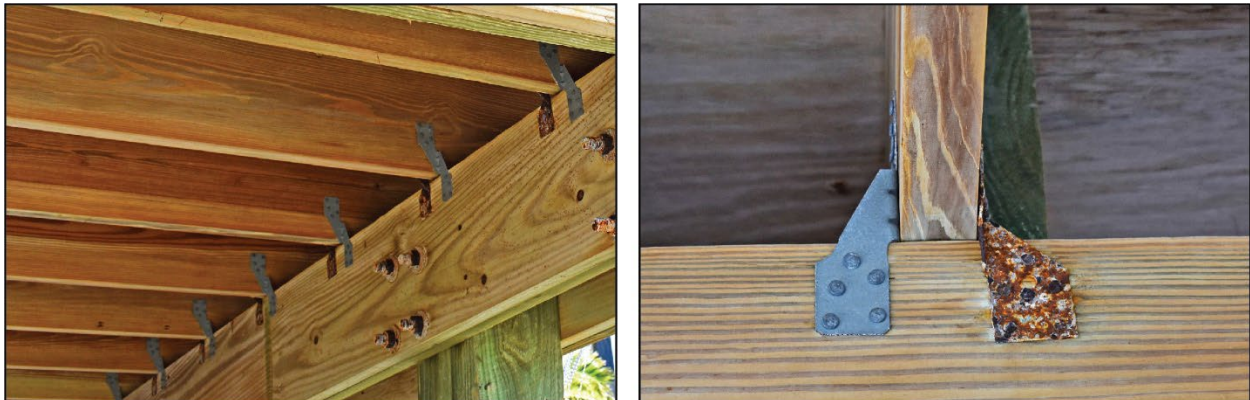
While proper maintenance was performed, the connectors shown are not ideal for support elements that may be subjected to flood loads, see Hurricane Sandy Recovery Advisory 1, *Improving Connections in Elevated Coastal Residential Buildings* (2013c) for more information.

Figure 3-45: Example of new hurricane ties installed near old, rusted ties on Sanibel Island

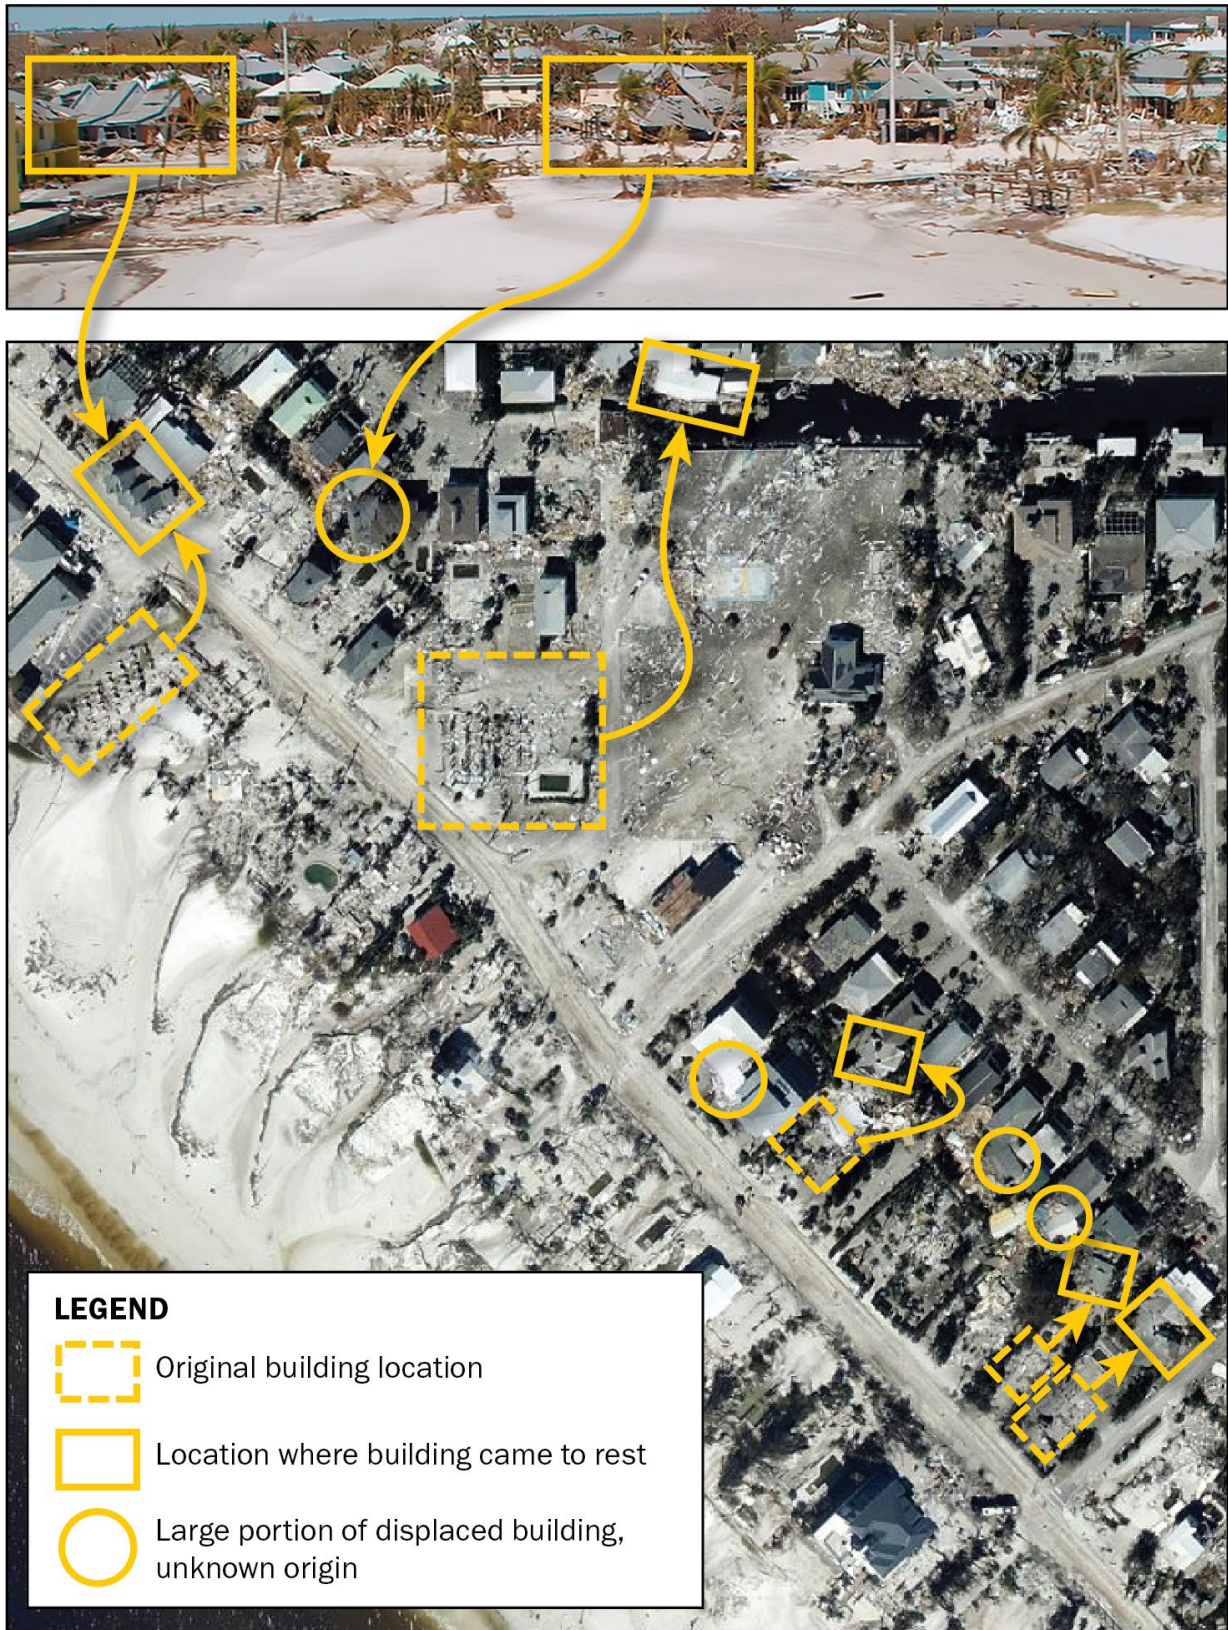
Figure 3-46: Overview of various displaced buildings on Fort Myers Beach

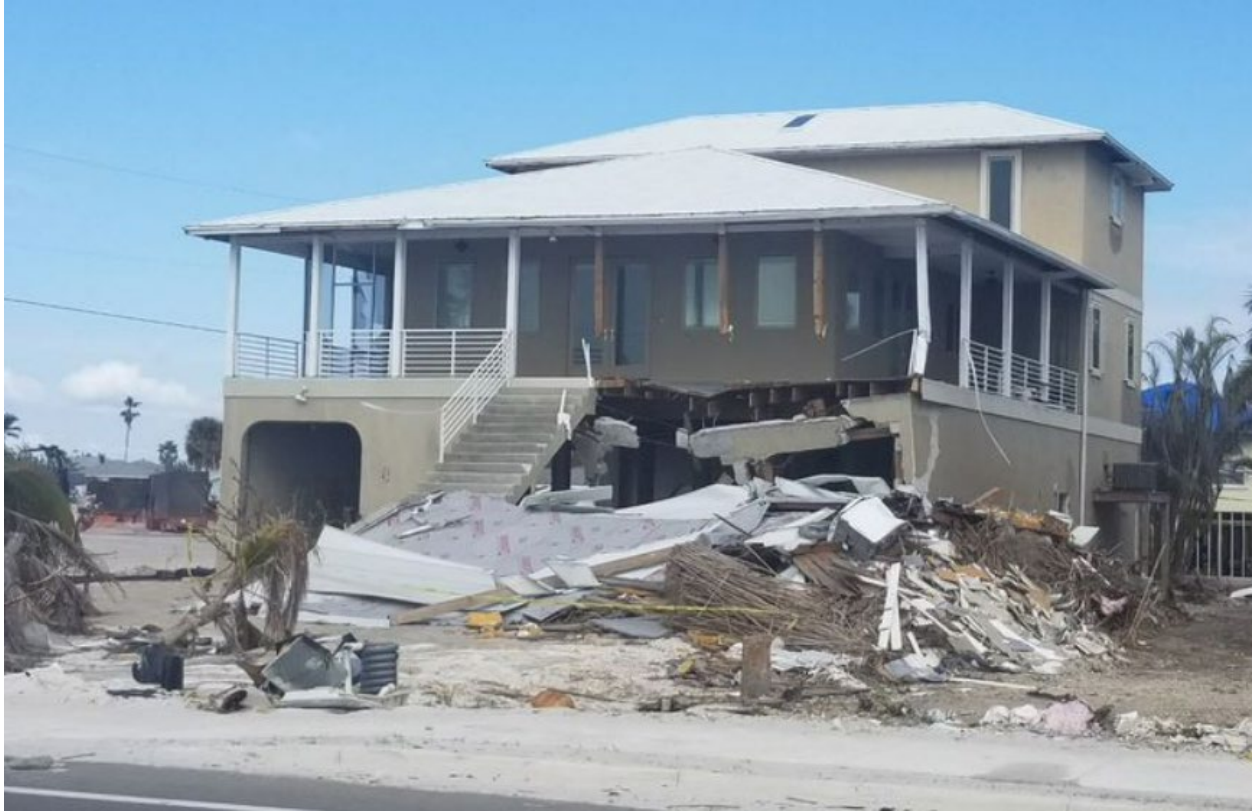
The porch likely failed due to debris impact and damming during Hurricane Ian. The debris had been cleaned up between this house and the neighboring house when photo was taken.

Figure 3-47: House with a failed porch and debris piled against the house in Fort Myers Beach (Lee County, Zone VE)
