Mitigation Assessment Team Report

Hurricane Ian in Florida

Building Performance Observations,
Recommendations, and Technical Guidance

FEMA P-2342/December 2023

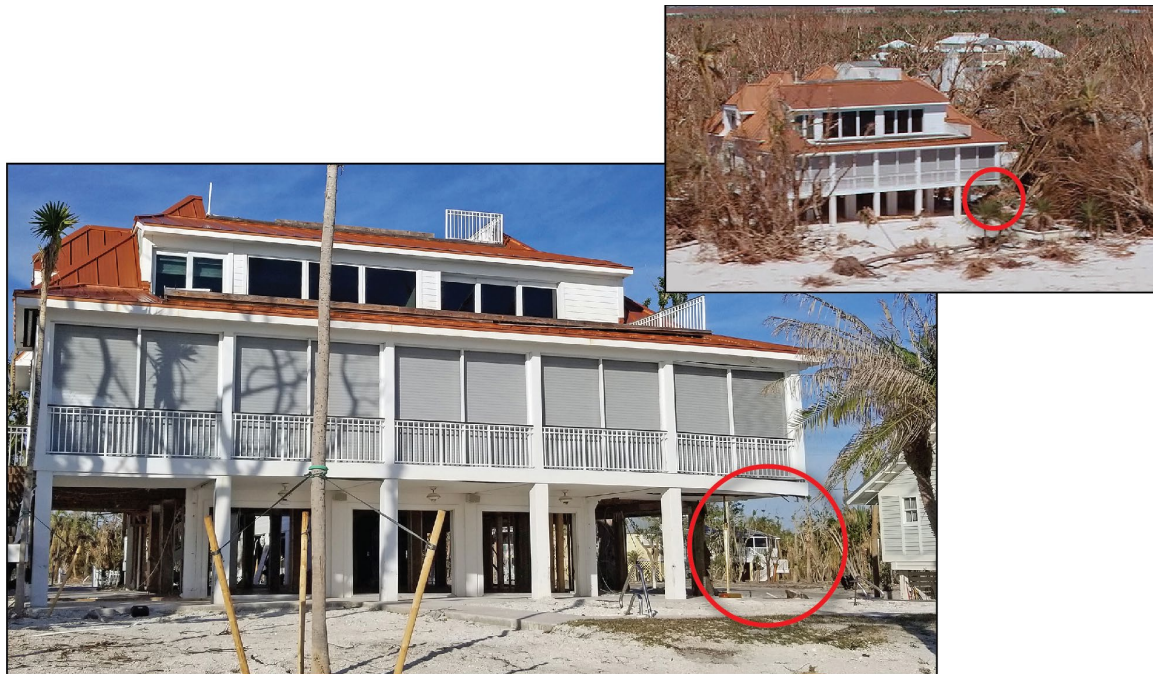
Top right inset was captured by FDEP contracted videography on October 2, 2022. Bottom photo was taken during the MAT in January 2023 after debris had been cleaned up and the temporary support was installed. The temporary support is a single lally column. It is inboard of the corner and is inside of the red circle in the bottom image.

Figure 3-48: House with missing column and temporary support structure in Sanibel (Lee County, Zone VE, Seaward of CCCL)

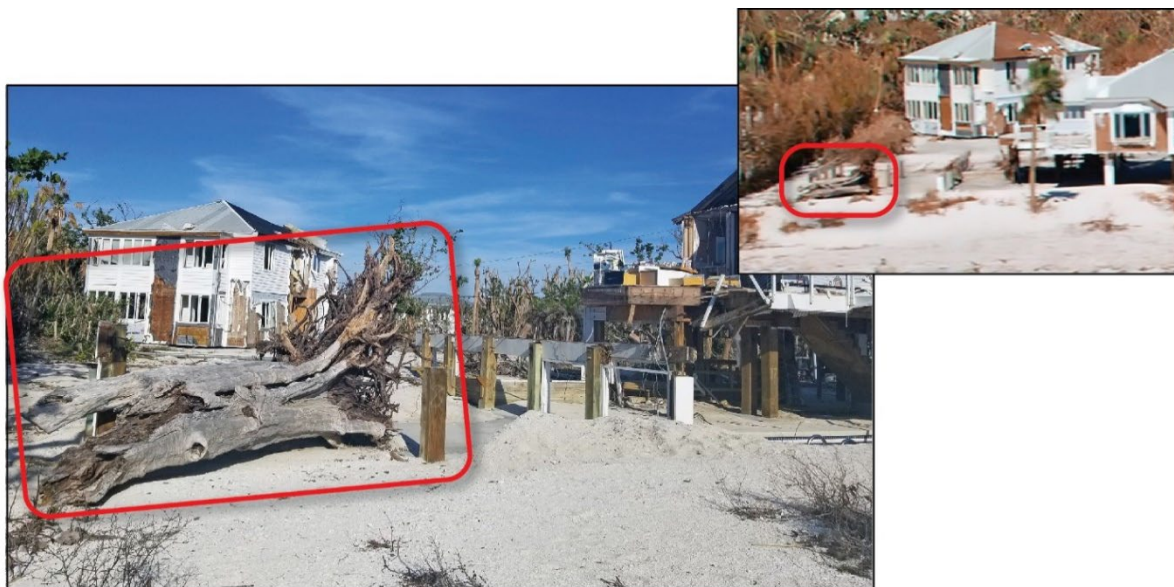
Figure 3-49: Driftwood lying between the piles of a foundation without a structure in Sanibel (Lee County, Zone VE, Seaward of CCCL)

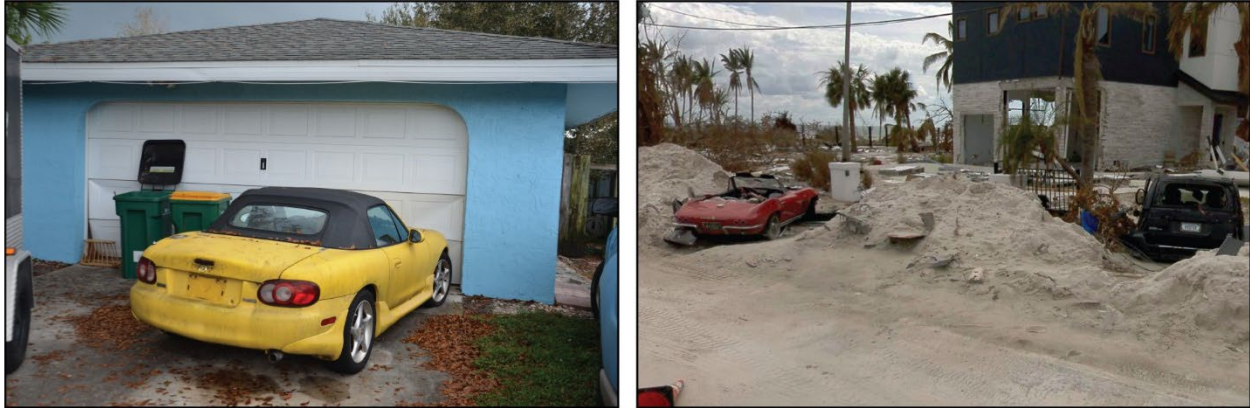
The left photo shows an automobile that was transported by approximately 22-inch-deep (or less) floodwater and damaged a garage door. The right photo shows two automobiles that were transported by floodwater on Fort Myers Beach.

Figure 3-50: Examples of automobiles transported by flood waters

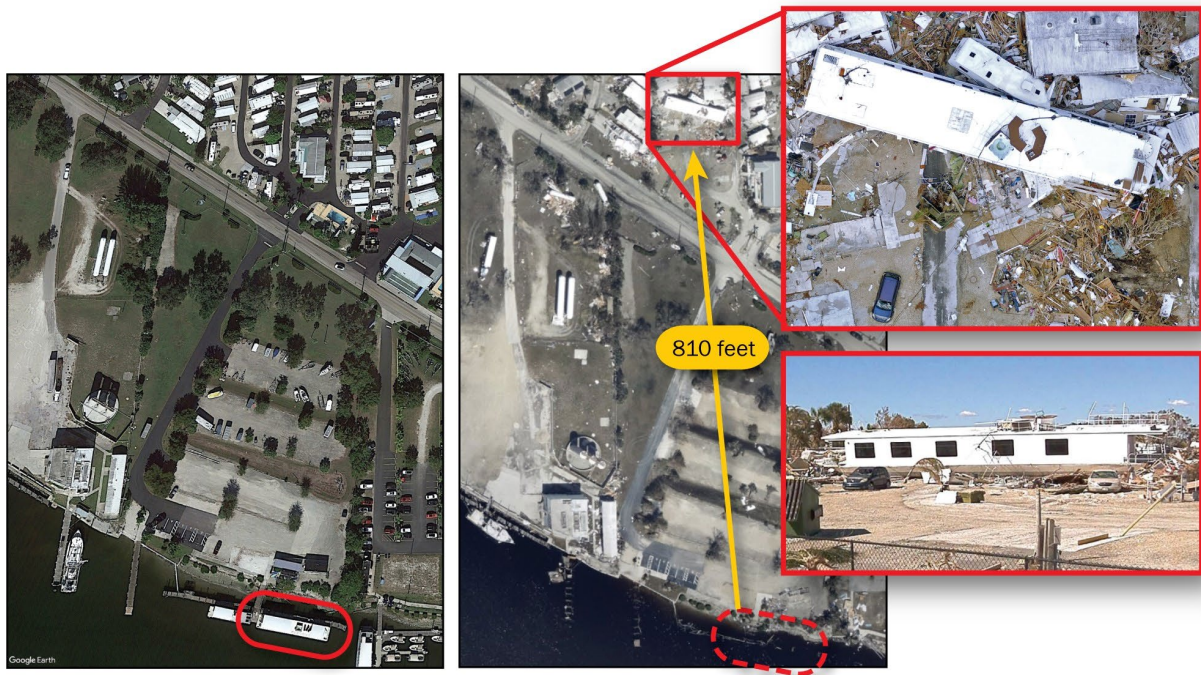
Figure 3-51: Before and after images of a houseboat that was transported by floodwater

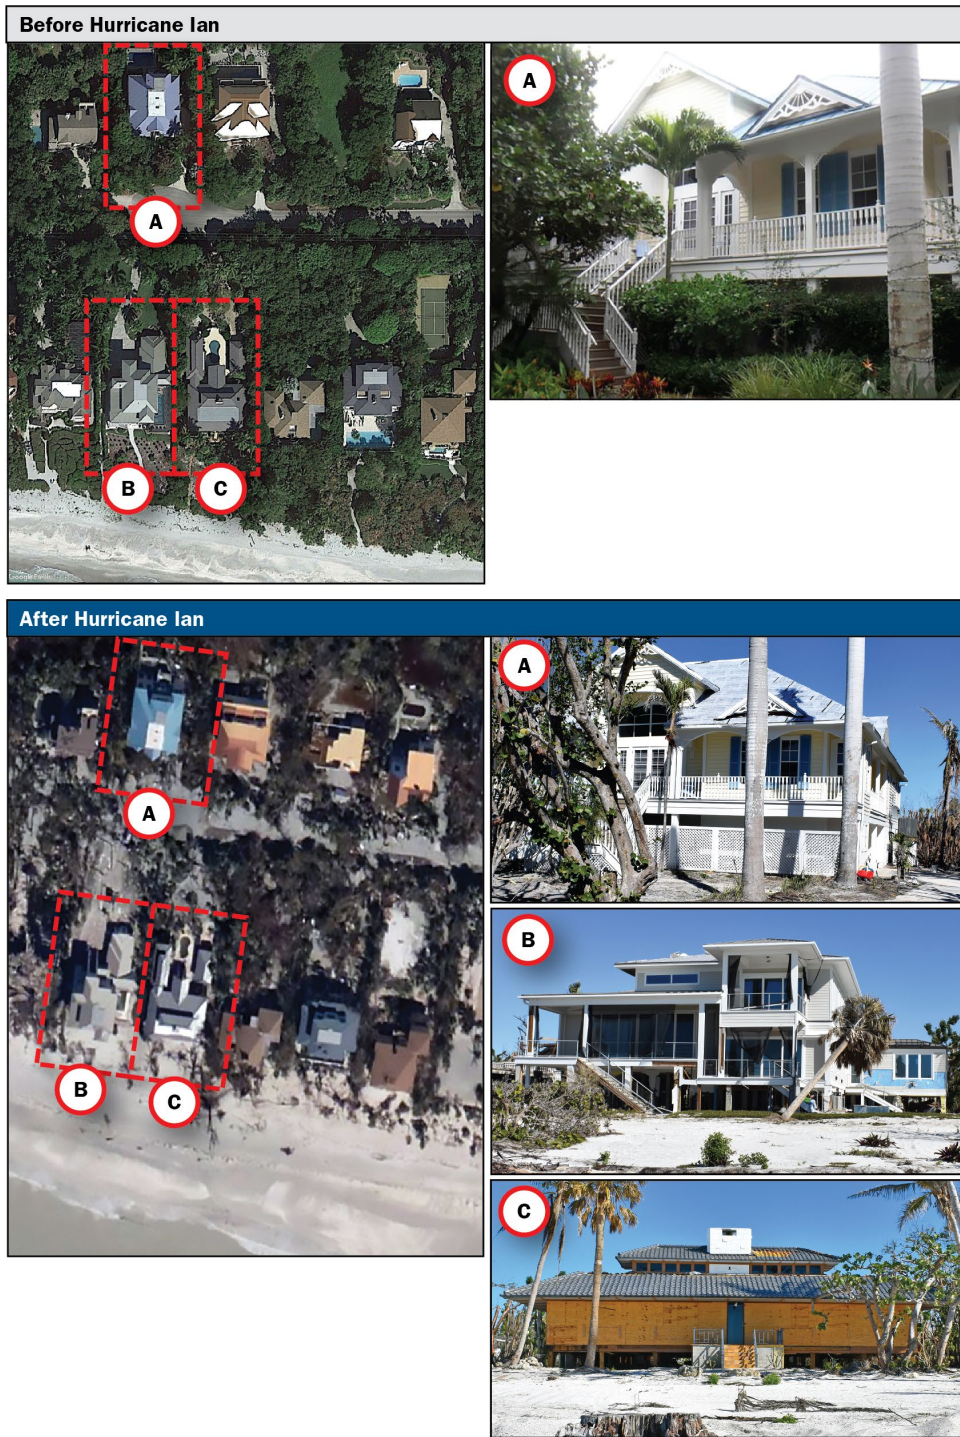
The second-row house (House A) had dense fronting vegetation before Hurricane Ian and had lattice that survived Hurricane Ian. The first-row houses (Houses B and C) experienced much greater damage than House A. House A's lesser damage is likely attributable to a combination of vegetation and first row structures.

Figure 3-52: Comparison of house performance on Sanibel (Zone VE/AE)

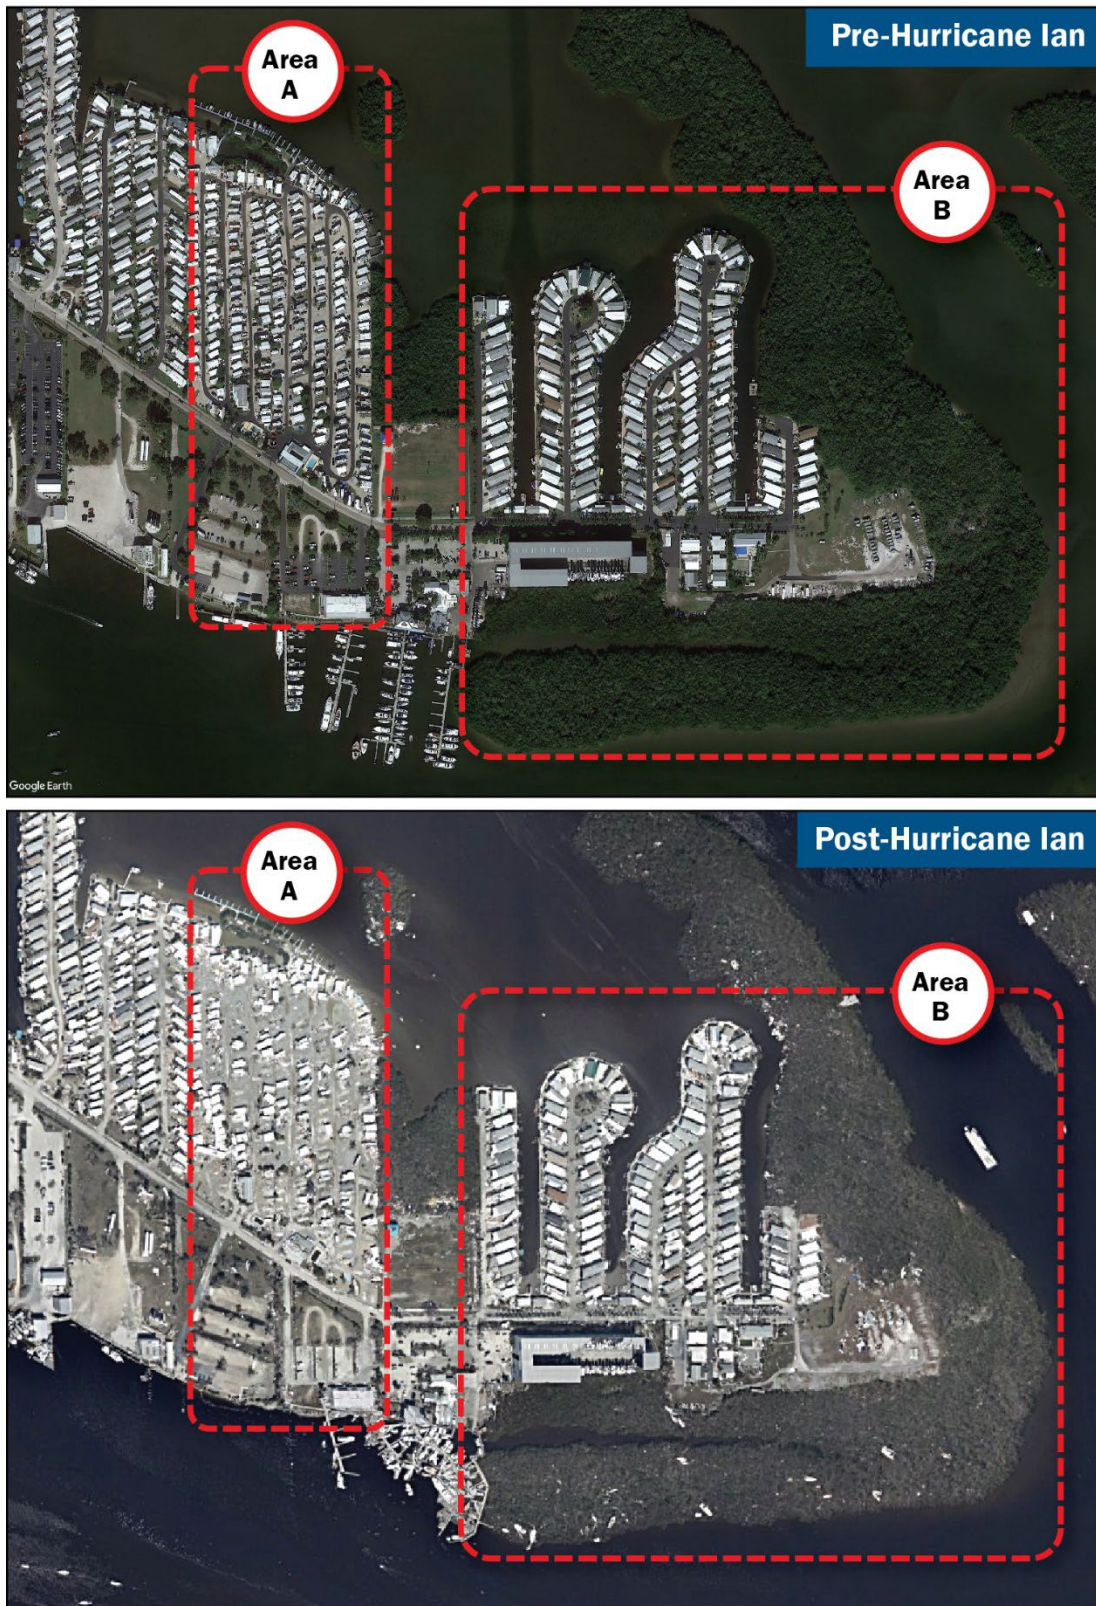
Figure 3-53 shows two areas in Fort Myers Beach with varying levels of building performance and flood-borne debris spread. Area A is a mixed development area that is classified as a recreational vehicle (RV) park but also has structures such as mobile homes (built before June 15, 1976) and manufactured homes (built after June 15, 1976). Area B consists of a mix of mobile homes and manufactured homes and is surrounded by wide, dense vegetation (mangroves). In general, the homes in Area A (build dates are grouped and only list 1969 and 1994) appear to be older and smaller than those in Area B (listed build dates range from 1966 to 2019). Figure 3-54 provides enlarged views of the two areas and shows that the homes in Area B performed better than those in Area A and that the mangroves surrounding Area B reduced the spread of flood-borne debris. Given the differences in age and type of construction between the two areas, the building performance between the two areas cannot be compared in relation to the vegetation alone. However, the flood-borne debris spread between the two areas provides for a good comparison.

Figure 3-53: Two areas in Fort Myers Beach; Area B is surrounded by dense vegetation (Zone VE)

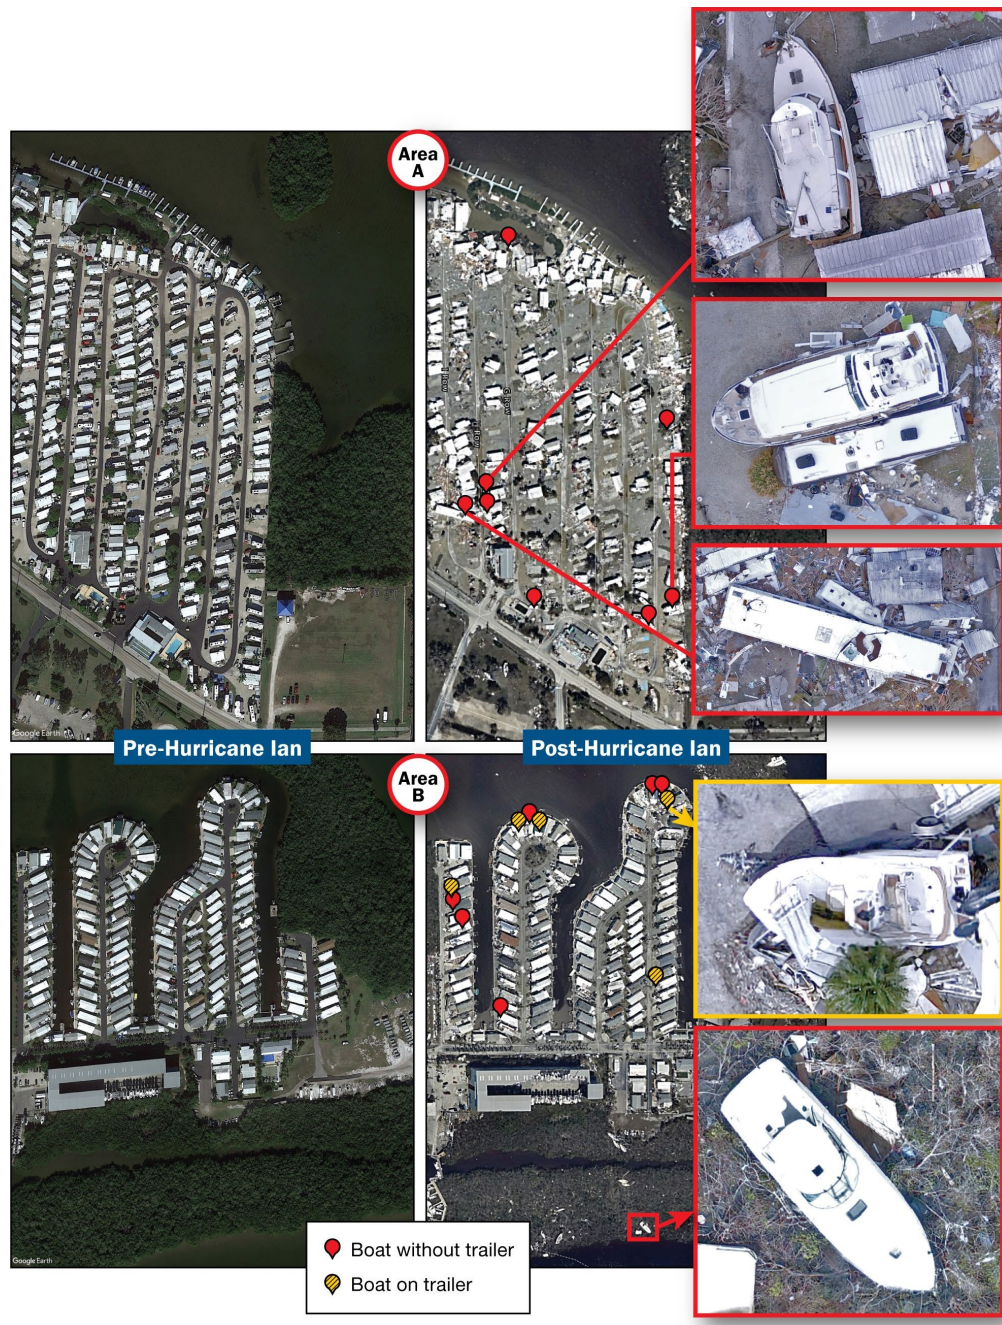
After Hurricane Ian, the residential portions of Area A and Area B had approximately eight and six displaced boats without trailers, respectively (based on aerial imagery) (Figure 3-54). Area A had more displaced boats and larger boats than Area B. Based on virtual measurements, the eight boats in Area A included one 100-foot-long boat, four 38- to 46-foot-long boats, and three 20- to 23-foot-long boats. In Area B, all six boats were approximately 16- to 22- foot-long boats. Based on the size of the boats in Area B and Area B's number of house docks, the boats in Area B may have been transported by floodwater from the docks behind the houses. An additional five displaced boats in Area B were on boat trailers. The boats on trailers are noted separately because they were landward of the vegetation before Hurricane Ian made landfall. The vegetated portion of Area B had more than 30 boats caught in the vegetation, they ranged in size from approximately 18 to 60 feet long. The surrounding vegetation aided in preventing these boats from traveling further inland into the residential portion of Area B as flood-borne debris.

The post-Hurricane Ian images show markers where displaced boats have been identified in the residential portions of the two areas. Representative boats are shown in inset images. The third boat inset picture shown in Area A is also discussed in Section 3.7 and Figure 3-51. Markers are not included for boats in the vegetated portions of Area B because of the large number of boats.

Figure 3-54: Enlarged views of pre- and post- Hurricane Ian imagery for the areas shown in Figure 3-53

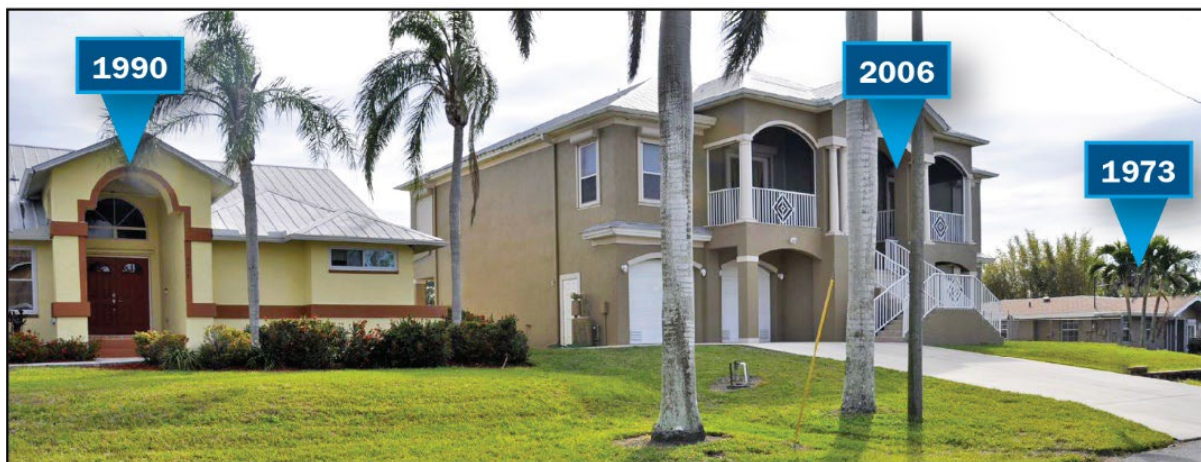
The MATs found several sites that enabled a comparison of newer versus older single-family houses. At this site, the 1990 and 2006 houses had less than 2 feet of flooding, with the 1990 house having floodwater in the lowest floor and the 2006 house having floodwater in its enclosure below the lowest floor; whereas, the 1973 house had approximately 7 feet of flooding in the lowest floor.

Figure 3-55: Example of side-by-side construction that the MAT compared (Lee County, Zone AE)

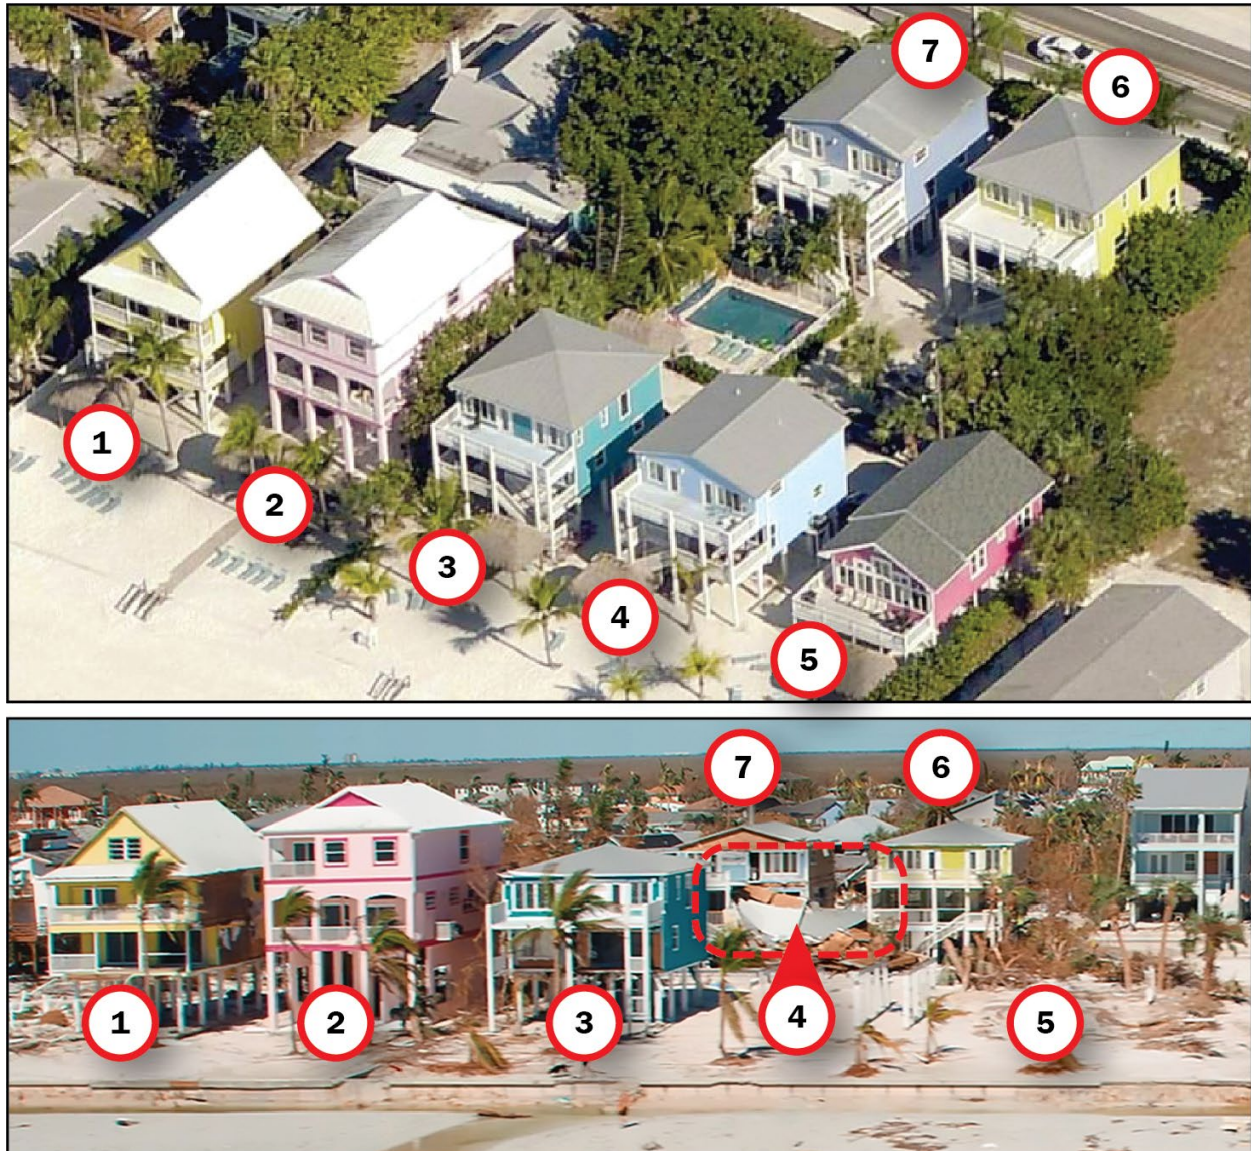
House #4 was moved from its foundation during Hurricane Ian; its post-storm location is indicated by the dotted line box. House #5, built in 1958 and having a lower elevation, was destroyed.

Figure 3-57: Seven elevated single-family houses in Lee County, built to different elevations

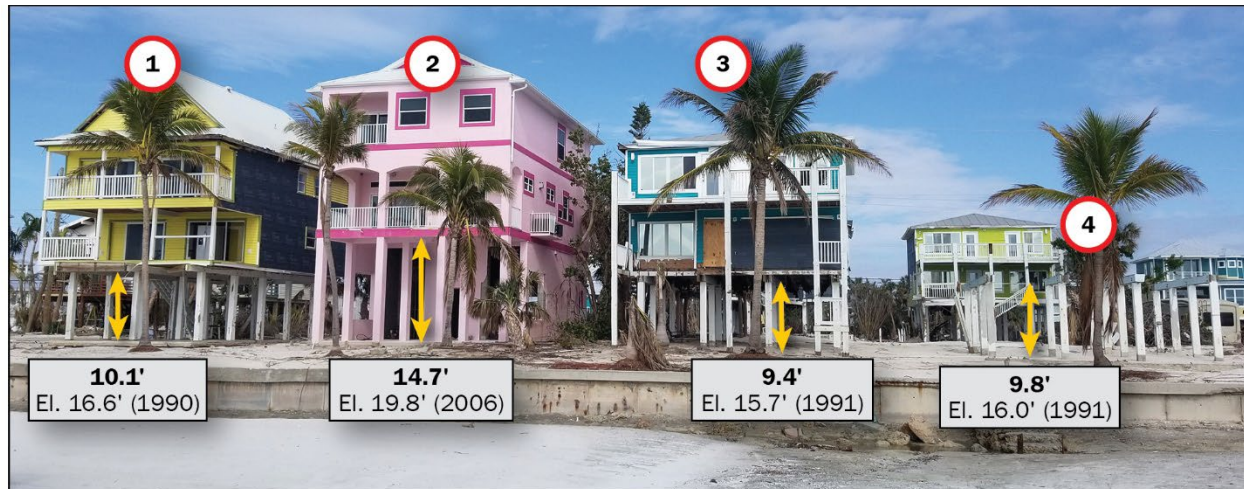
Figure 3-58: Field measurements of the four waterfront structures

Detailed field observations were recorded for the waterfront properties, houses #1 to #4. Of the houses shown in Figure 3-58, house #2 (2006) has the highest elevated lowest horizontal structural member supporting the lowest floor (14.7 feet field measured from slab) while house #3 (1991) has the lowest elevated horizontal structural member supporting the lowest floor (9.4 feet field measured from grade). See Table 3-5 for a summary of the approximate elevation of the lowest horizontal structural member of the lowest floor as well as observations for houses #1 to #5. Figure 3-59 shows examples of damage observed for each structure. A comparison of damage to these houses indicated significant differences based on the height of the building above grade. Structures with higher elevations above grade experienced less damage than those at lower elevations above grade. However, the varying performance of houses #3 and #4, which have similar elevations above grade, demonstrates that other factors also contributed to building performance. The contributing factors that lead to the failure of house #4 or the survival of house #3 are unknown. House #2 exhibited the least amount of damage and was elevated 3 to 4 feet higher than houses #1, #3, and #4. House #2 was required to comply with the CCCL 100-Year Storm Elevation requirements, which exceed the BFE by 4 feet. The other houses were not required to comply with CCCL 100-Year Storm Elevation requirements and were only required to be elevated to the BFE. The CCCL elevation requirements likely minimized the damage sustained by house #2.

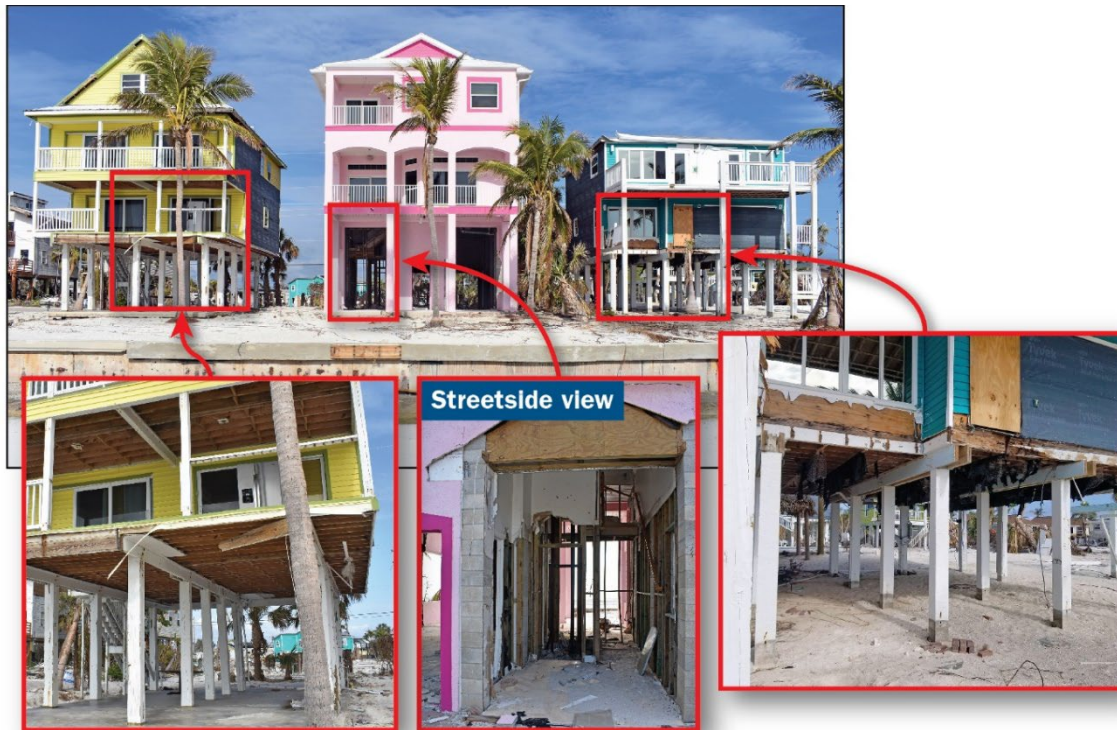
House ID Number (year built)	Approximate Elevation of Bottom of Lowest Horizontal Structural Member of the Lowest Floor (feet, NAVD 88)	Summary of Observations
1 (1990)	16.6 ^(a)	Damage included a missing exterior set of stairs, failed façade trim boards, missing railings, and almost complete removal of the underside floor joist covering. Although the team could not evaluate the interior of the building, water likely entered the lowest floor of the structure and caused additional damage.
2 (2006)	19.8 ^(b)	This house included an enclosure with breakaway walls and flood openings. Minimal damage was observed for this house, and floodwater likely did not enter the lowest floor. The breakaway walls appeared to perform as expected with the exception of some façade failure, which was likely due to improper separation from the breakaway wall components.
3 (1991)	15.7 ^(a)	Damage included a failed deck that further damaged the main structure, a door and windows were boarded and likely concealed damage to these elements, damaged underside floor joist covering, missing siding, and submerged electrical boxes. Although the team could not evaluate the interior of the building, water likely entered the lowest floor of the structure and caused additional damage given the boarding in place to temporarily close the home envelope.

4 (1991)	16.0 ^(a)	Complete loss. Main structure separated from the lowest horizontal structural members supporting the lowest floor.
5 (1958)	Unknown; lower than houses #1–#4 based on Figure 3-57	Complete loss.

Figure 3-59: Examples of damage observed for each of the three remaining waterfront structures

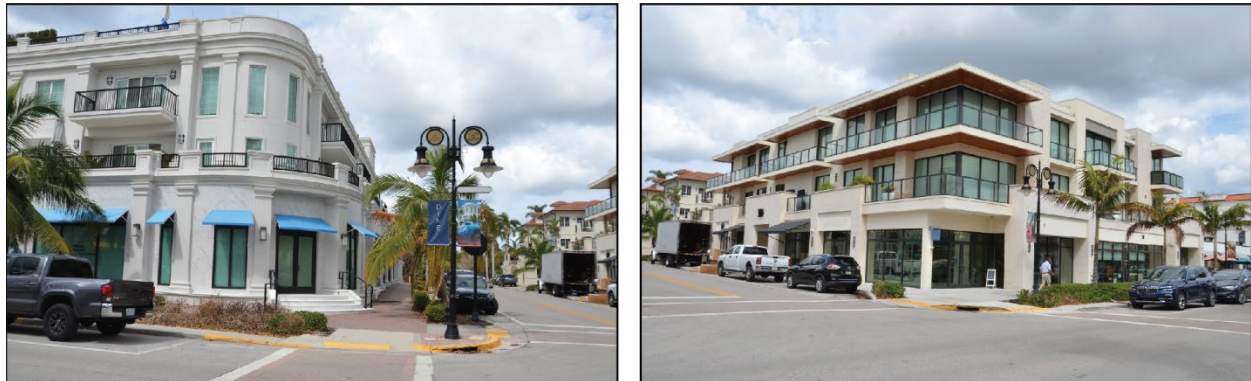
Figure 3-64: Downtown Naples (Collier County, Zone AE)

The building on the left in Figure 3-64 was built in 2018 on foundation walls and had fill of approximately 2 to 3 feet above grade to reach the DFE, requiring pedestrian access via stairs from street level. This building also included one level of below-grade parking. The building on the right in Figure 3-64 was built in 2019 and had a combination of wet and dry floodproofing measures that were intended to prevent floodwater from entering the commercial areas and to intentionally allow floodwater to enter and exit automatically in enclosures providing residential building access. The designs of the two buildings were intentionally different because the latter building owners considered direct pedestrian access (unimpeded by stairs) to store front commercial spaces important on corner lots in a high-density urban area.

The building on the left did not experience any flood damage, while the building on the right, for which the owners ineffectively deployed its designed dry floodproofing measures, had about 3 to 6 inches of flooding. This caused the retail spaces to be closed for about 7 days, according to one business owner, while repairs were made and business operations were restored. The floodproofing measures for the building on the right were ineffective because the wet and dry floodproofing measures conflicted with one another (areas intended to be fully dry floodproofed had flood openings). The building on the left was sufficiently elevated above Hurricane Ian flood levels, including an elevated ramp enabling access into a below-grade parking garage, which helped keep the entire building flood resistant without requiring human intervention. Figure 3-65 through Figure 3-67 provide representative pictures of the two buildings.

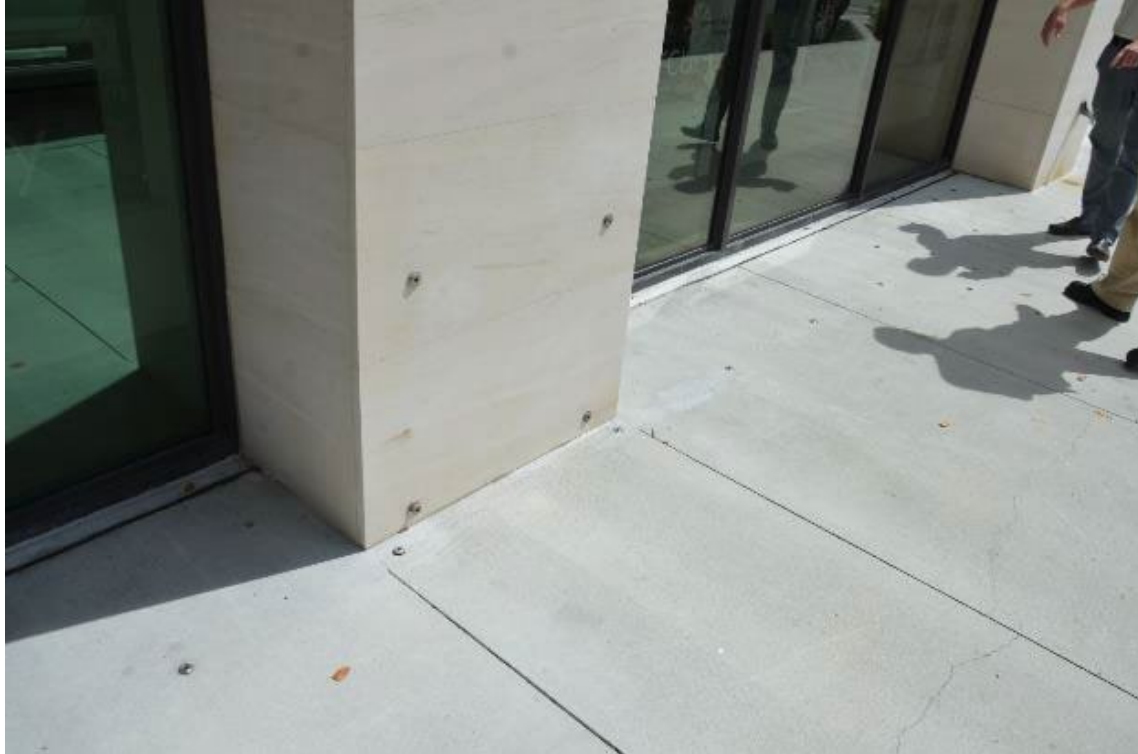
Figure 3-65: Anchors for active dry floodproofing measures on building in downtown Naples (Collier County, Zone AE)

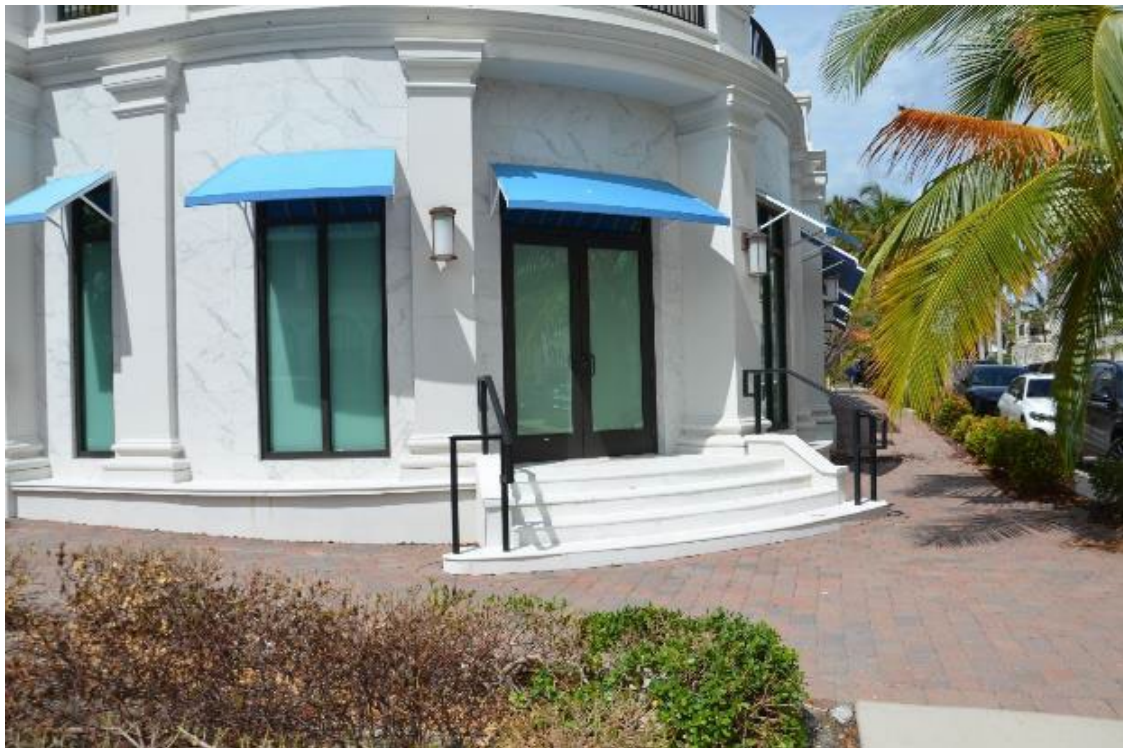
Figure 3-66: Building elevated on fill and foundation walls in downtown Naples (Collier County, Zone AE)

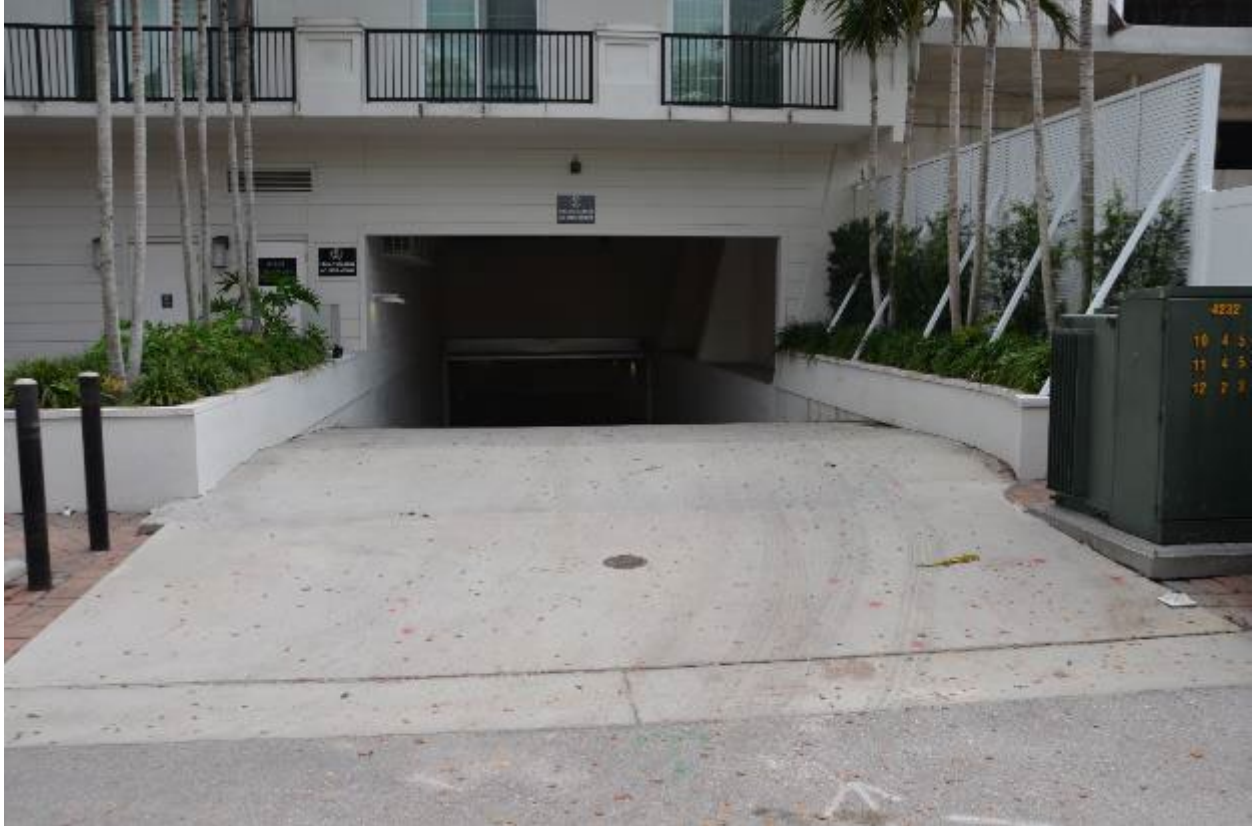
Figure 3-67: Below-grade parking with elevated ramp access in the building elevated on fill and foundation walls (Collier County, Zone AE)

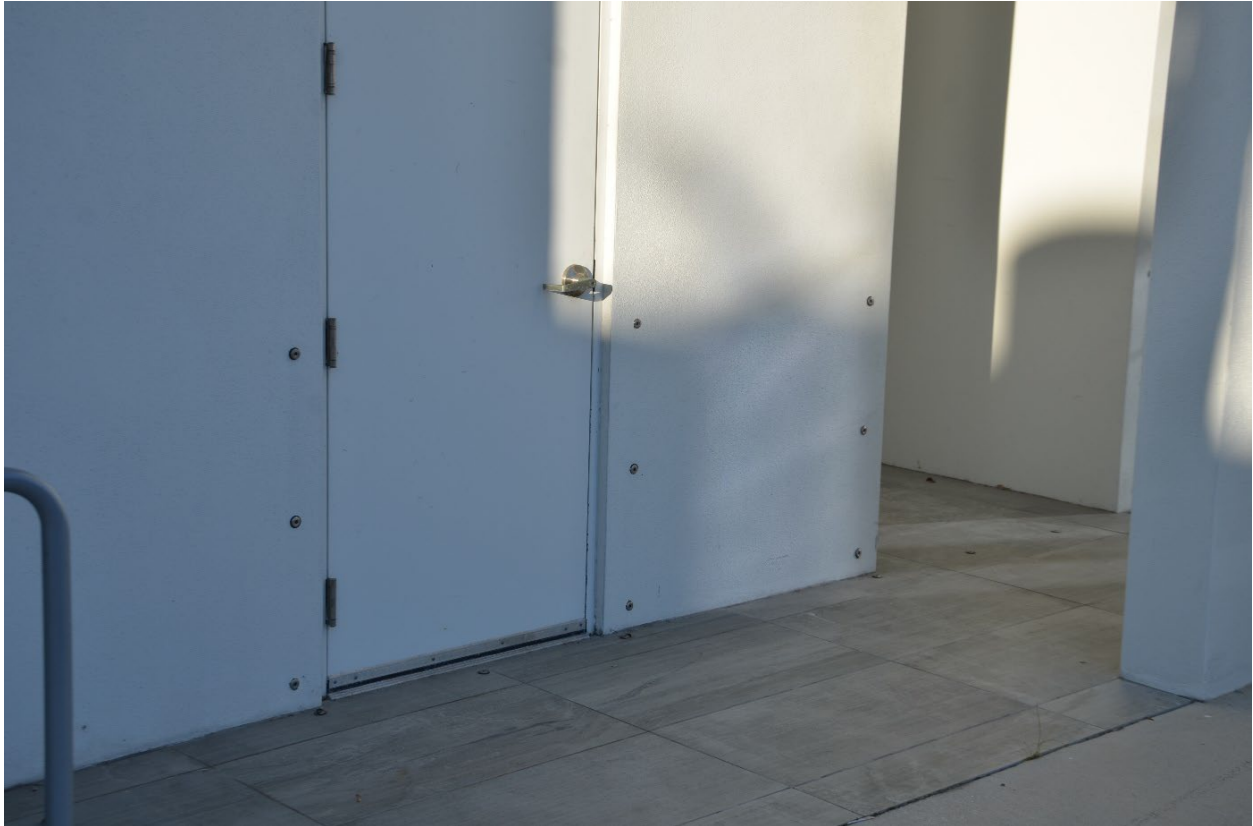
Across the October 2022 preliminary assessments and especially during the field work in January 2023, the MAT visited over a dozen buildings throughout Naples and Collier County that were designed to be dry floodproofed (Figure 3-68 through Figure 3-72). The MAT visited office buildings, restaurants, retail/storefronts, a post office, bank, coffee shop, and other non-residential buildings in areas that experienced flooding during Hurricane Ian (primarily in the vicinity of downtown Naples). Although the MAT was hoping to document lessons learned related to the performance of dry floodproofing measures, the most common observations from field assessments were that the dry floodproofing measures were often not deployed as designed. Figure 3-70 through Figure 3-72 illustrate barriers that were not deployed as designed for Hurricane Ian. Several of these buildings experienced flooding of 6 inches to 3 feet because the dry floodproofing measures (e.g., flood shields) were not deployed. This resulted in extensive flood inundation damage as well as weeks or months of business disruption while repairs were completed. Numerous businesses were still not in operation during the time of the MAT assessments, fully 4 months after landfall, and many were still weeks or months away from reopening because of repairs. Some of these businesses went out of business permanently, which could have been the result of not implementing available floodproofing measures in preparation for Hurricane Ian and sustaining significant flood damage.

Figure 3-68: Dry floodproofed office building; note anchors on each side of door frame to support opening barriers (Collier County, Zone AE)

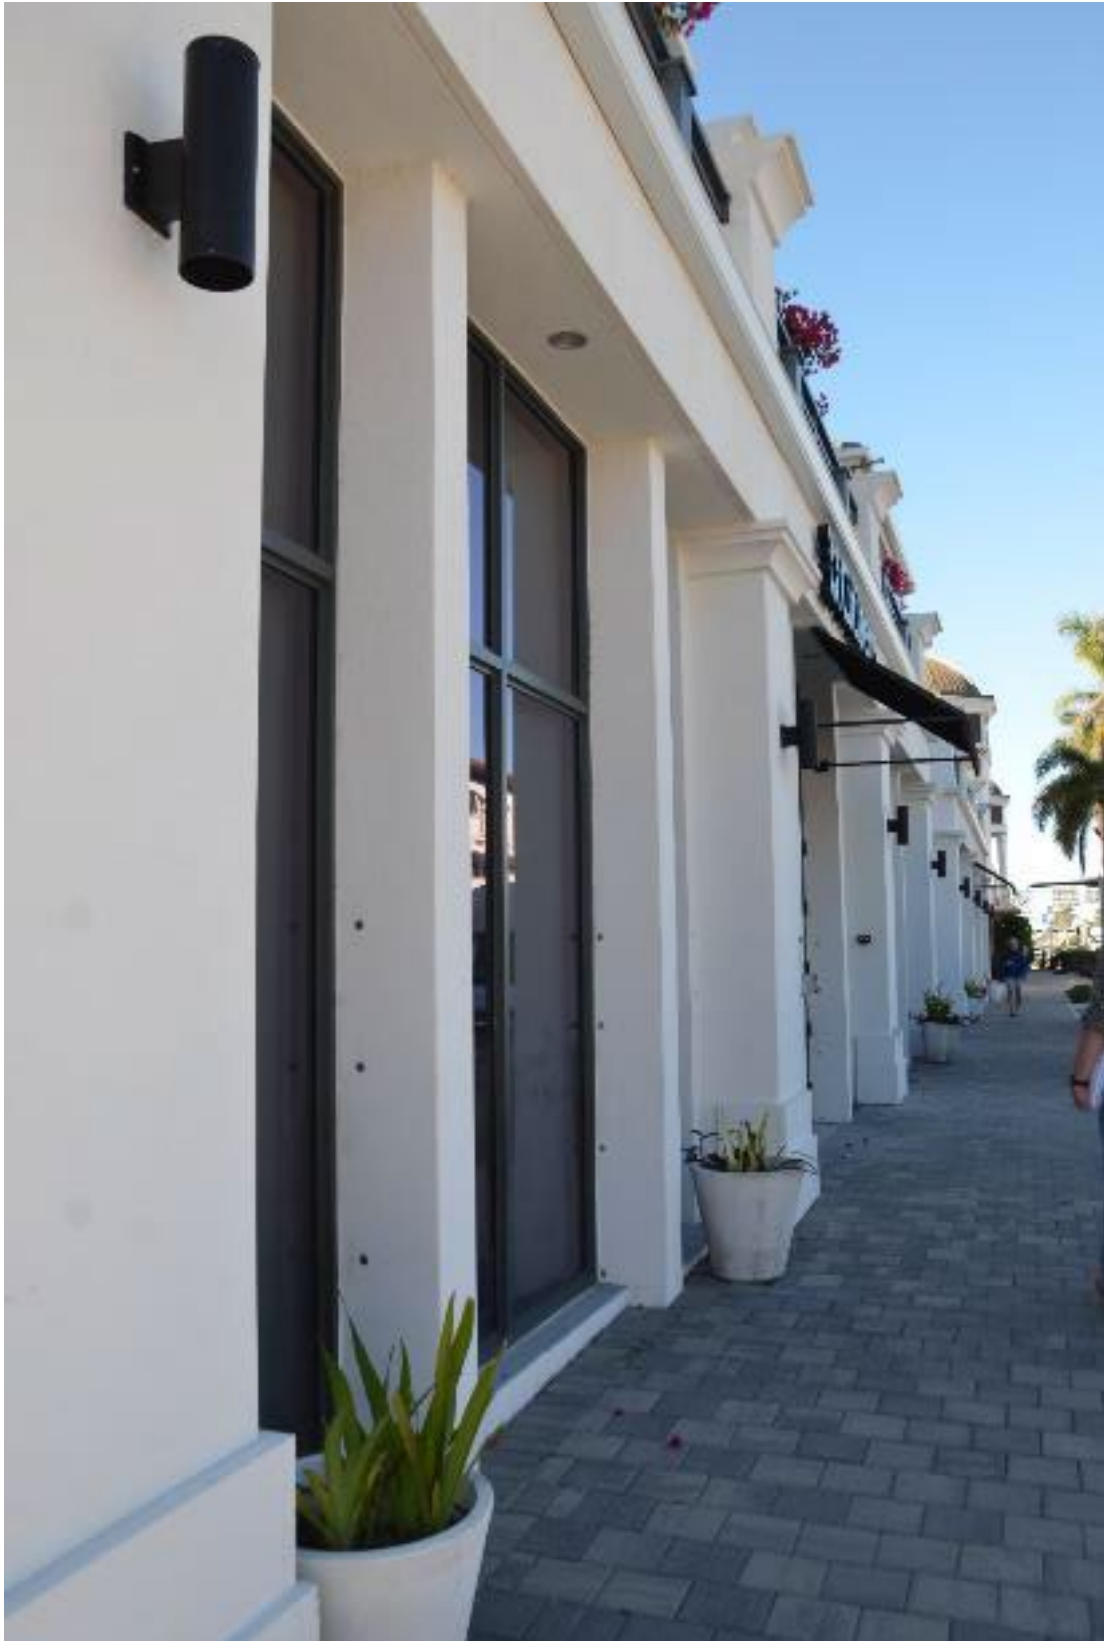
Figure 3-69: Dry floodproofed retail building; note anchors on each side of the window frame to support opening barriers (Collier County, Zone AE)

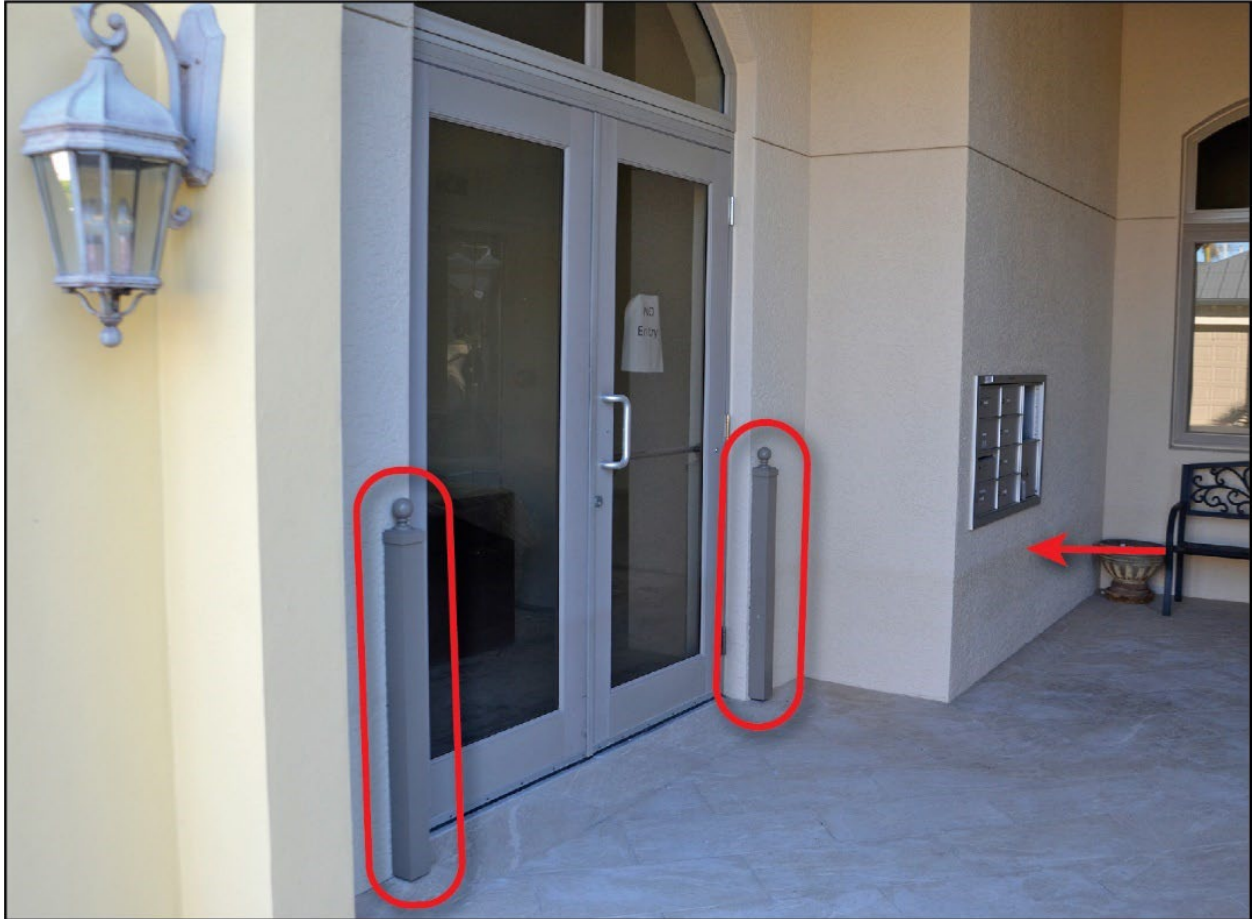
Figure 3-70: Office building where dry floodproofing measures were not deployed; note HWM (arrow) and posts for dry floodproofing measures (circled) (Collier County, Zone AE)

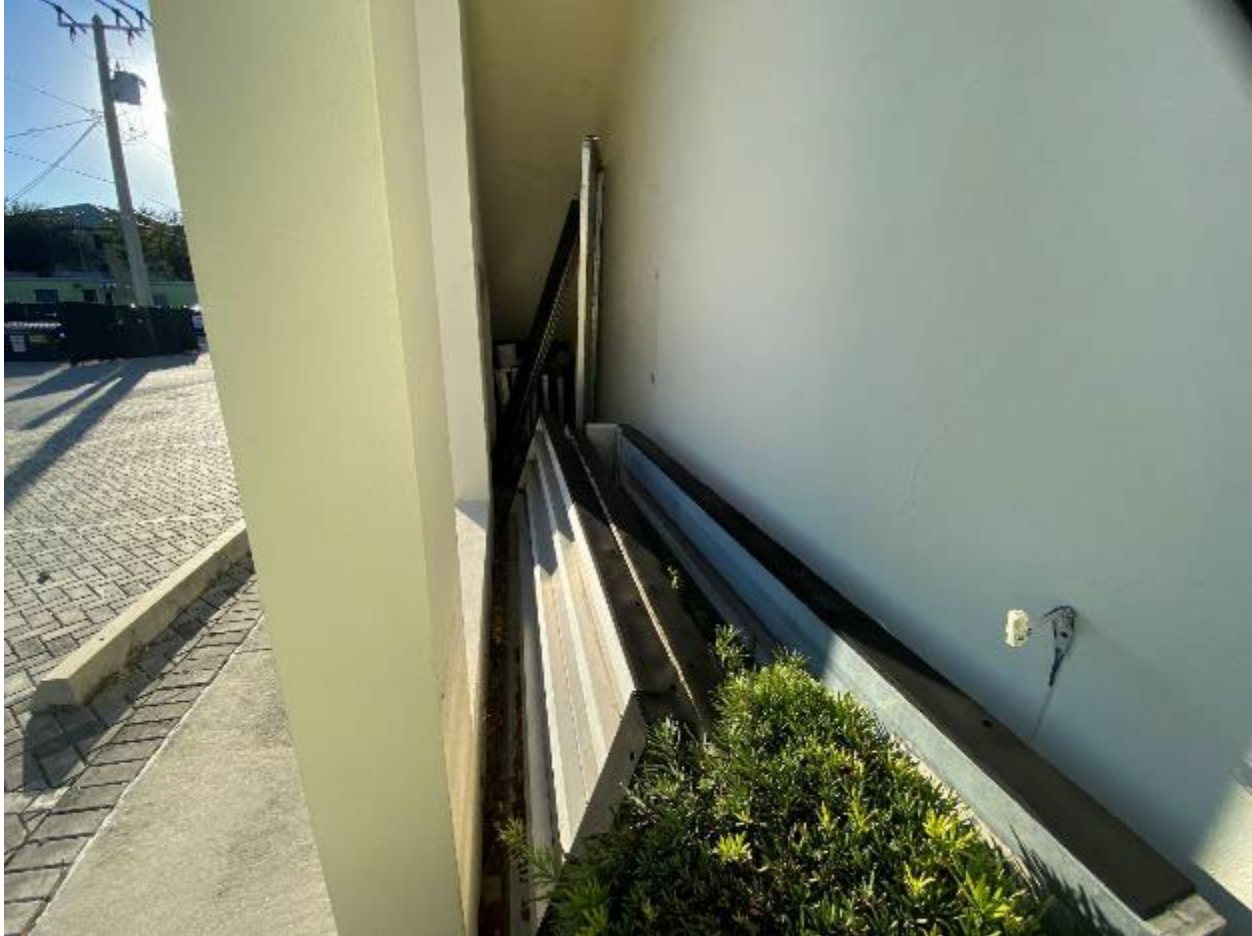
These opening barriers did not appear to have been moved from this onsite storage location for several months/years.

Figure 3-71: Opening barriers for an office building that were not deployed (Collier County, Zone AE)
