Mitigation Assessment Team Report

Hurricane Ian in Florida

Building Performance Observations,
Recommendations, and Technical Guidance

FEMA P-2342/December 2023

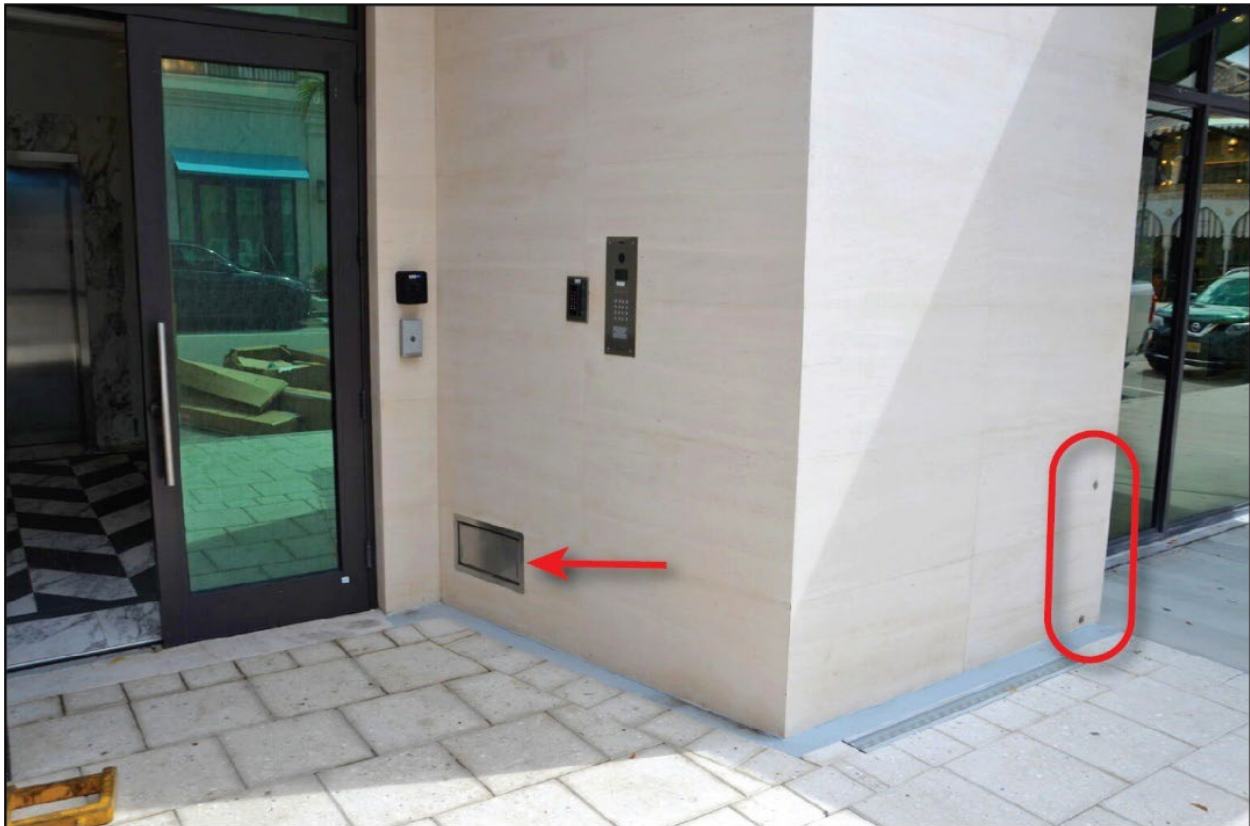
One relatively unique building that the MAT visited is a mixed-use building that was designed for a combination of dry and wet floodproofing measures (Figure 3-73). The plans indicated dry floodproofing of the retail non-residential space and wet floodproofing of the lobby; however, the construction/implementation was inconsistent with the design drawings, including one area that had flood openings immediately adjacent to connections for temporary barriers (Figure 3-74). While the dry floodproofing measures were installed along the storefronts just prior to Hurricane Ian, similar dry floodproofing measures were not installed at the rear entrances, resulting in 3 to 6 inches of flooding of the retail space. According to one of the store owners, the store and several other retail spaces were closed for at least a week to repair and restore business operations.

Figure 3-73: Mixed-use building with wet floodproofing measures (arrow) in residential access area and dry floodproofing measures (circle) in retail space/non-residential area (Collier County, Zone AE)

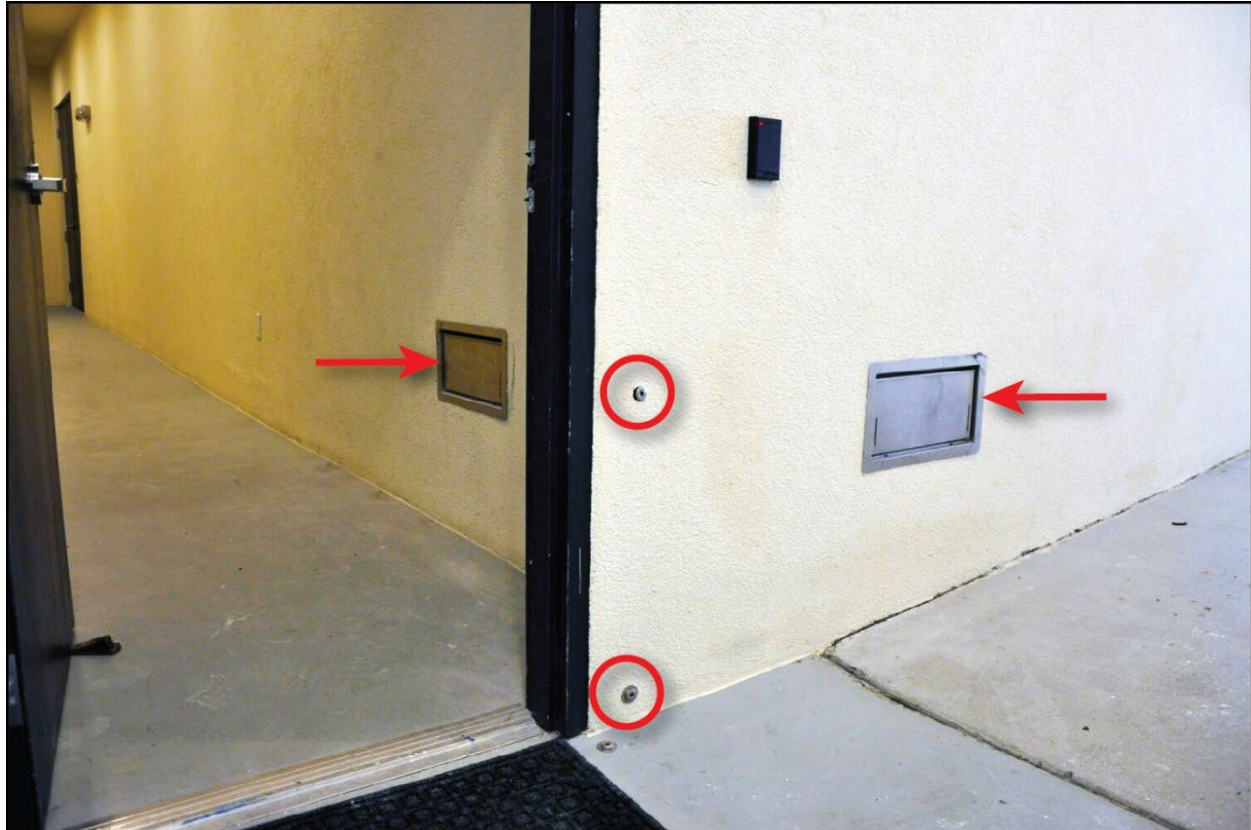
Red arrows indicate wet floodproofing measures and circles illustrate anchors for dry floodproofing measures for an enclosed area within a mixed-use building.

Figure 3-74: Inconsistent and counterproductive floodproofing measures in a mixed-use building (Collier County, Zone AE)

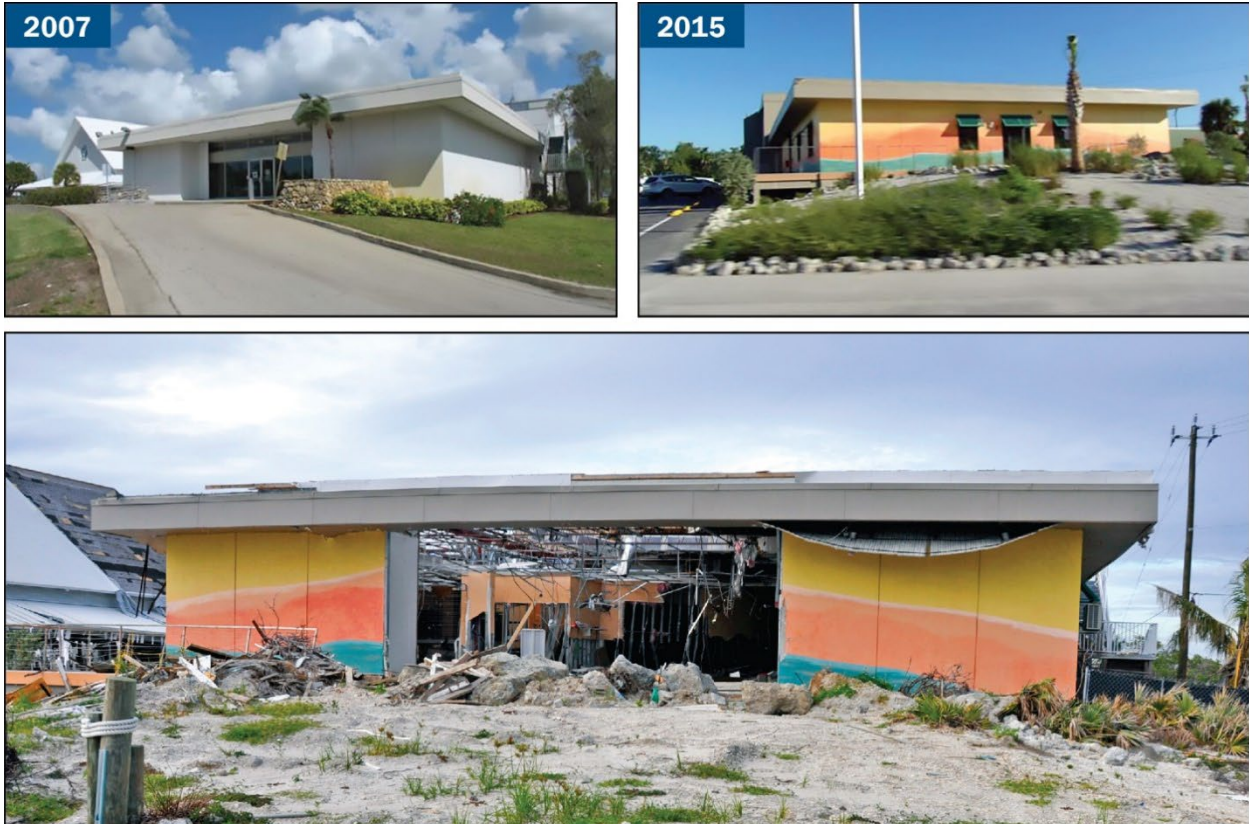
The Fort Myers Beach Town Hall was one of the few buildings observed by the MAT that had dry floodproofing measures implemented. Based on street view imagery taken in October, the entrance along the south facing wall (along Estero Boulevard and parallel to the coast) was destroyed by the storm surge. The flood loads returned the south-facing wall and entrance to its pre-2015 retrofit conditions (Figure 3-75 and Figure 3-76). Although this site was in Zone AE 13 based on the 2008 effective FIRM and remains in Zone AE 11 based on the November 2022 effective FIRM, the LiMWA is immediately along the southern limit of the parcel (Figure 3-77). An HWM of 11.4 feet NAVD 88 was collected by the USGS at the church adjacent to the Town Hall building. Based on observations made by the MAT in mid-January, the building implemented active dry floodproofing measures (Figure 3-78); however, it was unclear to what height or whether all the barriers were installed. The storm surge appeared to force its way in through the south wall/entrance then force its way back out through other openings (from the back side of the flood barriers). These site conditions and flood loads on the dry floodproofing measures reinforce flood-resistant design and construction requirements that prohibit dry floodproofing in Coastal High Hazard Areas. Figure 3-79 shows the barriers along the north wall main entrance having been blown out and Figure 3-80 shows an employee entrance door having been blown out.

Figure 3-75: Fort Myers Beach Town Hall south-facing wall 2015 through present (Lee County, Zone AE)

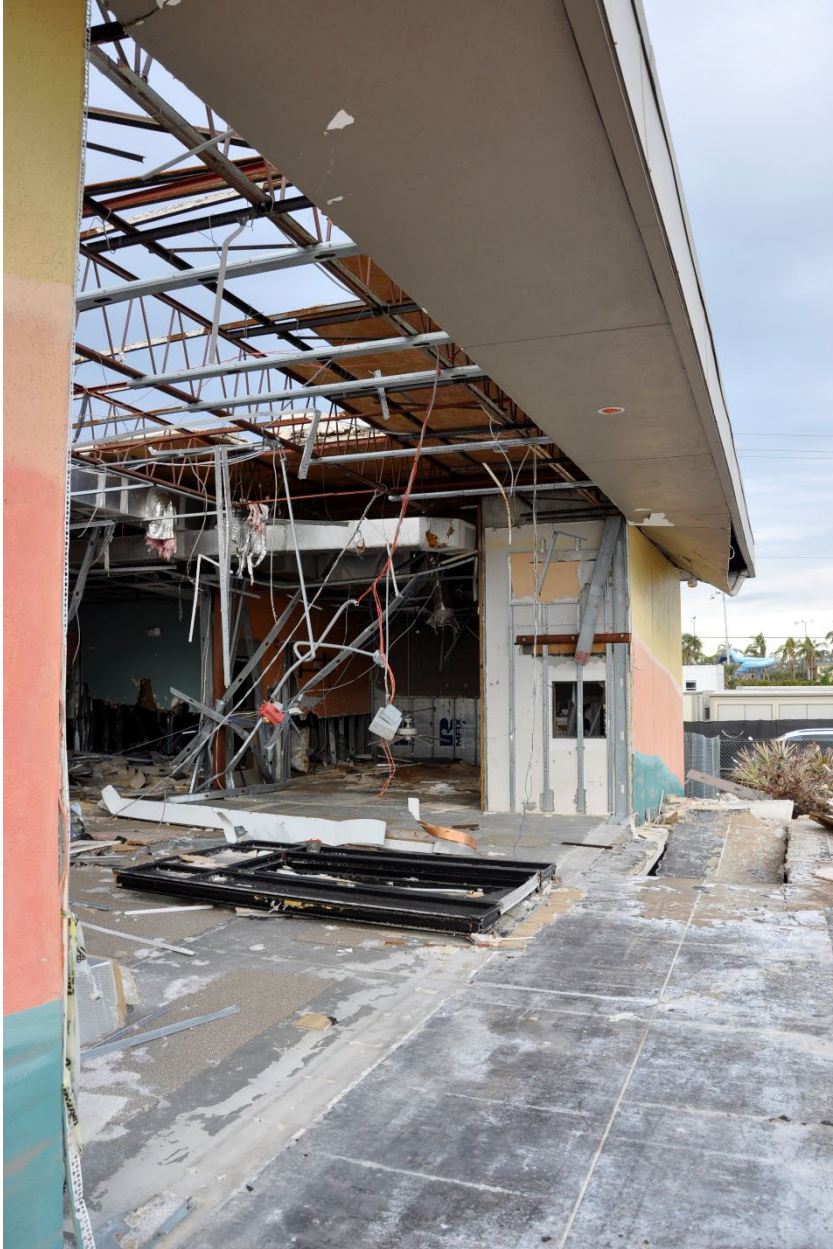
Figure 3-76: Fort Myers Beach Town Hall south-facing wall following Hurricane Ian (Lee County, Zone AE)

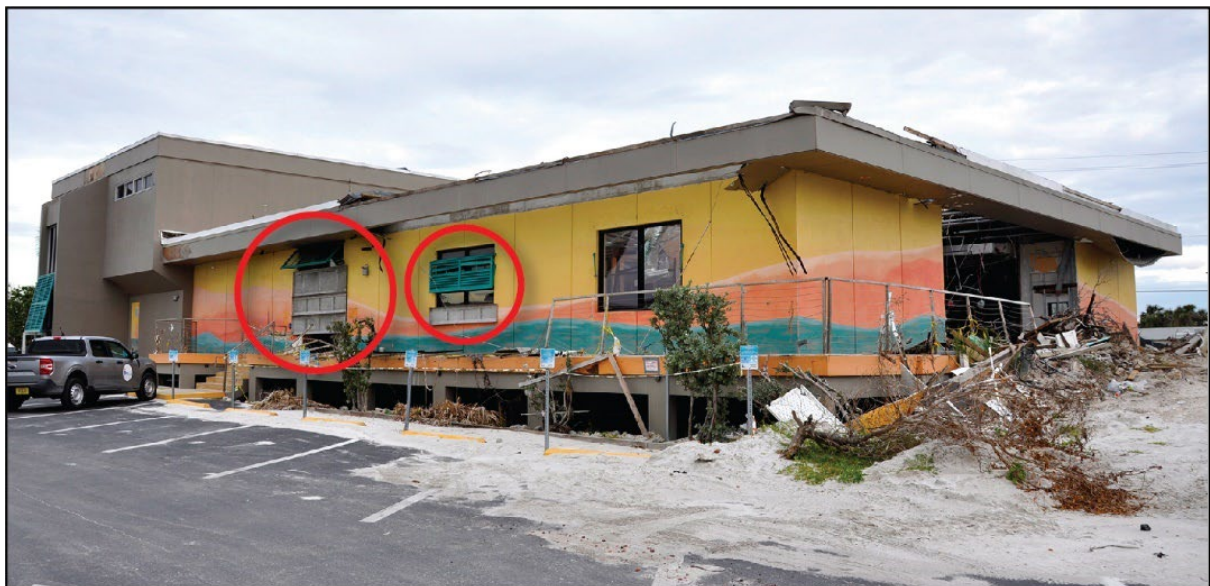
Figure 3-78: Dry floodproofing measures implemented (barriers circled) at Fort Myers Beach Town Hall (Lee County, Zone AE)

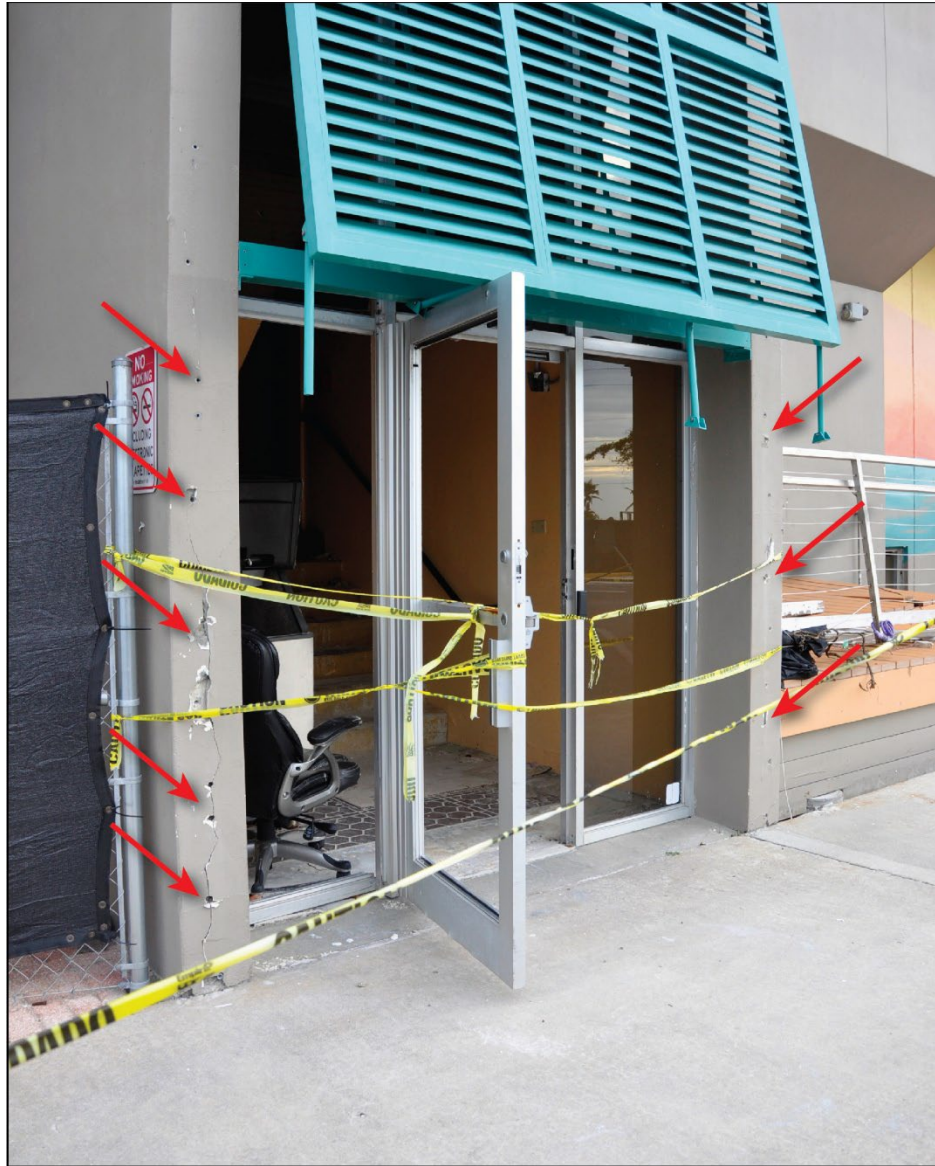
Red arrows indicate the locations of several anchors, which had minimal structural embedment, along the north-facing wall. The barriers along this entrance were pulled away from the wall as surge entered from the south side and forced its way through and back out of the building through the north side.

Figure 3-79: Dry floodproofing measures along north-facing wall at Fort Myers Beach Town Hall were blown out (Lee County, Zone AE)

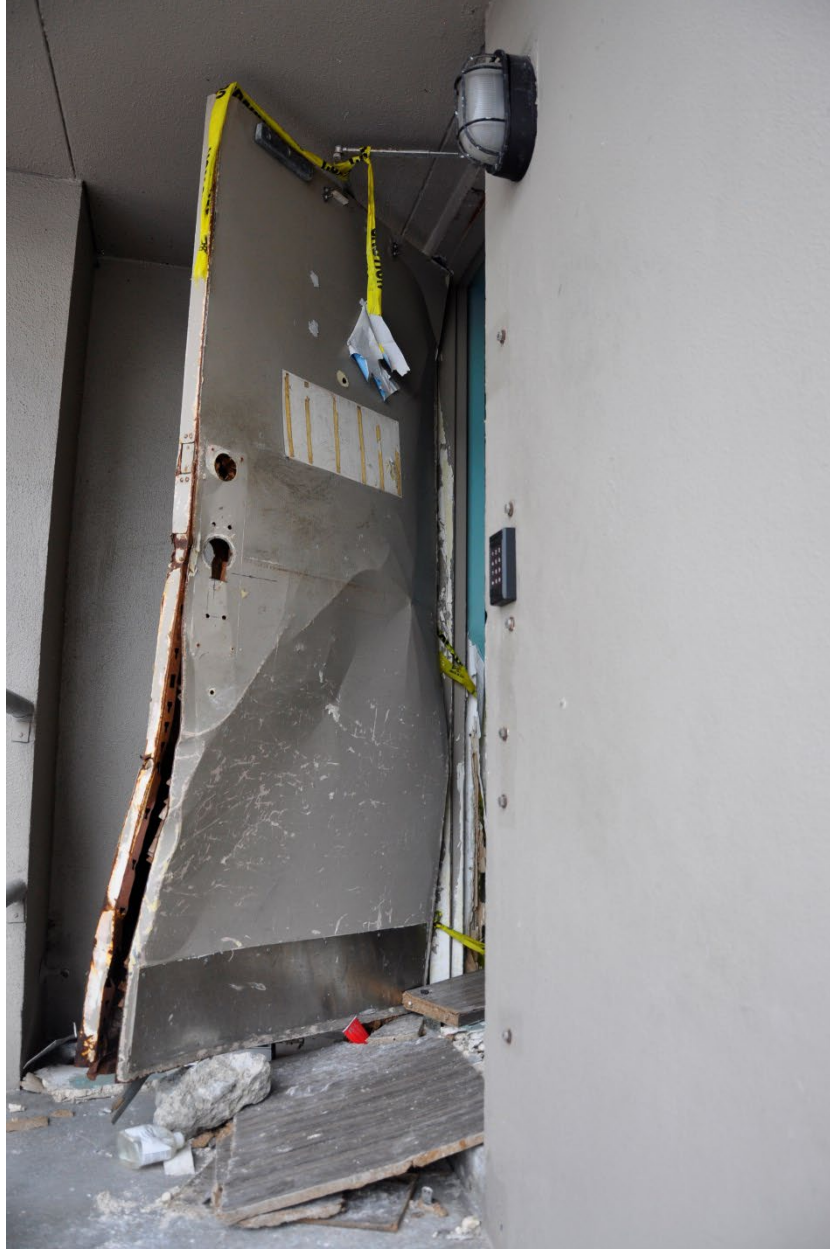
Figure 3-80: Employee entrance door blown out by flood loads at Fort Myers Beach Town Hall (Lee County, Zone AE)

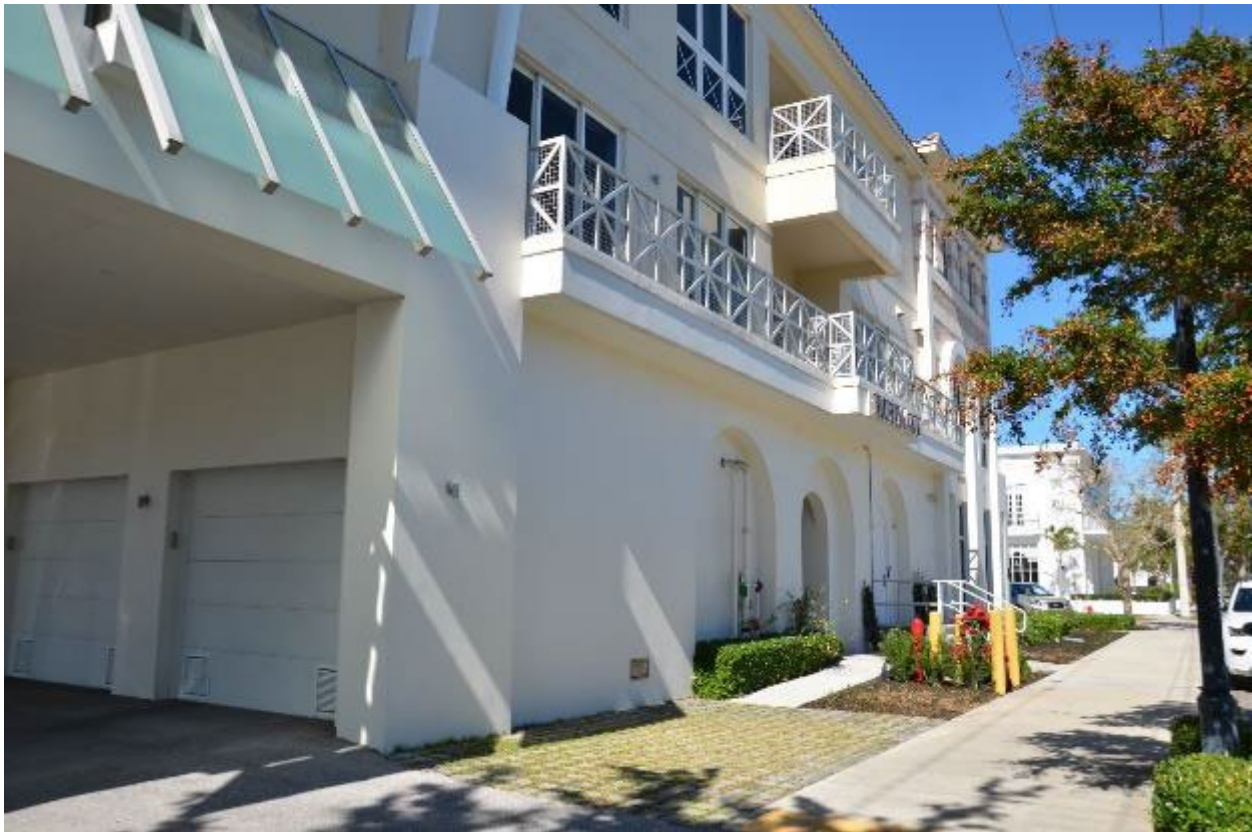
Figure 3-81: Mixed-use building with retail space and parking at grade, with residential apartments above (Collier County, Zone AE)

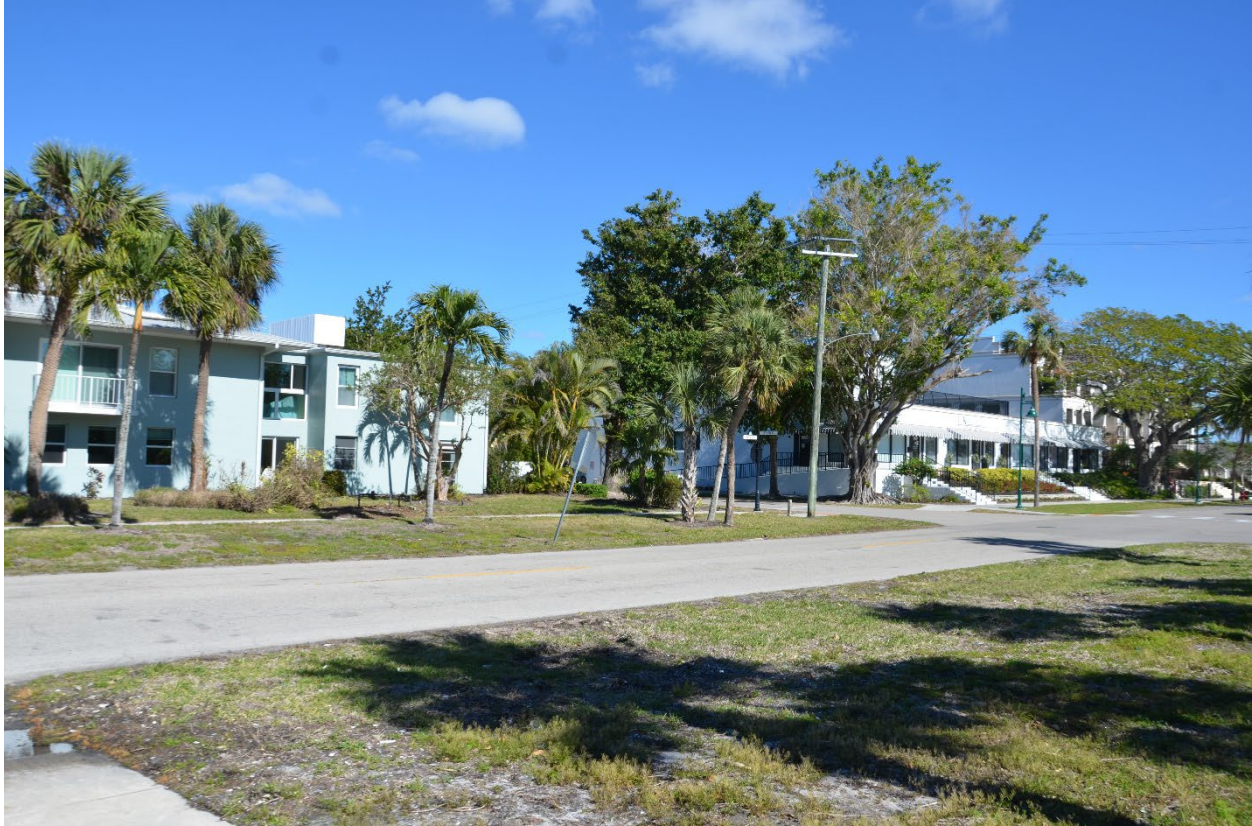
The building on the left had several feet of flooding and was still undergoing repairs 4 months after Hurricane Ian made landfall; there was no reported damage to the building on the far right, other than having limited access during the hurricane as the roads were flooded.

Figure 3-82: Older condominium complex to the left, newer building on the far right (Collier County, Zone AE)

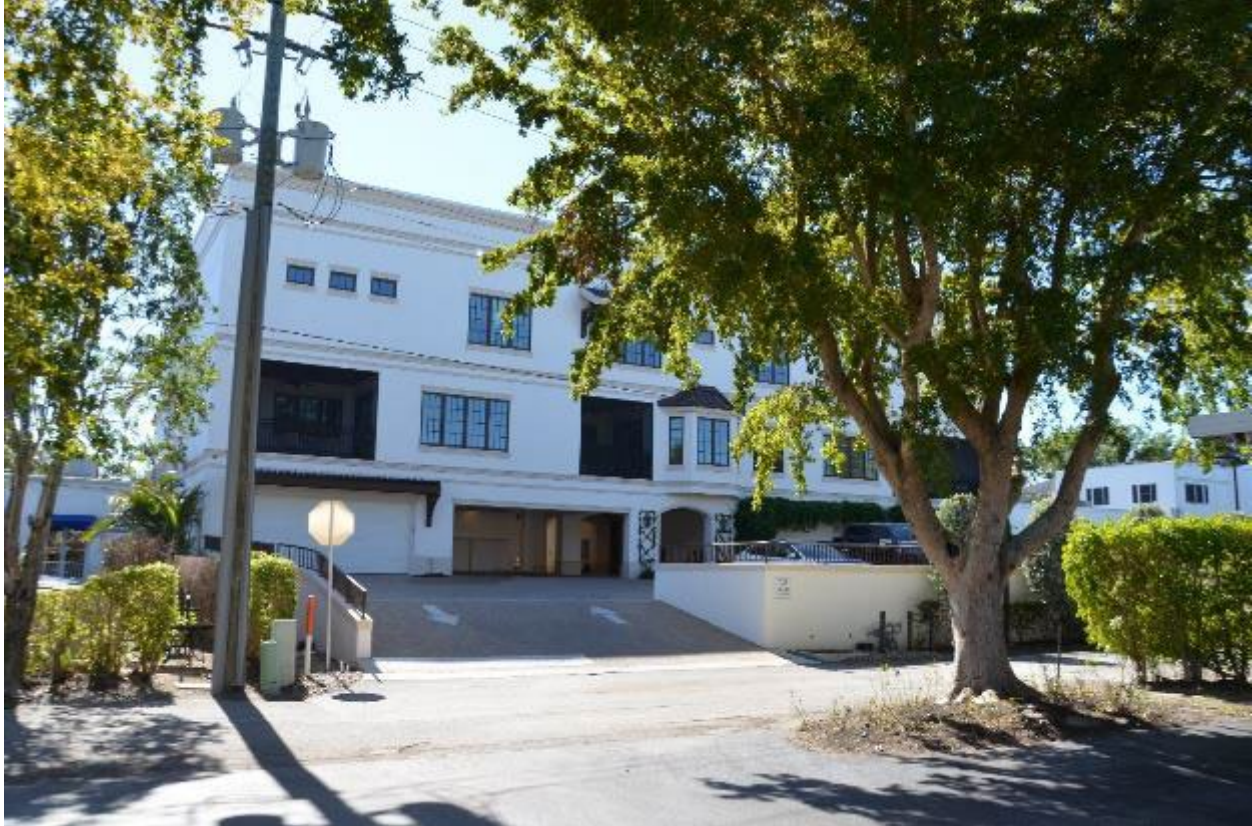
Based on a field interview with the tenant, the building was surrounded by floodwater several feet up the parking ramp, but the floodwater did not enter the garage enclosure. The building did not sustain flood damage.

Figure 3-83: The rear of an elevated on fill, mixed-use building with parking (Collier County, Zone AE)

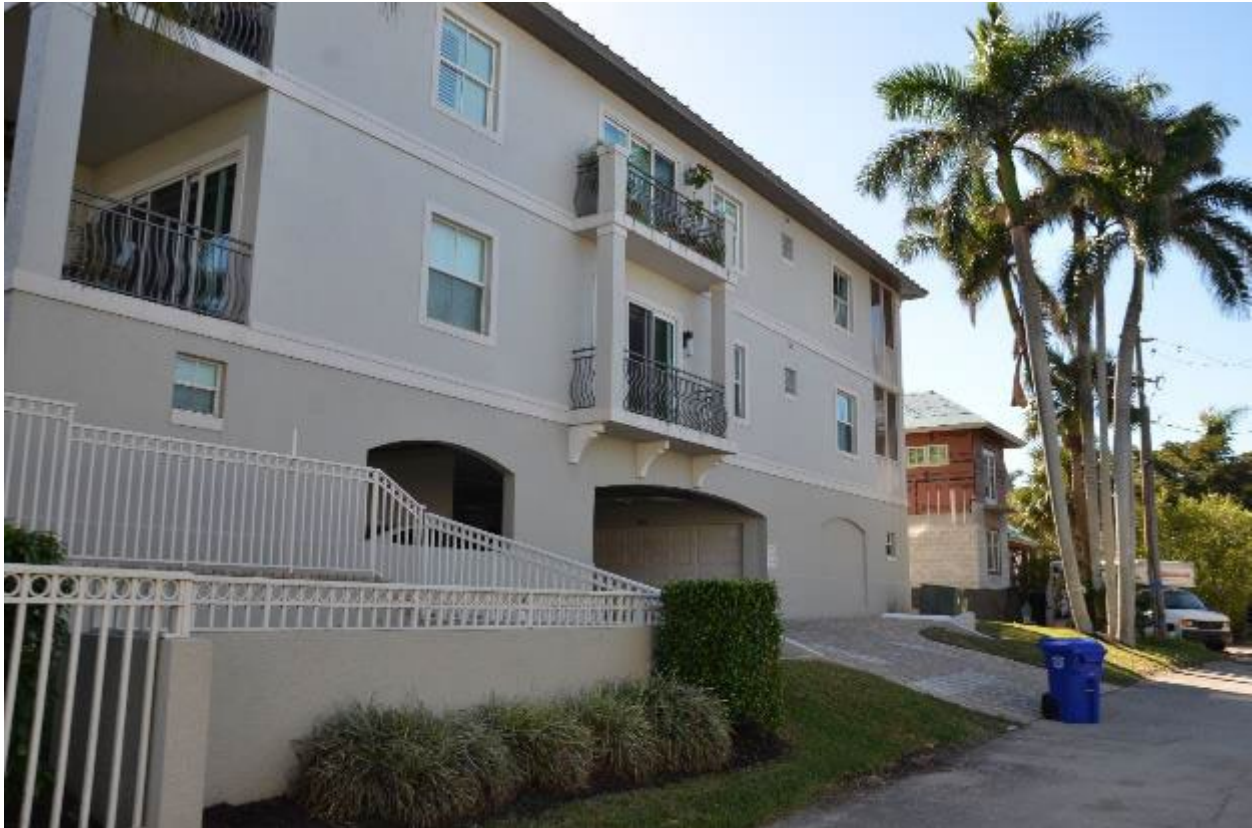
No flood damage was observed or reported to this building.

Figure 3-84: Newer multi-family building with parking enclosure below DFE and residential apartments above (Collier County, Zone AE)

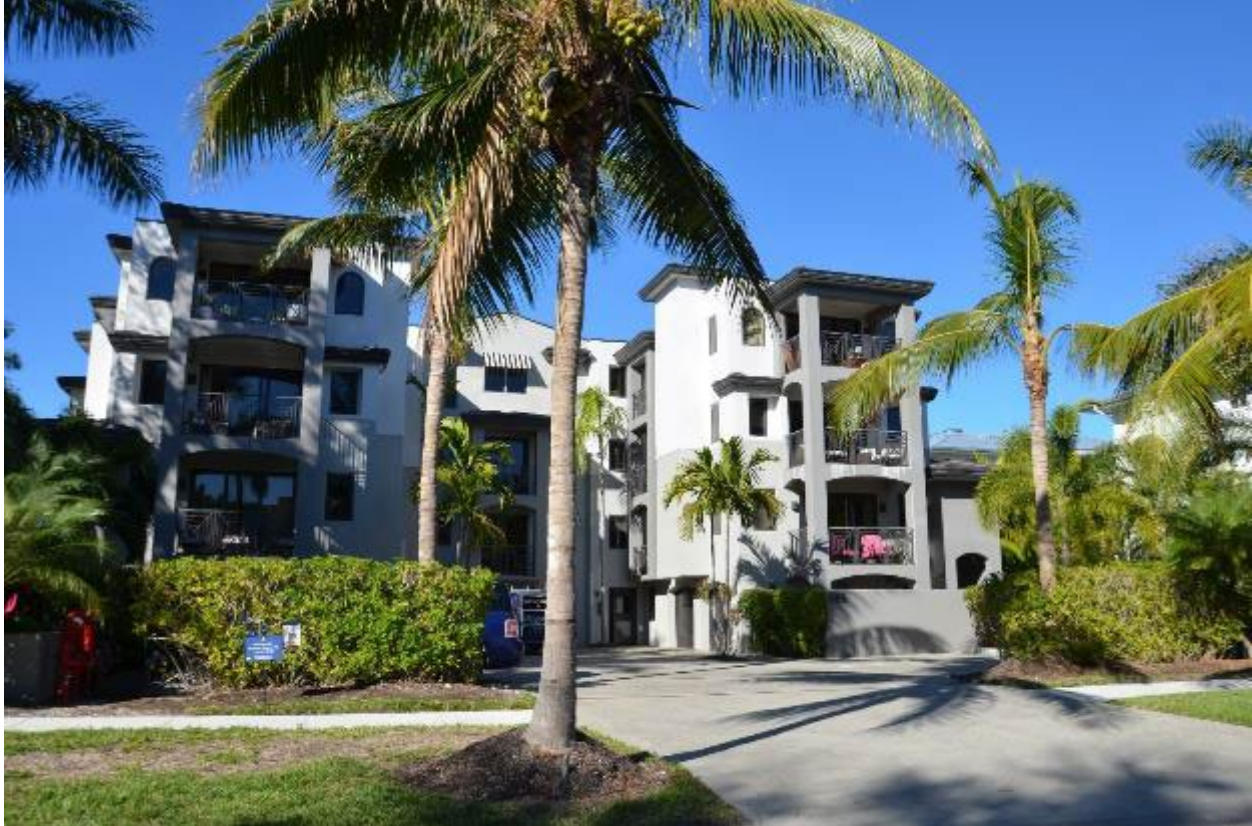
Damage in this elevated above-ground building was limited to non-flood damage-resistant materials in enclosures used for storage and access as well as damage to the elevator system.

Figure 3-85: Multi-family building with parking and storage enclosures below the DFE along with elevated residential condominiums (Collier County, Zone AE)

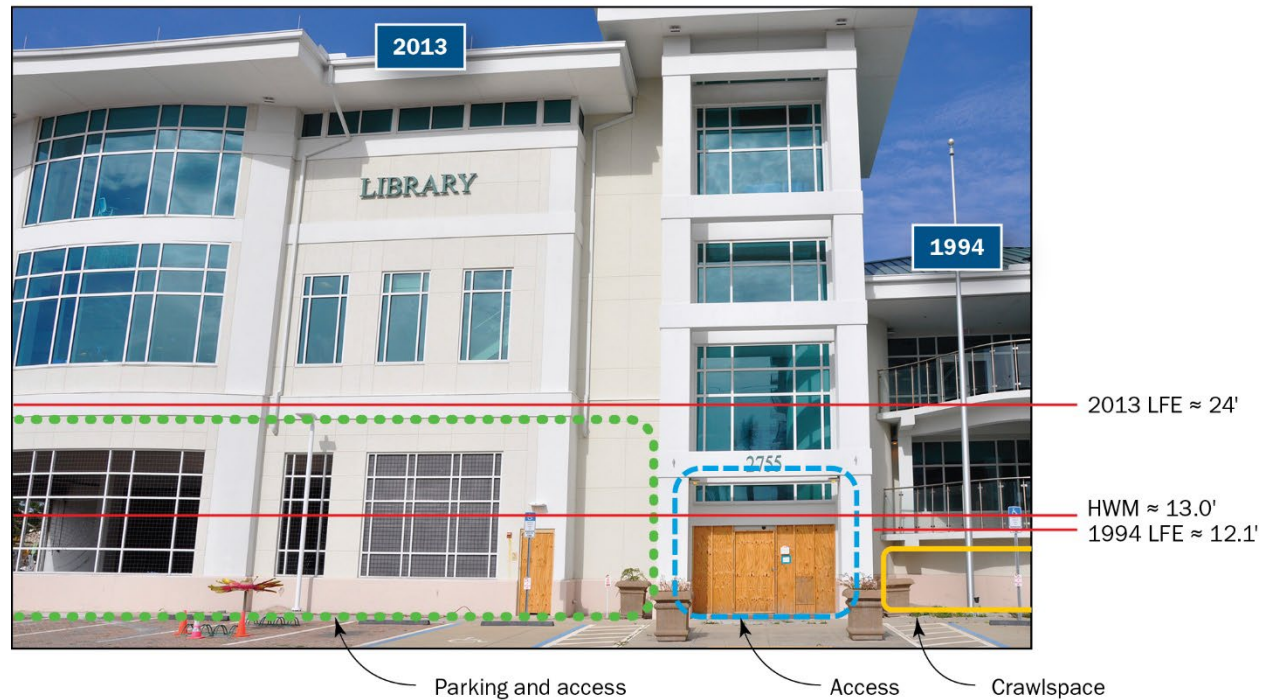
Figure 3-87: Fort Myers Beach Library (Lee County, Zone AE)

In 2013, an elevated addition with approximately 18,900 square feet was constructed adjacent to the 1994 structure. The lowest floor of the 2013 portion is at 24.15 feet NAVD 88. The main entry of the 1994 structure was altered to connect the 1994 portion of the library to the 2013 addition. The existing entry door was removed and re-located from the lowest floor elevation of 12.15 feet NAVD 88 to grade level at approximately 5 feet NAVD 88. The alteration created additional interior space that serves as an atrium between the 1994 and 2013 buildings. This atrium area was damaged by floodwater, and the MAT was unable to determine what flood damage prevention measures were incorporated into the new atrium (likely intended to be wet floodproofed). Figure 3-87 illustrates the 1994 and 2013 portions of the Fort Myers Beach Library.

The access is to interior space that serves as an atrium between the 1994 and 2013 buildings.

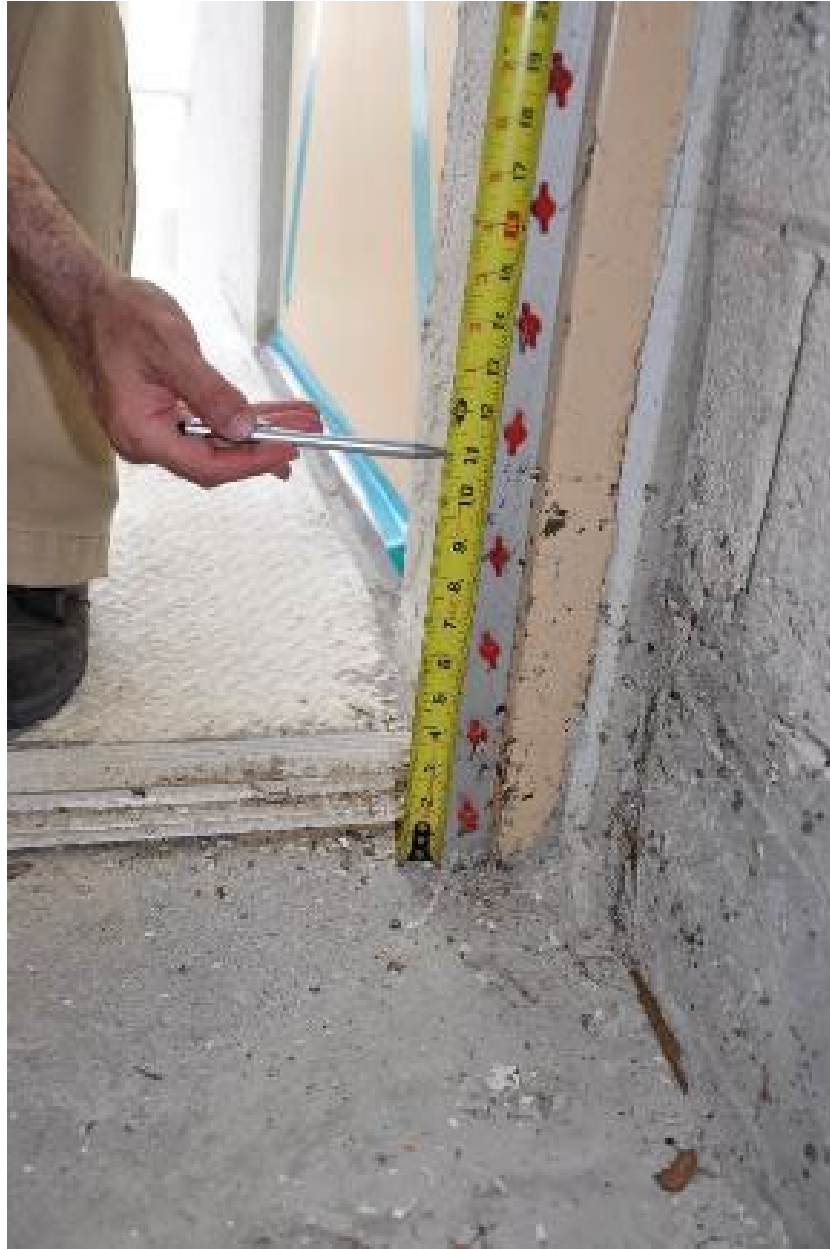
In 1994, a new two-story elevated addition (an approximately 15,300-square-foot building) was constructed over part of the original structure. The main entrance into the new library was located at the top of the exterior stairway, which is the lowest floor (12.15 feet NAVD 88). Interior HWMs approximately 12 inches above the lowest floor (approximately 13 feet NAVD 88) were observed during the MAT site visit.

Site conditions observed during the MAT did not indicate that all doors and windows below the BFE were protected against flooding. One egress opening in the 1994 portion of the building appeared to have some form of a panel track to facilitate dry floodproofing measures, but there is no indication that a panel was installed, as evidenced by an interior HWM observed during the MAT site visit. Figure 3-88 and Figure 3-89 show a representative HWM and interior damage. It is unclear whether the dry floodproofing measures to the 1994 portion of the library were original and retained or incorporated with the 2013 addition.

Figure 3-88: HWM observed at the Fort Myers Beach Library lowest floor of the 1994 building (Lee County, Zone AE)

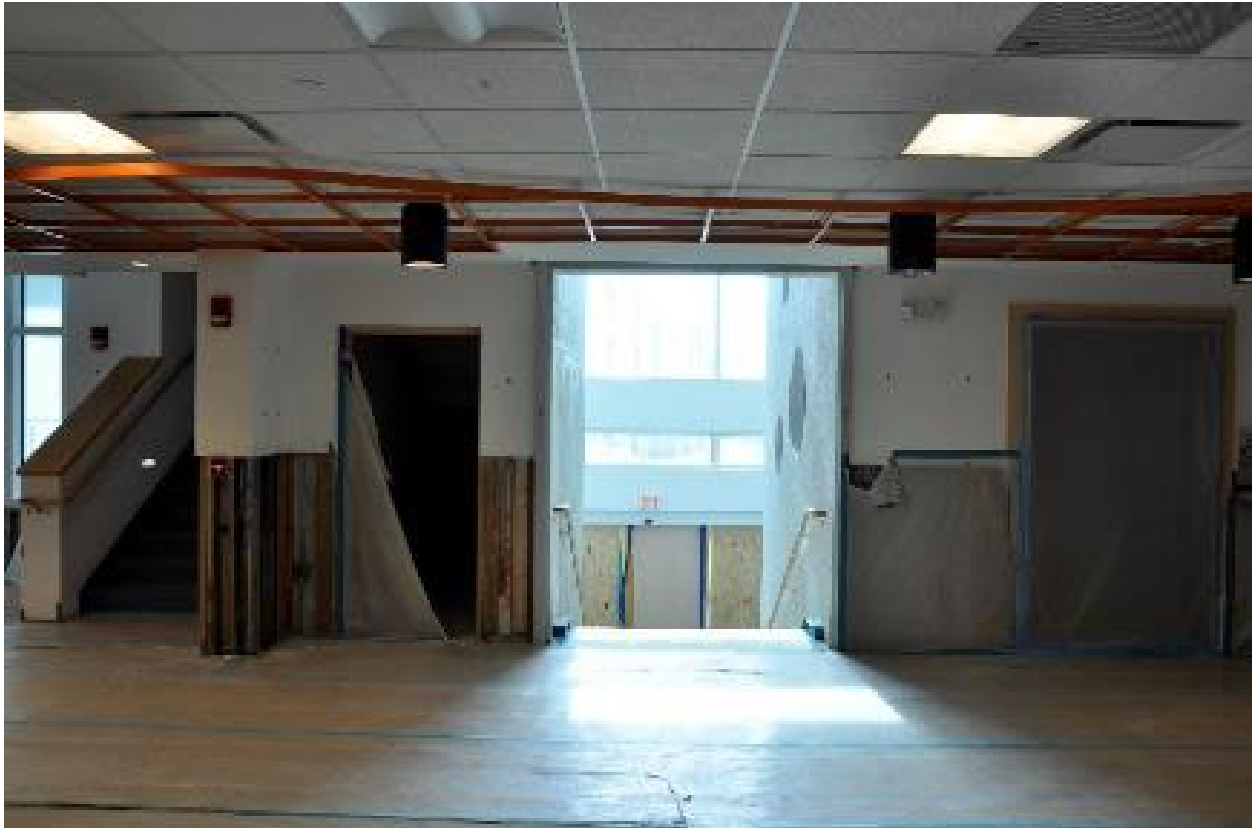
The multiple feet of drywall removal and the wood sheathing in the background are representative of interior flood damage at the lowest floor and enclosure below the lowest floor.

Figure 3-89: Representative interior flood damage within the 1994 portion of the Library (Lee County, Zone AE)

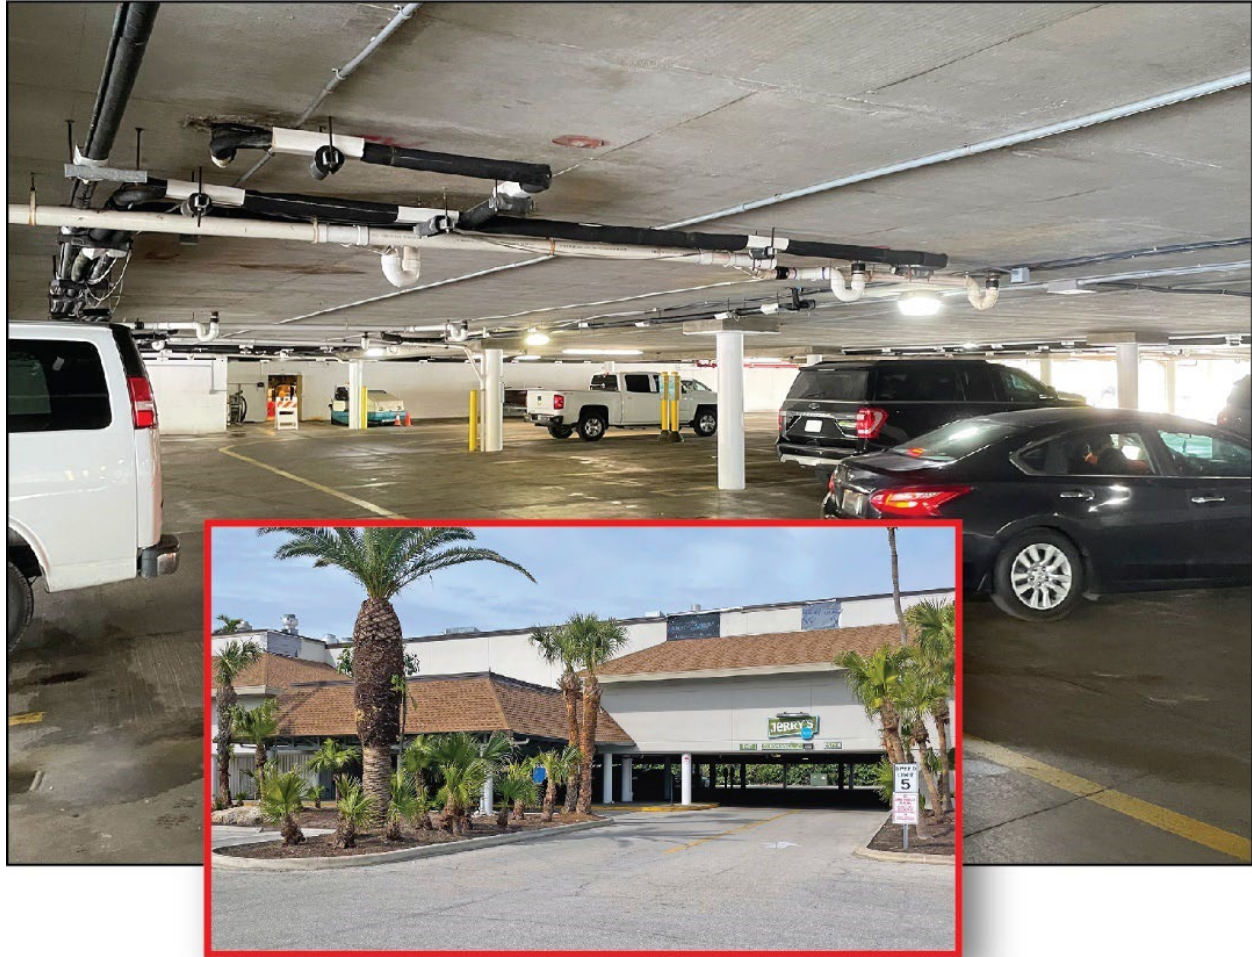
Jerry's Food Center, a community shopping center built in 1983, was in Zone A 10 (EL 12) NGVD 29 or 9 NAVD 88 based on the 1979 FIRM and in Zone AE 9 NAVD 88 based on the August 2008 FIRM (FEMA, 2008). The main building is elevated on columns, allowing an area underneath for parking (Figure 3-90).

Figure 3-90: Jerry's Food Center underground parking on Sanibel Island (Lee County, Zone AE)

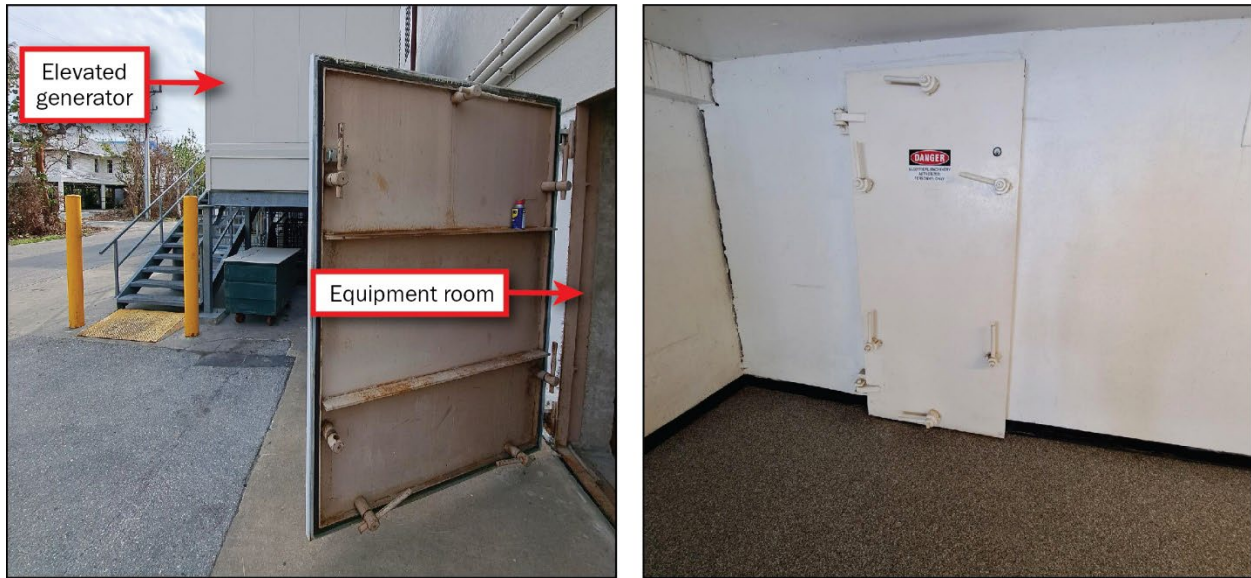
The backup generator, along with the building, were elevated approximately 7 feet above grade. Floodwater inundated this site with approximately 5 to 6 feet of storm surge above grade. The elevated interior portion of the store did not experience any flood inundation damage, and the elevated generator continued to operate until the fuel was depleted (the tank’s capacity was approximately 2,200 gallons). There were no indications or reports of structural damage from flood and/or wind loads during Hurricane Ian. Although wind damage to the building envelope enabled wind-driven rain to enter the building, requiring repairs to interior finishing and the replacement of content/equipment, the store reopened approximately 3 weeks after Hurricane Ian made landfall. Based on a field interview, the generator ran for several days, but once the fuel was depleted, it took days for fuel to be resupplied and most of the store’s refrigerated inventory was lost. At-grade MEP equipment rooms adjacent to the open parking area were constructed of poured concrete walls equipped with watertight doors. These enclosures and doors performed as designed and prevented floodwater from entering the electrical equipment rooms. The elevator and exterior conveyor belt underneath the lowest floor were not enclosed and were inundated by floodwater. At the time the MAT visited the site, the damage had not been repaired. Other enclosures at grade used primarily as storage rooms were not designed with watertight doors and flooded. The mechanical and electrical

rooms had minimal damage; however, none of these were formally certified to be dry floodproofed. The other enclosures did not appear to be deliberately wet floodproofed either. Figure 3-92 and Figure 3-93 provide representative pictures of these spaces. Jerry's Food Center had a reopening ceremony on Friday October 28, 2022.

Figure 3-92: Vaulted doors prevented floodwater from entering the equipment rooms (Lee County, Zone AE)

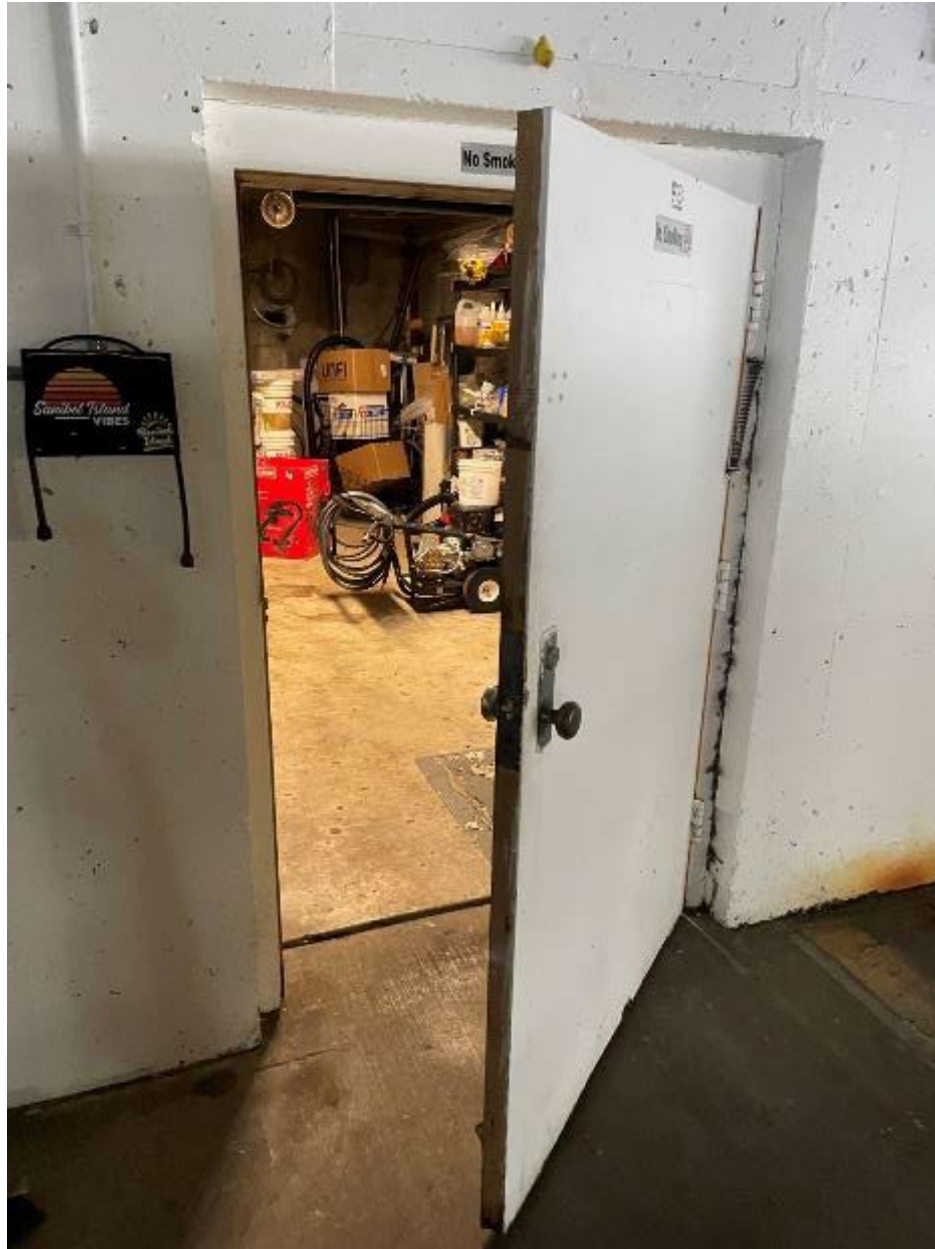
Figure 3-93: Ground level storage room was not floodproofed and sustained flood damage (Lee County, Zone AE)

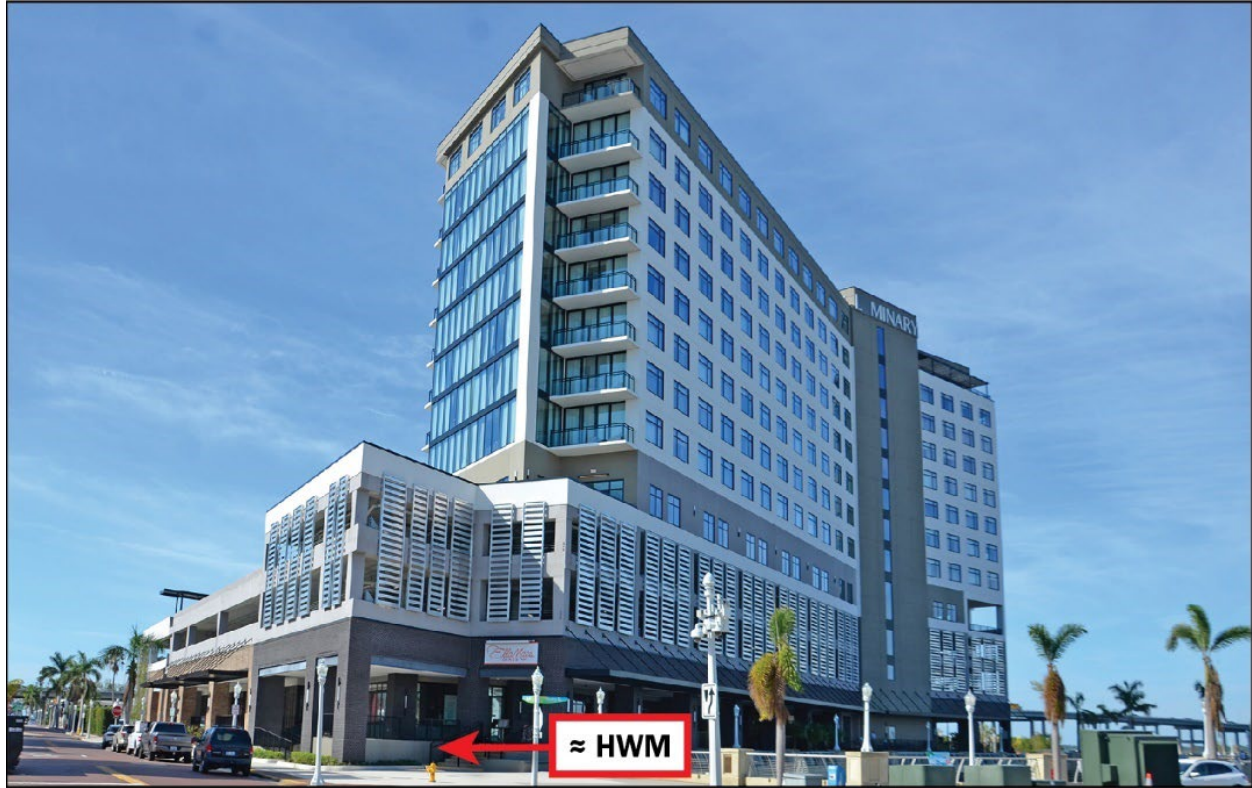
Based on the DFE at the time of construction, the 12-story hotel (Figure 3-95) was estimated to be elevated to at least 8 feet NAVD 88; HWMs collected by the USGS following Hurricane Ian in downtown Fort Myers near the hotel were 7.6 feet NAVD 88.

Figure 3-95: Luminary Hotel in downtown Fort Myers along the Caloosahatchee River (Lee County, Zone AE)

Within hours of sustaining 100+ mph winds and storm surge from Hurricane Ian, the Luminary Hotel was functioning on its emergency generator. The building experienced minor wind building envelope damage, and no floodwater entered the lowest floor of the building. In fact, the hotel served as one of the primary facilities to house first responders and emergency response personnel for weeks immediately following the hurricane.
