Mitigation Assessment Team Report

Hurricane Ian in Florida

Building Performance Observations,
Recommendations, and Technical Guidance

FEMA P-2342/December 2023

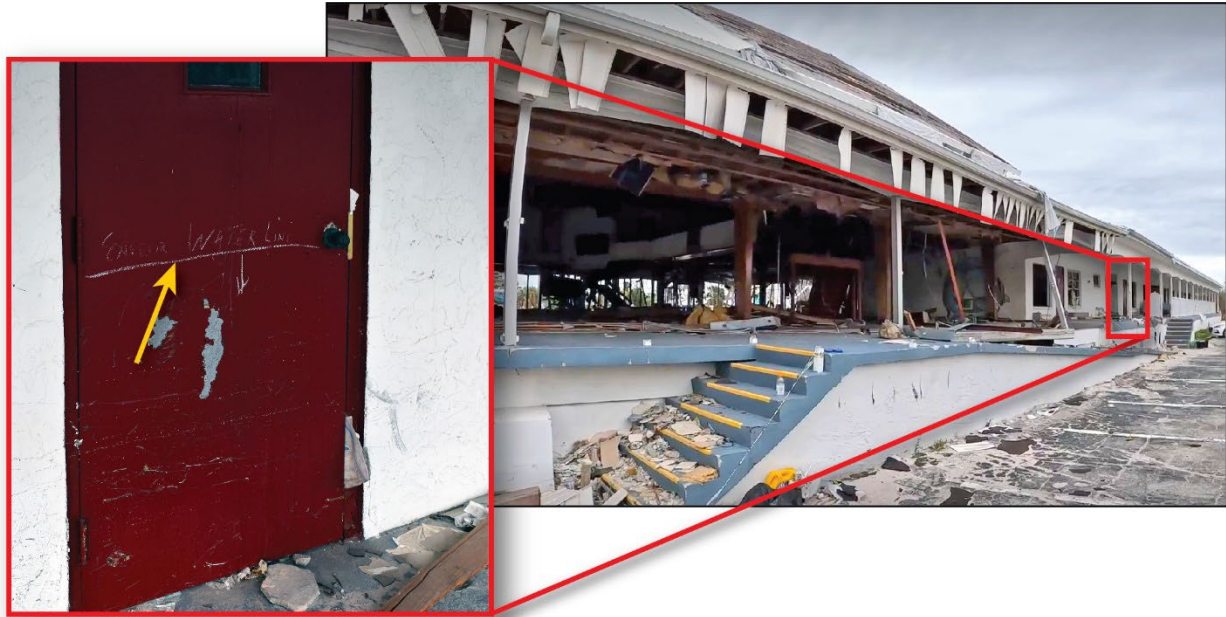
A recorded USGS HWM approximately 1,440 feet (480 yards) from the Chapel by the Sea Presbyterian Church is at an elevation of 12.7 feet NAVD 88. Figure 3-96 shows the building and USGS HWM location. Church members marked an exterior water line on the church as shown in Figure 3-97. Based on the mark’s alignment with the door handle, the HWM is approximately 3 feet above the floor at this location.

Right image depicts extensive damage to Chapel by the Sea caused by Hurricane Ian flood conditions and the location of an exterior water line marked by church members. Left image shows the exterior waterline mark.

Figure 3-97: Exterior water line marked (yellow arrow) at Chapel by the Sea

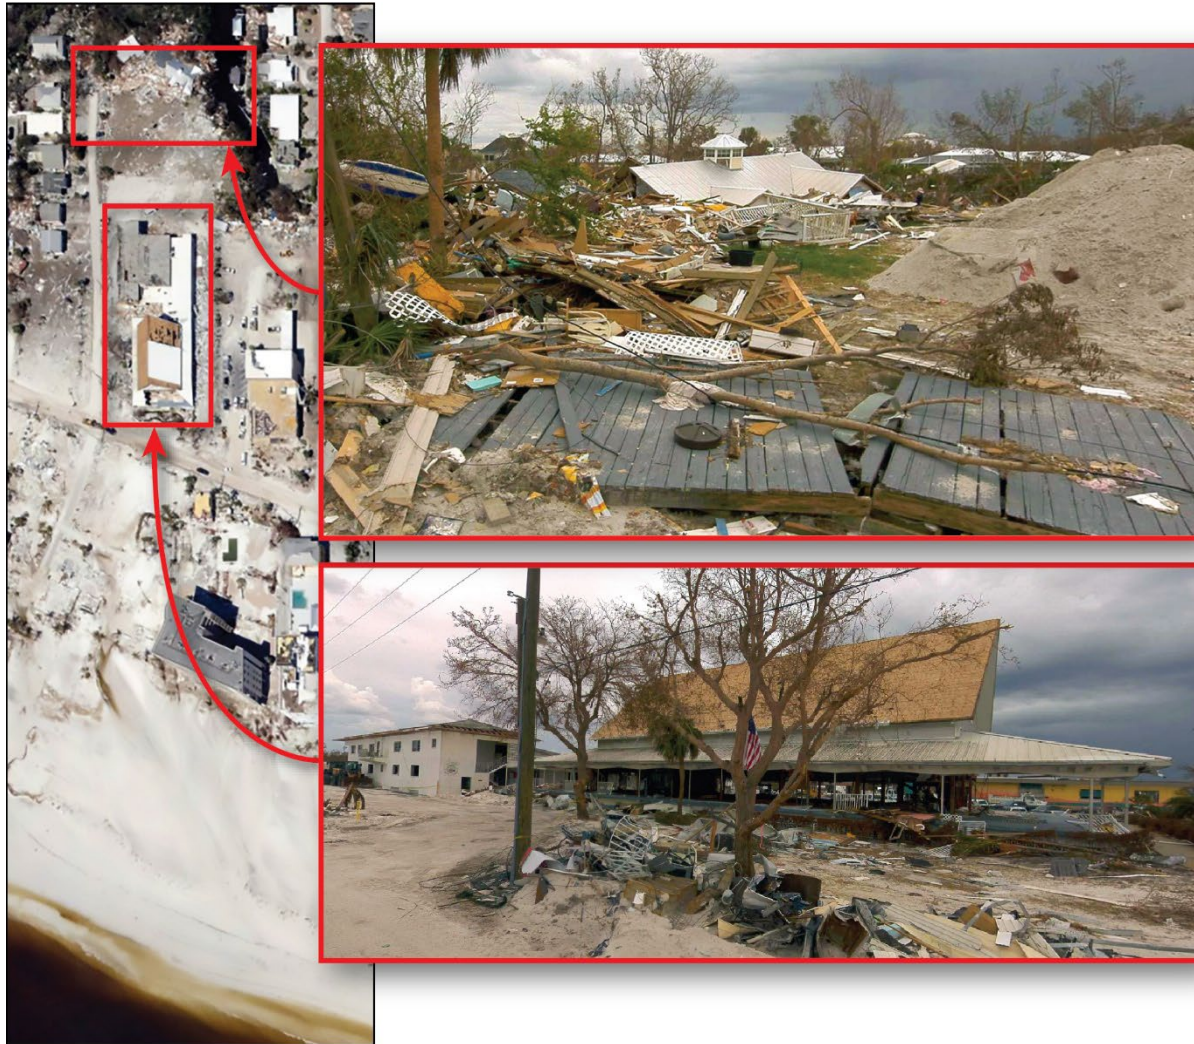
An inspection of the Chapel by the Sea's foundation in 2010 noted that structural support elements had deteriorated due to salt air and saltwater exposure. After the inspection, the foundation was structurally repaired and included the addition of waterproof paint. The foundation was re-inspected 1 month before Hurricane Ian, and the repairs were deemed successful and structurally sound. During Hurricane Ian, floodwater moved through and around the building, causing extensive damage and depositing widespread piles of debris around the church. Figure 3-98 shows the extent of debris in the area. The building also experienced wind damage, which led to additional water intrusion.

The left image provides an aerial overview of the area surrounding Chapel by the Sea. The top right image depicts various debris, including part of a house that was displaced during Hurricane Ian. The bottom right image shows a view from the west side of Chapel by the Sea. NOAA's aerial imagery shown here was collected 1 to 5 days after Hurricane Ian made landfall, and the StEER 360 imagery was collected 2 weeks after Hurricane Ian's landfall.

Figure 3-98: Overview of debris around Chapel by the Sea

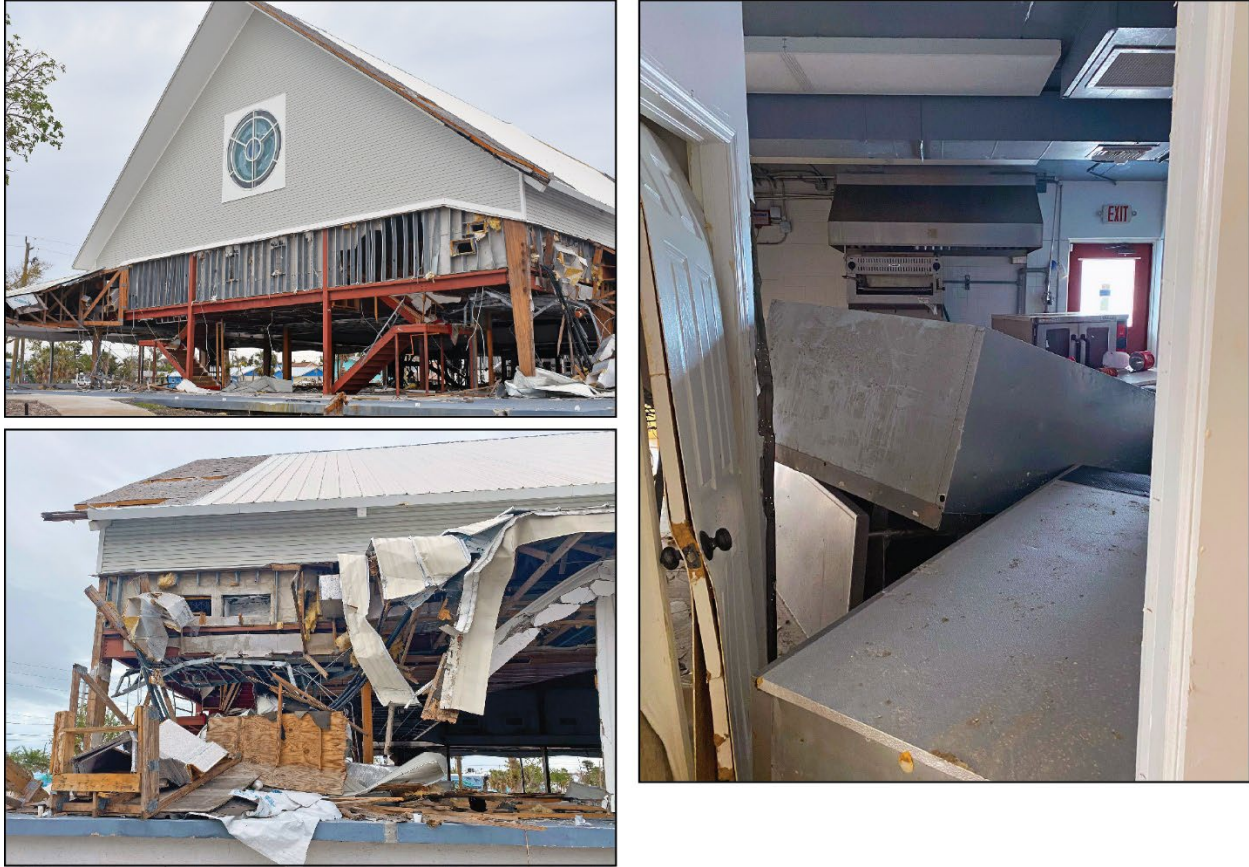
The structure was deemed structurally safe to enter following Hurricane Ian, but because of the extent of damage, no portions of the building were in stable condition. The MAT visited the site in January 2023, 114 days after Hurricane Ian made landfall in Fort Myers Beach. Damage to the building and contents included loss of new audio-video equipment; widespread façade and interior finishes damage; toppling of kitchen equipment such as large industrial refrigerators; and the widespread loss of contents, such as three grand pianos that were swept away in the floodwater. Extensive mold growth was observed during the visit. Figure 3-99 depicts examples of exterior and interior damage at Chapel by the Sea.

Figure 3-99: Examples of observed damage at Chapel by the Sea

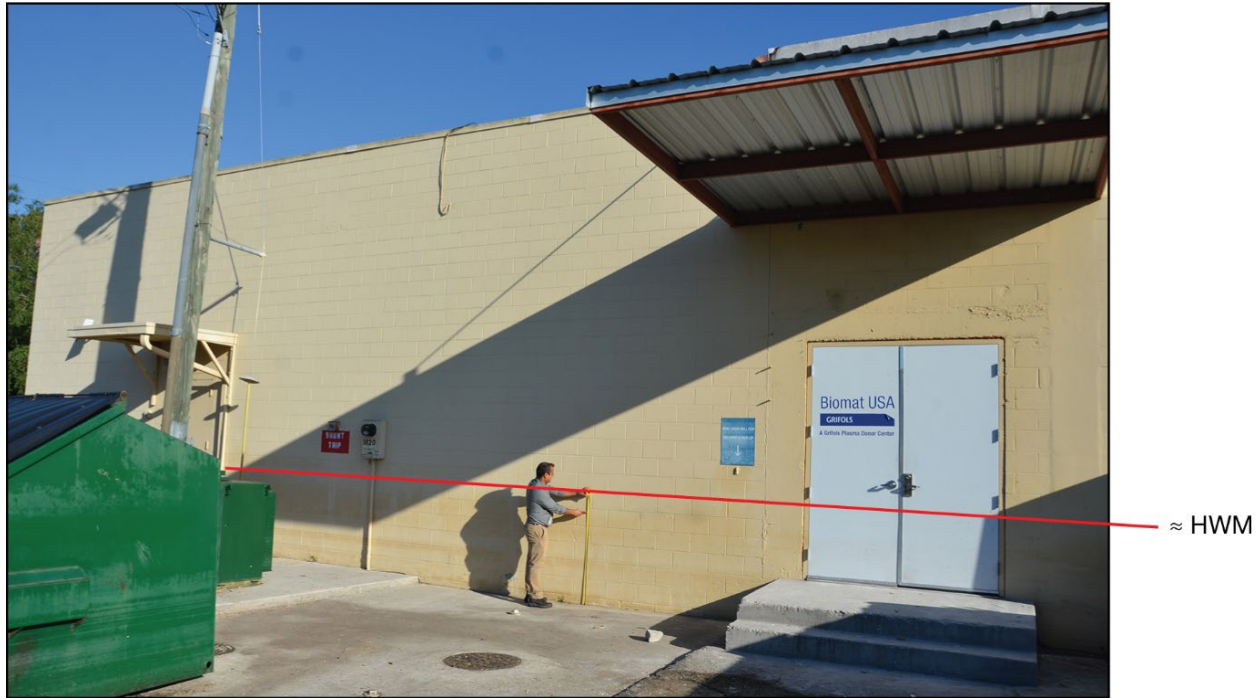
approximately 15 miles south of downtown Orlando, located within Kissimmee in an Zone AE with a BFE of 65 (Figure 3-101). The shopping center included Biomat USA Plasma Center, a 16,000-square-foot facility for plasma donations. Based on interviews with employees, an estimated 12 to 16 inches of floodwater from high-intensity rainfall entered the building interior during Hurricane Ian. An exterior HWM of 42 inches was identified along the property closest to the drainage canal (Figure 3-102). Patients were forced to coordinate alternative plasma services for 90 days before the plasma center reopened on January 25, 2023.

Figure 3-102: Rear of shopping center where a 42-inch HWM was identified (Orange County, Zone AE)

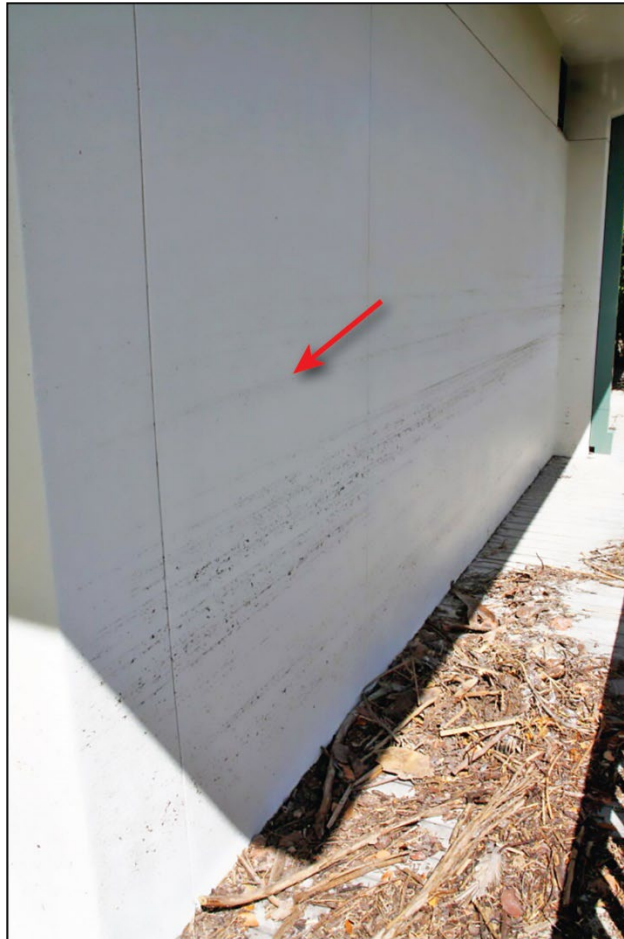
- A restroom in Vanderbilt Beach may have been protected from direct wave attack by adjacent mangroves. The 1994 existing building was dry floodproofed, but the closures were not installed prior to Hurricane Ian (Figure 3-103). USGS surveyed HWMs at an elevation of 11.4 feet NAVD 88. The facility lost power, but there was neither internal nor external structural damage.

The flood depth was approximately 5 feet; although the facility was designed to be dry floodproofed, the measures were not implemented.

Figure 3-103: HWMs on the exterior of public restroom in Vanderbilt Beach (Collier County, Zone AE, Seaward of CCCL)

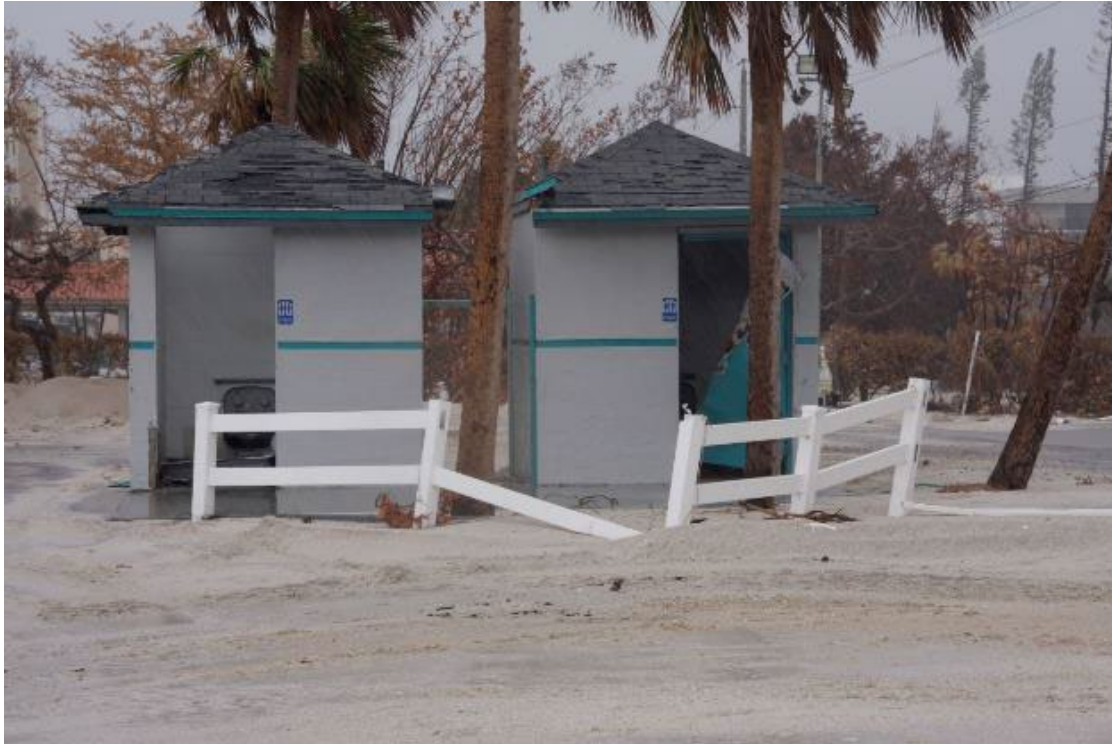
- Restrooms in Bonita Beach were two 1996 existing non-elevated CMU structures with flood openings (Figure 3-104). At the time of the pre-MAT, the doors to each of the restrooms were damaged or torn off, and there was visible damage to the plumbing fixtures inside each room. The facilities had both been demolished by the time the MAT visited in January 2023.

While the buildings were functional, there was both flood damage (doors and finishings) and wind damage (roof); this picture was taken in October, and the facilities were already demolished when the MAT visited in January.

Figure 3-104: Non-elevated restrooms on Bonita Beach at Little Hickory Island Beach Park (Lee County, Zone AE, Seaward of CCCL)

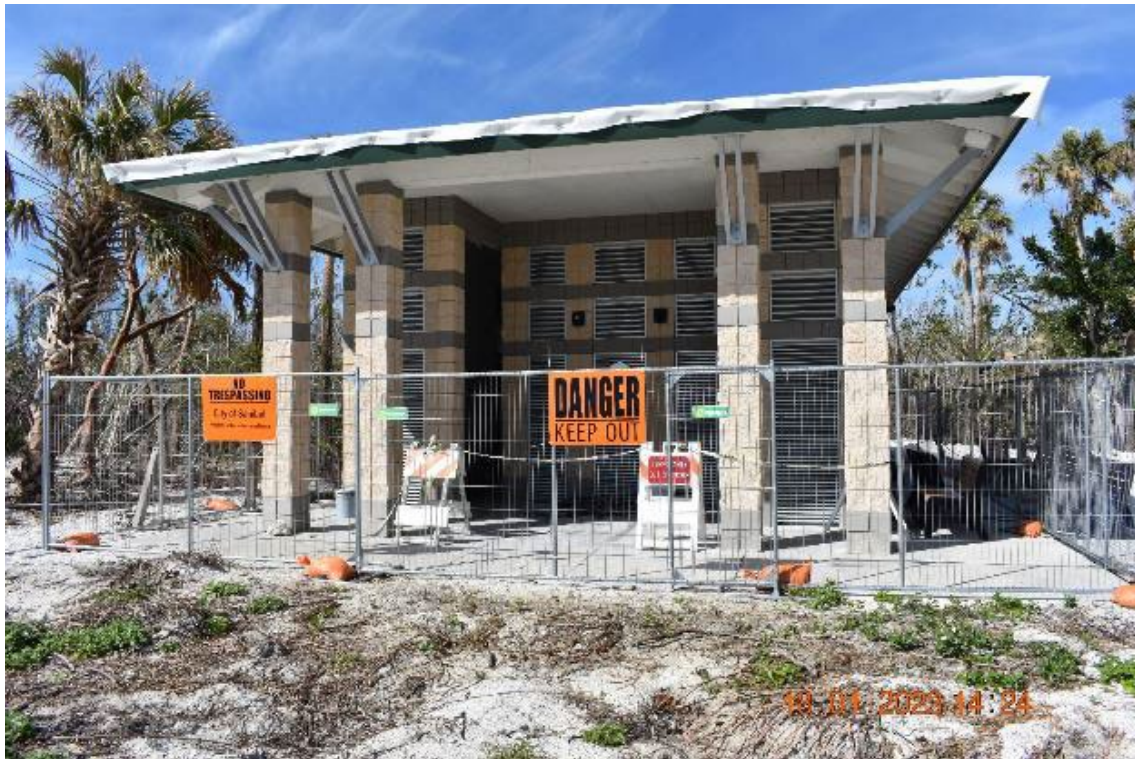
- A restroom in Sanibel Island at Lighthouse Point Park was gated off and could not be assessed (Figure 3-105). The facility is slab-on-grade, and the external structure of the building appeared to be intact with visible wind damage to the roof.

Although the MAT was unable to access it, the building appeared structurally intact from a perimeter assessment of it. Based on adjacent water marks, the building likely had 12 feet or more of flooding; the louvered walls likely contributed to its performance as surge waters likely entered the building relatively freely.

Figure 3-105: Public restroom facility in Sanibel Island at Lighthouse Beach Park (Lee County, Zone VE, Seaward of CCCL)

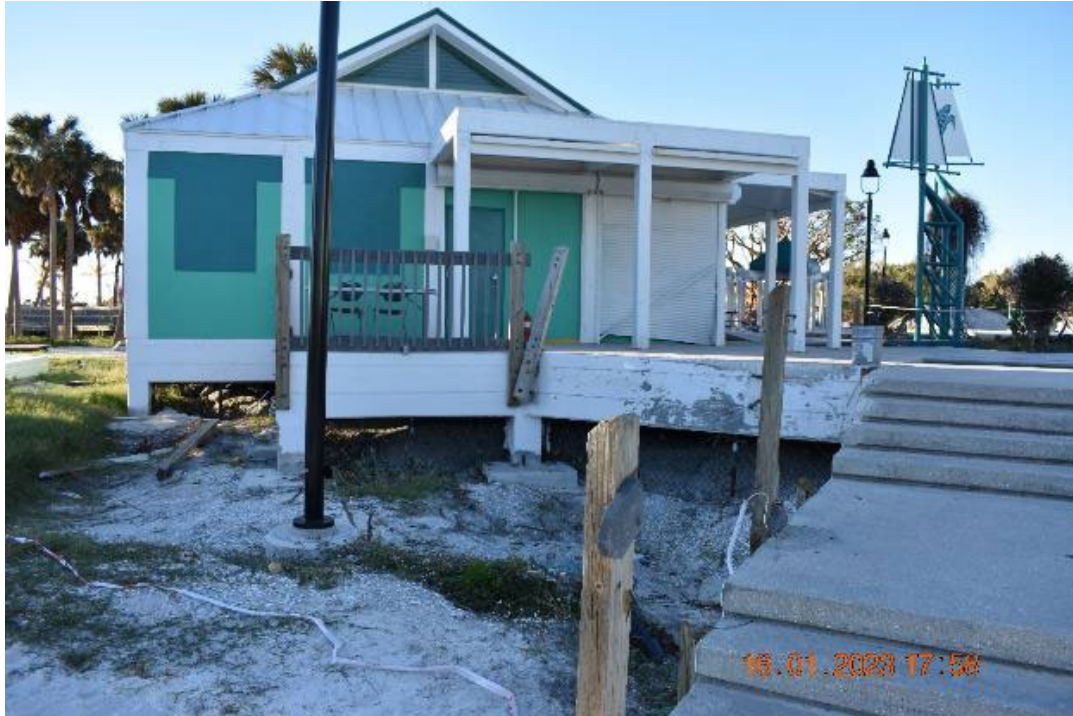
- The public restrooms on Fort Myers Beach were *elevated buildings* with varied performance. The 1993 facility in Bowditch Point Park (Figure 3-106) comprised several structures connected by a walkway. The facilities did not show any damage to internal or external components. The 1991 facility at Lynn Hall Memorial Park was subject to direct wave attack and suffered damage to the CMU walls of the structure (Figure 3-107). The foundations appeared to be intact.

With the exception of privacy panels and crawlspace damage, the facilities seemed largely intact.

Figure 3-106: Elevated restrooms at the north end of Fort Myers Beach in the Bowditch Point Park (Lee County, Zone VE, Seaward of CCCL)

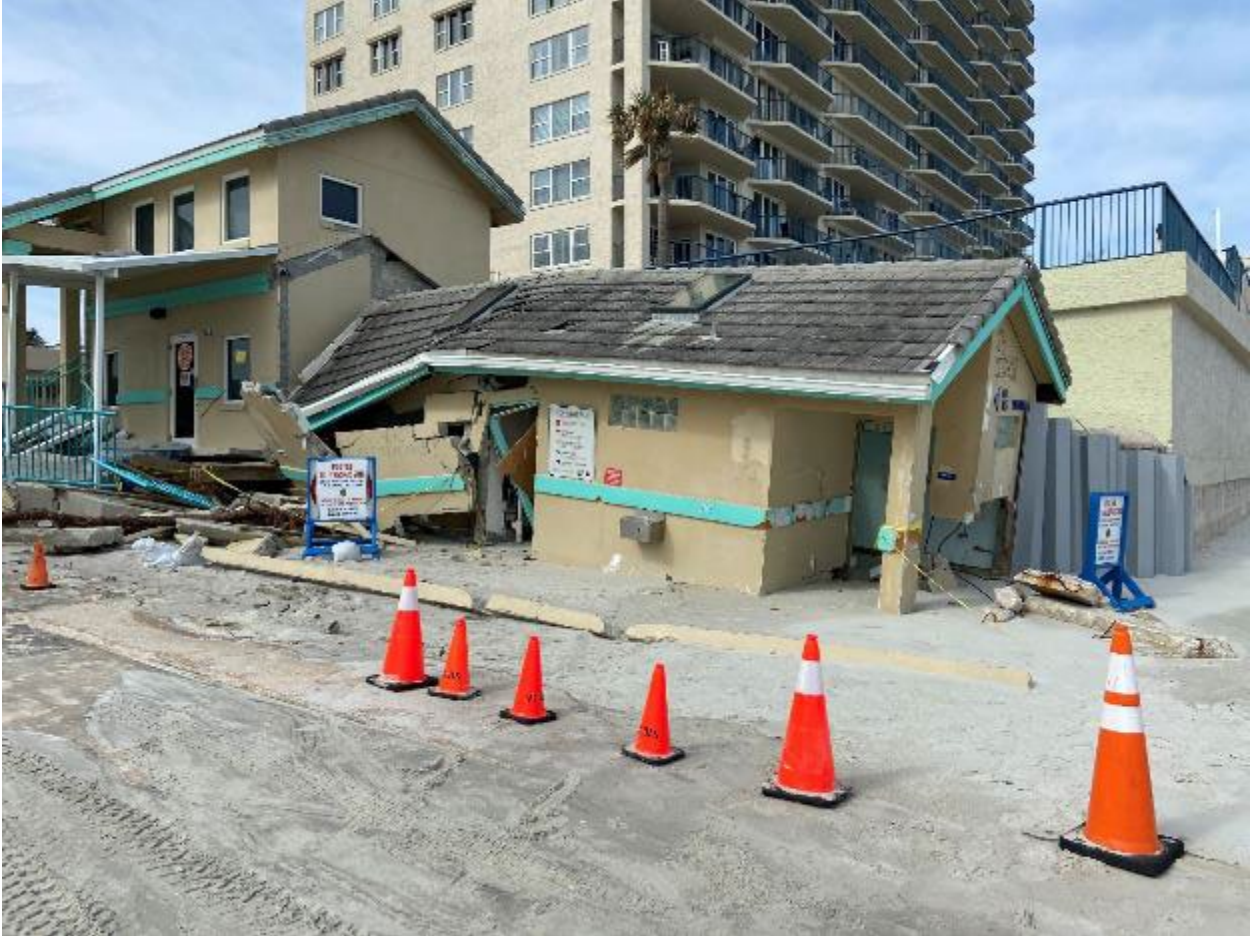
- A restroom in Daytona Beach Shores was a slab-on-grade structure that was heavily impacted by scour around the foundation, resulting in the destruction of the facility (Figure 3-108 and Figure 3-109).

Figure 3-108: Destroyed public restroom in Daytona Beach Shores (Volusia County, Zone VE, Seaward of CCCL)

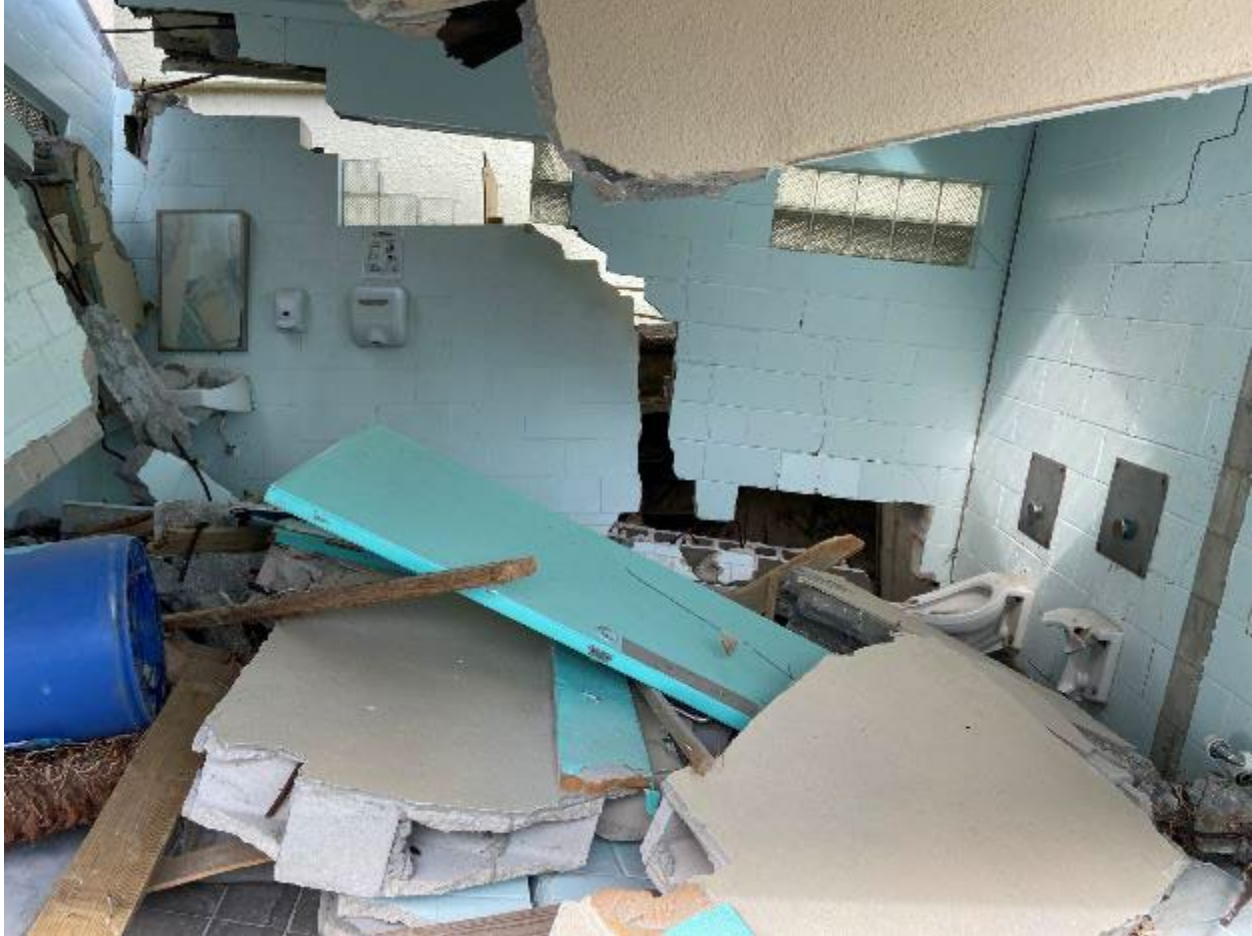
Figure 3-109: Interior of destroyed public restroom in Daytona Beach Shores (Volusia County, Zone VE, Seaward of CCCL)

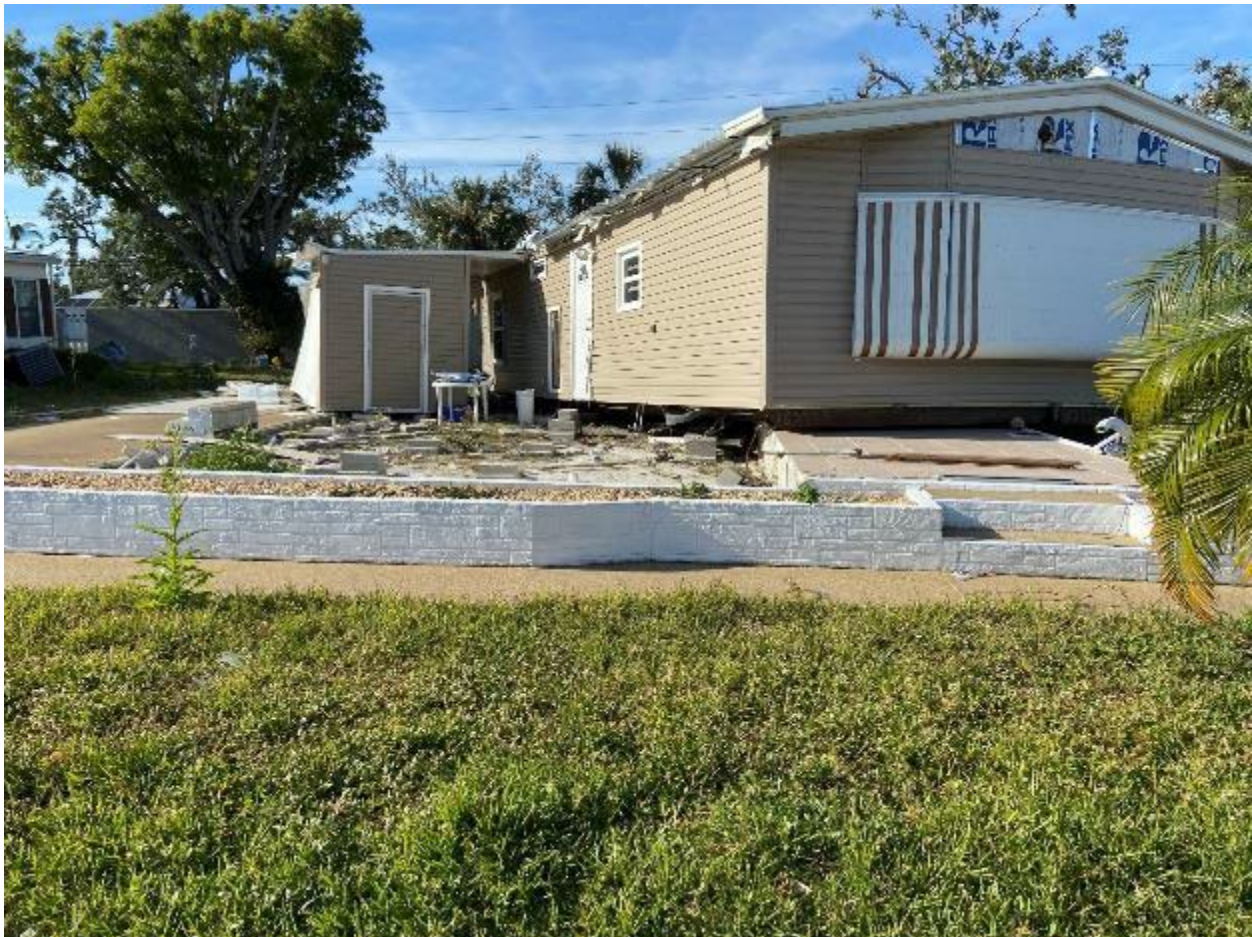
The MAT visited multiple sites where manufactured homes were retrofitted with tie downs under the Florida Hurricane Loss Mitigation Program; generally, the tie down retrofits, predominantly intended for wind damage reduction, were effective. In some extreme cases, manufactured homes were displaced from their foundations. In most cases where this was observed, the manufactured homes were not sufficiently elevated and/or had an insufficient load path and foundation to resist the flood loads (Figure 3-110 and Figure 3-111). The primary differentiator in the flood-resistance performance of manufactured homes was whether the bottom of the steel frame was elevated above

Figure 3-110: Manufactured home displaced from its foundation by flood loads (Lee County, Zone AE)

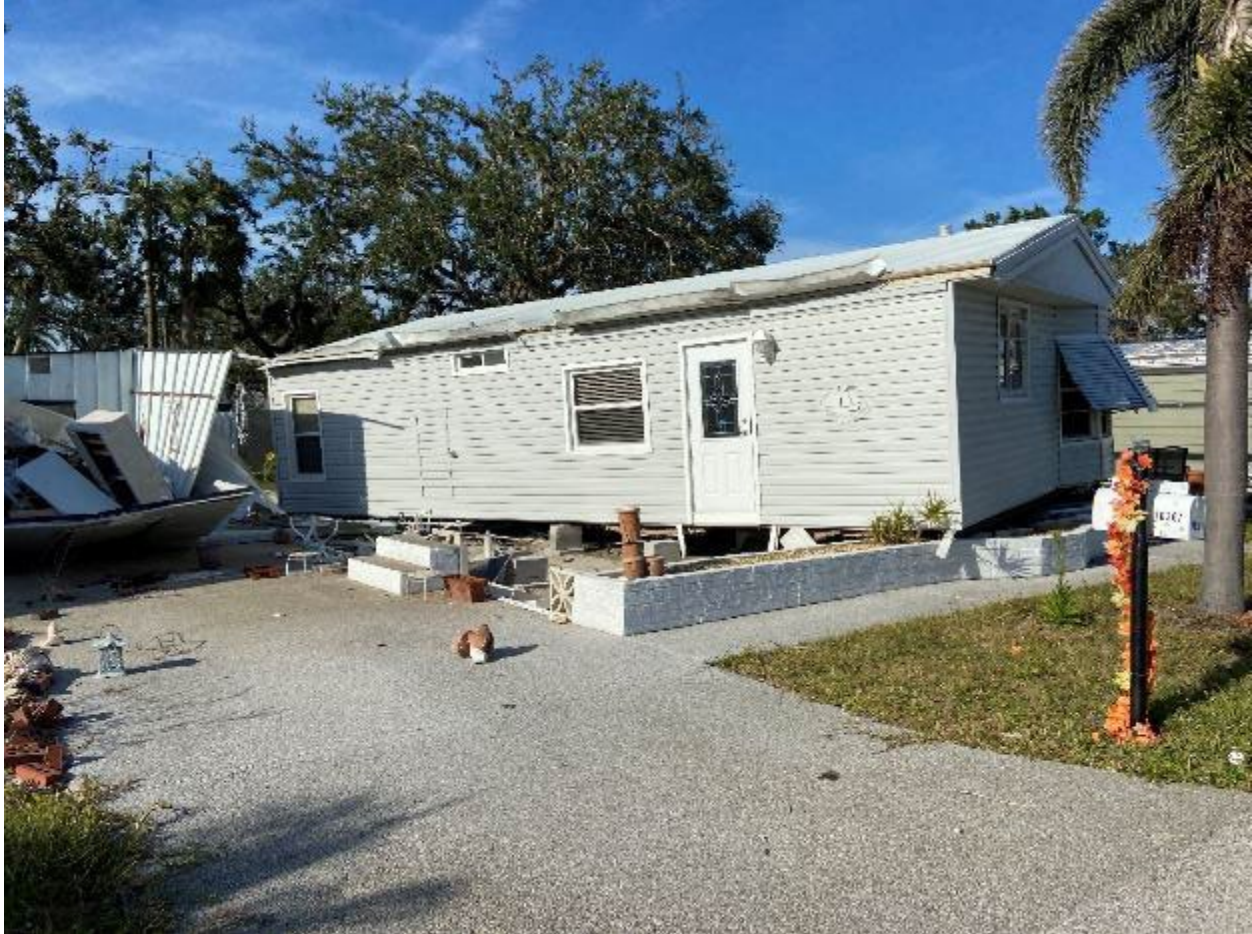
Figure 3-111: Manufactured home displaced from its foundation by flood loads (Lee County, Zone AE)

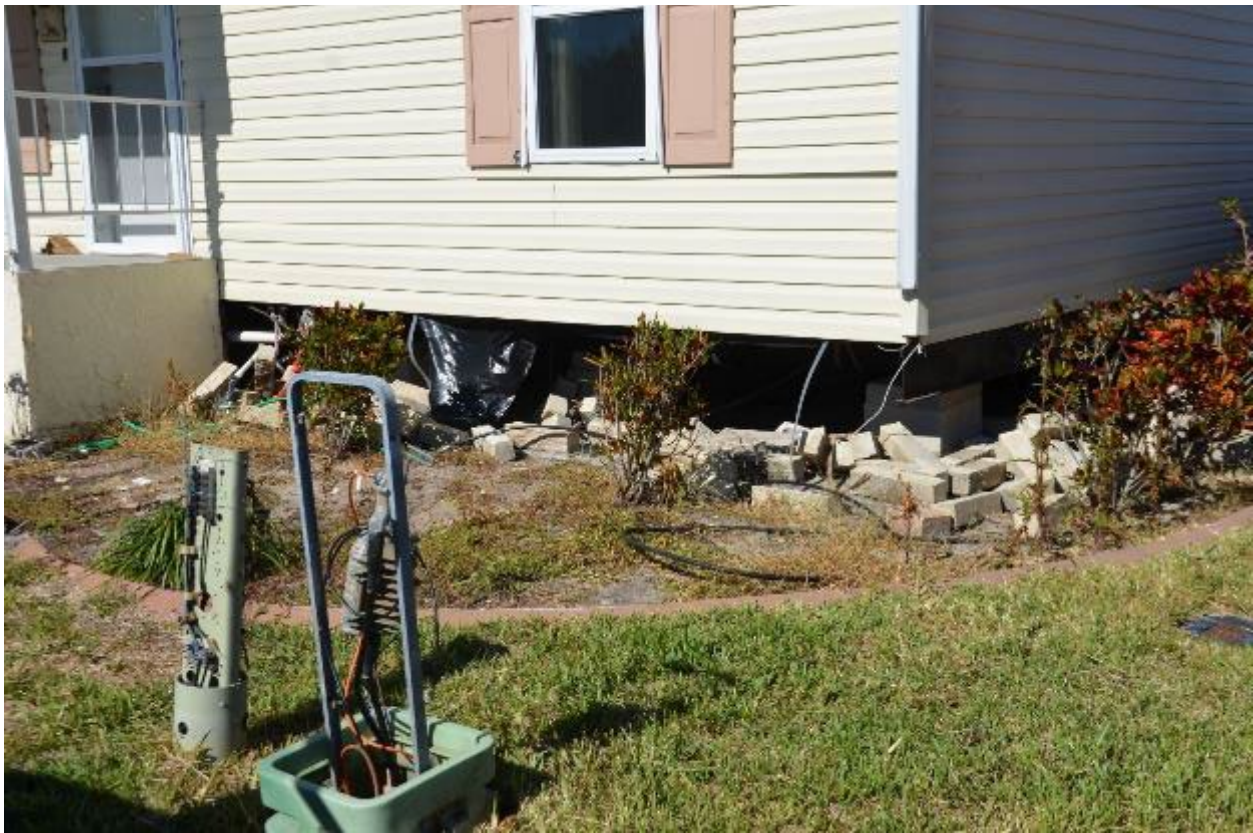
Village in Zone AE with a BFE of 8 NGVD 29 (approximately 7 NAVD 88). As a result, several of the newest manufactured homes (mid-1990s through mid-2000s, so pre-2008 FIRM) were installed at about 6 to 12 inches below the Hurricane Ian HWM. The MAT visited a manufactured home installed in 2000 that had approximately 4 inches of floodwater above the lowest floor during Hurricane Ian, and its unreinforced pier (dry-stacked block) wedges were displaced by the flooding. Other common damage observed throughout the community included flood damage to exterior accessory structures, interior finishings, exterior mechanical equipment (predominantly unelevated), ductwork below the lowest floor, and vinyl and brick skirting. A limited number of manufactured homes were observed with minimal flood damage; they were typically elevated higher, on reinforced piers, and had tie-downs. Homeowners interviewed along the road closest to the river where the most extreme damage was observed estimated their flood damage at approximately \$100,000. Figure 3-114 through Figure 3-118 show representative examples of manufactured homes in Old Bridge Village.

Figure 3-114: Typical manufactured home damage observed in Old Bridge Village (Lee County, Zone AE)

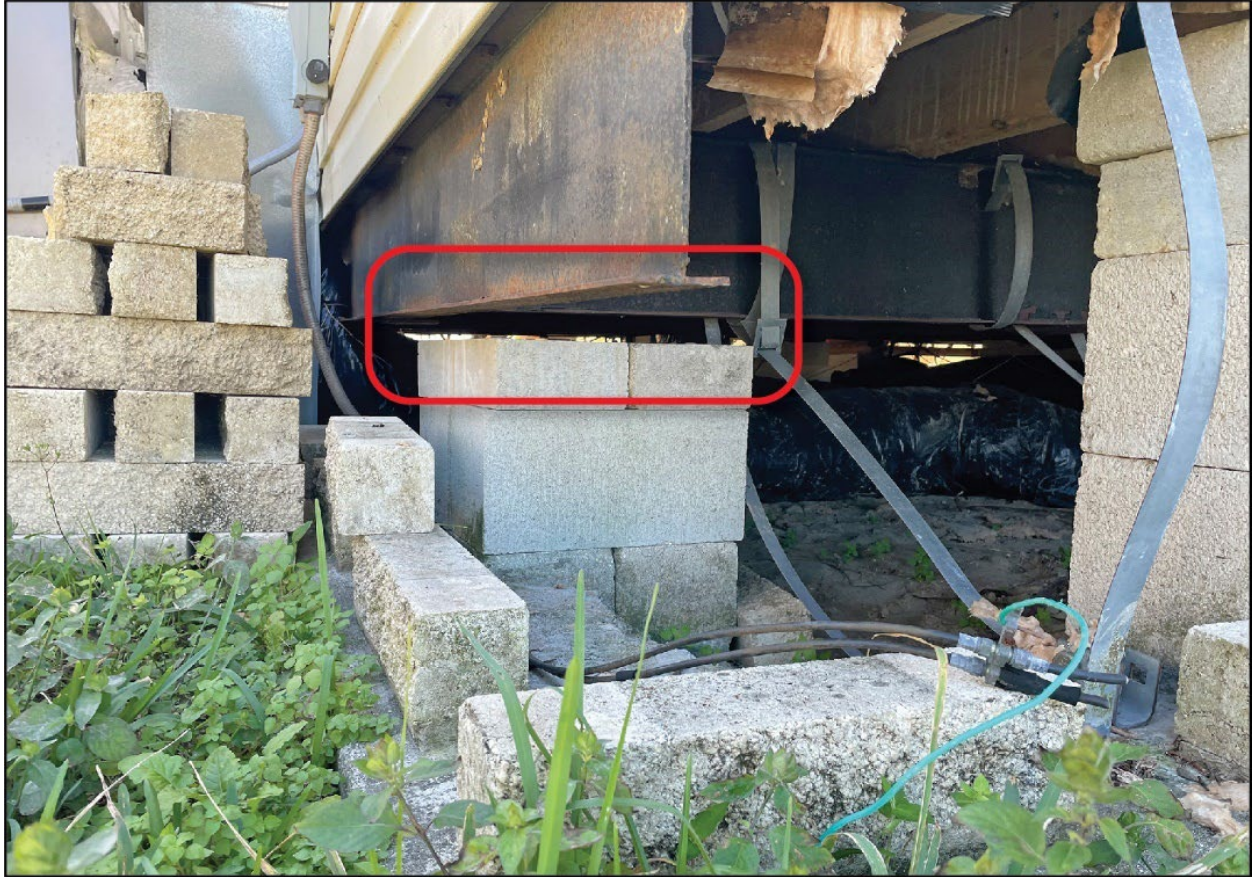
Figure 3-116: Manufactured home unreinforced pier (dry-stacked block) wedges displaced (red circle) during Hurricane Ian flooding (Lee County, Zone AE)

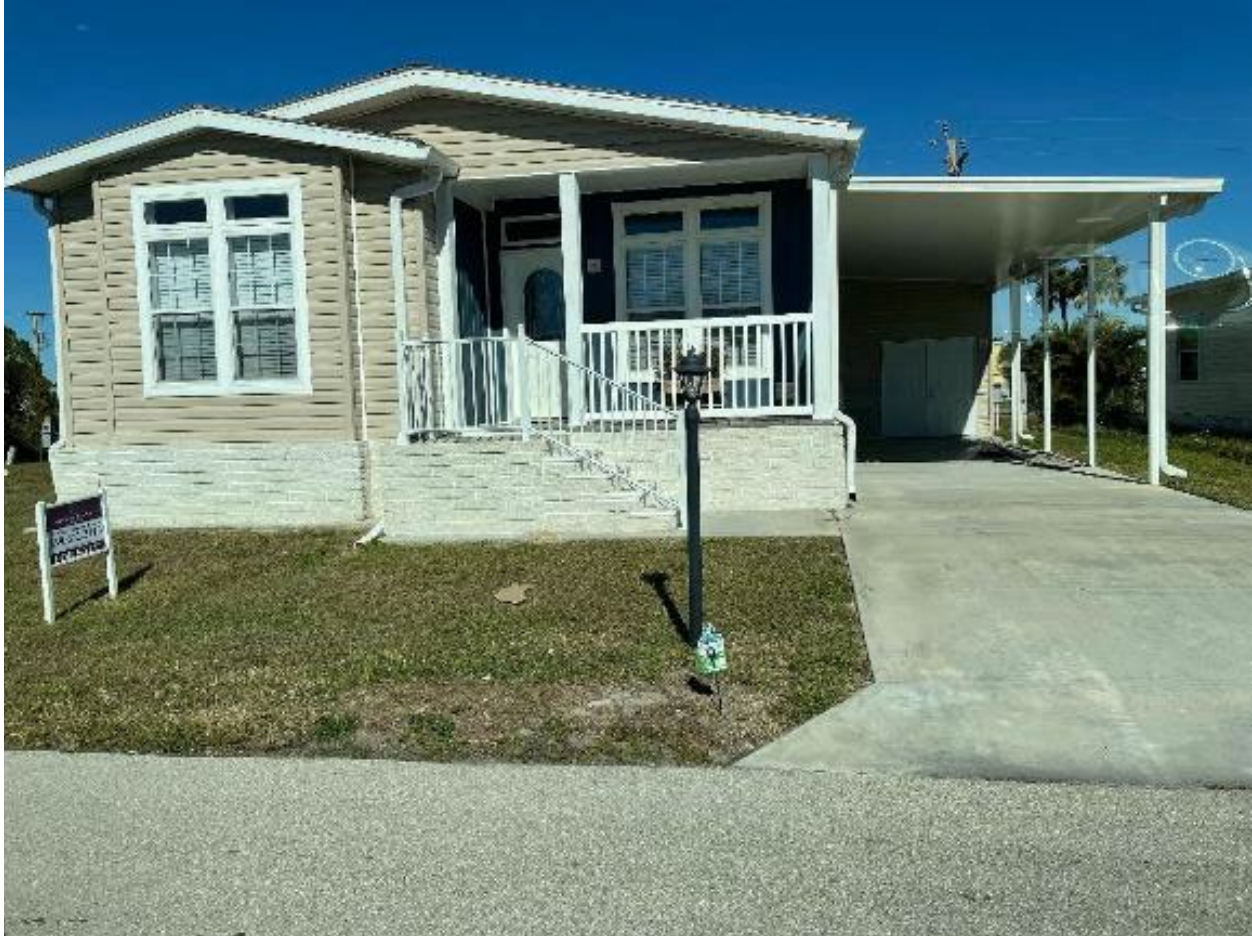
Figure 3-118: 2019 Elevated manufactured home in the Old Bridge Village with no foundation damage and primary flood damage limited to crawlspace and storage unit (Lee County, Zone AE)

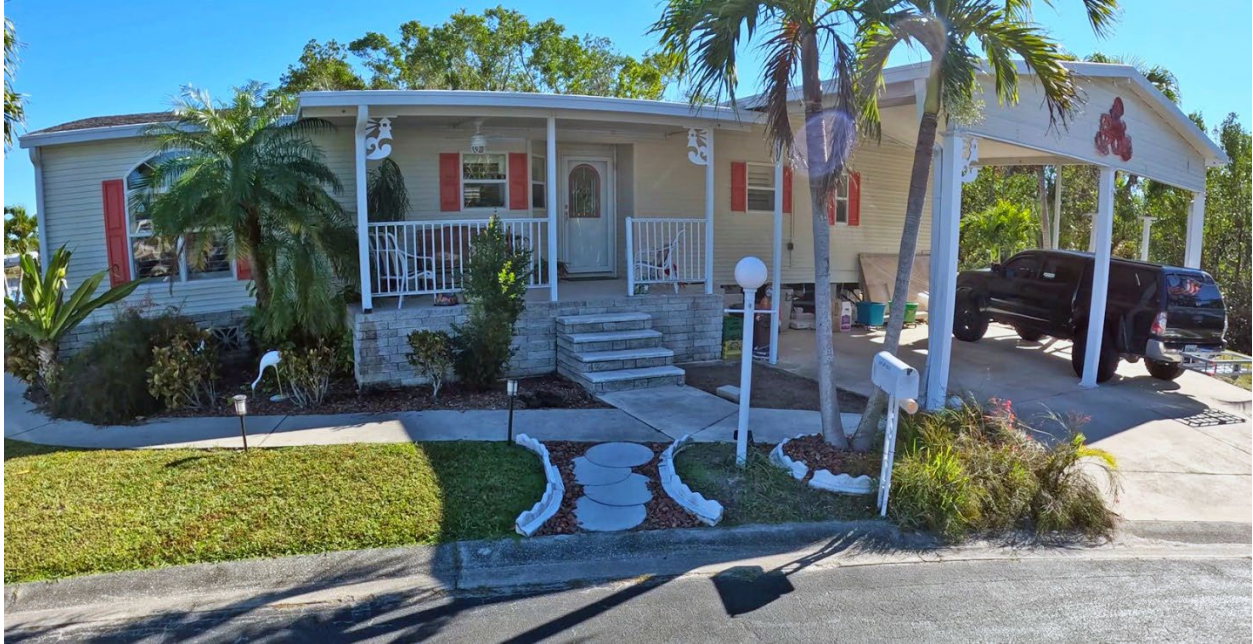
Figure 3-120: Representative manufactured home along Adam Drive that performed well, elevated approximately 3 feet above ground (Lee County, Zone AE)

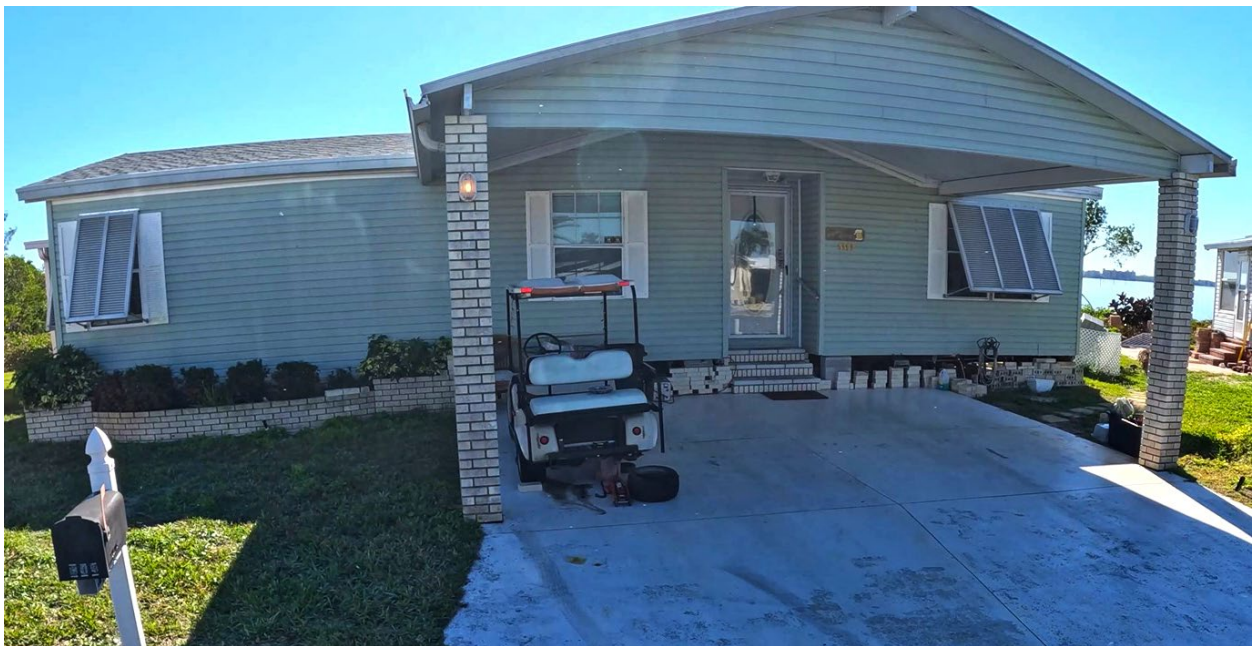
Figure 3-121: Representative manufactured home along Adam Drive that had interior flood damage, elevated approximately 1 foot above ground (Lee County, Zone AE)

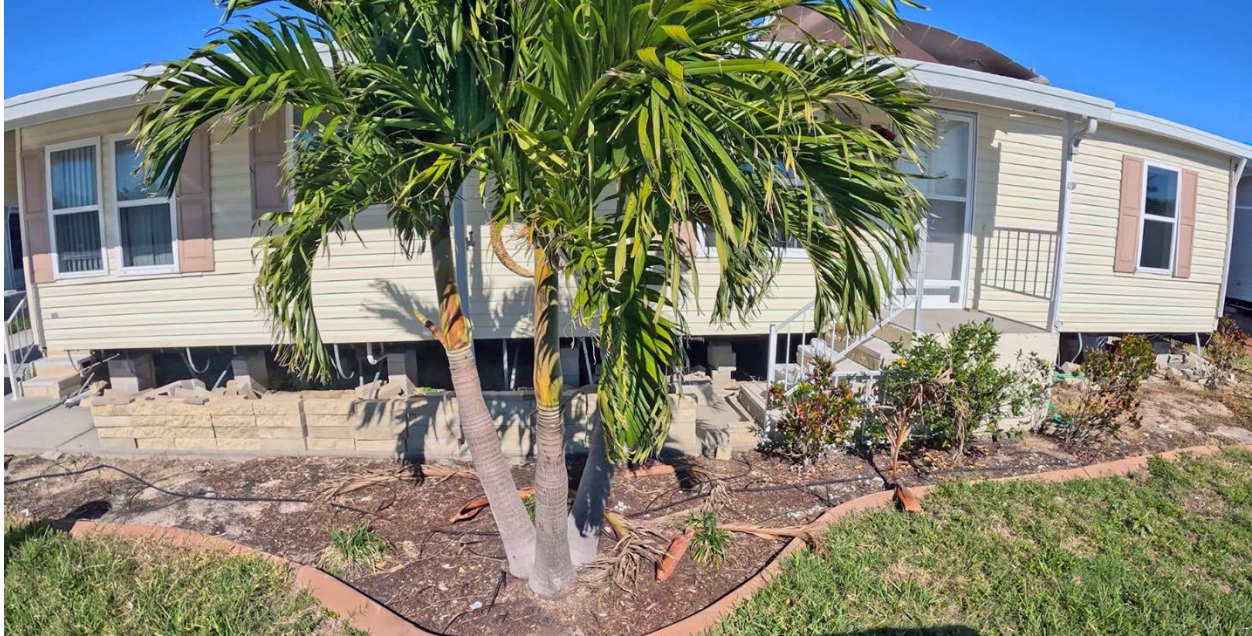
Figure 3-122: Representative manufactured home along Adam Drive that had interior flood damage, elevated approximately 2 feet above ground (Lee County, Zone AE)

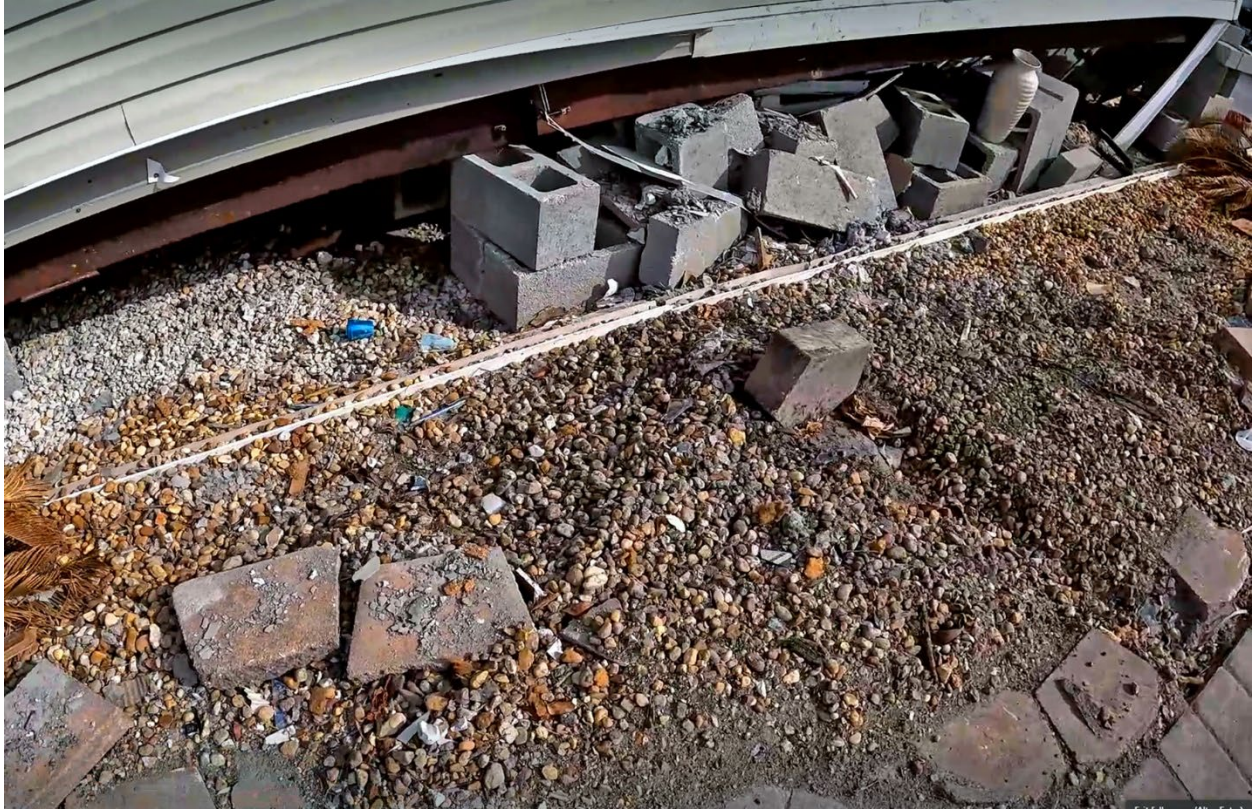
This manufactured home was in the area that likely experienced the greatest flood velocity based on field observations and analysis of aerial imagery. The flood loads destroyed the pier foundation and the manufactured home was displaced from its foundation.

Figure 3-127: Prior to Hurricane Ian, this manufactured home was elevated on unreinforced hollow-core masonry block piers approximately 4 feet above grade (Lee County, Zone VE)

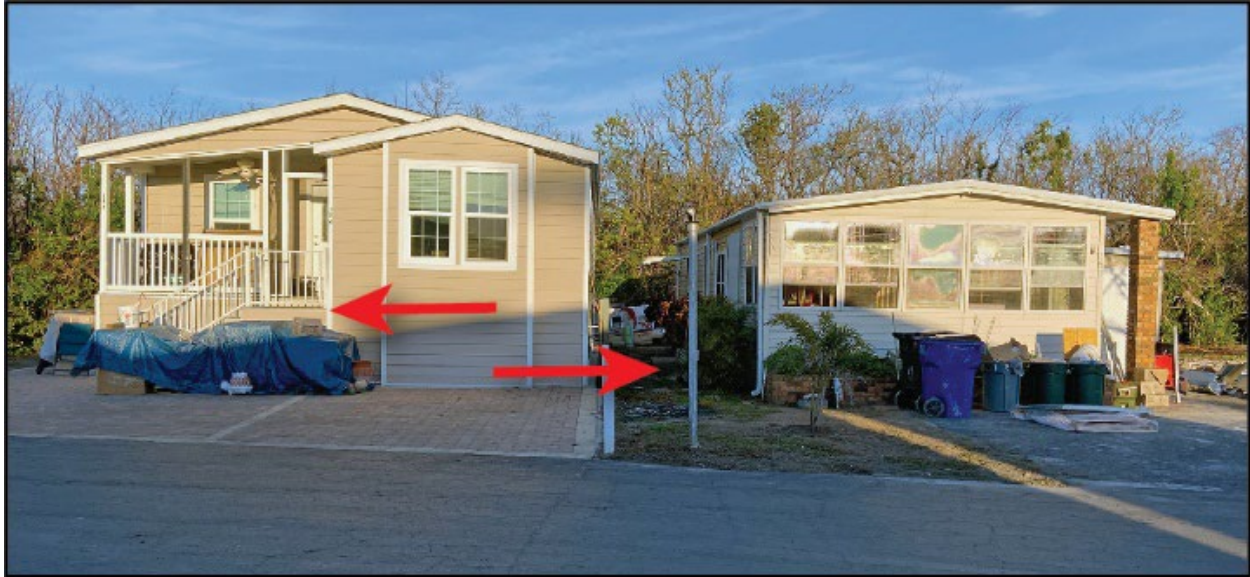
Although newer manufactured homes were typically elevated at least 2 to 3 feet above older adjacent ones, every manufactured home in this area was inundated because of the surge heights.

Figure 3-128: Lowest floor elevation differences, measured in multiple feet, were common in newer manufactured homes on Port Carlos Cove (Lee County, Zone AE)
