Mitigation Assessment Team Report

Hurricane Ian in Florida

Building Performance Observations,
Recommendations, and Technical Guidance

FEMA P-2342/December 2023

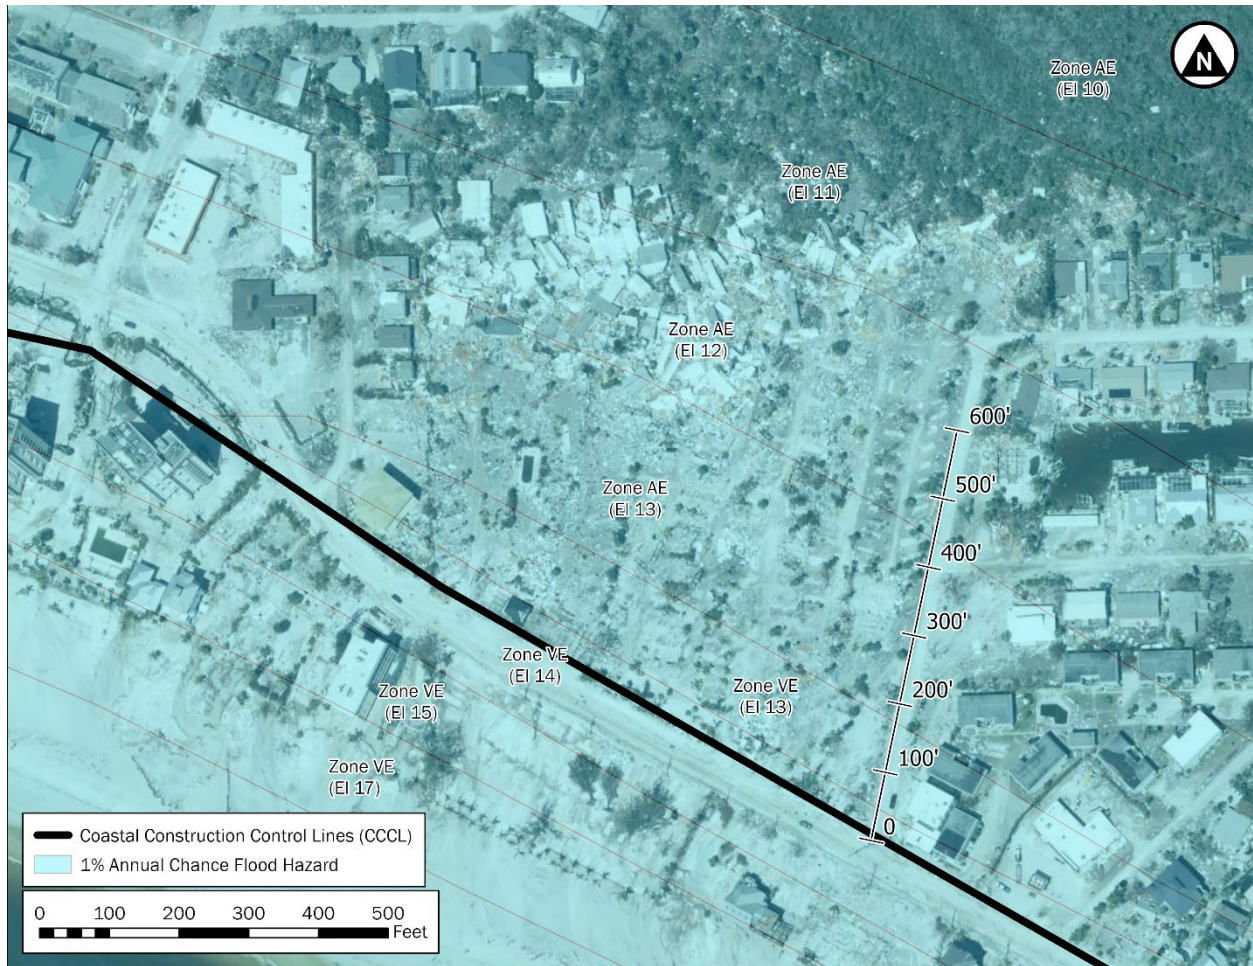
Of approximately 50 manufactured homes in the Gulf View Colony, the first was built in 1947 based on Lee County parcel data, and the latest house was constructed in 2005. Similarly, the RV park was established in 1951. Both the manufactured home community and the RV park were destroyed during the hurricane as evident in the before and after Hurricane Ian imagery (Figure 3-130 and Figure 3-131). This area experienced some of the most destructive Hurricane Ian damage to manufactured homes observed by the MAT.

The manufactured homes were displaced between 100 and 1,000 feet landward.

Figure 3-131: Post-Hurricane Ian imagery of Gulf View Colony and the Red Coconut Recreational Vehicle Park (Lee County, Zone VE & AE)

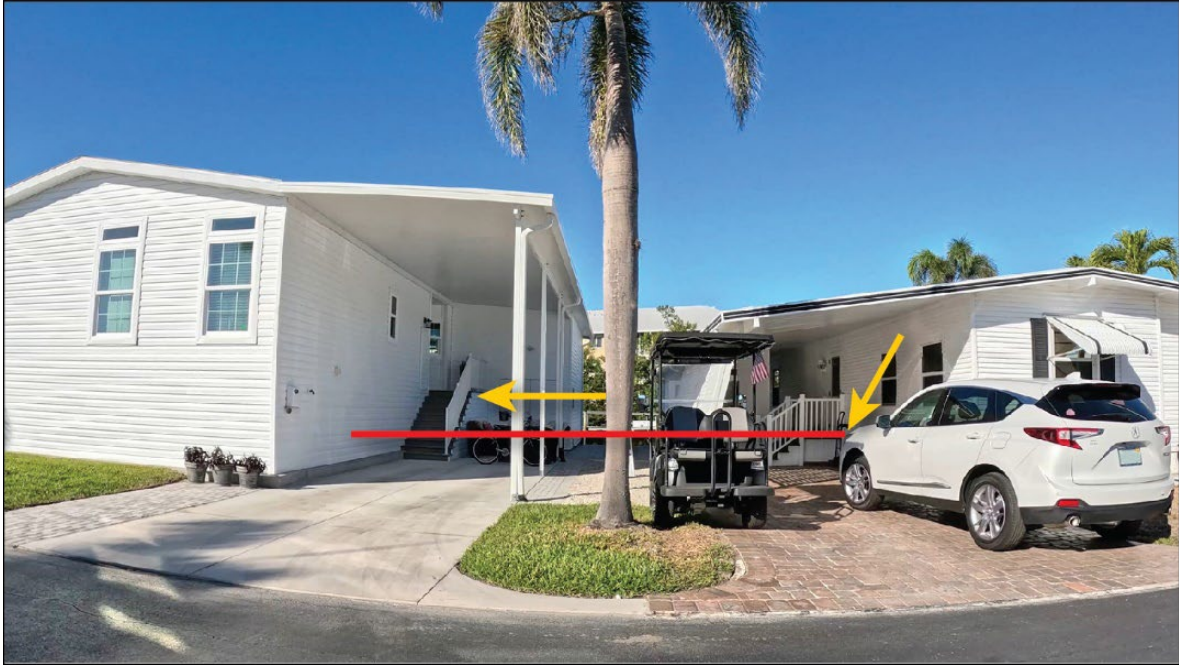
The manufactured home on the left is representative of one of the newest in the community and had no flood damage. The manufactured home on the right had crawlspace/ductwork damage along with some interior damage. The arrows reflect lowest floor and the red line is the approximate flood depth. The lowest floor elevation difference between these two properties was approximately 3 feet.

Figure 3-133: Representative elevated manufactured home in the Naples Land Yacht Harbor Community (Collier County, Zone AE)

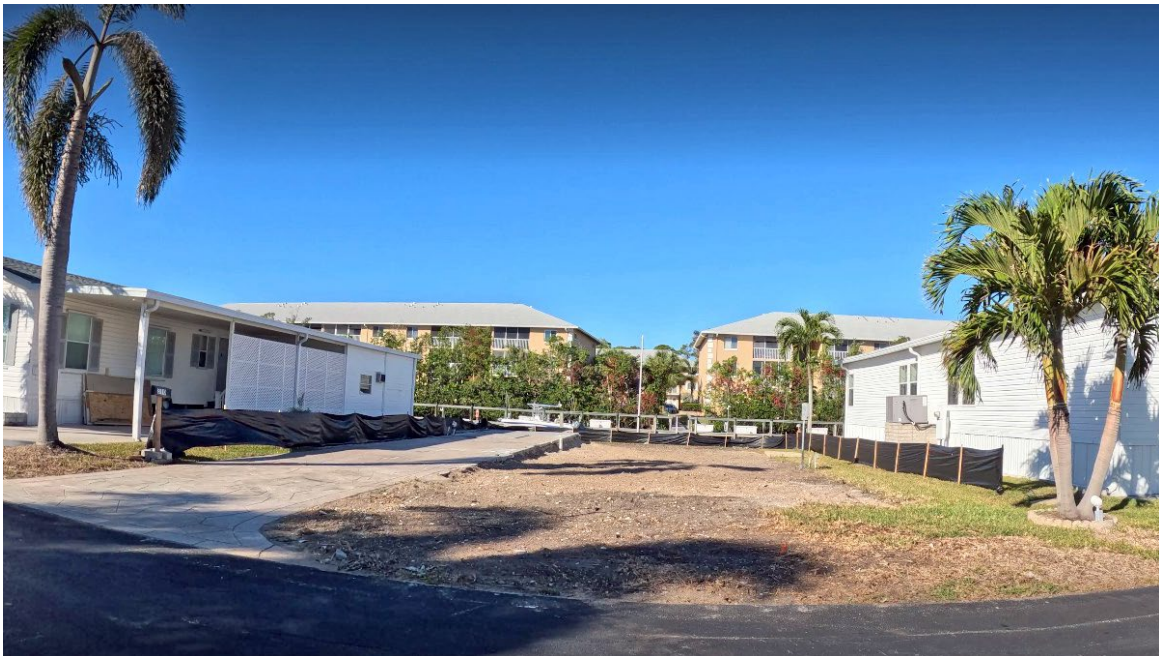
Figure 3-134: Empty lot where a manufactured home was demolished in the Naples Land Yacht Harbor Community (Collier County, Zone AE)

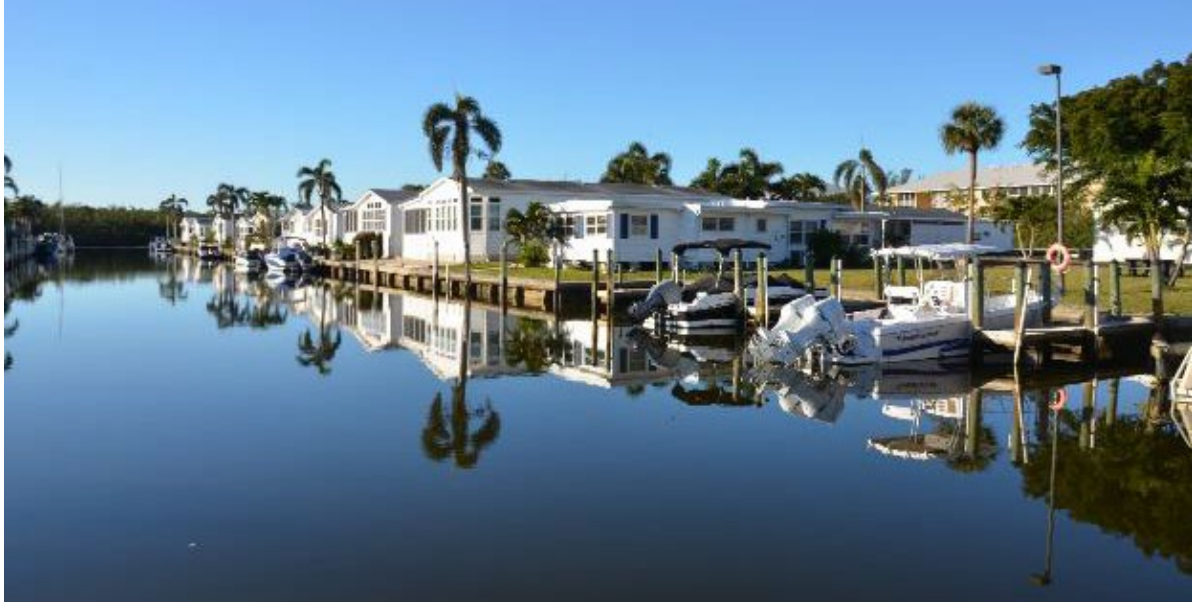
Figure 3-135: Representative waterfront properties in Naples Land Yacht Harbor, many of which received 18 inches or more of floodwater inside except where they were sufficiently elevated (Collier County, Zone AE)

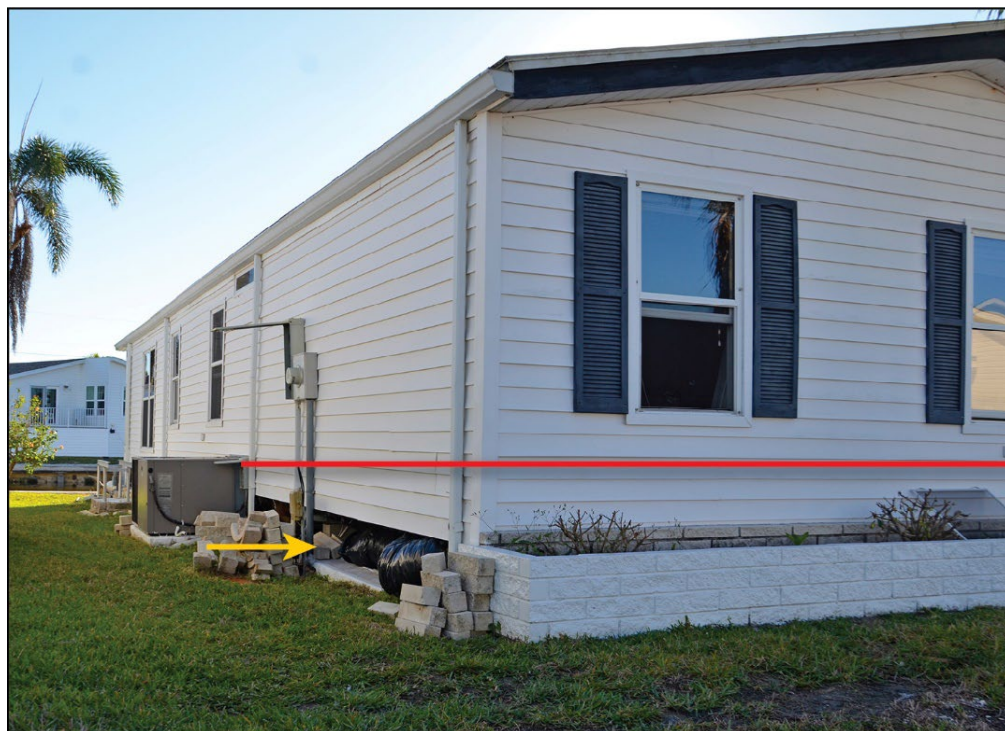
The yellow arrow highlights masonry skirt and crawlspace damage and the red line is the approximate flood depth.

Figure 3-136: Representative damage included interior damage as well as ductwork and heating, ventilation, and air conditioning (HVAC) replacement under and near manufactured homes (Collier County, Zone AE)

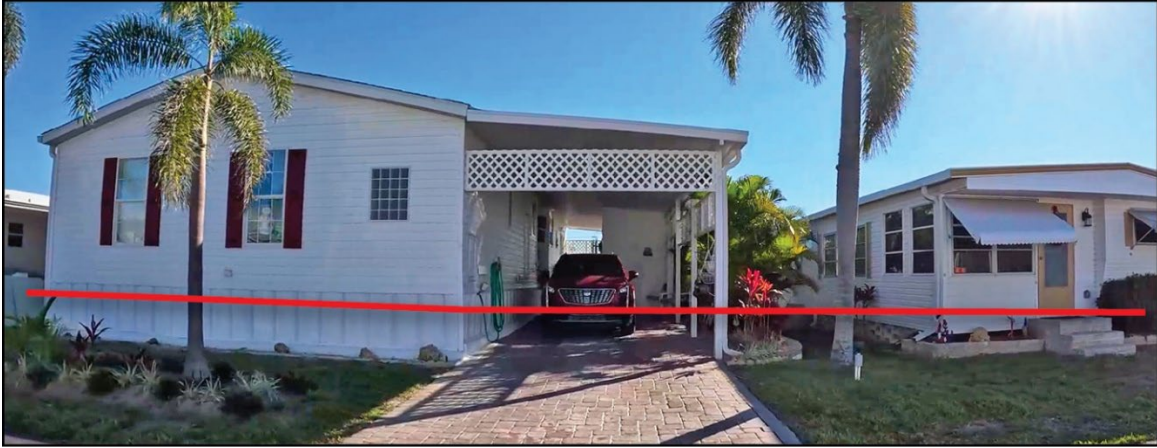
The red line is the approximate flood depth of the home on the left; the older manufactured home on the right had interior flood damage.

Figure 3-137: Elevated manufactured home on the left, elevated 6 inches above BFE, had no interior damage but ductwork had to be replaced (Collier County, Zone AE)

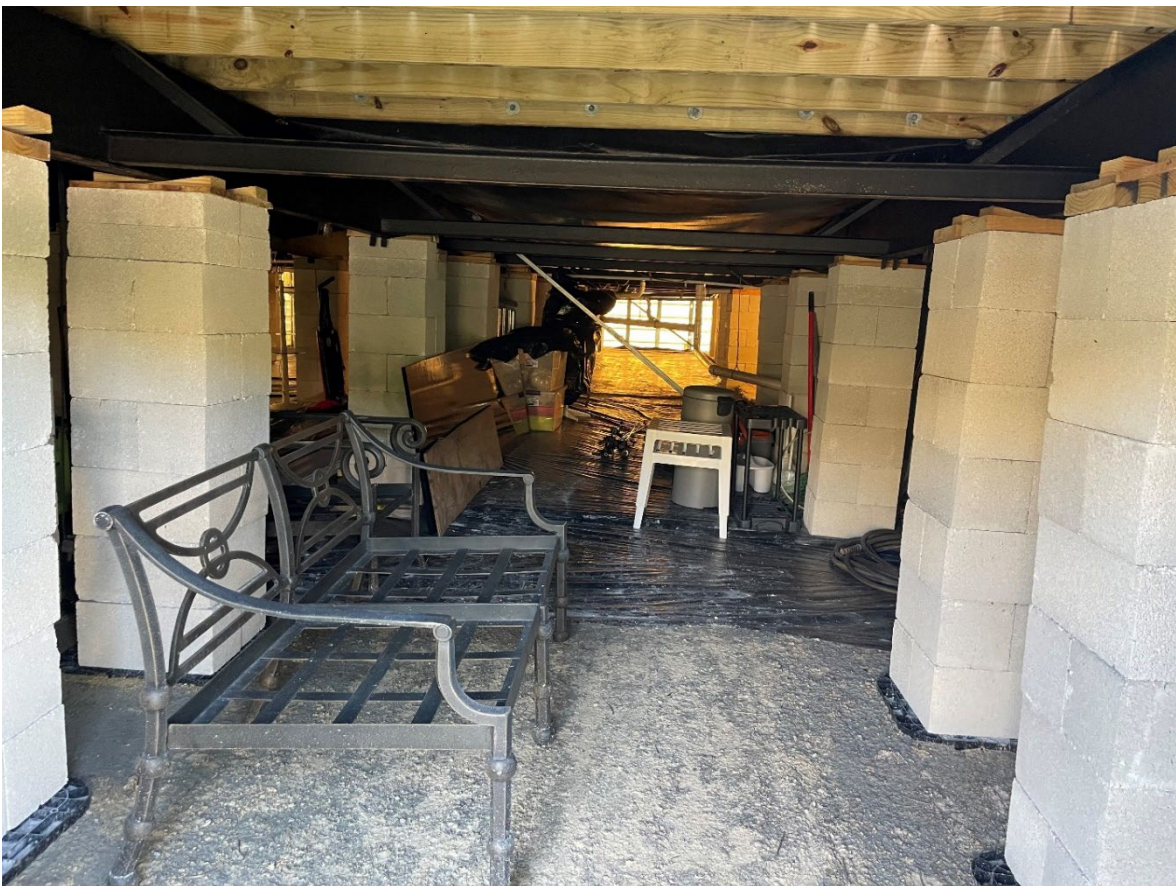
Figure 3-138: Representative foundation for newer elevated manufactured home in the Naples Land Yacht Harbor Community (Collier County, Zone AE)

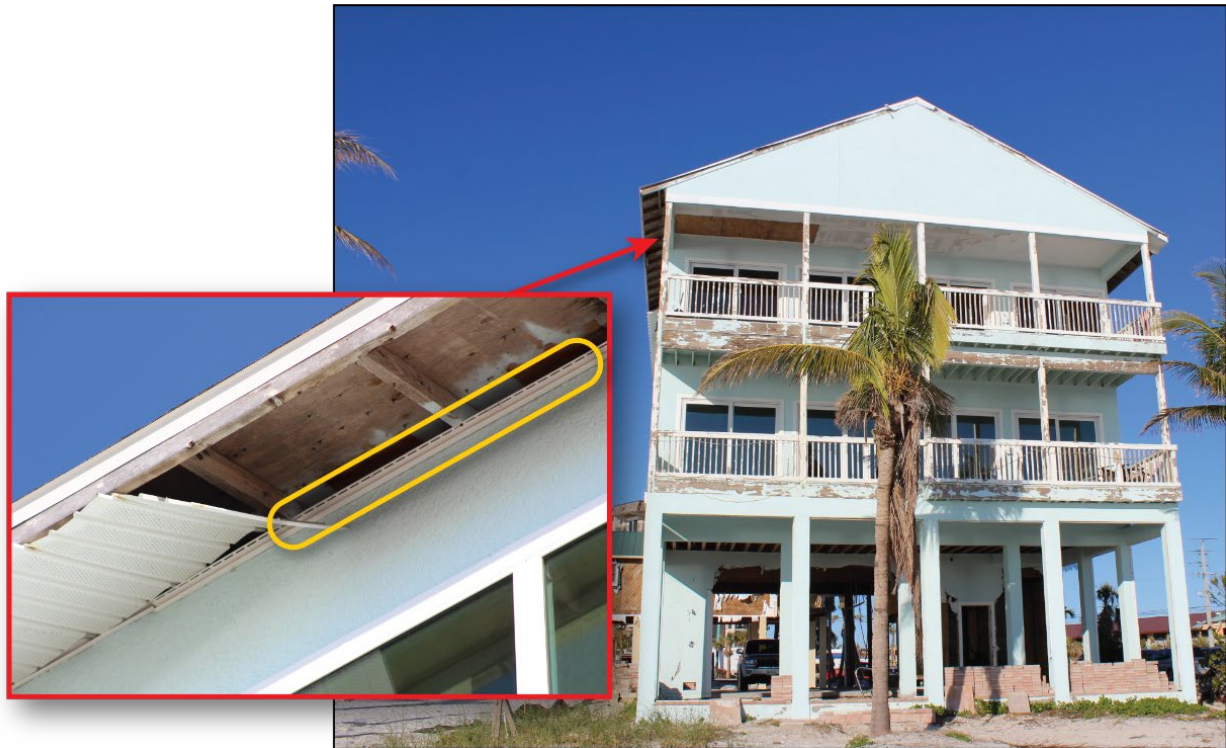
The waterfront house in Figure 4-2 is located on Fort Myers Beach, FL. The house was built in 2015 and suffered significant roof covering loss on the northwest side of the roof. Vinyl soffit panels failed along the eaves on both sides of the house. Although the soffit panels were fastened at the fascia (as evidenced by rust stains from fasteners on the soffit panel), the soffit panel was floated in the channel and not fastened at the exterior wall. The photograph shows the lack of a nailing strip at the wall. The soffit panel was floated in the channel that was attached to the roof framing. This house was built prior to the implementation of the improved soffit installation criteria in the 7th Edition

(2020) FBC. The homeowner indicated that this house experienced significant water intrusion primarily through the failed soffit panels.

Figure 4-2: House built in 2015 with roof covering and vinyl soffit damage (estimated wind speed [EWS] = 103 mph; design wind speed [DWS] = 159 mph) (Fort Myers Beach)

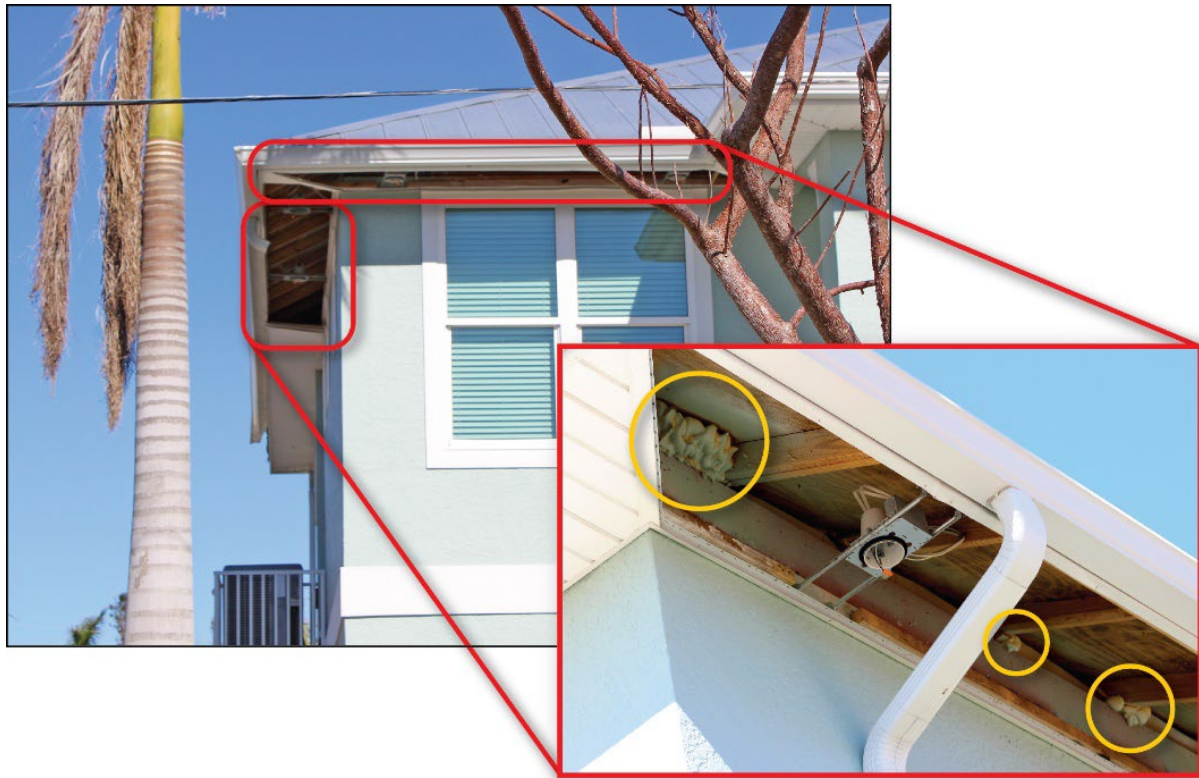
The house on Sanibel Island in Figure 4-3 was built to the 7th Edition (2020) FBC. The MAT observed significant damage to its vinyl soffit panels on the west, south, and east sides. The MAT noted two problems with this installation. The span of the soffit panel was approximately 24 inches as shown in Figure 4-4. The FBC requires an intermediate nailing strip for vinyl soffit panels that exceed 12 inches. As shown in Figure 4-3, the MAT did not find evidence that an intermediate nailing strip was installed. Although the soffit panel was fastened at the fascia and to a nailing strip at the exterior wall, an up-close inspection revealed the soffit was attached with staples that were fastened tightly against the nailing strip. The Vinyl Siding Institute's Vinyl Siding Installation Manual (includes installation guidelines for vinyl soffit as well) specifically recommends that fasteners not be driven tightly against vinyl products to allow for expansion and contraction. The manual recommends a clearance of approximately 1/32 inch between the fastener head and the vinyl. The MAT could not determine whether the staple fastener used was permitted in its Product Approval because the product was not labeled.

Notably, the house did not have any significant water intrusion according to the homeowner. Minor water intrusion through some of the windows was noted, but none through the soffit. Spray foam insulation was used in the attic area to create an unvented attic. Using spray foam insulation effectively separated the attic area from the soffit, which likely limited wind-driven rain from entering the attic area.

Figure 4-3: Post-FBC house (built in 2021) with vinyl soffit damage exposing the sprayed foam insulation in the attic (EWS = 109 mph; DWS = 161 mph) (Sanibel)

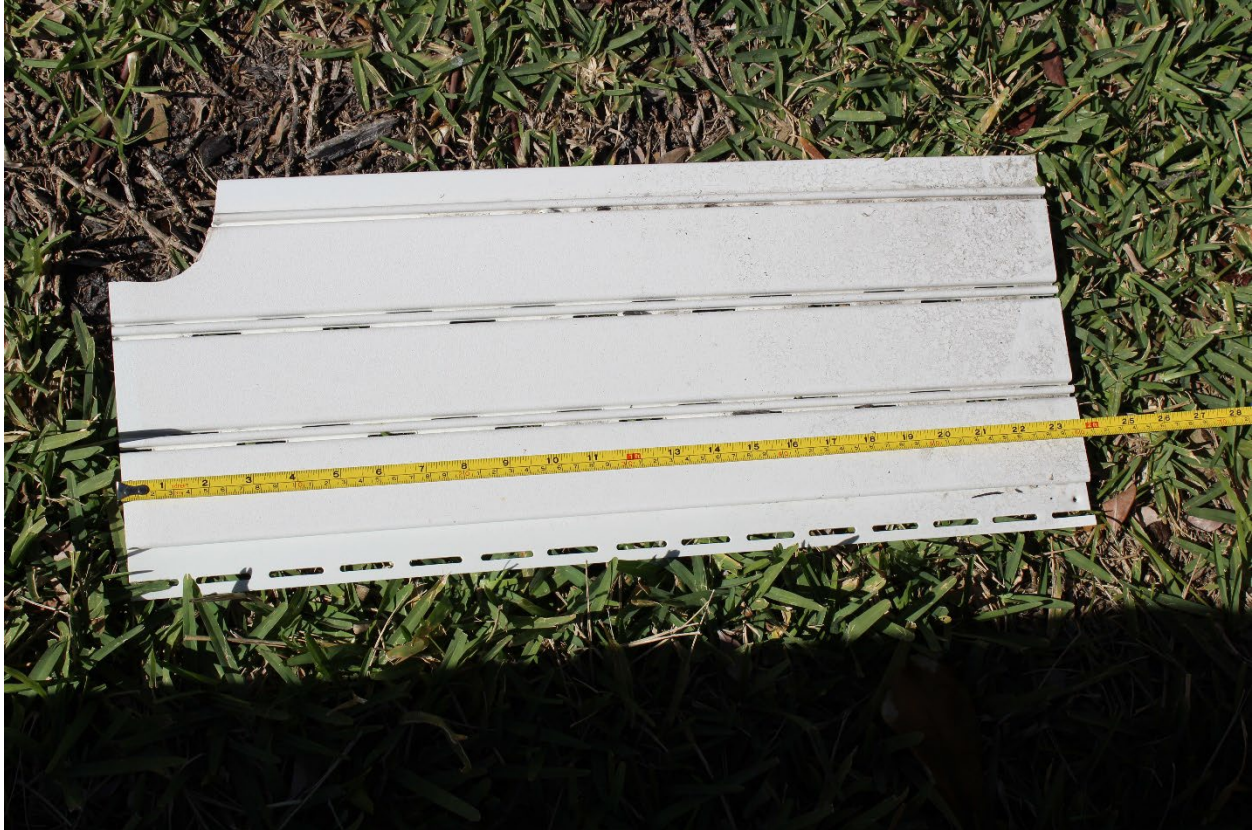
Figure 4-4: A vinyl soffit panel spanning approximately 24 inches that blew off the 2021 residence in Figure 4-3 (EWS = 109 mph; DWS = 161 mph) (Sanibel)

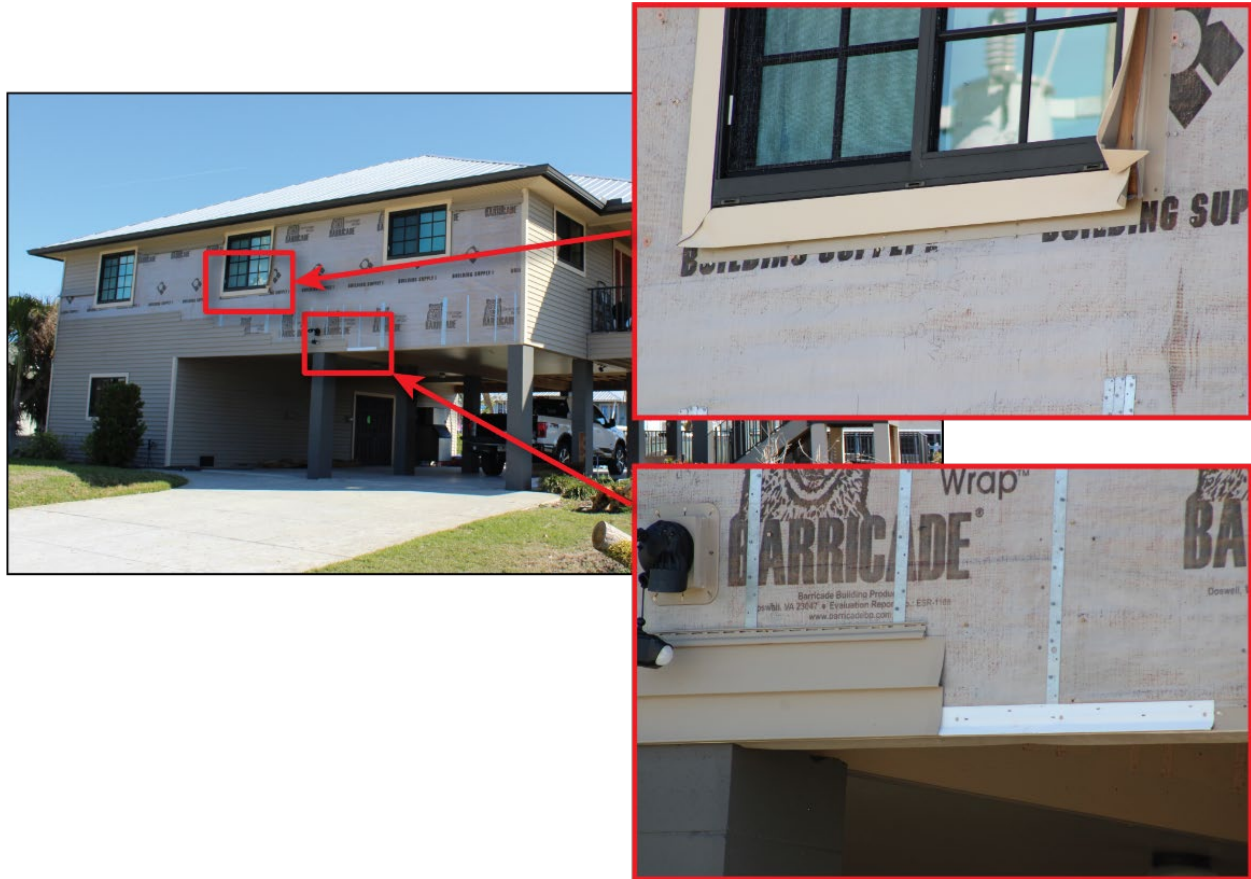
Figure 4-5 is a house in St. James City that is representative of the isolated vinyl siding damage observed. The house was built in 2014 and sustained significant vinyl siding damage on its west side. It appeared that an appropriate starter strip was used for the first course. However, utility trim was not used under the windows or the top of the wall to secure the top edge of the siding. If the top edge of the siding was not secured under the windows or at the top of the wall with utility trim, the siding would have been vulnerable at those locations.

Figure 4-5: A house built in 2014 with significant damage to the vinyl siding on the west side (EWS = 114 mph; DWS = 160 mph) (St. James City)

The next edition of the FBC (8th Edition [2023]) has been revised to specifically require the first course of vinyl siding to be secured using a starter strip approved by the manufacturer and for the top course of siding to be secured with utility trim under windows and at the top of walls.

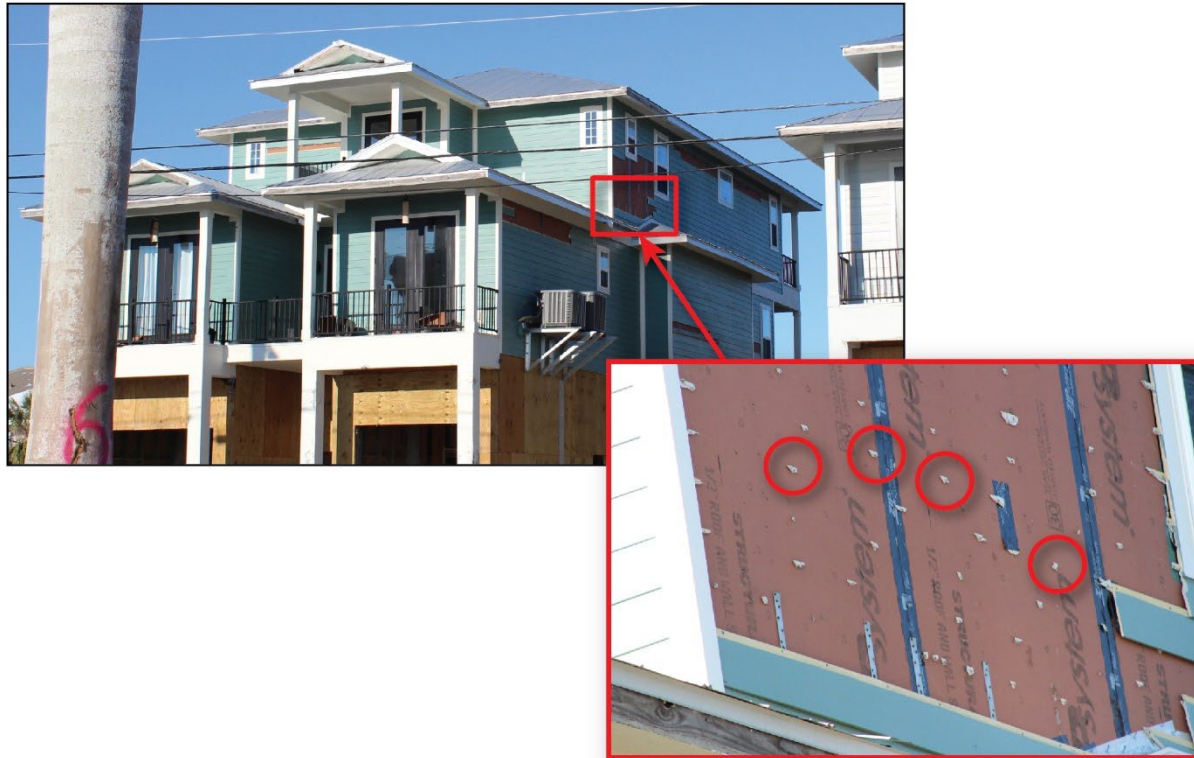
Figure 4-6 shows a house that was under construction at the time of the site visit. The building envelope on the upper floors appeared to have been completed when Hurricane Ian made landfall. The fiber cement siding on the upper floors failed due to a combination of fastener withdrawal and shear “punch-through” failure around the fastener heads as can be seen in the inset.

Figure 4-6: A house under construction with fiber cement siding failure (EWS = 104 mph; DWS = 160 mph) (Fort Myers Beach)

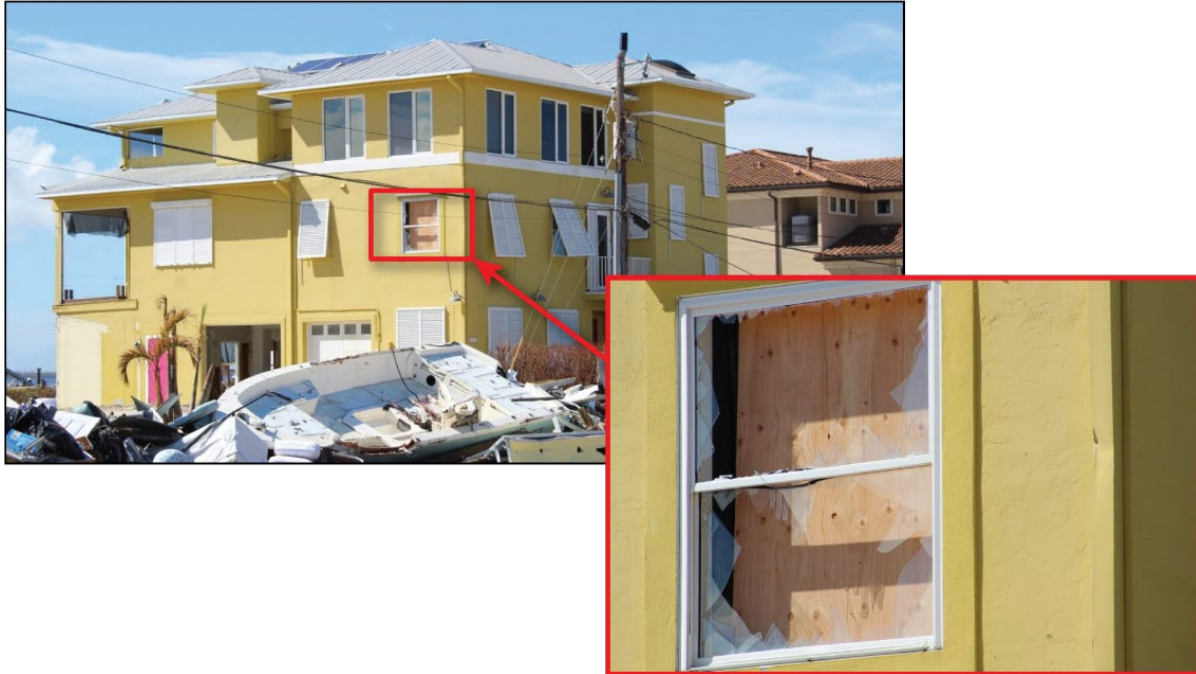
The MAT observed scattered instances of glazing failures that were likely due to wind-borne debris. The waterfront house in Figure 4-7 is located in St. James City, FL, and was built in 2003. One window had been broken, and based on the glass breakage pattern, the breakage was likely the result of wind-borne debris. Many of the glazed openings on this level of the house have louvered type shutters with stand-offs. This glazed opening appeared also to be protected with a similar type of shutter that detached from the building (one of the stand-offs is still attached). The MAT could not determine whether these shutters meet the ASTM International (ASTM) test standards ASTM E1886 and ASTM E1996 or the Testing Application Standard (TAS) 201, 202, and 203 test protocols (HVHZ) as required by the FBC. At the time this house was built, impact protection for glazed openings was not required by the FBC (2001 FBC).

Figure 4-7: A house built in 2003 with glazed opening damage (EWS = 114 mph; DWS = 160 mph) (St. James City)

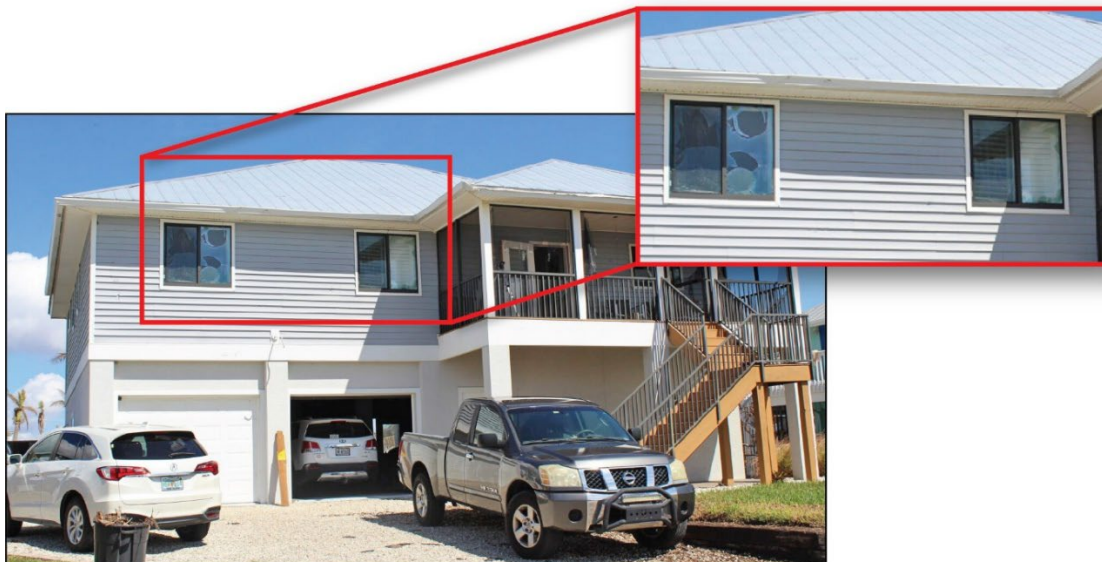
The house in Figure 4-8 is also located in St. James City, FL, and was built in 2016. The 5th Edition (2014) FBC was in effect when this house was built and required impact protection for glazed openings in this area. Three of the four glazed openings appeared to have been impacted by wind-borne debris. These glazed openings were likely impact resistant, though that cannot be determined with certainty without a closer inspection. While the outboard panes are clearly damaged, the inboard panes appeared to remain in place.

Figure 4-8: A house built in 2016 with glazed opening damage (EWS = 114 mph; DWS = 161 mph) (St. James City)

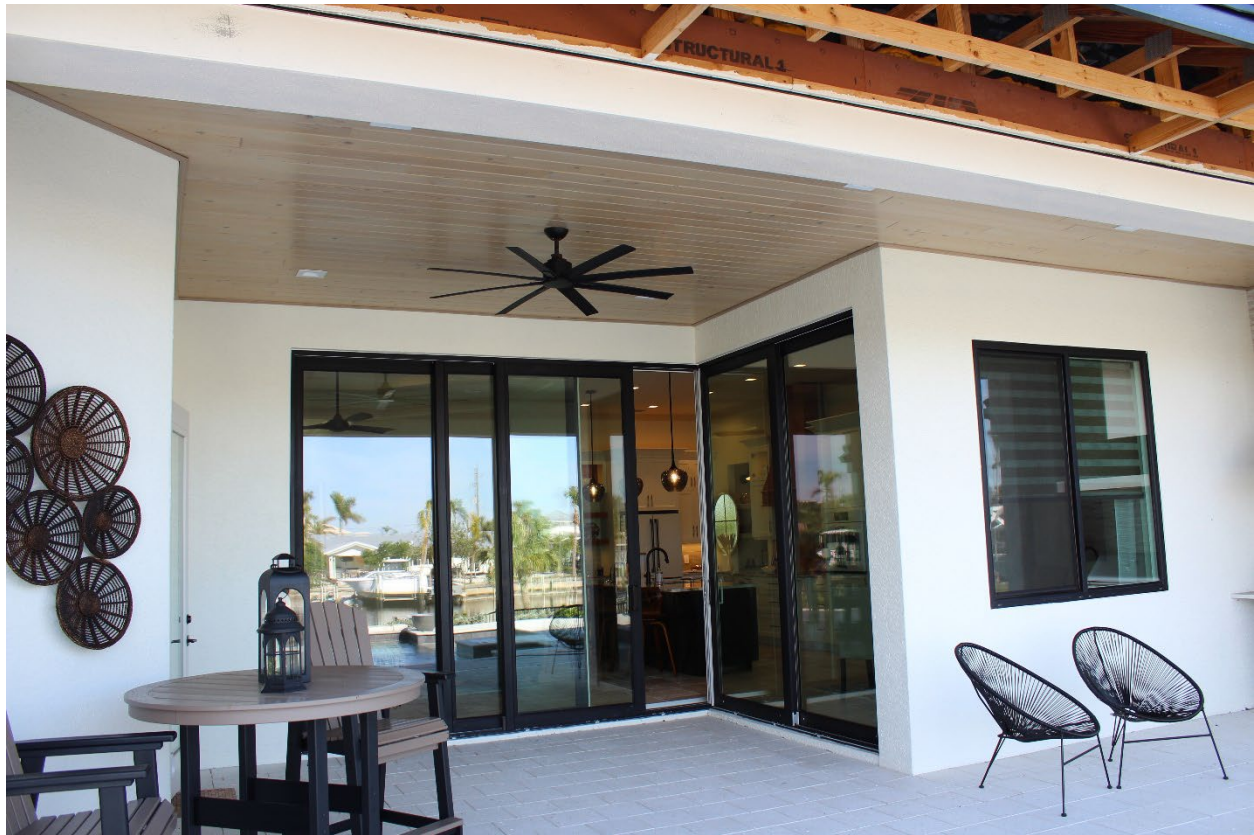
The MAT received numerous homeowner reports of water intrusion at windows and doors, particularly through sliding glass doors, at nearly all sites visited. Interior finishes and contents can be severely damaged by water intrusion through and around windows and doors. The house in Figure 4-9 was built in 2021 and is located in Punta Gorda, FL. The homeowner reported significant water intrusion due to wind-driven rain at both sliding glass doors in the rear of the house. This house was not impacted by storm surge. The three-panel sliding glass door was protected by an overhang. The ratio of the length of the overhang to its height above the door sill (overhang ratio) exceeded 1.0. For doors installed where the overhang ratio is equal to or greater than 1.0, the FBC does not require testing for water intrusion resistance (Section R609.3, Exception 2 of the 7th Edition [2020] FBCR). However, the code is not as clear for the adjacent two-panel sliding glass door in the perpendicular wall regarding water intrusion testing and protection by an overhang. Additionally, a nearby two-panel sliding glass door also in the rear of the same house, (Figure 4-10) was not protected by an overhang meeting the overhang ratio specified in the FBC to exempt water penetration resistance testing. Therefore, this door would have been required to be tested for water penetration resistance at 15% of its positive design pressure (DP) rating. According to the homeowner, significant water intrusion from wind-driven rain occurred around all these doors. Weepholes (see the two red circles in Figure 4-10) for draining water are visible in the photograph. The presence of weepholes indicates this door is a “contain and drain” product in that it allows water penetration to occur but contains the water in an integral sill pan and allows the water to drain to the exterior. The integral sill pan should include a sill riser (sill dam) on the interior side of the door to meet the water penetration resistance testing required by the FBC. The height of the sill riser depends on the required DP rating of the product. This door clearly lacked a sill riser as the back side of the track is flush with the interior tracks. It is not clear whether the door was installed without the sill riser or the homeowner removed the sill riser at some point. Without a sill riser, this door had little resistance to water intrusion from wind-driven rain. See Hurricane Ian in Florida Recovery Advisory 3, *Reducing Water Intrusion Through Windows and Doors* (2023d) for illustrations of typical sliding door integral sill pans and sill risers and for more information on the FBC exception for water intrusion testing for doors installed beneath overhangs.

Figure 4-9: A house built in 2021 with two- and three-panel sliding glass doors that experienced significant water intrusion (EWS = 130 mph; DWS = 151 mph) (Punta Gorda)

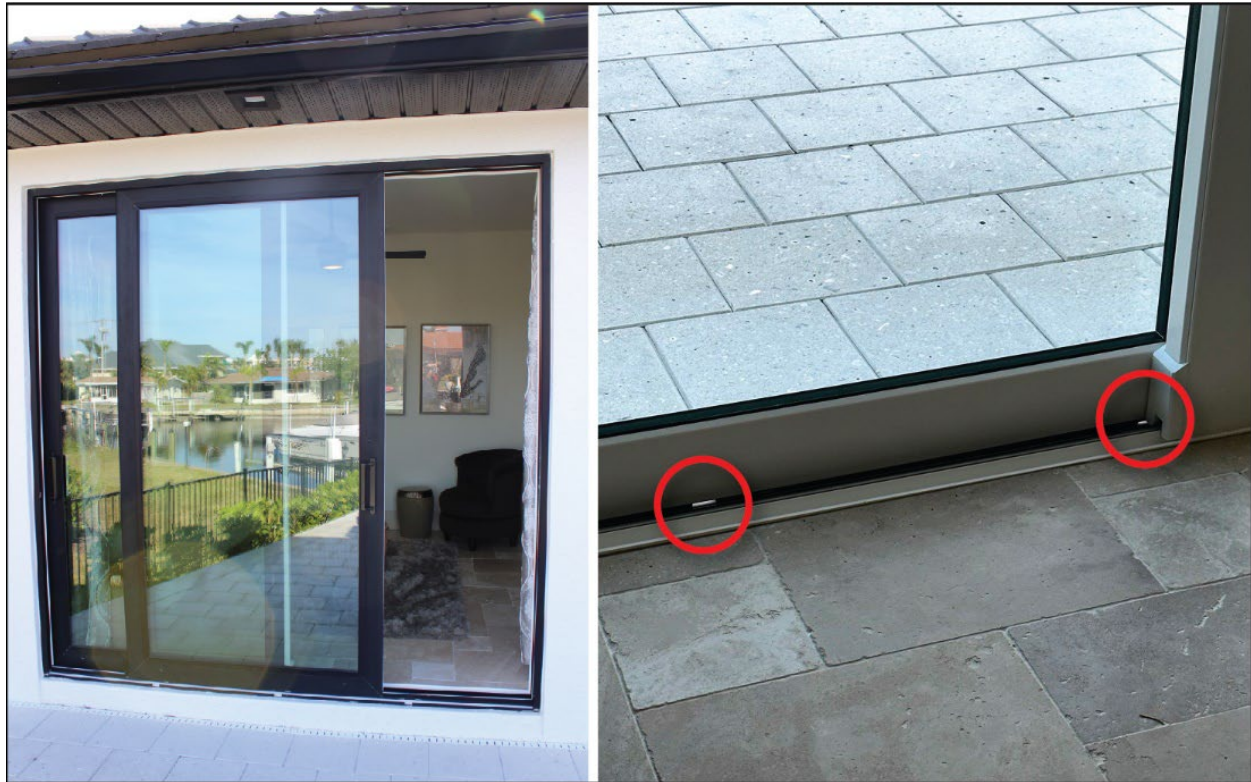
Figure 4-10: A house built in 2021 with a two-panel sliding glass door that experienced significant water intrusion due to wind-driven rain (the two red circles identify weepholes that enable water to exit) (EWS = 130 mph; DWS = 151 mph) (Punta Gorda)

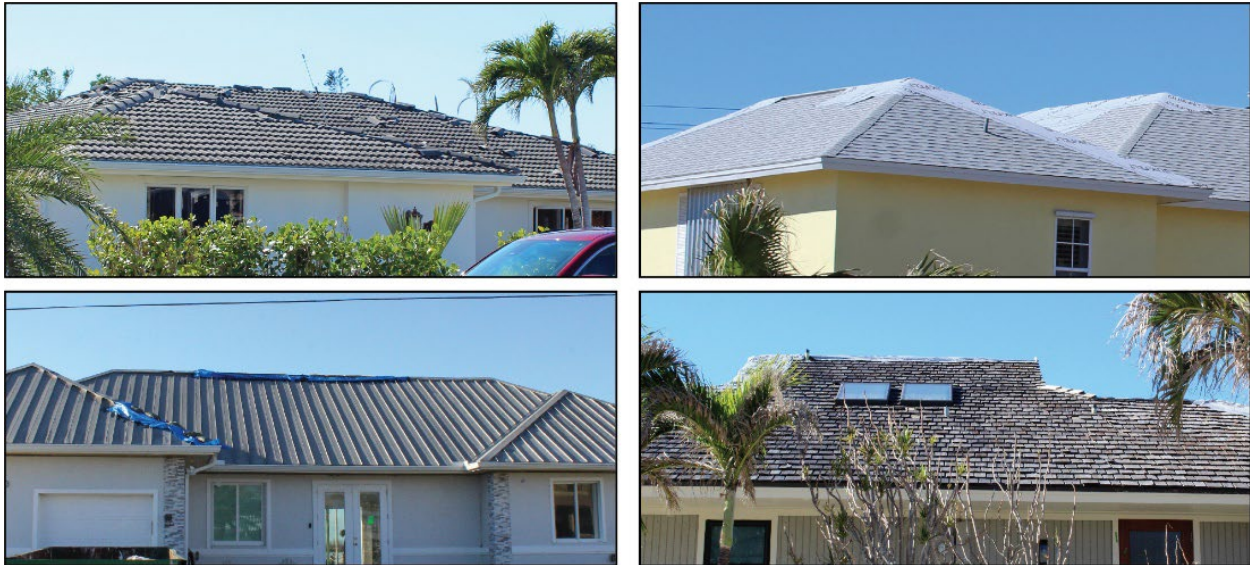
Figure 4-11 shows typical examples of hip and ridge failures observed. The estimated wind speeds from Hurricane Ian were far less than design-level wind speeds for this area.

Figure 4-11: Hip and ridge damage on four residences with different roof types: a tile roof (top left), asphalt shingle roof (top right), metal panel roof (bottom left), and cedar shake roof (bottom right)

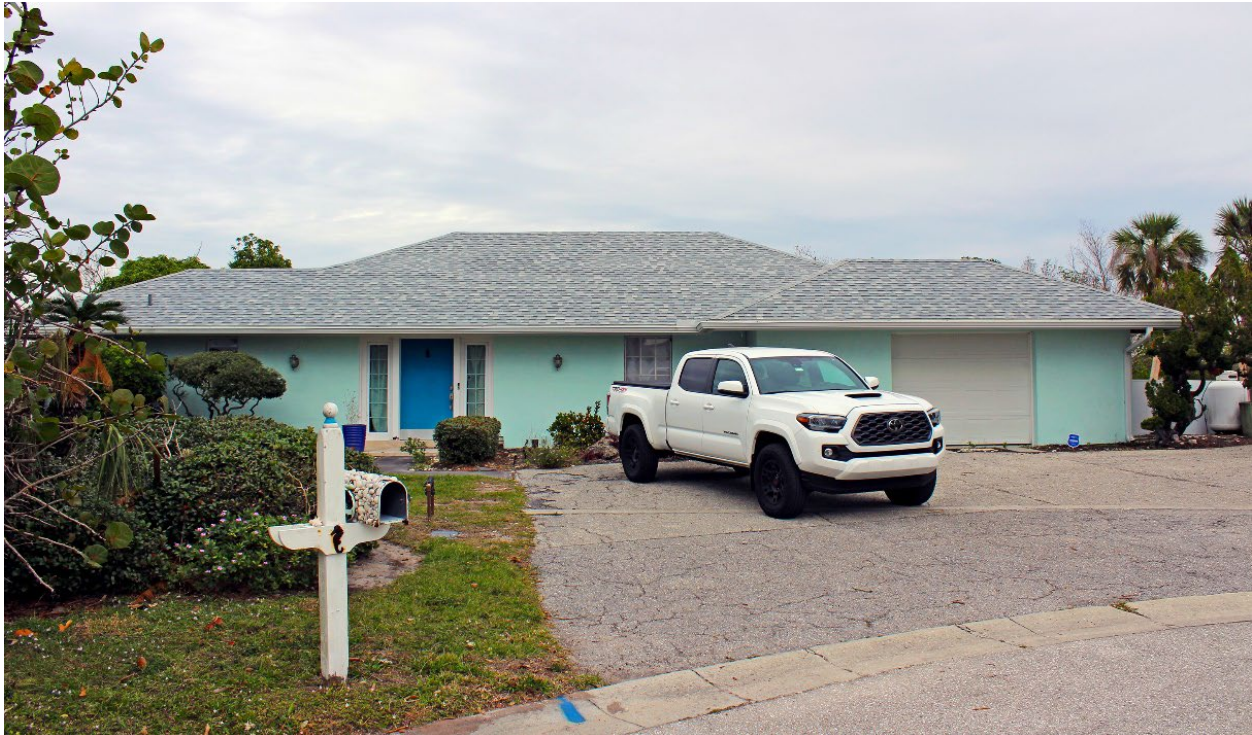
The MAT observed widespread damage to asphalt shingle roofs on both newer and older construction for all sites visited. However, the degree of damage varied considerably. Generally, newer asphalt shingle roofs significantly outperformed older asphalt shingle roof coverings (see Data Analysis of the Performance of Newer Roof Coverings). Figure 4-12 shows a house with an asphalt shingle roof in Placida, FL. Permit data extracted using a desktop analysis indicated an asphalt shingle roof replacement was performed in December 2020. As observed at the site visit and corroborated by the homeowner, the roof covering did not sustain any damage. However, the homeowner did report interior water damage due to water intrusion through the soffits. Figure 4-13 shows considerable asphalt shingle damage to older roof coverings on adjacent houses. The houses on this street with metal panel roofs did not have any damage that could be observed by the MAT during the site visits or from NOAA imagery.

Figure 4-12: A house with an asphalt shingle roof that was replaced in December 2020, with no damage (EWS = 128 mph; DWS = 155 mph) (Placida)

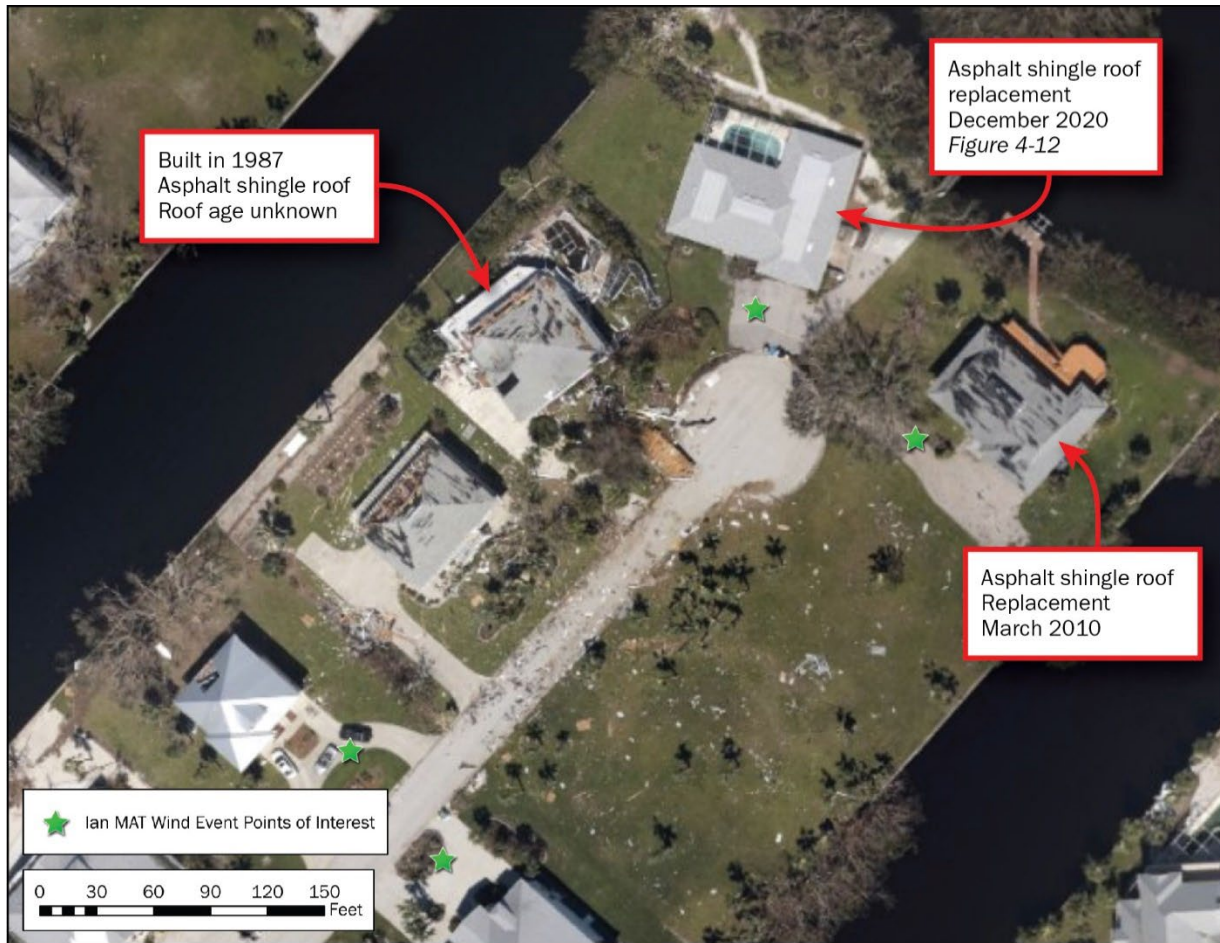
Figure 4-13: NOAA imagery of asphalt shingle damage on houses adjacent to the house shown in Figure 4-12 (EWS = 128 mph) (Placida)

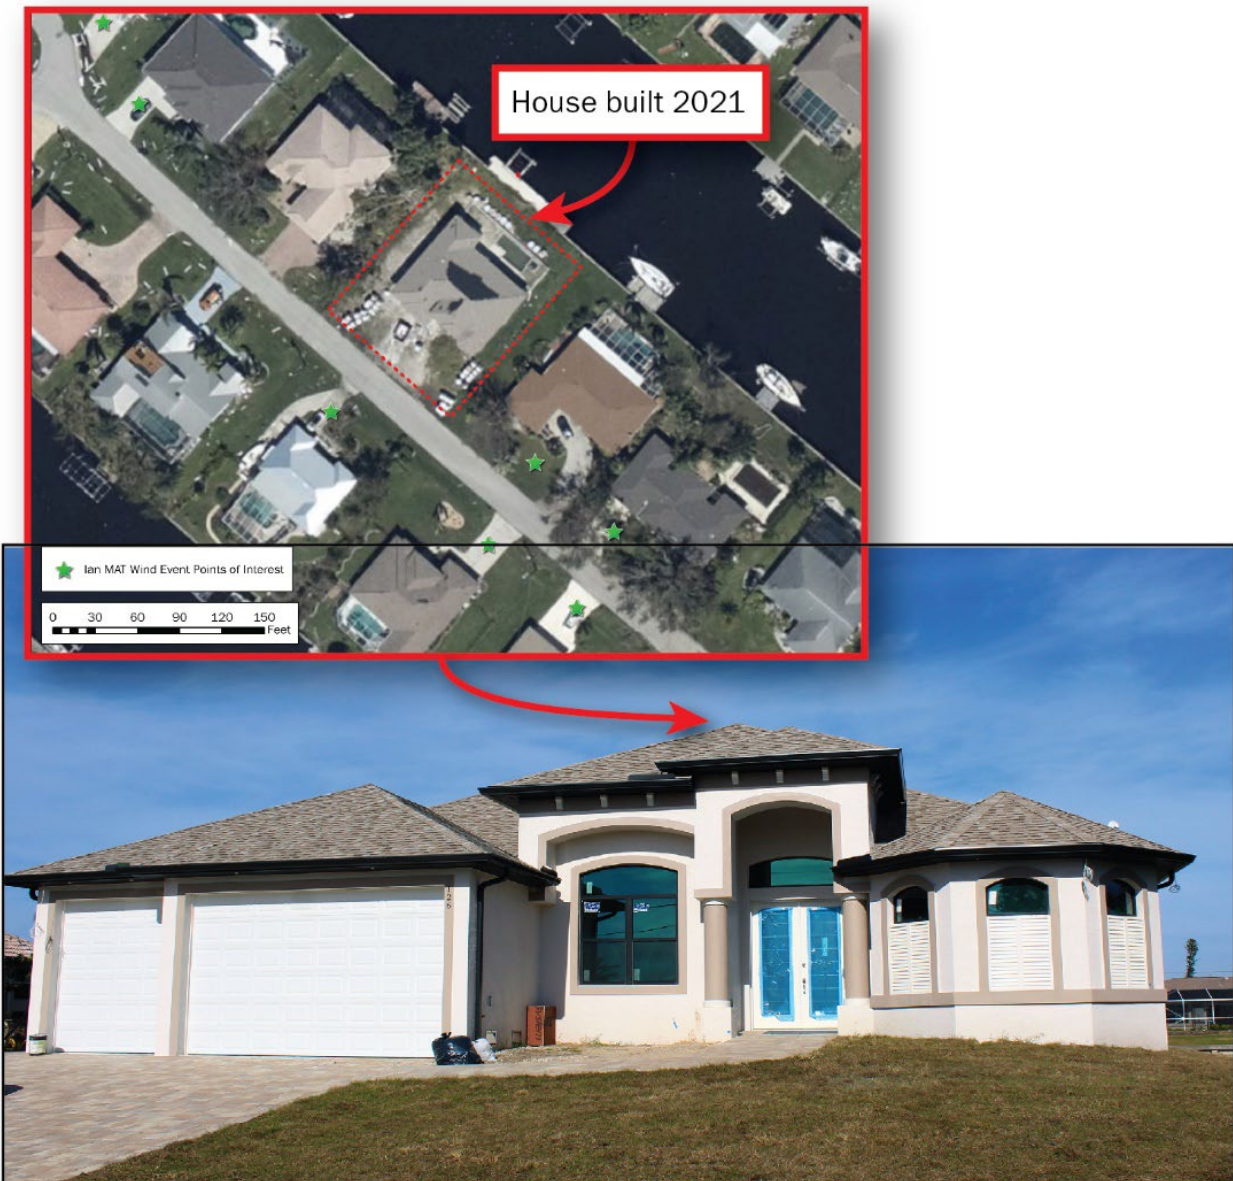
The house in Figure 4-14 was built in 2021. NOAA imagery indicates fairly significant asphalt shingle roof covering loss on the northeast roof slope (back of house). The homeowner indicated that while approximately 50% of the asphalt shingles on the back roof slope failed, the house did not experience any water intrusion through the roof or soffit. A self-adhered underlayment (sealed roof deck) was installed under the asphalt shingles and spray foam insulation was used in the attic area. The homeowner indicated that many houses on this street sustained significant water intrusion damage through soffits.

Figure 4-14: A house built in 2021 with significant asphalt shingle damage on the northeast roof slope (EWS = 127 mph; DWS = 150 mph). The inset above shows an aerial image of the house post-Hurricane Ian. (Port Charlotte)
