Mitigation Assessment Team Report

Hurricane Ian in Florida

Building Performance Observations,
Recommendations, and Technical Guidance

FEMA P-2342/December 2023

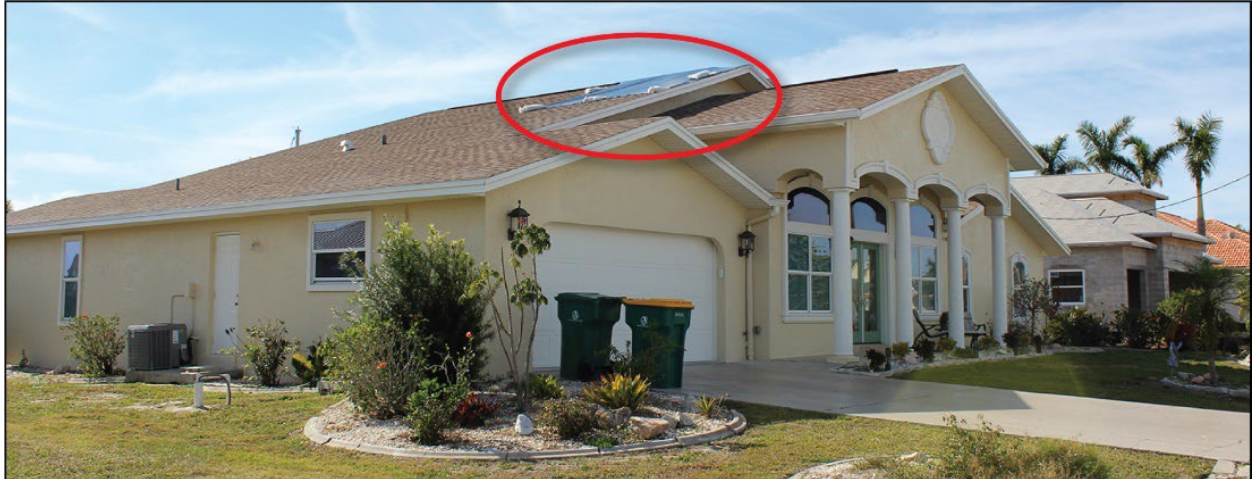
Figure 4-15 shows a house in Port Charlotte, FL, that had an asphalt shingle roof replacement in April 2022. NOAA imagery indicated minor damage near the ridge. A blue tarp was used to cover the damaged area to temporarily prevent water intrusion damage.

Figure 4-15: An asphalt shingle roof that was replaced in 2022 with minor damage near the ridge (EWS = 128 mph; DWS = 150 mph) (Port Charlotte)

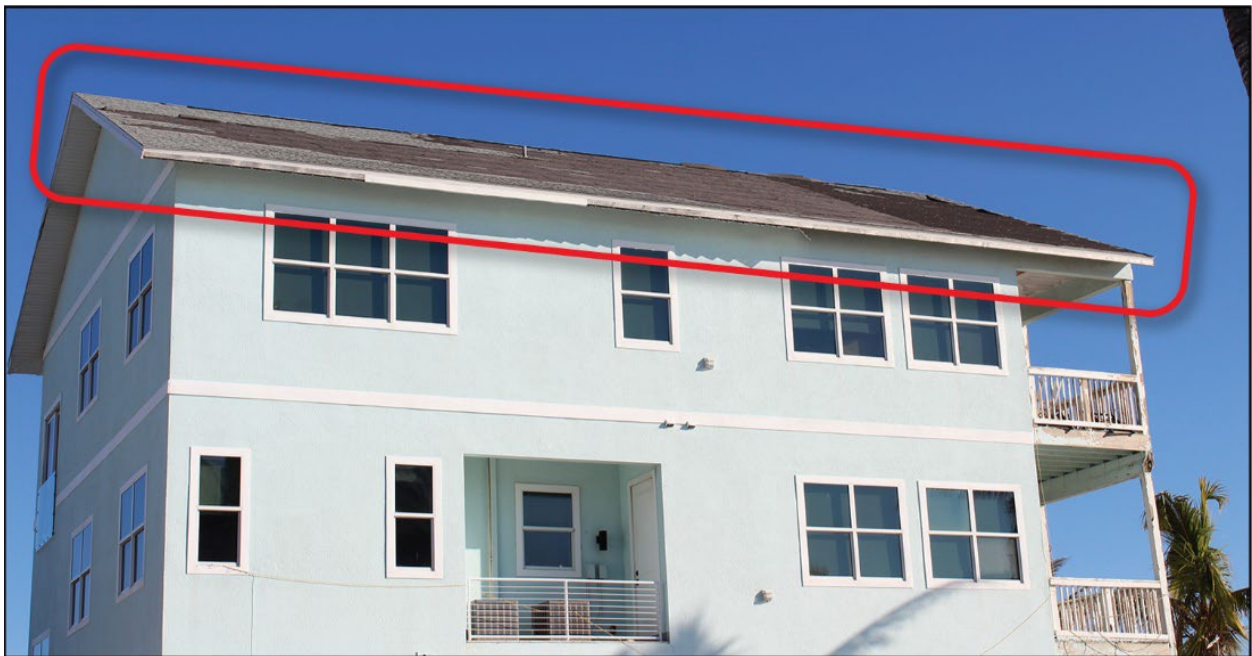
The house in Figure 4-16 was built in 2015 and suffered severe asphalt shingle roof covering damage on the northwest slope, but the underlayment stayed in place. The homeowner indicated the house experienced significant water intrusion damage, but it was mostly through the soffits. The darker colored underlayment on the right side of the picture is likely a newer/different underlayment material that was installed as part of some previous repair work.

Figure 4-16: A house built in 2015 with severe asphalt shingle damage (EWS = 103; DWS = 159) (Fort Myers Beach)

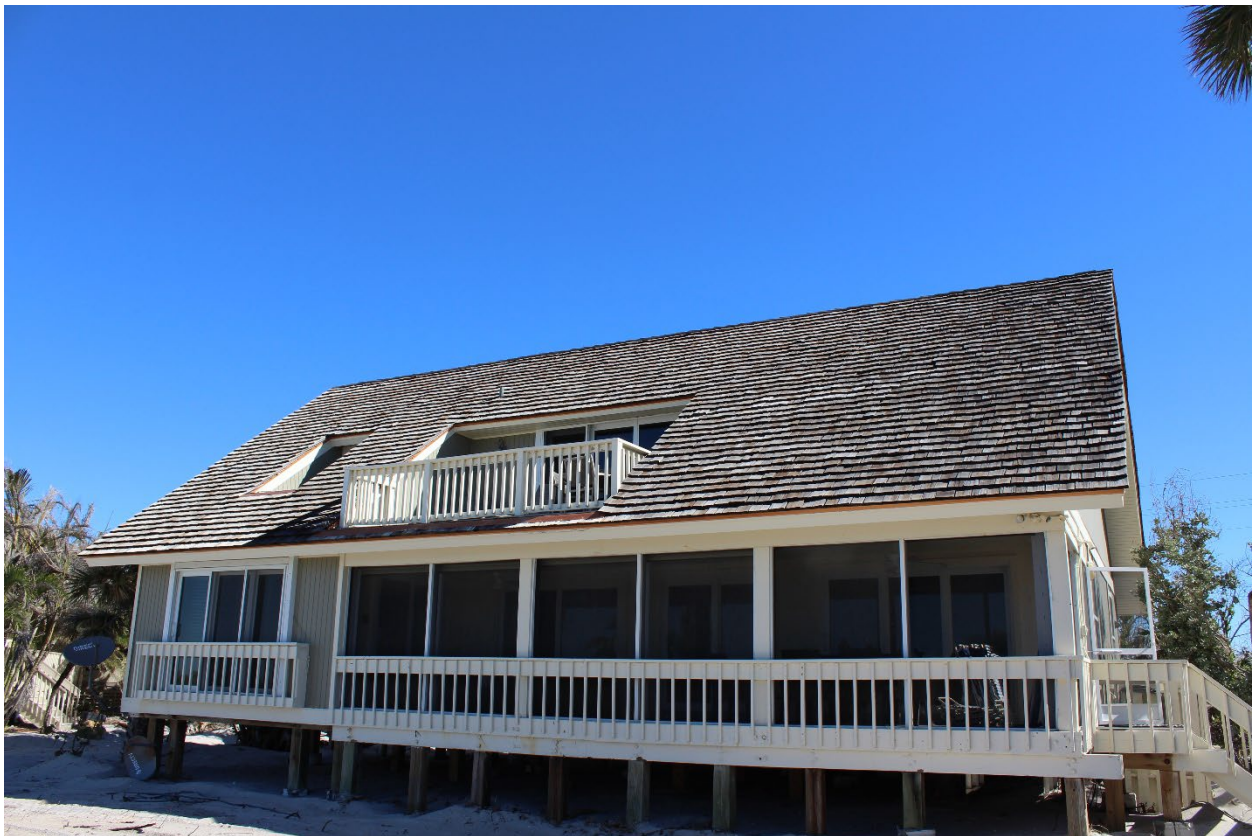
Figure 4-17: A house built in 1974 with a roof replacement in October 2019 with minor shake damage below the balcony (EWS = 123 mph; DWS = 162 mph) (Captiva)

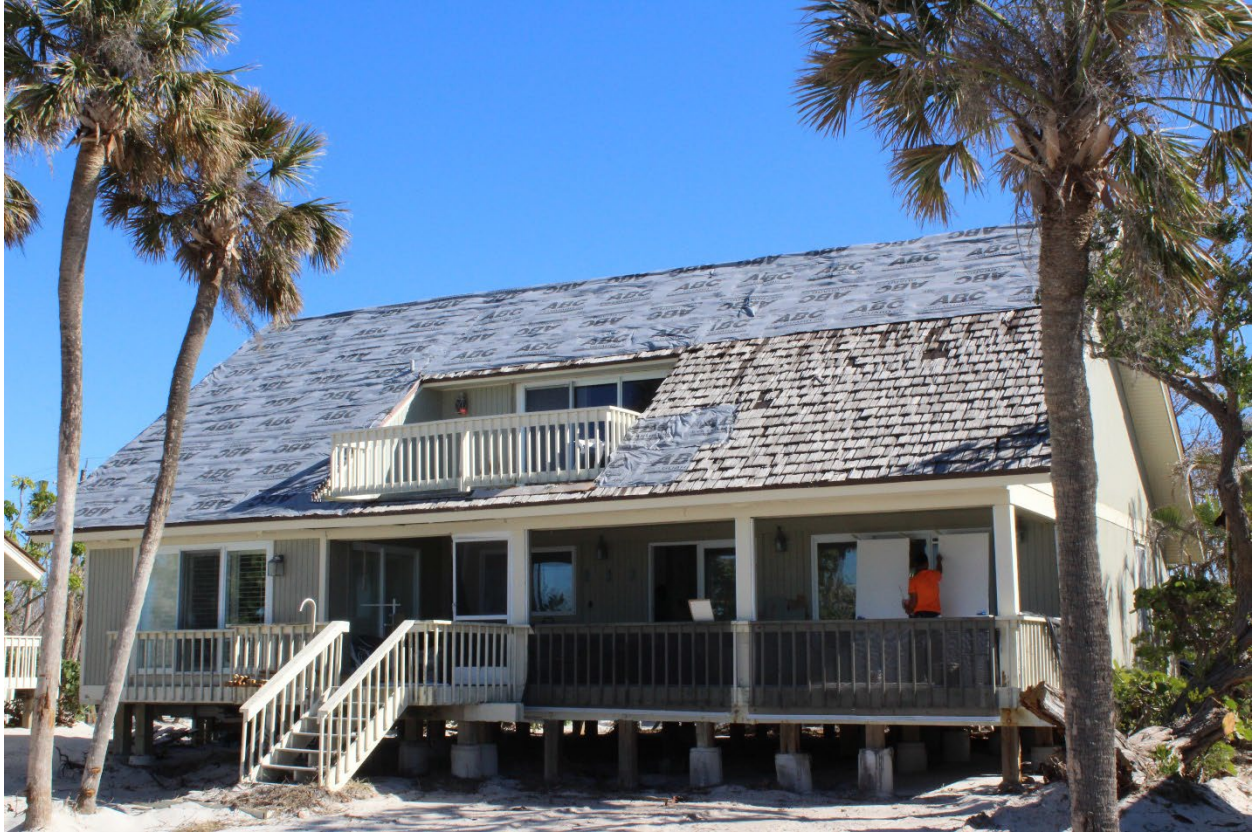
Figure 4-18: A house built in 1974 with an older roof covering with significant shake damage; large areas of the roof were covered with a synthetic underlayment to prevent further water intrusion (EWS = 123 mph) (Captiva)

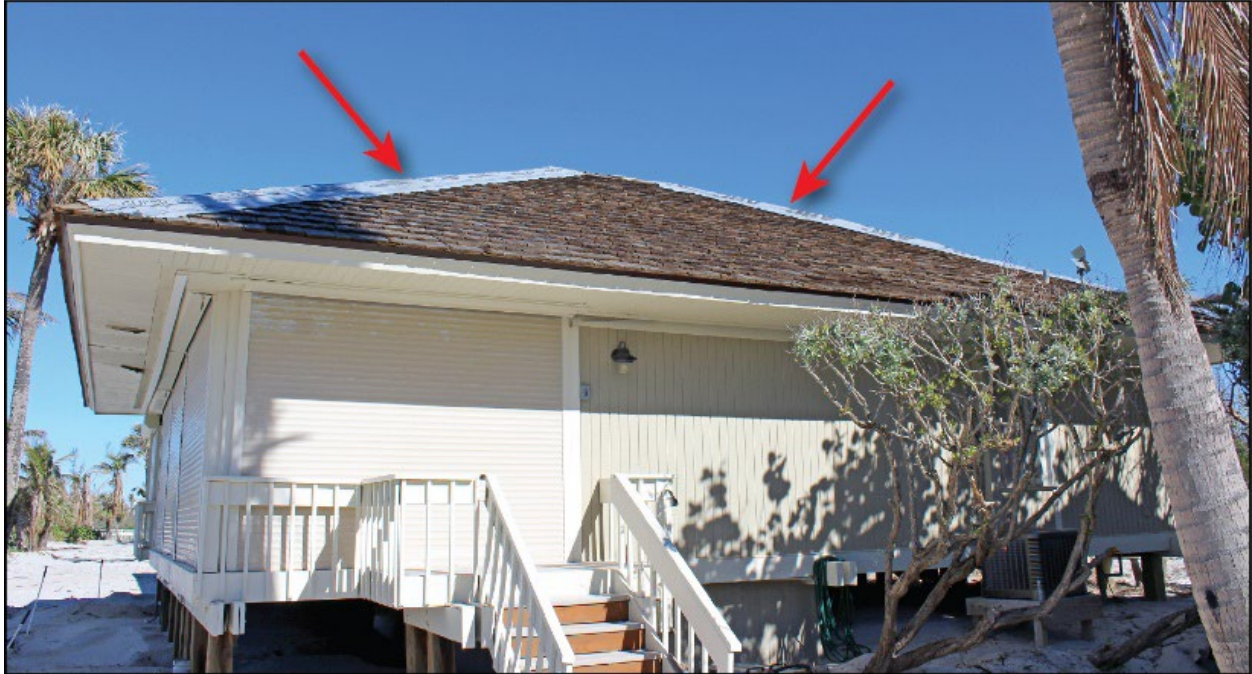
Figure 4-19: A house built in 1974 with a roof replacement in December 2021 with minor shake damage at hips (EWS = 123 mph; DWS = 162 mph) (Captiva)

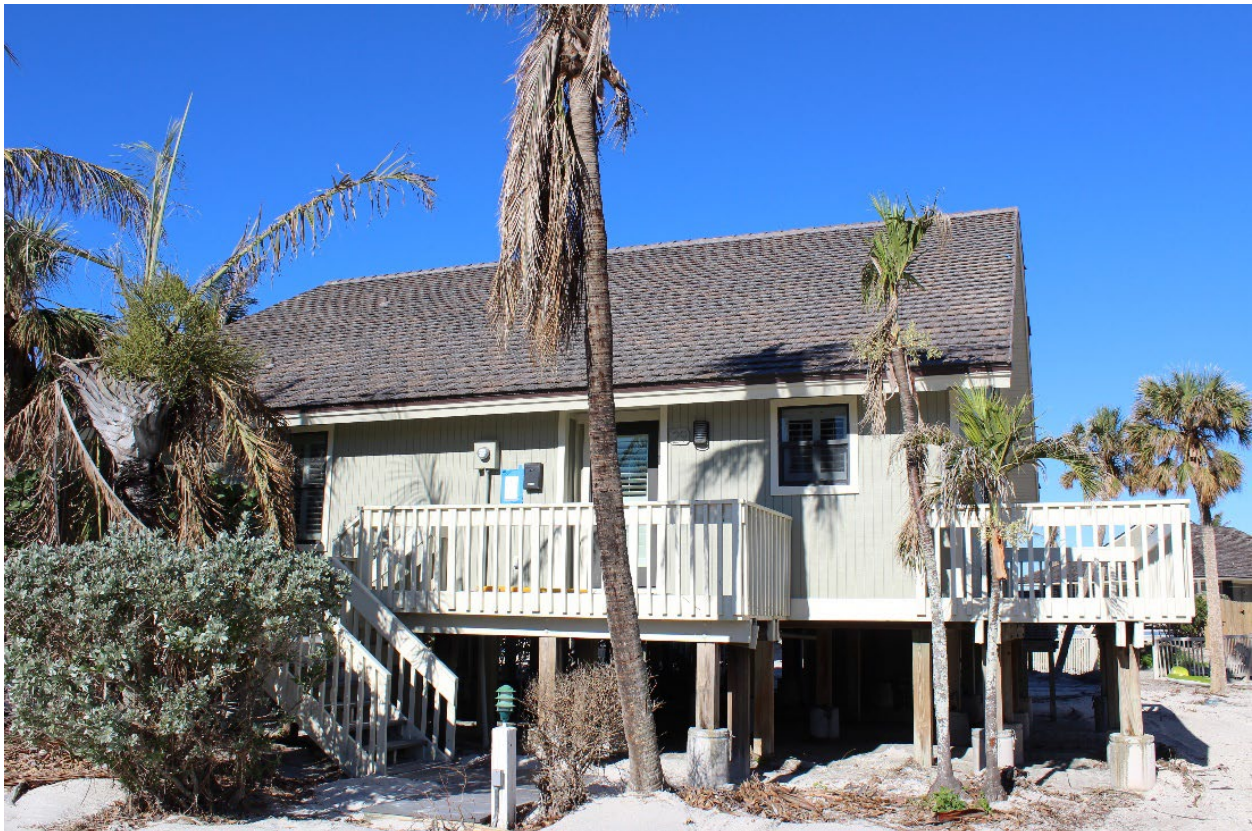
Figure 4-20: A house built in 1974 with a tile replacement in July 2020 with no visible damage (EWS = 123 mph, DWS = 162 mph) (Captiva)

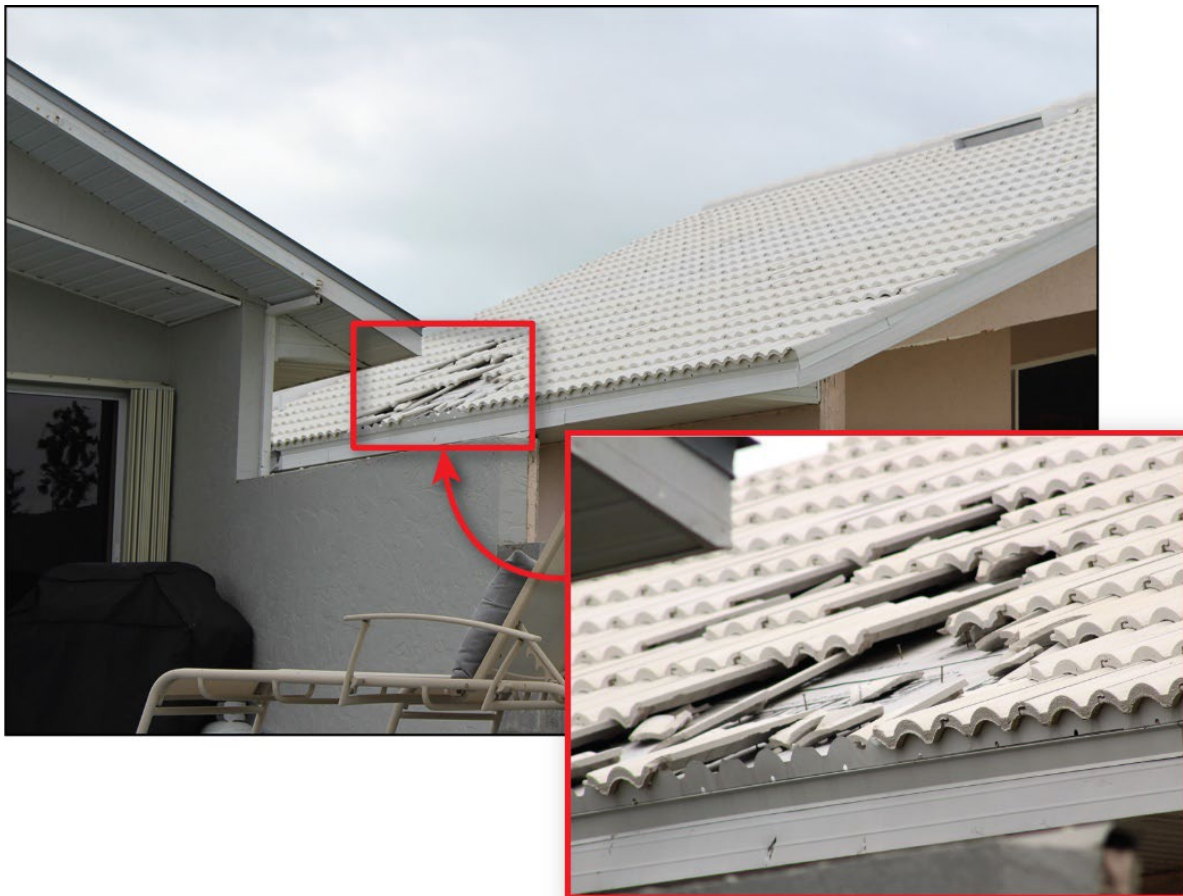
The tile roof on the house in Figure 4-21 was replaced in August 2021 and sustained minor damage near the eave. Two adjacent homes built in 1991/1992 with likely the original tile roof coverings are shown in Figure 4-22. These two roofs sustained significantly more damage than the tile roof that was replaced in August 2021.

Figure 4-21: A house with a tile roof that was replaced in August 2021 with minor damage near the eave (EWS = 126 mph; DWS = 155 mph) (Placida)

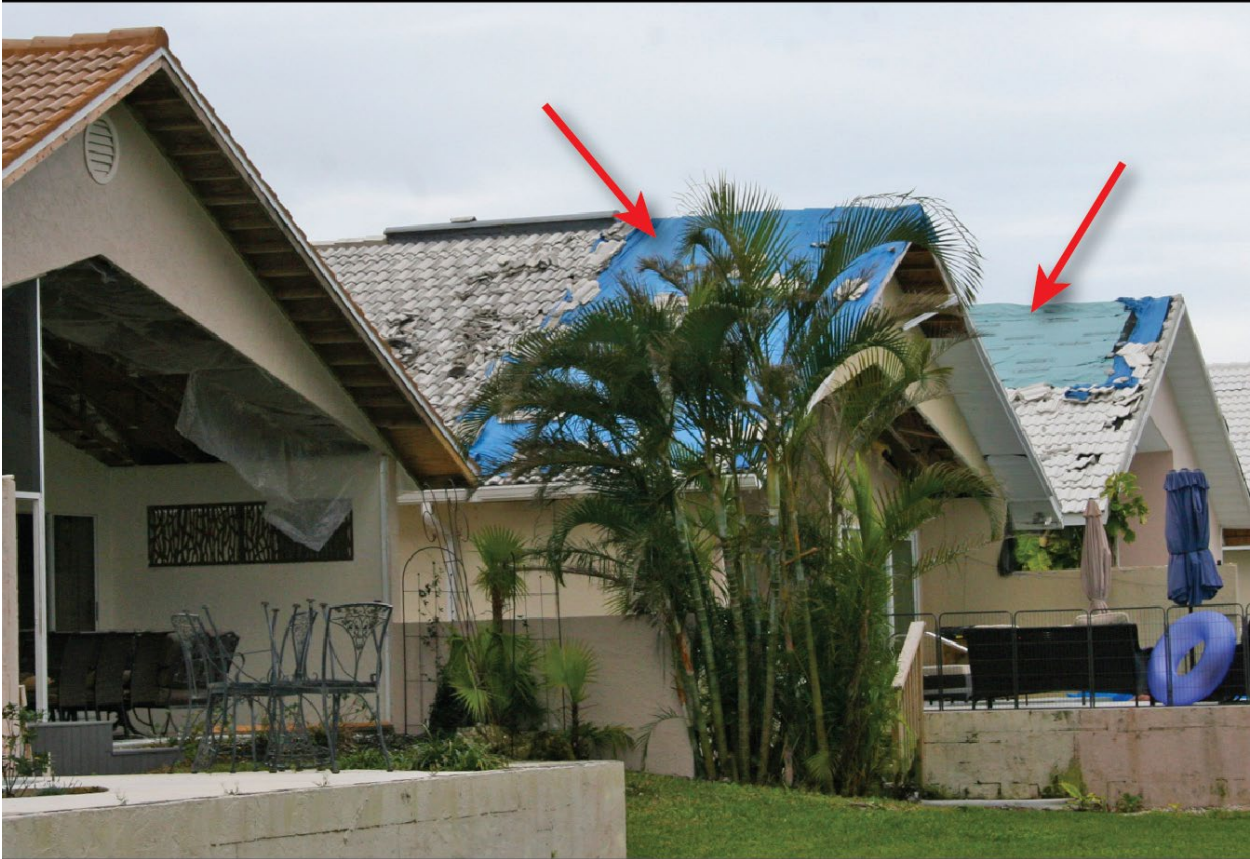
Figure 4-22: Roof tile damage to houses built in 1991/1992 with their original roof covering (EWS: 126 mph) (Placida)

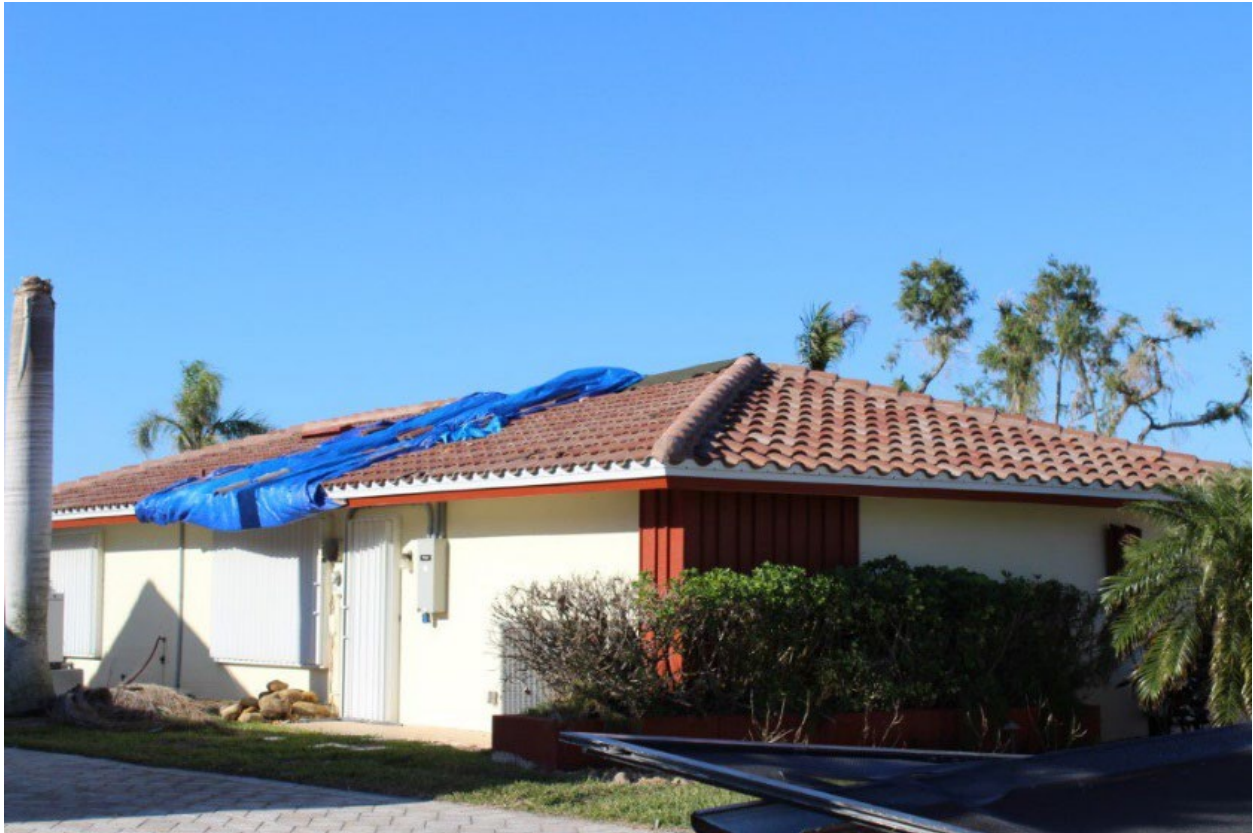
Figure 4-23 is a house built in 1973 in Pine Island, FL, that had a tile replacement in August 2022. Imagery indicates minor tile damage near the ridge in the area covered by the blue tarp.

Figure 4-23: A house constructed in 1973 with a tile roof that was replaced in August 2022 with minor damage (EWS = 120 mph) (Pine Island)

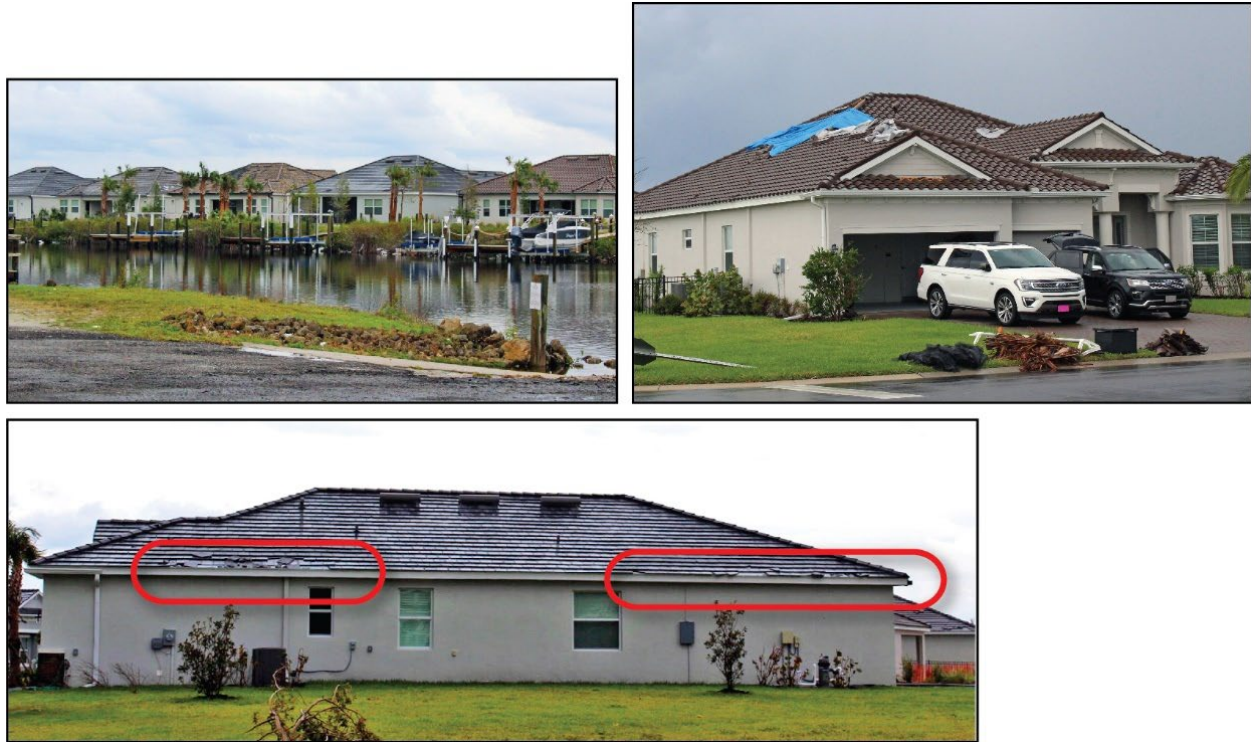
Figure 4-24 shows a neighborhood in Port Charlotte that was built in 2020 and 2021. Many of the tile roofs sustained minor to moderate damage, particularly at discontinuities, such as eaves, rakes, and hips and ridges. Tile in this neighborhood was adhered with a foam adhesive.

Figure 4-24: Neighborhood built in 2020 and 2021 with tile roof coverings with minor and moderate damage (EWS = 126 mph; DWS = 153 mph) (Port Charlotte)

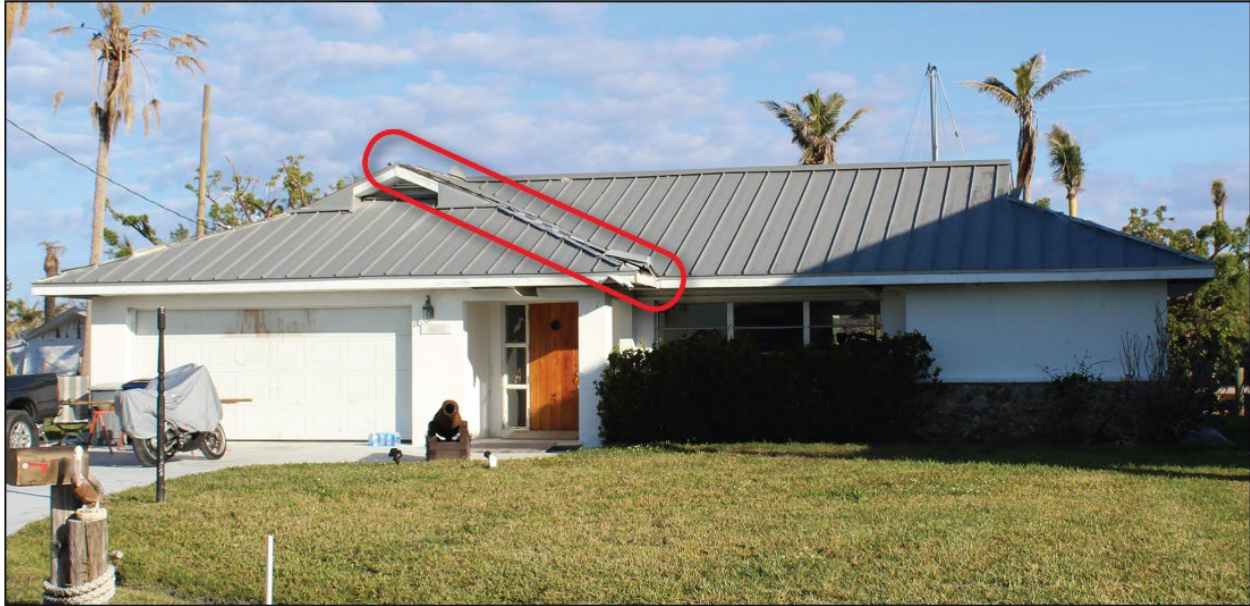
Figure 4-25: Typical hip cover damage on a metal panel roof (EWS: 115 mph; DWS: 161 mph) (St. James City)

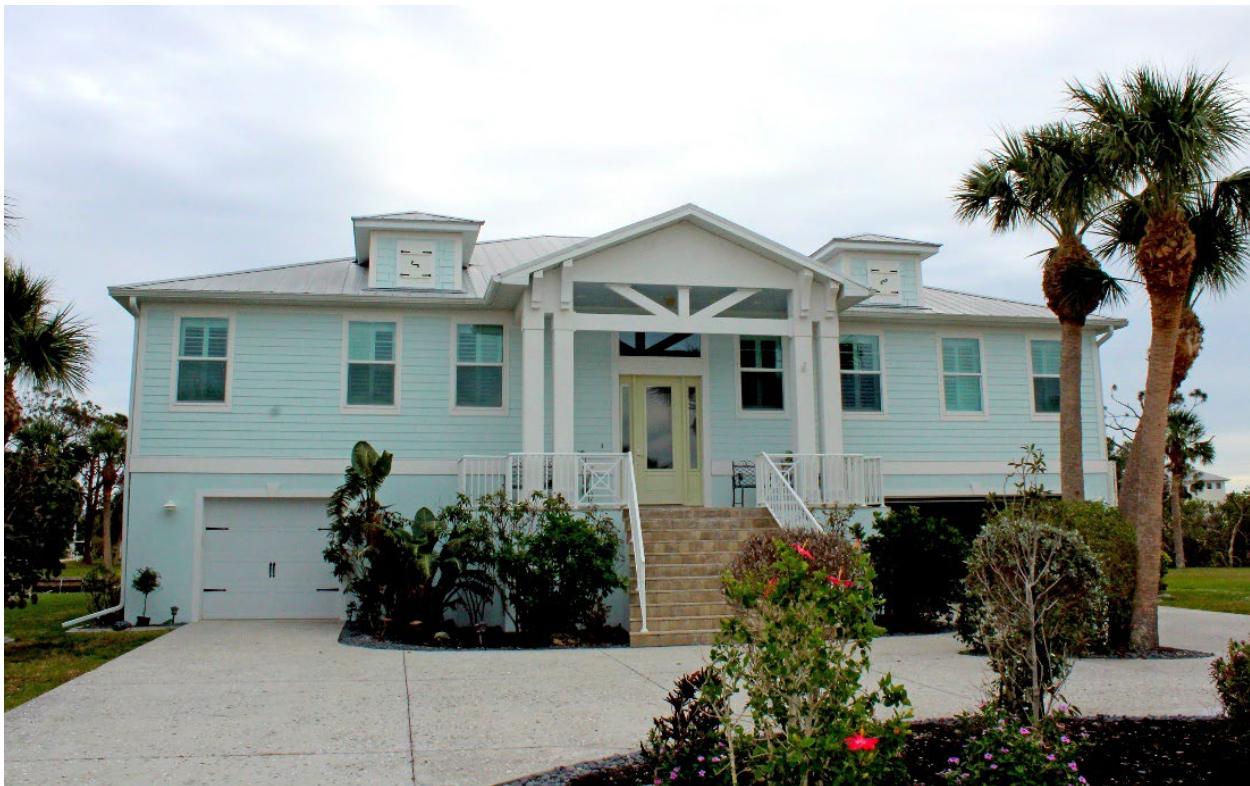
Figure 4-26: A house built in 2015 with a through-fastened metal roof with no damage observed (EWS = 120 mph; DWS = 160 mph) (Placida)

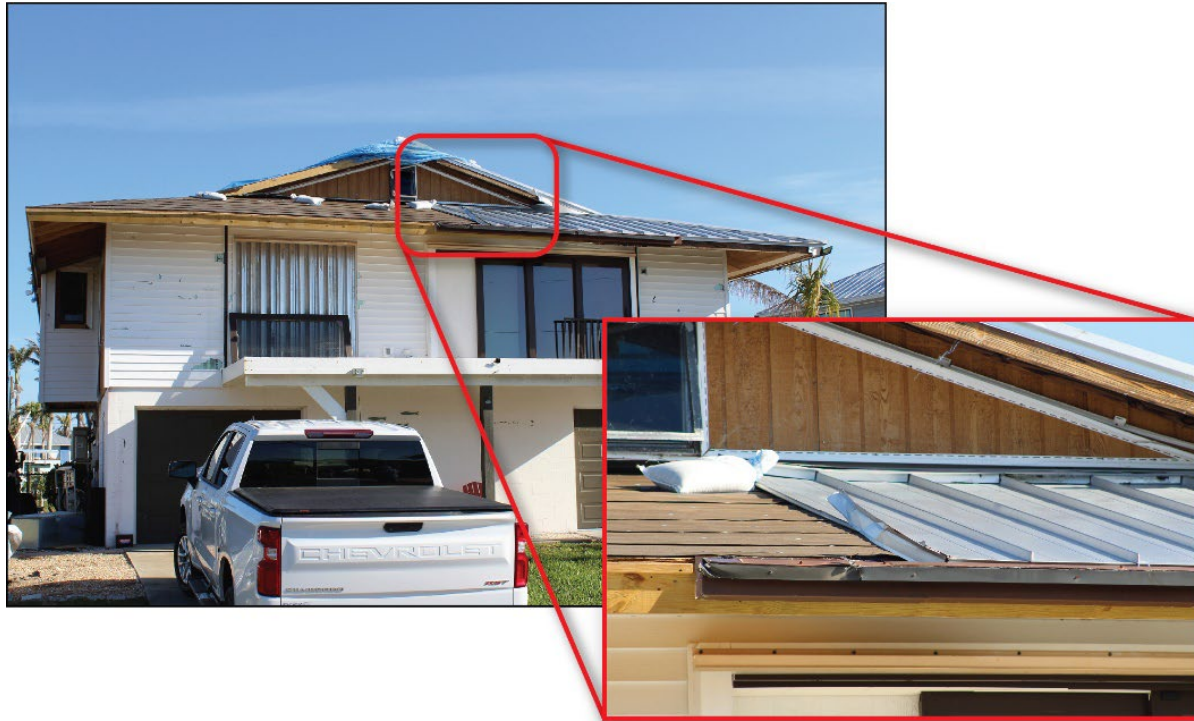
Figure 4-27 shows a standing seam metal roof replacement that was performed in 2018 in St. James City, FL. The MAT was unable to determine why this roof replacement performed poorly.

Figure 4-27: A house with a standing seam metal panel roof that was replaced in 2018 with severe damage (EWS = 115 mph; DWS = 161 mph) (St. James City)

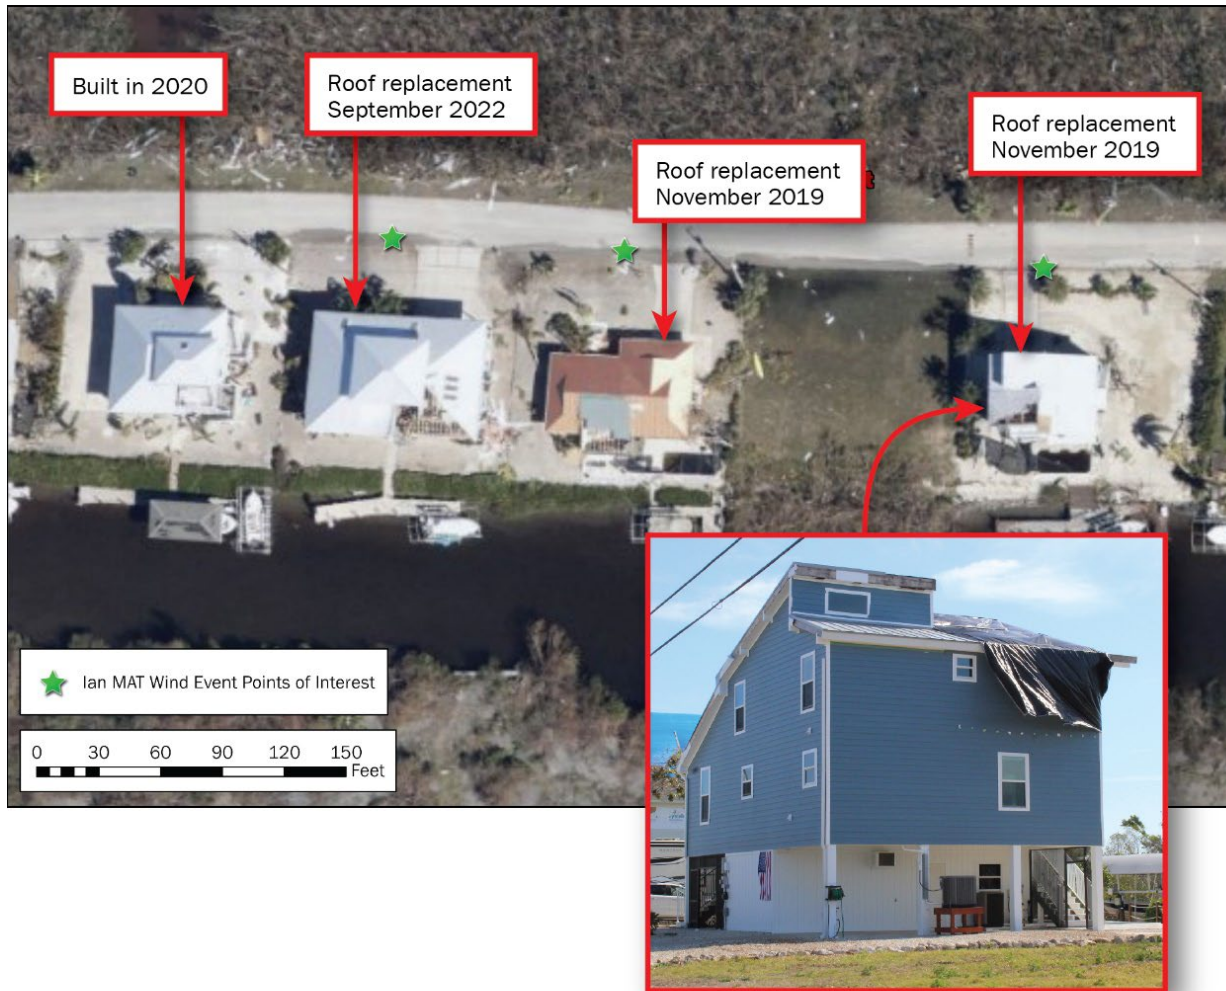
Newer houses (built to 2010 FBC and later) with original metal panel roofs appeared to outperform older houses with recent metal roof panel replacements. An example of this is shown in Figure 4-28. Based on NOAA imagery and site visits, the house built in 2020 had no visible damage to the metal panel roof covering. Other homes recently built on this street similarly showed no indication of visible damage. The houses where the roofs were replaced in 2019, 2020, and 2021 all sustained some damage to the metal panel roof coverings as indicated on the NOAA imagery and confirmed by site visits.

Figure 4-28: Metal panel roof cover damage on roofs that were recently replaced (EWS: 115 mph; DWS: 160 mph) (St. James City)

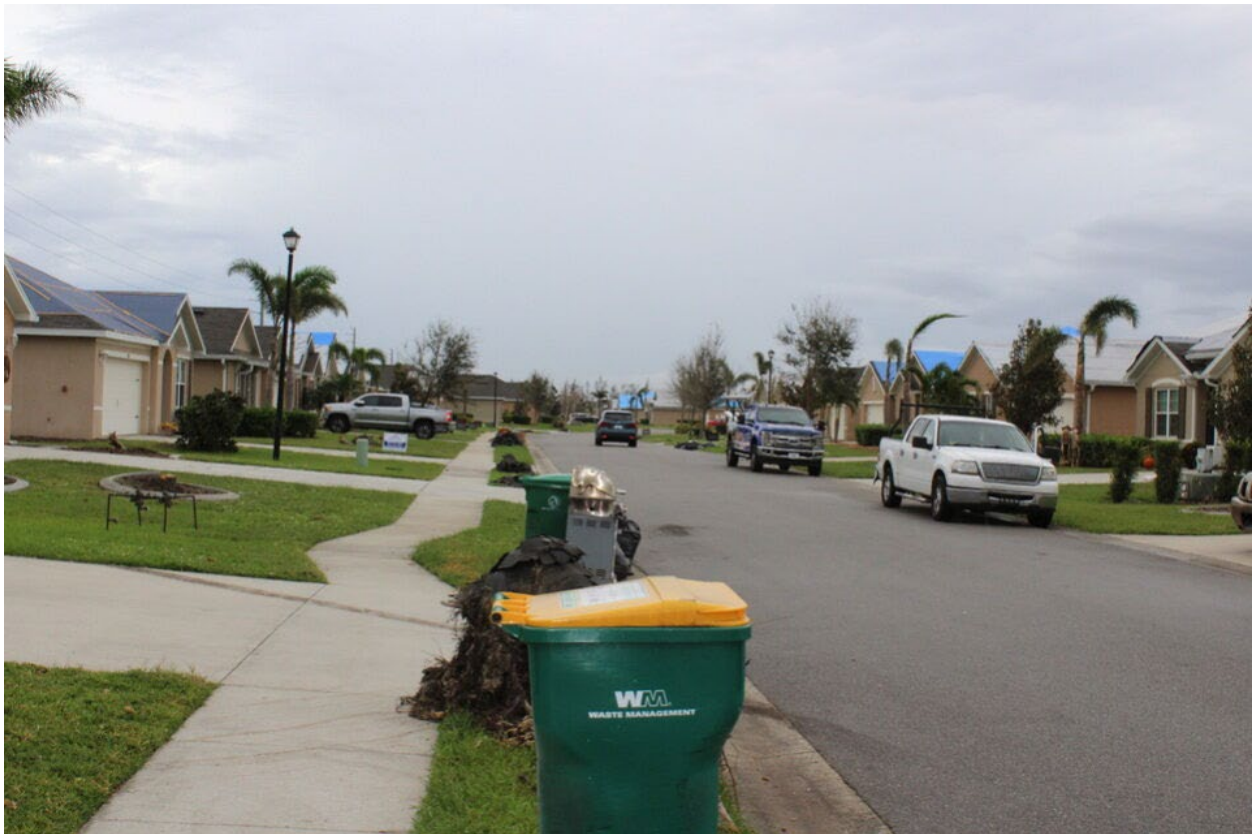
A key piece of evidence pointing to water intrusion damage is the presence of interior content debris piles near curbs. For the sites visited, the MAT observed fewer interior content debris piles by curbs overall than in recent major storms. The buildings in Figure 4-29, located in a neighborhood in Punta Gorda, FL, clearly suffered roof covering damage, as evidenced by the presence of tarps and other water-resistant materials placed on the roofs. However, as shown in the figure, there were limited amounts of interior contents by the curbs, indicating limited water intrusion damage to the interior of these buildings. This picture was taken by the pre-MAT approximately 2 weeks after Hurricane Ian impacted the area. The estimated maximum peak wind gust from Hurricane Ian in this area was 127 mph.

Figure 4-29: Limited amounts of interior contents by curbs in a Punta Gorda neighborhood (photo taken October 13, 2022) (EWS = 127 mph)

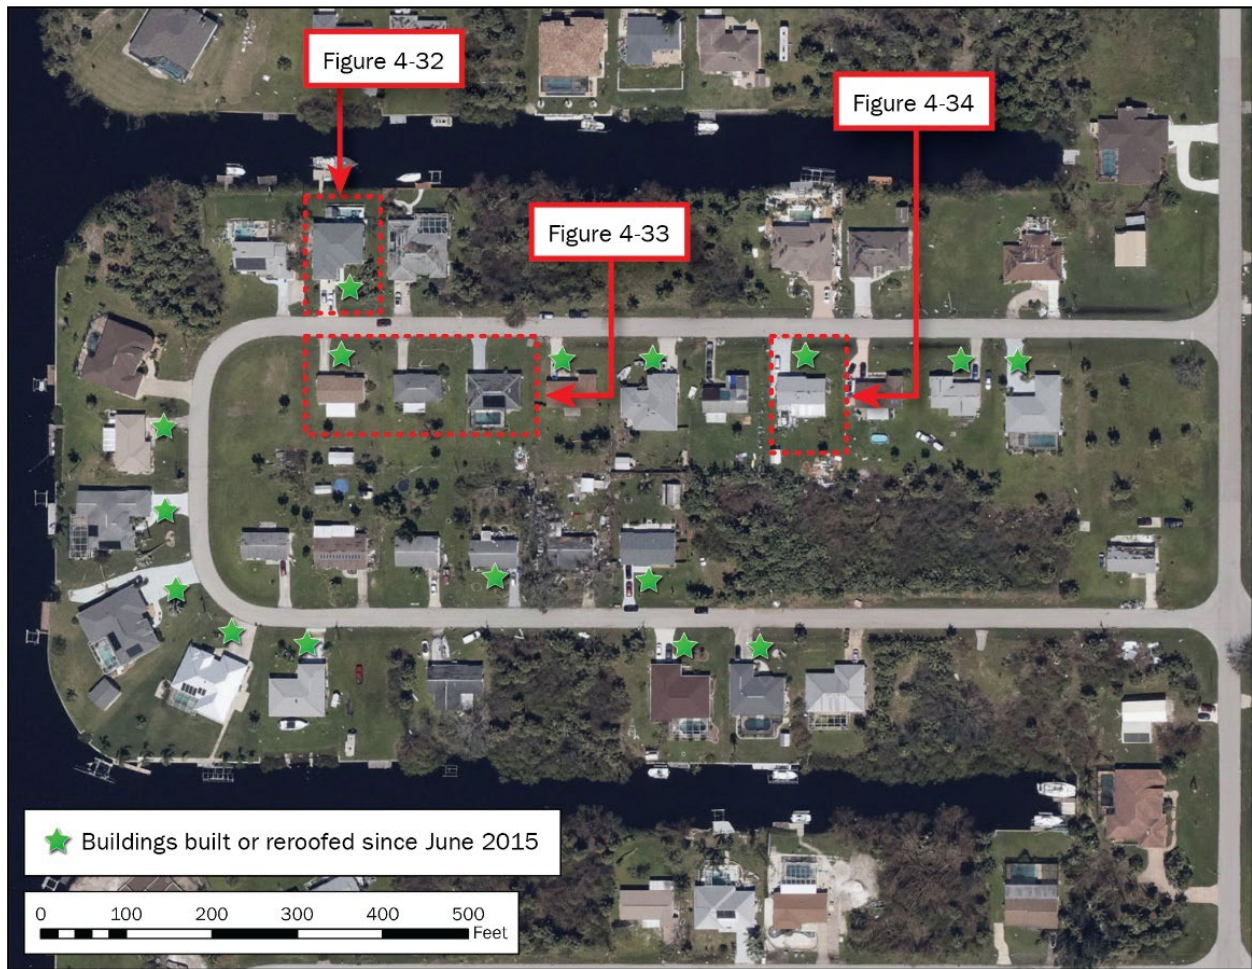
One example of a target cluster (Cluster 1) is shown in Figure 4-31. This area included a mixture of new construction, recent reroofs, and older roofs. The green stars indicate buildings that were built after June 2015 or had been reroofed since June 2015. The maximum estimated wind speed in this area during Hurricane Ian was 127 mph. The design wind speed for new construction is 151 mph. Figure 4-32 shows a house with a post-2020 asphalt shingle roof and no visible damage. Figure 4-33 and Figure 4-34 depict representative observations by the MAT in this area. The houses in

Figure 4-31: Cluster 1 for roof covering performance analysis; buildings built or reroofed since June 2015 shown with green stars and homes with additional images outlined in red (EWS = 127 mph) (Port Charlotte)

For the cluster shown in Figure 4-31 (Cluster 1), 34 buildings were evaluated. Sixteen of these buildings had roofs that were installed after June 2015. Two of the 16 buildings visited had visible roof covering damage. Seventeen of the 18 buildings with roof coverings installed prior to 2015 had visible roof covering damage. Neither of the two metal panel roof coverings observed in this cluster suffered damage.

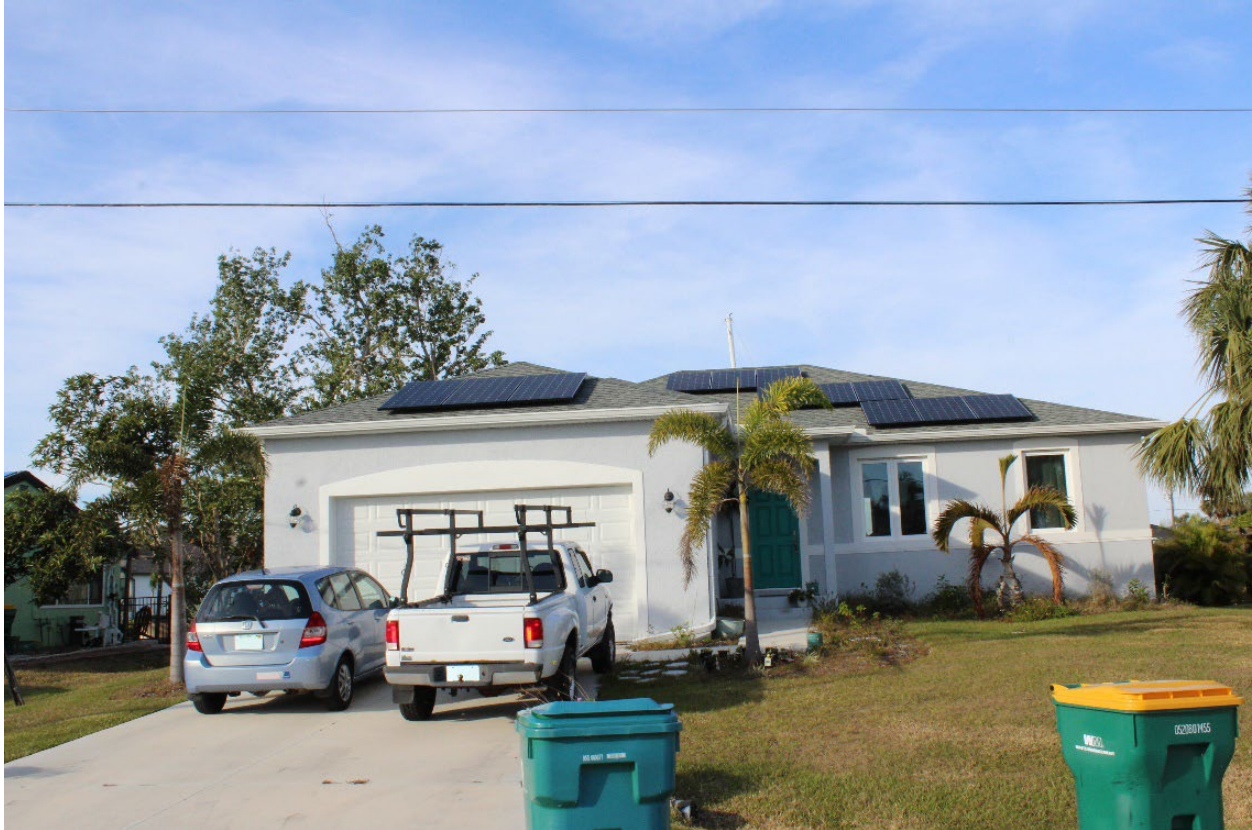
Figure 4-32: A house built post-2020 with asphalt shingle roof and photovoltaic panels; no damage observed (located in the Port Charlotte neighborhood in Figure 4-31) (EWS = 127 mph)

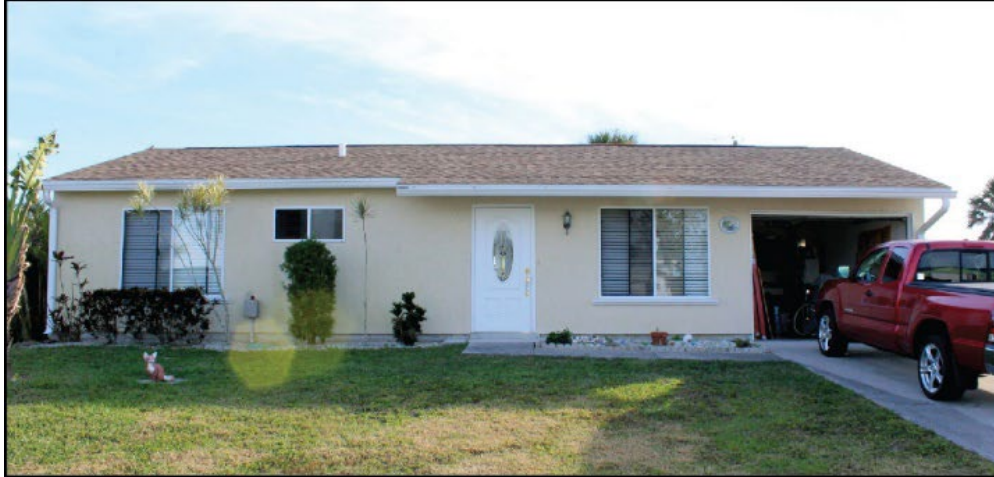
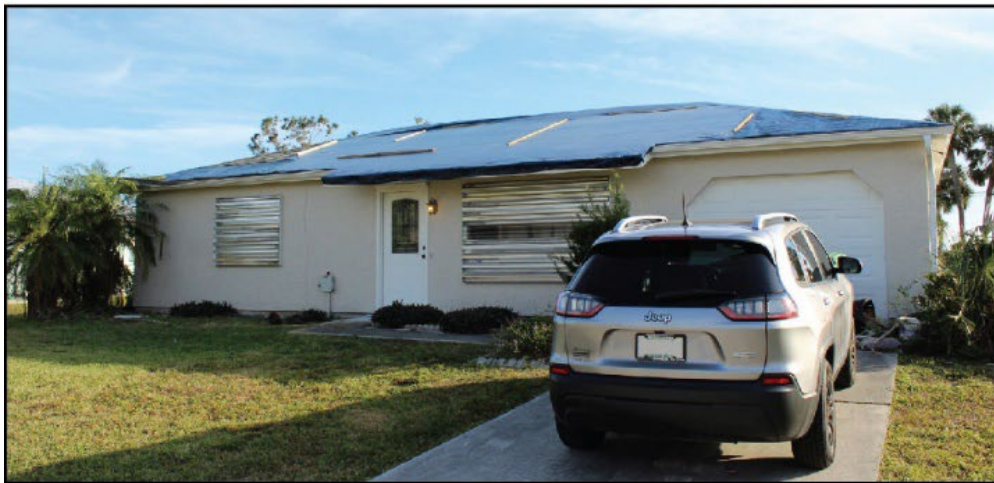
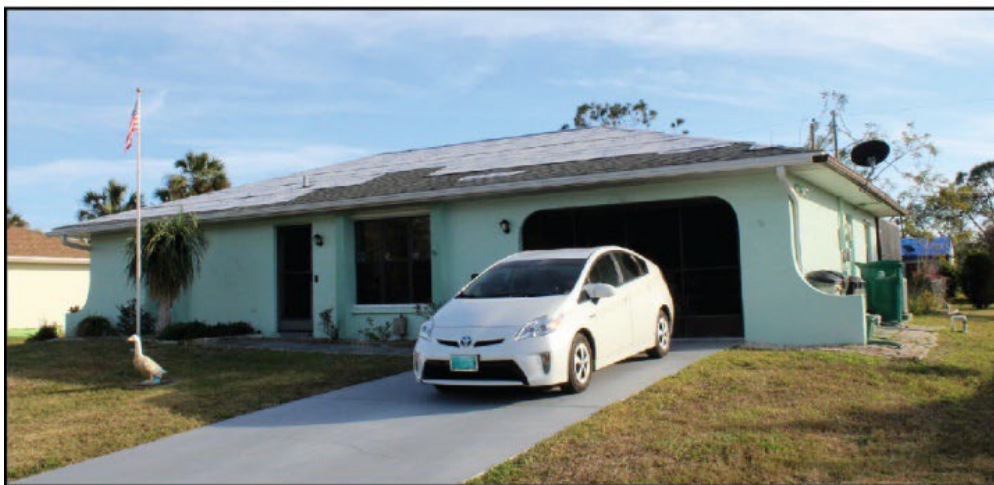
Figure 4-33 and Figure 4-34 were covered with blue tarps and/or synthetic underlayments to temporarily prevent water intrusion. NOAA imagery clearly indicates damage to these asphalt shingle roofs.

Figure 4-33: Houses with asphalt shingle roofs; top built in 1984 and reroofed in 2022 (no damage observed); middle built in 1984 (damage observed on NOAA imagery); bottom built in 1990 (damage observed on NOAA imagery) (located in the Port Charlotte neighborhood in Figure 4-31) (EWS = 127 mph)

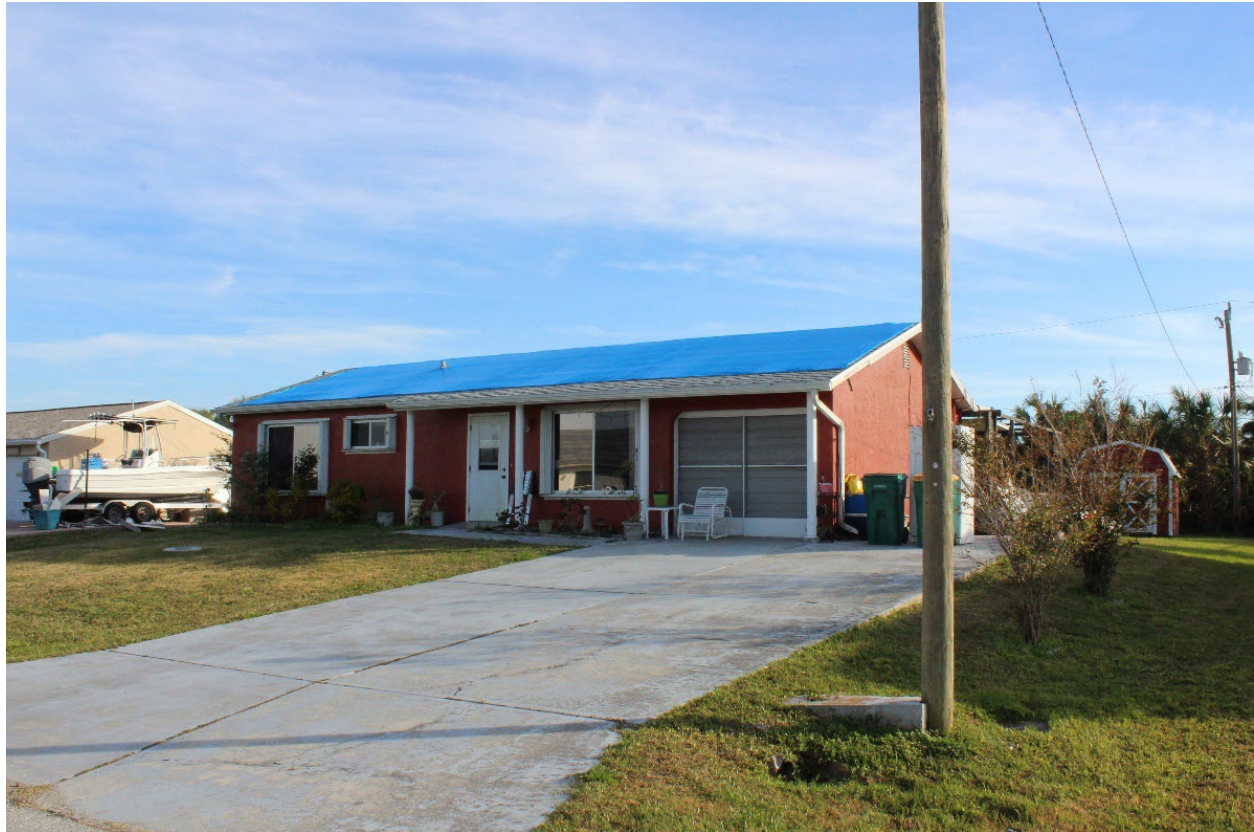
Figure 4-34: A house with asphalt shingle roof damage and tarp to help temporarily prevent water infiltration); built 1984 and reroofed in April 2022 (located in the Port Charlotte neighborhood in Figure 4-31) (EWS = 127 mph)

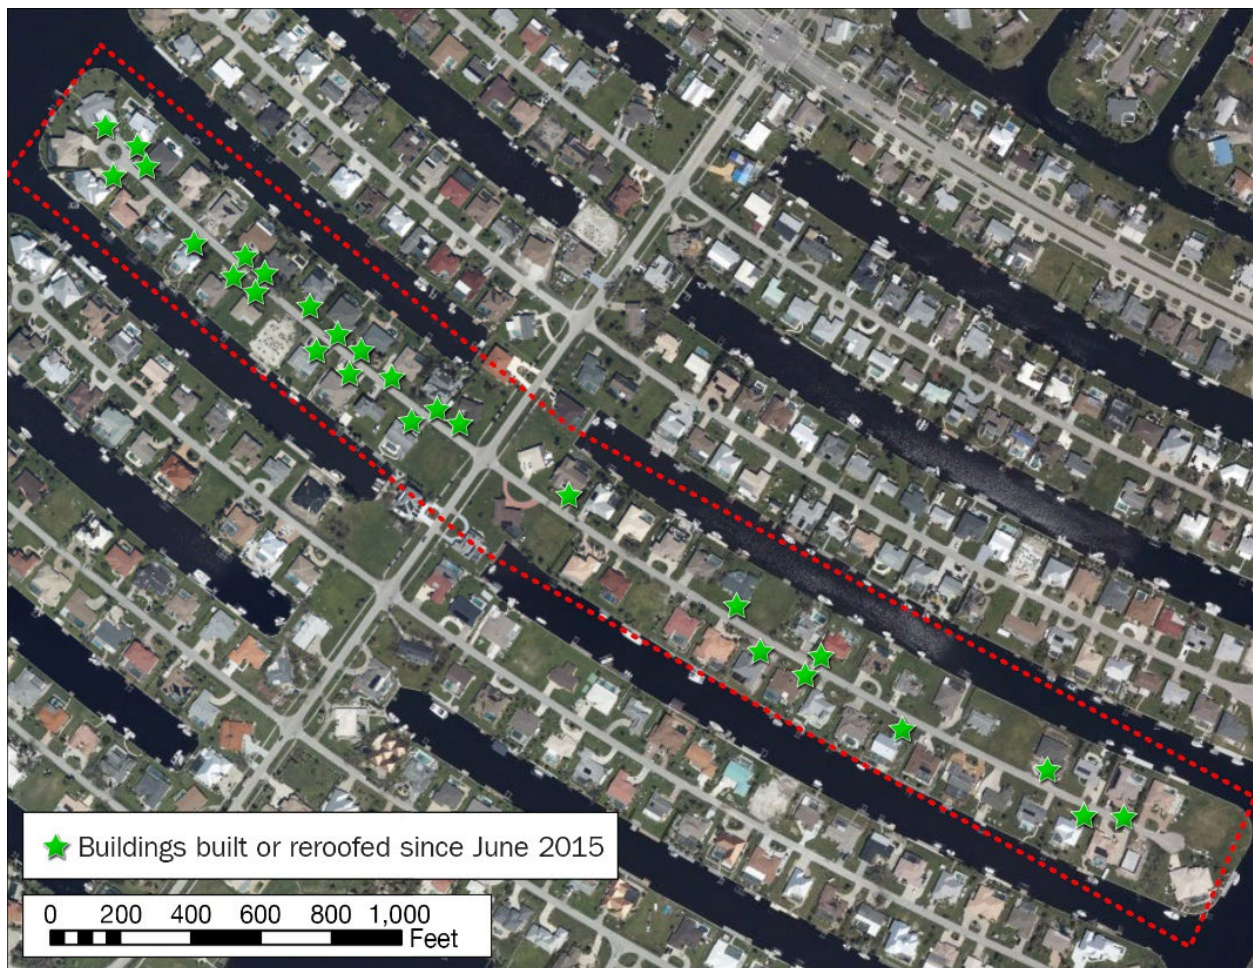
Figure 4-35 shows Cluster 2 with a mixture of new construction, recent reroofs, and older roofs. The maximum estimated wind speed in this area during Hurricane Ian was 128 mph. The design wind speed is 150 mph. Figure 4-36, Figure 4-37, and Figure 4-38 show representative damage observed by the MAT in this area.

Figure 4-35: Cluster 2 for roof covering performance analysis; buildings built or reroofed since June 2015 shown with green stars (EWS = 128 mph) (Port Charlotte)

For Cluster 2, 55 buildings were evaluated. Twenty-four of these buildings had roofs that were installed after June 2015. Eight of the 24 buildings had visible roof covering damage (33%). Fifteen

of the 21 buildings with roof coverings installed prior to 2015 had visible roof covering damage (71%).
