Mitigation Assessment Team Report

Hurricane Ian in Florida

Building Performance Observations,
Recommendations, and Technical Guidance

FEMA P-2342/December 2023

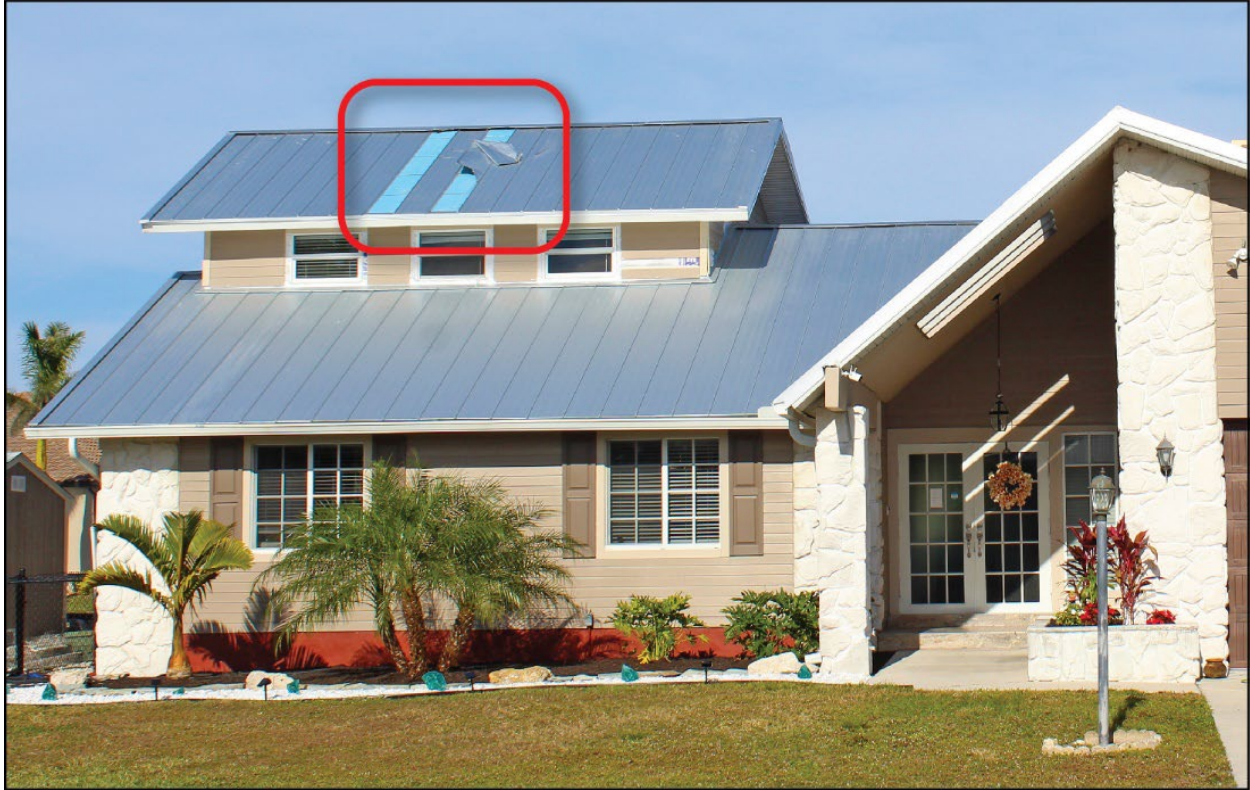
Figure 4-36: A house with metal roof; built in 1984 and reroofed in May 2022 (damage to a few metal panels) (EWS = 128 mph) (Port Charlotte)

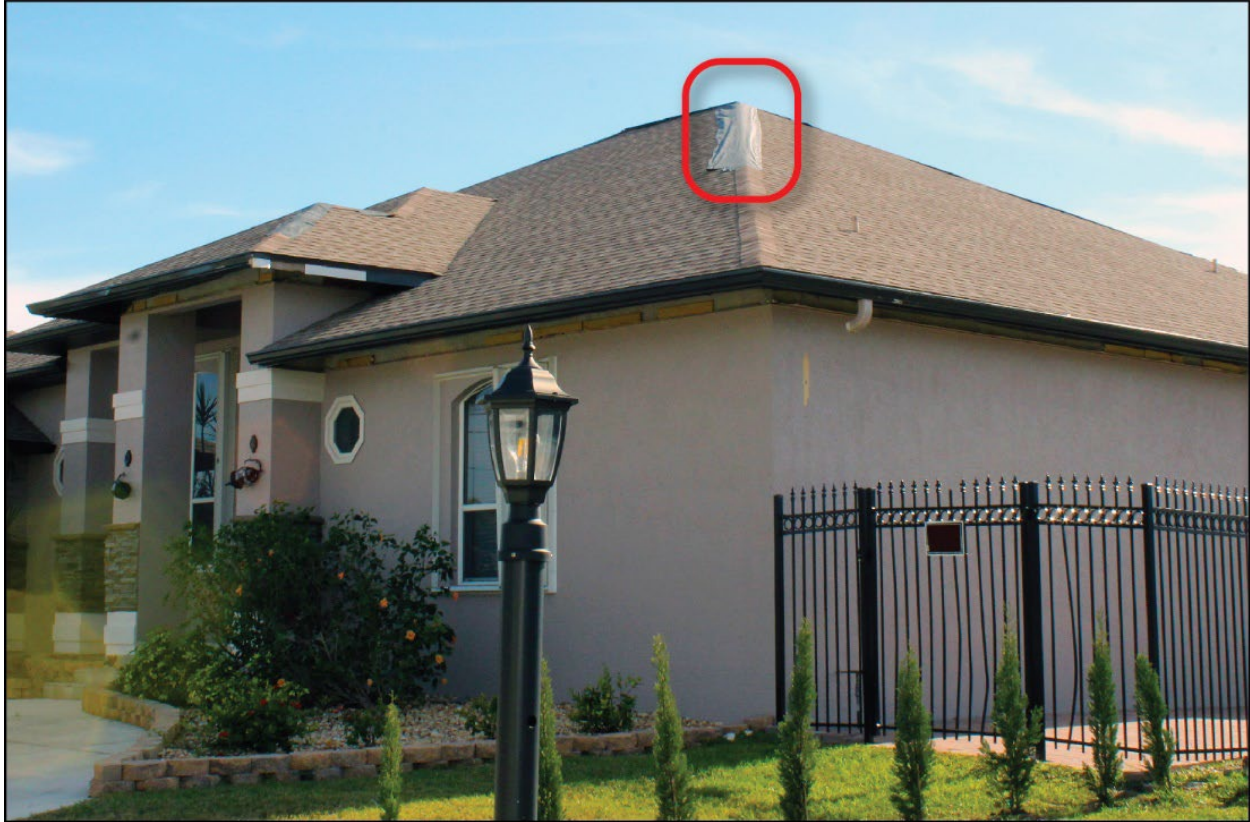
Figure 4-37: A house with asphalt shingle roof; built 1998 and reroofed August 2020 (minor hip shingle damage) (EWS = 128 mph) (Port Charlotte)

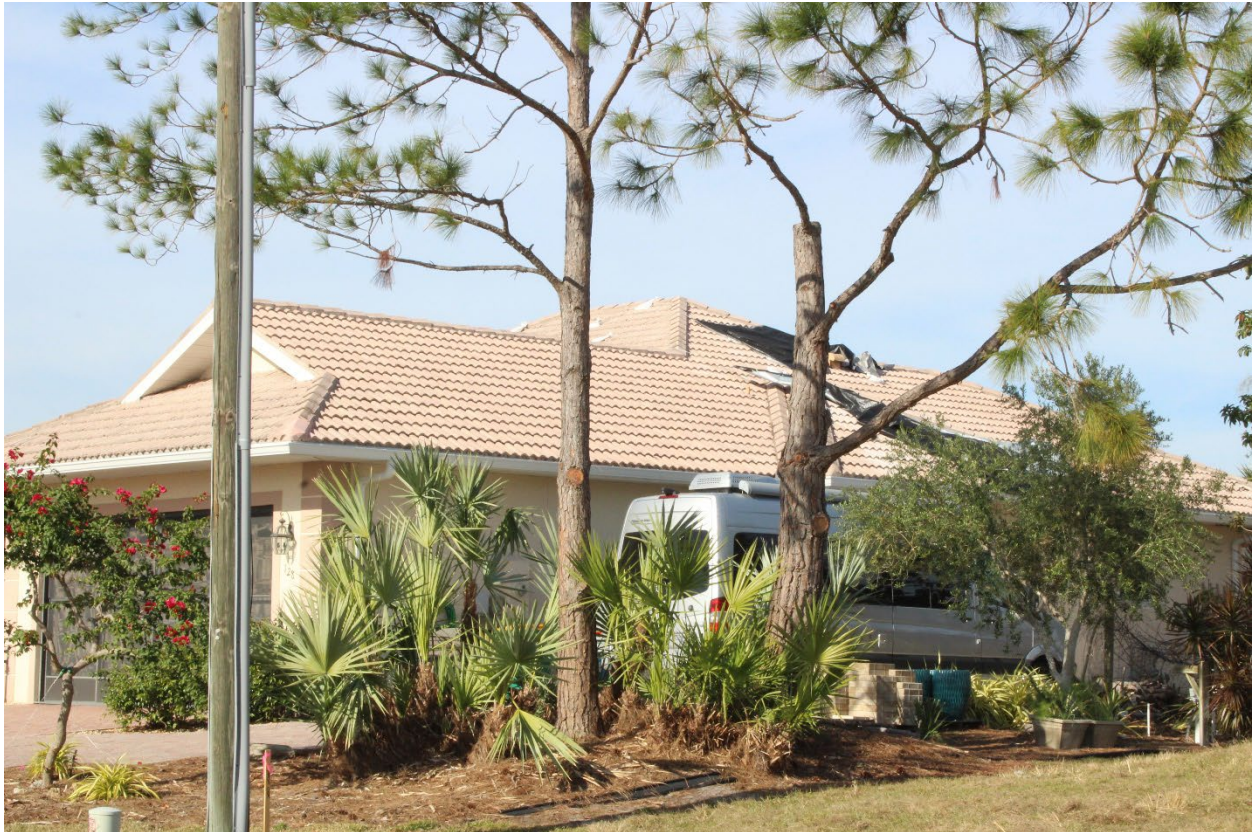
Figure 4-38: A house built in 2001 with a tile roof (tile damage as indicated by black tarp on the roof) (EWS = 128 mph) (Port Charlotte)

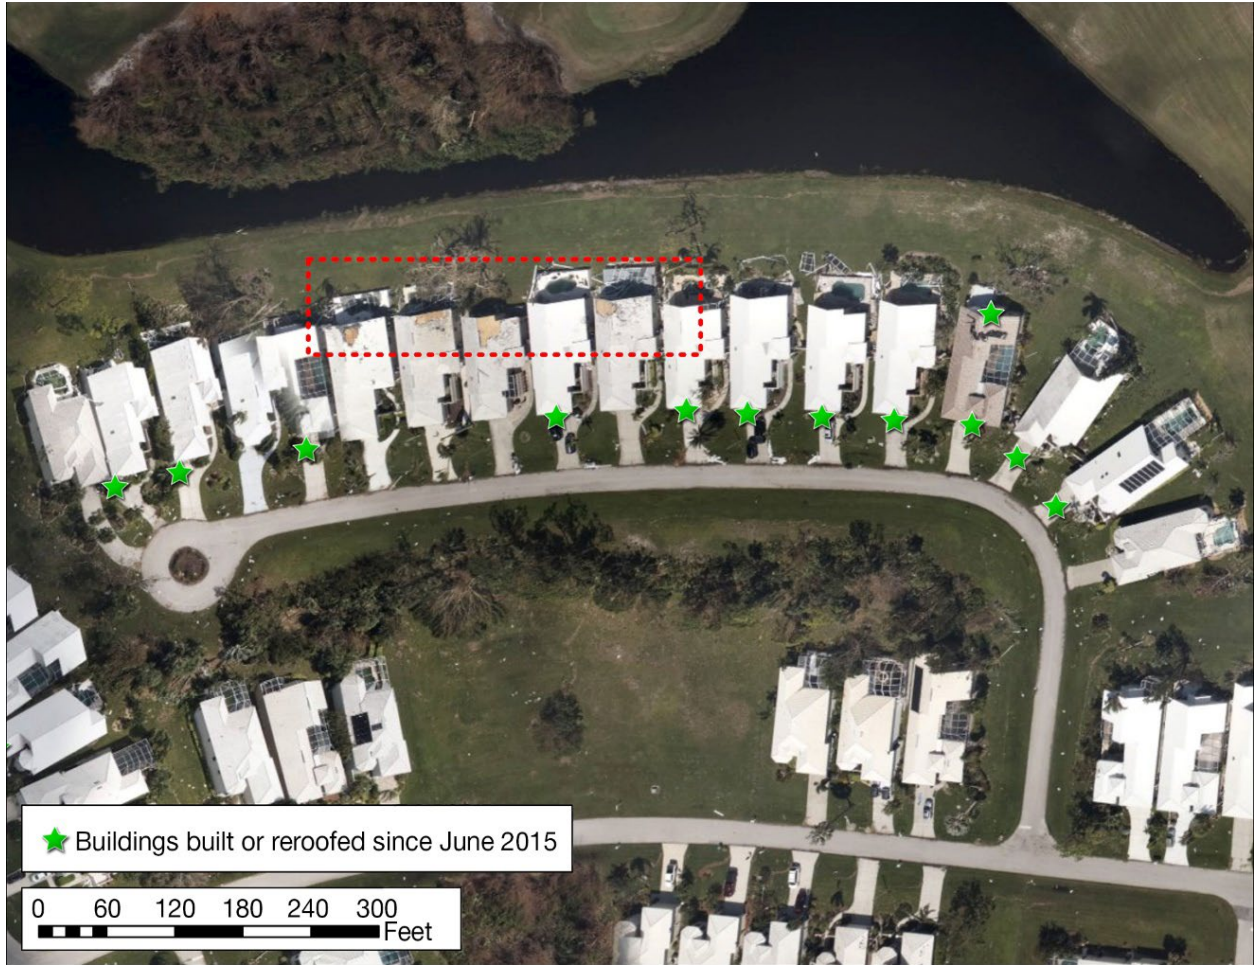
At another targeted cluster (Cluster 3), the MAT noted that many of the tile roofs on the buildings in Figure 4-39 in Placida, FL, had suffered damage and many had recently been replaced (tile roof replacement). Bare roof sheathing is visible on several buildings in the NOAA imagery. The maximum estimated wind speed for this area during Hurricane Ian was 126 mph. The design wind speed for this area is 156 mph. Tile was replaced on 11 of the 18 buildings in this area since 2019 and before Hurricane Ian made landfall (indicated by green stars). According to homeowners, most of the older roofs and the roofs that had been recently replaced were mechanically fastened. The MAT was able to confirm during the site visits that some of the newer roofs were mechanically fastened (see Figure 4-40). The newer roof coverings clearly suffered less damage overall than the older roof coverings. Figure 4-41 shows some of the worst damage observed on some of the older roof coverings (the tile roof in the far-left side of the picture was reroofed after Hurricane Ian). However, while less extensive than for the older roof coverings, many of the newer roof coverings also suffered some damage (see Figure 4-42 and Figure 4-43). Because many new roofs were installed and the wind speeds were far less than the design wind speeds, more roofing damage was observed than was anticipated.

Of the 11 houses that had been reroofed since June 2015, four had visible roof covering damage. Of the seven houses with roof coverings installed prior to June 2015, five had visible roof covering damage.

Figure 4-39: Roof tile damage on newer and older roofs (EWS = 126 mph) (Placida)

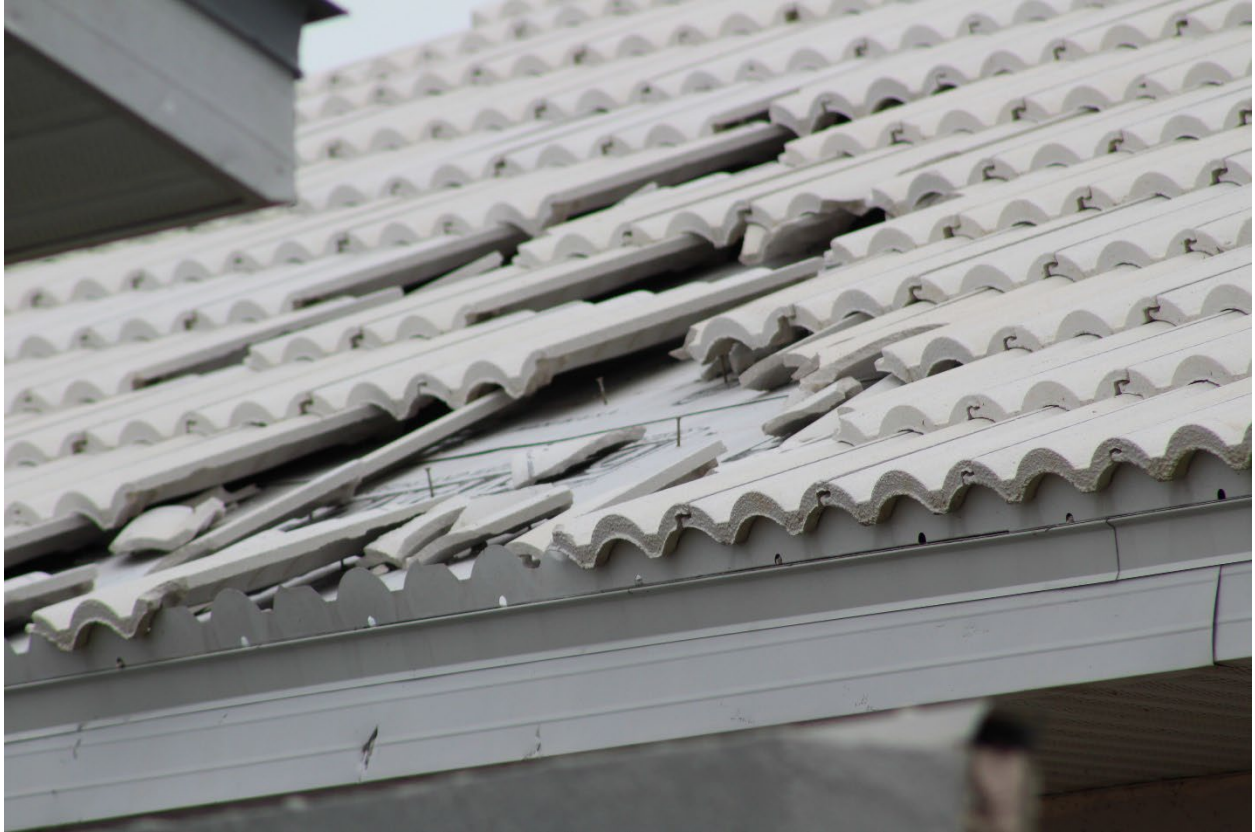
**Figure 4-40: Mechanically fastened tile roof in Placida that was replaced in August 2021
(EWS = 126 mph)**

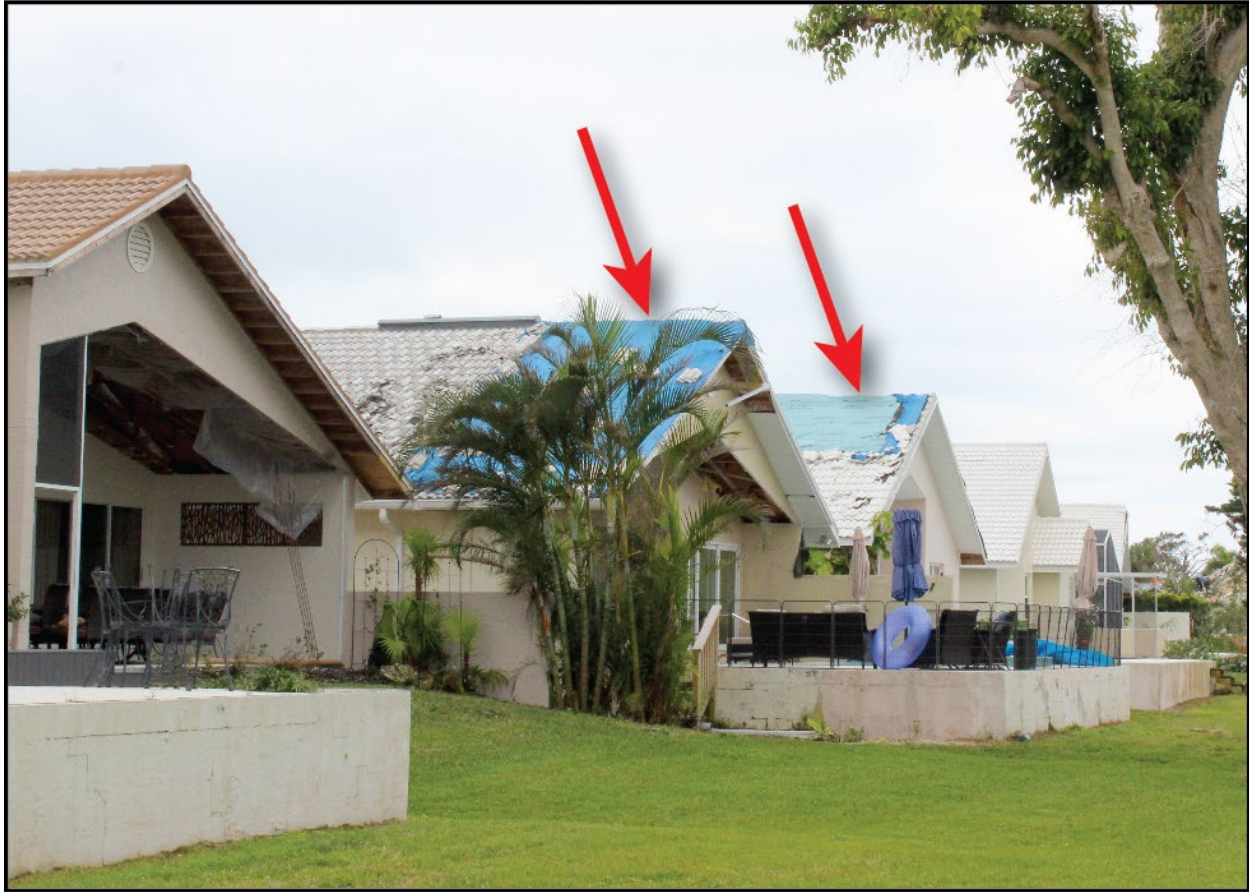
Figure 4-41: Roof tile damage to older tile roofs in Placida (EWS = 126 mph)

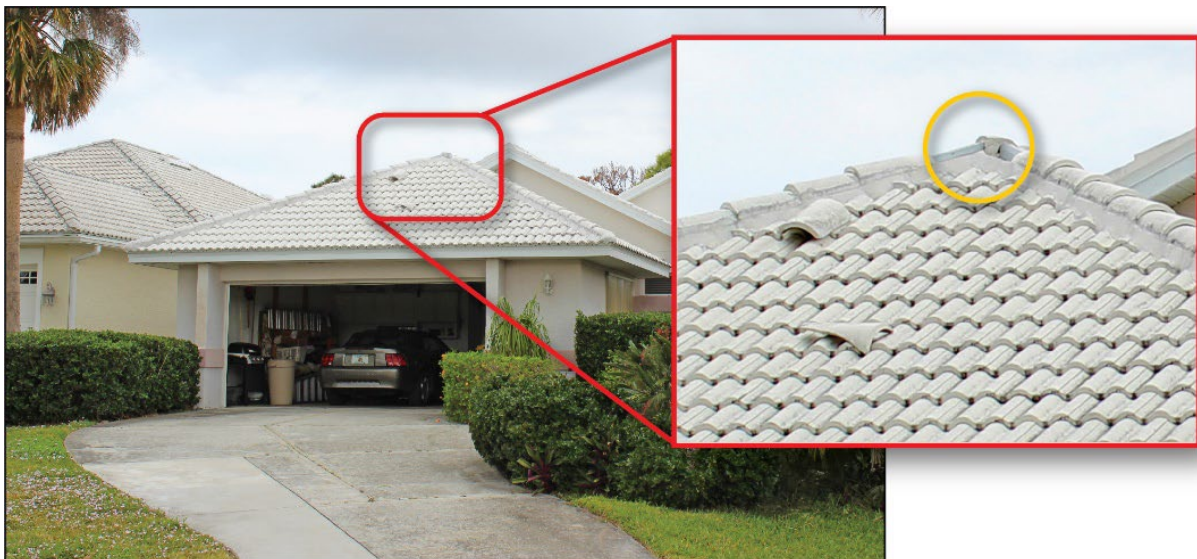
Figure 4-42: Roof tile damage to a roof in Placida that was replaced in September 2019 (EWS = 126 mph)

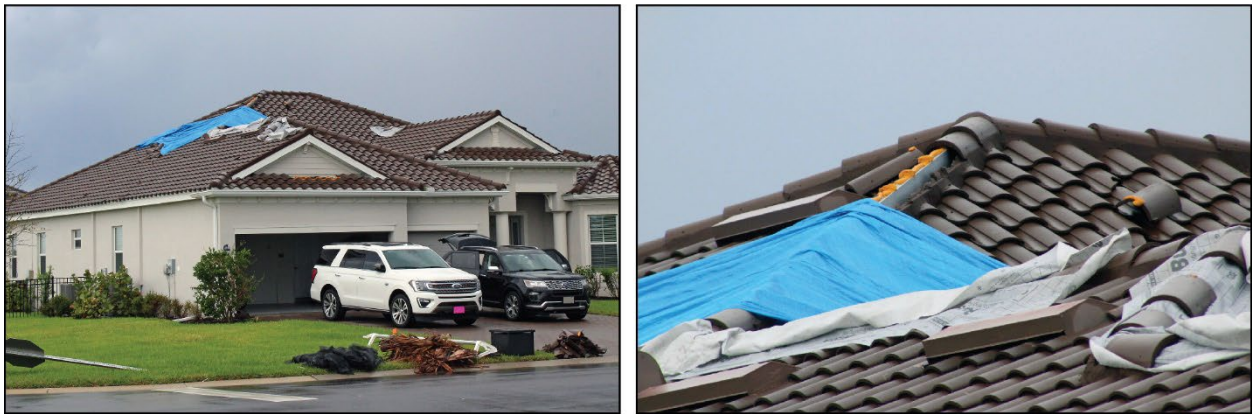
The most prevalent type of damage observed after Hurricane Ian, was damage to hips and ridges, which was observed on both newer and older roofs. Figure 4-43 shows typical hip and ridge damage to roof tile in a neighborhood built in 2020 and 2021. The maximum estimated wind speed in this area was 126 mph. The design wind speed is 153 mph. This type of damage was observed for all roof covering types. The lack of evidence of significant water intrusion due to roof covering damage was supported by numerous discussions with homeowners. While some homeowners indicated their

Figure 4-43: Roof tile damage (EWS = 126 mph; DWS = 153 mph) (Port Charlotte)

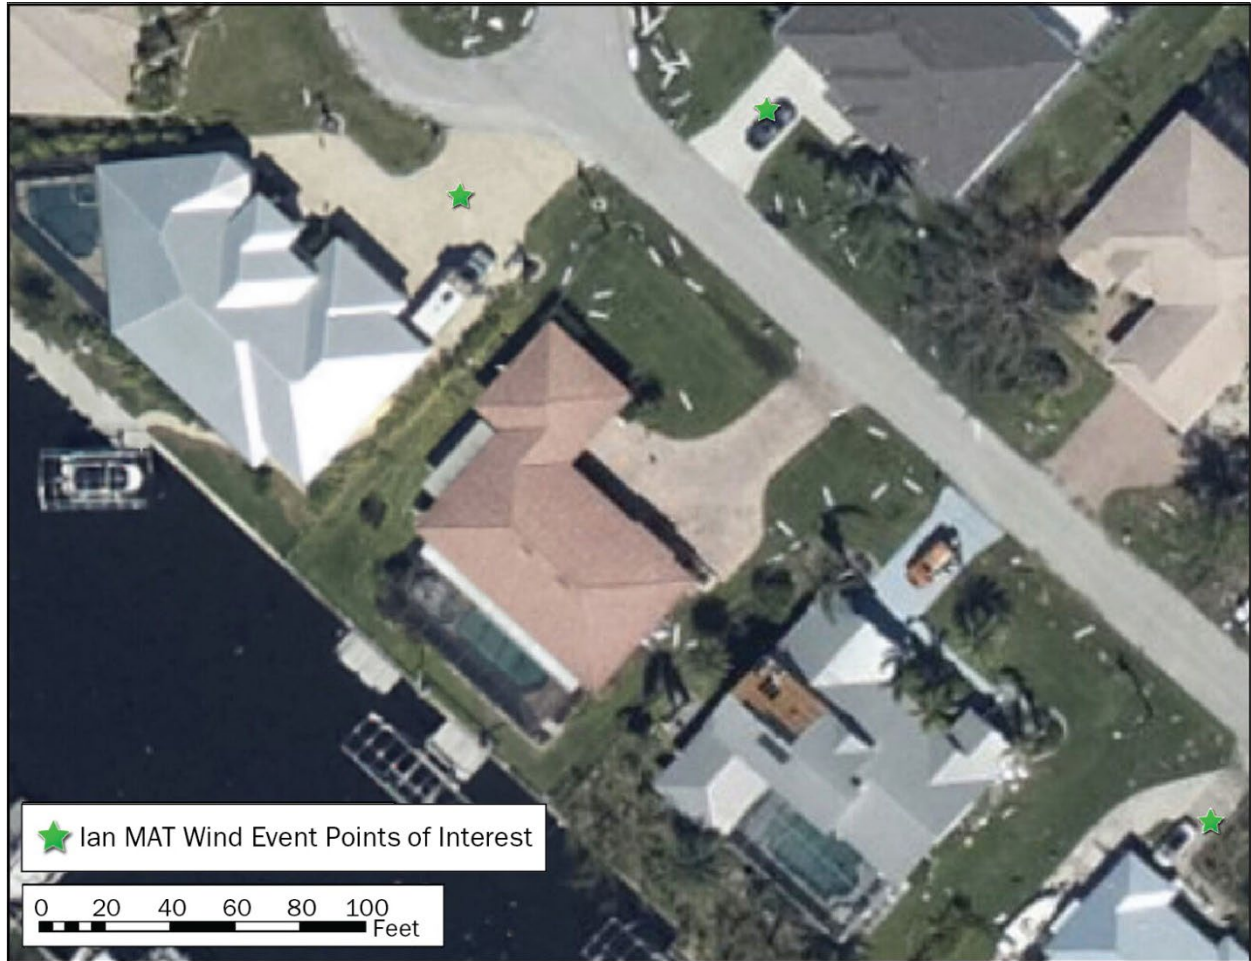
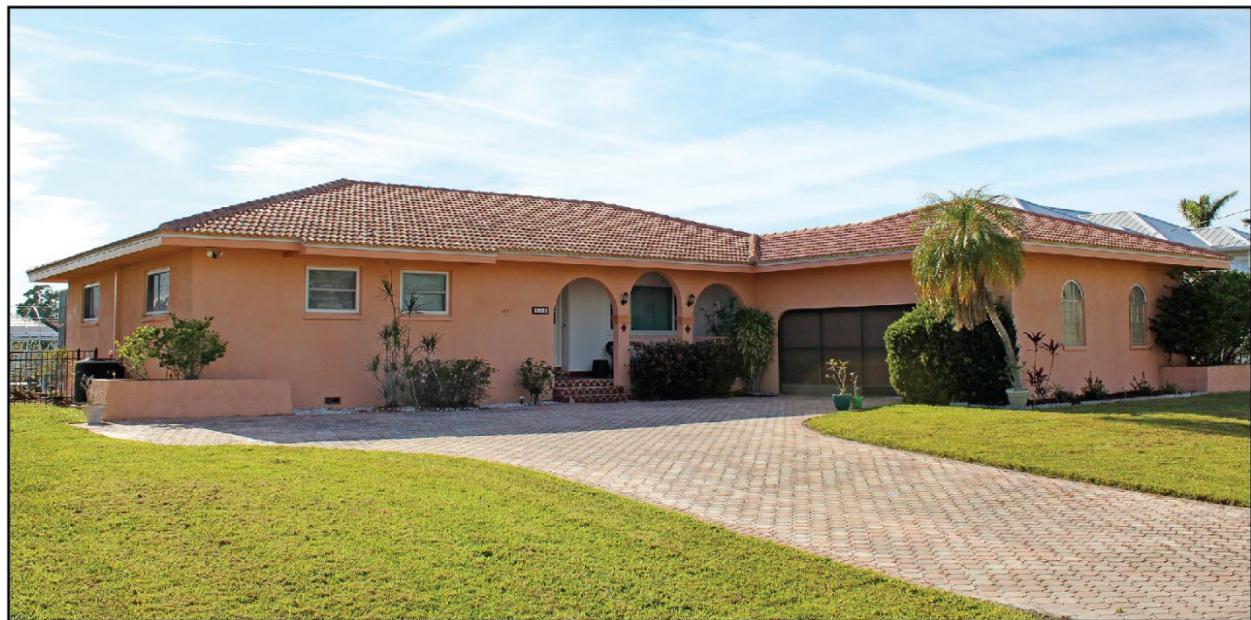
Discussions with homeowners and a desktop analysis performed after the site visits also revealed that many roof coverings were being replaced on roofs with minor to no discernable damage. Although the MAT visited the house with the tile roof in Figure 4-44, the MAT could not identify any damage to the roof on the NOAA imagery or from the site visit. However, a permit was pulled in March 2023 for a tile replacement for “storm-related repair/replacement.” Another example of this is the house shown in Figure 4-45, which was built in 2002 and replaced with asphalt shingles in February 2019. Using NOAA imagery and observations during the site visit, the MAT only saw minor hip shingle damage. However, a permit was issued in November 2022 for a complete asphalt shingle roof replacement.

Figure 4-44: A house built in 1975 with no observable roof covering damage, a “storm-related roof replacement” permit was issued post-Hurricane Ian (EWS = 128 mph) (Port Charlotte)

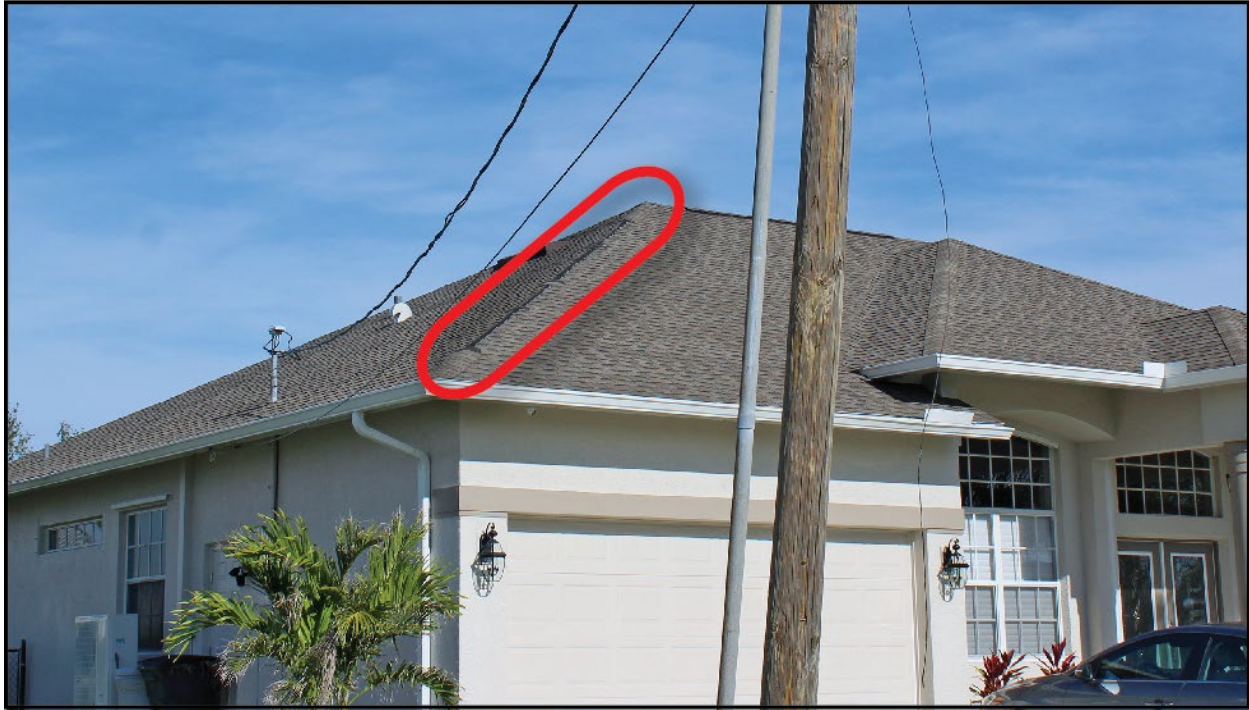
Figure 4-45: A house built in 2002 with an asphalt shingle roof replacement in 2019, with minor hip shingle damage, a “storm-related” roof replacement permit was issued post-Hurricane Ian (EWS = 128 mph) (Port Charlotte)

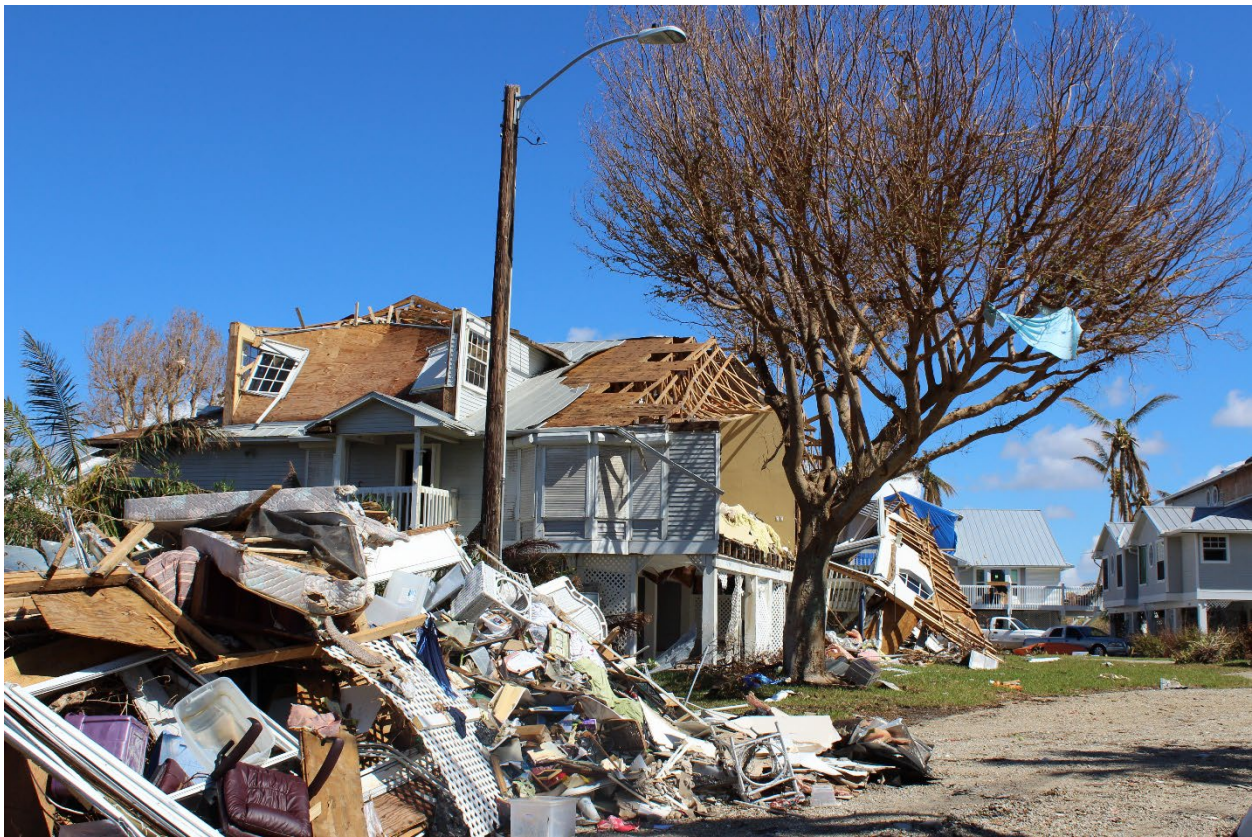
Figure 4-46 shows a two-family house built in 1990 in St. James City with significant structural damage from the storm. Figure 4-47 shows a house located about half a mile from the house in Figure 4-46; the house was built in 2022 and the MAT did not identify any damage to the house. The homeowner indicated the only damage sustained was to the screened enclosure at the back of the house.

As previously indicated, buildings built to building codes prior to the 2001 FBC, such as those shown in Figure 4-46 and Figure 4-48, are not provided with design wind speed in this report. Most building codes adopted locally in Florida prior to the 2001 FBC did not specify a wind speed limitation on using conventional construction methods. Thus, the MAT cannot determine with any degree of certainty whether these houses were designed to a specific wind speed (or wind design methodology) or built using conventional construction methods. With the implementation of the 2001 FBC, as well as the 2000 IRC and IBC, the use of conventional construction methods was limited based on wind speed. Where conventional construction was limited, design by a registered design professional or the use of one of the prescriptive “high wind” standards (American Wood Council’s [AWC’s] *Wood Frame Construction Manual* [WFCM], ICC 600, SSTD 10, etc.) was required. Conversely, buildings built to the 2001 FBC and later editions, like the houses depicted in Figure 4-47 and Figure 4-49, are provided with design wind speeds.

Figure 4-46: A Pre-FBC two-family home (built in 1990) with severe structural damage from wind (EWS = 113 mph) (St. James City)

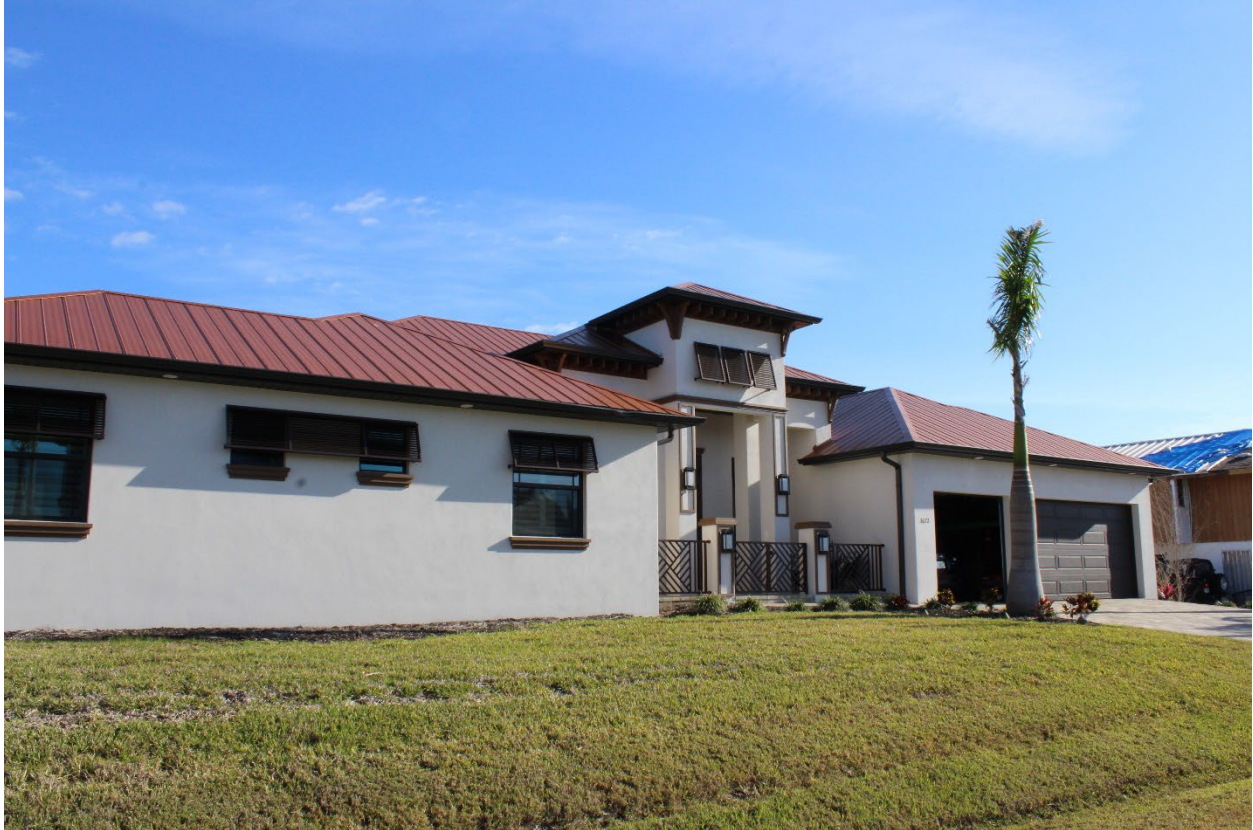
Figure 4-47: A house built in 2022 just before the storm with no visible damage (EWS = 113 mph; DWS = 161 mph) (St. James City)

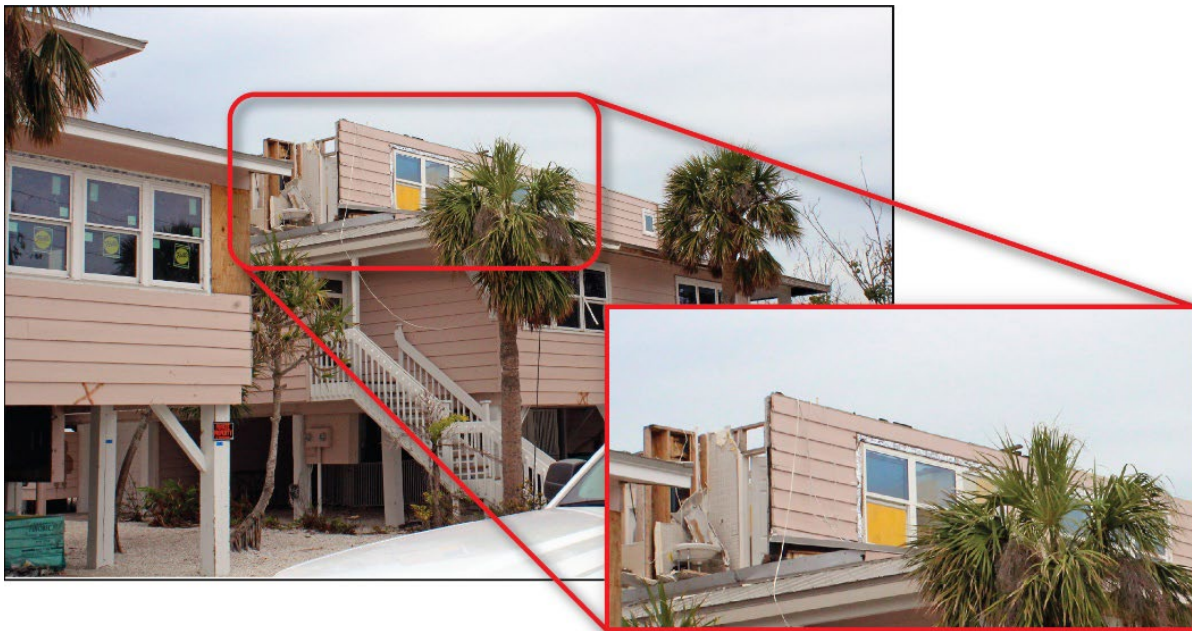
Figure 4-48 shows a multi-family condominium built in 1979 in Boca Grande. The second-story side walls and roof are missing, leaving the wood framing and interior exposed. Figure 4-49 is the house across the street from the condominium (Figure 4-48); built in 2022, the house showed no signs of damage. The discrepancy in performance between the houses in Figure 4-46 and Figure 4-47, and between the condominium in Figure 4-48 and the house in Figure 4-49 highlights the improved performance of buildings built to modern building codes. These observations are similar to those observed by the MAT in other recent hurricanes.

Figure 4-48: A multi-family condominium built in 1979 with wind damage to the roof and second-story side walls missing (EWS = 130 mph) (Boca Grande)

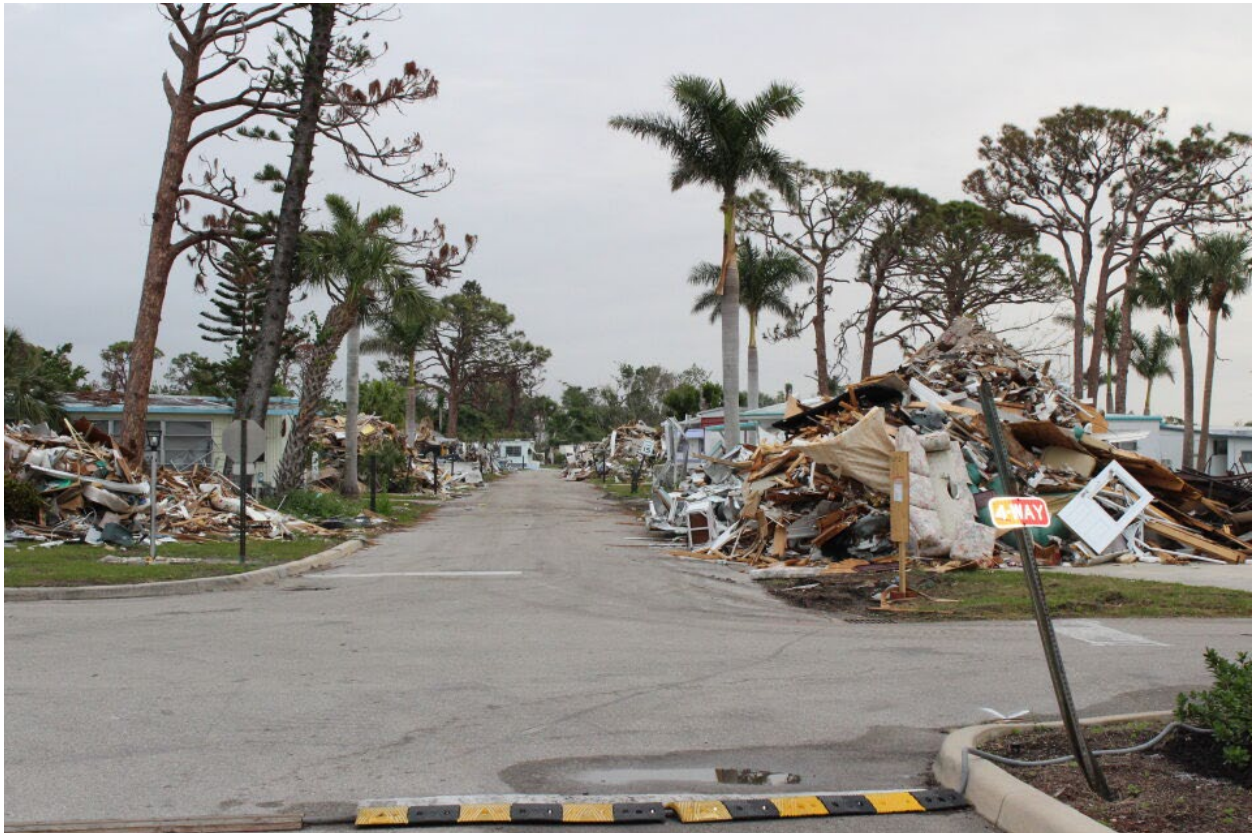
Aside from damage incurred from attached appurtenances as described in Section 4.4.2, structural damage to post-HUD manufactured homes was uncommon in Lee and Charlotte Counties. Conversely, many older manufactured homes were destroyed, as shown in Figure 4-50.

**Figure 4-50: Structural damage to pre-HUD manufactured homes
(EWS = 129 mph) (Lee County)**

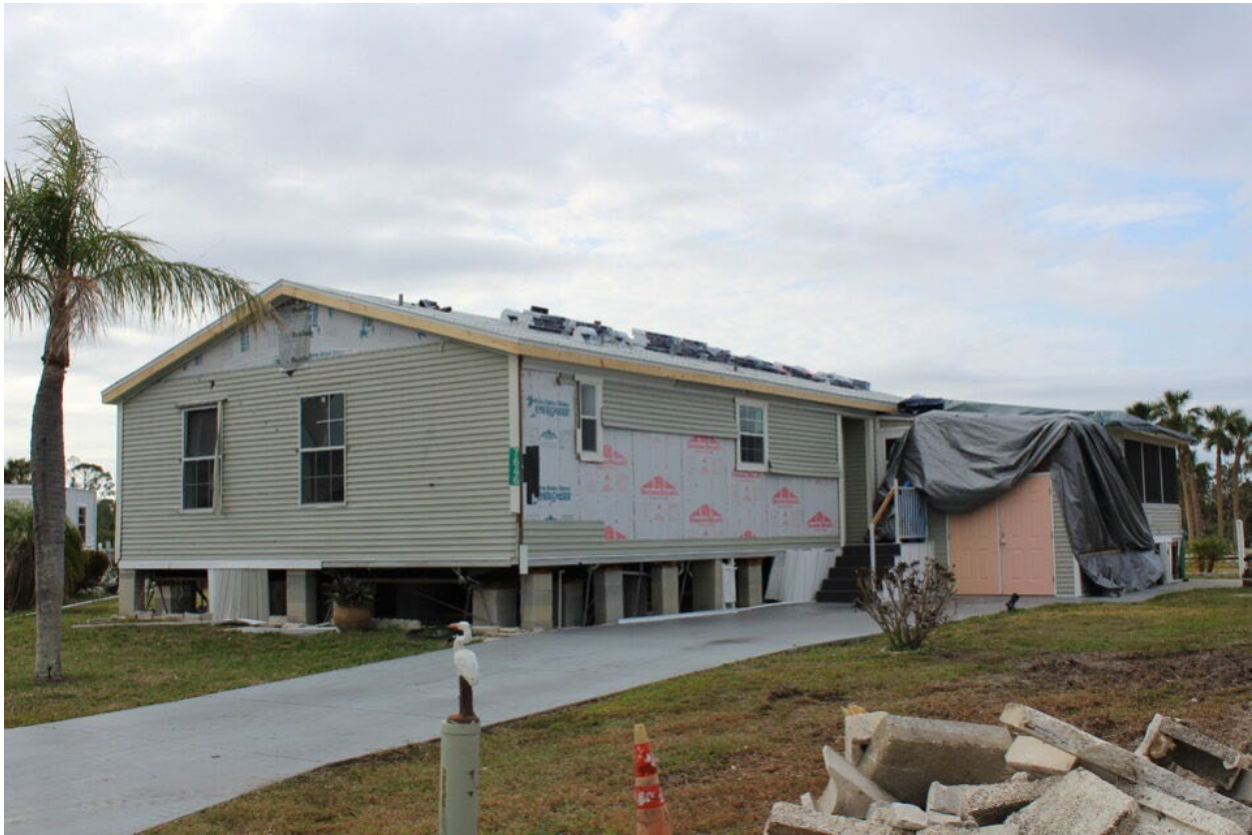
Figure 4-51 illustrates typical envelope damage to a post-1994 manufactured home in Charlotte County, including damage to the roof covering (asphalt shingle roof replacement is underway), vinyl siding, and fascia. The manufactured home also suffered wind-borne debris damage, as shown in Figure 4-52, where it appears the aluminum clamshell shutters (not rated to protect glazing in the WBDR⁴) failed or were not properly deployed. The image at right in Figure 4-52 shows shutters still in place along the adjacent wall. The Manufacturer's Data Plate was attached to the unit and indicated a model year of 2012 and Wind Zone III construction.

Figure 4-51: Roof covering, wall covering, and fascia damage to post-HUD manufactured home (EWS = 126 mph) (Charlotte County)

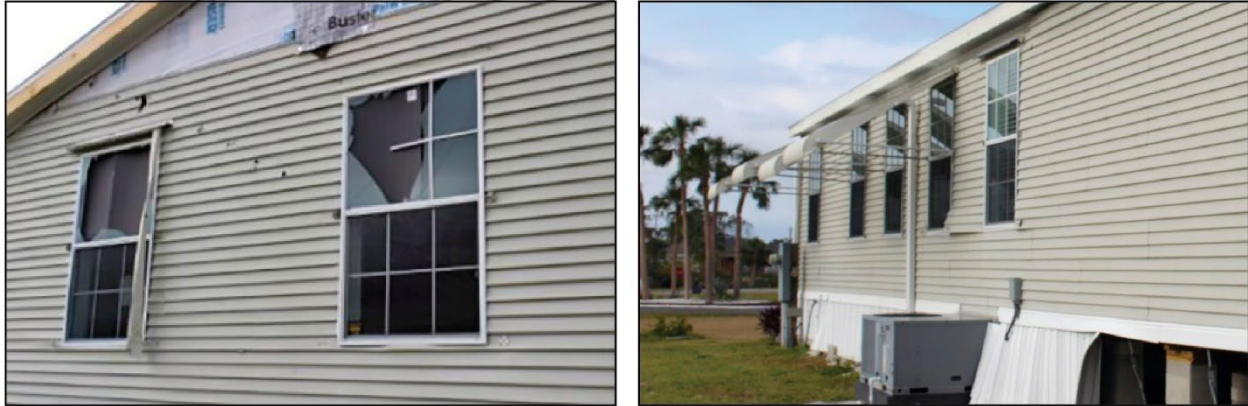
Figure 4-52: Wind-borne debris damage to glazing and non-rated impact protective system (left); aluminum clamshell shutters remain in place on adjacent wall of same post-HUD manufactured home (right) (EWS = 126 mph) (Charlotte County)

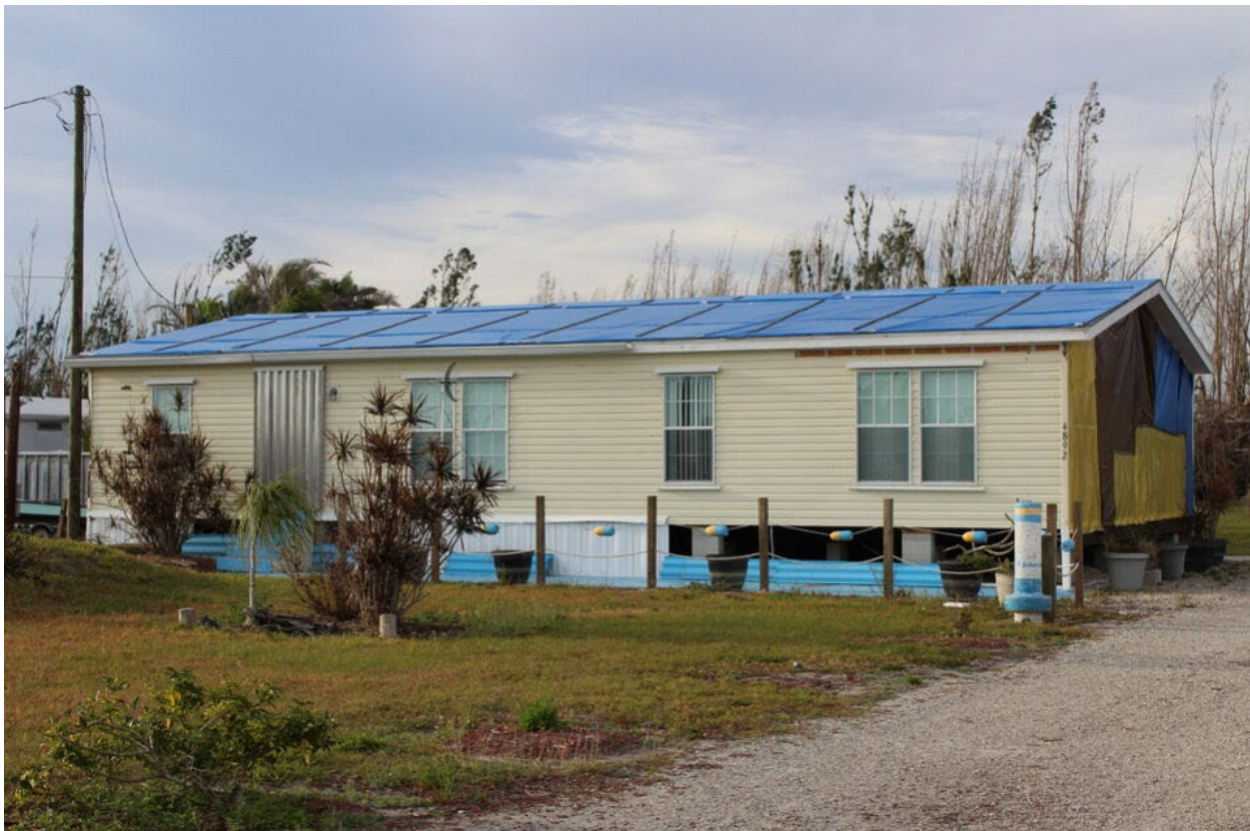
Figure 4-53 is another representative case of envelope damage to a post-1994 manufactured home. In this case, a tarp was placed over the damaged roof covering to help protect it from further damage. Siding was also blown off from the end wall and just below the fascia on the adjacent exterior wall. According to Lee County parcel data, the damaged manufactured home was installed (and assumed constructed) in 2005.

Figure 4-53: Post-HUD manufactured home with roof and wall covering damage (EWS = 118 mph) (Lee County)

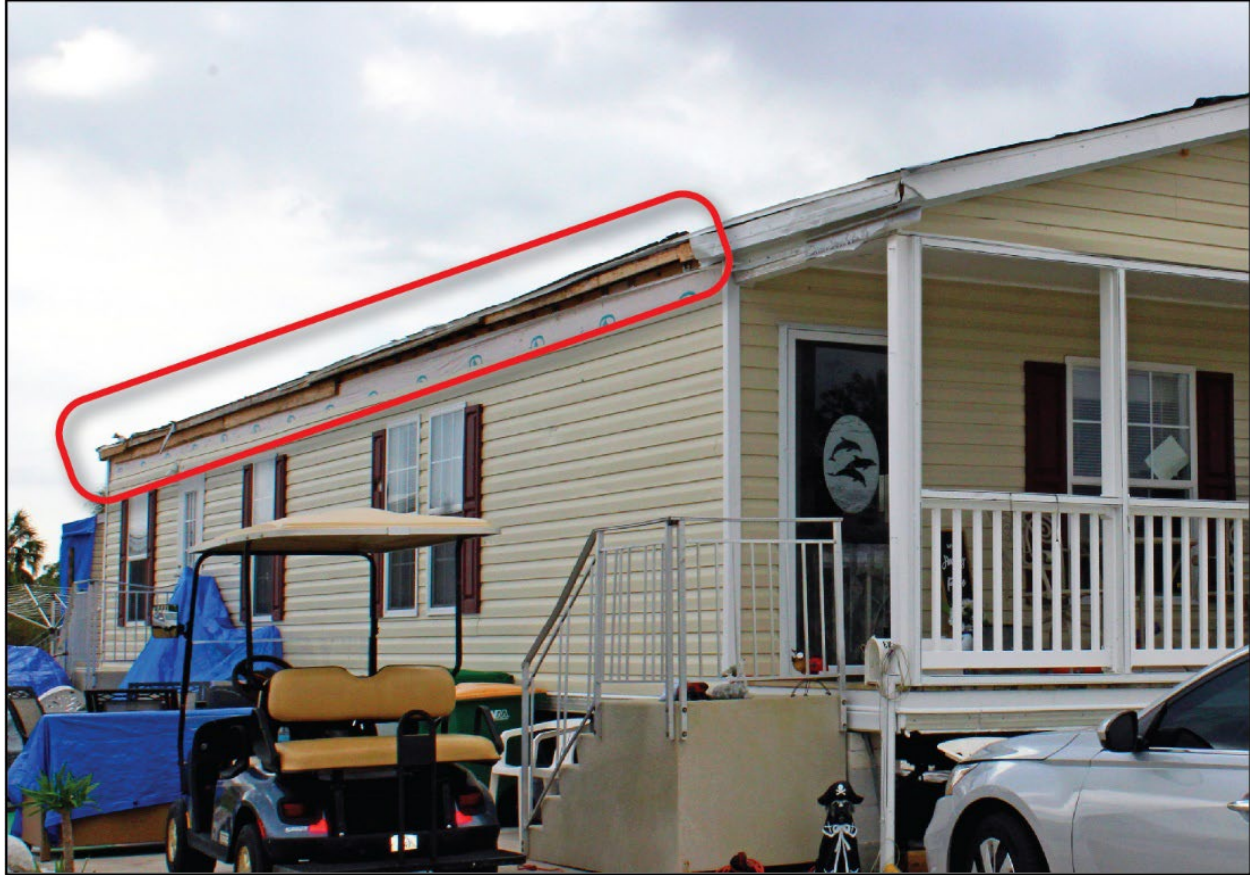
The following examples of post-HUD manufactured home damage initiated by improperly attached appurtenances were observed during the Hurricane Ian MAT deployment. Figure 4-54 shows a 2019 manufactured home in Charlotte County that lost the attached carport during Hurricane Ian, which created an opening along the entire length of the unit. A 1999 manufactured home located in Charlotte County and shown in Figure 4-55 lost the front portion of the attached carport, opening the envelope to wind-driven rain and potentially initiating or exacerbating the roof damage observed over the main unit. Note that neither carport was supported by posts along the exterior wall; instead, the appurtenances were attached along the top of the exterior wall.

Figure 4-54: A 2019 manufactured home where the loss of the carport damaged the main unit where it was attached, as indicated by the red rectangle (EWS = 126 mph) (Charlotte County)

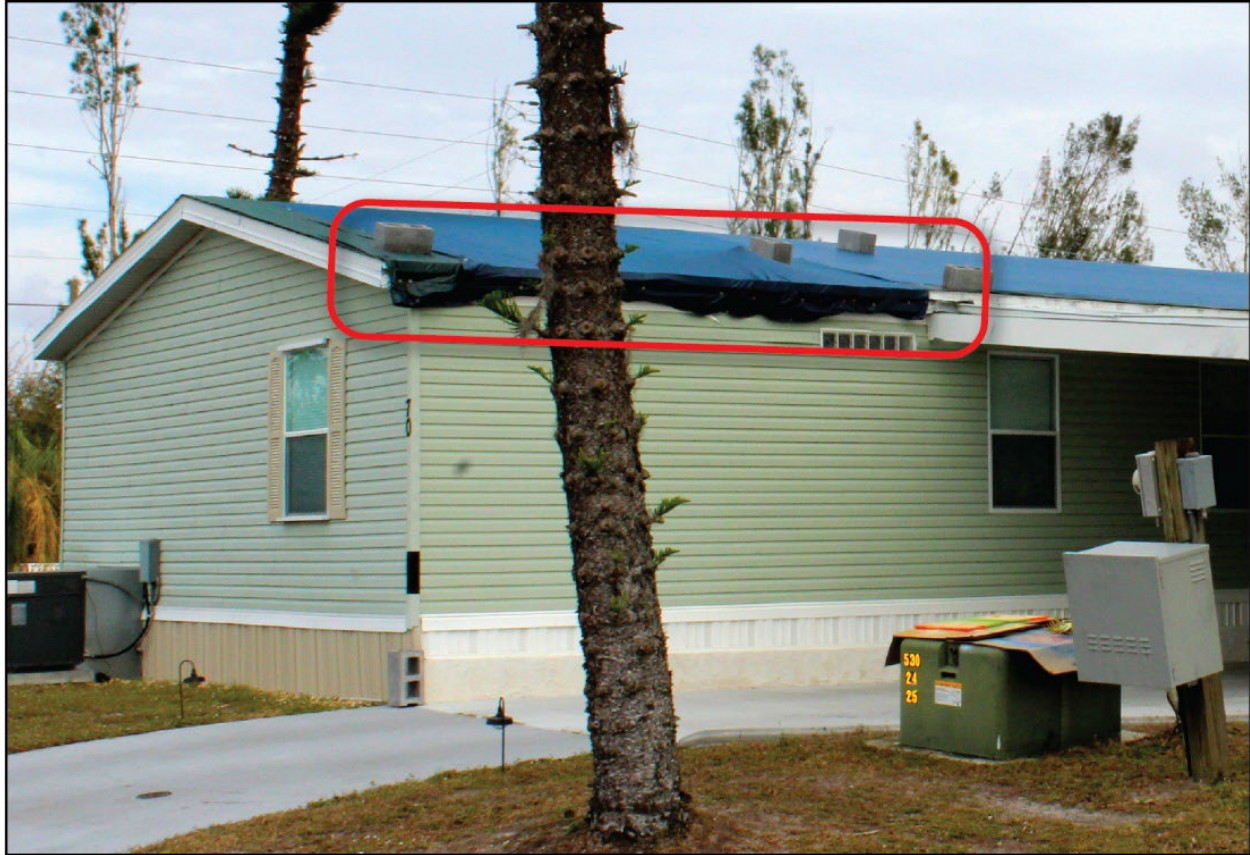
Figure 4-55: 1999 manufactured home; damage to main unit from loss of the front section of the attached carport, as indicated by the red rectangle (EWS = 129 mph) (Charlotte County)
