Mitigation Assessment Team Report

Hurricane Ian in Florida

Building Performance Observations,
Recommendations, and Technical Guidance

FEMA P-2342/December 2023

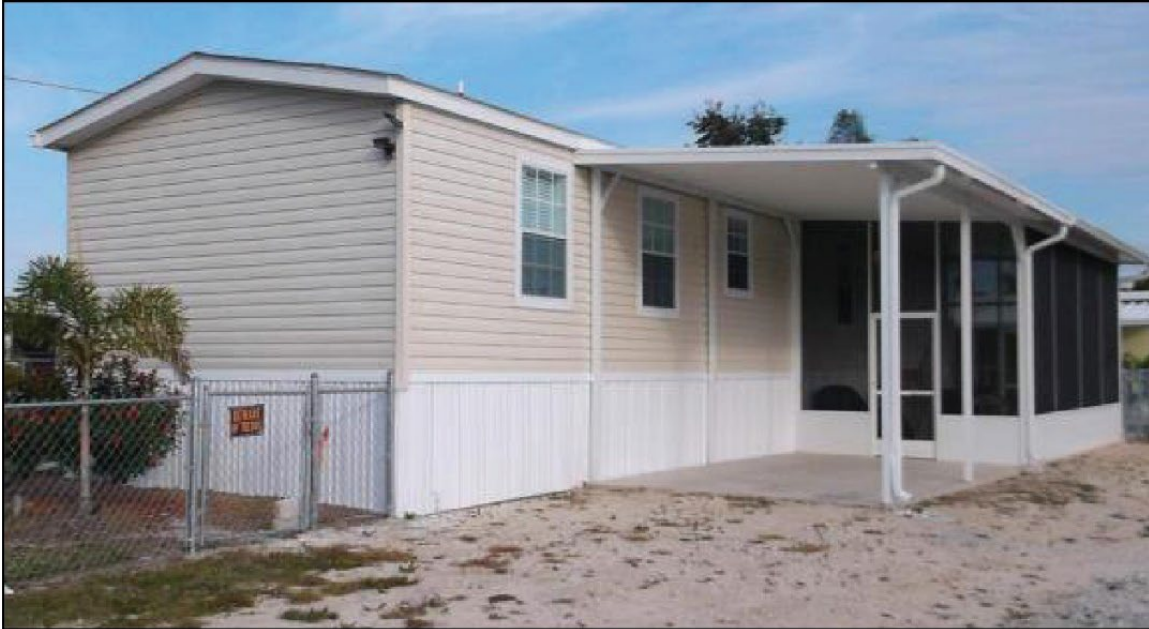
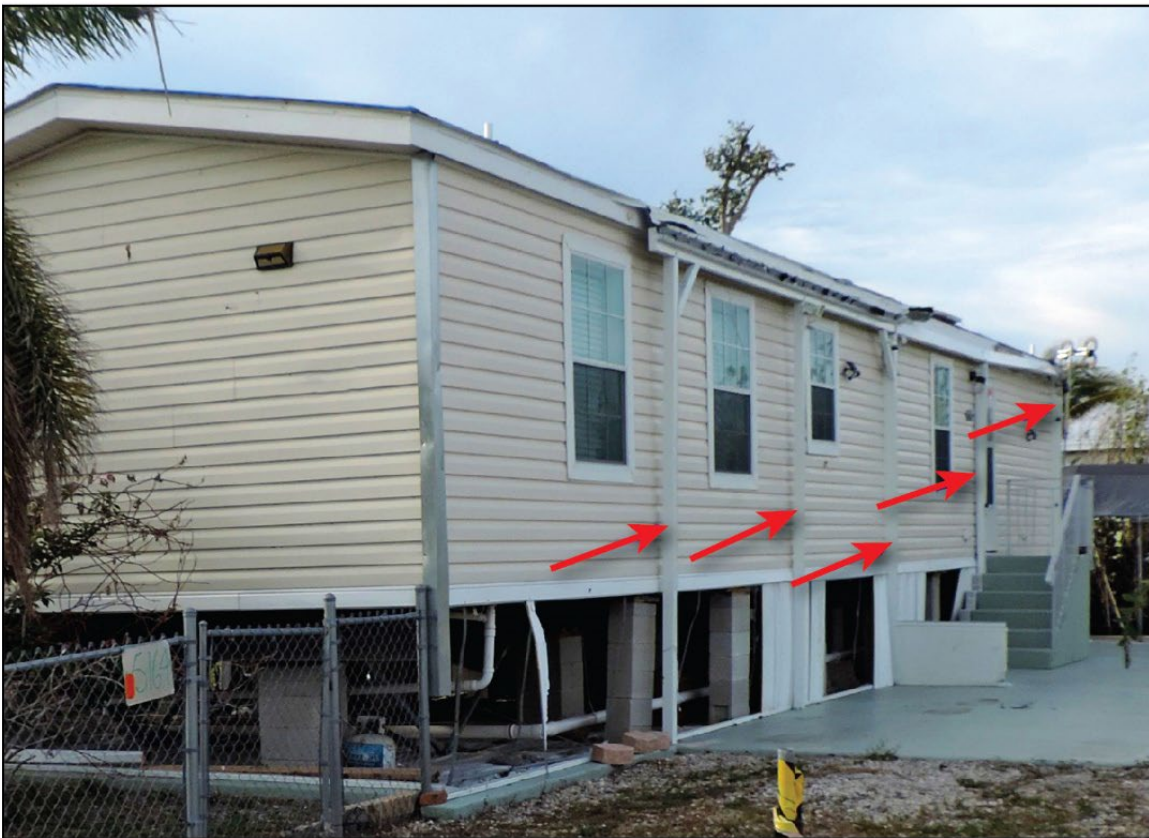
The MAT also observed manufactured homes where appurtenances were destroyed, but because they were supported independently by columns along the main unit, their failure didn't cause further or significant damage to the main unit. Figure 4-56 shows a 2014 manufactured home located in Lee County that lost the patio roof structure and screened porch but was left intact. The 2005 manufactured home located in Charlotte County, shown in Figure 4-57 lost the front portion of the double carport to high winds but did not suffer additional damage because, in accordance with Section 15C-2.0081 of the Florida Administrative Code, it was not structurally attached to the main unit.

Figure 4-56: Pre-storm image of a 2014 manufactured home that appeared to be undamaged by destroyed carport (top); red arrows indicate posts remaining from lost carport (bottom) (EWS = 118 mph) (Lee County)

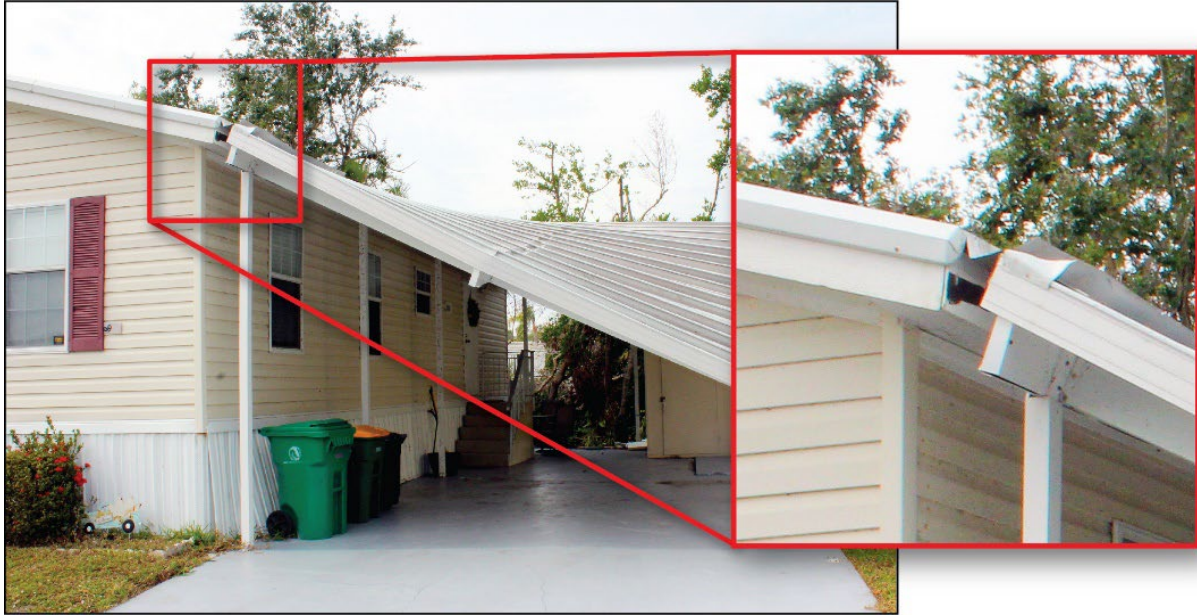
Figure 4-57: A 2005 manufactured home with damaged carport; red square shows where independent support column prevented damage from spreading to the main unit (EWS = 129 mph) (Charlotte County)

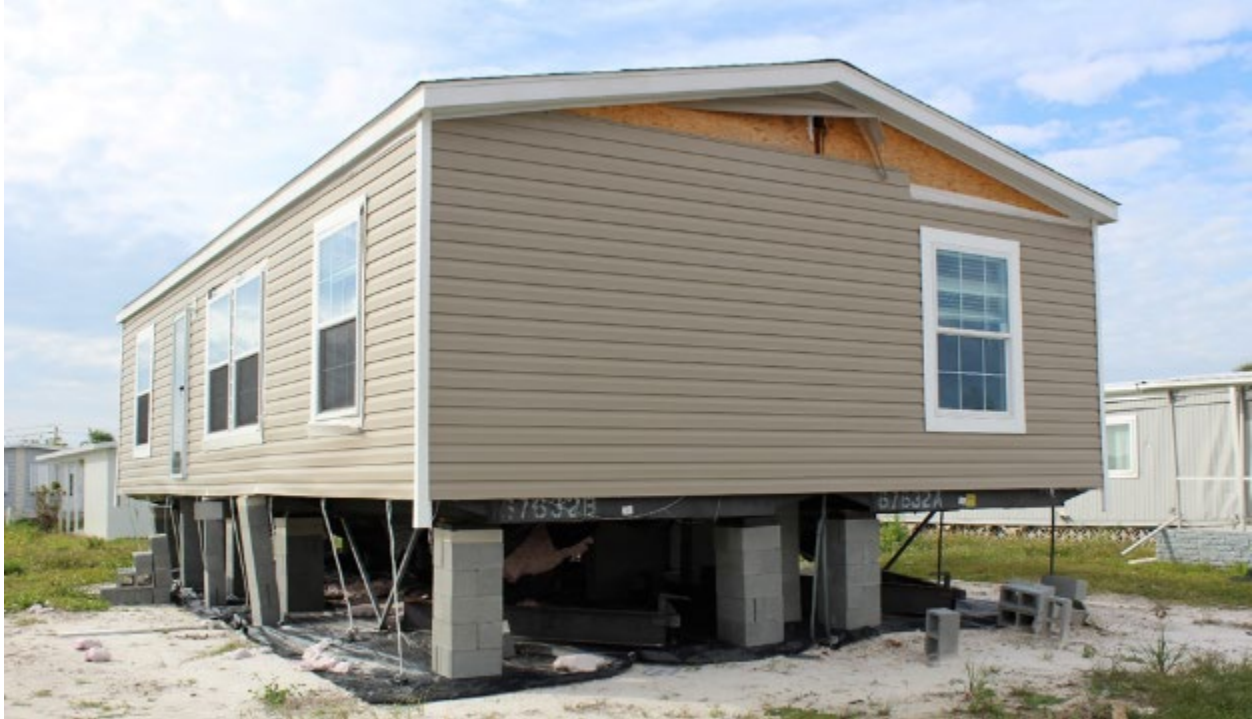
When observing wind-related performance of manufactured homes post-Hurricane Ian, the MAT looked for evidence of anchorage failures. Among the anchoring failures observed were a manufactured home in Lee County that appeared to have been lifted and set back down again due to buoyant forces from floodwater inundation (see Figure 4-58). Several manufactured homes appeared to have been delivered prior to the storm but were not yet permanently installed (see the example in Figure 4-59), The MAT observed no apparent wind-related anchoring failures of installed post-HUD code manufactured homes.

Figure 4-58: Manufactured home with shifted, unstable dry-stack pier foundation; observations included a HWM approximately 6 inches above the top of the finished floor (Lee County)

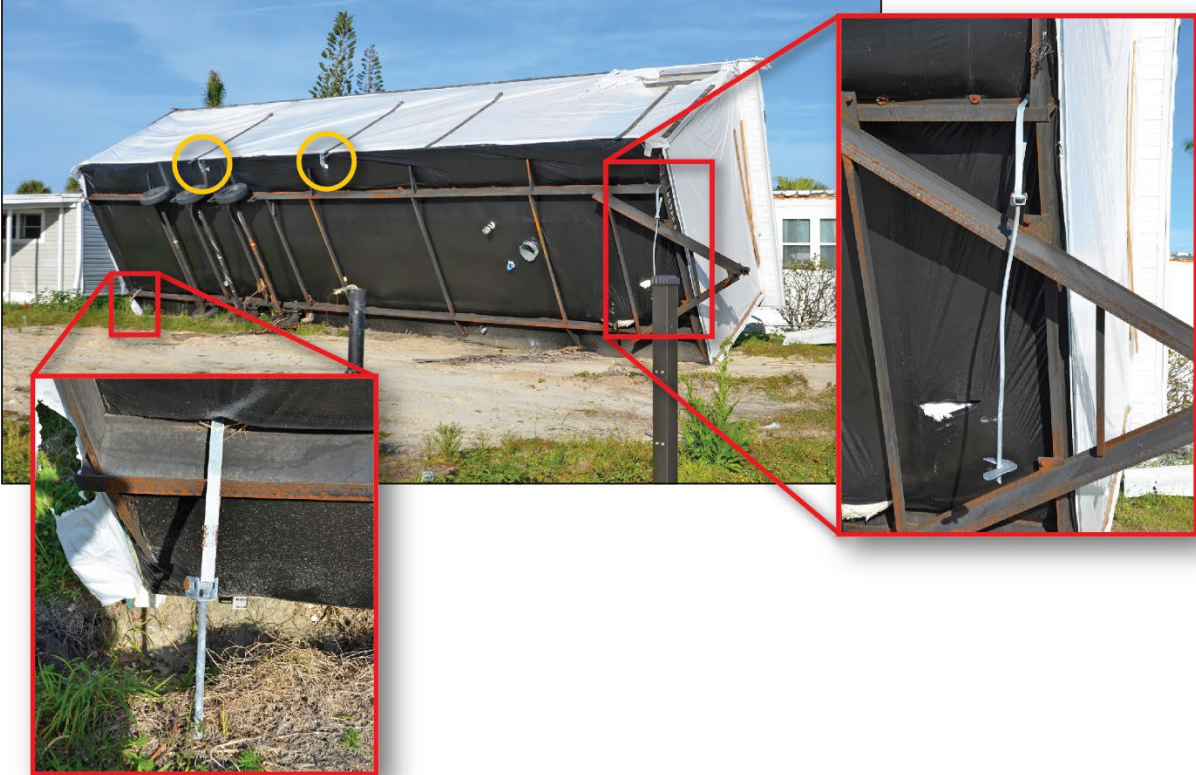
Figure 4-59 shows an overturned manufactured home and running gear assembly (chassis subsystem consisting of suspension springs, drawbar, axles, bearings, wheels, hubs, tires, and brakes with their related hardware)⁵ that appeared to have been temporarily anchored and awaiting permanent installation prior to the onset of the storm. The MAT concluded that the temporary anchors failed when subjected to Hurricane Ian’s high winds. The rectangle with inset on the right side of the figure shows an intact 48-inch-long helical anchor that withdrew from the surrounding soil; the two circles show the remaining metal straps from anchors that failed in tension, and the rectangle with inset on the left side of the figure shows an anchor that remained in place. Although Section 15C-2.011 of the Florida Administrative Code requires the manufactured home dealer to disclose whether the running gear assembly is included in the sale of the unit, the MAT found no requirements for pre-installation anchorage in either the Florida Administrative Code or the HUD codes.

Figure 4-59: Overturned manufactured home that appeared to have been delivered but not yet permanently installed prior to the storm (EWS = 129 mph) (Lee County)

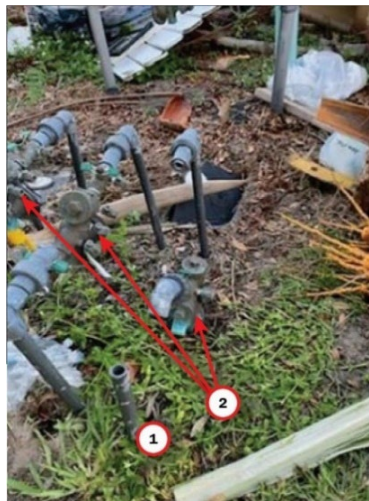
The loss of potable water service was most widespread in Lee County, where almost all utility providers reported a complete loss of potable water service. This near county-wide outage resulted in the most serious impacts to the operations of critical facilities. While critical facilities in Charlotte and DeSoto Counties did experience potable water outages, the outages were more isolated and had location-specific issues. The primary cause of the loss of potable water in Lee County was the breaking of thousands of small-diameter pipes in residential areas. Service lines in residential areas were commonly broken through two scenarios. In the first scenario, trees planted over or near residential service lines, which run from the water main in the street to the house, were uprooted. In the process of uprooting, the service lines were pulled up by the tree’s root ball and broken. In the second scenario, above-grade meters, backflow preventor valves, and service lines were broken by either flood or wind-borne debris (Figure 5-2).

Broken above-grade service lines (1) and water meters with backflow preventor valves (2)

Figure 5-2: Broken above-grade potable water lines (Lee County)

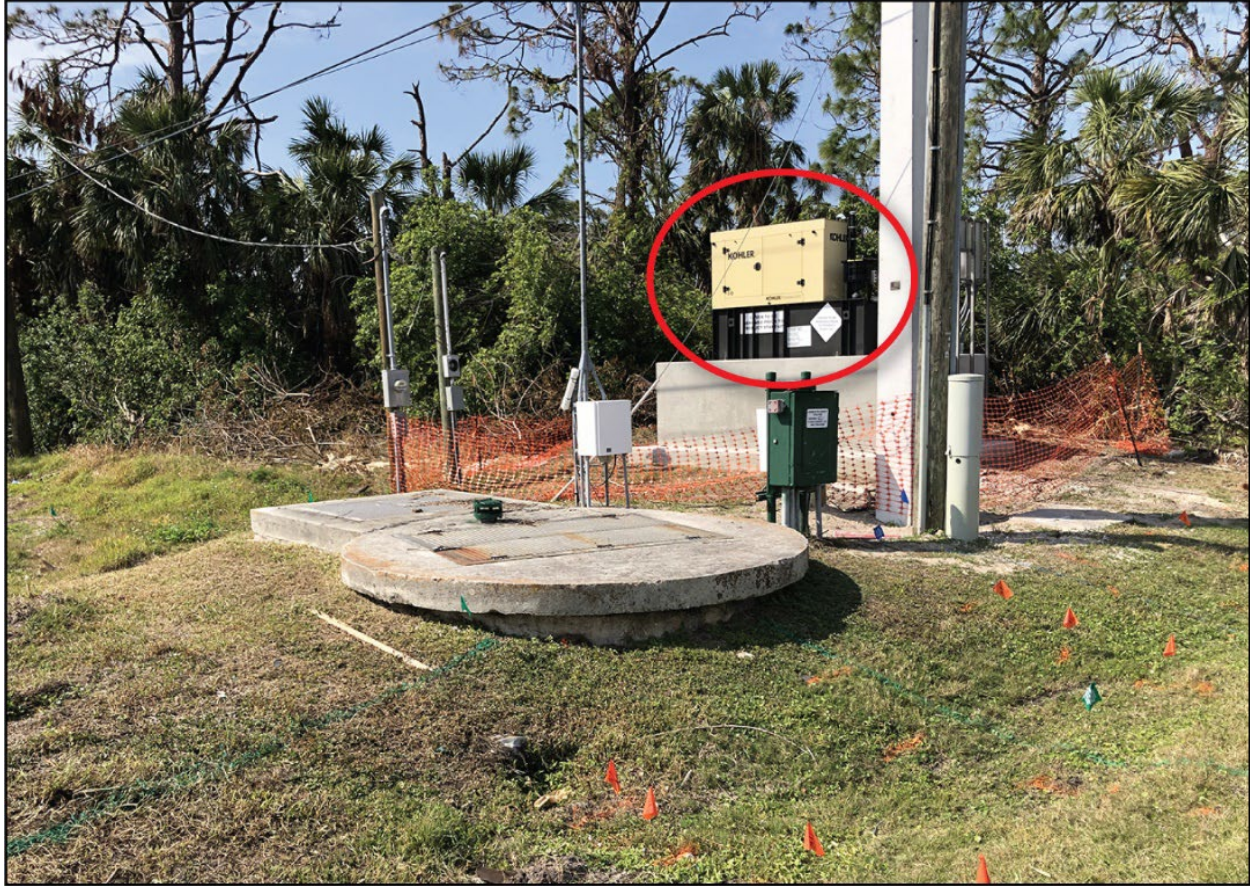
Loss of sewage service was often tied to loss of power or to locations where floodwater inundated lift stations (Figure 5-3). For lift stations that lost power and were not equipped with standby generators, the wells could not be emptied, resulting in backups within their area of service. In areas where floodwater inundated lift stations, at-grade electrical equipment failed and the wet wells were filled with floodwater, surcharging the sewer system in the area.

Figure 5-3: At-grade sewer lift station repaired after Hurricane Ian (Charlotte County)

The generator (circled) for the lift station has been elevated to help reduce flood vulnerability and improve resilience for future events.

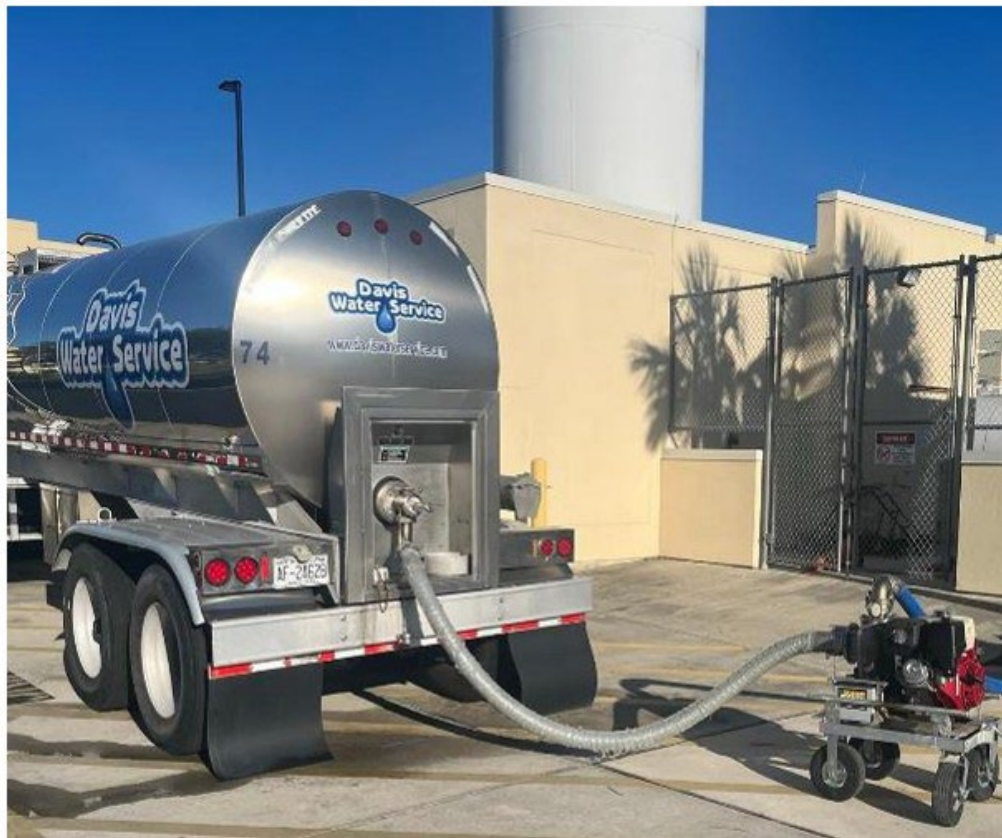
Building engineers and managers used a variety of approaches to minimize the impact the potable water outage had on the operations of the hospitals. Bucket brigades initially took water from on-site stormwater detention ponds and later from water trucks, to manually recharge toilets to enable flushing. Without water for cooling systems, the temperature and humidity indoors rose rapidly, resulting in high heat-index temperatures that added stress and risk to patients. To supplement the water supply needed for chillers and cooling towers used in the HVAC systems, hoses with pumps were run to stormwater ponds or existing groundwater wells. When stormwater was used, chemicals were added to the water to prevent the growth of algae and bacteria inside the cooling system. In addition to water from stormwater ponds, once roads were passible, water was pumped from potable water trucks to supplement water supply and to help increase water pressure (Figure 5-4).

Figure 5-4: Potable water truck and pump supplemented on-site stormwater for operating HVAC equipment and flushing toilets (Lee County)

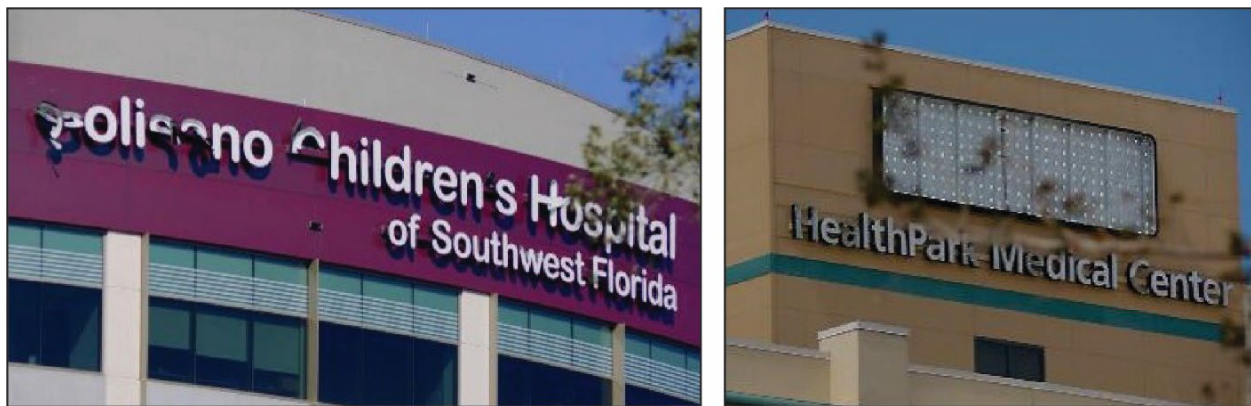
Figure 5-5: Superficial wind damage at hospitals (Lee County)

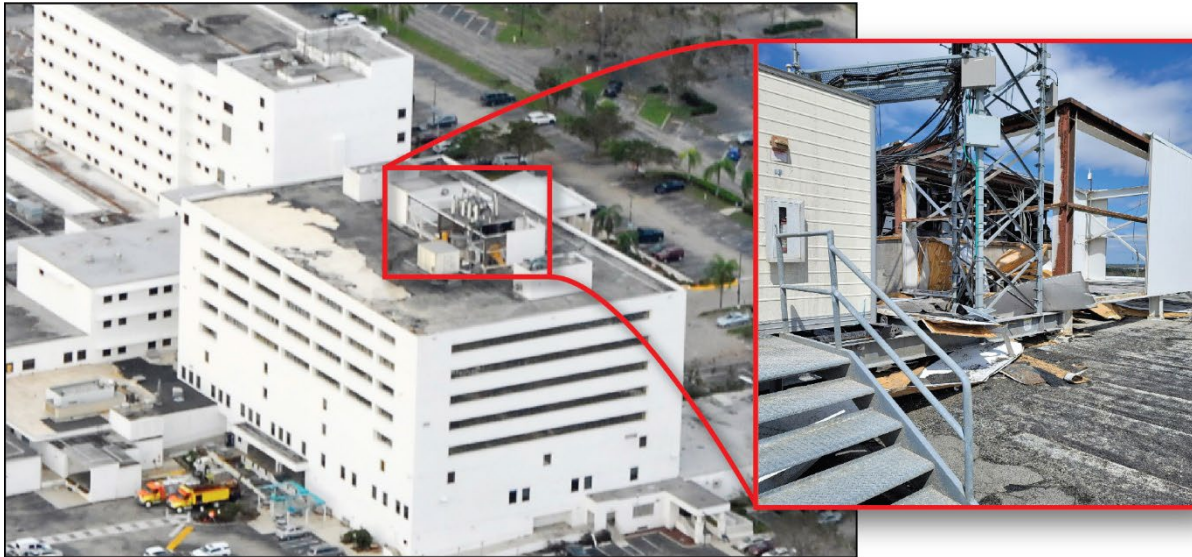
During Hurricane Ian, sections of the roof cover and the rooftop elevator penthouse of Lee Memorial Hospital were damaged (Figure 5-7). The damage to the roof cover was not unexpected, as the cover was 20 years old and was scheduled to be replaced. The damage to the penthouse resulted in damage to three of the hospital’s four elevators.

- Roof cover, rooftop elevator penthouse, and three elevators were damaged.
- Hospital operations prioritized the usage of the non-damaged elevator for critical activities, such as moving patients between floors, until repairs were completed.

Figure 5-7: Damage to elevator penthouse at Lee Memorial Hospital (Lee County)

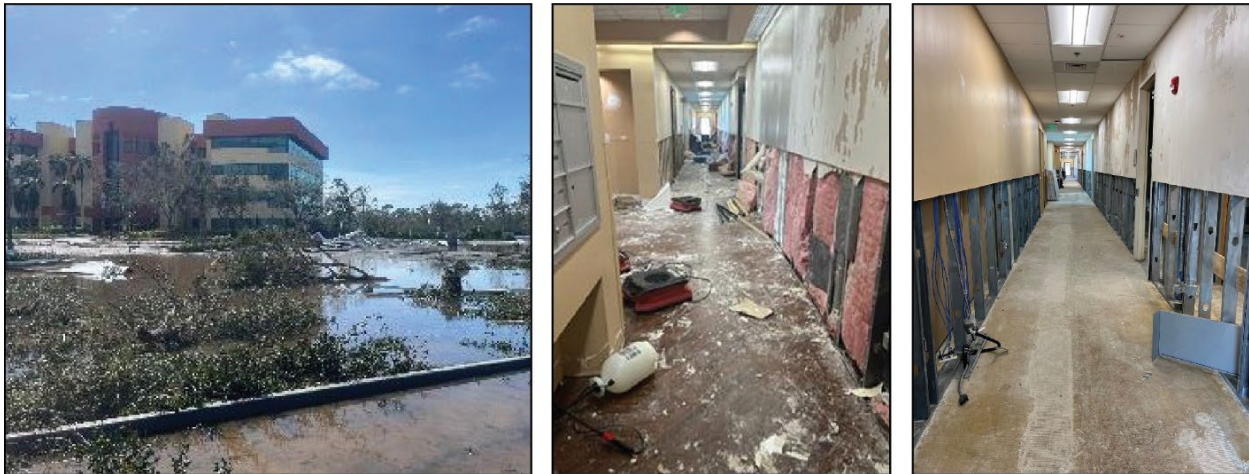
Measured Water Surface Depth = 6 inches above the lowest floor

The water level at Medical Plaza One was estimated to be roughly 6 inches above the lowest floor.

Figure 5-8: Flood damage at Medical Plaza One (Lee County, Zone AE)

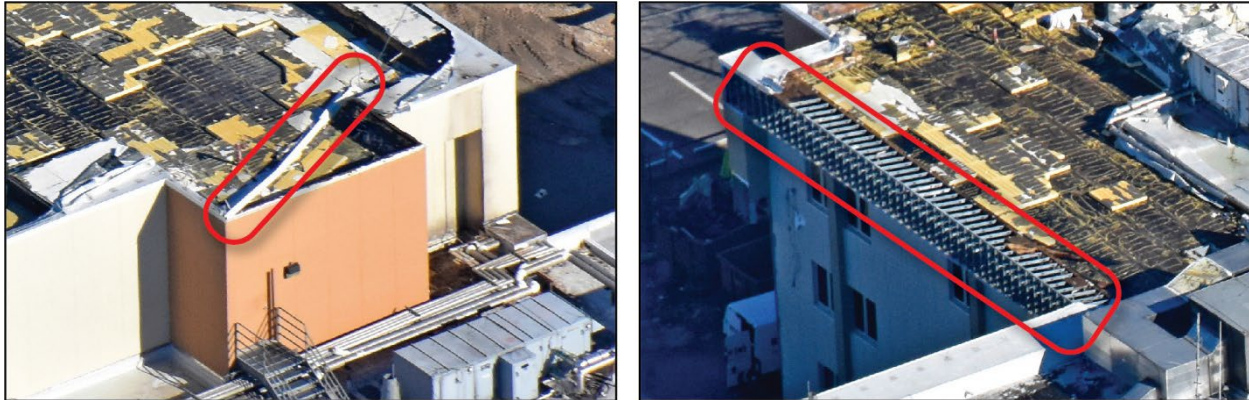
During Hurricane Ian, roof and rooftop equipment failures caused building damage that resulted in a loss of operational capacity for a southwest Florida hospital, whose operators requested to remain anonymous in this report. While available data prevented the MAT from accurately determining the failure progression, post-event aerial imagery suggests that the roof membrane, installed in 2021, detached at two locations on the roof. One location was over a stairwell at the east end of the main hospital tower. The second location was along the mansard that runs along the south side of that tower (Figure 5-10). Both locations are in portions of the roof where suction pressures are at their greatest. When the roof membrane detached from these areas, the roof membrane inflated. The inflated roof membrane displaced five rooftop exhaust fans, which breached the building envelope and allowed water to enter the building. One of the displaced exhaust fans struck a pressurized wet fire protection standpipe that extended above the roof line (Figure 5-11). The impact from the exhaust fan caused a valve to break, which allowed more water to enter the breached envelope.

Figure 5-10: Detached nailing strip over a stairwell (left) and damaged mansard envelope system (right) (Southwest Florida)

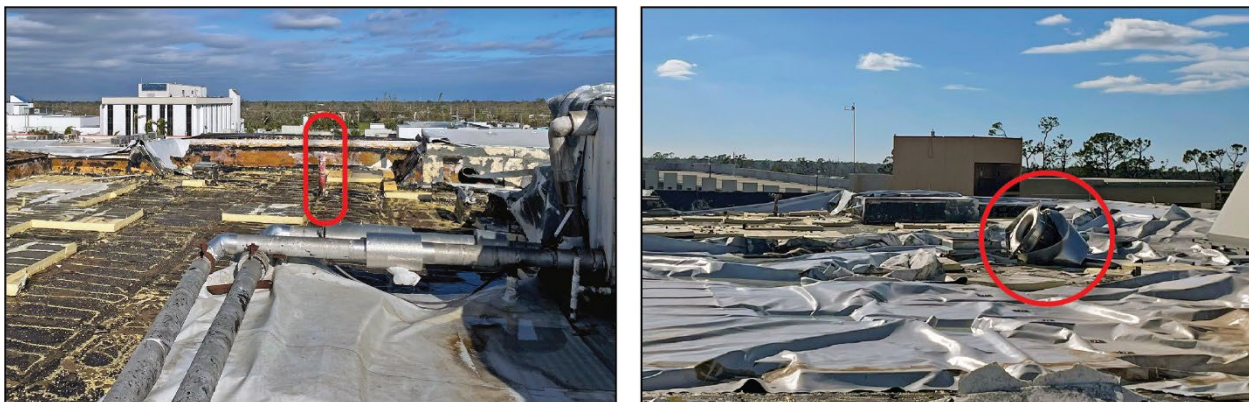
Eventually water from the wet fire protection standpipe and rainwater flowed down through the fourth and third Intensive Care Unit floors and to the patient care rooms on the second and first floors. The water entering the hospital forced hospital staff to relocate patients to dry areas on the lowest floor, in wings of the hospital that were separate from the water infiltration. After Hurricane Ian passed, 161 patients had to be evacuated, as a result of the damage, to other hospitals in Florida on the morning of September 29, 2022. After all patients were evacuated, the hospital closed for repairs.

Figure 5-11: Damaged wet fire protection standpipe (left) that resulted in significant water intrusion and damaged exhaust fan and roof cover (right) (Southwest Florida)

The health care group operating this southwest Florida hospital operates dozens of hospitals in Florida. In anticipation of Hurricane Ian, the group pre-staged 40,000 square feet of modified bitumen roofing, roofing components, and other building materials at a local warehouse to accelerate storm damage repair. Three days after Hurricane Ian made landfall, the roof damage was repaired, within 7 days the emergency room (ER) reopened, and within 100 days the hospital was fully operational.

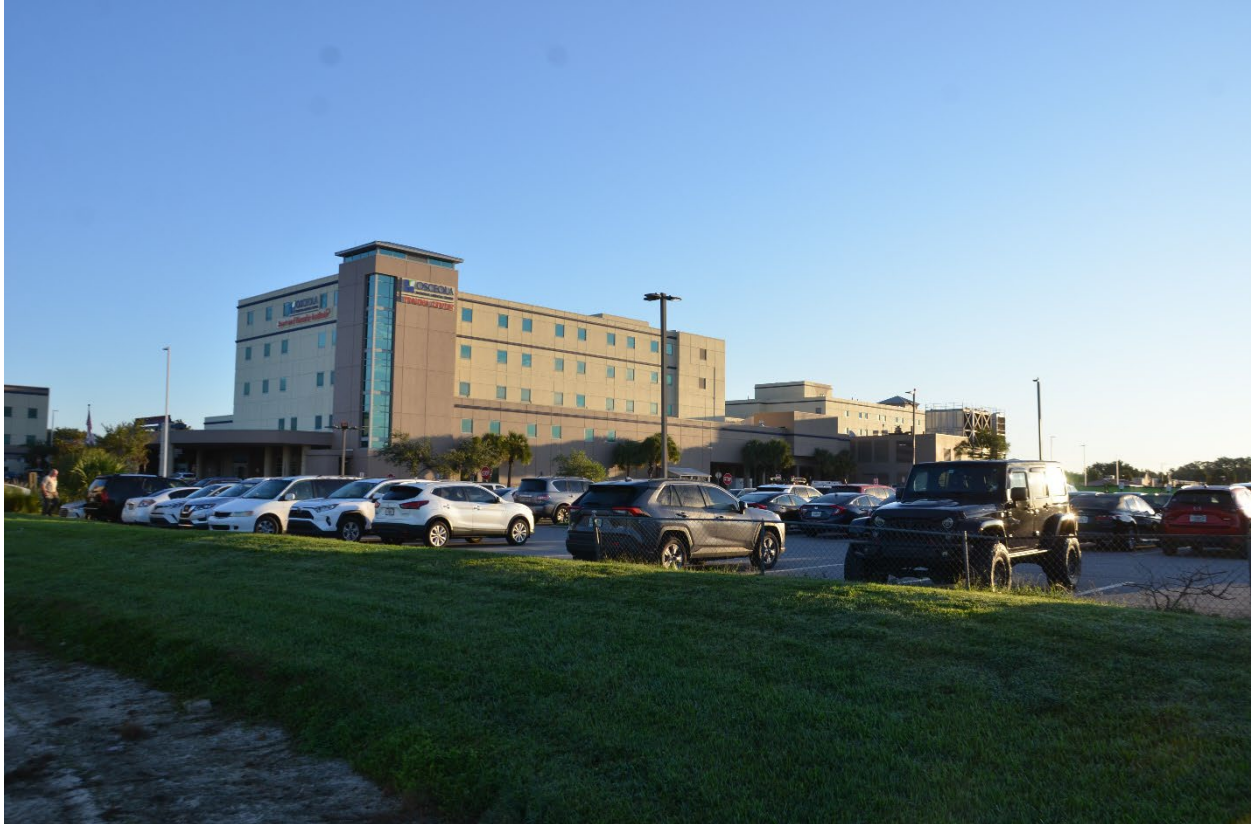
During Hurricane Ian, the hospital campus was flooded, which caused minor flooding of some portions of the hospital (parking garage, helipad, access roads); however, floodwater did not enter the hospital buildings. Water damage to the hospital interior was primarily caused by wind-driven rain and was relatively minor. During the hurricane, 79 staff vehicles were flooded in the parking deck and parking lots as well. Although the flooding of the campus resulted in its isolation, the campus did not have to be evacuated. However, accessing the buildings became more and more challenging, and this significantly impacted the hospital's ability to service the general public. Two hospital helipads were under water and the hospital was temporarily inaccessible by vehicle, resulting in it being isolated and closed to incoming patients for approximately 2 hours. Facility managers established a new ER access for ambulances at a higher point on the hospital campus, enabling the hospital to open to incoming patients again. Although the hospital was temporarily isolated by floodwater and lost electrical utility power, four generators provided sufficient backup power to service the critical functions for the hospital, including the trauma center and its critical operations. Although the hospital did have to limit the use of five rooms because of water intrusion from wind-driven rain and relocate patients within the hospital, it did not evacuate any patients. With the exception of the 2-hour window in which the new access routes were determined, the hospital remained fully operational (Figure 5-13 through Figure 5-17).

Figure 5-14: Osceola Regional Medical Center Trauma Center parking lots that were flooded (Osceola County, Zone AE)

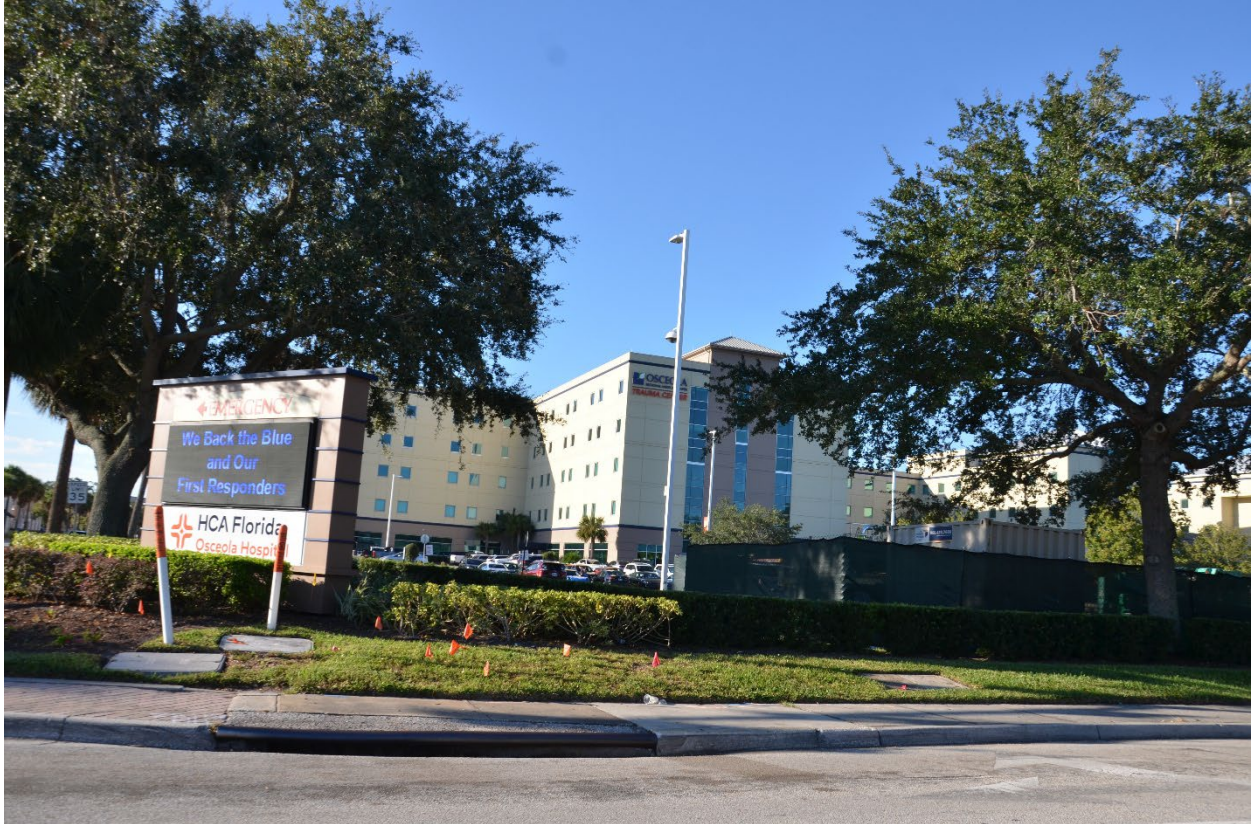
Figure 5-15: Access roads at Osceola Regional Medical Center Trauma Center that flooded, isolating the hospital for 2 hours (Osceola County, Zone AE)

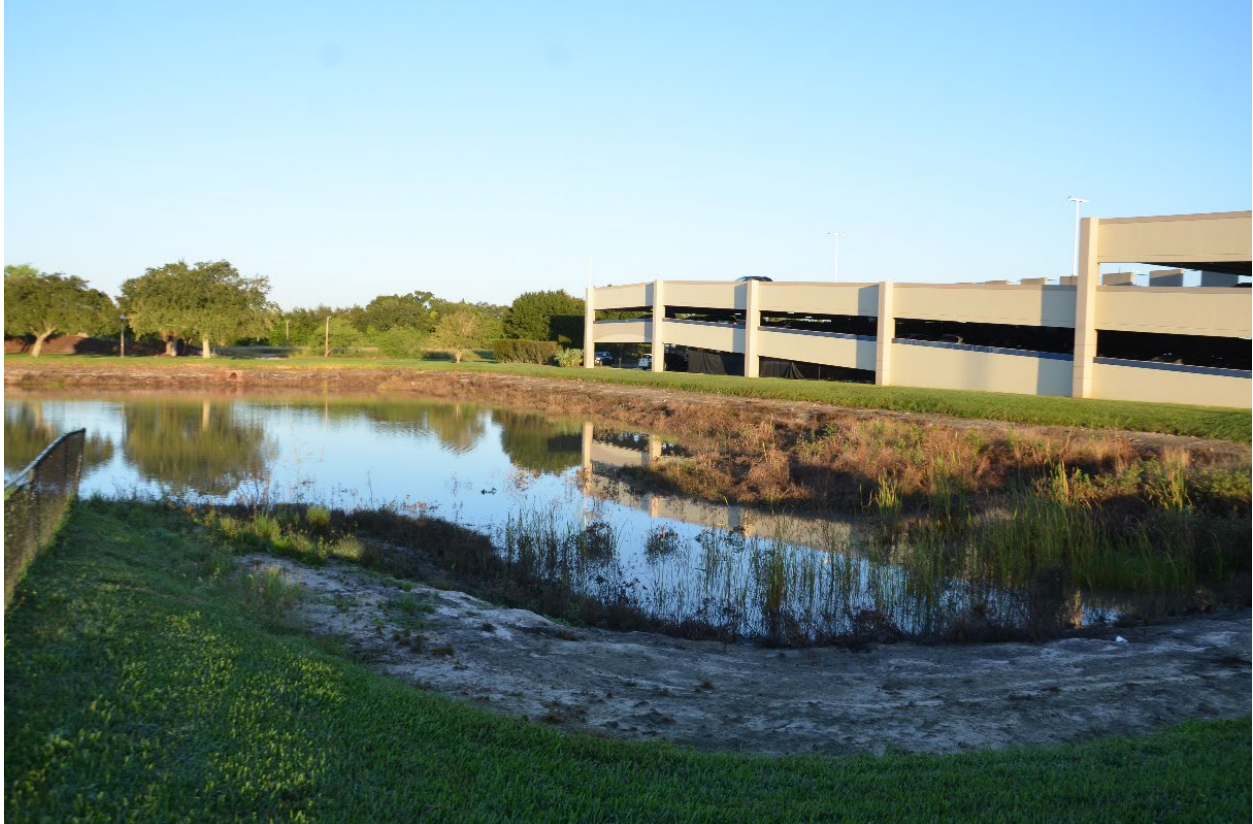
Figure 5-16: Osceola Regional Medical Center Trauma Center parking garage that had approximately 21 inches of water at ground level during Hurricane Ian (Osceola County, Zone AE)

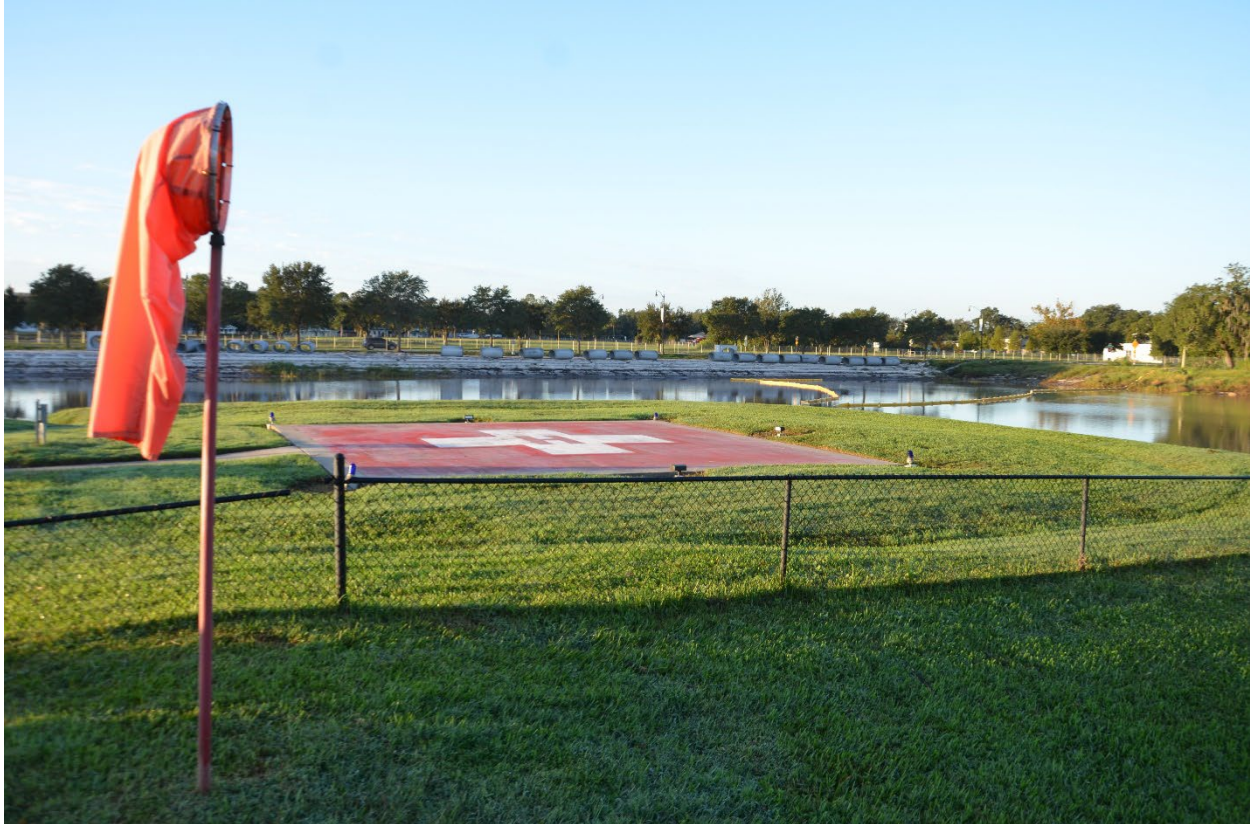
Figure 5-17: Two helipads at Osceola Regional Medical Center Trauma Center that were submerged and inoperable for at least 2 hours during Hurricane Ian (Osceola County, Zone AE)

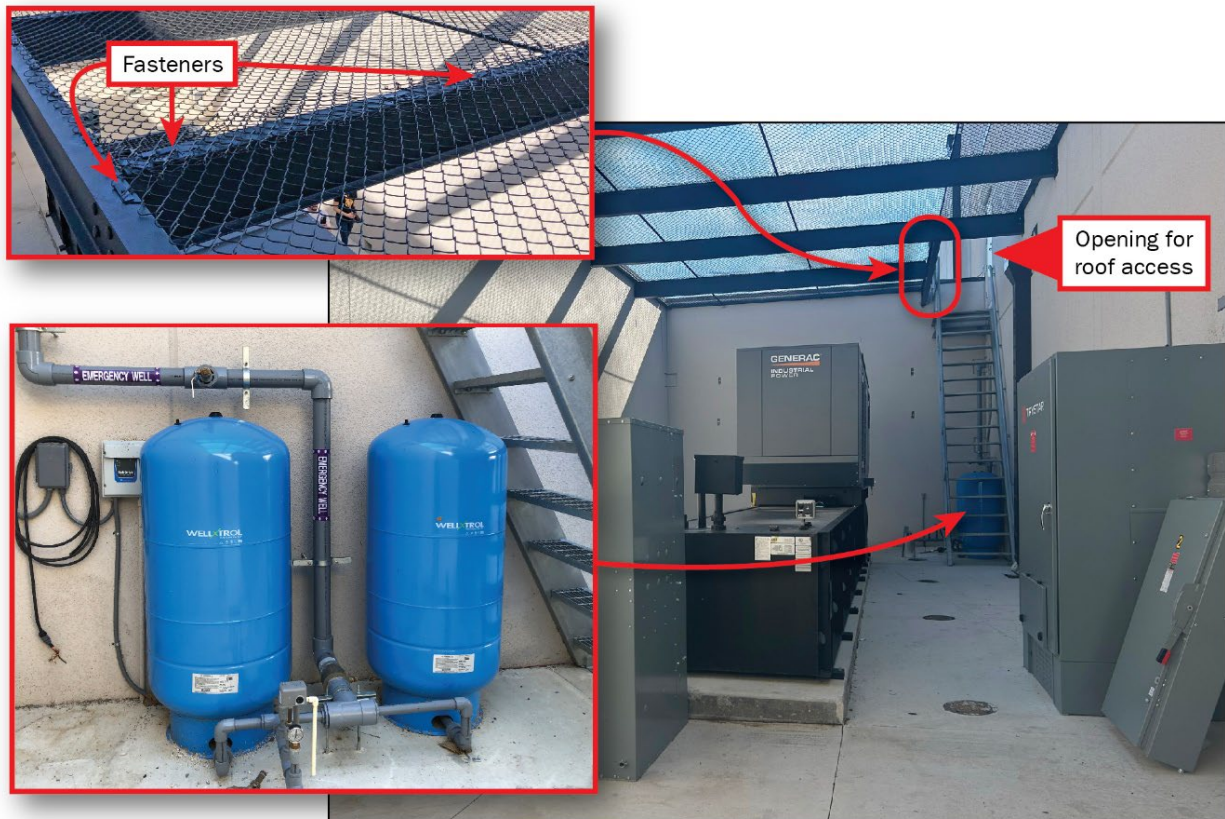
vertical missiles, a system composed of chain-link mesh, supported by steel beams is attached to the walls. The chain-link system appears to work by dissipating energy through extensive deflection of the material. At the generator enclosure, vertical missiles can potentially enter through the opening for the access ladder to the rooftop HVAC enclosure. Given this opening, the enclosure system does not appear to meet ICC 500 requirements, nor FEMA P-361 criteria, for wind load or impact rating. Other non-compliance issues with this enclosure system could not be confirmed by the MAT.

Enclosure walls are impact-rated but the chain-link mesh cover above does not appear to meet ICC 500 requirements for wind load or impact rating.

Figure 5-21: Babcock Ranch safe room enclosure for generator and backup well (Charlotte County)

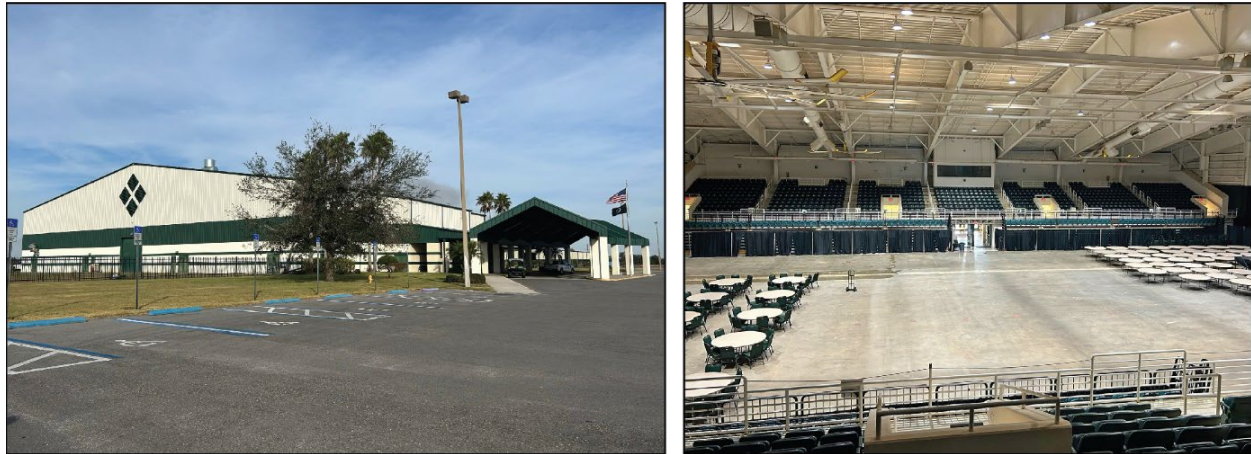
The Turner Center is a pre-engineered metal building constructed of long span trusses. ARC HESSS V1.0 recommends against using these types of buildings as shelters.

Figure 5-23: Exterior (left) and interior (right) photos of the Turner Center (DeSoto County)

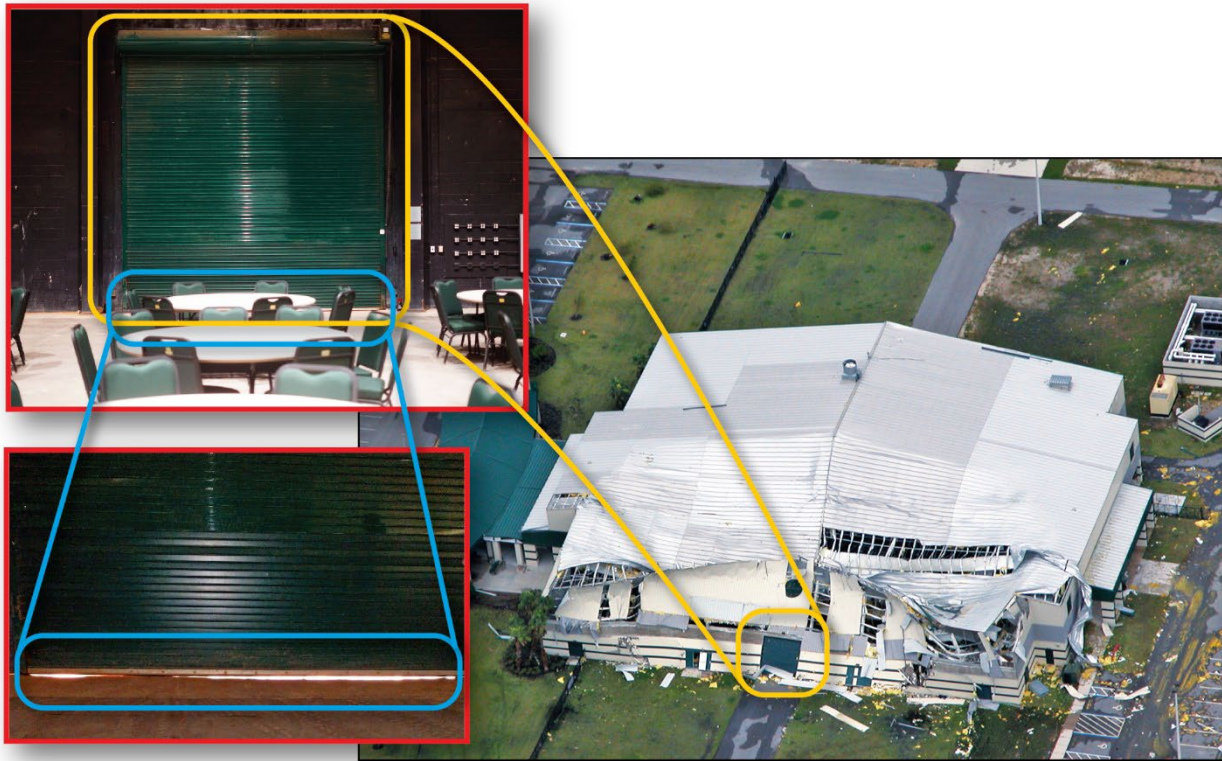
The Hurricane Charley MAT report indicates that the facility was designed per ASCE 7-98 to 140 mph wind speeds with an importance factor of 1.0¹⁰ and met EHPA minimum requirements. However, the Florida Department of Community Affairs (FDCA) had not evaluated compliance with EHPA design requirements at the time of the Hurricane Charley MAT report. During Hurricane Charley, the east gable end wall partially collapsed, potentially due to faulty roof clips; as a result, shelter occupants were evacuated to a nearby high school. During Hurricane Ian, occupants reported hearing a rattling sound and seeing a large deflection of the door and significant water intrusion coming from a large roll-up door on the same wall that failed during Hurricane Charley (Figure 5-24). Although the shelter was not evacuated, occupants moved away from the door; some sheltered in interior hallways and stairwells, concerned that a door failure was imminent. There was also water intrusion in the northeast and northwest corners of the structure; the cause of this water intrusion is still under investigation. The Hurricane Charley MAT report states the area experienced 3-second wind gusts of between 110 and 120 mph, which may have been locally higher due to terrain effects. During Hurricane Ian, the estimated wind speed at the shelter location was approximately 119 mph.

The Turner Center experienced partial collapse to a gable end wall during Hurricane Charley in 2004 (right aerial view). During Hurricane Ian, a large roll-up door (inset on left) on the same gable end wall rattled and deflected, enabling water to enter and causing shelter occupants to feel unsafe. In the bottom inset, the blue circle shows the gap at the bottom of the door caused by the door deflecting.

Figure 5-24: Comparison of damage to the Turner Center in Hurricane Charley versus Hurricane Ian (DeSoto County)

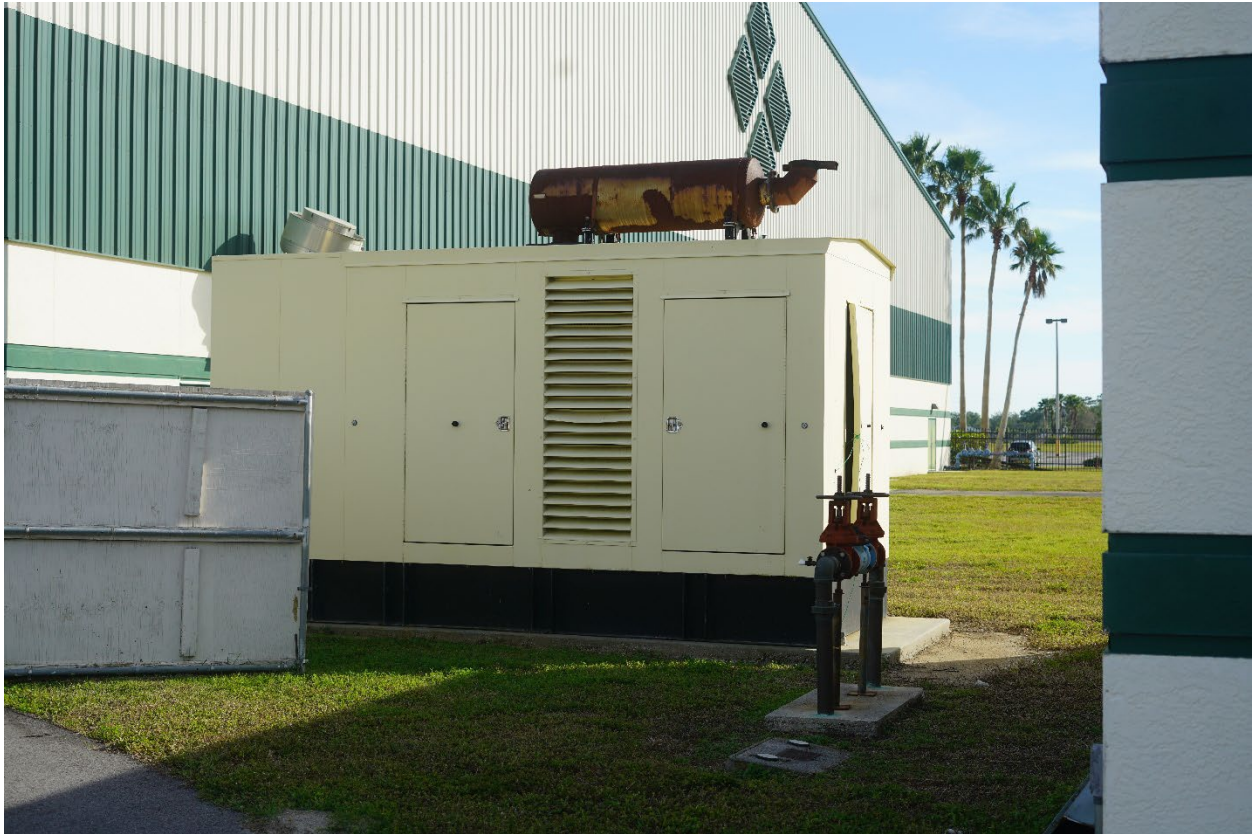
The shelter faced a number of operational challenges in addition to the structural performance issues. The shelter lost both municipal power and potable water during Hurricane Ian. Although the shelter has an emergency generator (Figure 5-25), the generator failed 30 minutes after utility power was lost, leaving shelter residents without power for 2 to 3 days. Staff did not know why the generator failed and did not know whether it was routinely maintained¹¹ and tested. The MAT observed that the generator was manufactured in April 2002. The date it was installed could not be determined. When Hurricane Ian made landfall, the generator may have been in service for over 20 years.

Figure 5-25: Generator at the Turner Center that failed during Hurricane Ian (DeSoto County)

After the fan belt was replaced, the generator was restarted, and power was restored to the equipment supplied by the generator. The equipment supplied by the other generator never lost power and remained operational for the entire utility power outage.

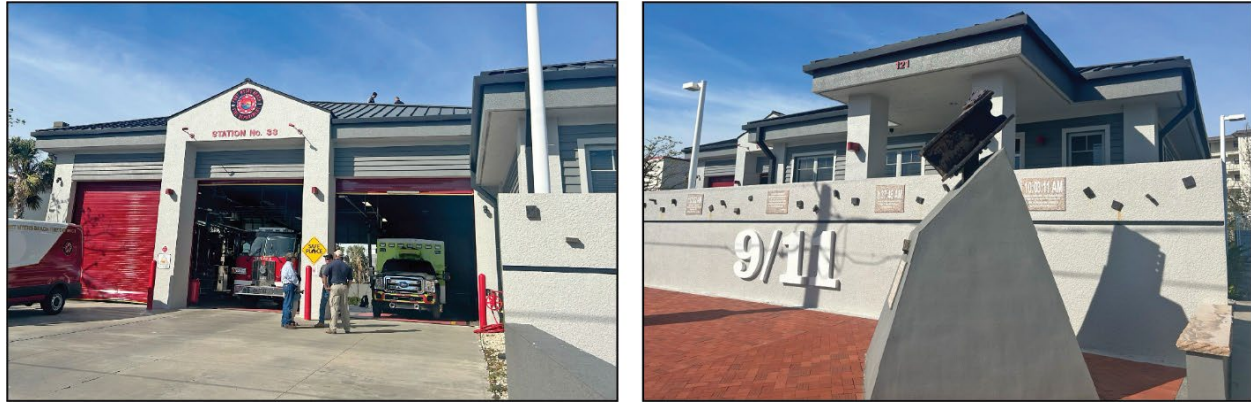
Figure 5-29: Fort Myers Beach Fire Station #33 apparatus bay (left) and commercial and residential area (right) (Lee County, Zone AE)

During Hurricane Ian, flood depths in the apparatus bay reached 60 inches or 12.59 feet NAVD 88 or 1.21 feet below the FPE. Based on the FIS in effect when Hurricane Ian made landfall, the flood elevation correlates to a flood event with approximately a 200-year recurrence interval. Floodproofing measures performed as anticipated during Hurricane Ian. The dry floodproofing prevented floodwater from entering protected areas.
