Mitigation Assessment Team Report

Hurricane Ian in Florida

Building Performance Observations,
Recommendations, and Technical Guidance

FEMA P-2342/December 2023

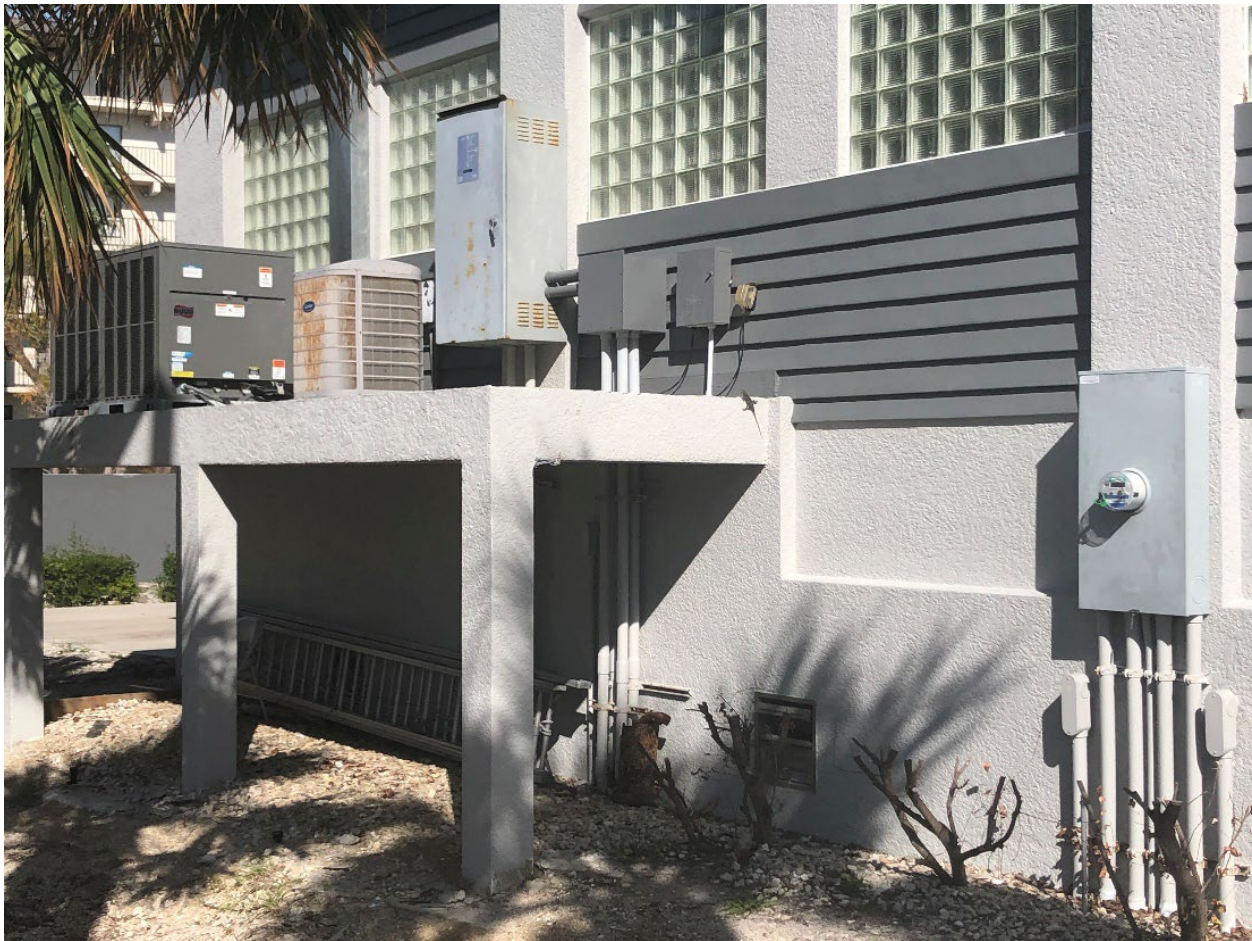
Mechanical and electrical equipment are elevated and equipment below the BFE is minimized. Elevated equipment includes the electrical service and distribution equipment, the standby generator that supplies the entire facility,¹³ the automatic transfer switch (ATS) that controls the generator and utility power, and the air conditioning equipment (Figure 5-31).

Figure 5-31: Equipment elevated on a platform (Lee County, Zone AE)

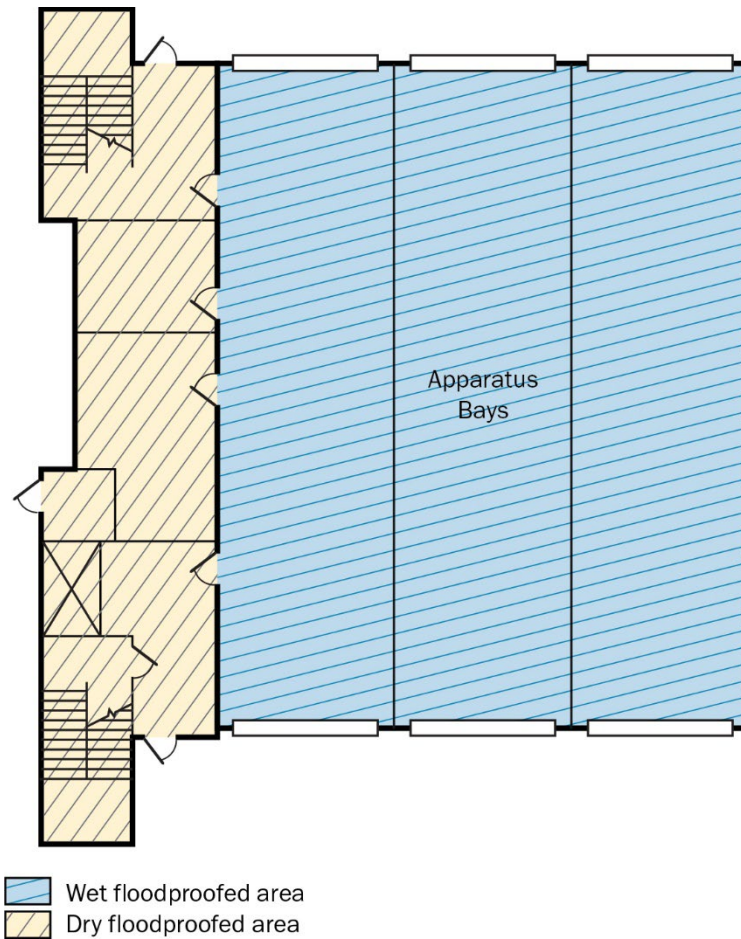
Figure 5-34: Floodproofing measures implemented in Fire Station #32

The building was designed in 2006 and constructed in 2007. Dry and wet floodproofing were included in the design. The apparatus bay is wet floodproofed and equipped with nine automatic flood vents that allow for the automatic entry and exit of floodwater. The remaining portions of the first floor are dry floodproofed (Figure 5-34).

The FPE for the dry-floodproofed areas is 12 feet NGVD 29 (10.8 feet NAVD 88) or BFE+1. Dry floodproofing measures include the solid grouting of all first-floor walls, the application of a polymer cement waterproofing, and the installation of gasketed aluminum flood barriers for all doors that access the dry-floodproofed areas. Figure 5-35 shows the receiving components for the stop logs. Those components include devices to hold the logs in place and compress their gaskets (Figure 5-36). The stop logs are stored on site (Figure 5-37).

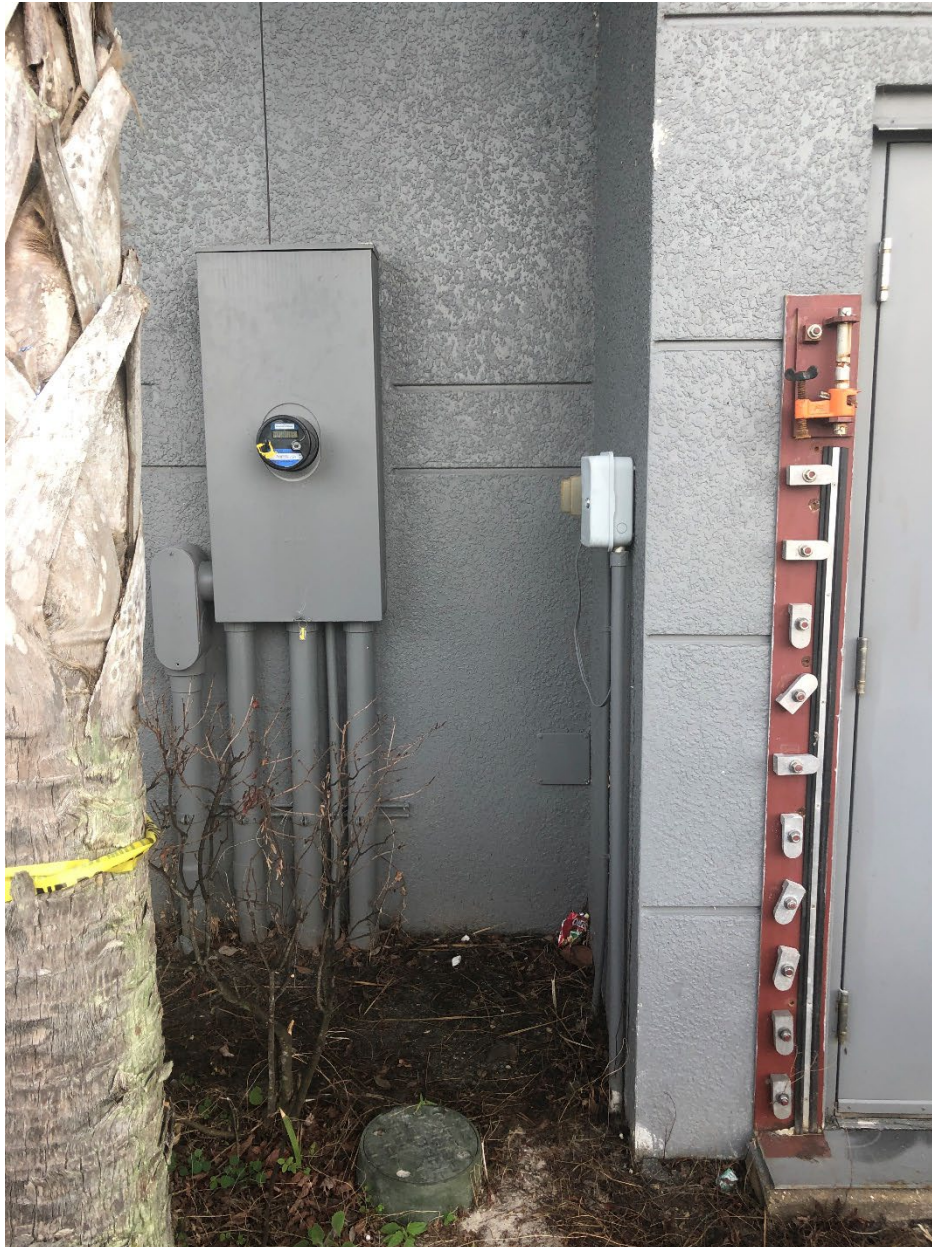
The electrical utility meter, which is mounted on the northeast side of the building near the elevator shaft, is not elevated and not protected by dry floodproofing (Figure 5-41).

Figure 5-41: Electrical utility meter that is not elevated nor protected by dry floodproofing (Lee County, Zone AE)

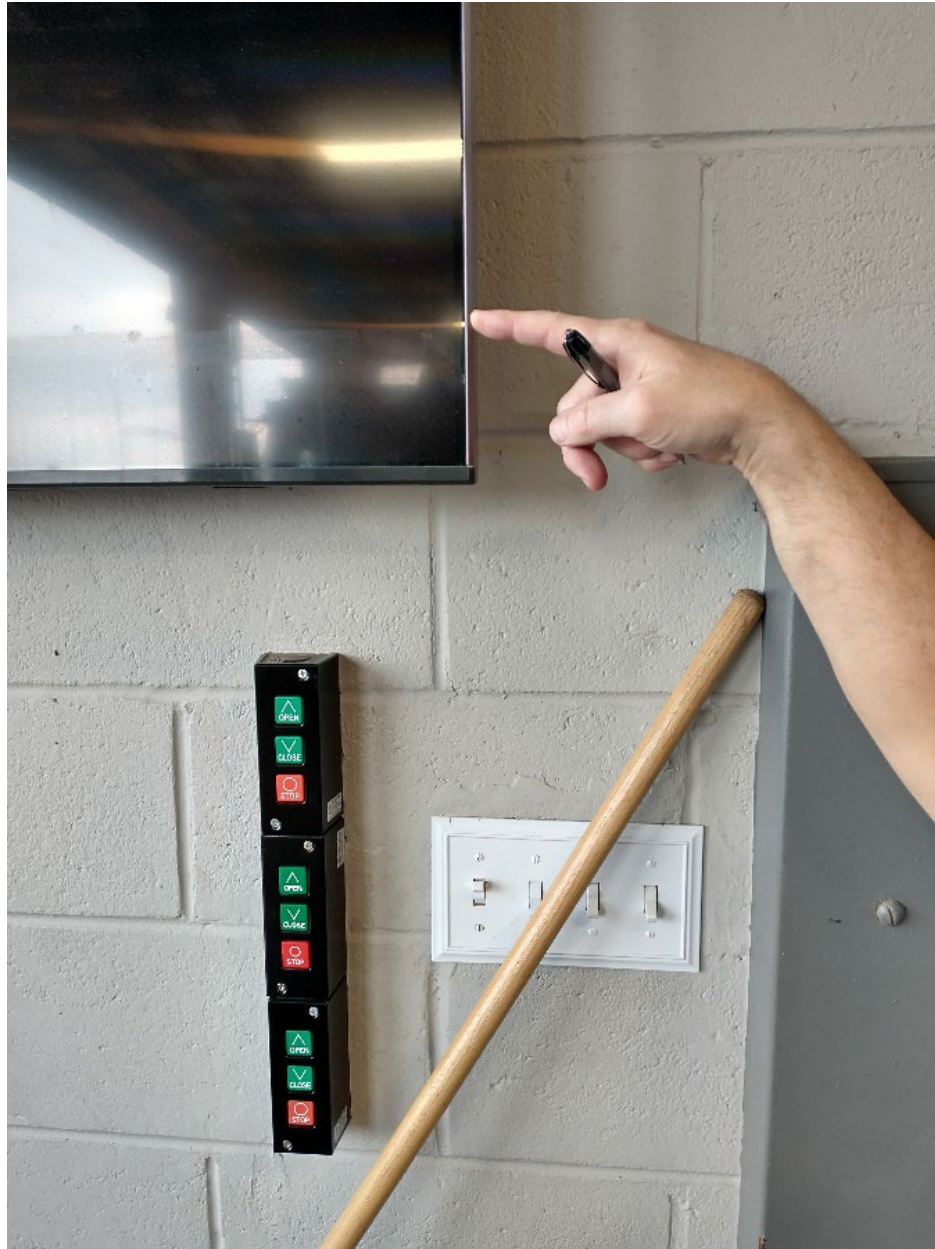
During Hurricane Ian, floodwater within the apparatus bay reached an elevation of 13.32 NGVD 29 (12.14 feet NAVD 88), which exceeded the FPE by 1.32 feet (Figure 5-42).

The flood elevations correlate to a flood event with approximately a 150-year recurrence interval.

Figure 5-42: HWM observed by the MAT (Lee County, Zone AE)

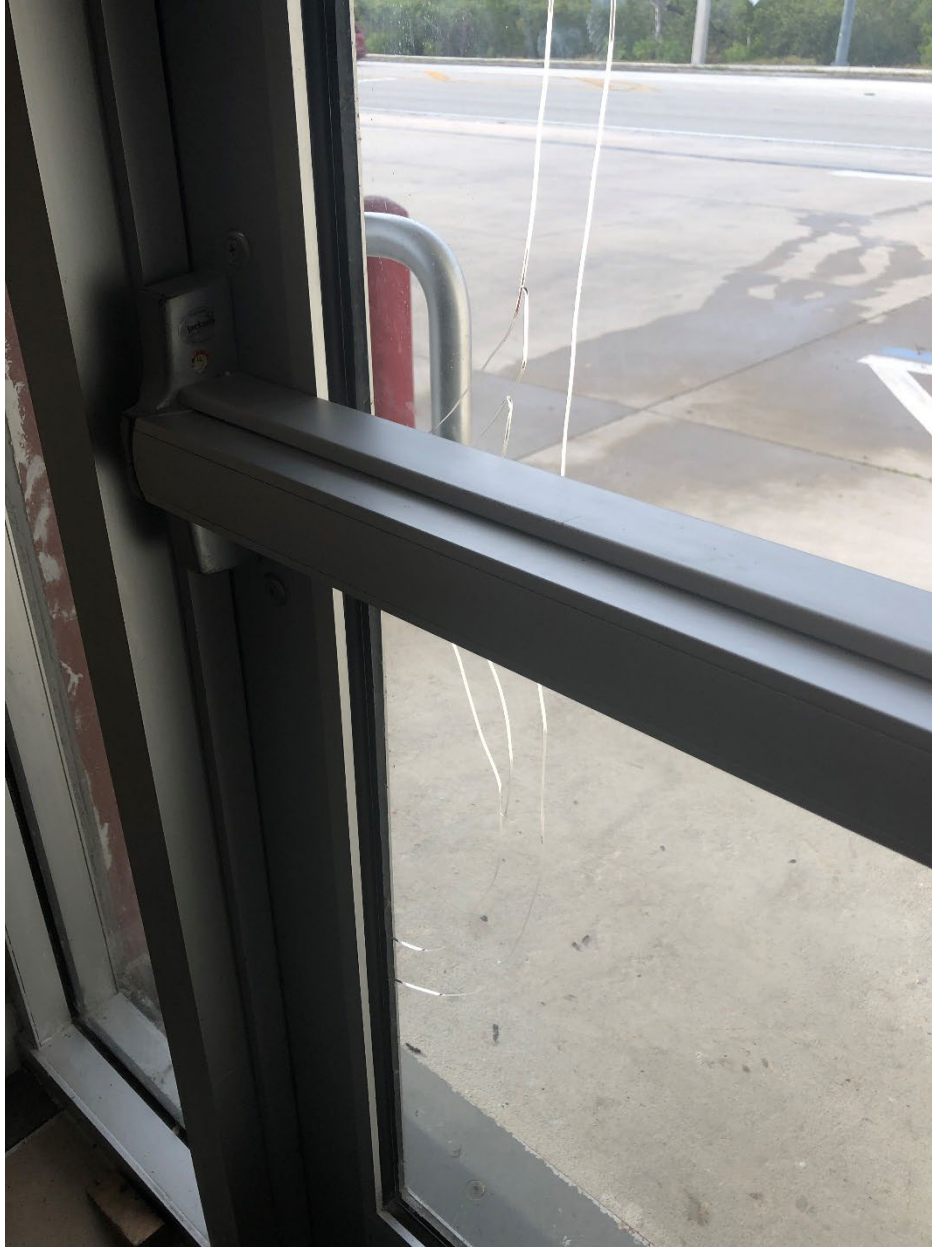
Floodwater overtopped the flood barriers and completely inundated the dry-floodproofed areas. Staff reported that equipment in the hydraulic elevator pit was extensively damaged and required replacement. Submerged electrical equipment and submerged materials that were not flood damage-resistant had to be removed. Glazing in the storefront-style front entrance door, which is located behind flood barriers, was broken (Figure 5-43). Damage likely resulted from the rate at which floodwater filled the dry-floodproofed areas and from the overall air tightness of the door, which prevented flood levels on either side of the door to equalize.

Figure 5-43: Front door glazing damaged by floodwater (Lee County, Zone AE)

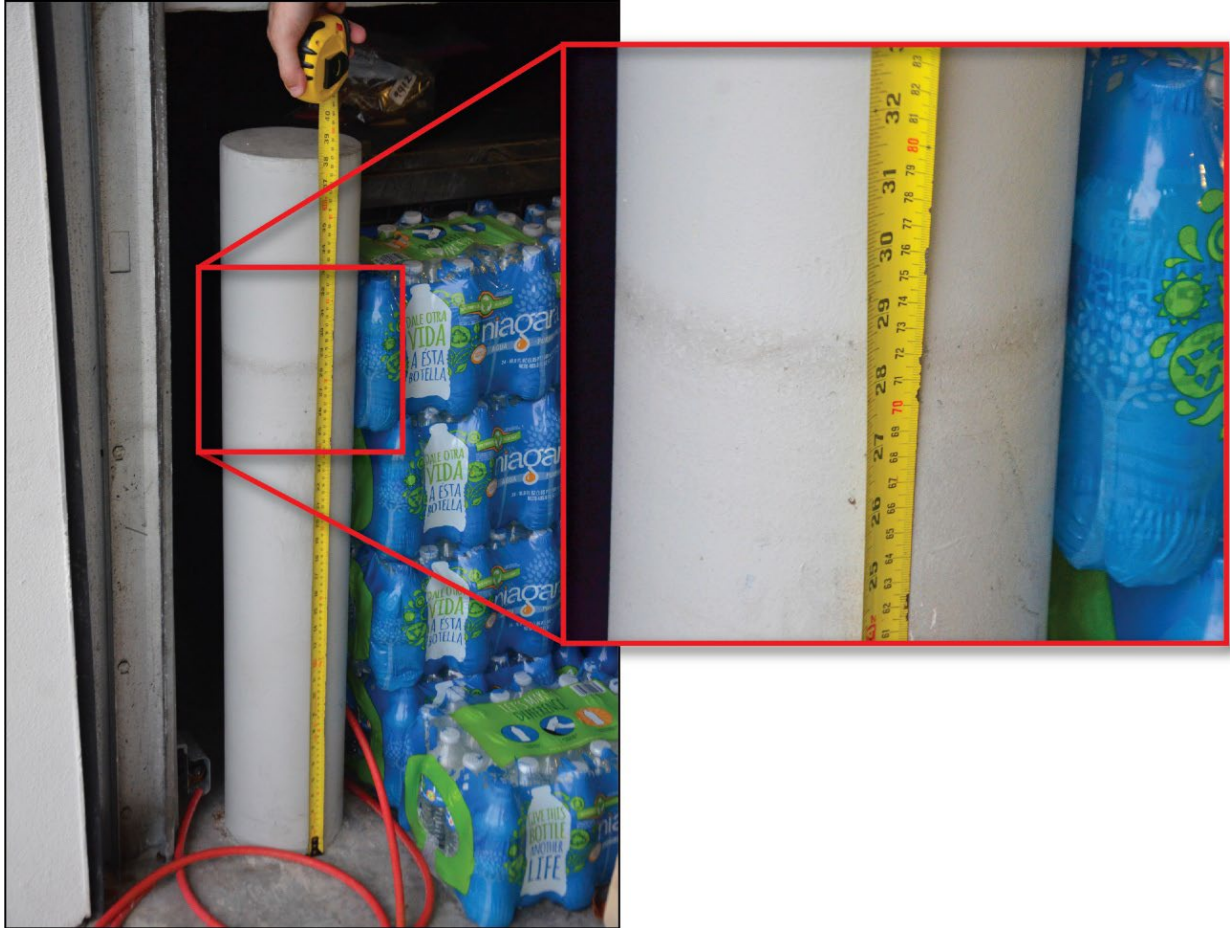
Figure 5-46: 28-inch HWM at City of Naples Fire Station #1 (Collier County, Zone AE)

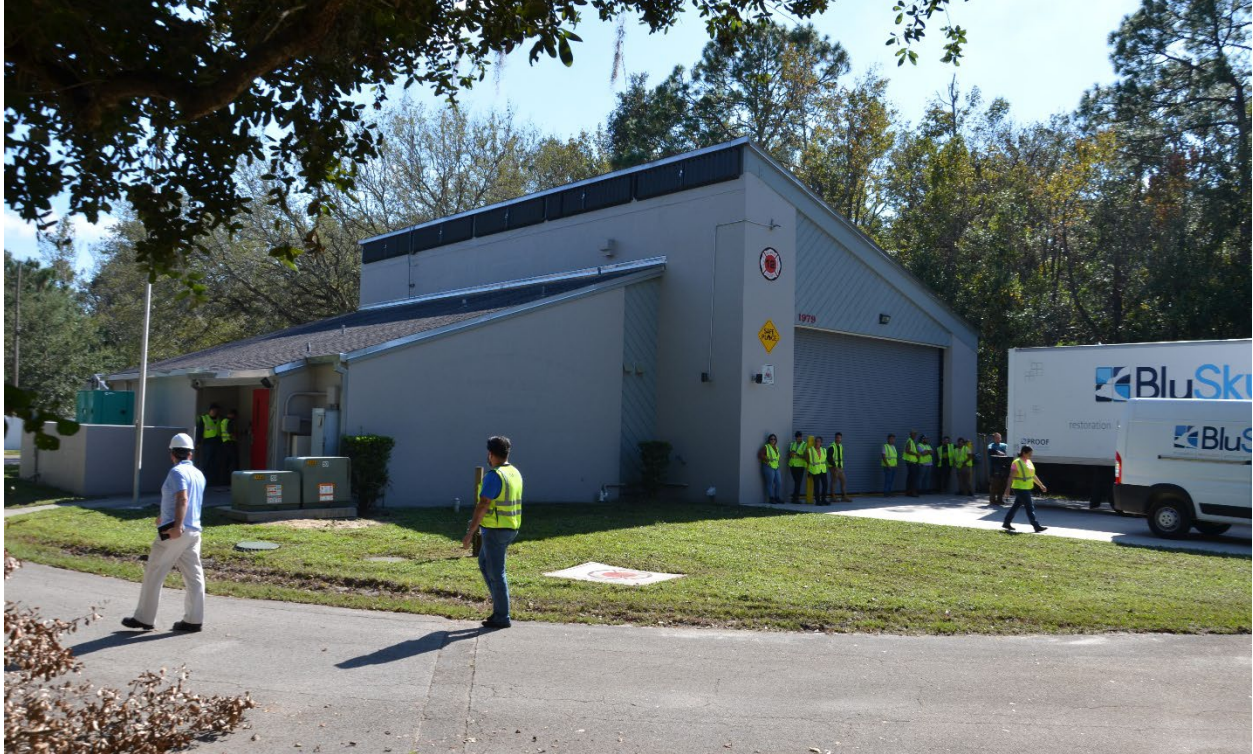
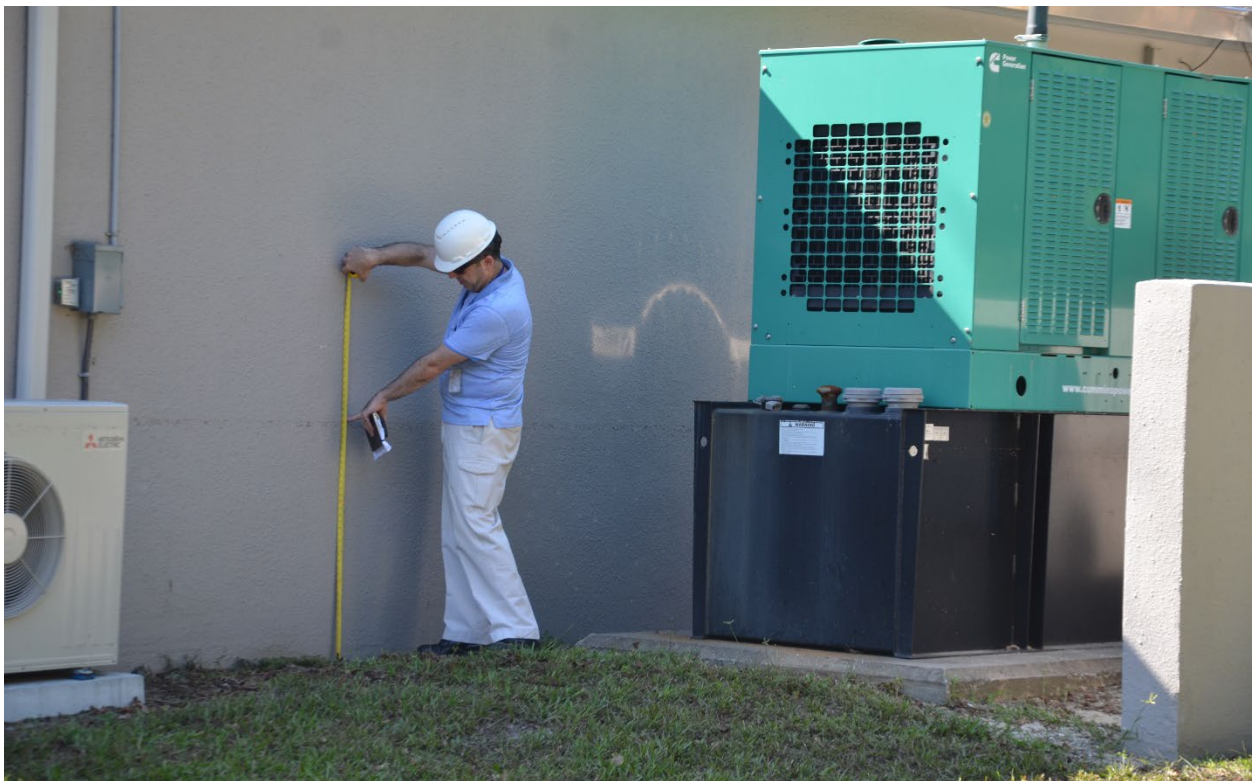
Figure 5-50: Volusia County Fire Station #12 with generator on right, elevated above Hurricane Ian floodwaters (Volusia County)

- Estimated flood depths within the fire station were 36 inches despite the fire station's location outside the SFHA.
- As a result of the flood damage to the facility, the fire station was closed and taken out of service until repairs were made. Repairs to flood damage were still being performed in June 2023.

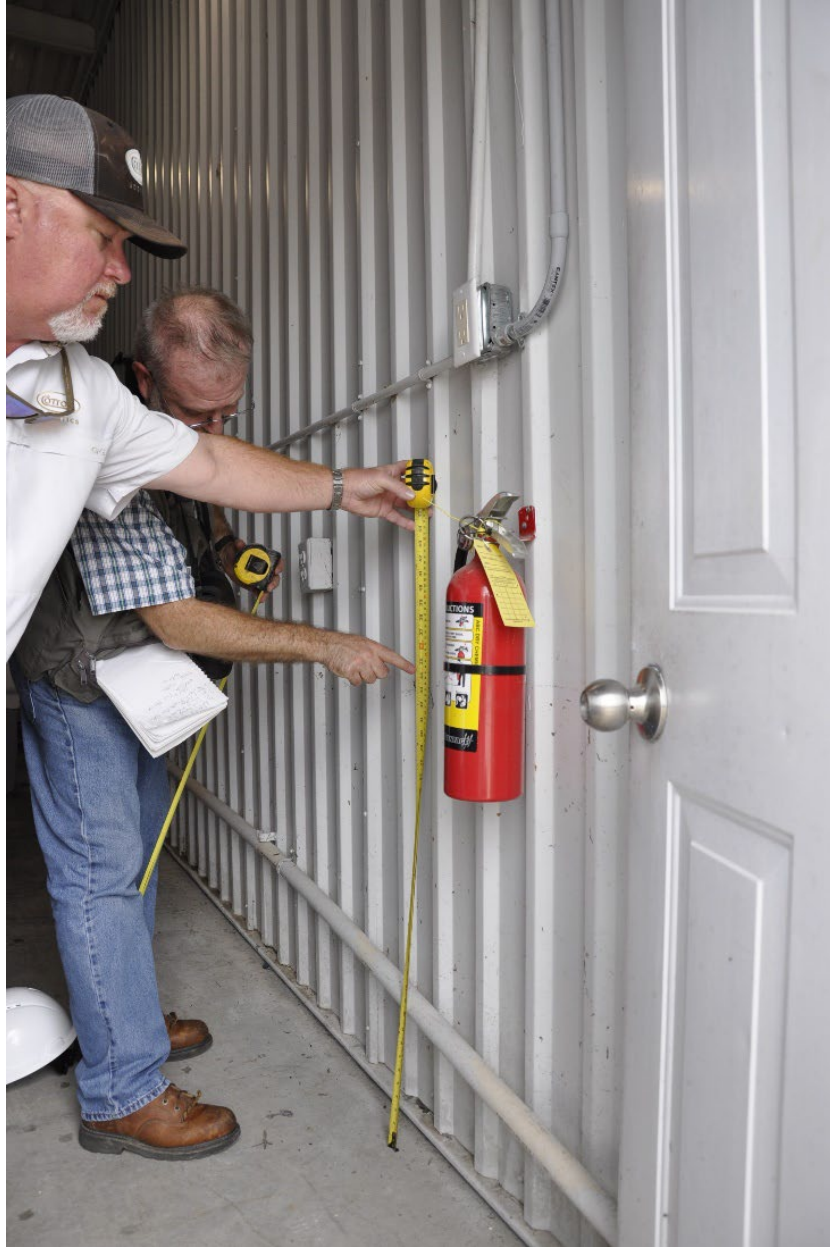
Figure 5-54: Everglades City Fire Station #60 with HWM (Collier County, Zone AE)

- Although there was no indication of structural damage to the fire station, approximately 3 feet of flooding required most interior finishings to be removed.
- After the station flooded, the fire department personnel operated from a motorhome parked adjacent to the fire station while repairs were already underway.
- The elevated generator is above the HWM and did not appear to be damaged by floodwater.

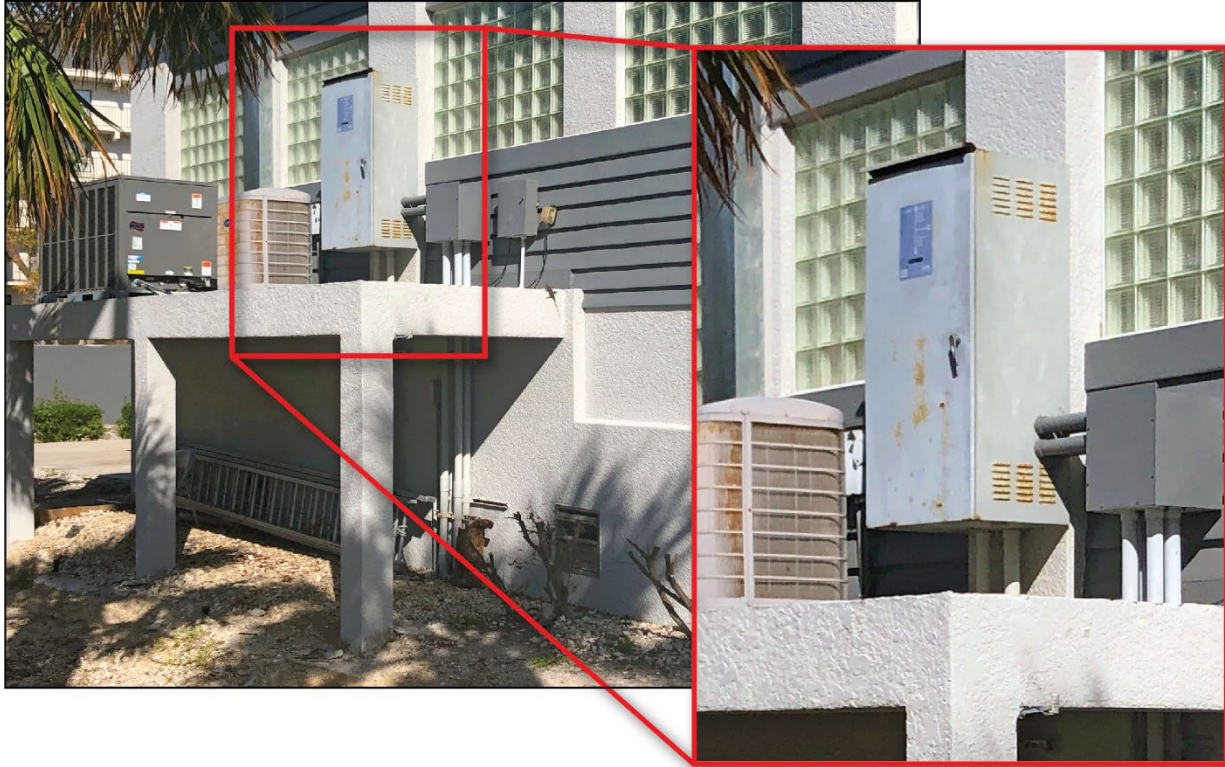
Staff also reported that the ATS for the standby generator was damaged when the wind loads forced its enclosure door to open and allowed wind-driven rain to enter (Figure 5-58). During the MAT site visit, the enclosure door was closed and latched, and no physical damage was evident to the door or its latching mechanism. The interior of the enclosure could not be observed. The ATS was not operational and could only be operated manually.

Figure 5-58: ATS damaged during Hurricane Ian (Lee County)

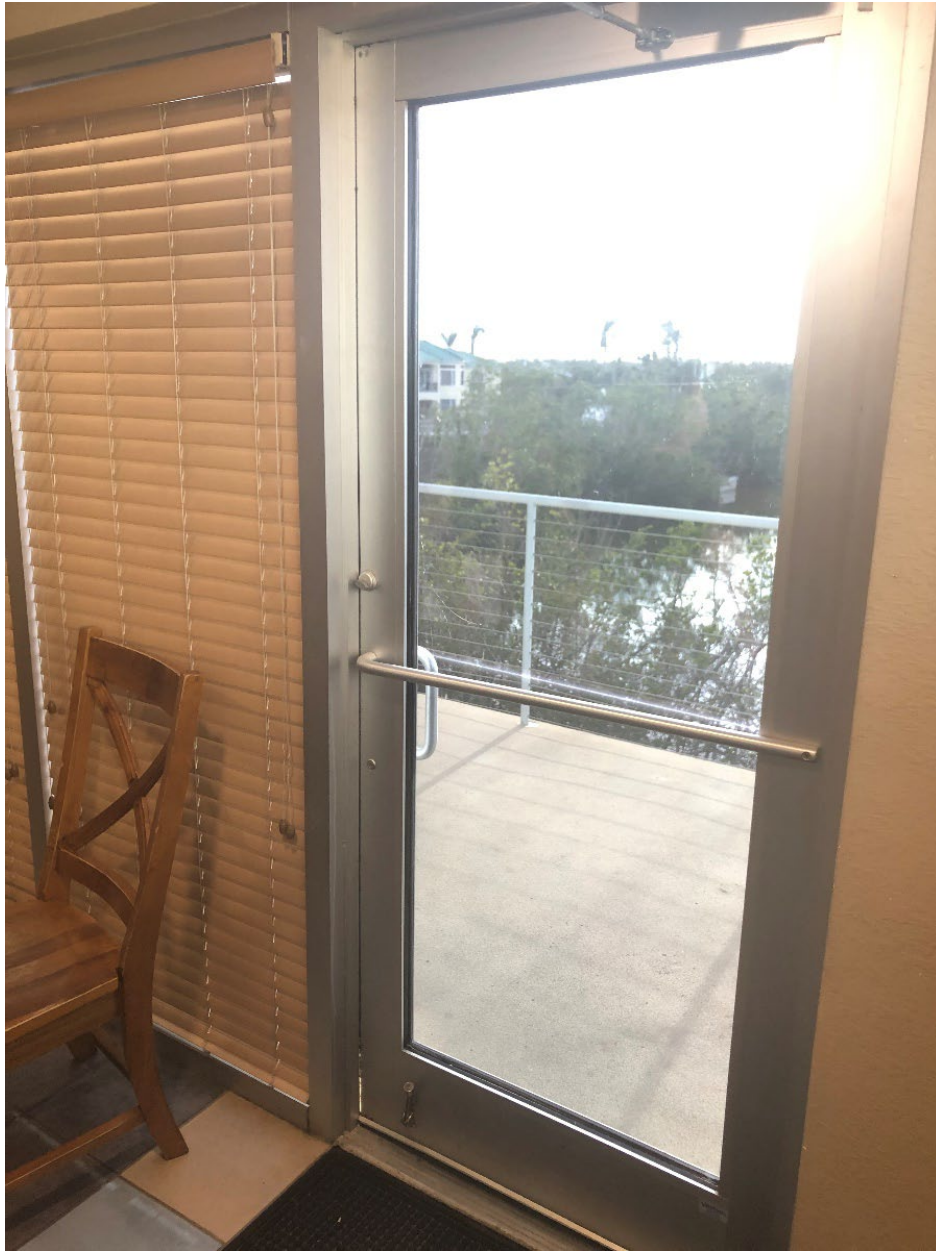
During Hurricane Ian, fire station staff reported that two exterior doors blew open. Both doors lead out onto the balcony on the right side of the building. One door accessed the balcony from the dining room (Figure 5-61); the second accessed the balcony from the corridor to the rear of the building. Both doors have three-point latches (head, threshold, and latch).

Figure 5-61: Door from dining area to balcony that blew open during Hurricane Ian (Lee County)

The cause of the doors opening during Hurricane Ian could not be determined. The documentation provided suggests that the doors are rated for positive and negative pressures of +70 and -80 psf respectively, which exceed the C&C corner zone pressures specified on the structural drawings. The relatively low wind speeds experienced during Hurricane Ian suggest that the doors may have been left unlatched inadvertently. The MAT did observe that the receiving slots in the head and threshold were significantly larger than the diameters of the corresponding latching mechanisms (Figure 5-62). This could allow the door panel to move excessively within the door frame and could contribute to a potential latch failure.

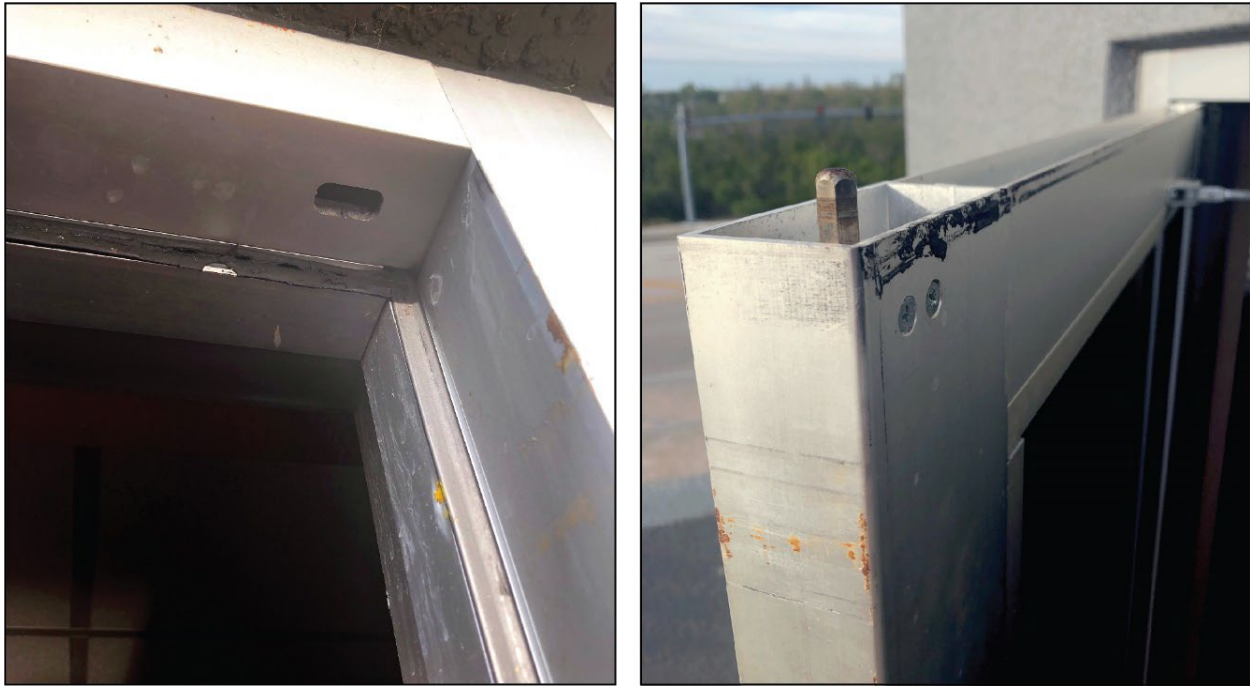
Figure 5-62: Receiving slot (left) is significantly larger than latching mechanism (right) (Lee County)

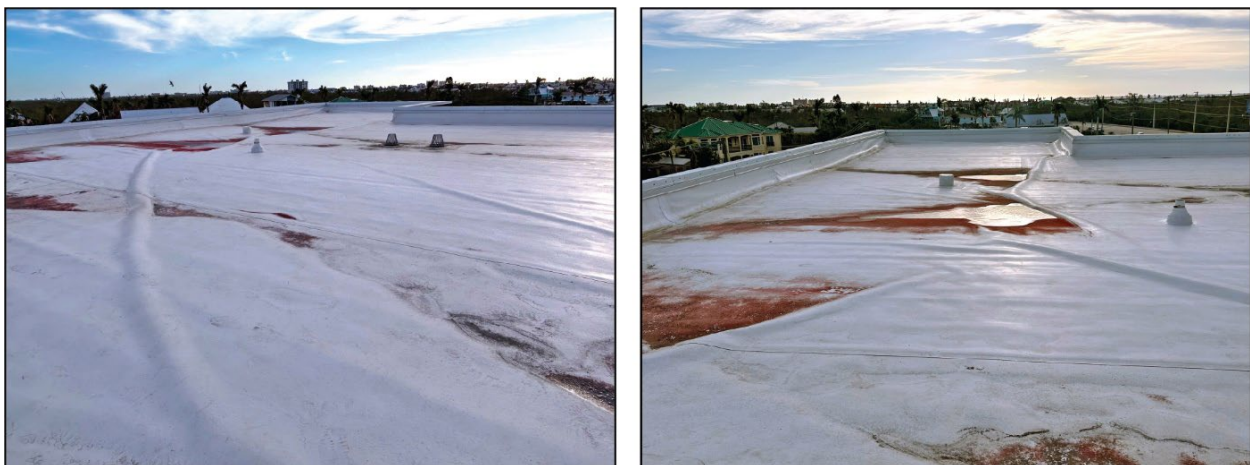
The roofs are surfaced with unballasted single-ply membranes. The membranes are not fully adhered, and within the field of the roof, no evidence of mechanical fastening was observed.

The MAT observed several vertically displaced and rippled sections of the roof membrane (Figure 5-63). Stains on the roof membrane suggest that some of the rippled sections may have existed before Hurricane Ian.

Figure 5-63: Displaced and rippled roof membrane (Lee County)

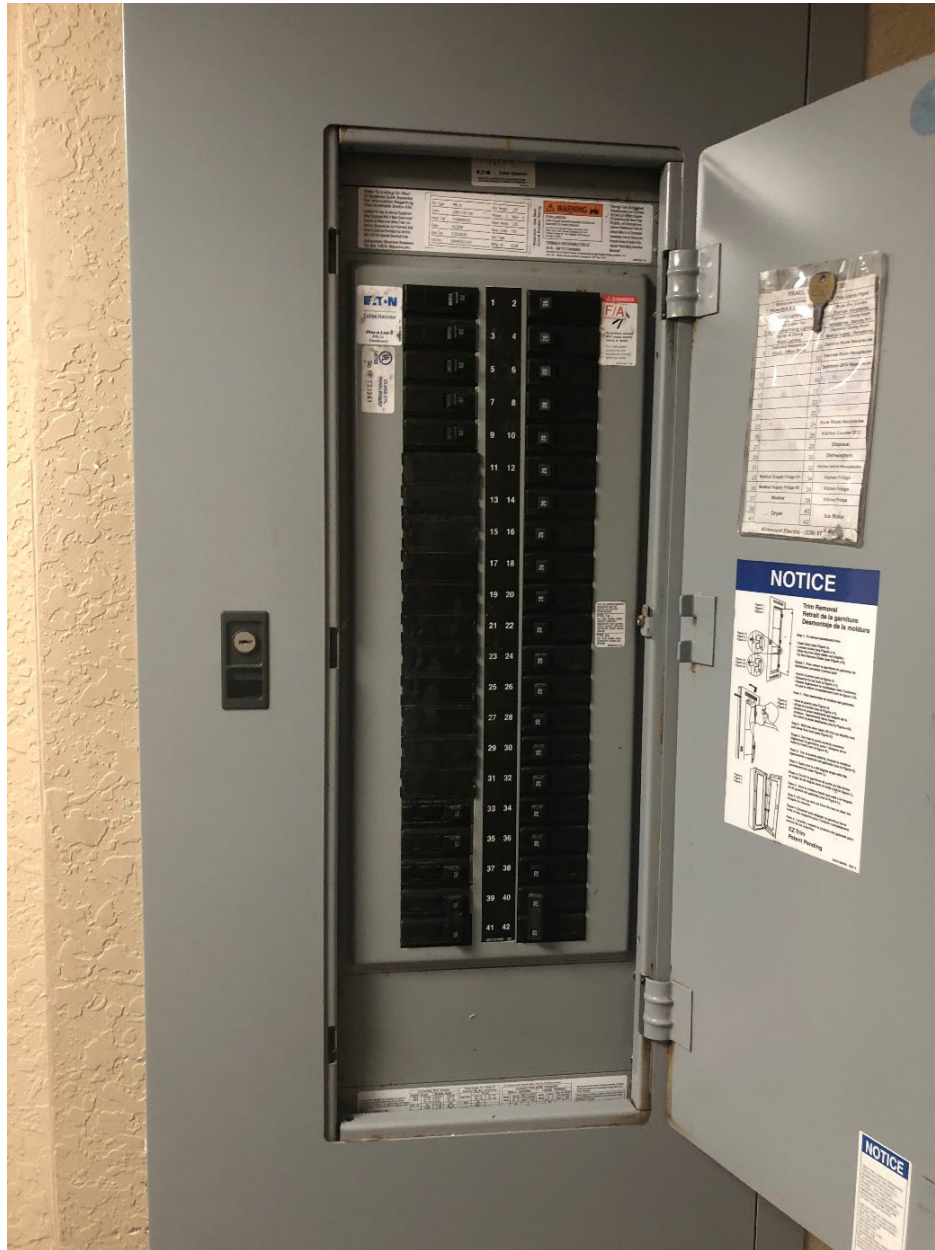
Fire station staff reported that during Hurricane Ian, water flowed into a branch circuit panelboard located on the third floor (Figure 5-64). Subsequent investigation determined that a roof cap for a

Figure 5-64: Third-floor panelboard that experienced water entry during Hurricane Ian (Lee County)

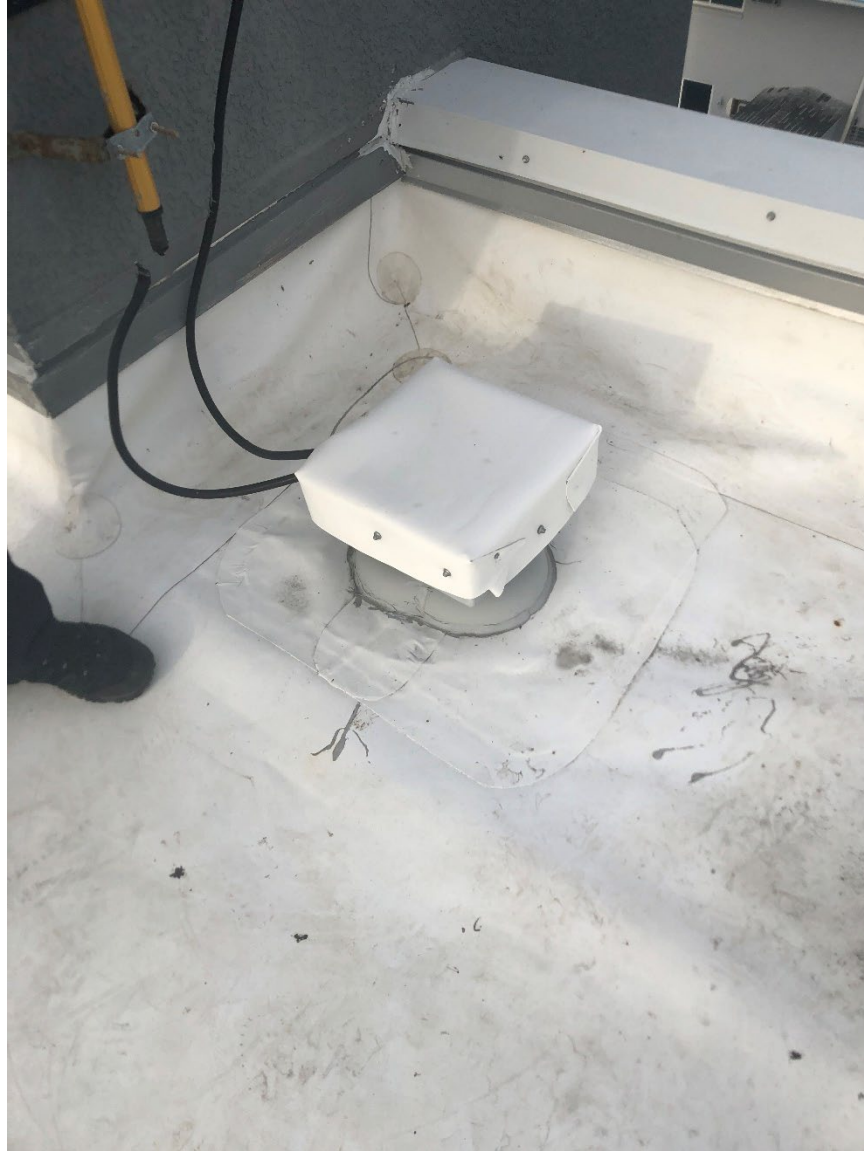
roof penetration for communication cables (Figure 5-65) dislodged during Hurricane Ian and allowed water to enter the building. The water then flowed down a grounding cable that ran toward the panelboard. By the time the MAT visited the site, the cap had been repaired.

Figure 5-65: Roof cap for communication cables that was dislodged during Hurricane Ian (Lee County)

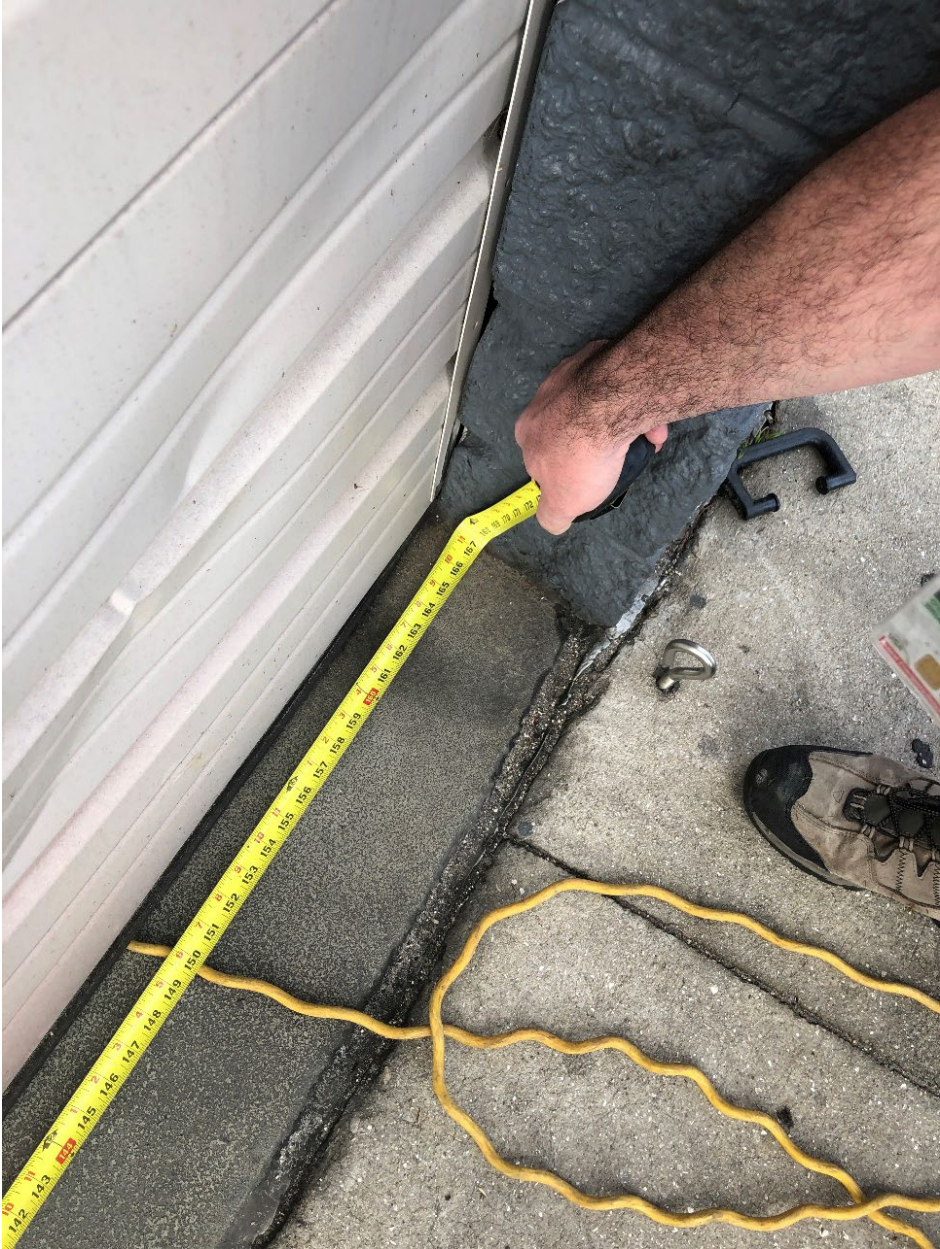
Portions of the apparatus bay doors were damaged. The damage appeared to have resulted from wind-borne debris impact. The doors are equipped with debris curtains. Whether the curtains were in place during the storm is unknown (Figure 5-70).

Figure 5-70: Damage to apparatus bay door (Charlotte County)

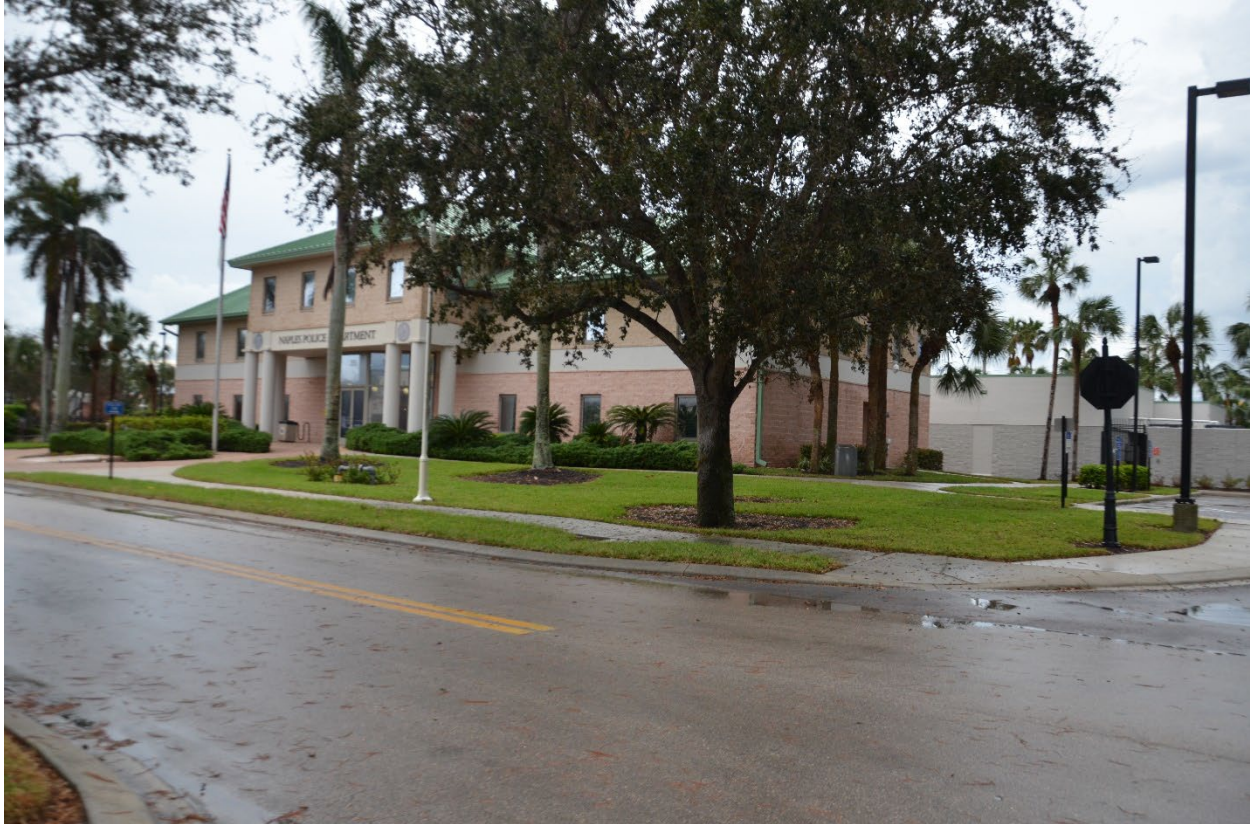
Figure 5-74: Naples Police Department with the 1999 addition in the foreground and the older 1978 structure in the background to the right (Collier County, Zone AE)

- Interior flooding caused damage to flooring, interior finishes, and contents.
- Damage forced staff to relocate away from their common areas, which affected command and control, impacting the police department's operations during and after Hurricane Ian.

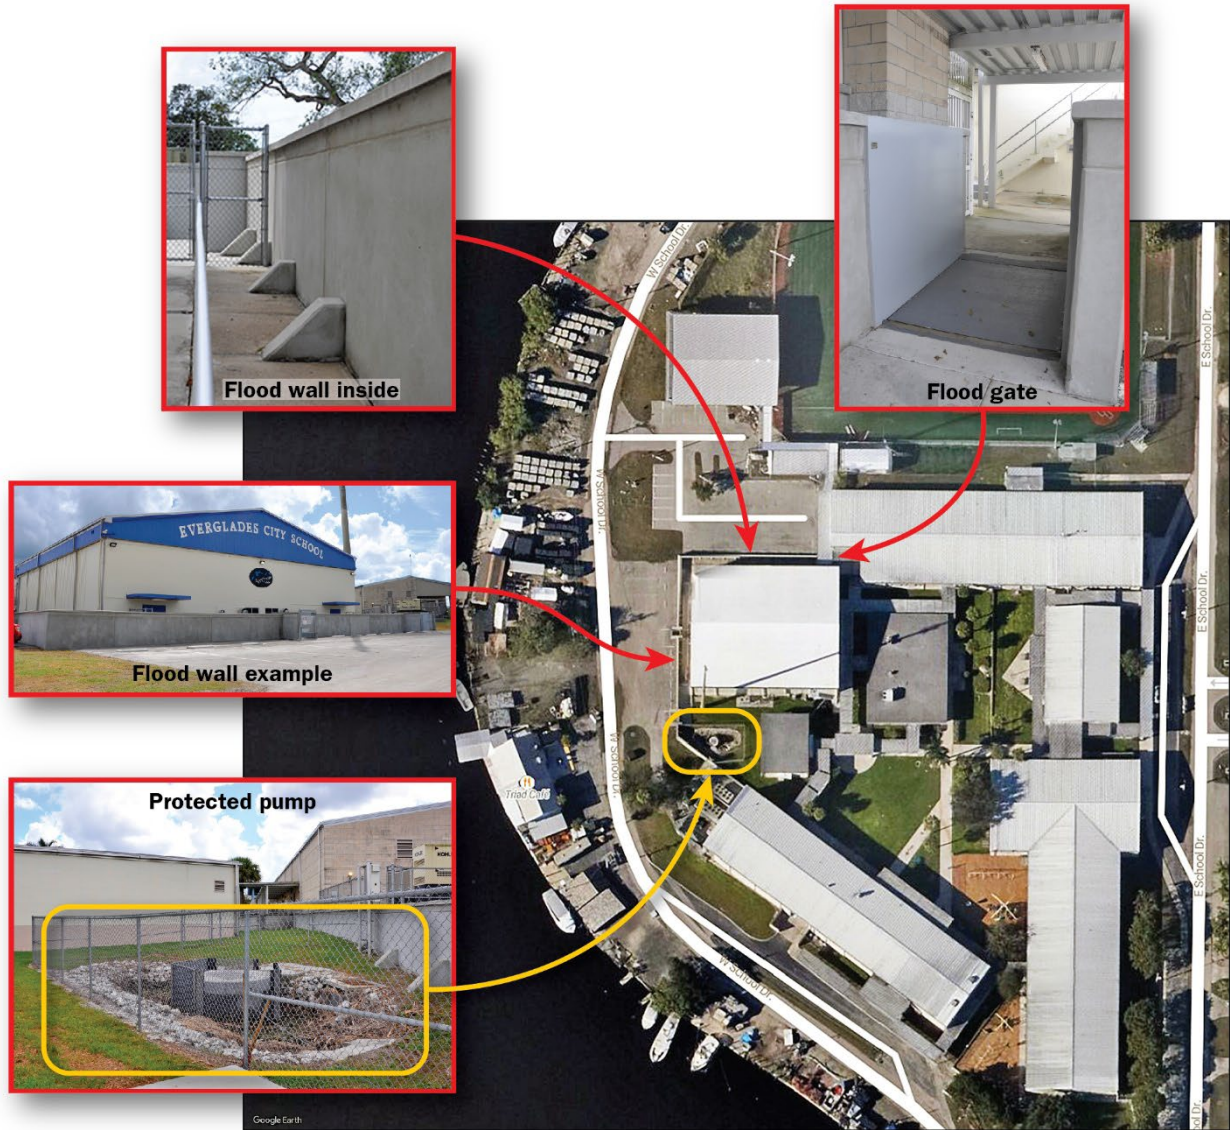
Though much of Everglades City was inundated by floodwater during Hurricane Ian, the Everglades City School did not experience any flood damage. Based on HWMs measured on the floodwall as well as security camera footage during Hurricane Ian, the floodwall system avoided the kind of damage that was experienced during Hurricane Irma (at least) as Hurricane Ian surge levels reached within a foot of the top of the floodwall (Figure 5-78). When the pre-MAT visited the school (Wednesday, October 12, 2022), the school campus was in full operation, and the administrative staff and faculty at the school could not have been happier with the performance of the mitigation measures implemented following Hurricane Irma.

Figure 5-76: Everglades City School flood protection system (Collier County, Zone AE)

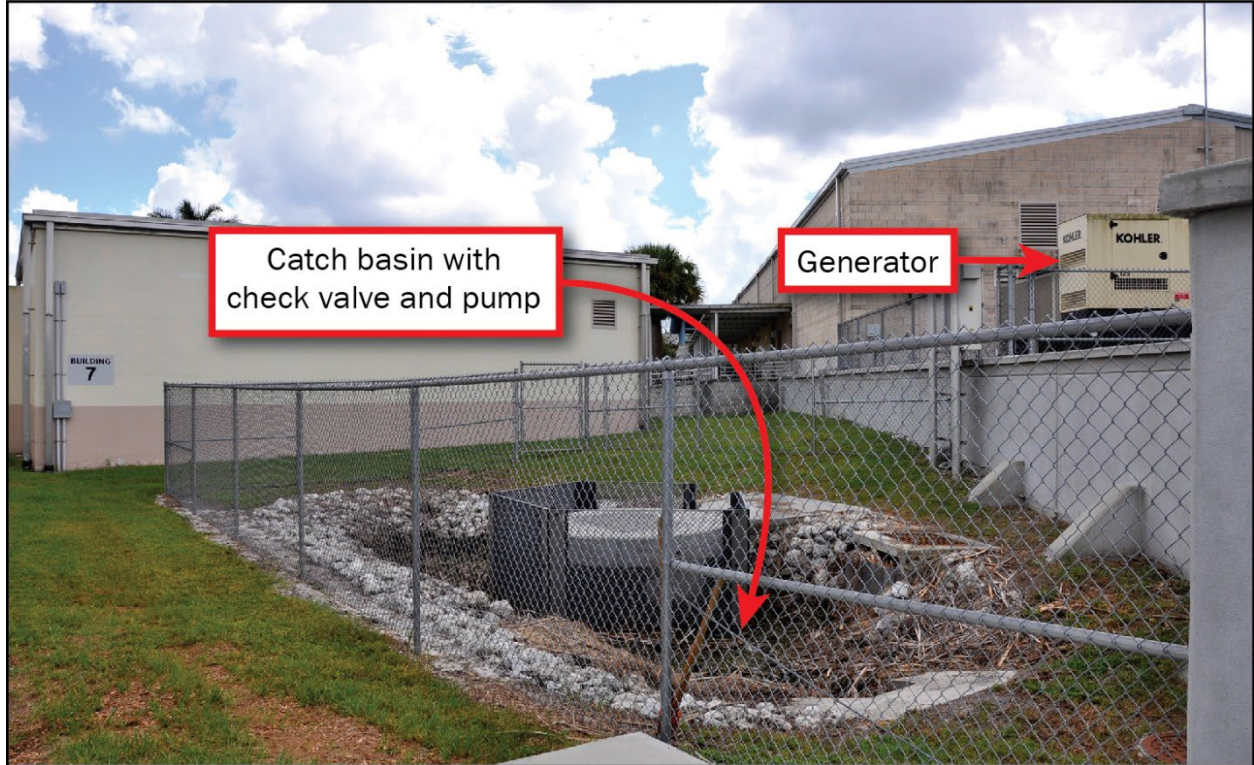
Figure 5-77: Interior perimeter drainage measures at Everglades City School (Collier County, Zone AE)
