Mitigation Assessment Team Report

Hurricane Ian in Florida

Building Performance Observations,
Recommendations, and Technical Guidance

FEMA P-2342/December 2023

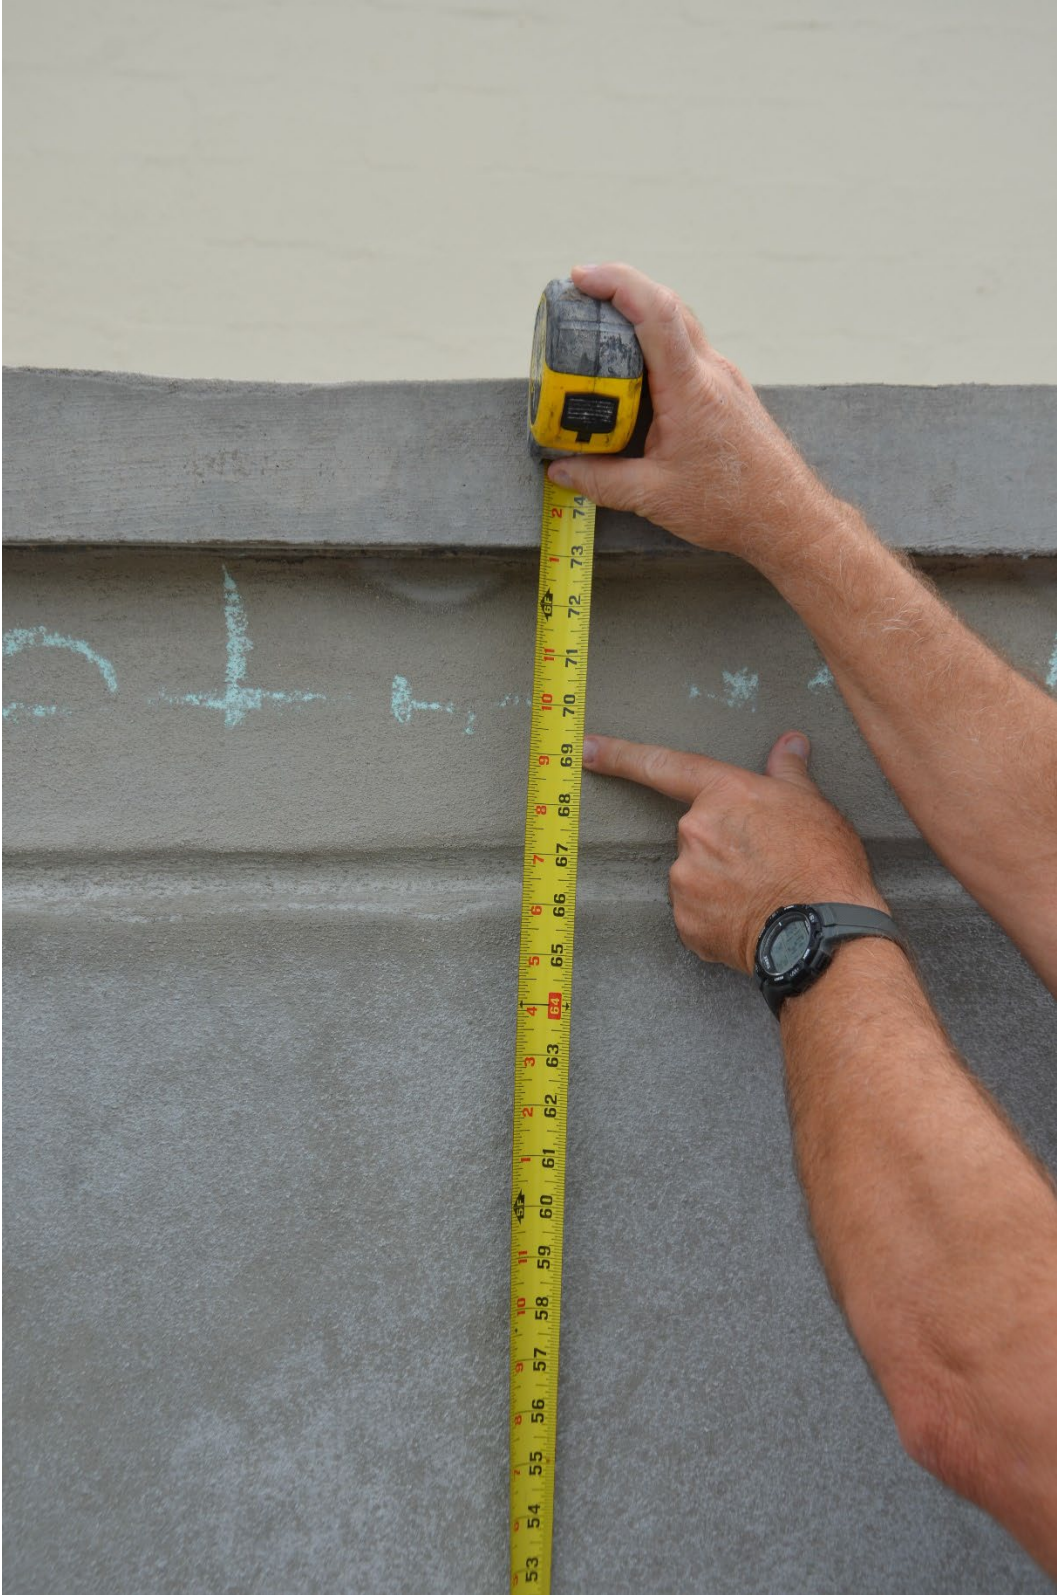
Figure 5-78: Hurricane Ian HWM along the west side of Everglades City School (Collier County, Zone AE)

- The recently installed floodwall system was a success and prevented the kind of damage that was experienced during Hurricane Irma.
- When the pre-MAT visited the school (Wednesday, October 12, 2022), the school campus was in full operation.

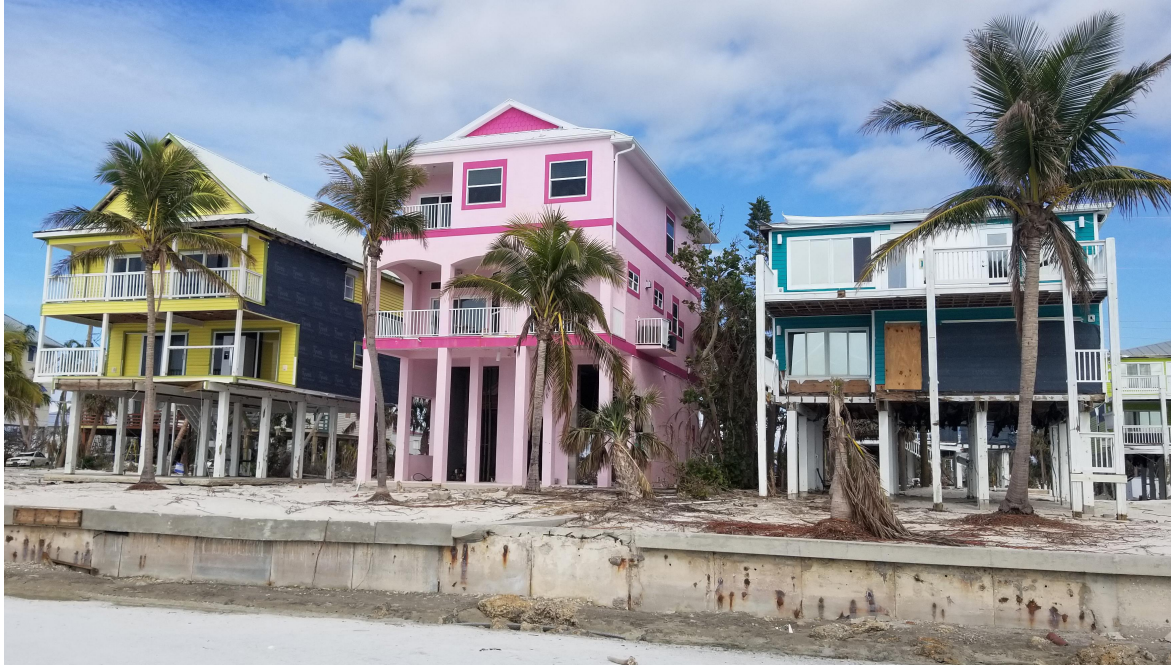
Figure 1: Three neighboring buildings with varying degrees of elevation and damage on Fort Myers Beach, Florida, after Hurricane Ian. The right-most building has the lowest elevation of the three and the most damage to the lower levels, whereas the middle building has the highest elevation and minimal damage to the lower levels.

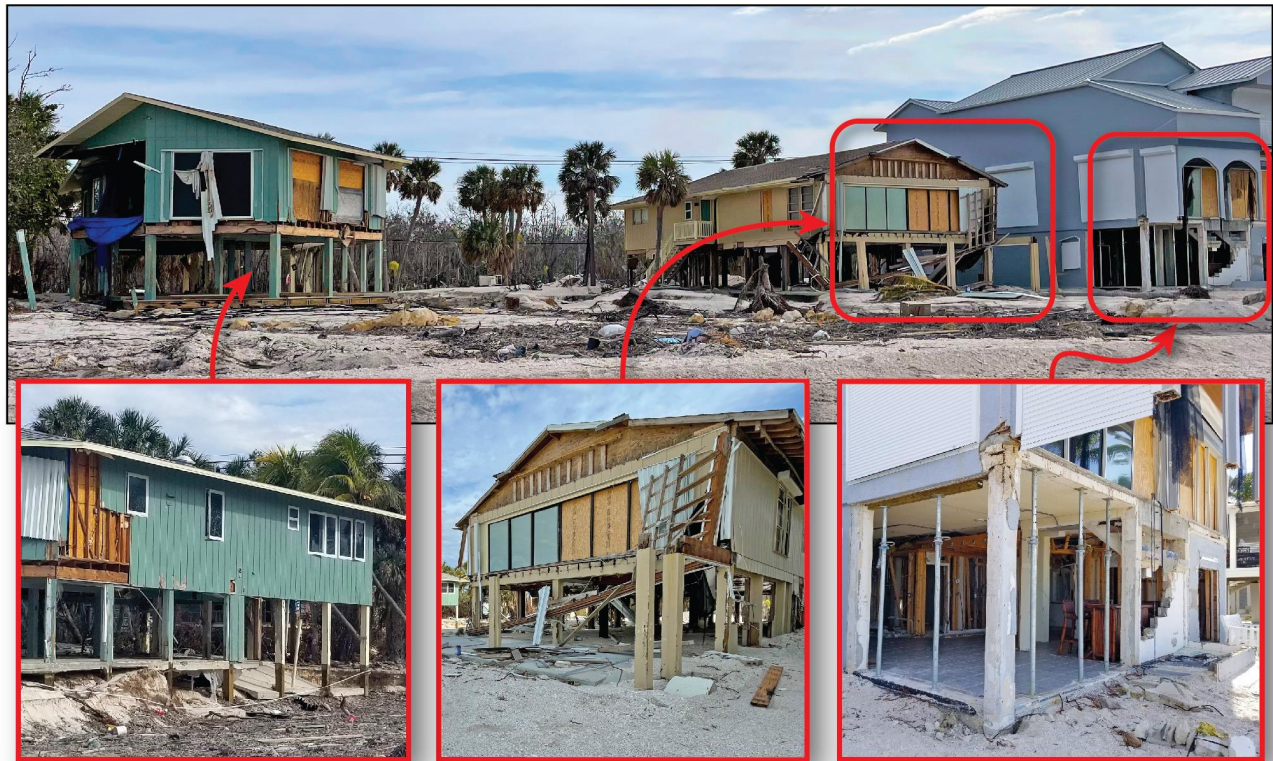
Figure 2: Image (top) shows waterfront houses damaged by coastal flood effects such as waves and velocity in Bonita Springs, Florida. Image (bottom left) shows siding damage above the lowest floor and significant scour, image (bottom center) shows complete loss of a deck as well as damage to glass doors, image (bottom right) shows structural damage to a concrete column and complete loss of a porch.

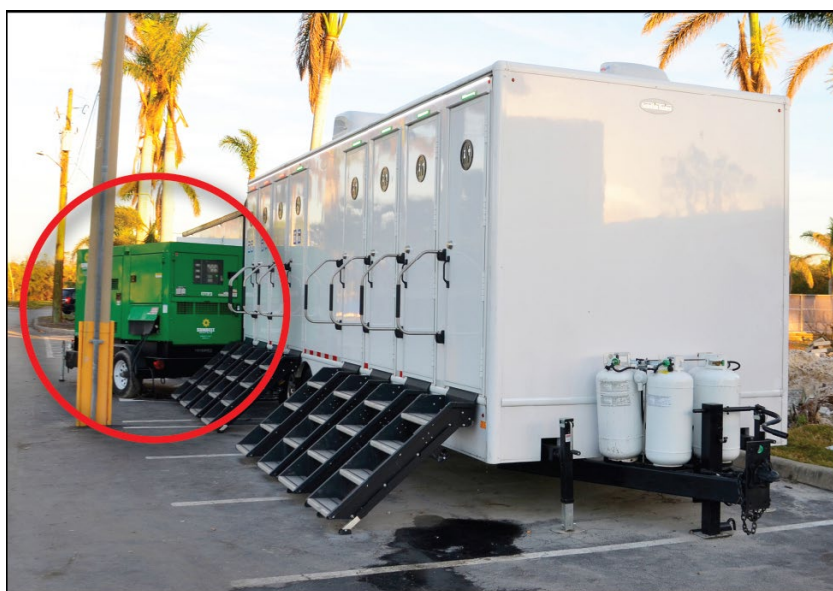
Portable water closets, handwashing stations, showers, or laundry units can be purchased or rented. Figure 4 shows an example of an eight-station shower trailer providing services to a heavily damaged area of Florida following Hurricane Ian. Power for the trailer is supplied by a portable generator, circled within Figure 4, and hot water is provided by an LP on-demand water heater with propane tanks, located on the “tongue” or front of the trailer. The trailer features a mechanical room (not shown in the photo) with a water tank. A waste holding tank stores the graywater. Maintenance of this trailer includes refilling of the propane tanks and water tank, and disposal of the waste holding tank.

Figure 4: Example of portable shower trailer in Port Carlos Cove, FL

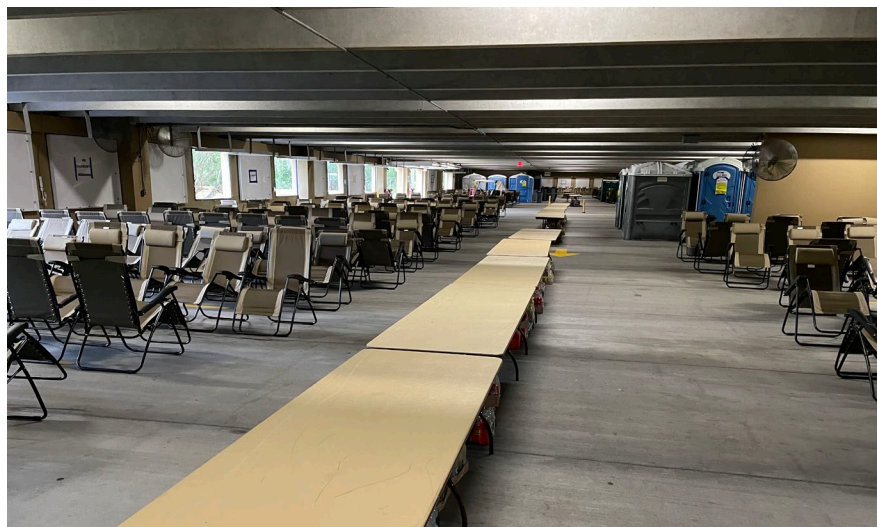
The Hurricane Ian Mitigation Assessment Team (MAT) visited a parking garage at a retirement community that deployed portable water closets for community residents prior to activation of the facility as an HES (Figure 5). The Team also visited several shelters and hospitals that brought in portable water closets, showers, and/or laundry units after the hurricane made landfall, once the facilities were accessible. These portable systems are an option to enable continued facility functionality during utility outages. Contracting with a portable sanitation company well in advance of an event will lessen supply challenges, which are often exacerbated given the high demand for these portable units following an event.

Figure 5: Example of portable water closets for use in a garage that was converted into an HES

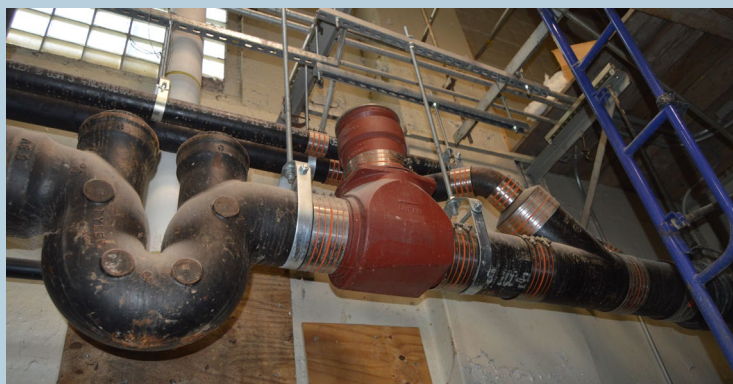
Figure 6: Example Backflow Preventor for sewer lateral

To prevent raw sewage from flowing into a building, some type of check valve or backflow preventer (**Figure 6**) can often be installed to prevent floodwaters from pressurizing the system and entering the building. To mitigate the potential pressurization in the sanitary sewer system from floodwaters, an ejector pump can be installed to force the raw sewage past the backflow prevention device.

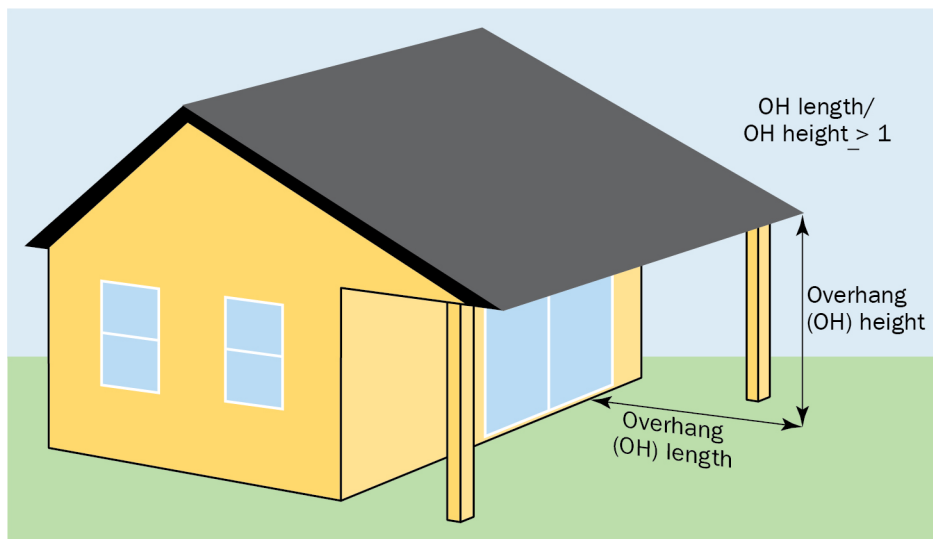
The overhang exception, shown in Figure 3, applies where the length of the overhang is greater than or equal to the overhang height (OH ratio equal to or greater than 1). While the overhang exception may provide sufficient protection in areas outside hurricane-prone regions, it will not protect doors from the wind-driven horizontal rain that commonly occurs during hurricanes.

Figure 3: Overhang exception to water penetration testing for doors in the FBCB and FBCR.

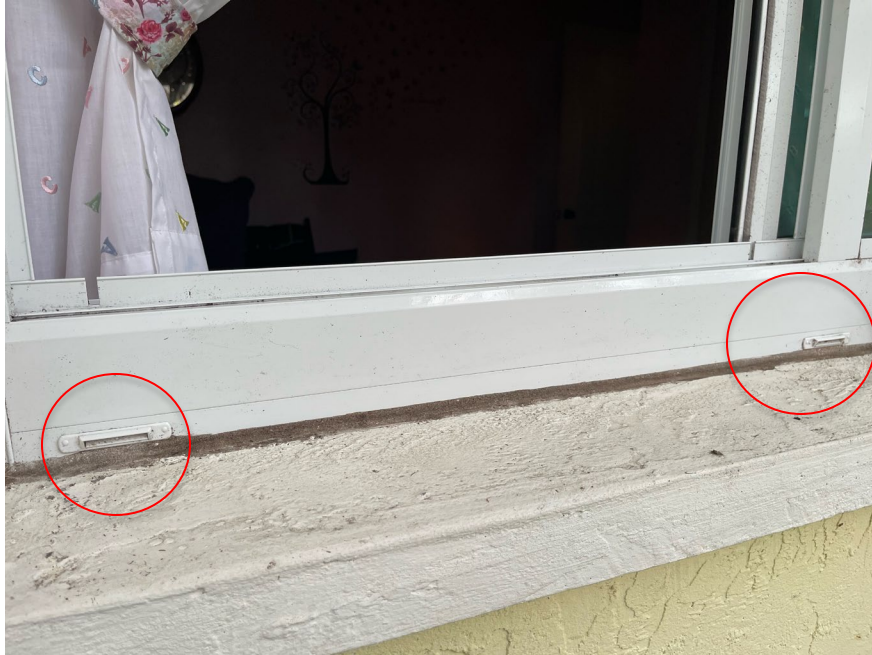
Figure 8: Typical drainage weepholes (red circles). Photo used with permission.

Periodically inspect drainage openings (weep holes). As discussed previously in this Recovery Advisory, drainage holes are a key element of “contain and drain” products and should not be covered or plugged with caulk. They must be kept clean and free of debris to allow water that gets in the product to drain to the exterior of the building as shown in Figure 8.

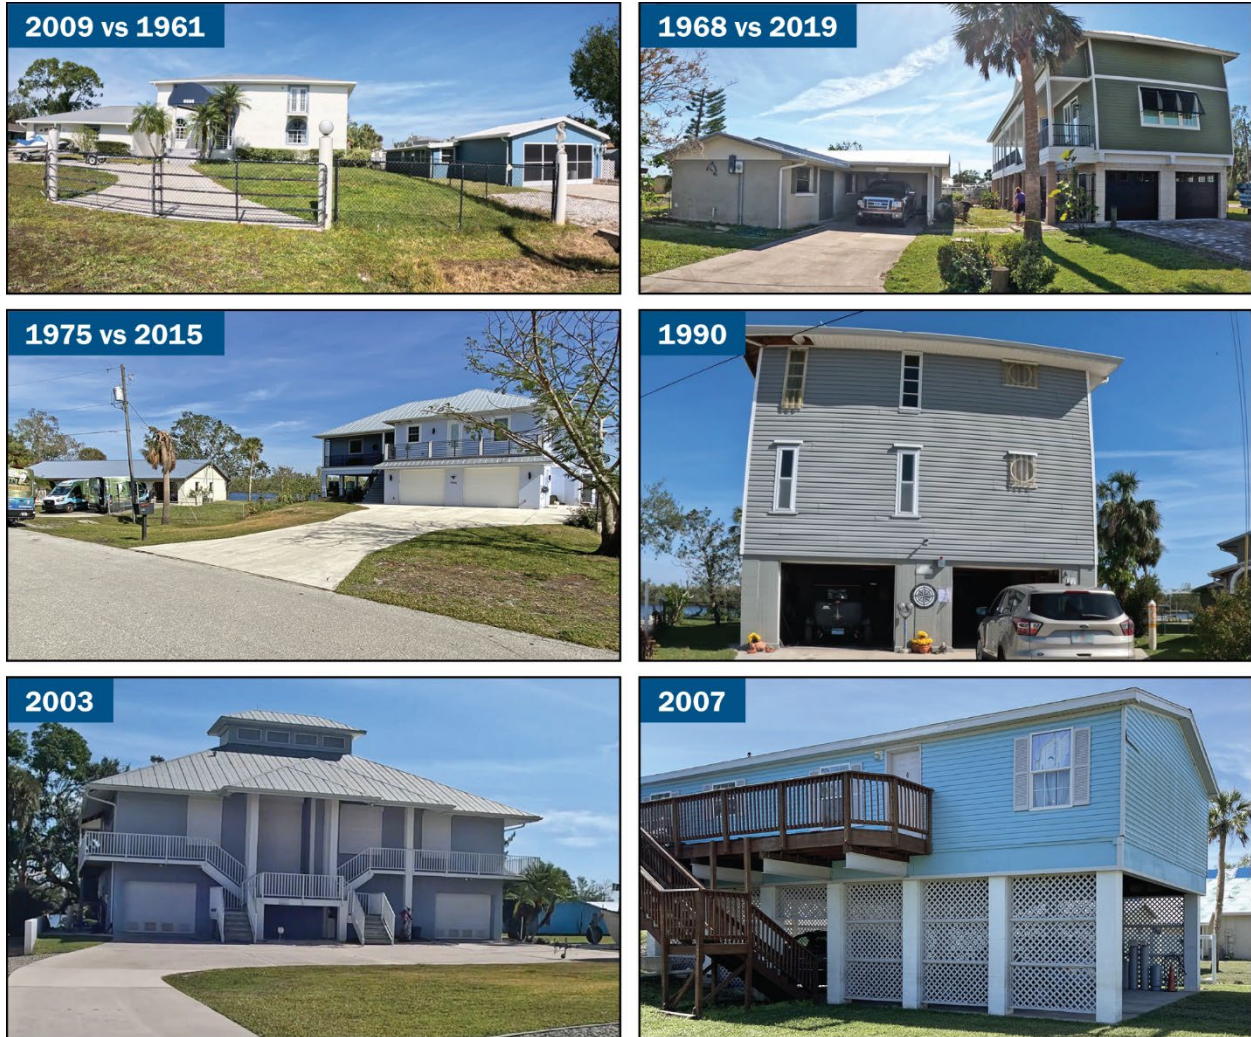
The houses in this area are predominantly non-elevated; in rare circumstances where the houses are elevated, areas below the lowest floor are enclosed (either partially or fully). Although no HWMs were identified by the MAT in the vicinity of this neighborhood, estimated flood levels were approximately 4 feet in older slab-on-grade houses based on interviews with homeowners during site visits. No major structural damage was observed; damage was predominantly related to interior walls and finishes, which had been or were being removed. Figure 4 provides examples of representative single-family houses within Area of Interest No. 1.

Figure 4: Representative single-family houses in Area of Interest No. 1 from 1961 to 2019

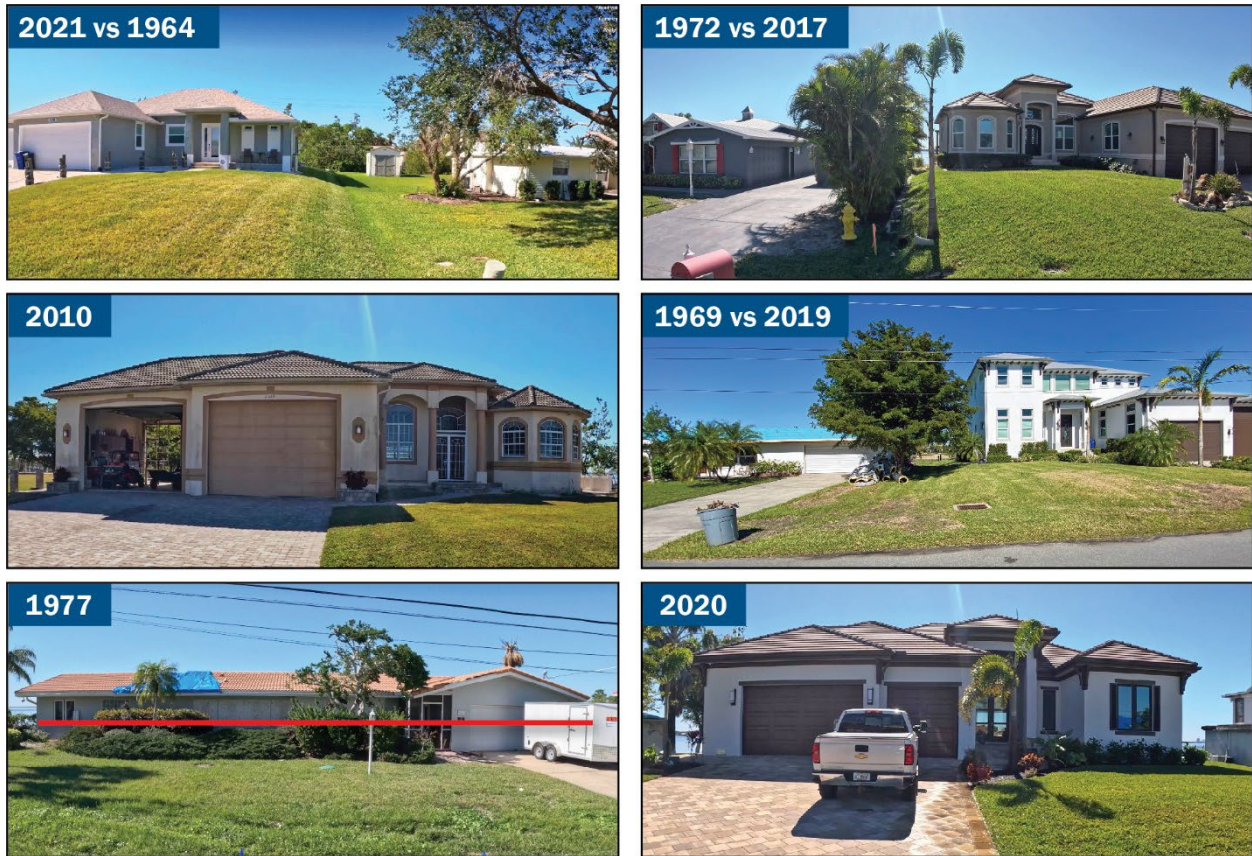
Most houses in this area are built on fill, with newer post-FIRM construction built to the required elevation at the time of construction. The elevation of older slab-on-grade houses is approximately 5 feet NAVD 88 based on recordings from surveyors embedded with the MAT; estimated flood depths in older houses were approximately 3 feet. No major structural damage was observed, damage was predominantly related to interior walls and finishes, which had been or were being removed. Figure 6 provides examples of representative single-family houses within Area of Interest No. 2.

Figure 6: Representative single-family houses in Area of Interest No. 2 from the 1960s to 2020

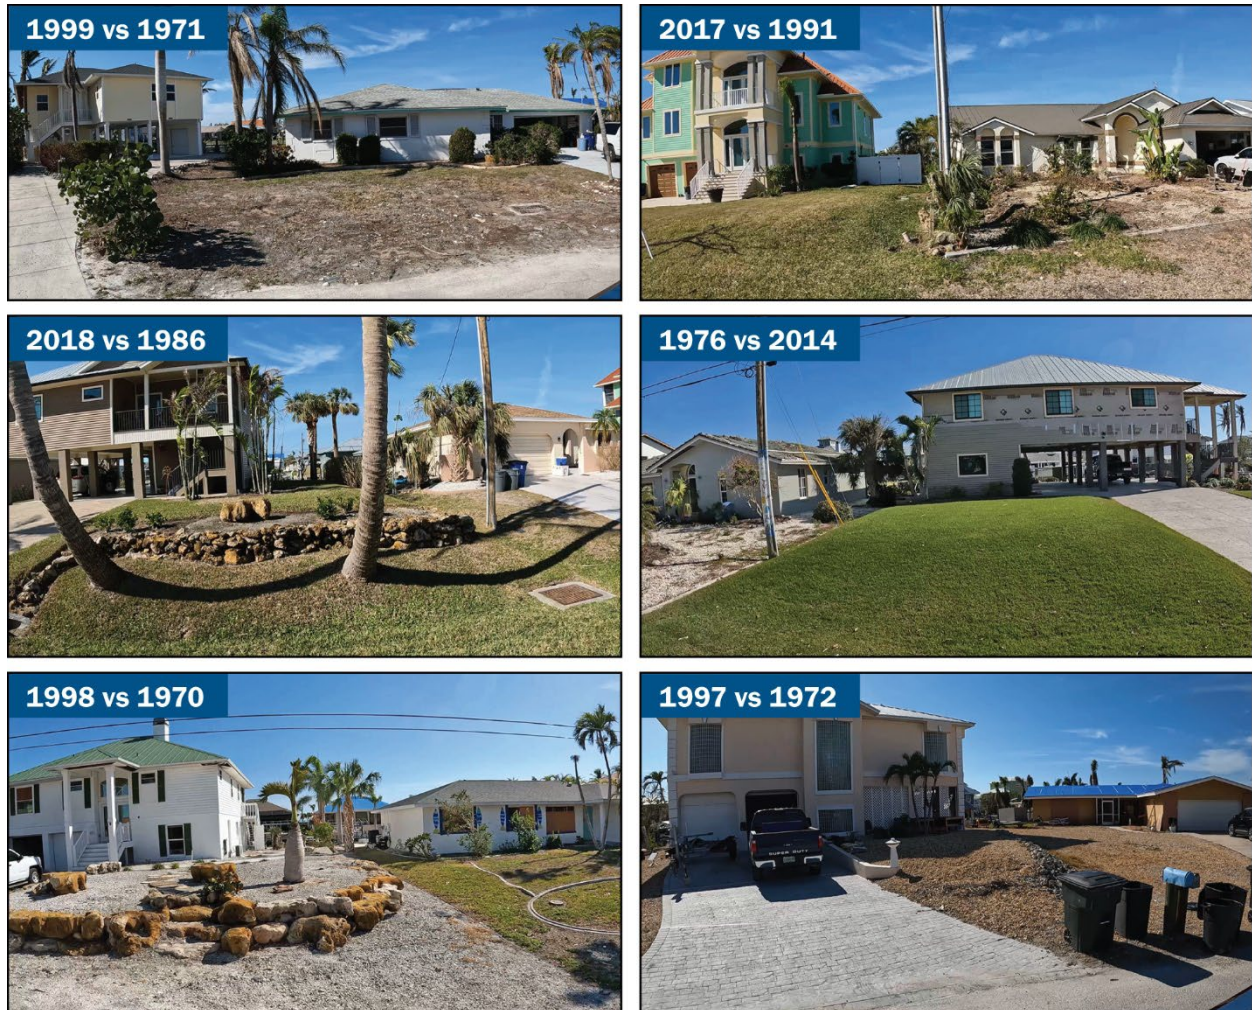
The houses in this area are a relatively even mixture of *elevated* and *non-elevated buildings*, with a slightly higher percentage of *non-elevated buildings*. Areas below the lowest floor are enclosed (either partially or fully) in two-thirds to three-quarters of the *elevated buildings*. No major structural damage was observed; damage was predominantly related to interior walls and finishes, which had been or were being removed. During site visits, homeowners reported 3 feet of water in non-elevated houses as well as in enclosures, including garages below the lowest floor of elevated houses. Relative to the other 11 Areas of Interest, this area is closest to the hurricane track and houses had noticeable wind damage as well. Figure 8 provides examples of representative single-family houses within Area of Interest No. 3.

Figure 8: Representative single-family houses in Area of Interest No. 3 from 1971 to 2018

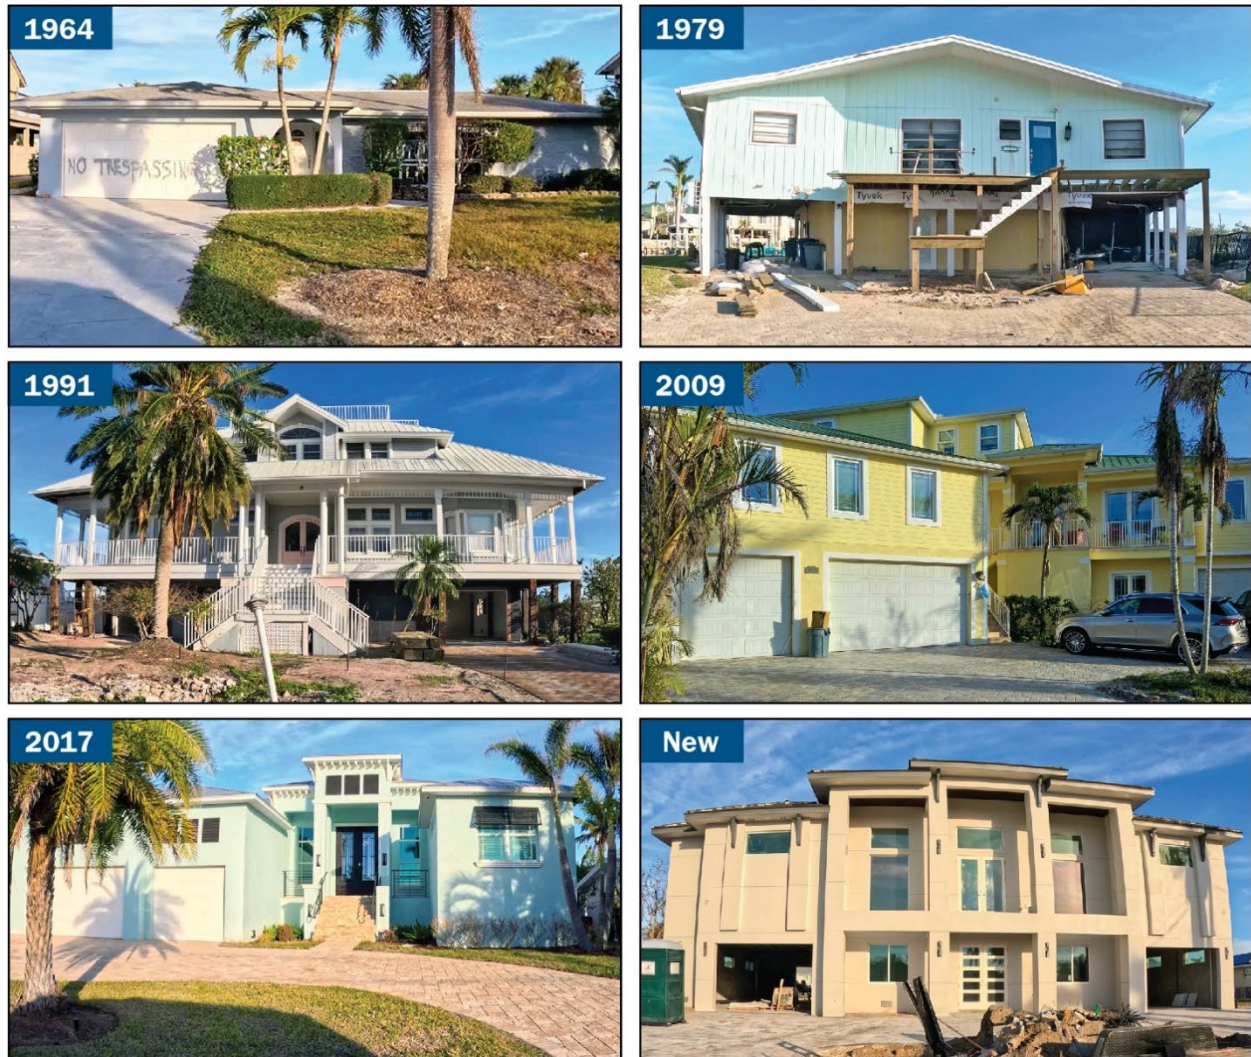
Figure 10: Representative single-family houses in Area of Interest No. 4 from the 1960s to present

Conditions in this area during Hurricane Ian included inundation from surge with some evidence of velocity and wave action, including boats and other flood-borne debris impacting buildings. Ground elevations generally ranged from 4 to 6 feet NAVD 88, and homeowners reported flood depths of 6 to 8 feet of water in their ground floors/enclosures. As a note, most *elevated buildings* throughout the area had enclosures. In addition, more than 60% of the houses (106 of 171) had an active flood insurance policy, and the distribution of the age of construction for these insured houses was relatively consistent with the entire area. The MAT Survey Team was able to collect some representative elevations including garage, lowest floor, and mechanical equipment along the eastern most street; non-elevated houses were estimated at 6 feet NAVD 88, and the lowest floor elevations in *elevated buildings* were 11 feet NAVD

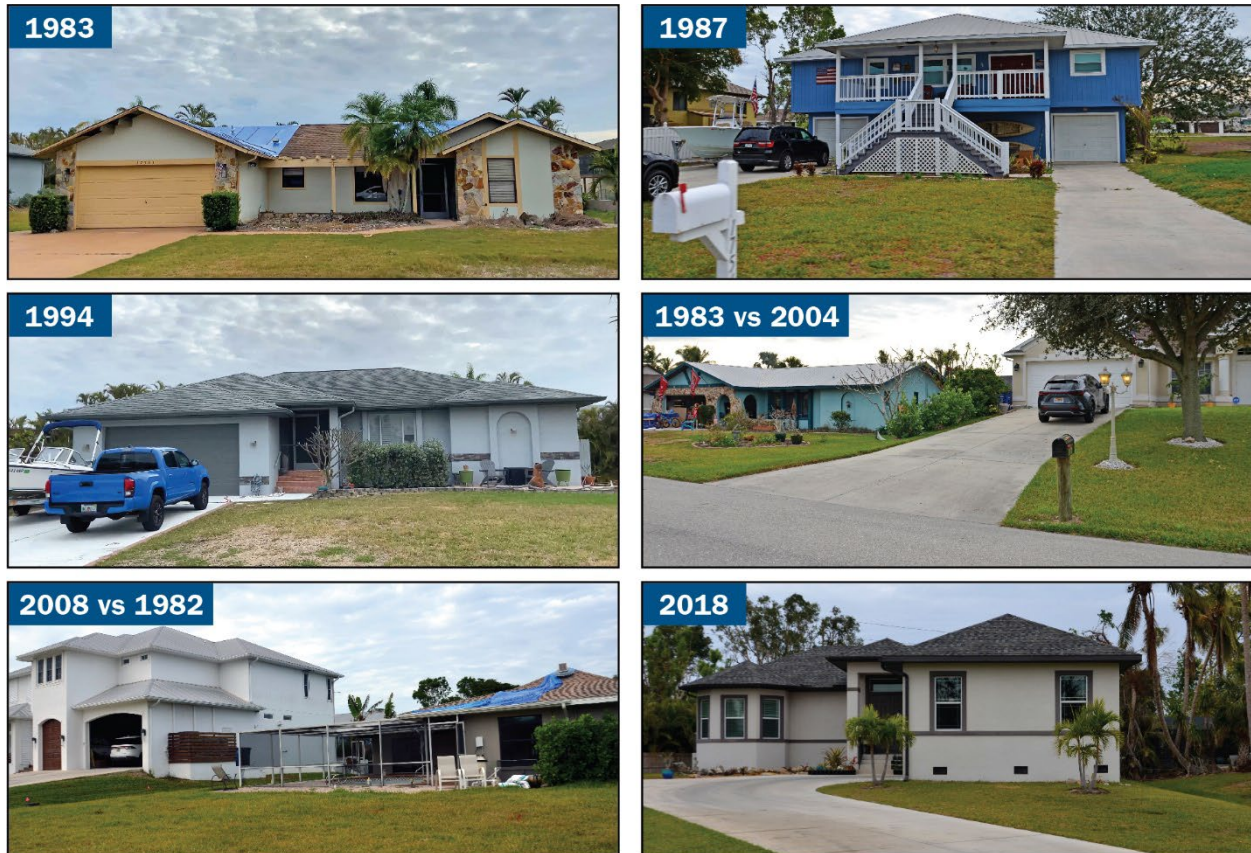
Figure 13: Representative single-family houses in Area of Interest No. 5 from the 1980s to present

Non-elevated buildings had extensive interior damage, whereas damage to *elevated buildings* varied based on the amount elevated and the use flood damage-resistant materials in enclosures. Building performance in this subdivision was generally as expected with newer *elevated buildings* having considerably less damage than older *non-elevated buildings*. Considering the HWM is equal to the BFE (10 feet NAVD 88) in this area, a primary differentiator was whether or not the building was constructed to exceed the NFIP minimum elevation requirement. The policy data across the 103 buildings with policies in this area, a 65% insurance take up rate, was consistent with the observations in the field. The average building claims for houses built after 1990 are about half those built in the 1980s and building claims for the limited number of *elevated buildings* are about half those for *non-elevated buildings*, which is the predominant building type in this area. Table 31 through Table 35 provide the number of houses built by decade, the number of insured buildings, and a summary of NFIP building and contents claims by decade as well as by building type (elevated vs non-elevated). The percentages in Table 31 are intended to help illustrate how similar the distribution of buildings built by decade is compared to the distribution of policies by decade.

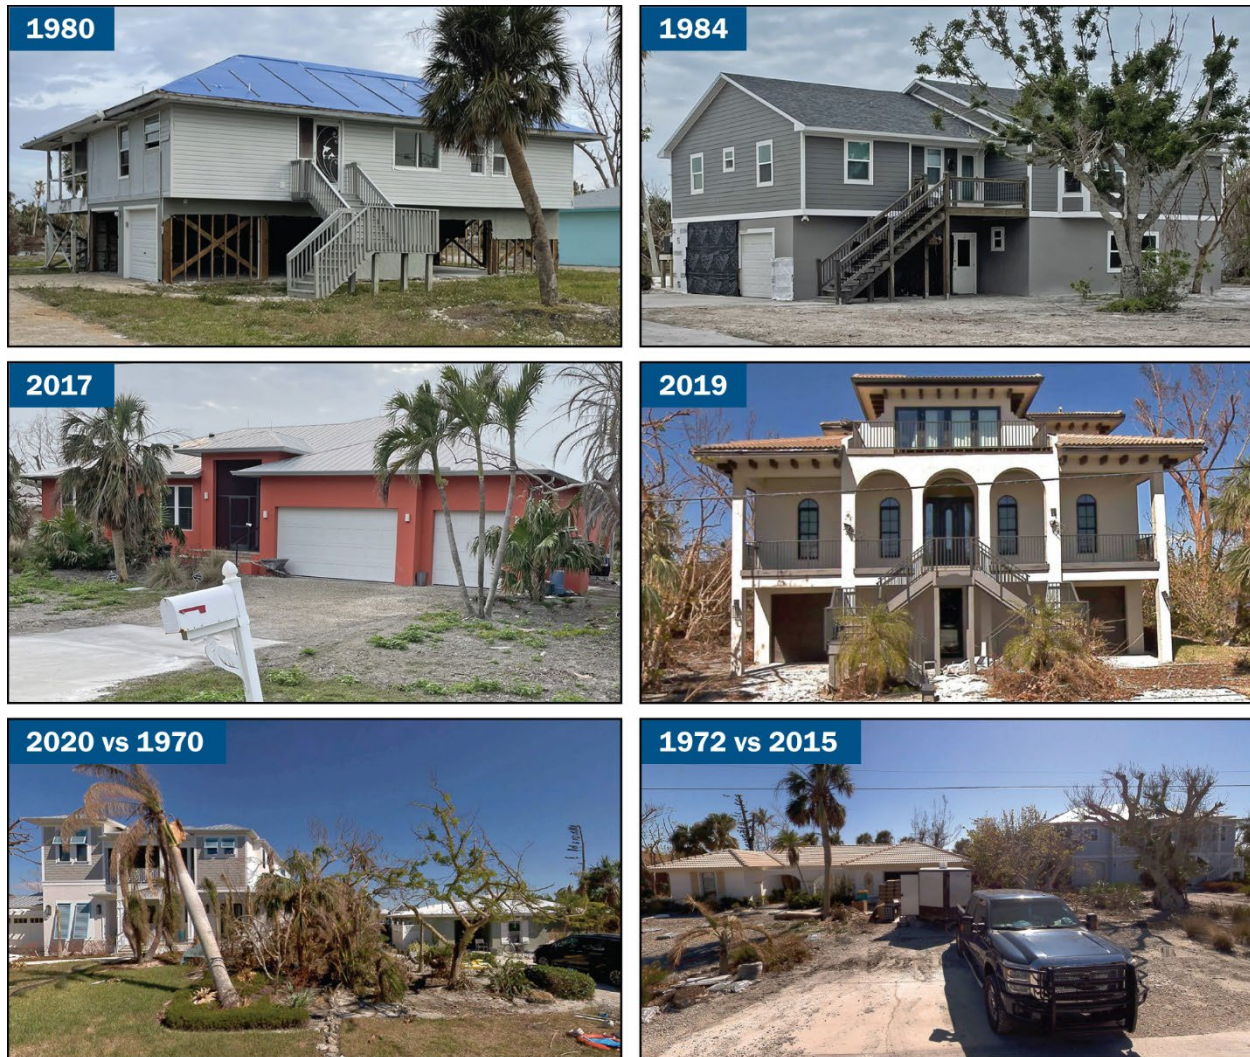
The houses in this area are predominantly elevated, likely because of the proximity to the coast as this Area of Interest is just north of Gulf Drive on Sanibel Island. Approximately 4 feet of water was reported by homeowners in garages and other enclosures below *elevated buildings*. Limited to no damage was reported above the lowest floor of the *elevated buildings* visited. Some structural damage was observed to *non-elevated buildings* and a few slab-on-grade houses were already demolished. Figure 15 provides examples of representative single-family houses within Area of Interest No. 6.

Figure 15: Representative single-family houses in Area of Interest No. 6 from 1970 to 2020

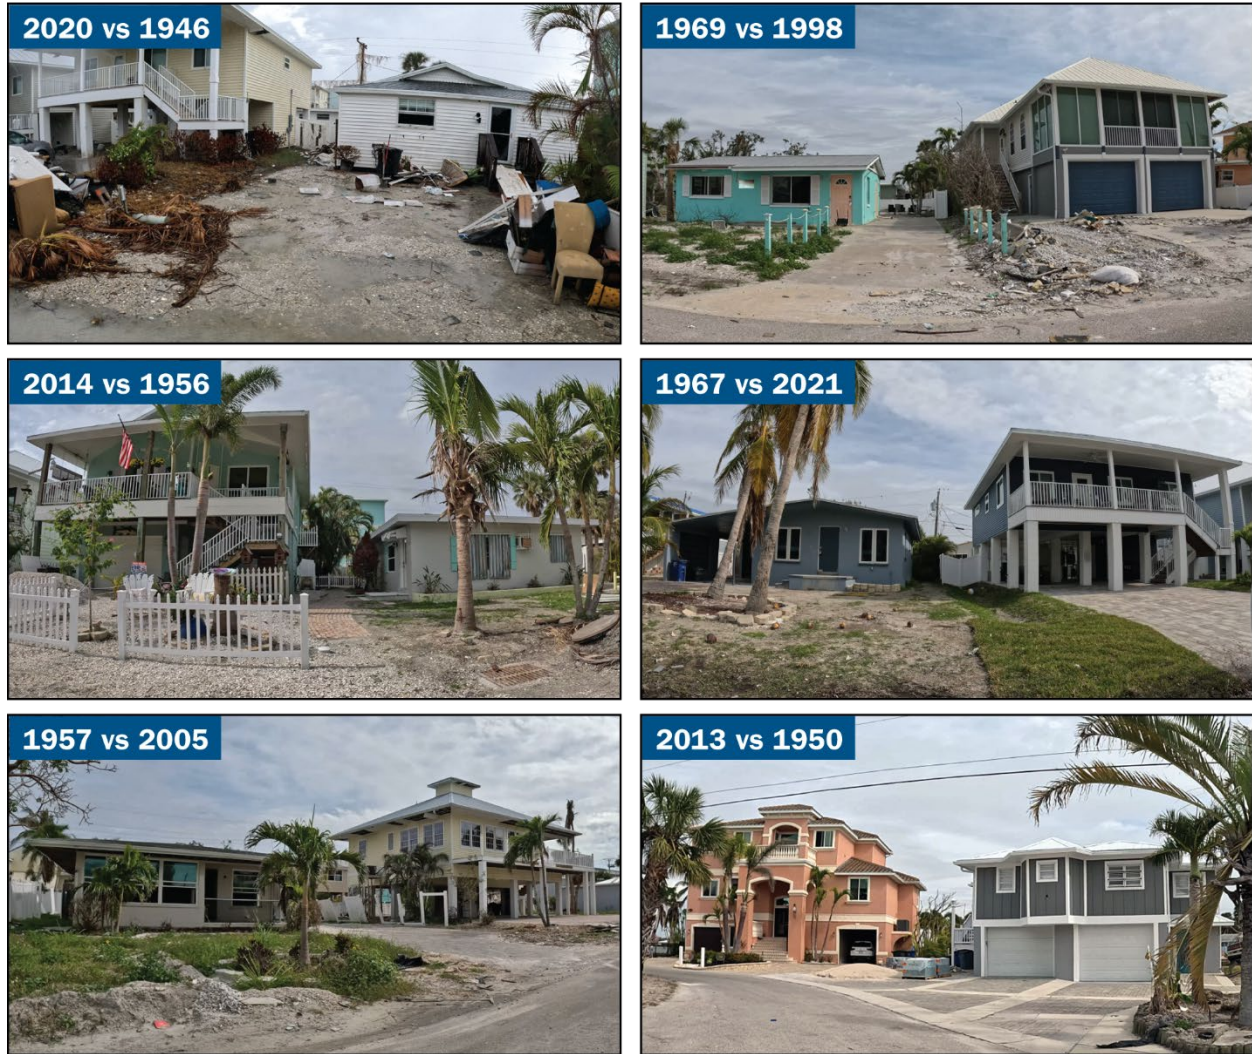
Figure 17: Representative single-family houses in Area of Interest No. 7 from 1946 to 2021

Some structural damage was observed in this area, especially to slab-on-grade, single-story construction and older *elevated buildings* with insufficient loads or foundations to withstand the storm surge on Estero Island; in some cases, mainly older *non-elevated buildings*, houses were being demolished. Most buildings, unless sufficiently elevated above the floodwaters, had extensive interior damage with finishes having been or being removed. Some of highest flood depths observed by the MAT were noted in this area; however, like other areas, observed building performance was generally as expected with newer *elevated buildings* having considerably less damage than older *non-elevated buildings*. The policy data, including the average building claims being consistently lower for newer houses, reinforced observations made in the field. Note this area had one of the highest average building claims per square foot for pre-1980 construction (\$131.18), which was expected considering the excessive flood depths and the higher percentage of older *non-elevated buildings*. Table 41 through Table 45 provide the number of houses built by decade, the number of insured buildings, and a summary of NFIP building and contents claims by decade as well as by building type (elevated vs non-elevated). The percentages in Table 41 are intended to help illustrate how similar the distribution of buildings built by decade is compared to the distribution of policies by decade.

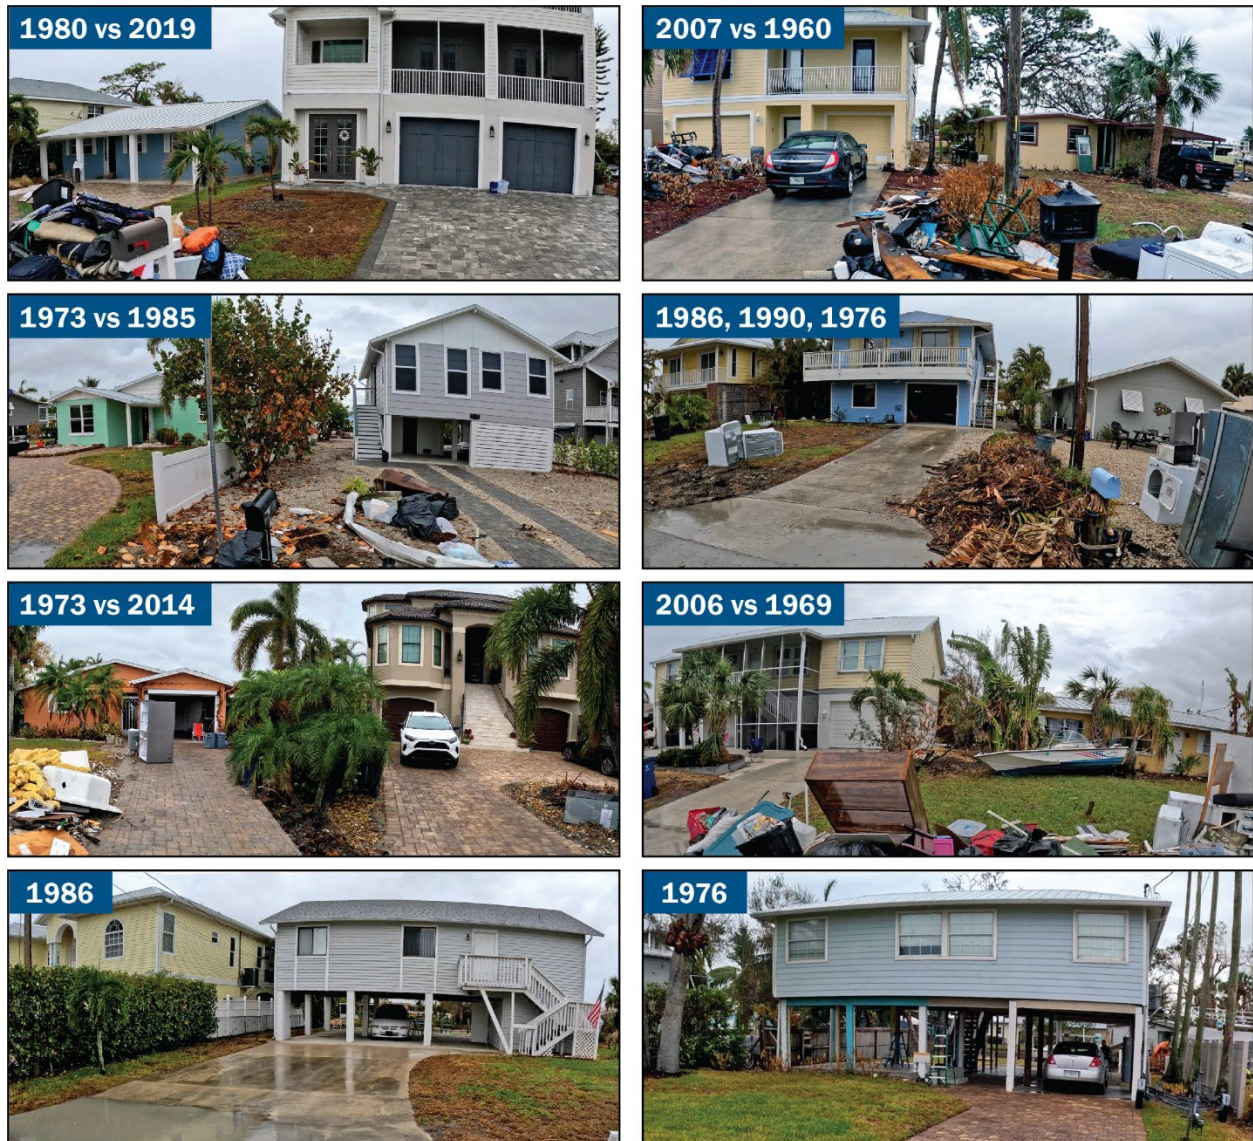
The houses in this area are a relatively even mixture of elevated and *non-elevated buildings*, with a slightly higher percentage of *elevated buildings*. Areas below the lowest floor are enclosed (either partially or fully) in three-quarters or more of the *elevated buildings*. No major structural damage was observed; damage was predominantly related to interior walls and finishes, which had been or were being removed. During site visits, homeowners reported 6 feet of water in non-elevated houses as well as in enclosures below the lowest floor of elevated houses. Figure 19 provides examples of representative single-family houses within Area of Interest No. 8.

Figure 19: Representative single-family houses in Area of Interest No. 8 from the 1960s to 2019

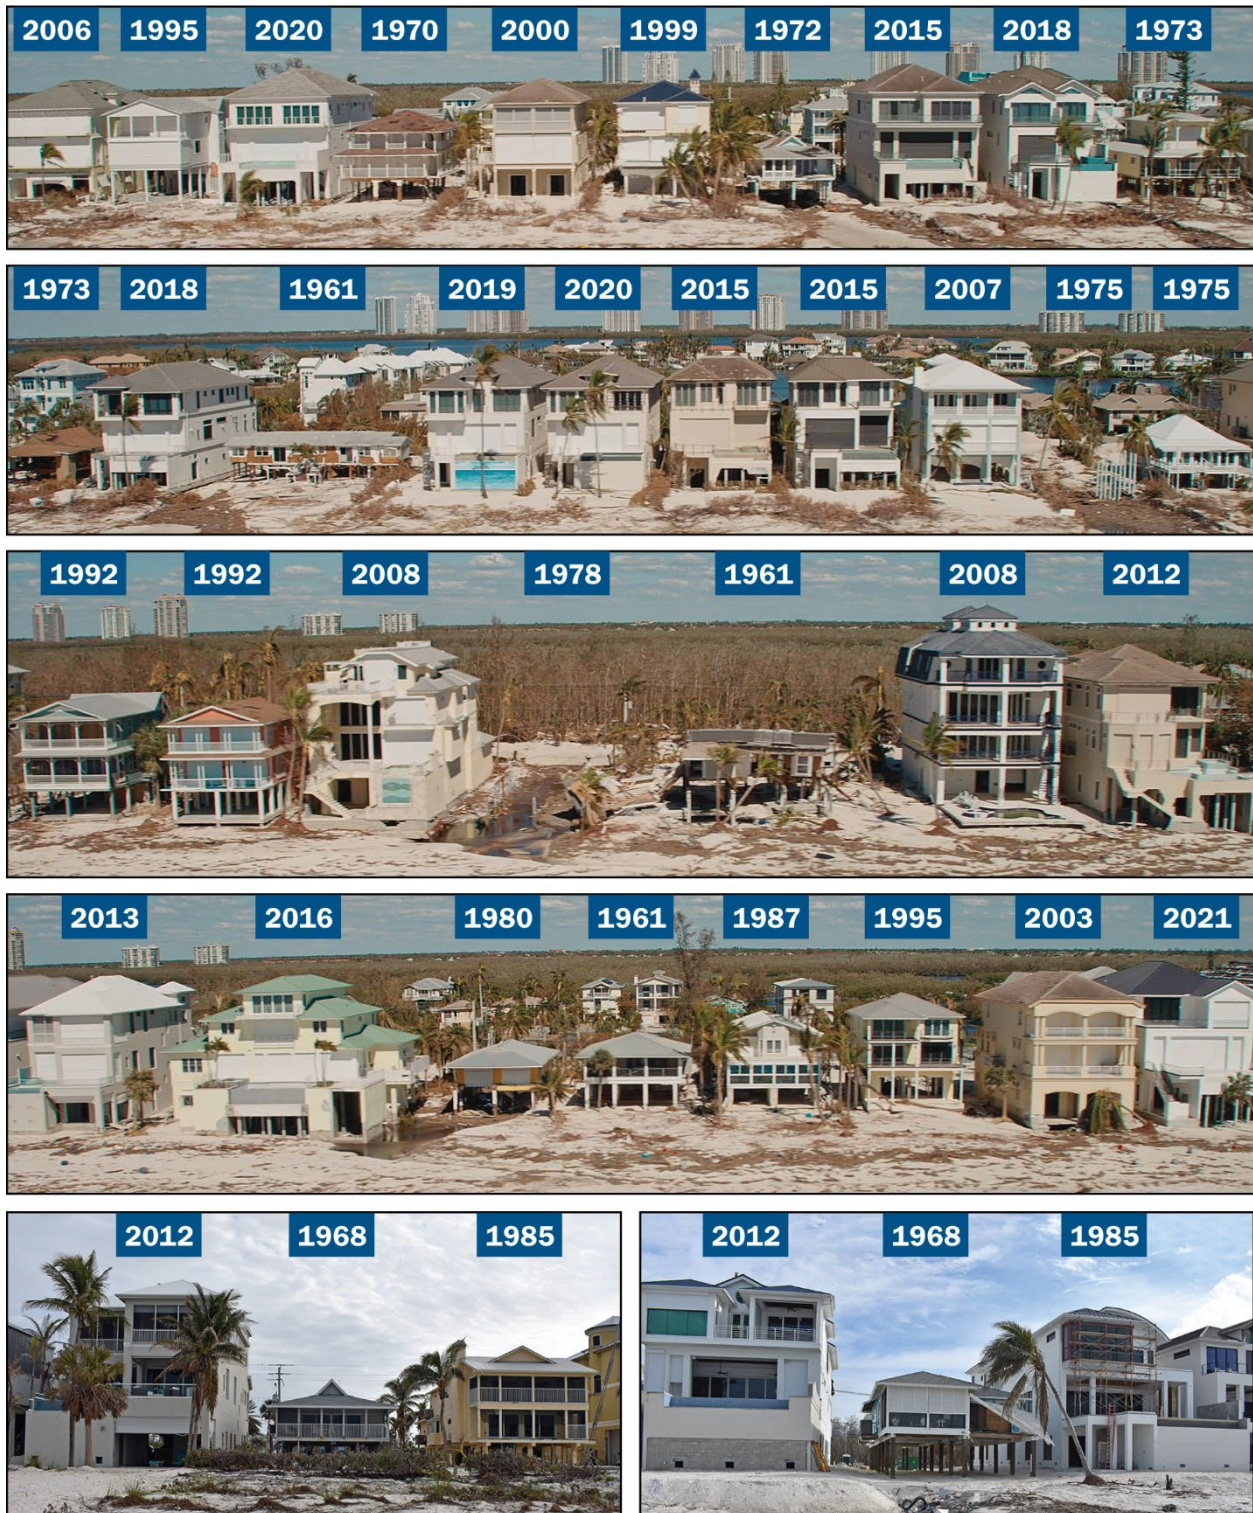
The 28% flood insurance take up rate (56 of 197 buildings with flood insurance) is not ideal for a representative analysis, but this area was selected because it is representative of observations for single-family construction immediately along the coast of the Gulf of Mexico. The houses in this area with NFIP policies are a relatively even mixture of *elevated* and *non-elevated buildings*, with a slightly higher percentage of *elevated buildings* and with the pre-1980 construction being predominantly non-elevated and the newer post-1980 construction being predominantly elevated. Building performance varied greatly in this area, with several older non-elevated or insufficiently *elevated buildings* immediately along the coast destroyed by storm surge, in many cases only leaving remnants of the building foundation. On the other hand, several newer, properly *elevated buildings* sustained minimal structural damage with damage limited to the loss of breakaway walls, interior finishes, and other non-flood damage-resistant materials below the lowest floor of the *elevated buildings*. Figure 21 provides examples of representative single-family houses within Area of Interest No. 9.

Figure 21: Representative single-family houses in Area of Interest No. 9 from 1961 to 2021

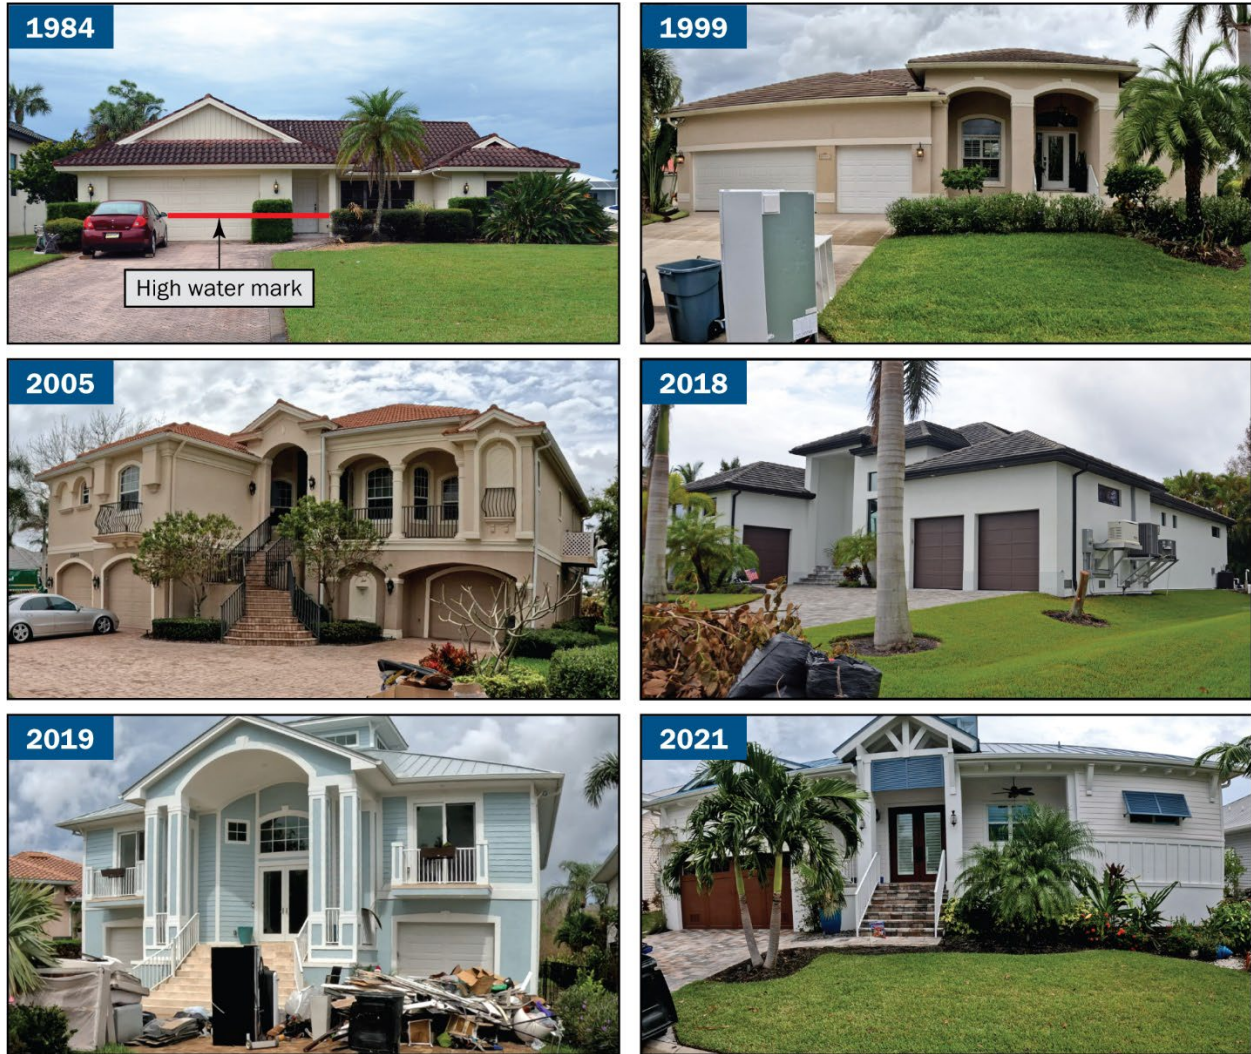
The houses in this area are predominantly non-elevated (about 75%). In cases where the houses are elevated, areas below the lowest floor are enclosed (either partially or fully). The MAT recorded HWMs ranging from 2 to 3 feet above the lowest floor in slab-on-grade houses. Homeowners verified flood depths ranged anywhere from 0 to 3 feet throughout the area. No major structural damage was observed. Damage was predominantly related to interior walls and finishes, which had been or were being removed. Figure 23 provides examples of representative single-family houses within Area of Interest No. 10 along with a HWM recorded by the MAT on a 1984 house during the pre-MAT visit in October.

Figure 23: Representative single-family houses in Area of Interest No. 10 from 1984 to 2021
