Mitigation Assessment Team Report

Hurricane Ian in Florida

Building Performance Observations,
Recommendations, and Technical Guidance

FEMA P-2342/December 2023

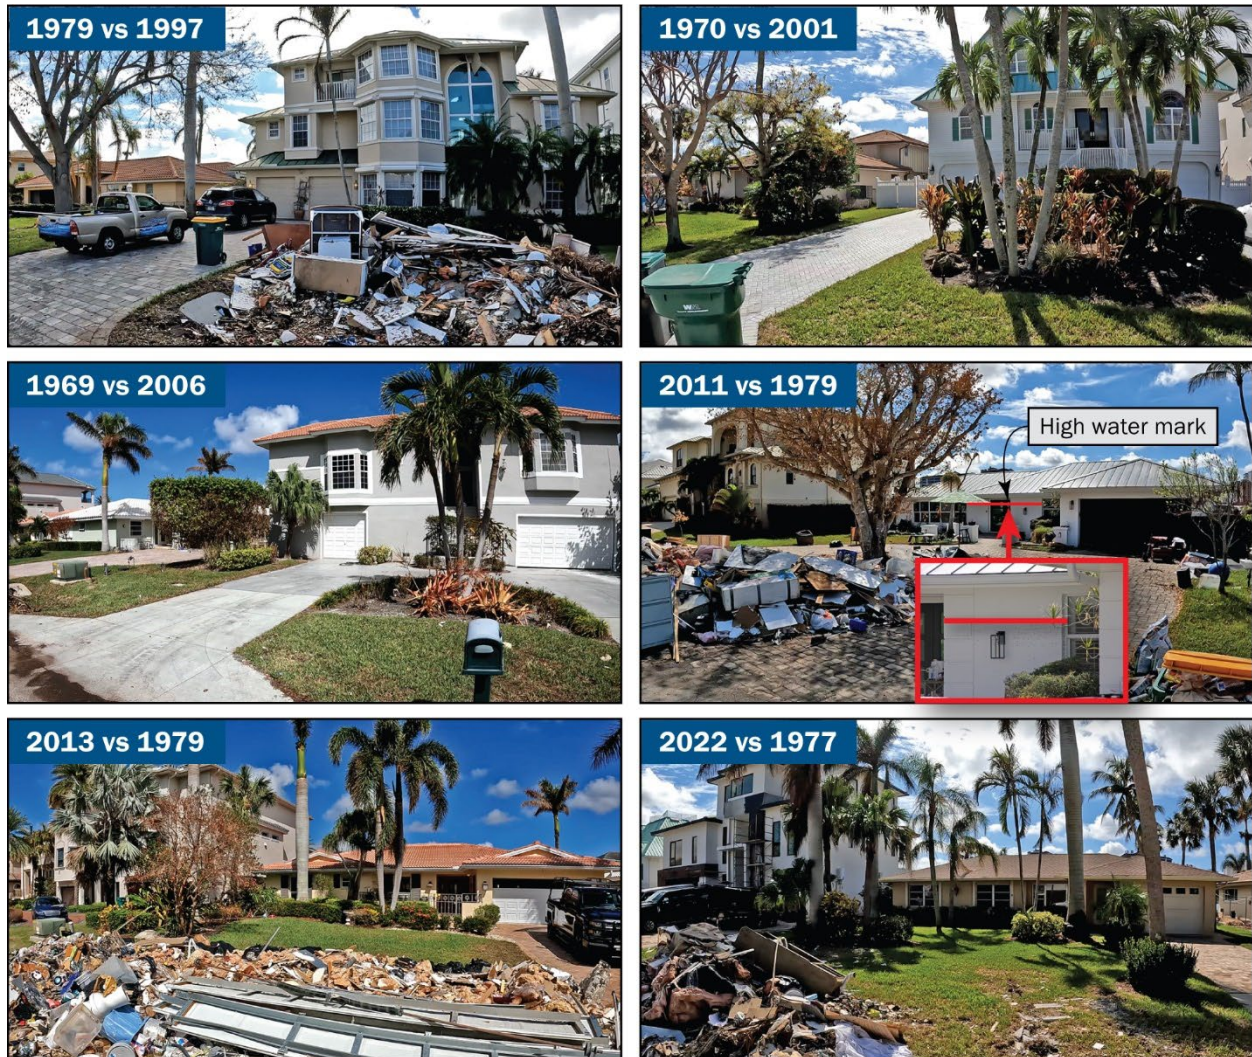
The houses in this area are about two-thirds non-elevated and one-third *elevated buildings*, and in cases where the houses were *elevated buildings*, areas below the lowest floor are enclosed (either partially or fully). The MAT recorded HWMs ranging from 4 to 5 feet above the lowest floor in slab-on-grade houses. Homeowners verified flood depths ranged anywhere from 2 to 6 feet throughout the area. No major structural damage was observed, damage was predominantly related to interior walls and finishes, which had been or were being removed. Figure 25 provides examples of representative single-family houses within Area of Interest No. 11 along with a HWM recorded by the MAT on a 1979 house during the pre-MAT visit in October.

Figure 25: Representative single-family houses in Area of Interest No. 11 from 1969 to 2022

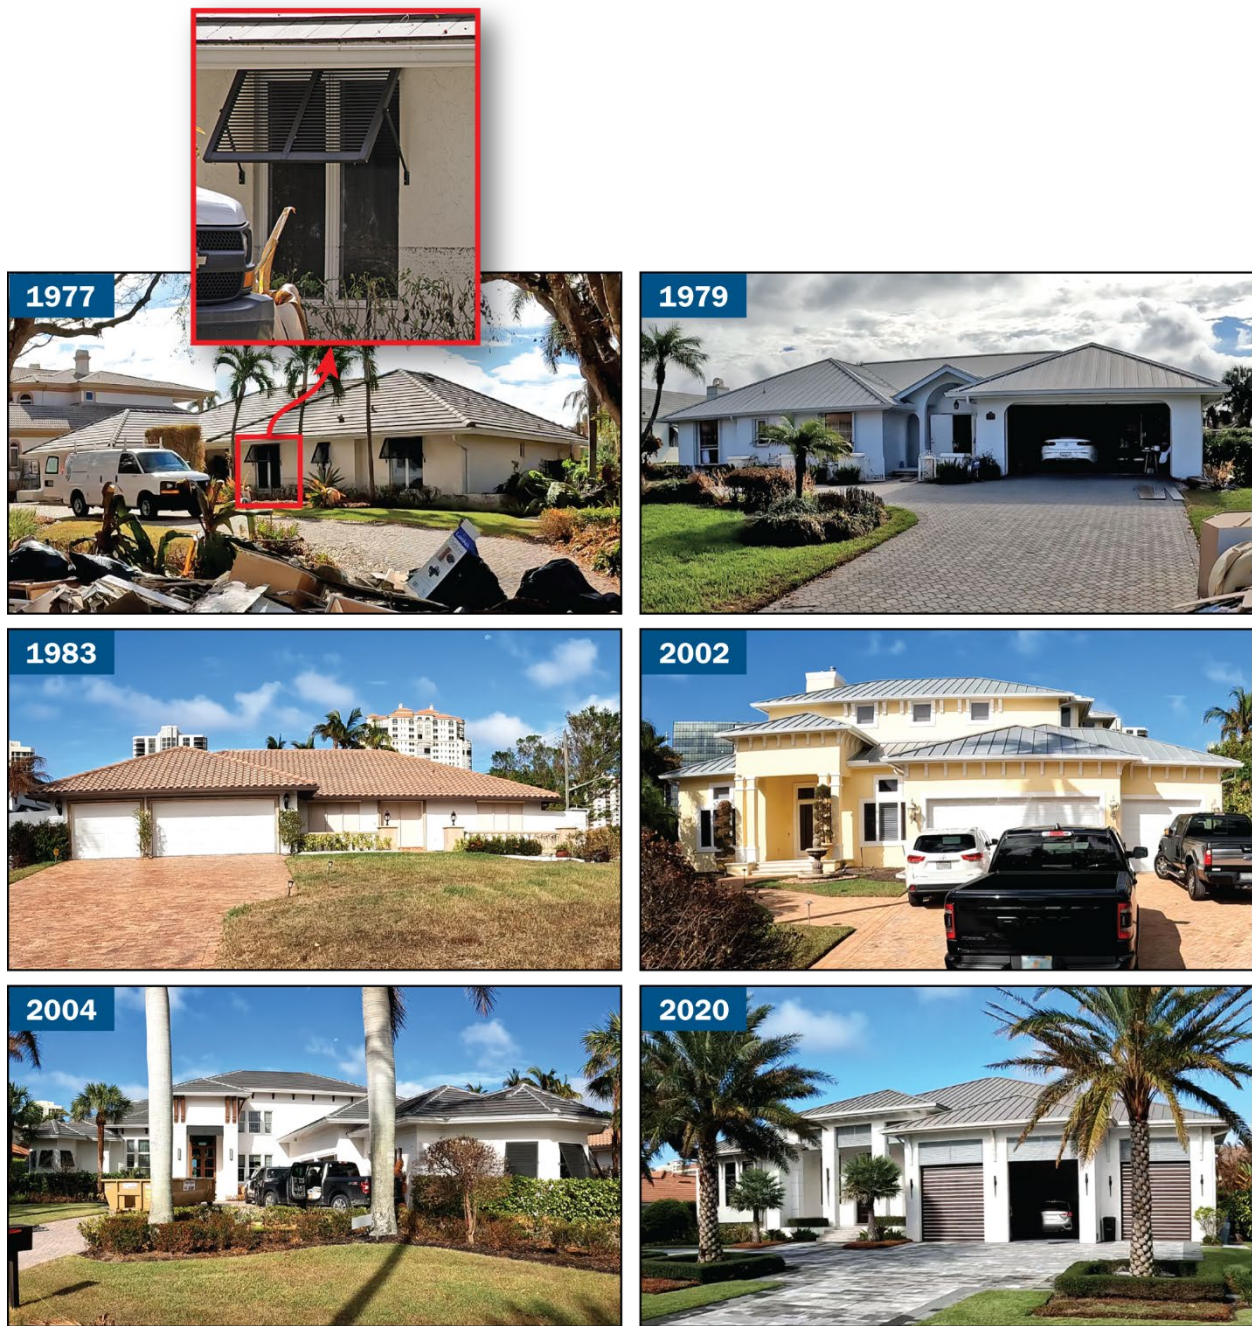
The houses in this area are predominantly non-elevated. In rare circumstances where the houses are elevated, areas below the lowest floor are enclosed (either partially or fully). Estimated flood levels were approximately 2 to 3 feet in older slab-on-grade houses based on HWMs recorded by the MAT and interviews with homeowners during site visits. No major structural damage was observed; damage was predominantly related to interior walls and finishes, which had been or were being removed. Figure 27 provides examples of representative single-family houses within Area of Interest No. 12 along with a HWM recorded by the MAT on a 1977 house during the pre-MAT in October.

Figure 27: Representative single-family houses in Area of Interest No. 12 from 1977 to 2020

Building performance in this area was generally as expected with newer buildings having considerably less damage than older buildings. Two primary field observations were the extent and depth of flooding in this area approximately 45 miles south of Hurricane Ian’s track and the large size of the houses. The policy data was consistent with field observations as this Area of Interest has the highest average building claim per building (\$154,724) and the second largest average building size (3,029 square feet). The data also correlate with the lack of *elevated buildings* as only 2 of the 108 policies are for *elevated buildings*, both of which were built in the 1970s. On average, post-2010 building claims are one-fifth those of pre-1980 buildings (\$15.19 per square foot versus \$77.02 per square foot). The average building claim for houses built in the 2000s is greater than those in the 1990s, which is unexpected. Aside from verifying 7 of the 19 buildings built in the 2000s have a \$250,000 maximum building claim, a preliminary explanation for the reduced building performance in newer buildings could not be determined. Table 66 through Table 70 provide the number of houses built by decade, the number of insured buildings, and a summary of NFIP building and contents claims by decade as well as by building type (elevated vs non-elevated). The percentages in Table 66 are intended to help illustrate how similar the distribution of buildings built by decade is compared to the distribution of policies by decade.
